DINO Cycle 6

Final Report

Road Inventory and Condition Assessment of Paved Routes Dinosaur National Monument

Report Date: June 2018

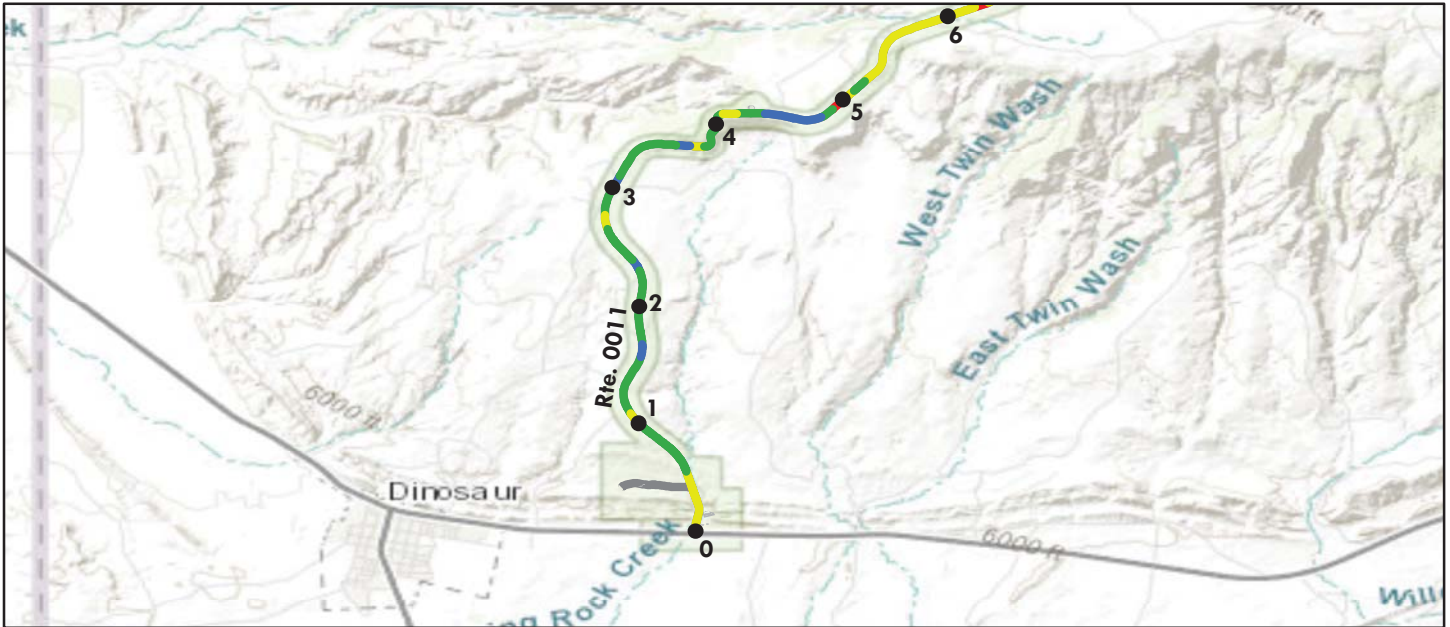
ROUTE 0011: HARPERS CORNER ROAD

Route Condition Legend – Pavement Condition Rating (PCR)						
Poor (0 - 60)	Fair (61- 84)	Good (85 - 94)	Excellent (95 - 100)	Not Rated		
Colors on map represent condition scores at 0.10-mile intervals. See Appendix for definitions and formulas.						
Inspection Date: 8/15/2017	Beginning Section MP	0	1	2	3	4
Paved Length (Miles): 31.88	Section Length (MI)	1	1	1	1	1
Surface Type: ASPHALT	Route Summary					
Roadway Condition Information						
Pavement Condition Rating (PCR)	90	82	90	91	91	91
Surface Condition Rating (SCR)	94	88	90	89	90	91
Roughness Condition Index (RCI)	85	73	89	94	93	90
Distress Index Values						
Structural Crack Index	95	89	94	95	94	91
Alligator Crack Index	100	100	100	100	100	100
Longitudinal Crack Index	95	89	94	95	94	91
Transverse Cracking Index	94	88	90	89	90	91
Patching Index	100	97	100	100	100	99
Rutting Index	94	95	96	96	95	95
International Roughness Index (IRI)	154	190	143	130	133	141

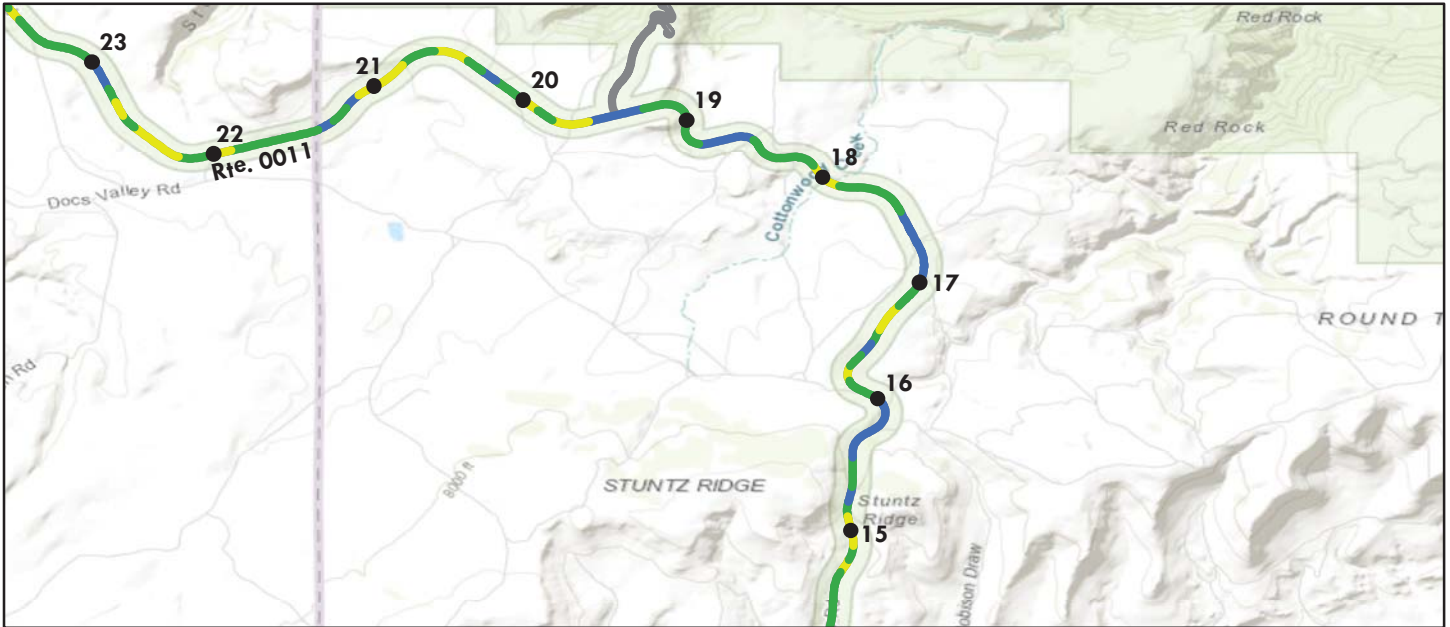
ROUTE 0011: HARPERS CORNER ROAD

Route Condition Legend – Pavement Condition Rating (PCR)						
Poor (0 - 60)	Fair (61- 84)	Good (85 - 94)	Excellent (95 - 100)	Not Rated		
Colors on map represent condition scores at 0.10-mile intervals. See Appendix for definitions and formulas.						
Inspection Date: 8/15/2017	Beginning Section MP	15	16	17	18	19
Paved Length (Miles): 31.88	Section Length (MI)	1	1	1	1	1
Surface Type: ASPHALT	Route Summary					
Roadway Condition Information						
Pavement Condition Rating (PCR)	90	92	88	96	91	91
Surface Condition Rating (SCR)	94	94	91	96	94	96
Roughness Condition Index (RCI)	85	90	84	95	86	83
Distress Index Values						
Structural Crack Index	95	98	100	96	96	98
Alligator Crack Index	100	100	100	100	100	100
Longitudinal Crack Index	95	98	100	96	96	98
Transverse Cracking Index	94	98	99	98	94	96
Patching Index	100	99	99	100	100	100
Rutting Index	94	94	91	96	96	96
International Roughness Index (IRI)	154	140	158	127	152	160

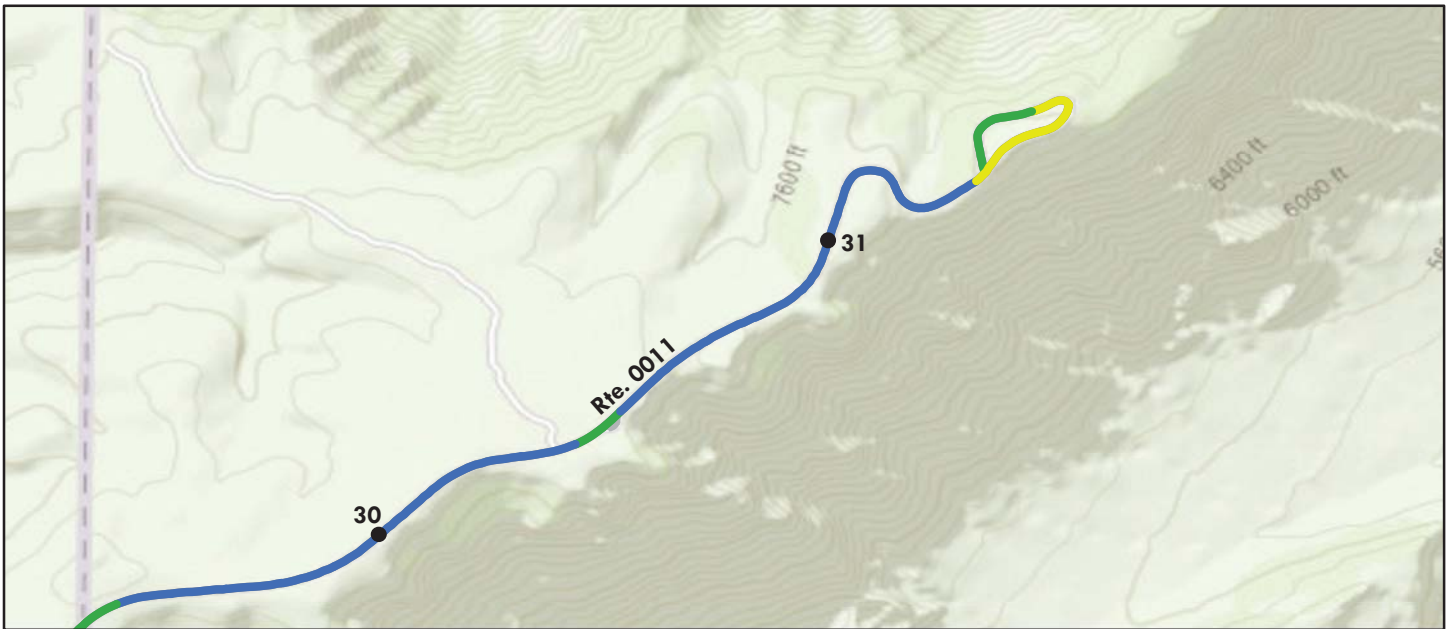
ROUTE 0011: HARPERS CORNER ROAD

Inspection Date:	8/15/2017	Beginning Section MP	30	31			
Paved Length (Miles):	31.88	Section Length (MI)	1	0.88			
Surface Type:	ASPHALT	Route Summary					
Roadway Condition Information							
Pavement Condition Rating (PCR)	90	98	89				
Surface Condition Rating (SCR)	94	97	88				
Roughness Condition Index (RCI)	85	100	91				
Distress Index Values							
Structural Crack Index	95	100	88				
Alligator Crack Index	100	100	100				
Longitudinal Crack Index	95	100	88				
Transverse Cracking Index	94	100	98				
Patching Index	100	100	100				
Rutting Index	94	97	97				
International Roughness Index (IRI)	154	100	139				
Lane & Width Information							
Number of Lanes	2	2	1				
Paved Width (ft)	26.7	21.8	19.6				
Lane Width (ft)	10.3	10	10.3

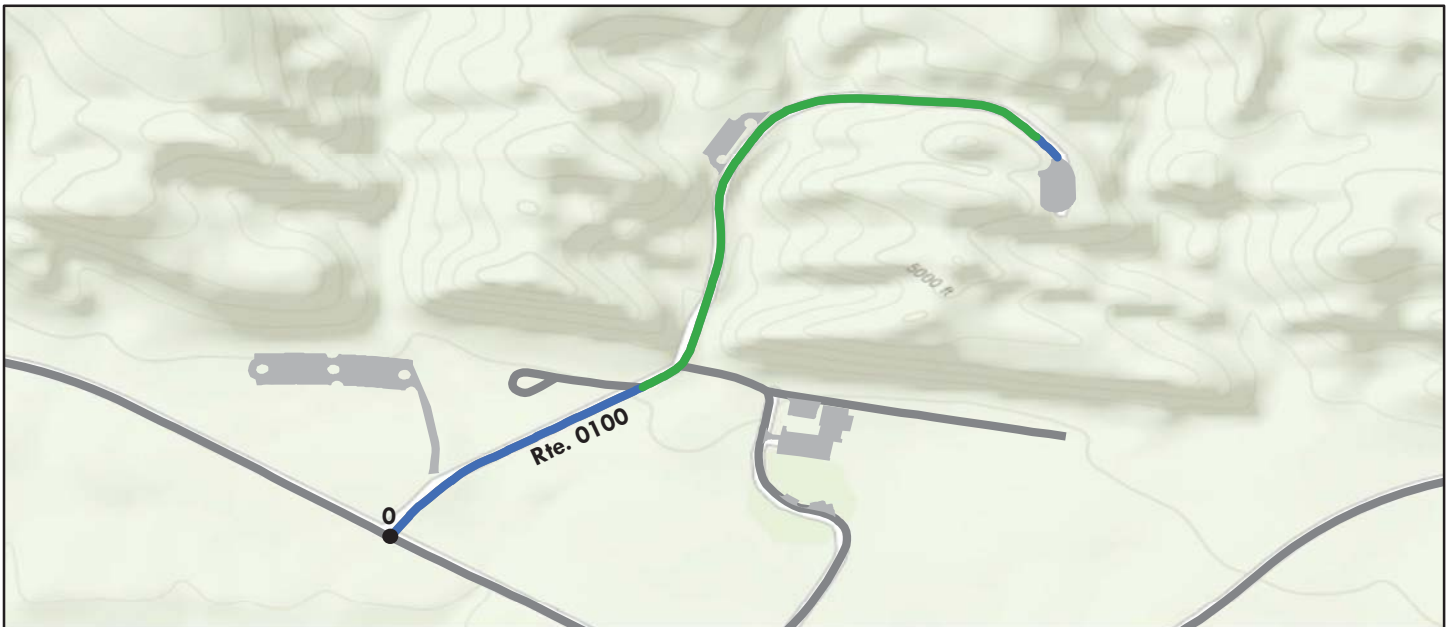
ROUTE 0100: QUARRY ACCESS ROAD

Inspection Date:	8/15/2017	Beginning Section MP	0				
Paved Length (Miles):	0.62	Section Length (MI)	0.62				
Surface Type:	ASPHALT	Route Summary					
Roadway Condition Information							
Pavement Condition Rating (PCR)	92	92					
Surface Condition Rating (SCR)	97	97					
Roughness Condition Index (RCI)	85	85					
Distress Index Values							
Structural Crack Index	97	97					
Alligator Crack Index	100	100					
Longitudinal Crack Index	97	97					
Transverse Cracking Index	97	97					
Patching Index	100	100					
Rutting Index	99	99					
International Roughness Index (IRI)	154	154					
Lane & Width Information							
Number of Lanes	2	2					
Paved Width (ft)	27.5	27.5					
Lane Width (ft)	10.2	10.2

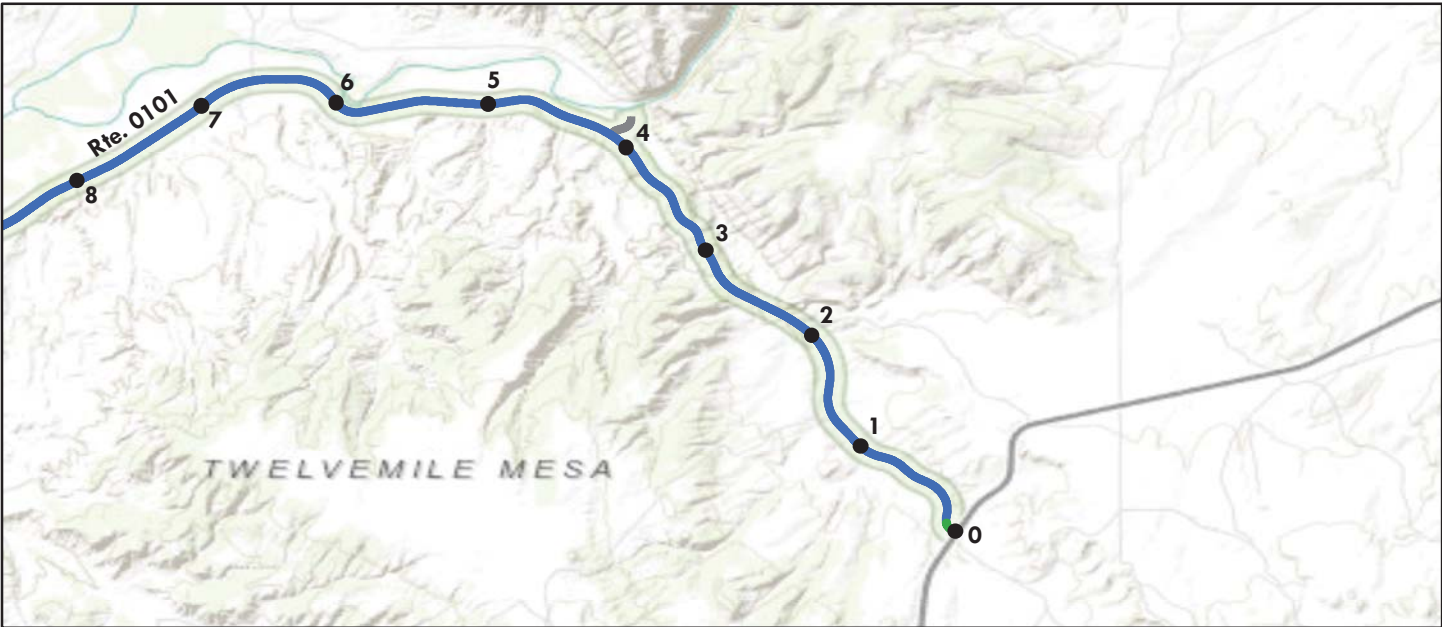
ROUTE 0101: DEERLODGE ENTRANCE ROAD

Route Condition Legend – Pavement Condition Rating (PCR)						
Poor (0 - 60)	Fair (61- 84)	Good (85 - 94)	Excellent (95 - 100)	Not Rated		
Colors on map represent condition scores at 0.10-mile intervals. See Appendix for definitions and formulas.						
Inspection Date: 8/15/2017	Beginning Section MP	0	1	2	3	4
Paved Length (Miles): 12.67	Section Length (MI)	1	1	1	1	1
Surface Type: ASPHALT	Route Summary					
Roadway Condition Information						
Pavement Condition Rating (PCR)	100	100	100	100	100	100
Surface Condition Rating (SCR)	100	100	100	100	100	100
Roughness Condition Index (RCI)	100	100	100	100	100	100
Distress Index Values						
Structural Crack Index	100	100	100	100	100	100
Alligator Crack Index	100	100	100	100	100	100
Longitudinal Crack Index	100	100	100	100	100	100
Transverse Cracking Index	100	100	100	100	100	100
Patching Index	100	100	100	100	100	100
Rutting Index	100	100	100	100	100	100
International Roughness Index (IRI)	58	65	58	60	62	53

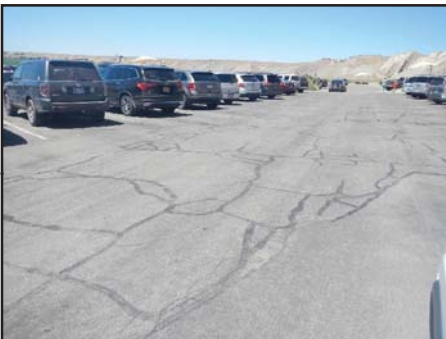
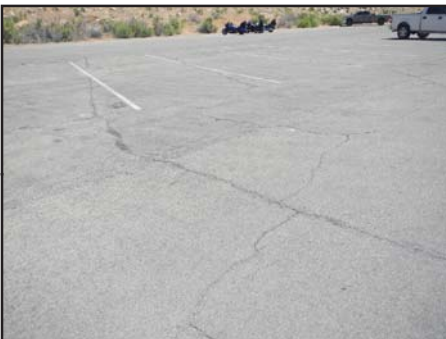
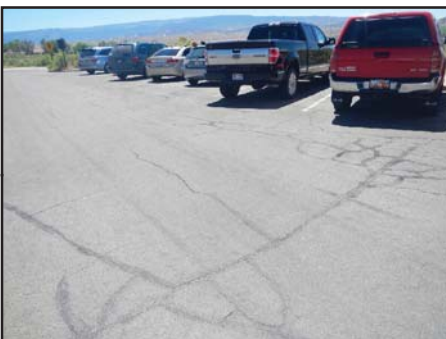
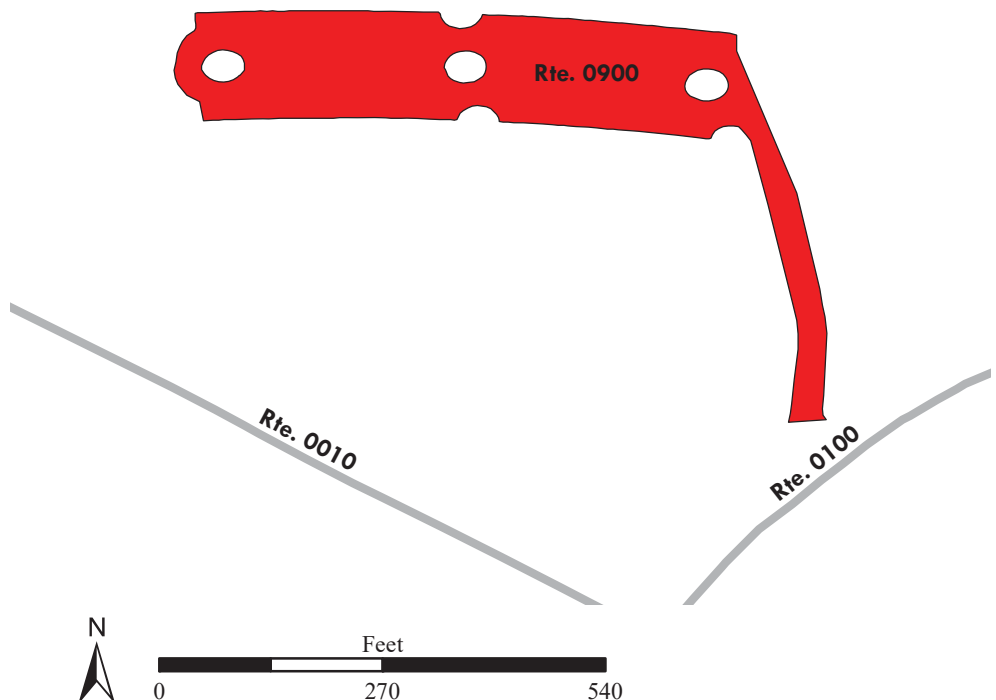
ROUTE 0901: QUARRY VISITORS CENTER PARKING

Inspection Date	FMSS Number	User Access	Surface Type
6/23/2017	69032	PUBLIC	ASPHALT
Area (Sq. Ft.)	Lane Miles (11' Widths)	Curb Reveal (Inches)	Curb Recommendation
21,123	0.364	6	DO NOTHING
Curb Type		Curb & Gutter Type	
CONCRETE		CONCRETE	
Pavement Recommendation		Condition Rating / PCR	
LIGHT 3R TREATMENTS		FAIR / 73

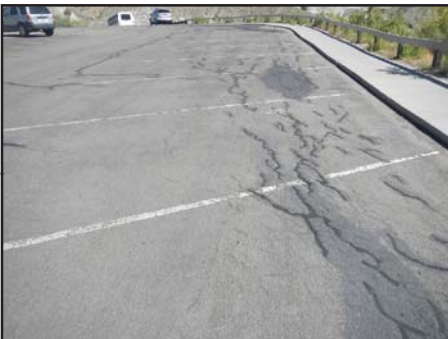
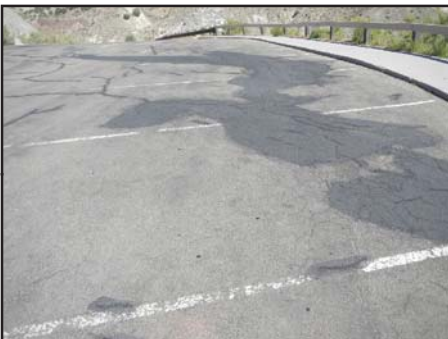
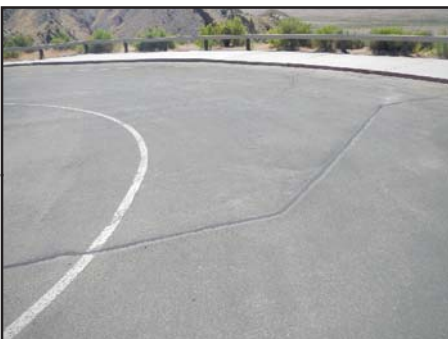
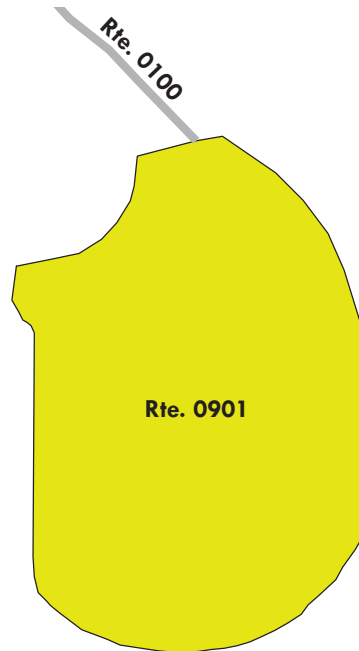
ROUTE 0902: GREEN RIVER CAMPGROUND OVERLOOK

Inspection Date	FMSS Number	User Access	Surface Type
6/23/2017	69469	PUBLIC	ASPHALT
Area (Sq. Ft.)	Lane Miles (11' Widths)	Curb Reveal (Inches)	Curb Recommendation
11,221	0.193	7	LIGHT REPAIR
Curb Type		Curb & Gutter Type	
ASPHALT		NO CURB AND GUTTER	
Pavement Recommendation		Condition Rating / PCR	
HEAVY 3R TREATMENTS		POOR / 53

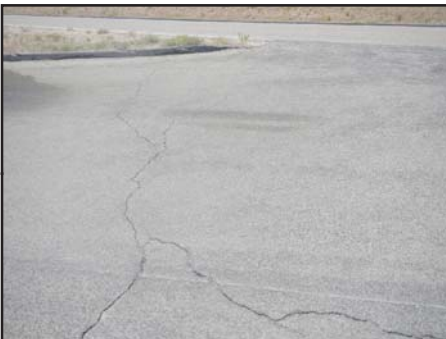
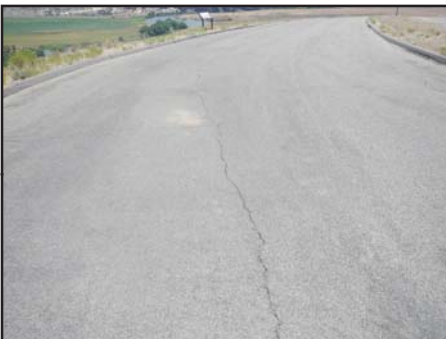
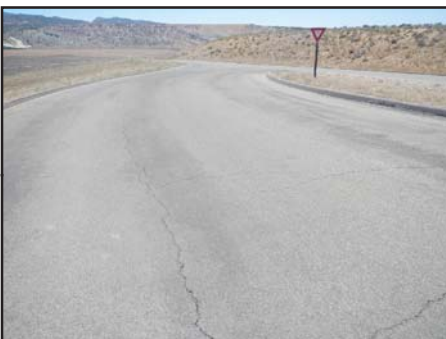
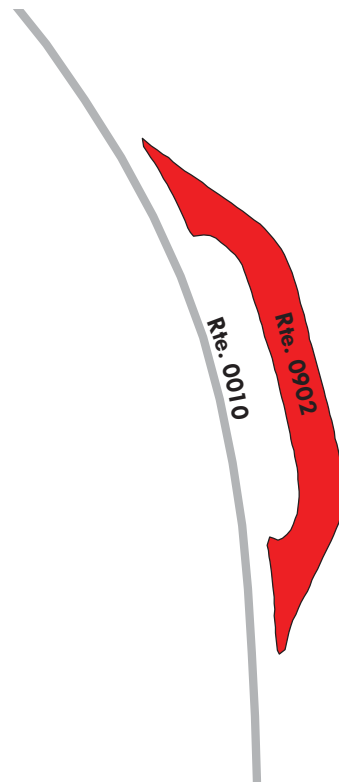
ROUTE 0903: SPLIT MOUNTAIN CAMPGROUND BOAT RAMP PARKING

Inspection Date	FMSS Number	User Access	Surface Type
6/23/2017	69212	PUBLIC	ASPHALT
Area (Sq. Ft.)	Lane Miles (11' Widths)	Curb Reveal (Inches)	Curb Recommendation
17,902	0.308	NOT APPLICABLE	NOT APPLICABLE
Curb Type		Curb & Gutter Type	
NO CURB		NO CURB AND GUTTER	
Pavement Recommendation		Condition Rating / PCR	
PREVENTIVE MAINTENANCE		GOOD / 90

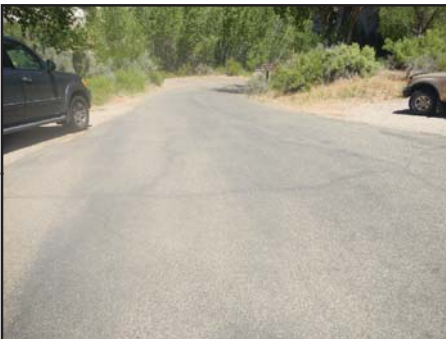
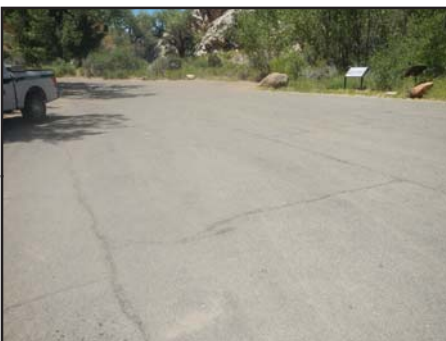
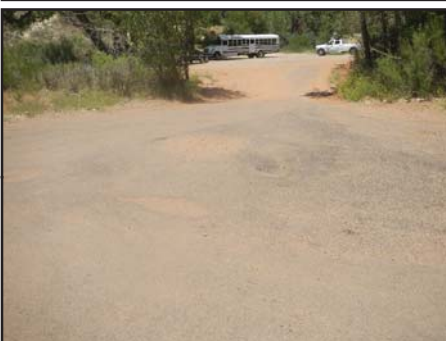
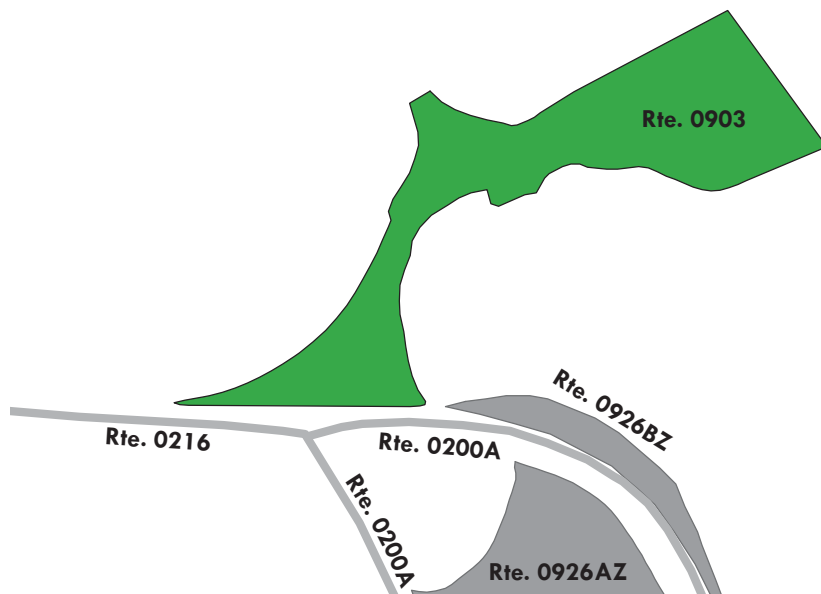
ROUTE 0904A: HEADQUARTERS PUBLIC PARKING AREA A

Inspection Date	FMSS Number	User Access	Surface Type
6/22/2017	68795	PUBLIC	ASPHALT
Area (Sq. Ft.)	Lane Miles (11' Widths)	Curb Reveal (Inches)	Curb Recommendation
17,639	0.304	NOT APPLICABLE	DO NOTHING
Curb Type		Curb & Gutter Type	
NO CURB		CONCRETE	
Pavement Recommendation		Condition Rating / PCR	
HEAVY 3R TREATMENTS		POOR / 53

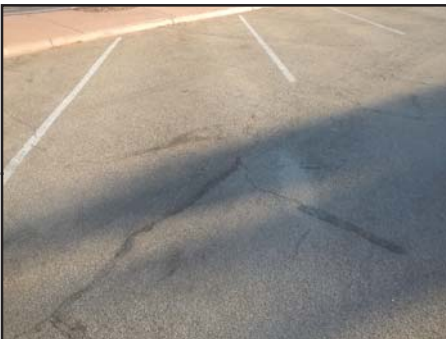
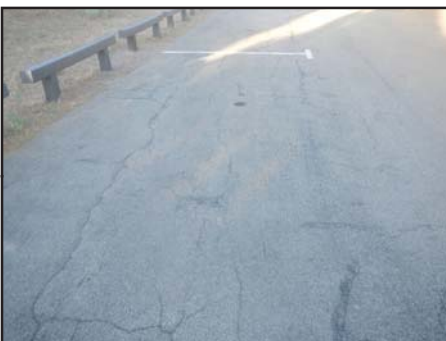
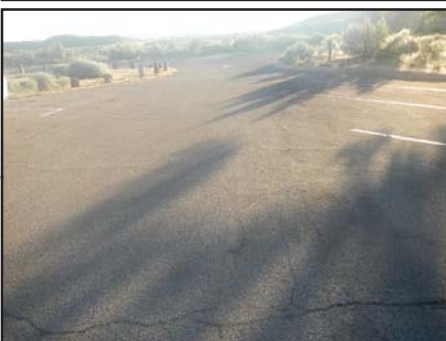
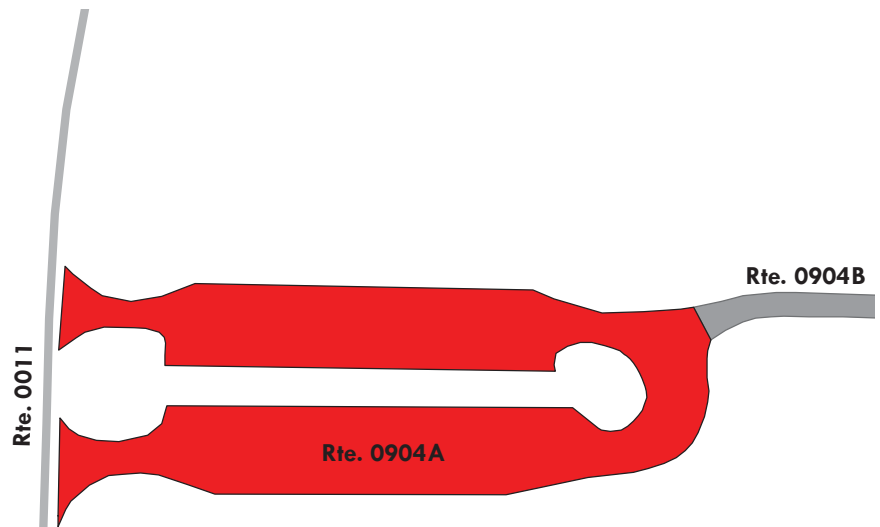
ROUTE 0904B: HEADQUARTERS EMPLOYEE PARKING AREA B

Inspection Date	FMSS Number	User Access	Surface Type
6/22/2017	249246	NONPUBLIC	ASPHALT
Area (Sq. Ft.)	Lane Miles (11' Widths)	Curb Reveal (Inches)	Curb Recommendation
6,191	0.107	NOT APPLICABLE	DO NOTHING
Curb Type		Curb & Gutter Type	
NO CURB		CONCRETE	
Pavement Recommendation		Condition Rating / PCR	
HEAVY 3R TREATMENTS		POOR / 53

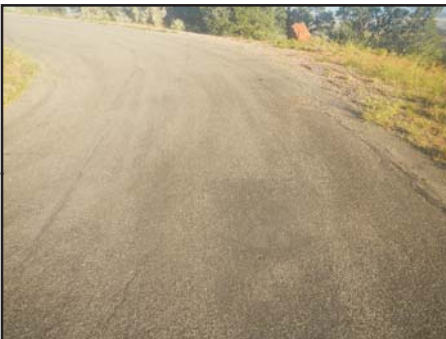
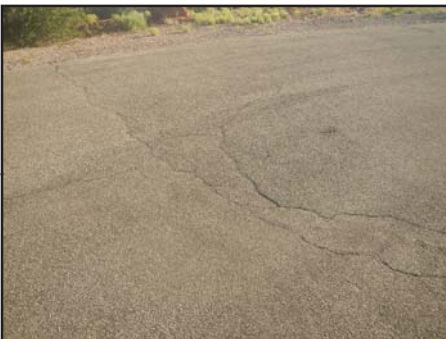
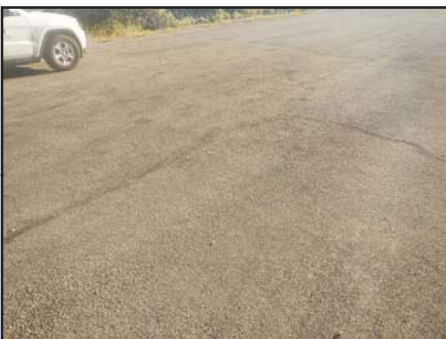
ROUTE 0905: PARKING AREA AT MP 3.74

Inspection Date	FMSS Number	User Access	Surface Type
6/22/2017	68812	PUBLIC	ASPHALT
Area (Sq. Ft.)	Lane Miles (11' Widths)	Curb Reveal (Inches)	Curb Recommendation
7,643	0.132	NOT APPLICABLE	LIGHT REPAIR
Curb Type		Curb & Gutter Type	
NO CURB		CONCRETE	
Pavement Recommendation		Condition Rating / PCR	
HEAVY 3R TREATMENTS		POOR / 53

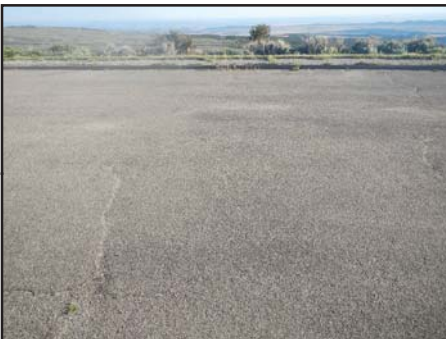
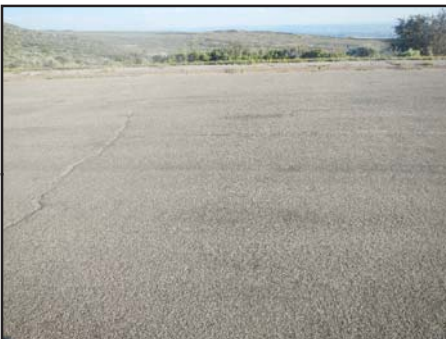
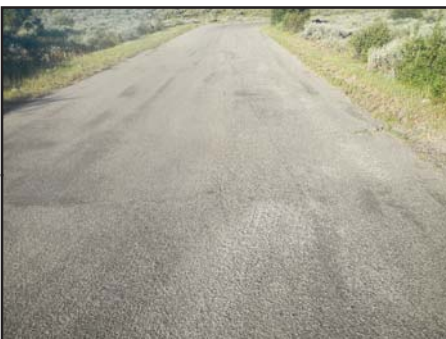
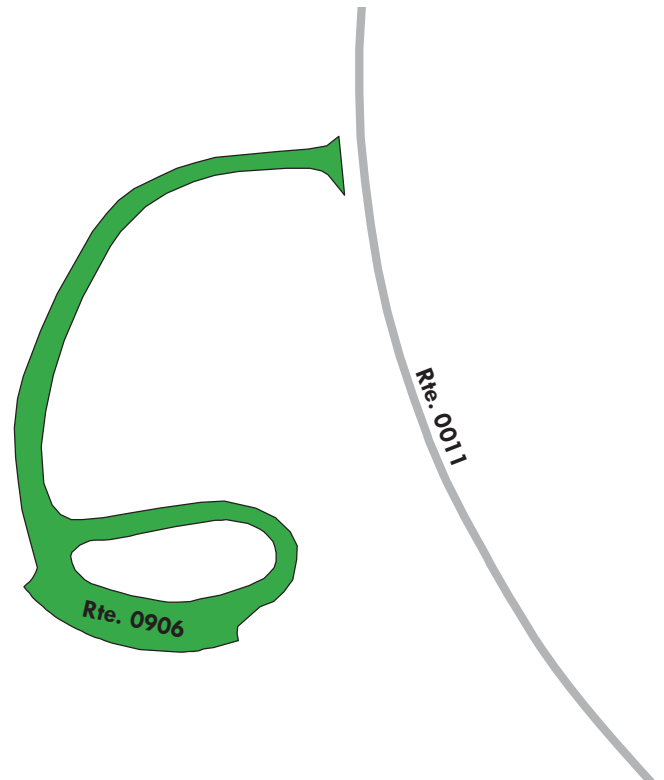
ROUTE 0906: ESCALANTE OVERLOOK PARKING AREA

Inspection Date	FMSS Number	User Access	Surface Type
6/22/2017	68488	PUBLIC	ASPHALT
Area (Sq. Ft.)	Lane Miles (11' Widths)	Curb Reveal (Inches)	Curb Recommendation
35,380	0.609	NOT APPLICABLE	DO NOTHING
Curb Type		Curb & Gutter Type	
NO CURB		CONCRETE	
Pavement Recommendation		Condition Rating / PCR	
PREVENTIVE MAINTENANCE		GOOD / 90

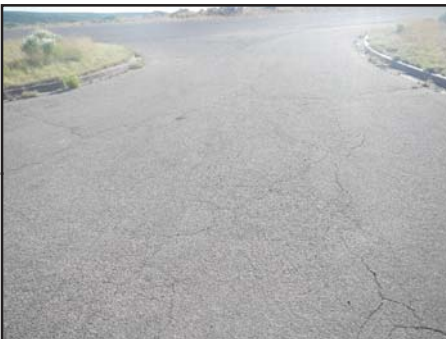
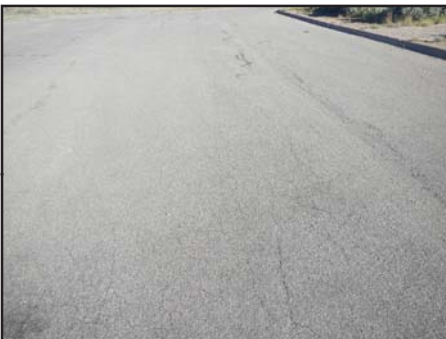
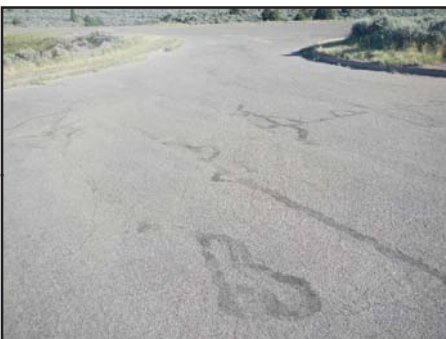
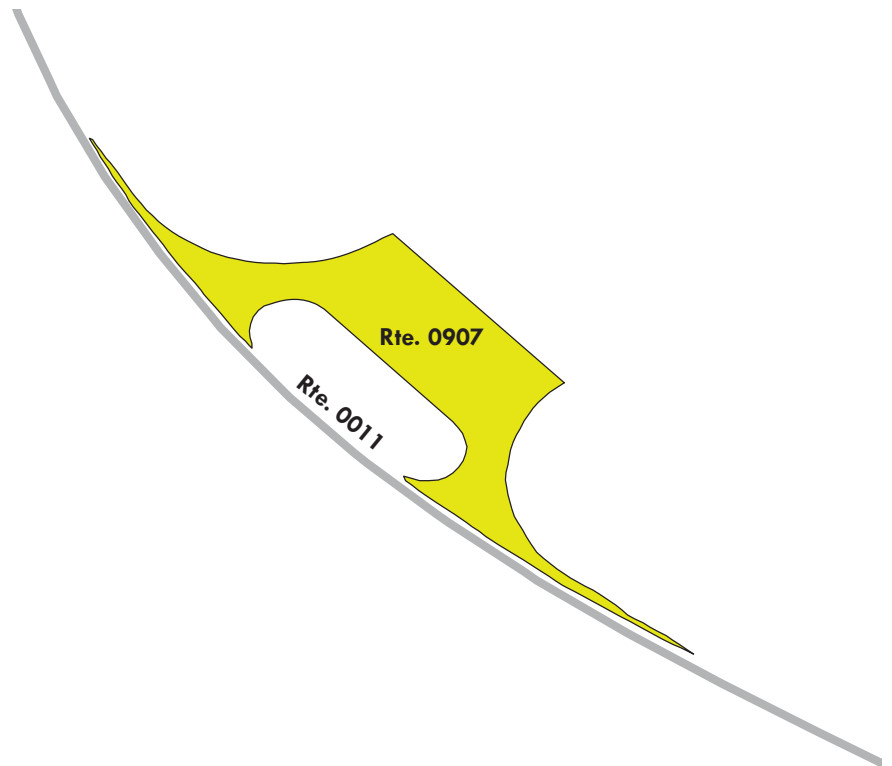
ROUTE 0907: PARKING AREA AT MP 25.15

Inspection Date	FMSS Number	User Access	Surface Type
6/22/2017	68815	PUBLIC	ASPHALT
Area (Sq. Ft.)	Lane Miles (11' Widths)	Curb Reveal (Inches)	Curb Recommendation
11,037	0.19	NOT APPLICABLE	DO NOTHING
Curb Type		Curb & Gutter Type	
NO CURB		CONCRETE	
Pavement Recommendation		Condition Rating / PCR	
LIGHT 3R TREATMENTS		FAIR / 73

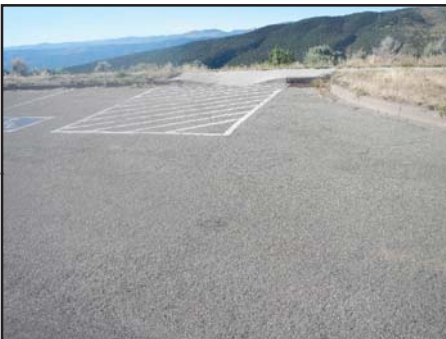
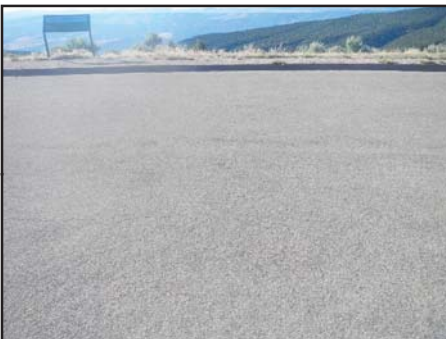
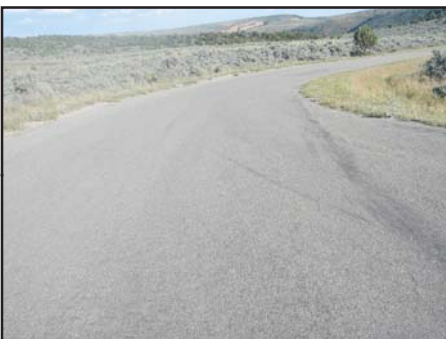
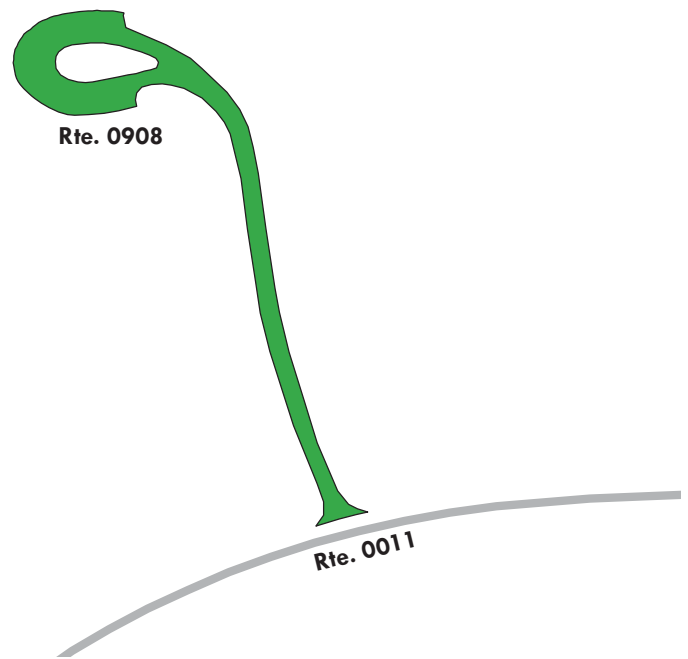
ROUTE 0908: ISLAND PARK OVERLOOK PARKING AREA

Inspection Date	FMSS Number	User Access	Surface Type
6/22/2017	68508	PUBLIC	ASPHALT
Area (Sq. Ft.)	Lane Miles (11' Widths)	Curb Reveal (Inches)	Curb Recommendation
31,341	0.54	NOT APPLICABLE	DO NOTHING
Curb Type		Curb & Gutter Type	
NO CURB		CONCRETE	
Pavement Recommendation		Condition Rating / PCR	
PREVENTIVE MAINTENANCE		GOOD / 90

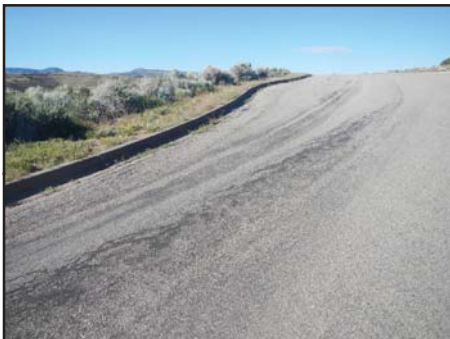
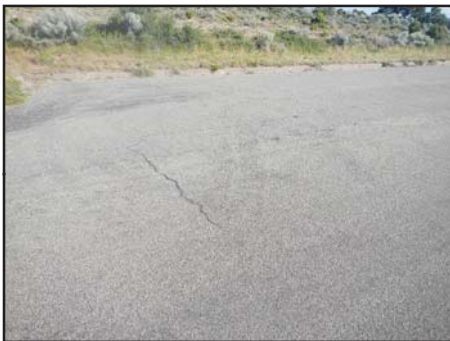
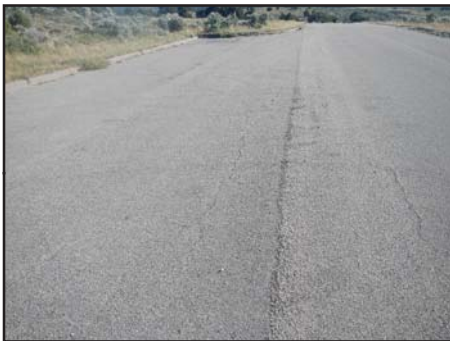
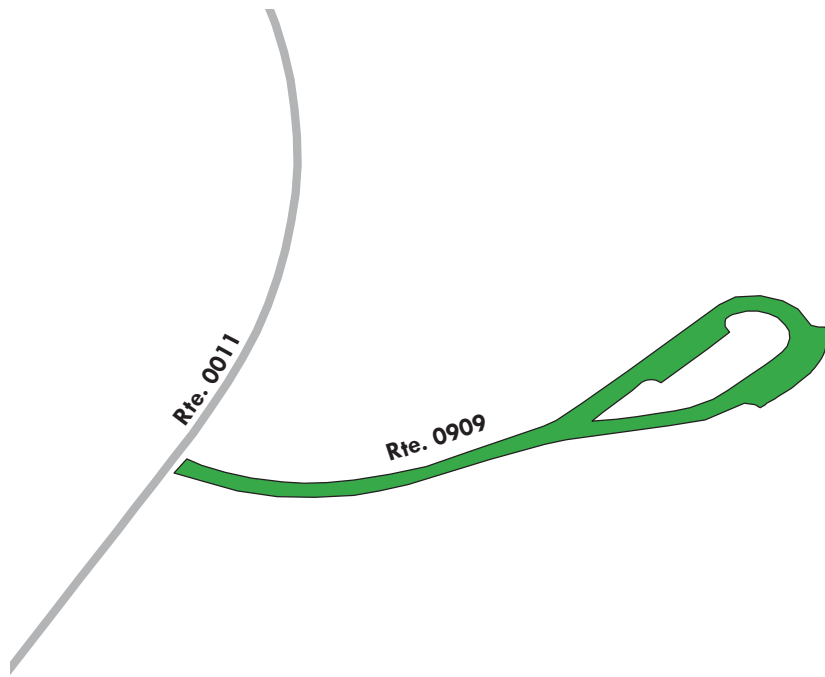
ROUTE 0909: IRON SPRINGS BENCH PARKING AREA

Inspection Date	FMSS Number	User Access	Surface Type
6/22/2017	68510	PUBLIC	ASPHALT
Area (Sq. Ft.)	Lane Miles (11' Widths)	Curb Reveal (Inches)	Curb Recommendation
47,583	0.819	NOT APPLICABLE	DO NOTHING
Curb Type		Curb & Gutter Type	
NO CURB		CONCRETE	
Pavement Recommendation		Condition Rating / PCR	
PREVENTIVE MAINTENANCE		GOOD / 90

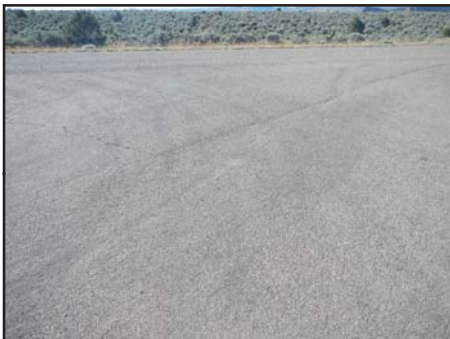
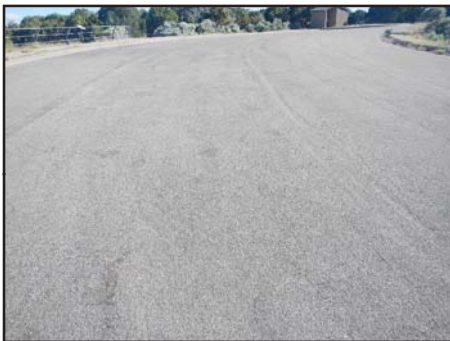
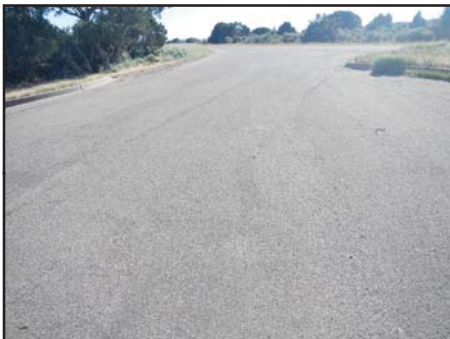
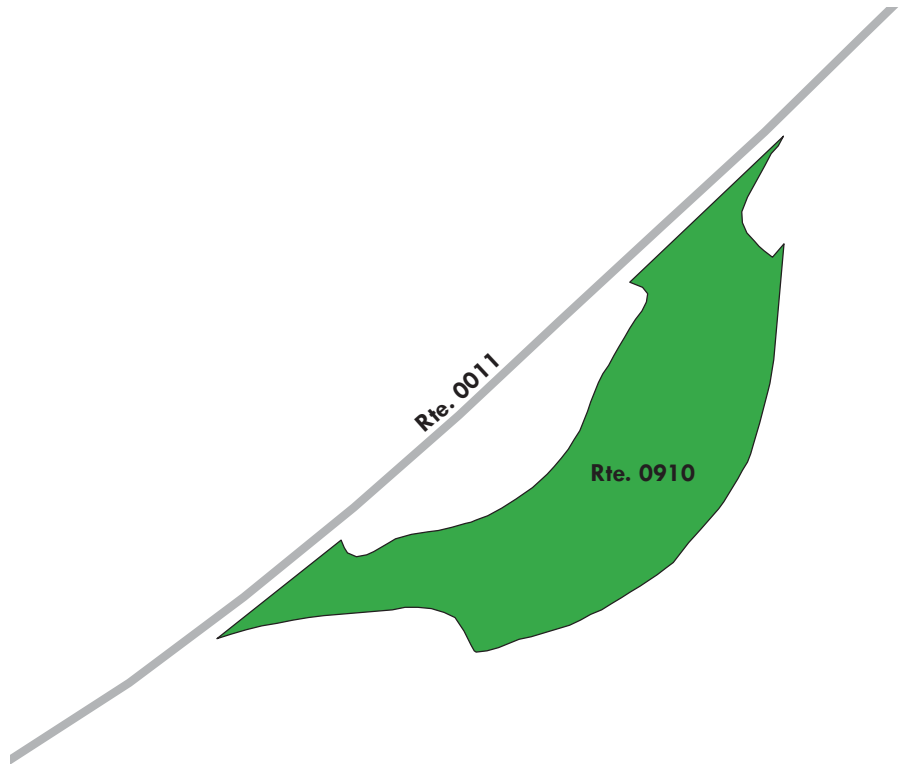
ROUTE 0910: ECHO PARK OVERLOOK PARKING AREA

Inspection Date	FMSS Number	User Access	Surface Type
6/22/2017	68521	PUBLIC	ASPHALT
Area (Sq. Ft.)	Lane Miles (11' Widths)	Curb Reveal (Inches)	Curb Recommendation
11,819	0.203	NOT APPLICABLE	DO NOTHING
Curb Type		Curb & Gutter Type	
NO CURB		CONCRETE	
Pavement Recommendation		Condition Rating / PCR	
PREVENTIVE MAINTENANCE		GOOD / 90

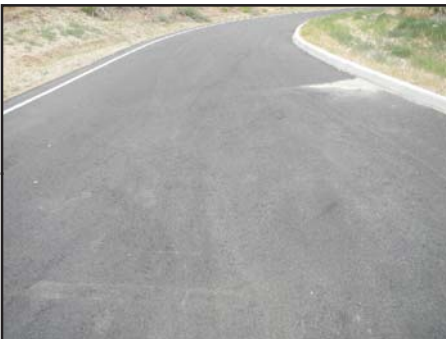
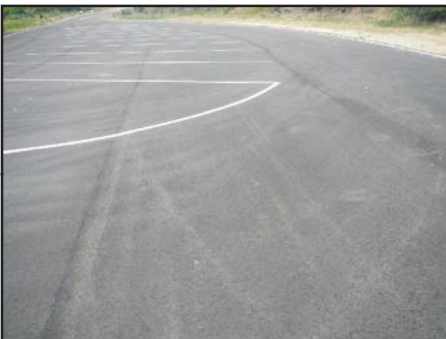
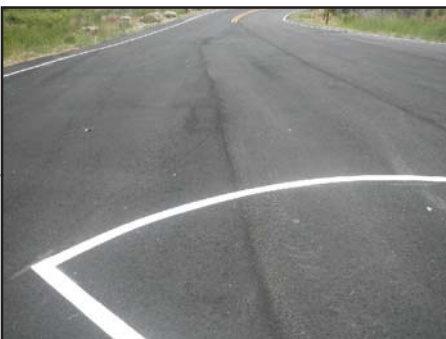
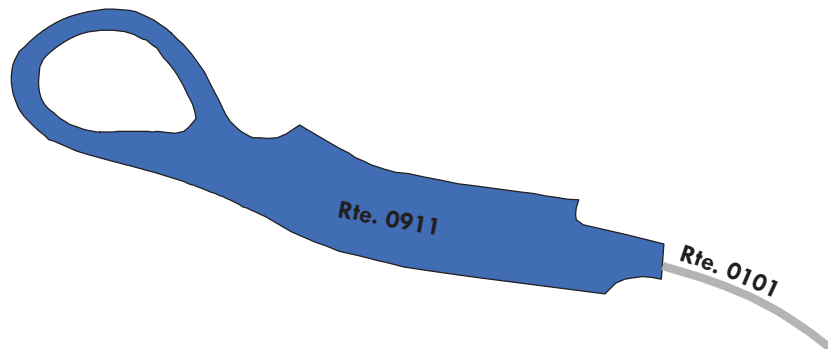
ROUTE 0911: DEERLODGE ENTRANCE ROAD PARKING

Inspection Date	FMSS Number	User Access	Surface Type
6/22/2017	68816	PUBLIC	ASPHALT
Area (Sq. Ft.)	Lane Miles (11' Widths)	Curb Reveal (Inches)	Curb Recommendation
17,824	0.307	6	DO NOTHING
Curb Type		Curb & Gutter Type	
CONCRETE		NO CURB AND GUTTER	
Pavement Recommendation		Condition Rating / PCR	
DO NOTHING		EXCELLENT / 97

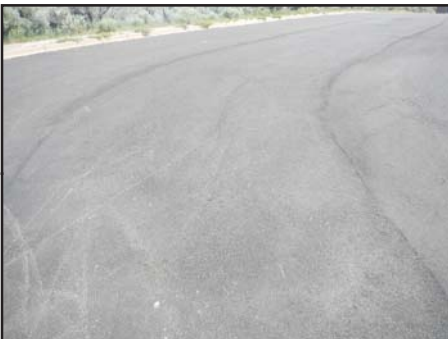
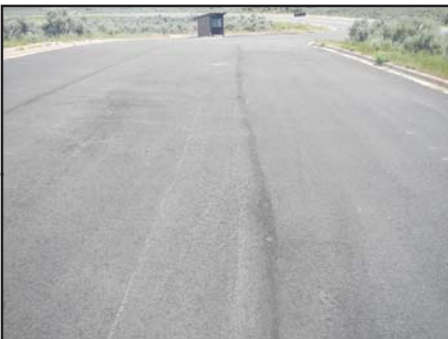
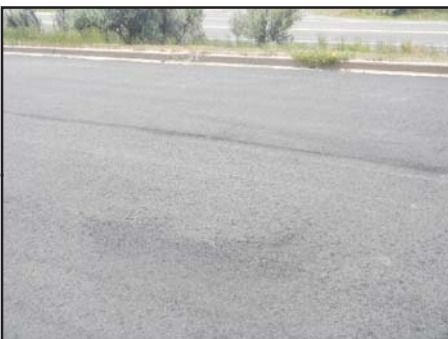
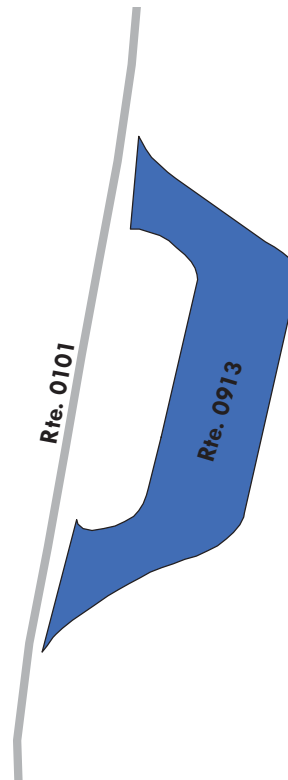
ROUTE 0913: DEERLODGE INFORMATION KIOSK PARKING AREA AT MP 0.13

Inspection Date	FMSS Number	User Access	Surface Type
6/22/2017	68819	PUBLIC	ASPHALT
Area (Sq. Ft.)	Lane Miles (11' Widths)	Curb Reveal (Inches)	Curb Recommendation
9,817	0.169	NOT APPLICABLE	DO NOTHING
Curb Type		Curb & Gutter Type	
NO CURB		CONCRETE	
Pavement Recommendation		Condition Rating / PCR	
DO NOTHING		EXCELLENT / 97

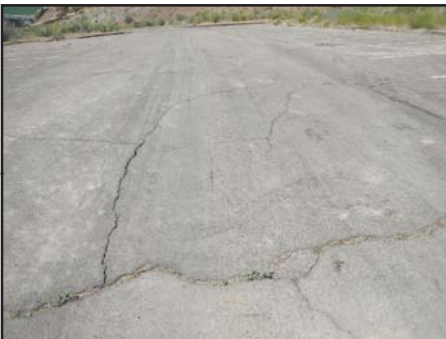
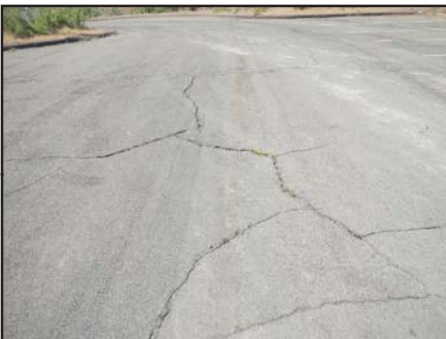
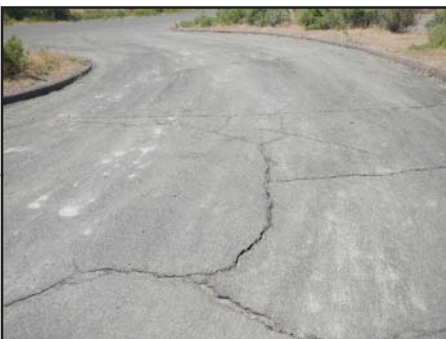
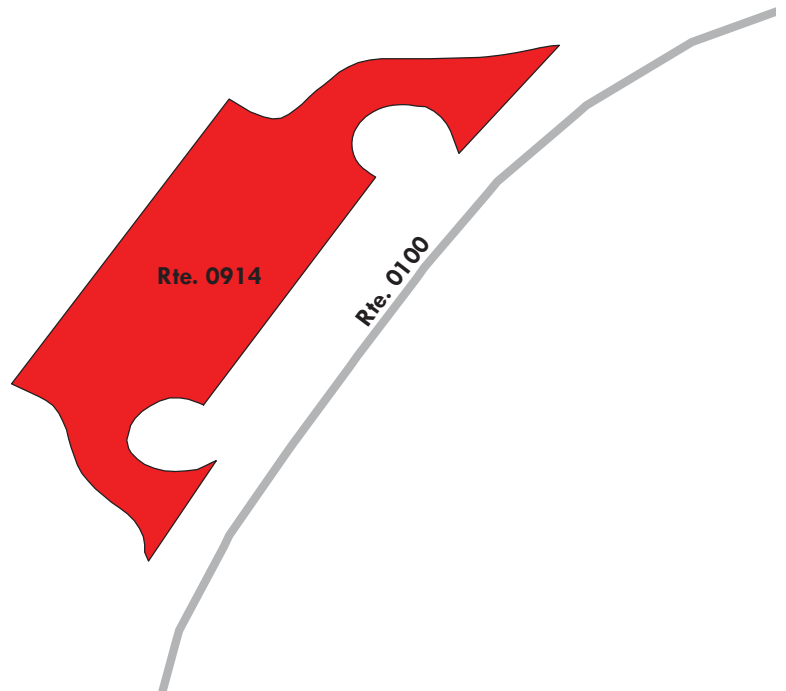
ROUTE 0914: QUARRY VISITOR CENTER MIDDLE PARKING LOT

Inspection Date	FMSS Number	User Access	Surface Type
6/23/2017	68825	PUBLIC	ASPHALT
Area (Sq. Ft.)	Lane Miles (11' Widths)	Curb Reveal (Inches)	Curb Recommendation
15,605	0.269	6	REPLACE
Curb Type		Curb & Gutter Type	
ASPHALT AND WOOD		NO CURB AND GUTTER	
Pavement Recommendation		Condition Rating / PCR	
HEAVY 3R TREATMENTS		POOR / 53

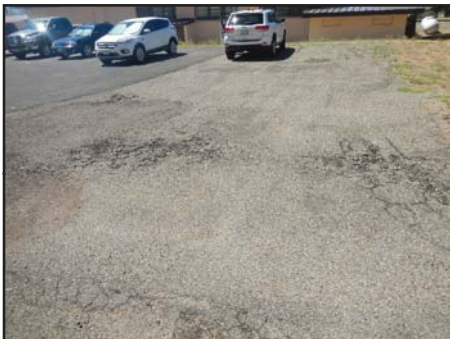
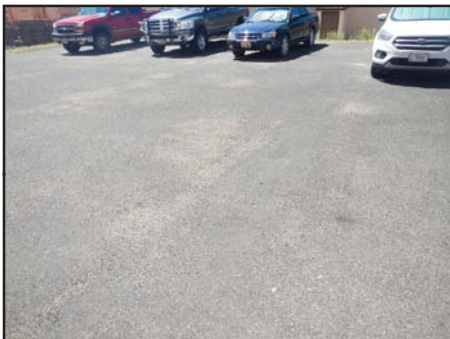
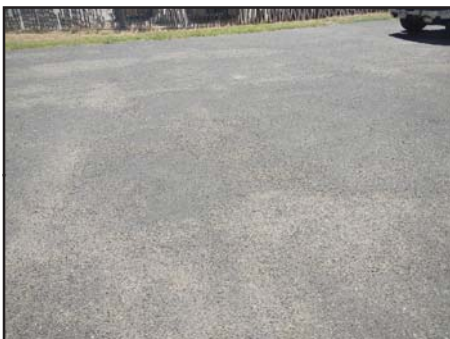
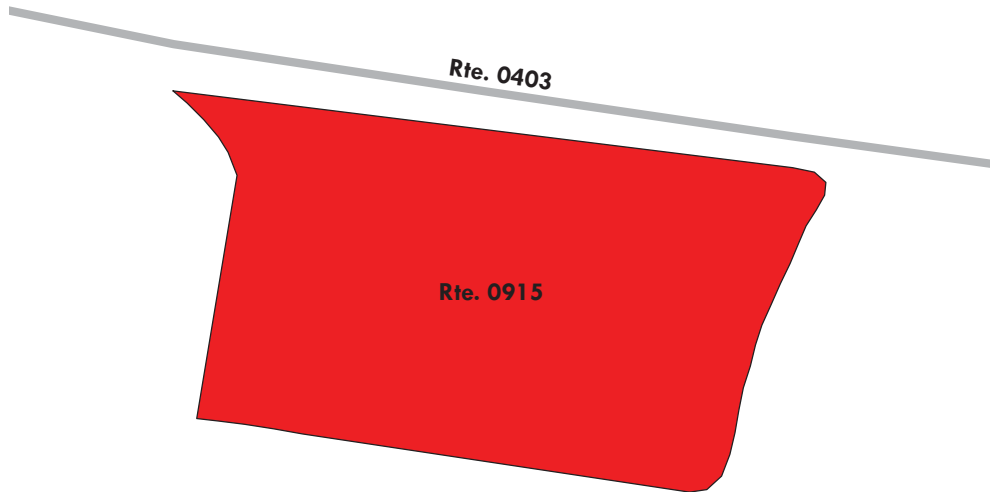
Inspection Date	FMSS Number	User Access	Surface Type
6/23/2017	68806	NONPUBLIC	ASPHALT
Area (Sq. Ft.)	Lane Miles (11' Widths)	Curb Reveal (Inches)	Curb Recommendation
6,656	0.115	NOT APPLICABLE	NOT APPLICABLE
Curb Type		Curb & Gutter Type	
NO CURB		NO CURB AND GUTTER	
Pavement Recommendation		Condition Rating / PCR	
RECONSTRUCTION		POOR / 30

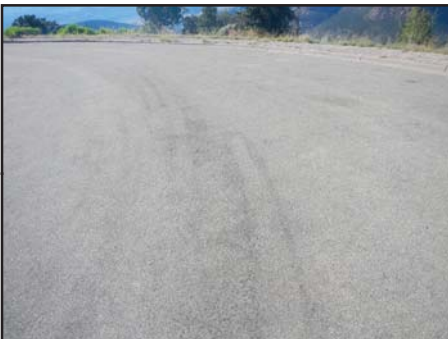
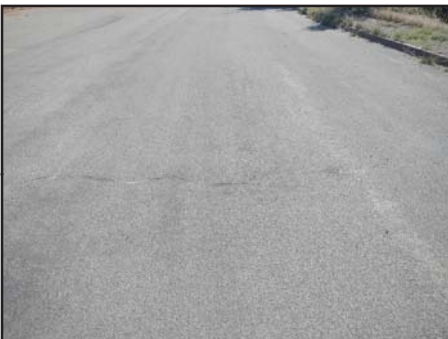
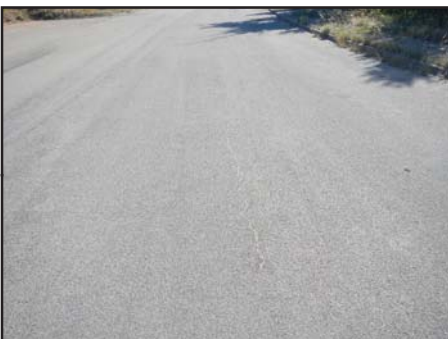
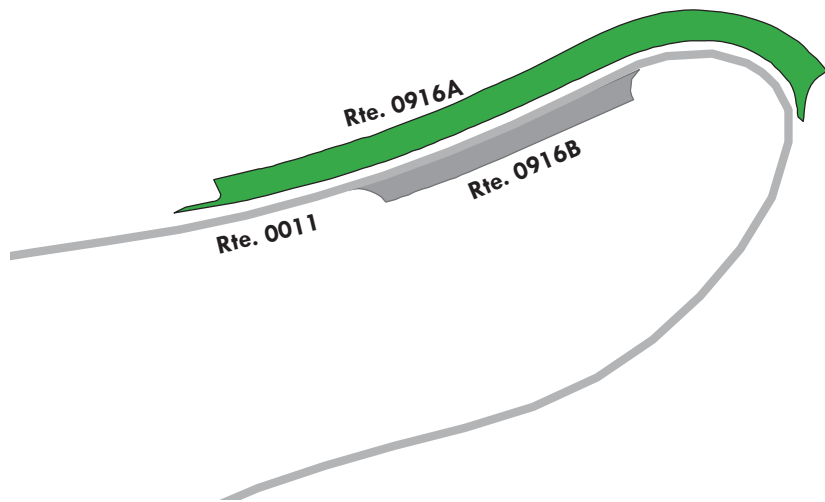
ROUTE 0916A: HARPERS CORNER PARKING AREA A

Inspection Date	FMSS Number	User Access	Surface Type
6/22/2017	68371	PUBLIC	ASPHALT
Area (Sq. Ft.)	Lane Miles (11' Widths)	Curb Reveal (Inches)	Curb Recommendation
13,248	0.228	NOT APPLICABLE	DO NOTHING
Curb Type		Curb & Gutter Type	
NO CURB		CONCRETE	
Pavement Recommendation		Condition Rating / PCR	
PREVENTIVE MAINTENANCE		GOOD / 90

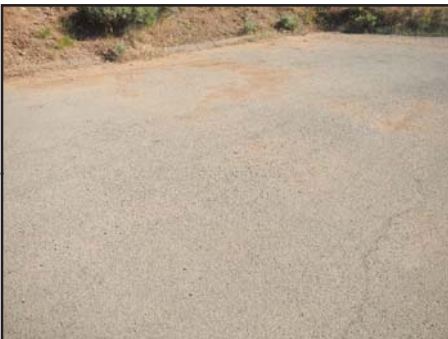
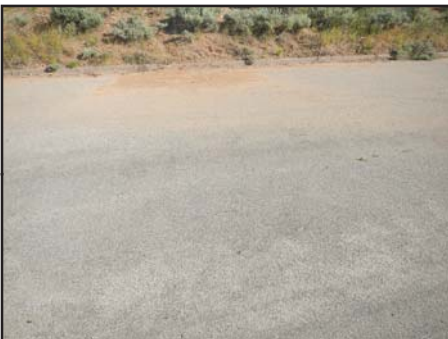
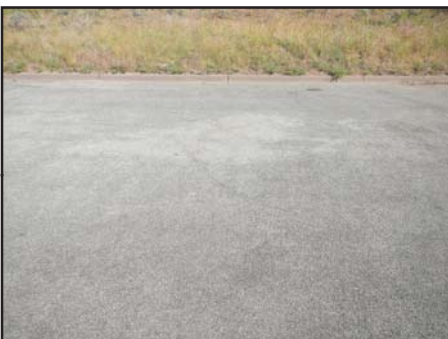
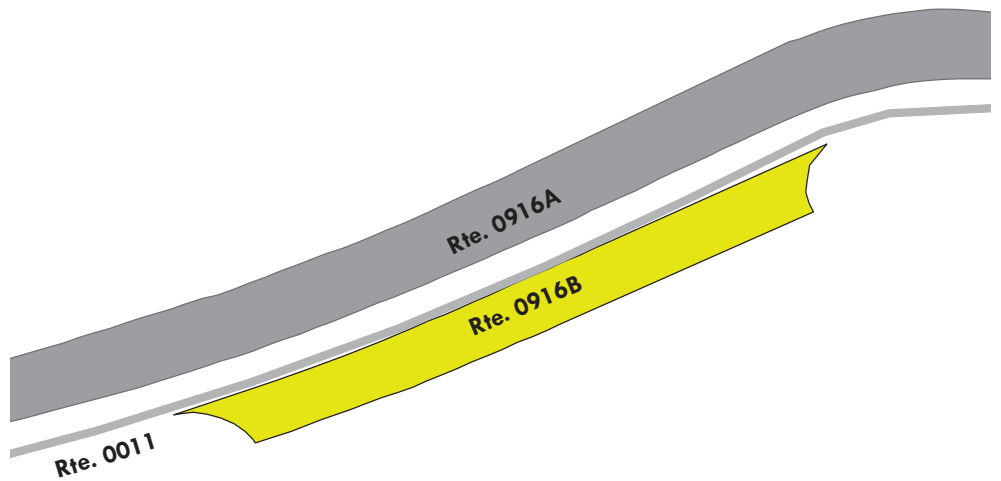
ROUTE 0916B: HARPERS CORNER PARKING AREA B

Inspection Date	FMSS Number	User Access	Surface Type
6/22/2017	104944	PUBLIC	ASPHALT
Area (Sq. Ft.)	Lane Miles (11' Widths)	Curb Reveal (Inches)	Curb Recommendation
4,565	0.079	NOT APPLICABLE	DO NOTHING
Curb Type		Curb & Gutter Type	
NO CURB		CONCRETE	
Pavement Recommendation		Condition Rating / PCR	
LIGHT 3R TREATMENTS		FAIR / 73
