DINO Cycle 6

Final Report

Road Inventory and Condition Assessment of Paved Routes Dinosaur National Monument

Report Date: June 2018

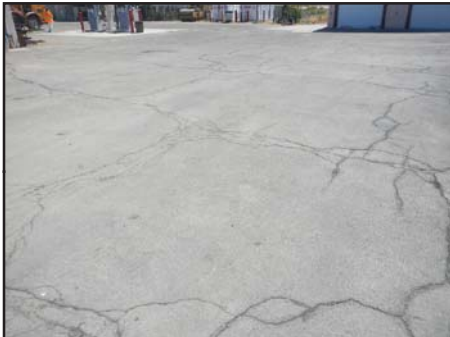
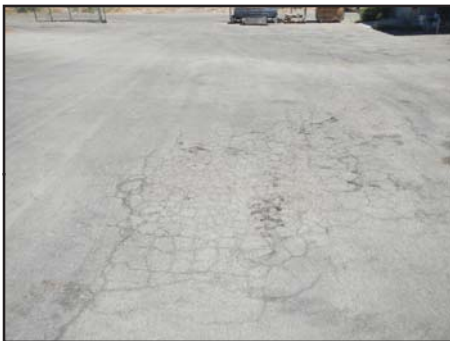
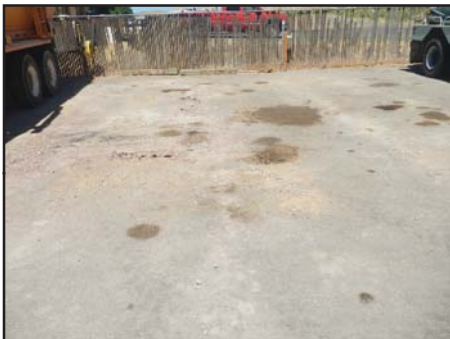
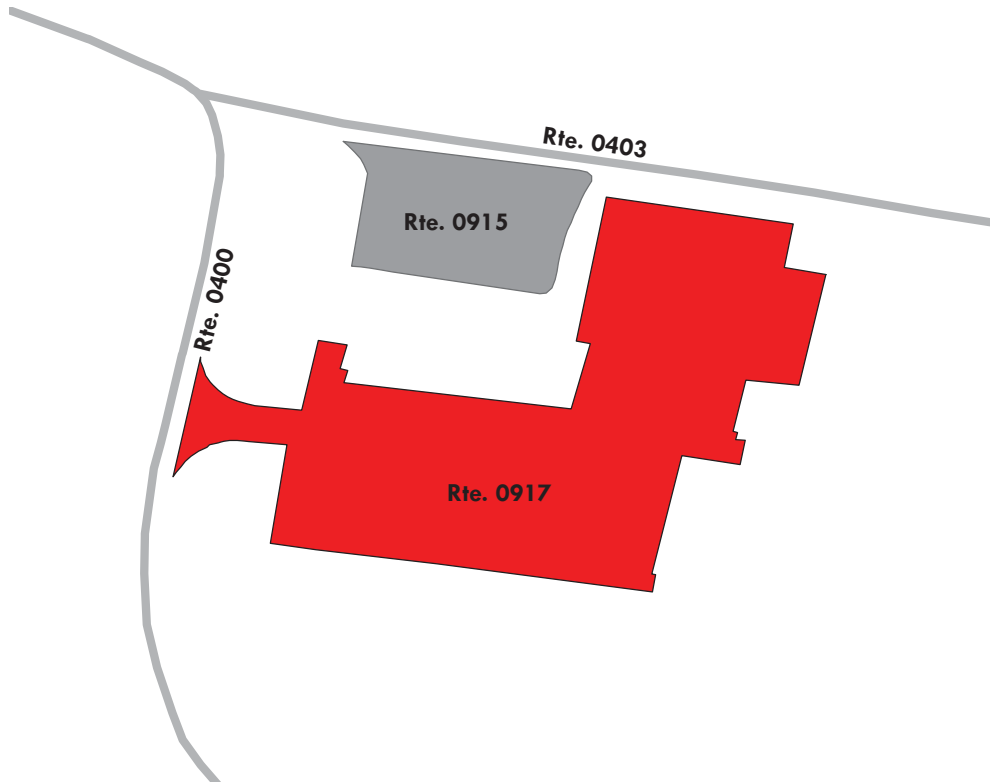
ROUTE 0917: QUARRY MAINTENANCE YARD

Inspection Date	FMSS Number	User Access	Surface Type
6/23/2017	68802	NONPUBLIC	ASPHALT
Area (Sq. Ft.)	Lane Miles (11' Widths)	Curb Reveal (Inches)	Curb Recommendation
29,444	0.507	NOT APPLICABLE	NOT APPLICABLE
Curb Type		Curb & Gutter Type	
NO CURB		NO CURB AND GUTTER	
Pavement Recommendation		Condition Rating / PCR	
RECONSTRUCTION		POOR / 30

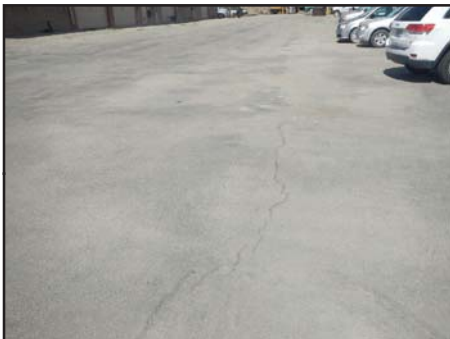
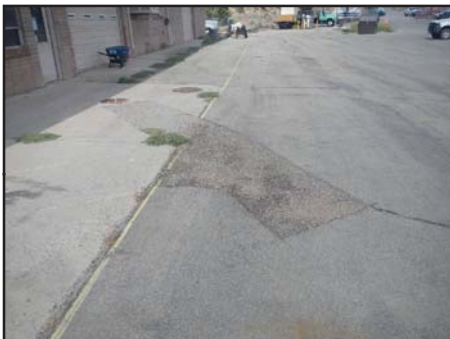
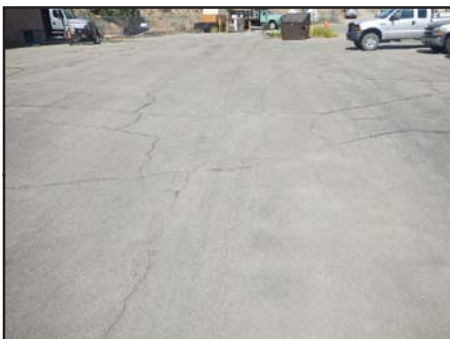
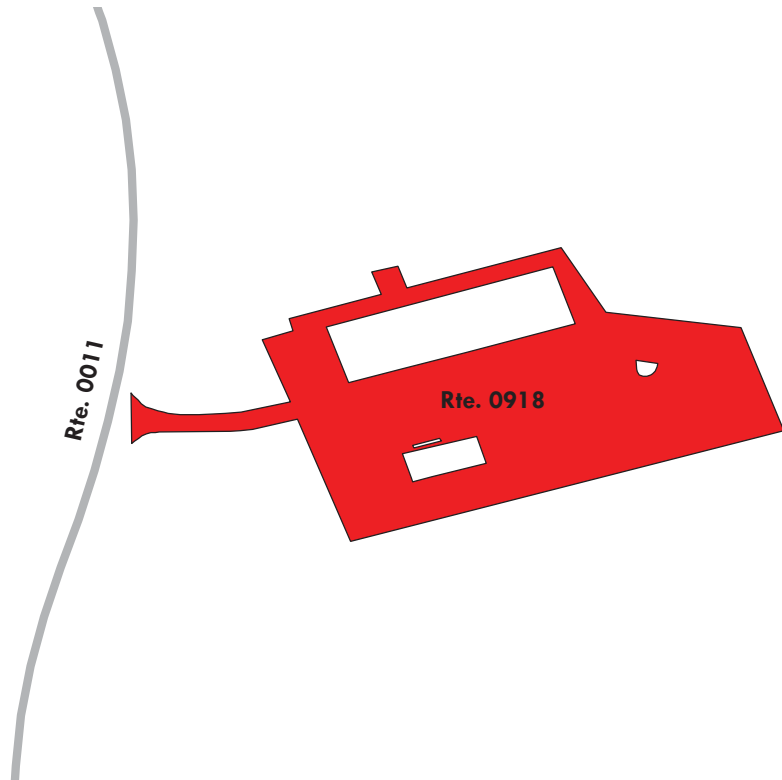
ROUTE 0918: YAMPA MAINTENANCE PARKING YARD

Inspection Date	FMSS Number	User Access	Surface Type
6/22/2017	68793	NONPUBLIC	ASPHALT
Area (Sq. Ft.)	Lane Miles (11' Widths)	Curb Reveal (Inches)	Curb Recommendation
65,422	1.126	NOT APPLICABLE	NOT APPLICABLE
Curb Type		Curb & Gutter Type	
NO CURB		NO CURB AND GUTTER	
Pavement Recommendation		Condition Rating / PCR	
HEAVY 3R TREATMENTS		POOR / 53

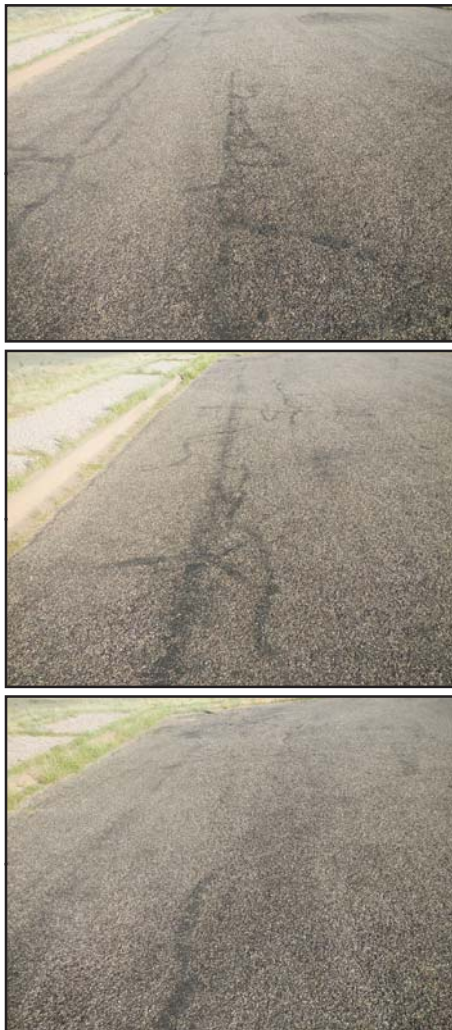
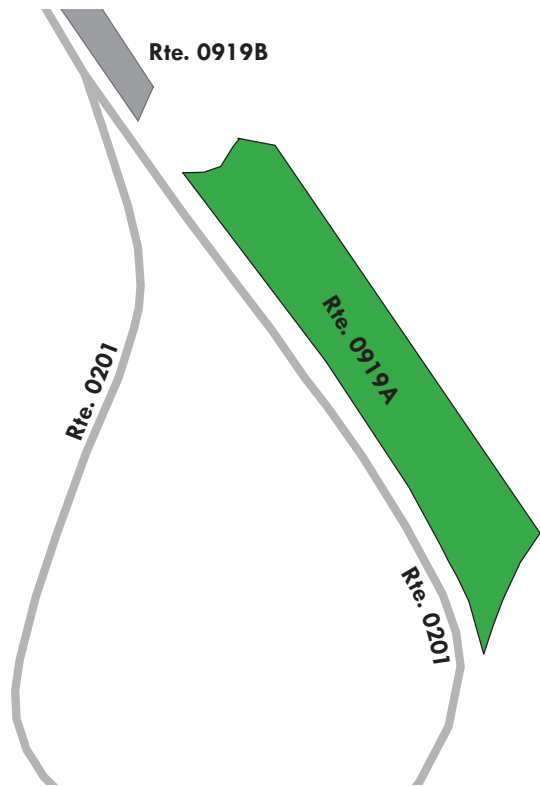
ROUTE 0919A: CANYON OVERLOOK PARKING AREA A

Inspection Date	FMSS Number	User Access	Surface Type
6/22/2017	68494	PUBLIC	ASPHALT
Area (Sq. Ft.)	Lane Miles (11' Widths)	Curb Reveal (Inches)	Curb Recommendation
2,754	0.047	NOT APPLICABLE	DO NOTHING
Curb Type		Curb & Gutter Type	
NO CURB		CONCRETE	
Pavement Recommendation		Condition Rating / PCR	
PREVENTIVE MAINTENANCE		GOOD / 90

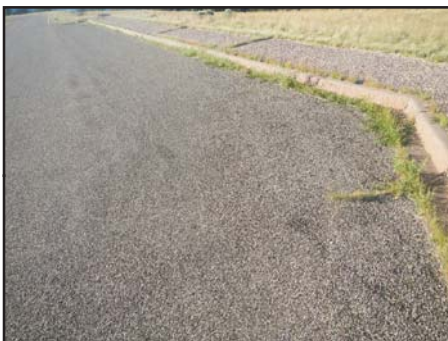
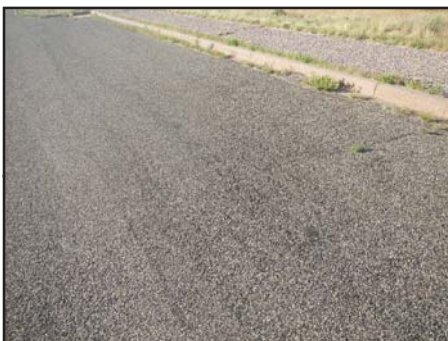
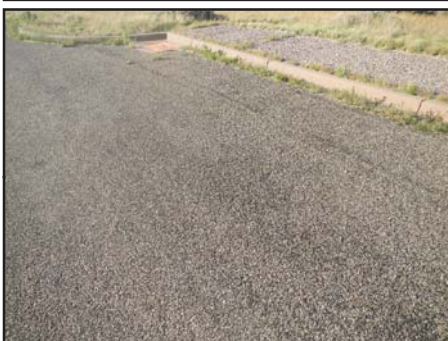
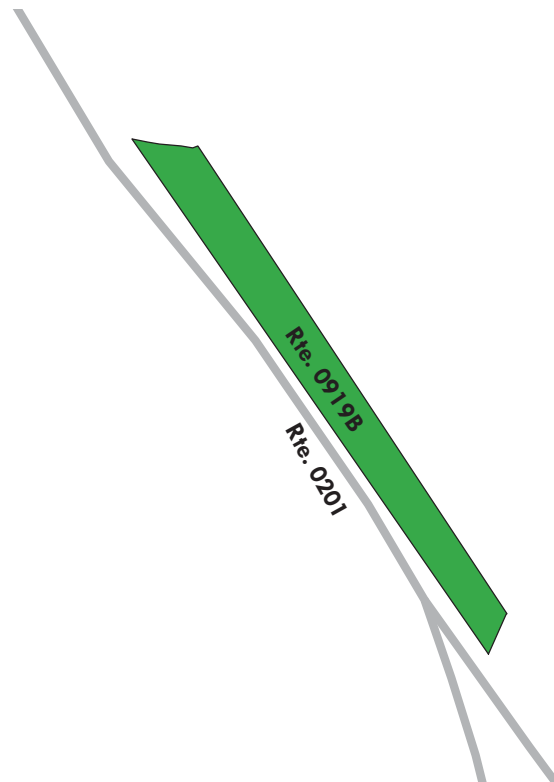
ROUTE 0919B: CANYON OVERLOOK PARKING AREA B

Inspection Date	FMSS Number	User Access	Surface Type
6/22/2017	104947	PUBLIC	ASPHALT
Area (Sq. Ft.)	Lane Miles (11' Widths)	Curb Reveal (Inches)	Curb Recommendation
1,139	0.02	NOT APPLICABLE	DO NOTHING
Curb Type		Curb & Gutter Type	
NO CURB		CONCRETE	
Pavement Recommendation		Condition Rating / PCR	
PREVENTIVE MAINTENANCE		GOOD / 90

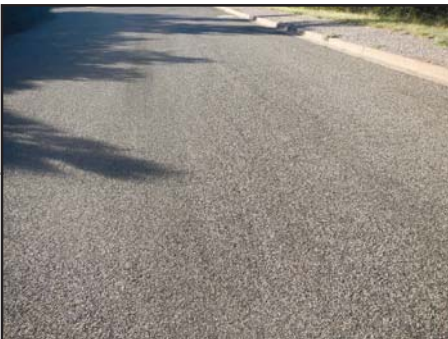
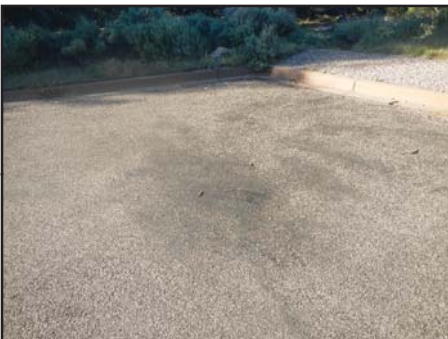
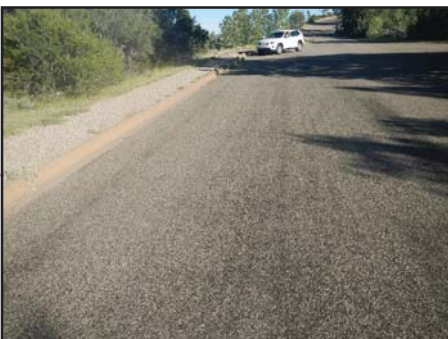
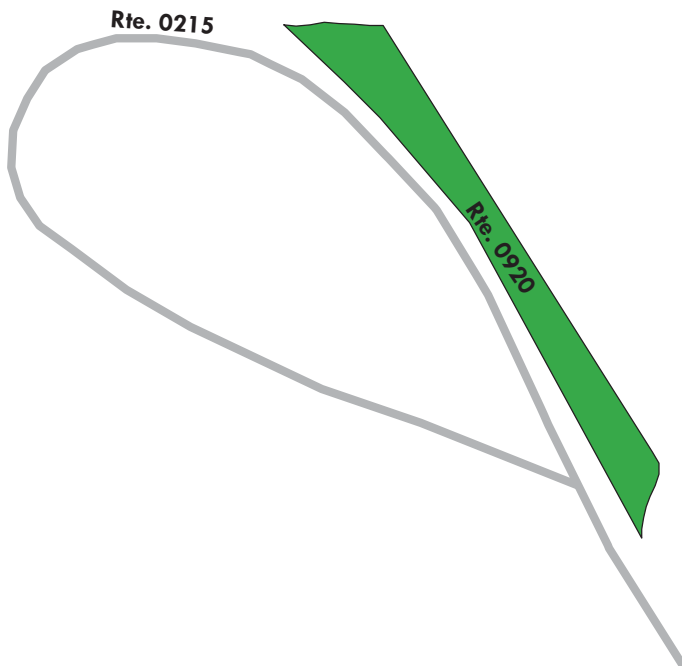
ROUTE 0920: CANYON OVERLOOK LOWER ROAD PARKING AREA

Inspection Date	FMSS Number	User Access	Surface Type
6/22/2017	68496	PUBLIC	ASPHALT
Area (Sq. Ft.)	Lane Miles (11' Widths)	Curb Reveal (Inches)	Curb Recommendation
2,987	0.051	NOT APPLICABLE	DO NOTHING
Curb Type		Curb & Gutter Type	
NO CURB		CONCRETE	
Pavement Recommendation		Condition Rating / PCR	
PREVENTIVE MAINTENANCE		GOOD / 90

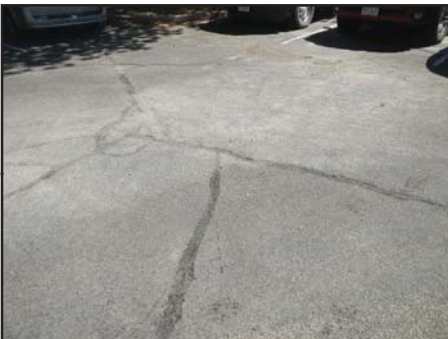
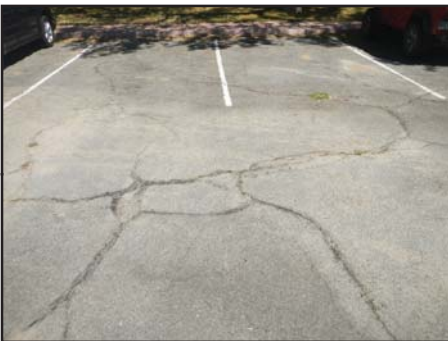
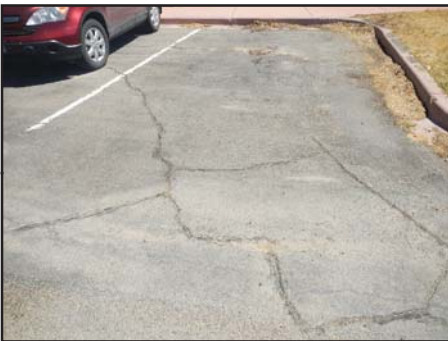
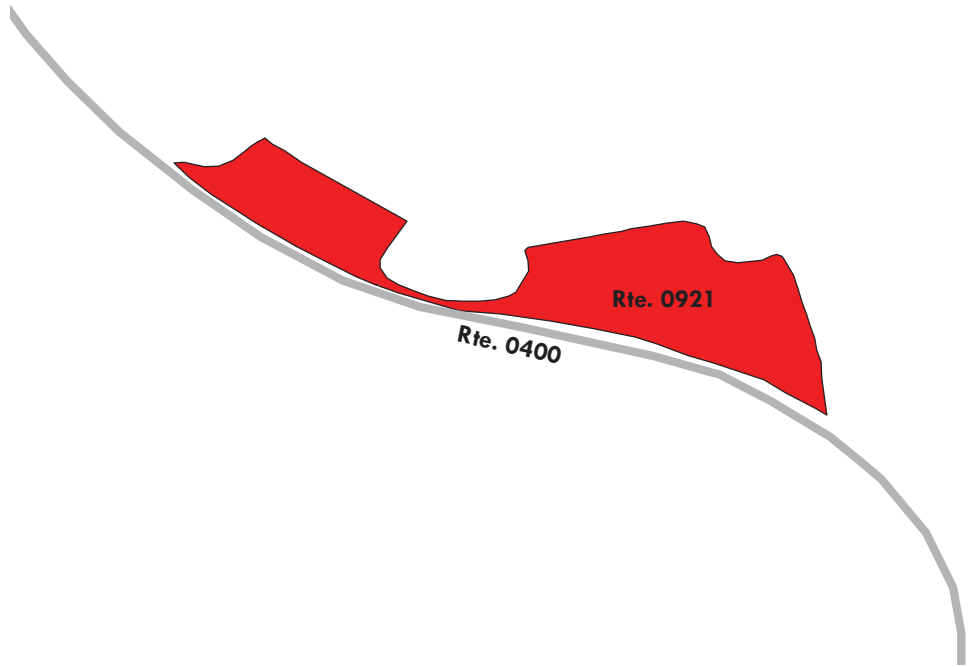
ROUTE 0921: GRD SEASONAL HOUSING PARKING

Inspection Date	FMSS Number	User Access	Surface Type
6/23/2017	69088	NONPUBLIC	ASPHALT
Area (Sq. Ft.)	Lane Miles (11' Widths)	Curb Reveal (Inches)	Curb Recommendation
4,532	0.078	NOT APPLICABLE	DO NOTHING
Curb Type		Curb & Gutter Type	
NO CURB		CONCRETE	
Pavement Recommendation		Condition Rating / PCR	
HEAVY 3R TREATMENTS		POOR / 53

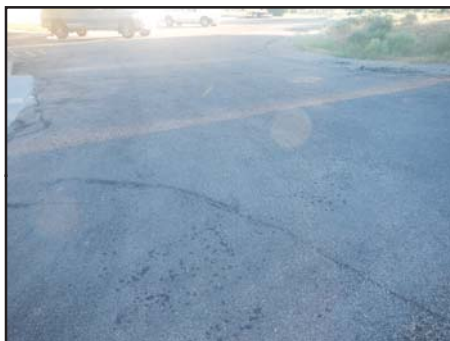
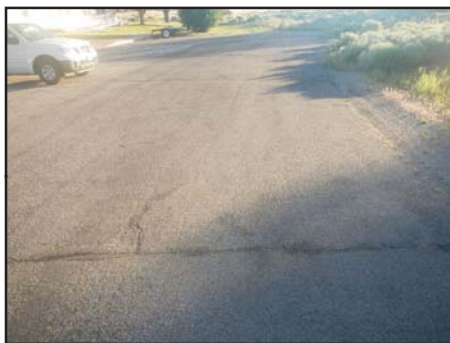
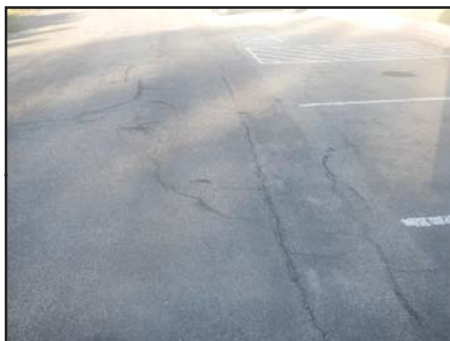
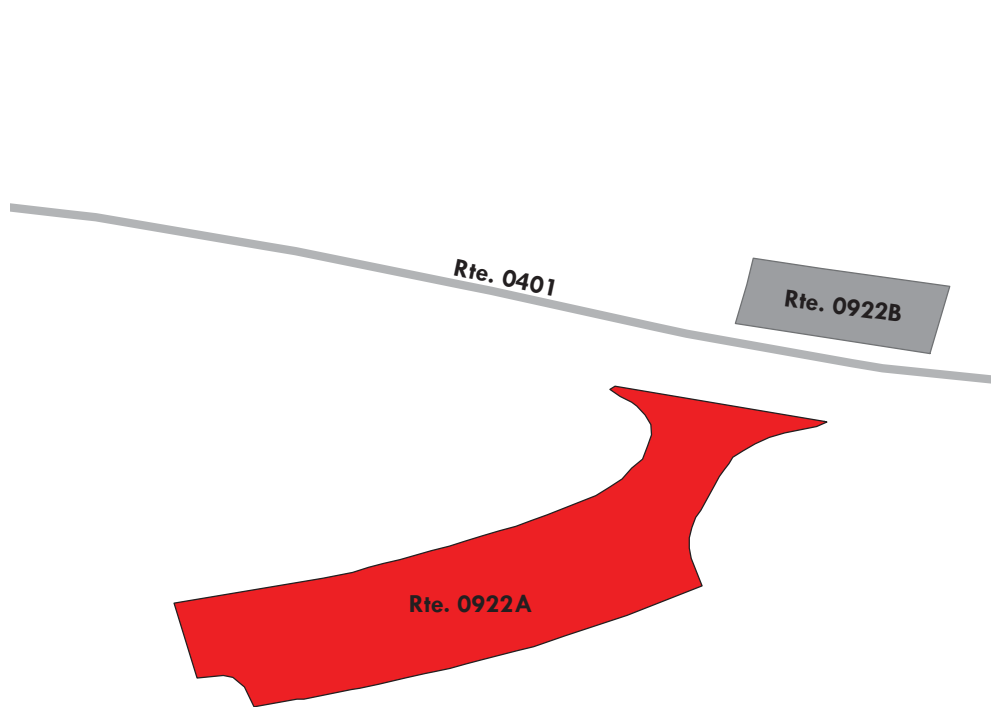
ROUTE 0922A: HEADQUARTERS HOUSING PARKING AREA A

Inspection Date	FMSS Number	User Access	Surface Type
6/22/2017	104951	NONPUBLIC	ASPHALT
Area (Sq. Ft.)	Lane Miles (11' Widths)	Curb Reveal (Inches)	Curb Recommendation
6,123	0.105	NOT APPLICABLE	DO NOTHING
Curb Type		Curb & Gutter Type	
NO CURB		CONCRETE	
Pavement Recommendation		Condition Rating / PCR	
HEAVY 3R TREATMENTS		POOR / 53

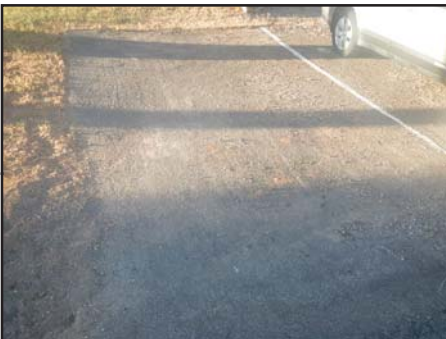
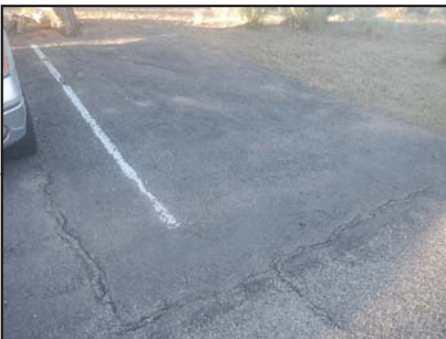
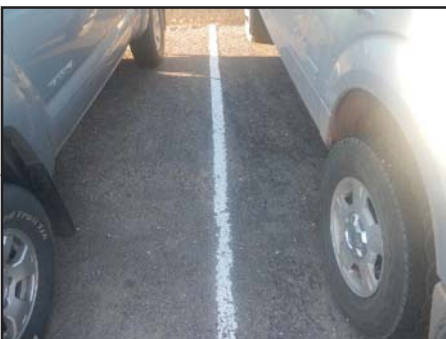
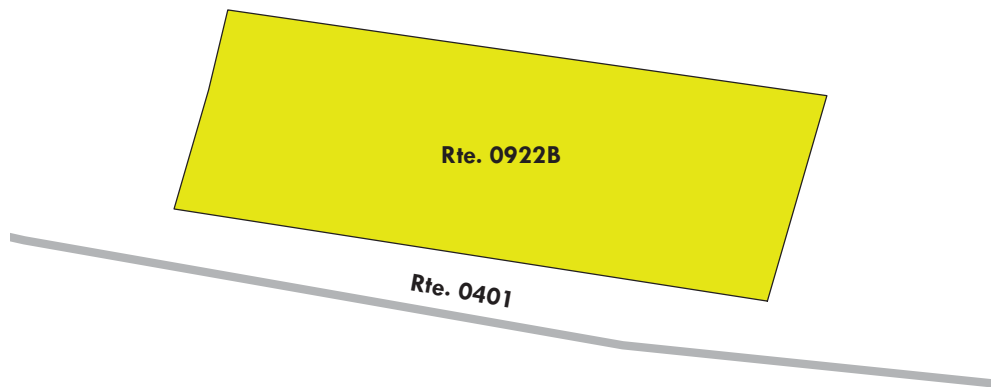
Inspection Date	FMSS Number	User Access	Surface Type
6/22/2017	104958	NONPUBLIC	ASPHALT
Area (Sq. Ft.)	Lane Miles (11' Widths)	Curb Reveal (Inches)	Curb Recommendation
1,179	0.02	NOT APPLICABLE	NOT APPLICABLE
Curb Type		Curb & Gutter Type	
NO CURB		NO CURB AND GUTTER	
Pavement Recommendation		Condition Rating / PCR	
LIGHT 3R TREATMENTS		FAIR / 73

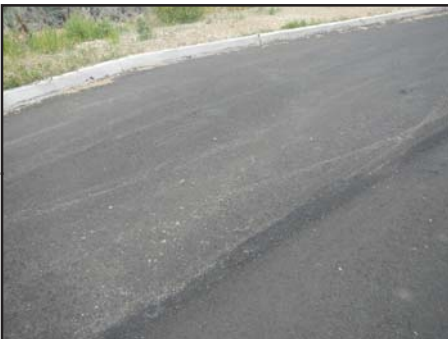
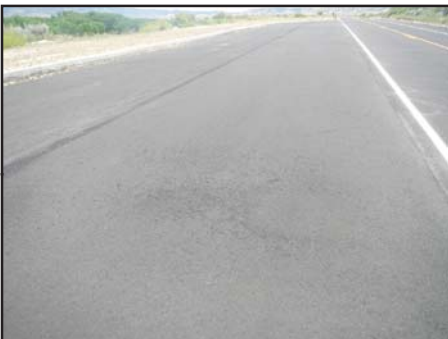
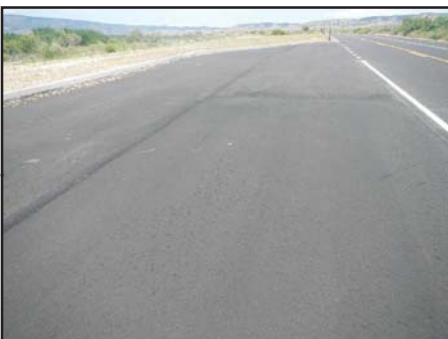
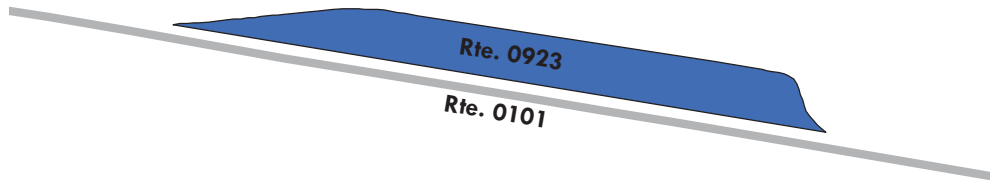
ROUTE 0923: YAMPA RIVER PARKING AREA AT MP 10.8

Inspection Date	FMSS Number	User Access	Surface Type
6/22/2017	104962	PUBLIC	ASPHALT
Area (Sq. Ft.)	Lane Miles (11' Widths)	Curb Reveal (Inches)	Curb Recommendation
15,188	0.262	7	DO NOTHING
Curb Type		Curb & Gutter Type	
CONCRETE		NO CURB AND GUTTER	
Pavement Recommendation		Condition Rating / PCR	
DO NOTHING		EXCELLENT / 97

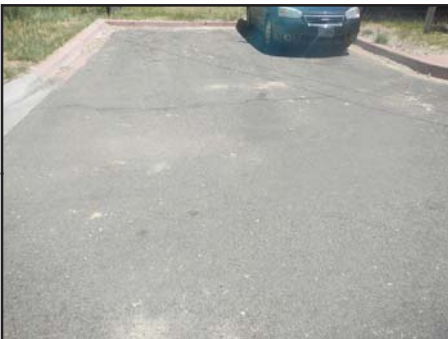
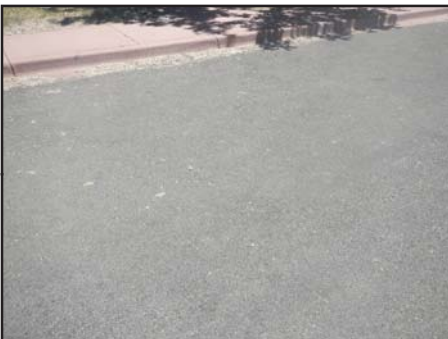
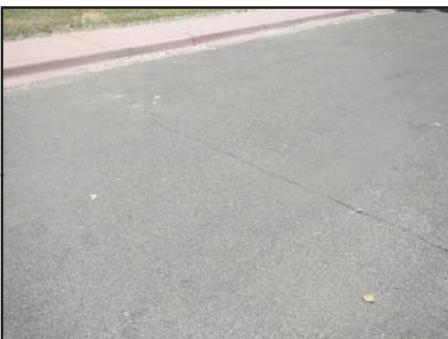
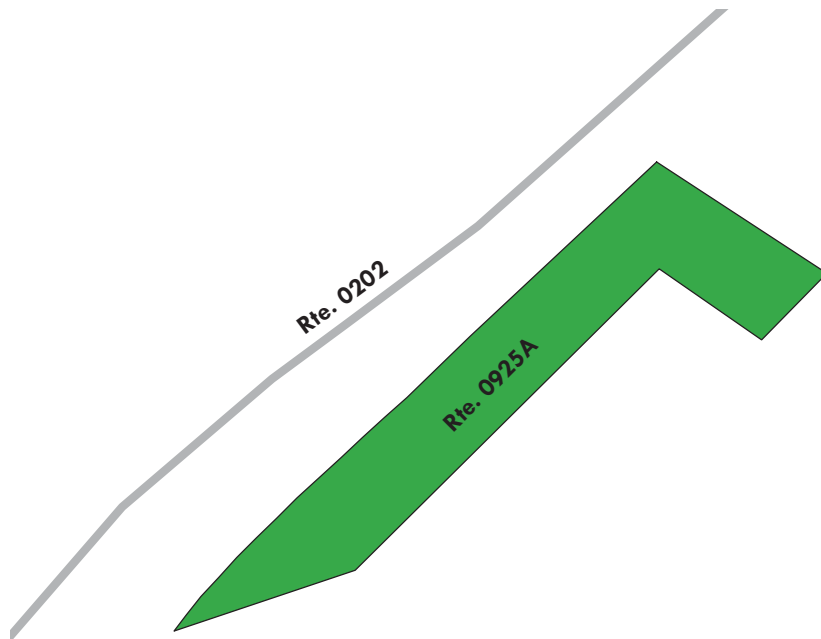
ROUTE 0925A: GREEN RIVER CAMPGROUND PARKING AREA A

Inspection Date	FMSS Number	User Access	Surface Type
6/23/2017	104992	PUBLIC	ASPHALT
Area (Sq. Ft.)	Lane Miles (11' Widths)	Curb Reveal (Inches)	Curb Recommendation
1,835	0.032	NOT APPLICABLE	DO NOTHING
Curb Type		Curb & Gutter Type	
NO CURB		CONCRETE	
Pavement Recommendation		Condition Rating / PCR	
PREVENTIVE MAINTENANCE		GOOD / 90

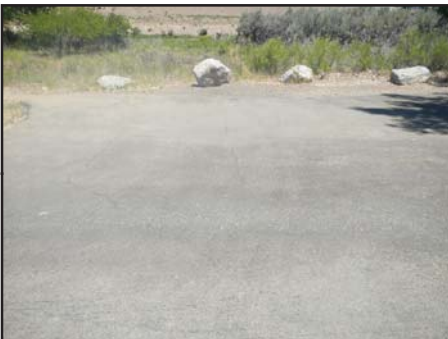
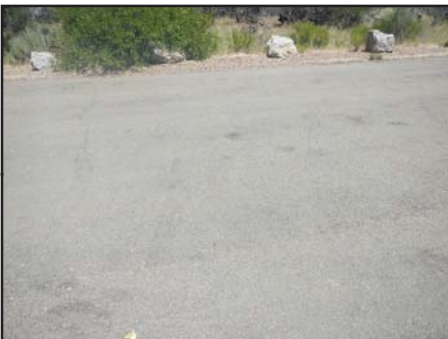
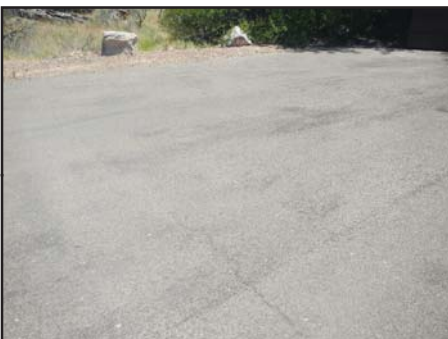
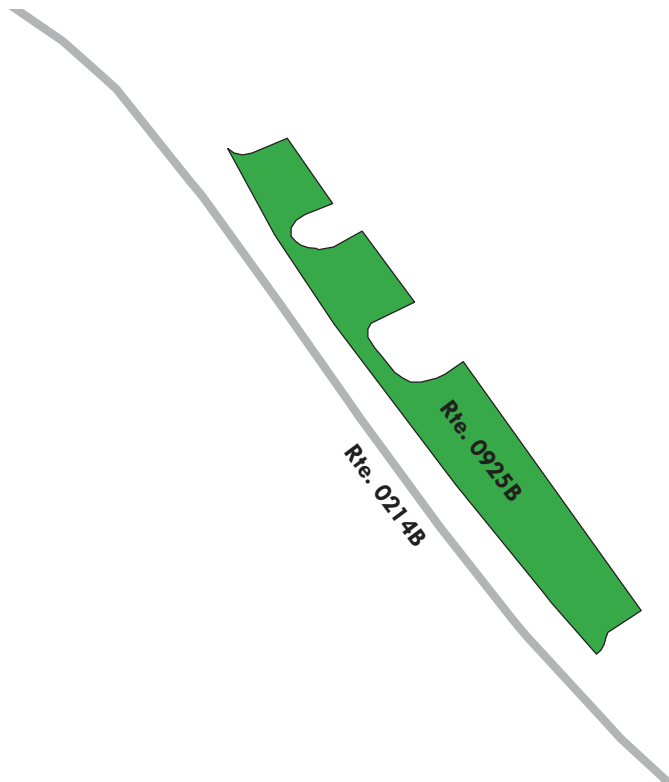
ROUTE 0925B: GREEN RIVER CAMPGROUND PARKING AREA B

Inspection Date	FMSS Number	User Access	Surface Type
6/23/2017	105028	PUBLIC	ASPHALT
Area (Sq. Ft.)	Lane Miles (11' Widths)	Curb Reveal (Inches)	Curb Recommendation
4,910	0.085	NOT APPLICABLE	NOT APPLICABLE
Curb Type		Curb & Gutter Type	
NO CURB		NO CURB AND GUTTER	
Pavement Recommendation		Condition Rating / PCR	
PREVENTIVE MAINTENANCE		GOOD / 90

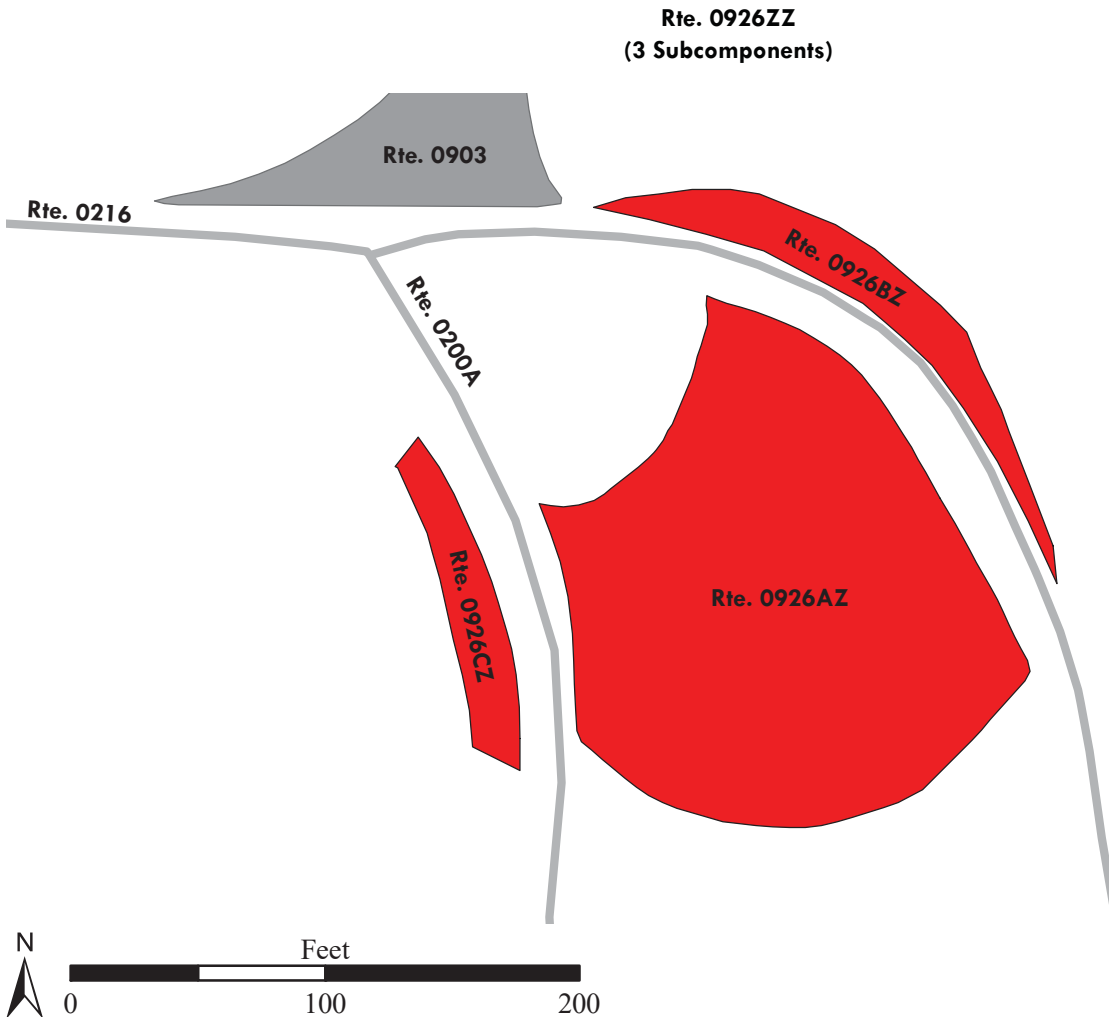
ROUTE 0926ZZ: SPLIT MOUNTAIN CAMPGROUND BOAT TRAILER PARKING AREAS

Inspection Date	FMSS Number	User Access	Surface Type
6/23/2017	99972	PUBLIC	ASPHALT
Area (Sq. Ft.)	Lane Miles (11' Widths)	Condition Rating / PCR	
23,951	0.412	SUMMARY / 53

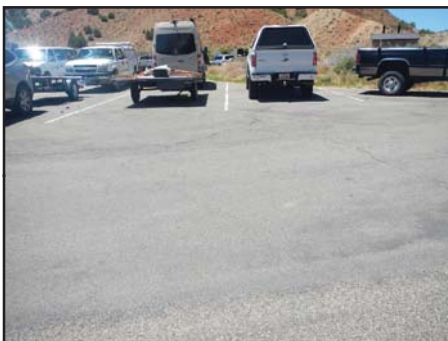
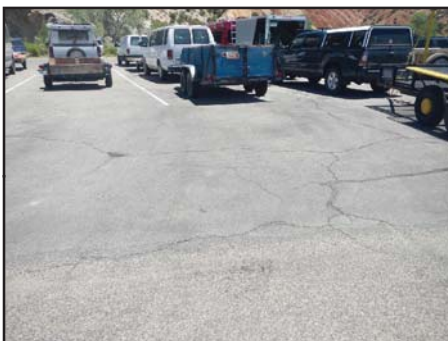
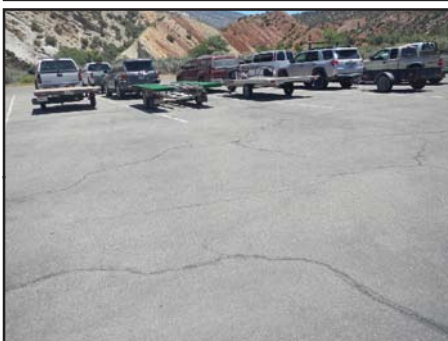
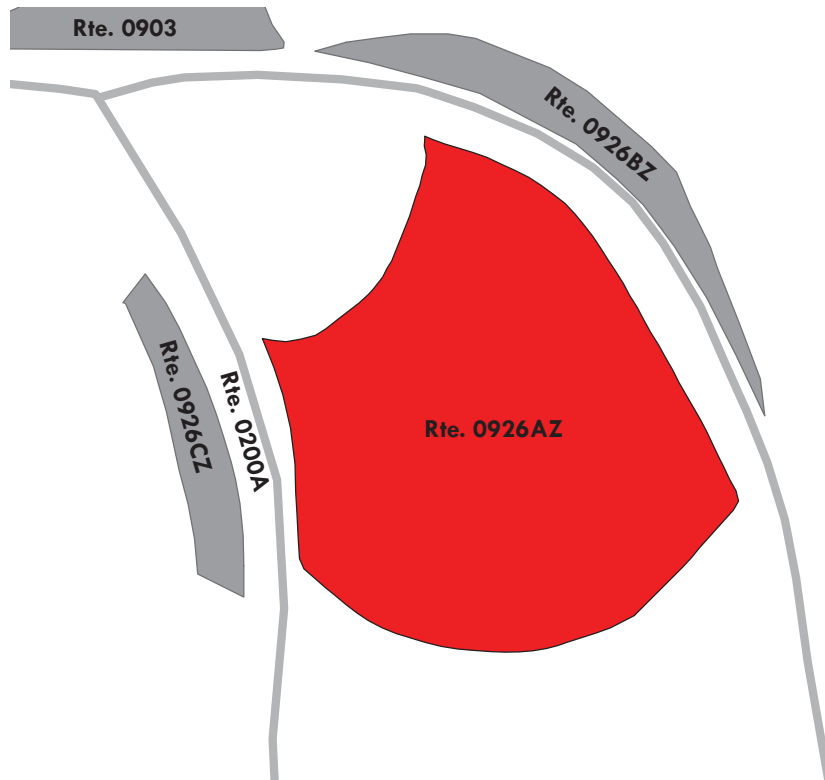
ROUTE 0926AZ: SPLIT MOUNTAIN CAMPGROUND BOAT TRAILER PARKING A

Inspection Date	FMSS Number	User Access	Surface Type
6/23/2017	99972	PUBLIC	ASPHALT
Area (Sq. Ft.)	Lane Miles (11' Widths)	Curb Reveal (Inches)	Curb Recommendation
19,409	0.334	NOT APPLICABLE	NOT APPLICABLE
Curb Type		Curb & Gutter Type	
NO CURB		NO CURB AND GUTTER	
Pavement Recommendation		Condition Rating / PCR	
HEAVY 3R TREATMENTS		POOR / 53

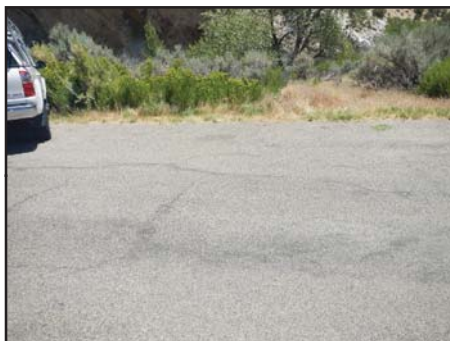
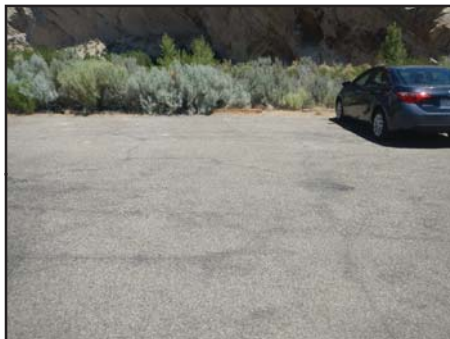
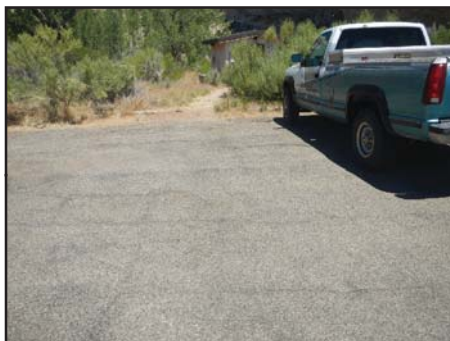
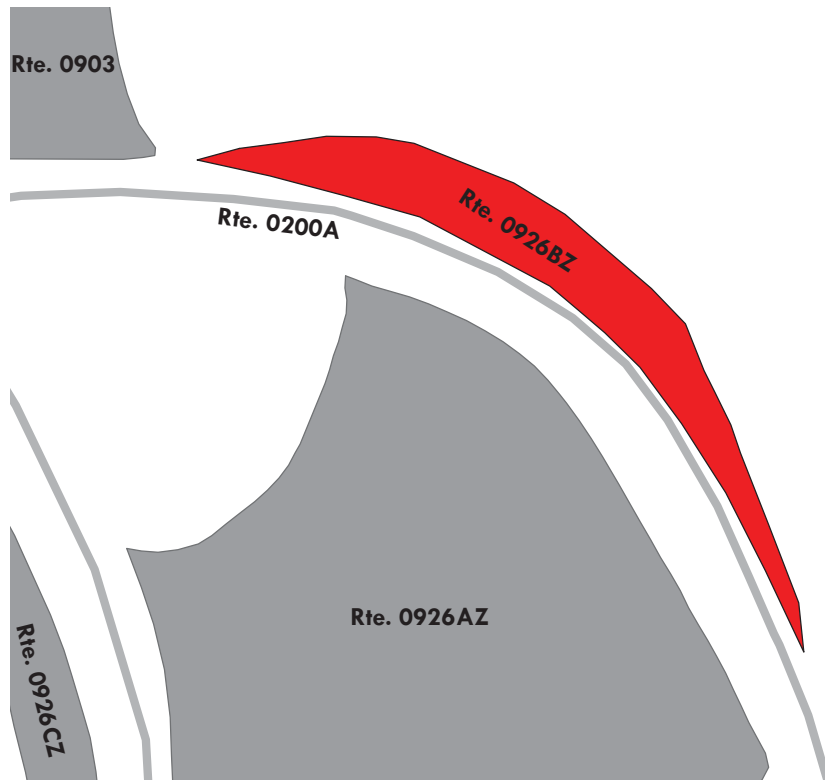
ROUTE 0926BZ: SPLIT MOUNTAIN CAMPGROUND BOAT TRAILER PARKING B

Inspection Date	FMSS Number	User Access	Surface Type
6/23/2017	99972	PUBLIC	ASPHALT
Area (Sq. Ft.)	Lane Miles (11' Widths)	Curb Reveal (Inches)	Curb Recommendation
2,758	0.047	NOT APPLICABLE	NOT APPLICABLE
Curb Type		Curb & Gutter Type	
NO CURB		NO CURB AND GUTTER	
Pavement Recommendation		Condition Rating / PCR	
HEAVY 3R TREATMENTS		POOR / 53

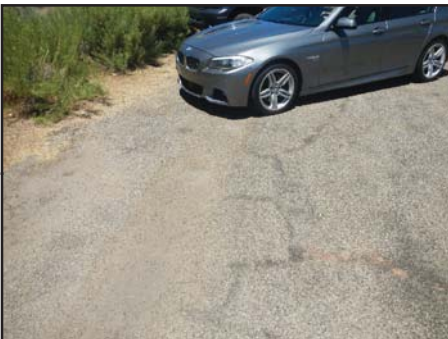
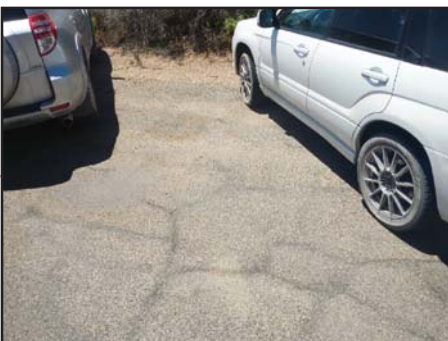
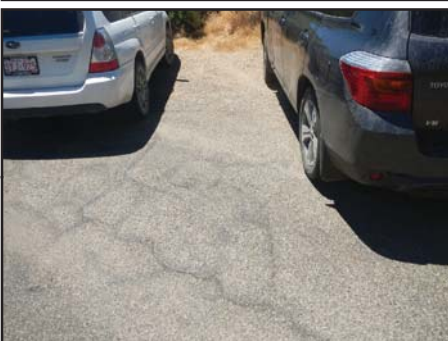
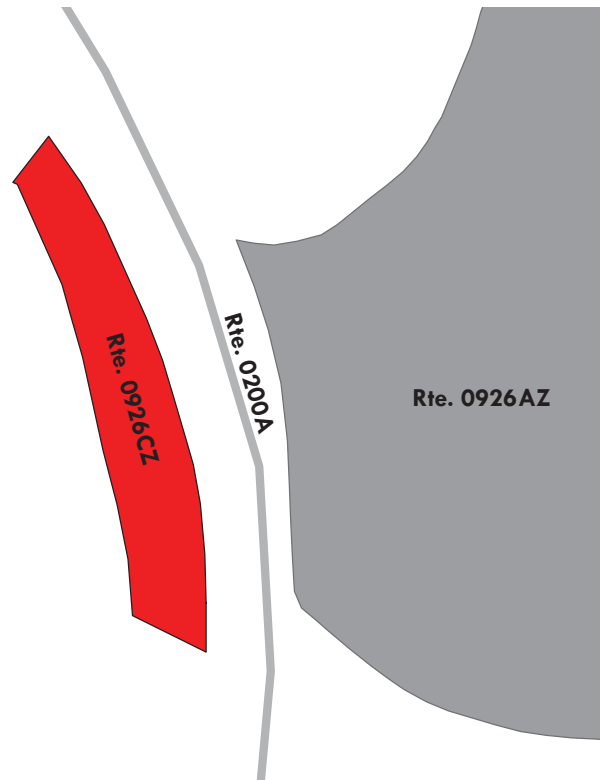
ROUTE 0926CZ: SPLIT MOUNTAIN CAMPGROUND BOAT TRAILER PARKING C

Inspection Date	FMSS Number	User Access	Surface Type
6/23/2017	99972	PUBLIC	ASPHALT
Area (Sq. Ft.)	Lane Miles (11' Widths)	Curb Reveal (Inches)	Curb Recommendation
1,784	0.031	NOT APPLICABLE	NOT APPLICABLE
Curb Type		Curb & Gutter Type	
NO CURB		NO CURB AND GUTTER	
Pavement Recommendation		Condition Rating / PCR	
HEAVY 3R TREATMENTS		POOR / 53

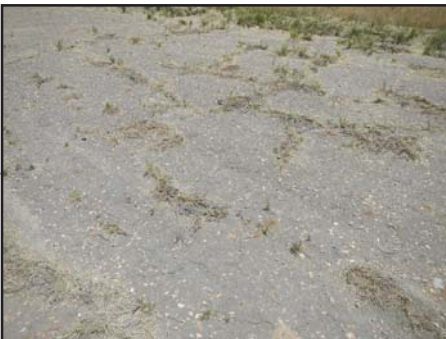
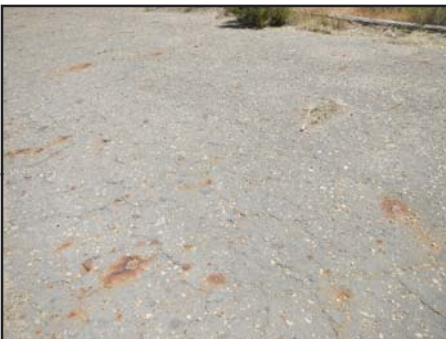
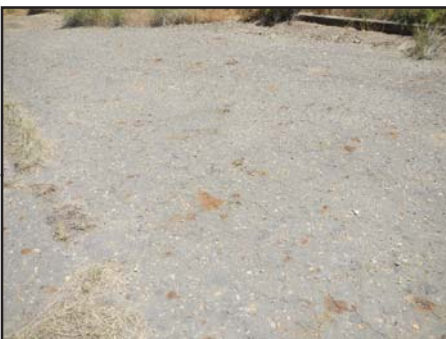
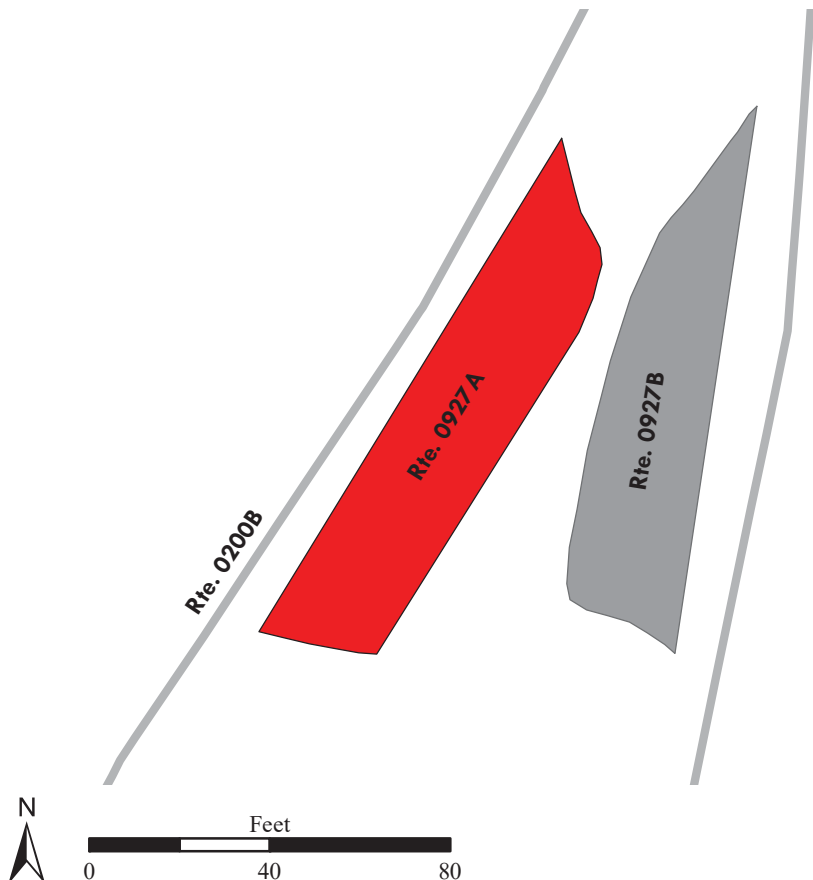
ROUTE 0927A: SPLIT MOUNTAIN CAMPGROUND SPUR PARKING A

Inspection Date	FMSS Number	User Access	Surface Type
6/23/2017	105040	PUBLIC	ASPHALT
Area (Sq. Ft.)	Lane Miles (11' Widths)	Curb Reveal (Inches)	Curb Recommendation
2,161	0.037	5	MODERATE REPAIR
Curb Type		Curb & Gutter Type	
WOOD		NO CURB AND GUTTER	
Pavement Recommendation		Condition Rating / PCR	
RECONSTRUCTION		POOR / 30

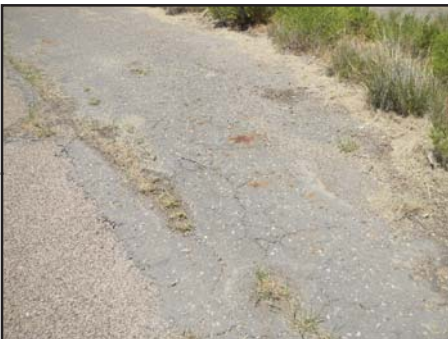
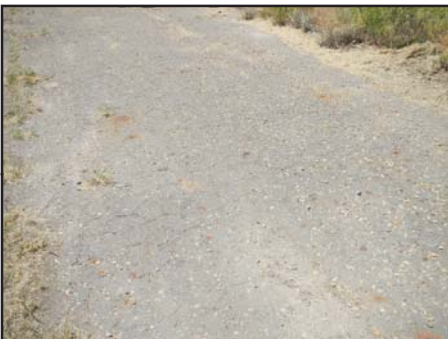
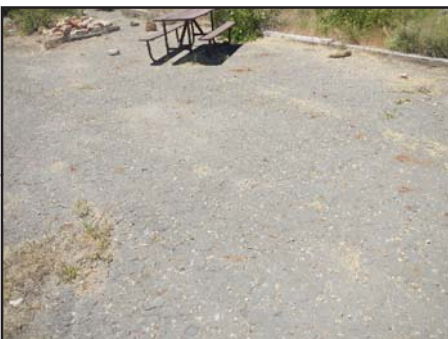
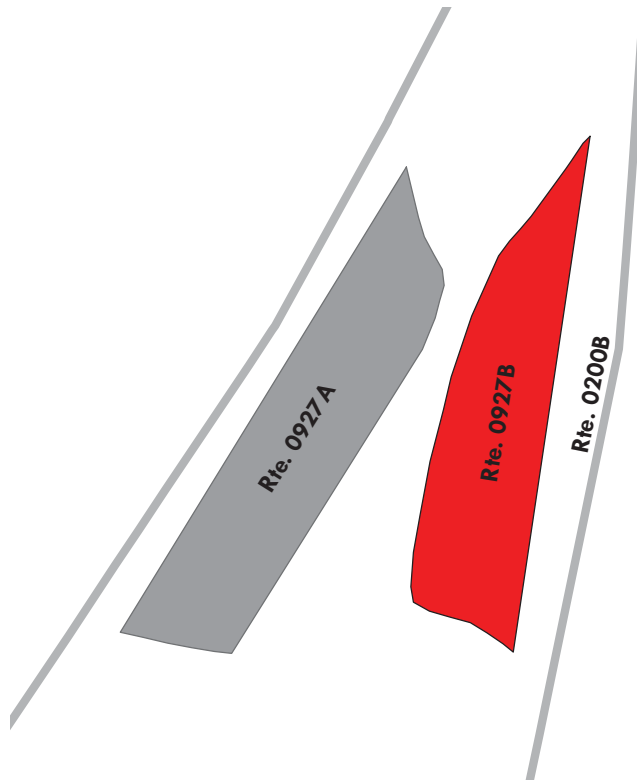
ROUTE 0927B: SPLIT MOUNTAIN CAMPGROUND SPUR PARKING B

Inspection Date	FMSS Number	User Access	Surface Type
6/23/2017	105042	PUBLIC	ASPHALT
Area (Sq. Ft.)	Lane Miles (11' Widths)	Curb Reveal (Inches)	Curb Recommendation
1,790	0.031	5	MODERATE REPAIR
Curb Type		Curb & Gutter Type	
WOOD		NO CURB AND GUTTER	
Pavement Recommendation		Condition Rating / PCR	
RECONSTRUCTION		POOR / 30

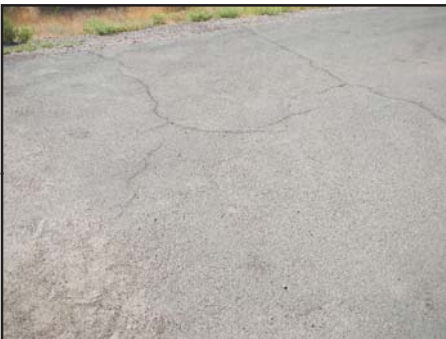
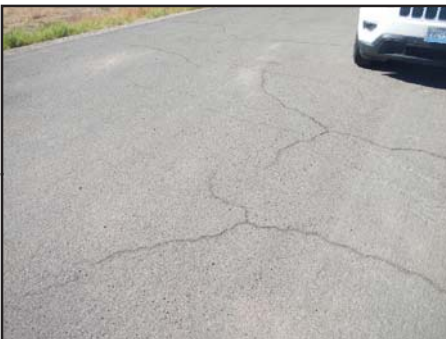
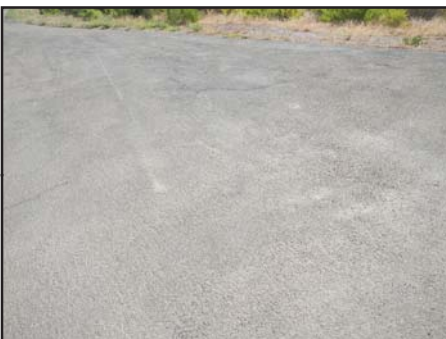
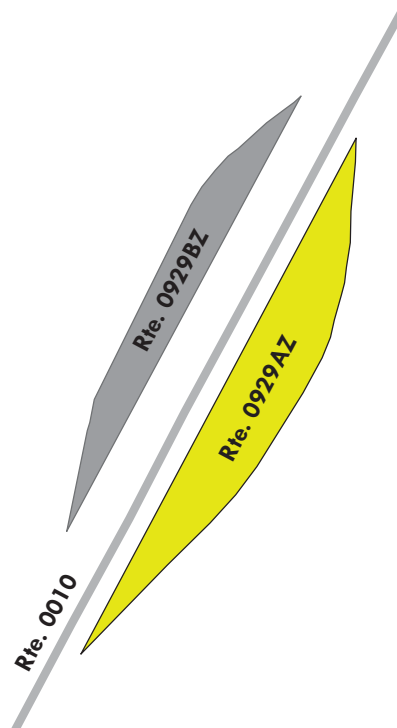
ROUTE 0929AZ: GRD ENTRANCE PULLOUT A AT MP 0.03

Inspection Date	FMSS Number	User Access	Surface Type
6/23/2017	249247	PUBLIC	ASPHALT
Area (Sq. Ft.)	Lane Miles (11' Widths)	Curb Reveal (Inches)	Curb Recommendation
4,380	0.075	NOT APPLICABLE	NOT APPLICABLE
Curb Type		Curb & Gutter Type	
NO CURB		NO CURB AND GUTTER	
Pavement Recommendation		Condition Rating / PCR	
LIGHT 3R TREATMENTS		FAIR / 73

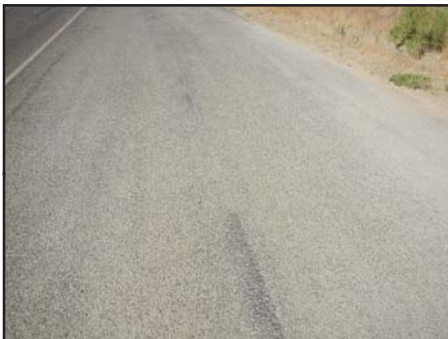
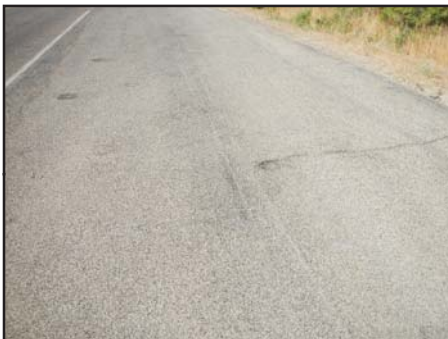
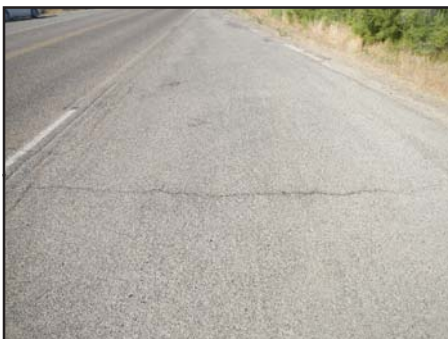
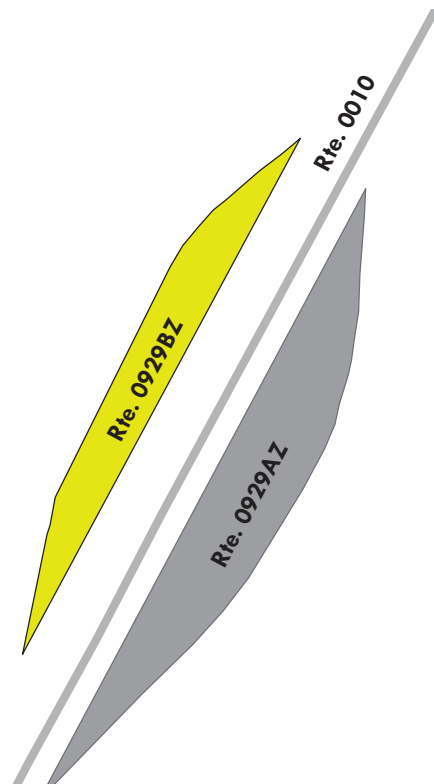
ROUTE 0929BZ: GRD ENTRANCE PULLOUT B AT MP 0.03

Inspection Date	FMISS Number	User Access	Surface Type
6/23/2017	249247	PUBLIC	ASPHALT
Area (Sq. Ft.)	Lane Miles (11' Widths)	Curb Reveal (Inches)	Curb Recommendation
2,568	0.044	NOT APPLICABLE	NOT APPLICABLE
Curb Type		Curb & Gutter Type	
NO CURB		NO CURB AND GUTTER	
Pavement Recommendation		Condition Rating / PCR	
LIGHT 3R TREATMENTS		FAIR / 73

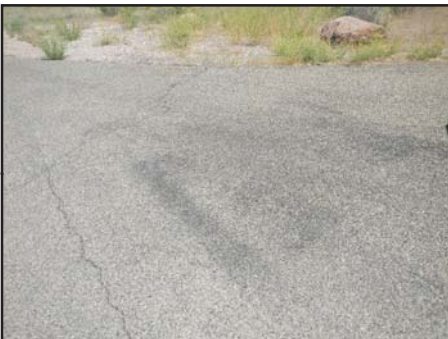
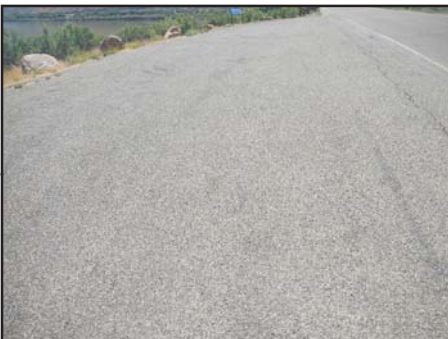
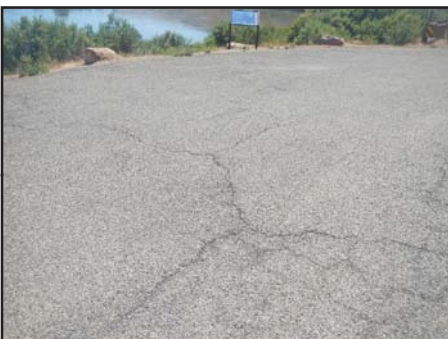
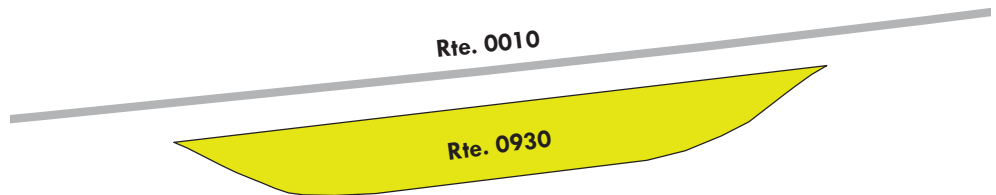
ROUTE 0930: MANCOS SEA PULLOUT

Inspection Date	FMSS Number	User Access	Surface Type
6/23/2017	249248	PUBLIC	ASPHALT
Area (Sq. Ft.)	Lane Miles (11' Widths)	Curb Reveal (Inches)	Curb Recommendation
2,833	0.049	NOT APPLICABLE	NOT APPLICABLE
Curb Type		Curb & Gutter Type	
NO CURB		NO CURB AND GUTTER	
Pavement Recommendation		Condition Rating / PCR	
LIGHT 3R TREATMENTS		FAIR / 73

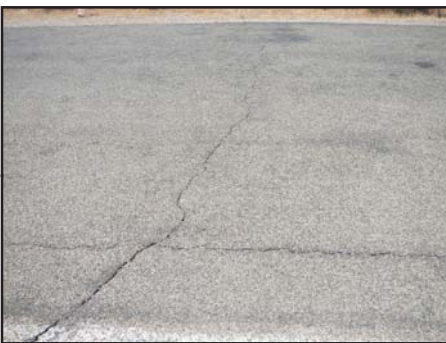
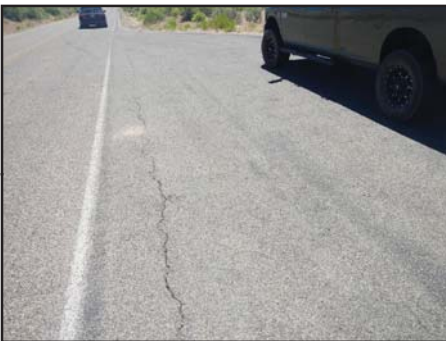
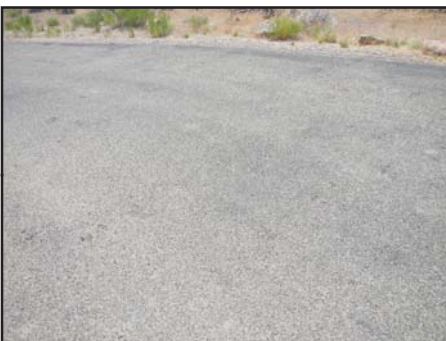
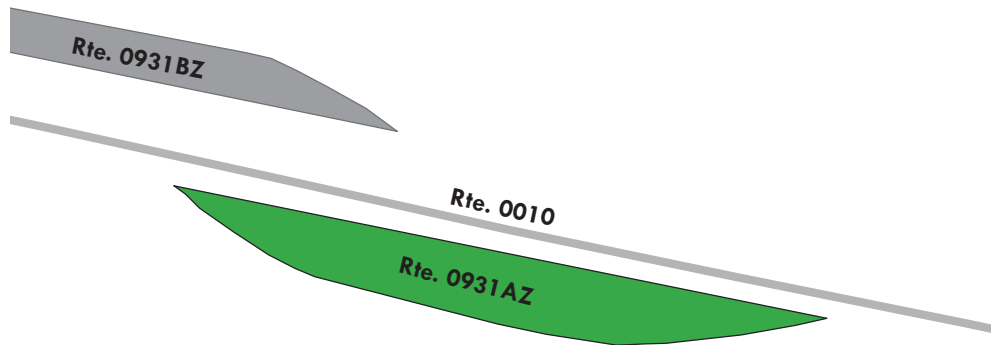
ROUTE 0931AZ: SWELTER SHELTER PULLOUT A

Inspection Date	FMSS Number	User Access	Surface Type
6/23/2017	249249	PUBLIC	ASPHALT
Area (Sq. Ft.)	Lane Miles (11' Widths)	Curb Reveal (Inches)	Curb Recommendation
2,216	0.038	NOT APPLICABLE	NOT APPLICABLE
Curb Type		Curb & Gutter Type	
NO CURB		NO CURB AND GUTTER	
Pavement Recommendation		Condition Rating / PCR	
PREVENTIVE MAINTENANCE		GOOD / 90
