DINO Cycle 6

Final Report

Road Inventory and Condition Assessment of Paved Routes Dinosaur National Monument

Report Date: June 2018

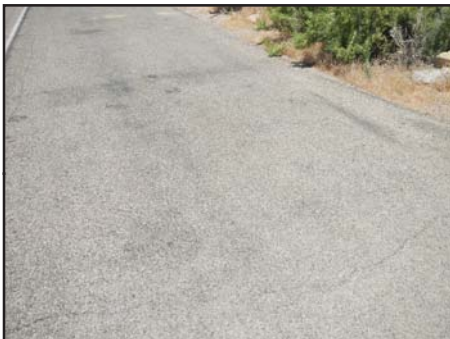
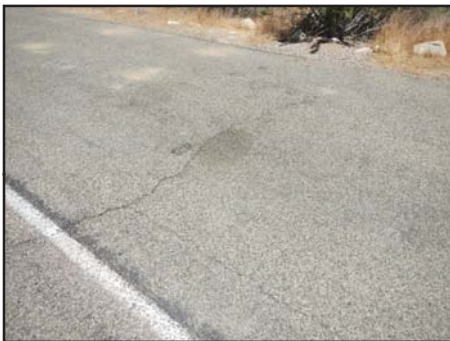
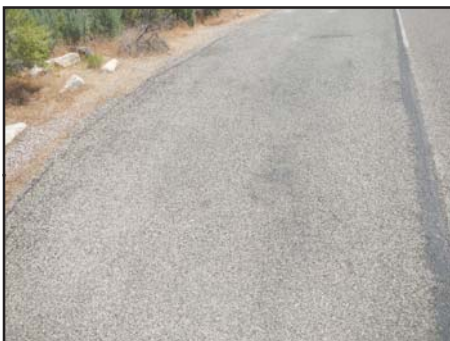
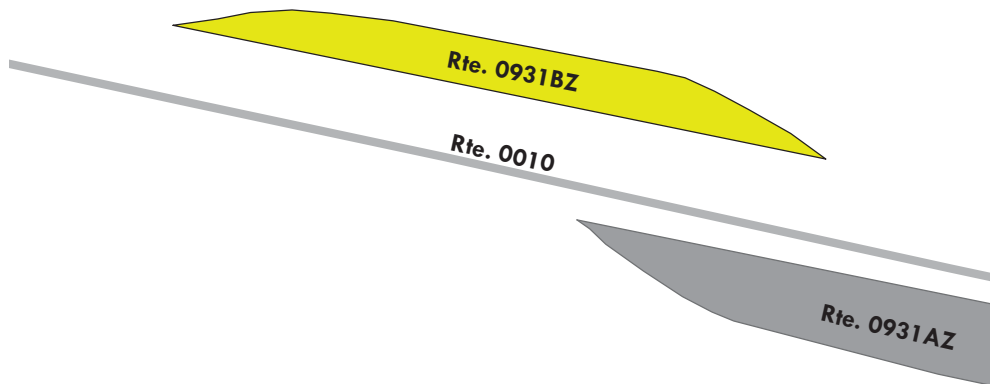
ROUTE 0931BZ: SWELTER SHELTER PULLOUT B

Inspection Date	FMSS Number	User Access	Surface Type
6/23/2017	249249	PUBLIC	ASPHALT
Area (Sq. Ft.)	Lane Miles (11' Widths)	Curb Reveal (Inches)	Curb Recommendation
1,370	0.024	NOT APPLICABLE	NOT APPLICABLE
Curb Type		Curb & Gutter Type	
NO CURB		NO CURB AND GUTTER	
Pavement Recommendation		Condition Rating / PCR	
LIGHT 3R TREATMENTS		FAIR / 73

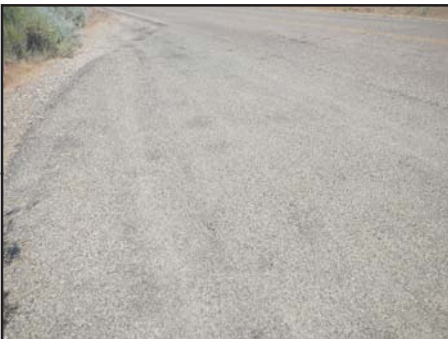
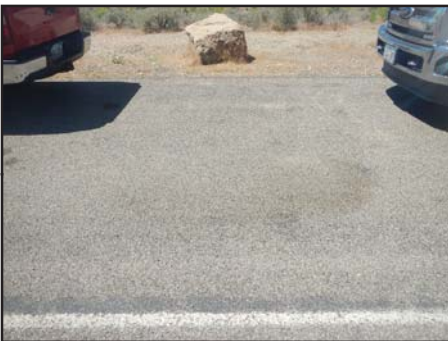
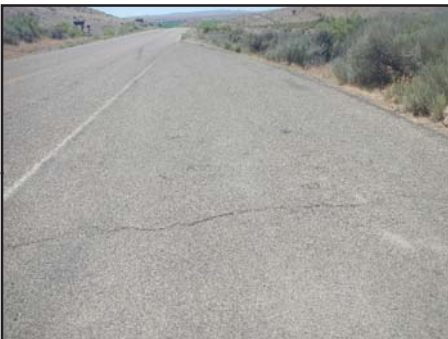
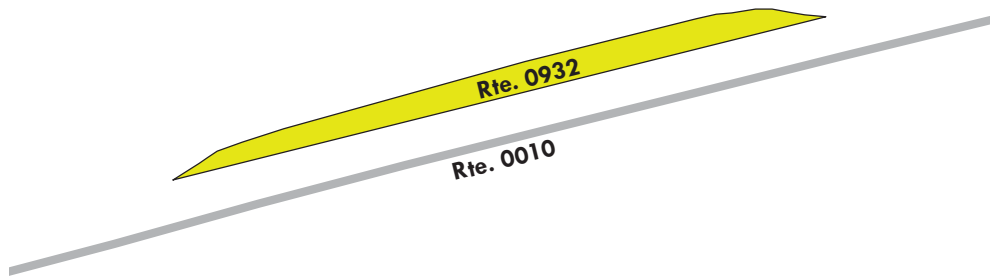
ROUTE 0932: SOUND OF SILENCE PULLOUT

Inspection Date	FMSS Number	User Access	Surface Type
6/23/2017	N/A	PUBLIC	ASPHALT
Area (Sq. Ft.)	Lane Miles (11' Widths)	Curb Reveal (Inches)	Curb Recommendation
2,413	0.042	NOT APPLICABLE	NOT APPLICABLE
Curb Type		Curb & Gutter Type	
NO CURB		NO CURB AND GUTTER	
Pavement Recommendation		Condition Rating / PCR	
LIGHT 3R TREATMENTS		FAIR / 73

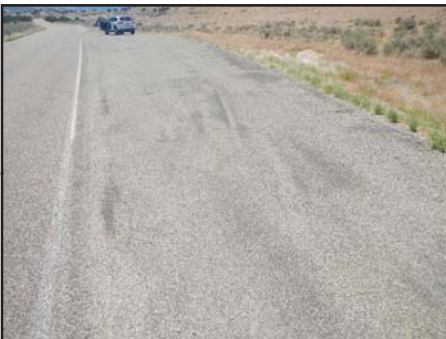
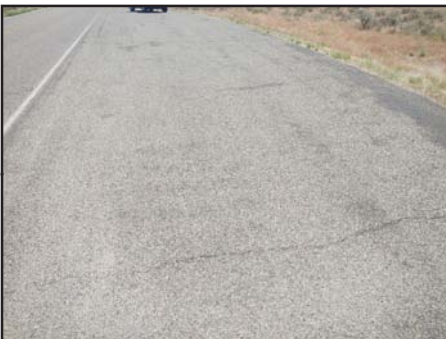
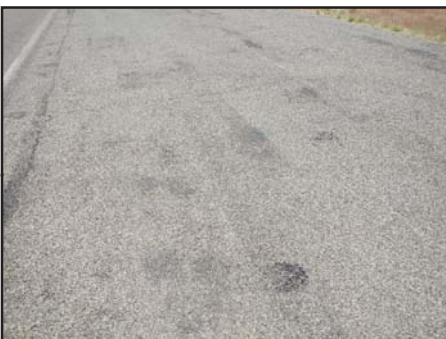
ROUTE 0933: PULLOUT AT MP 4.03

Inspection Date	FMSS Number	User Access	Surface Type
6/23/2017	249250	PUBLIC	ASPHALT
Area (Sq. Ft.)	Lane Miles (11' Widths)	Curb Reveal (Inches)	Curb Recommendation
2,229	0.038	NOT APPLICABLE	NOT APPLICABLE
Curb Type		Curb & Gutter Type	
NO CURB		NO CURB AND GUTTER	
Pavement Recommendation		Condition Rating / PCR	
PREVENTIVE MAINTENANCE		GOOD / 90

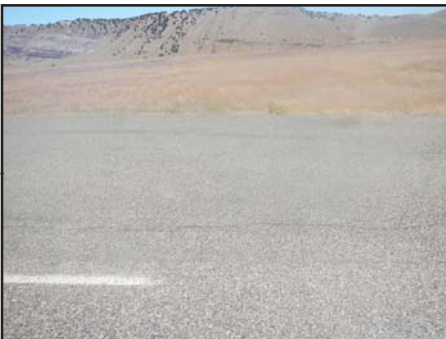
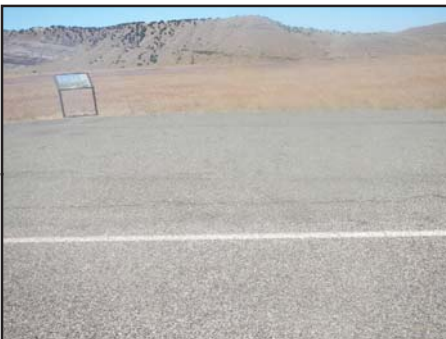
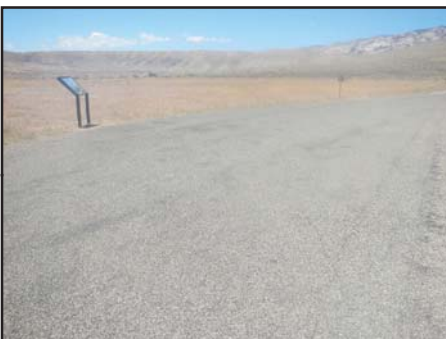
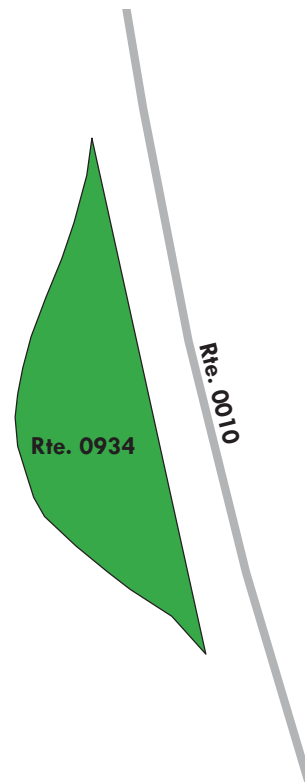
ROUTE 0934: MORRISON PULLOUT

Inspection Date	FMSS Number	User Access	Surface Type
6/23/2017	249251	PUBLIC	ASPHALT
Area (Sq. Ft.)	Lane Miles (11' Widths)	Curb Reveal (Inches)	Curb Recommendation
1,601	0.028	NOT APPLICABLE	NOT APPLICABLE
Curb Type		Curb & Gutter Type	
NO CURB		NO CURB AND GUTTER	
Pavement Recommendation		Condition Rating / PCR	
PREVENTIVE MAINTENANCE		GOOD / 90

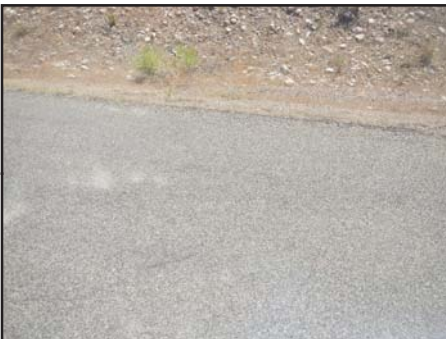
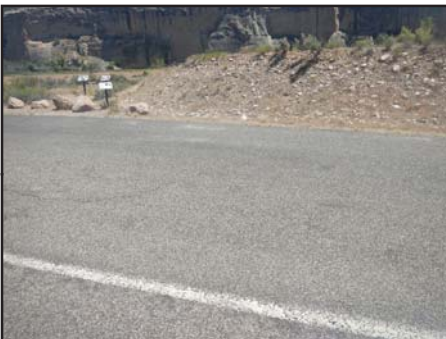
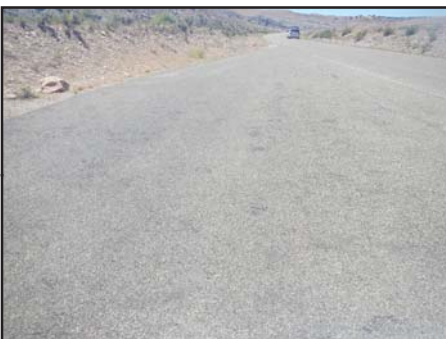
ROUTE 0936: CHEW PULLOUT

Inspection Date	FMSS Number	User Access	Surface Type
6/23/2017	249253	PUBLIC	ASPHALT
Area (Sq. Ft.)	Lane Miles (11' Widths)	Curb Reveal (Inches)	Curb Recommendation
1,292	0.022	NOT APPLICABLE	NOT APPLICABLE
Curb Type		Curb & Gutter Type	
NO CURB		NO CURB AND GUTTER	
Pavement Recommendation		Condition Rating / PCR	
PREVENTIVE MAINTENANCE		GOOD / 90

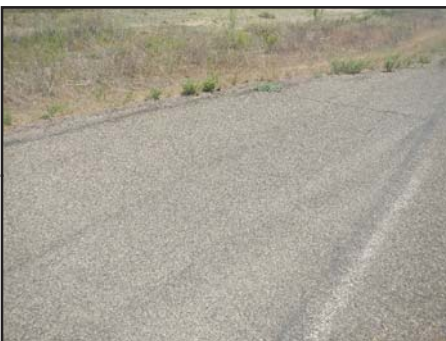
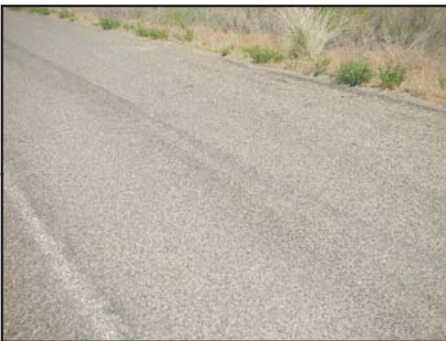
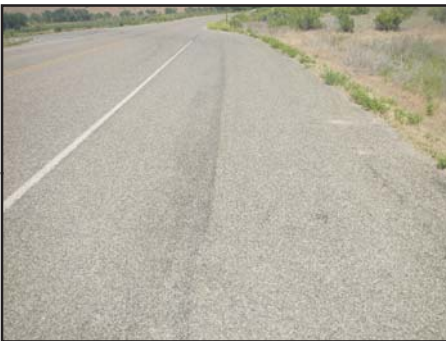
ROUTE 0938: CUB CREEK PULLOUT

Inspection Date	FMSS Number	User Access	Surface Type
6/23/2017	249255	PUBLIC	ASPHALT
Area (Sq. Ft.)	Lane Miles (11' Widths)	Curb Reveal (Inches)	Curb Recommendation
2,288	0.039	NOT APPLICABLE	NOT APPLICABLE
Curb Type		Curb & Gutter Type	
NO CURB		NO CURB AND GUTTER	
Pavement Recommendation		Condition Rating / PCR	
LIGHT 3R TREATMENTS		FAIR / 73

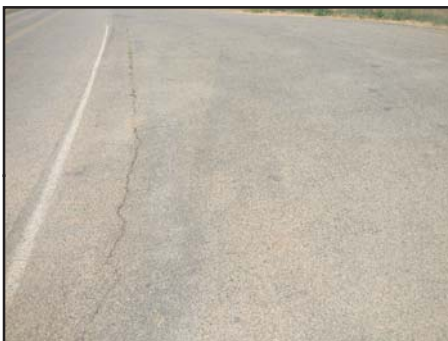
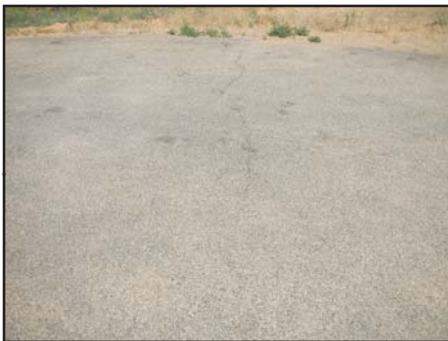
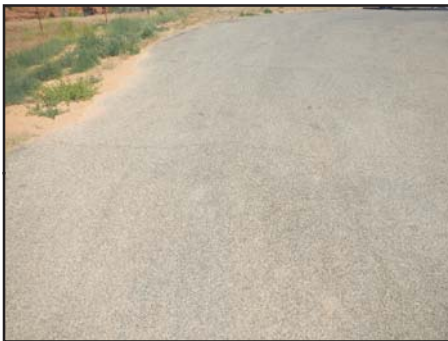
ROUTE 0939: PLUG HAT PICNIC AREA PARKING

Inspection Date	FMSS Number	User Access	Surface Type
6/22/2017	68828	PUBLIC	ASPHALT
Area (Sq. Ft.)	Lane Miles (11' Widths)	Curb Reveal (Inches)	Curb Recommendation
21,690	0.373	NOT APPLICABLE	DO NOTHING
Curb Type		Curb & Gutter Type	
NO CURB		CONCRETE	
Pavement Recommendation		Condition Rating / PCR	
PREVENTIVE MAINTENANCE		GOOD / 90

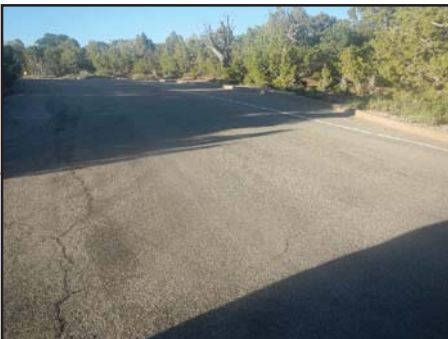
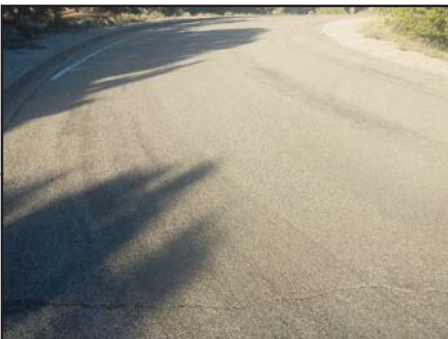
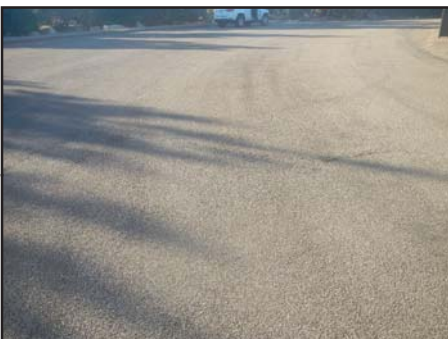
ROUTE 0940: DEERLODGE BOATER PARKING

Inspection Date	FMSS Number	User Access	Surface Type
6/22/2017	N/A	PUBLIC	ASPHALT
Area (Sq. Ft.)	Lane Miles (11' Widths)	Curb Reveal (Inches)	Curb Recommendation
3,849	0.066	NOT APPLICABLE	NOT APPLICABLE
Curb Type		Curb & Gutter Type	
NO CURB		NO CURB AND GUTTER	
Pavement Recommendation		Condition Rating / PCR	
DO NOTHING		EXCELLENT / 97

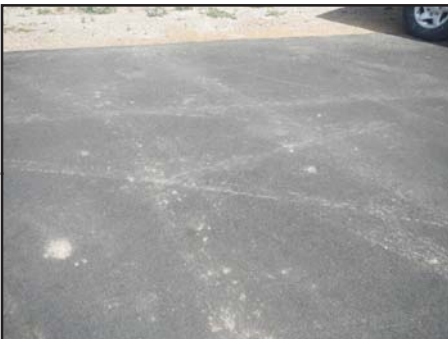
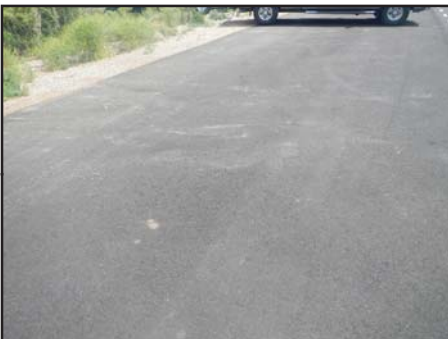
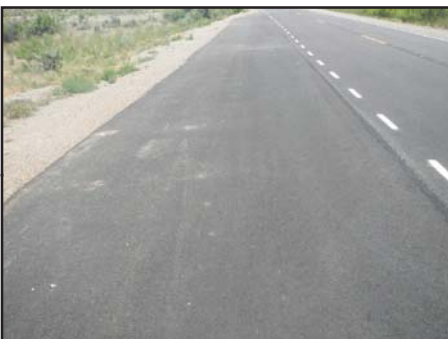
ROUTE 0941: SPLIT MOUNTAIN OVERLOOK

Inspection Date	FMSS Number	User Access	Surface Type
6/23/2017	N/A	PUBLIC	ASPHALT
Area (Sq. Ft.)	Lane Miles (11' Widths)	Curb Reveal (Inches)	Curb Recommendation
3,114	0.054	NOT APPLICABLE	NOT APPLICABLE
Curb Type		Curb & Gutter Type	
NO CURB		NO CURB AND GUTTER	
Pavement Recommendation		Condition Rating / PCR	
PREVENTIVE MAINTENANCE		GOOD / 90
