FLNI Cycle 6

Final Report

Road Inventory and Condition Assessment of Paved Routes Flight 93 National Memorial

Flight 93 National Memorial in Pennsylvania

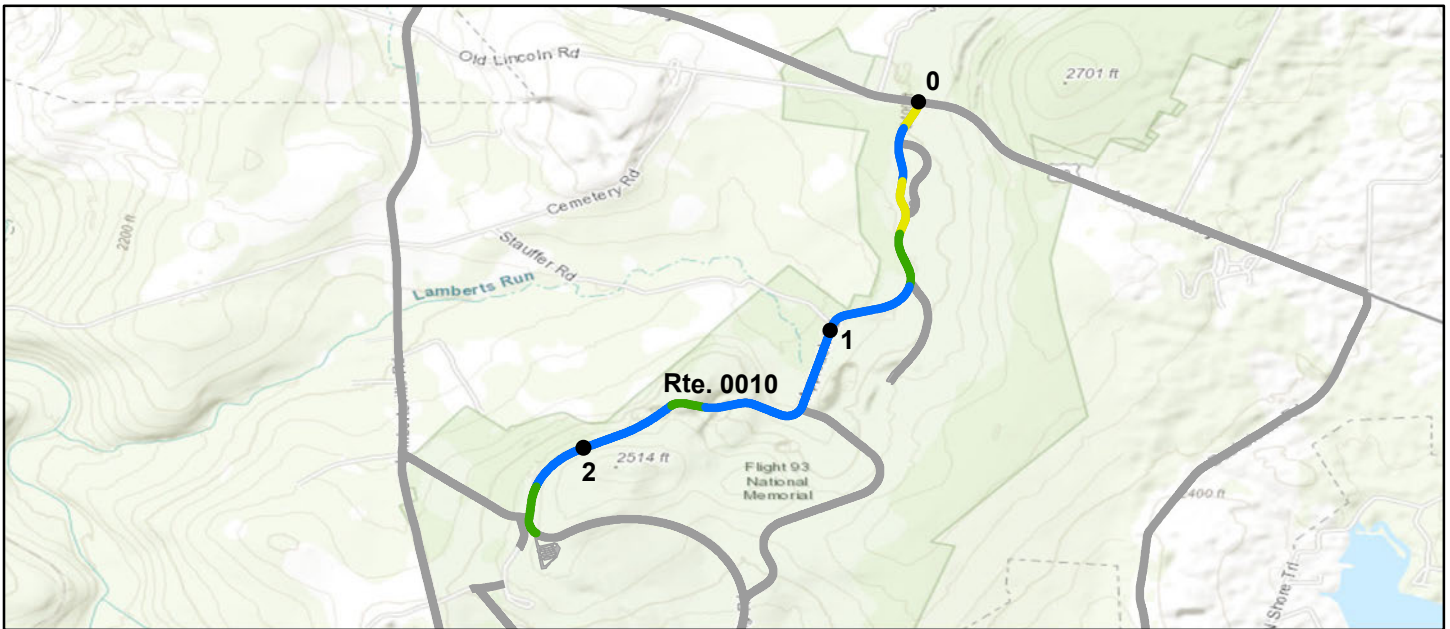
ROUTE 0010: FLIGHT 93 ENTRANCE ROAD

Route Condition Legend – Pavement Condition Rating (PCR)						
Poor (0 - 60)	Fair (61- 84)	Good (85 - 94)	Excellent (95 - 100)	Not Rated		
Colors on map represent condition scores at 0.10-mile intervals. See Appendix for definitions and formulas.						
Inspection Date: 11/12/2020	Beginning Section MP	0	1	2		
Paved Length (Miles): 2.38	Section Length (MI)	1	1	0.38		
Surface Type: ASPHALT	Route Summary					
Roadway Condition Information						
Pavement Condition Rating (PCR)	96	92	98	96		
Surface Condition Rating (SCR)	93	90	96	94		
Roughness Condition Index (RCI)	100	95	100	100		
Distress Index Values						
Structural Crack Index	93	90	96	94		
Alligator Crack Index	100	100	100	100		
Longitudinal Crack Index	93	90	96	94		
Transverse Cracking Index	97	97	98	99		
Patching Index	100	100	100	100		
Rutting Index	99	99	100	98		
International Roughness Index (IRI)	105	126	79	113		
Lane & Width Information						
Number of Lanes	2	2	2	2

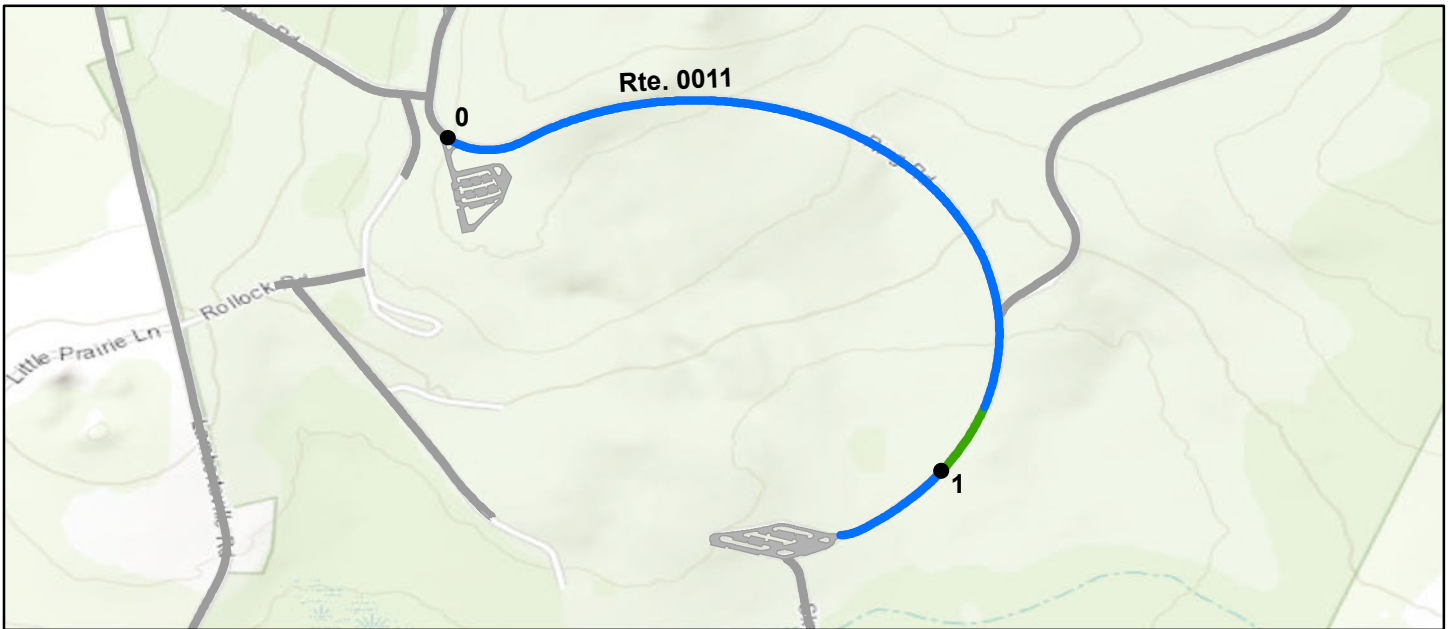
ROUTE 0011: RING ROAD

Route Condition Legend – Pavement Condition Rating (PCR)									
Poor (0 - 60)		Fair (61- 84)		Good (85 - 94)		Excellent (95 - 100)		Not Rated	
Colors on map represent condition scores at 0.10-mile intervals. See Appendix for definitions and formulas.									
Inspection Date:	11/12/2020	Beginning Section MP	0	1					
Paved Length (Miles):	1.14	Section Length (MI)	1	0.14					
Surface Type:	ASPHALT	Route Summary							
Roadway Condition Information									
Pavement Condition Rating (PCR)	98	98	98						
Surface Condition Rating (SCR)	96	97	96						
Roughness Condition Index (RCI)	100	100	100						
Distress Index Values									
Structural Crack Index	99	99	100						
Alligator Crack Index	100	100	100						
Longitudinal Crack Index	99	99	100						
Transverse Cracking Index	99	99	96						
Patching Index	100	100	100						
Rutting Index	96	97	97						
International Roughness Index (IRI)	97	96	104						
Lane & Width Information

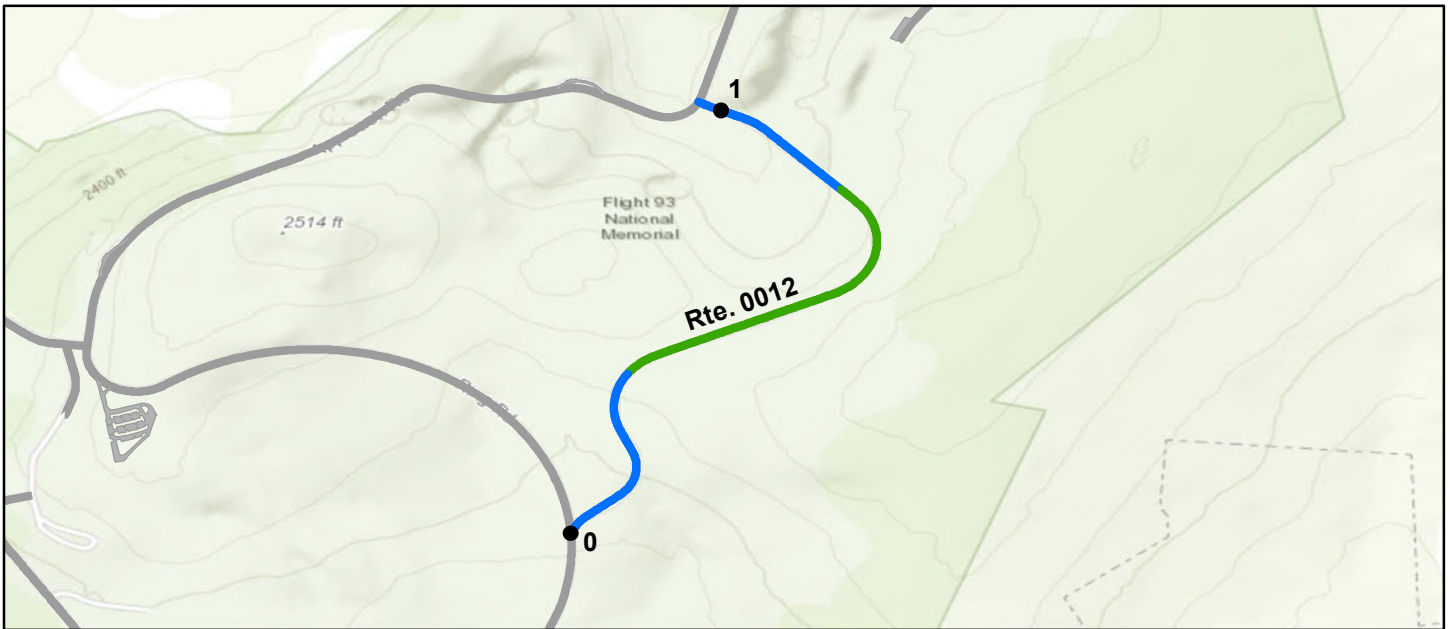
ROUTE 0012: RETURN ROAD

Inspection Date:	11/12/2020	Beginning Section MP	0	1			
	Paved Length (Miles):	1.03	Section Length (MI)	1	0.03		
Surface Type:	ASPHALT	Route Summary					
Roadway Condition Information							
Pavement Condition Rating (PCR)	93	93	95				
Surface Condition Rating (SCR)	93	93	95				
Roughness Condition Index (RCI)	N/A	N/A	N/A				
Distress Index Values							
Structural Crack Index	100	100	100				
Alligator Crack Index	100	100	100				
Longitudinal Crack Index	100	100	100				
Transverse Cracking Index	100	100	100				
Patching Index	100	100	100				
Rutting Index	93	93	95				
International Roughness Index (IRI)	N/A	N/A	N/A				
Lane & Width Information							
Number of Lanes	1	1	1				
Paved Width (ft)	11.5	11.5	11.1				
Lane Width (ft)	10.4	10.4	10.2

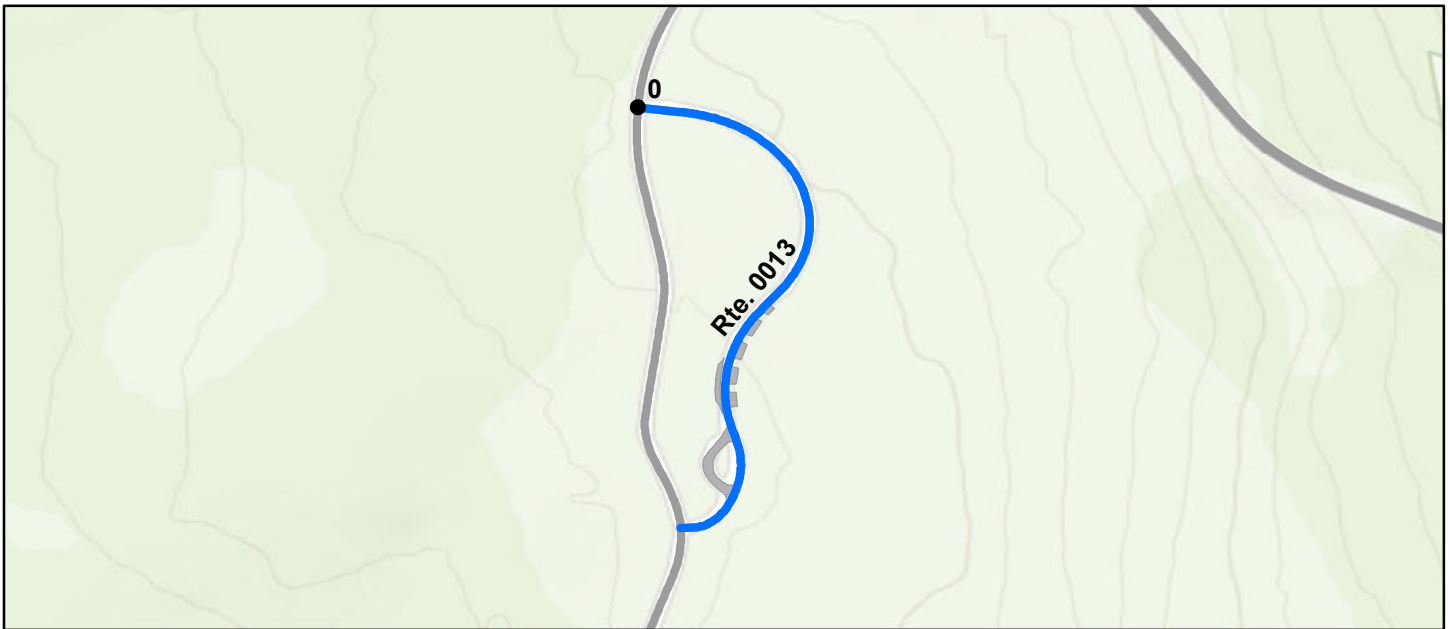
ROUTE 0013: TOWER OF VOICES ROAD

Route Condition Legend – Pavement Condition Rating (PCR)						
Poor (0 - 60)		Fair (61- 84)		Good (85 - 94)		Excellent (95 - 100)
						Not Rated
Colors on map represent condition scores at 0.10-mile intervals. See Appendix for definitions and formulas.						
Inspection Date:	11/12/2020	Beginning Section MP	0			
Paved Length (Miles):	0.33	Section Length (MI)	0.33			
Surface Type:	ASPHALT	Route Summary				
Roadway Condition Information						
Pavement Condition Rating (PCR)	98	98				
Surface Condition Rating (SCR)	98	98				
Roughness Condition Index (RCI)	N/A	N/A				
Distress Index Values						
Structural Crack Index	100	100				
Alligator Crack Index	100	100				
Longitudinal Crack Index	100	100				
Transverse Cracking Index	98	98				
Patching Index	100	100				
Rutting Index	99	99				
International Roughness Index (IRI)	N/A	N/A				
Lane & Width Information						
Number of Lanes	1	1				
Paved Width (ft)	16.3	16.3

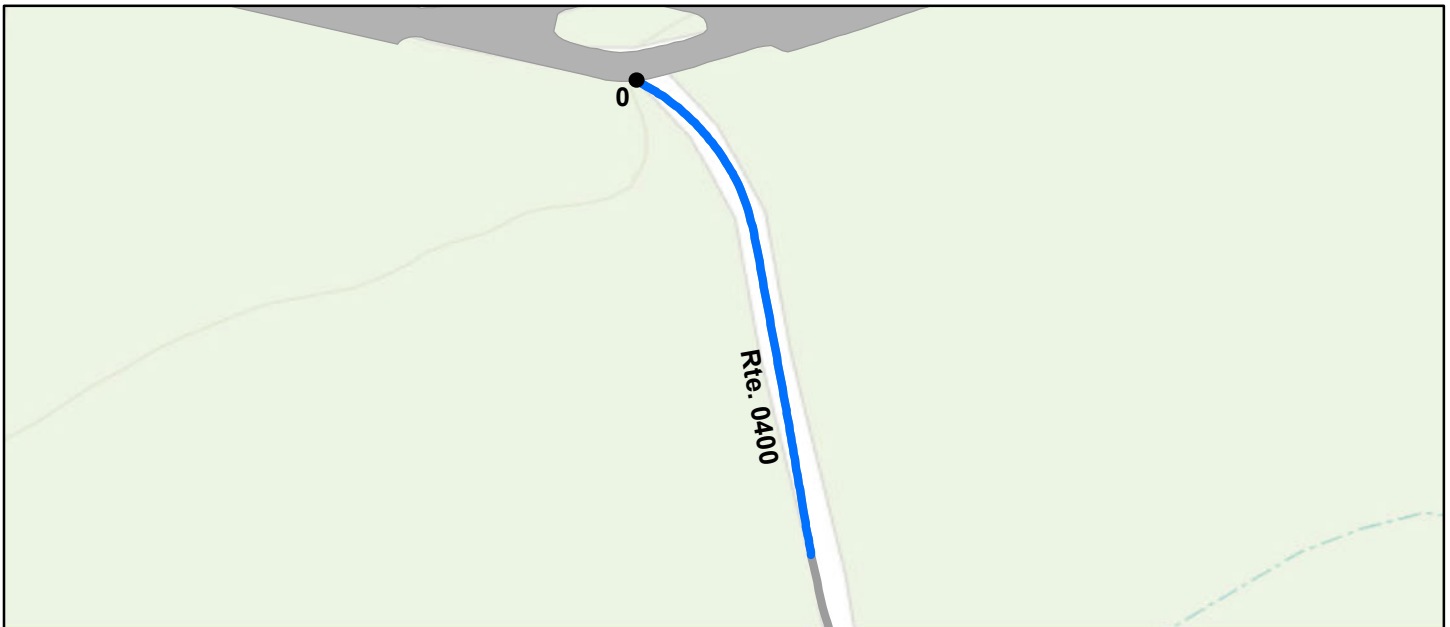
ROUTE 0400: SKYLINE ROAD SOUTH

Inspection Date: 11/12/2020	Beginning Section MP	0				
Paved Length (Miles): 0.08	Section Length (MI)	0.08				
Surface Type: ASPHALT	Route Summary					
Roadway Condition Information						
Pavement Condition Rating (PCR)	99	99				
Surface Condition Rating (SCR)	99	99				
Roughness Condition Index (RCI)	N/A	N/A				
Distress Index Values						
Structural Crack Index	99	99				
Alligator Crack Index	100	100				
Longitudinal Crack Index	99	99				
Transverse Cracking Index	100	100				
Patching Index	100	100				
Rutting Index	99	99				
International Roughness Index (IRI)	N/A	N/A				
Lane & Width Information						
Number of Lanes	2	2				
Paved Width (ft)	21.8	21.8				
Lane Width (ft)	10.9	10.9

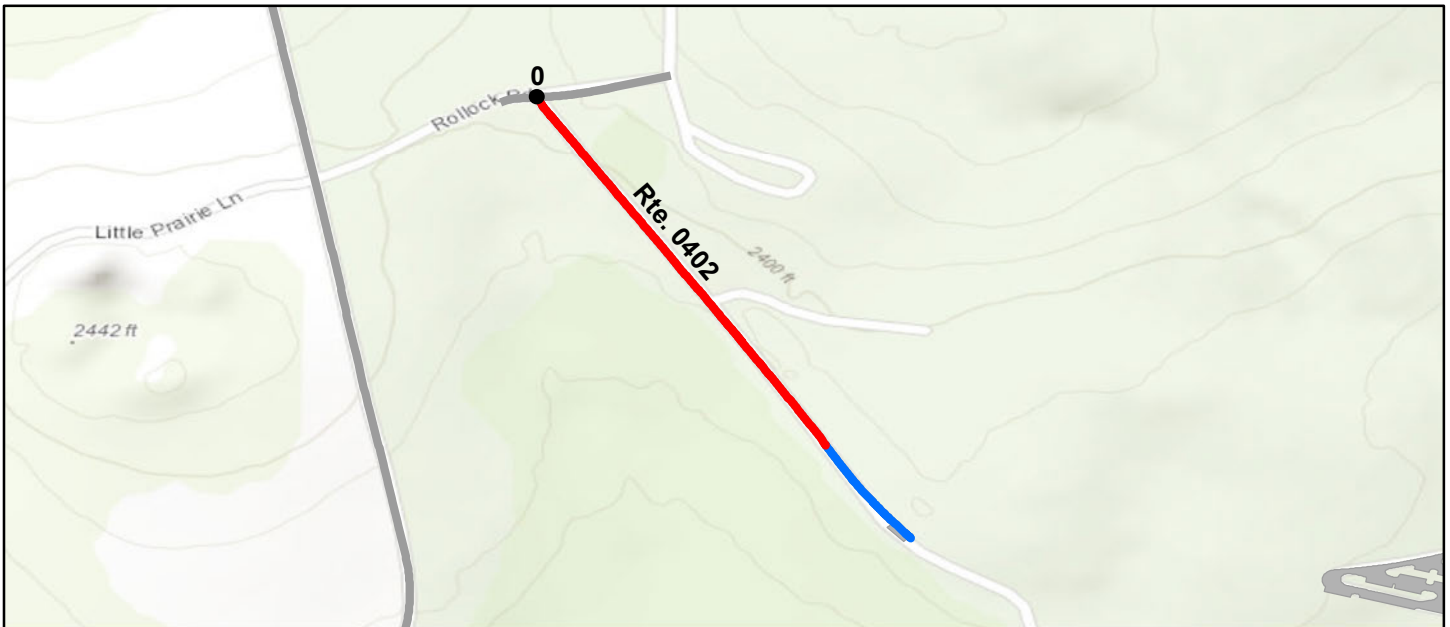
ROUTE 0402: FAMILY PARKING ACCESS ROAD

Route Condition Legend – Pavement Condition Rating (PCR)						
Poor (0 - 60)	Fair (61- 84)	Good (85 - 94)	Excellent (95 - 100)	Not Rated		
Colors on map represent condition scores at 0.10-mile intervals. See Appendix for definitions and formulas.						
Inspection Date:	11/12/2020	Beginning Section MP	0			
Paved Length (Miles):	0.38	Section Length (MI)	0.38			
Surface Type:	ASPHALT	Route Summary				
Roadway Condition Information						
Pavement Condition Rating (PCR)	19	19				
Surface Condition Rating (SCR)	19	19				
Roughness Condition Index (RCI)	N/A	N/A				
Distress Index Values						
Structural Crack Index	19	19				
Alligator Crack Index	42	42				
Longitudinal Crack Index	77	77				
Transverse Cracking Index	62	62				
Patching Index	100	100				
Rutting Index	94	94				
International Roughness Index (IRI)	N/A	N/A				
Lane & Width Information						
Number of Lanes	2	2				
Paved Width (ft)	17.2	17.2				
Lane Width (ft)	8.4	8.4

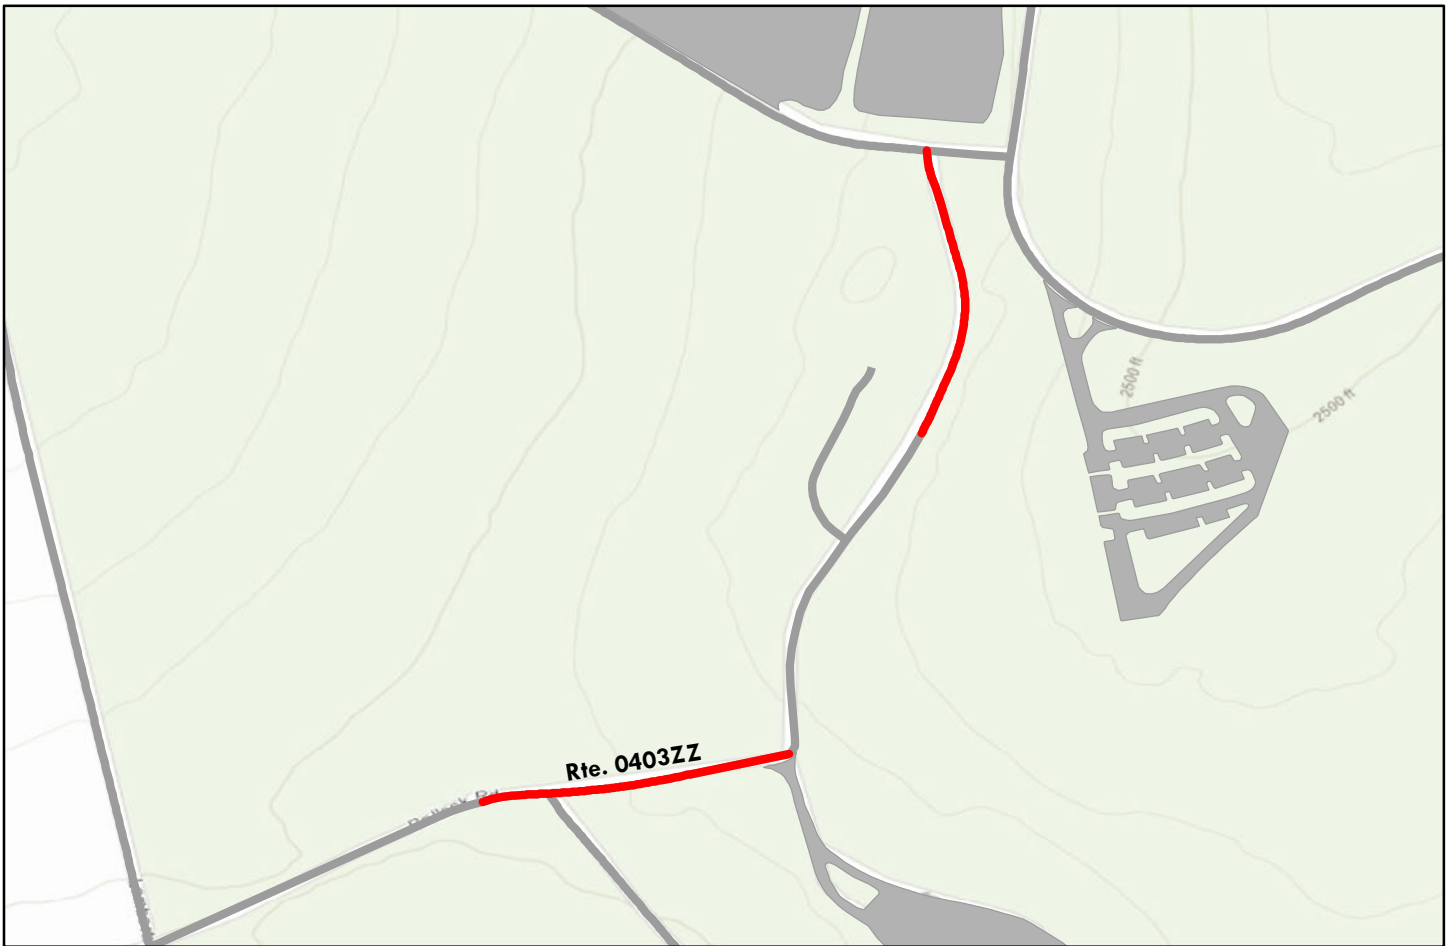
ROUTE 0403ZZ: ROLLOCK ROAD

Route Condition Legend – Pavement Condition Rating (PCR)						
Poor (0 - 60)	Fair (61- 84)	Good (85 - 94)	Excellent (95 - 100)	Not Rated		
See Appendix for definitions and formulas						
Inspection Date:	11/12/2020					
Paved Length (Miles):	0.22					
Surface Type:	ASPHALT	Route Summary				
Roadway Condition Information						
Pavement Condition Rating (PCR)	51					
Lane & Width Information						
Number of Lanes	2					
Paved Width (ft)	22					
Lane Width (ft)	11

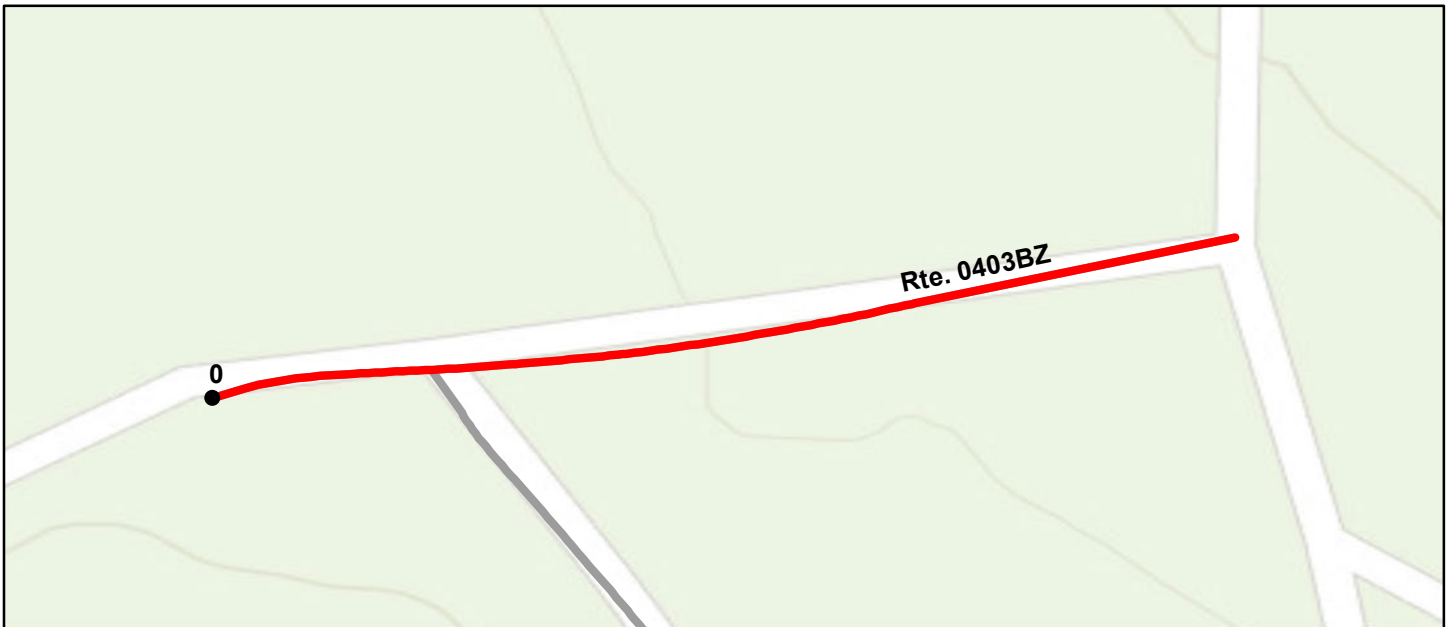
Subcomponent of Route FLNI-0403ZZ

Route Condition Legend – Pavement Condition Rating (PCR)						
Poor (0 - 60)		Fair (61- 84)		Good (85 - 94)		Excellent (95 - 100)
						Not Rated
Colors on map represent condition scores at 0.10-mile intervals. See Appendix for definitions and formulas.						
Inspection Date:	11/12/2020	Beginning Section MP	0			
Paved Length (Miles):	0.1	Section Length (MI)	0.1			
Surface Type:	ASPHALT	Route Summary				
Roadway Condition Information						
Pavement Condition Rating (PCR)	0	0				
Surface Condition Rating (SCR)	0	0				
Roughness Condition Index (RCI)	N/A	N/A				
Distress Index Values						
Structural Crack Index	0	0				
Alligator Crack Index	0	0				
Longitudinal Crack Index	71	71				
Transverse Cracking Index	82	82				
Patching Index	99	99				
Rutting Index	86	86				
International Roughness Index (IRI)	N/A	N/A				
Lane & Width Information						
Number of Lanes	2	2				
Paved Width (ft)	22.1	22.1				
Lane Width (ft)	11	11

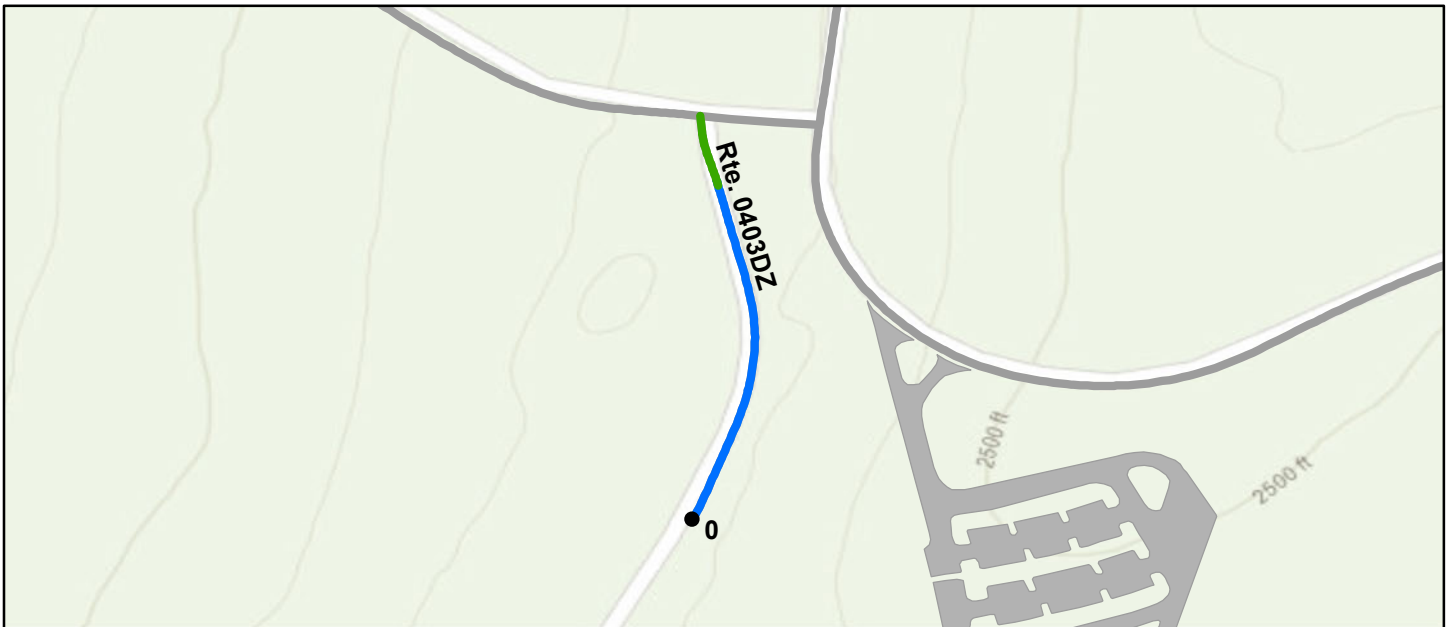
Subcomponent of Route FLNI-0403ZZ

Inspection Date: 11/12/2020	Beginning Section MP	0				
Paved Length (Miles): 0.12	Section Length (MI)	0.12				
Surface Type: ASPHALT	Route Summary					
Roadway Condition Information						
Pavement Condition Rating (PCR)	96	96				
Surface Condition Rating (SCR)	96	96				
Roughness Condition Index (RCI)	N/A	N/A				
Distress Index Values						
Structural Crack Index	98	98				
Alligator Crack Index	100	100				
Longitudinal Crack Index	98	98				
Transverse Cracking Index	98	98				
Patching Index	100	100				
Rutting Index	96	96				
International Roughness Index (IRI)	N/A	N/A				
Lane & Width Information						
Number of Lanes	2	2				
Paved Width (ft)	22	22				
Lane Width (ft)	11	11

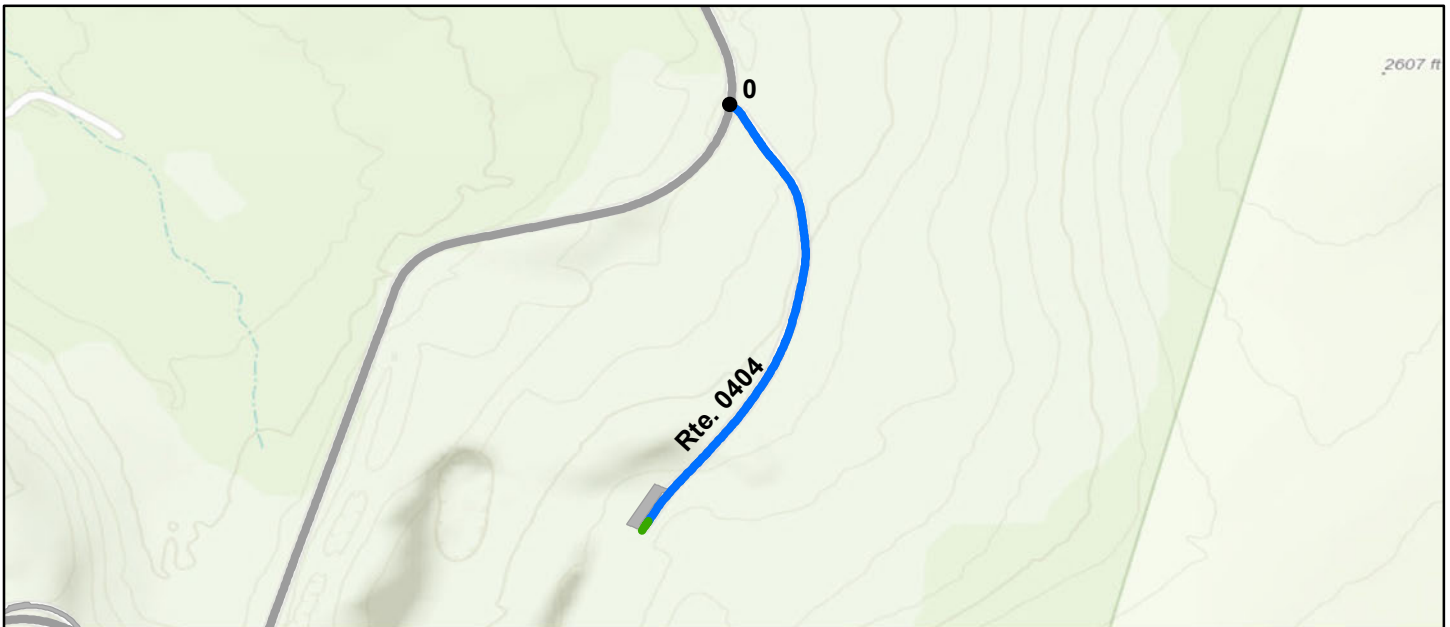
ROUTE 0404: HEADQUARTERS ENTRANCE ROAD

Route Condition Legend – Pavement Condition Rating (PCR)						
Poor (0 - 60)	Fair (61- 84)	Good (85 - 94)	Excellent (95 - 100)	Not Rated		
Colors on map represent condition scores at 0.10-mile intervals. See Appendix for definitions and formulas.						
Inspection Date:	11/12/2020	Beginning Section MP	0			
Paved Length (Miles):	0.41	Section Length (MI)	0.41			
Surface Type:	ASPHALT	Route Summary				
Roadway Condition Information						
Pavement Condition Rating (PCR)	98	98				
Surface Condition Rating (SCR)	98	98				
Roughness Condition Index (RCI)	N/A	N/A				
Distress Index Values						
Structural Crack Index	100	100				
Alligator Crack Index	100	100				
Longitudinal Crack Index	100	100				
Transverse Cracking Index	98	98				
Patching Index	100	100				
Rutting Index	100	100				
International Roughness Index (IRI)	N/A	N/A				
Lane & Width Information						
Number of Lanes	2	2				
Paved Width (ft)	22.2	22.2

Lane Width (ft)	11.1	11.1

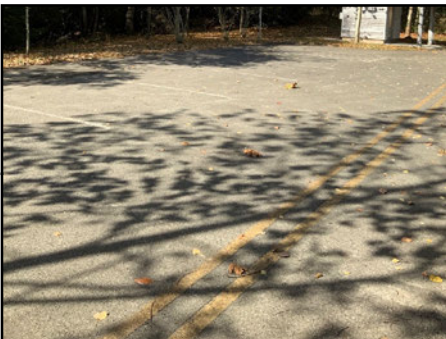
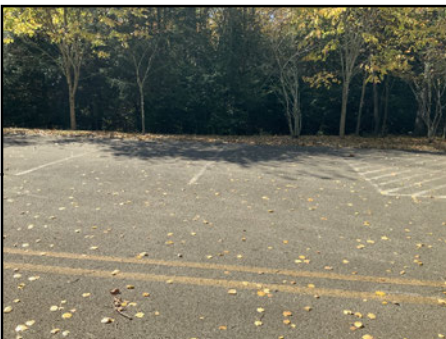
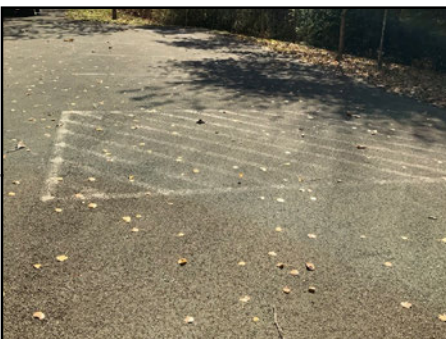
Inspection Date	FMSS Number	User Access	Surface Type
10/21/2019	236981	NONPUBLIC	ASPHALT
Area (Sq. Ft.)	Lane Miles (11' Widths)	Curb Reveal (Inches)	Curb Recommendation
1,505	0.026	NOT APPLICABLE	NOT APPLICABLE
Curb Type		Curb & Gutter Type	
NO CURB		NO CURB AND GUTTER	
Pavement Recommendation		Condition Rating / PCR	
PREVENTIVE MAINTENANCE		GOOD / 90

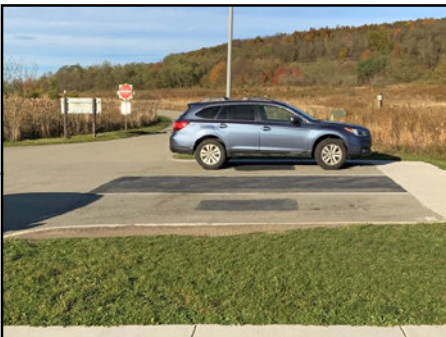
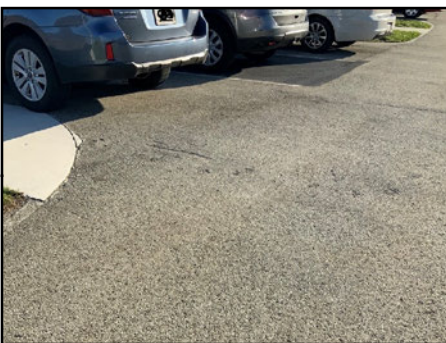
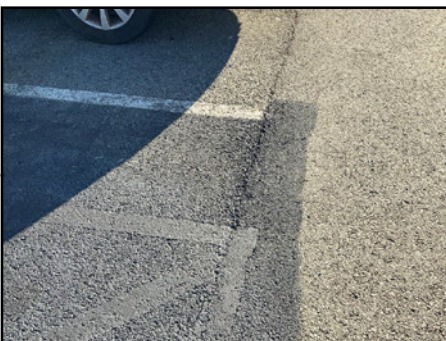
ROUTE 0902AZ: TOWER OF VOICES HANDICAPPED PARKING

Inspection Date	FMSS Number	User Access	Surface Type
10/21/2019	239299	PUBLIC	ASPHALT
Area (Sq. Ft.)	Lane Miles (11' Widths)	Curb Reveal (Inches)	Curb Recommendation
532	0.009	NOT APPLICABLE	NOT APPLICABLE
Curb Type		Curb & Gutter Type	
NO CURB		NO CURB AND GUTTER	
Pavement Recommendation		Condition Rating / PCR	
PREVENTIVE MAINTENANCE		GOOD / 90

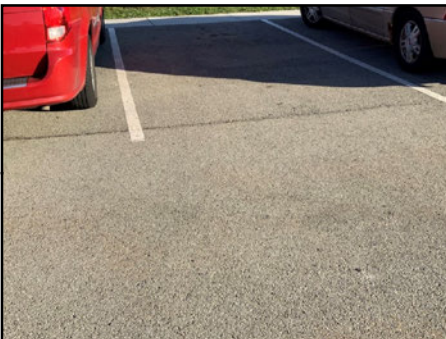
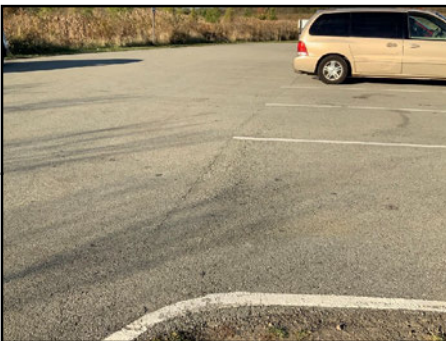
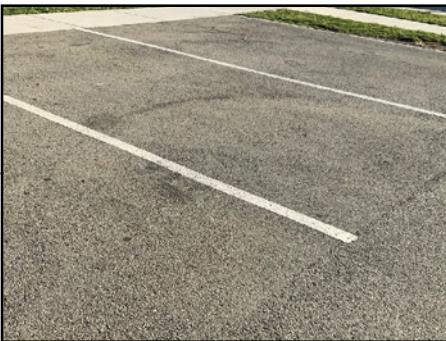
ROUTE 0902BZ: TOWER OF VOICES PARKING AREA B

Inspection Date	FMSS Number	User Access	Surface Type
10/21/2019	239299	PUBLIC	ASPHALT
Area (Sq. Ft.)	Lane Miles (11' Widths)	Curb Reveal (Inches)	Curb Recommendation
942	0.016	NOT APPLICABLE	NOT APPLICABLE
Curb Type		Curb & Gutter Type	
NO CURB		NO CURB AND GUTTER	
Pavement Recommendation		Condition Rating / PCR	
PREVENTIVE MAINTENANCE		GOOD / 90

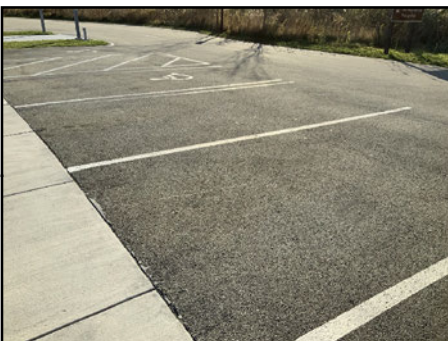
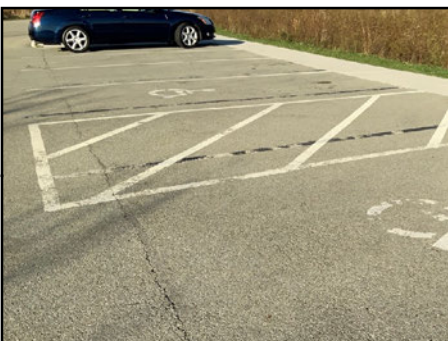
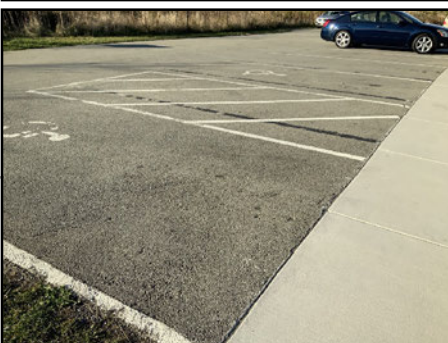
ROUTE 0902CZ: TOWER OF VOICES PARKING AREA C

Inspection Date	FMSS Number	User Access	Surface Type
10/21/2019	239299	PUBLIC	ASPHALT
Area (Sq. Ft.)	Lane Miles (11' Widths)	Curb Reveal (Inches)	Curb Recommendation
926	0.016	NOT APPLICABLE	NOT APPLICABLE
Curb Type		Curb & Gutter Type	
NO CURB		NO CURB AND GUTTER	
Pavement Recommendation		Condition Rating / PCR	
PREVENTIVE MAINTENANCE		GOOD / 90

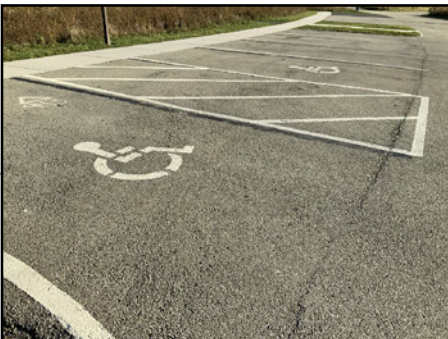
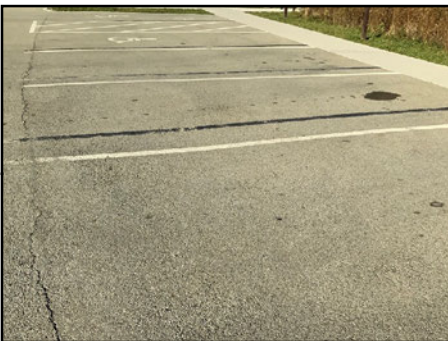
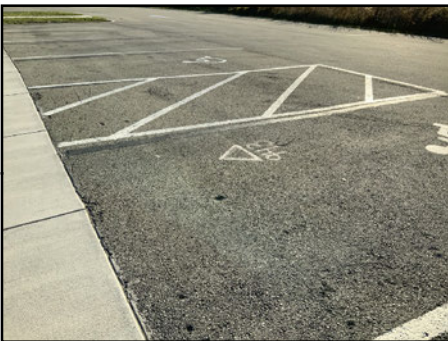
ROUTE 0902DZ: TOWER OF VOICES PARKING AREA D

Inspection Date	FMSS Number	User Access	Surface Type
10/21/2019	239299	PUBLIC	ASPHALT
Area (Sq. Ft.)	Lane Miles (11' Widths)	Curb Reveal (Inches)	Curb Recommendation
973	0.017	NOT APPLICABLE	NOT APPLICABLE
Curb Type		Curb & Gutter Type	
NO CURB		NO CURB AND GUTTER	
Pavement Recommendation		Condition Rating / PCR	
PREVENTIVE MAINTENANCE		GOOD / 90

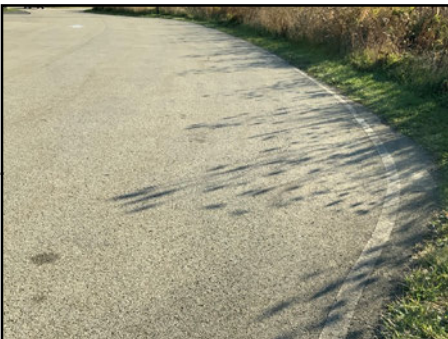
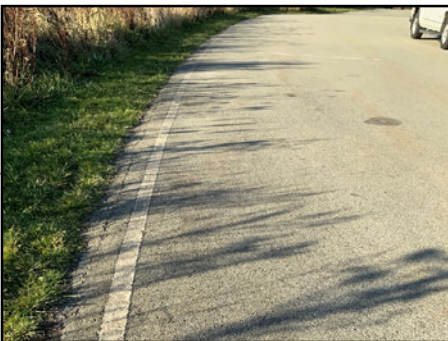
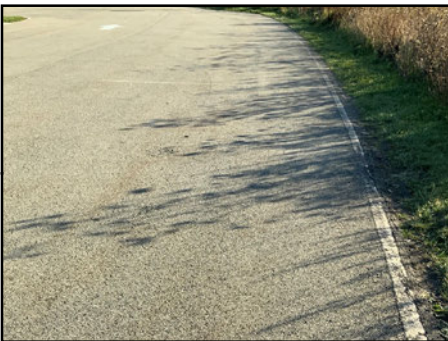
ROUTE 0902EZ: TOWER OF VOICES BUS PARKING AREA

Inspection Date	FMSS Number	User Access	Surface Type
10/21/2019	239299	PUBLIC	ASPHALT
Area (Sq. Ft.)	Lane Miles (11' Widths)	Curb Reveal (Inches)	Curb Recommendation
1,816	0.031	NOT APPLICABLE	NOT APPLICABLE
Curb Type		Curb & Gutter Type	
NO CURB		NO CURB AND GUTTER	
Pavement Recommendation		Condition Rating / PCR	
PREVENTIVE MAINTENANCE		GOOD / 90

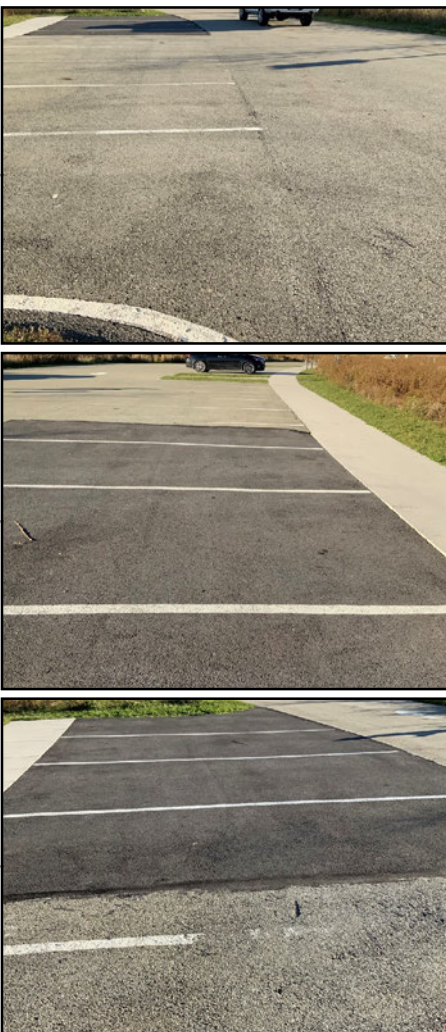
ROUTE 0902FZ: TOWER OF VOICES PARKING AREA F

Inspection Date	FMSS Number	User Access	Surface Type
10/21/2019	239299	PUBLIC	ASPHALT
Area (Sq. Ft.)	Lane Miles (11' Widths)	Curb Reveal (Inches)	Curb Recommendation
870	0.015	NOT APPLICABLE	NOT APPLICABLE
Curb Type		Curb & Gutter Type	
NO CURB		NO CURB AND GUTTER	
Pavement Recommendation		Condition Rating / PCR	
LIGHT 3R TREATMENTS		FAIR / 73

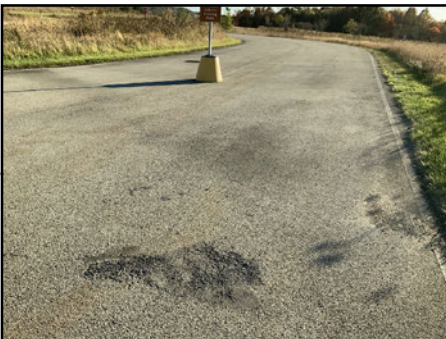
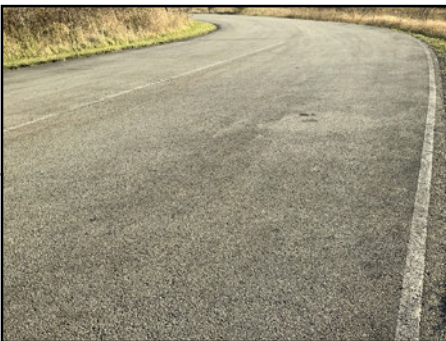
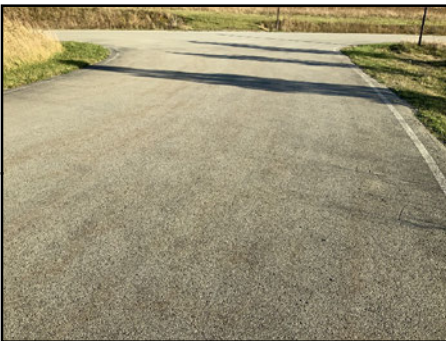
ROUTE 0902GZ: TOWER OF VOICES PARKING AREA G

Inspection Date	FMSS Number	User Access	Surface Type
10/21/2019	239299	PUBLIC	ASPHALT
Area (Sq. Ft.)	Lane Miles (11' Widths)	Curb Reveal (Inches)	Curb Recommendation
6,029	0.104	NOT APPLICABLE	NOT APPLICABLE
Curb Type		Curb & Gutter Type	
NO CURB		NO CURB AND GUTTER	
Pavement Recommendation		Condition Rating / PCR	
PREVENTIVE MAINTENANCE		GOOD / 90

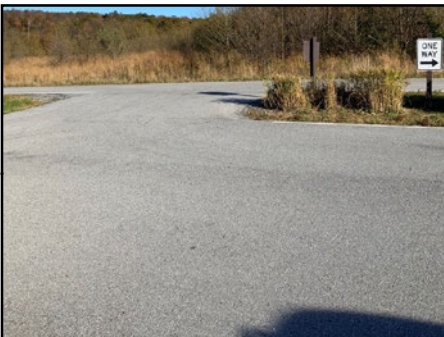
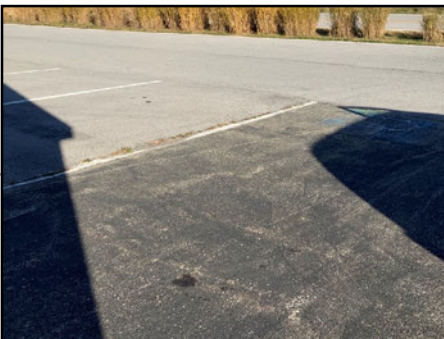
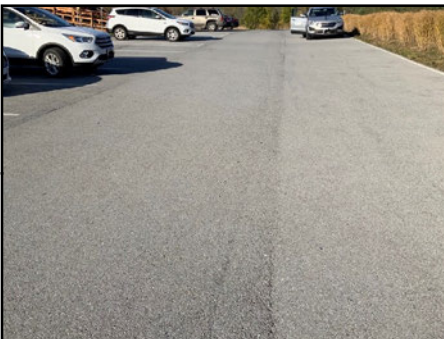
ROUTE 0903: HEADQUARTERS PARKING

Inspection Date	FMSS Number	User Access	Surface Type
10/21/2019	239300	NONPUBLIC	ASPHALT
Area (Sq. Ft.)	Lane Miles (11' Widths)	Curb Reveal (Inches)	Curb Recommendation
9,352	0.161	NOT APPLICABLE	NOT APPLICABLE
Curb Type		Curb & Gutter Type	
NO CURB		NO CURB AND GUTTER	
Pavement Recommendation		Condition Rating / PCR	
LIGHT 3R TREATMENTS		FAIR / 73

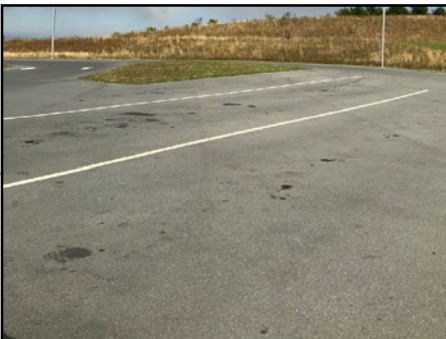
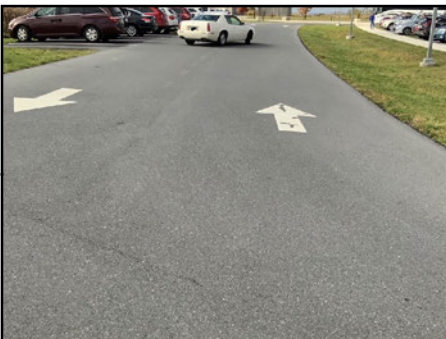
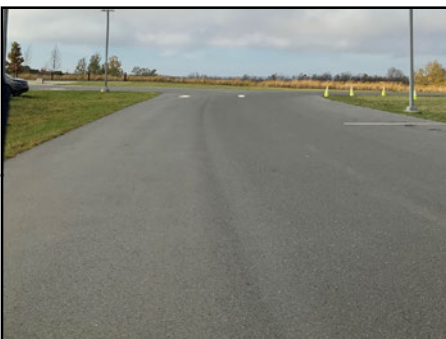
ROUTE 0904: VISITOR CENTER PARKING

Inspection Date	FMSS Number	User Access	Surface Type
10/21/2019	241424	PUBLIC	ASPHALT
Area (Sq. Ft.)	Lane Miles (11' Widths)	Curb Reveal (Inches)	Curb Recommendation
81,430	1.402	NOT APPLICABLE	NOT APPLICABLE
Curb Type		Curb & Gutter Type	
NO CURB		NO CURB AND GUTTER	
Pavement Recommendation		Condition Rating / PCR	
PREVENTIVE MAINTENANCE		GOOD / 90

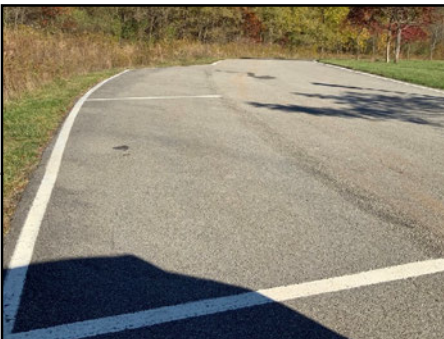
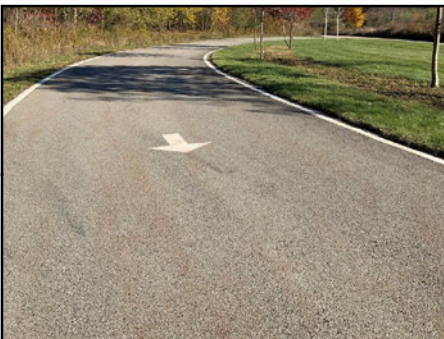
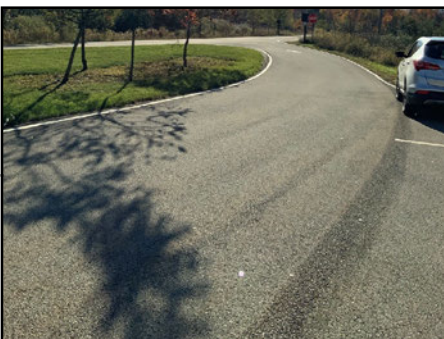
ROUTE 0905: FLIGHT 93 ENTRANCE TURN-AROUND (NORTH)

Inspection Date	FMSS Number	User Access	Surface Type
10/21/2019	N/A	PUBLIC	ASPHALT
Area (Sq. Ft.)	Lane Miles (11' Widths)	Curb Reveal (Inches)	Curb Recommendation
7,939	0.137	NOT APPLICABLE	NOT APPLICABLE
Curb Type		Curb & Gutter Type	
NO CURB		NO CURB AND GUTTER	
Pavement Recommendation		Condition Rating / PCR	
DO NOTHING		EXCELLENT / 97

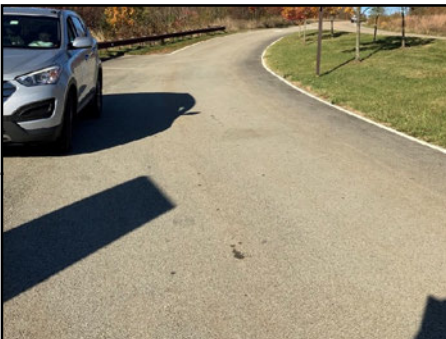
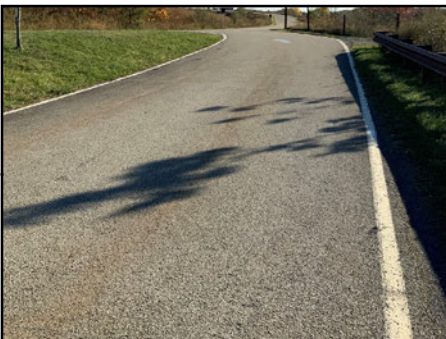
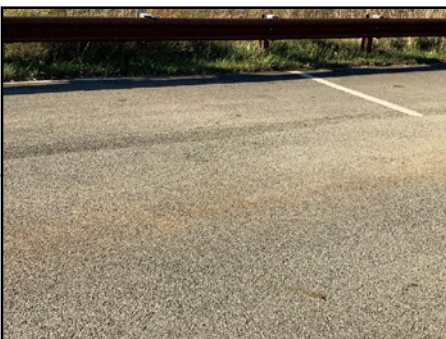
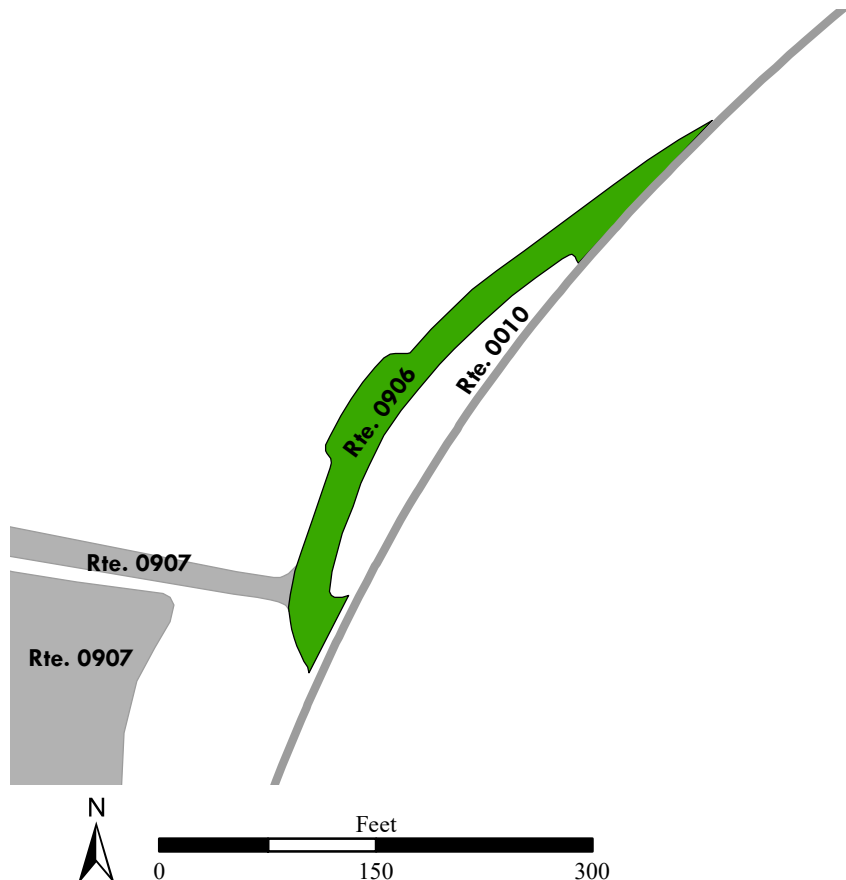
ROUTE 0915: STUZMAN PARKING

Inspection Date	FMSS Number	User Access	Surface Type
10/21/2019	N/A	NONPUBLIC	ASPHALT
Area (Sq. Ft.)	Lane Miles (11' Widths)	Curb Reveal (Inches)	Curb Recommendation
817	0.014	NOT APPLICABLE	NOT APPLICABLE
Curb Type		Curb & Gutter Type	
NO CURB		NO CURB AND GUTTER	
Pavement Recommendation		Condition Rating / PCR	
PREVENTIVE MAINTENANCE		GOOD / 90

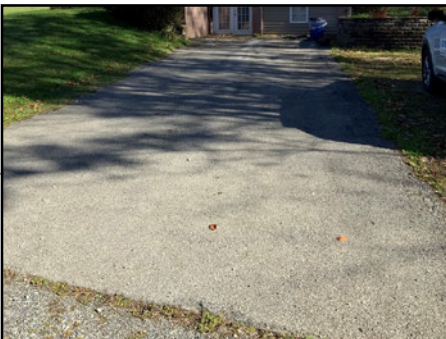
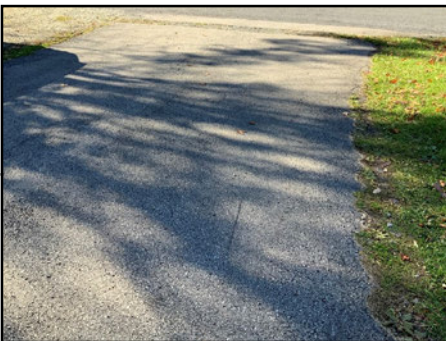
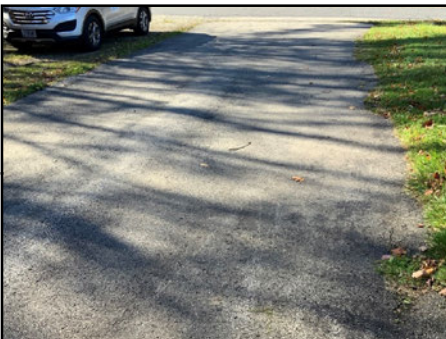
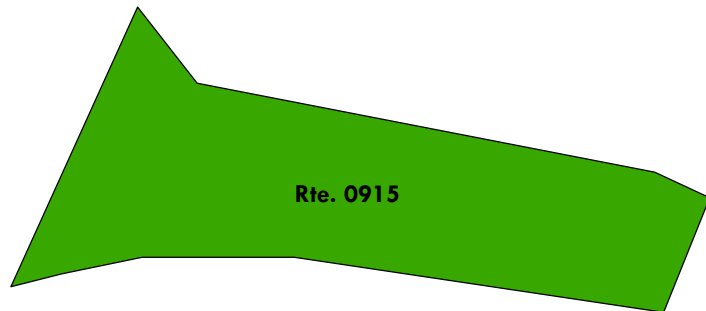
ROUTE 0917: MAINTENANCE PARKING

Inspection Date	FMSS Number	User Access	Surface Type
10/21/2019	247280	NONPUBLIC	ASPHALT
Area (Sq. Ft.)	Lane Miles (11' Widths)	Curb Reveal (Inches)	Curb Recommendation
14,915	0.257	NOT APPLICABLE	NOT APPLICABLE
Curb Type		Curb & Gutter Type	
NO CURB		NO CURB AND GUTTER	
Pavement Recommendation		Condition Rating / PCR	
PREVENTIVE MAINTENANCE		GOOD / 90
