FOMA Cycle 6

Final Report

Road Inventory and Condition Assessment of Paved Routes Fort Matanzas National Monument

Report Date: April 2020

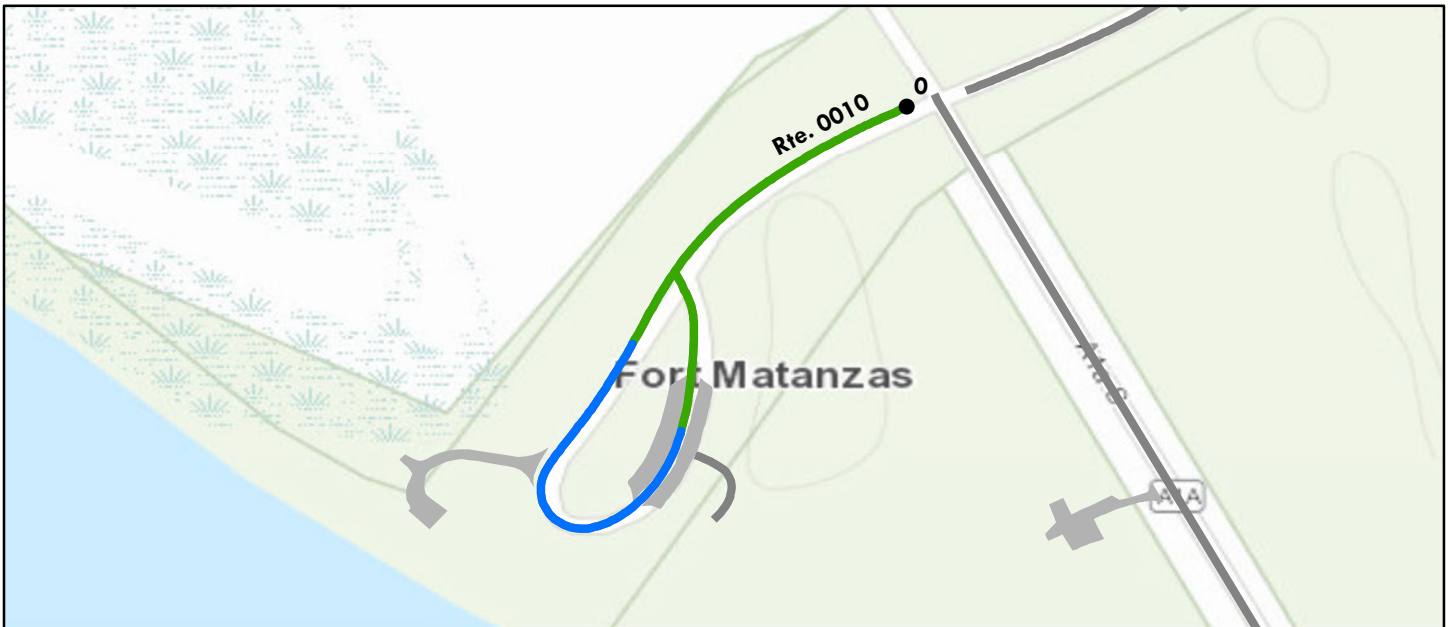
ROUTE 0010: VISITOR CENTER ACCESS ROAD

Inspection Date: 4/4/2019	Beginning Section MP	0				
Paved Length (Miles): 0.24	Section Length (MI)	0.24				
Surface Type: ASPHALT	Route Summary					
Roadway Condition Information						
Pavement Condition Rating (PCR)	91	91				
Surface Condition Rating (SCR)	91	91				
Roughness Condition Index (RCI)	N/A	N/A				
Distress Index Values						
Structural Crack Index	96	96				
Alligator Crack Index	100	100				
Longitudinal Crack Index	96	96				
Transverse Cracking Index	91	91				
Patching Index	100	100				
Rutting Index	99	99				
International Roughness Index (IRI)	N/A	N/A				
Lane & Width Information						
Number of Lanes	1	1				
Paved Width (ft)	19.9	19.9				
Lane Width (ft)	15.5	15.5

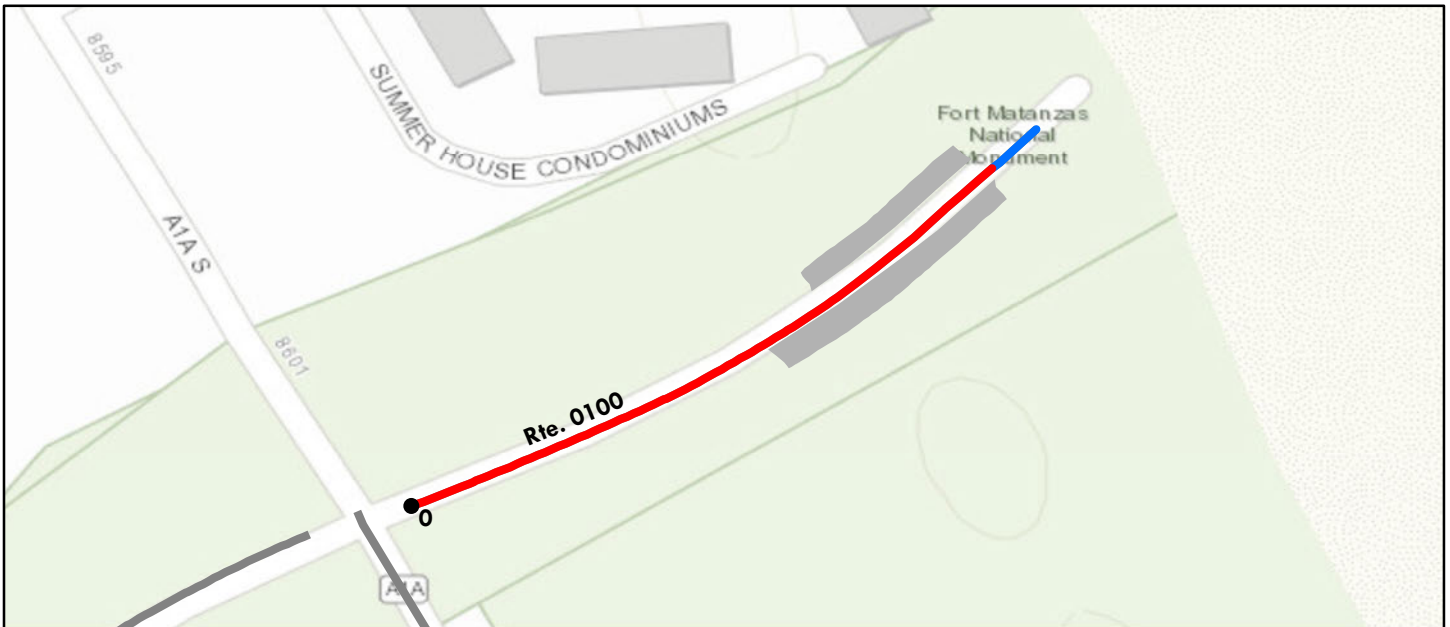
ROUTE 0100: BEACH ACCESS ROAD

Inspection Date:	4/4/2019	Beginning Section MP	0				
Paved Length (Miles):	0.11	Section Length (MI)	0.11				
Surface Type:	ASPHALT	Route Summary					
Roadway Condition Information							
Pavement Condition Rating (PCR)	51	51					
Surface Condition Rating (SCR)	51	51					
Roughness Condition Index (RCI)	N/A	N/A					
Distress Index Values							
Structural Crack Index	92	92					
Alligator Crack Index	100	100					
Longitudinal Crack Index	92	92					
Transverse Cracking Index	51	51					
Patching Index	100	100					
Rutting Index	99	99					
International Roughness Index (IRI)	N/A	N/A					
Lane & Width Information							
Number of Lanes	2	2					
Paved Width (ft)	22	22					
Lane Width (ft)	11	11

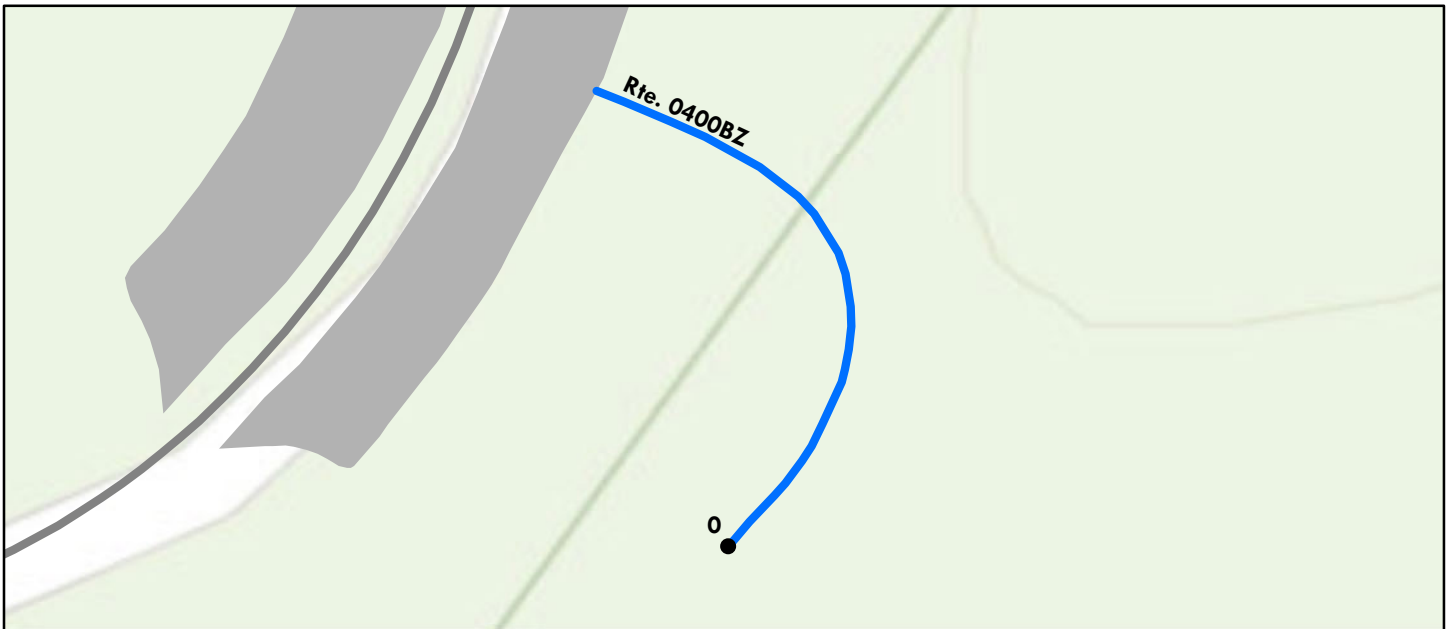
Subcomponent of Route FOMA-0400ZZ

Route Condition Legend – Pavement Condition Rating (PCR)						
Poor (0 - 60)	Fair (61- 84)	Good (85 - 94)	Excellent (95 - 100)	Not Rated		
See Appendix for definitions and formulas						
Inspection Date: 4/4/2019	Beginning Section MP	0.00				
Paved Length (Miles): 0.02	Section Length (MI)	0.02				
Surface Type: ASPHALT	Route Summary					
Roadway Condition Information						
Pavement Condition Rating (PCR)	97	97				
Surface Condition Rating (SCR)	97	97				
Roughness Condition Index (RCI)	N/A	N/A				
Distress Index Values						
Structural Crack Index	97	97				
Alligator Crack Index	97	97				
Longitudinal Crack Index	97	97				
Transverse Cracking Index	97	97				
Patching Index	97	97				
Rutting Index	97	97				
International Roughness Index (IRI)	N/A	N/A				
Lane & Width Information						
Number of Lanes	1	1				
Paved Width (ft)	13.6	13.6				
Lane Width (ft)	13.6	13.6

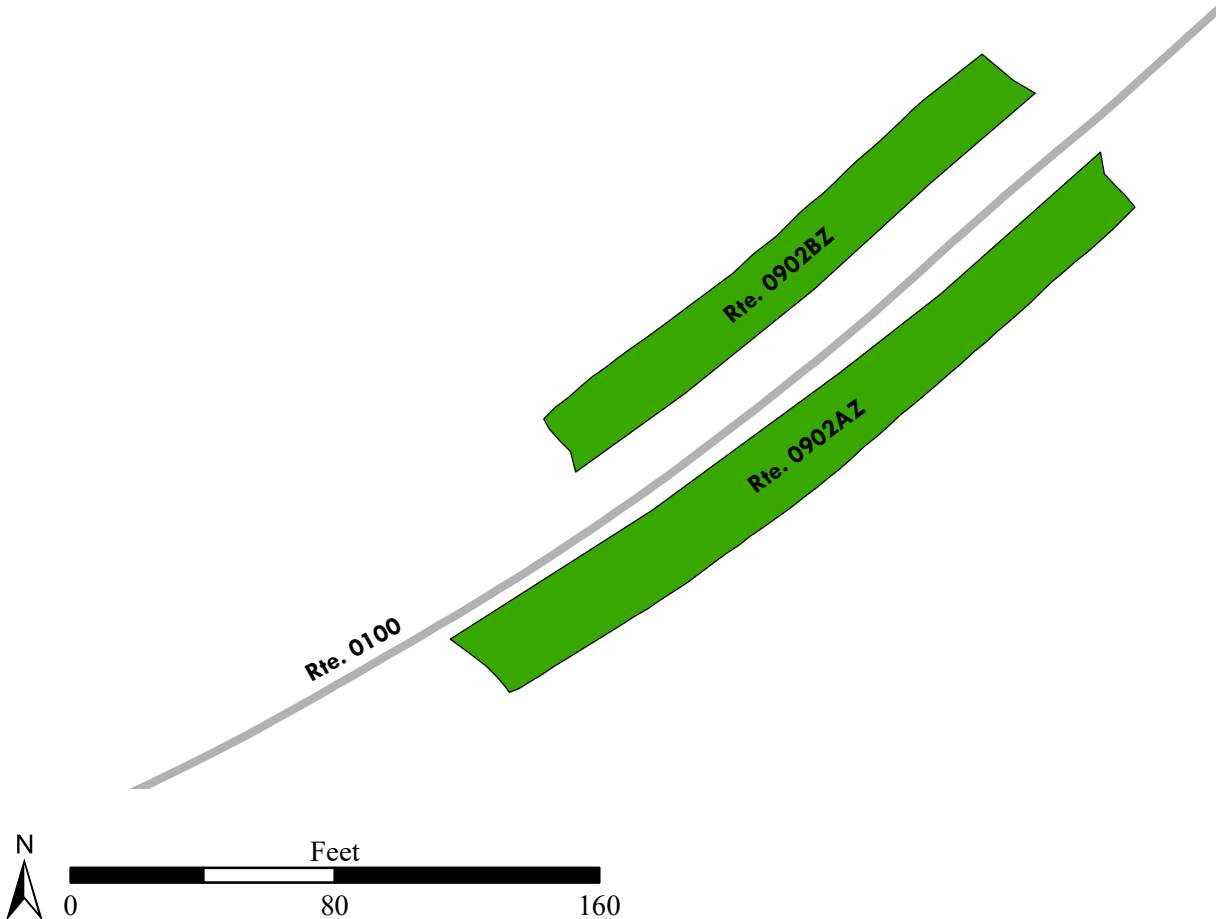
ROUTE 0902AZ: BEACH ACCESS PARKING AREA A

Inspection Date	FMSS Number	User Access	Surface Type
4/4/2019	37040	PUBLIC	ASPHALT
Area (Sq. Ft.)	Lane Miles (11' Widths)	Curb Reveal (Inches)	Curb Recommendation
4,681	0.081	NOT APPLICABLE	NOT APPLICABLE
Curb Type		Curb & Gutter Type	
NO CURB		NO CURB AND GUTTER	
Pavement Recommendation		Condition Rating / PCR	
PREVENTIVE MAINTENANCE		GOOD / 90
