FOMR Cycle 6

Final Report

Road Inventory and Condition Assessment of Paved Routes Fort Monroe National Monument

Report Date: September 2021

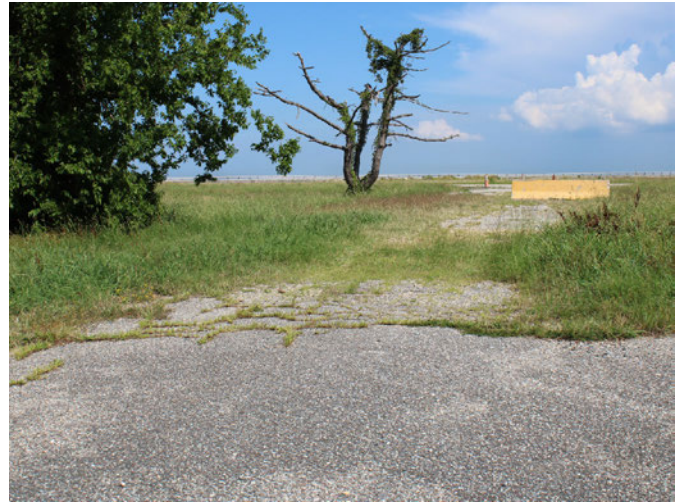
FOMR_0103BZ_2486.JPG

NOT RATED DUE TO OVERGROWN CONDITIONS.

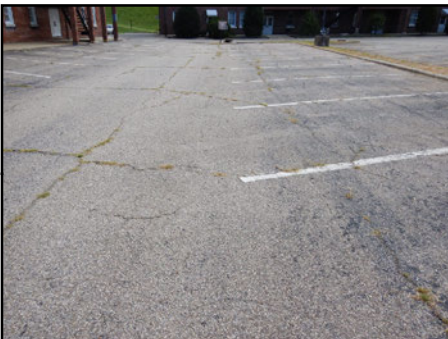
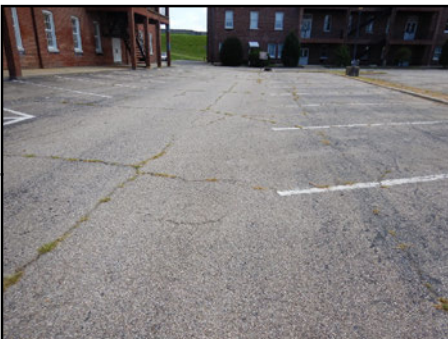
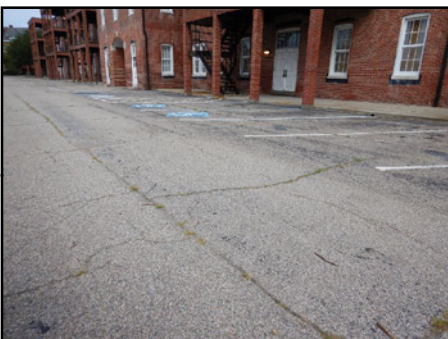
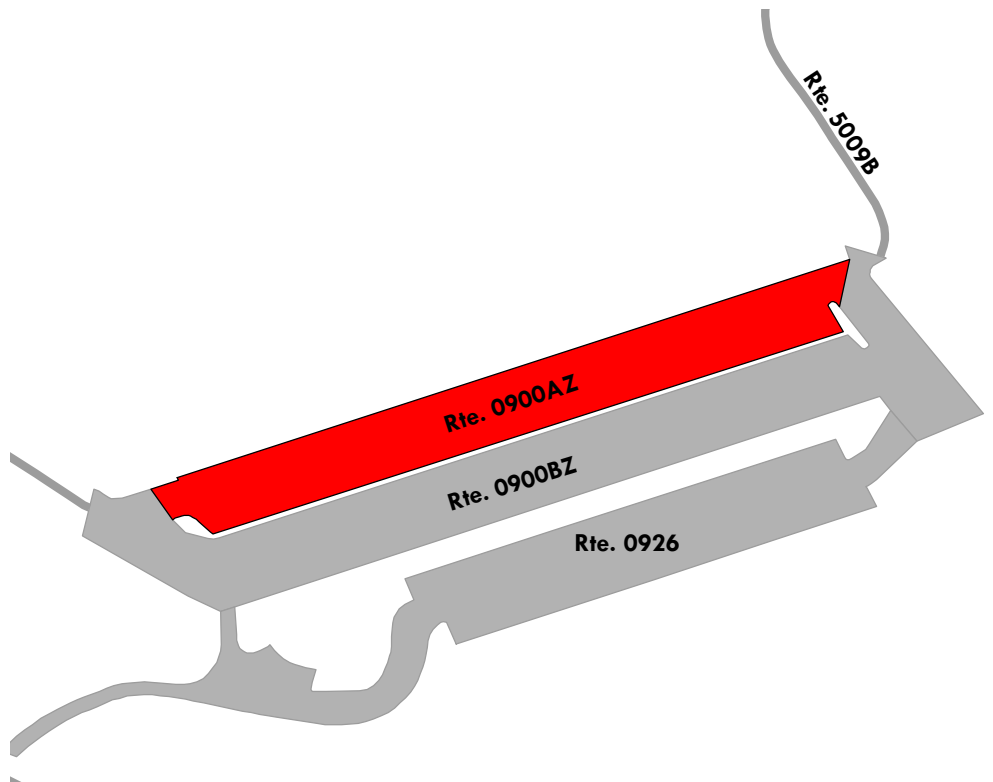
ROUTE 0900BZ: PARADE OVERFLOW PARKING B

Inspection Date	FMSS Number	User Access	Surface Type
7/19/2019	248829	PUBLIC	ASPHALT
Area (Sq. Ft.)	Lane Miles (11' Widths)	Curb Reveal (Inches)	Curb Recommendation
33,669	0.58	3	MODERATE REPAIR
Curb Type		Curb & Gutter Type	
CONCRETE AND WOOD		NO CURB AND GUTTER	
Pavement Recommendation		Condition Rating / PCR	
HEAVY 3R TREATMENTS		POOR / 53

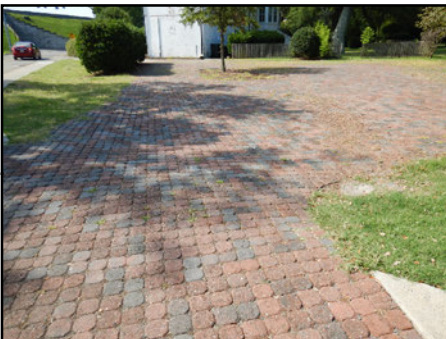
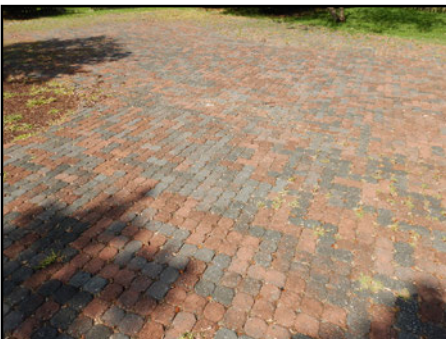
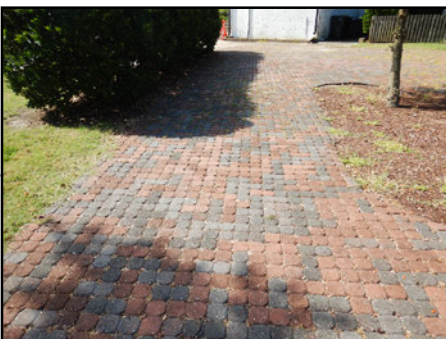
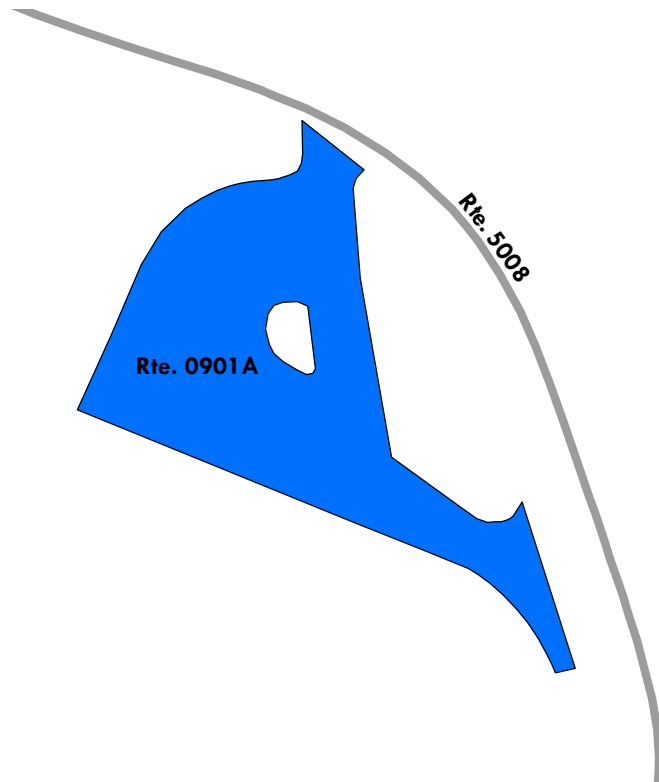
ROUTE 0901A: QUARTERS 1 PARKING

Inspection Date	FMSS Number	User Access	Surface Type
7/19/2019		PUBLIC	BRICK PAVERS
Area (Sq. Ft.)	Lane Miles (11' Widths)	Curb Reveal (Inches)	Curb Recommendation
4,414	0.076	NOT APPLICABLE	DO NOTHING
Curb Type		Curb & Gutter Type	
NO CURB		CONCRETE	
Pavement Recommendation		Condition Rating / PCR	
DO NOTHING		EXCELLENT / 97

Note: Parking area consists of multiple surface types: 1 part Asphalt at 721 square feet; 1 part brick at 3,693 square feet.

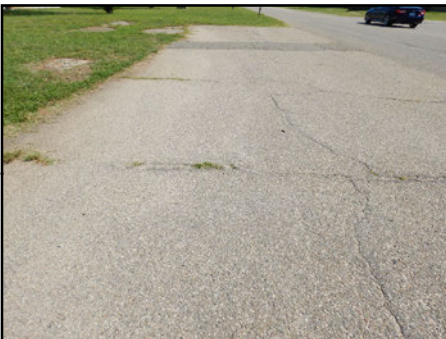
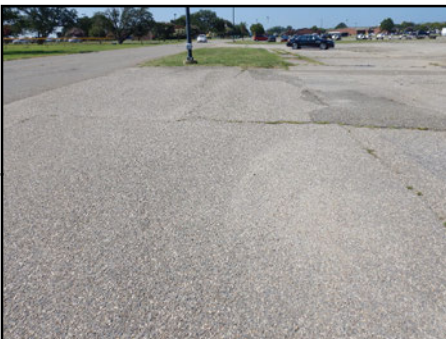
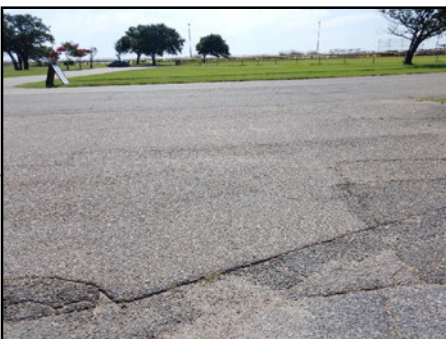
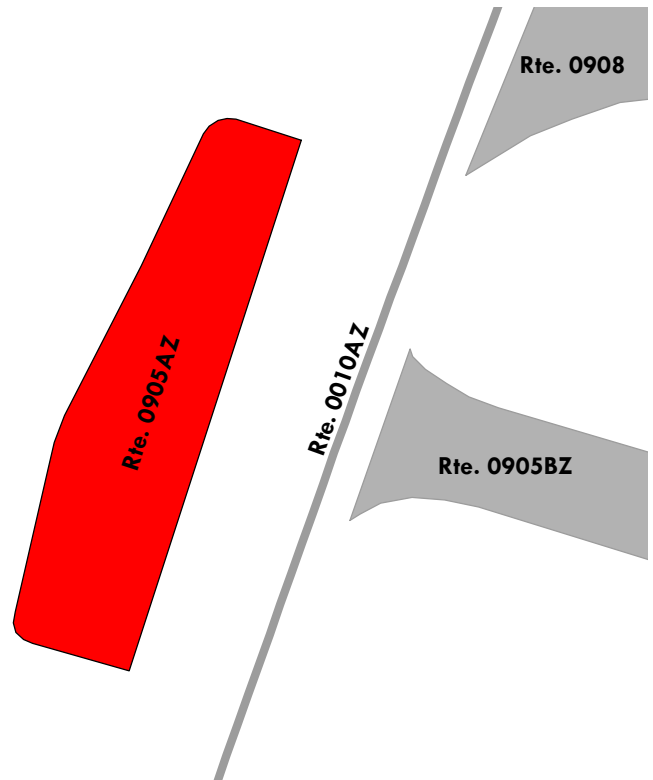
ROUTE 0905AZ: DERUSSY FIELD PARKING A

Inspection Date	FMSS Number	User Access	Surface Type
7/19/2019	248461	PUBLIC	ASPHALT
Area (Sq. Ft.)	Lane Miles (11' Widths)	Curb Reveal (Inches)	Curb Recommendation
2,365	0.041	NOT APPLICABLE	NOT APPLICABLE
Curb Type		Curb & Gutter Type	
NO CURB		NO CURB AND GUTTER	
Pavement Recommendation		Condition Rating / PCR	
HEAVY 3R TREATMENTS		POOR / 53

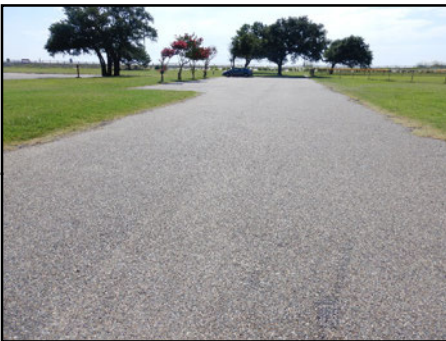
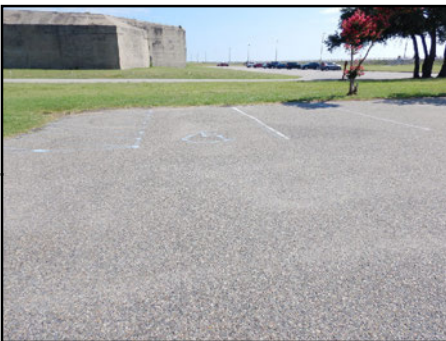
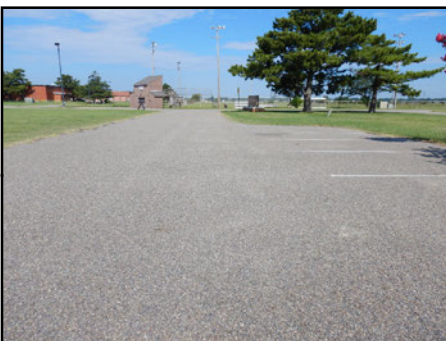
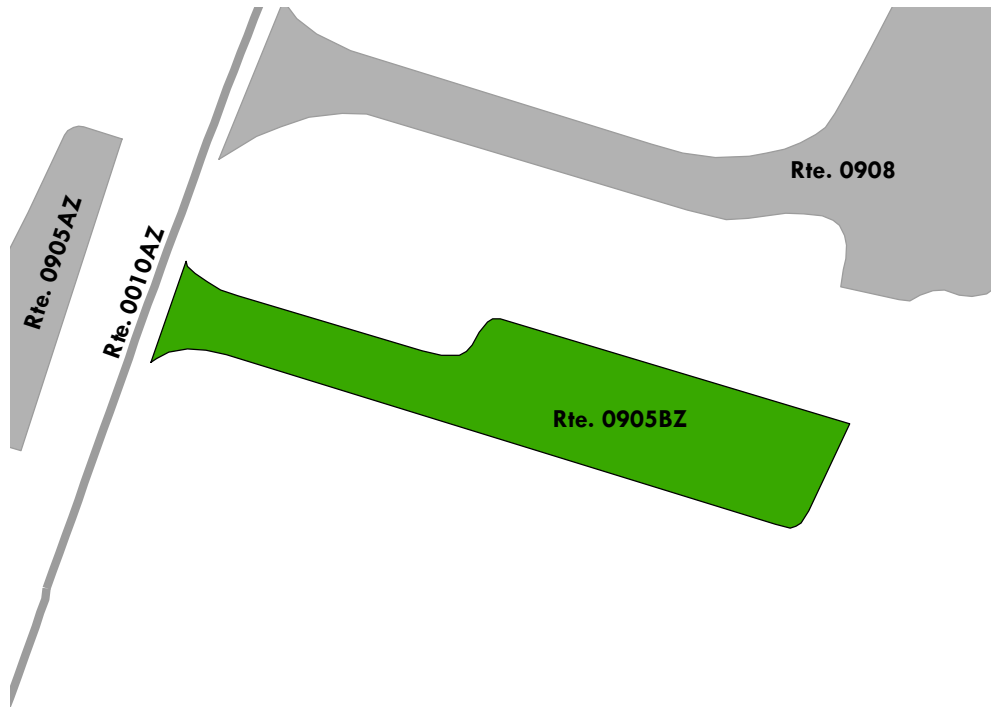
ROUTE 0905BZ: DERUSSY FIELD PARKING B

Inspection Date	FMSS Number	User Access	Surface Type
7/19/2019	248461	PUBLIC	ASPHALT
Area (Sq. Ft.)	Lane Miles (11' Widths)	Curb Reveal (Inches)	Curb Recommendation
6,310	0.109	NOT APPLICABLE	NOT APPLICABLE
Curb Type		Curb & Gutter Type	
NO CURB		NO CURB AND GUTTER	
Pavement Recommendation		Condition Rating / PCR	
PREVENTIVE MAINTENANCE		GOOD / 90

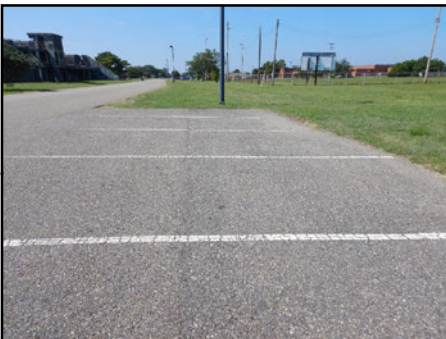
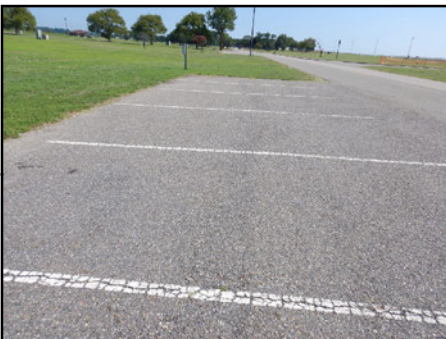
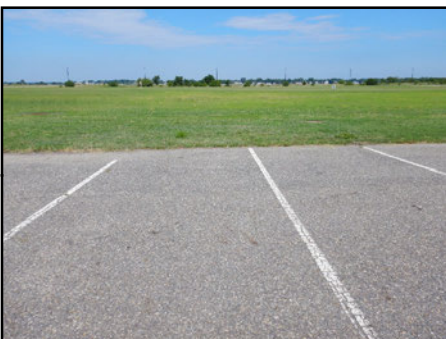
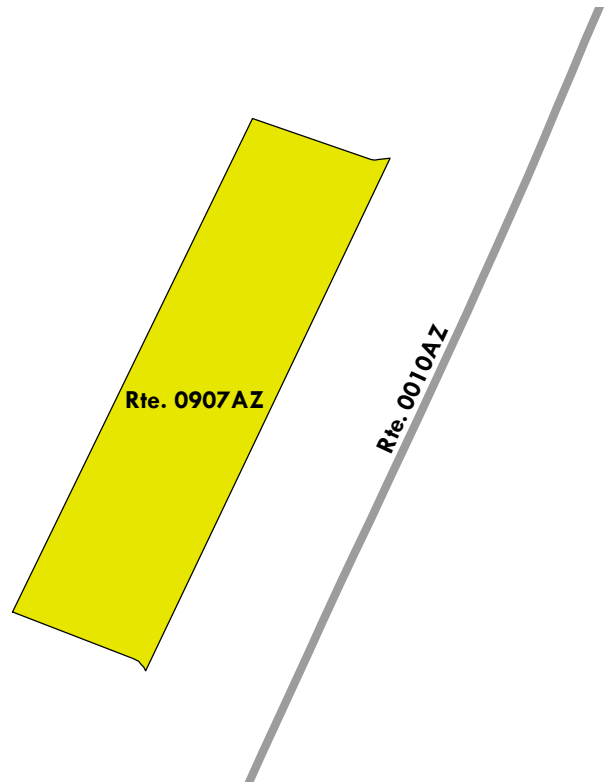
ROUTE 0907AZ: FENWICK ROAD PARKING A

Inspection Date	FMISS Number	User Access	Surface Type
7/19/2019	248828	PUBLIC	ASPHALT
Area (Sq. Ft.)	Lane Miles (11' Widths)	Curb Reveal (Inches)	Curb Recommendation
2,332	0.04	NOT APPLICABLE	NOT APPLICABLE
Curb Type		Curb & Gutter Type	
NO CURB		NO CURB AND GUTTER	
Pavement Recommendation		Condition Rating / PCR	
LIGHT 3R TREATMENTS		FAIR / 73

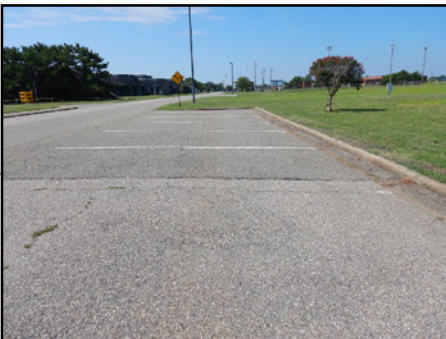
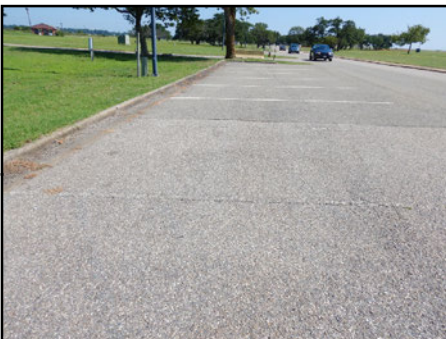
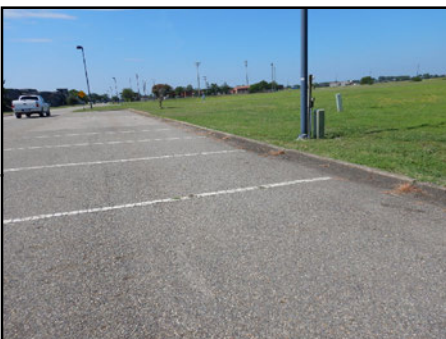
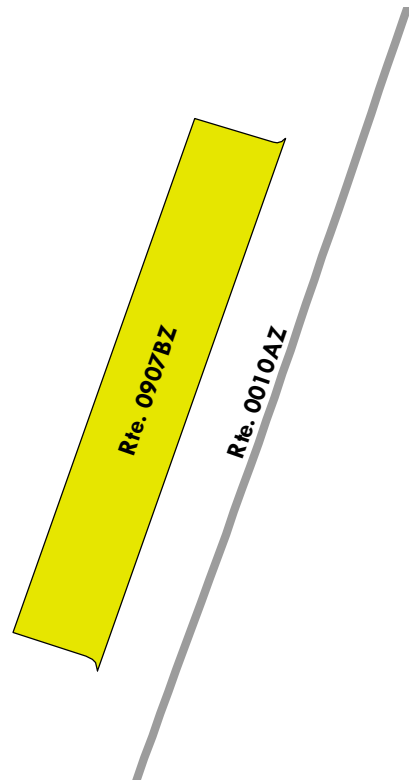
ROUTE 0907BZ: FENWICK ROAD PARKING B

Inspection Date	FMSS Number	User Access	Surface Type
7/19/2019	248828	PUBLIC	ASPHALT
Area (Sq. Ft.)	Lane Miles (11' Widths)	Curb Reveal (Inches)	Curb Recommendation
3,900	0.067	NOT APPLICABLE	DO NOTHING
Curb Type		Curb & Gutter Type	
NO CURB		CONCRETE	
Pavement Recommendation		Condition Rating / PCR	
LIGHT 3R TREATMENTS		FAIR / 73

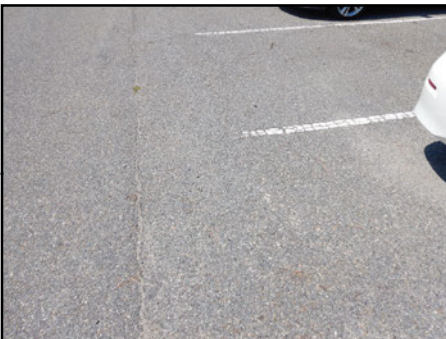
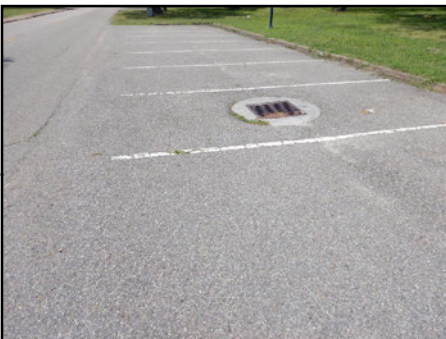
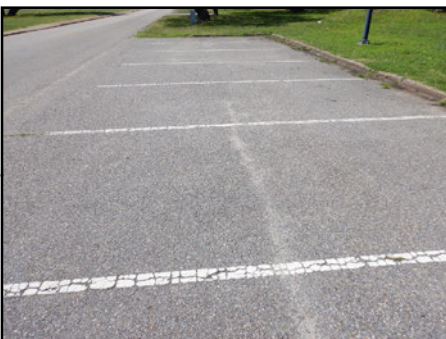
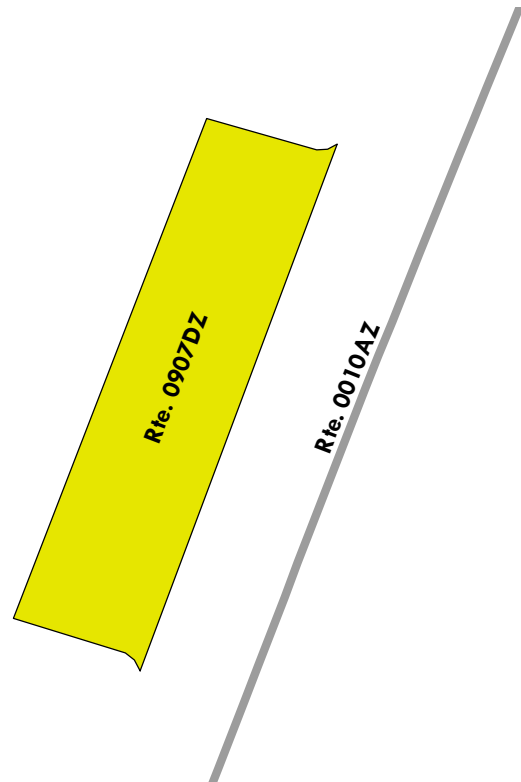
ROUTE 0907DZ: FENWICK ROAD PARKING D

Inspection Date	FMSS Number	User Access	Surface Type
7/19/2019	248828	PUBLIC	ASPHALT
Area (Sq. Ft.)	Lane Miles (11' Widths)	Curb Reveal (Inches)	Curb Recommendation
2,502	0.043	NOT APPLICABLE	DO NOTHING
Curb Type		Curb & Gutter Type	
NO CURB		CONCRETE	
Pavement Recommendation		Condition Rating / PCR	
LIGHT 3R TREATMENTS		FAIR / 73

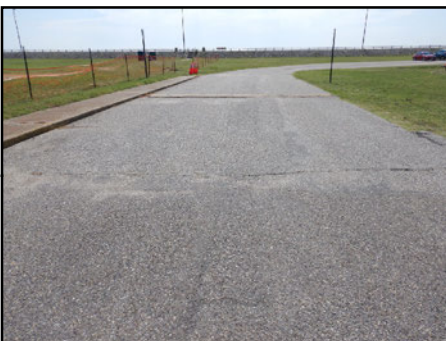
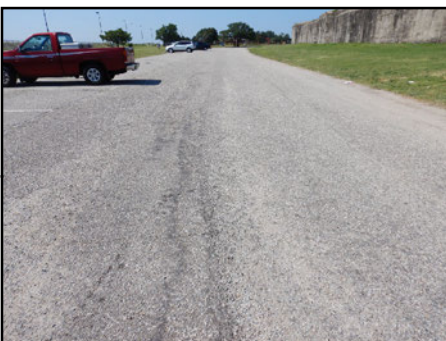
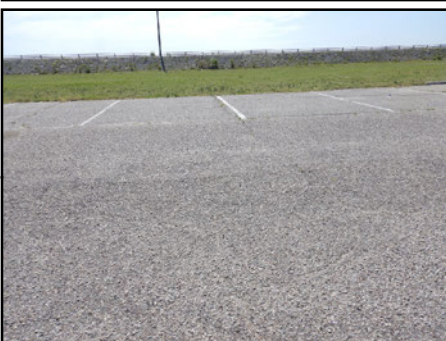
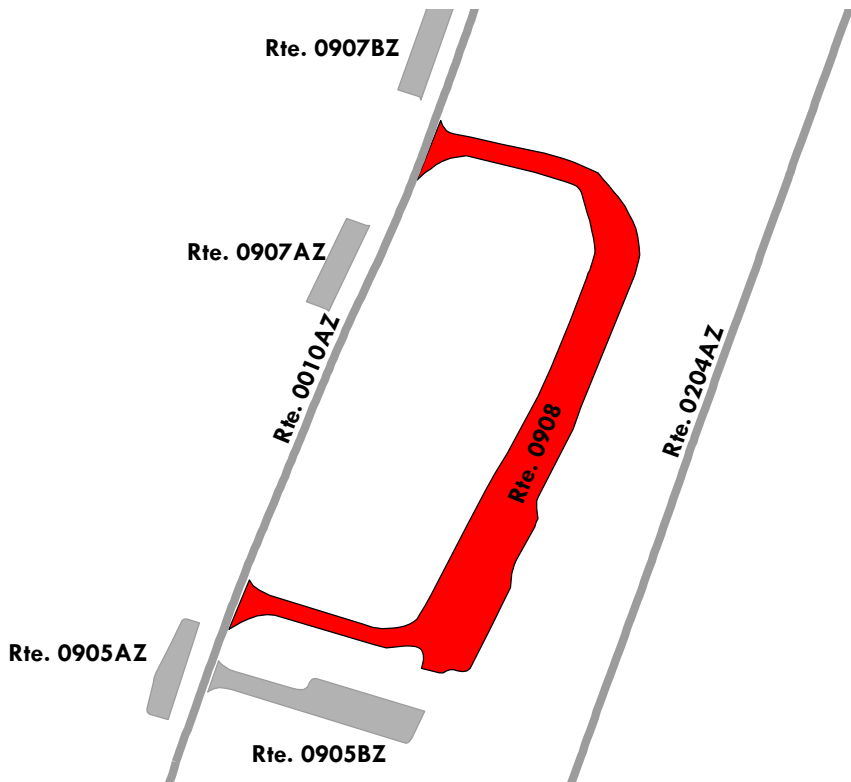
ROUTE 0908: BATTERY DERUSSY PARKING

Inspection Date	FMSS Number	User Access	Surface Type
7/19/2019	248460	PUBLIC	ASPHALT
Area (Sq. Ft.)	Lane Miles (11' Widths)	Curb Reveal (Inches)	Curb Recommendation
35,594	0.613	3	DO NOTHING
Curb Type		Curb & Gutter Type	
CONCRETE		NO CURB AND GUTTER	
Pavement Recommendation		Condition Rating / PCR	
HEAVY 3R TREATMENTS		POOR / 53

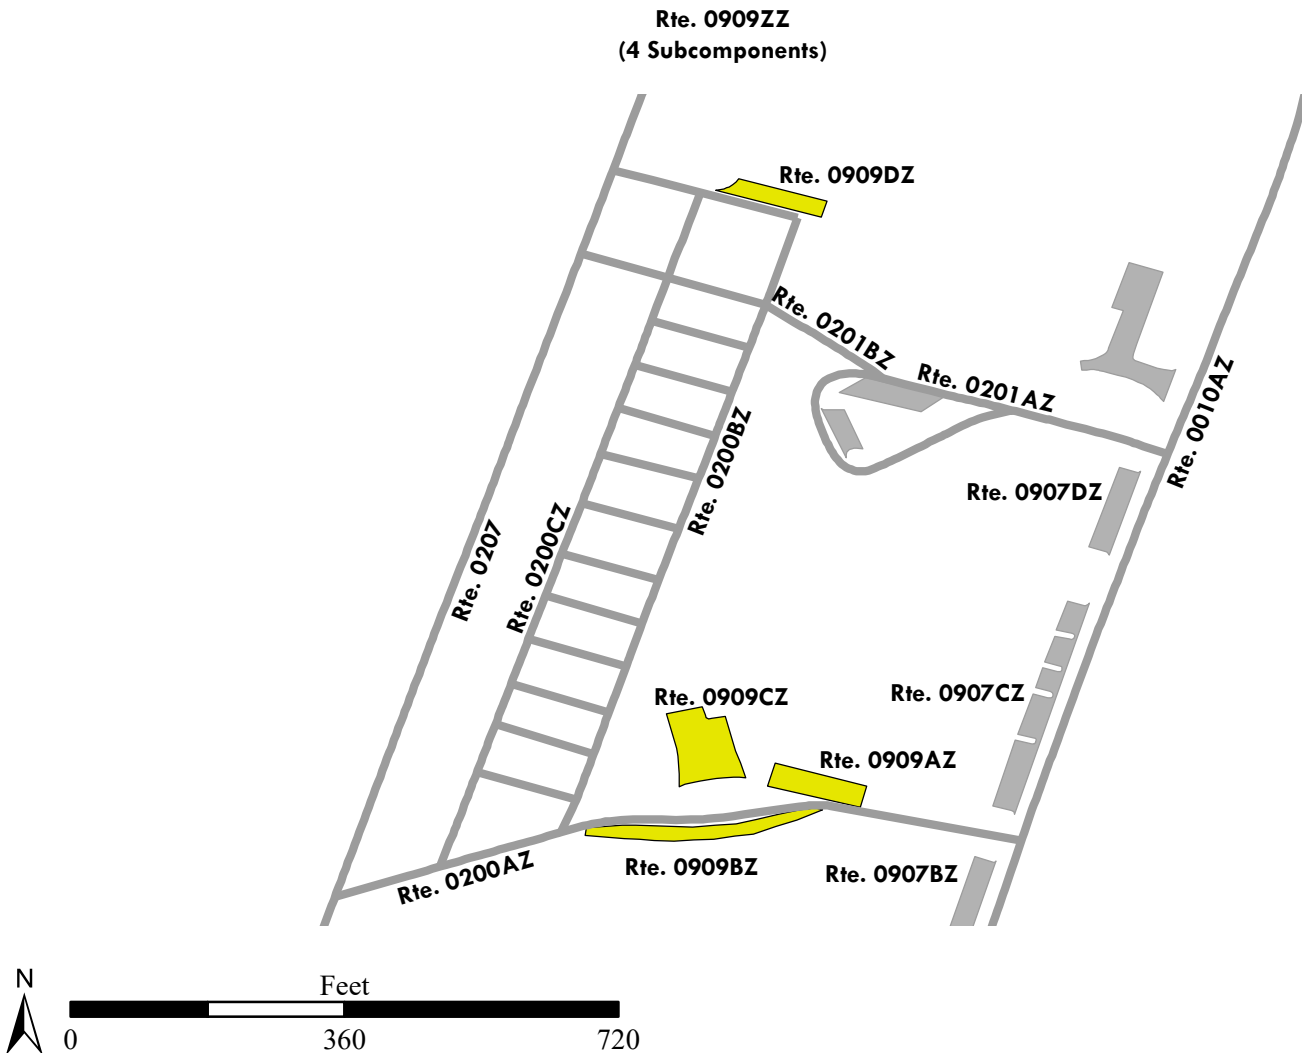
ROUTE 0909ZZ: WALKER AIRFIELD PARKING AREAS

Inspection Date	FMSS Number	User Access	Surface Type
7/19/2019	248818	PUBLIC	CONCRETE
Area (Sq. Ft.)	Lane Miles (11' Widths)	Condition Rating / PCR	
14,813	0.255	SUMMARY /	61

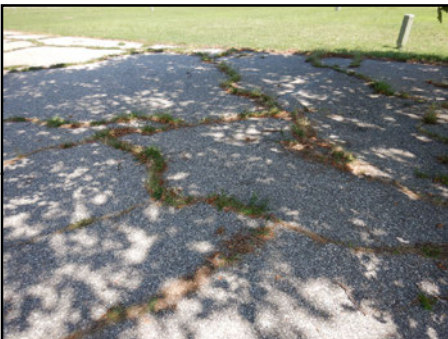
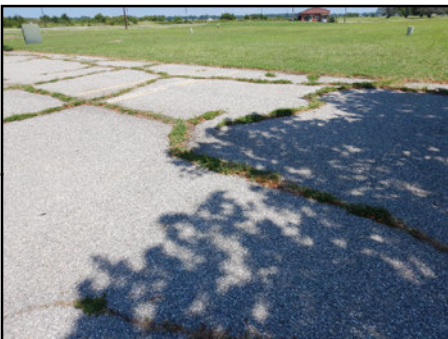
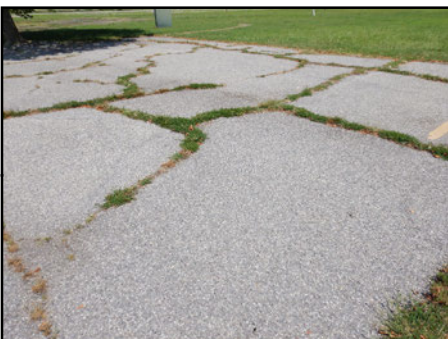
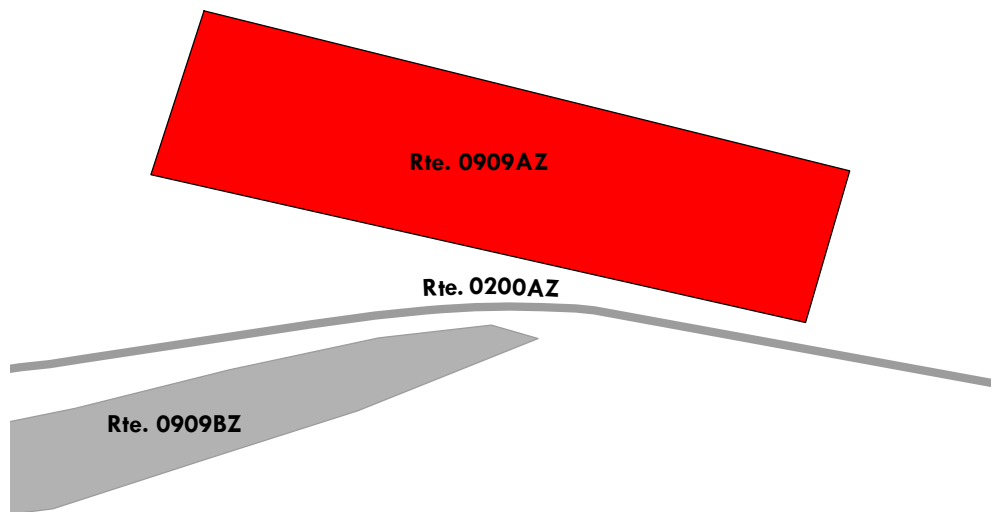
ROUTE 0909AZ: WALKER AIRFIELD PARKING A

Inspection Date	FMISS Number	User Access	Surface Type
7/19/2019	248818	PUBLIC	ASPHALT
Area (Sq. Ft.)	Lane Miles (11' Widths)	Curb Reveal (Inches)	Curb Recommendation
3,068	0.053	NOT APPLICABLE	NOT APPLICABLE
Curb Type		Curb & Gutter Type	
NO CURB		NO CURB AND GUTTER	
Pavement Recommendation		Condition Rating / PCR	
HEAVY 3R TREATMENTS		POOR / 53

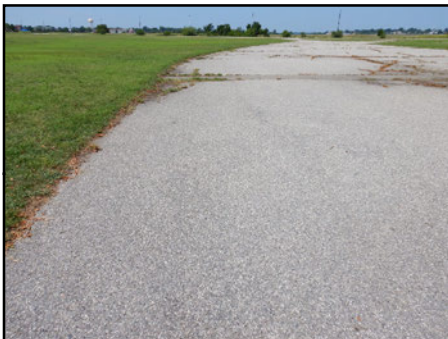
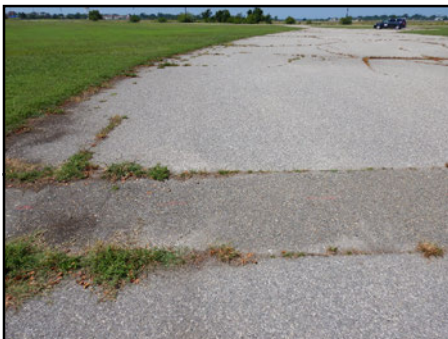
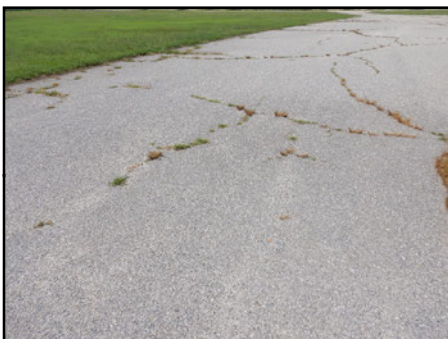
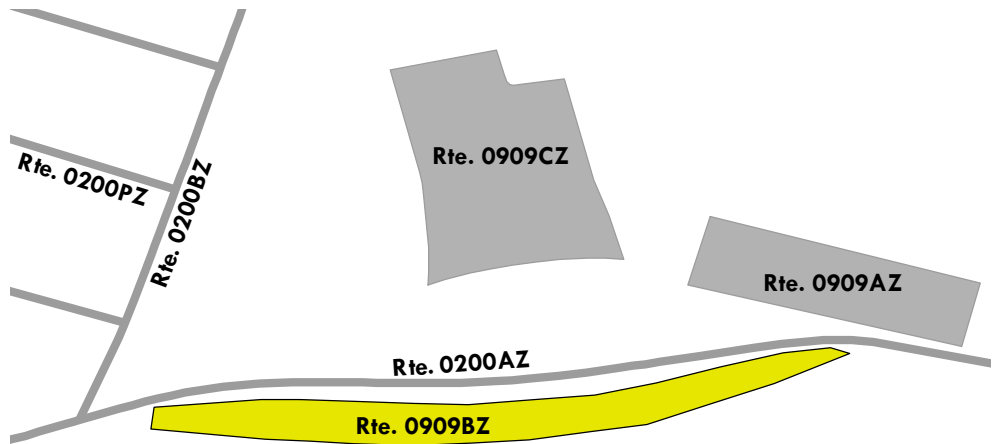
ROUTE 0909BZ: WALKER AIRFIELD PARKING B

Inspection Date	FMSS Number	User Access	Surface Type
7/19/2019	248818	PUBLIC	ASPHALT
Area (Sq. Ft.)	Lane Miles (11' Widths)	Curb Reveal (Inches)	Curb Recommendation
3,897	0.067	NOT APPLICABLE	NOT APPLICABLE
Curb Type		Curb & Gutter Type	
NO CURB		NO CURB AND GUTTER	
Pavement Recommendation		Condition Rating / PCR	
LIGHT 3R TREATMENTS		FAIR / 73

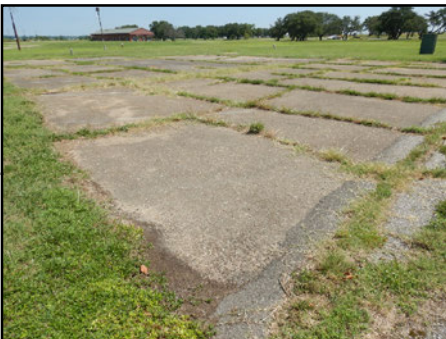
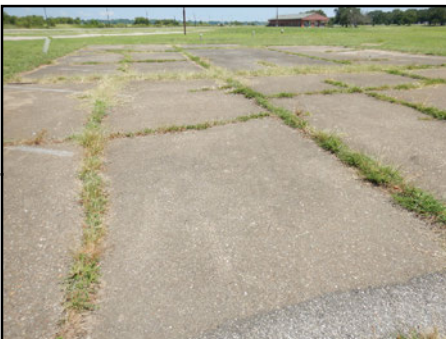
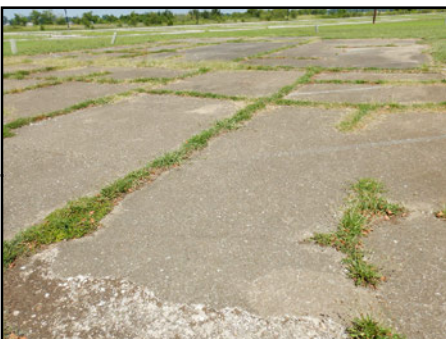
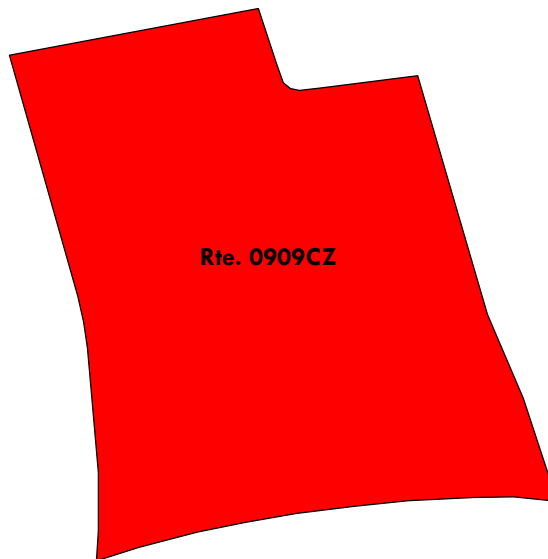
ROUTE 0909CZ: WALKER AIRFIELD PARKING C

Inspection Date	FMISS Number	User Access	Surface Type
7/19/2019	248818	PUBLIC	CONCRETE
Area (Sq. Ft.)	Lane Miles (11' Widths)	Curb Reveal (Inches)	Curb Recommendation
5,594	0.096	NOT APPLICABLE	NOT APPLICABLE
Curb Type		Curb & Gutter Type	
NO CURB		NO CURB AND GUTTER	
Pavement Recommendation		Condition Rating / PCR	
HEAVY 3R TREATMENTS		POOR / 53

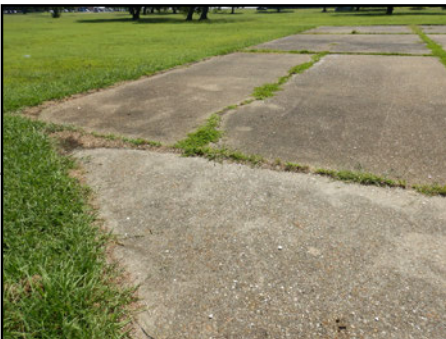
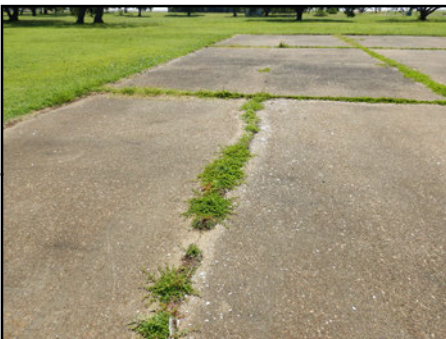
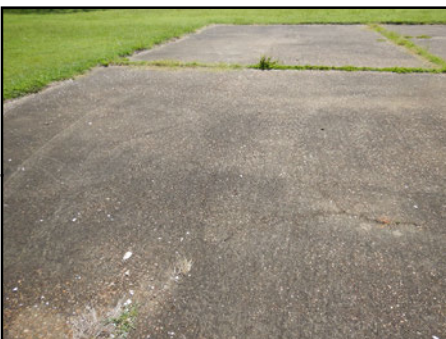
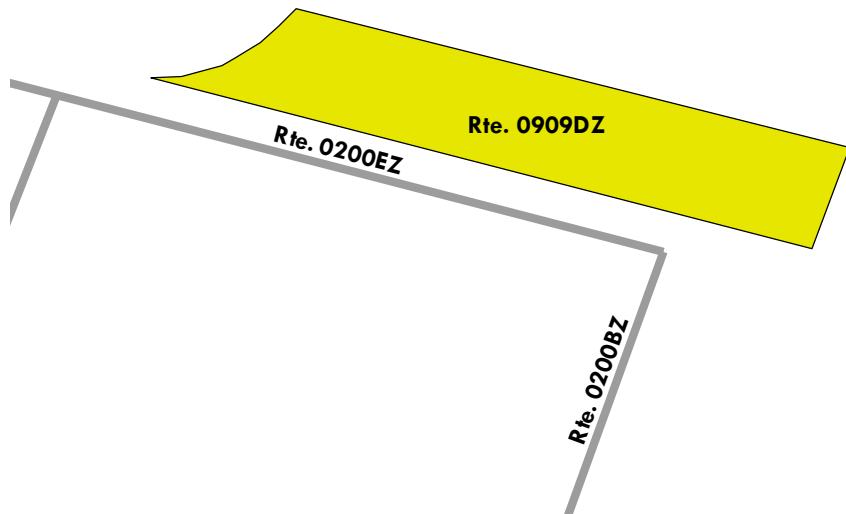
ROUTE 0909DZ: WALKER AIRFIELD PARKING D

Inspection Date	FMSS Number	User Access	Surface Type
7/19/2019	248818	PUBLIC	CONCRETE
Area (Sq. Ft.)	Lane Miles (11' Widths)	Curb Reveal (Inches)	Curb Recommendation
2,254	0.039	NOT APPLICABLE	NOT APPLICABLE
Curb Type		Curb & Gutter Type	
NO CURB		NO CURB AND GUTTER	
Pavement Recommendation		Condition Rating / PCR	
LIGHT 3R TREATMENTS		FAIR / 73

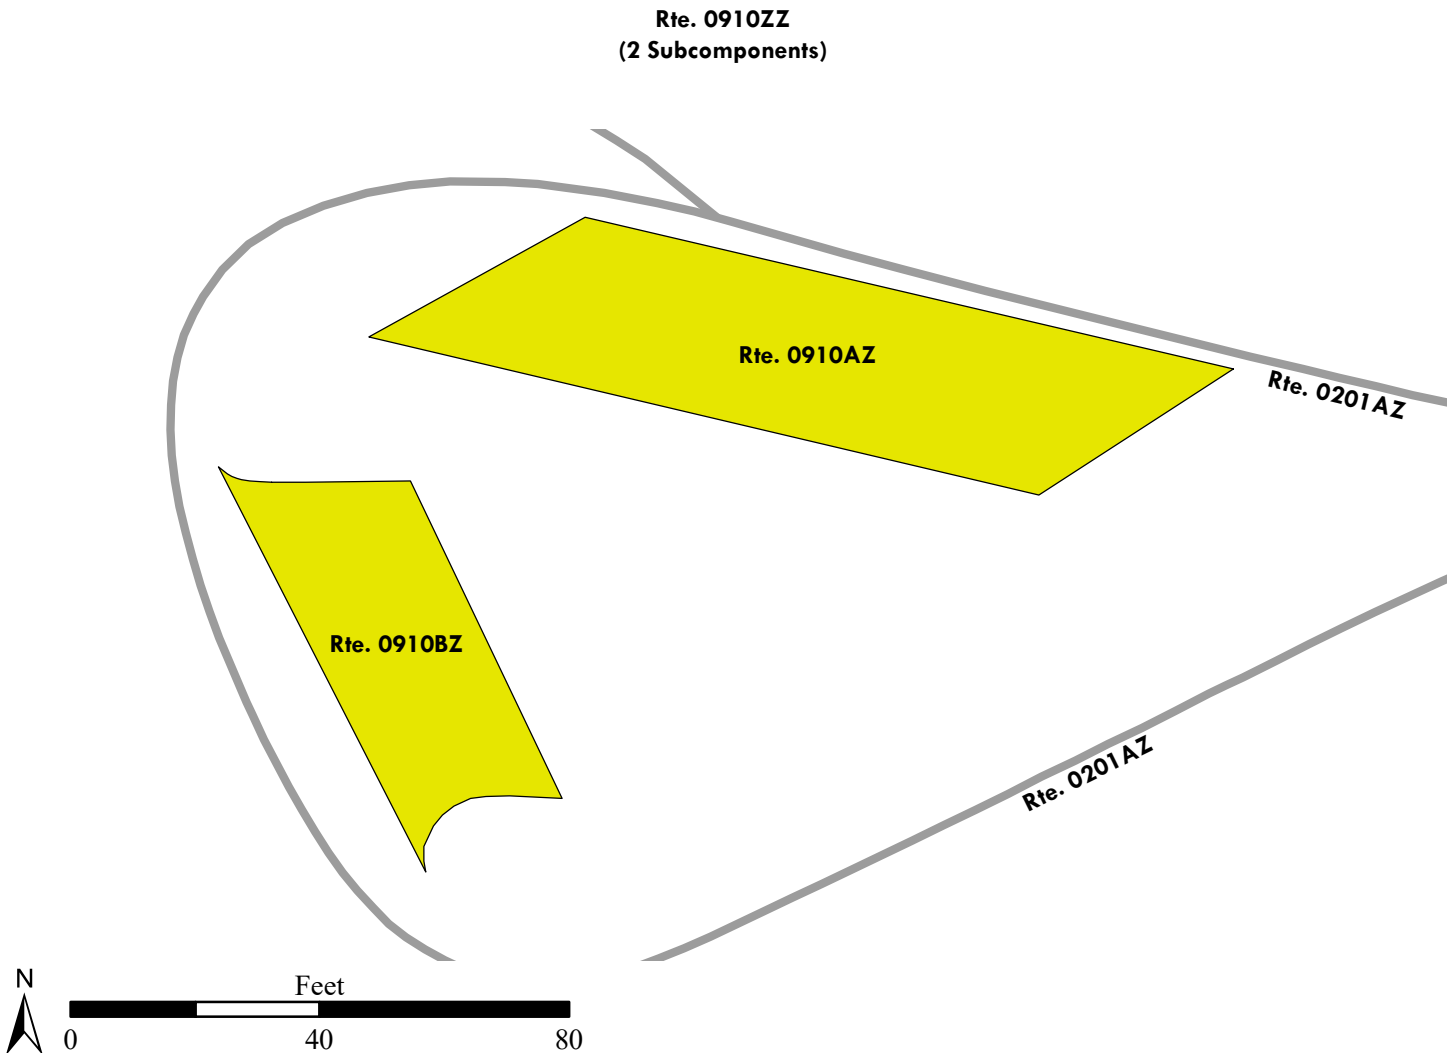
ROUTE 0910ZZ: BUILDING 247 PARKING AREAS

Inspection Date	FMSS Number	User Access	Surface Type
7/19/2019	248817	PUBLIC	ASPHALT
Area (Sq. Ft.)	Lane Miles (11' Widths)	Condition Rating / PCR	
3,543	0.061	SUMMARY / 73

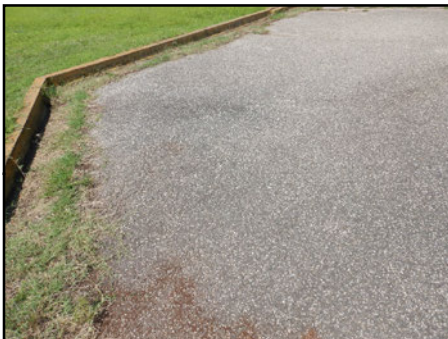
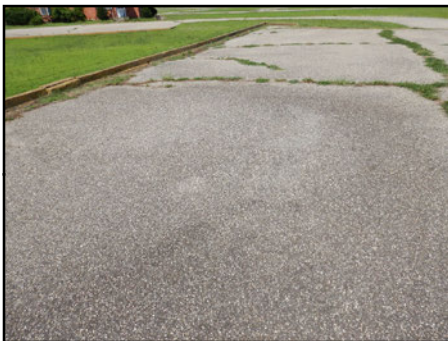
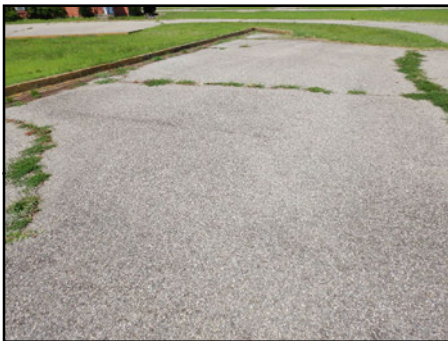
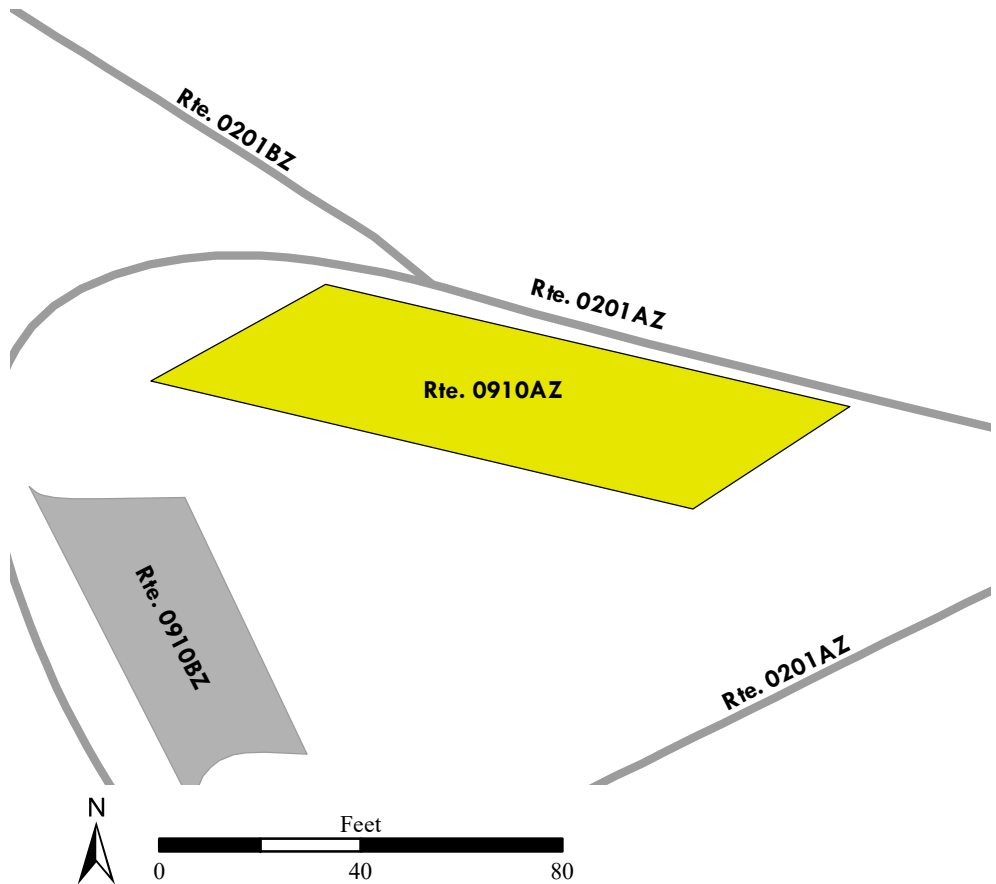
ROUTE 0910AZ: BUILDING 247 PARKING A

Inspection Date	FMSS Number	User Access	Surface Type
7/19/2019	248817	PUBLIC	ASPHALT
Area (Sq. Ft.)	Lane Miles (11' Widths)	Curb Reveal (Inches)	Curb Recommendation
2,328	0.04	NOT APPLICABLE	LIGHT REPAIR
Curb Type		Curb & Gutter Type	
NO CURB		CONCRETE	
Pavement Recommendation		Condition Rating / PCR	
LIGHT 3R TREATMENTS		FAIR / 73

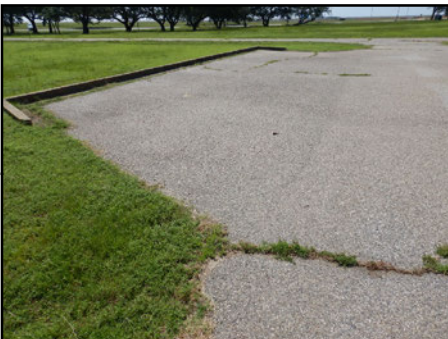
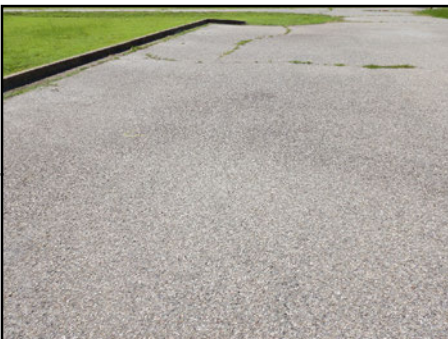
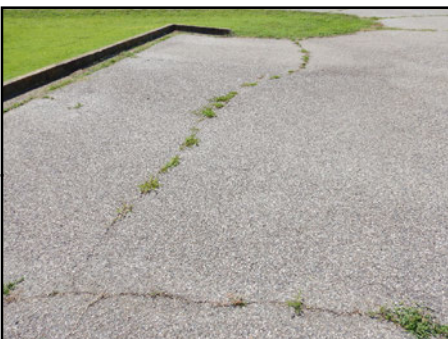
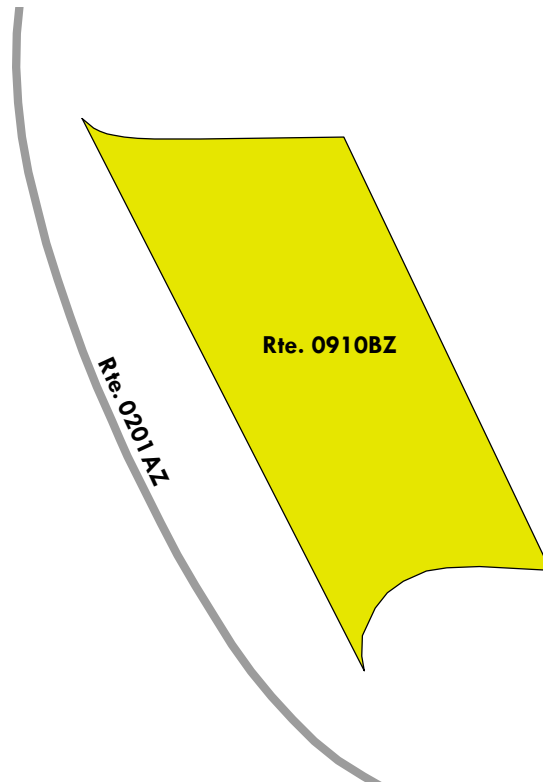
ROUTE 0910BZ: BUILDING 247 PARKING B

Inspection Date	FMISS Number	User Access	Surface Type
7/19/2019	248817	PUBLIC	ASPHALT
Area (Sq. Ft.)	Lane Miles (11' Widths)	Curb Reveal (Inches)	Curb Recommendation
1,215	0.021	NOT APPLICABLE	DO NOTHING
Curb Type		Curb & Gutter Type	
NO CURB		CONCRETE	
Pavement Recommendation		Condition Rating / PCR	
LIGHT 3R TREATMENTS		FAIR / 73

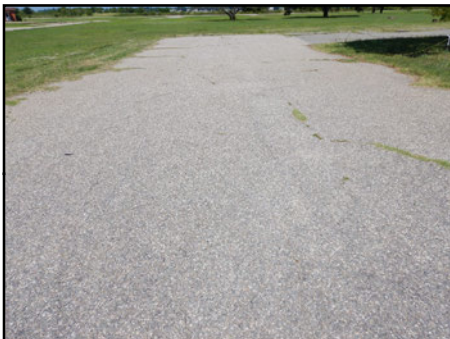
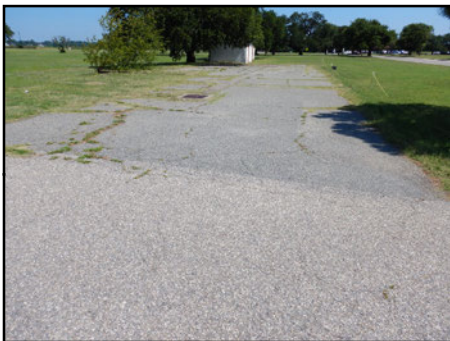
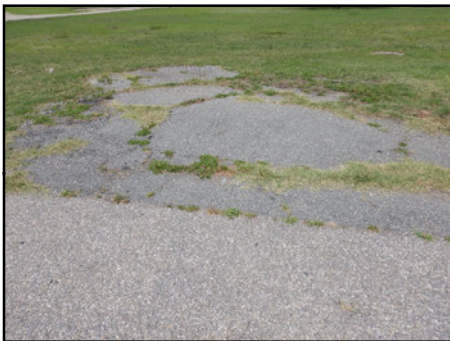
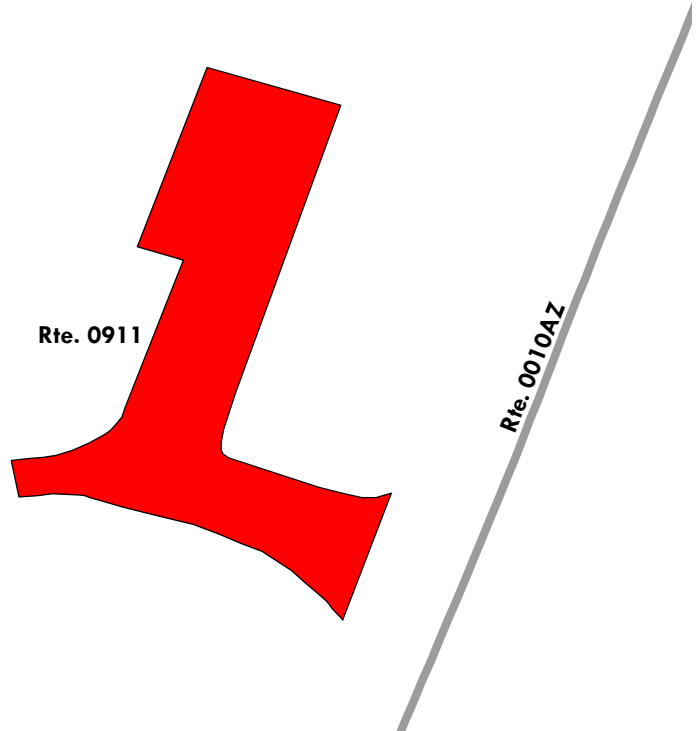
Inspection Date	FMSS Number	User Access	Surface Type
7/19/2019	248459	PUBLIC	ASPHALT
Area (Sq. Ft.)	Lane Miles (11' Widths)	Curb Reveal (Inches)	Curb Recommendation
6,250	0.108	NOT APPLICABLE	NOT APPLICABLE
Curb Type		Curb & Gutter Type	
NO CURB		NO CURB AND GUTTER	
Pavement Recommendation		Condition Rating / PCR	
HEAVY 3R TREATMENTS		POOR / 53

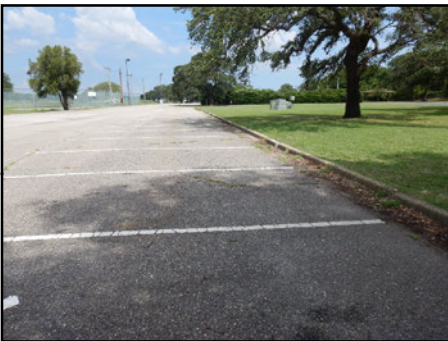
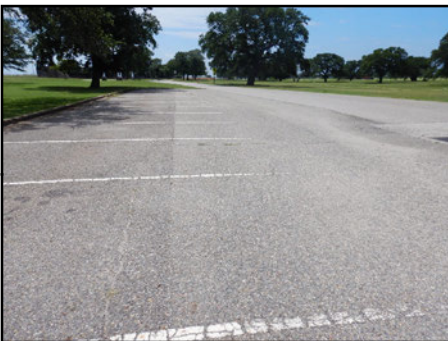
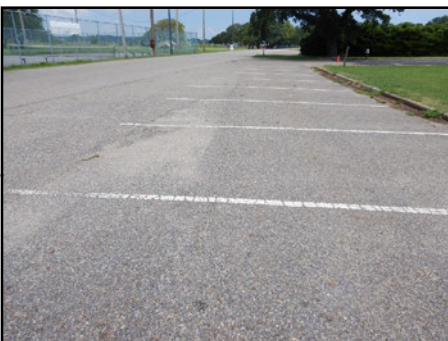
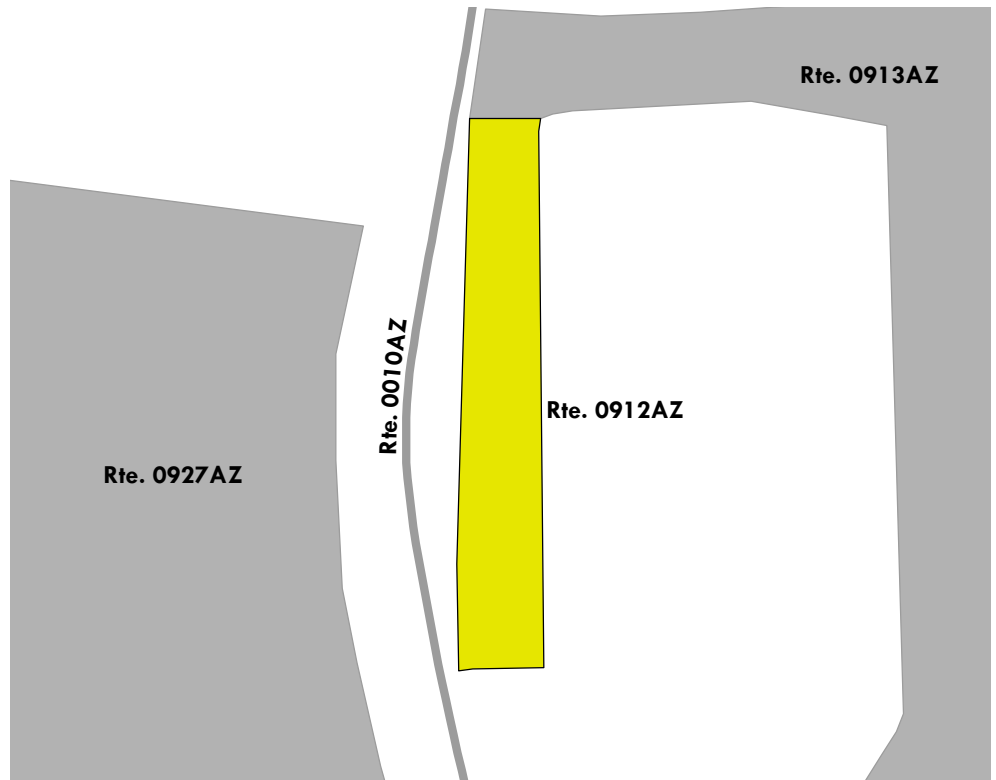
ROUTE 0912AZ: FENWICK TENNIS COURT PARKING A

Inspection Date	FMSS Number	User Access	Surface Type
7/19/2019	248823	PUBLIC	ASPHALT
Area (Sq. Ft.)	Lane Miles (11' Widths)	Curb Reveal (Inches)	Curb Recommendation
4,633	0.08	NOT APPLICABLE	LIGHT REPAIR
Curb Type		Curb & Gutter Type	
NO CURB		CONCRETE	
Pavement Recommendation		Condition Rating / PCR	
LIGHT 3R TREATMENTS		FAIR / 73

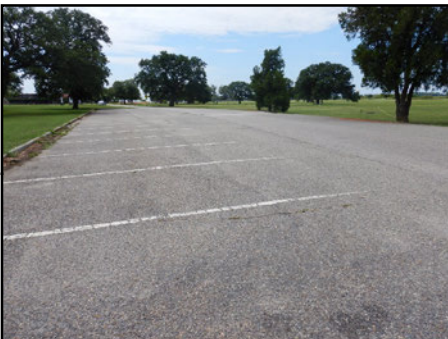
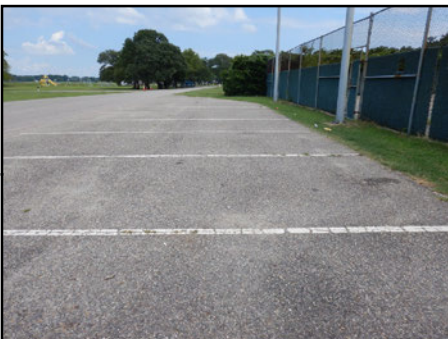
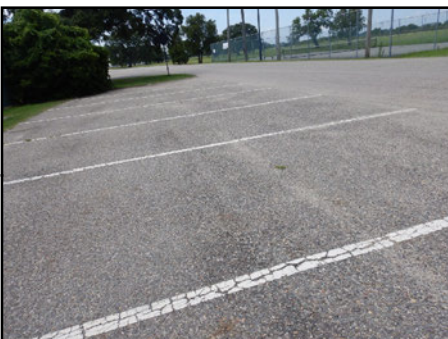
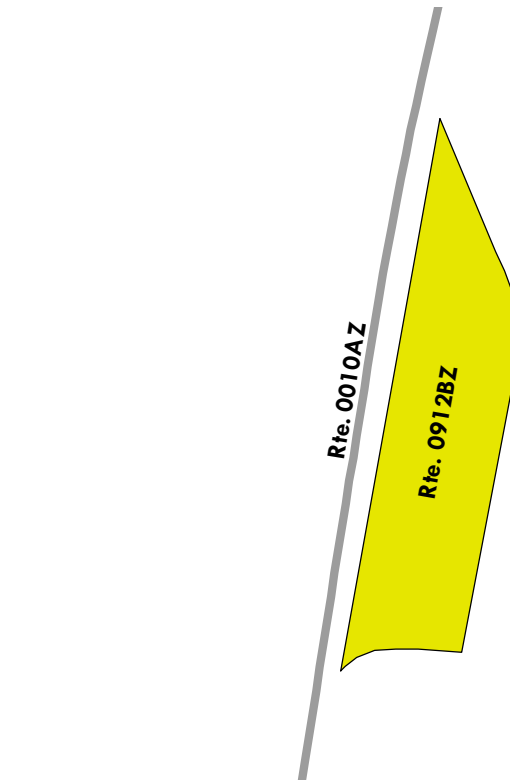
ROUTE 0912BZ: FENWICK TENNIS COURT PARKING B

Inspection Date	FMSS Number	User Access	Surface Type
7/19/2019	248823	PUBLIC	ASPHALT
Area (Sq. Ft.)	Lane Miles (11' Widths)	Curb Reveal (Inches)	Curb Recommendation
2,652	0.046	NOT APPLICABLE	NOT APPLICABLE
Curb Type		Curb & Gutter Type	
NO CURB		NO CURB AND GUTTER	
Pavement Recommendation		Condition Rating / PCR	
LIGHT 3R TREATMENTS		FAIR / 73
