FOMR Cycle 6

Final Report

Road Inventory and Condition Assessment of Paved Routes Fort Monroe National Monument

Report Date: September 2021

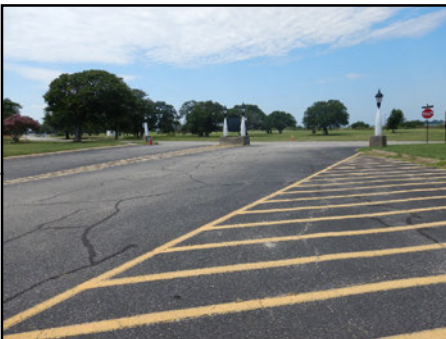
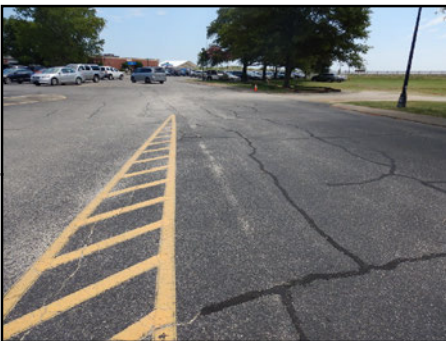
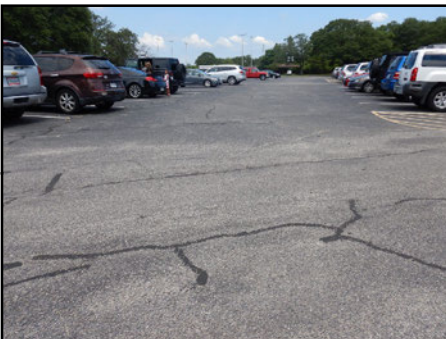
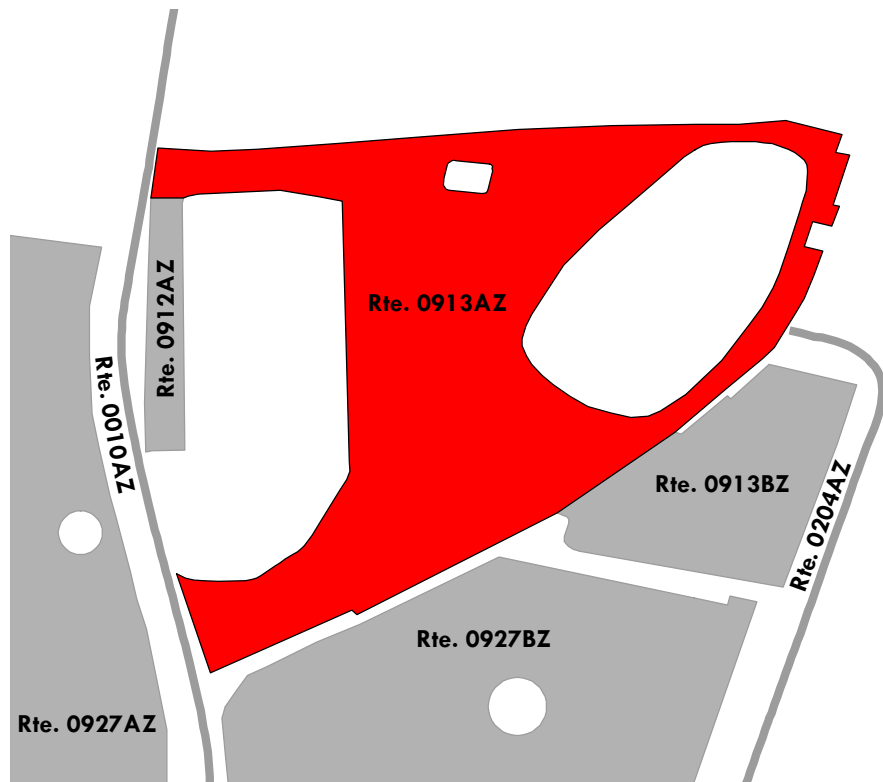
ROUTE 0913AZ: PARADISE OCEAN CLUB PARKING

Inspection Date	FMSS Number	User Access	Surface Type
7/19/2019	248822	PUBLIC	ASPHALT
Area (Sq. Ft.)	Lane Miles (11' Widths)	Curb Reveal (Inches)	Curb Recommendation
71,506	1.231	4	DO NOTHING
Curb Type		Curb & Gutter Type	
CONCRETE		CONCRETE	
Pavement Recommendation		Condition Rating / PCR	
HEAVY 3R TREATMENTS		POOR / 53

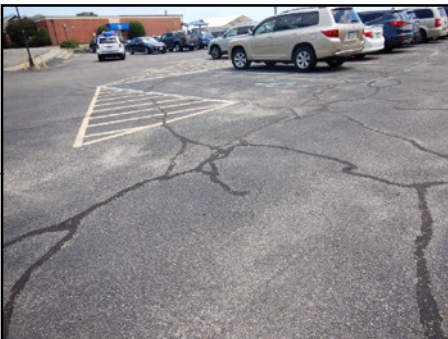
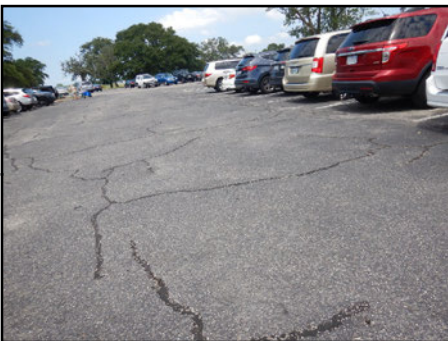
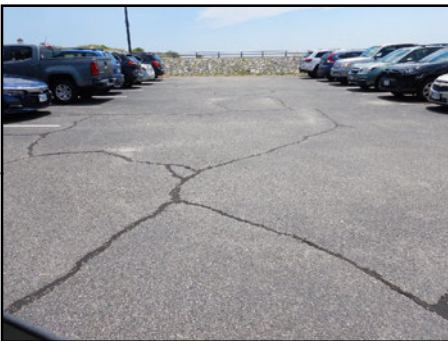
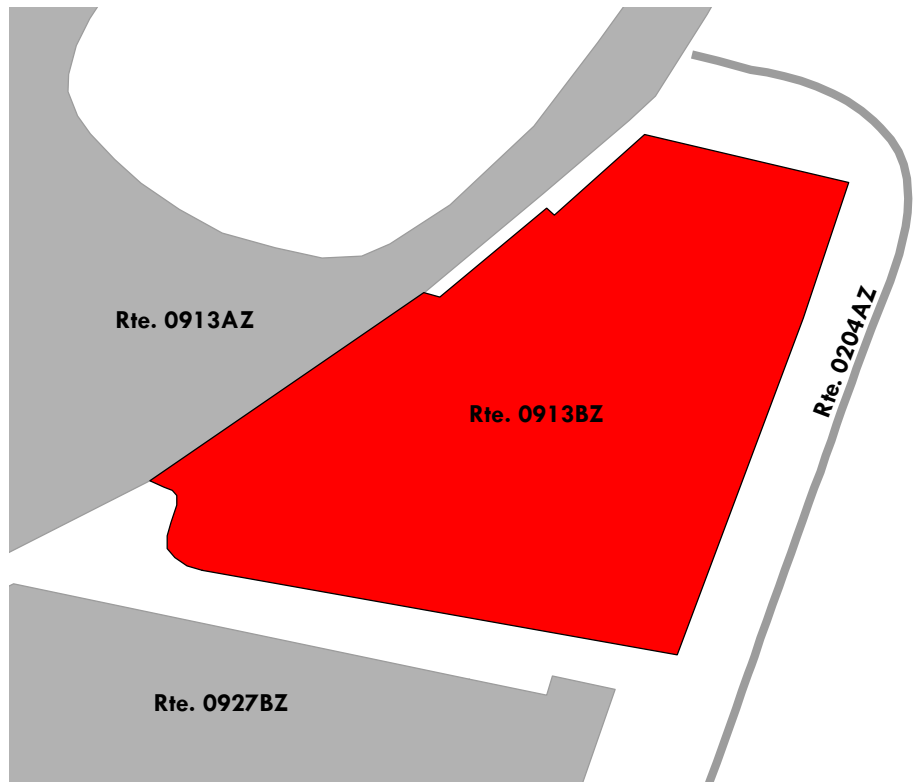
ROUTE 0913BZ: PARADISE OCEAN CLUB OVERFLOW PARKING

Inspection Date	FMSS Number	User Access	Surface Type
7/19/2019	248822	PUBLIC	ASPHALT
Area (Sq. Ft.)	Lane Miles (11' Widths)	Curb Reveal (Inches)	Curb Recommendation
19,003	0.327	NOT APPLICABLE	NOT APPLICABLE
Curb Type		Curb & Gutter Type	
NO CURB		NO CURB AND GUTTER	
Pavement Recommendation		Condition Rating / PCR	
HEAVY 3R TREATMENTS		POOR / 53

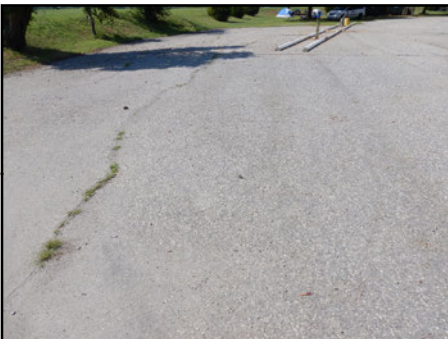
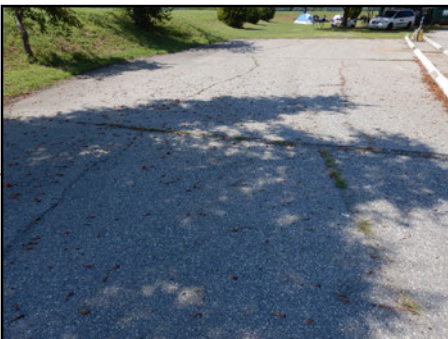
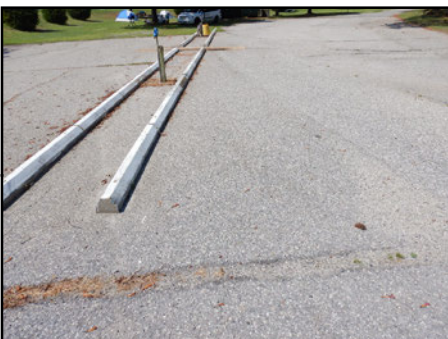
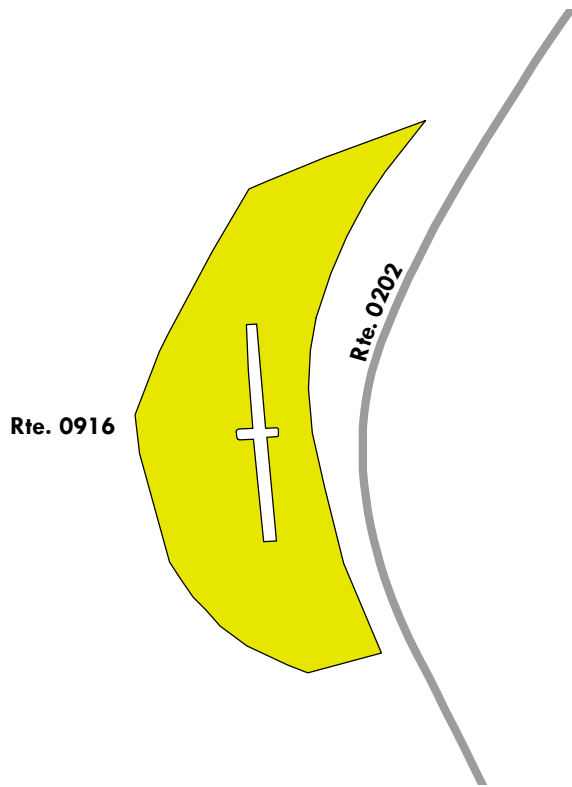
ROUTE 0916: FULLER LANE DUMP STATION PARKING

Inspection Date	FMSS Number	User Access	Surface Type
7/19/2019	248560	PUBLIC	ASPHALT
Area (Sq. Ft.)	Lane Miles (11' Widths)	Curb Reveal (Inches)	Curb Recommendation
7,431	0.128	NOT APPLICABLE	NOT APPLICABLE
Curb Type		Curb & Gutter Type	
NO CURB		NO CURB AND GUTTER	
Pavement Recommendation		Condition Rating / PCR	
LIGHT 3R TREATMENTS		FAIR / 73

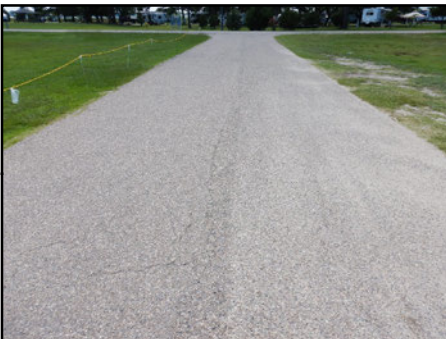
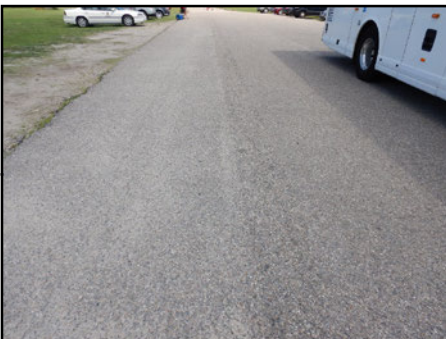
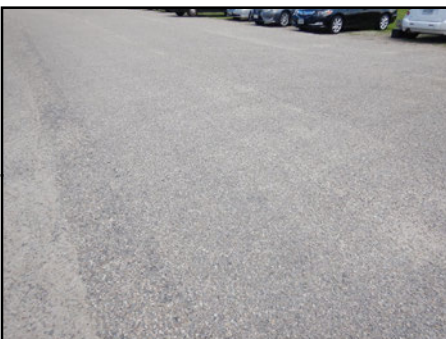
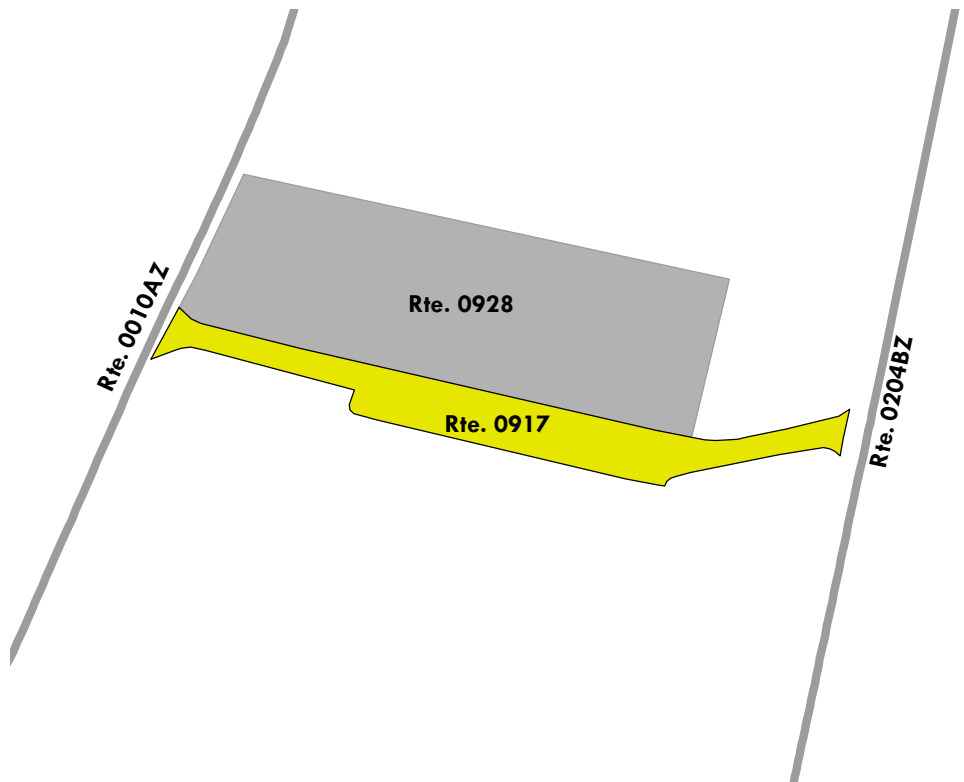
ROUTE 0917: SHELTER #5 PARKING

Inspection Date	FMSS Number	User Access	Surface Type
7/19/2019	248462	PUBLIC	ASPHALT
Area (Sq. Ft.)	Lane Miles (11' Widths)	Curb Reveal (Inches)	Curb Recommendation
12,517	0.216	NOT APPLICABLE	NOT APPLICABLE
Curb Type		Curb & Gutter Type	
NO CURB		NO CURB AND GUTTER	
Pavement Recommendation		Condition Rating / PCR	
LIGHT 3R TREATMENTS		FAIR / 73

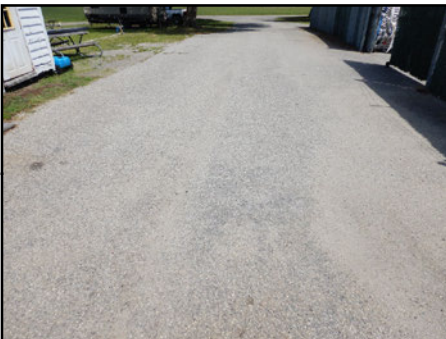
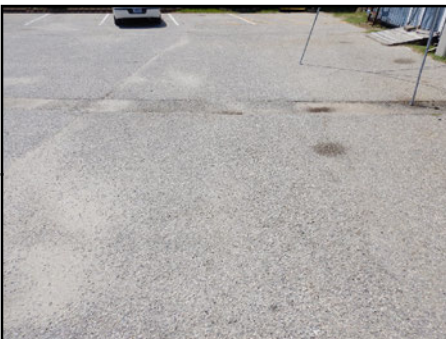
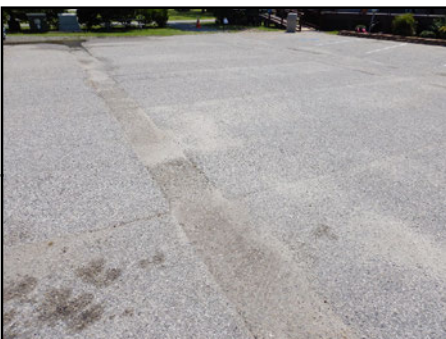
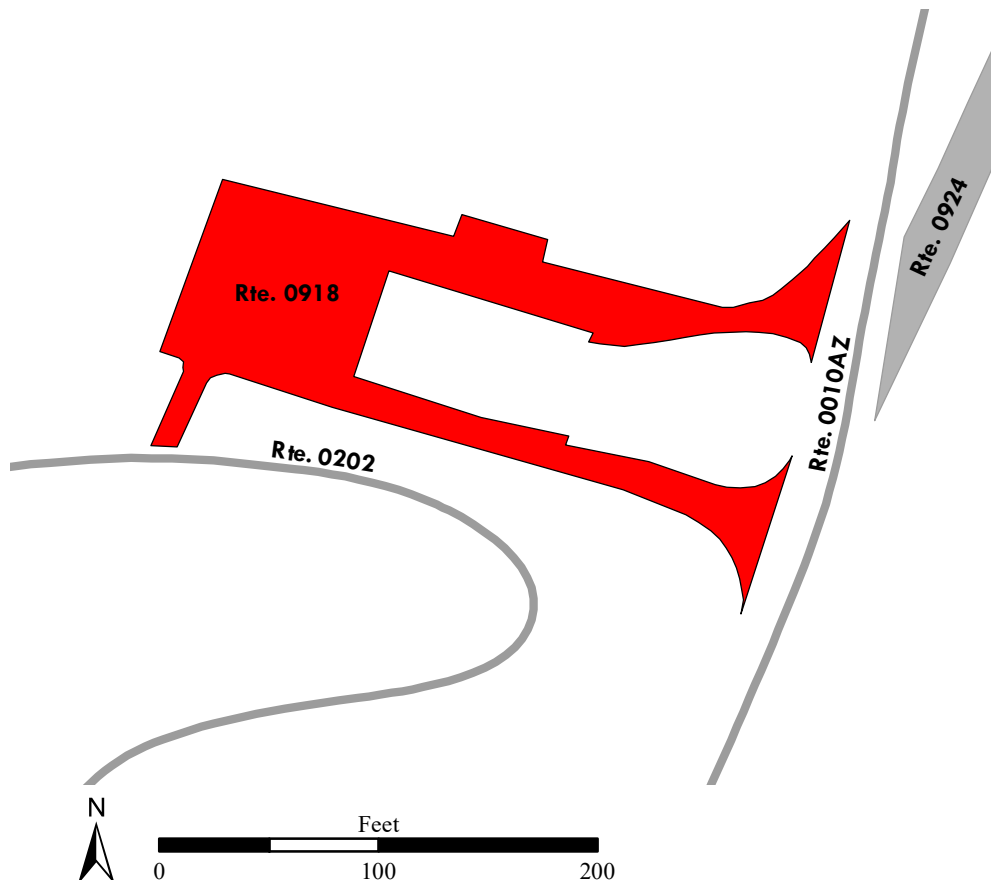
ROUTE 0918: CAMPGROUND CAMPSTORE PARKING

Inspection Date	FMSS Number	User Access	Surface Type
7/19/2019	248559	PUBLIC	ASPHALT
Area (Sq. Ft.)	Lane Miles (11' Widths)	Curb Reveal (Inches)	Curb Recommendation
13,469	0.232	NOT APPLICABLE	NOT APPLICABLE
Curb Type		Curb & Gutter Type	
NO CURB		NO CURB AND GUTTER	
Pavement Recommendation		Condition Rating / PCR	
HEAVY 3R TREATMENTS		POOR / 53

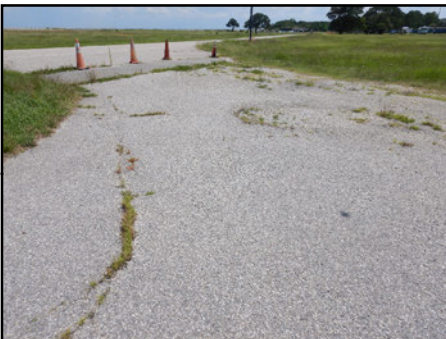
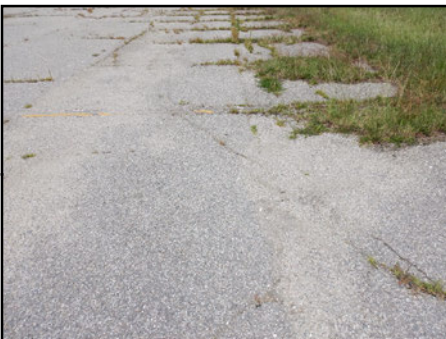
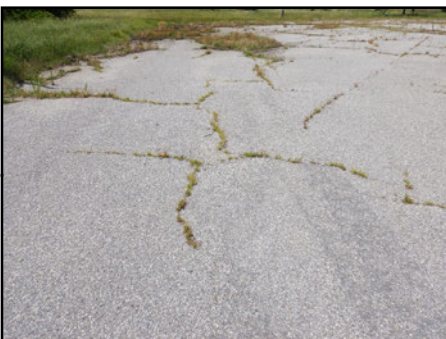
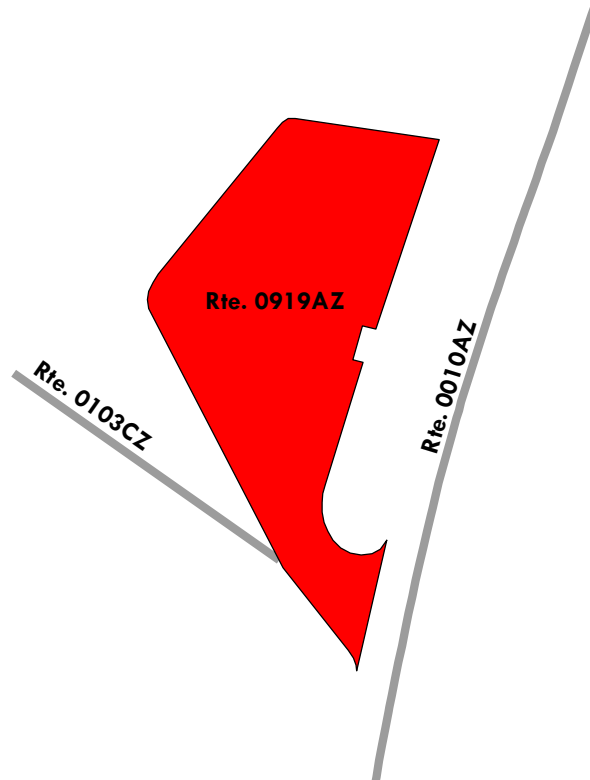
ROUTE 0919AZ: MILL CREEK OVERLOOK LOWER PARKING

Inspection Date	FMSS Number	User Access	Surface Type
7/19/2019		PUBLIC	ASPHALT
Area (Sq. Ft.)	Lane Miles (11' Widths)	Curb Reveal (Inches)	Curb Recommendation
16,541	0.285	NOT APPLICABLE	NOT APPLICABLE
Curb Type		Curb & Gutter Type	
NO CURB		NO CURB AND GUTTER	
Pavement Recommendation		Condition Rating / PCR	
HEAVY 3R TREATMENTS		POOR / 53

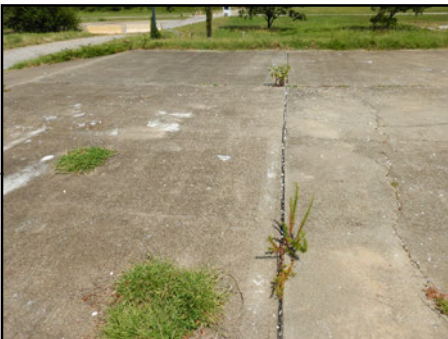
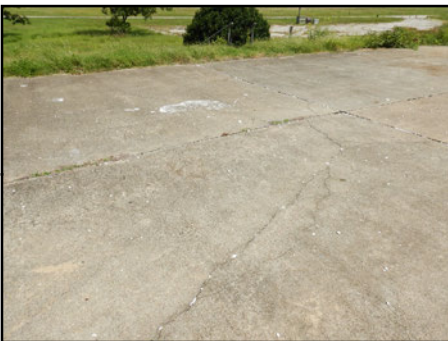
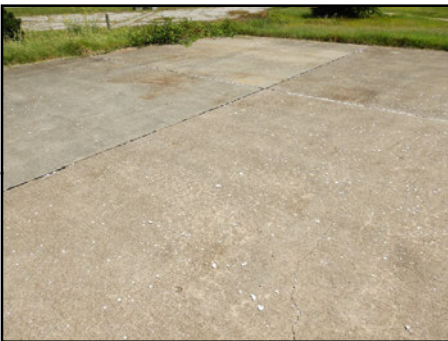
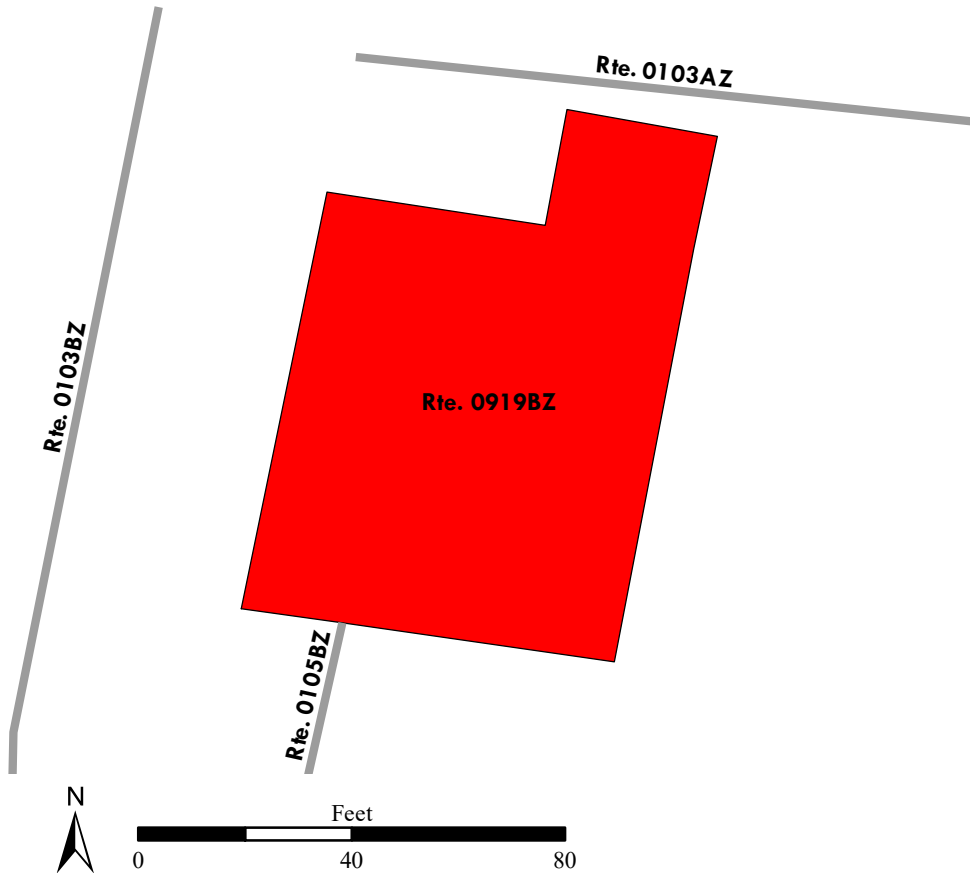
ROUTE 0919CZ: MILL CREEK OVERLOOK TRAILSIDE PARKING

Inspection Date	FMSS Number	User Access	Surface Type
7/19/2019		PUBLIC	CONCRETE
Area (Sq. Ft.)	Lane Miles (11' Widths)	Curb Reveal (Inches)	Curb Recommendation
4,965	0.085	NOT APPLICABLE	NOT APPLICABLE
Curb Type		Curb & Gutter Type	
NO CURB		NO CURB AND GUTTER	
Pavement Recommendation		Condition Rating / PCR	
LIGHT 3R TREATMENTS		FAIR / 73

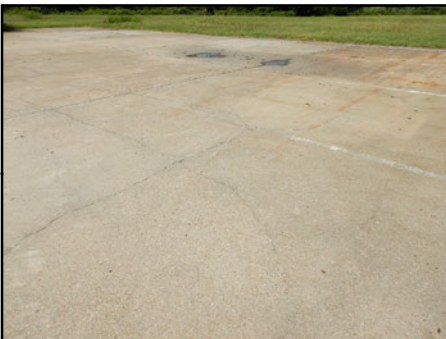
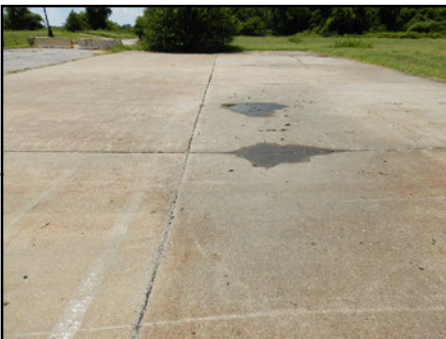
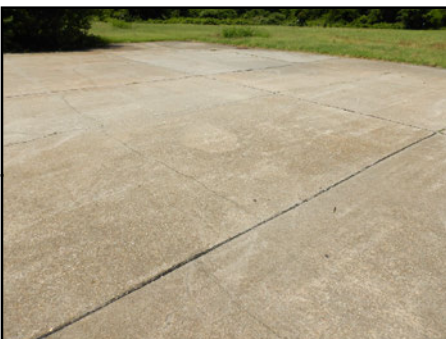
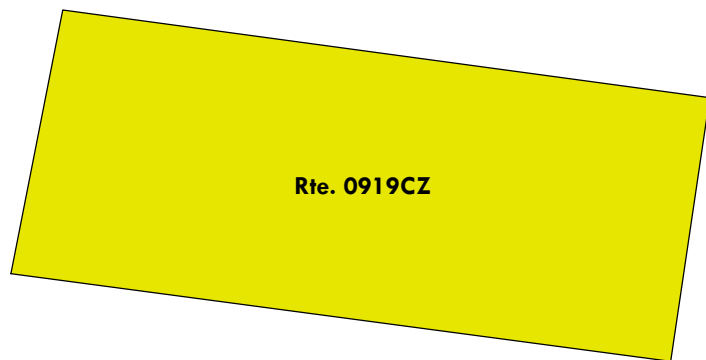
ROUTE 0924: NORTH BEACH FIELD PARKING

Inspection Date	FMSS Number	User Access	Surface Type
7/19/2019		PUBLIC	CONCRETE
Area (Sq. Ft.)	Lane Miles (11' Widths)	Curb Reveal (Inches)	Curb Recommendation
17,037	0.293	NOT APPLICABLE	NOT APPLICABLE
Curb Type		Curb & Gutter Type	
NO CURB		NO CURB AND GUTTER	
Pavement Recommendation		Condition Rating / PCR	
HEAVY 3R TREATMENTS		POOR / 53

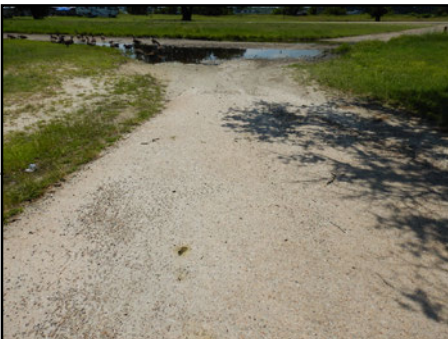
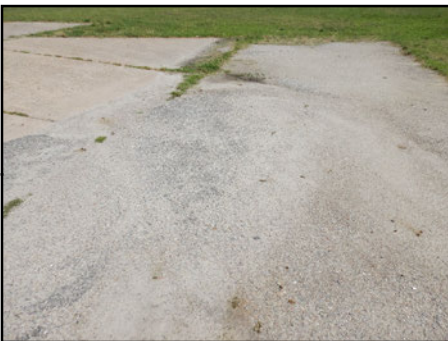
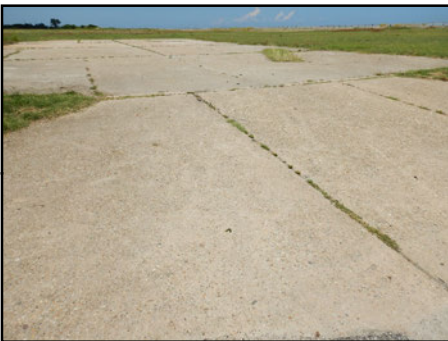
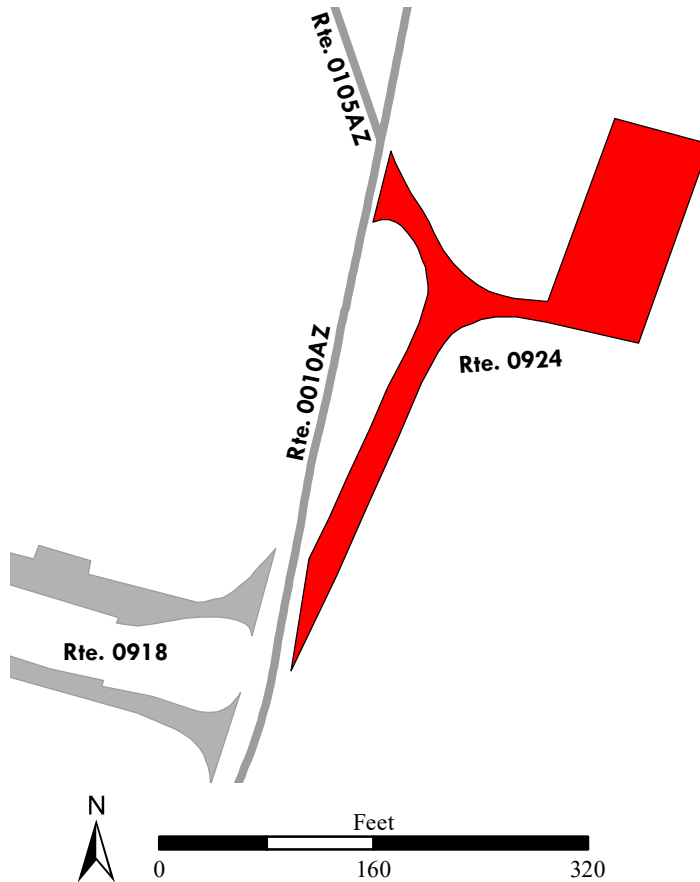
ROUTE 0926: PARADE GROUND PARKING

Inspection Date	FMSS Number	User Access	Surface Type
7/19/2019	248830	PUBLIC	BRICK PAVERS
Area (Sq. Ft.)	Lane Miles (11' Widths)	Curb Reveal (Inches)	Curb Recommendation
26,506	0.456	NOT APPLICABLE	NOT APPLICABLE
Curb Type		Curb & Gutter Type	
NO CURB		NO CURB AND GUTTER	
Pavement Recommendation		Condition Rating / PCR	
DO NOTHING		EXCELLENT / 97
