GARI Cycle 6

Final Report

Road Inventory and Condition Assessment of Paved Routes Gauley River National Recreation Area

Report Date: April 2022

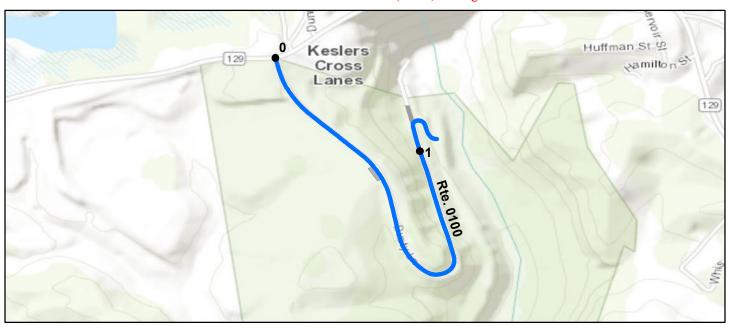
ROUTE 0100: GAULEY TAILWATERS ACCESS ROAD

Route (Condition Legend – Pav	ement Condi	tion Rating (PCR)		
Poor (0 - 60			(85 - 94)	Excellent (Not Ra	ted
Colors	on map represent con	dition scores at 0.10-mile	intervals. Se	e Appendix fo	or definitions	and formulas.	
Inspection Date:	7/14/2021	Beginning Section MP	0	1			
Paved Length (Mile	es): 1.15	Section Length (MI)	1	0.15			
Surface Type:	ASPHALT	Route Summary					
Roadway Condition	Information						
Pavement Condition	n Rating (PCR)	100	100	100			
Surface Condition R	ating (SCR)	100	100	100			
Roughness Condition	n Index (RCI)	100	100	100			
Distress Index Value	es						
Structural Crack Inc	dex	100	100	100			
Alligator Crack Ind	lex	100	100	100			
Longitudinal Crack	Index	100	100	100			
Transverse Crackin	g Index	100	100	100			
Patching Index		100	100	100			
Rutting Index		100	100	100			
International Rough	nness Index (IRI)	85	85	85			
Lane & Width Info	rmation						
Number of Lanes		2	2	2			
Paved Width (ft)		19.6	19.2	22

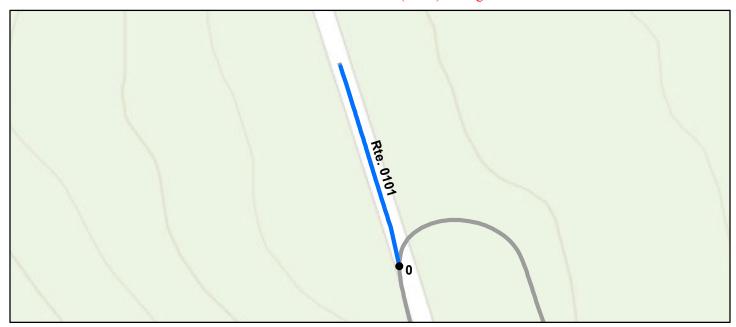
ROUTE 0101: HYDROPLANT ROAD

Dout	e Condition Legend – Pav	oment Cond	ition Dating (PCD)	
		(85 - 94)	Excellent (95 - 100)	Not Rated
	•	· /		
Colors on map represent c	ondition scores at 0.10-mile	e intervals. Se	e Appendix for definition	ons and formulas.
Inspection Date: 7/14/2021	Beginning Section MP	0		
Paved Length (Miles): 0.04	Section Length (MI)	0.04		
Surface Type: ASPHALT	Route Summary			
Roadway Condition Information				
Pavement Condition Rating (PCR)	100	100		
Surface Condition Rating (SCR)	100	100		
Roughness Condition Index (RCI)	N/A	N/A		
Distress Index Values				
Structural Crack Index	100	100		
Alligator Crack Index	100	100		
Longitudinal Crack Index	100	100		
Transverse Cracking Index	100	100		
Patching Index	100	100		
Rutting Index	100	100		
International Roughness Index (IRI)	N/A	N/A		
Lane & Width Information				
Number of Lanes	2	2		
Paved Width (ft)	17.2	17.2		
Lane Width (ft)	8.6	8.6

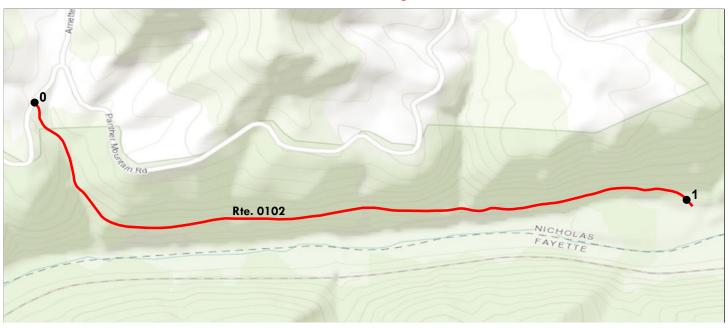
ROUTE 0102: MASONS BRANCH ACCESS ROAD

Route (Condition Legend – Pav	ement Condi	tion Rating (PCR)		
Poor (0 - 60	_		(85 - 94)	Excellent (9		Not Ra	ted
,		See Appendix for def					
Inspection Date:	10/26/2020	Beginning Section MP	0.00				
Paved Length (Mile	es): 1.05	Section Length (MI)	1.05				
Surface Type:	ASPHALT	Route Summary					
Roadway Condition	n Information						
Pavement Conditio	on Rating (PCR)	53	53				
Surface Condition R	Rating (SCR)	53	53				
Roughness Conditio	on Index (RCI)	N/A	N/A				
Distress Index Valu	es						
Structural Crack In	ıdex	N/A	N/A				
Alligator Crack Inc	dex	53	53				
Longitudinal Crack	x Index	90	90				
Transverse Crackin	ng Index	90	90				
Patching Index		73	73				
Rutting Index		90	90				
International Roug	hness Index (IRI)	N/A	N/A				
Lane & Width Info	rmation						
Number of Lanes		1	1				
Paved Width (ft)		9	9				
Lane Width (ft)		9	9
