GRSA Cycle 6

Final Report

Road Inventory and Condition Assessment of Paved Routes Great Sand Dunes National Park and Preserve

Report Date: December 2017

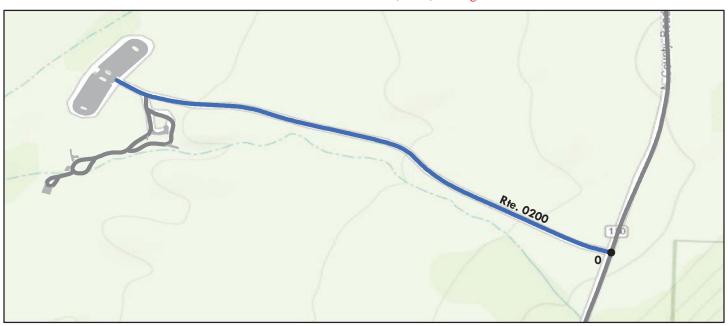
ROUTE 0200: DUNES PARKING ACCESS ROAD

Route (Condition Legend – Pav	ement Condi	tion Rating (PCR)		
Poor (0 - 6				Excellent (95 - 100)		Not Rated	
		See Appendix for def	finitions and f	ormulas			
Inspection Date:	5/30/2017	Beginning Section MP	0				
Paved Length (Miles): 0.53		Section Length (MI)	0.53				
Surface Type:	ASPHALT	Route Summary					
Roadway Condition	n Information						
Pavement Condition	on Rating (PCR)	99	99				
Surface Condition R	Rating (SCR)	99	99				
Roughness Condition	on Index (RCI)	100	100				
Distress Index Values							
Structural Crack In	ıdex	100	100				
Alligator Crack Inc	dex	100	100				
Longitudinal Crack	x Index	100	100				
Transverse Crackin	ng Index	99	99				
Patching Index		100	100				
Rutting Index		99	99				
International Roughness Index (IRI)		90	90				
Lane & Width Info	rmation						
Number of Lanes		2	2				
Paved Width (ft)		24.2	24.2				
Lane Width (ft)		11.4	11.4

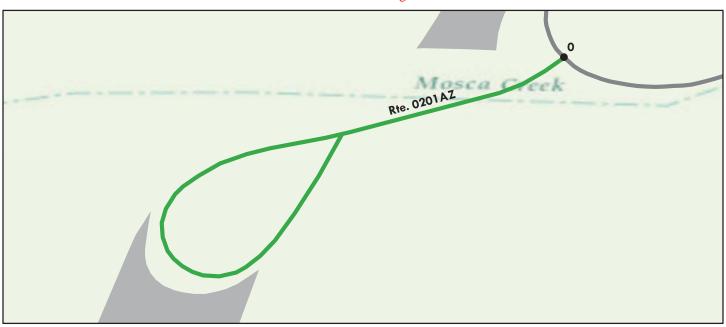
Subcomponent of Route GRSA-0201ZZ

Route	Condition Legend – Pav	ement Condi	ition Rating (P	CR)		
Poor (0 - 60) Fair (61- 84) Good ((85 - 94)	Excellent (95	5 - 100)	Not Ra	ted
	See Appendix for def	initions and f	ormulas			
Inspection Date: 5/30/2017	Beginning Section MP	0.00				
Paved Length (Miles): 0.05	Section Length (MI)	0.05				
Surface Type: ASPHALT	Route Summary					
Roadway Condition Information						
Pavement Condition Rating (PCR)	90	90				
Surface Condition Rating (SCR)	90	90				
Roughness Condition Index (RCI)	N/A	N/A				
Distress Index Values						
Structural Crack Index	N/A	N/A				
Alligator Crack Index	97	97				
Longitudinal Crack Index	97	97				
Transverse Cracking Index	90	90				
Patching Index	97	97				
Rutting Index	90	90				
International Roughness Index (IRI)	N/A	N/A				
Lane & Width Information						
Number of Lanes	1	1				
Paved Width (ft)	10	10				
Lane Width (ft)	10	10

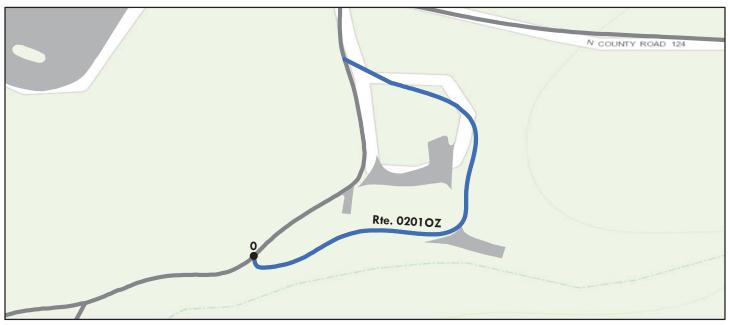
Subcomponent of Route GRSA-0201ZZ

Route (Condition Legend – Pav	ement Condi	tion Rating (PCR)		
Poor (0 - 60			(85 - 94)	Excellent (9		Not Ra	ted
		See Appendix for de	finitions and f	ormulas	,		
Inspection Date:	5/30/2017	Beginning Section MP	0				
Paved Length (Miles	s): 0.09	Section Length (MI)	0.09				
Surface Type:	ASPHALT	Route Summary				•	
Roadway Condition	Information						
Pavement Condition	n Rating (PCR)	95	95				
Surface Condition Ra	ating (SCR)	95	95				
Roughness Condition	n Index (RCI)	N/A	N/A				
Distress Index Value	es						
Structural Crack Inc	lex	100	100				
Alligator Crack Inde	ex	100	100				
Longitudinal Crack	Index	100	100				
Transverse Cracking	g Index	100	100				
Patching Index		100	100				
Rutting Index		95	95				
International Rough	ness Index (IRI)	N/A	N/A				
Lane & Width Infor	mation						
Number of Lanes		1	1				
Paved Width (ft)		13	13				
Lane Width (ft)		13	13

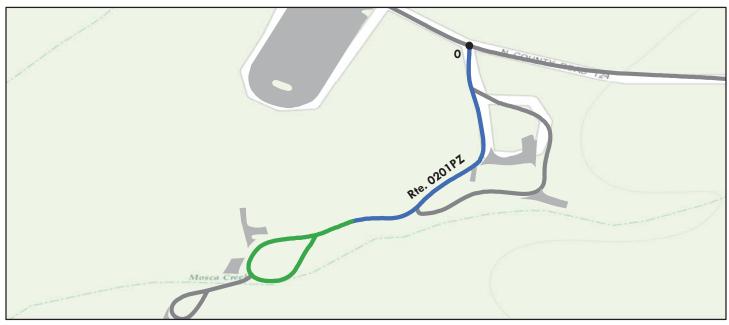
ROUTE 0201PZ: DUNES PICNIC AREA LOOP PRIMARY

Route (Condition Legend – Pav	ement Condi	ition Rating (PCR)		
Poor (0 - 6			(85 - 94)	Excellent (Not Ra	ted
		See Appendix for def	finitions and f	ormulas			
Inspection Date:	5/30/2017	Beginning Section MP	0				
Paved Length (Mile	es): 0.17	Section Length (MI)	0.17				
Surface Type:	ASPHALT	Route Summary			•		
Roadway Condition	n Information						
Pavement Condition	on Rating (PCR)	95	95				
Surface Condition F	Rating (SCR)	95	95				
Roughness Condition	on Index (RCI)	N/A	N/A				
Distress Index Valu	ies						
Structural Crack In	ıdex	100	100				
Alligator Crack Inc	dex	100	100				
Longitudinal Cracl	x Index	100	100				
Transverse Crackin	ng Index	99	99				
Patching Index		100	100				
Rutting Index		95	95				
International Roug	hness Index (IRI)	N/A	N/A				
Lane & Width Info	rmation						
Number of Lanes		1	1				
Paved Width (ft)		19.2	19.2				
Lane Width (ft)		13.1	13.1

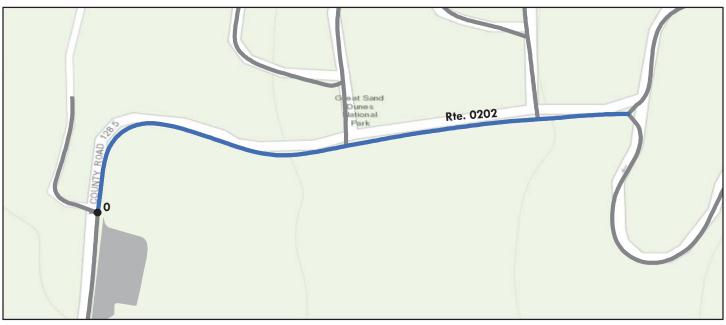
ROUTE 0202: PINON FLATS CAMPGROUND ROAD

Route (Condition Legend – Pav	ement Condi	ition Rating (PCR)		
Poor (0 - 60)			(85 - 94)	Excellent (9		Not Ra	ted
1 301 (0 30)	7 441 (0	See Appendix for def			200)	1100 210	
Inspection Date:	5/30/2017	Beginning Section MP					
Paved Length (Miles	s): 0.21	Section Length (MI)	0.21				
Surface Type:	ASPHALT	Route Summary					
Roadway Condition	Information						
Pavement Condition		99	99				
Surface Condition Ra	ating (SCR)	99	99				
Roughness Condition	n Index (RCI)	N/A	N/A				
Distress Index Value	es						
Structural Crack Inc	lex	100	100				
Alligator Crack Inde	ex	100	100				
Longitudinal Crack	Index	100	100				
Transverse Cracking	g Index	99	99				
Patching Index		100	100				
Rutting Index		99	99				
International Rough	ness Index (IRI)	N/A	N/A				
Lane & Width Infor	mation						
Number of Lanes		2	2				
Paved Width (ft)		20.8	20.8				
Lane Width (ft)		10.3	10.3

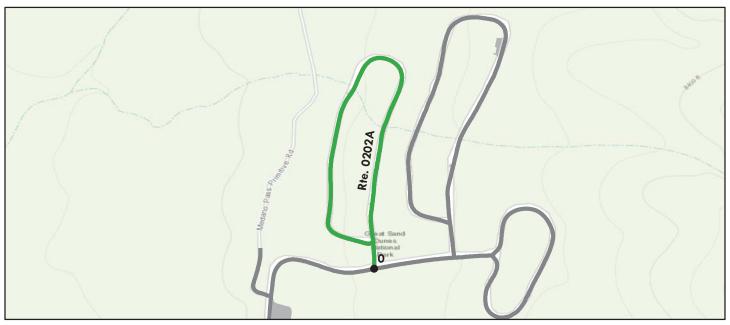
ROUTE 0202A: PINON FLATS CAMPGROUND LOOP A

Route (Condition Legend – Pav	ement Condi	ition Rating (PCR)		
Poor (0 - 60)	_		(85 - 94)	Excellent (9		Not Rat	ted
	- 55.00 (5	See Appendix for det					
Inspection Date:	5/30/2017	Beginning Section MP	0				
Paved Length (Miles	s): 0.43	Section Length (MI)	0.43				
Surface Type:	ASPHALT	Route Summary					
Roadway Condition	Information						
Pavement Condition	Rating (PCR)	88	88				
Surface Condition Ra	ting (SCR)	88	88				
Roughness Condition	Index (RCI)	N/A	N/A				
Distress Index Value	s						
Structural Crack Ind	ex	91	91				
Alligator Crack Inde	ex	100	100				
Longitudinal Crack	Index	91	91				
Transverse Cracking	Index	88	88				
Patching Index		100	100				
Rutting Index		98	98				
International Roughi	ness Index (IRI)	N/A	N/A				
Lane & Width Inform	mation						
Number of Lanes		1	1				
Paved Width (ft)		16.4	16.4				
Lane Width (ft)		15.3	15.3

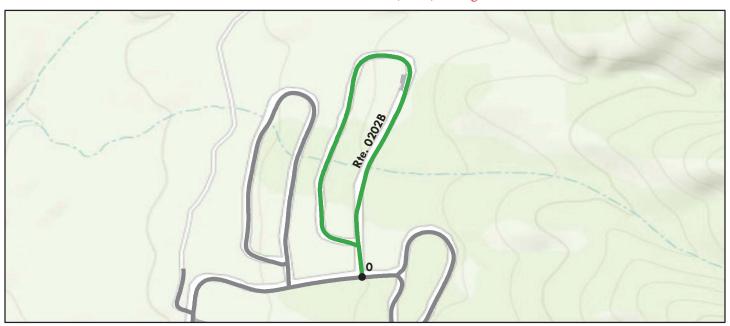
ROUTE 0202B: PINON FLATS CAMPGROUND LOOP B

Route (Condition Legend – Pav	ement Condi	ition Rating (PCR)		
Poor (0 - 60			(85 - 94)	Excellent (9		Not Ra	ted
		See Appendix for det	finitions and f	ormulas	·		
Inspection Date:	5/30/2017	Beginning Section MP	0				
Paved Length (Mile	es): 0.49	Section Length (MI)	0.49				
Surface Type:	ASPHALT	Route Summary					
Roadway Condition	Information						
Pavement Conditio	n Rating (PCR)	90	90				
Surface Condition R	ating (SCR)	90	90				
Roughness Condition	n Index (RCI)	N/A	N/A				
Distress Index Value	es						
Structural Crack In-	dex	96	96				
Alligator Crack Ind	lex	100	100				
Longitudinal Crack	Index	96	96				
Transverse Crackin	g Index	90	90				
Patching Index		100	100				
Rutting Index		97	97				
International Rough	nness Index (IRI)	N/A	N/A				
Lane & Width Info	rmation						
Number of Lanes		1	1				
Paved Width (ft)		14.6	14.6				
Lane Width (ft)		13.4	13.4

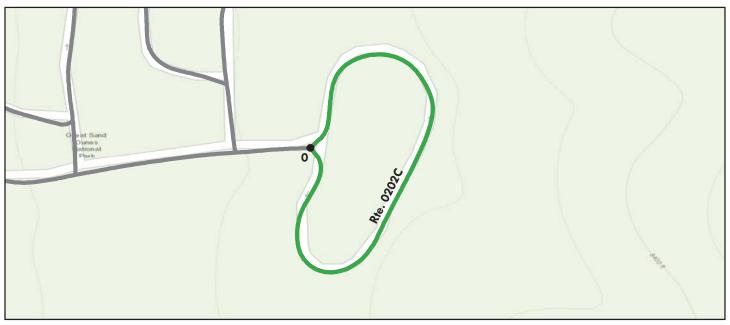
ROUTE 0202C: PINON FLATS CAMPGROUND LOOP C

Route (Condition Legend – Pav	rement Condi	ition Rating (PCR)		
Poor (0 - 60)			(85 - 94)	Excellent (Not Ra	ted
1 301 (0 30))	See Appendix for det				1100 2100	
Inspection Date:	5/30/2017	Beginning Section MP	0				
Paved Length (Miles	s): 0.25	Section Length (MI)	0.25				
Surface Type:	ASPHALT	Route Summary					
Roadway Condition	Information						
Pavement Condition	n Rating (PCR)	92	92				
Surface Condition Ra	ating (SCR)	92	92				
Roughness Condition	n Index (RCI)	N/A	N/A				
Distress Index Value	es						
Structural Crack Inc	lex	98	98				
Alligator Crack Inde	ex	100	100				
Longitudinal Crack	Index	98	98				
Transverse Cracking	g Index	92	92				
Patching Index		100	100				
Rutting Index		96	96				
International Rough	ness Index (IRI)	N/A	N/A				
Lane & Width Infor	mation						
Number of Lanes		2	2				
Paved Width (ft)		18.1	18.1				
Lane Width (ft)		9	9

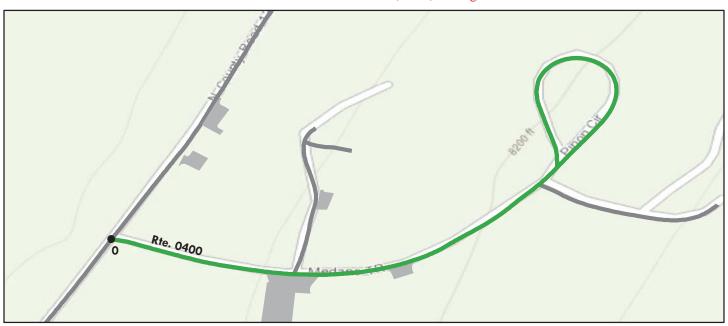
ROUTE 0400: RESIDENCE AND UTILITY ROAD

Route (Condition Legend – Pav	ement Condi	tion Rating (PCR)		
Poor (0 - 60	_		(85 - 94)	Excellent (9		Not Ra	ted
		See Appendix for def	finitions and f	ormulas	,		
Inspection Date:	5/30/2017	Beginning Section MP	0				
Paved Length (Mile	s): 0.37	Section Length (MI)	0.37				
Surface Type:	ASPHALT	Route Summary					
Roadway Condition	Information						
Pavement Condition	n Rating (PCR)	88	88				
Surface Condition R	ating (SCR)	88	88				
Roughness Condition	n Index (RCI)	N/A	N/A				
Distress Index Value	es						
Structural Crack Inc	dex	99	99				
Alligator Crack Ind	ex	100	100				
Longitudinal Crack	Index	99	99				
Transverse Crackin	g Index	88	88				
Patching Index		100	100				
Rutting Index		99	99				
International Rough	nness Index (IRI)	N/A	N/A				
Lane & Width Infor	rmation						
Number of Lanes		2	2				
Paved Width (ft)		20	20				
Lane Width (ft)		10	10

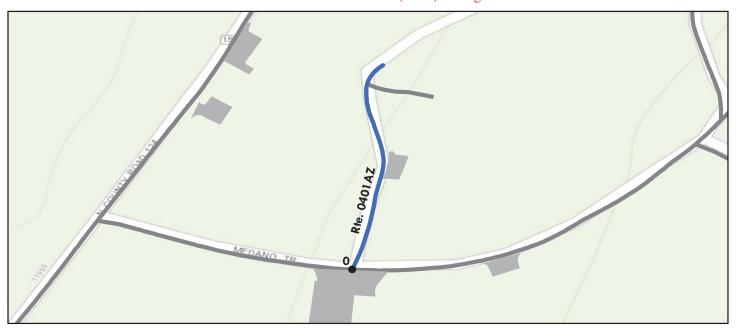
Subcomponent of Route GRSA-0401ZZ

Route (Condition Legend – Pav	ement Condi	tion Rating (PCR)		
Poor (0 - 6			(85 - 94)	Excellent (Not Ra	ted
		See Appendix for def	initions and f	ormulas			
Inspection Date:	5/30/2017	Beginning Section MP	0				
Paved Length (Mile	es): 0.09	Section Length (MI)	0.09				
Surface Type:	ASPHALT	Route Summary					
Roadway Condition	n Information						
Pavement Condition	on Rating (PCR)	95	95				
Surface Condition F	Rating (SCR)	95	95				
Roughness Condition	on Index (RCI)	N/A	N/A				
Distress Index Valu	ies						
Structural Crack In	ndex	99	99				
Alligator Crack Inc	dex	100	100				
Longitudinal Cracl	k Index	99	99				
Transverse Crackin	ng Index	95	95				
Patching Index		100	100				
Rutting Index		99	99				
International Roug	hness Index (IRI)	N/A	N/A				
Lane & Width Info	rmation						
Number of Lanes		1	1				
Paved Width (ft)		12	12				
Lane Width (ft)		12	12

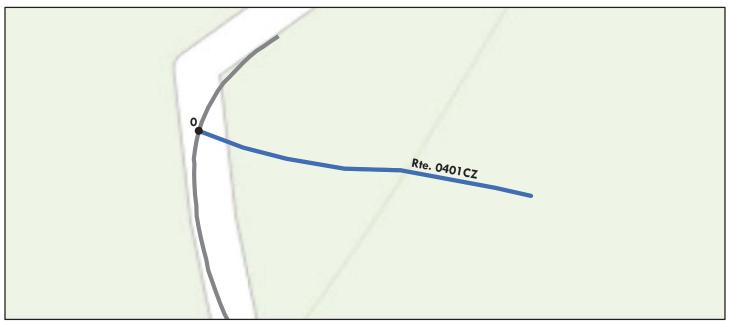
ROUTE 0401CZ: RESOURCE MANAGEMENT DRIVEWAY

Route (Condition Legend – Pav	ement Condi	ition Rating (PCR)		
Poor (0 - 6	_		(85 - 94)	Excellent (Not Ra	ted
		See Appendix for def	finitions and f	ormulas			
Inspection Date:	5/30/2017	Beginning Section MP	0				
Paved Length (Mile	es): 0.02	Section Length (MI)	0.02				
Surface Type:	ASPHALT	Route Summary		•			
Roadway Condition	n Information						
Pavement Condition	on Rating (PCR)	97	97				
Surface Condition F	Rating (SCR)	97	97				
Roughness Condition	on Index (RCI)	N/A	N/A				
Distress Index Valu	ies						
Structural Crack In	ndex	100	100				
Alligator Crack Inc	dex	100	100				
Longitudinal Cracl	k Index	100	100				
Transverse Crackin	ng Index	99	99				
Patching Index		99	99				
Rutting Index		97	97				
International Roug	hness Index (IRI)	N/A	N/A				
Lane & Width Info	rmation						
Number of Lanes		1	1				
Paved Width (ft)		10.8	10.8				
Lane Width (ft)		10.8	10.8

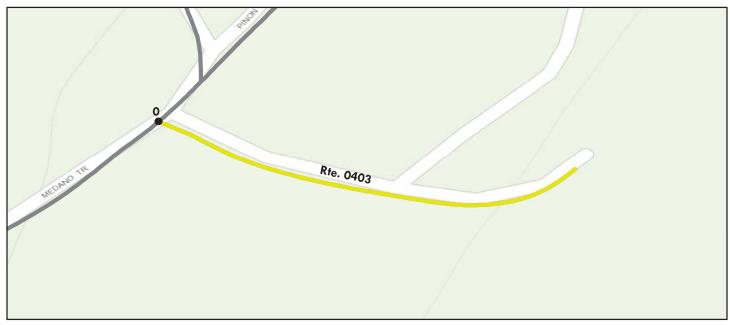
ROUTE 0403: NEW RESIDENCE ROAD

Route Condition Legend – Pavement Condition Rating (PCR)						
Poor (0 - 60			(85 - 94)	Excellent (Not Ra	ted
		See Appendix for det	1		· ·		
Inspection Date:	5/30/2017	Beginning Section MP	0				
Paved Length (Mile	es): 0.09	Section Length (MI)	0.09				
Surface Type:	ASPHALT	Route Summary					
Roadway Condition	Information						
Pavement Condition	n Rating (PCR)	84	84				
Surface Condition R	ating (SCR)	84	84				
Roughness Condition	n Index (RCI)	N/A	N/A				
Distress Index Value	es						
Structural Crack Inc	dex	97	97				
Alligator Crack Ind	lex	100	100				
Longitudinal Crack	Index	97	97				
Transverse Crackin	g Index	84	84				
Patching Index		100	100				
Rutting Index		98	98				
International Roughness Index (IRI)		N/A	N/A				
Lane & Width Info	rmation						·
Number of Lanes		2	2				
Paved Width (ft)		20.2	20.2				
Lane Width (ft)		10.1	10.1
