GUIIS Cycle 6

Final Report

Road Inventory and Condition Assessment of Paved Routes Gulf Islands National Seashore

Report Date: October 2020

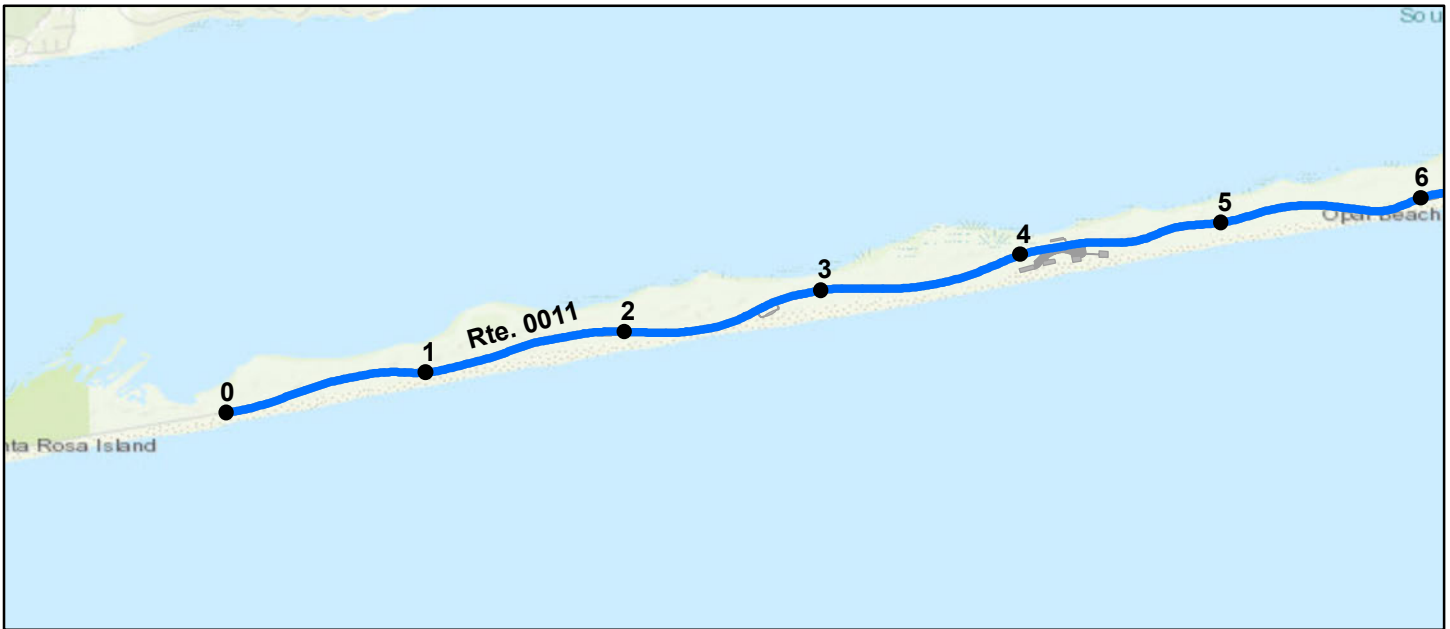
ROUTE 0011: J. EARLE BOWDEN WAY / STATE HIGHWAY 399

Route Condition Legend – Pavement Condition Rating (PCR)						
Poor (0 - 60)	Fair (61- 84)	Good (85 - 94)	Excellent (95 - 100)	Not Rated		
Colors on map represent condition scores at 0.10-mile intervals. See Appendix for definitions and formulas.						
Inspection Date: 4/11/2019	Beginning Section MP	0	1	2	3	4
Paved Length (Miles): 7.29	Section Length (MI)	1	1	1	1	1
Surface Type: ASPHALT	Route Summary					
Roadway Condition Information						
Pavement Condition Rating (PCR)	100	100	100	100	100	100
Surface Condition Rating (SCR)	100	100	100	100	100	100
Roughness Condition Index (RCI)	100	100	100	100	100	100
Distress Index Values						
Structural Crack Index	100	100	100	100	100	100
Alligator Crack Index	100	100	100	100	100	100
Longitudinal Crack Index	100	100	100	100	100	100
Transverse Cracking Index	100	100	100	100	100	100
Patching Index	100	100	100	100	100	100
Rutting Index	100	100	100	100	100	100
International Roughness Index (IRI)	63	73	63	59	58	60

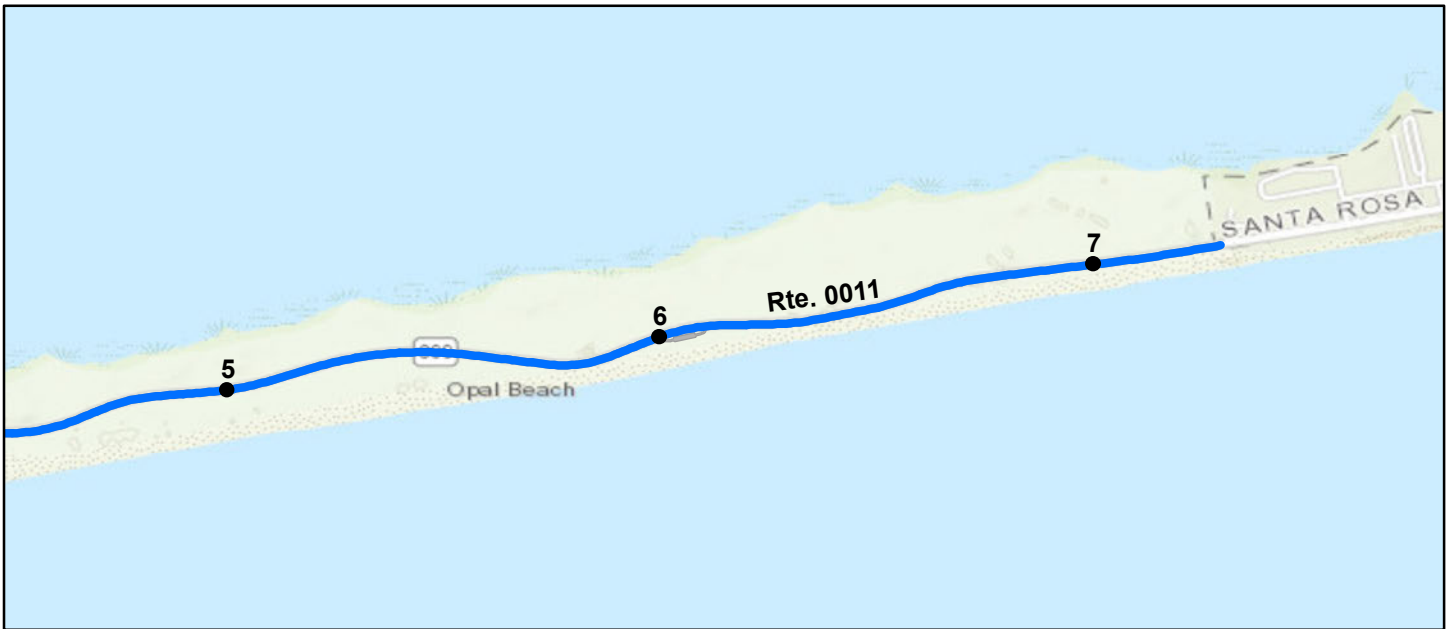
ROUTE 0011: J. EARLE BOWDEN WAY / STATE HIGHWAY 399

Route Condition Legend – Pavement Condition Rating (PCR)						
Poor (0 - 60)	Fair (61- 84)	Good (85 - 94)	Excellent (95 - 100)	Not Rated		
Colors on map represent condition scores at 0.10-mile intervals. See Appendix for definitions and formulas.						
Inspection Date: 4/11/2019	Beginning Section MP	5	6	7		
Paved Length (Miles): 7.29	Section Length (MI)	1	1	0.29		
Surface Type: ASPHALT	Route Summary					
Roadway Condition Information						
Pavement Condition Rating (PCR)	100	100	100	100		
Surface Condition Rating (SCR)	100	100	100	100		
Roughness Condition Index (RCI)	100	100	100	100		
Distress Index Values						
Structural Crack Index	100	100	100	100		
Alligator Crack Index	100	100	100	100		
Longitudinal Crack Index	100	100	100	100		
Transverse Cracking Index	100	100	100	100		
Patching Index	100	100	100	100		
Rutting Index	100	100	100	100		
International Roughness Index (IRI)	63	68	60	64		
Lane & Width Information

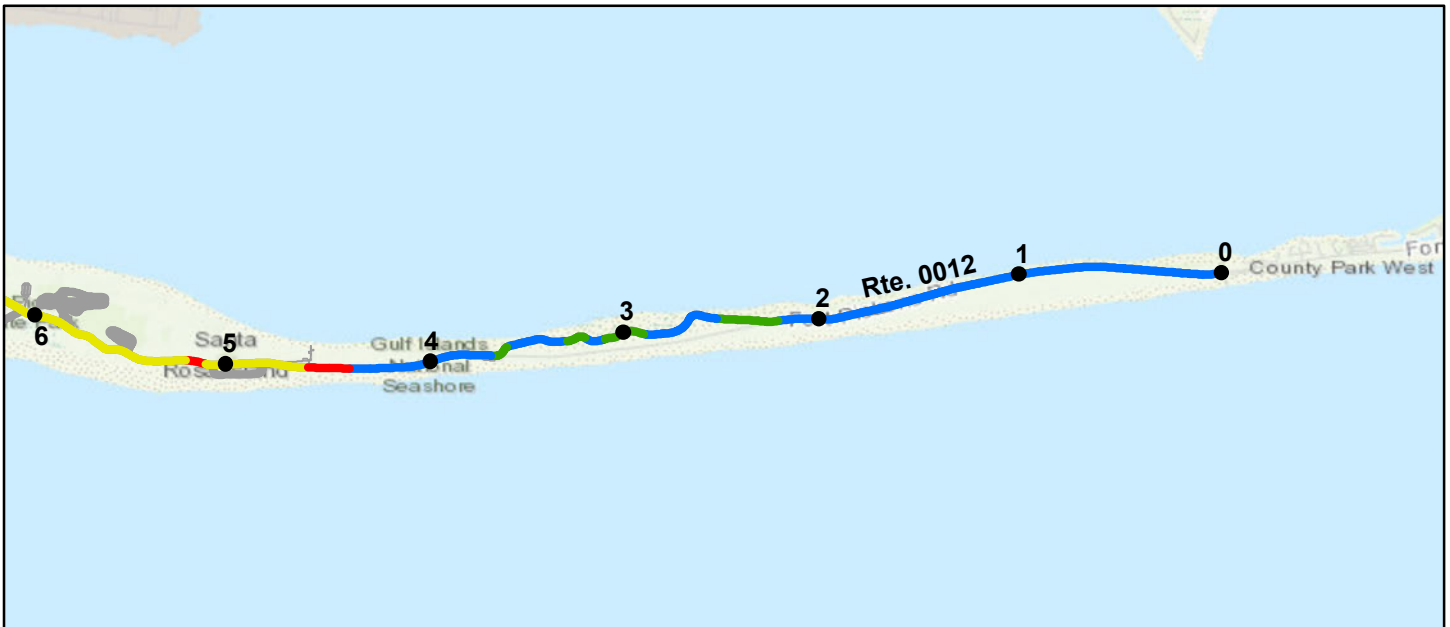
ROUTE 0012: FORT PICKENS ROAD

Inspection Date:	4/13/2019	Beginning Section MP	0	1	2	3	4
		Section Length (MI)	1	1	1	1	1
Paved Length (Miles):	7.22	Route Summary					
Surface Type:	ASPHALT						
Roadway Condition Information							
Pavement Condition Rating (PCR)	87	99	100	97	99	77	
Surface Condition Rating (SCR)	78	99	100	95	99	62	
Roughness Condition Index (RCI)	100	100	100	100	100	100	
Distress Index Values							
Structural Crack Index	97	100	100	100	100	86	
Alligator Crack Index	100	100	100	100	100	100	
Longitudinal Crack Index	97	100	100	100	100	86	
Transverse Cracking Index	78	100	100	100	100	62	
Patching Index	100	100	100	100	99	100	
Rutting Index	99	99	100	95	99	99	
International Roughness Index (IRI)	96	82	68	108	115	84	
Lane & Width Information							
Number of Lanes	2	2	2	2	2	2	
Paved Width (ft)	24.8	27	27.1	27.7	28.9	27.3	
Lane Width (ft)	9.3	9.7	9.9	9.9	10	9.6

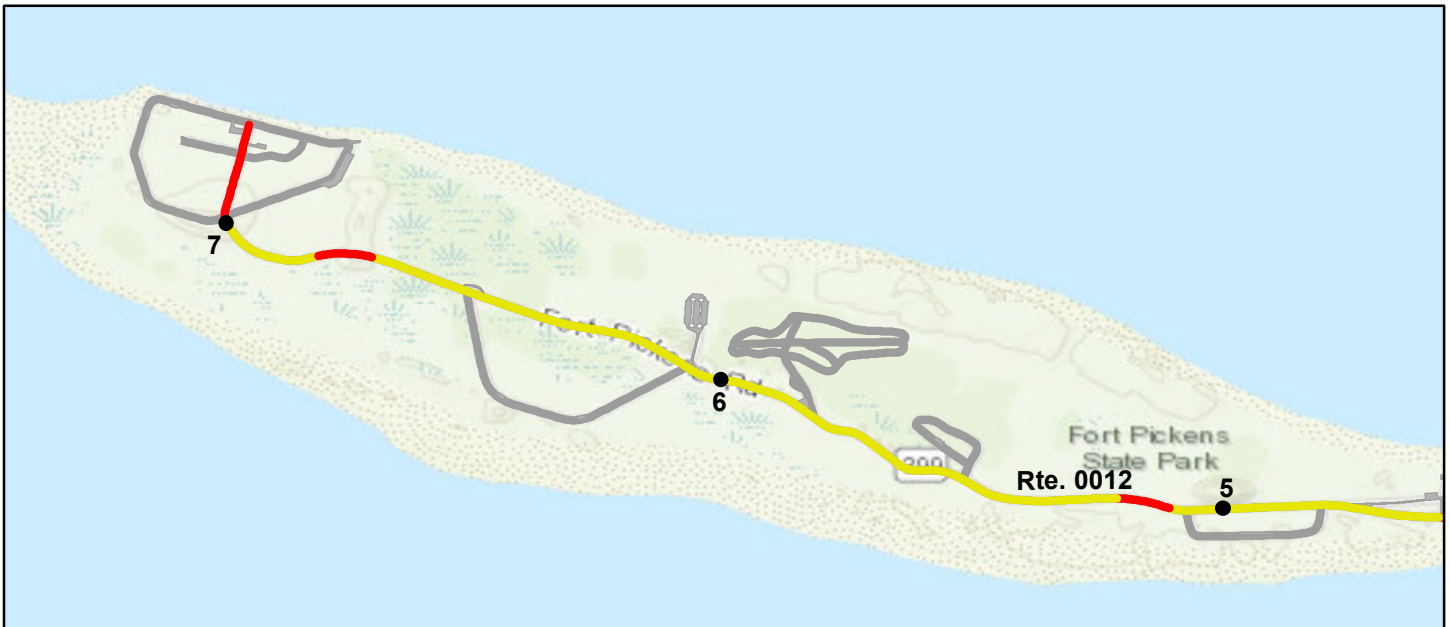
ROUTE 0012: FORT PICKENS ROAD

Beginning Section MP	5	6	7		
Inspection Date:	4/13/2019	Section Length (MI)	1	1	0.21		
Paved Length (Miles):	7.22	Route Summary					
Surface Type:	ASPHALT						
Roadway Condition Information							
Pavement Condition Rating (PCR)	87	66	69	56			
Surface Condition Rating (SCR)	78	44	49	30			
Roughness Condition Index (RCI)	100	100	100	95			
Distress Index Values							
Structural Crack Index	97	97	98	92			
Alligator Crack Index	100	100	100	100			
Longitudinal Crack Index	97	97	98	92			
Transverse Cracking Index	78	44	49	30			
Patching Index	100	100	100	100			
Rutting Index	99	99	100	99			
International Roughness Index (IRI)	96	104	104	128			
Lane & Width Information							
Number of Lanes	2	2	2	2			
Paved Width (ft)	24.8	18.2	18.5	18.7			
Lane Width (ft)	9.3	8.1	8	8

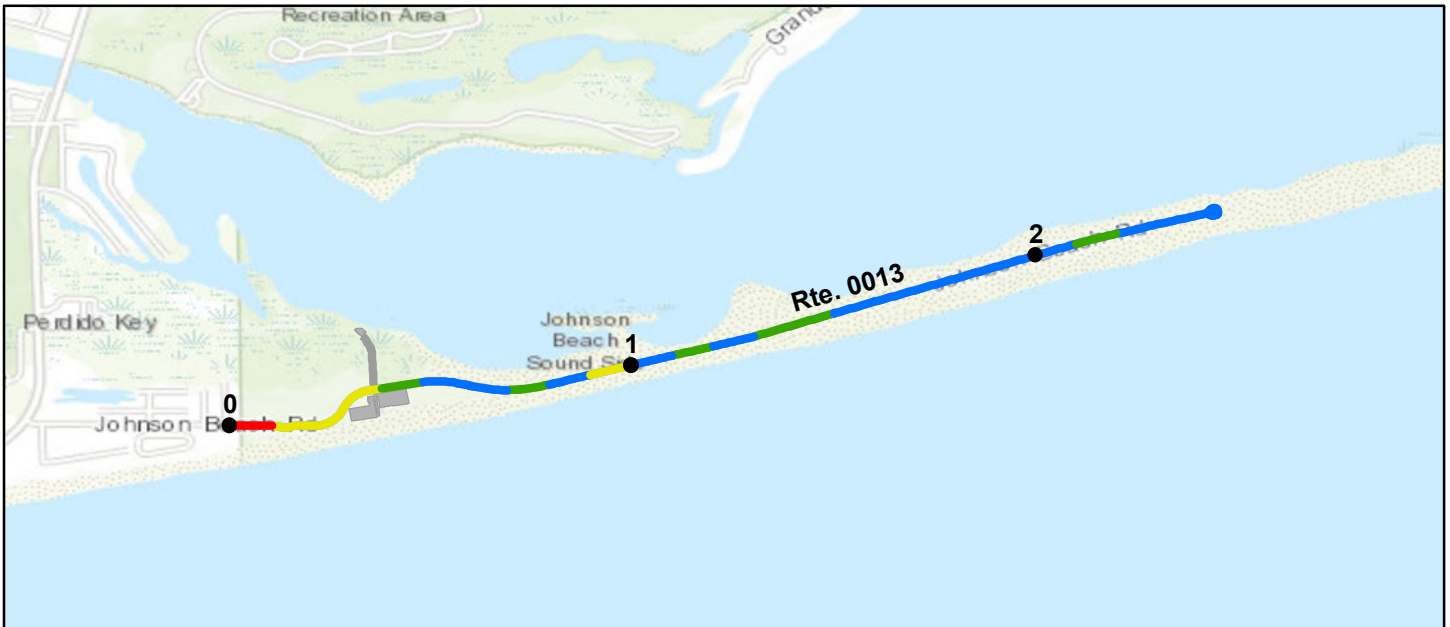
ROUTE 0013: JOHNSON BEACH ROAD

Route Condition Legend – Pavement Condition Rating (PCR)						
Poor (0 - 60)	Fair (61- 84)	Good (85 - 94)	Excellent (95 - 100)	Not Rated		
Colors on map represent condition scores at 0.10-mile intervals. See Appendix for definitions and formulas.						
Inspection Date: 4/11/2019	Beginning Section MP	0	1	2		
Paved Length (Miles): 2.48	Section Length (MI)	1	1	0.48		
Surface Type: ASPHALT	Route Summary					
Roadway Condition Information						
Pavement Condition Rating (PCR)	92	83	97	96		
Surface Condition Rating (SCR)	92	83	97	96		
Roughness Condition Index (RCI)	N/A	N/A	N/A	N/A		
Distress Index Values						
Structural Crack Index	96	96	97	96		
Alligator Crack Index	100	100	100	100		
Longitudinal Crack Index	96	96	97	96		
Transverse Cracking Index	92	83	97	99		
Patching Index	100	100	100	100		
Rutting Index	100	100	100	100		
International Roughness Index (IRI)	N/A	N/A	N/A	N/A		
Lane & Width Information						
Number of Lanes	2	2	2	2

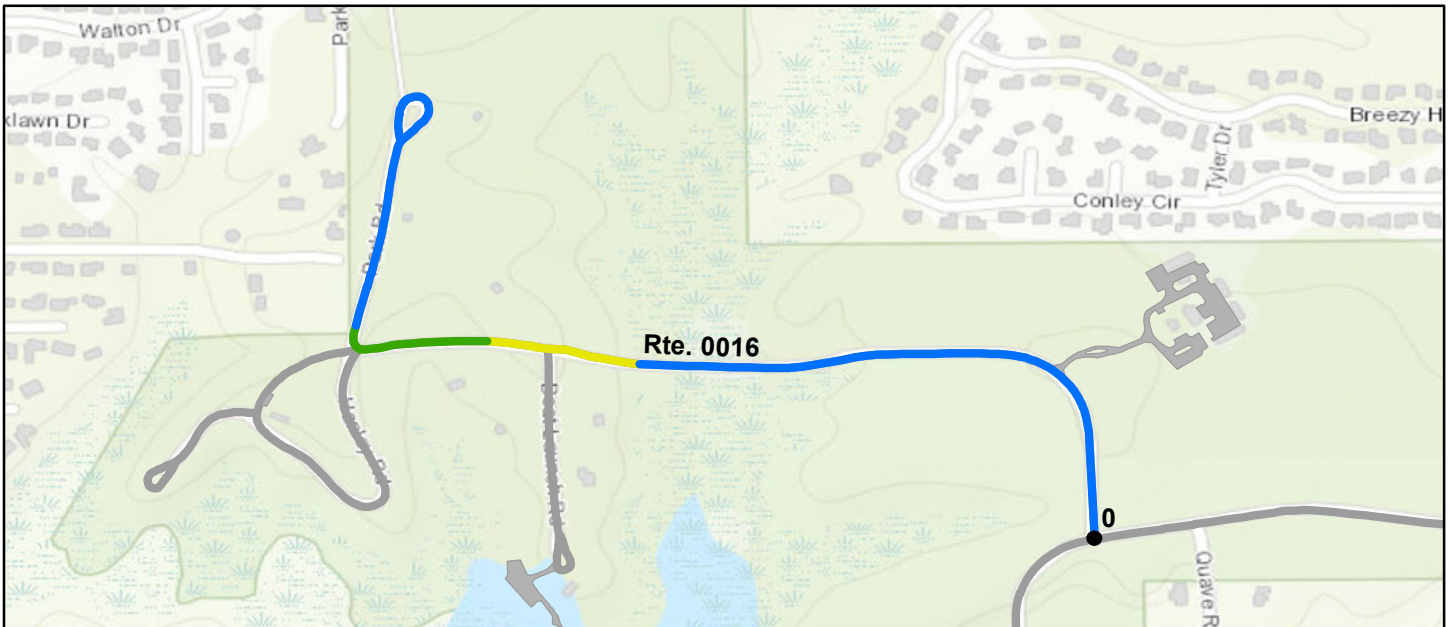
ROUTE 0016: ROBERT MCGEE ROAD

Route Condition Legend – Pavement Condition Rating (PCR)						
Poor (0 - 60)	Fair (61- 84)	Good (85 - 94)	Excellent (95 - 100)	Not Rated		
Colors on map represent condition scores at 0.10-mile intervals. See Appendix for definitions and formulas.						
Inspection Date:	4/13/2019	Beginning Section MP	0			
Paved Length (Miles):	0.82	Section Length (MI)	0.82			
Surface Type:	ASPHALT	Route Summary				
Roadway Condition Information						
Pavement Condition Rating (PCR)	95	95				
Surface Condition Rating (SCR)	95	95				
Roughness Condition Index (RCI)	N/A	N/A				
Distress Index Values						
Structural Crack Index	99	99				
Alligator Crack Index	100	100				
Longitudinal Crack Index	99	99				
Transverse Cracking Index	95	95				
Patching Index	100	100				
Rutting Index	100	100				
International Roughness Index (IRI)	N/A	N/A				
Lane & Width Information						
Number of Lanes	2	2				
Paved Width (ft)	21	21				
Lane Width (ft)	9.4	9.4

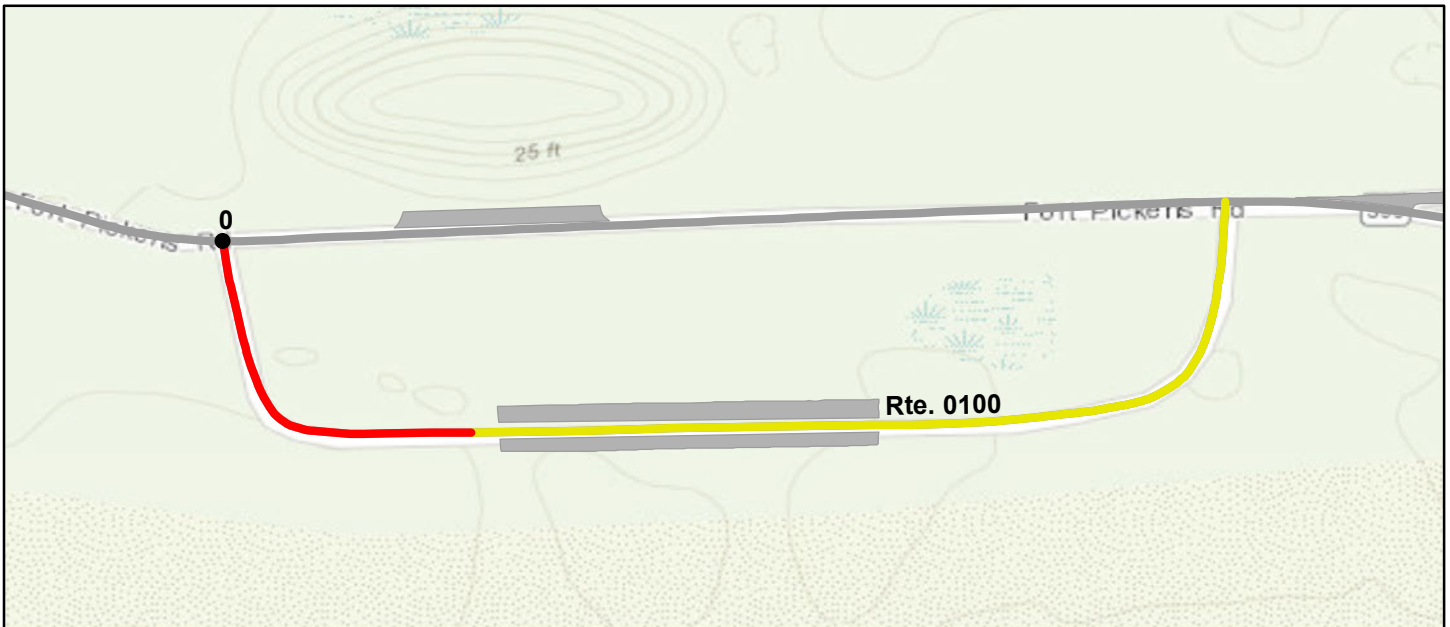
ROUTE 0100: LANGDON BEACH ACCESS ROAD

Route Condition Legend – Pavement Condition Rating (PCR)						
Poor (0 - 60)	Fair (61- 84)	Good (85 - 94)	Excellent (95 - 100)	Not Rated		
Colors on map represent condition scores at 0.10-mile intervals. See Appendix for definitions and formulas.						
Inspection Date:	4/12/2019	Beginning Section MP	0			
Paved Length (Miles):	0.33	Section Length (MI)	0.33			
Surface Type:	ASPHALT	Route Summary				
Roadway Condition Information						
Pavement Condition Rating (PCR)	60	60				
Surface Condition Rating (SCR)	60	60				
Roughness Condition Index (RCI)	N/A	N/A				
Distress Index Values						
Structural Crack Index	85	85				
Alligator Crack Index	100	100				
Longitudinal Crack Index	85	85				
Transverse Cracking Index	60	60				
Patching Index	100	100				
Rutting Index	95	95				
International Roughness Index (IRI)	N/A	N/A				
Lane & Width Information						
Number of Lanes	2	2				
Paved Width (ft)	20.1	20.1				
Lane Width (ft)	9.1	9.1

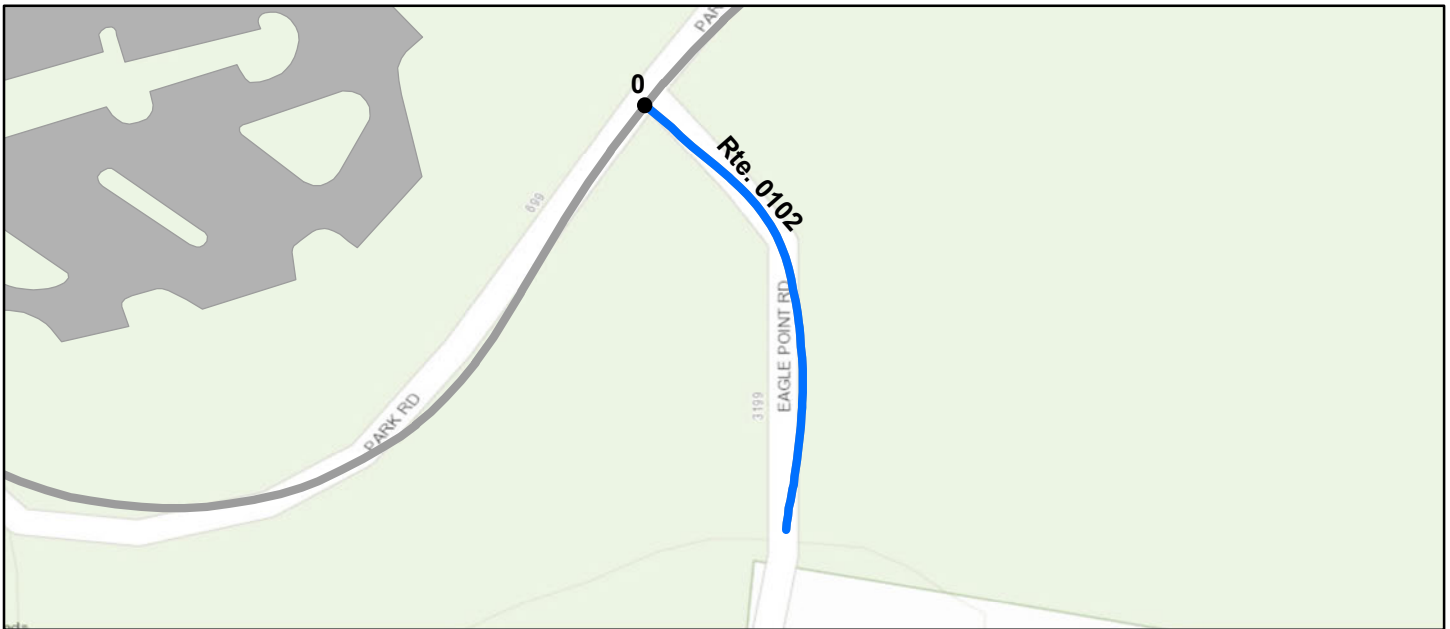
ROUTE 0102: EAGLE POINT ROAD

Route Condition Legend – Pavement Condition Rating (PCR)						
Poor (0 - 60)	Fair (61- 84)	Good (85 - 94)	Excellent (95 - 100)	Not Rated		
Colors on map represent condition scores at 0.10-mile intervals. See Appendix for definitions and formulas.						
Inspection Date: 4/13/2019	Beginning Section MP	0				
Paved Length (Miles): 0.06	Section Length (MI)	0.06				
Surface Type: ASPHALT	Route Summary					
Roadway Condition Information						
Pavement Condition Rating (PCR)	96	96				
Surface Condition Rating (SCR)	96	96				
Roughness Condition Index (RCI)	N/A	N/A				
Distress Index Values						
Structural Crack Index	99	99				
Alligator Crack Index	100	100				
Longitudinal Crack Index	99	99				
Transverse Cracking Index	98	98				
Patching Index	100	100				
Rutting Index	96	96				
International Roughness Index (IRI)	N/A	N/A				
Lane & Width Information						
Number of Lanes	2	2				
Paved Width (ft)	16.8	16.8				
Lane Width (ft)	8.4	8.4

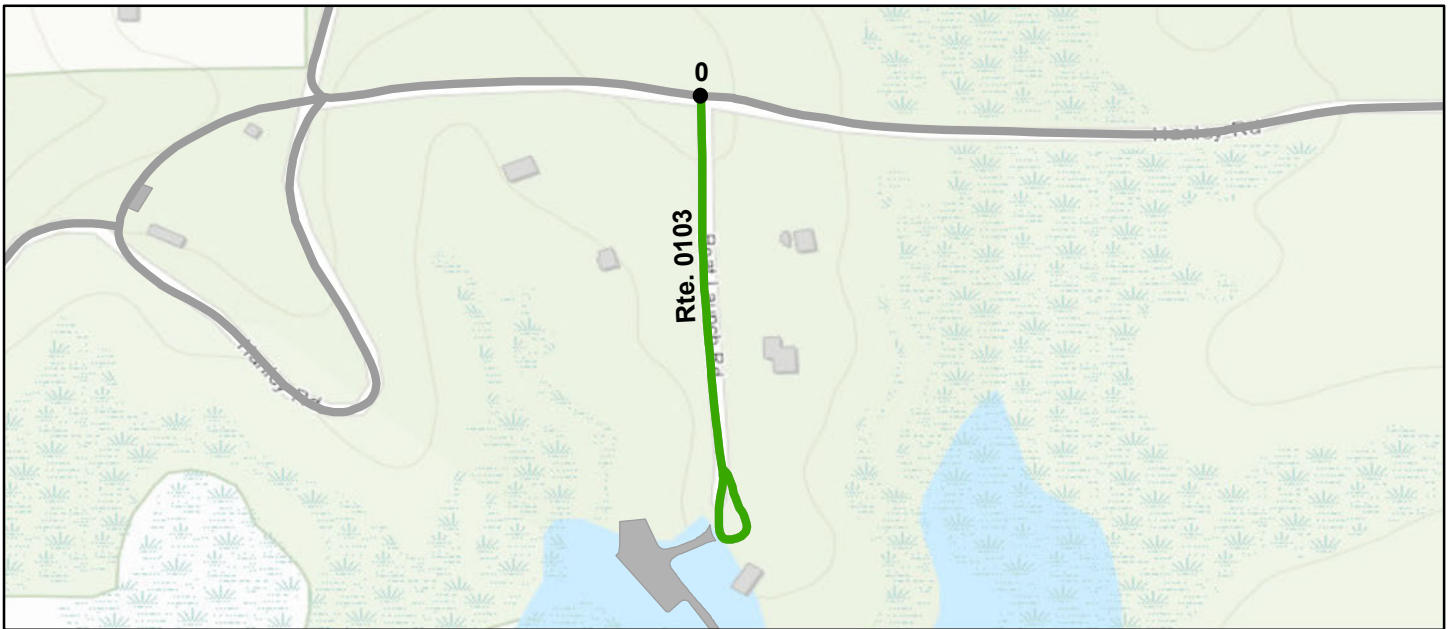
ROUTE 0103: BOAT LAUNCH ROAD

Route Condition Legend – Pavement Condition Rating (PCR)						
Poor (0 - 60)	Fair (61- 84)	Good (85 - 94)	Excellent (95 - 100)	Not Rated		
Colors on map represent condition scores at 0.10-mile intervals. See Appendix for definitions and formulas.						
Inspection Date:	4/13/2019	Beginning Section MP	0			
Paved Length (Miles):	0.19	Section Length (MI)	0.19			
Surface Type:	ASPHALT	Route Summary				
Roadway Condition Information						
Pavement Condition Rating (PCR)	86	86				
Surface Condition Rating (SCR)	86	86				
Roughness Condition Index (RCI)	N/A	N/A				
Distress Index Values						
Structural Crack Index	93	93				
Alligator Crack Index	100	100				
Longitudinal Crack Index	93	93				
Transverse Cracking Index	86	86				
Patching Index	100	100				
Rutting Index	99	99				
International Roughness Index (IRI)	N/A	N/A				
Lane & Width Information						
Number of Lanes	2	2				
Paved Width (ft)	17.6	17.6				
Lane Width (ft)	9.2	9.2

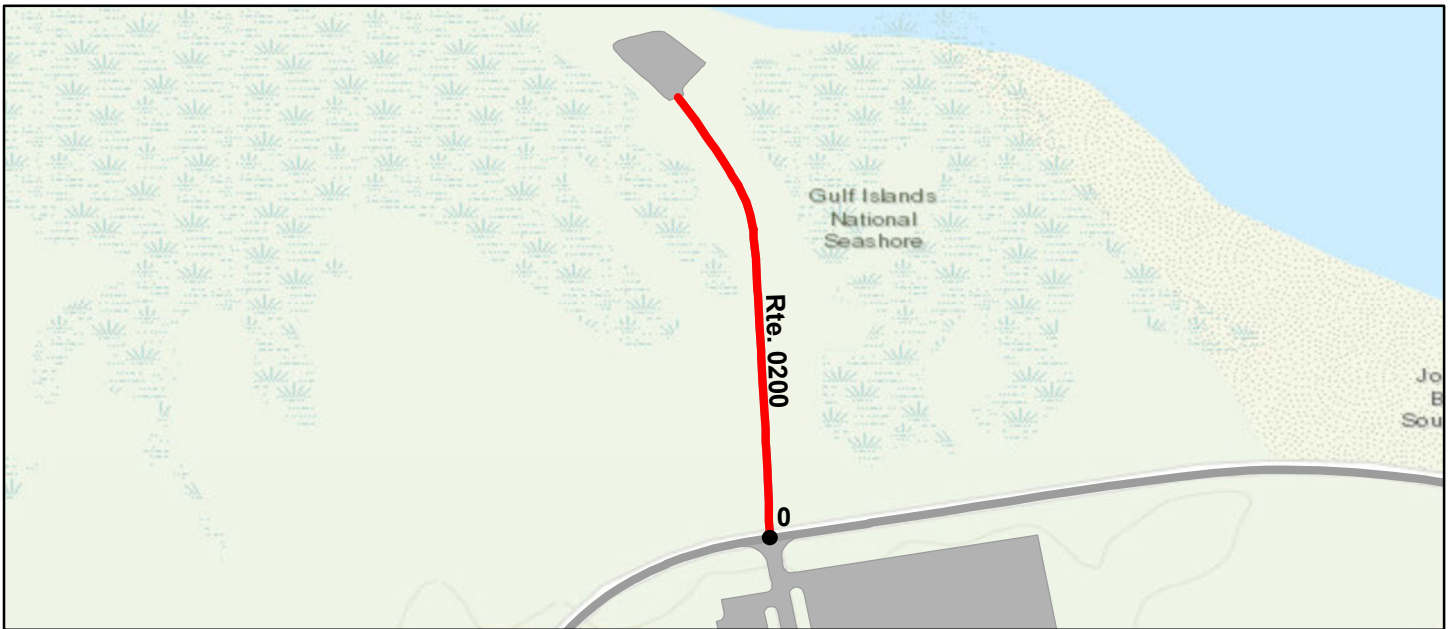
ROUTE 0200: NATURE TRAIL ACCESS ROAD

Inspection Date: 4/11/2019	Beginning Section MP	0				
Paved Length (Miles): 0.15	Section Length (MI)	0.15				
Surface Type: ASPHALT	Route Summary					
Roadway Condition Information						
Pavement Condition Rating (PCR)	44	44				
Surface Condition Rating (SCR)	44	44				
Roughness Condition Index (RCI)	N/A	N/A				
Distress Index Values						
Structural Crack Index	91	91				
Alligator Crack Index	100	100				
Longitudinal Crack Index	91	91				
Transverse Cracking Index	44	44				
Patching Index	100	100				
Rutting Index	100	100				
International Roughness Index (IRI)	N/A	N/A				
Lane & Width Information						
Number of Lanes	2	2				
Paved Width (ft)	20.3	20.3				
Lane Width (ft)	8.2	8.2

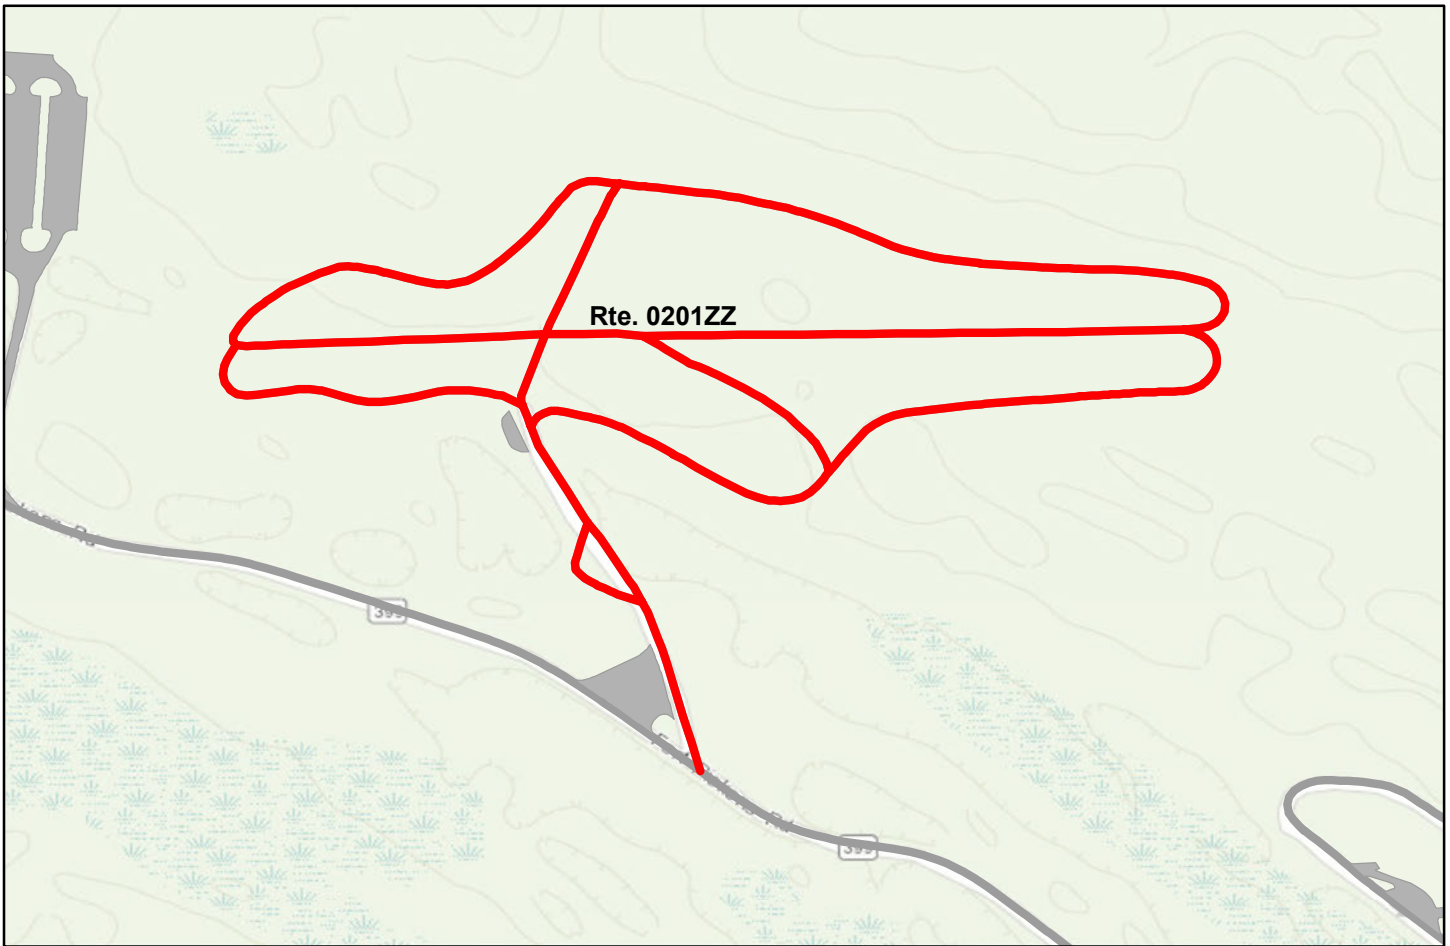
ROUTE 0201ZZ: FORT PICKENS CAMPGROUND LOOPS B-E

Route Condition Legend – Pavement Condition Rating (PCR)						
Poor (0 - 60)	Fair (61- 84)	Good (85 - 94)	Excellent (95 - 100)	Not Rated		
See Appendix for definitions and formulas						
Inspection Date:	4/12/2019					
Paved Length (Miles):	1.37					
Surface Type:	ASPHALT	Route Summary				
Roadway Condition Information						
Pavement Condition Rating (PCR)	55					
Lane & Width Information						
Number of Lanes	1					
Paved Width (ft)	12.3					
Lane Width (ft)	10.9

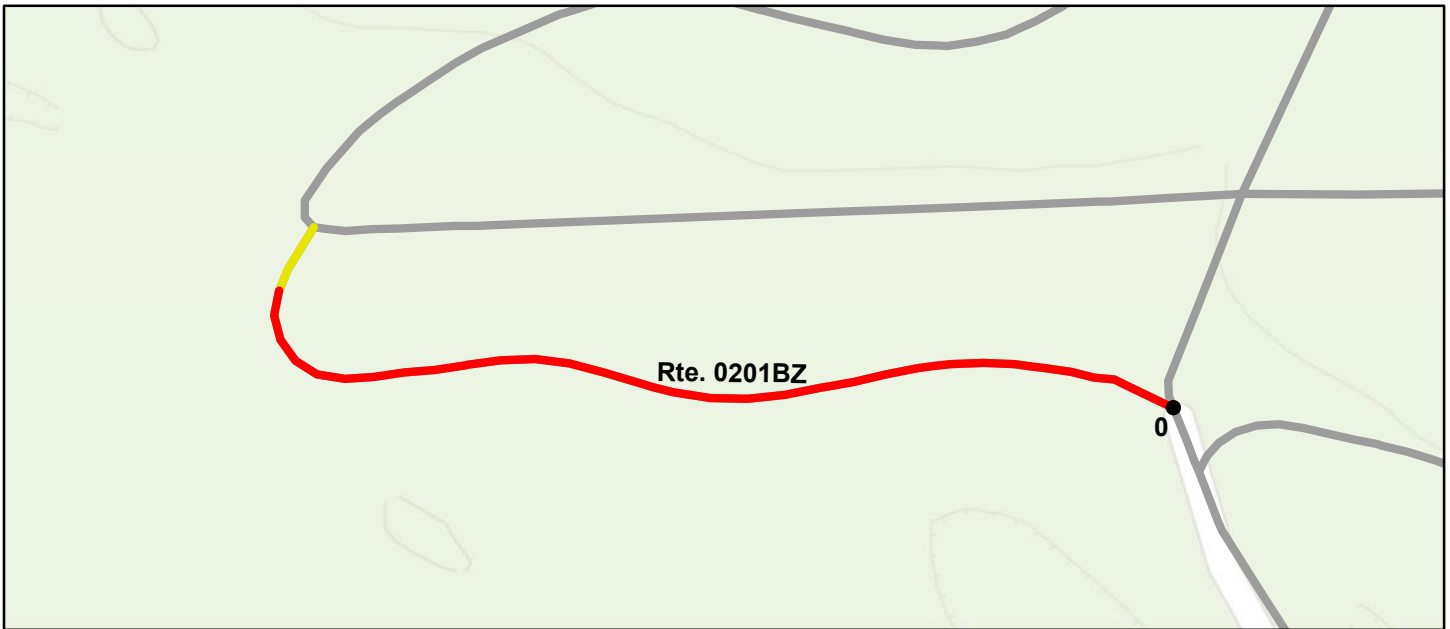
ROUTE 0201BZ: FORT PICKENS CAMPGROUND LOOP B

Route Condition Legend – Pavement Condition Rating (PCR)						
Poor (0 - 60)	Fair (61- 84)	Good (85 - 94)	Excellent (95 - 100)	Not Rated		
Colors on map represent condition scores at 0.10-mile intervals. See Appendix for definitions and formulas.						
Inspection Date:	4/12/2019	Beginning Section MP	0			
Paved Length (Miles):	0.11	Section Length (MI)	0.11			
Surface Type:	ASPHALT	Route Summary				
Roadway Condition Information						
Pavement Condition Rating (PCR)	39	39				
Surface Condition Rating (SCR)	39	39				
Roughness Condition Index (RCI)	N/A	N/A				
Distress Index Values						
Structural Crack Index	88	88				
Alligator Crack Index	100	100				
Longitudinal Crack Index	88	88				
Transverse Cracking Index	39	39				
Patching Index	100	100				
Rutting Index	95	95				
International Roughness Index (IRI)	N/A	N/A				
Lane & Width Information						
Number of Lanes	1	1				
Paved Width (ft)	11.3	11.3				
Lane Width (ft)	11.3	11.3

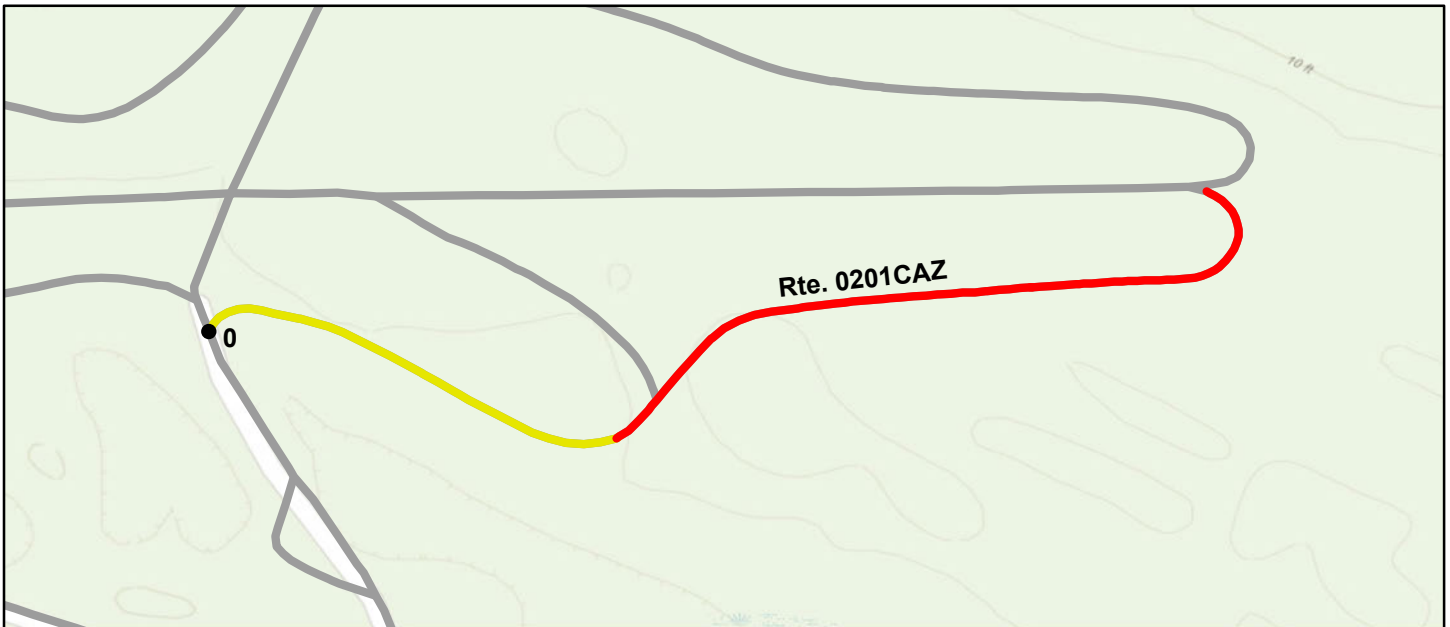
ROUTE 0201CAZ: FORT PICKENS CAMPGROUND LOOP C SITES C26 - C49

Inspection Date: 4/12/2019	Beginning Section MP	0				
Paved Length (Miles): 0.26	Section Length (MI)	0.26				
Surface Type: ASPHALT	Route Summary					
Roadway Condition Information						
Pavement Condition Rating (PCR)	59	59				
Surface Condition Rating (SCR)	59	59				
Roughness Condition Index (RCI)	N/A	N/A				
Distress Index Values						
Structural Crack Index	91	91				
Alligator Crack Index	100	100				
Longitudinal Crack Index	91	91				
Transverse Cracking Index	59	59				
Patching Index	100	100				
Rutting Index	98	98				
International Roughness Index (IRI)	N/A	N/A				
Lane & Width Information						
Number of Lanes	1	1				
Paved Width (ft)	11.2	11.2				
Lane Width (ft)	11.2	11.2

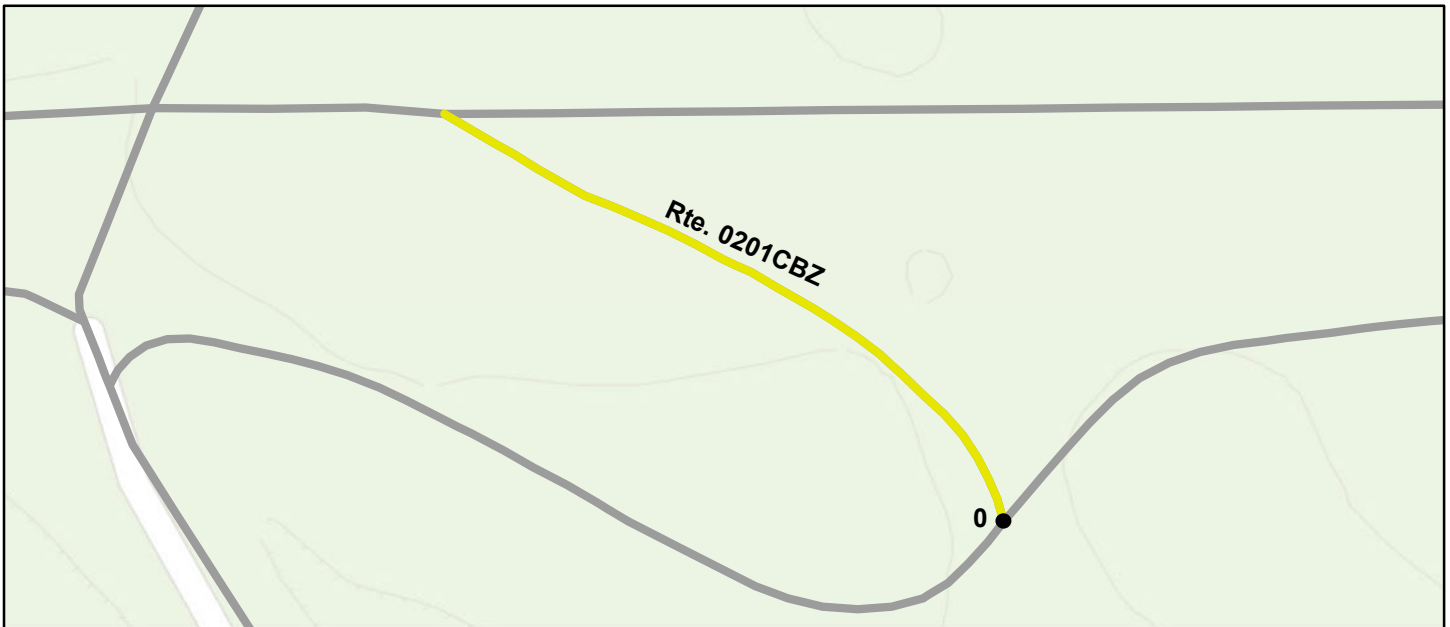
ROUTE 0201CBZ: FORT PICKENS CAMPGROUND LOOP C SITES C14 - C25

Route Condition Legend – Pavement Condition Rating (PCR)						
Poor (0 - 60)	Fair (61- 84)	Good (85 - 94)	Excellent (95 - 100)	Not Rated		
Colors on map represent condition scores at 0.10-mile intervals. See Appendix for definitions and formulas.						
Inspection Date: 4/12/2019	Beginning Section MP	0				
Paved Length (Miles): 0.08	Section Length (MI)	0.08				
Surface Type: ASPHALT	Route Summary					
Roadway Condition Information						
Pavement Condition Rating (PCR)	65	65				
Surface Condition Rating (SCR)	65	65				
Roughness Condition Index (RCI)	N/A	N/A				
Distress Index Values						
Structural Crack Index	95	95				
Alligator Crack Index	100	100				
Longitudinal Crack Index	95	95				
Transverse Cracking Index	65	65				
Patching Index	100	100				
Rutting Index	93	93				
International Roughness Index (IRI)	N/A	N/A				
Lane & Width Information						
Number of Lanes	1	1				
Paved Width (ft)	11.4	11.4				
Lane Width (ft)	11.4	11.4

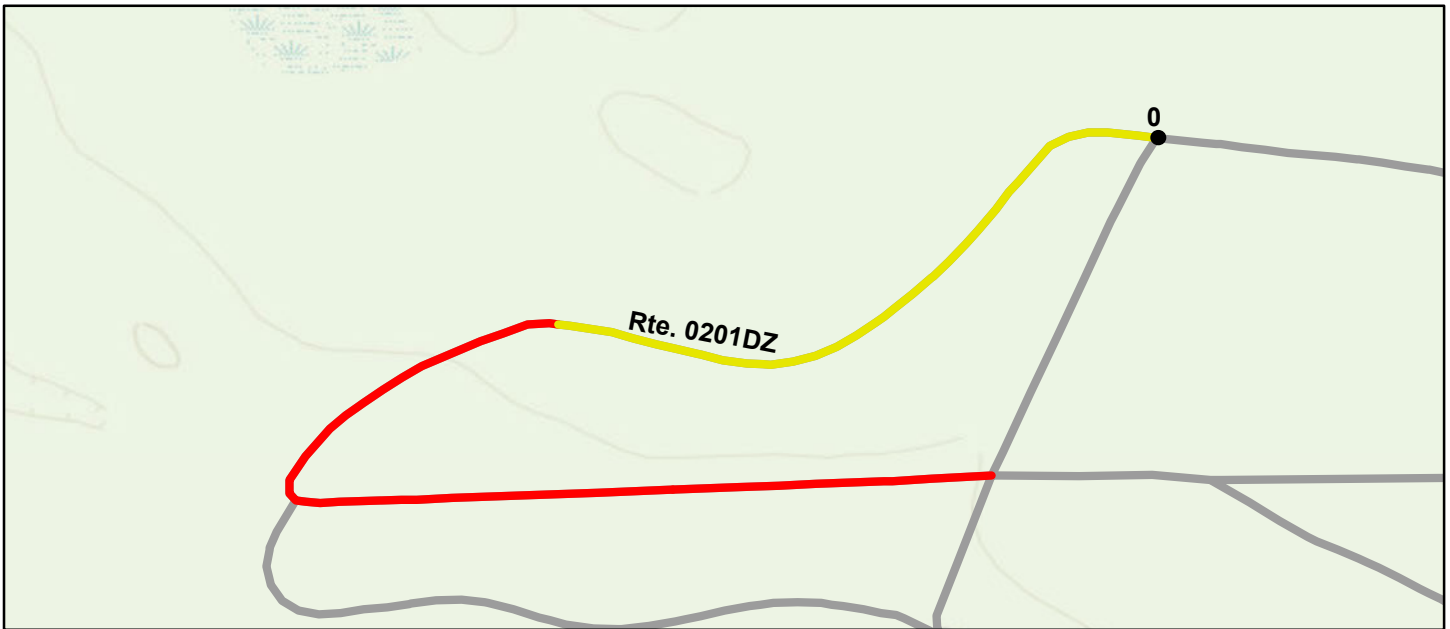
ROUTE 0201DZ: FORT PICKENS CAMPGROUND LOOP D

Route Condition Legend – Pavement Condition Rating (PCR)						
Poor (0 - 60)	Fair (61- 84)	Good (85 - 94)	Excellent (95 - 100)	Not Rated		
Colors on map represent condition scores at 0.10-mile intervals. See Appendix for definitions and formulas.						
Inspection Date:	4/12/2019	Beginning Section MP	0			
Paved Length (Miles):	0.24	Section Length (MI)	0.24			
Surface Type:	ASPHALT	Route Summary				
Roadway Condition Information						
Pavement Condition Rating (PCR)	57	57				
Surface Condition Rating (SCR)	57	57				
Roughness Condition Index (RCI)	N/A	N/A				
Distress Index Values						
Structural Crack Index	91	91				
Alligator Crack Index	100	100				
Longitudinal Crack Index	91	91				
Transverse Cracking Index	57	57				
Patching Index	100	100				
Rutting Index	94	94				
International Roughness Index (IRI)	N/A	N/A				
Lane & Width Information						
Number of Lanes	1	1				
Paved Width (ft)	10.8	10.8				
Lane Width (ft)	10.8	10.8

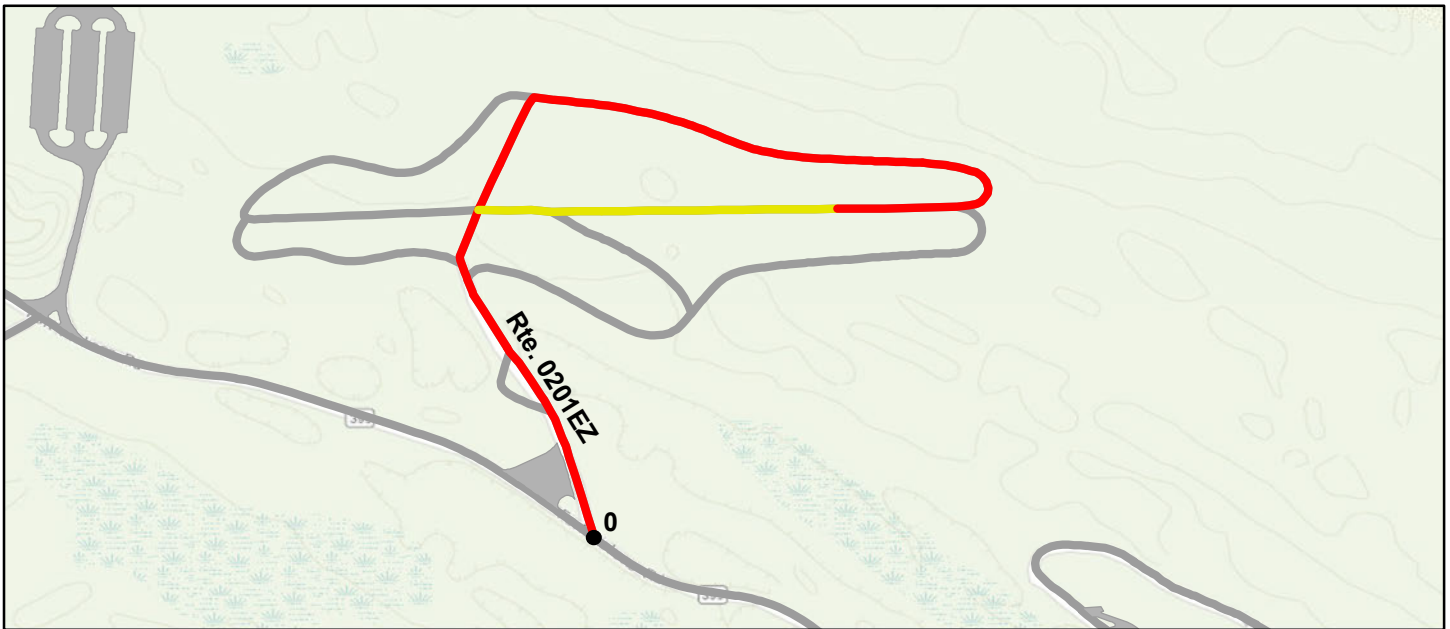
ROUTE 0201EZ: FORT PICKENS CAMPGROUND LOOP E

Route Condition Legend – Pavement Condition Rating (PCR)						
Poor (0 - 60)	Fair (61- 84)	Good (85 - 94)	Excellent (95 - 100)	Not Rated		
Colors on map represent condition scores at 0.10-mile intervals. See Appendix for definitions and formulas.						
Inspection Date: 4/12/2019	Beginning Section MP	0				
Paved Length (Miles): 0.66	Section Length (MI)	0.66				
Surface Type: ASPHALT	Route Summary					
Roadway Condition Information						
Pavement Condition Rating (PCR)	54	54				
Surface Condition Rating (SCR)	54	54				
Roughness Condition Index (RCI)	N/A	N/A				
Distress Index Values						
Structural Crack Index	93	93				
Alligator Crack Index	100	100				
Longitudinal Crack Index	93	93				
Transverse Cracking Index	54	54				
Patching Index	100	100				
Rutting Index	94	94				
International Roughness Index (IRI)	N/A	N/A				
Lane & Width Information						
Number of Lanes	1	1				
Paved Width (ft)	13.4	13.4				
Lane Width (ft)	10.4	10.4

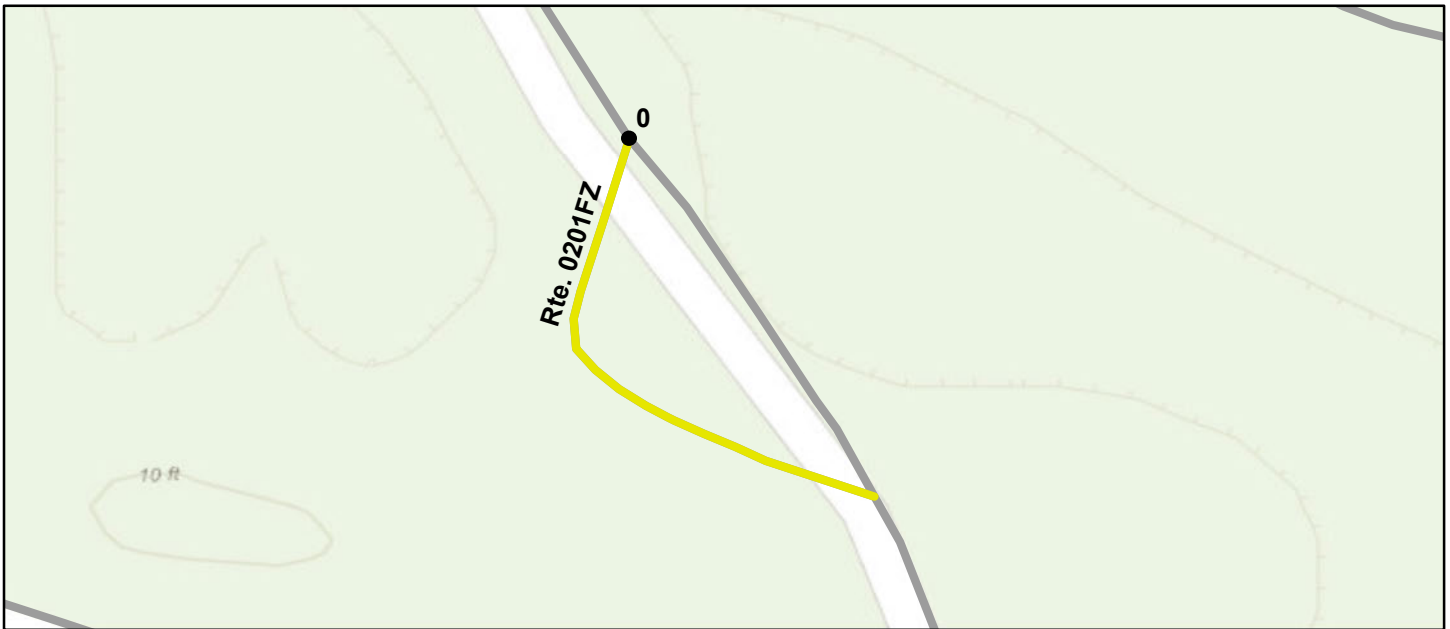
ROUTE 0201FZ: FORT PICKENS CAMPGROUND TURN AROUND

Route Condition Legend – Pavement Condition Rating (PCR)						
Poor (0 - 60)	Fair (61- 84)	Good (85 - 94)	Excellent (95 - 100)	Not Rated		
Colors on map represent condition scores at 0.10-mile intervals. See Appendix for definitions and formulas.						
Inspection Date: 4/12/2019	Beginning Section MP	0				
Paved Length (Miles): 0.03	Section Length (MI)	0.03				
Surface Type: ASPHALT	Route Summary					
Roadway Condition Information						
Pavement Condition Rating (PCR)	75	75				
Surface Condition Rating (SCR)	75	75				
Roughness Condition Index (RCI)	N/A	N/A				
Distress Index Values						
Structural Crack Index	97	97				
Alligator Crack Index	100	100				
Longitudinal Crack Index	97	97				
Transverse Cracking Index	75	75				
Patching Index	100	100				
Rutting Index	98	98				
International Roughness Index (IRI)	N/A	N/A				
Lane & Width Information						
Number of Lanes	1	1				
Paved Width (ft)	16	16				
Lane Width (ft)	16	16

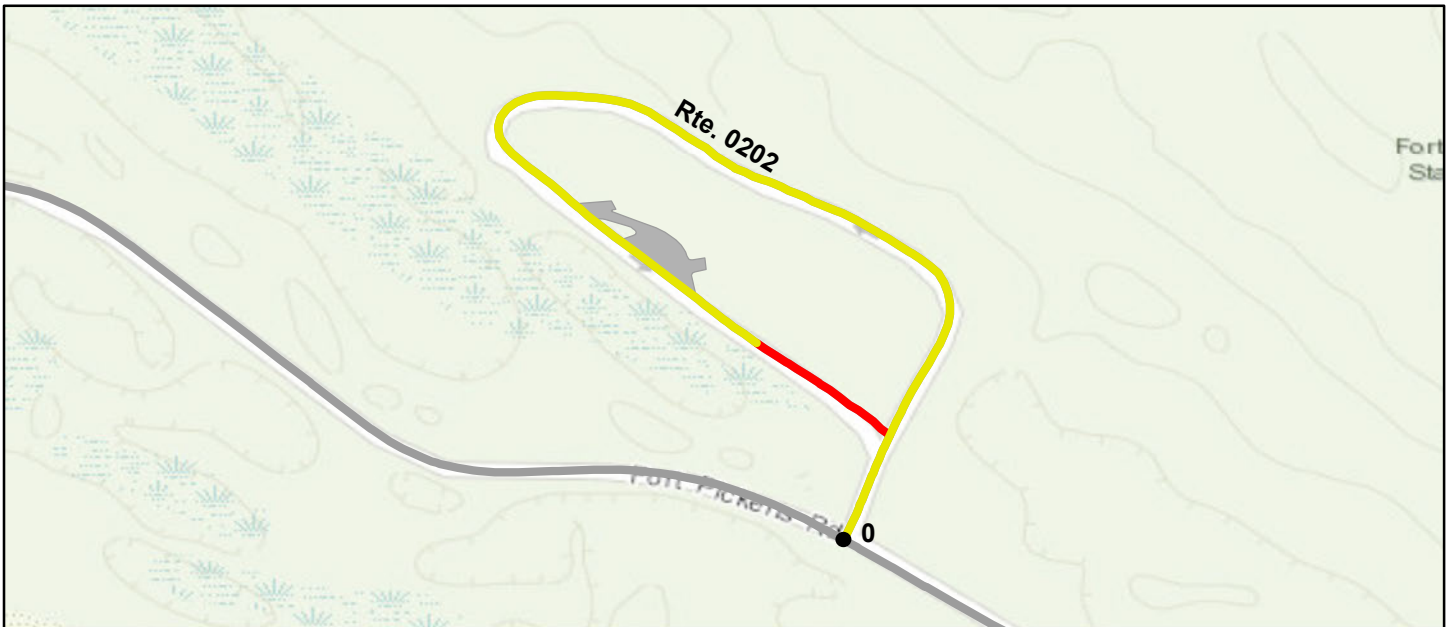
ROUTE 0202: FORT PICKENS CAMPGROUND MAIN LOOP A

Route Condition Legend – Pavement Condition Rating (PCR)						
Poor (0 - 60)	Fair (61- 84)	Good (85 - 94)	Excellent (95 - 100)	Not Rated		
Colors on map represent condition scores at 0.10-mile intervals. See Appendix for definitions and formulas.						
Inspection Date: 4/12/2019	Beginning Section MP	0				
Paved Length (Miles): 0.34	Section Length (MI)	0.34				
Surface Type: ASPHALT	Route Summary					
Roadway Condition Information						
Pavement Condition Rating (PCR)	71	71				
Surface Condition Rating (SCR)	71	71				
Roughness Condition Index (RCI)	N/A	N/A				
Distress Index Values						
Structural Crack Index	92	92				
Alligator Crack Index	100	100				
Longitudinal Crack Index	92	92				
Transverse Cracking Index	71	71				
Patching Index	100	100				
Rutting Index	97	97				
International Roughness Index (IRI)	N/A	N/A				
Lane & Width Information						
Number of Lanes	1	1				
Paved Width (ft)	13	13				
Lane Width (ft)	11.8	11.8
