GUIIS Cycle 6

Final Report

Road Inventory and Condition Assessment of Paved Routes Gulf Islands National Seashore

Report Date: October 2020

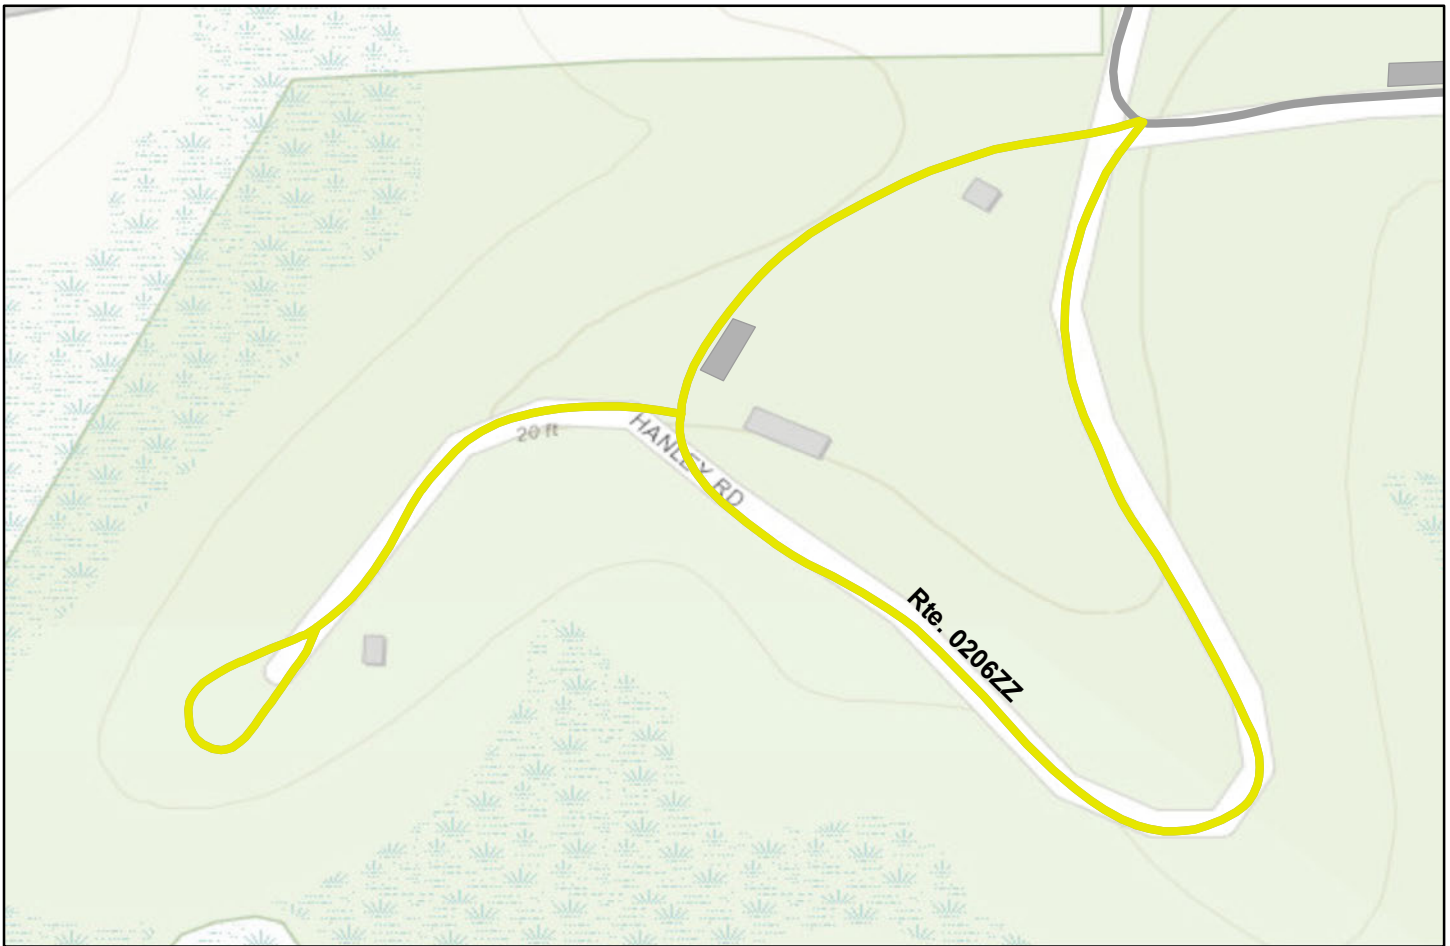
ROUTE 0206ZZ: DAVIS BAYOU CAMPGROUND ROADS

Route Condition Legend – Pavement Condition Rating (PCR)						
Poor (0 - 60)	Fair (61- 84)	Good (85 - 94)	Excellent (95 - 100)	Not Rated		
See Appendix for definitions and formulas						
Inspection Date:	4/13/2019					
Paved Length (Miles):	0.43					
Surface Type:	ASPHALT	Route Summary				
Roadway Condition Information						
Pavement Condition Rating (PCR)	66					
Lane & Width Information						
Number of Lanes	1					
Paved Width (ft)	17.3					
Lane Width (ft)	15.7

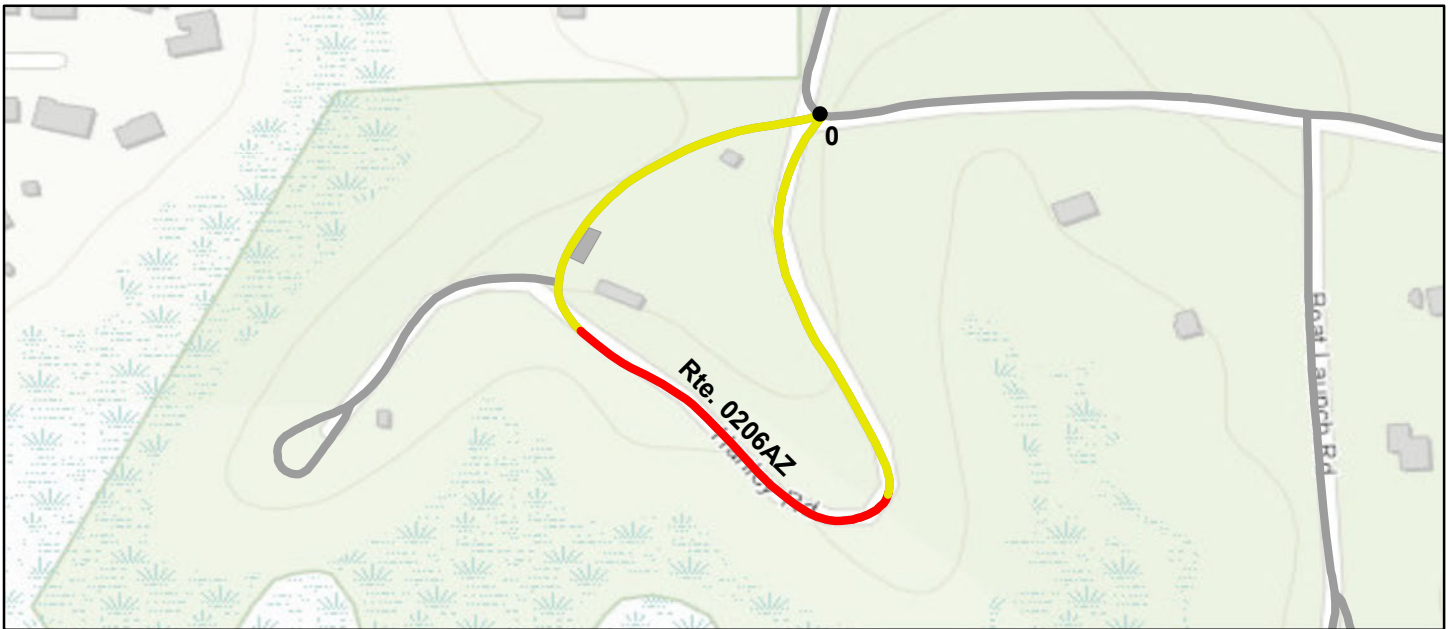
ROUTE 0206AZ: DAVIS BAYOU CAMPGROUND LOOP A

Route Condition Legend – Pavement Condition Rating (PCR)						
Poor (0 - 60)	Fair (61- 84)	Good (85 - 94)	Excellent (95 - 100)	Not Rated		
Colors on map represent condition scores at 0.10-mile intervals. See Appendix for definitions and formulas.						
Inspection Date:	4/13/2019	Beginning Section MP	0			
Paved Length (Miles):	0.31	Section Length (MI)	0.31			
Surface Type:	ASPHALT	Route Summary				
Roadway Condition Information						
Pavement Condition Rating (PCR)	60	60				
Surface Condition Rating (SCR)	60	60				
Roughness Condition Index (RCI)	N/A	N/A				
Distress Index Values						
Structural Crack Index	77	77				
Alligator Crack Index	100	100				
Longitudinal Crack Index	77	77				
Transverse Cracking Index	60	60				
Patching Index	100	100				
Rutting Index	95	95				
International Roughness Index (IRI)	N/A	N/A				
Lane & Width Information						
Number of Lanes	1	1				
Paved Width (ft)	16.6	16.6				
Lane Width (ft)	16.6	16.6

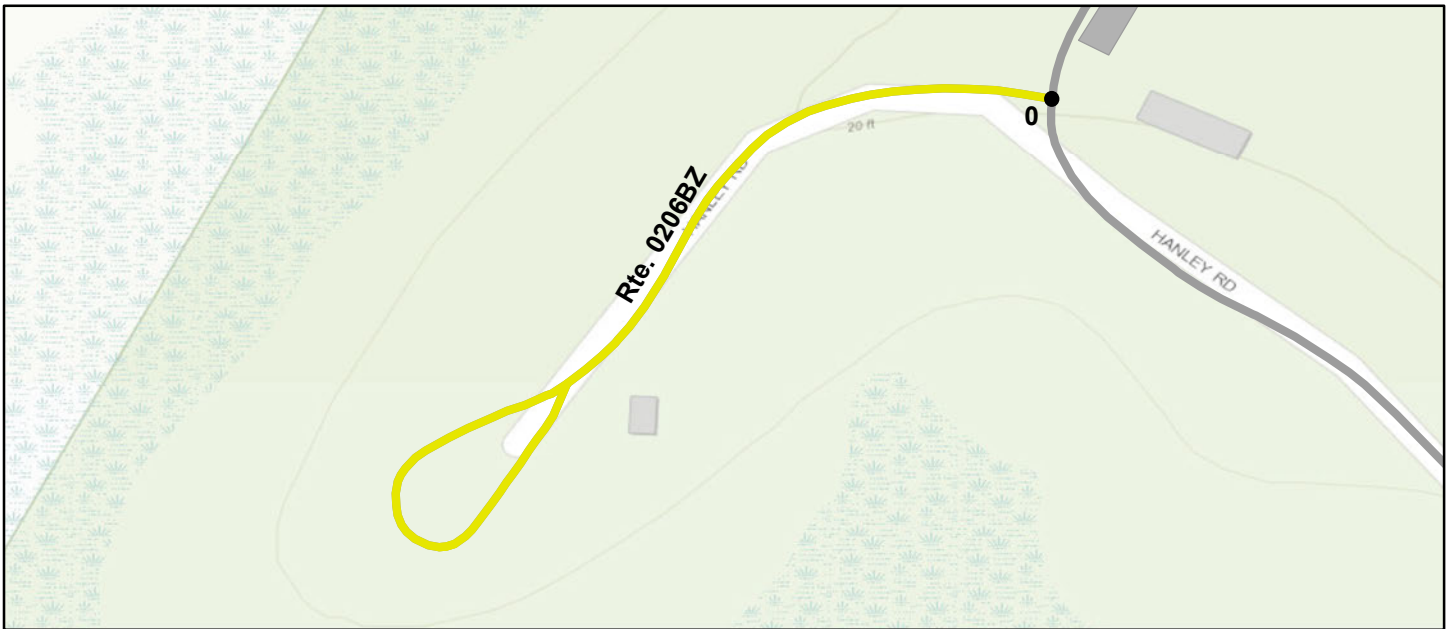
ROUTE 0206BZ: DAVIS BAYOU CAMPGROUND LOOP B

Route Condition Legend – Pavement Condition Rating (PCR)						
Poor (0 - 60)	Fair (61- 84)	Good (85 - 94)	Excellent (95 - 100)	Not Rated		
Colors on map represent condition scores at 0.10-mile intervals. See Appendix for definitions and formulas.						
Inspection Date: 4/13/2019	Beginning Section MP	0				
Paved Length (Miles): 0.12	Section Length (MI)	0.12				
Surface Type: ASPHALT	Route Summary					
Roadway Condition Information						
Pavement Condition Rating (PCR)	81	81				
Surface Condition Rating (SCR)	81	81				
Roughness Condition Index (RCI)	N/A	N/A				
Distress Index Values						
Structural Crack Index	85	85				
Alligator Crack Index	100	100				
Longitudinal Crack Index	85	85				
Transverse Cracking Index	81	81				
Patching Index	100	100				
Rutting Index	95	95				
International Roughness Index (IRI)	N/A	N/A				
Lane & Width Information						
Number of Lanes	2	2				
Paved Width (ft)	19.2	19.2				
Lane Width (ft)	13.3	13.3

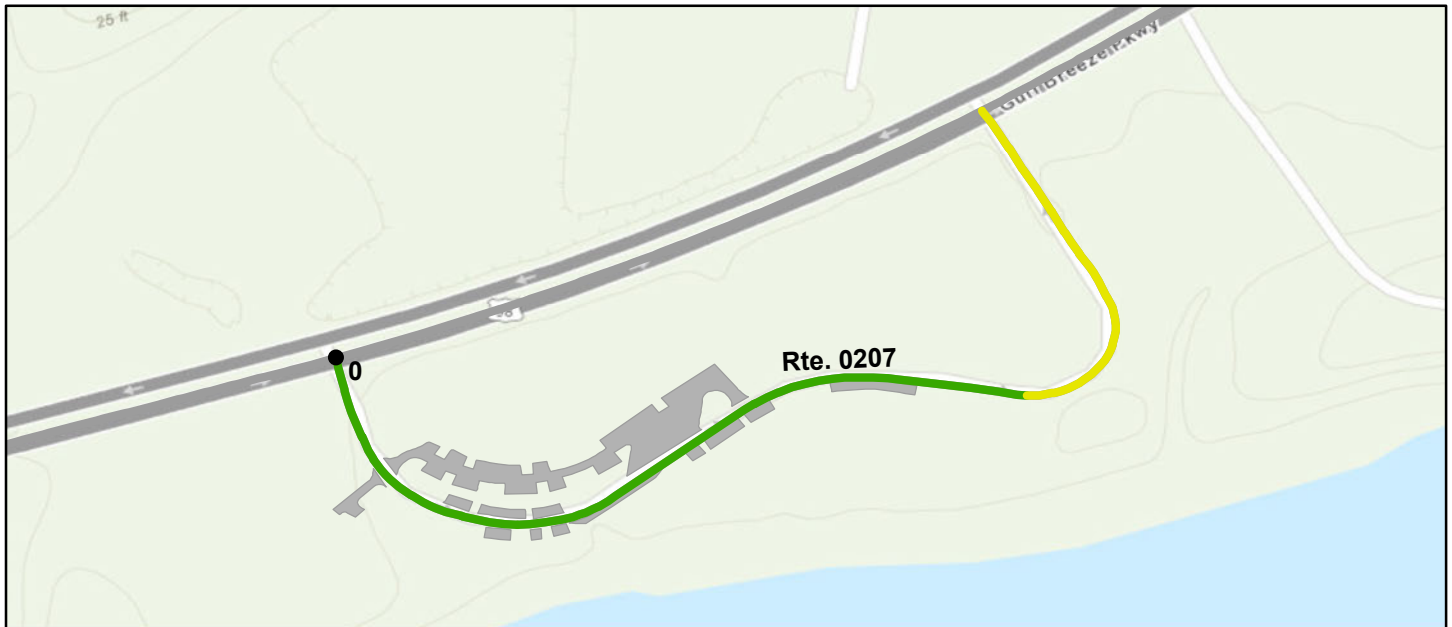
ROUTE 0207: HEADQUARTERS AND VISITOR CENTER ACCESS ROAD

Inspection Date:	4/11/2019	Beginning Section MP	0				
Paved Length (Miles):	0.44	Section Length (MI)	0.44				
Surface Type:	ASPHALT	Route Summary					
Roadway Condition Information							
Pavement Condition Rating (PCR)	84	84					
Surface Condition Rating (SCR)	84	84					
Roughness Condition Index (RCI)	N/A	N/A					
Distress Index Values							
Structural Crack Index	96	96					
Alligator Crack Index	100	100					
Longitudinal Crack Index	96	96					
Transverse Cracking Index	84	84					
Patching Index	100	100					
Rutting Index	97	97					
International Roughness Index (IRI)	N/A	N/A					
Lane & Width Information							
Number of Lanes	2	2					
Paved Width (ft)	24.2	24.2					
Lane Width (ft)	16.2	16.2

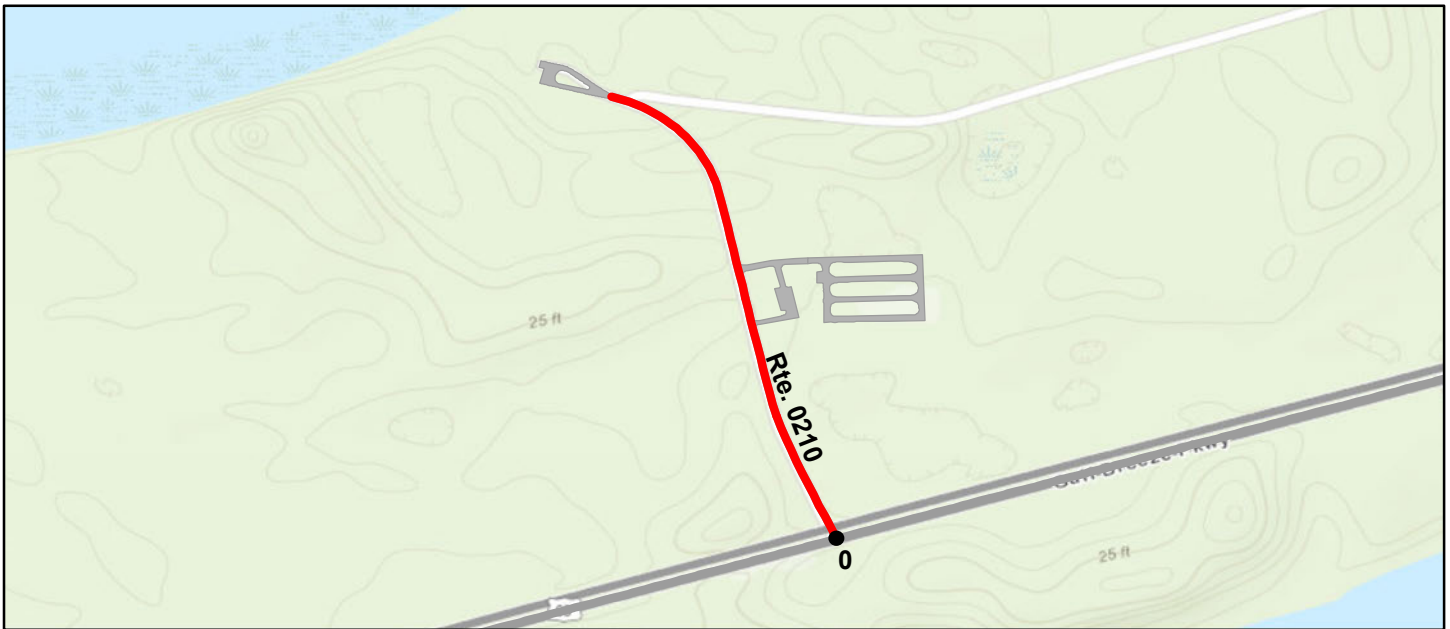
ROUTE 0210: NAVAL LIVE OAKS ROAD

Inspection Date:	4/12/2019	Beginning Section MP	0				
Paved Length (Miles):	0.4	Section Length (MI)	0.4				
Surface Type:	ASPHALT	Route Summary					
Roadway Condition Information							
Pavement Condition Rating (PCR)	12	12					
Surface Condition Rating (SCR)	12	12					
Roughness Condition Index (RCI)	N/A	N/A					
Distress Index Values							
Structural Crack Index	36	36					
Alligator Crack Index	100	100					
Longitudinal Crack Index	36	36					
Transverse Cracking Index	12	12					
Patching Index	100	100					
Rutting Index	98	98					
International Roughness Index (IRI)	N/A	N/A					
Lane & Width Information							
Number of Lanes	2	2					
Paved Width (ft)	19.7	19.7					
Lane Width (ft)	9.8	9.8

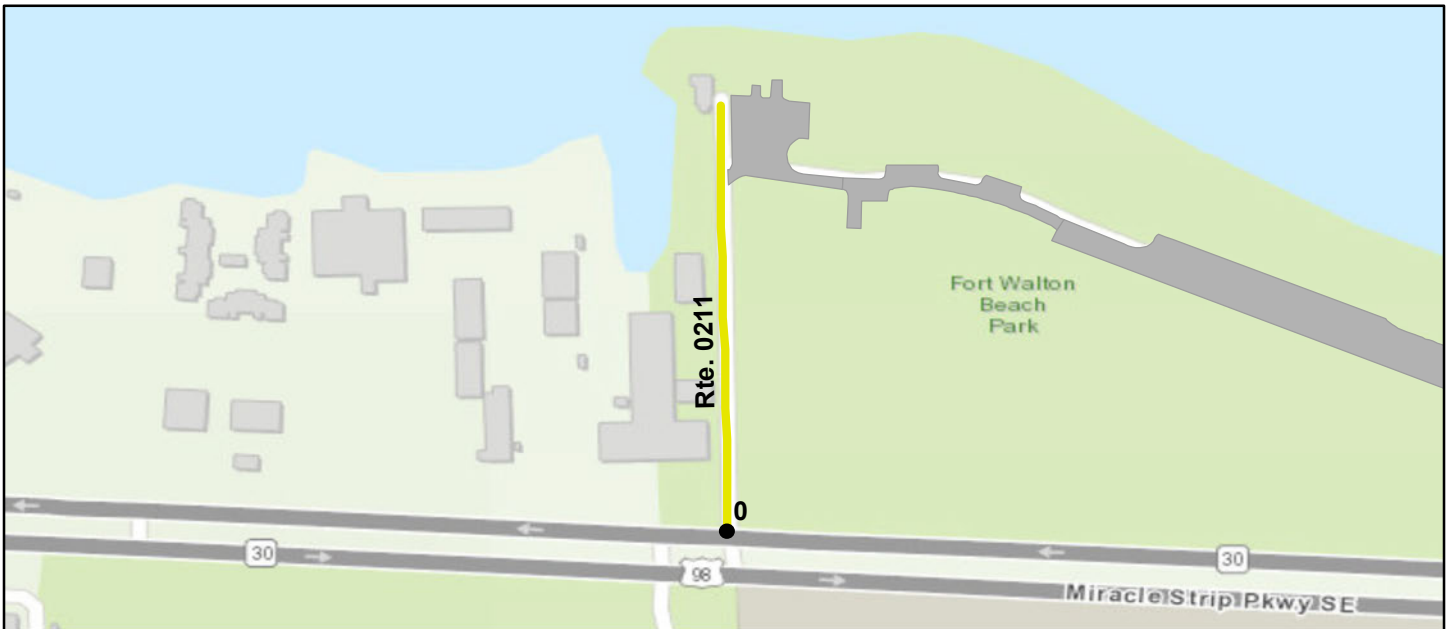
ROUTE 0211: OKALOOSA WEST ACCESS ROAD

Route Condition Legend – Pavement Condition Rating (PCR)						
Poor (0 - 60)	Fair (61- 84)	Good (85 - 94)	Excellent (95 - 100)	Not Rated		
See Appendix for definitions and formulas						
Inspection Date:	4/11/2019	Beginning Section MP	0.00			
Paved Length (Miles):	0.14	Section Length (MI)	0.14			
Surface Type:	ASPHALT	Route Summary				
Roadway Condition Information						
Pavement Condition Rating (PCR)	73	73				
Surface Condition Rating (SCR)	73	73				
Roughness Condition Index (RCI)	N/A	N/A				
Distress Index Values						
Structural Crack Index	N/A	N/A				
Alligator Crack Index	90	90				
Longitudinal Crack Index	90	90				
Transverse Cracking Index	73	73				
Patching Index	90	90				
Rutting Index	73	73				
International Roughness Index (IRI)	N/A	N/A				
Lane & Width Information						
Number of Lanes	2	2				
Paved Width (ft)	17	17				
Lane Width (ft)	8.5	8.5

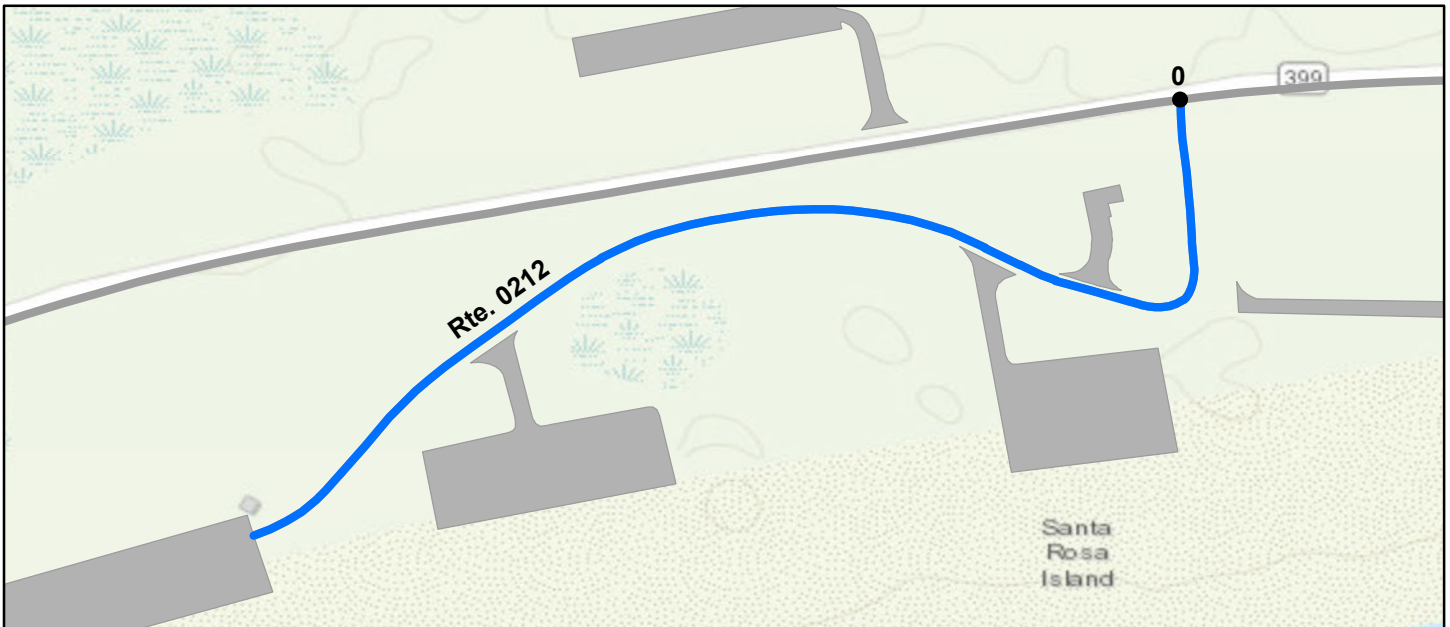
ROUTE 0212: OPAL BEACH ROAD

Inspection Date: 4/11/2019	Beginning Section MP	0				
Paved Length (Miles): 0.33	Section Length (MI)	0.33				
Surface Type: ASPHALT	Route Summary					
Roadway Condition Information						
Pavement Condition Rating (PCR)	100	100				
Surface Condition Rating (SCR)	100	100				
Roughness Condition Index (RCI)	N/A	N/A				
Distress Index Values						
Structural Crack Index	100	100				
Alligator Crack Index	100	100				
Longitudinal Crack Index	100	100				
Transverse Cracking Index	100	100				
Patching Index	100	100				
Rutting Index	100	100				
International Roughness Index (IRI)	N/A	N/A				
Lane & Width Information						
Number of Lanes	2	2				
Paved Width (ft)	33	33				
Lane Width (ft)	12.1	12.1

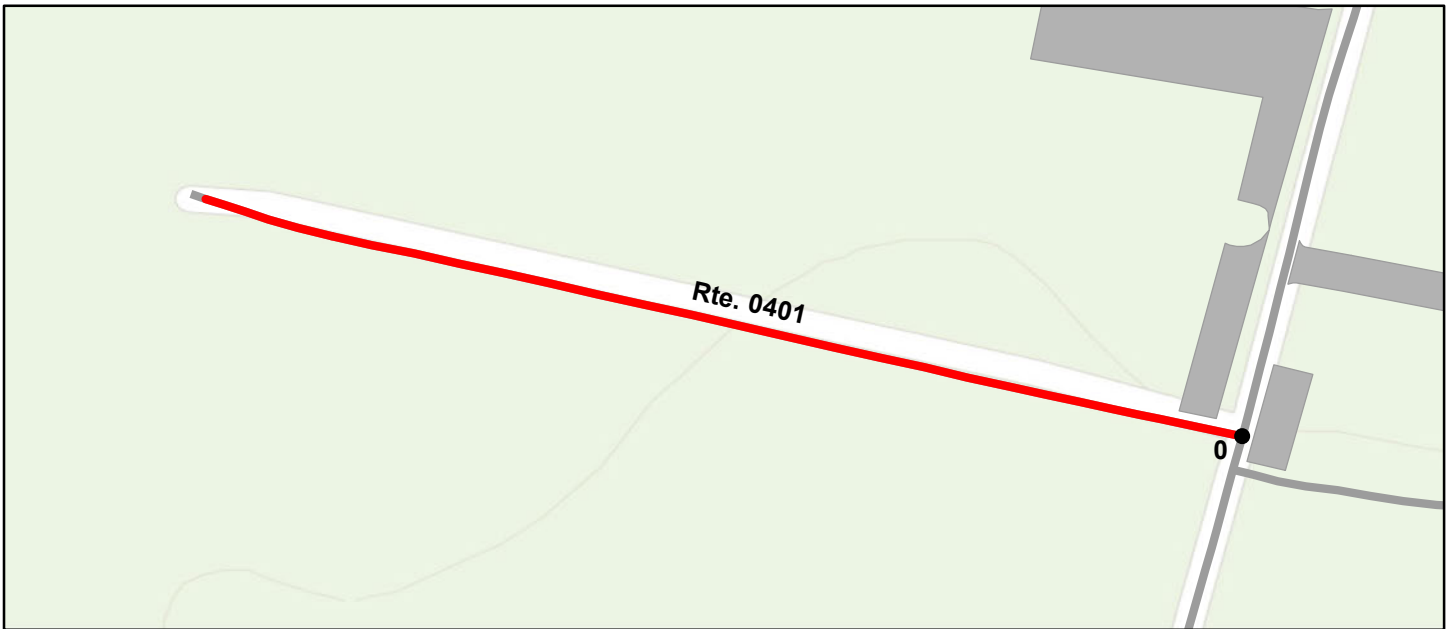
ROUTE 0401: FORT PICKENS DISTRICT OFFICE ROAD

Route Condition Legend – Pavement Condition Rating (PCR)						
Poor (0 - 60)	Fair (61- 84)	Good (85 - 94)	Excellent (95 - 100)	Not Rated		
Colors on map represent condition scores at 0.10-mile intervals. See Appendix for definitions and formulas.						
Inspection Date: 4/12/2019	Beginning Section MP	0				
Paved Length (Miles): 0.11	Section Length (MI)	0.11				
Surface Type: ASPHALT	Route Summary					
Roadway Condition Information						
Pavement Condition Rating (PCR)	21	21				
Surface Condition Rating (SCR)	21	21				
Roughness Condition Index (RCI)	N/A	N/A				
Distress Index Values						
Structural Crack Index	63	63				
Alligator Crack Index	100	100				
Longitudinal Crack Index	63	63				
Transverse Cracking Index	21	21				
Patching Index	100	100				
Rutting Index	92	92				
International Roughness Index (IRI)	N/A	N/A				
Lane & Width Information						
Number of Lanes	1	1				
Paved Width (ft)	9.5	9.5				
Lane Width (ft)	9.5	9.5

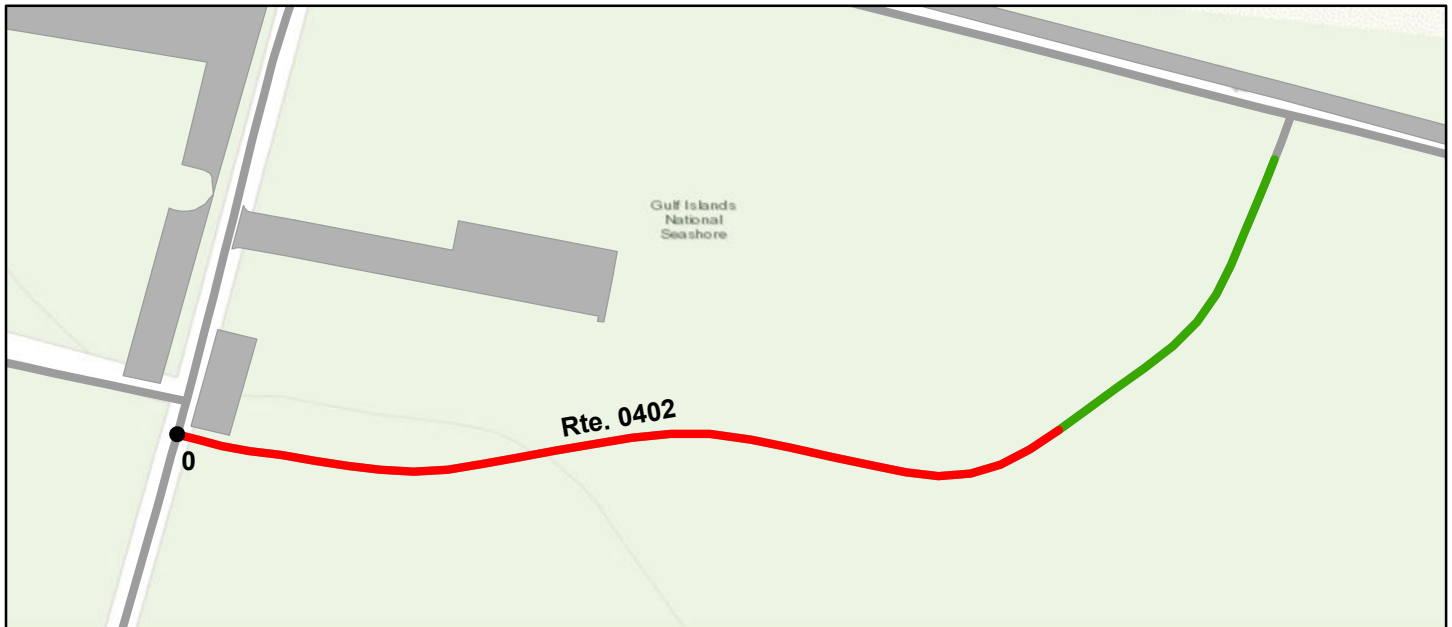
ROUTE 0402: FORT PICKENS SERVICE ROAD

Route Condition Legend – Pavement Condition Rating (PCR)										
Poor (0 - 60)		Fair (61- 84)		Good (85 - 94)		Excellent (95 - 100)		Not Rated		
Colors on map represent condition scores at 0.10-mile intervals. See Appendix for definitions and formulas.										
Inspection Date: 4/12/2019		Beginning Section MP		0						
Paved Length (Miles): 0.14		Section Length (MI)		0.14						
Surface Type: ASPHALT		Route Summary								
Roadway Condition Information										
Pavement Condition Rating (PCR)		45		45						
Surface Condition Rating (SCR)		45		45						
Roughness Condition Index (RCI)		N/A		N/A						
Distress Index Values										
Structural Crack Index		95		95						
Alligator Crack Index		100		100						
Longitudinal Crack Index		95		95						
Transverse Cracking Index		45		45						
Patching Index		100		100						
Rutting Index		94		94						
International Roughness Index (IRI)		N/A		N/A						
Lane & Width Information

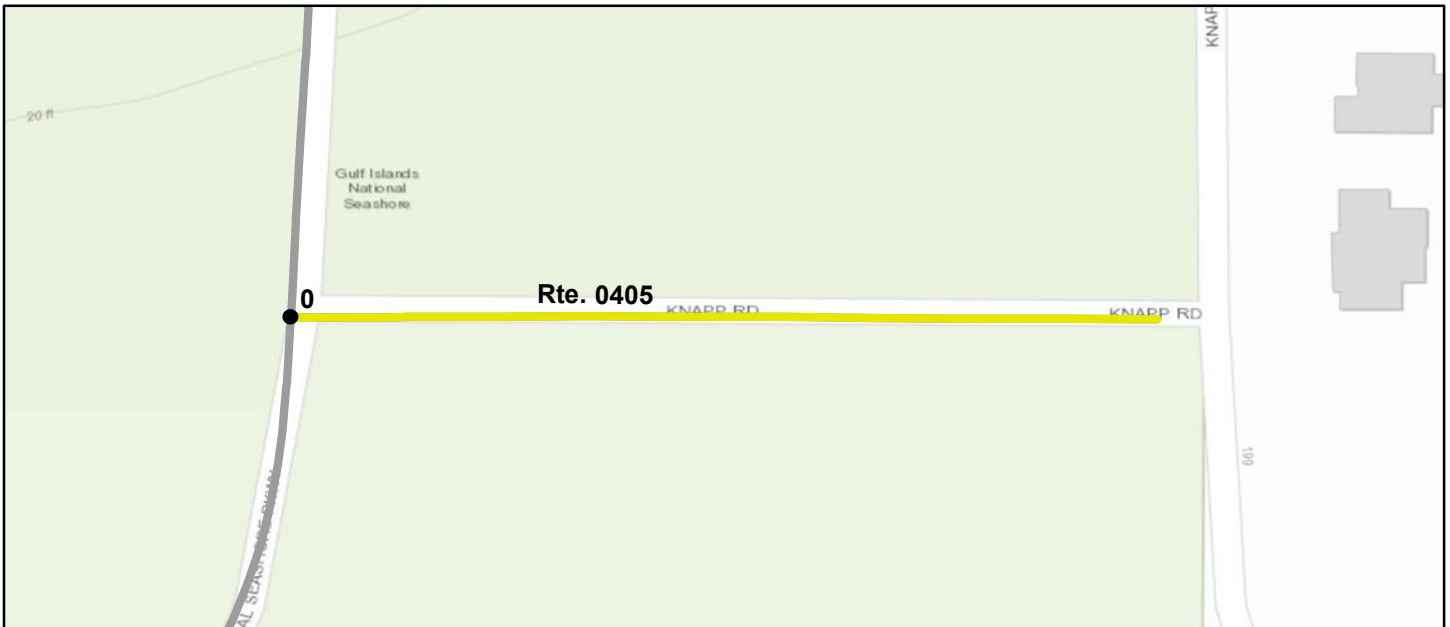
ROUTE 0405: VFW ROAD

Inspection Date:	4/13/2019	Beginning Section MP	0				
Paved Length (Miles):	0.09	Section Length (MI)	0.09				
Surface Type:	ASPHALT	Route Summary					
Roadway Condition Information							
Pavement Condition Rating (PCR)	74	74					
Surface Condition Rating (SCR)	74	74					
Roughness Condition Index (RCI)	N/A	N/A					
Distress Index Values							
Structural Crack Index	97	97					
Alligator Crack Index	100	100					
Longitudinal Crack Index	97	97					
Transverse Cracking Index	76	76					
Patching Index	74	74					
Rutting Index	96	96					
International Roughness Index (IRI)	N/A	N/A					
Lane & Width Information							
Number of Lanes	2	2					
Paved Width (ft)	23.4	23.4					
Lane Width (ft)	9.3	9.3

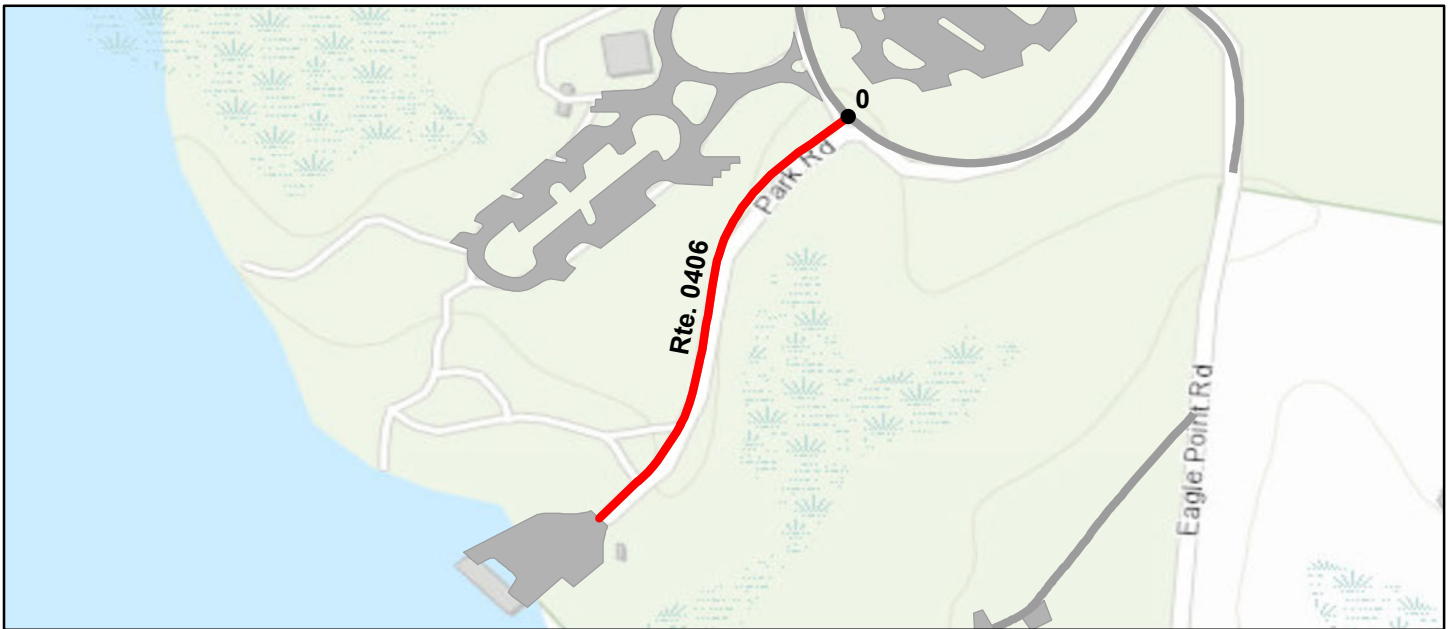
ROUTE 0406: GOVERNMENT BOAT DOCK ROAD

Route Condition Legend – Pavement Condition Rating (PCR)						
Poor (0 - 60)	Fair (61- 84)	Good (85 - 94)	Excellent (95 - 100)	Not Rated		
Colors on map represent condition scores at 0.10-mile intervals. See Appendix for definitions and formulas.						
Inspection Date:	4/13/2019	Beginning Section MP	0			
Paved Length (Miles):	0.13	Section Length (MI)	0.13			
Surface Type:	ASPHALT	Route Summary				
Roadway Condition Information						
Pavement Condition Rating (PCR)	0	0				
Surface Condition Rating (SCR)	0	0				
Roughness Condition Index (RCI)	N/A	N/A				
Distress Index Values						
Structural Crack Index	71	71				
Alligator Crack Index	100	100				
Longitudinal Crack Index	71	71				
Transverse Cracking Index	0	0				
Patching Index	100	100				
Rutting Index	99	99				
International Roughness Index (IRI)	N/A	N/A				
Lane & Width Information						
Number of Lanes	2	2				
Paved Width (ft)	17.8	17.8				
Lane Width (ft)	7.4	7.4

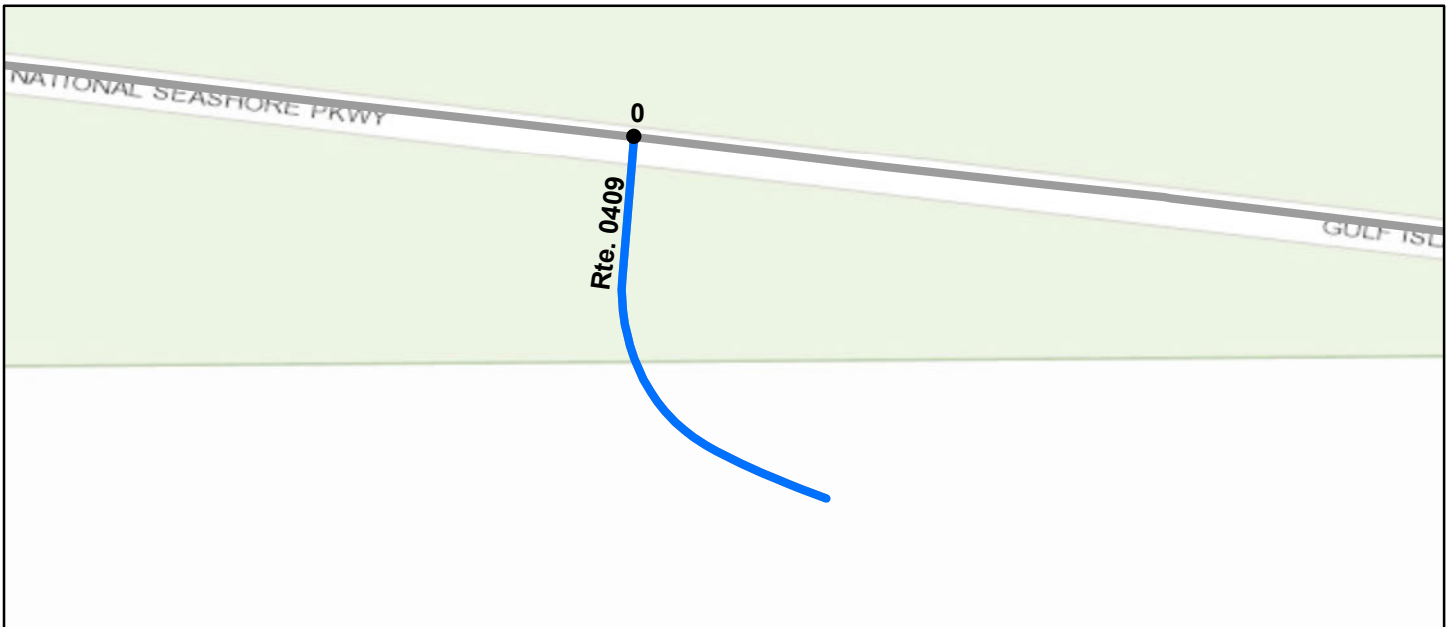
ROUTE 0409: CEDAR POINT CAMPUS ROAD

Inspection Date: 4/13/2019	Beginning Section MP	0				
Paved Length (Miles): 0.04	Section Length (MI)	0.04				
Surface Type: ASPHALT	Route Summary					
Roadway Condition Information						
Pavement Condition Rating (PCR)	96	96				
Surface Condition Rating (SCR)	96	96				
Roughness Condition Index (RCI)	N/A	N/A				
Distress Index Values						
Structural Crack Index	100	100				
Alligator Crack Index	100	100				
Longitudinal Crack Index	100	100				
Transverse Cracking Index	100	100				
Patching Index	100	100				
Rutting Index	96	96				
International Roughness Index (IRI)	N/A	N/A				
Lane & Width Information						
Number of Lanes	2	2				
Paved Width (ft)	23.1	23.1				
Lane Width (ft)	10.6	10.6

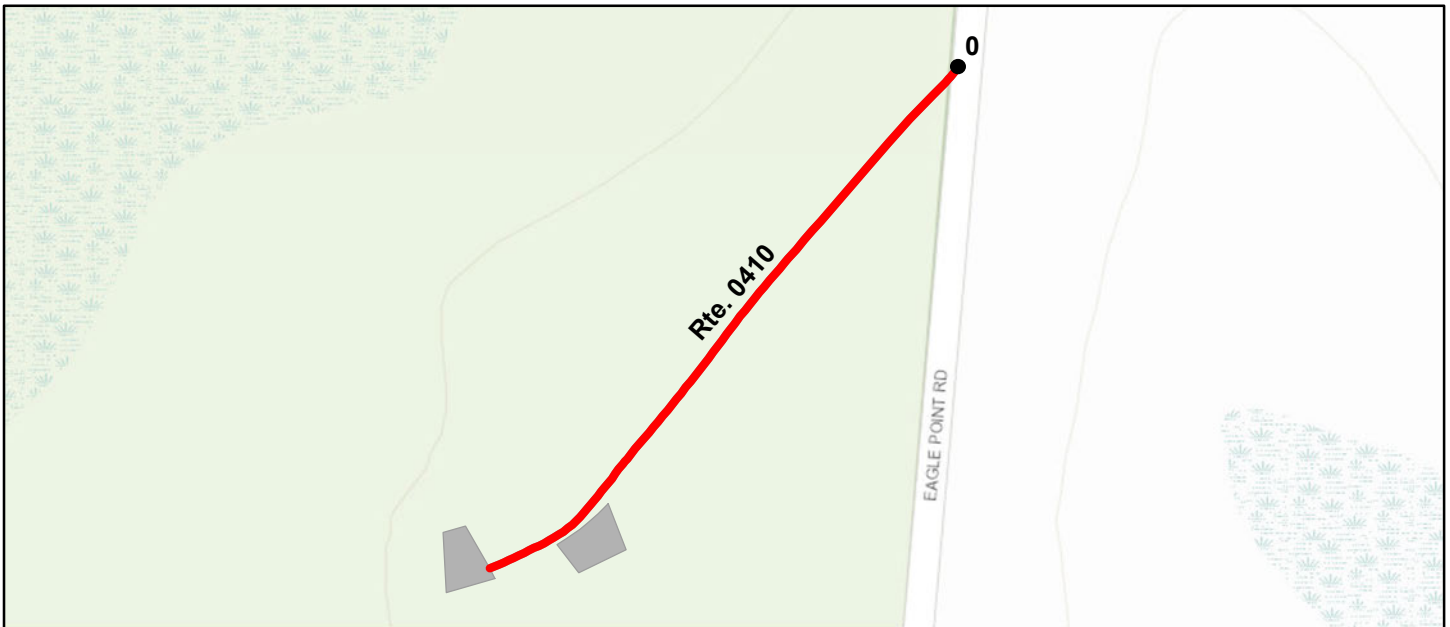
ROUTE 0410: YATES HOUSE COMPOUND ROAD

Route Condition Legend – Pavement Condition Rating (PCR)						
Poor (0 - 60)	Fair (61- 84)	Good (85 - 94)	Excellent (95 - 100)	Not Rated		
Colors on map represent condition scores at 0.10-mile intervals. See Appendix for definitions and formulas.						
Inspection Date:	4/13/2019	Beginning Section MP	0			
Paved Length (Miles):	0.08	Section Length (MI)	0.08			
Surface Type:	ASPHALT	Route Summary				
Roadway Condition Information						
Pavement Condition Rating (PCR)	0	0				
Surface Condition Rating (SCR)	0	0				
Roughness Condition Index (RCI)	N/A	N/A				
Distress Index Values						
Structural Crack Index	13	13				
Alligator Crack Index	96	96				
Longitudinal Crack Index	17	17				
Transverse Cracking Index	0	0				
Patching Index	94	94				
Rutting Index	93	93				
International Roughness Index (IRI)	N/A	N/A				
Lane & Width Information						
Number of Lanes	1	1				
Paved Width (ft)	12.5	12.5				
Lane Width (ft)	12.5	12.5

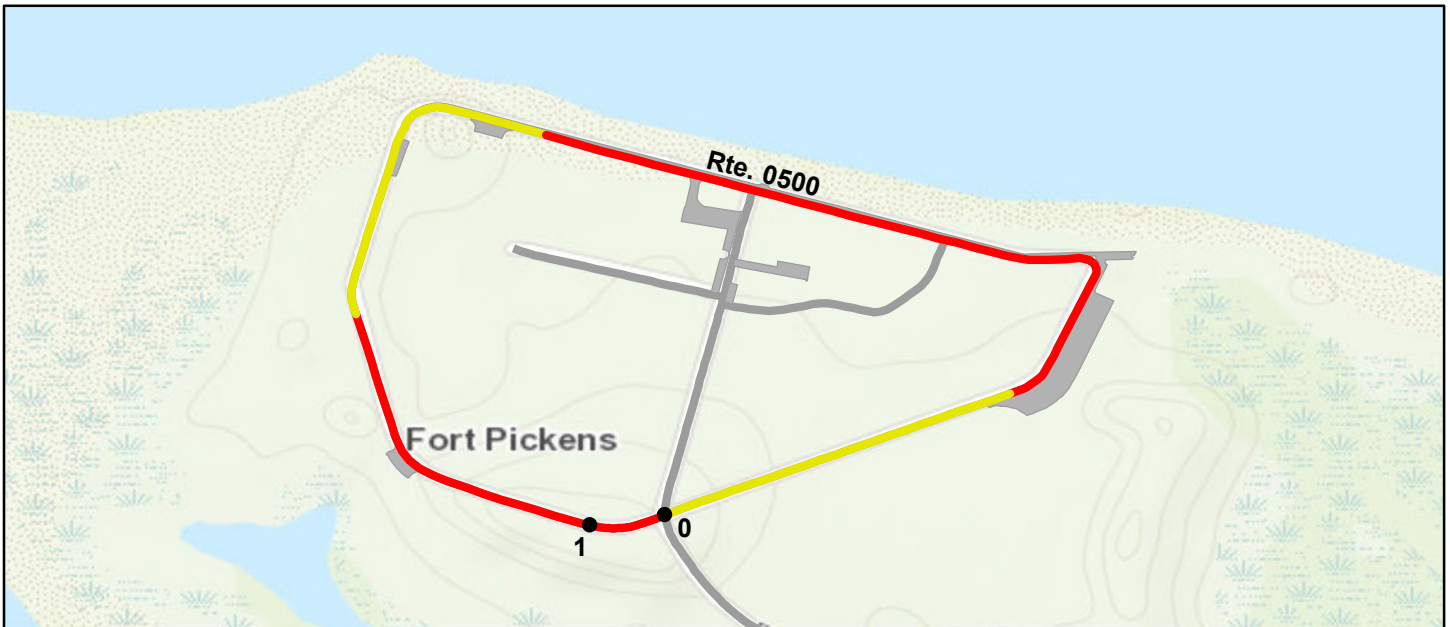
ROUTE 0500: FORT PICKENS LOOP ROAD

Route Condition Legend – Pavement Condition Rating (PCR)						
Poor (0 - 60)	Fair (61- 84)	Good (85 - 94)	Excellent (95 - 100)	Not Rated		
Colors on map represent condition scores at 0.10-mile intervals. See Appendix for definitions and formulas.						
Inspection Date: 4/12/2019	Beginning Section MP	0	1			
Paved Length (Miles): 1.03	Section Length (MI)	1	0.03			
Surface Type: ASPHALT	Route Summary					
Roadway Condition Information						
Pavement Condition Rating (PCR)	62	62	47			
Surface Condition Rating (SCR)	39	39	47			
Roughness Condition Index (RCI)	97	97	N/A			
Distress Index Values						
Structural Crack Index	89	88	98			
Alligator Crack Index	100	100	100			
Longitudinal Crack Index	89	88	98			
Transverse Cracking Index	39	39	47			
Patching Index	100	100	100			
Rutting Index	98	98	96			
International Roughness Index (IRI)	123	123	N/A			
Lane & Width Information						
Number of Lanes	1	1	1			
Paved Width (ft)	16.6	16.7	14.4

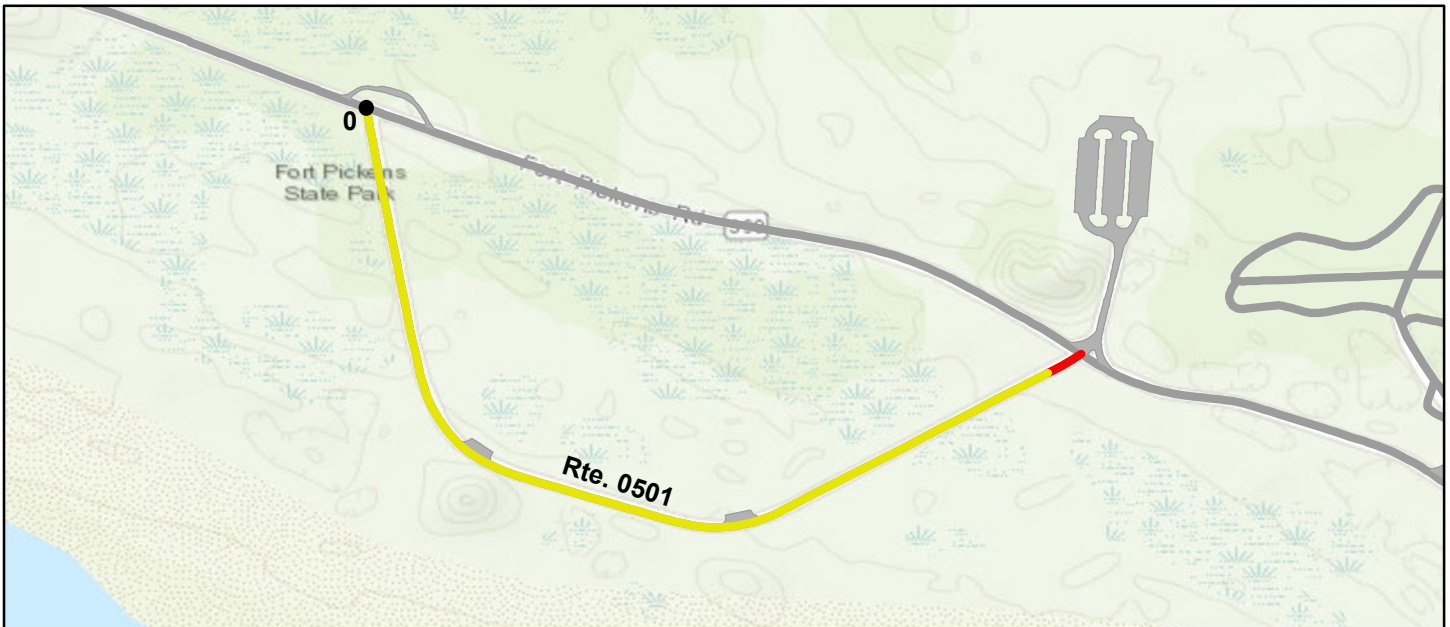
ROUTE 0501: BATTERY 234 LOOP ROAD

Inspection Date:	4/12/2019	Beginning Section MP	0				
Paved Length (Miles):	0.62	Section Length (MI)	0.62				
Surface Type:	ASPHALT	Route Summary					
Roadway Condition Information							
Pavement Condition Rating (PCR)		80	80				
Surface Condition Rating (SCR)		67	67				
Roughness Condition Index (RCI)		100	100				
Distress Index Values							
Structural Crack Index		99	99				
Alligator Crack Index		100	100				
Longitudinal Crack Index		99	99				
Transverse Cracking Index		67	67				
Patching Index		100	100				
Rutting Index		99	99				
International Roughness Index (IRI)		106	106				
Lane & Width Information							
Number of Lanes		1	1				
Paved Width (ft)		12	12				
Lane Width (ft)		12	12

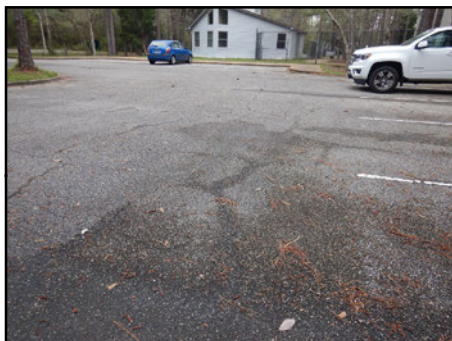
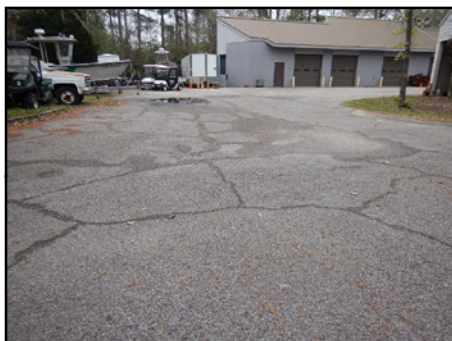
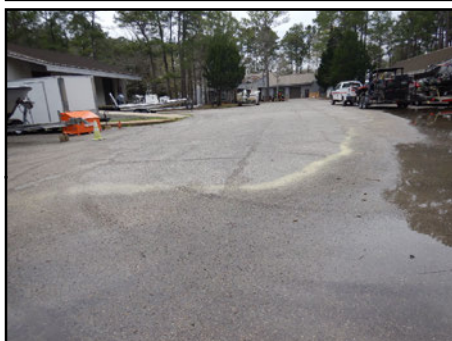
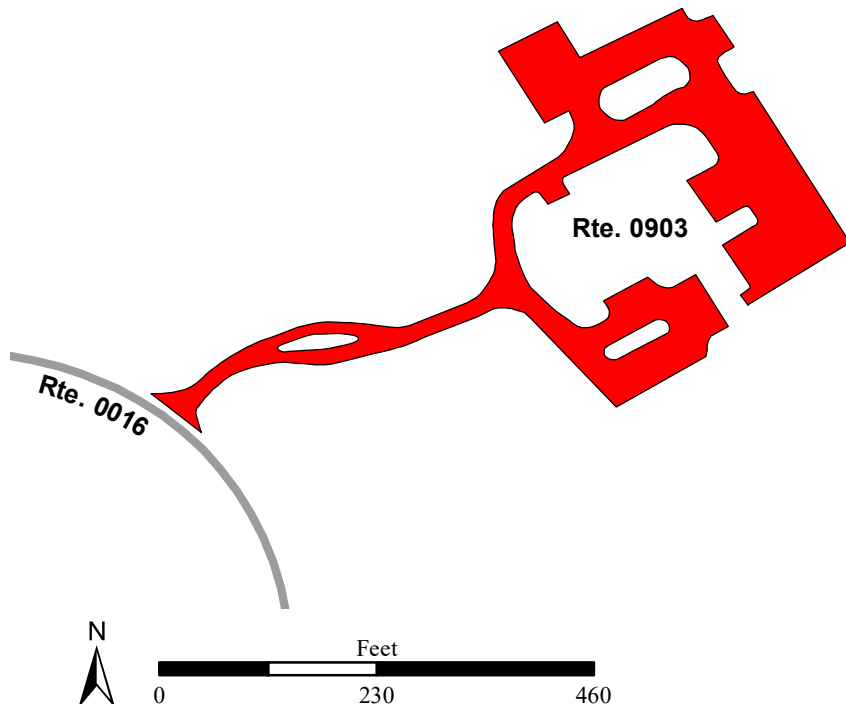
ROUTE 0903: DAVIS BAYOU MAINTENANCE PARKING

Inspection Date	FMSS Number	User Access	Surface Type
3/16/2019	72700	NONPUBLIC	ASPHALT
Area (Sq. Ft.)	Lane Miles (11' Widths)	Curb Reveal (Inches)	Curb Recommendation
57,802	0.995	3	DO NOTHING
Curb Type		Curb & Gutter Type	
CONCRETE		NO CURB AND GUTTER	
Pavement Recommendation		Condition Rating / PCR	
HEAVY 3R TREATMENTS		POOR / 53

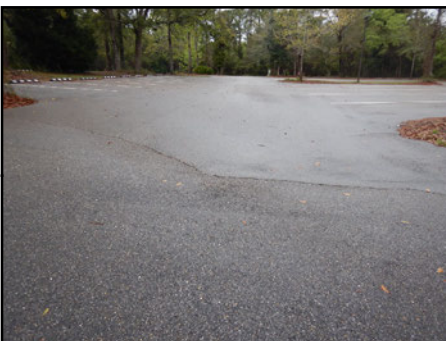
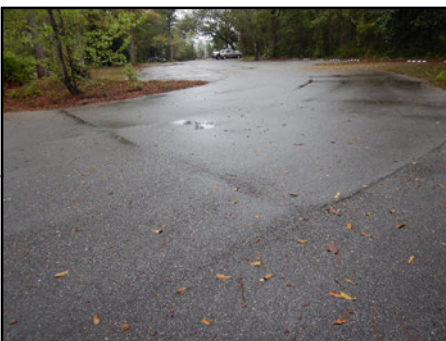
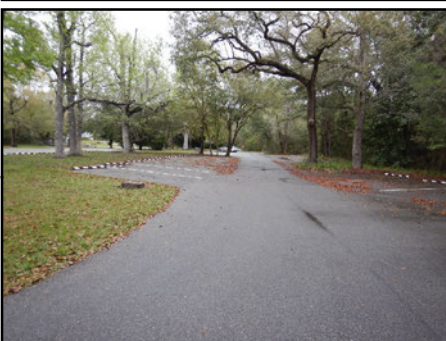
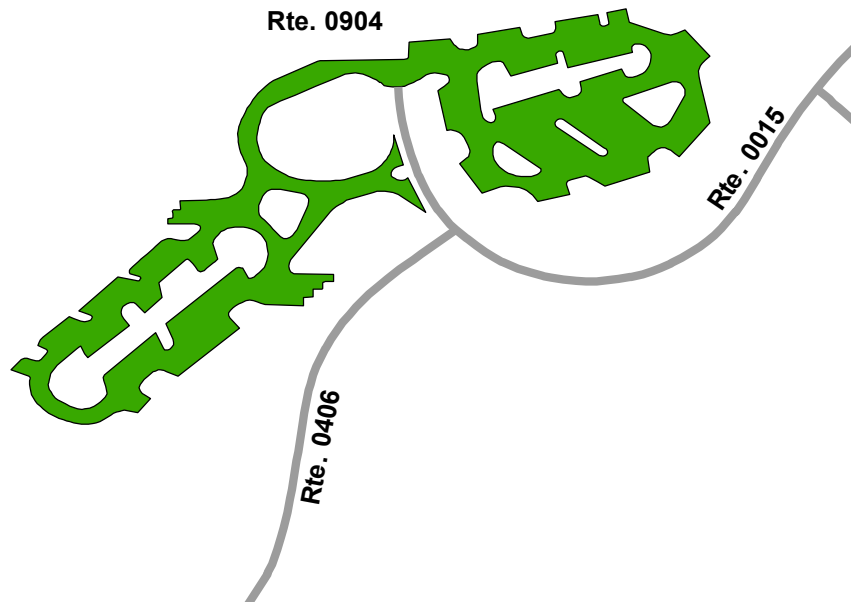
ROUTE 0904: DAVIS BAYOU VISITOR CENTER PARKING

Inspection Date	FMSS Number	User Access	Surface Type
3/16/2019	72702	PUBLIC	ASPHALT
Area (Sq. Ft.)	Lane Miles (11' Widths)	Curb Reveal (Inches)	Curb Recommendation
98,742	1.7	NOT APPLICABLE	NOT APPLICABLE
Curb Type		Curb & Gutter Type	
NO CURB		NO CURB AND GUTTER	
Pavement Recommendation		Condition Rating / PCR	
PREVENTIVE MAINTENANCE		GOOD / 90

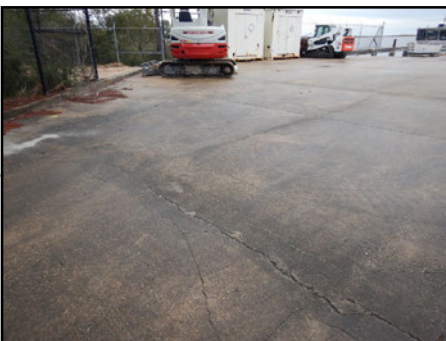
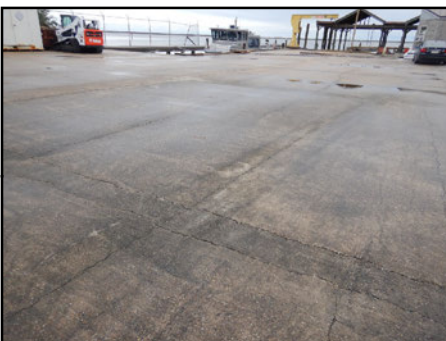
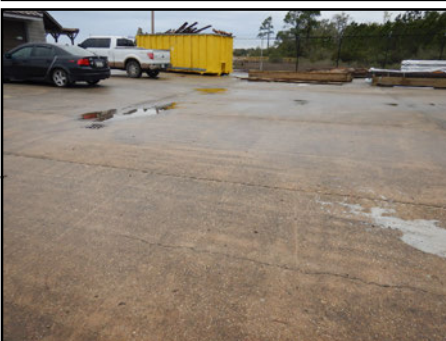
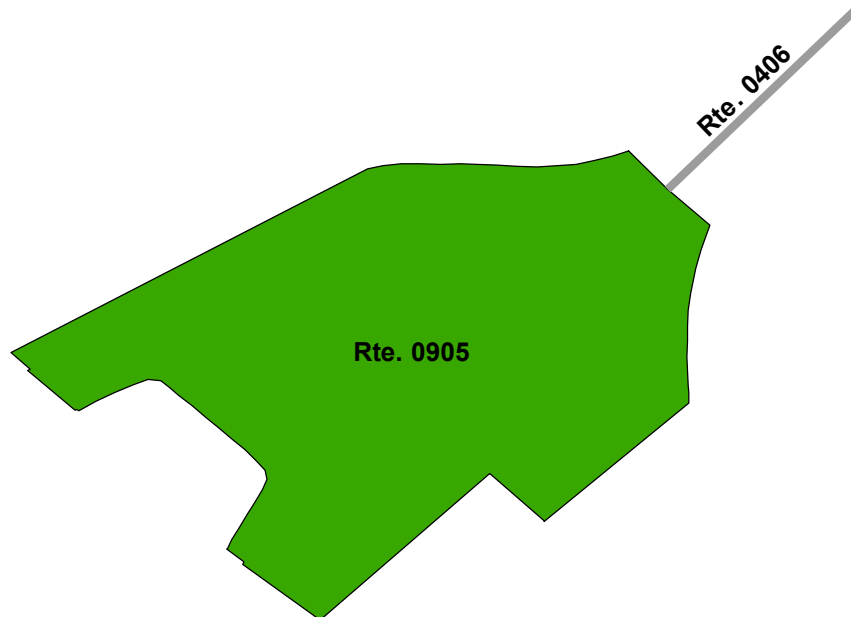
ROUTE 0905: GOVERNMENT BOAT DOCK PARKING

Inspection Date	FMSS Number	User Access	Surface Type
3/16/2019	72704	NONPUBLIC	CONCRETE
Area (Sq. Ft.)	Lane Miles (11' Widths)	Curb Reveal (Inches)	Curb Recommendation
14,520	0.25	5	LIGHT REPAIR
Curb Type		Curb & Gutter Type	
CONCRETE		NO CURB AND GUTTER	
Pavement Recommendation		Condition Rating / PCR	
PREVENTIVE MAINTENANCE		GOOD / 90

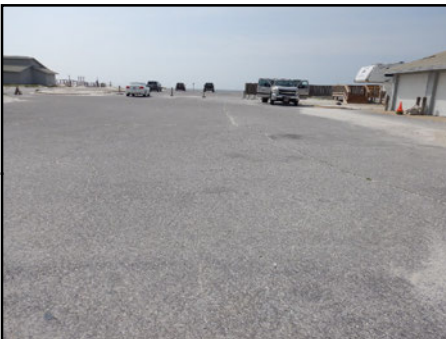
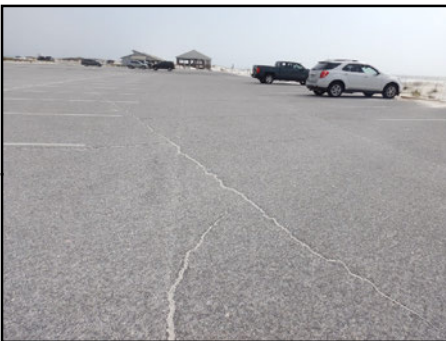
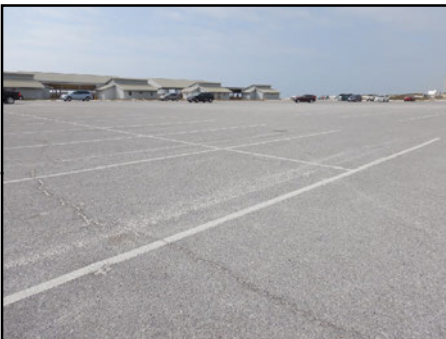
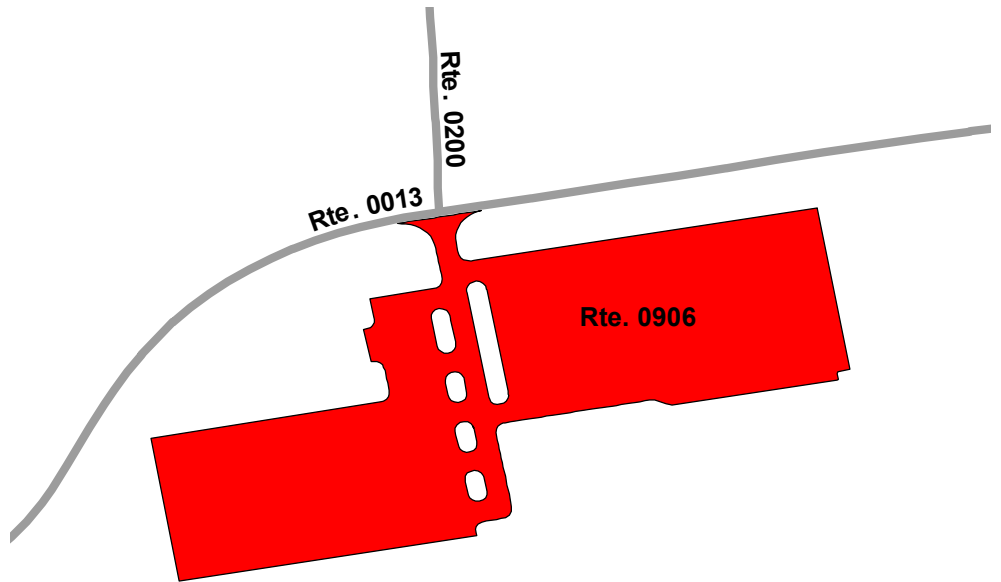
ROUTE 0906: ROSAMOND JOHNSON BEACH ACCESS PARKING

Inspection Date	FMSS Number	User Access	Surface Type
3/14/2019	72706	PUBLIC	ASPHALT
Area (Sq. Ft.)	Lane Miles (11' Widths)	Curb Reveal (Inches)	Curb Recommendation
153,249	2.639	NOT APPLICABLE	DO NOTHING
Curb Type		Curb & Gutter Type	
NO CURB		CONCRETE	
Pavement Recommendation		Condition Rating / PCR	
HEAVY 3R TREATMENTS		POOR / 53
