GUIIS Cycle 6

Final Report

Road Inventory and Condition Assessment of Paved Routes Gulf Islands National Seashore

Report Date: October 2020

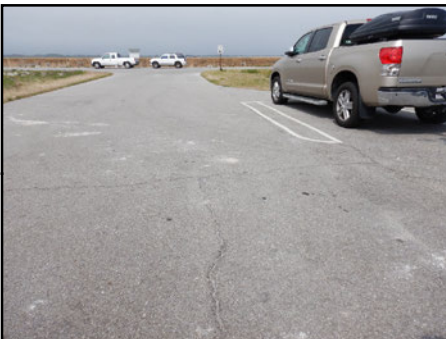
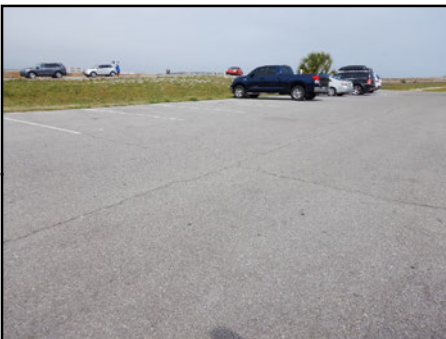
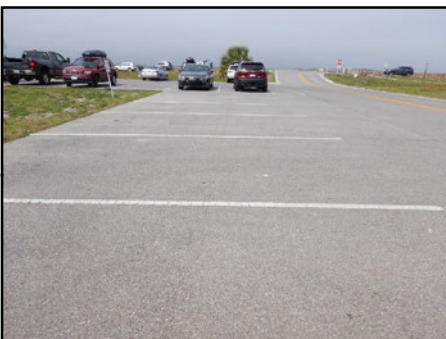
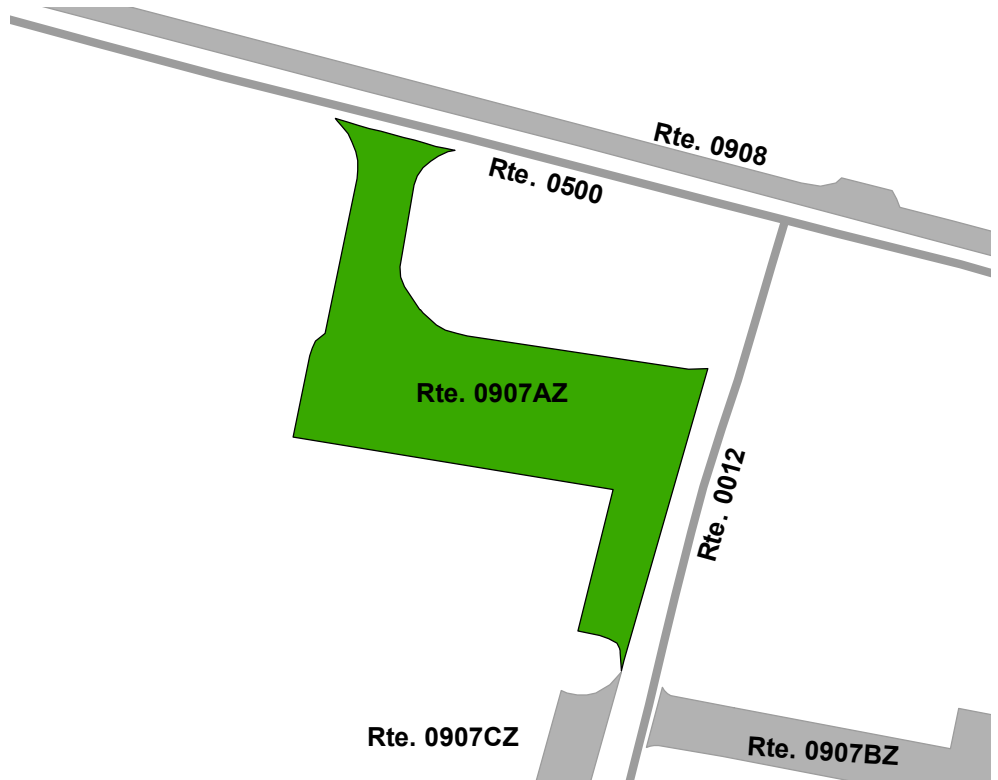
ROUTE 0907AZ: FORT PICKENS DISTRICT PARKING A

Inspection Date	FMSS Number	User Access	Surface Type
3/14/2019	72708	PUBLIC	ASPHALT
Area (Sq. Ft.)	Lane Miles (11' Widths)	Curb Reveal (Inches)	Curb Recommendation
13,758	0.237	NOT APPLICABLE	NOT APPLICABLE
Curb Type		Curb & Gutter Type	
NO CURB		NO CURB AND GUTTER	
Pavement Recommendation		Condition Rating / PCR	
PREVENTIVE MAINTENANCE		GOOD / 90

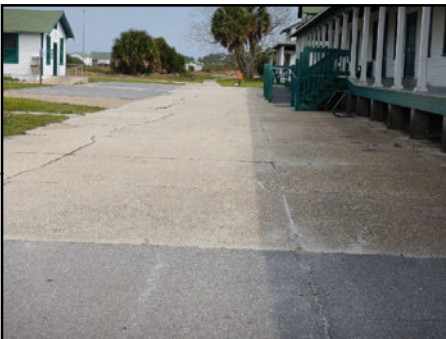
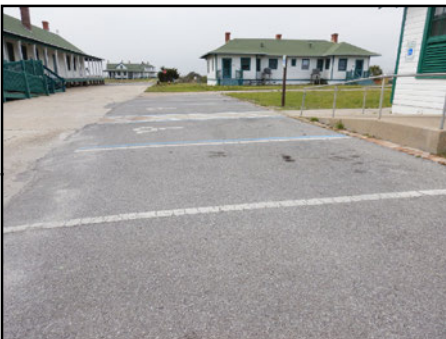
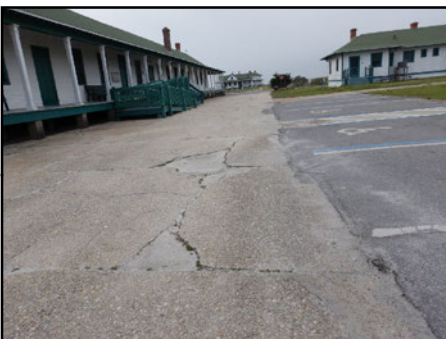
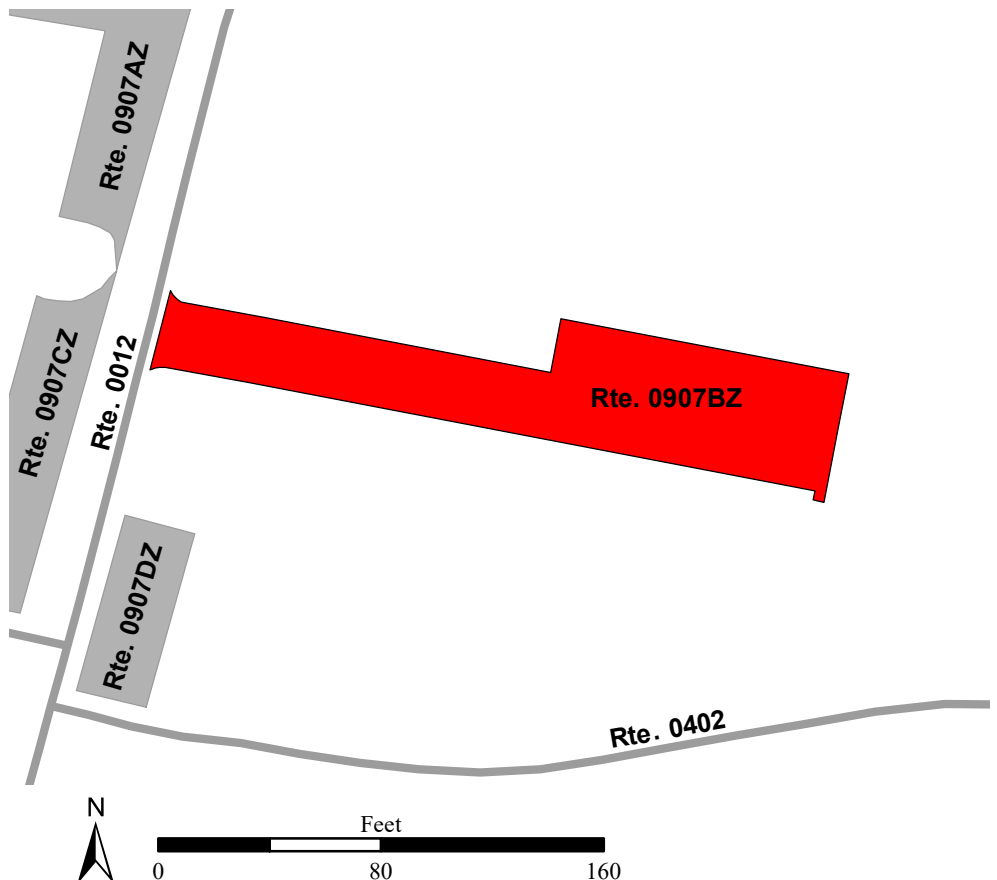
ROUTE 0907BZ: FORT PICKENS DISTRICT PARKING B

Inspection Date	FMSS Number	User Access	Surface Type
3/14/2019	72708	PUBLIC	CONCRETE
Area (Sq. Ft.)	Lane Miles (11' Widths)	Curb Reveal (Inches)	Curb Recommendation
6,876	0.118	1	DO NOTHING
Curb Type		Curb & Gutter Type	
CONCRETE		NO CURB AND GUTTER	
Pavement Recommendation		Condition Rating / PCR	
HEAVY 3R TREATMENTS		POOR / 53

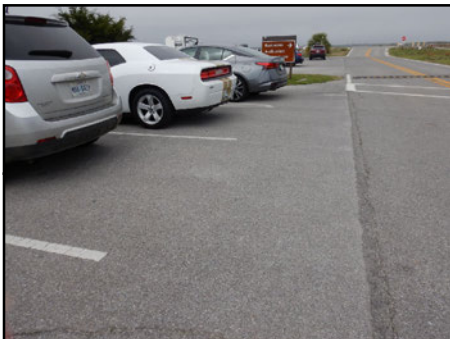
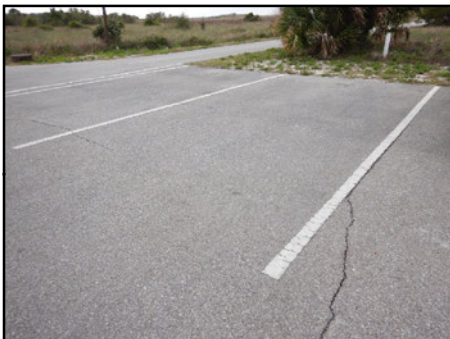
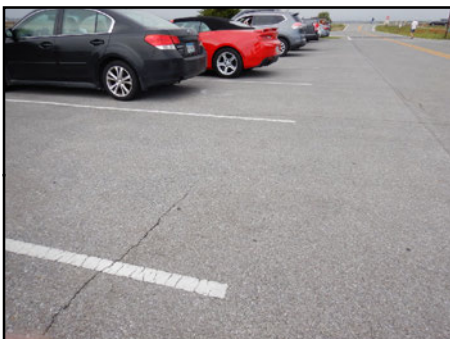
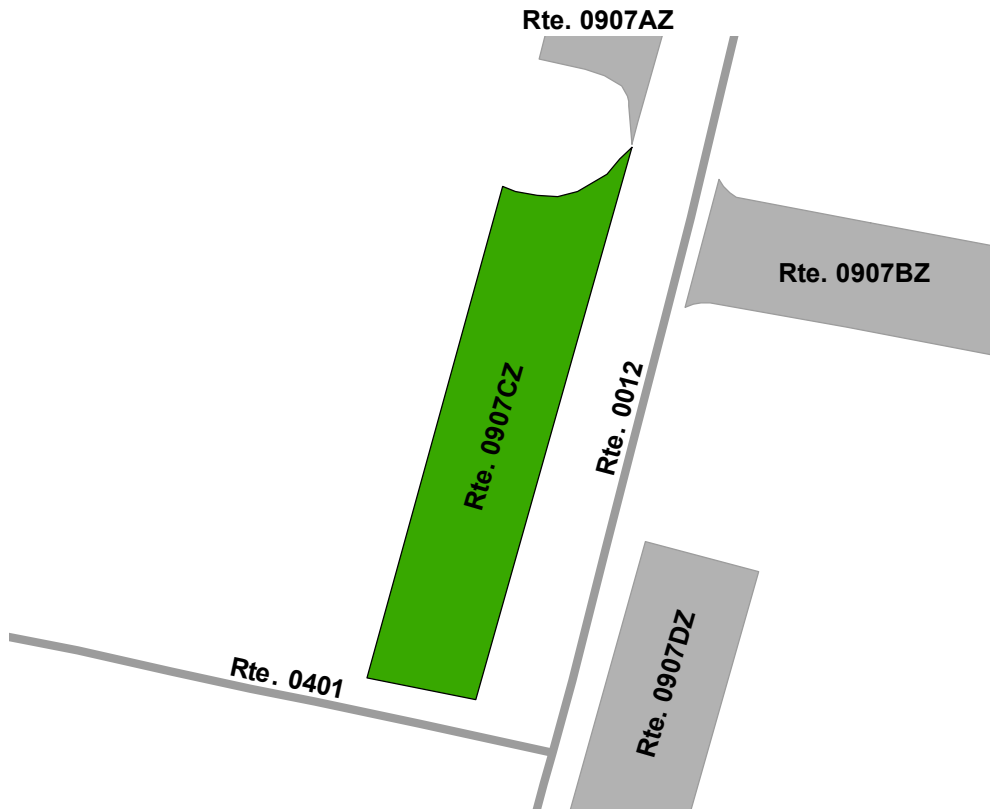
Inspection Date	FMSS Number	User Access	Surface Type
3/14/2019	72708	PUBLIC	ASPHALT
Area (Sq. Ft.)	Lane Miles (11' Widths)	Curb Reveal (Inches)	Curb Recommendation
2,482	0.043	NOT APPLICABLE	NOT APPLICABLE
Curb Type		Curb & Gutter Type	
NO CURB		NO CURB AND GUTTER	
Pavement Recommendation		Condition Rating / PCR	
PREVENTIVE MAINTENANCE		GOOD / 90

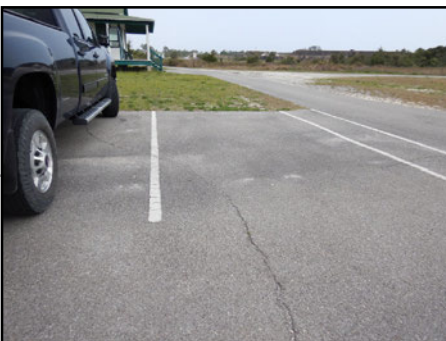
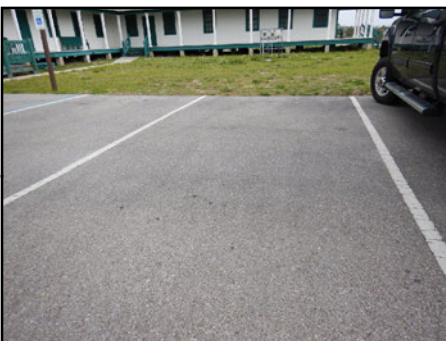
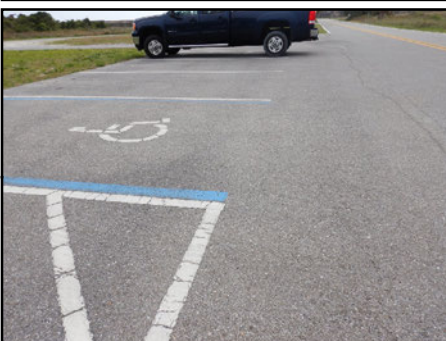
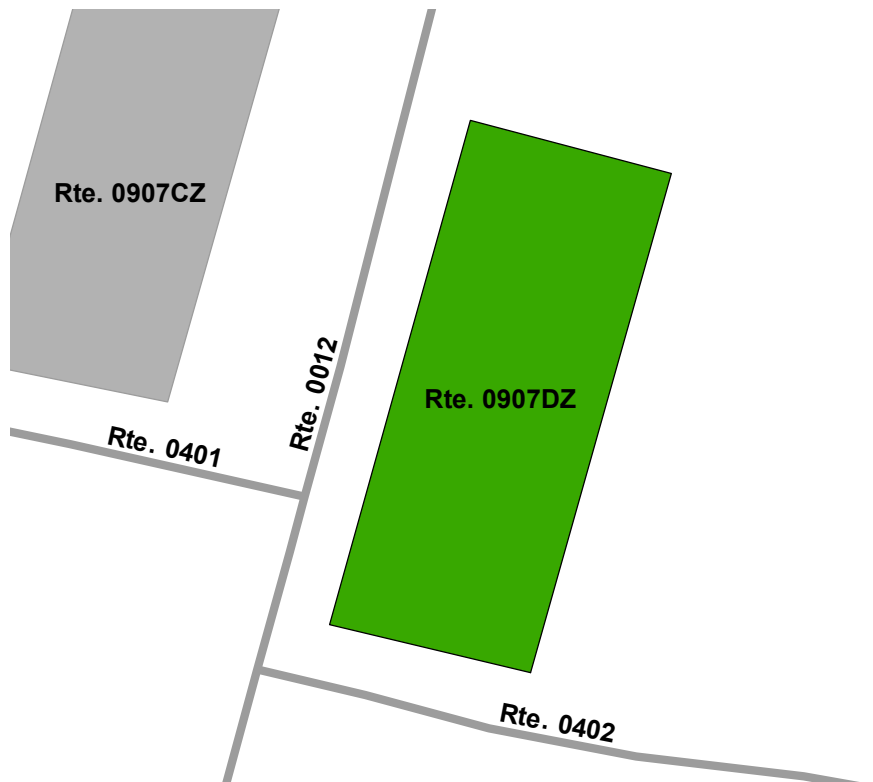
ROUTE 0907DZ: FORT PICKENS DISTRICT PARKING D

Inspection Date	FMSS Number	User Access	Surface Type
3/14/2019	72708	PUBLIC	ASPHALT
Area (Sq. Ft.)	Lane Miles (11' Widths)	Curb Reveal (Inches)	Curb Recommendation
1,451	0.025	NOT APPLICABLE	NOT APPLICABLE
Curb Type		Curb & Gutter Type	
NO CURB		NO CURB AND GUTTER	
Pavement Recommendation		Condition Rating / PCR	
PREVENTIVE MAINTENANCE		GOOD / 90

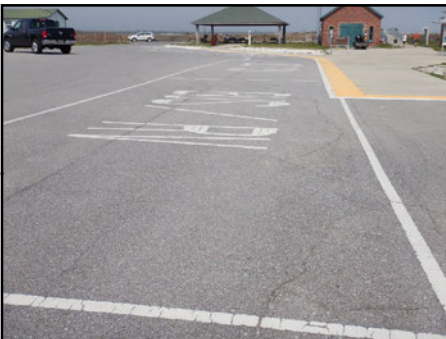
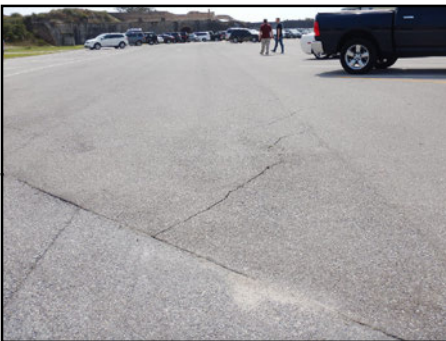
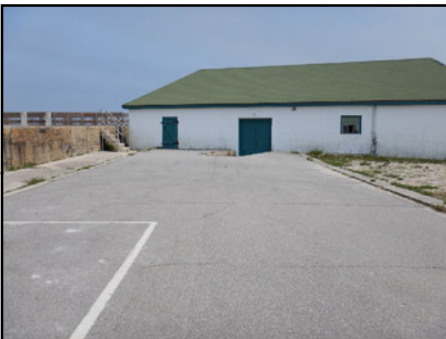
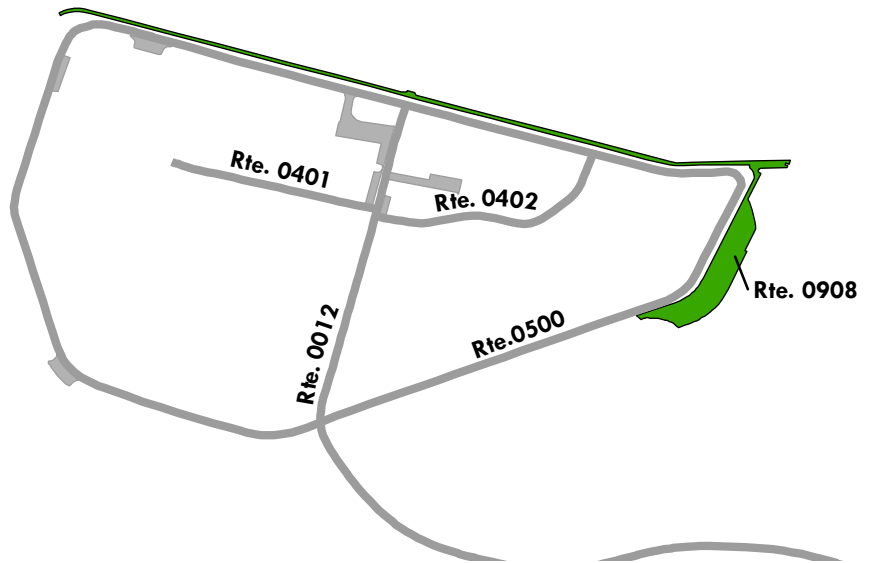
ROUTE 0908: FORT PICKENS PARKING

Inspection Date	FMSS Number	User Access	Surface Type
3/14/2019	72710	PUBLIC	ASPHALT
Area (Sq. Ft.)	Lane Miles (11' Widths)	Curb Reveal (Inches)	Curb Recommendation
58,973	1.015	1	DO NOTHING
Curb Type		Curb & Gutter Type	
CONCRETE		NO CURB AND GUTTER	
Pavement Recommendation		Condition Rating / PCR	
PREVENTIVE MAINTENANCE		GOOD / 90

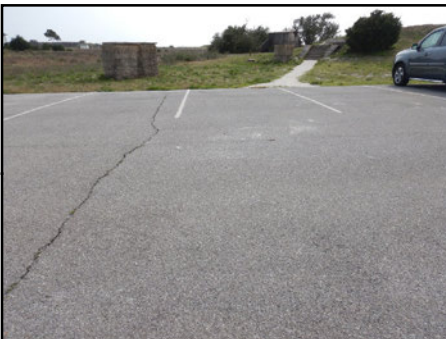
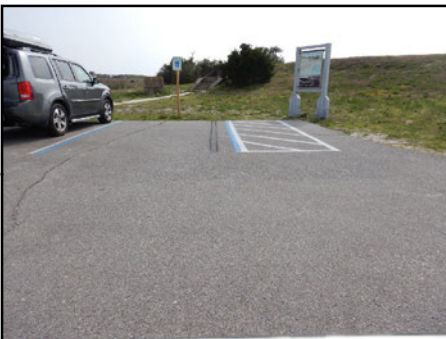
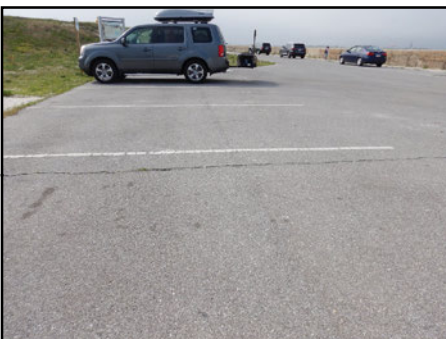
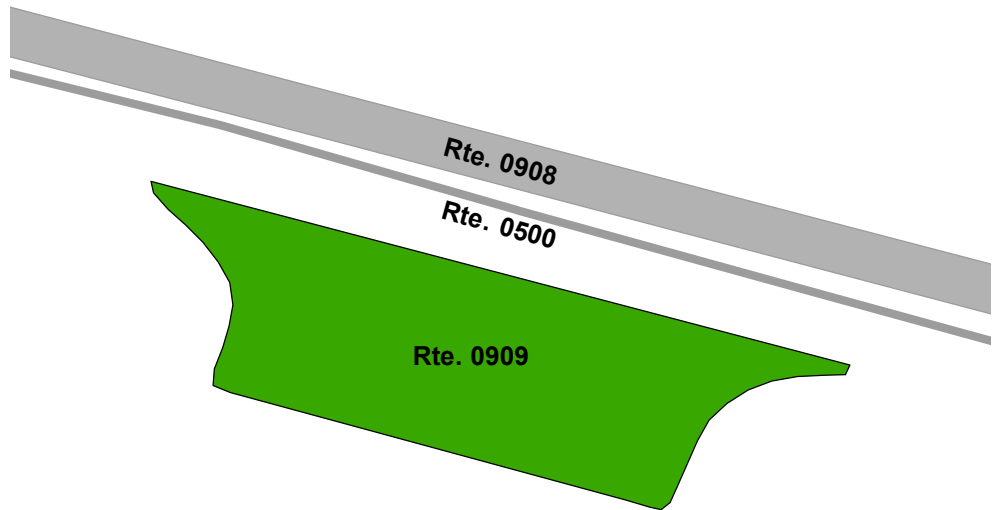
ROUTE 0909: BATTERY TRUEMAN PARKING

Inspection Date	FMSS Number	User Access	Surface Type
3/14/2019	72711	PUBLIC	ASPHALT
Area (Sq. Ft.)	Lane Miles (11' Widths)	Curb Reveal (Inches)	Curb Recommendation
3,381	0.058	NOT APPLICABLE	NOT APPLICABLE
Curb Type		Curb & Gutter Type	
NO CURB		NO CURB AND GUTTER	
Pavement Recommendation		Condition Rating / PCR	
PREVENTIVE MAINTENANCE		GOOD / 90

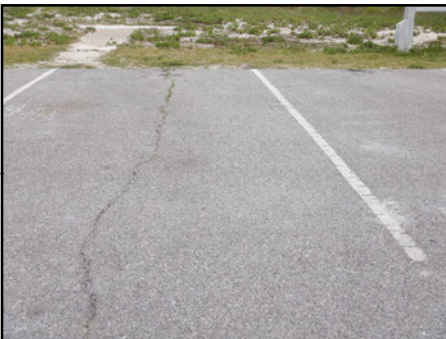
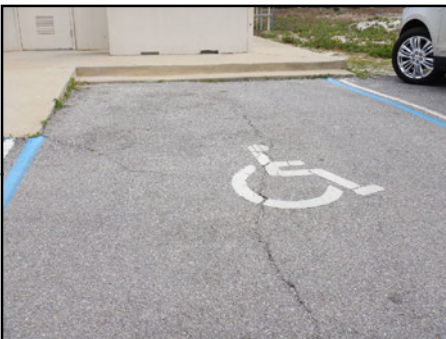
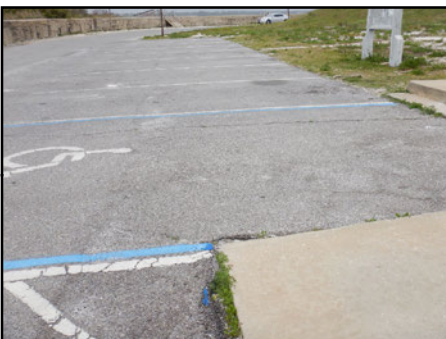
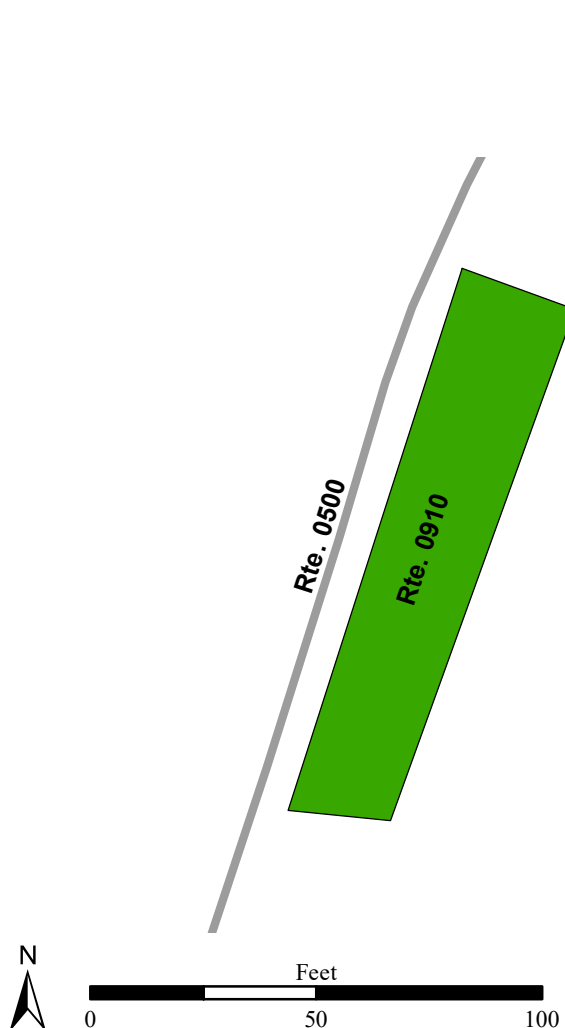
ROUTE 0910: JETTIES RESTROOM PARKING

Inspection Date	FMSS Number	User Access	Surface Type
3/14/2019	72714	PUBLIC	ASPHALT
Area (Sq. Ft.)	Lane Miles (11' Widths)	Curb Reveal (Inches)	Curb Recommendation
2,583	0.044	NOT APPLICABLE	NOT APPLICABLE
Curb Type		Curb & Gutter Type	
NO CURB		NO CURB AND GUTTER	
Pavement Recommendation		Condition Rating / PCR	
PREVENTIVE MAINTENANCE		GOOD / 90

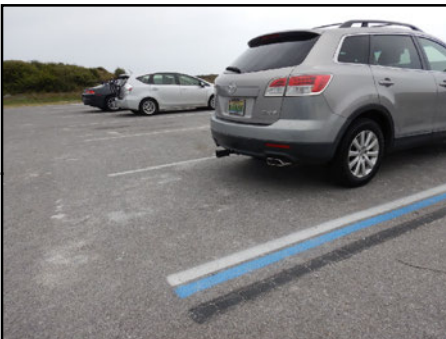
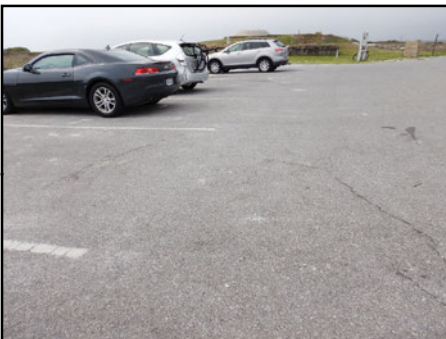
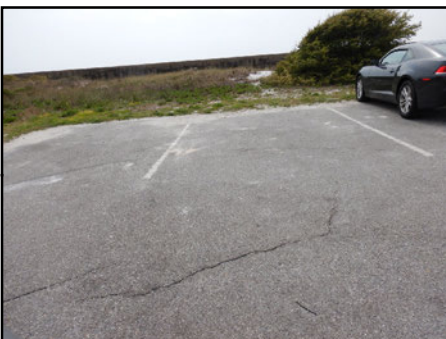
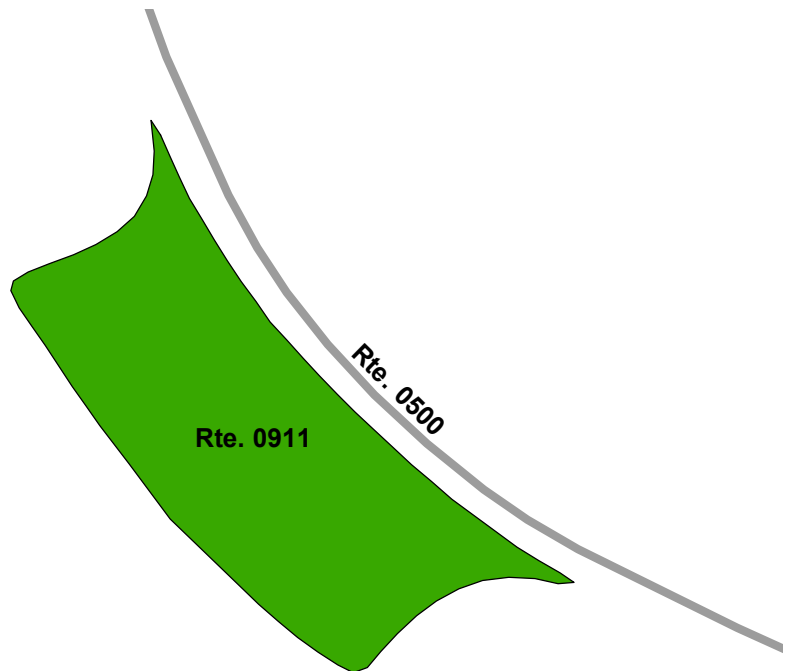
ROUTE 0911: BATTERY PAYNE PARKING

Inspection Date	FMSS Number	User Access	Surface Type
3/14/2019	72717	PUBLIC	ASPHALT
Area (Sq. Ft.)	Lane Miles (11' Widths)	Curb Reveal (Inches)	Curb Recommendation
3,842	0.066	NOT APPLICABLE	NOT APPLICABLE
Curb Type		Curb & Gutter Type	
NO CURB		NO CURB AND GUTTER	
Pavement Recommendation		Condition Rating / PCR	
PREVENTIVE MAINTENANCE		GOOD / 90

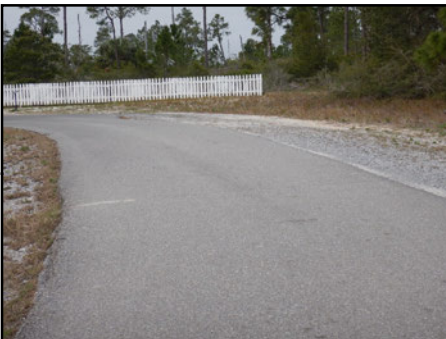
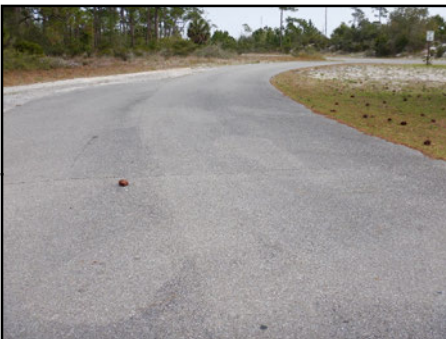
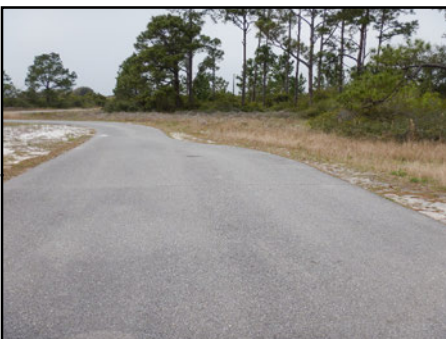
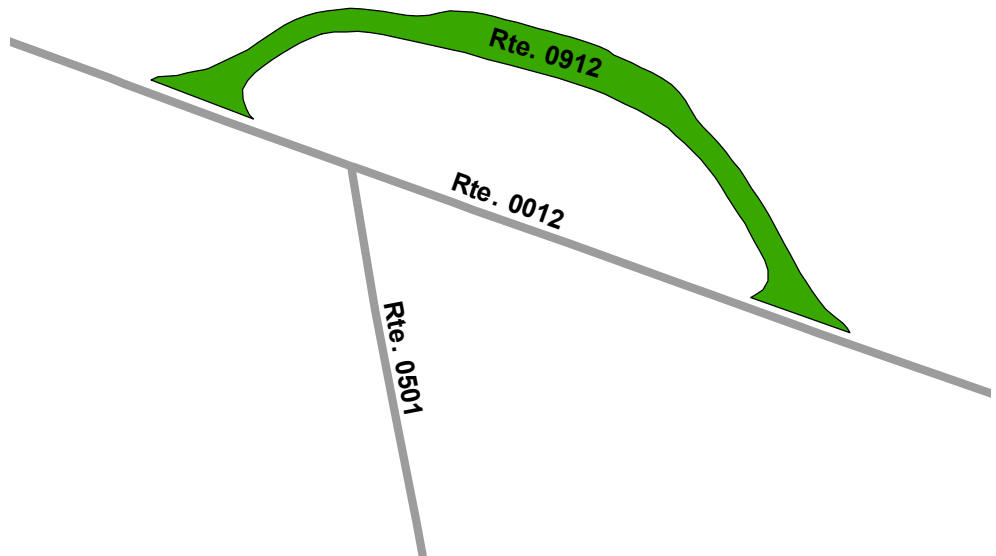
ROUTE 0912: GRAVES PARKING

Inspection Date	FMSS Number	User Access	Surface Type
3/14/2019	72720	PUBLIC	ASPHALT
Area (Sq. Ft.)	Lane Miles (11' Widths)	Curb Reveal (Inches)	Curb Recommendation
5,188	0.089	NOT APPLICABLE	NOT APPLICABLE
Curb Type		Curb & Gutter Type	
NO CURB		NO CURB AND GUTTER	
Pavement Recommendation		Condition Rating / PCR	
PREVENTIVE MAINTENANCE		GOOD / 90

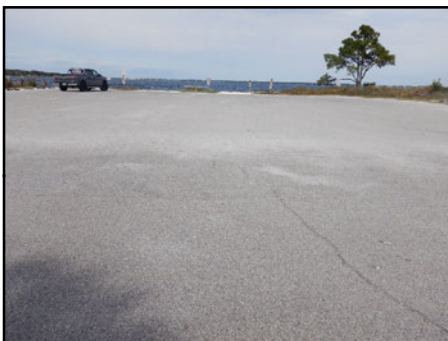
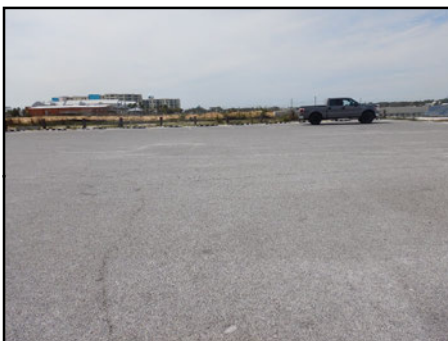
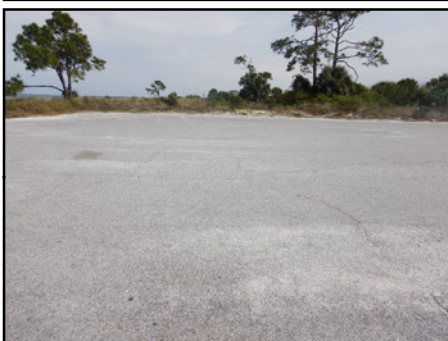
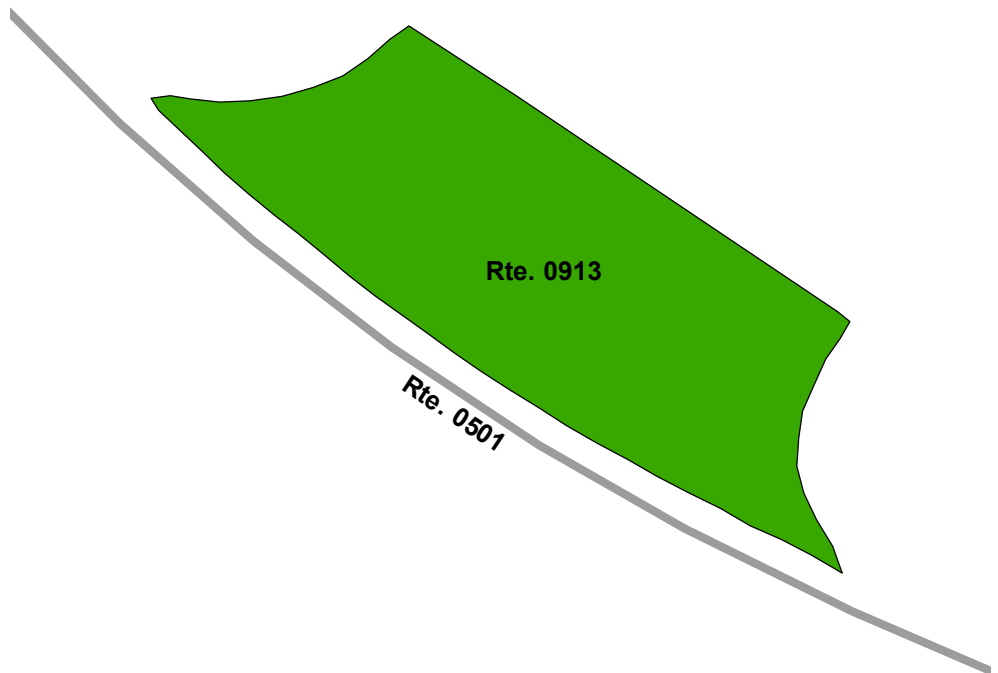
ROUTE 0913: BATTERY 234 PARKING

Inspection Date	FMSS Number	User Access	Surface Type
3/15/2019	72722	PUBLIC	ASPHALT
Area (Sq. Ft.)	Lane Miles (11' Widths)	Curb Reveal (Inches)	Curb Recommendation
3,603	0.062	NOT APPLICABLE	NOT APPLICABLE
Curb Type		Curb & Gutter Type	
NO CURB		NO CURB AND GUTTER	
Pavement Recommendation		Condition Rating / PCR	
PREVENTIVE MAINTENANCE		GOOD / 90

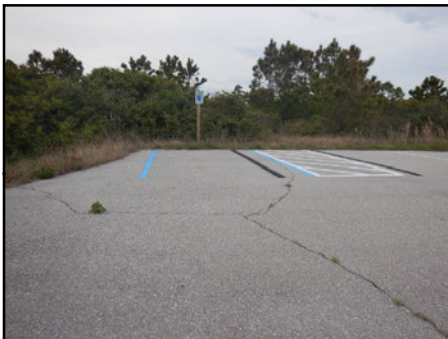
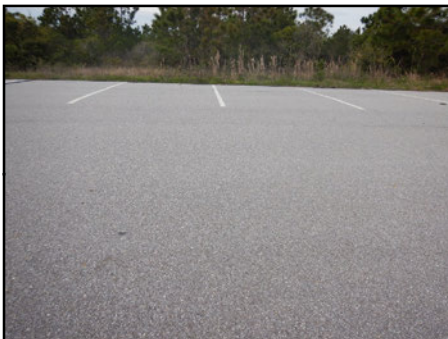
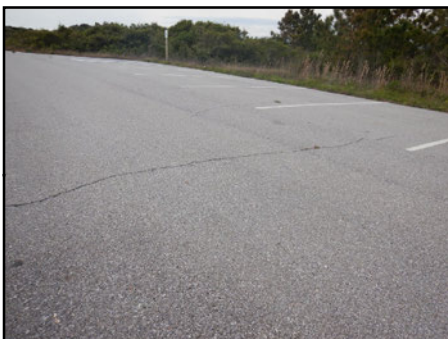
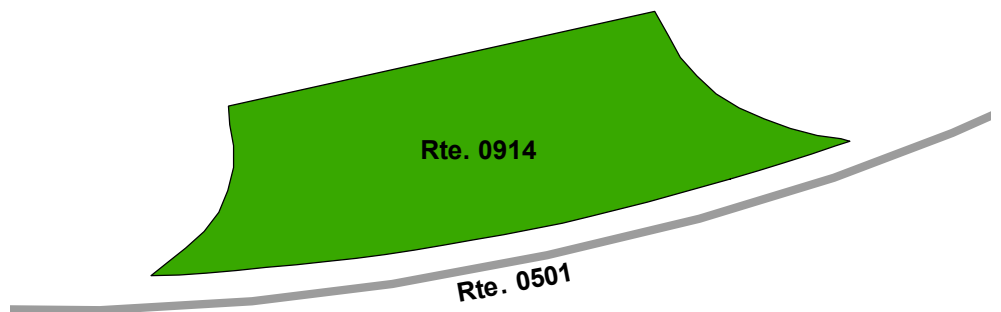
ROUTE 0914: BATTERY COOPER PARKING

Inspection Date	FMSS Number	User Access	Surface Type
3/15/2019	72728	PUBLIC	ASPHALT
Area (Sq. Ft.)	Lane Miles (11' Widths)	Curb Reveal (Inches)	Curb Recommendation
3,366	0.058	NOT APPLICABLE	NOT APPLICABLE
Curb Type		Curb & Gutter Type	
NO CURB		NO CURB AND GUTTER	
Pavement Recommendation		Condition Rating / PCR	
PREVENTIVE MAINTENANCE		GOOD / 90

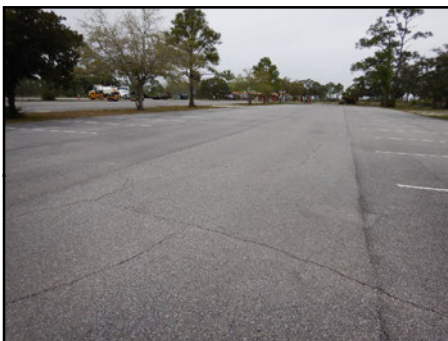
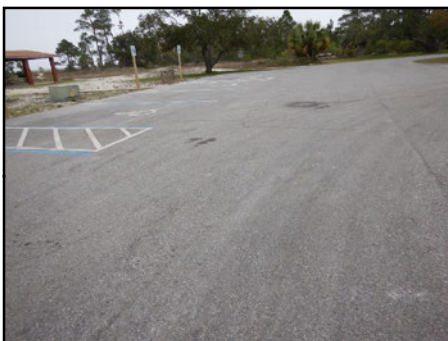
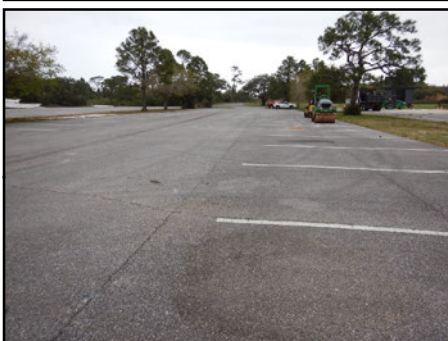
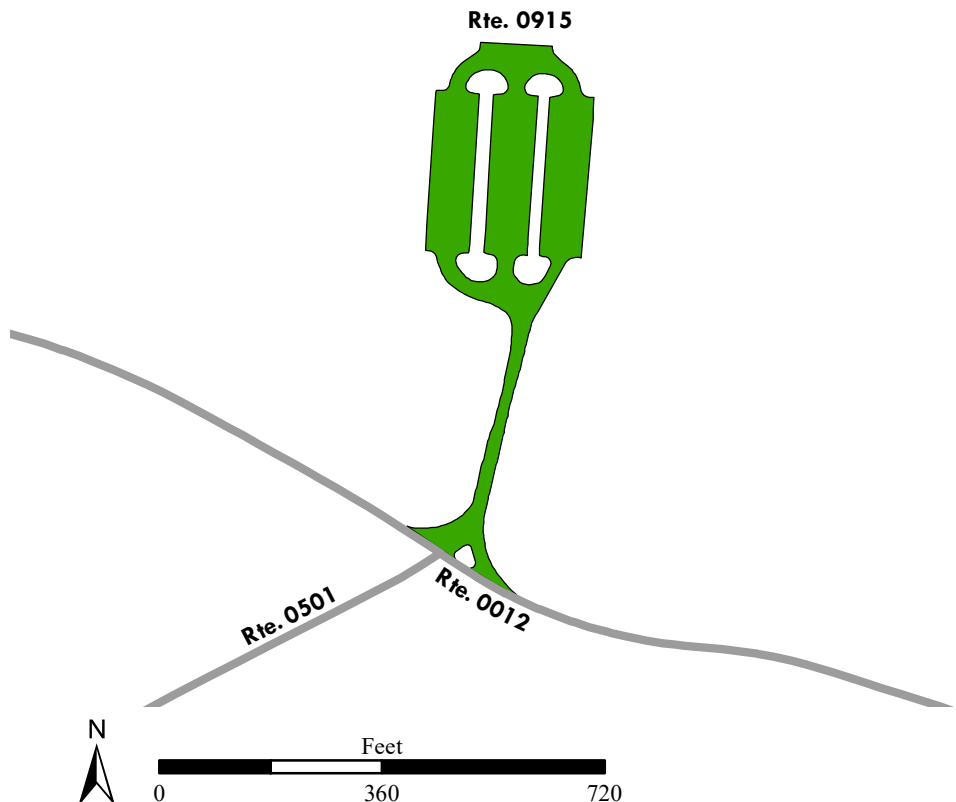
ROUTE 0915: BATTERY WORTH PICNIC ACCESS AND PARKING

Inspection Date	FMSS Number	User Access	Surface Type
3/14/2019	72731	PUBLIC	ASPHALT
Area (Sq. Ft.)	Lane Miles (11' Widths)	Curb Reveal (Inches)	Curb Recommendation
76,684	1.32	NOT APPLICABLE	NOT APPLICABLE
Curb Type		Curb & Gutter Type	
NO CURB		NO CURB AND GUTTER	
Pavement Recommendation		Condition Rating / PCR	
PREVENTIVE MAINTENANCE		GOOD / 90

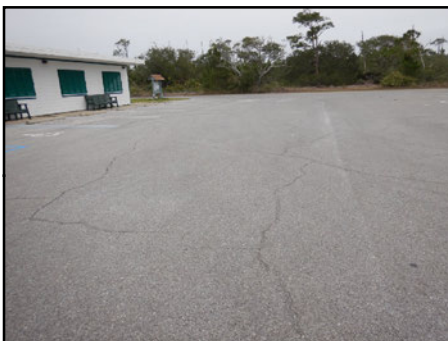
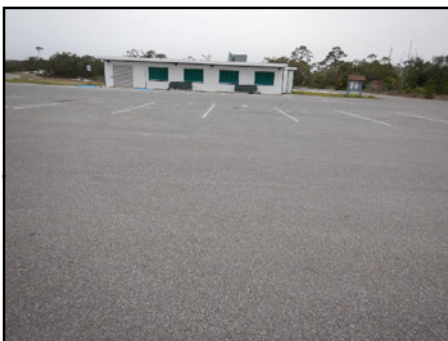
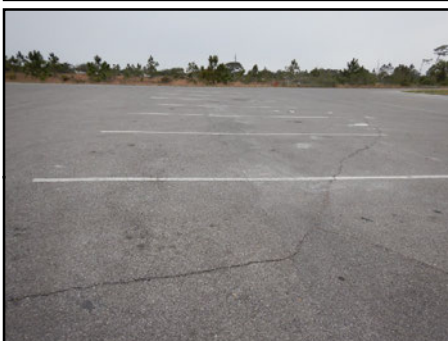
Inspection Date	FMSS Number	User Access	Surface Type
3/14/2019	79900	PUBLIC	ASPHALT
Area (Sq. Ft.)	Lane Miles (11' Widths)	Curb Reveal (Inches)	Curb Recommendation
12,633	0.218	NOT APPLICABLE	NOT APPLICABLE
Curb Type		Curb & Gutter Type	
NO CURB		NO CURB AND GUTTER	
Pavement Recommendation		Condition Rating / PCR	
LIGHT 3R TREATMENTS		FAIR / 73

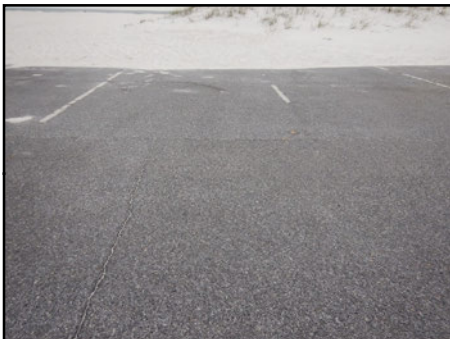
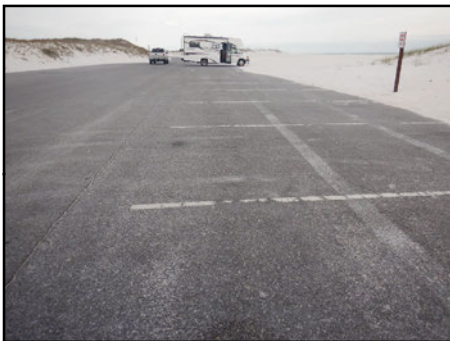
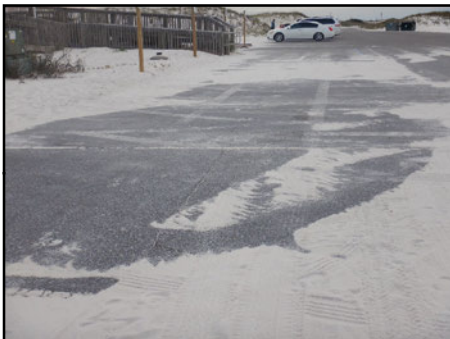
ROUTE 0918AZ: LANGDON BEACH PARKING A

Inspection Date	FMSS Number	User Access	Surface Type
3/15/2019	72745	PUBLIC	ASPHALT
Area (Sq. Ft.)	Lane Miles (11' Widths)	Curb Reveal (Inches)	Curb Recommendation
9,410	0.162	NOT APPLICABLE	NOT APPLICABLE
Curb Type		Curb & Gutter Type	
NO CURB		NO CURB AND GUTTER	
Pavement Recommendation		Condition Rating / PCR	
PREVENTIVE MAINTENANCE		GOOD / 90

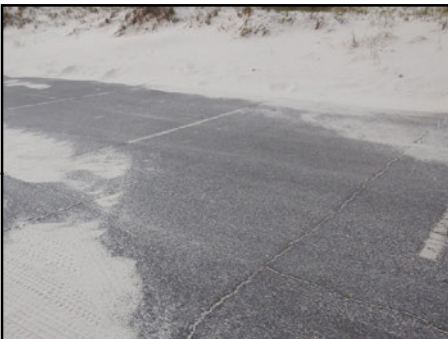
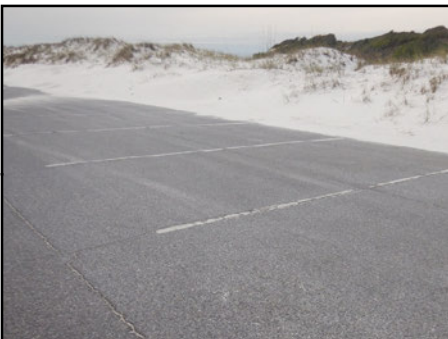
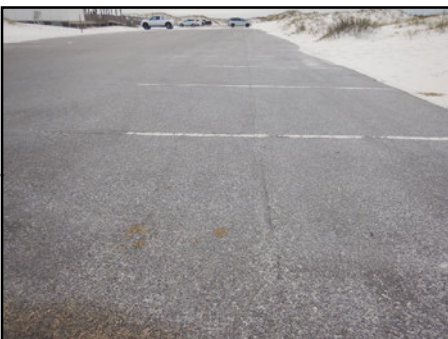
ROUTE 0918BZ: LANGDON BEACH PARKING B

Inspection Date	FMSS Number	User Access	Surface Type
3/15/2019	72745	PUBLIC	ASPHALT
Area (Sq. Ft.)	Lane Miles (11' Widths)	Curb Reveal (Inches)	Curb Recommendation
9,903	0.171	NOT APPLICABLE	NOT APPLICABLE
Curb Type		Curb & Gutter Type	
NO CURB		NO CURB AND GUTTER	
Pavement Recommendation		Condition Rating / PCR	
PREVENTIVE MAINTENANCE		GOOD / 90

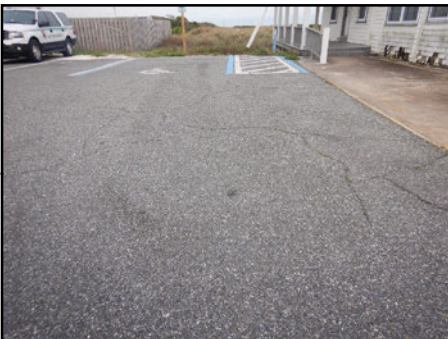
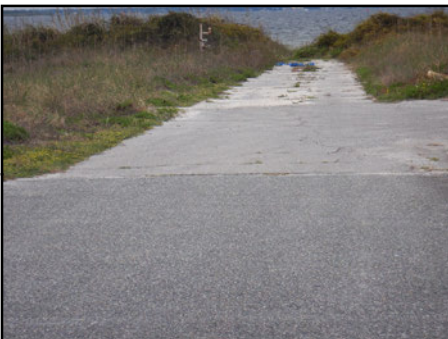
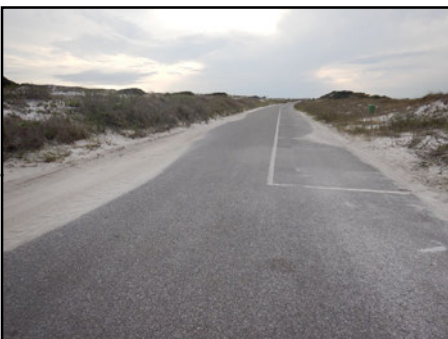
ROUTE 0919: CAMPGROUND REGISTRATION / RANGER STATION COMPLEX PARKING

Inspection Date	FMSS Number	User Access	Surface Type
3/15/2019	72748	PUBLIC	ASPHALT
Area (Sq. Ft.)	Lane Miles (11' Widths)	Curb Reveal (Inches)	Curb Recommendation
43,849	0.755	NOT APPLICABLE	NOT APPLICABLE
Curb Type		Curb & Gutter Type	
NO CURB		NO CURB AND GUTTER	
Pavement Recommendation		Condition Rating / PCR	
PREVENTIVE MAINTENANCE		GOOD / 90

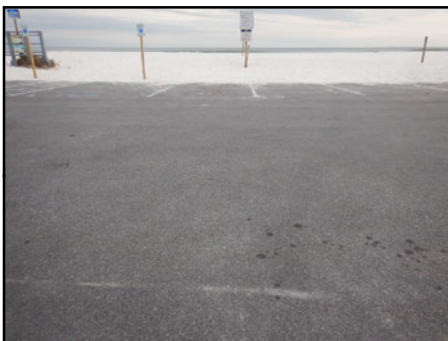
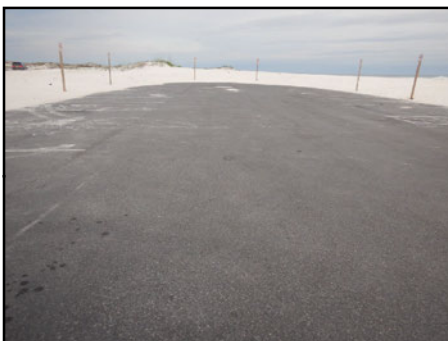
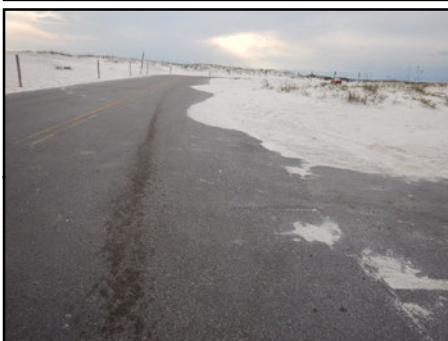
ROUTE 0920: PUBLIC BEACH PARKING #22

Inspection Date	FMSS Number	User Access	Surface Type
3/15/2019	72756	PUBLIC	ASPHALT
Area (Sq. Ft.)	Lane Miles (11' Widths)	Curb Reveal (Inches)	Curb Recommendation
14,640	0.252	NOT APPLICABLE	NOT APPLICABLE
Curb Type		Curb & Gutter Type	
NO CURB		NO CURB AND GUTTER	
Pavement Recommendation		Condition Rating / PCR	
PREVENTIVE MAINTENANCE		GOOD / 90

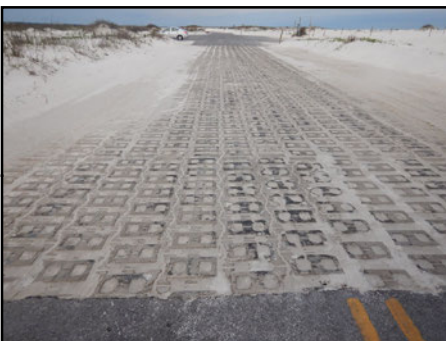
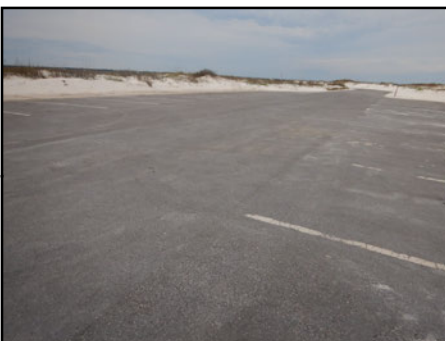
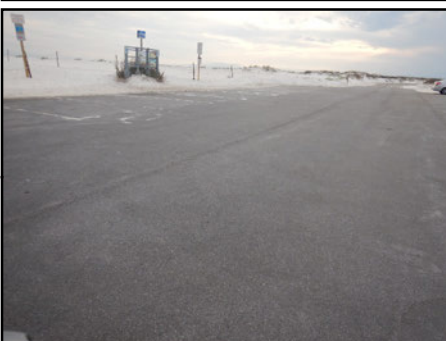
ROUTE 0921: PUBLIC BEACH PARKING #21

Inspection Date	FMSS Number	User Access	Surface Type
3/15/2019	72766	PUBLIC	ASPHALT
Area (Sq. Ft.)	Lane Miles (11' Widths)	Curb Reveal (Inches)	Curb Recommendation
22,366	0.385	NOT APPLICABLE	NOT APPLICABLE
Curb Type		Curb & Gutter Type	
NO CURB		NO CURB AND GUTTER	
Pavement Recommendation		Condition Rating / PCR	
PREVENTIVE MAINTENANCE		GOOD / 90

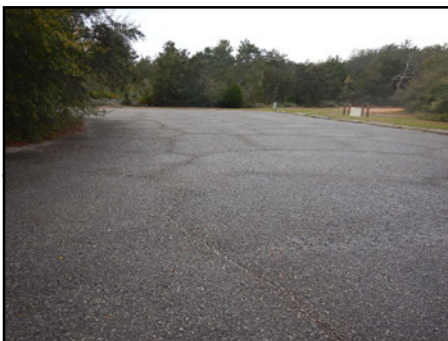
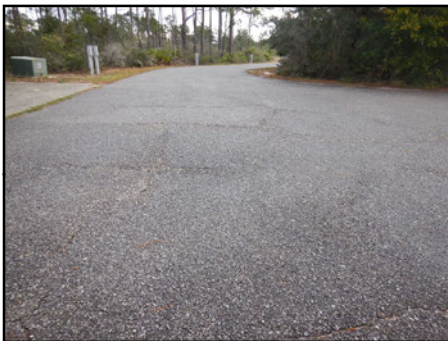
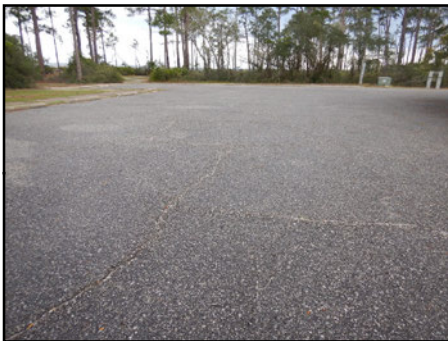
ROUTE 0922: NAVAL LIVE OAKS GROUP CAMPING AREA PARKING

Inspection Date	FMSS Number	User Access	Surface Type
3/15/2019	72773	PUBLIC	ASPHALT
Area (Sq. Ft.)	Lane Miles (11' Widths)	Curb Reveal (Inches)	Curb Recommendation
13,821	0.238	NOT APPLICABLE	NOT APPLICABLE
Curb Type		Curb & Gutter Type	
NO CURB		NO CURB AND GUTTER	
Pavement Recommendation		Condition Rating / PCR	
HEAVY 3R TREATMENTS		POOR / 53

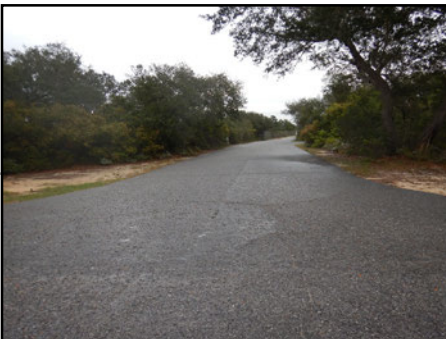
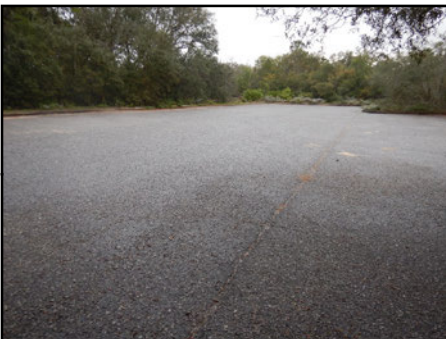
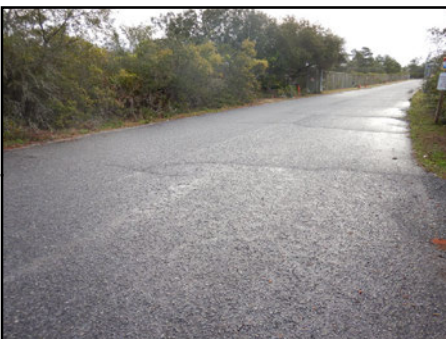
ROUTE 0923: NAVAL LIVE OAKS NORTH PARKING

Inspection Date	FMSS Number	User Access	Surface Type
3/15/2019	72781	PUBLIC	ASPHALT
Area (Sq. Ft.)	Lane Miles (11' Widths)	Curb Reveal (Inches)	Curb Recommendation
18,787	0.323	NOT APPLICABLE	LIGHT REPAIR
Curb Type		Curb & Gutter Type	
NO CURB		CONCRETE	
Pavement Recommendation		Condition Rating / PCR	
LIGHT 3R TREATMENTS		FAIR / 73

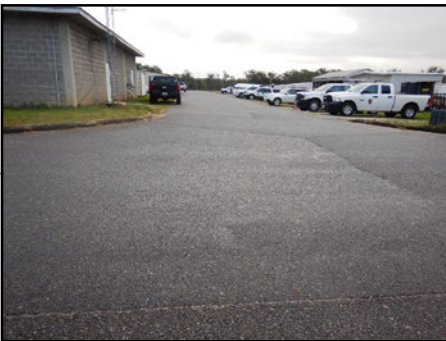
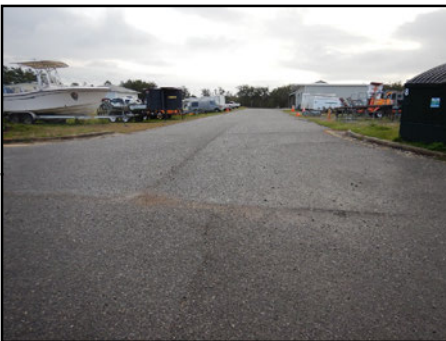
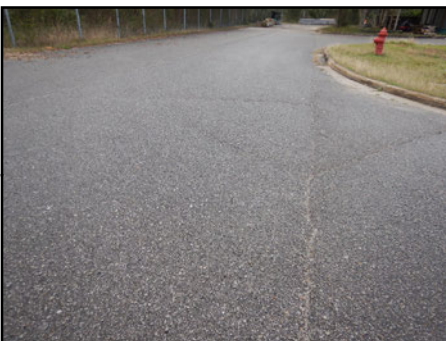
ROUTE 0924: NAVAL LIVE OAKS MAINTENANCE COMPLEX PARKING

Inspection Date	FMSS Number	User Access	Surface Type
3/15/2019	72783	NONPUBLIC	ASPHALT
Area (Sq. Ft.)	Lane Miles (11' Widths)	Curb Reveal (Inches)	Curb Recommendation
48,595	0.837	NOT APPLICABLE	LIGHT REPAIR
Curb Type		Curb & Gutter Type	
NO CURB		CONCRETE	
Pavement Recommendation		Condition Rating / PCR	
LIGHT 3R TREATMENTS		FAIR / 73

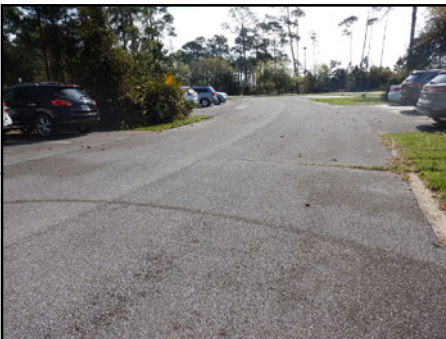
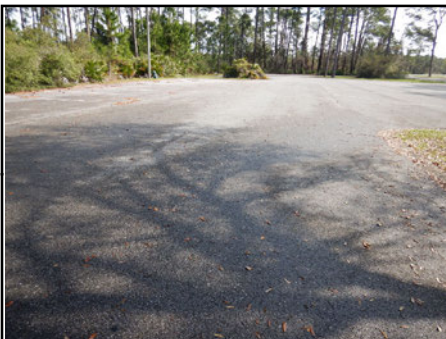
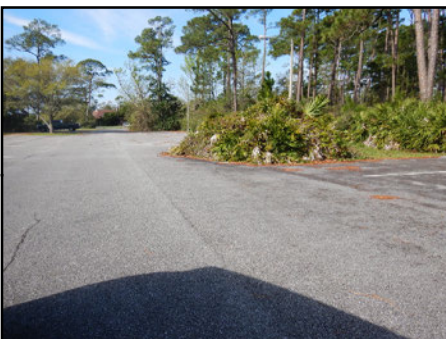
ROUTE 0925AZ: HEADQUARTERS & VISITORS CENTER PARKING A

Inspection Date	FMSS Number	User Access	Surface Type
3/15/2019	72784	PUBLIC	ASPHALT
Area (Sq. Ft.)	Lane Miles (11' Widths)	Curb Reveal (Inches)	Curb Recommendation
42,167	0.726	NOT APPLICABLE	NOT APPLICABLE
Curb Type		Curb & Gutter Type	
NO CURB		NO CURB AND GUTTER	
Pavement Recommendation		Condition Rating / PCR	
PREVENTIVE MAINTENANCE		GOOD / 90

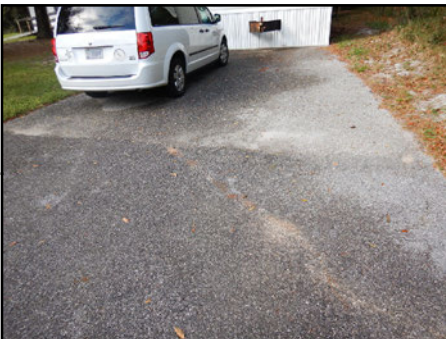
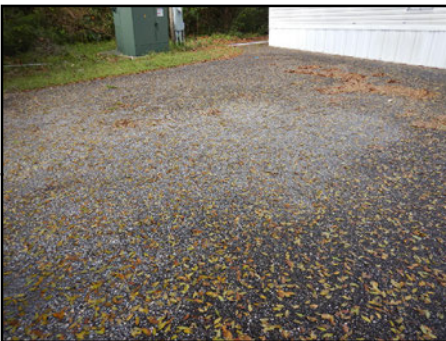
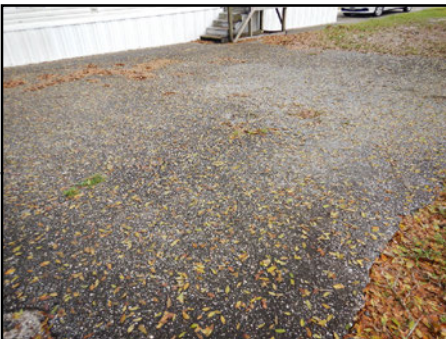
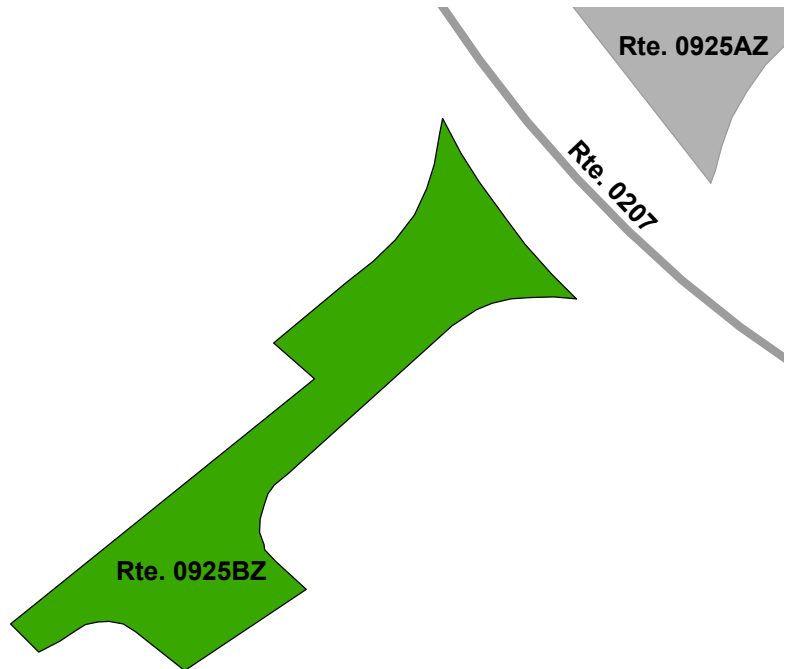
Inspection Date	FMSS Number	User Access	Surface Type
3/15/2019	72784	PUBLIC	ASPHALT
Area (Sq. Ft.)	Lane Miles (11' Widths)	Curb Reveal (Inches)	Curb Recommendation
1,940	0.033	NOT APPLICABLE	NOT APPLICABLE
Curb Type		Curb & Gutter Type	
NO CURB		NO CURB AND GUTTER	
Pavement Recommendation		Condition Rating / PCR	
PREVENTIVE MAINTENANCE		GOOD / 90

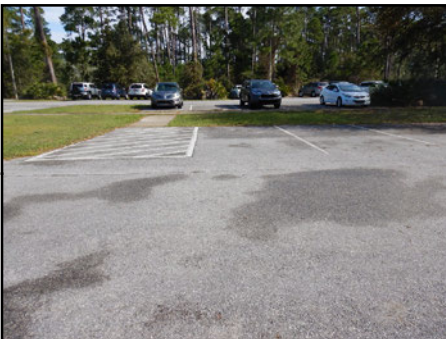
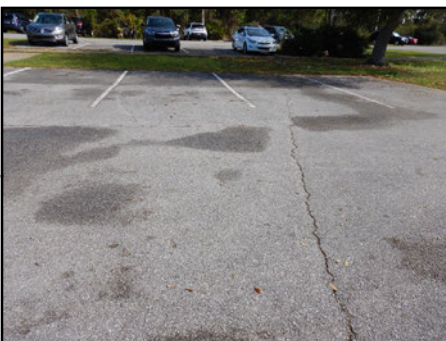
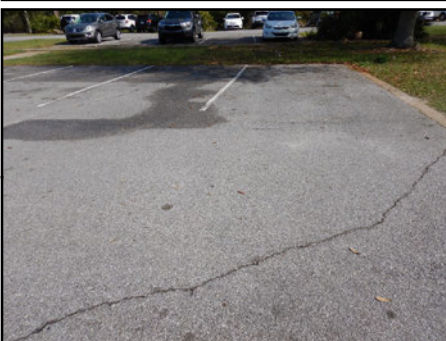
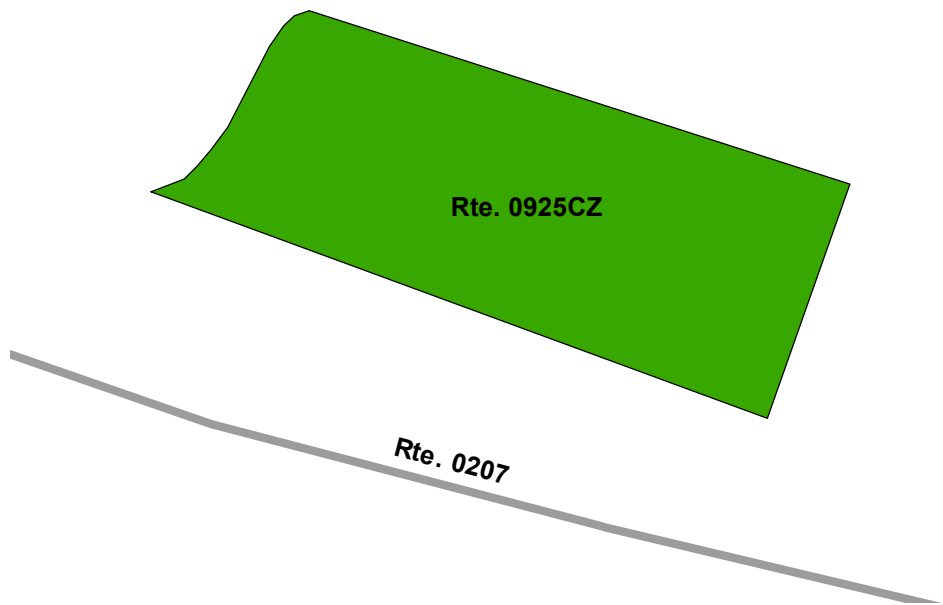
ROUTE 0925CZ: HEADQUARTERS & VISITORS CENTER PARKING C

Inspection Date	FMISS Number	User Access	Surface Type
3/15/2019	72784	PUBLIC	ASPHALT
Area (Sq. Ft.)	Lane Miles (11' Widths)	Curb Reveal (Inches)	Curb Recommendation
1,007	0.017	NOT APPLICABLE	NOT APPLICABLE
Curb Type		Curb & Gutter Type	
NO CURB		NO CURB AND GUTTER	
Pavement Recommendation		Condition Rating / PCR	
PREVENTIVE MAINTENANCE		GOOD / 90
