GUIIS Cycle 6

Final Report

Road Inventory and Condition Assessment of Paved Routes Gulf Islands National Seashore

Report Date: October 2020

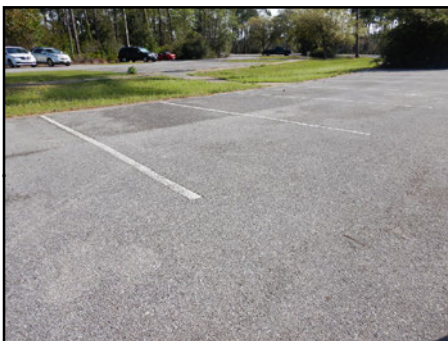
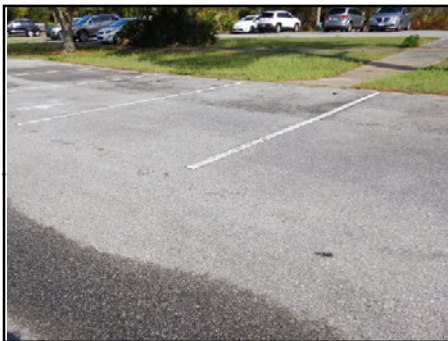
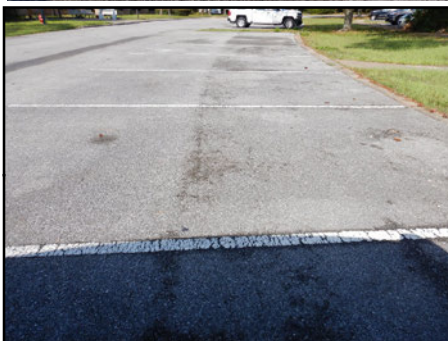
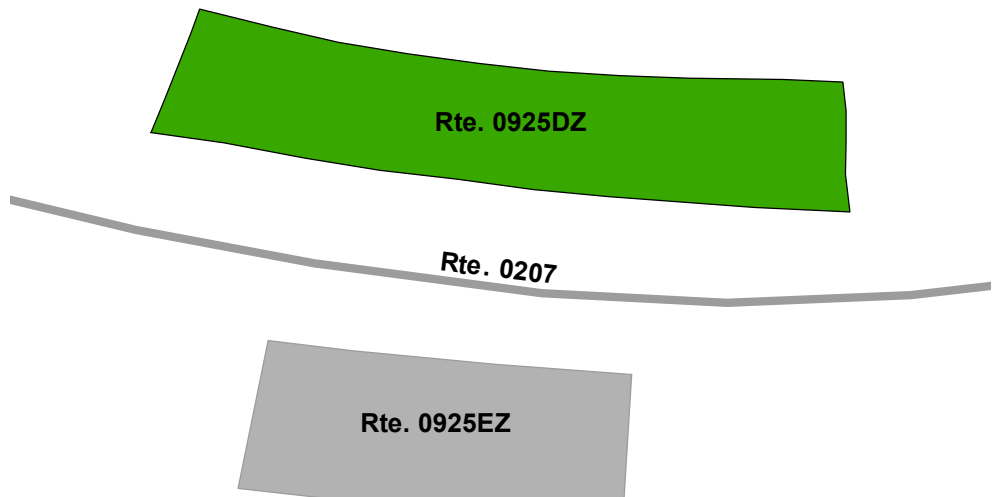
ROUTE 0925DZ: HEADQUARTERS & VISITORS CENTER PARKING D

Inspection Date	FMSS Number	User Access	Surface Type
3/15/2019	72784	PUBLIC	ASPHALT
Area (Sq. Ft.)	Lane Miles (11' Widths)	Curb Reveal (Inches)	Curb Recommendation
1,574	0.027	NOT APPLICABLE	NOT APPLICABLE
Curb Type		Curb & Gutter Type	
NO CURB		NO CURB AND GUTTER	
Pavement Recommendation		Condition Rating / PCR	
PREVENTIVE MAINTENANCE		GOOD / 90

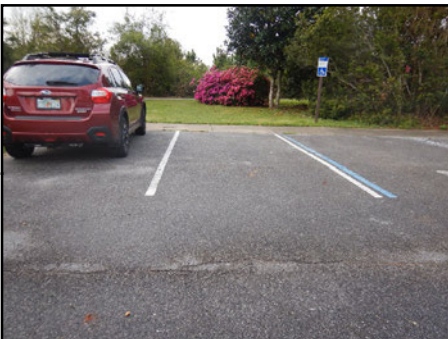
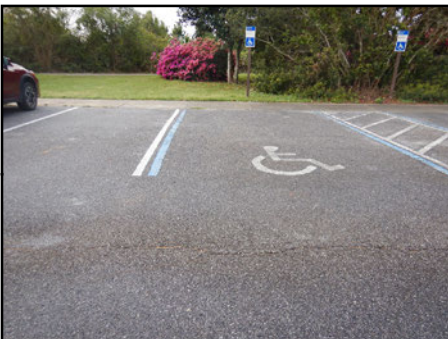
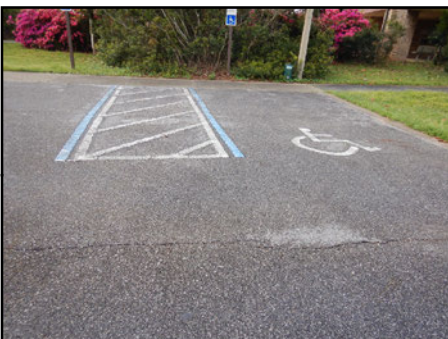
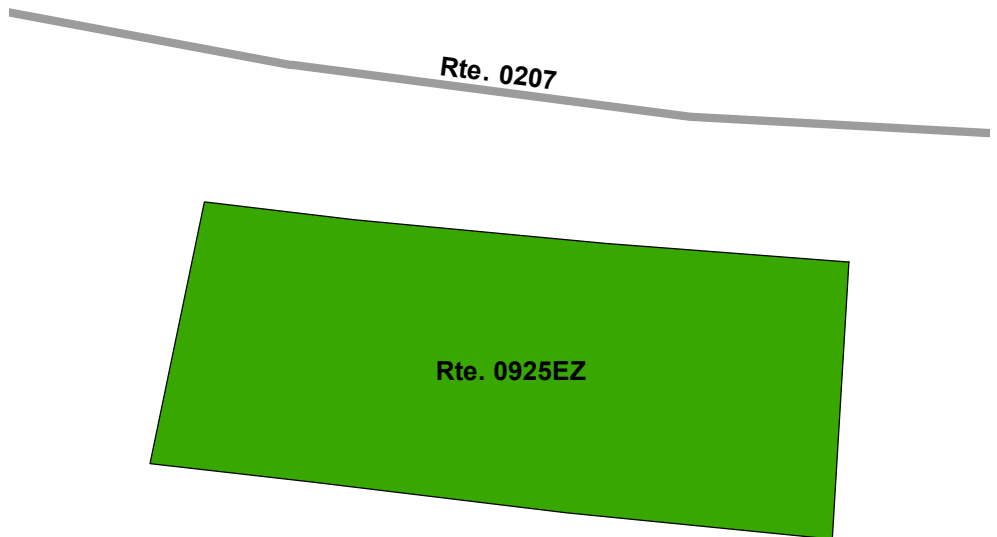
ROUTE 0925EZ: HEADQUARTERS & VISITORS CENTER PARKING E

Inspection Date	FMSS Number	User Access	Surface Type
3/15/2019	72784	PUBLIC	ASPHALT
Area (Sq. Ft.)	Lane Miles (11' Widths)	Curb Reveal (Inches)	Curb Recommendation
1,087	0.019	NOT APPLICABLE	NOT APPLICABLE
Curb Type		Curb & Gutter Type	
NO CURB		NO CURB AND GUTTER	
Pavement Recommendation		Condition Rating / PCR	
PREVENTIVE MAINTENANCE		GOOD / 90

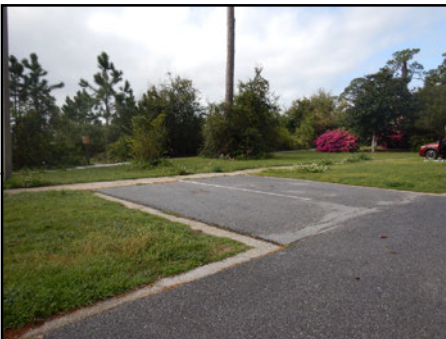
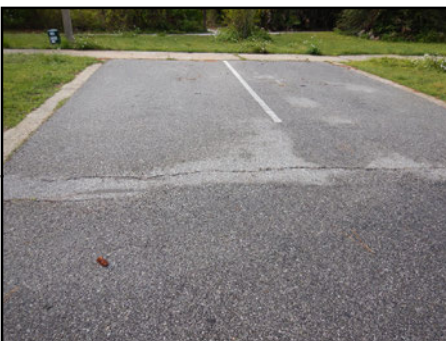
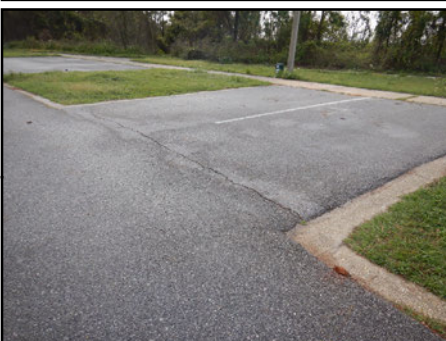
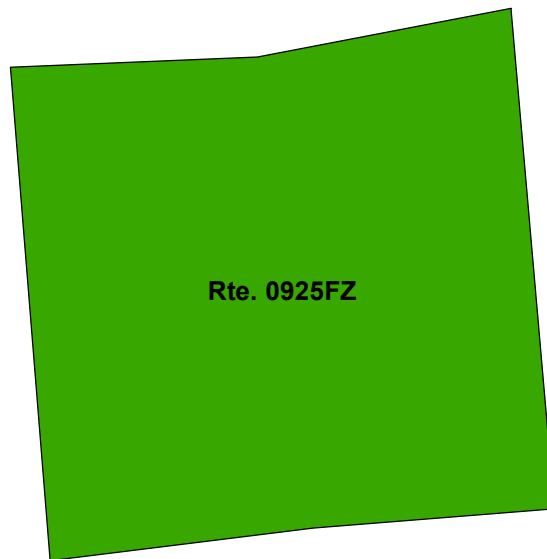
ROUTE 0925FZ: HEADQUARTERS & VISITORS CENTER PARKING F

Inspection Date	FMSS Number	User Access	Surface Type
3/15/2019	72784	PUBLIC	ASPHALT
Area (Sq. Ft.)	Lane Miles (11' Widths)	Curb Reveal (Inches)	Curb Recommendation
449	0.008	1	DO NOTHING
Curb Type		Curb & Gutter Type	
CONCRETE		NO CURB AND GUTTER	
Pavement Recommendation		Condition Rating / PCR	
PREVENTIVE MAINTENANCE		GOOD / 90

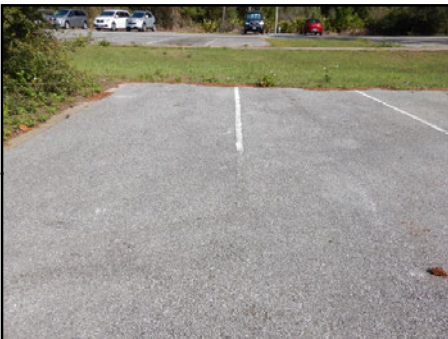
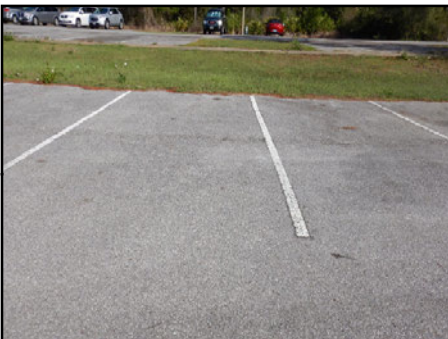
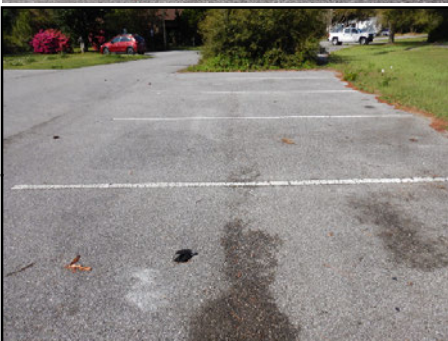
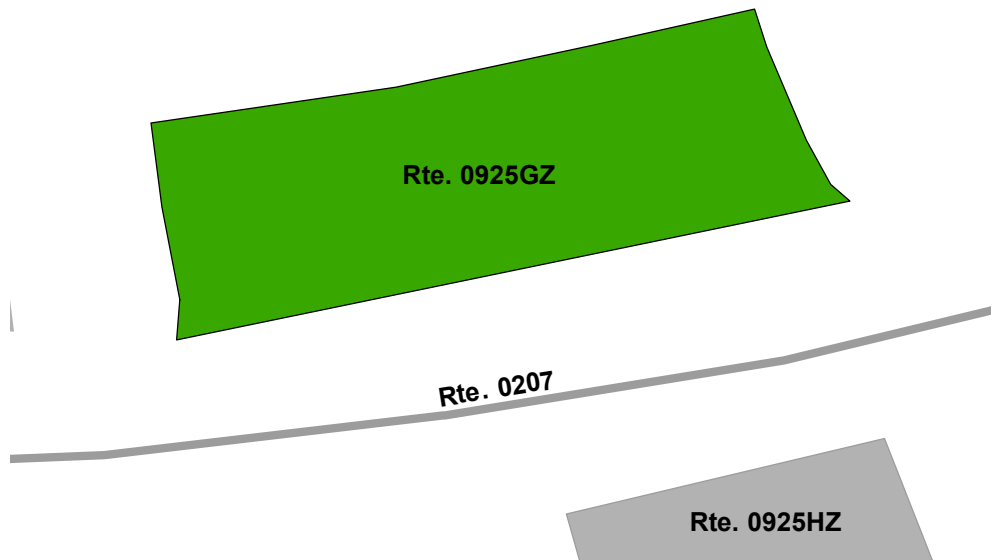
ROUTE 0925GZ: HEADQUARTERS & VISITORS CENTER PARKING G

Inspection Date	FMSS Number	User Access	Surface Type
3/15/2019	72784	PUBLIC	ASPHALT
Area (Sq. Ft.)	Lane Miles (11' Widths)	Curb Reveal (Inches)	Curb Recommendation
1,142	0.02	NOT APPLICABLE	NOT APPLICABLE
Curb Type		Curb & Gutter Type	
NO CURB		NO CURB AND GUTTER	
Pavement Recommendation		Condition Rating / PCR	
PREVENTIVE MAINTENANCE		GOOD / 90

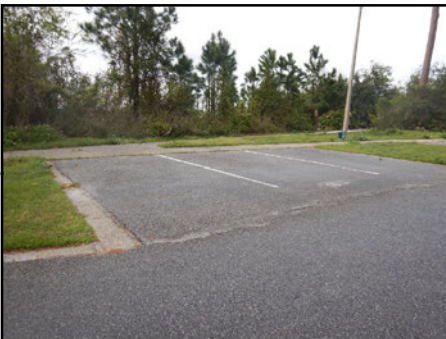
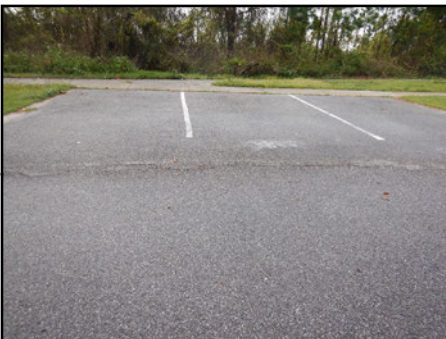
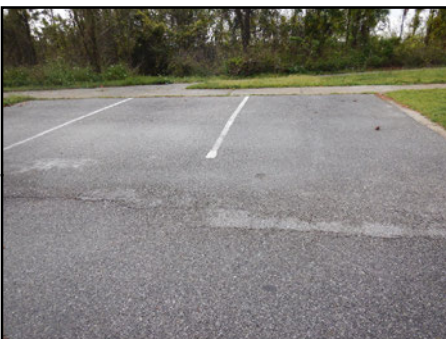
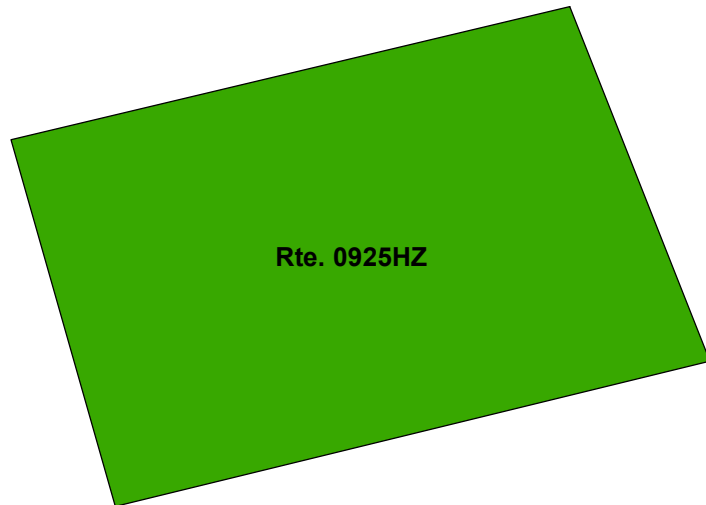
ROUTE 0925HZ: HEADQUARTERS & VISITORS CENTER PARKING H

Inspection Date	FMSS Number	User Access	Surface Type
3/15/2019	72784	PUBLIC	ASPHALT
Area (Sq. Ft.)	Lane Miles (11' Widths)	Curb Reveal (Inches)	Curb Recommendation
626	0.011	1	DO NOTHING
Curb Type		Curb & Gutter Type	
CONCRETE		NO CURB AND GUTTER	
Pavement Recommendation		Condition Rating / PCR	
PREVENTIVE MAINTENANCE		GOOD / 90

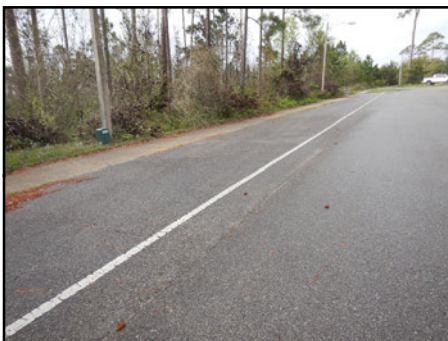
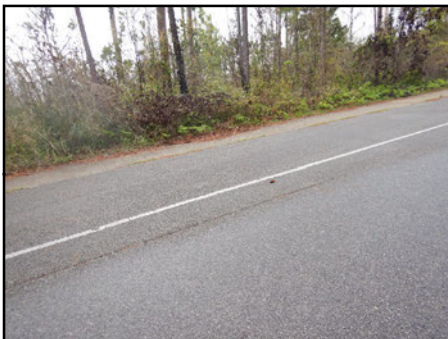
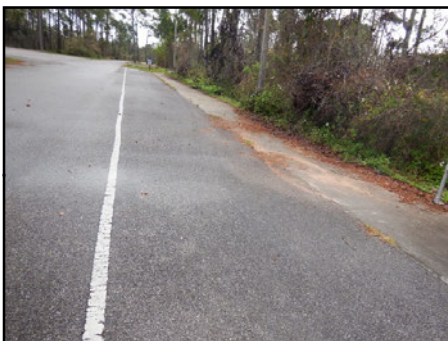
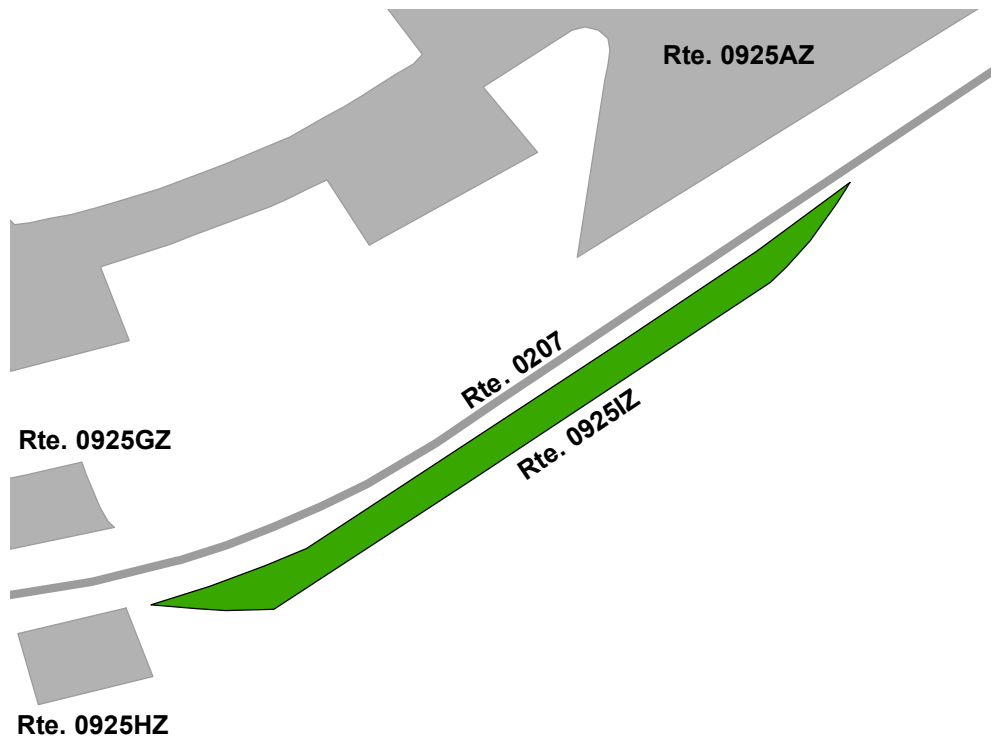
ROUTE 0925IZ: HEADQUARTERS & VISITORS CENTER PARKING I

Inspection Date	FMSS Number	User Access	Surface Type
3/15/2019	72784	PUBLIC	ASPHALT
Area (Sq. Ft.)	Lane Miles (11' Widths)	Curb Reveal (Inches)	Curb Recommendation
1,848	0.032	NOT APPLICABLE	NOT APPLICABLE
Curb Type		Curb & Gutter Type	
NO CURB		NO CURB AND GUTTER	
Pavement Recommendation		Condition Rating / PCR	
PREVENTIVE MAINTENANCE		GOOD / 90

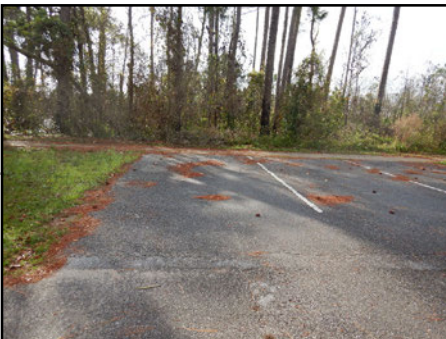
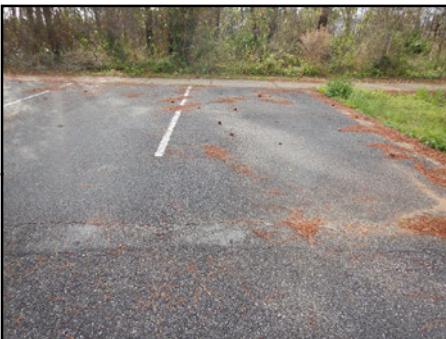
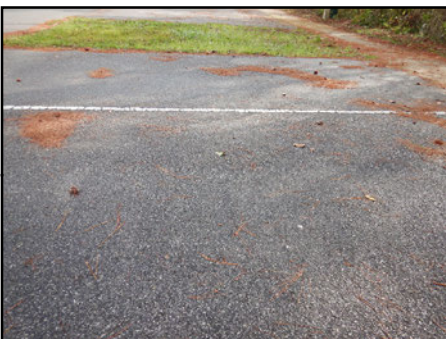
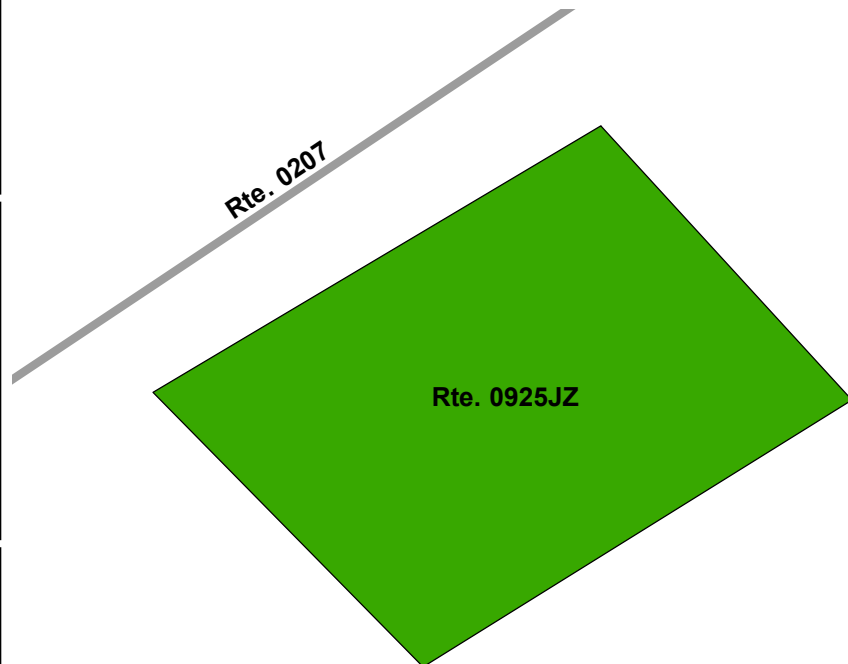
ROUTE 0925JZ: HEADQUARTERS & VISITORS CENTER PARKING J

Inspection Date	FMSS Number	User Access	Surface Type
3/15/2019	72784	PUBLIC	ASPHALT
Area (Sq. Ft.)	Lane Miles (11' Widths)	Curb Reveal (Inches)	Curb Recommendation
656	0.011	NOT APPLICABLE	NOT APPLICABLE
Curb Type		Curb & Gutter Type	
NO CURB		NO CURB AND GUTTER	
Pavement Recommendation		Condition Rating / PCR	
PREVENTIVE MAINTENANCE		GOOD / 90

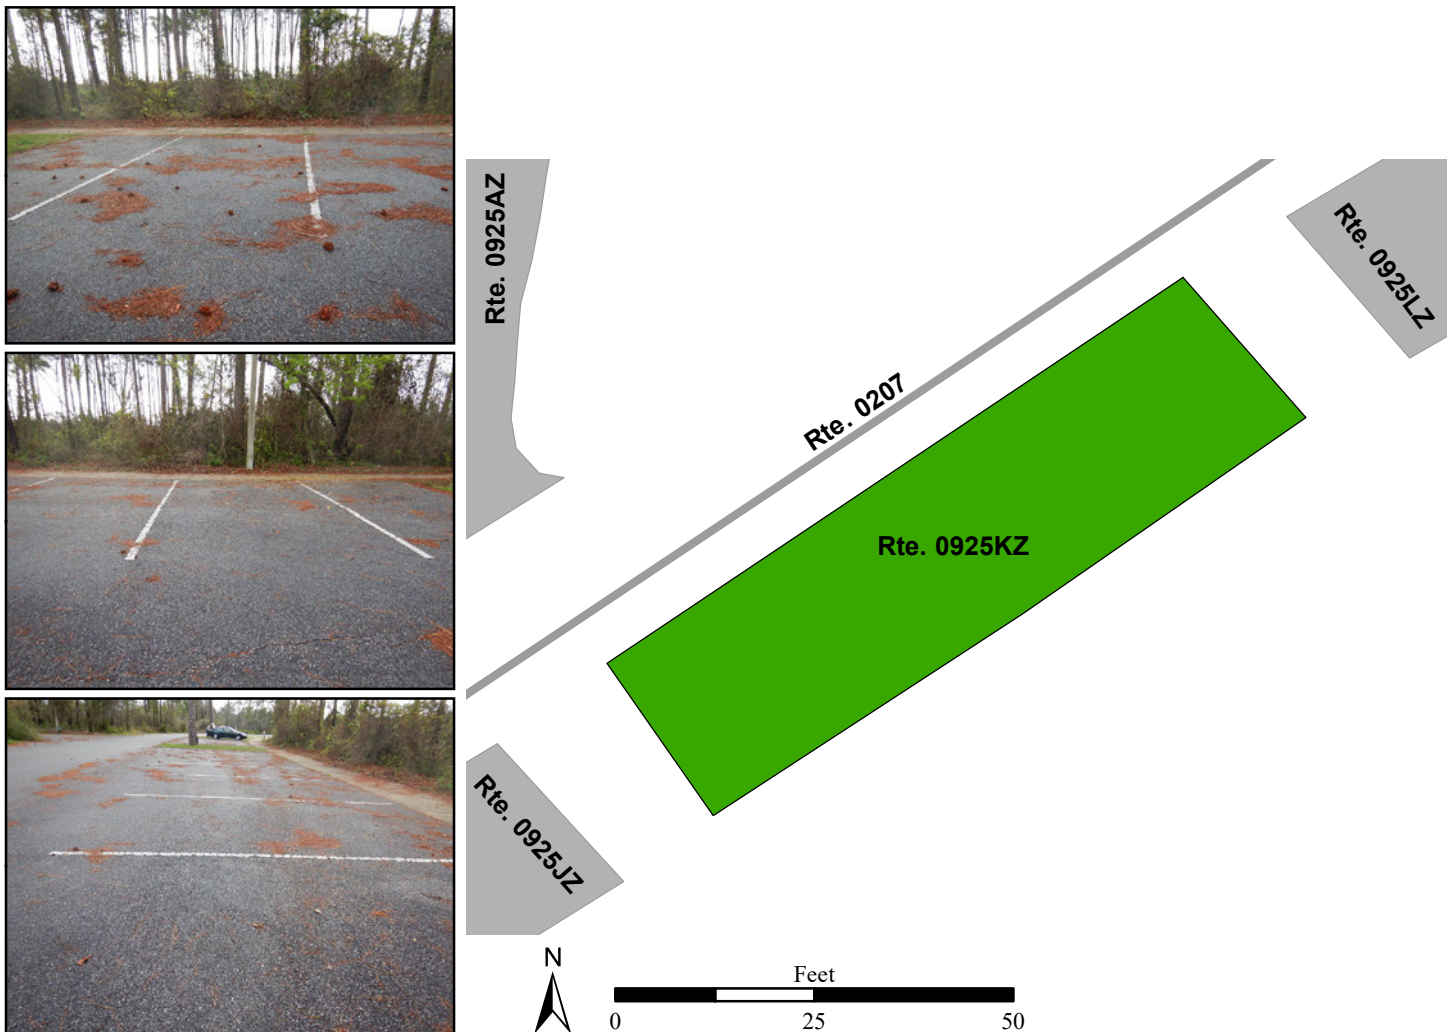
ROUTE 0925KZ: HEADQUARTERS & VISITORS CENTER PARKING K

Inspection Date	FMSS Number	User Access	Surface Type
3/15/2019	72784	PUBLIC	ASPHALT
Area (Sq. Ft.)	Lane Miles (11' Widths)	Curb Reveal (Inches)	Curb Recommendation
1,804	0.031	NOT APPLICABLE	NOT APPLICABLE
Curb Type		Curb & Gutter Type	
NO CURB		NO CURB AND GUTTER	
Pavement Recommendation		Condition Rating / PCR	
PREVENTIVE MAINTENANCE		GOOD / 90

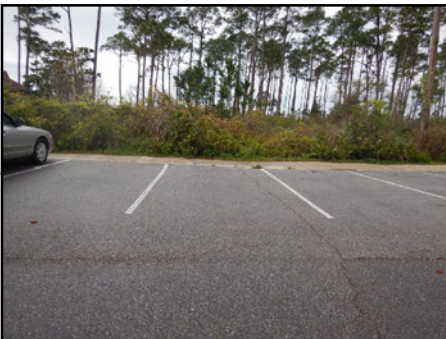
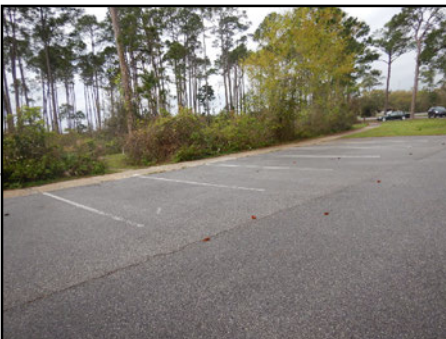
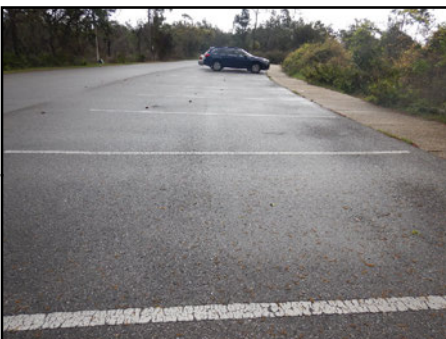
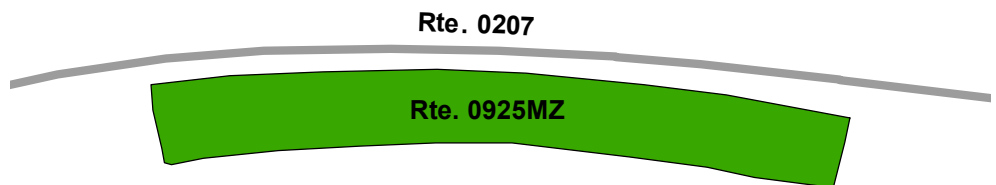
ROUTE 0925MZ: HEADQUARTERS & VISITORS CENTER PARKING M

Inspection Date	FMSS Number	User Access	Surface Type
3/15/2019	72784	PUBLIC	ASPHALT
Area (Sq. Ft.)	Lane Miles (11' Widths)	Curb Reveal (Inches)	Curb Recommendation
3,209	0.055	NOT APPLICABLE	NOT APPLICABLE
Curb Type		Curb & Gutter Type	
NO CURB		NO CURB AND GUTTER	
Pavement Recommendation		Condition Rating / PCR	
PREVENTIVE MAINTENANCE		GOOD / 90

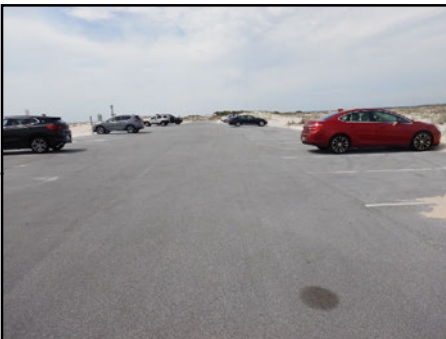
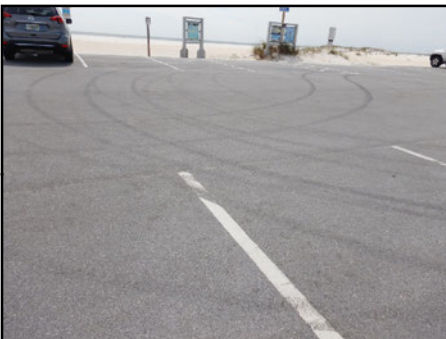
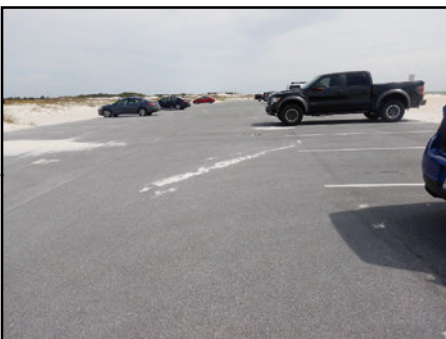
ROUTE 0926: PUBLIC PARKING #8

Inspection Date	FMSS Number	User Access	Surface Type
3/15/2019	72786	PUBLIC	ASPHALT
Area (Sq. Ft.)	Lane Miles (11' Widths)	Curb Reveal (Inches)	Curb Recommendation
26,387	0.454	NOT APPLICABLE	NOT APPLICABLE
Curb Type		Curb & Gutter Type	
NO CURB		NO CURB AND GUTTER	
Pavement Recommendation		Condition Rating / PCR	
PREVENTIVE MAINTENANCE		GOOD / 90

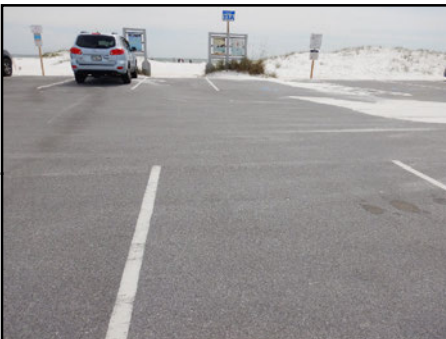
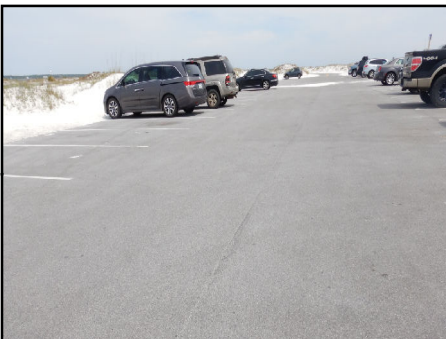
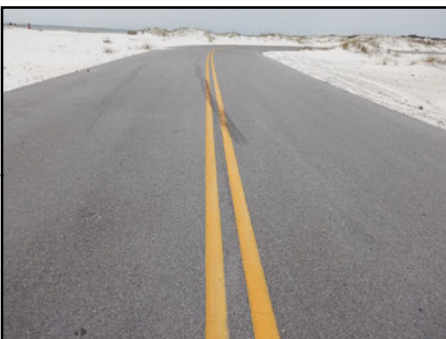
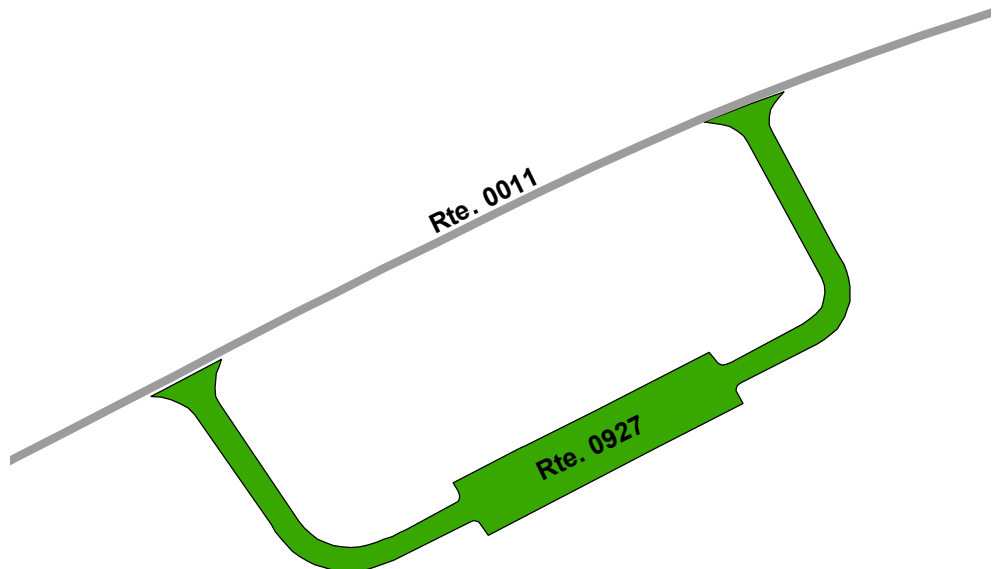
ROUTE 0927: PUBLIC PARKING #7

Inspection Date	FMSS Number	User Access	Surface Type
3/15/2019	72787	PUBLIC	ASPHALT
Area (Sq. Ft.)	Lane Miles (11' Widths)	Curb Reveal (Inches)	Curb Recommendation
32,452	0.559	NOT APPLICABLE	NOT APPLICABLE
Curb Type		Curb & Gutter Type	
NO CURB		NO CURB AND GUTTER	
Pavement Recommendation		Condition Rating / PCR	
PREVENTIVE MAINTENANCE		GOOD / 90

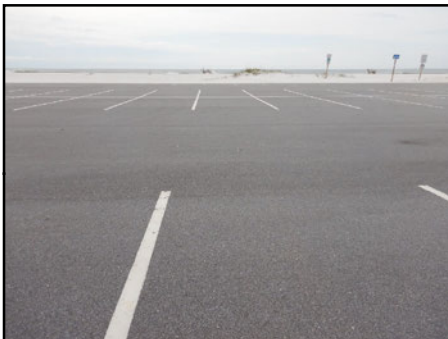
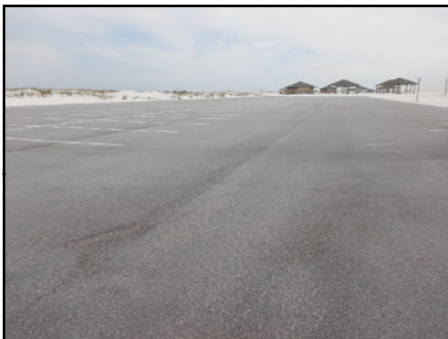
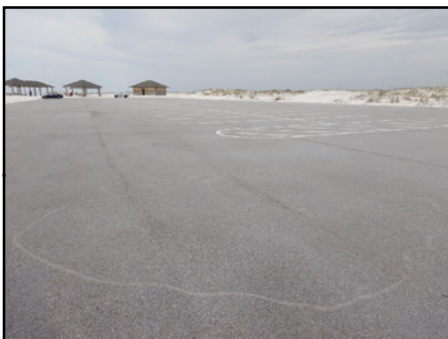
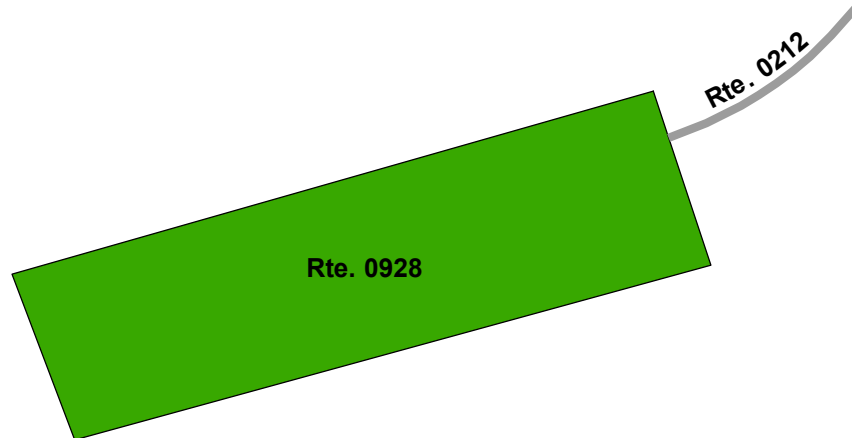
ROUTE 0928: OPAL BEACH PARKING #5

Inspection Date	FMSS Number	User Access	Surface Type
3/15/2019	72789	PUBLIC	ASPHALT
Area (Sq. Ft.)	Lane Miles (11' Widths)	Curb Reveal (Inches)	Curb Recommendation
46,217	0.796	NOT APPLICABLE	NOT APPLICABLE
Curb Type		Curb & Gutter Type	
NO CURB		NO CURB AND GUTTER	
Pavement Recommendation		Condition Rating / PCR	
PREVENTIVE MAINTENANCE		GOOD / 90

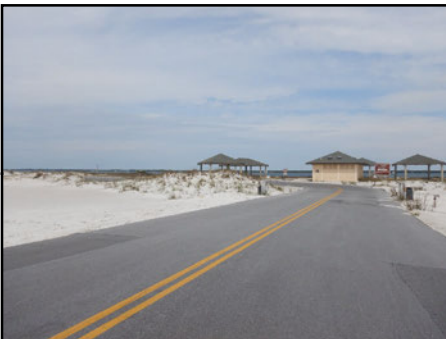
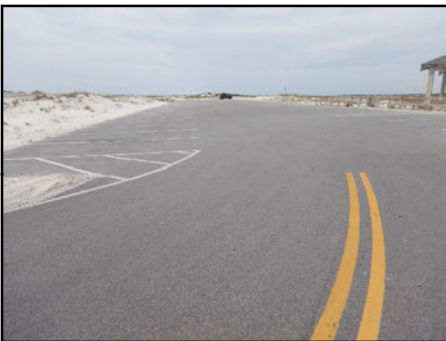
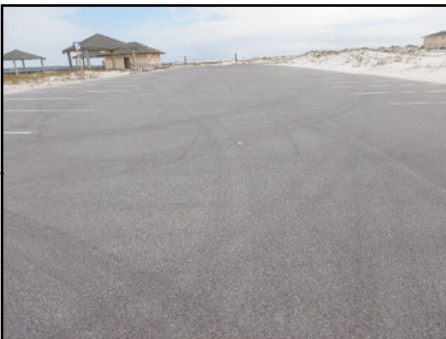
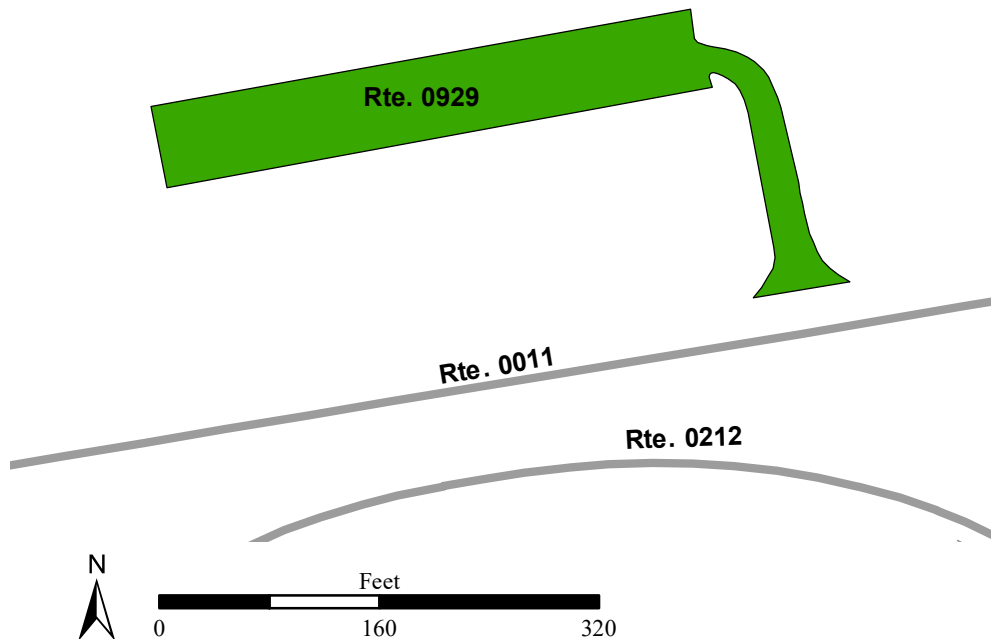
ROUTE 0929: PUBLIC PARKING #6

Inspection Date	FMSS Number	User Access	Surface Type
3/15/2019	72791	PUBLIC	ASPHALT
Area (Sq. Ft.)	Lane Miles (11' Widths)	Curb Reveal (Inches)	Curb Recommendation
25,224	0.434	NOT APPLICABLE	NOT APPLICABLE
Curb Type		Curb & Gutter Type	
NO CURB		NO CURB AND GUTTER	
Pavement Recommendation		Condition Rating / PCR	
PREVENTIVE MAINTENANCE		GOOD / 90

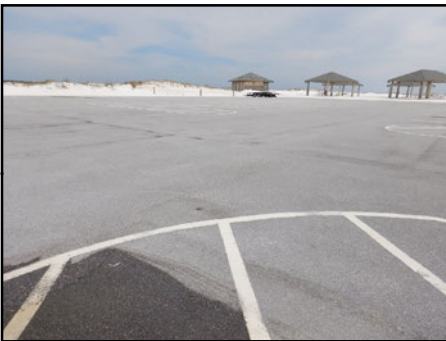
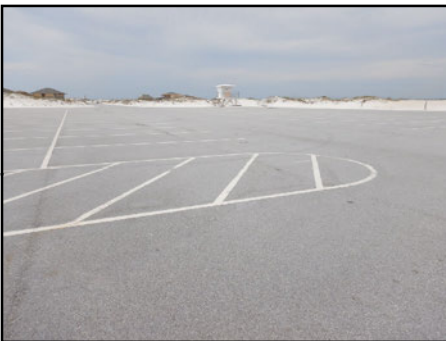
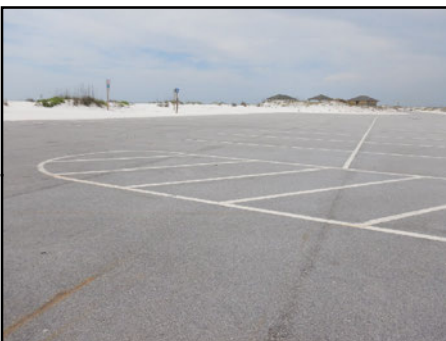
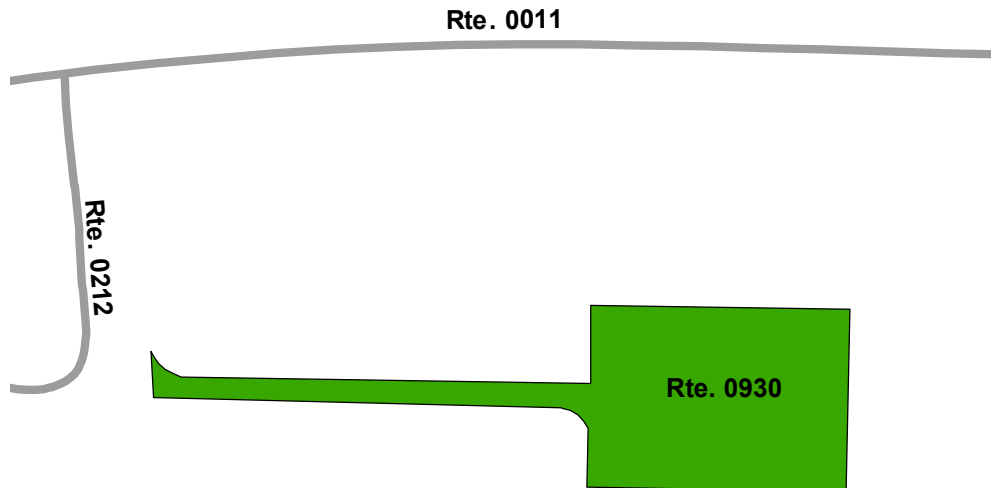
ROUTE 0930: OPAL BEACH PARKING #2 EAST

Inspection Date	FMSS Number	User Access	Surface Type
3/15/2019	72793	PUBLIC	ASPHALT
Area (Sq. Ft.)	Lane Miles (11' Widths)	Curb Reveal (Inches)	Curb Recommendation
49,284	0.849	NOT APPLICABLE	NOT APPLICABLE
Curb Type		Curb & Gutter Type	
NO CURB		NO CURB AND GUTTER	
Pavement Recommendation		Condition Rating / PCR	
PREVENTIVE MAINTENANCE		GOOD / 90

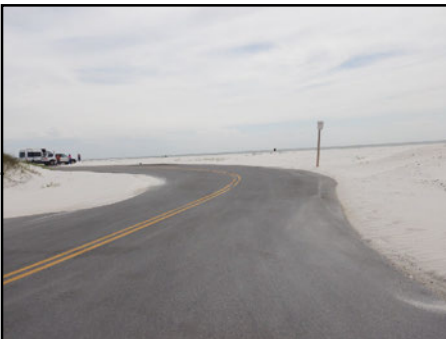
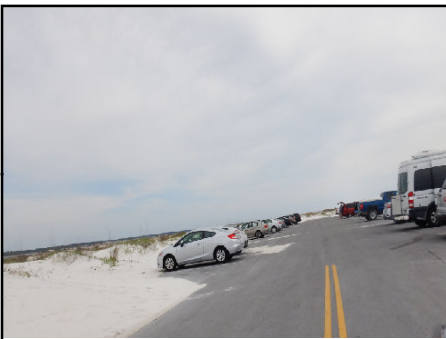
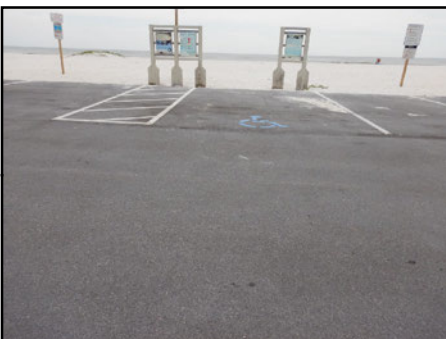
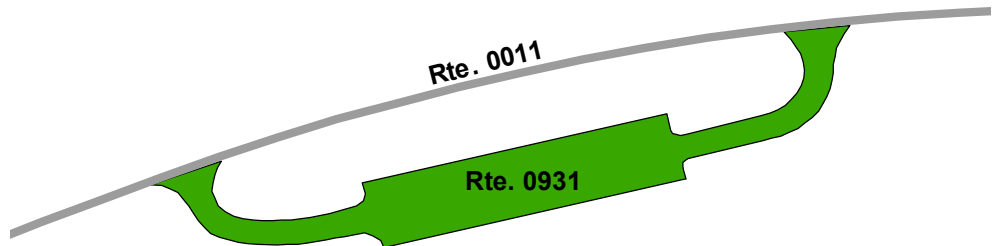
ROUTE 0931: PUBLIC PARKING #1

Inspection Date	FMSS Number	User Access	Surface Type
3/15/2019	72795	PUBLIC	ASPHALT
Area (Sq. Ft.)	Lane Miles (11' Widths)	Curb Reveal (Inches)	Curb Recommendation
26,214	0.451	NOT APPLICABLE	NOT APPLICABLE
Curb Type		Curb & Gutter Type	
NO CURB		NO CURB AND GUTTER	
Pavement Recommendation		Condition Rating / PCR	
PREVENTIVE MAINTENANCE		GOOD / 90

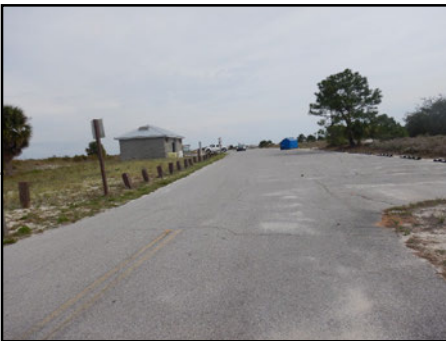
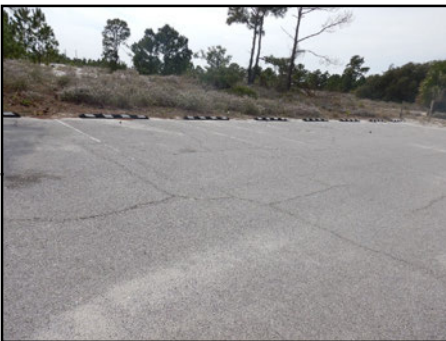
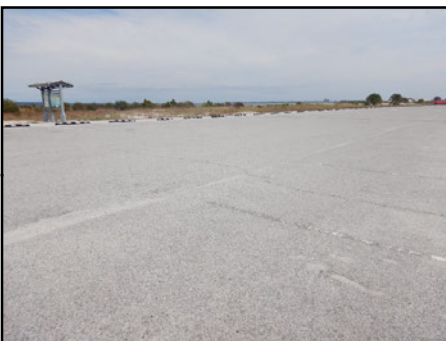
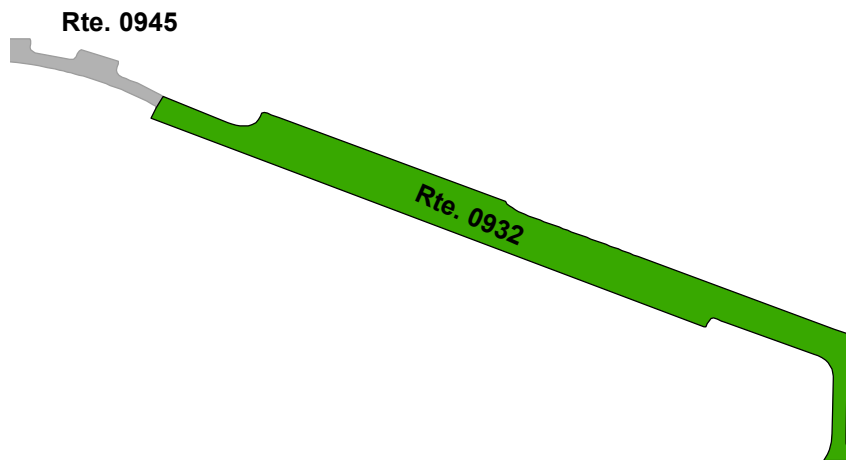
ROUTE 0932: OKALOOSA PARKING

Inspection Date	FMSS Number	User Access	Surface Type
3/15/2019	72796	PUBLIC	ASPHALT
Area (Sq. Ft.)	Lane Miles (11' Widths)	Curb Reveal (Inches)	Curb Recommendation
70,073	1.206	NOT APPLICABLE	NOT APPLICABLE
Curb Type		Curb & Gutter Type	
NO CURB		NO CURB AND GUTTER	
Pavement Recommendation		Condition Rating / PCR	
PREVENTIVE MAINTENANCE		GOOD / 90

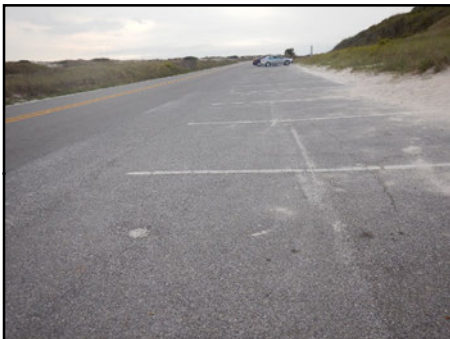
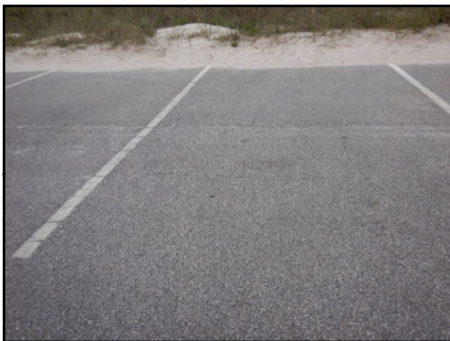
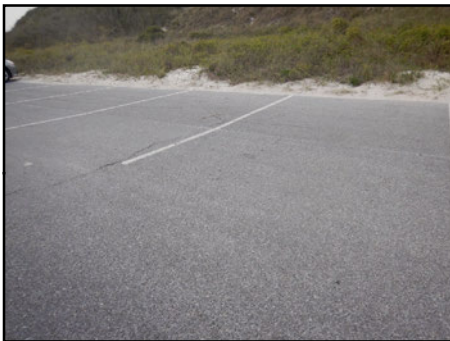
ROUTE 0933: BATTERY LANGDON PARKING

Inspection Date	FMSS Number	User Access	Surface Type
3/15/2019	102988	PUBLIC	ASPHALT
Area (Sq. Ft.)	Lane Miles (11' Widths)	Curb Reveal (Inches)	Curb Recommendation
6,246	0.108	NOT APPLICABLE	NOT APPLICABLE
Curb Type		Curb & Gutter Type	
NO CURB		NO CURB AND GUTTER	
Pavement Recommendation		Condition Rating / PCR	
PREVENTIVE MAINTENANCE		GOOD / 90

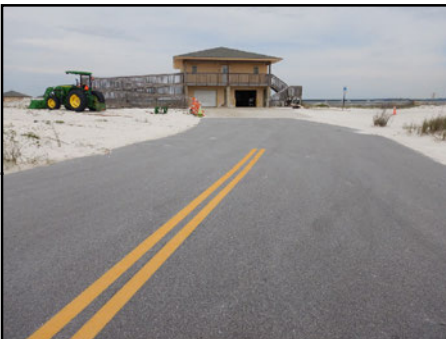
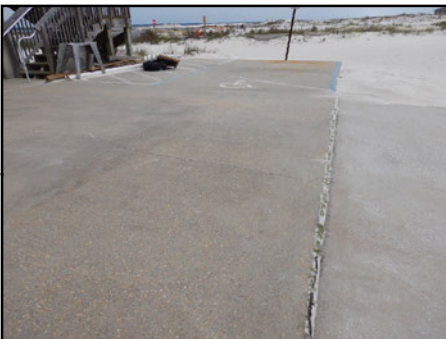
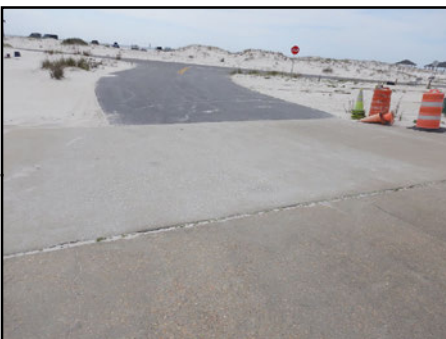
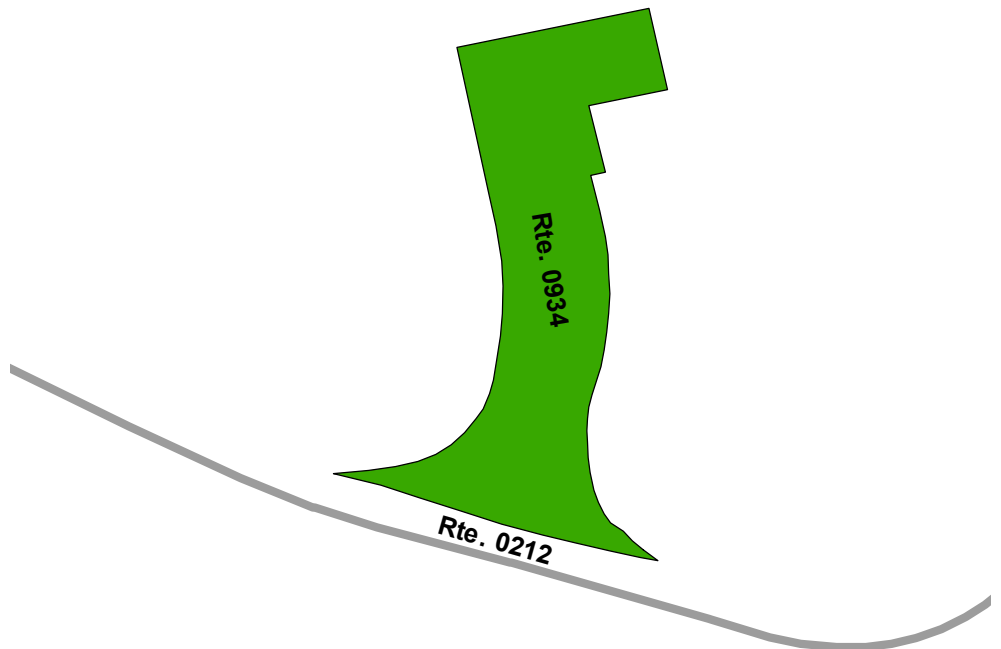
Inspection Date	FMSS Number	User Access	Surface Type
3/15/2019	102993	NONPUBLIC	ASPHALT
Area (Sq. Ft.)	Lane Miles (11' Widths)	Curb Reveal (Inches)	Curb Recommendation
4,985	0.086	NOT APPLICABLE	NOT APPLICABLE
Curb Type		Curb & Gutter Type	
NO CURB		NO CURB AND GUTTER	
Pavement Recommendation		Condition Rating / PCR	
PREVENTIVE MAINTENANCE		GOOD / 90

Note: Parking Area Consists of Multiple Surface Types: 1 Part Asphalt At 3,223 Square Feet; 1 Part Concrete At 1,762 Square Feet.

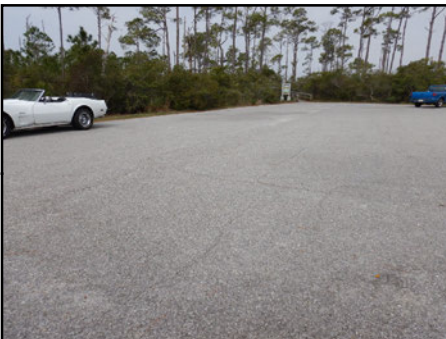
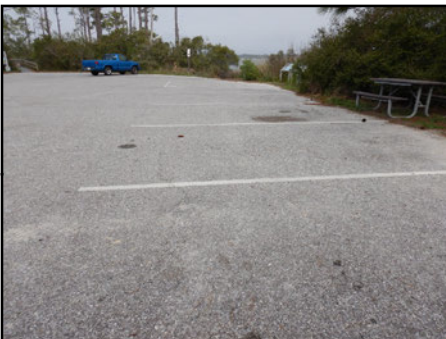
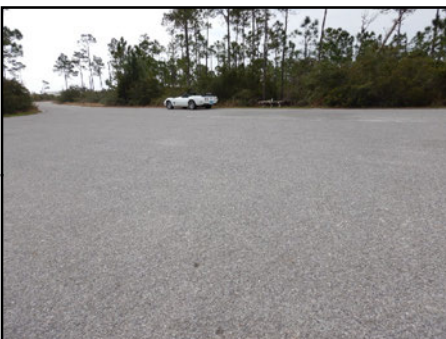
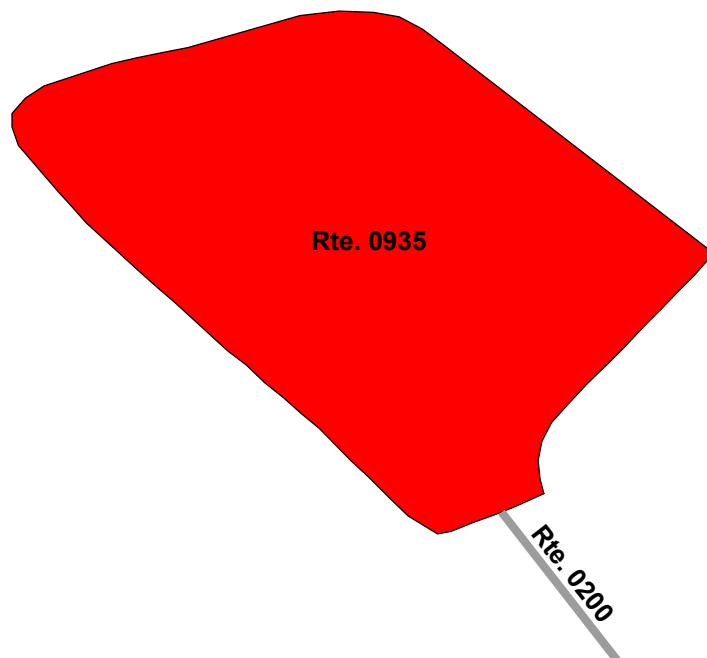
ROUTE 0935: NATURE TRAIL PARKING

Inspection Date	FMSS Number	User Access	Surface Type
3/14/2019	59589	PUBLIC	ASPHALT
Area (Sq. Ft.)	Lane Miles (11' Widths)	Curb Reveal (Inches)	Curb Recommendation
9,077	0.156	NOT APPLICABLE	NOT APPLICABLE
Curb Type		Curb & Gutter Type	
NO CURB		NO CURB AND GUTTER	
Pavement Recommendation		Condition Rating / PCR	
HEAVY 3R TREATMENTS		POOR / 53

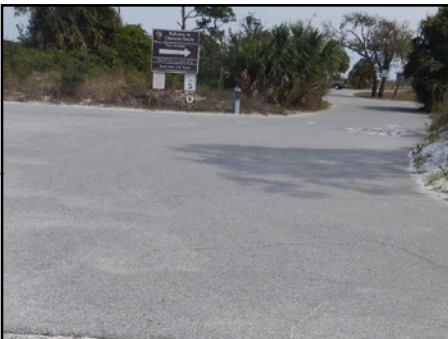
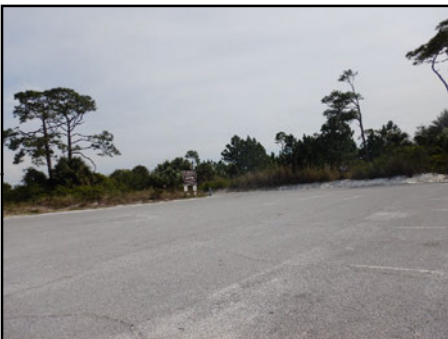
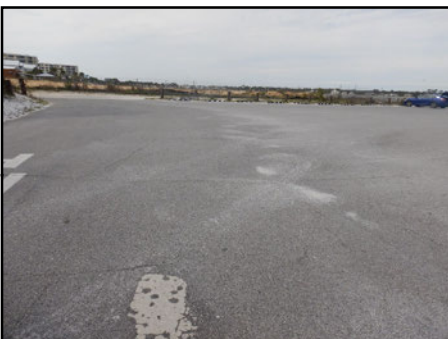
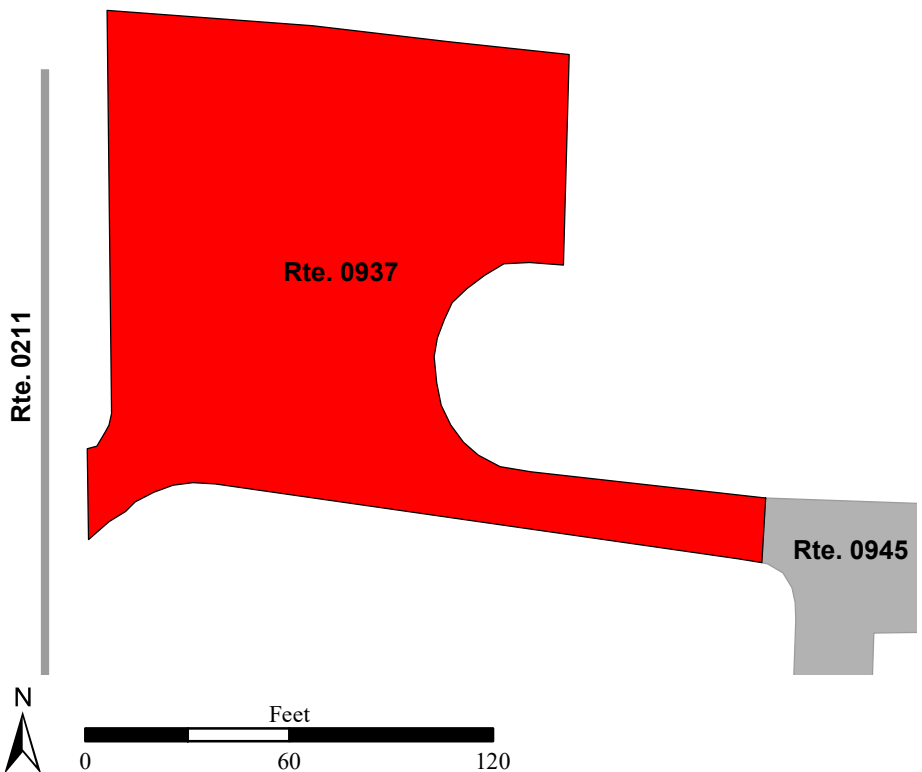
ROUTE 0937: OKALOOSA BOAT LAUNCH PARKING

Inspection Date	FMSS Number	User Access	Surface Type
3/15/2019	113842	PUBLIC	ASPHALT
Area (Sq. Ft.)	Lane Miles (11' Widths)	Curb Reveal (Inches)	Curb Recommendation
16,380	0.282	NOT APPLICABLE	NOT APPLICABLE
Curb Type		Curb & Gutter Type	
NO CURB		NO CURB AND GUTTER	
Pavement Recommendation		Condition Rating / PCR	
HEAVY 3R TREATMENTS		POOR / 53

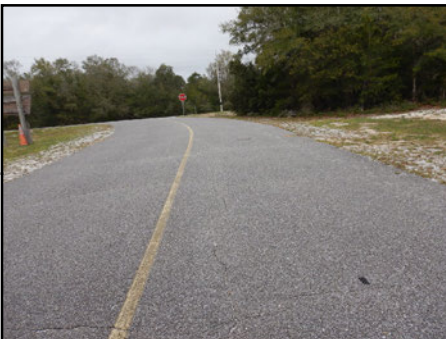
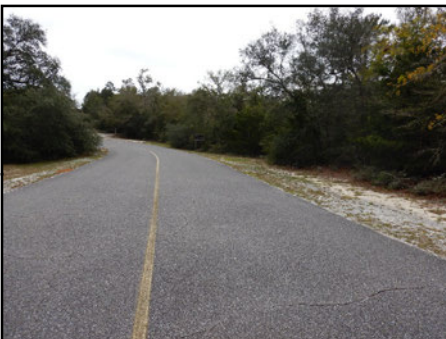
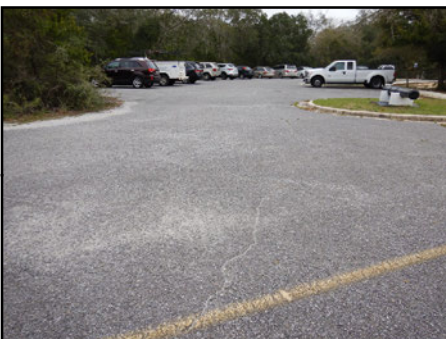
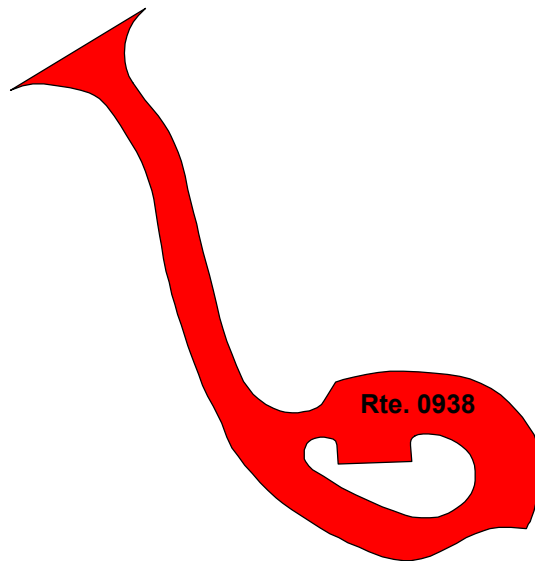
ROUTE 0938: FORT BARRANCAS PARKING

Inspection Date	FMSS Number	User Access	Surface Type
3/14/2019	59057	PUBLIC	ASPHALT
Area (Sq. Ft.)	Lane Miles (11' Widths)	Curb Reveal (Inches)	Curb Recommendation
20,673	0.356	NOT APPLICABLE	LIGHT REPAIR
Curb Type		Curb & Gutter Type	
NO CURB		CONCRETE	
Pavement Recommendation		Condition Rating / PCR	
HEAVY 3R TREATMENTS		POOR / 53

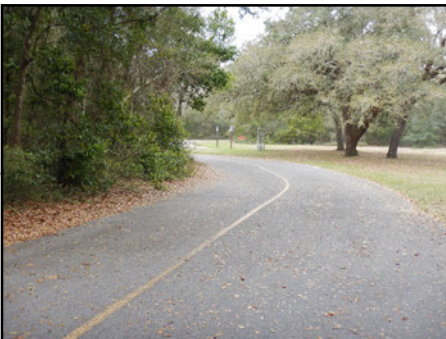
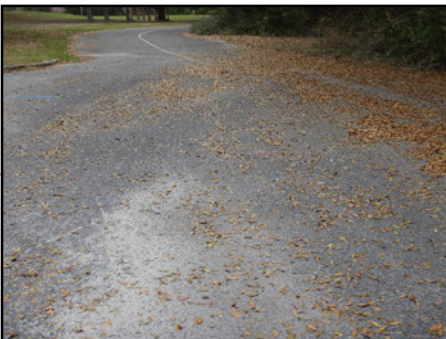
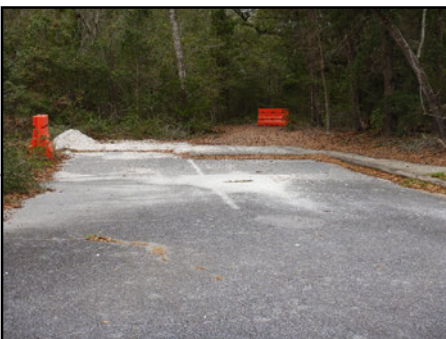
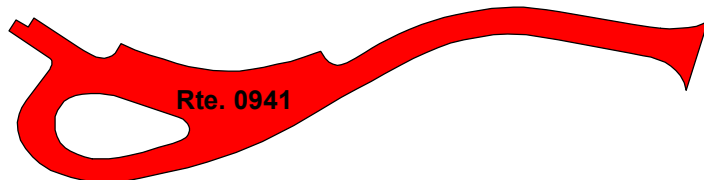
ROUTE 0941: ADVANCE REDOUBT PARKING

Inspection Date	FMSS Number	User Access	Surface Type
3/14/2019	108369	PUBLIC	ASPHALT
Area (Sq. Ft.)	Lane Miles (11' Widths)	Curb Reveal (Inches)	Curb Recommendation
18,059	0.311	NOT APPLICABLE	MODERATE REPAIR
Curb Type		Curb & Gutter Type	
NO CURB		CONCRETE	
Pavement Recommendation		Condition Rating / PCR	
HEAVY 3R TREATMENTS		POOR / 53
