GUIIS Cycle 6

Final Report

Road Inventory and Condition Assessment of Paved Routes Gulf Islands National Seashore

Report Date: October 2020

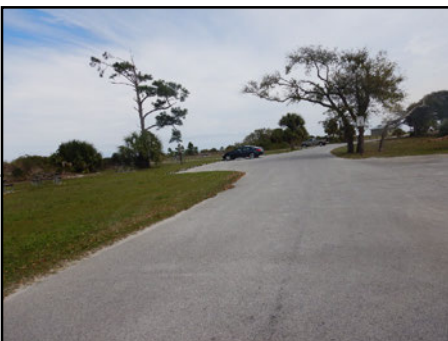
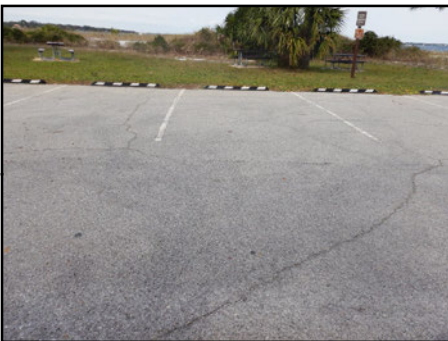
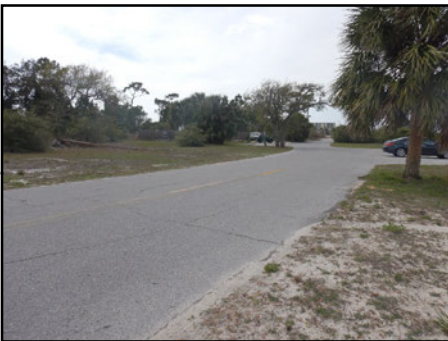
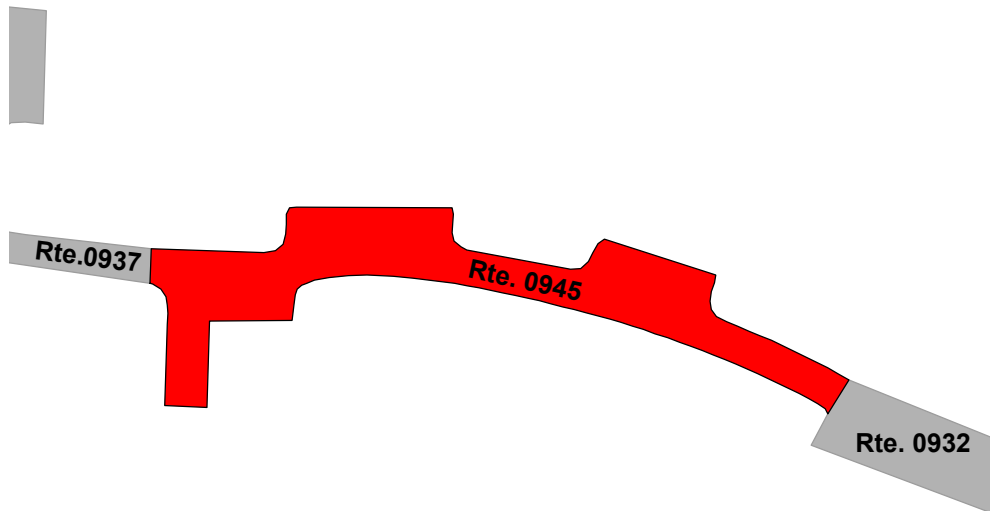
ROUTE 0945: OKALOOSA PICNIC AREA PARKING

Inspection Date	FMSS Number	User Access	Surface Type
3/15/2019	113843	PUBLIC	ASPHALT
Area (Sq. Ft.)	Lane Miles (11' Widths)	Curb Reveal (Inches)	Curb Recommendation
11,553	0.199	NOT APPLICABLE	NOT APPLICABLE
Curb Type		Curb & Gutter Type	
NO CURB		NO CURB AND GUTTER	
Pavement Recommendation		Condition Rating / PCR	
HEAVY 3R TREATMENTS		POOR / 53

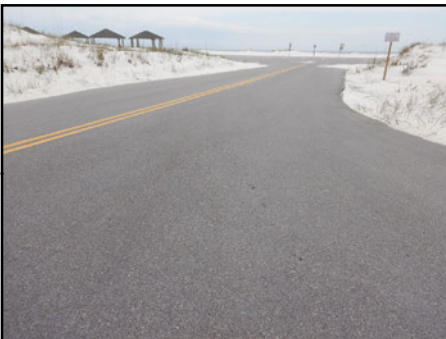
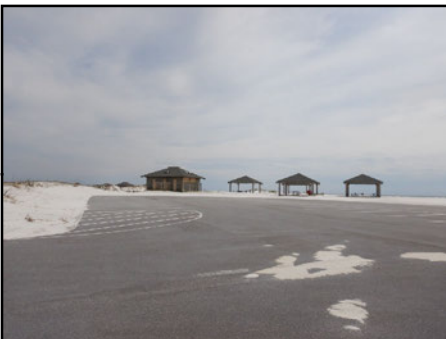
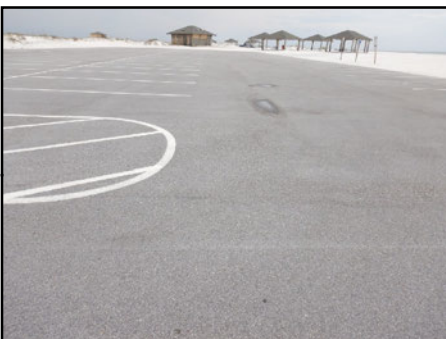
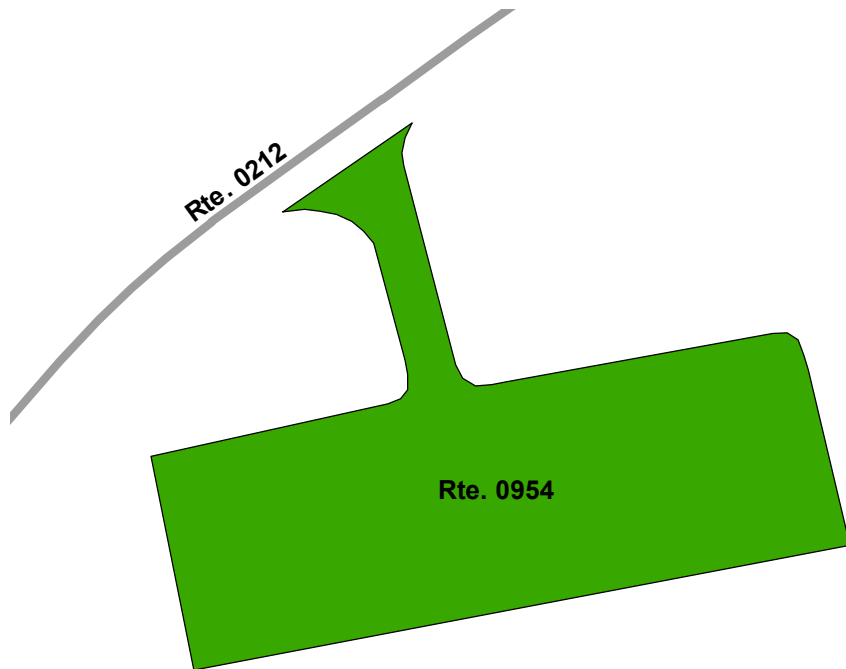
ROUTE 0954: OPAL BEACH PARKING #4 WEST

Inspection Date	FMSS Number	User Access	Surface Type
3/15/2019	116835	PUBLIC	ASPHALT
Area (Sq. Ft.)	Lane Miles (11' Widths)	Curb Reveal (Inches)	Curb Recommendation
42,583	0.733	NOT APPLICABLE	NOT APPLICABLE
Curb Type		Curb & Gutter Type	
NO CURB		NO CURB AND GUTTER	
Pavement Recommendation		Condition Rating / PCR	
PREVENTIVE MAINTENANCE		GOOD / 90

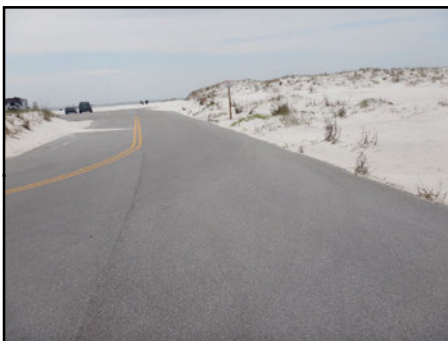
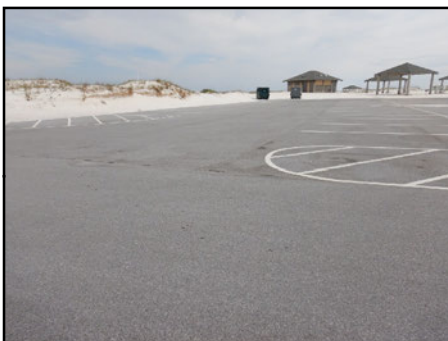
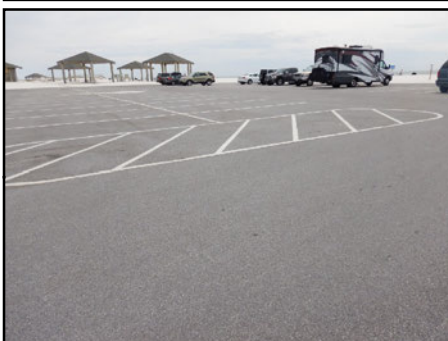
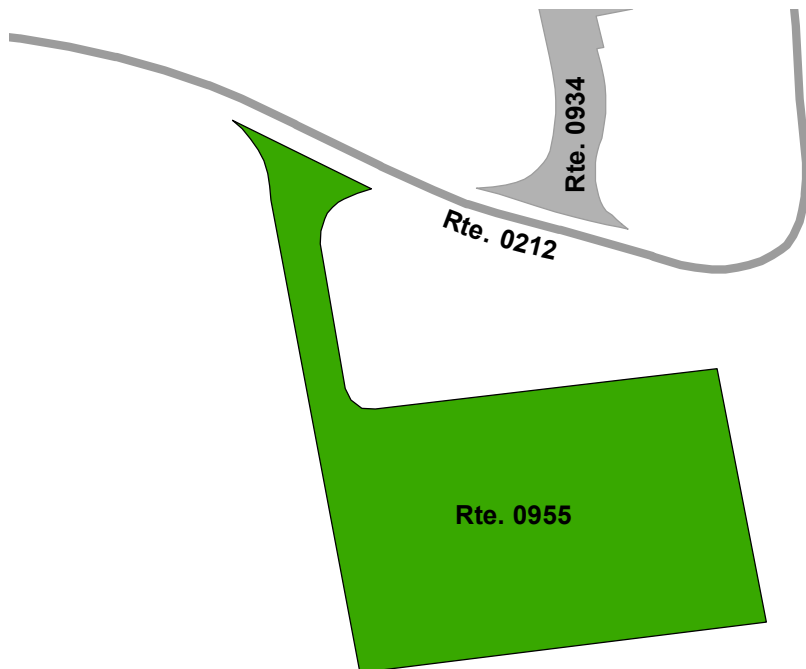
ROUTE 0955: OPAL BEACH PARKING #3 EAST

Inspection Date	FMSS Number	User Access	Surface Type
3/15/2019	59515	PUBLIC	ASPHALT
Area (Sq. Ft.)	Lane Miles (11' Widths)	Curb Reveal (Inches)	Curb Recommendation
39,595	0.682	NOT APPLICABLE	NOT APPLICABLE
Curb Type		Curb & Gutter Type	
NO CURB		NO CURB AND GUTTER	
Pavement Recommendation		Condition Rating / PCR	
PREVENTIVE MAINTENANCE		GOOD / 90

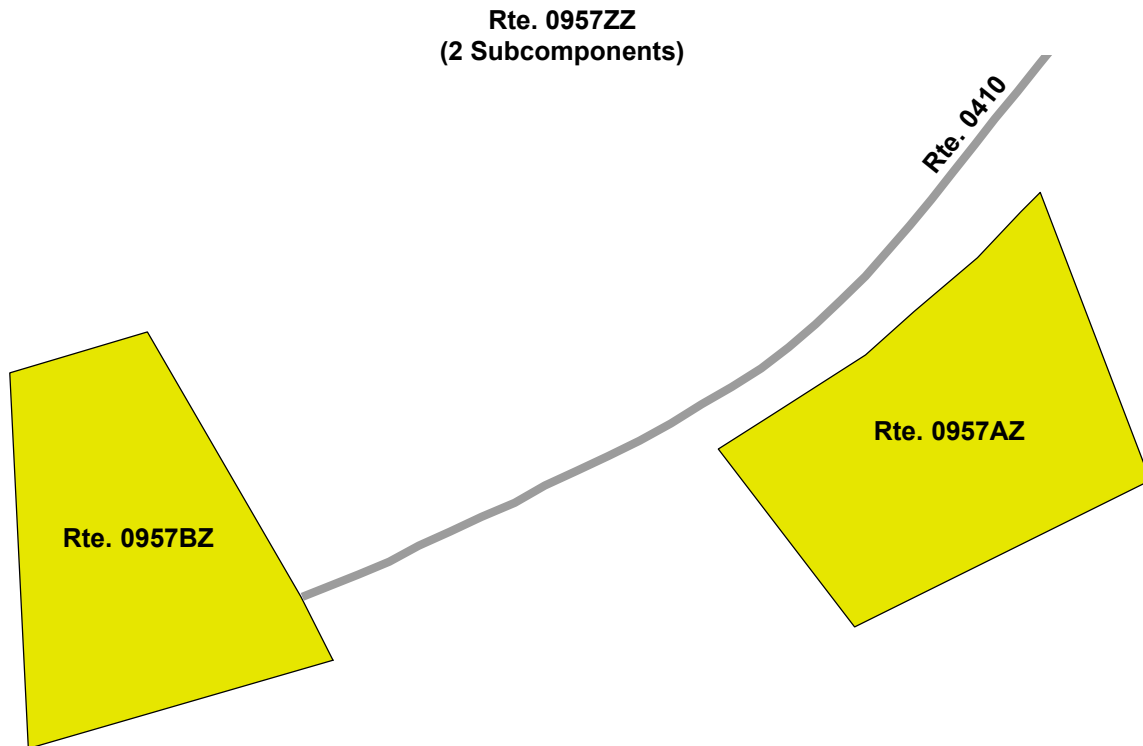
ROUTE 0957ZZ: YATES HOUSE COMPOUND RV PARKING AREAS

Inspection Date	FMSS Number	User Access	Surface Type
3/16/2019	N/A	NONPUBLIC	ASPHALT
Area (Sq. Ft.)	Lane Miles (11' Widths)	Condition Rating / PCR	
1,661	0.029	SUMMARY / 63

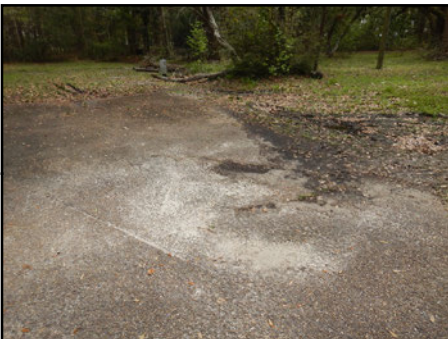
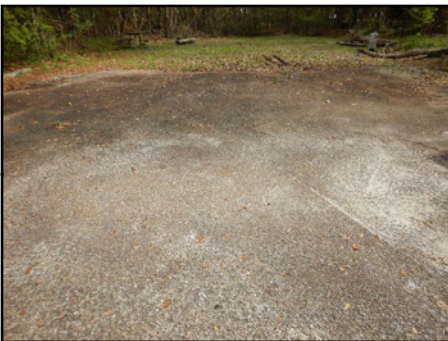
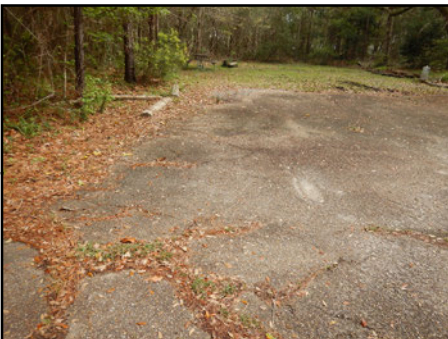
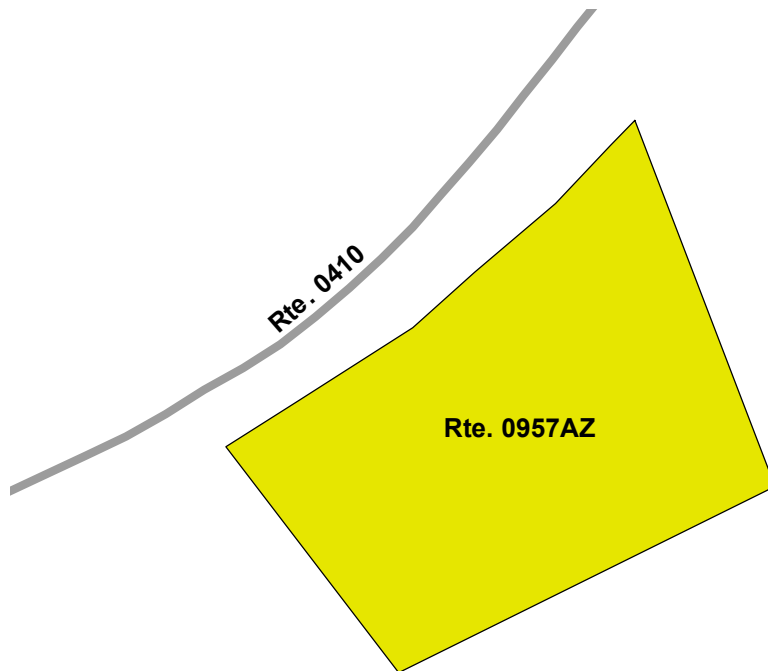
ROUTE 0957AZ: YATES HOUSE COMPOUND RV PARKING 1

Inspection Date	FMSS Number	User Access	Surface Type
3/16/2019	N/A	NONPUBLIC	ASPHALT
Area (Sq. Ft.)	Lane Miles (11' Widths)	Curb Reveal (Inches)	Curb Recommendation
865	0.015	NOT APPLICABLE	NOT APPLICABLE
Curb Type		Curb & Gutter Type	
NO CURB		NO CURB AND GUTTER	
Pavement Recommendation		Condition Rating / PCR	
LIGHT 3R TREATMENTS		FAIR / 73

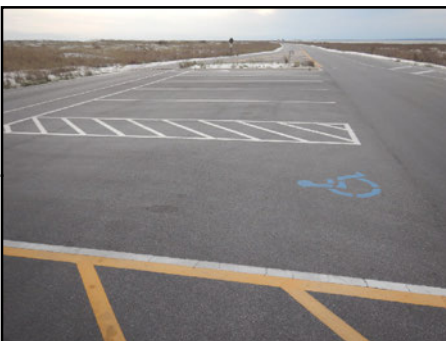
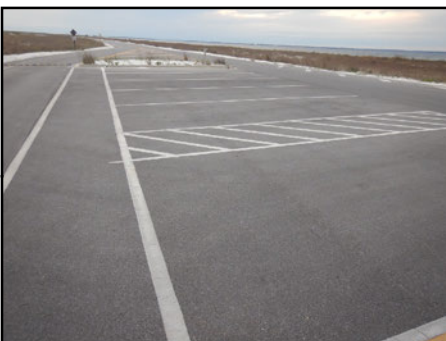
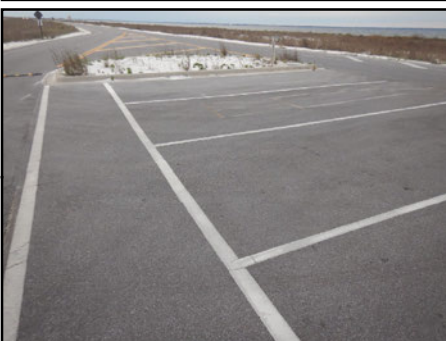
ROUTE 0958AZ: ENTRANCE STATION PARKING

Inspection Date	FMSS Number	User Access	Surface Type
3/15/2019	N/A	PUBLIC	ASPHALT
Area (Sq. Ft.)	Lane Miles (11' Widths)	Curb Reveal (Inches)	Curb Recommendation
1,727	0.03	NOT APPLICABLE	DO NOTHING
Curb Type		Curb & Gutter Type	
NO CURB		CONCRETE	
Pavement Recommendation		Condition Rating / PCR	
DO NOTHING		EXCELLENT / 97

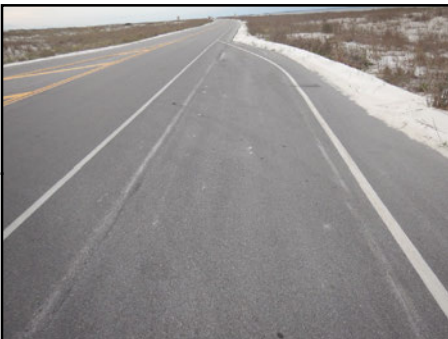
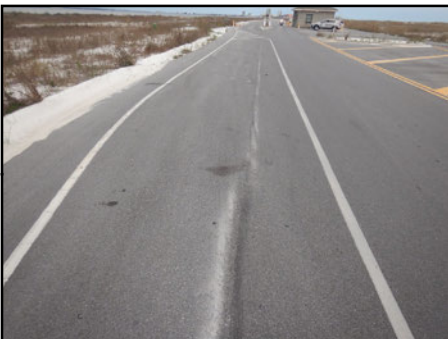
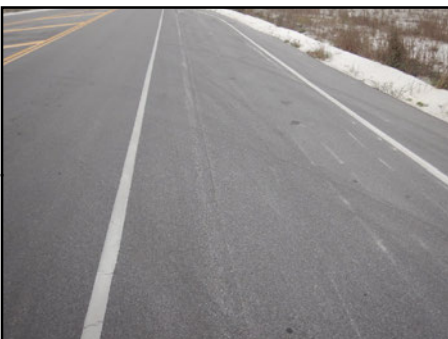
ROUTE 0958BZ: BUS ENTRANCE STATION PARKING

Inspection Date	FMSS Number	User Access	Surface Type
3/15/2019	N/A	PUBLIC	ASPHALT
Area (Sq. Ft.)	Lane Miles (11' Widths)	Curb Reveal (Inches)	Curb Recommendation
1,085	0.019	NOT APPLICABLE	NOT APPLICABLE
Curb Type		Curb & Gutter Type	
NO CURB		NO CURB AND GUTTER	
Pavement Recommendation		Condition Rating / PCR	
DO NOTHING		EXCELLENT / 97

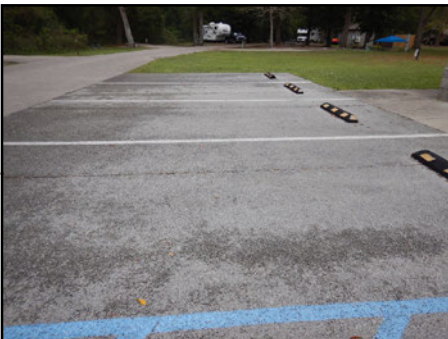
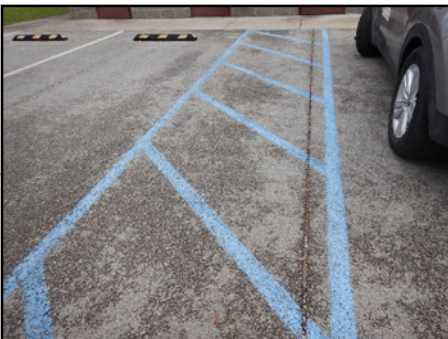
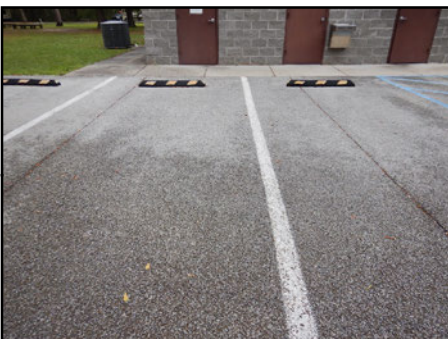
ROUTE 0959: DAVIS BAYOU CAMPGROUND LOOP A RESTROOM PARKING

Inspection Date	FMSS Number	User Access	Surface Type
3/16/2019	N/A	PUBLIC	ASPHALT
Area (Sq. Ft.)	Lane Miles (11' Widths)	Curb Reveal (Inches)	Curb Recommendation
977	0.017	NOT APPLICABLE	NOT APPLICABLE
Curb Type		Curb & Gutter Type	
NO CURB		NO CURB AND GUTTER	
Pavement Recommendation		Condition Rating / PCR	
PREVENTIVE MAINTENANCE		GOOD / 90

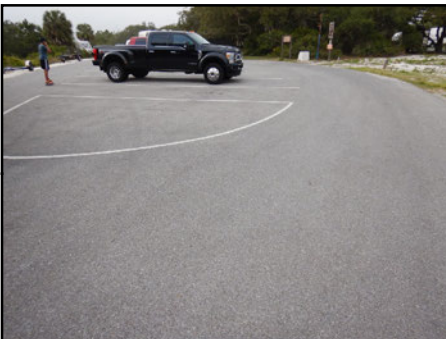
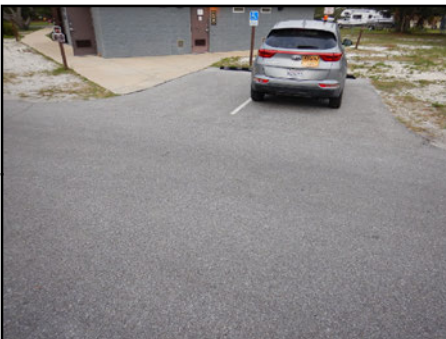
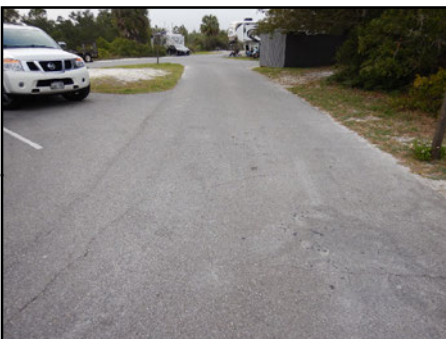
ROUTE 0961: FORT PICKENS CAMPGROUND MAIN LOOP A PARKING

Inspection Date	FMSS Number	User Access	Surface Type
3/14/2019	N/A	PUBLIC	ASPHALT
Area (Sq. Ft.)	Lane Miles (11' Widths)	Curb Reveal (Inches)	Curb Recommendation
5,919	0.102	NOT APPLICABLE	NOT APPLICABLE
Curb Type		Curb & Gutter Type	
NO CURB		NO CURB AND GUTTER	
Pavement Recommendation		Condition Rating / PCR	
PREVENTIVE MAINTENANCE		GOOD / 90
