GUMO Cycle 6

Final Report

Road Inventory and Condition Assessment of Paved Routes Guadalupe Mountains National Park

Report Date: July 2017

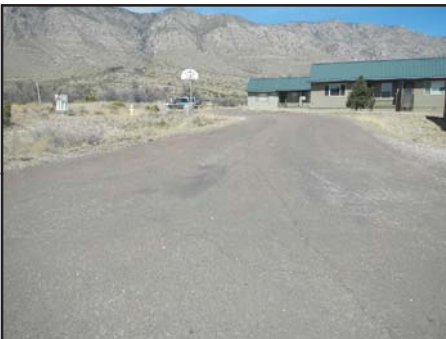
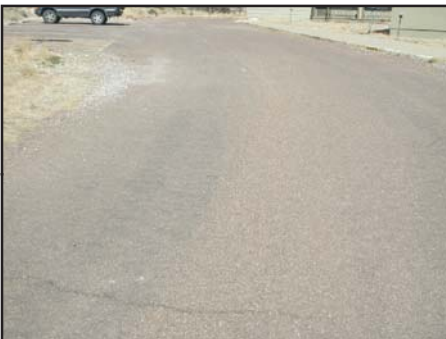
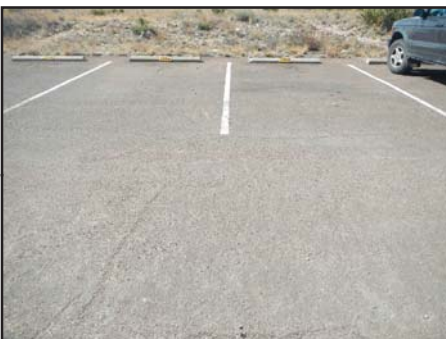
Inspection Date	FMSS Number	User Access	Surface Type
2/26/2017	68302	NONPUBLIC	ASPHALT
Area (Sq. Ft.)	Lane Miles (11' Widths)	Curb Reveal (Inches)	Curb Recommendation
6,706	0.115	NOT APPLICABLE	NOT APPLICABLE
Curb Type		Curb & Gutter Type	
NO CURB		NO CURB AND GUTTER	
Pavement Recommendation		Condition Rating / PCR	
PREVENTIVE MAINTENANCE		GOOD / 90

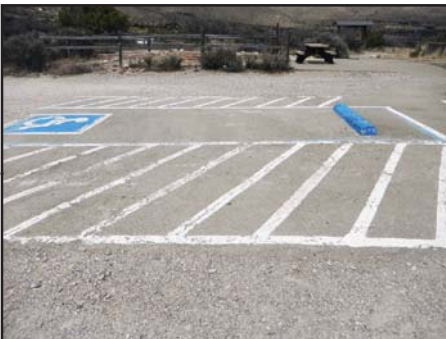
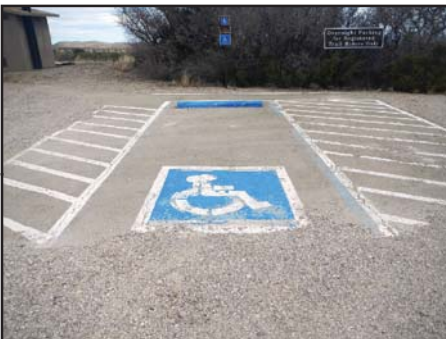
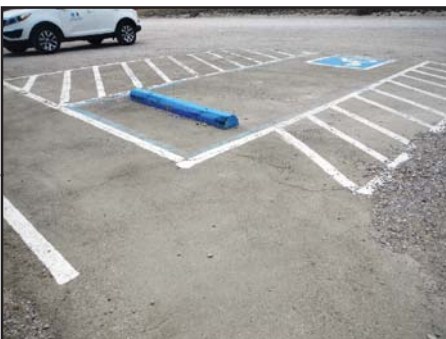
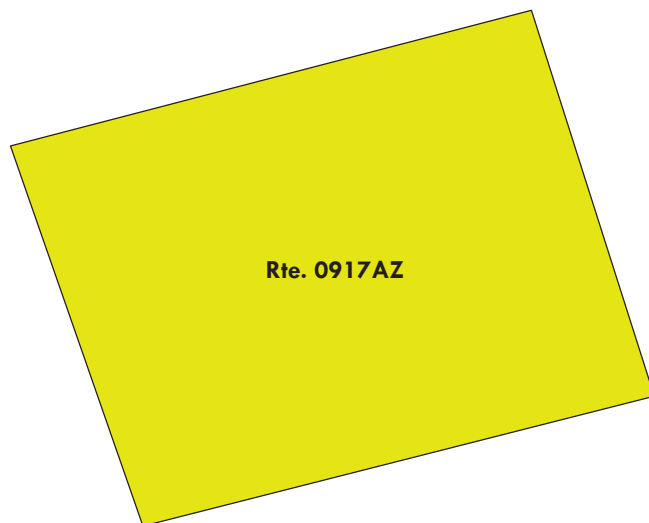
Inspection Date	FMSS Number	User Access	Surface Type
2/26/2017	110166	PUBLIC	CONCRETE
Area (Sq. Ft.)	Lane Miles (11' Widths)	Curb Reveal (Inches)	Curb Recommendation
569	0.01	NOT APPLICABLE	NOT APPLICABLE
Curb Type		Curb & Gutter Type	
NO CURB		NO CURB AND GUTTER	
Pavement Recommendation		Condition Rating / PCR	
LIGHT 3R TREATMENTS		FAIR / 73

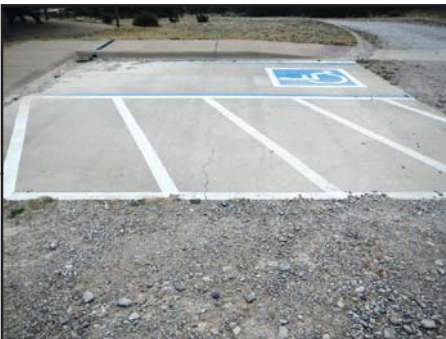
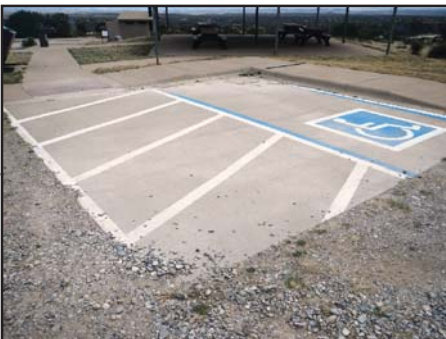
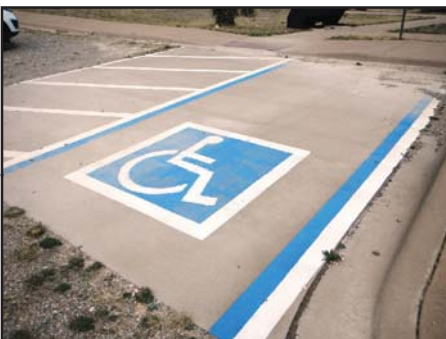
Inspection Date	FMSS Number	User Access	Surface Type
2/26/2017	110166	PUBLIC	CONCRETE
Area (Sq. Ft.)	Lane Miles (11' Widths)	Curb Reveal (Inches)	Curb Recommendation
353	0.006	NOT APPLICABLE	DO NOTHING
Curb Type		Curb & Gutter Type	
NO CURB		CONCRETE	
Pavement Recommendation		Condition Rating / PCR	
PREVENTIVE MAINTENANCE		GOOD / 90
