HEHO Cycle 6

Final Report

Road Inventory and Condition Assessment of Paved Routes Herbert Hoover National Historic Site

Report Date: August 2018

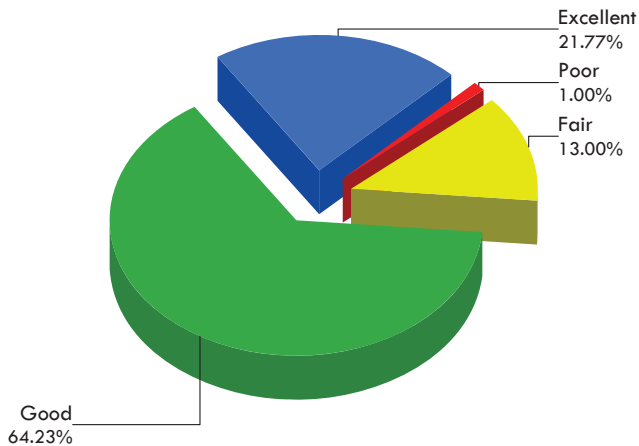
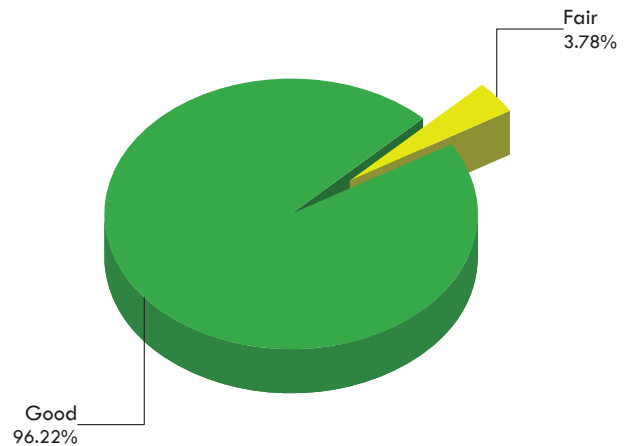
Figure 1: Pavement Condition Rating Breakdown for Paved Roads and Parking Areas

Cycle 6 Lane Miles and Overall Pavement Condition		
	Lanes Miles*	Pavement Condition Rating**
Paved Roads	2.62	89
Parking Areas	1.75	89

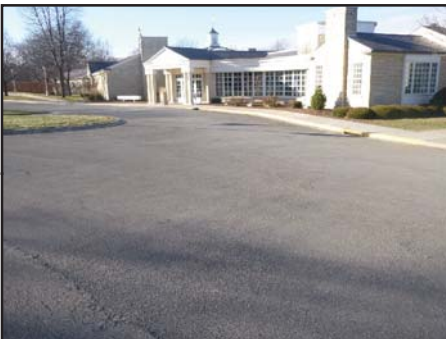
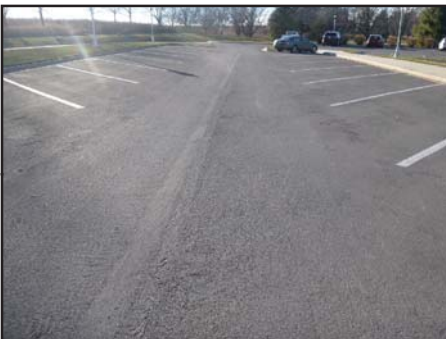
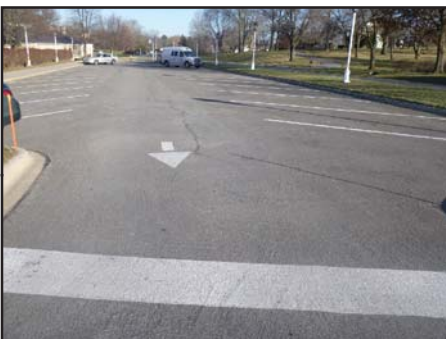
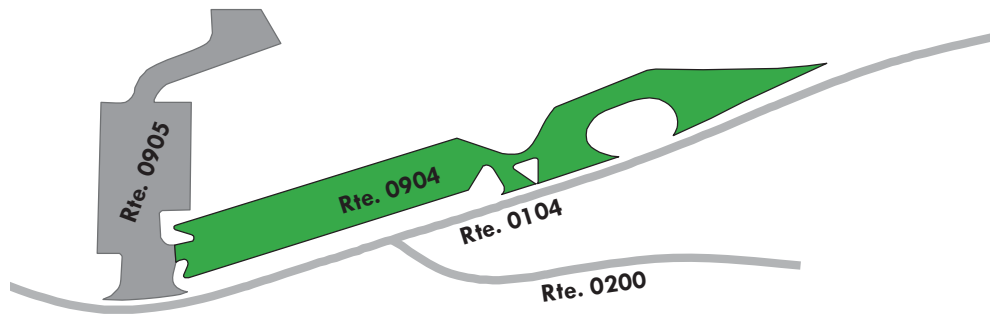
ROUTE 0905: LIBRARY OVERFLOW PARKING LOT

Route No.	FMSS No.	Route Name	User Access	Surf. Type	Area (Sq. Ft.)	Pavement Condition Rating (PCR)	<u>Asphalt Surface Distresses</u>						<u>Concrete Surface Distresses</u>				
							Alligator Cracking	Longitudinal / Transverse Cracking	Rutting / Distortions	Potholes / Patching	HMA Patching	Surface Raveling / Bleeding	Joint Faulting	Slab Cracking	Joint Distresses	Delamination / Pop-Outs	Potholes / Patching
HEHO-0900	64293	VISITOR CENTER PARKING	PUBLIC	CO	18,624	90							90	90	90	90	90
HEHO-0901	82548	WATER STREET PARKING LOT	PUBLIC	CO	28,288	90							97	90	90	90	90
HEHO-0902	64593	POST OFFICE DOCK PARKING	NONPUBLIC	CO	4,908	90							97	90	90	90	90
HEHO-0903	64302	SECOND STREET PARKING LOT	PUBLIC	CO	3,853	73							90	90	73	73	90
HEHO-0904	64300	LIBRARY VISITOR PARKING LOT	PUBLIC	AS	18,771	90	97	90	97	97	90	97					
HEHO-0905	64298	LIBRARY OVERFLOW PARKING LOT	PUBLIC	AS	13,387	90	97	90	97	97	97	97

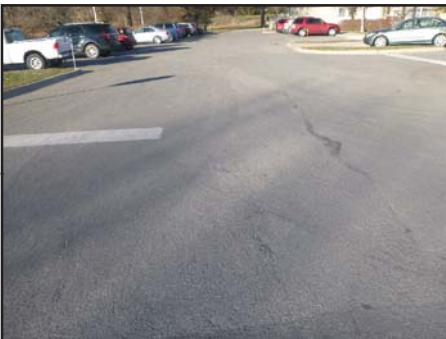
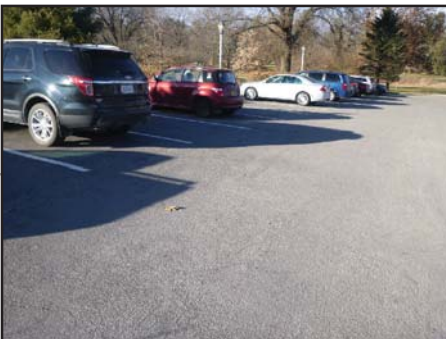
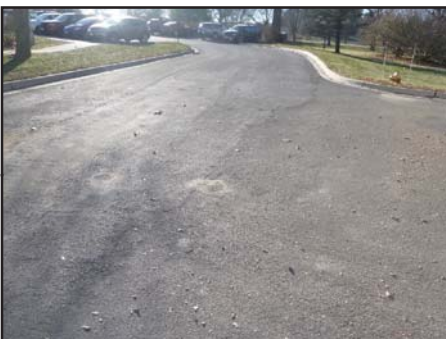
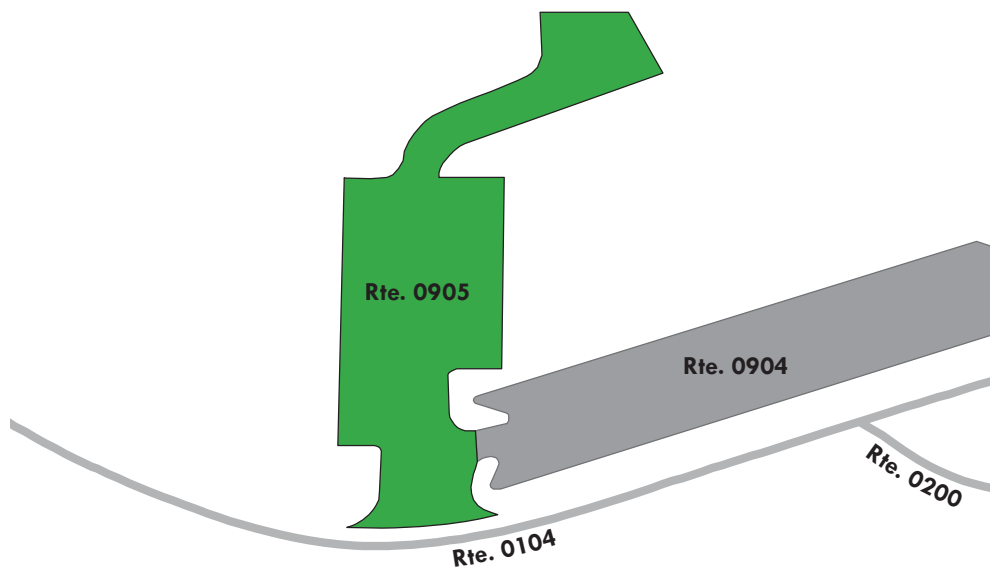
ROUTE 0906: PICNIC AREA PARKING LOT

HEHO-0906	64301	PICNIC AREA PARKING LOT	PUBLIC	AS	4,813	90	97	90	90	97	97	90					
HEHO-0907	64295	GRAVESITE PARKING LOT	PUBLIC	AS	2,259	90	97	90	90	97	97	97					
HEHO-0908	64598	MACKAY PARKING LOT	NONPUBLIC	CO	1,052	90							97	90	97	97	97
HEHO-0909	103701	HERBERT HOOVER MAINTENANCE LOT	NONPUBLIC	CO	5,879	90							90	90	90	90	90
