HOBE Cycle 6

Final Report

Road Inventory and Condition Assessment of Paved Routes Horseshoe Bend National Military Park

**Federal Highway Administration
Eastern Federal Lands Highway Division
Road Inventory Program (RIP)**

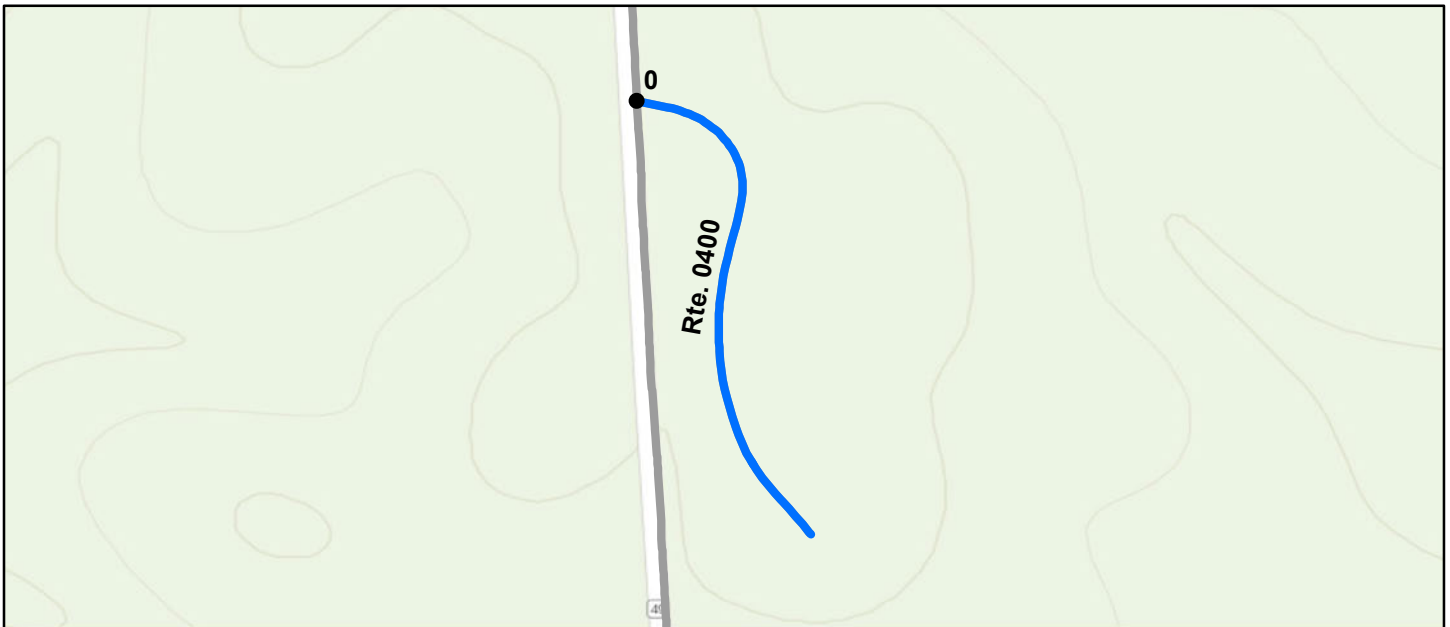
ROUTE 0400: QUARTERS DRIVEWAY

Inspection Date: 10/17/2020	Beginning Section MP	0				
Paved Length (Miles): 0.93	Section Length (MI)	0.93				
Surface Type: ASPHALT	Route Summary					
Roadway Condition Information						
Pavement Condition Rating (PCR)	98	98				
Surface Condition Rating (SCR)	99	99				
Roughness Condition Index (RCI)	96	96				
Distress Index Values						
Structural Crack Index	100	100				
Alligator Crack Index	100	100				
Longitudinal Crack Index	100	100				
Transverse Cracking Index	100	100				
Patching Index	100	100				
Rutting Index	99	99				
International Roughness Index (IRI)	125	125				
Lane & Width Information						
Number of Lanes	2	2				
Paved Width (ft)	19.5	19.5				
Lane Width (ft)	9.7	9.7

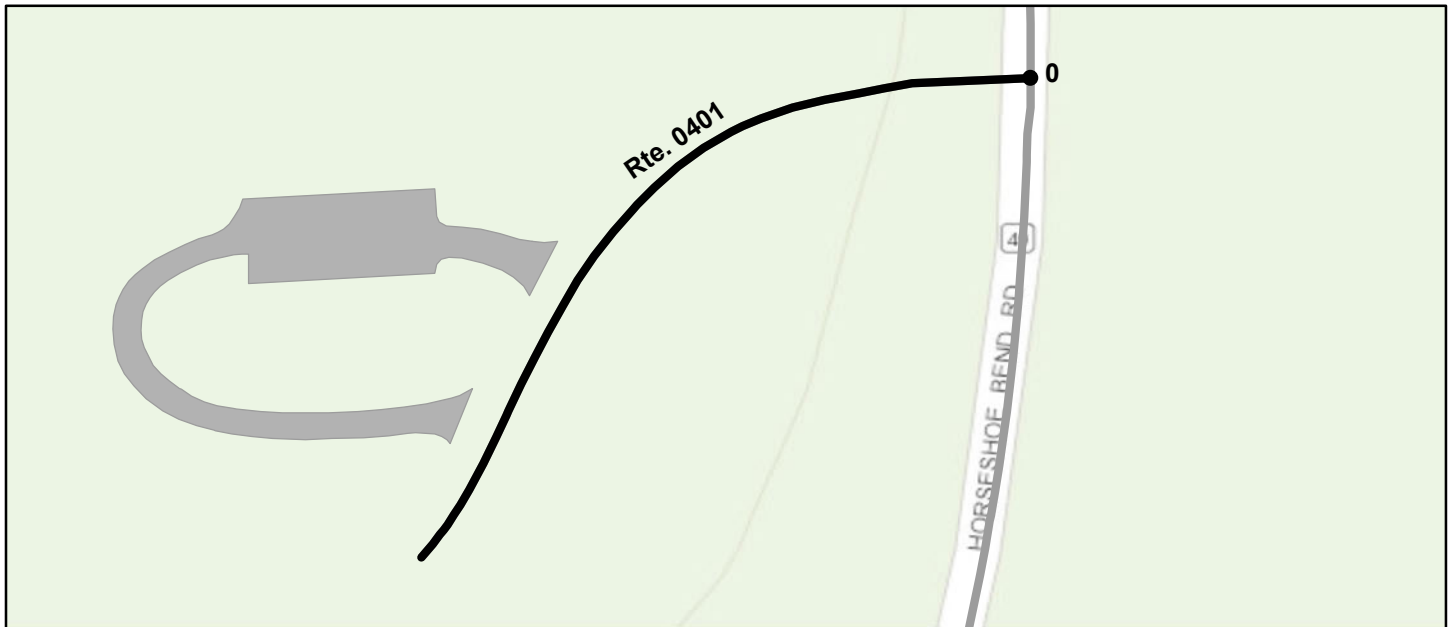
ROUTE 0401: MAINTENANCE DRIVE

Route Condition Legend – Pavement Condition Rating (PCR)						
Poor (0 - 60)	Fair (61- 84)	Good (85 - 94)	Excellent (95 - 100)	Not Rated		
Colors on map represent condition scores at 0.10-mile intervals. See Appendix for definitions and formulas.						
Inspection Date: 10/17/2020	Beginning Section MP	0				
Paved Length (Miles): 0.12	Section Length (MI)	0.12				
Surface Type: ASPHALT	Route Summary					
Roadway Condition Information						
Pavement Condition Rating (PCR)	98	98				
Surface Condition Rating (SCR)	98	98				
Roughness Condition Index (RCI)	N/A	N/A				
Distress Index Values						
Structural Crack Index	100	100				
Alligator Crack Index	100	100				
Longitudinal Crack Index	100	100				
Transverse Cracking Index	98	98				
Patching Index	100	100				
Rutting Index	99	99				
International Roughness Index (IRI)	N/A	N/A				
Lane & Width Information						
Number of Lanes	2	2				
Paved Width (ft)	19.8	19.8

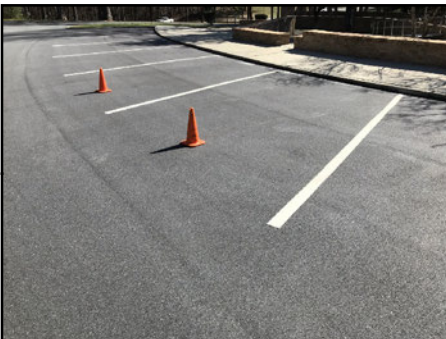
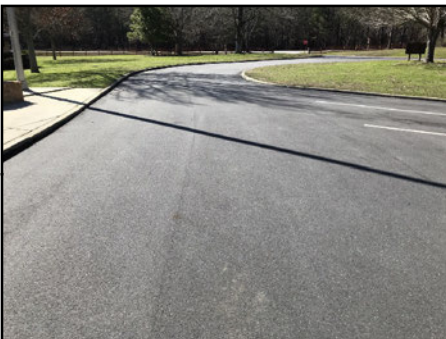
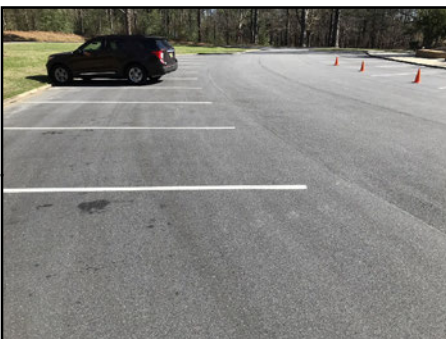
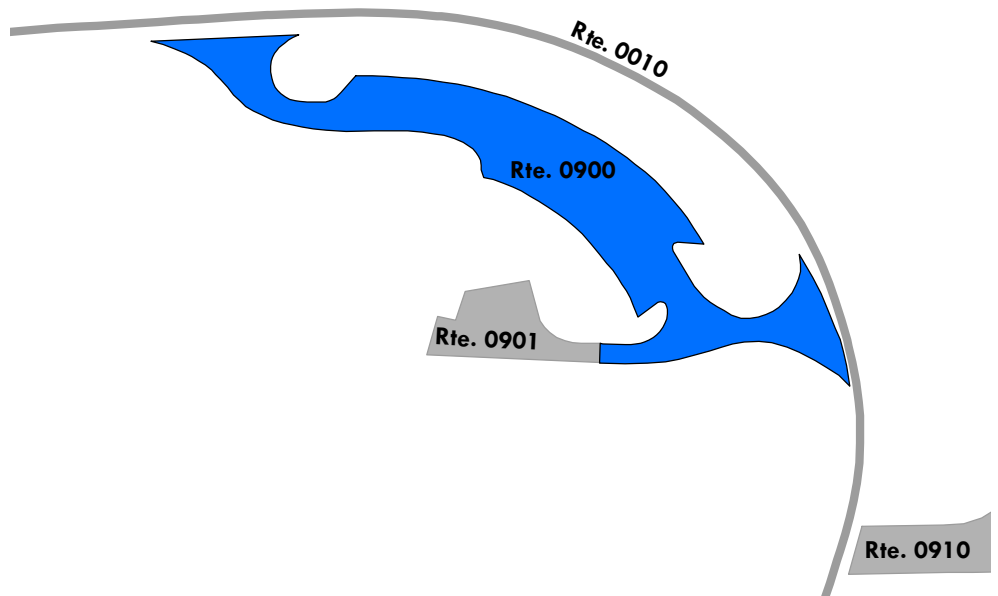
Inspection Date	FMSS Number	User Access	Surface Type
2/22/2020	50266	PUBLIC	ASPHALT
Area (Sq. Ft.)	Lane Miles (11' Widths)	Curb Reveal (Inches)	Curb Recommendation
20,479	0.353	3	DO NOTHING
Curb Type		Curb & Gutter Type	
CONCRETE		NO CURB AND GUTTER	
Pavement Recommendation		Condition Rating / PCR	
DO NOTHING		EXCELLENT / 97

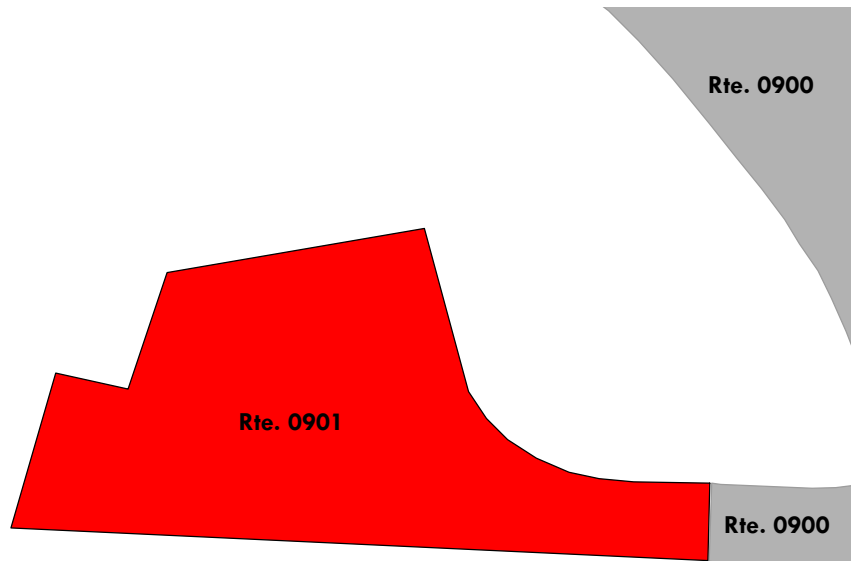
ROUTE 0901: EMPLOYEE PARKING

Inspection Date	FMSS Number	User Access	Surface Type
2/22/2020	50268	NONPUBLIC	ASPHALT
Area (Sq. Ft.)	Lane Miles (11' Widths)	Curb Reveal (Inches)	Curb Recommendation
3,498	0.06	NOT APPLICABLE	NOT APPLICABLE
Curb Type		Curb & Gutter Type	
NO CURB		NO CURB AND GUTTER	
Pavement Recommendation		Condition Rating / PCR	
HEAVY 3R TREATMENTS		POOR / 53

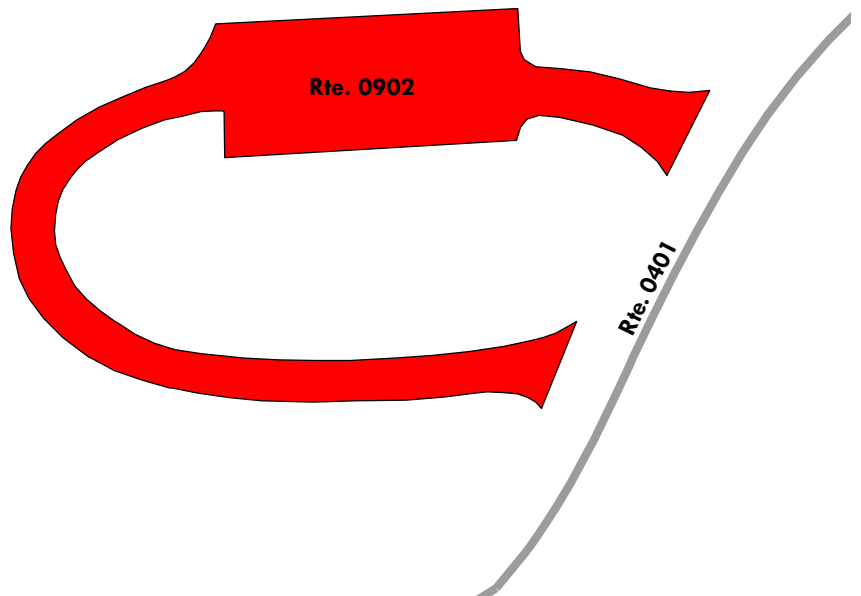
ROUTE 0902: MAINTENANCE AREA PARKING

Inspection Date	FMSS Number	User Access	Surface Type
2/22/2020	50269	NONPUBLIC	ASPHALT
Area (Sq. Ft.)	Lane Miles (11' Widths)	Curb Reveal (Inches)	Curb Recommendation
5,550	0.096	NOT APPLICABLE	NOT APPLICABLE
Curb Type		Curb & Gutter Type	
NO CURB		NO CURB AND GUTTER	
Pavement Recommendation		Condition Rating / PCR	
RECONSTRUCTION		POOR / 30

Multiple Surface Types:
 Asphalt = 5,324 sq. ft.
 Concrete = 226 sq. ft.

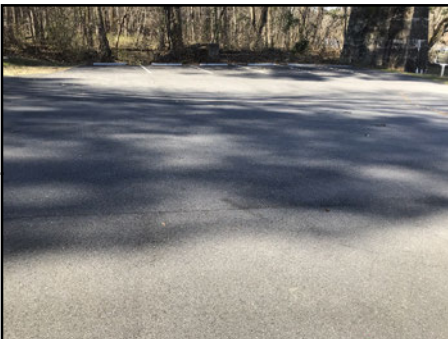
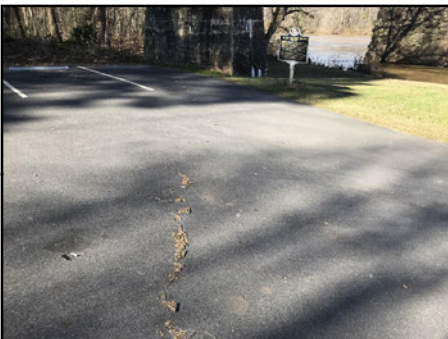
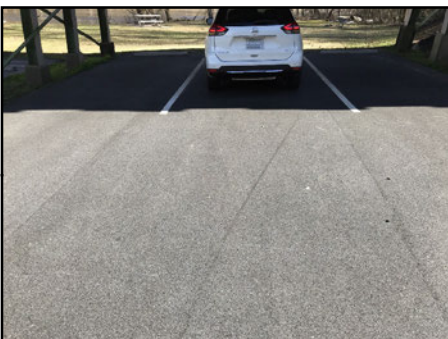
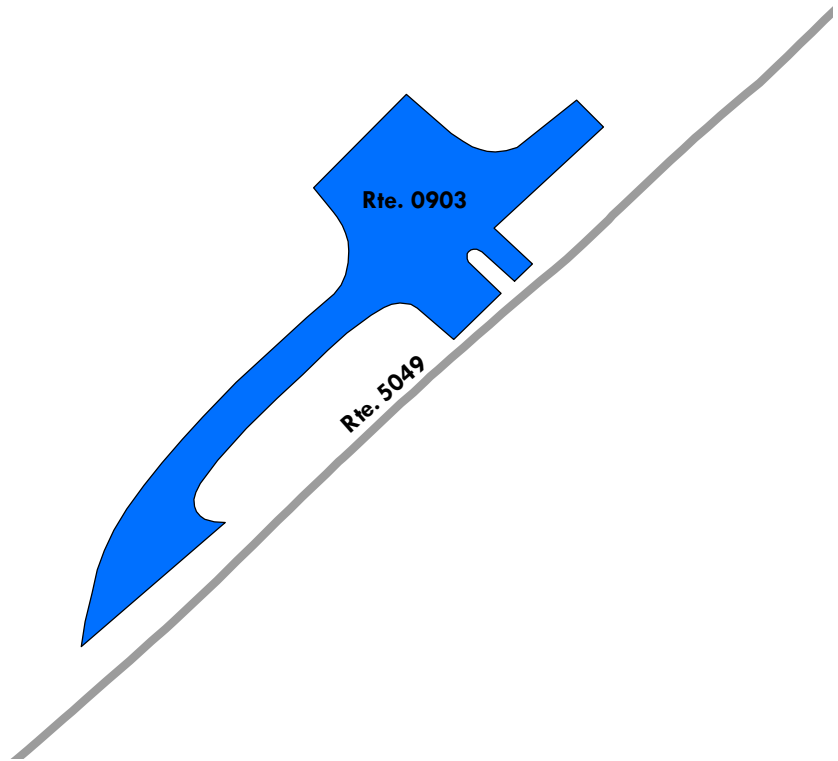
ROUTE 0903: BOAT RAMP AREA PARKING

Inspection Date	FMSS Number	User Access	Surface Type
2/22/2020	50270	PUBLIC	ASPHALT
Area (Sq. Ft.)	Lane Miles (11' Widths)	Curb Reveal (Inches)	Curb Recommendation
10,288	0.177	NOT APPLICABLE	NOT APPLICABLE
Curb Type		Curb & Gutter Type	
NO CURB		NO CURB AND GUTTER	
Pavement Recommendation		Condition Rating / PCR	
DO NOTHING		EXCELLENT / 97

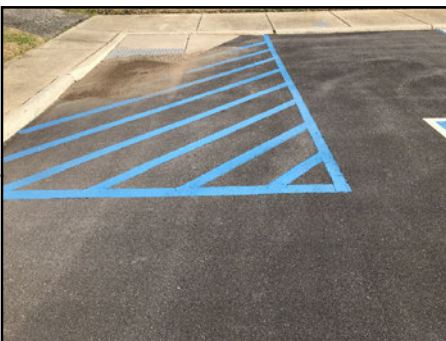
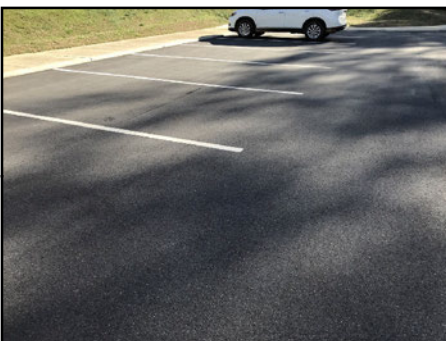
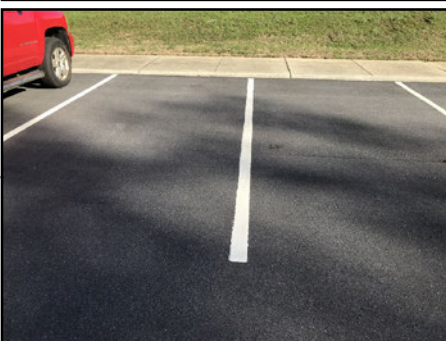
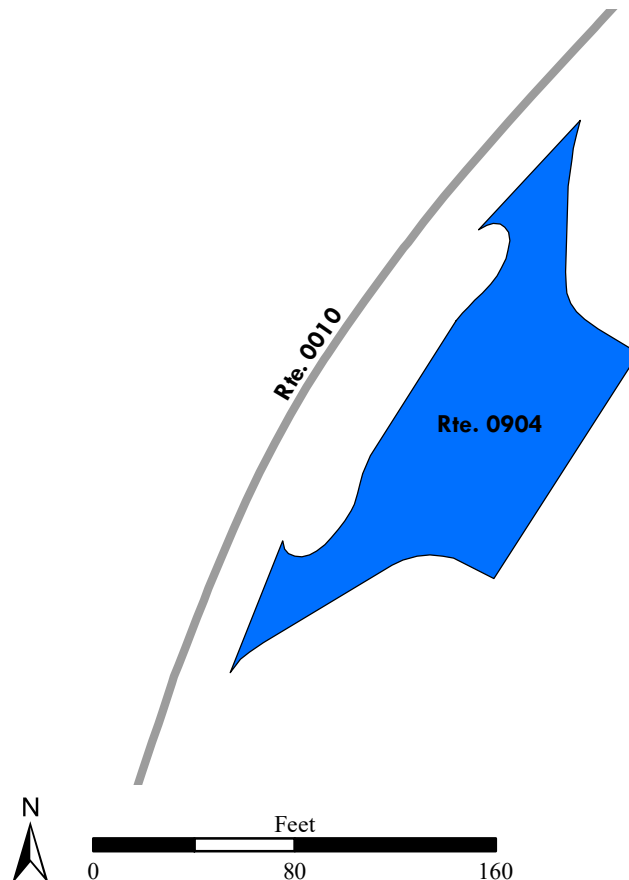
ROUTE 0904: COTTON PATCH HILL PARKING

Inspection Date	FMSS Number	User Access	Surface Type
2/22/2020	50271	PUBLIC	ASPHALT
Area (Sq. Ft.)	Lane Miles (11' Widths)	Curb Reveal (Inches)	Curb Recommendation
8,543	0.147	3	DO NOTHING
Curb Type		Curb & Gutter Type	
CONCRETE		NO CURB AND GUTTER	
Pavement Recommendation		Condition Rating / PCR	
DO NOTHING		EXCELLENT / 97

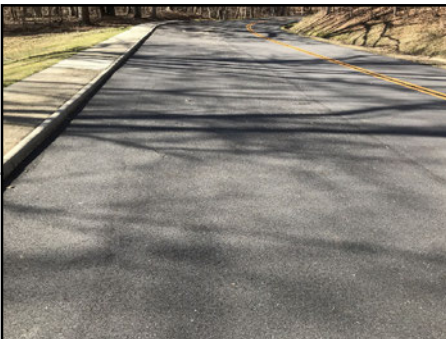
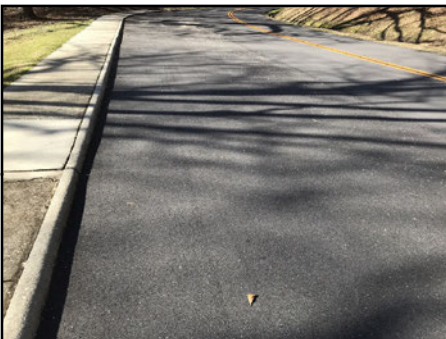
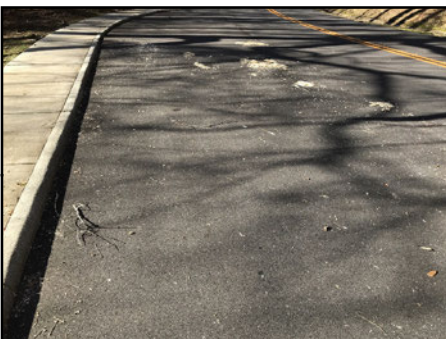
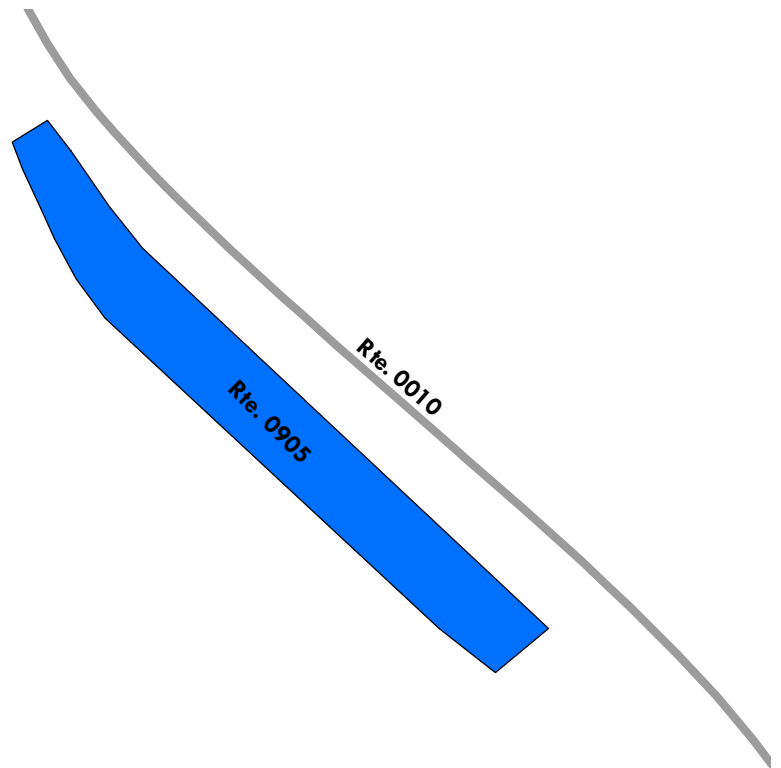
ROUTE 0905: TOUR STOP #1 PULLOFF

Inspection Date	FMSS Number	User Access	Surface Type
2/22/2020	50273	PUBLIC	ASPHALT
Area (Sq. Ft.)	Lane Miles (11' Widths)	Curb Reveal (Inches)	Curb Recommendation
3,817	0.066	3	DO NOTHING
Curb Type		Curb & Gutter Type	
CONCRETE		NO CURB AND GUTTER	
Pavement Recommendation		Condition Rating / PCR	
DO NOTHING		EXCELLENT / 97

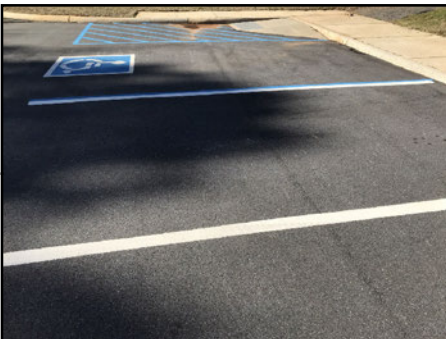
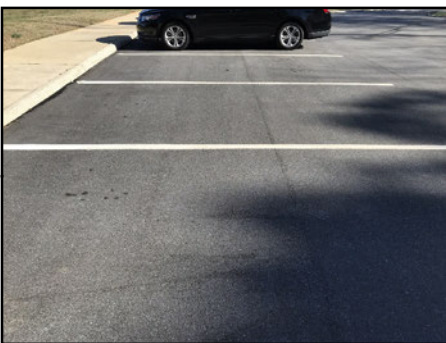
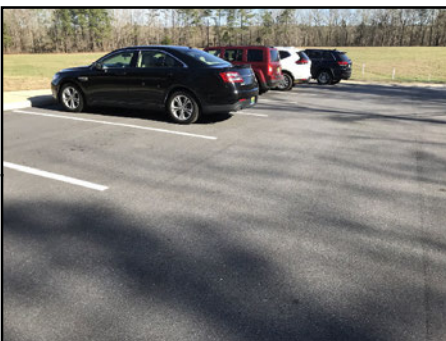
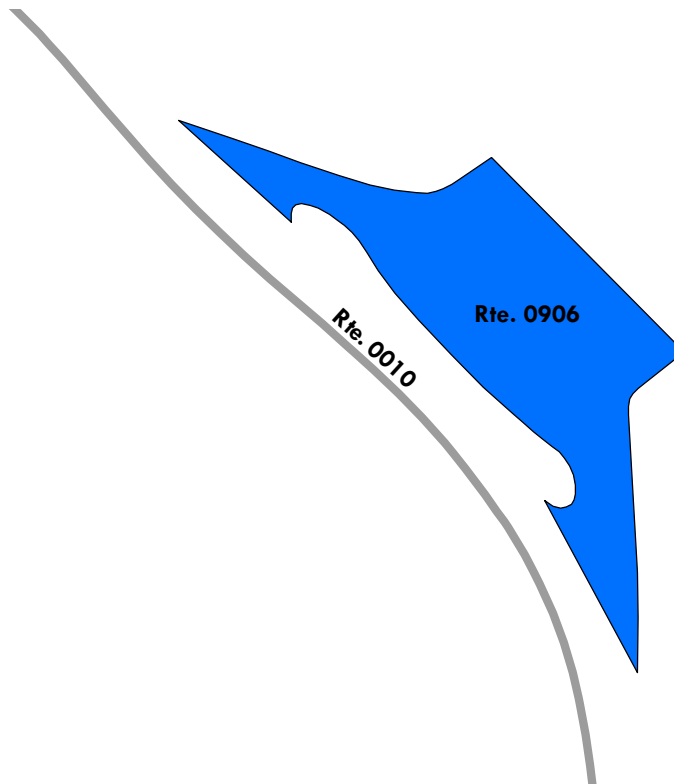
ROUTE 0906: GUN HILL PARKING

Inspection Date	FMSS Number	User Access	Surface Type
2/22/2020	50274	PUBLIC	ASPHALT
Area (Sq. Ft.)	Lane Miles (11' Widths)	Curb Reveal (Inches)	Curb Recommendation
8,861	0.153	4	DO NOTHING
Curb Type		Curb & Gutter Type	
CONCRETE		NO CURB AND GUTTER	
Pavement Recommendation		Condition Rating / PCR	
DO NOTHING		EXCELLENT / 97

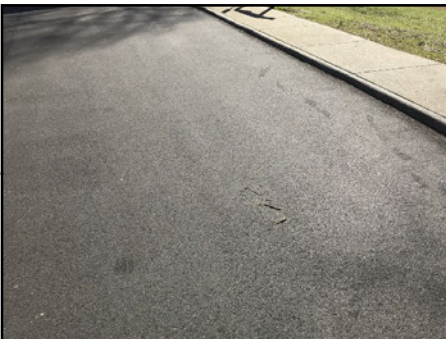
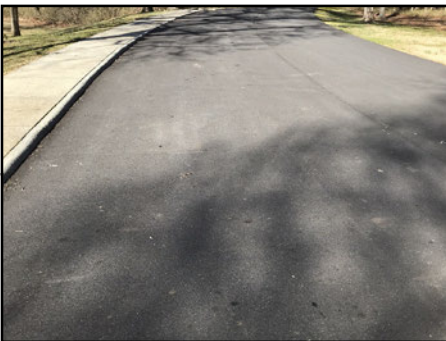
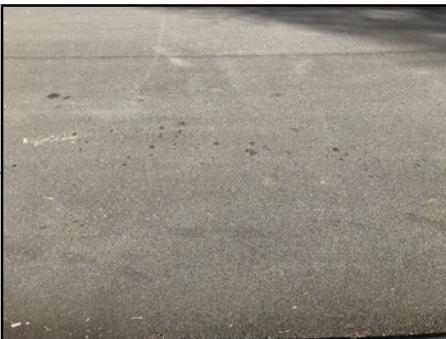
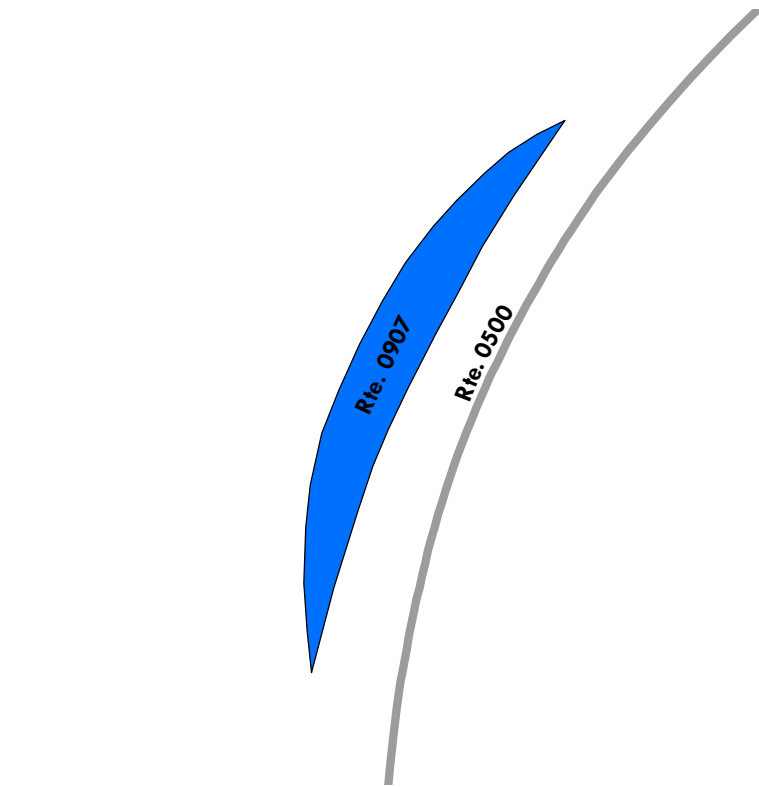
ROUTE 0907: TOUR STOP #3 PULLOFF

Inspection Date	FMSS Number	User Access	Surface Type
2/22/2020	50275	PUBLIC	ASPHALT
Area (Sq. Ft.)	Lane Miles (11' Widths)	Curb Reveal (Inches)	Curb Recommendation
4,509	0.078	3	DO NOTHING
Curb Type		Curb & Gutter Type	
CONCRETE		NO CURB AND GUTTER	
Pavement Recommendation		Condition Rating / PCR	
DO NOTHING		EXCELLENT / 97

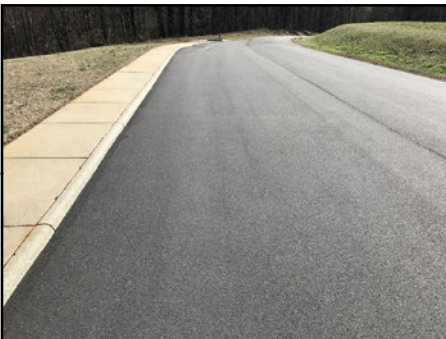
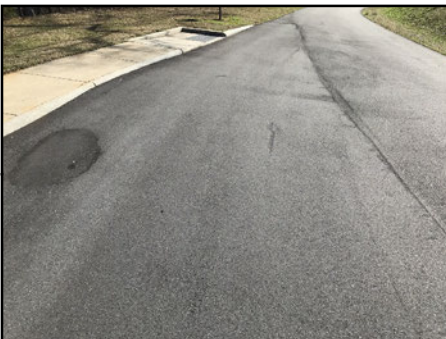
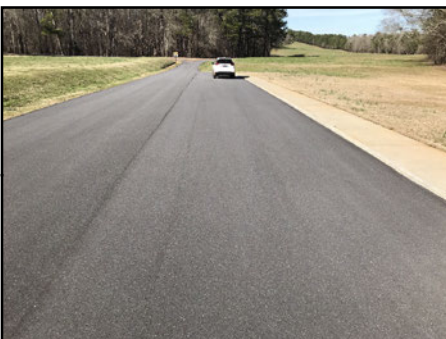
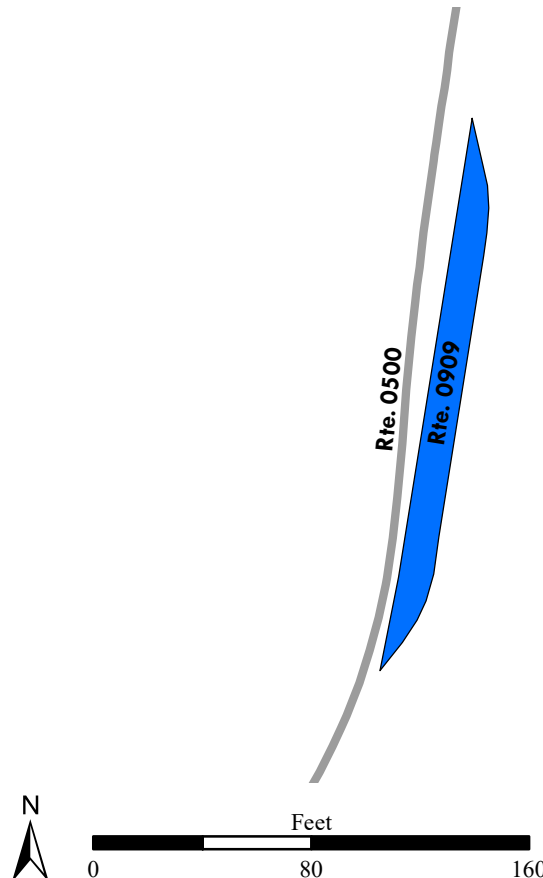
ROUTE 0909: TOUR STOP #5 PULLOFF

Inspection Date	FMSS Number	User Access	Surface Type
2/22/2020	50279	PUBLIC	ASPHALT
Area (Sq. Ft.)	Lane Miles (11' Widths)	Curb Reveal (Inches)	Curb Recommendation
1,818	0.031	4	DO NOTHING
Curb Type		Curb & Gutter Type	
CONCRETE		NO CURB AND GUTTER	
Pavement Recommendation		Condition Rating / PCR	
DO NOTHING		EXCELLENT / 97
