HOFR Cycle 6

Final Report

Road Inventory and Condition Assessment of Paved Routes Home of Franklin D. Roosevelt National Historic Site

Report Date: June 2021

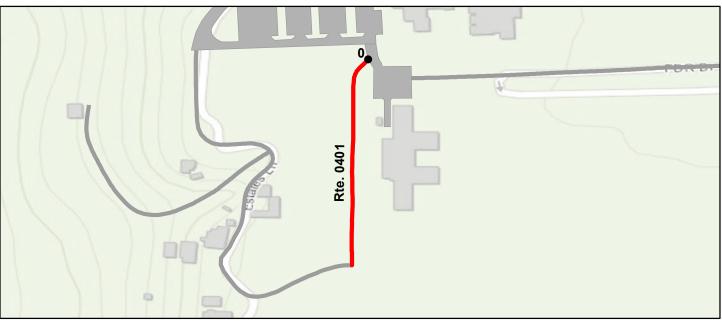
Home of Franklin D. Roosevelt National Historic Site ROUTE 0401: LIBRARY SERVICE ROAD

| Route | Condition Legend – Pav | ement Condi | tion Rating (PCR) |) | | |
|---|---|---|---|---|--|--|
| Pavement Condition Rating (PCR) | 0 | 0 | | | | |
| Structural Crack Index | 0 | 0 | | | | |
| Longitudinal Crack Index | 0 | 0 | | | | |
| Transverse Cracking Index | 61 | 61 | | | | |

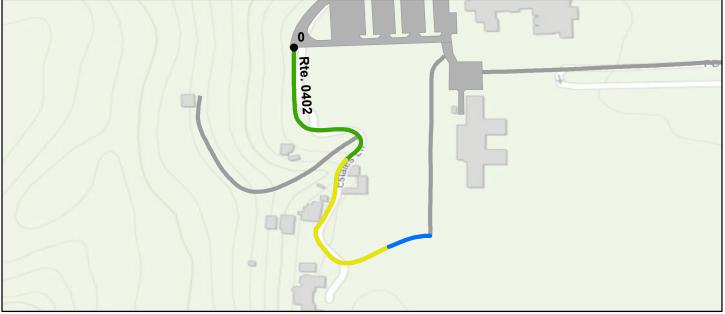
Home of Franklin D. Roosevelt National Historic Site ROUTE 0402: SERVICE ROAD

| Route Condition Legend – Pavement Condition Rating (PCR) | | | | | |
|--|---|---|---|---|--|
| Pavement Condition Rating (PCR) | 79 | 79 | | | |
| Structural Crack Index | 79 | 79 | | | |
| Longitudinal Crack Index | 82 | 82 | | | |

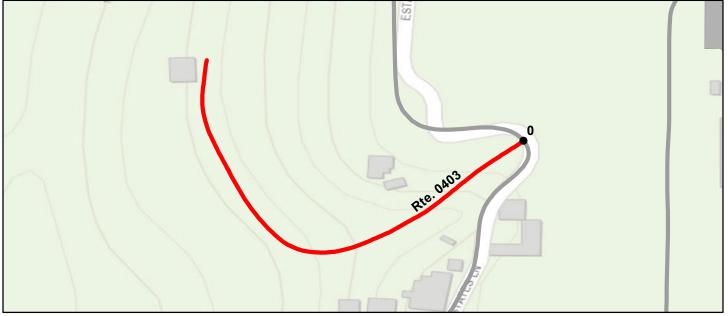
Home of Franklin D. Roosevelt National Historic Site ROUTE 0403: DUPLEX ROAD

| Rout | e Condition Legend – Pav | ement Cond | ition Rating (PCR) | |
|---|---|---|---|---|
| Pavement Condition Rating (PCR) | 50 | 50 | | |
| Structural Crack Index | 50 | 50 | | |
| Longitudinal Crack Index | 61 | 61 | | |

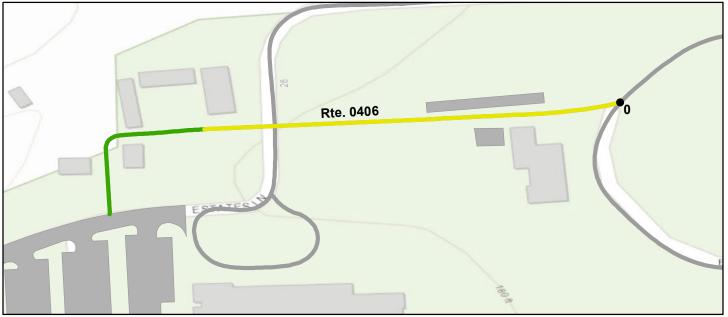
ROUTE 0406: BELLEFIELD MANSION REAR SERVICE DRIVE

| Route | Route Condition Legend – Pavement Condition Rating (PCR) | | | | | | | |
|---|---|---|---|---|--|--|--|--|
| Pavement Condition Rating (PCR) | 80 | 80 | | | | | | |
| Structural Crack Index | 80 | 80 | | | | | | |
| Longitudinal Crack Index | 87 | 87 | | | | | | |
| Transverse Cracking Index | 84 | 84 | | | | | | |

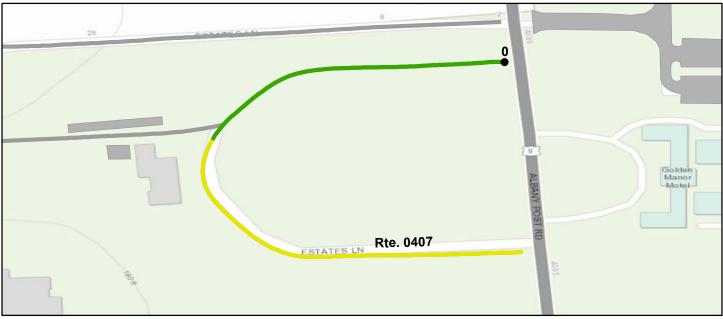
Home of Franklin D. Roosevelt National Historic Site ROUTE 0407: BELLEFIELD MANSION LOOP

| Route C | Route Condition Legend – Pavement Condition Rating (PCR) | | | | | | | |
|---|---|--|---|--|---|--|--|--|
| Pavement Condition Rating (PCR) | 85 | 85 | | | | | | |
| Longitudinal Crack Index | 86 | 86 | | | | | | |
