HOSP Cycle 6

Final Report

Road Inventory and Condition Assessment of Paved Routes Hot Springs National Park

**Federal Highway Administration
Eastern Federal Lands Highway Division
Road Inventory Program (RIP)**

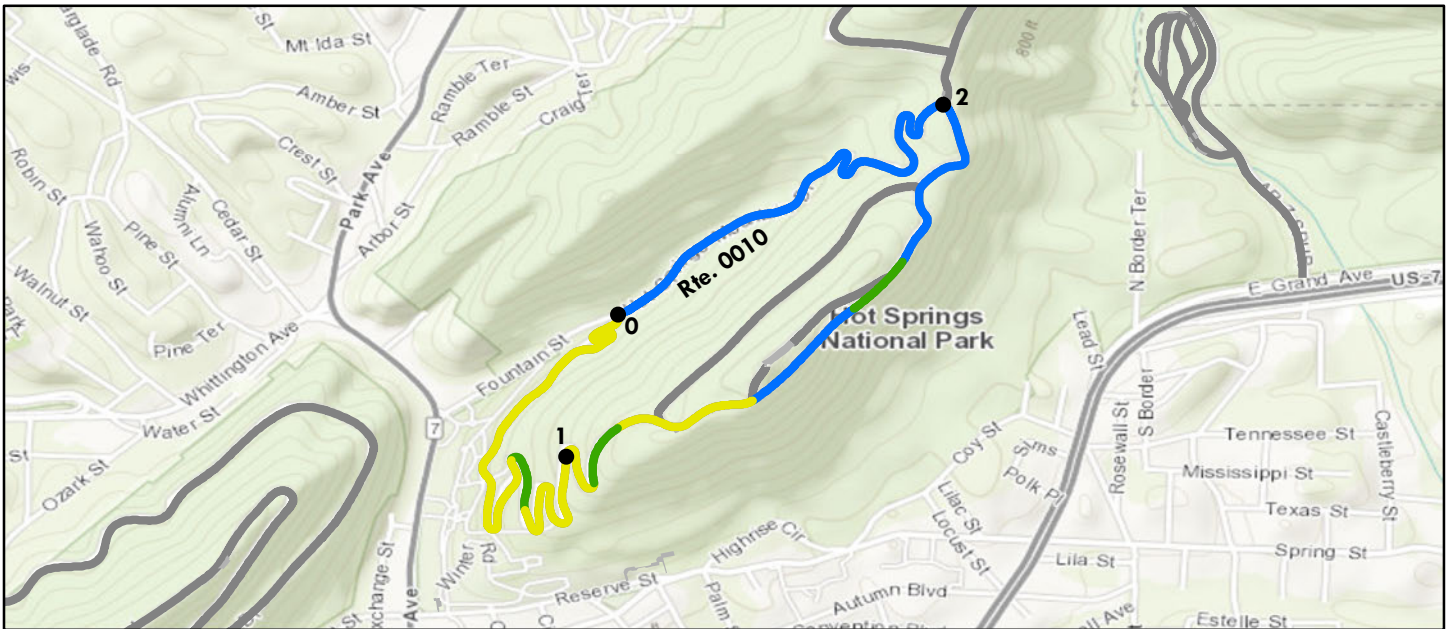
ROUTE 0010: HOT SPRINGS MOUNTAIN DRIVE

Route Condition Legend – Pavement Condition Rating (PCR)						
Poor (0 - 60)	Fair (61- 84)	Good (85 - 94)	Excellent (95 - 100)	Not Rated		
Colors on map represent condition scores at 0.10-mile intervals. See Appendix for definitions and formulas.						
Inspection Date: 5/9/2019	Beginning Section MP	0	1	2		
Paved Length (Miles): 2.74	Section Length (MI)	1	1	0.74		
Surface Type: CONCRETE	Route Summary					
Roadway Condition Information						
Pavement Condition Rating (PCR)	87	75	89	98		
Surface Condition Rating (SCR)	98	N/A	97	98		
Roughness Condition Index (RCI)	N/A	N/A	N/A	N/A		
Distress Index Values						
Structural Crack Index	99	N/A	98	99		
Alligator Crack Index	100	N/A	100	100		
Longitudinal Crack Index	99	N/A	98	99		
Transverse Cracking Index	99	N/A	99	99		
Patching Index	100	N/A	100	100		
Rutting Index	98	N/A	97	98		
International Roughness Index (IRI)	N/A	N/A	N/A	N/A		
Lane & Width Information

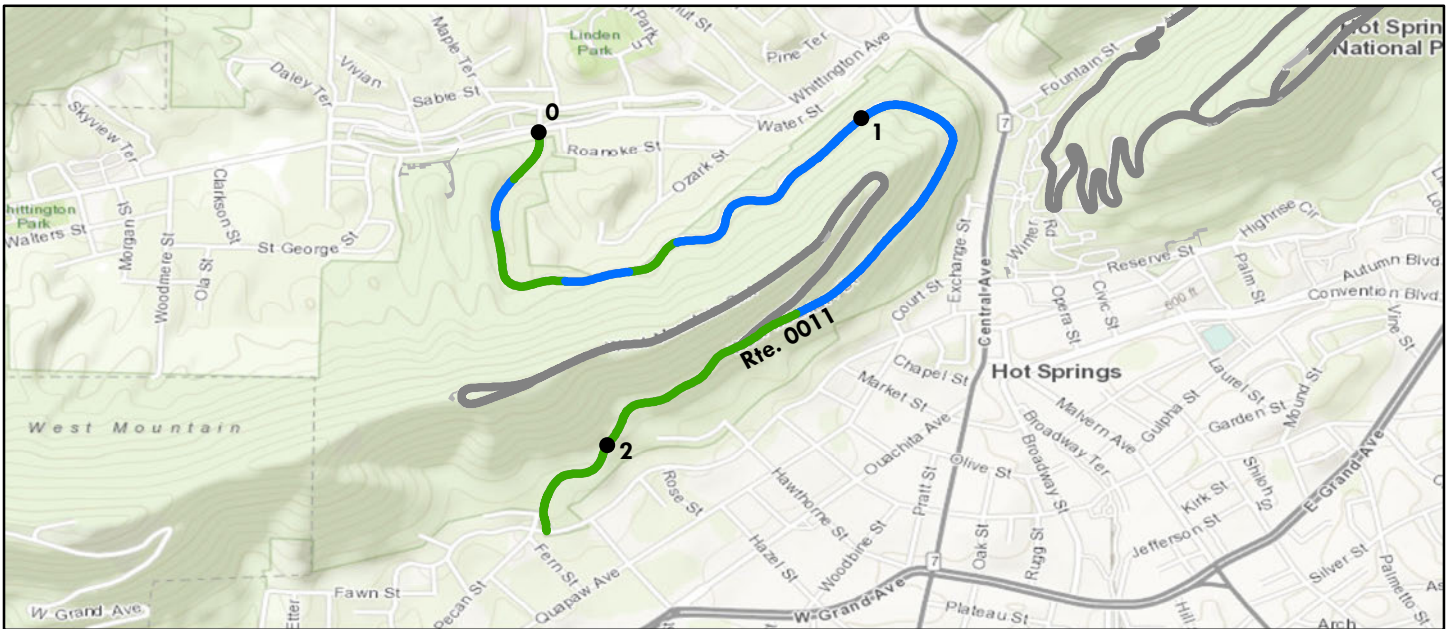
ROUTE 0011: WEST MOUNTAIN DRIVE

Inspection Date:	5/9/2019	Beginning Section MP	0	1	2		
Paved Length (Miles):	2.21	Section Length (MI)	1	1	0.21		
Surface Type:	ASPHALT	Route Summary					
Roadway Condition Information							
Pavement Condition Rating (PCR)	94	95	94	93			
Surface Condition Rating (SCR)	98	99	97	97			
Roughness Condition Index (RCI)	89	89	90	87			
Distress Index Values							
Structural Crack Index	98	99	97	97			
Alligator Crack Index	100	100	100	100			
Longitudinal Crack Index	98	99	97	97			
Transverse Cracking Index	99	99	98	99			
Patching Index	100	100	100	100			
Rutting Index	100	100	100	99			
International Roughness Index (IRI)	143	143	142	150			
Lane & Width Information							
Number of Lanes	2	2	2	2			
Paved Width (ft)	21.7	21.3	21.8	22.8			
Lane Width (ft)	9.8	9.7	9.9	10.5

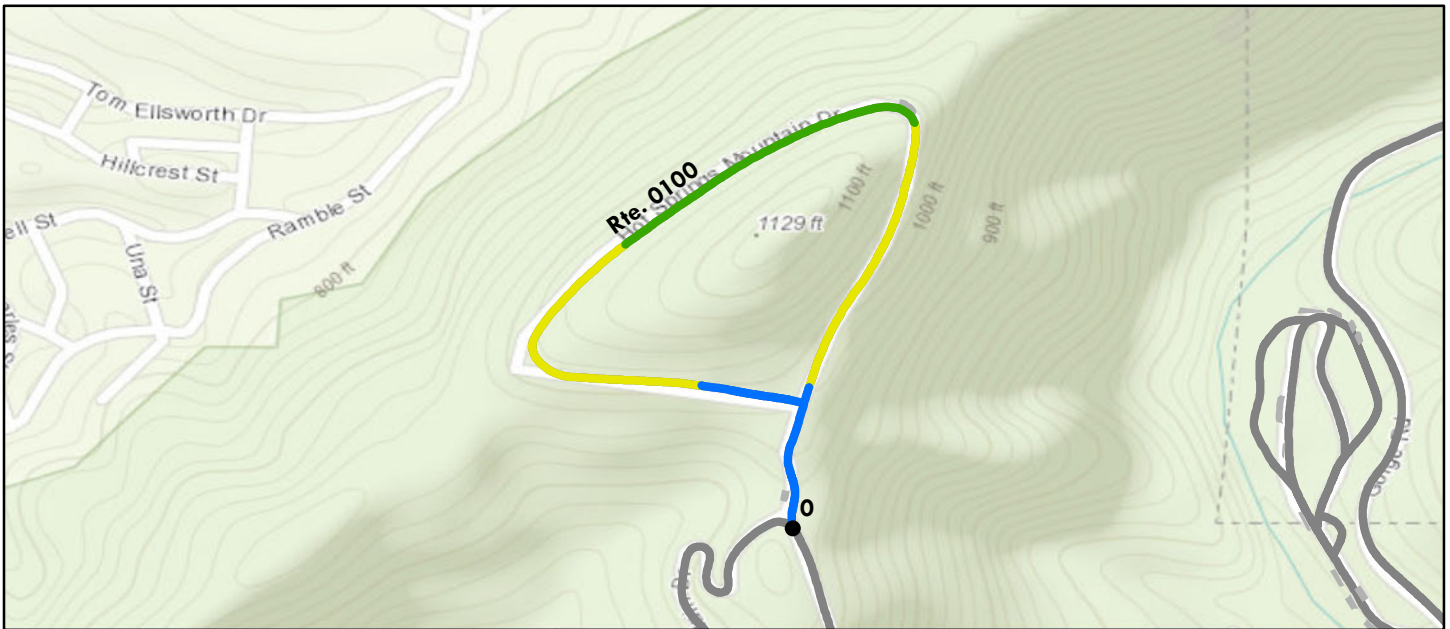
ROUTE 0100: NORTH MOUNTAIN LOOP ROAD

Route Condition Legend – Pavement Condition Rating (PCR)						
Poor (0 - 60)	Fair (61- 84)	Good (85 - 94)	Excellent (95 - 100)	Not Rated		
Colors on map represent condition scores at 0.10-mile intervals. See Appendix for definitions and formulas.						
Inspection Date: 5/9/2019	Beginning Section MP	0				
Paved Length (Miles): 0.76	Section Length (MI)	0.76				
Surface Type: ASPHALT	Route Summary					
Roadway Condition Information						
Pavement Condition Rating (PCR)	81	81				
Surface Condition Rating (SCR)	96	96				
Roughness Condition Index (RCI)	58	58				
Distress Index Values						
Structural Crack Index	98	98				
Alligator Crack Index	100	100				
Longitudinal Crack Index	98	98				
Transverse Cracking Index	97	97				
Patching Index	100	100				
Rutting Index	96	96				
International Roughness Index (IRI)	249	249				
Lane & Width Information						
Number of Lanes	1	1				
Paved Width (ft)	15.9	15.9				
Lane Width (ft)	12.8	12.8

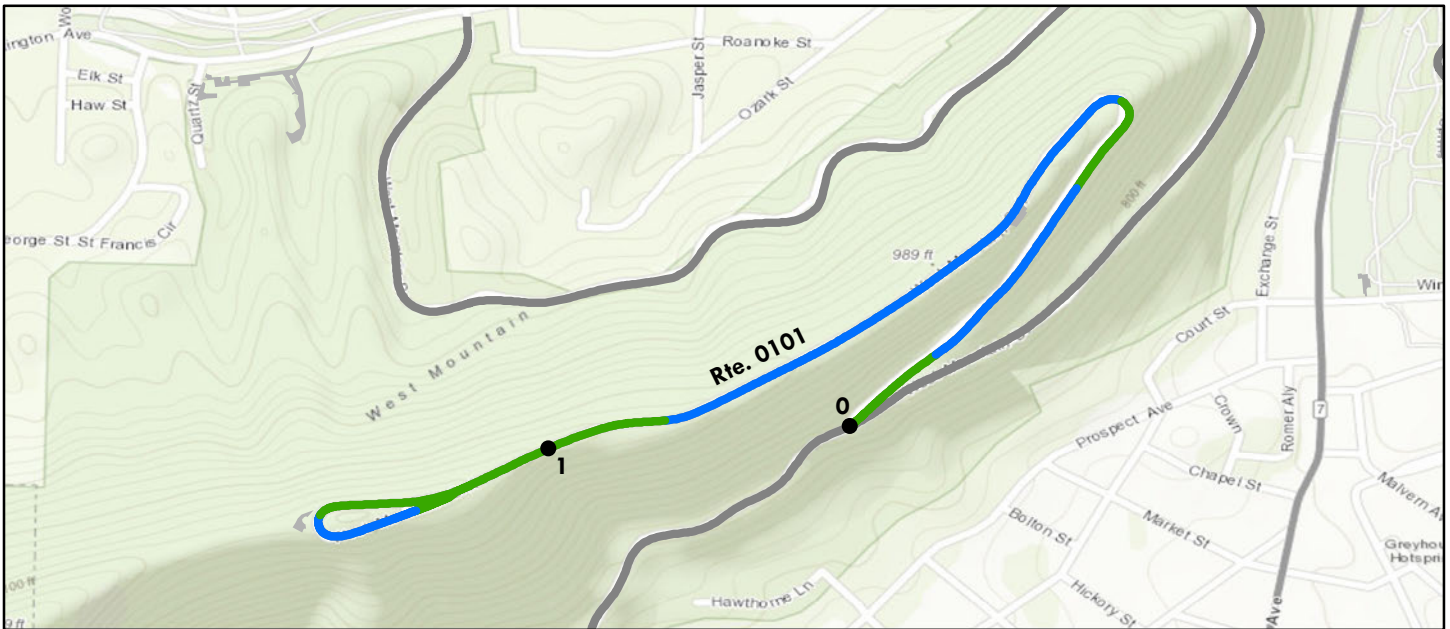
ROUTE 0101: WEST MOUNTAIN SUMMIT ROAD

Route Condition Legend – Pavement Condition Rating (PCR)						
Poor (0 - 60)	Fair (61- 84)	Good (85 - 94)	Excellent (95 - 100)	Not Rated		
Colors on map represent condition scores at 0.10-mile intervals. See Appendix for definitions and formulas.						
Inspection Date: 5/9/2019	Beginning Section MP	0	1			
Paved Length (Miles): 1.34	Section Length (MI)	1	0.34			
Surface Type: ASPHALT	Route Summary					
Roadway Condition Information						
Pavement Condition Rating (PCR)	95	96	92			
Surface Condition Rating (SCR)	97	98	94			
Roughness Condition Index (RCI)	92	93	89			
Distress Index Values						
Structural Crack Index	98	98	98			
Alligator Crack Index	100	100	100			
Longitudinal Crack Index	98	98	98			
Transverse Cracking Index	97	98	94			
Patching Index	100	100	100			
Rutting Index	100	100	99			
International Roughness Index (IRI)	134	131	144			
Lane & Width Information						
Number of Lanes	2	2	1			
Paved Width (ft)	20.2	21.2	17.4

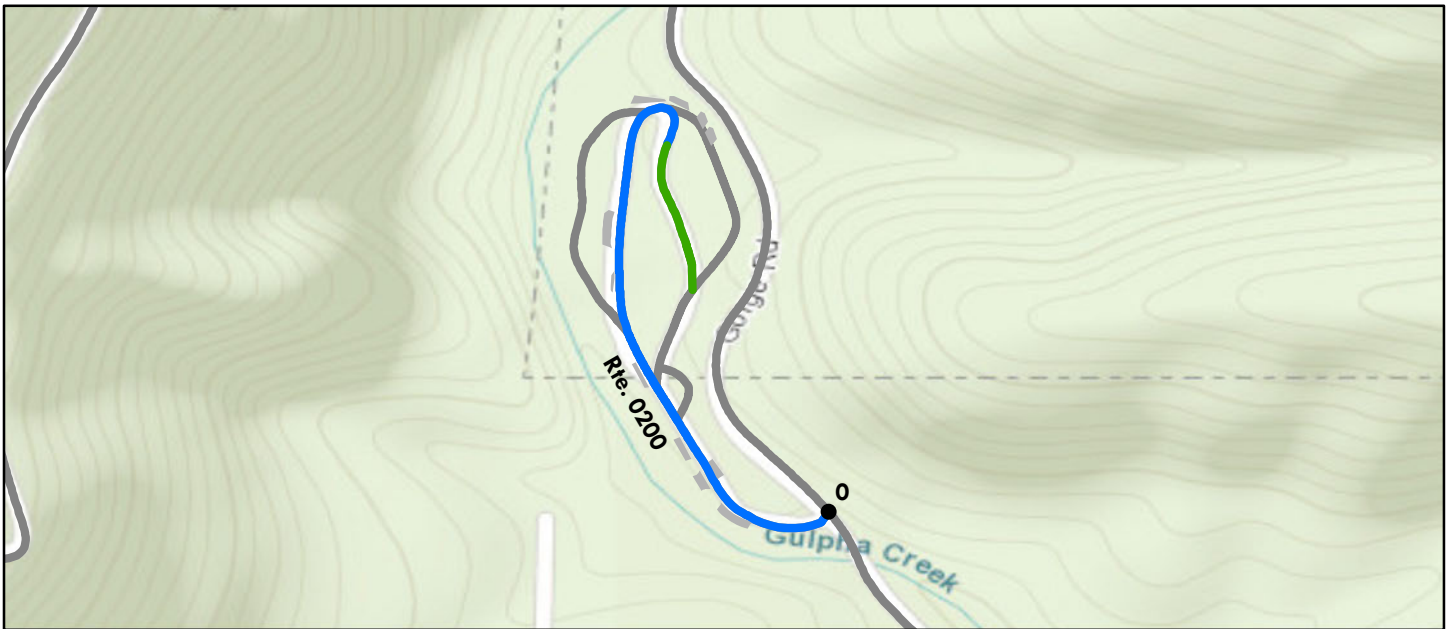
ROUTE 0200: GULPHA GORGE CAMPGROUND ROAD

Route Condition Legend – Pavement Condition Rating (PCR)						
Poor (0 - 60)	Fair (61- 84)	Good (85 - 94)	Excellent (95 - 100)	Not Rated		
Colors on map represent condition scores at 0.10-mile intervals. See Appendix for definitions and formulas.						
Inspection Date: 5/9/2019	Beginning Section MP	0				
Paved Length (Miles): 0.38	Section Length (MI)	0.38				
Surface Type: ASPHALT	Route Summary					
Roadway Condition Information						
Pavement Condition Rating (PCR)	95	95				
Surface Condition Rating (SCR)	95	95				
Roughness Condition Index (RCI)	N/A	N/A				
Distress Index Values						
Structural Crack Index	98	98				
Alligator Crack Index	100	100				
Longitudinal Crack Index	98	98				
Transverse Cracking Index	95	95				
Patching Index	99	99				
Rutting Index	98	98				
International Roughness Index (IRI)	N/A	N/A				
Lane & Width Information						
Number of Lanes	2	2				
Paved Width (ft)	21.4	21.4				
Lane Width (ft)	10.7	10.7

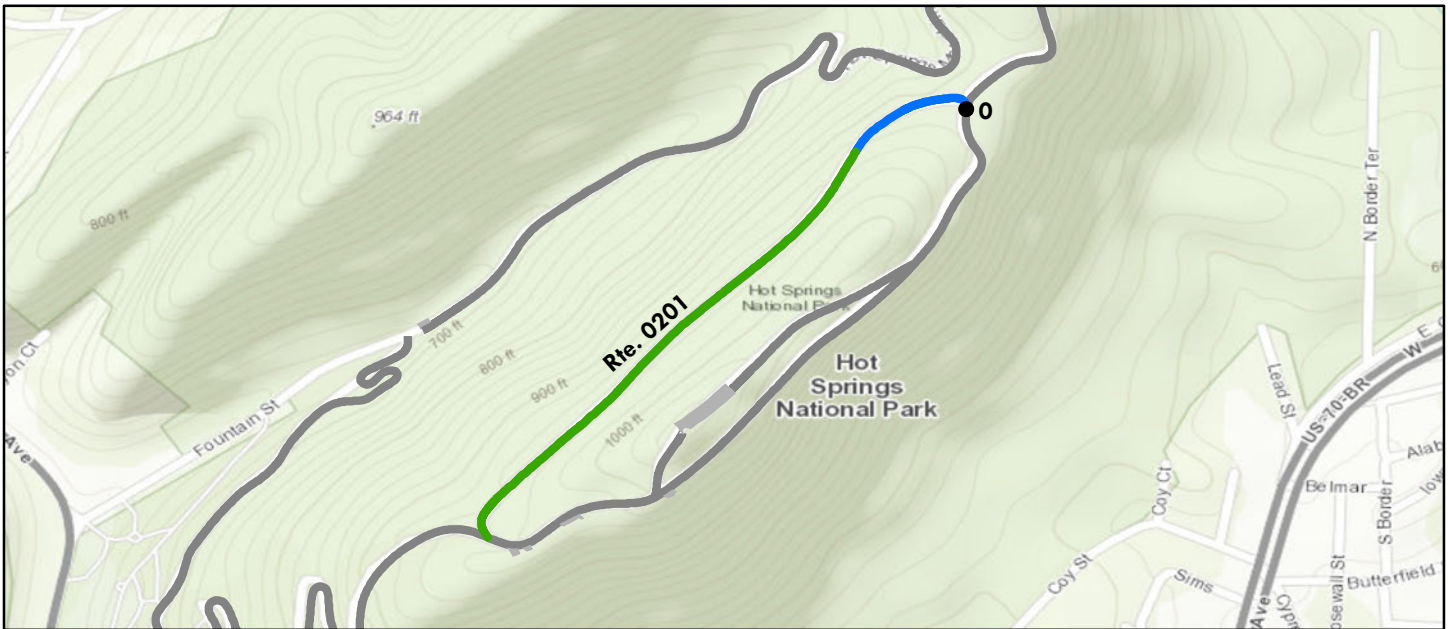
ROUTE 0201: TOWER RETURN ROAD

Inspection Date: 5/9/2019	Beginning Section MP	0				
Paved Length (Miles): 0.53	Section Length (MI)	0.53				
Surface Type: ASPHALT	Route Summary					
Roadway Condition Information						
Pavement Condition Rating (PCR)	89	89				
Surface Condition Rating (SCR)	99	99				
Roughness Condition Index (RCI)	74	74				
Distress Index Values						
Structural Crack Index	99	99				
Alligator Crack Index	100	100				
Longitudinal Crack Index	99	99				
Transverse Cracking Index	99	99				
Patching Index	100	100				
Rutting Index	99	99				
International Roughness Index (IRI)	188	188				
Lane & Width Information						
Number of Lanes	1	1				
Paved Width (ft)	15	15				
Lane Width (ft)	13.3	13.3

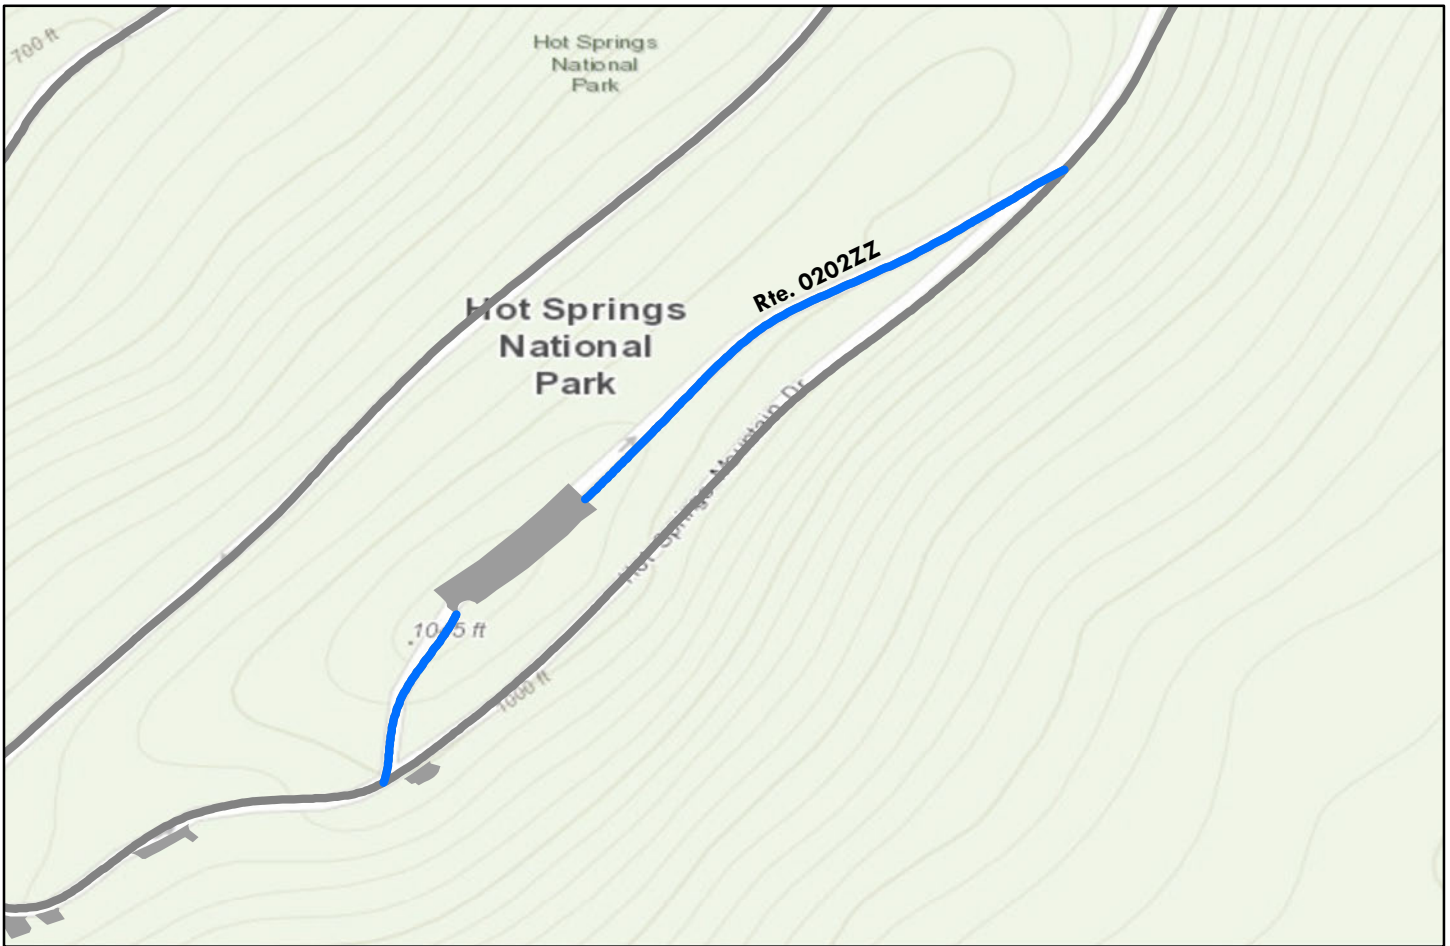
ROUTE 0202ZZ: TOWER PARKING ROADS

Route Condition Legend – Pavement Condition Rating (PCR)						
Poor (0 - 60)	Fair (61- 84)	Good (85 - 94)	Excellent (95 - 100)	Not Rated		
See Appendix for definitions and formulas						
Inspection Date: 5/9/2019						
Paved Length (Miles): 0.22						
Surface Type: ASPHALT	Route Summary					
Roadway Condition Information						
Pavement Condition Rating (PCR)	98					
Lane & Width Information						
Number of Lanes	1					
Paved Width (ft)	14.9					
Lane Width (ft)	13.7

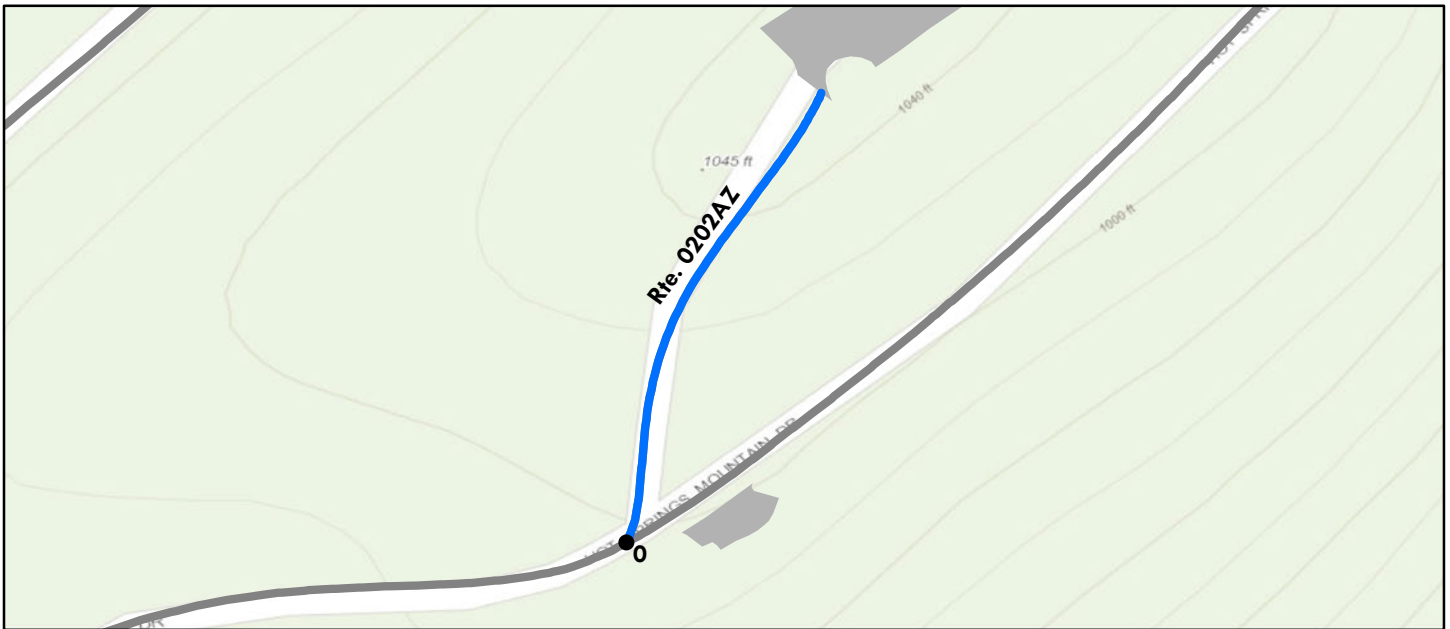
ROUTE 0202AZ: TOWER PARKING ENTRANCE ROAD

Route Condition Legend – Pavement Condition Rating (PCR)						
Poor (0 - 60)	Fair (61- 84)	Good (85 - 94)	Excellent (95 - 100)	Not Rated		
Colors on map represent condition scores at 0.10-mile intervals. See Appendix for definitions and formulas.						
Inspection Date: 5/9/2019	Beginning Section MP	0				
Paved Length (Miles): 0.06	Section Length (MI)	0.06				
Surface Type: ASPHALT	Route Summary					
Roadway Condition Information						
Pavement Condition Rating (PCR)	96	96				
Surface Condition Rating (SCR)	96	96				
Roughness Condition Index (RCI)	N/A	N/A				
Distress Index Values						
Structural Crack Index	99	99				
Alligator Crack Index	100	100				
Longitudinal Crack Index	99	99				
Transverse Cracking Index	96	96				
Patching Index	100	100				
Rutting Index	96	96				
International Roughness Index (IRI)	N/A	N/A				
Lane & Width Information						
Number of Lanes	1	1				
Paved Width (ft)	13.7	13.7				
Lane Width (ft)	12.2	12.2

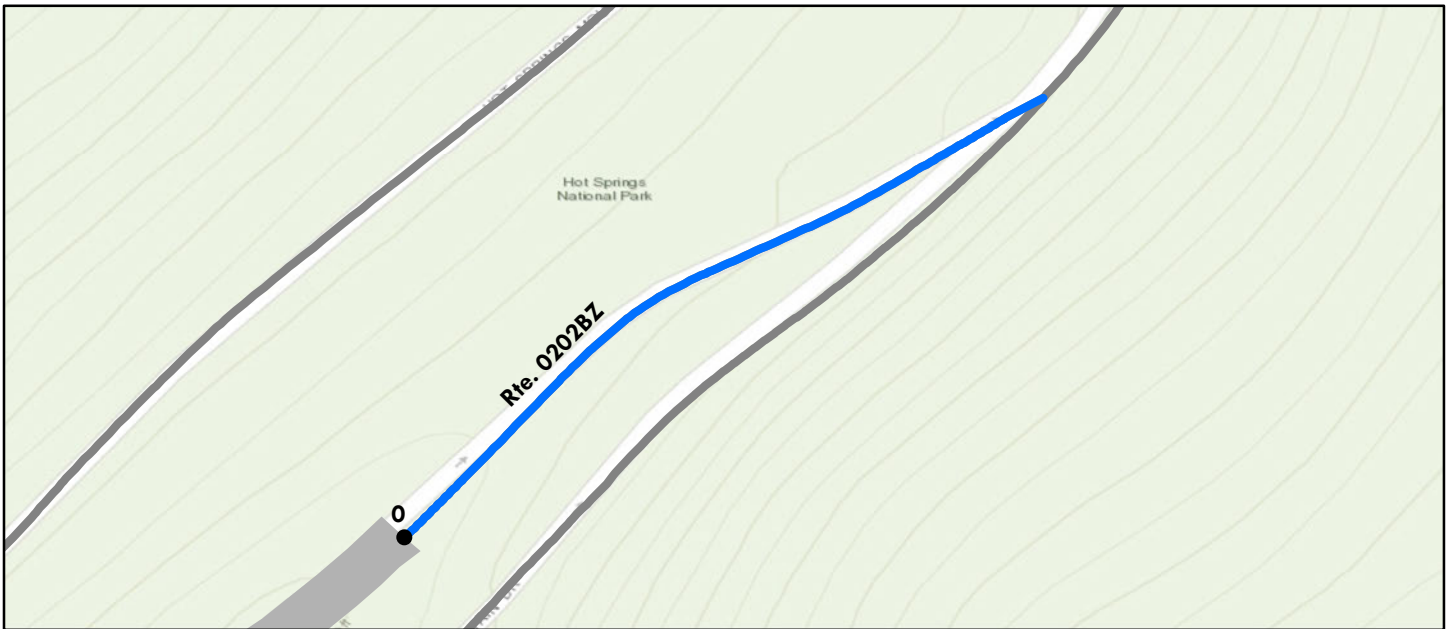
ROUTE 0202BZ: TOWER PARKING EXIT ROAD

Route Condition Legend – Pavement Condition Rating (PCR)						
Poor (0 - 60)	Fair (61- 84)	Good (85 - 94)	Excellent (95 - 100)	Not Rated		
Colors on map represent condition scores at 0.10-mile intervals. See Appendix for definitions and formulas.						
Inspection Date: 5/9/2019	Beginning Section MP	0				
Paved Length (Miles): 0.16	Section Length (MI)	0.16				
Surface Type: ASPHALT	Route Summary					
Roadway Condition Information						
Pavement Condition Rating (PCR)	98	98				
Surface Condition Rating (SCR)	98	98				
Roughness Condition Index (RCI)	N/A	N/A				
Distress Index Values						
Structural Crack Index	98	98				
Alligator Crack Index	100	100				
Longitudinal Crack Index	98	98				
Transverse Cracking Index	98	98				
Patching Index	100	100				
Rutting Index	99	99				
International Roughness Index (IRI)	N/A	N/A				
Lane & Width Information						
Number of Lanes	1	1				
Paved Width (ft)	15.3	15.3				
Lane Width (ft)	14.3	14.3

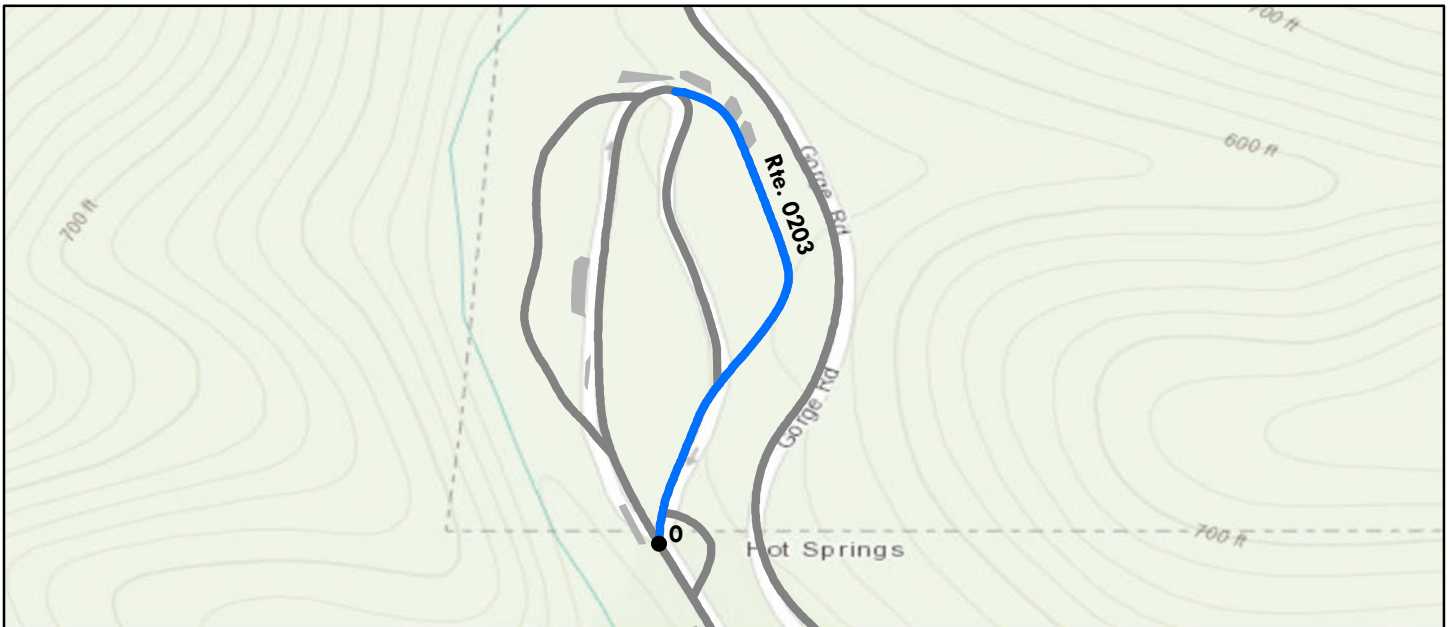
ROUTE 0203: GULPHA GORGE CAMPGROUND UPPER LOOP

Route Condition Legend – Pavement Condition Rating (PCR)						
Poor (0 - 60)	Fair (61- 84)	Good (85 - 94)	Excellent (95 - 100)	Not Rated		
Colors on map represent condition scores at 0.10-mile intervals. See Appendix for definitions and formulas.						
Inspection Date: 5/9/2019	Beginning Section MP	0				
Paved Length (Miles): 0.17	Section Length (MI)	0.17				
Surface Type: ASPHALT	Route Summary					
Roadway Condition Information						
Pavement Condition Rating (PCR)	99	99				
Surface Condition Rating (SCR)	99	99				
Roughness Condition Index (RCI)	N/A	N/A				
Distress Index Values						
Structural Crack Index	99	99				
Alligator Crack Index	100	100				
Longitudinal Crack Index	99	99				
Transverse Cracking Index	99	99				
Patching Index	100	100				
Rutting Index	99	99				
International Roughness Index (IRI)	N/A	N/A				
Lane & Width Information						
Number of Lanes	2	2				
Paved Width (ft)	21.6	21.6				
Lane Width (ft)	10.8	10.8

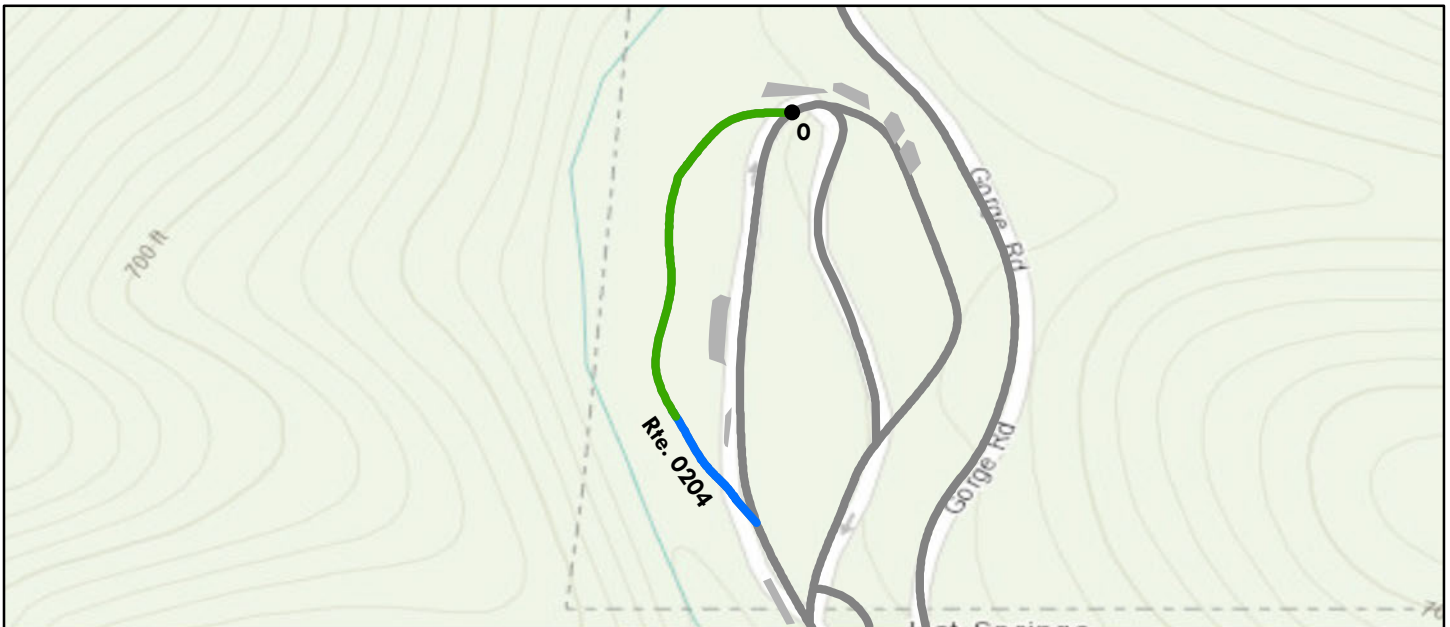
ROUTE 0204: GULPHA GORGE CAMPGROUND LOWER LOOP

Route Condition Legend – Pavement Condition Rating (PCR)						
Poor (0 - 60)	Fair (61- 84)	Good (85 - 94)	Excellent (95 - 100)	Not Rated		
Colors on map represent condition scores at 0.10-mile intervals. See Appendix for definitions and formulas.						
Inspection Date: 5/9/2019	Beginning Section MP	0				
Paved Length (Miles): 0.13	Section Length (MI)	0.13				
Surface Type: ASPHALT	Route Summary					
Roadway Condition Information						
Pavement Condition Rating (PCR)	93	93				
Surface Condition Rating (SCR)	93	93				
Roughness Condition Index (RCI)	N/A	N/A				
Distress Index Values						
Structural Crack Index	98	98				
Alligator Crack Index	100	100				
Longitudinal Crack Index	98	98				
Transverse Cracking Index	93	93				
Patching Index	100	100				
Rutting Index	98	98				
International Roughness Index (IRI)	N/A	N/A				
Lane & Width Information						
Number of Lanes	1	1				
Paved Width (ft)	15	15				
Lane Width (ft)	15	15

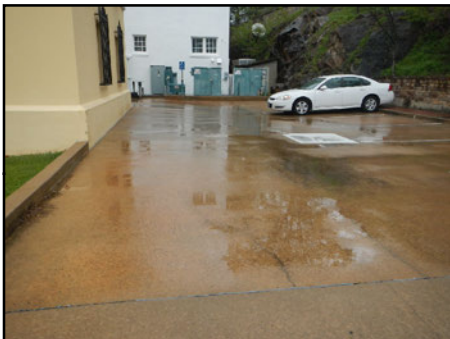
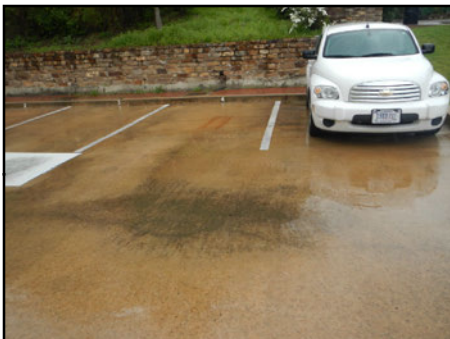
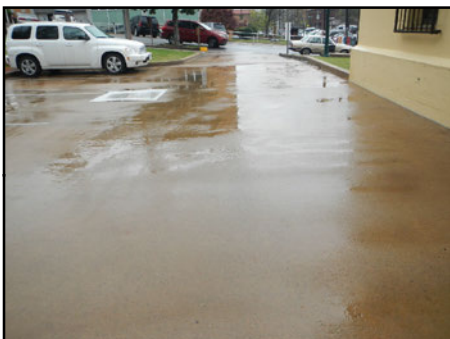
Inspection Date	FMSS Number	User Access	Surface Type
4/7/2018	82245	NONPUBLIC	CONCRETE
Area (Sq. Ft.)	Lane Miles (11' Widths)	Curb Reveal (Inches)	Curb Recommendation
3,243	0.056	6	DO NOTHING
Curb Type		Curb & Gutter Type	
CONCRETE		NO CURB AND GUTTER	
Pavement Recommendation		Condition Rating / PCR	
PREVENTIVE MAINTENANCE		GOOD / 90

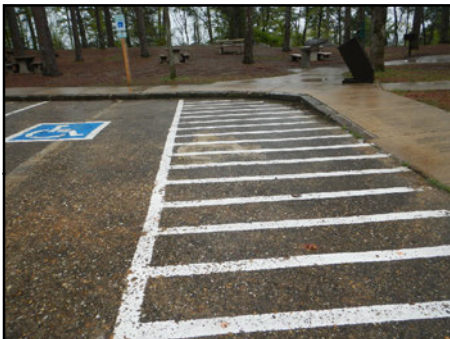
Inspection Date	FMSS Number	User Access	Surface Type
4/7/2018	82247	PUBLIC	CONCRETE
Area (Sq. Ft.)	Lane Miles (11' Widths)	Curb Reveal (Inches)	Curb Recommendation
676	0.012	6	DO NOTHING
Curb Type		Curb & Gutter Type	
STONE		NO CURB AND GUTTER	
Pavement Recommendation		Condition Rating / PCR	
PREVENTIVE MAINTENANCE		GOOD / 90

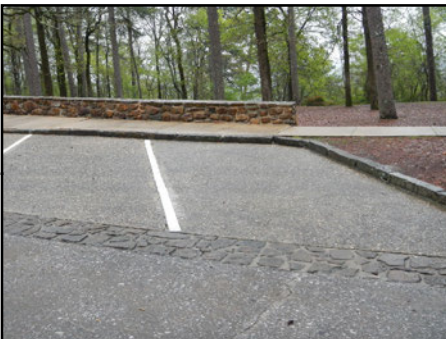
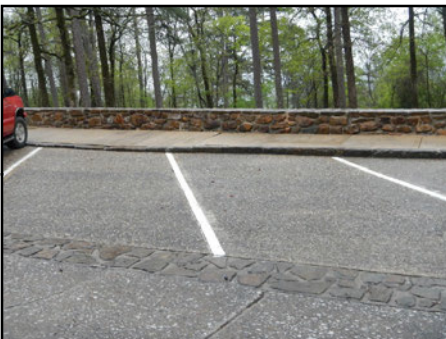
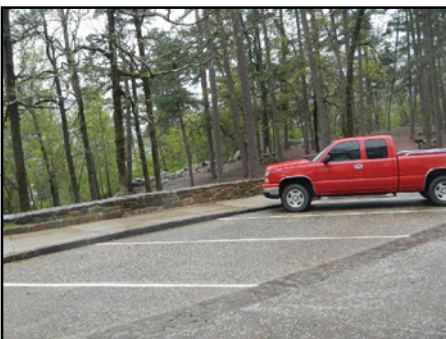
ROUTE 0901C: HOT SPRINGS MOUNTAIN PICNIC AREA PARKING C

Inspection Date	FMSS Number	User Access	Surface Type
4/7/2018	82248	PUBLIC	CONCRETE
Area (Sq. Ft.)	Lane Miles (11' Widths)	Curb Reveal (Inches)	Curb Recommendation
1,641	0.028	6	DO NOTHING
Curb Type		Curb & Gutter Type	
STONE		NO CURB AND GUTTER	
Pavement Recommendation		Condition Rating / PCR	
PREVENTIVE MAINTENANCE		GOOD / 90

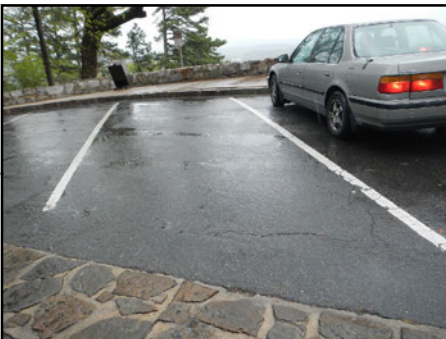
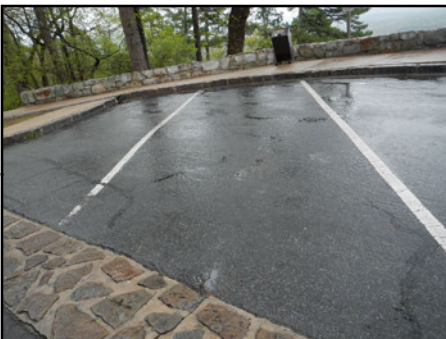
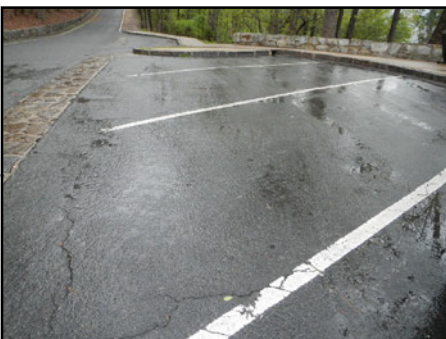
ROUTE 0902: PAGODA PARKING AREA

Inspection Date	FMSS Number	User Access	Surface Type
4/7/2018	82249	PUBLIC	ASPHALT
Area (Sq. Ft.)	Lane Miles (11' Widths)	Curb Reveal (Inches)	Curb Recommendation
1,053	0.018	6	DO NOTHING
Curb Type		Curb & Gutter Type	
STONE		NO CURB AND GUTTER	
Pavement Recommendation		Condition Rating / PCR	
PREVENTIVE MAINTENANCE		GOOD / 90

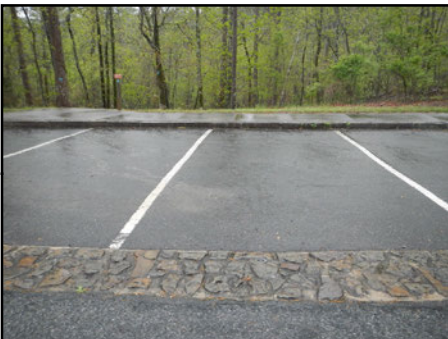
ROUTE 0903: SHELTER HOUSE PARKING AREA

Inspection Date	FMSS Number	User Access	Surface Type
4/7/2018	82250	PUBLIC	ASPHALT
Area (Sq. Ft.)	Lane Miles (11' Widths)	Curb Reveal (Inches)	Curb Recommendation
935	0.016	6	DO NOTHING
Curb Type		Curb & Gutter Type	
STONE		NO CURB AND GUTTER	
Pavement Recommendation		Condition Rating / PCR	
PREVENTIVE MAINTENANCE		GOOD / 90

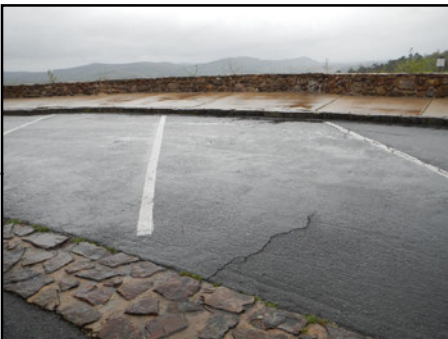
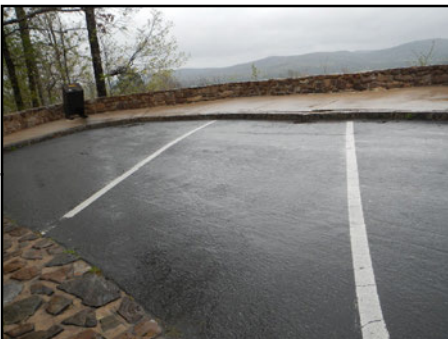
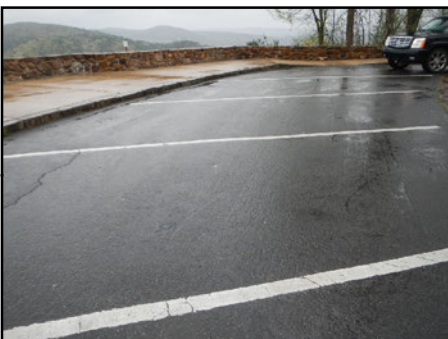
ROUTE 0904: NORTH MOUNTAIN PARKING AREA

Inspection Date	FMSS Number	User Access	Surface Type
4/7/2018	82251	PUBLIC	ASPHALT
Area (Sq. Ft.)	Lane Miles (11' Widths)	Curb Reveal (Inches)	Curb Recommendation
1,389	0.024	6	DO NOTHING
Curb Type		Curb & Gutter Type	
STONE		NO CURB AND GUTTER	
Pavement Recommendation		Condition Rating / PCR	
PREVENTIVE MAINTENANCE		GOOD / 90

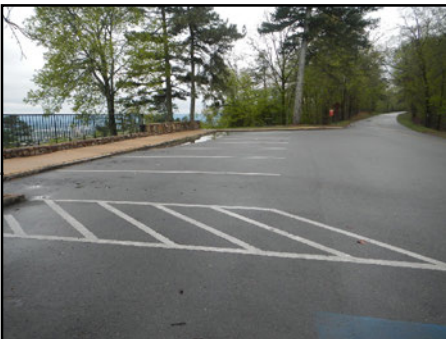
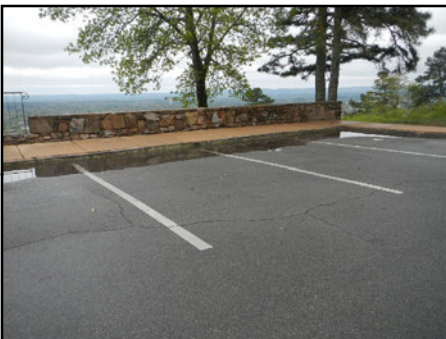
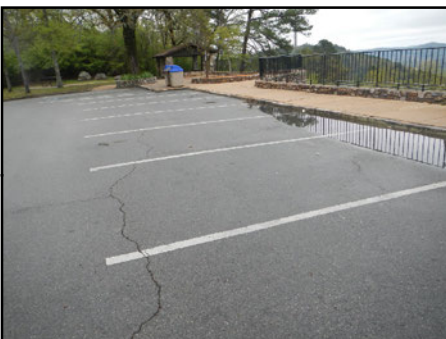
ROUTE 0905: WEST MOUNTAIN PICNIC AREA PARKING

Inspection Date	FMSS Number	User Access	Surface Type
4/7/2018	82252	PUBLIC	ASPHALT
Area (Sq. Ft.)	Lane Miles (11' Widths)	Curb Reveal (Inches)	Curb Recommendation
3,903	0.067	4	DO NOTHING
Curb Type		Curb & Gutter Type	
STONE		NO CURB AND GUTTER	
Pavement Recommendation		Condition Rating / PCR	
PREVENTIVE MAINTENANCE		GOOD / 90

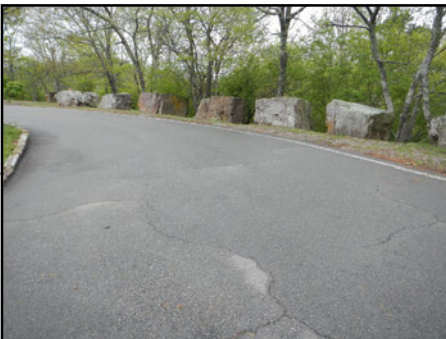
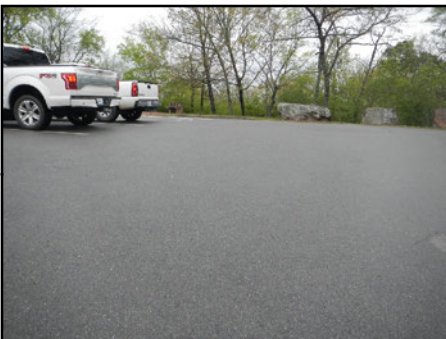
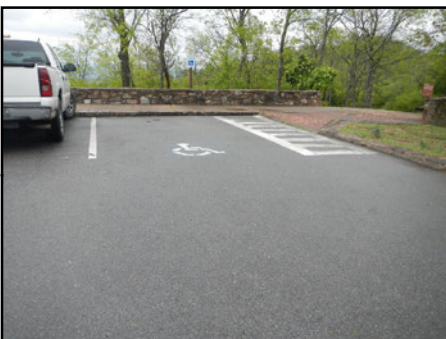
ROUTE 0906: WEST MOUNTAIN SUMMIT PARKING AREA

Inspection Date	FMSS Number	User Access	Surface Type
4/7/2018	82253	PUBLIC	ASPHALT
Area (Sq. Ft.)	Lane Miles (11' Widths)	Curb Reveal (Inches)	Curb Recommendation
3,373	0.058	4	DO NOTHING
Curb Type		Curb & Gutter Type	
CONCRETE AND STONE		NO CURB AND GUTTER	
Pavement Recommendation		Condition Rating / PCR	
PREVENTIVE MAINTENANCE		GOOD / 90

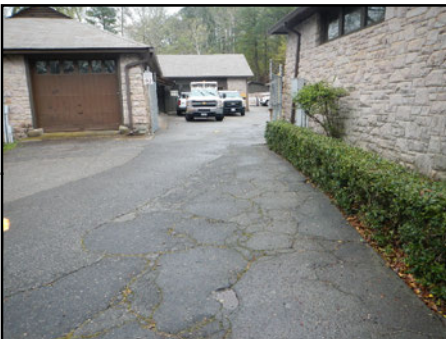
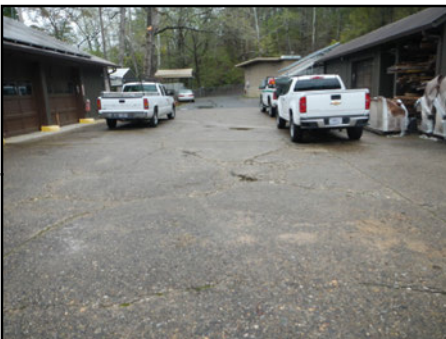
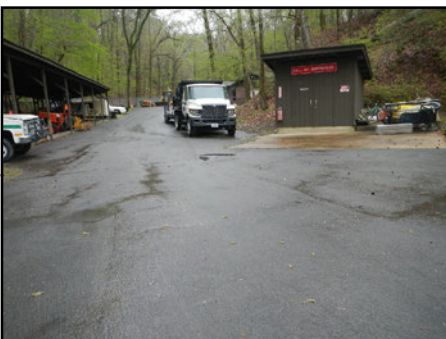
ROUTE 0907: MAINTENANCE AREA PARKING

Inspection Date	FMSS Number	User Access	Surface Type
4/7/2018	82254	NONPUBLIC	ASPHALT
Area (Sq. Ft.)	Lane Miles (11' Widths)	Curb Reveal (Inches)	Curb Recommendation
27,207	0.468	NOT APPLICABLE	NOT APPLICABLE
Curb Type		Curb & Gutter Type	
NO CURB		NO CURB AND GUTTER	
Pavement Recommendation		Condition Rating / PCR	
PREVENTIVE MAINTENANCE		FAIR / 73

Note: Parking area consists of multiple surface types: 2 parts Asphalt at 20,734 square feet; 2 parts Concrete at 6,473 square feet.

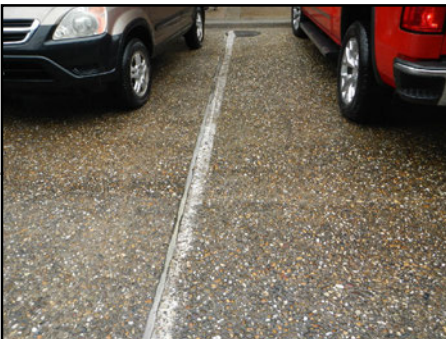
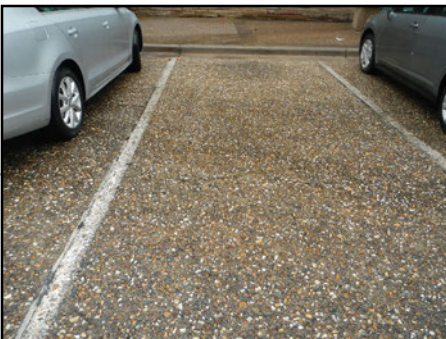
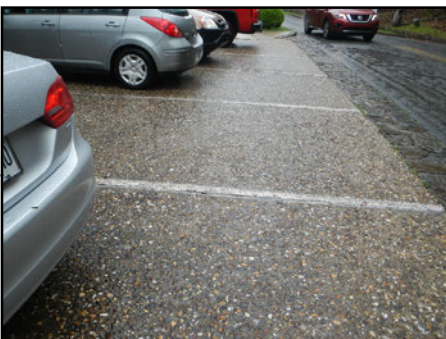
ROUTE 0908: HAPPY HOLLOW PARKING AREA

Inspection Date	FMSS Number	User Access	Surface Type
4/7/2018	82255	PUBLIC	CONCRETE
Area (Sq. Ft.)	Lane Miles (11' Widths)	Curb Reveal (Inches)	Curb Recommendation
1,070	0.018	NOT APPLICABLE	DO NOTHING
Curb Type		Curb & Gutter Type	
NO CURB		CONCRETE	
Pavement Recommendation		Condition Rating / PCR	
PREVENTIVE MAINTENANCE		GOOD / 90

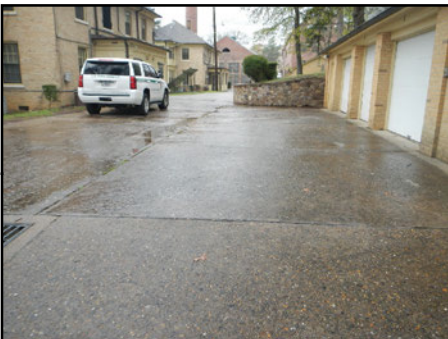
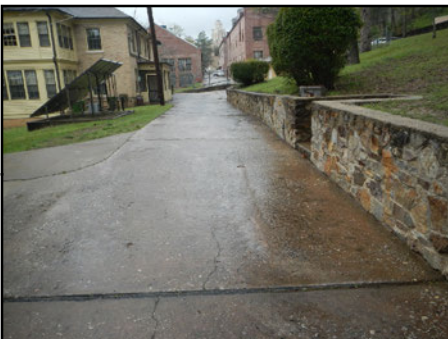
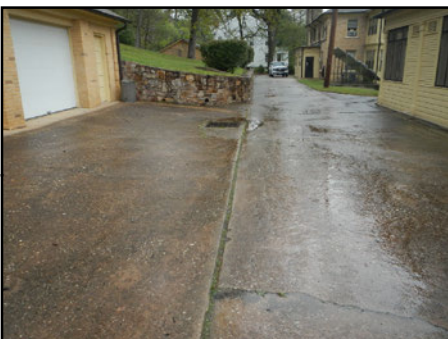
ROUTE 0909: RANGER STATION PARKING

Inspection Date	FMSS Number	User Access	Surface Type
4/7/2018	82256	NONPUBLIC	CONCRETE
Area (Sq. Ft.)	Lane Miles (11' Widths)	Curb Reveal (Inches)	Curb Recommendation
13,894	0.239	6	DO NOTHING
Curb Type		Curb & Gutter Type	
CONCRETE		NO CURB AND GUTTER	
Pavement Recommendation		Condition Rating / PCR	
PREVENTIVE MAINTENANCE		GOOD / 90

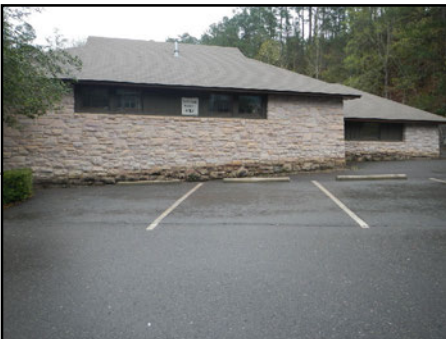
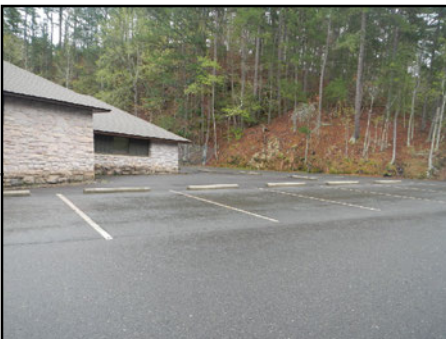
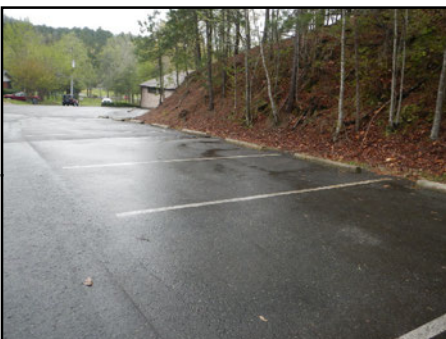
ROUTE 0910: MAINTENANCE AREA EMPLOYEE PARKING

Inspection Date	FMSS Number	User Access	Surface Type
4/7/2018	82257	NONPUBLIC	ASPHALT
Area (Sq. Ft.)	Lane Miles (11' Widths)	Curb Reveal (Inches)	Curb Recommendation
3,537	0.061	NOT APPLICABLE	NOT APPLICABLE
Curb Type		Curb & Gutter Type	
NO CURB		NO CURB AND GUTTER	
Pavement Recommendation		Condition Rating / PCR	
PREVENTIVE MAINTENANCE		GOOD / 90

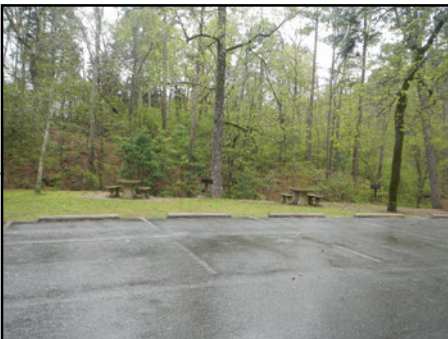
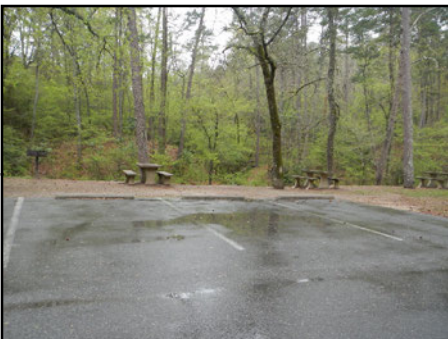
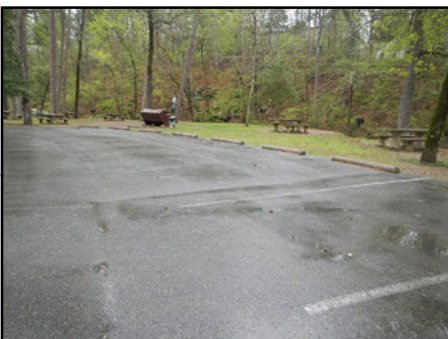
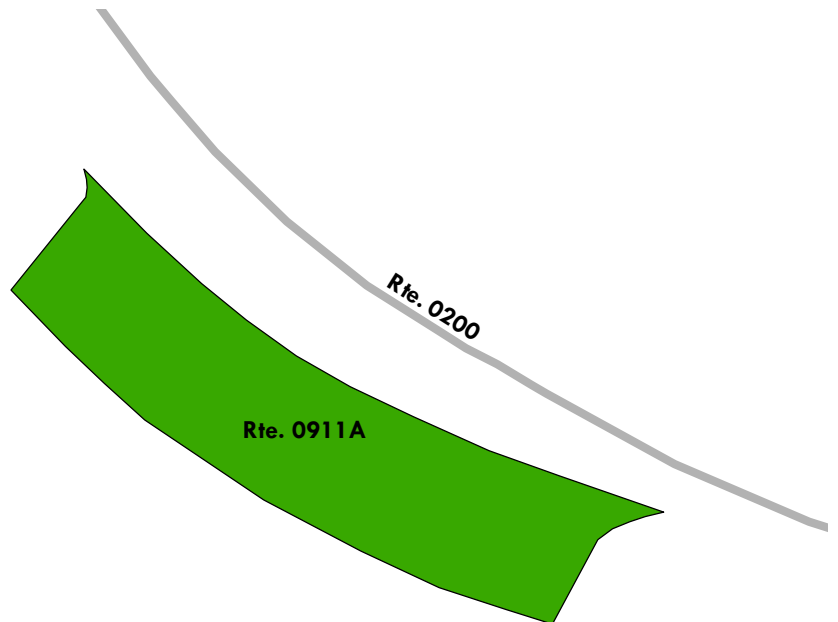
Inspection Date	FMSS Number	User Access	Surface Type
4/7/2018	82258	PUBLIC	ASPHALT
Area (Sq. Ft.)	Lane Miles (11' Widths)	Curb Reveal (Inches)	Curb Recommendation
1,947	0.034	NOT APPLICABLE	NOT APPLICABLE
Curb Type		Curb & Gutter Type	
NO CURB		NO CURB AND GUTTER	
Pavement Recommendation		Condition Rating / PCR	
PREVENTIVE MAINTENANCE		GOOD / 90

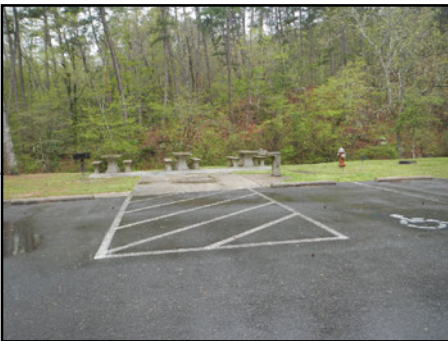
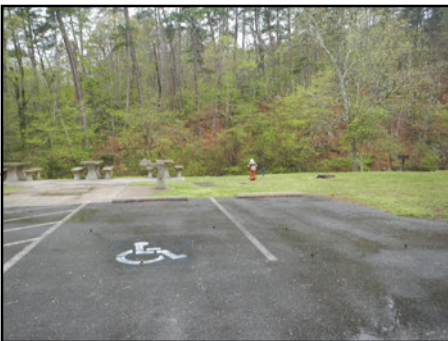
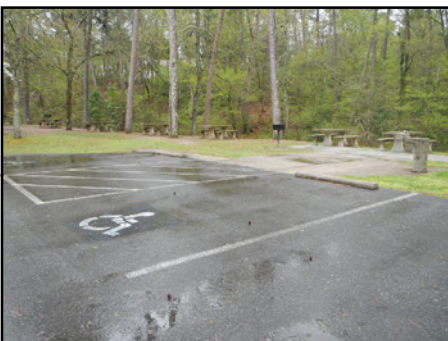
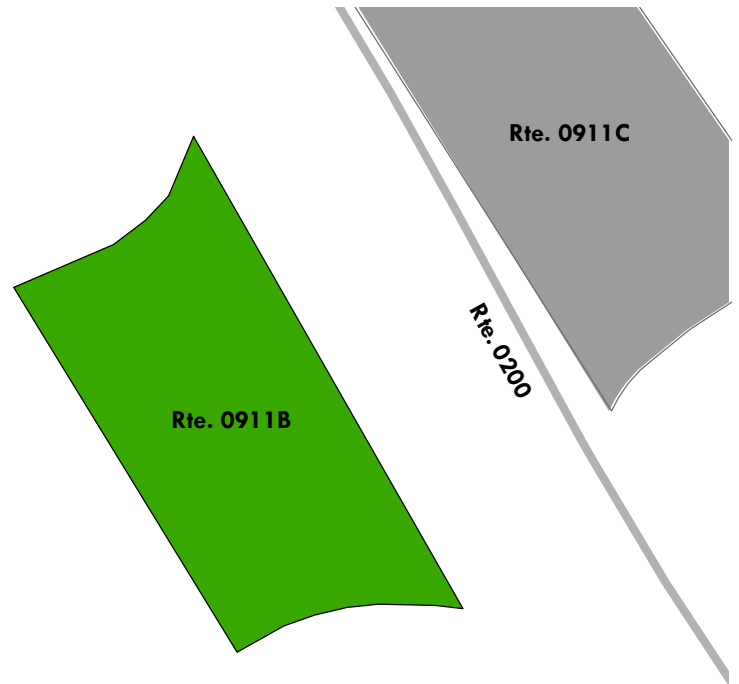
ROUTE 0911B: GULPHA GORGE CAMPGROUND PARKING AREA B

Inspection Date	FMSS Number	User Access	Surface Type
4/7/2018	82259	PUBLIC	ASPHALT
Area (Sq. Ft.)	Lane Miles (11' Widths)	Curb Reveal (Inches)	Curb Recommendation
1,038	0.018	NOT APPLICABLE	NOT APPLICABLE
Curb Type		Curb & Gutter Type	
NO CURB		NO CURB AND GUTTER	
Pavement Recommendation		Condition Rating / PCR	
PREVENTIVE MAINTENANCE		GOOD / 90

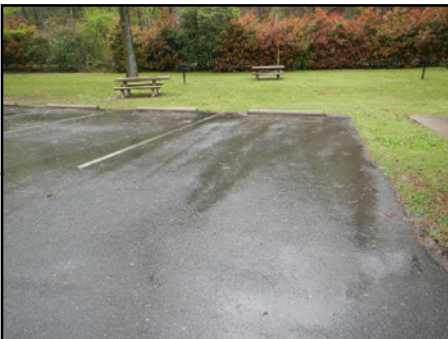
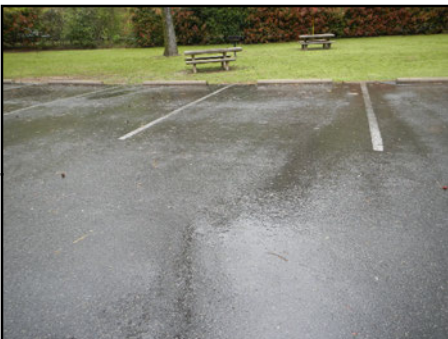
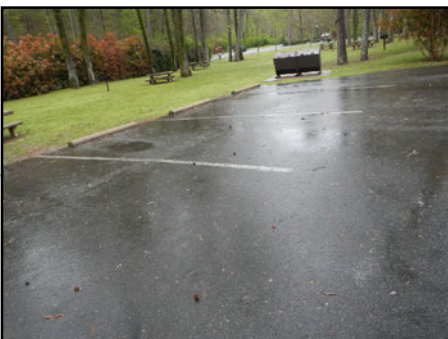
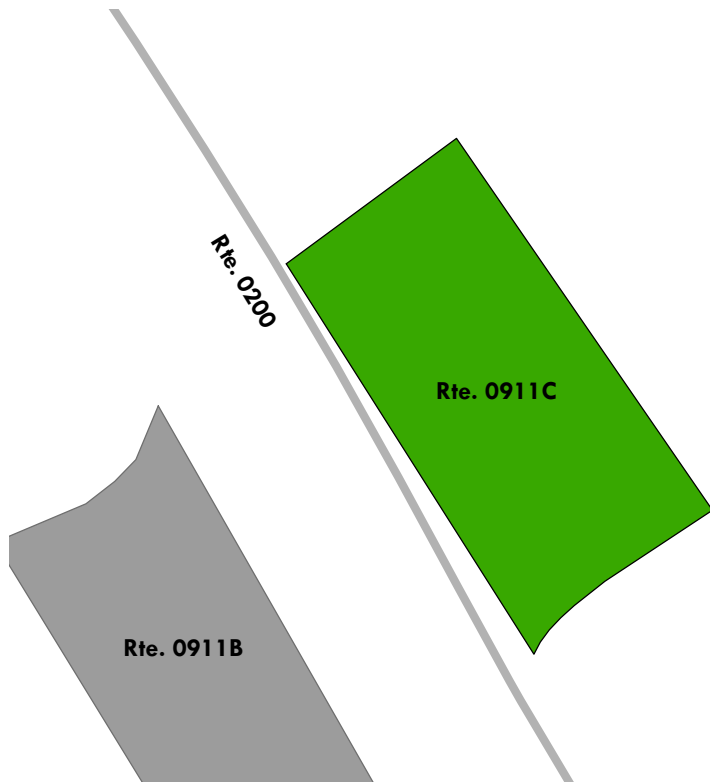
ROUTE 0911C: GULPHA GORGE CAMPGROUND PARKING AREA C

Inspection Date	FMSS Number	User Access	Surface Type
4/7/2018	82239	PUBLIC	ASPHALT
Area (Sq. Ft.)	Lane Miles (11' Widths)	Curb Reveal (Inches)	Curb Recommendation
1,238	0.021	NOT APPLICABLE	NOT APPLICABLE
Curb Type		Curb & Gutter Type	
NO CURB		NO CURB AND GUTTER	
Pavement Recommendation		Condition Rating / PCR	
PREVENTIVE MAINTENANCE		GOOD / 90
