HOSP Cycle 6

Final Report

Road Inventory and Condition Assessment of Paved Routes Hot Springs National Park

**Federal Highway Administration
Eastern Federal Lands Highway Division
Road Inventory Program (RIP)**

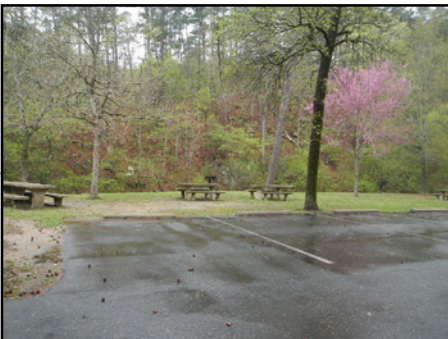
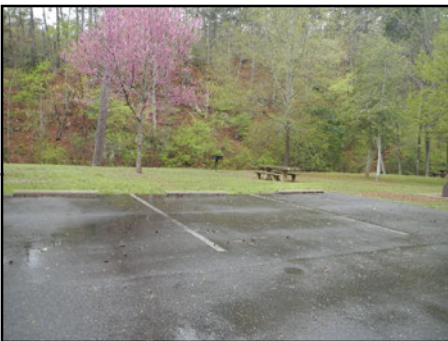
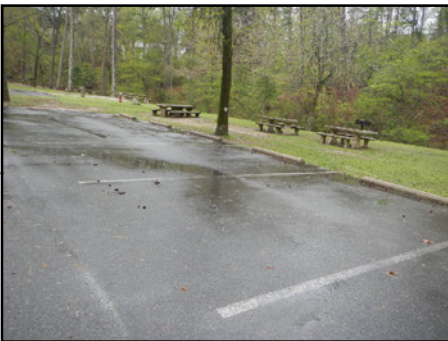
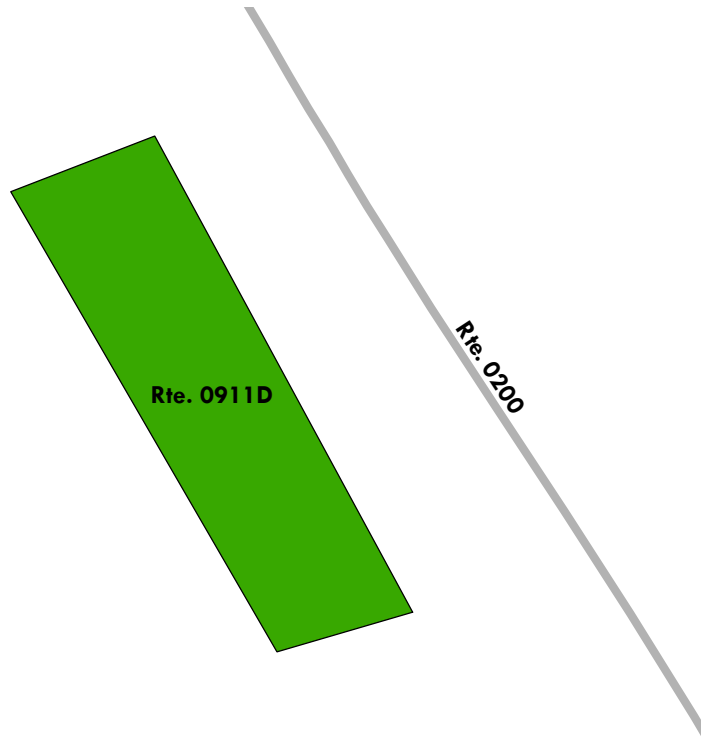
ROUTE 0911D: GULPHA GORGE CAMPGROUND PARKING AREA D

Inspection Date	FMSS Number	User Access	Surface Type
4/7/2018	82240	PUBLIC	ASPHALT
Area (Sq. Ft.)	Lane Miles (11' Widths)	Curb Reveal (Inches)	Curb Recommendation
1,071	0.018	NOT APPLICABLE	NOT APPLICABLE
Curb Type		Curb & Gutter Type	
NO CURB		NO CURB AND GUTTER	
Pavement Recommendation		Condition Rating / PCR	
PREVENTIVE MAINTENANCE		GOOD / 90

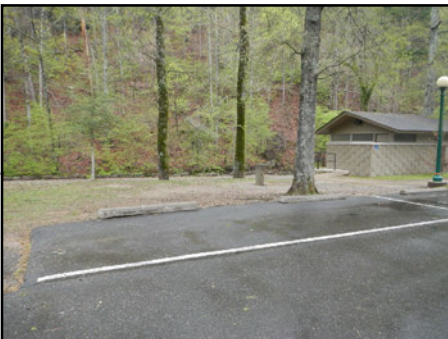
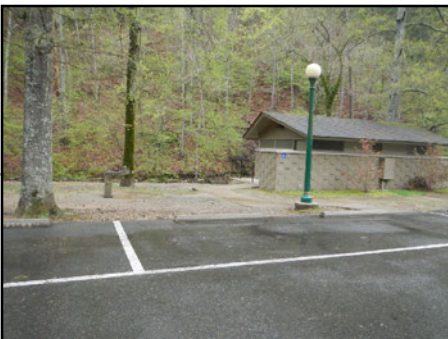
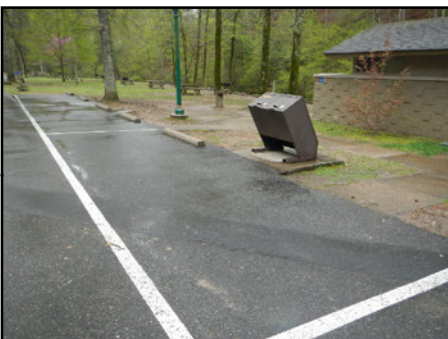
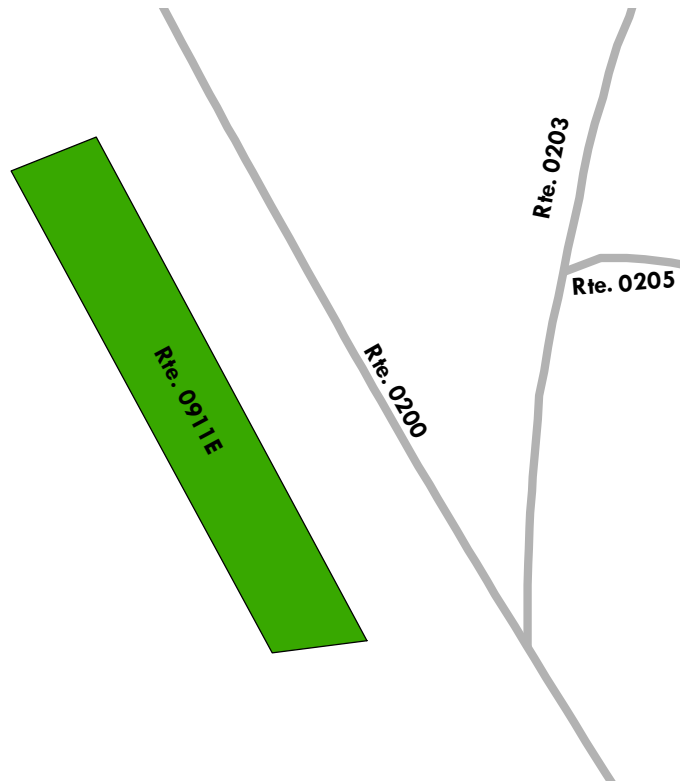
ROUTE 0911E: GULPHA GORGE CAMPGROUND PARKING AREA E

Inspection Date	FMSS Number	User Access	Surface Type
4/7/2018	82241	PUBLIC	ASPHALT
Area (Sq. Ft.)	Lane Miles (11' Widths)	Curb Reveal (Inches)	Curb Recommendation
782	0.013	NOT APPLICABLE	NOT APPLICABLE
Curb Type		Curb & Gutter Type	
NO CURB		NO CURB AND GUTTER	
Pavement Recommendation		Condition Rating / PCR	
PREVENTIVE MAINTENANCE		GOOD / 90

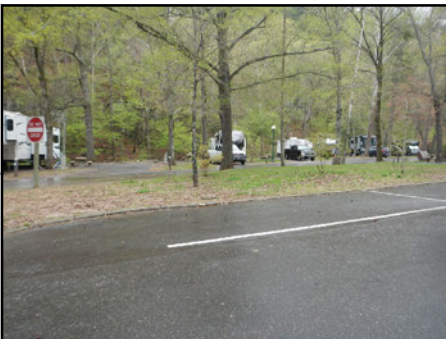
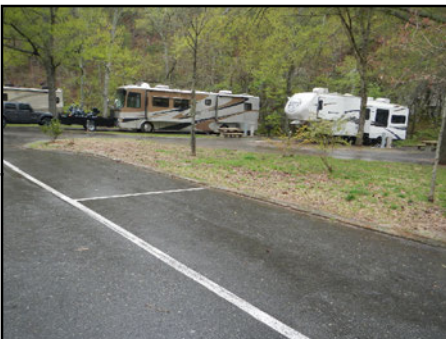
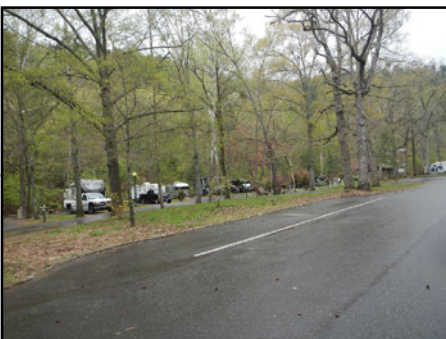
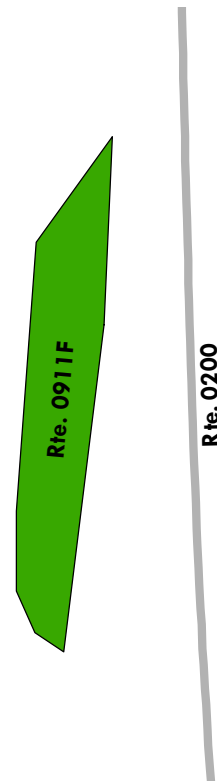
ROUTE 0911F: GULPHA GORGE CAMPGROUND PARKING AREA F

Inspection Date	FMSS Number	User Access	Surface Type
4/7/2018	82243	PUBLIC	ASPHALT
Area (Sq. Ft.)	Lane Miles (11' Widths)	Curb Reveal (Inches)	Curb Recommendation
347	0.006	2	DO NOTHING
Curb Type		Curb & Gutter Type	
STONE		NO CURB AND GUTTER	
Pavement Recommendation		Condition Rating / PCR	
PREVENTIVE MAINTENANCE		GOOD / 90

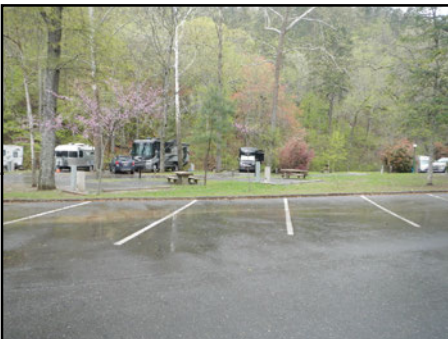
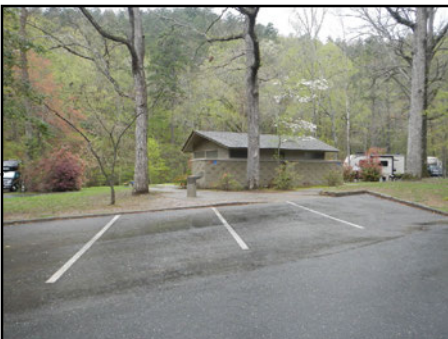
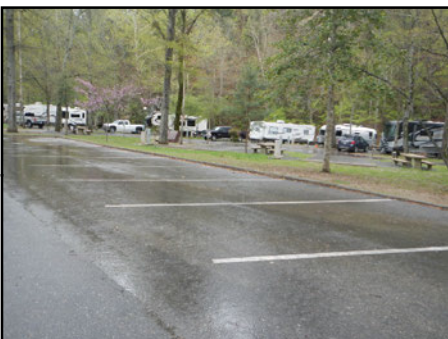
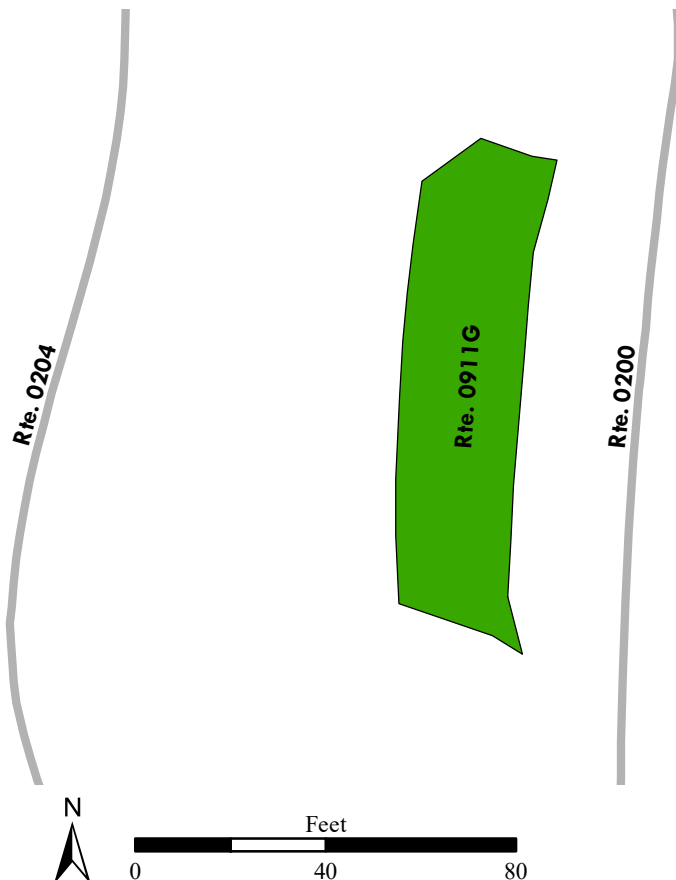
ROUTE 0911G: GULPHA GORGE CAMPGROUND PARKING AREA G

Inspection Date	FMSS Number	User Access	Surface Type
4/7/2018	82244	PUBLIC	ASPHALT
Area (Sq. Ft.)	Lane Miles (11' Widths)	Curb Reveal (Inches)	Curb Recommendation
2,058	0.035	4	DO NOTHING
Curb Type		Curb & Gutter Type	
STONE		NO CURB AND GUTTER	
Pavement Recommendation		Condition Rating / PCR	
PREVENTIVE MAINTENANCE		GOOD / 90

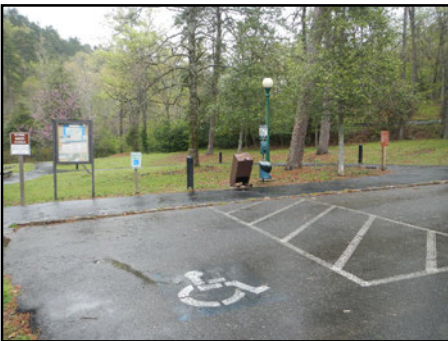
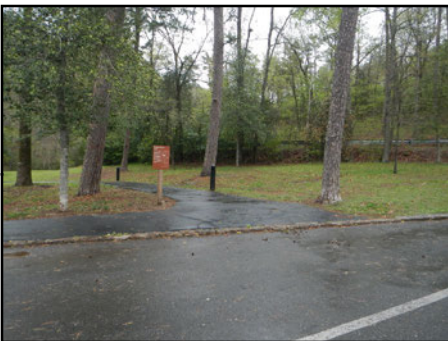
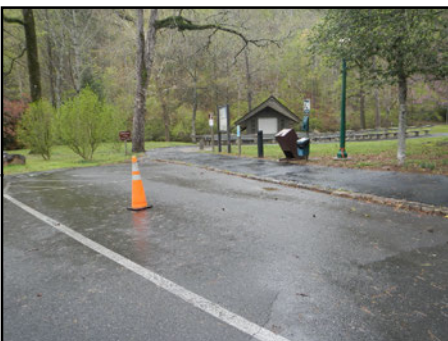
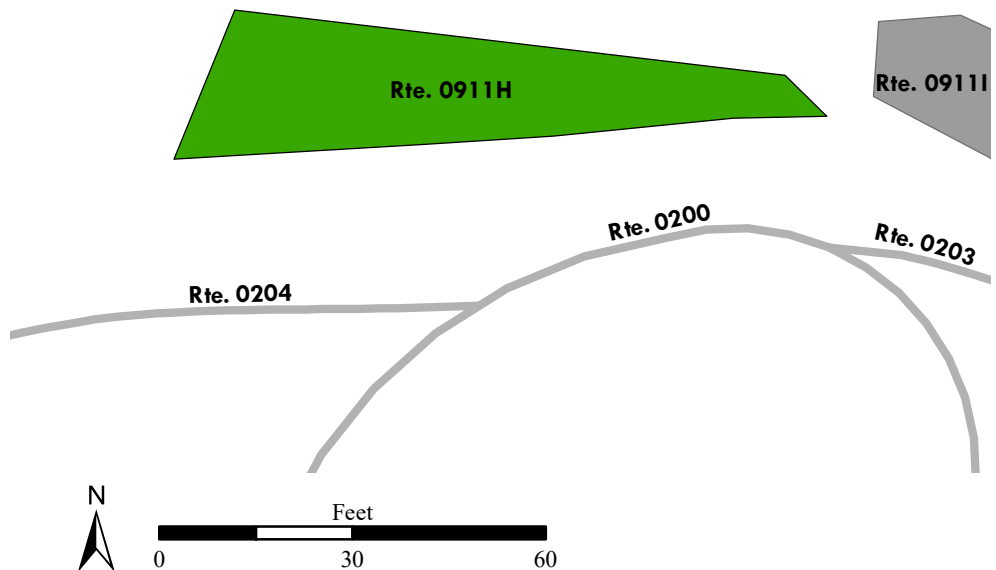
ROUTE 0911H: GULPHA GORGE CAMPGROUND PARKING AREA H

Inspection Date	FMSS Number	User Access	Surface Type
4/7/2018	82234	PUBLIC	ASPHALT
Area (Sq. Ft.)	Lane Miles (11' Widths)	Curb Reveal (Inches)	Curb Recommendation
1,139	0.02	4	DO NOTHING
Curb Type		Curb & Gutter Type	
STONE		NO CURB AND GUTTER	
Pavement Recommendation		Condition Rating / PCR	
PREVENTIVE MAINTENANCE		GOOD / 90

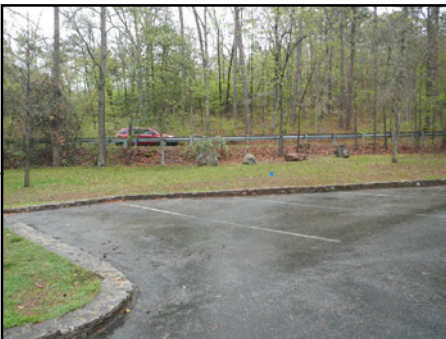
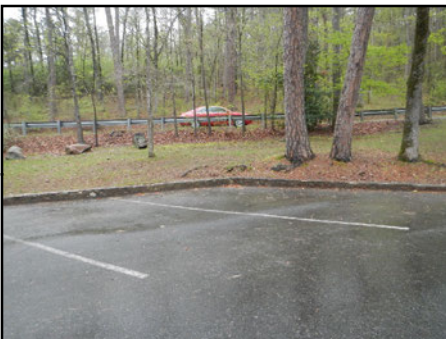
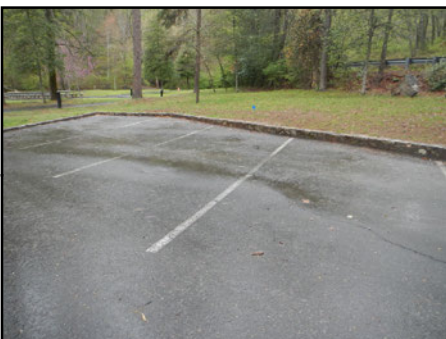
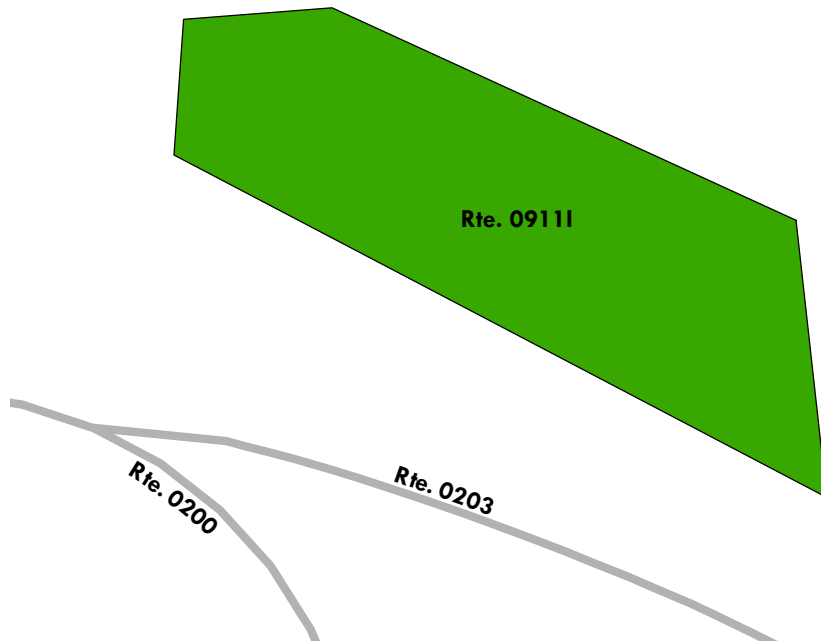
ROUTE 0911I: GULPHA GORGE CAMPGROUND PARKING AREA I

Inspection Date	FMSS Number	User Access	Surface Type
4/7/2018	82235	PUBLIC	ASPHALT
Area (Sq. Ft.)	Lane Miles (11' Widths)	Curb Reveal (Inches)	Curb Recommendation
887	0.015	6	DO NOTHING
Curb Type		Curb & Gutter Type	
STONE		NO CURB AND GUTTER	
Pavement Recommendation		Condition Rating / PCR	
PREVENTIVE MAINTENANCE		GOOD / 90

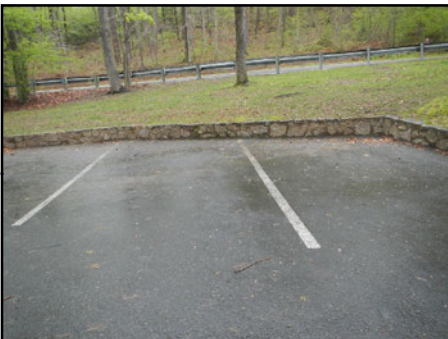
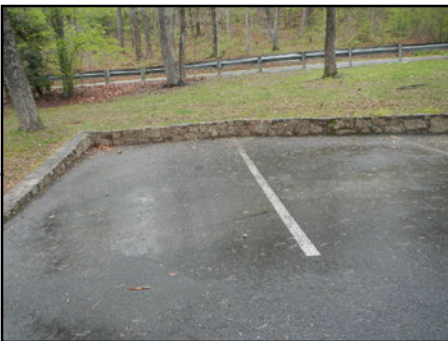
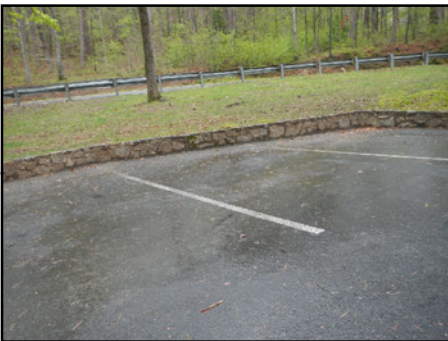
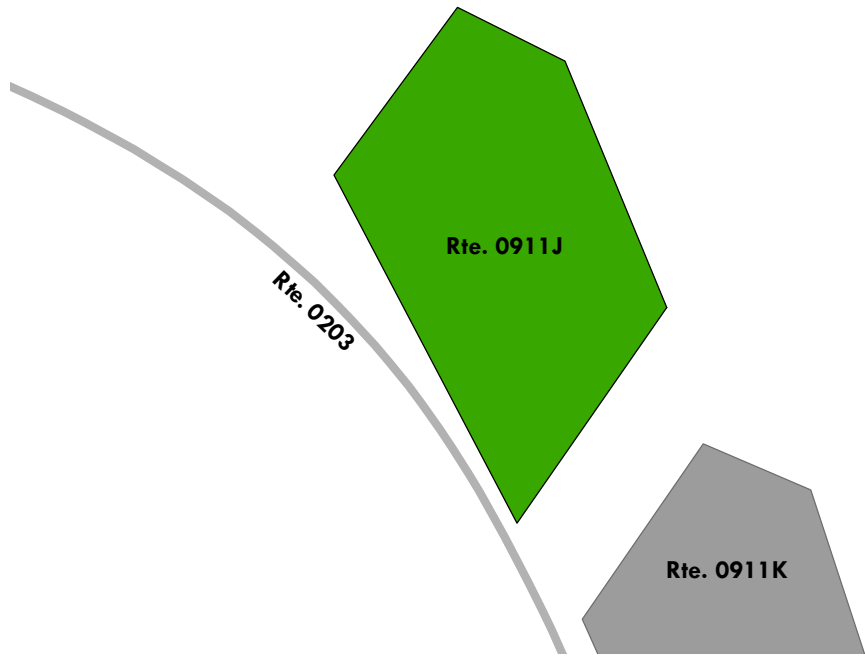
ROUTE 0911J: GULPHA GORGE CAMPGROUND PARKING AREA J

Inspection Date	FMSS Number	User Access	Surface Type
4/7/2018	82237	PUBLIC	ASPHALT
Area (Sq. Ft.)	Lane Miles (11' Widths)	Curb Reveal (Inches)	Curb Recommendation
747	0.013	10	DO NOTHING
Curb Type		Curb & Gutter Type	
STONE		NO CURB AND GUTTER	
Pavement Recommendation		Condition Rating / PCR	
PREVENTIVE MAINTENANCE		GOOD / 90

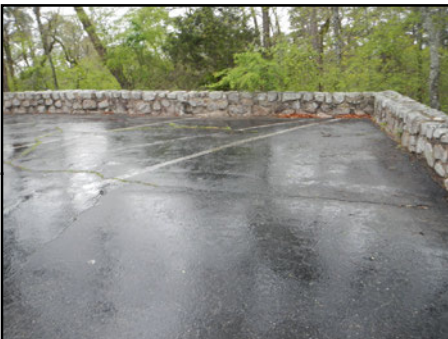
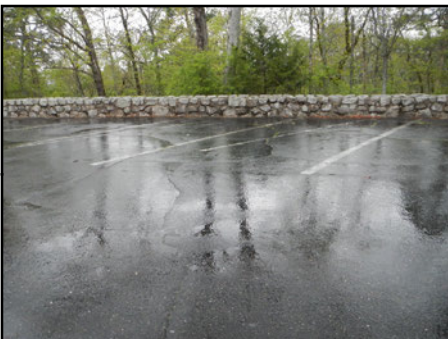
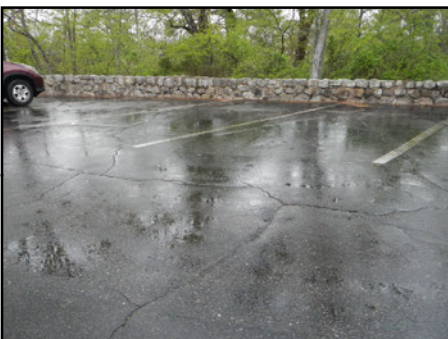
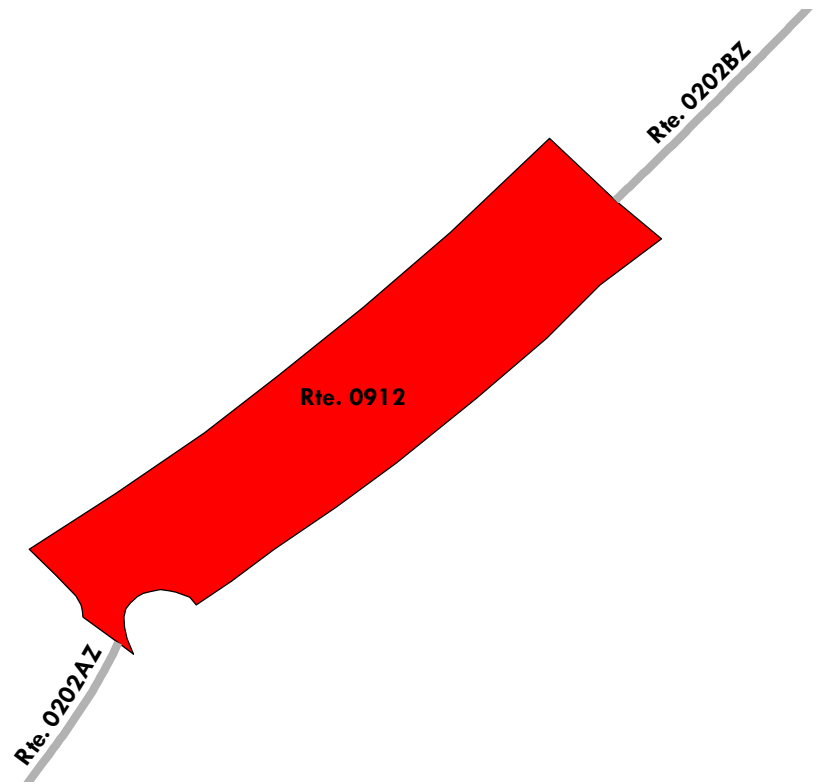
ROUTE 0912: TOWER PARKING

Inspection Date	FMSS Number	User Access	Surface Type
4/7/2018	236379	PUBLIC	ASPHALT
Area (Sq. Ft.)	Lane Miles (11' Widths)	Curb Reveal (Inches)	Curb Recommendation
15,330	0.264	NOT APPLICABLE	NOT APPLICABLE
Curb Type		Curb & Gutter Type	
NO CURB		NO CURB AND GUTTER	
Pavement Recommendation		Condition Rating / PCR	
HEAVY 3R TREATMENTS		POOR / 53
