Final Report

Road Inventory and Condition Assessment of Paved Routes Indiana Dunes National Park

Prepared By: Federal Highway Administration Eastern Federal Lands Highway Division Road Inventory Program (RIP)

Report Date: January 2021

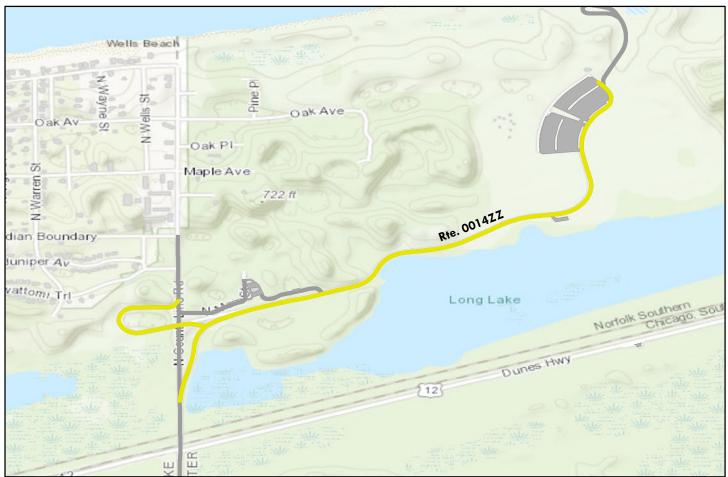
Indiana Dunes National Park ROUTE 0014ZZ: WEST BEACH ACCESS ROADS

Route Condition Legend – Pavement Condition Rating (PCR)							
Poor (0 - 60) Fair (6	1- 84) Good (85 - 94)		Excellent (95 - 100)		Not Rated		
	See Appendix for definitions and formulas						
Inspection Date: 6/21/2019							
Paved Length (Miles): 1.55							
Surface Type: ASPHALT	Route Summary		• • •				
Roadway Condition Information							
Pavement Condition Rating (PCR)	77						
Lane & Width Information							
Number of Lanes	2						
Paved Width (ft)	24.2						
Lane Width (ft)	10.7

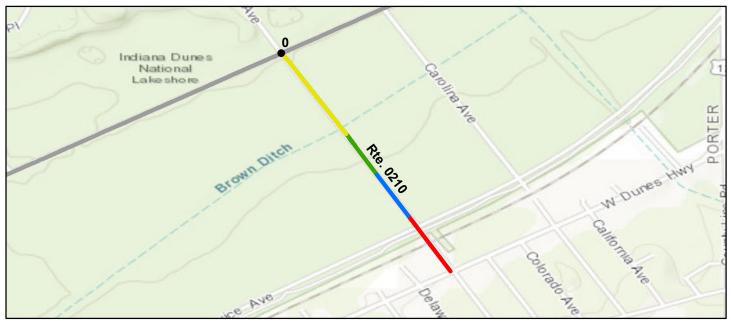
ROUTE 0210: CENTRAL AVENUE

Route Condition Legend – Pavement Condition Rating (PCR)						
Poor (0 - 60) Fai	r (61- 84) Good	(85 - 94)	Excellent (95 - 100)	Not Rated		
Colors on map represent	condition scores at 0.10-mile	e intervals. Se	e Appendix for definition	ns and formulas.		
Inspection Date: 6/21/2019	Beginning Section MP	0				
Paved Length (Miles): 0.54	Section Length (MI)	0.54				
Surface Type: ASPHALT	Route Summary			• • •		
Roadway Condition Information						
Pavement Condition Rating (PCR)	73	73				
Surface Condition Rating (SCR)	82	82				
Roughness Condition Index (RCI)	59	59				
Distress Index Values						
Structural Crack Index	93	93				
Alligator Crack Index	100	100				
Longitudinal Crack Index	93	93				
Transverse Cracking Index	82	82				
Patching Index	100	100				
Rutting Index	98	98				
International Roughness Index (IRI)	244	244				
Lane & Width Information						
Number of Lanes	2	2				
Paved Width (ft)	17.3	17.3

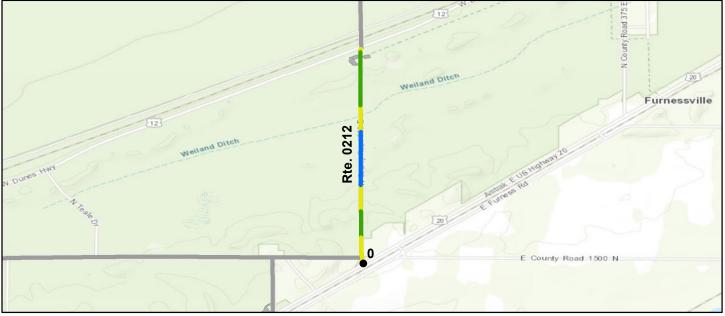
Indiana Dunes National Park ROUTE 0212: KEMIL ROAD (300 EAST ROAD)

Route C	Condition Legend – Pav	ement Condi	tion Rating (PCR)	
Poor (0 - 60) Fair (6	1- 84) Good ((85 - 94)	Excellent (95 - 100) Not Rated
Colors on map represent con	dition scores at 0.10-mile	e intervals. Se	e Appendix for defini	tions and formulas.
Inspection Date: 6/21/2019	Beginning Section MP	0		
Paved Length (Miles): 0.81	Section Length (MI)	0.81		
Surface Type: ASPHALT	Route Summary			
Roadway Condition Information				
Pavement Condition Rating (PCR)	87	87		
Surface Condition Rating (SCR)	82	82		
Roughness Condition Index (RCI)	95	95		
Distress Index Values				
Structural Crack Index	93	93		
Alligator Crack Index	100	100		
Longitudinal Crack Index	93	93		
Transverse Cracking Index	82	82		
Patching Index	100	100		
Rutting Index	99	99		
International Roughness Index (IRI)	127	127		
Lane & Width Information				
Number of Lanes	2	2		
Paved Width (ft)	18.3	18.3		
Lane Width (ft)	9.1	9.1

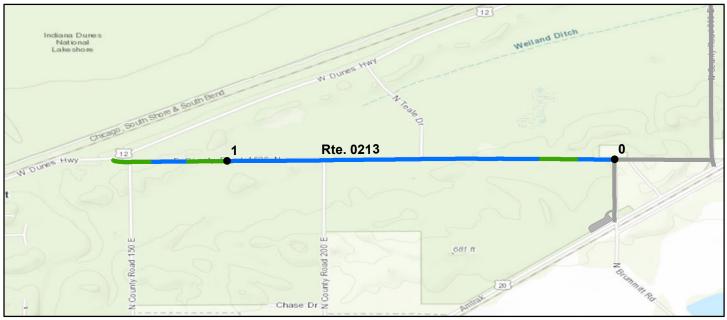
Indiana Dunes National Park ROUTE 0213: FURNESSVILLE ROAD (1500 NORTH ROAD)

Route	Condition Legend – Pav	ement Condi	tion Rating (P	PCR)	
Poor (0 - 60) Fair (61- 84) Good	(85 - 94)	Excellent (9	5 - 100)	Not Rated
Colors on map represent con	ndition scores at 0.10-mile	e intervals. Se	e Appendix for	definitions	and formulas.
Inspection Date: 6/21/2019	Beginning Section MP	0	1		
Paved Length (Miles): 1.3	Section Length (MI)	1	0.29		
Surface Type: ASPHALT	Route Summary				
Roadway Condition Information					
Pavement Condition Rating (PCR)	96	97	94		
Surface Condition Rating (SCR)	99	100	98		
Roughness Condition Index (RCI)	92	93	88		
Distress Index Values					
Structural Crack Index	99	100	98		
Alligator Crack Index	100	100	100		
Longitudinal Crack Index	99	100	98		
Transverse Cracking Index	100	100	100		
Patching Index	100	100	100		
Rutting Index	100	100	100		
International Roughness Index (IRI)	135	132	145		
Lane & Width Information					
Number of Lanes	2	2	2		
Paved Width (ft)	17.2	17.3	17

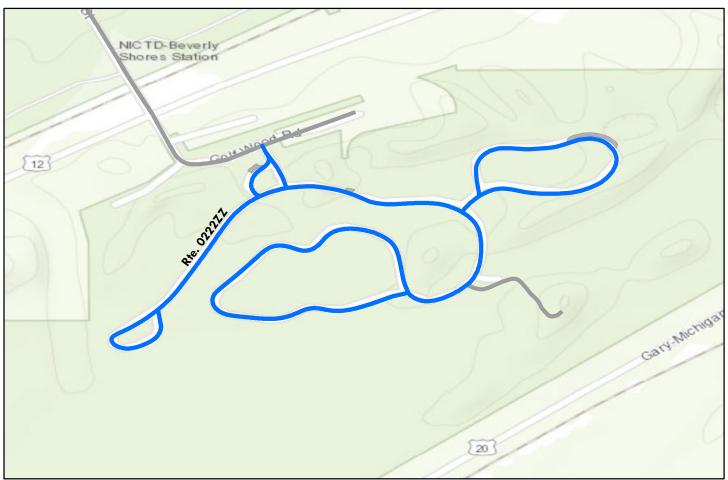
Indiana Dunes National Park ROUTE 0222ZZ: DUNEWOOD CAMPGROUND ACCESS ROADS

Route Condition Legend – Pavement Condition Rating (PCR)							
Poor (0 - 60) Fa	nir (61- 84)	Good (85 - 94)	Excellent (9	5 - 100)	Not Ra	ted	
	See Apper	ndix for definitions and	d formulas				
Inspection Date: 6/21/2019							
Paved Length (Miles): 1.4							
Surface Type: ASPHALT	Route Sum	nary	•				
Roadway Condition Information							
Pavement Condition Rating (PCR)	97	7					
Lane & Width Information							
Number of Lanes	2						
Paved Width (ft)	18.	9					
Lane Width (ft)	13.	3

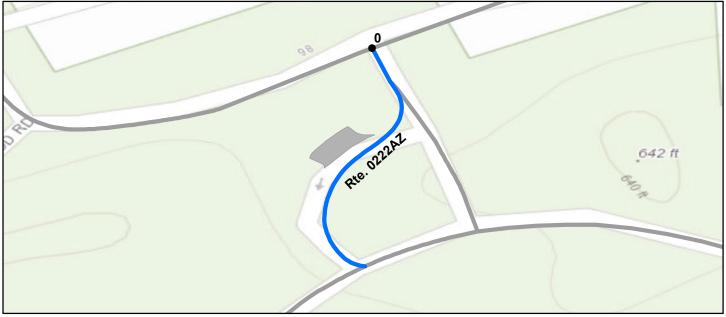
Indiana Dunes National Park ROUTE 0222AZ: DUNEWOOD CAMPGROUND ACCESS ROAD LOOP AZ

Rout	e Condition Legend – Pav	ement Cond	ition Rating (PCR)	
Poor (0 - 60) Fair	(61- 84) Good	(85 - 94)	Excellent (95 - 100)	Not Rated
Colors on map represent c	ondition scores at 0.10-mile	e intervals. Se	e Appendix for definition	ns and formulas.
Inspection Date: 6/21/2019	Beginning Section MP	0		
Paved Length (Miles): 0.06	Section Length (MI)	0.06		
Surface Type: ASPHALT	Route Summary			• •
Roadway Condition Information				
Pavement Condition Rating (PCR)	95	95		
Surface Condition Rating (SCR)	95	95		
Roughness Condition Index (RCI)	N/A	N/A		
Distress Index Values				
Structural Crack Index	98	98		
Alligator Crack Index	100	100		
Longitudinal Crack Index	98	98		
Transverse Cracking Index	95	95		
Patching Index	100	100		
Rutting Index	98	98		
International Roughness Index (IRI)	N/A	N/A		
Lane & Width Information				
Number of Lanes	1	1		
Paved Width (ft)	14.8	14.8		
Lane Width (ft)	13.8	13.8

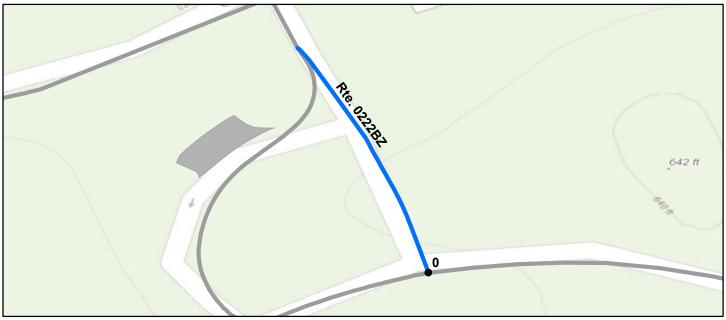
Indiana Dunes National Park ROUTE 0222BZ: DUNEWOOD CAMPGROUND ACCESS ROAD LOOP BZ

Route	Condition Legend – Pav	ement Condi	ition Rating (PCR)	
Poor (0 - 60) Fair (61- 84) Good	(85 - 94)	Excellent (95 - 100)	Not Rated
Colors on map represent co	ndition scores at 0.10-mile	e intervals. Se	e Appendix for definition	ns and formulas.
Inspection Date: 6/21/2019	Beginning Section MP	0		
Paved Length (Miles): 0.04	Section Length (MI)	0.04		
Surface Type: ASPHALT	Route Summary		• •	
Roadway Condition Information				
Pavement Condition Rating (PCR)	98	98		
Surface Condition Rating (SCR)	98	98		
Roughness Condition Index (RCI)	N/A	N/A		
Distress Index Values				
Structural Crack Index	100	100		
Alligator Crack Index	100	100		
Longitudinal Crack Index	100	100		
Transverse Cracking Index	99	99		
Patching Index	100	100		
Rutting Index	98	98		
International Roughness Index (IRI)	N/A	N/A		
Lane & Width Information				
Number of Lanes	1	1		
Paved Width (ft)	11.6	11.6		
Lane Width (ft)	11.6	11.6

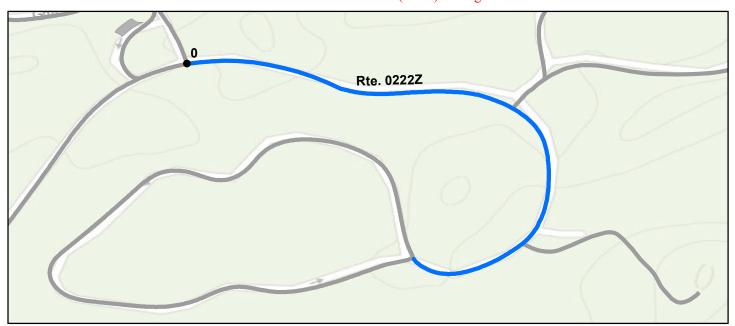
Indiana Dunes National Park ROUTE 0222Z: DUNEWOOD CAMPGROUND ACCESS ROAD LOOPA

Ro	ite Condition Legend – Pav	ement Cond	ition Rating (PCR)	
Poor (0 - 60) Fa	ir (61- 84) Good	(85 - 94)	Excellent (95 - 100)	Not Rated
Colors on map represent	condition scores at 0.10-mile	e intervals. Se	e Appendix for definition	ns and formulas.
Inspection Date: 6/21/2019	Beginning Section MP	0		
Paved Length (Miles): 0.29	Section Length (MI)	0.29		
Surface Type: ASPHALT	Route Summary		•	•
Roadway Condition Information				
Pavement Condition Rating (PCR)	98	98		
Surface Condition Rating (SCR)	98	98		
Roughness Condition Index (RCI)	N/A	N/A		
Distress Index Values				
Structural Crack Index	100	100		
Alligator Crack Index	100	100		
Longitudinal Crack Index	100	100		
Transverse Cracking Index	98	98		
Patching Index	100	100		
Rutting Index	100	100		
International Roughness Index (IRI)	N/A	N/A		
Lane & Width Information				
Number of Lanes	2	2		
Paved Width (ft)	25	25		
Lane Width (ft)	12.1	12.1

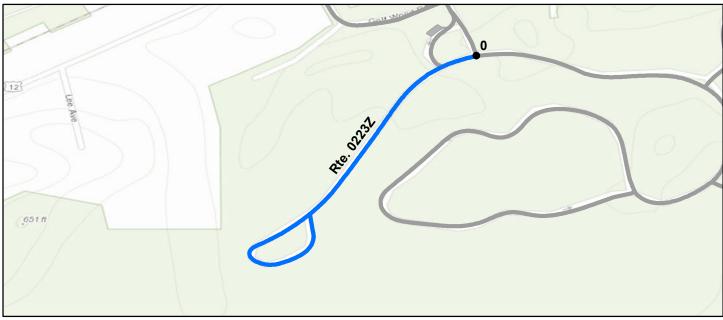
Indiana Dunes National Park ROUTE 0223Z: DUNEWOOD CAMPGROUND ACCESS ROAD LOOP C

Route Condition Legend – Pavement Condition Rating (PCR)					
Poor (0 - 60) Fair (6	61-84) Good	(85 - 94)	Excellent (95 - 100)	Not Rated	
Colors on map represent con	dition scores at 0.10-mile	e intervals. Se	e Appendix for definition	s and formulas.	
Inspection Date: 6/21/2019	Beginning Section MP	0			
Paved Length (Miles): 0.29	Section Length (MI)	0.29			
Surface Type: ASPHALT	Route Summary		•		
Roadway Condition Information					
Pavement Condition Rating (PCR)	97	97			
Surface Condition Rating (SCR)	97	97			
Roughness Condition Index (RCI)	N/A	N/A			
Distress Index Values					
Structural Crack Index	100	100			
Alligator Crack Index	100	100			
Longitudinal Crack Index	100	100			
Transverse Cracking Index	97	97			
Patching Index	100	100			
Rutting Index	100	100			
International Roughness Index (IRI)	N/A	N/A			
Lane & Width Information					
Number of Lanes	2	2			
Paved Width (ft)	23.1	23.1			
Lane Width (ft)	12	12

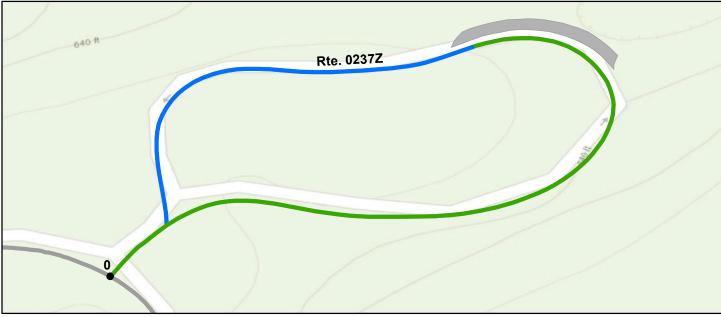
Indiana Dunes National Park ROUTE 0237Z: DUNEWOOD CAMPGROUND ACCESS ROAD LOOP D (DOUGLAS LOOP)

Rout	e Condition Legend – Pav	ement Cond	ition Rating (PCR)	
Poor (0 - 60) Fair	(61- 84) Good	(85 - 94)	Excellent (95 - 100)	Not Rated
Colors on map represent c	ondition scores at 0.10-mile	e intervals. Se	e Appendix for definition	ns and formulas.
Inspection Date: 6/21/2019	Beginning Section MP	0		
Paved Length (Miles): 0.32	Section Length (MI)	0.32		
Surface Type: ASPHALT	Route Summary			- · · ·
Roadway Condition Information				
Pavement Condition Rating (PCR)	93	93		
Surface Condition Rating (SCR)	93	93		
Roughness Condition Index (RCI)	N/A	N/A		
Distress Index Values				
Structural Crack Index	99	99		
Alligator Crack Index	100	100		
Longitudinal Crack Index	99	99		
Transverse Cracking Index	93	93		
Patching Index	100	100		
Rutting Index	100	100		
International Roughness Index (IRI)	N/A	N/A		
Lane & Width Information				
Number of Lanes	1	1		
Paved Width (ft)	17.2	17.2		
Lane Width (ft)	14.7	14.7

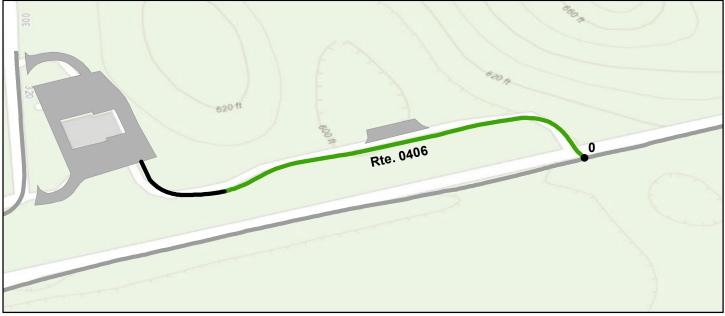
Indiana Dunes National Park ROUTE 0406: WEST BEACH SERVICE ROAD

Debris on the route; not rated at very end.
