LABE Cycle 6

Final Report

Road Inventory and Condition Assessment of Paved Routes Lava Beds National Monument

Report Date: November 2015

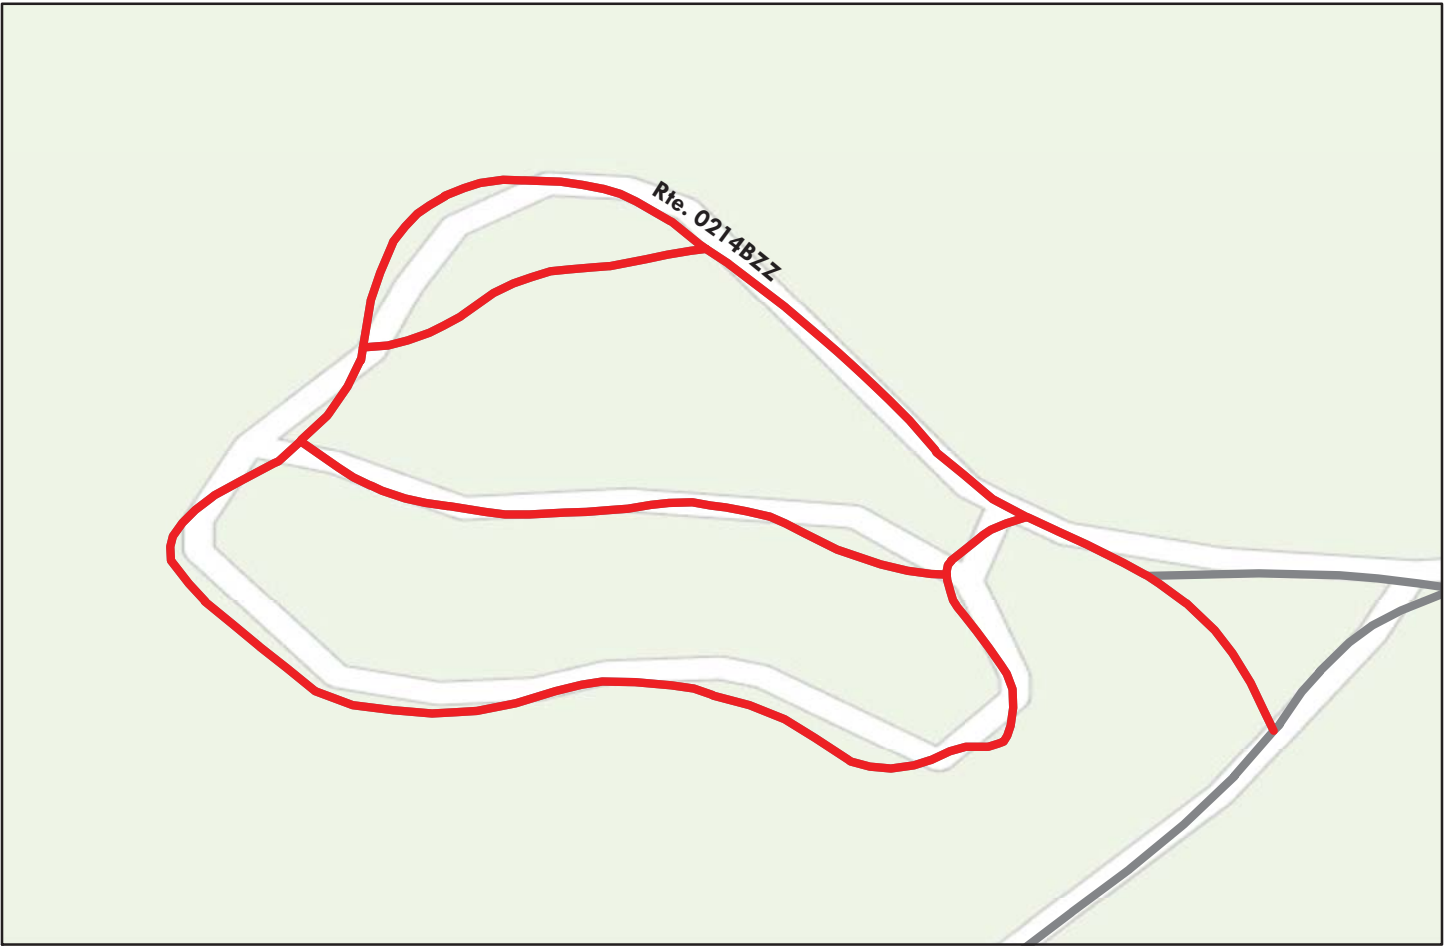
ROUTE 0214BZZ: CAMPGROUND LOOPS

Route Condition Legend – Pavement Condition Rating (PCR)						
Poor (0 - 60)	Fair (61- 84)	Good (85 - 94)	Excellent (95 - 100)	Not Rated		
See Appendix for definitions and formulas						
Inspection Date: 5/24/2015						
Paved Length (Miles): 0.49						
Surface Type: ASPHALT	Route Summary					
Roadway Condition Information						
Pavement Condition Rating (PCR)	51					
Lane & Width Information						
Number of Lanes	0					
Paved Width (ft)	17.9					
Lane Width (ft)	15.2

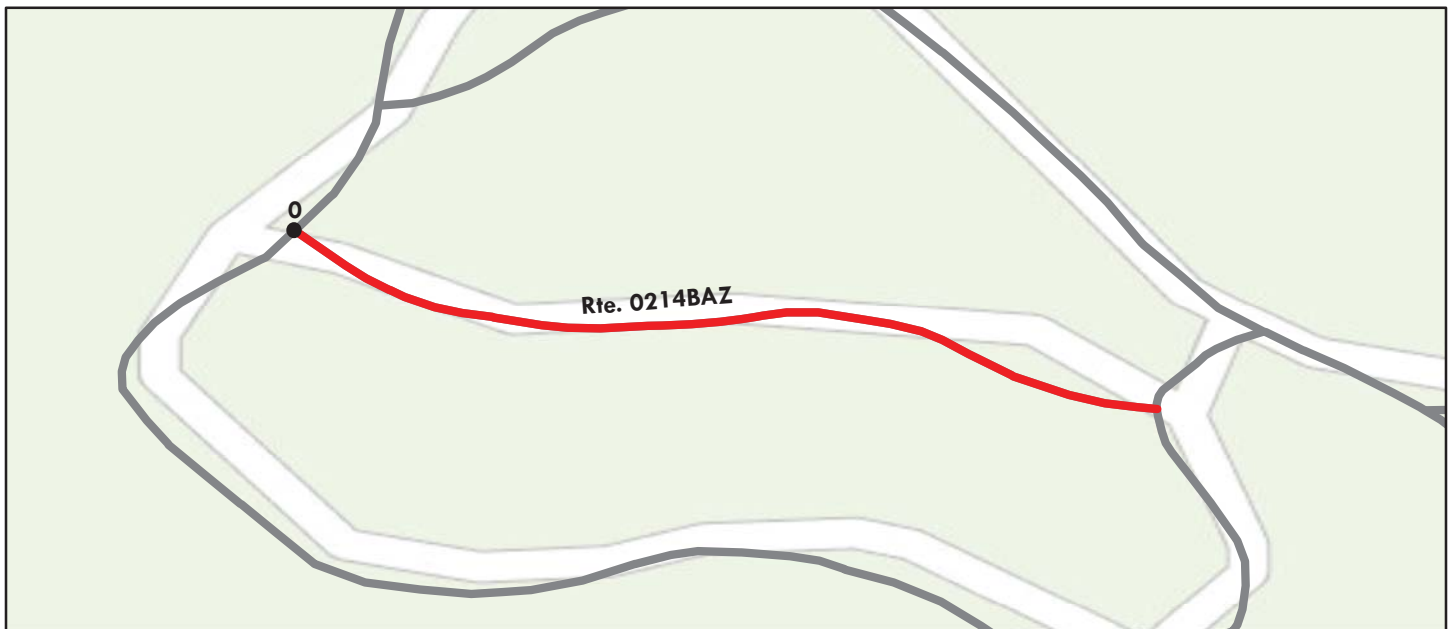
ROUTE 0214BAZ: CAMPGROUND LOOP B ROAD A

Route Condition Legend – Pavement Condition Rating (PCR)						
Poor (0 - 60)	Fair (61- 84)	Good (85 - 94)	Excellent (95 - 100)	Not Rated		
See Appendix for definitions and formulas						
Inspection Date: 5/24/2015	Beginning Section MP	0				
Paved Length (Miles): 0.08	Section Length (MI)	0.08				
Surface Type: ASPHALT	Route Summary					
Roadway Condition Information						
Pavement Condition Rating (PCR)	56	56				
Surface Condition Rating (SCR)	56	56				
Roughness Condition Index (RCI)	N/A	N/A				
Distress Index Values						
Structural Crack Index	89	89				
Alligator Crack Index	100	100				
Longitudinal Crack Index	89	89				
Transverse Cracking Index	56	56				
Patching Index	100	100				
Rutting Index	92	92				
International Roughness Index (IRI)	N/A	N/A				
Lane & Width Information						
Number of Lanes	2	2				
Paved Width (ft)	18.8	18.8				
Lane Width (ft)	11.3	11.3

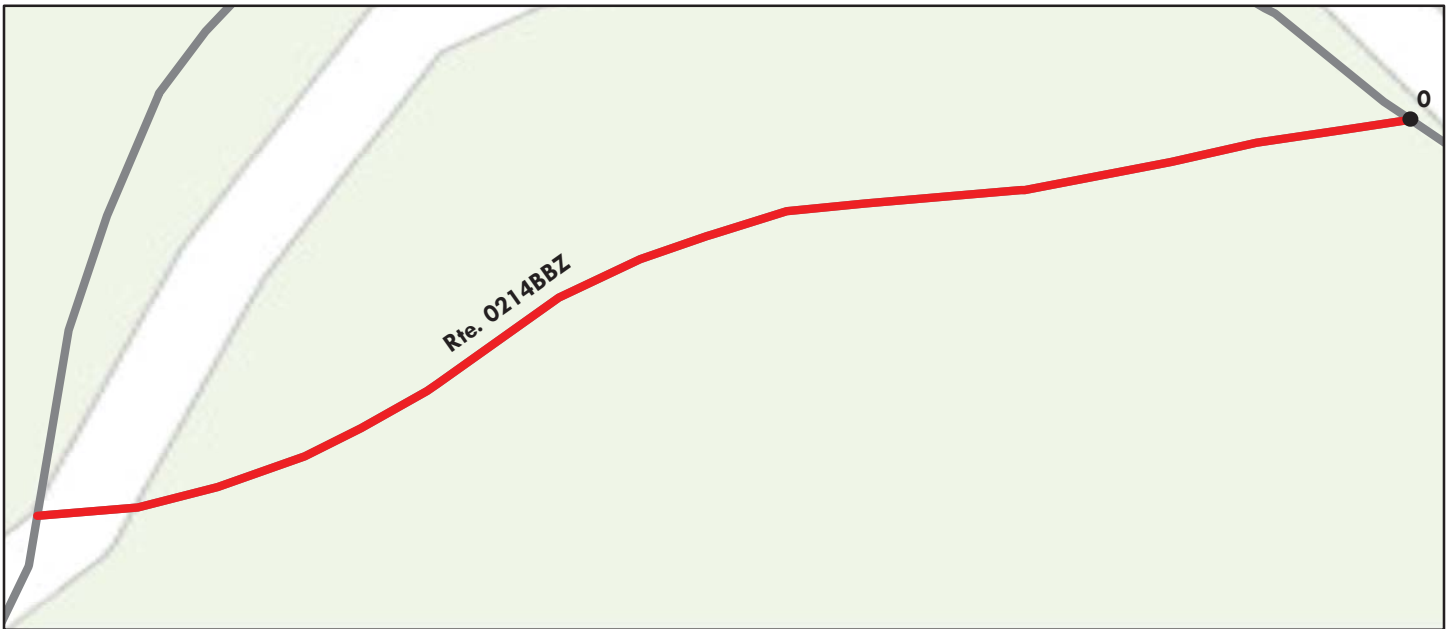
ROUTE 0214BBZ: CAMPGROUND LOOP B ROAD B

Route Condition Legend – Pavement Condition Rating (PCR)						
Poor (0 - 60)	Fair (61- 84)	Good (85 - 94)	Excellent (95 - 100)	Not Rated		
See Appendix for definitions and formulas						
Inspection Date: 5/24/2015	Beginning Section MP	0				
Paved Length (Miles): 0.04	Section Length (MI)	0.04				
Surface Type: ASPHALT	Route Summary					
Roadway Condition Information						
Pavement Condition Rating (PCR)	45	45				
Surface Condition Rating (SCR)	45	45				
Roughness Condition Index (RCI)	N/A	N/A				
Distress Index Values						
Structural Crack Index	69	69				
Alligator Crack Index	100	100				
Longitudinal Crack Index	69	69				
Transverse Cracking Index	45	45				
Patching Index	100	100				
Rutting Index	87	87				
International Roughness Index (IRI)	N/A	N/A				
Lane & Width Information						
Number of Lanes	1	1				
Paved Width (ft)	12.3	12.3				
Lane Width (ft)	12.3	12.3

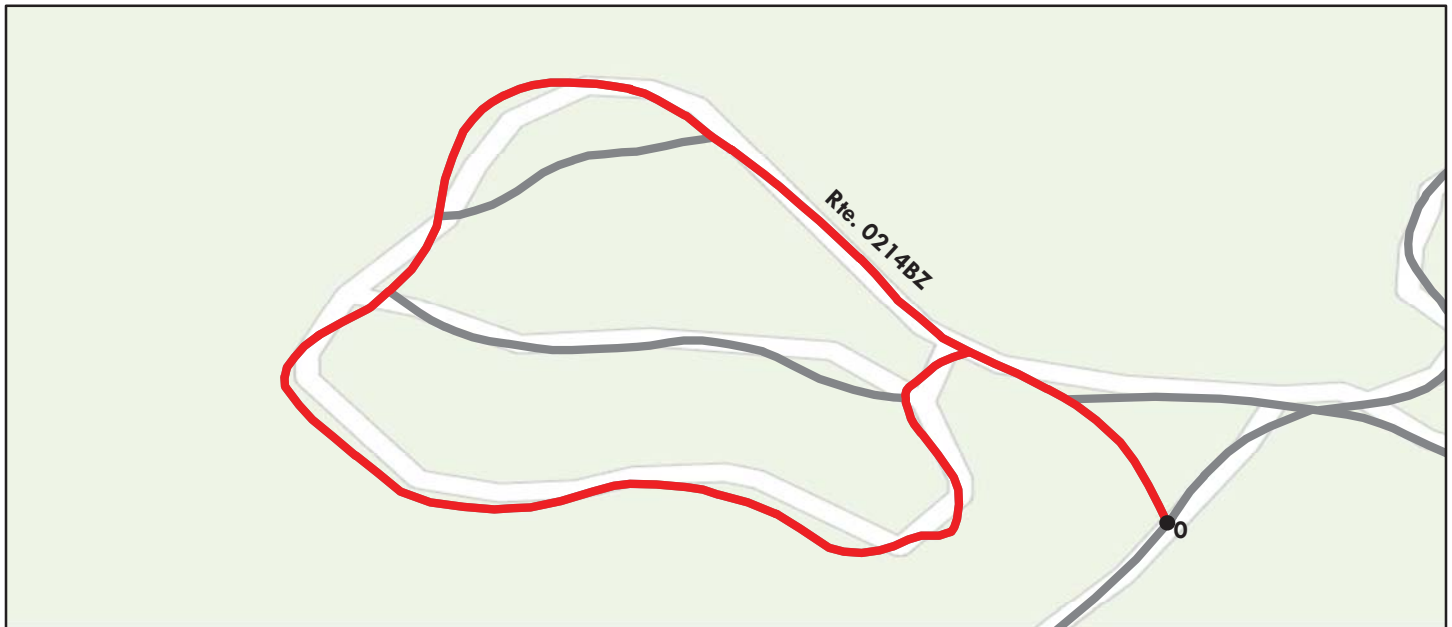
Subcomponent of Route LABE-0214BZZ

Route Condition Legend – Pavement Condition Rating (PCR)						
Poor (0 - 60)	Fair (61- 84)	Good (85 - 94)	Excellent (95 - 100)	Not Rated		
See Appendix for definitions and formulas						
Inspection Date: 5/24/2015	Beginning Section MP	0				
Paved Length (Miles): 0.37	Section Length (MI)	0.37				
Surface Type: ASPHALT	Route Summary					
Roadway Condition Information						
Pavement Condition Rating (PCR)	50	50				
Surface Condition Rating (SCR)	50	50				
Roughness Condition Index (RCI)	N/A	N/A				
Distress Index Values						
Structural Crack Index	83	83				
Alligator Crack Index	100	100				
Longitudinal Crack Index	83	83				
Transverse Cracking Index	50	50				
Patching Index	100	100				
Rutting Index	93	93				
International Roughness Index (IRI)	N/A	N/A				
Lane & Width Information						
Number of Lanes	1	1				
Paved Width (ft)	18.3	18.3				
Lane Width (ft)	16.3	16.3

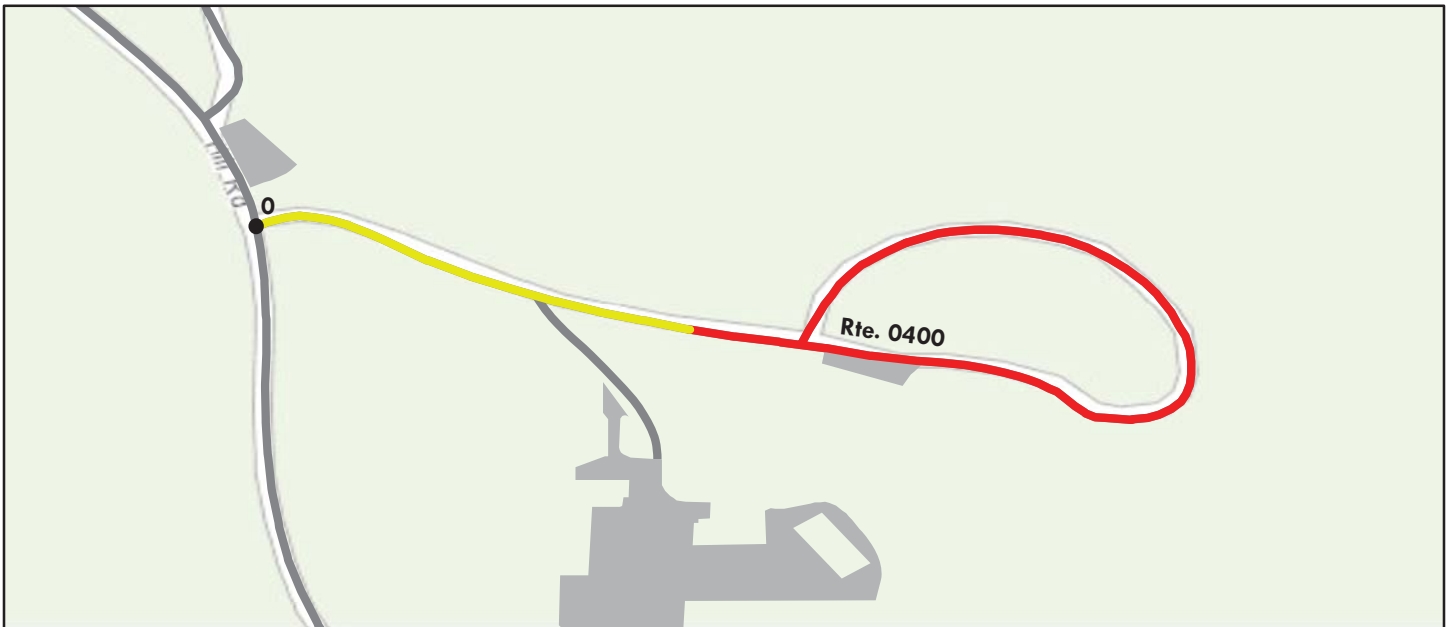
ROUTE 0400: RESIDENCE SPUR

Route Condition Legend – Pavement Condition Rating (PCR)						
Poor (0 - 60)	Fair (61- 84)	Good (85 - 94)	Excellent (95 - 100)	Not Rated		
See Appendix for definitions and formulas						
Inspection Date: 5/24/2015	Beginning Section MP	0				
Paved Length (Miles): 0.34	Section Length (MI)	0.34				
Surface Type: ASPHALT	Route Summary					
Roadway Condition Information						
Pavement Condition Rating (PCR)	57	57				
Surface Condition Rating (SCR)	57	57				
Roughness Condition Index (RCI)	N/A	N/A				
Distress Index Values						
Structural Crack Index	94	94				
Alligator Crack Index	100	100				
Longitudinal Crack Index	94	94				
Transverse Cracking Index	57	57				
Patching Index	100	100				
Rutting Index	96	96				
International Roughness Index (IRI)	N/A	N/A				
Lane & Width Information						
Number of Lanes	2	2				
Paved Width (ft)	18	18				
Lane Width (ft)	9	9

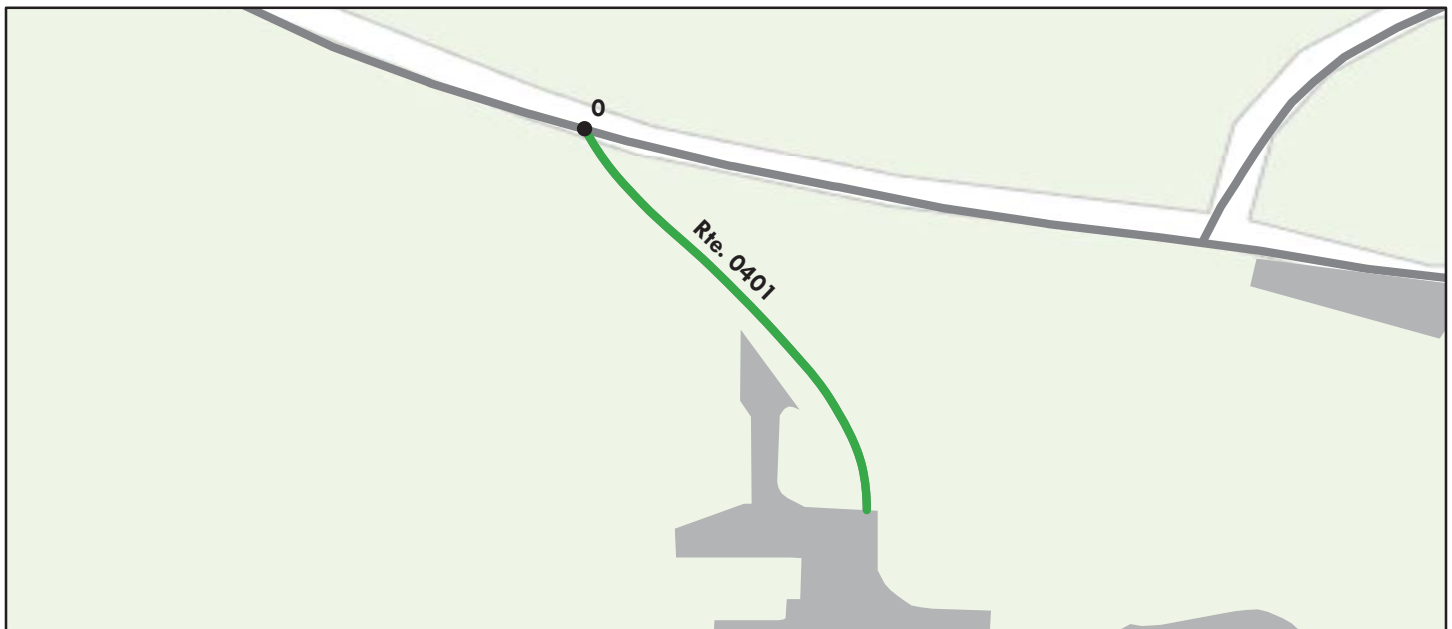
ROUTE 0401: MAINTENANCE SPUR

Route Condition Legend – Pavement Condition Rating (PCR)						
Poor (0 - 60)	Fair (61- 84)	Good (85 - 94)	Excellent (95 - 100)	Not Rated		
See Appendix for definitions and formulas						
Inspection Date: 5/24/2015	Beginning Section MP	0				
Paved Length (Miles): 0.06	Section Length (MI)	0.06				
Surface Type: ASPHALT	Route Summary					
Roadway Condition Information						
Pavement Condition Rating (PCR)	85	85				
Surface Condition Rating (SCR)	85	85				
Roughness Condition Index (RCI)	N/A	N/A				
Distress Index Values						
Structural Crack Index	92	92				
Alligator Crack Index	100	100				
Longitudinal Crack Index	92	92				
Transverse Cracking Index	85	85				
Patching Index	100	100				
Rutting Index	91	91				
International Roughness Index (IRI)	N/A	N/A				
Lane & Width Information						
Number of Lanes	2	2				
Paved Width (ft)	14.7	14.7				
Lane Width (ft)	7.4	7.4

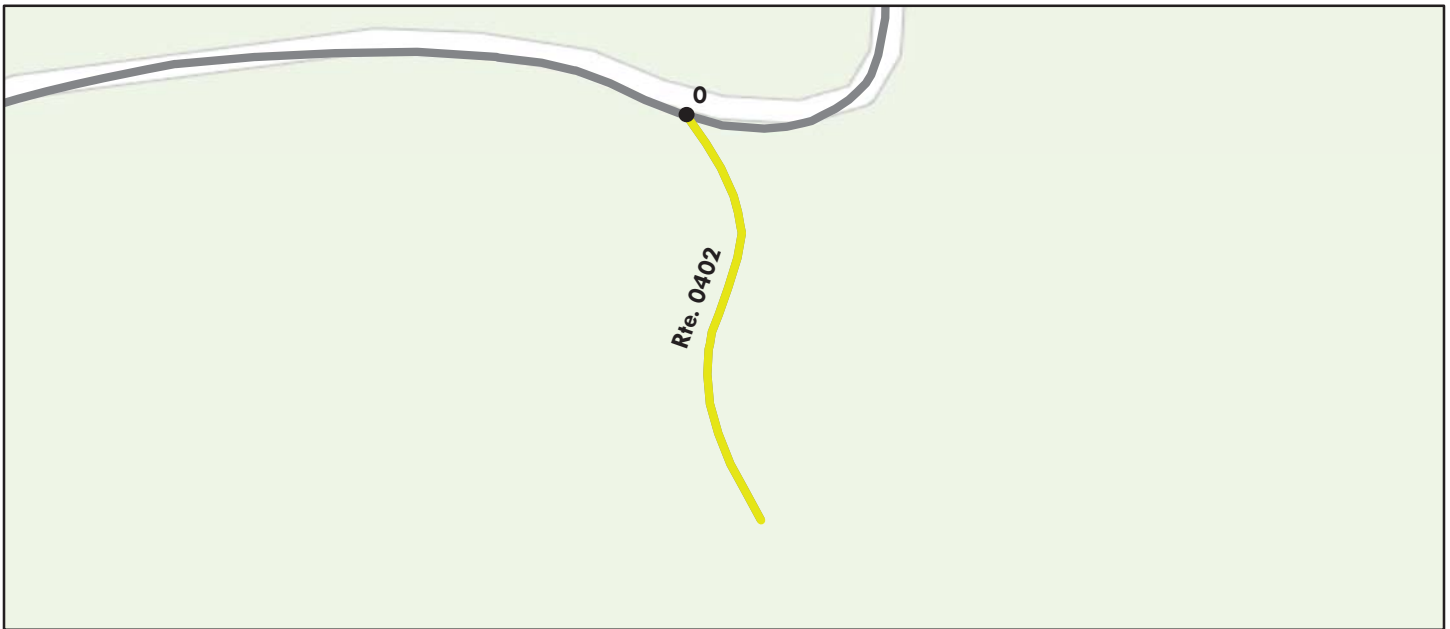
ROUTE 0402: CAMPGROUND SERVICE ROAD

Route Condition Legend – Pavement Condition Rating (PCR)						
Poor (0 - 60)	Fair (61- 84)	Good (85 - 94)	Excellent (95 - 100)	Not Rated		
See Appendix for definitions and formulas						
Inspection Date: 5/24/2015	Beginning Section MP	0				
Paved Length (Miles): 0.07	Section Length (MI)	0.07				
Surface Type: ASPHALT	Route Summary					
Roadway Condition Information						
Pavement Condition Rating (PCR)	82	82				
Surface Condition Rating (SCR)	82	82				
Roughness Condition Index (RCI)	N/A	N/A				
Distress Index Values						
Structural Crack Index	100	100				
Alligator Crack Index	100	100				
Longitudinal Crack Index	100	100				
Transverse Cracking Index	82	82				
Patching Index	100	100				
Rutting Index	91	91				
International Roughness Index (IRI)	N/A	N/A				
Lane & Width Information						
Number of Lanes	2	2				
Paved Width (ft)	14.5	14.5				
Lane Width (ft)	7.2	7.2

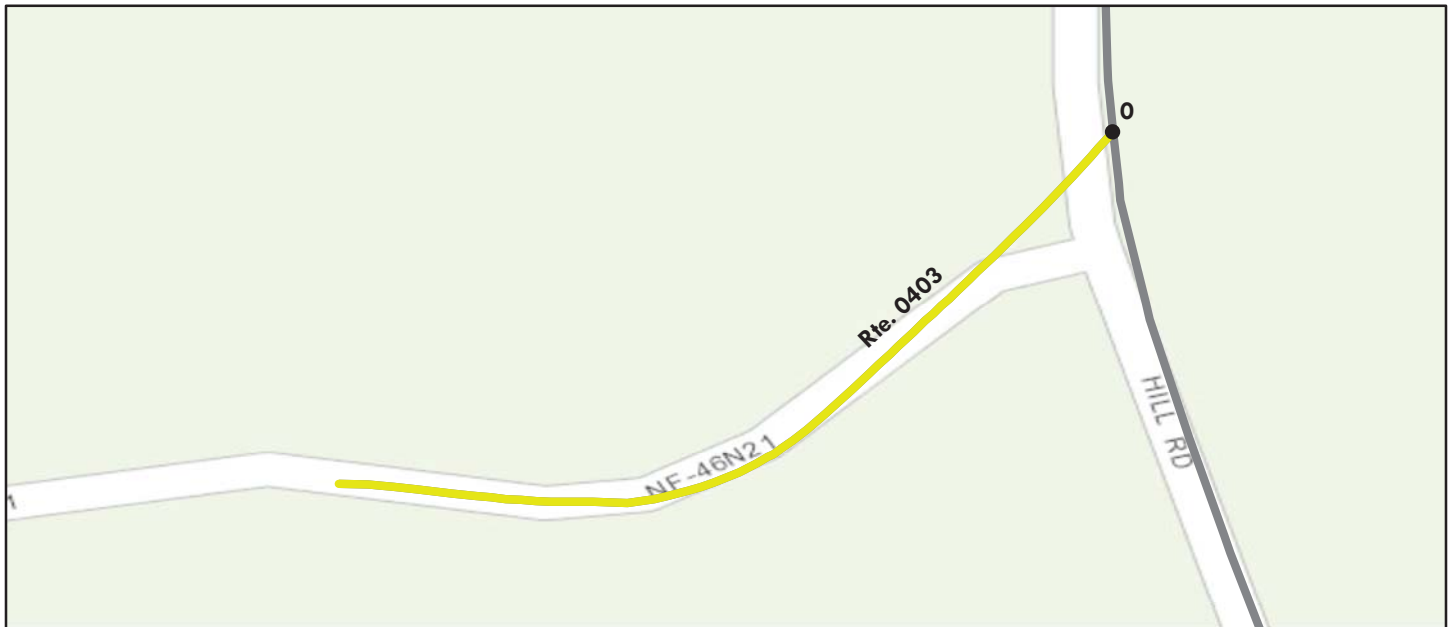
ROUTE 0403: GOLD DIGGERS PASS ROAD

Route Condition Legend – Pavement Condition Rating (PCR)						
Poor (0 - 60)	Fair (61- 84)	Good (85 - 94)	Excellent (95 - 100)	Not Rated		
See Appendix for definitions and formulas						
Inspection Date: 5/24/2015	Beginning Section MP	0				
Paved Length (Miles): 0.06	Section Length (MI)	0.06				
Surface Type: ASPHALT	Route Summary					
Roadway Condition Information						
Pavement Condition Rating (PCR)	80	80				
Surface Condition Rating (SCR)	80	80				
Roughness Condition Index (RCI)	N/A	N/A				
Distress Index Values						
Structural Crack Index	100	100				
Alligator Crack Index	100	100				
Longitudinal Crack Index	100	100				
Transverse Cracking Index	80	80				
Patching Index	100	100				
Rutting Index	97	97				
International Roughness Index (IRI)	N/A	N/A				
Lane & Width Information						
Number of Lanes	2	2				
Paved Width (ft)	16.8	16.8				
Lane Width (ft)	8.4	8.4

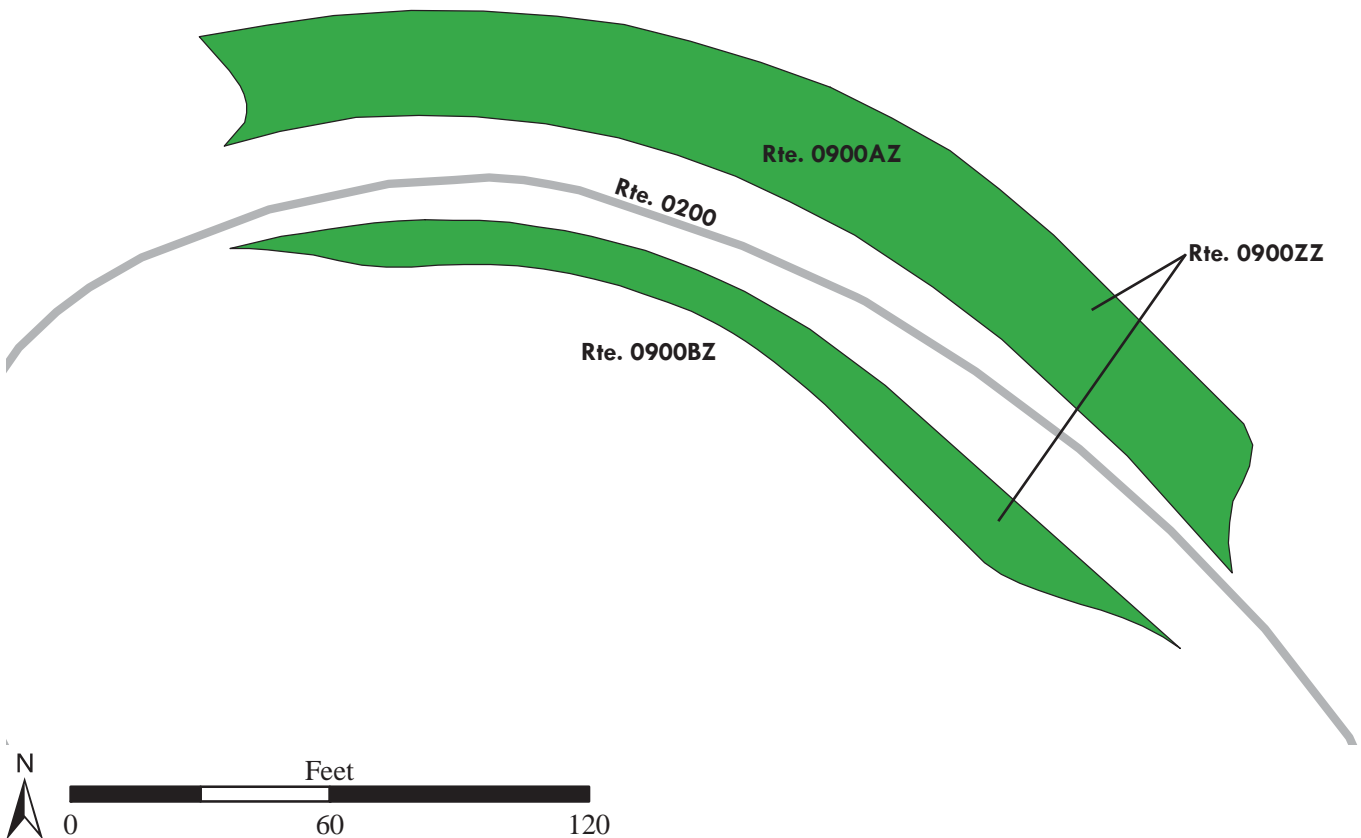
ROUTE 0900AZ: EAST WILDLIFE OVERLOOK PARKING A

Inspection Date	FMSS Number	User Access	Surface Type
11/6/2014	72531	PUBLIC	ASPHALT
Area (Sq. Ft.)	Lane Miles (11' Widths)	Curb Reveal (Inches)	Curb Recommendation
5,123	0.088	NOT APPLICABLE	DO NOTHING
Curb Type		Curb & Gutter Type	
NO CURB		CONCRETE	
Pavement Recommendation		Condition Rating / PCR	
PREVENTIVE MAINTENANCE		GOOD / 90

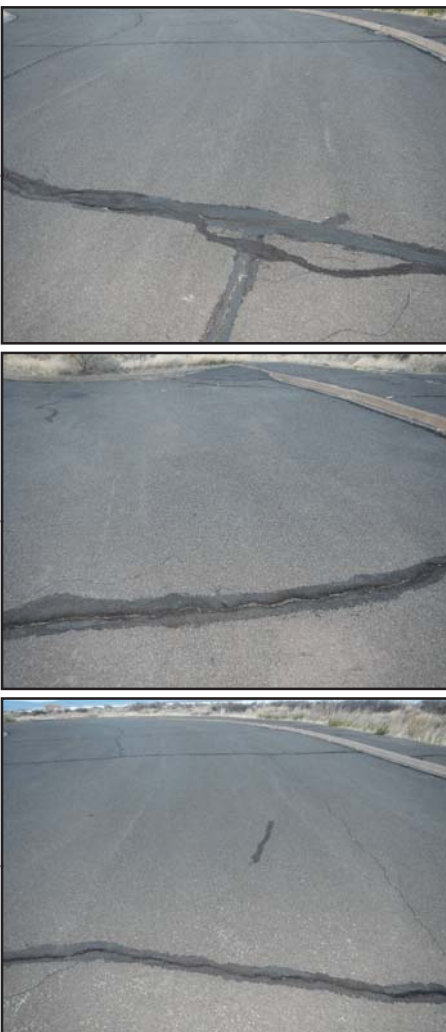
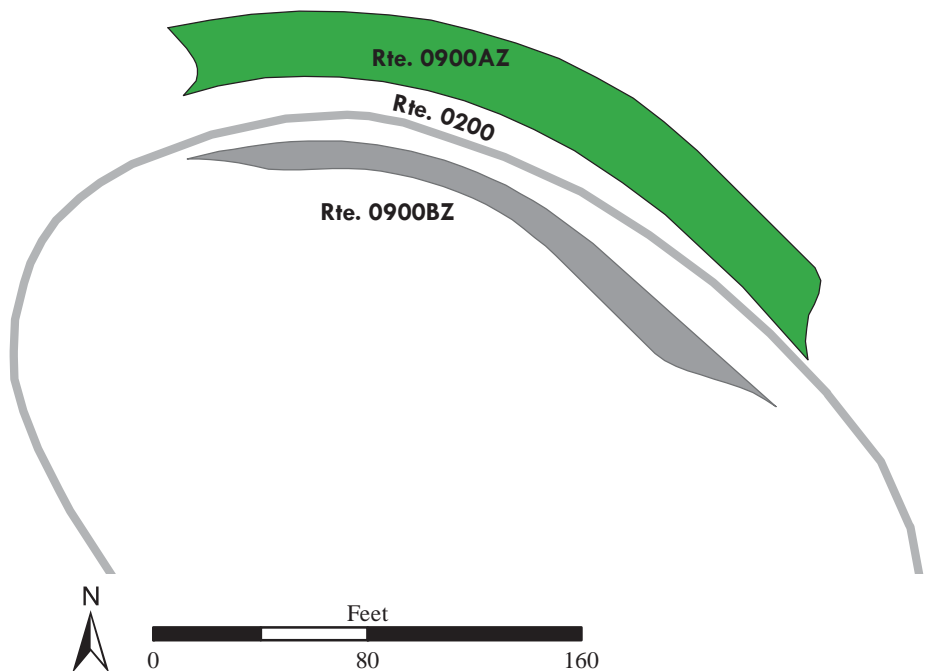
ROUTE 0900BZ: EAST WILDLIFE OVERLOOK PARKING B

Inspection Date	FMSS Number	User Access	Surface Type
11/6/2014	72531	PUBLIC	ASPHALT
Area (Sq. Ft.)	Lane Miles (11' Widths)	Curb Reveal (Inches)	Curb Recommendation
1,797	0.031	NOT APPLICABLE	DO NOTHING
Curb Type		Curb & Gutter Type	
NO CURB		CONCRETE	
Pavement Recommendation		Condition Rating / PCR	
PREVENTIVE MAINTENANCE		GOOD / 90

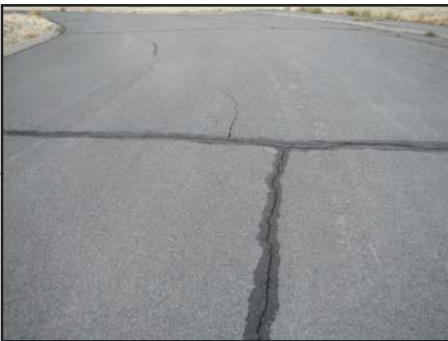
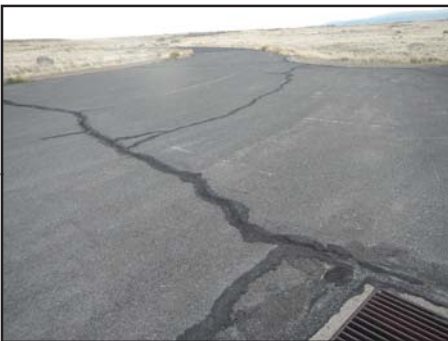
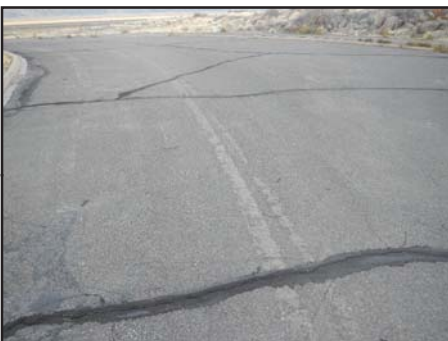
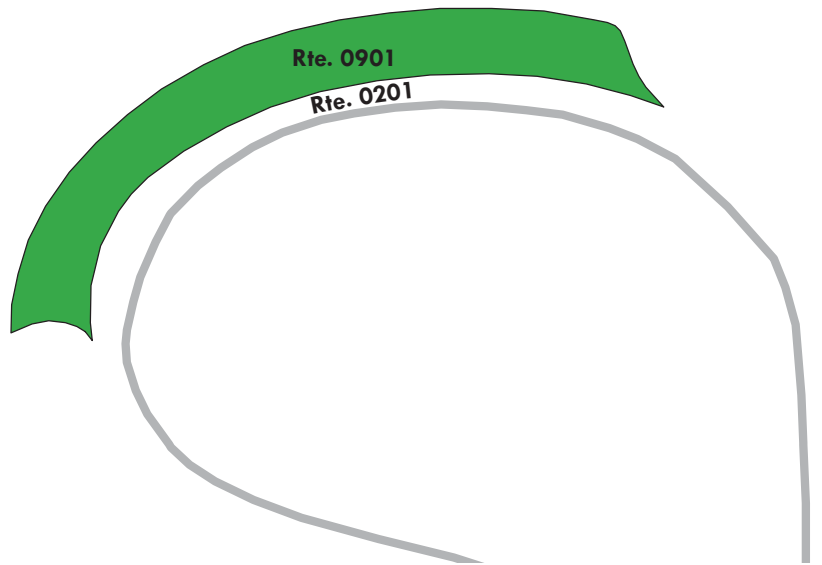
ROUTE 0902: CAPTAIN JACK'S STRONGHOLD PARKING

Inspection Date	FMSS Number	User Access	Surface Type
11/6/2014	72498	PUBLIC	ASPHALT
Area (Sq. Ft.)	Lane Miles (11' Widths)	Curb Reveal (Inches)	Curb Recommendation
31,139	0.536	NOT APPLICABLE	DO NOTHING
Curb Type		Curb & Gutter Type	
NO CURB		CONCRETE	
Pavement Recommendation		Condition Rating / PCR	
HEAVY 3R TREATMENTS		POOR / 53

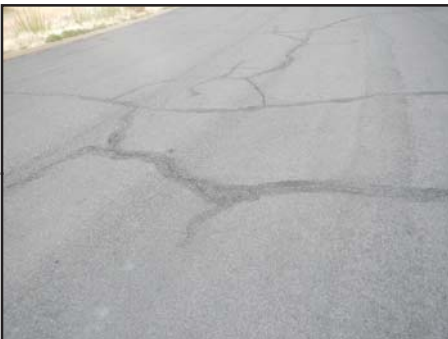
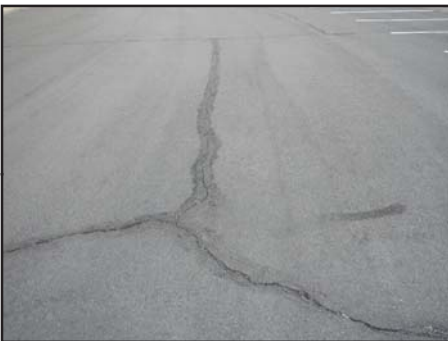
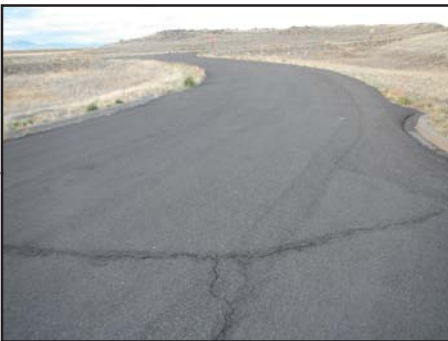
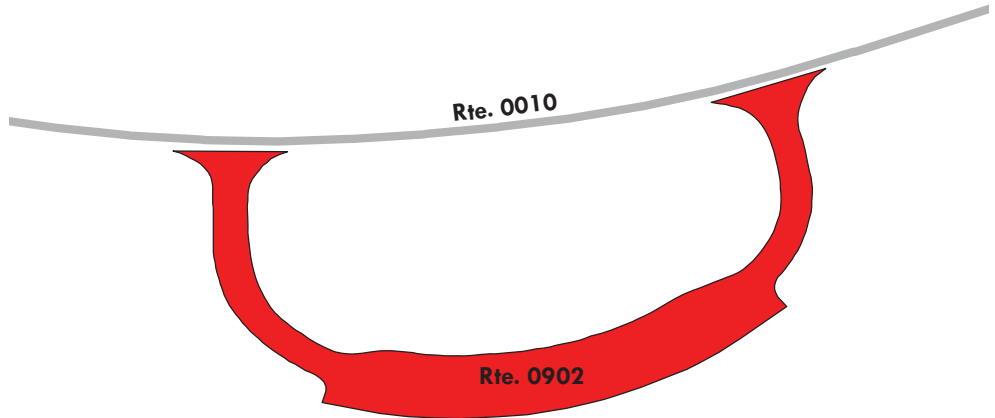
ROUTE 0903: CANBYS CROSS PARKING

Inspection Date	FMSS Number	User Access	Surface Type
11/6/2014	72522	PUBLIC	ASPHALT
Area (Sq. Ft.)	Lane Miles (11' Widths)	Curb Reveal (Inches)	Curb Recommendation
16,349	0.281	NOT APPLICABLE	DO NOTHING
Curb Type		Curb & Gutter Type	
NO CURB		CONCRETE	
Pavement Recommendation		Condition Rating / PCR	
PREVENTIVE MAINTENANCE		GOOD / 90

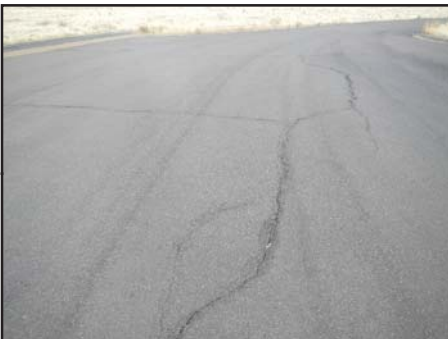
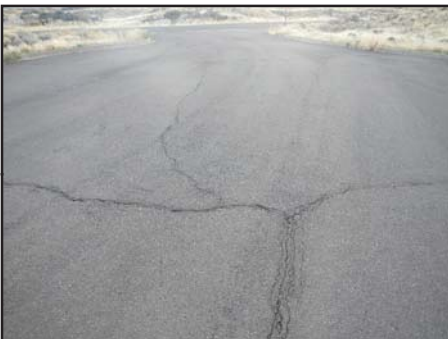
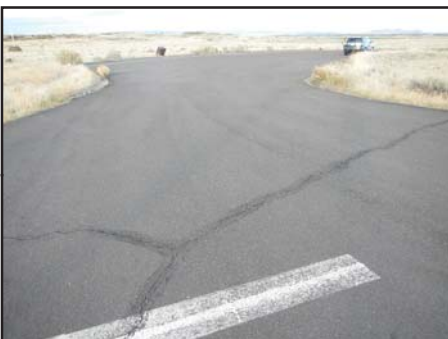
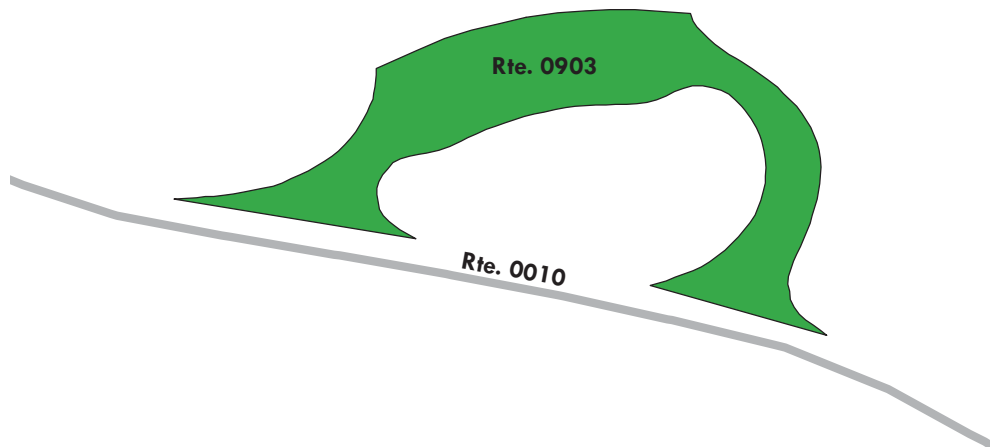
ROUTE 0904: GILLEMS CAMP PARKING

Inspection Date	FMSS Number	User Access	Surface Type
11/6/2014	72520	PUBLIC	ASPHALT
Area (Sq. Ft.)	Lane Miles (11' Widths)	Curb Reveal (Inches)	Curb Recommendation
21,198	0.365	NOT APPLICABLE	DO NOTHING
Curb Type		Curb & Gutter Type	
NO CURB		CONCRETE	
Pavement Recommendation		Condition Rating / PCR	
HEAVY 3R TREATMENTS		POOR / 53

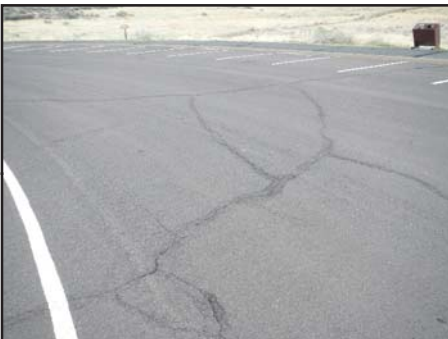
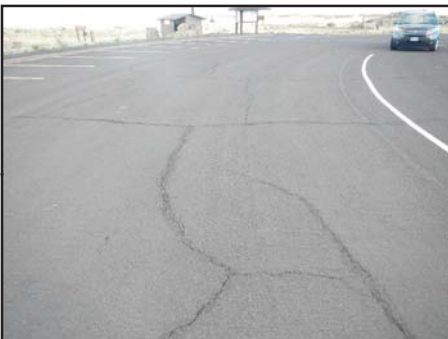
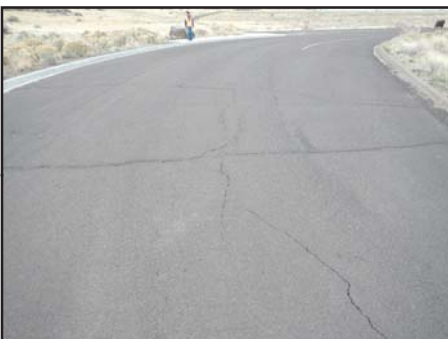
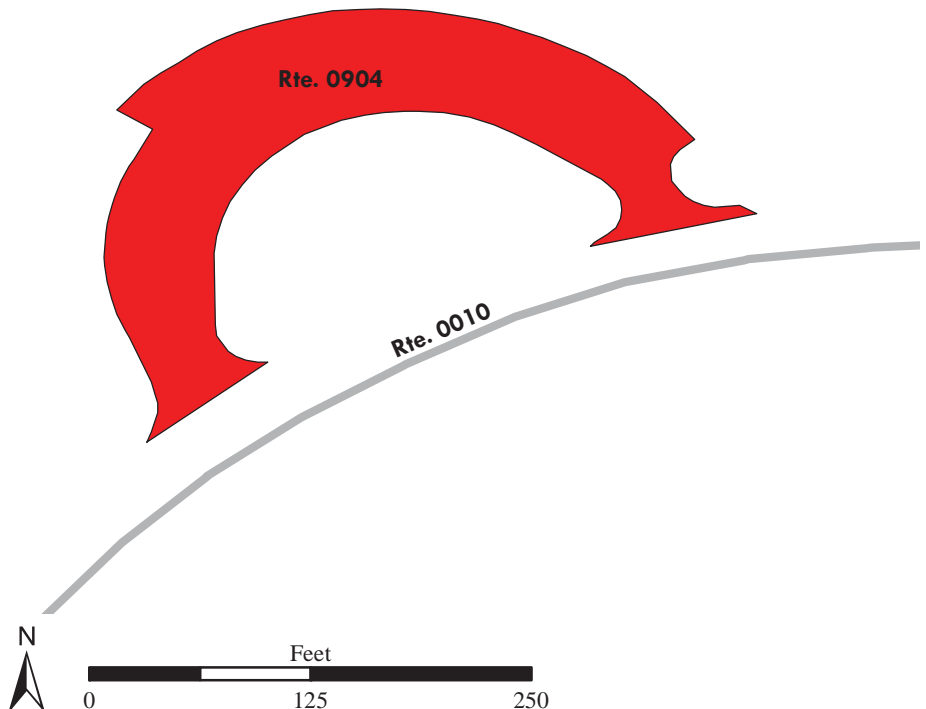
ROUTE 0905: MERRIL ICE CAVE PARKING

Inspection Date	FMSS Number	User Access	Surface Type
11/6/2014	72519	PUBLIC	ASPHALT
Area (Sq. Ft.)	Lane Miles (11' Widths)	Curb Reveal (Inches)	Curb Recommendation
7,044	0.121	NOT APPLICABLE	DO NOTHING
Curb Type		Curb & Gutter Type	
NO CURB		CONCRETE	
Pavement Recommendation		Condition Rating / PCR	
HEAVY 3R TREATMENTS		POOR / 53

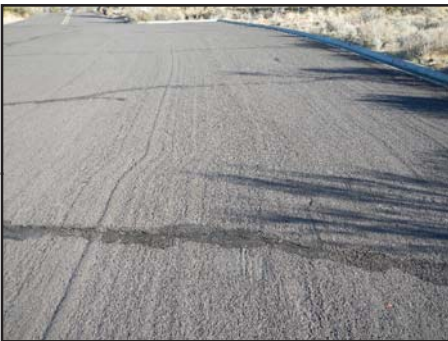
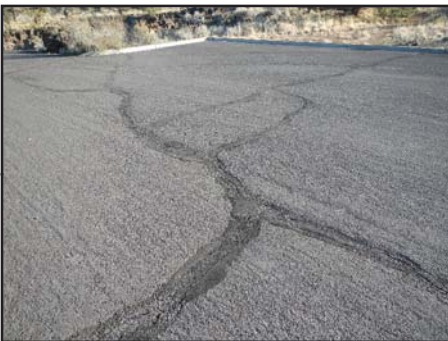
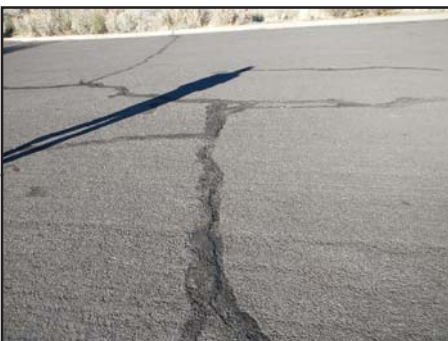
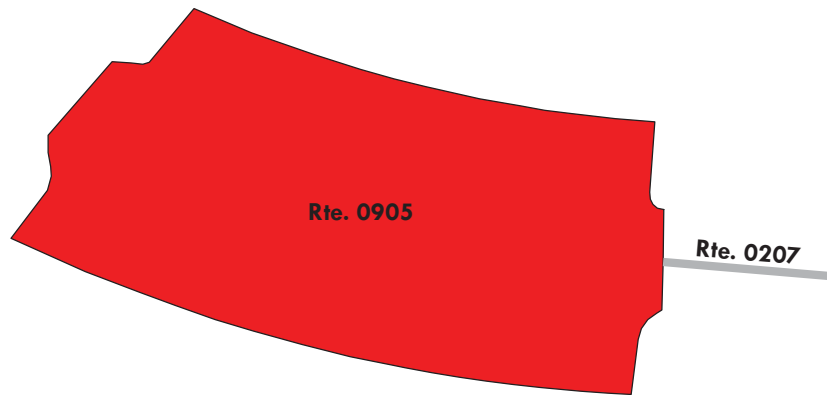
ROUTE 0906: SKULL CAVE PARKING

Inspection Date	FMSS Number	User Access	Surface Type
11/6/2014	72518	PUBLIC	ASPHALT
Area (Sq. Ft.)	Lane Miles (11' Widths)	Curb Reveal (Inches)	Curb Recommendation
5,391	0.093	NOT APPLICABLE	DO NOTHING
Curb Type		Curb & Gutter Type	
NO CURB		CONCRETE	
Pavement Recommendation		Condition Rating / PCR	
PREVENTIVE MAINTENANCE		GOOD / 90

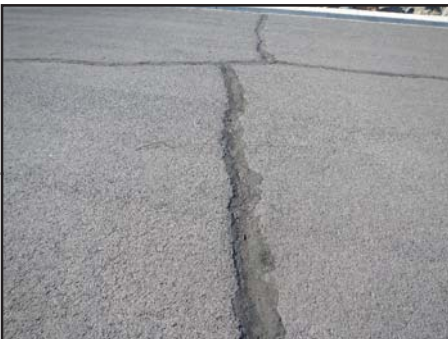
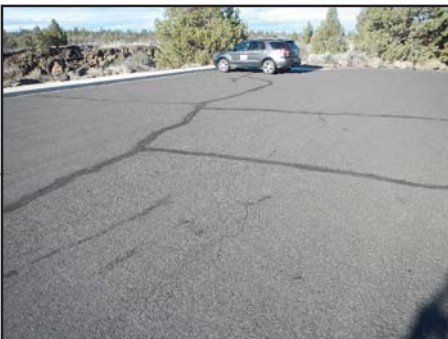
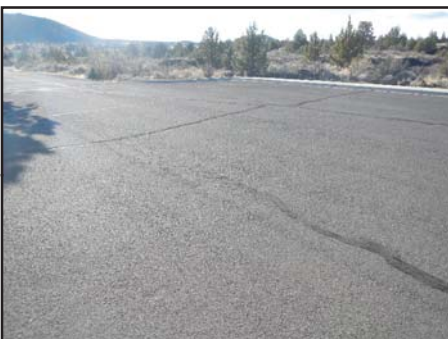
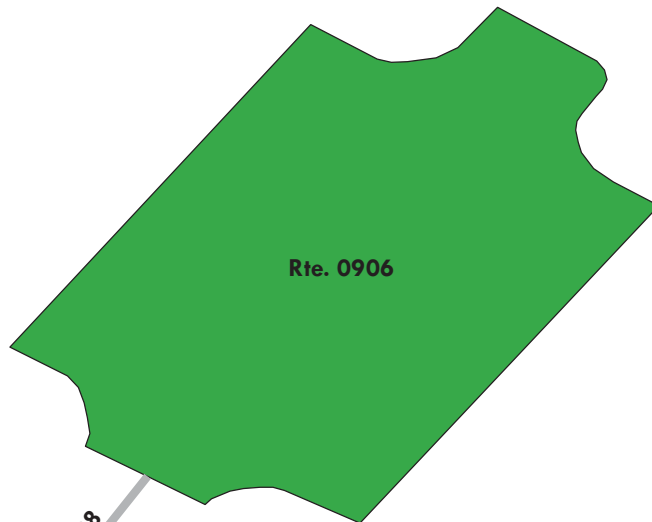
ROUTE 0907: VALENTINE CAVE PARKING

Inspection Date	FMSS Number	User Access	Surface Type
11/6/2014	72517	PUBLIC	ASPHALT
Area (Sq. Ft.)	Lane Miles (11' Widths)	Curb Reveal (Inches)	Curb Recommendation
15,482	0.267	NOT APPLICABLE	DO NOTHING
Curb Type		Curb & Gutter Type	
NO CURB		CONCRETE	
Pavement Recommendation		Condition Rating / PCR	
HEAVY 3R TREATMENTS		POOR / 53

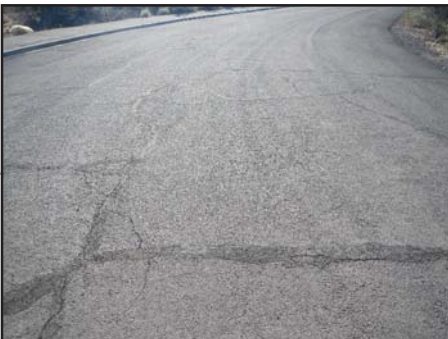
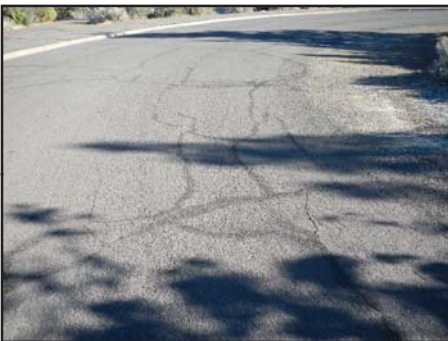
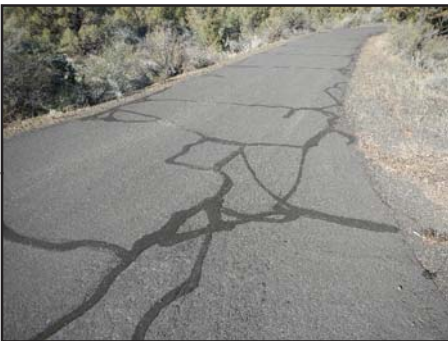
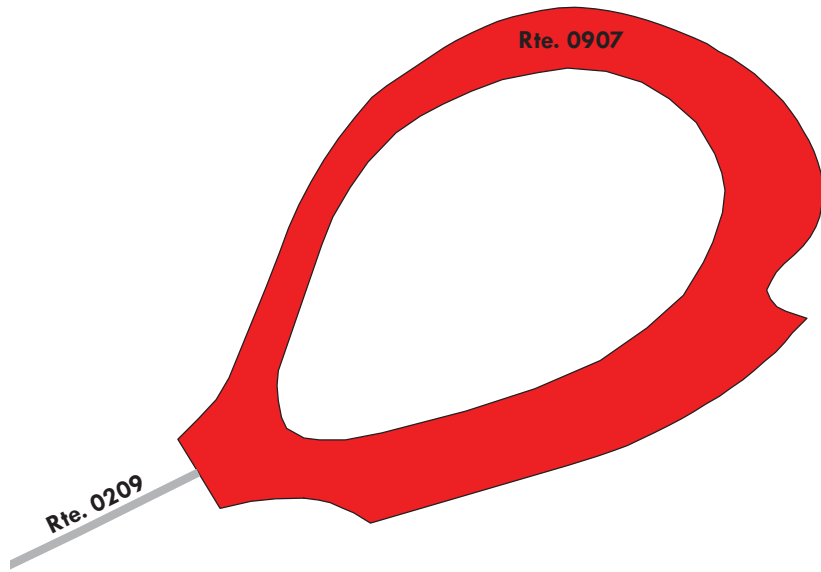
ROUTE 0909: ADMINISTRATIVE MAINTENANCE PARKING

Inspection Date	FMSS Number	User Access	Surface Type
11/6/2014	72515	NONPUBLIC	ASPHALT
Area (Sq. Ft.)	Lane Miles (11' Widths)	Curb Reveal (Inches)	Curb Recommendation
52,408	0.902	5	DO NOTHING
Curb Type		Curb & Gutter Type	
STONE		NO CURB AND GUTTER	
Pavement Recommendation		Condition Rating / PCR	
HEAVY 3R TREATMENTS		POOR / 53

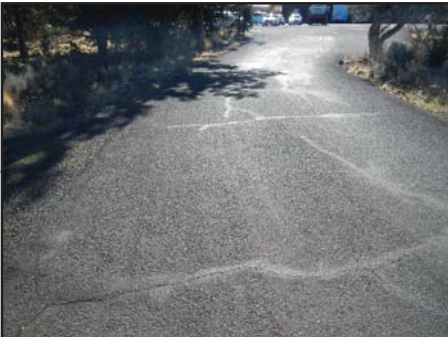
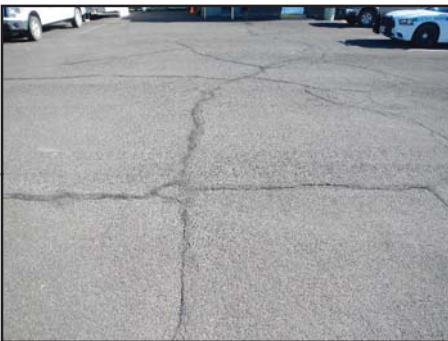
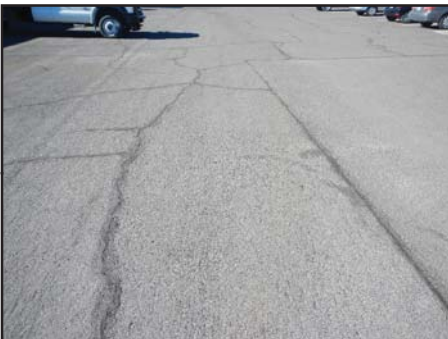
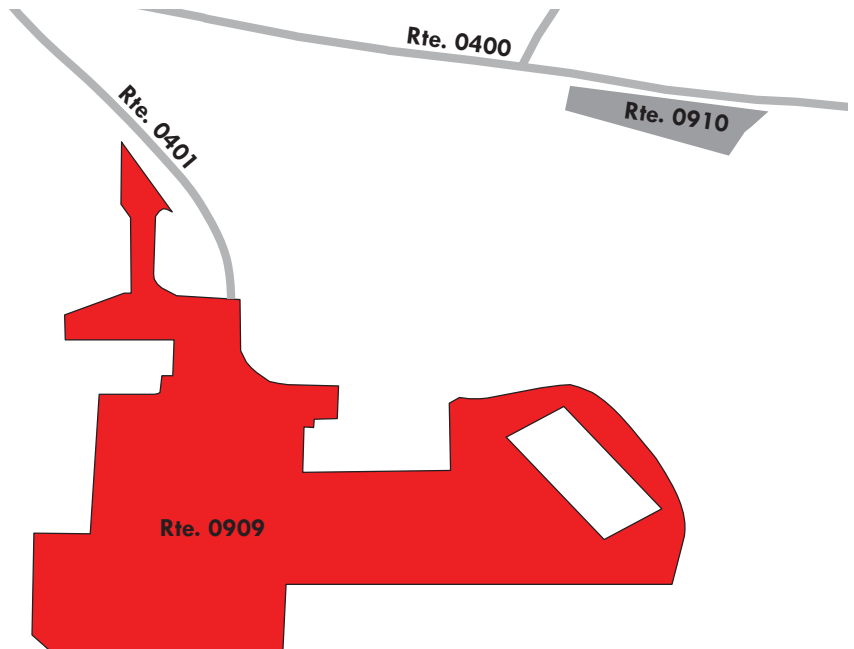
ROUTE 0910: APARTMENT PARKING

Inspection Date	FMSS Number	User Access	Surface Type
11/6/2014	74358	NONPUBLIC	ASPHALT
Area (Sq. Ft.)	Lane Miles (11' Widths)	Curb Reveal (Inches)	Curb Recommendation
2,895	0.05	NOT APPLICABLE	DO NOTHING
Curb Type		Curb & Gutter Type	
NO CURB		CONCRETE	
Pavement Recommendation		Condition Rating / PCR	
HEAVY 3R TREATMENTS		POOR / 53

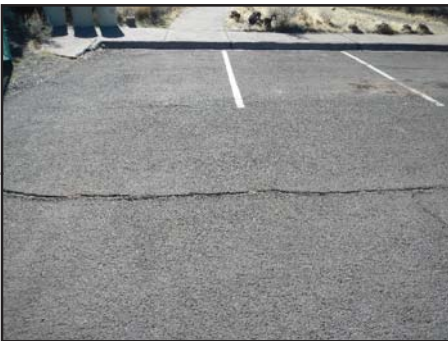
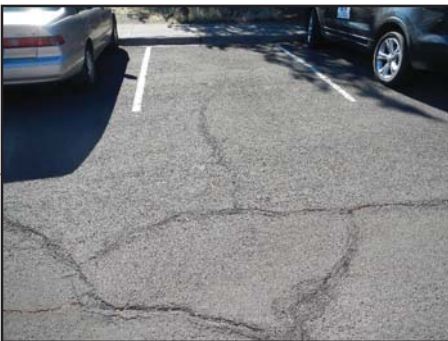
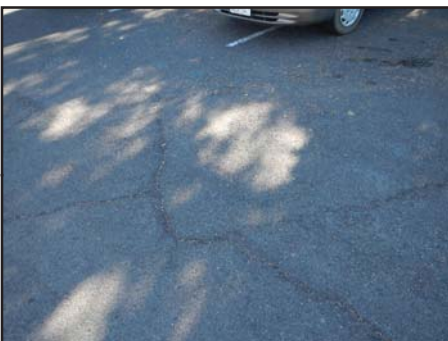
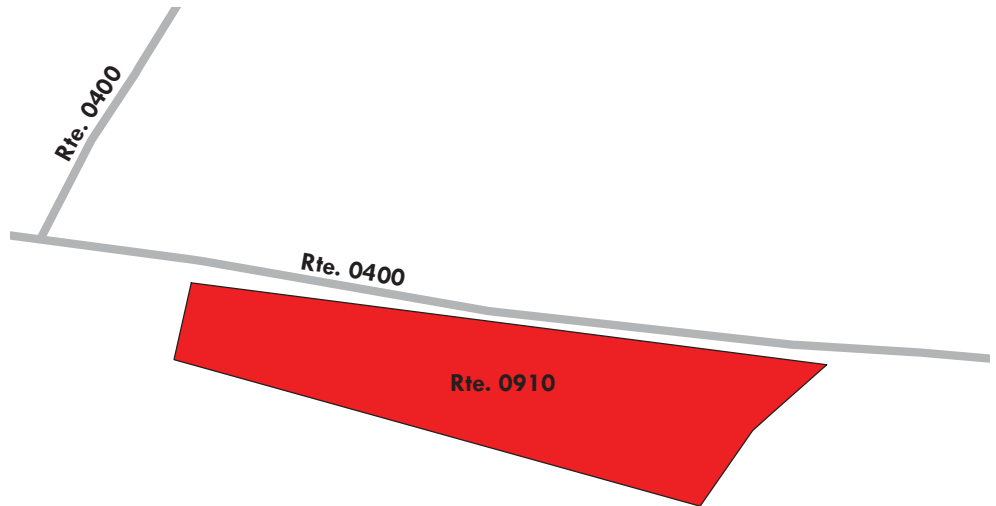
ROUTE 0911: INDIAN WELL CAVE PARKING

Inspection Date	FMSS Number	User Access	Surface Type
11/6/2014	102396	PUBLIC	ASPHALT
Area (Sq. Ft.)	Lane Miles (11' Widths)	Curb Reveal (Inches)	Curb Recommendation
4,653	0.08	NOT APPLICABLE	NOT APPLICABLE
Curb Type		Curb & Gutter Type	
NO CURB		NO CURB AND GUTTER	
Pavement Recommendation		Condition Rating / PCR	
HEAVY 3R TREATMENTS		POOR / 53

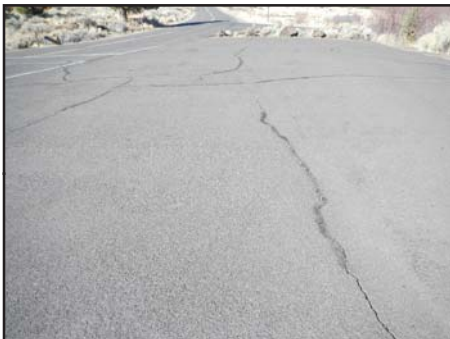
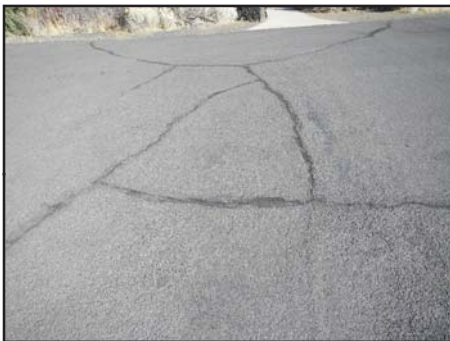
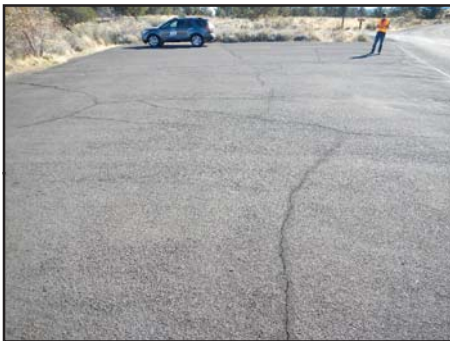
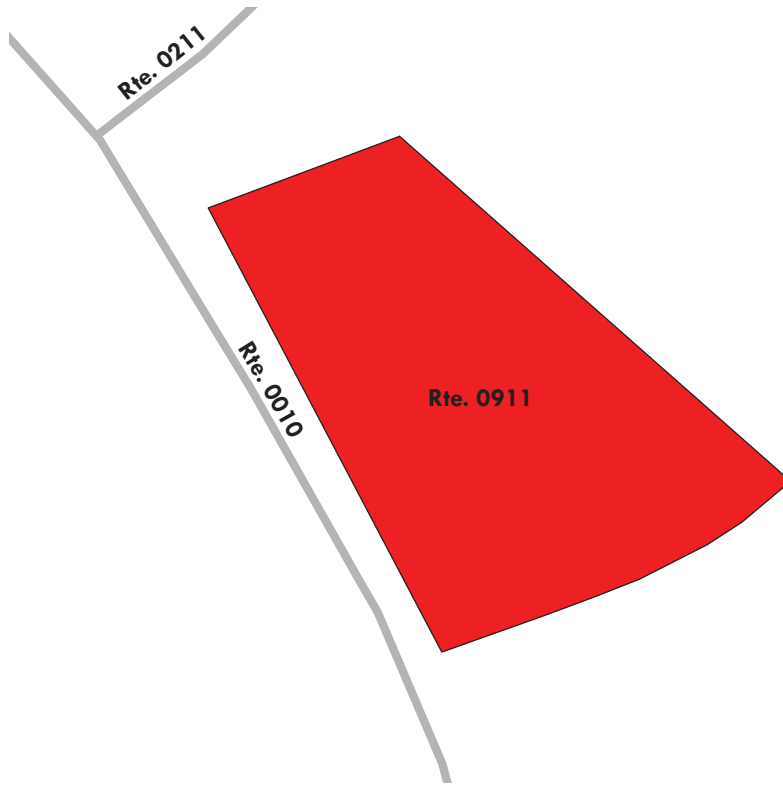
ROUTE 0912: VISITOR CENTER PARKING

Inspection Date	FMSS Number	User Access	Surface Type
11/6/2014	72657	PUBLIC	ASPHALT
Area (Sq. Ft.)	Lane Miles (11' Widths)	Curb Reveal (Inches)	Curb Recommendation
47,056	0.81	6	DO NOTHING
Curb Type		Curb & Gutter Type	
CONCRETE		NO CURB AND GUTTER	
Pavement Recommendation		Condition Rating / PCR	
HEAVY 3R TREATMENTS		POOR / 53
