LABE Cycle 6

Final Report

Road Inventory and Condition Assessment of Paved Routes Lava Beds National Monument

Report Date: November 2015

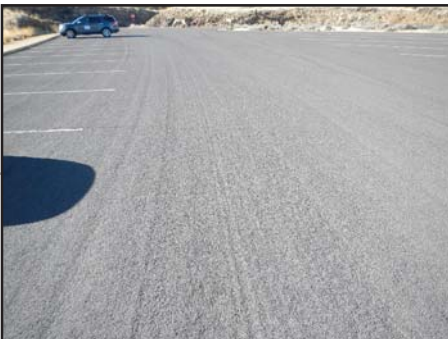
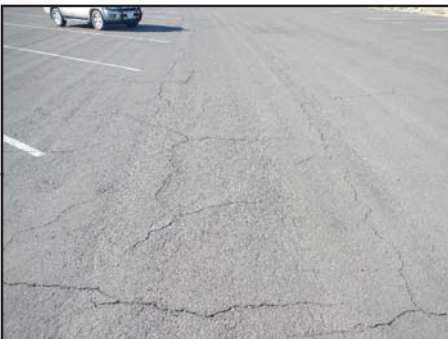
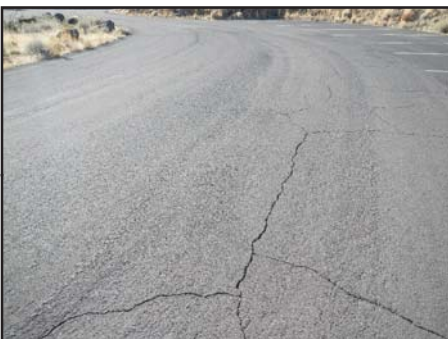
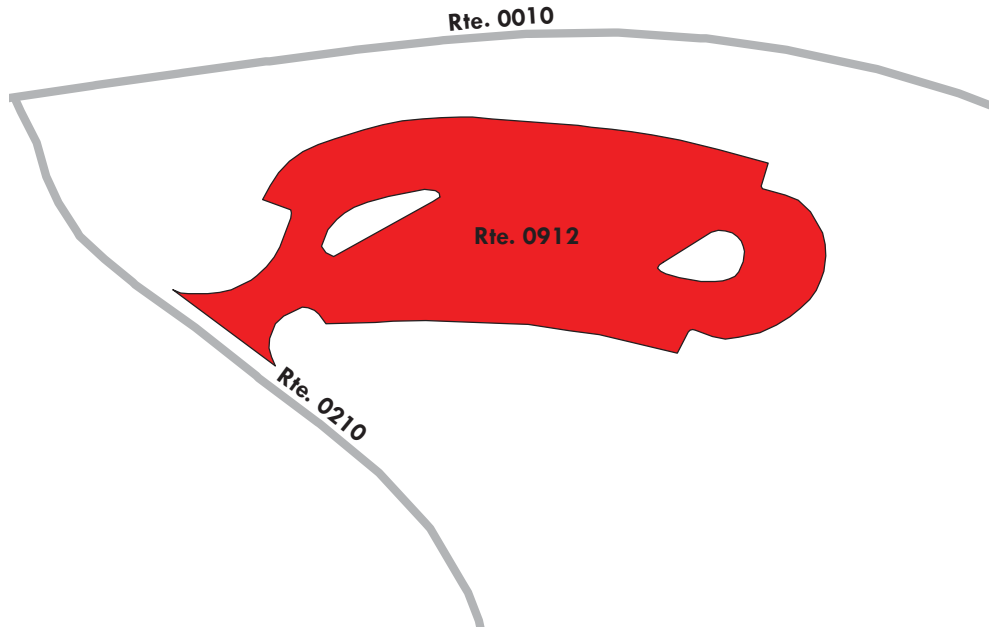
ROUTE 0913: BUNCHGRASS TRAIL SCENIC OVERLOOK PARKING

Inspection Date	FMSS Number	User Access	Surface Type
11/6/2014	72503	PUBLIC	ASPHALT
Area (Sq. Ft.)	Lane Miles (11' Widths)	Curb Reveal (Inches)	Curb Recommendation
5,592	0.096	NOT APPLICABLE	DO NOTHING
Curb Type		Curb & Gutter Type	
NO CURB		CONCRETE	
Pavement Recommendation		Condition Rating / PCR	
LIGHT 3R TREATMENTS		FAIR / 73

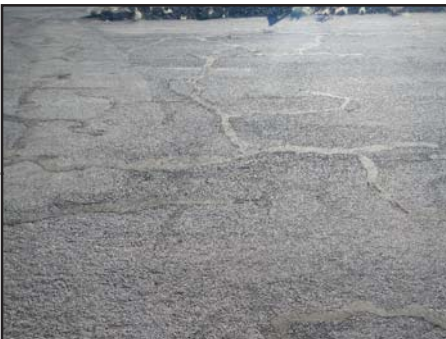
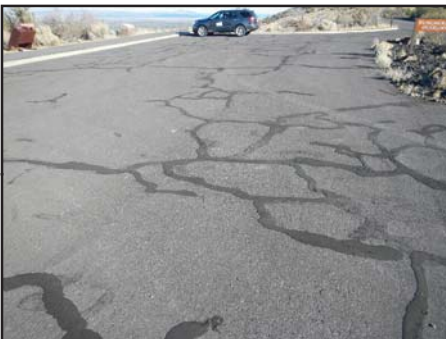
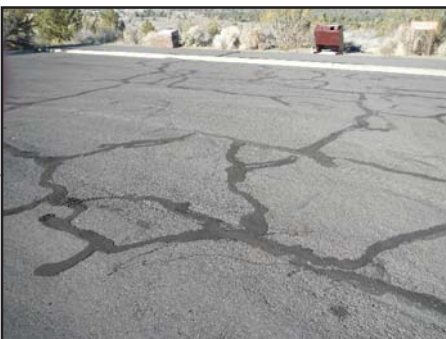
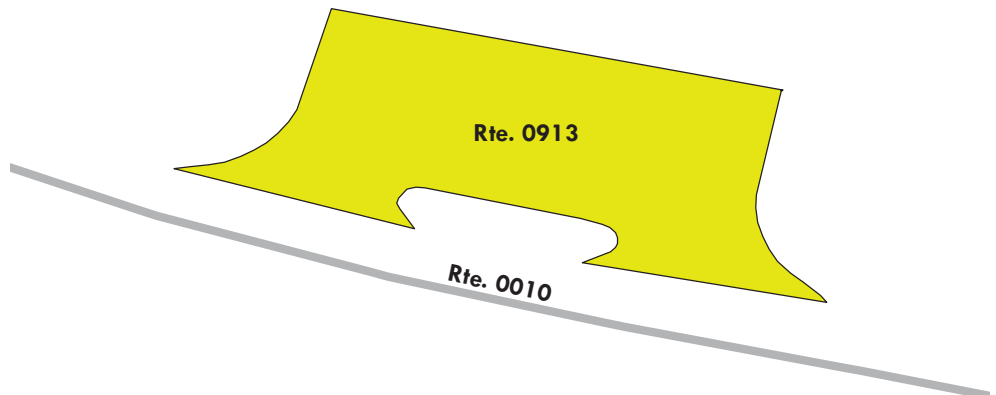
ROUTE 0914: BALCONY/BOULEVARD CAVE PARKING

Inspection Date	FMSS Number	User Access	Surface Type
11/6/2014	72500	PUBLIC	ASPHALT
Area (Sq. Ft.)	Lane Miles (11' Widths)	Curb Reveal (Inches)	Curb Recommendation
7,352	0.127	NOT APPLICABLE	DO NOTHING
Curb Type		Curb & Gutter Type	
NO CURB		CONCRETE	
Pavement Recommendation		Condition Rating / PCR	
HEAVY 3R TREATMENTS		POOR / 53

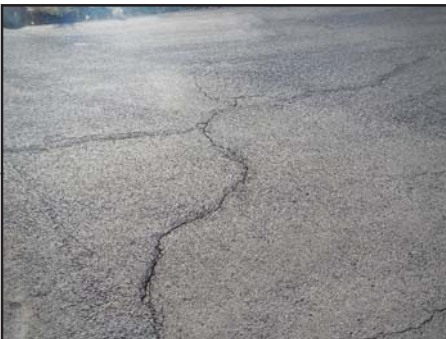
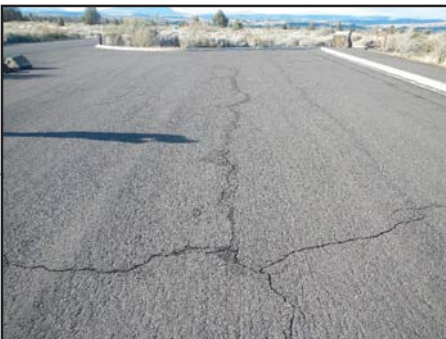
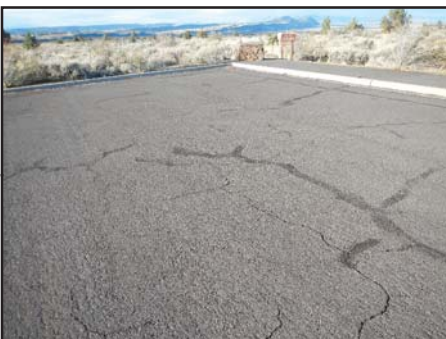
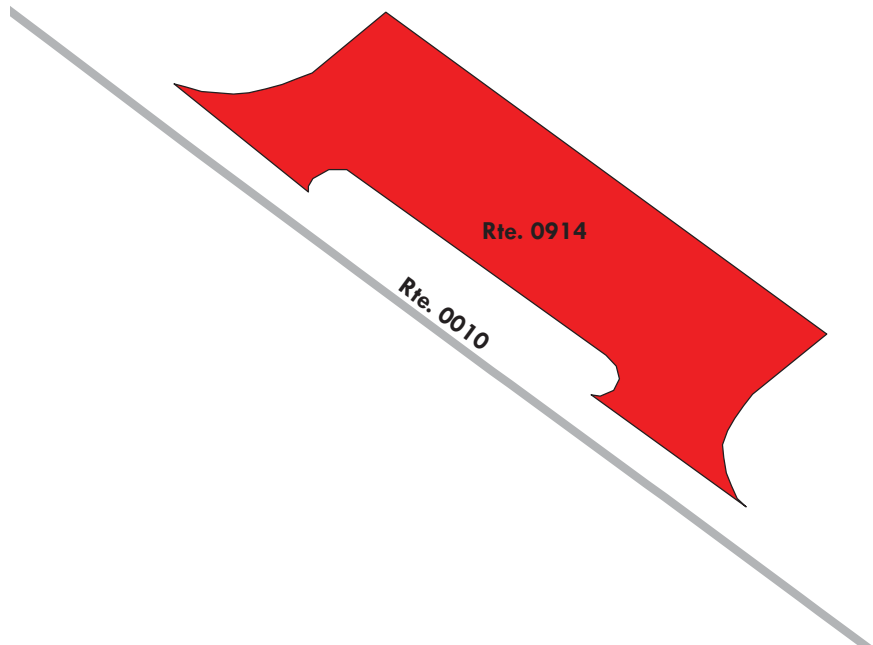
ROUTE 0915: BLACK CRATER/THOMAS WRIGHT BATTLEFIELD PARKING

Inspection Date	FMSS Number	User Access	Surface Type
11/6/2014	72497	PUBLIC	ASPHALT
Area (Sq. Ft.)	Lane Miles (11' Widths)	Curb Reveal (Inches)	Curb Recommendation
7,392	0.127	NOT APPLICABLE	DO NOTHING
Curb Type		Curb & Gutter Type	
NO CURB		CONCRETE	
Pavement Recommendation		Condition Rating / PCR	
HEAVY 3R TREATMENTS		POOR / 53

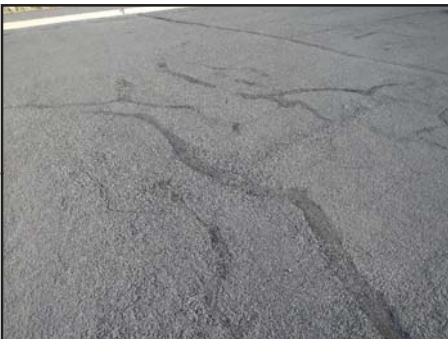
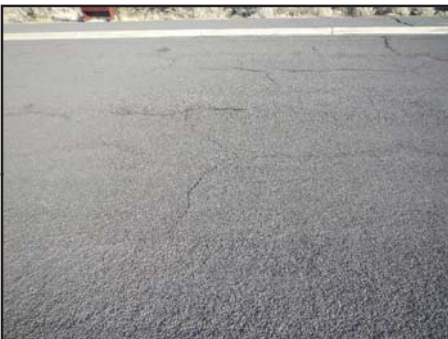
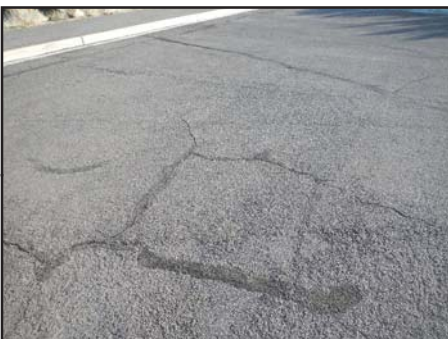
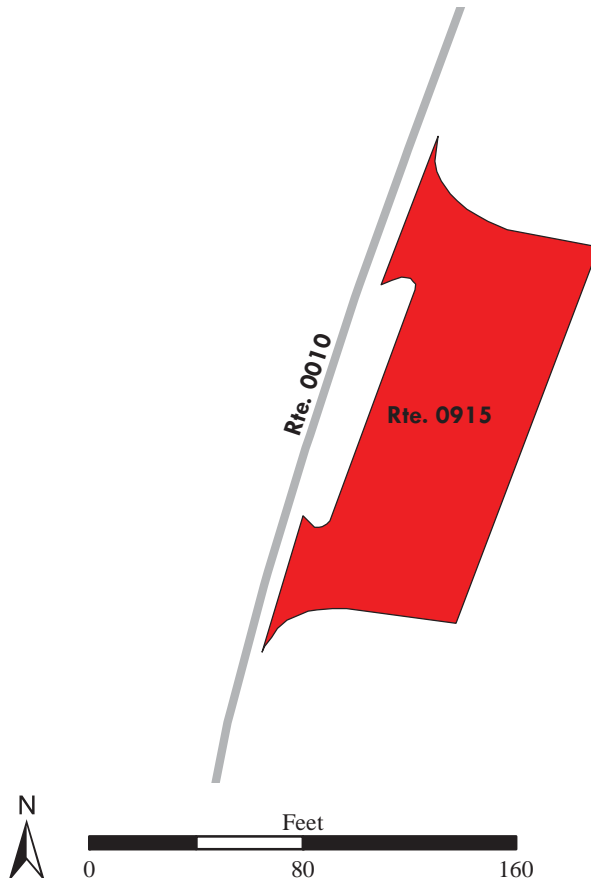
ROUTE 0916: DEVILS HOMESTEAD OVERLOOK PARKING

Inspection Date	FMSS Number	User Access	Surface Type
11/6/2014	72492	PUBLIC	ASPHALT
Area (Sq. Ft.)	Lane Miles (11' Widths)	Curb Reveal (Inches)	Curb Recommendation
18,742	0.323	NOT APPLICABLE	DO NOTHING
Curb Type		Curb & Gutter Type	
NO CURB		CONCRETE	
Pavement Recommendation		Condition Rating / PCR	
HEAVY 3R TREATMENTS		POOR / 53

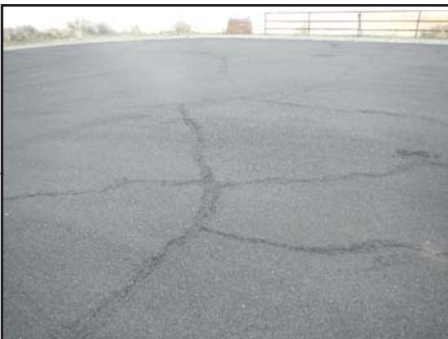
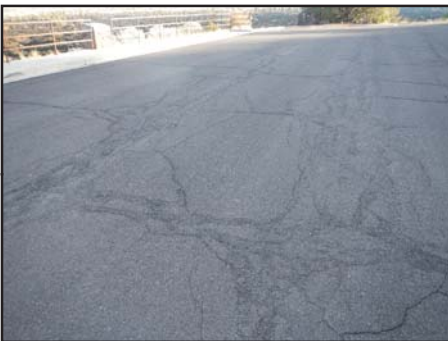
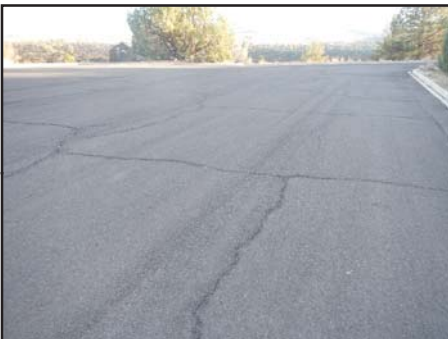
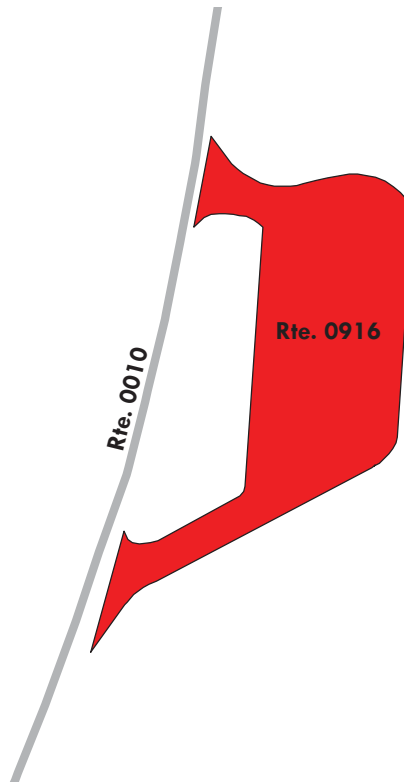
ROUTE 0917: HOSPITAL ROCK PARKING

Inspection Date	FMSS Number	User Access	Surface Type
11/6/2014	72490	PUBLIC	ASPHALT
Area (Sq. Ft.)	Lane Miles (11' Widths)	Curb Reveal (Inches)	Curb Recommendation
16,210	0.279	NOT APPLICABLE	DO NOTHING
Curb Type		Curb & Gutter Type	
NO CURB		CONCRETE	
Pavement Recommendation		Condition Rating / PCR	
HEAVY 3R TREATMENTS		POOR / 53

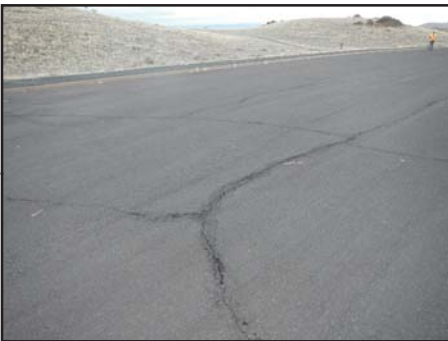
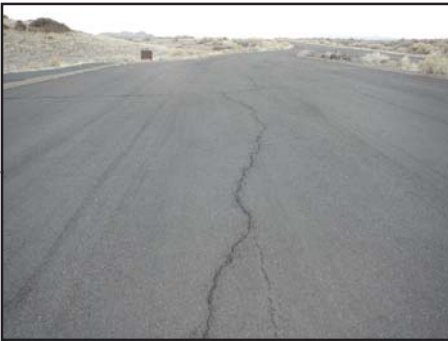
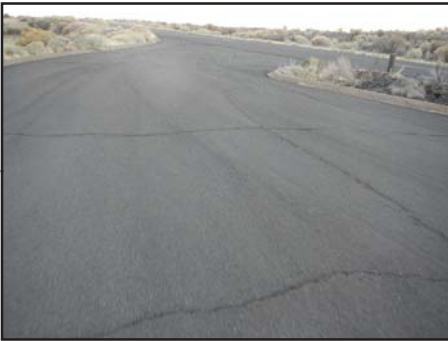
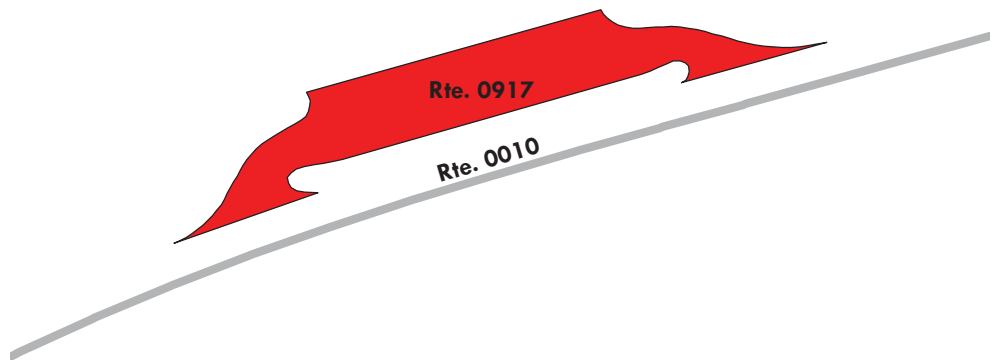
ROUTE 0918: SYMBOL BRIDGE TRAIL PARKING

Inspection Date	FMSS Number	User Access	Surface Type
11/6/2014	72489	PUBLIC	ASPHALT
Area (Sq. Ft.)	Lane Miles (11' Widths)	Curb Reveal (Inches)	Curb Recommendation
1,598	0.028	NOT APPLICABLE	DO NOTHING
Curb Type		Curb & Gutter Type	
NO CURB		CONCRETE	
Pavement Recommendation		Condition Rating / PCR	
LIGHT 3R TREATMENTS		FAIR / 73
