# LAMR Cycle 6

## Final Report

### Road Inventory and Condition Assessment of Paved Routes Lake Meredith National Recreation Area

Report Date: April 2018

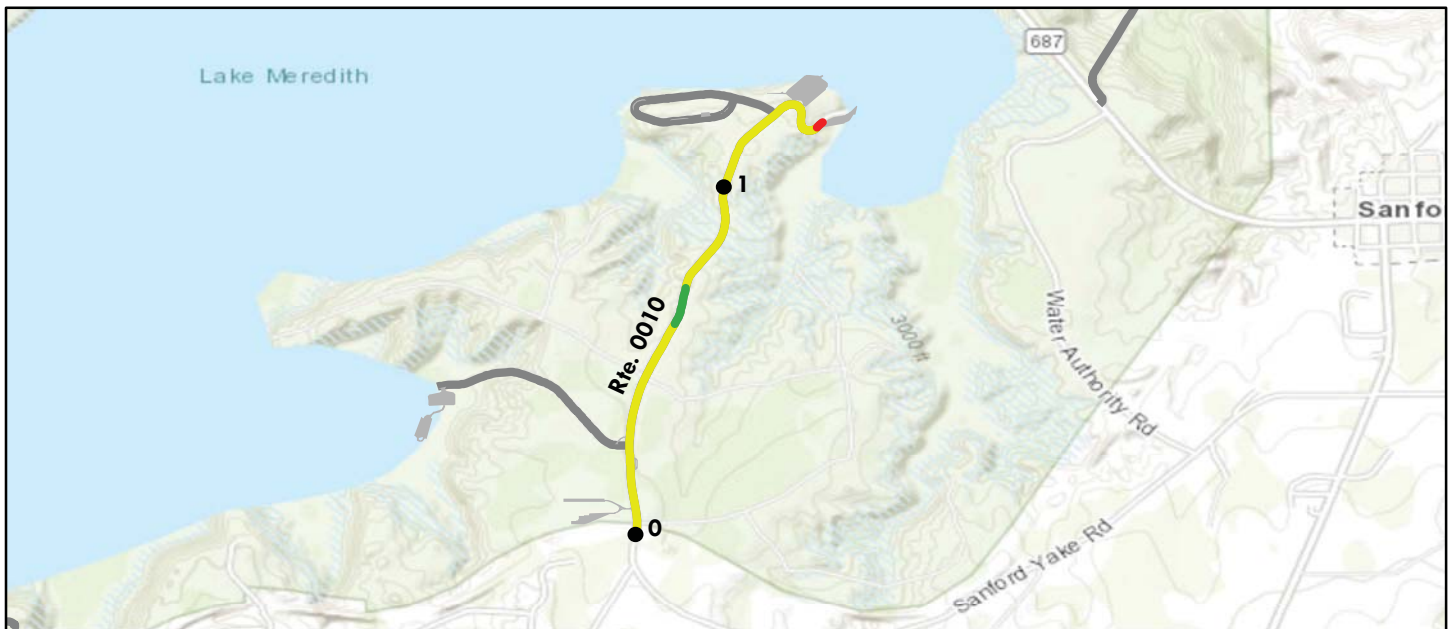
## ROUTE 0010: SANFORD YAKE ROAD

Inspection Date:	11/8/2017	Beginning Section MP	0	1			
Paved Length (Miles):	1.42	Section Length (MI)	1	0.42			
Surface Type:	ASPHALT	Route Summary					
Roadway Condition Information							
Pavement Condition Rating (PCR)	76	78	71				
Surface Condition Rating (SCR)	63	63	63				
Roughness Condition Index (RCI)	96	100	83				
Distress Index Values							
Structural Crack Index	88	87	89				
Alligator Crack Index	100	100	100				
Longitudinal Crack Index	88	87	89				
Transverse Cracking Index	63	63	63				
Patching Index	100	100	100				
Rutting Index	99	99	98				
International Roughness Index (IRI)	125	111	161				
Lane & Width Information							
Number of Lanes	2	2	2				
Paved Width (ft)	24.1	24	24.6				
Lane Width (ft)	10	10.1	9.7

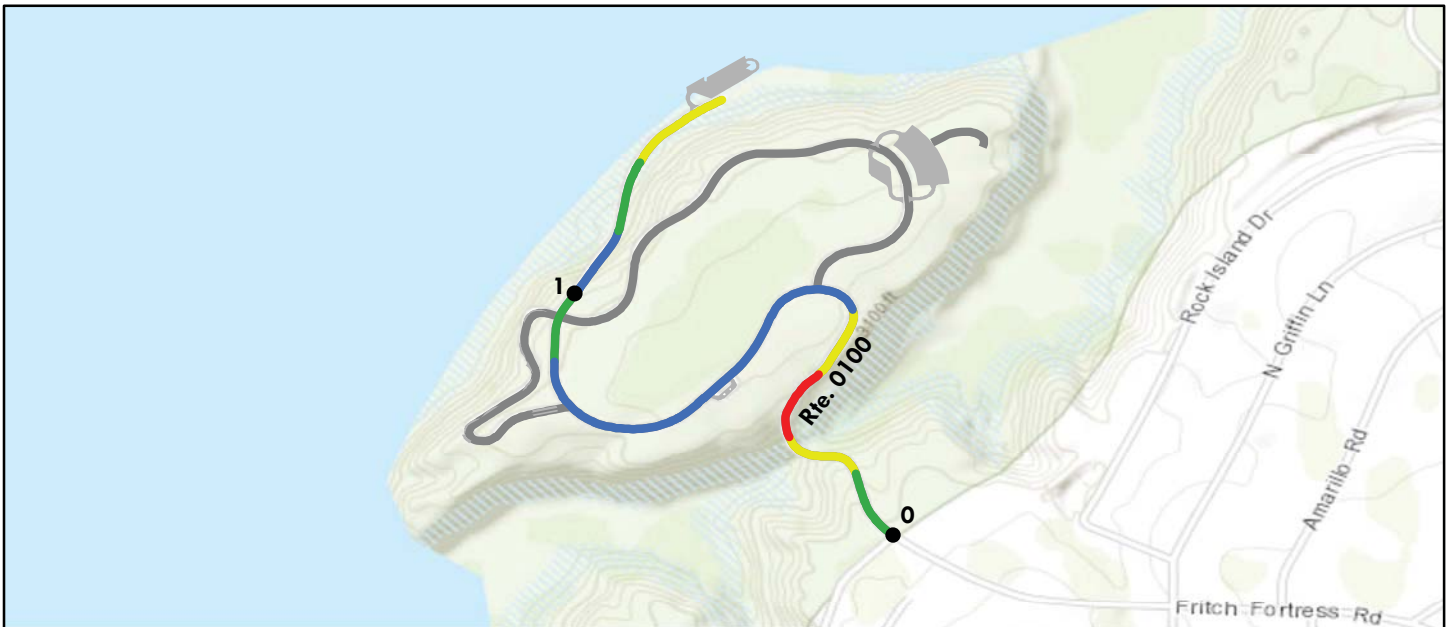
## ROUTE 0100: FRITCH FORTRESS ROAD

Inspection Date:	11/8/2017	Beginning Section MP	0	1			
Paved Length (Miles):	1.33	Section Length (MI)	1	0.33			
Surface Type:	ASPHALT	Route Summary					
Roadway Condition Information							
Pavement Condition Rating (PCR)	91	92	86				
Surface Condition Rating (SCR)	90	89	90				
Roughness Condition Index (RCI)	92	97	79				
Distress Index Values							
Structural Crack Index	90	89	94				
Alligator Crack Index	100	100	100				
Longitudinal Crack Index	90	89	94				
Transverse Cracking Index	90	89	90				
Patching Index	99	100	98				
Rutting Index	99	99	98				
International Roughness Index (IRI)	134	121	171				
Lane & Width Information							
Number of Lanes	2	2	2				
Paved Width (ft)	30.1	29.9	30.3				
Lane Width (ft)	12.3	12.1	12.7

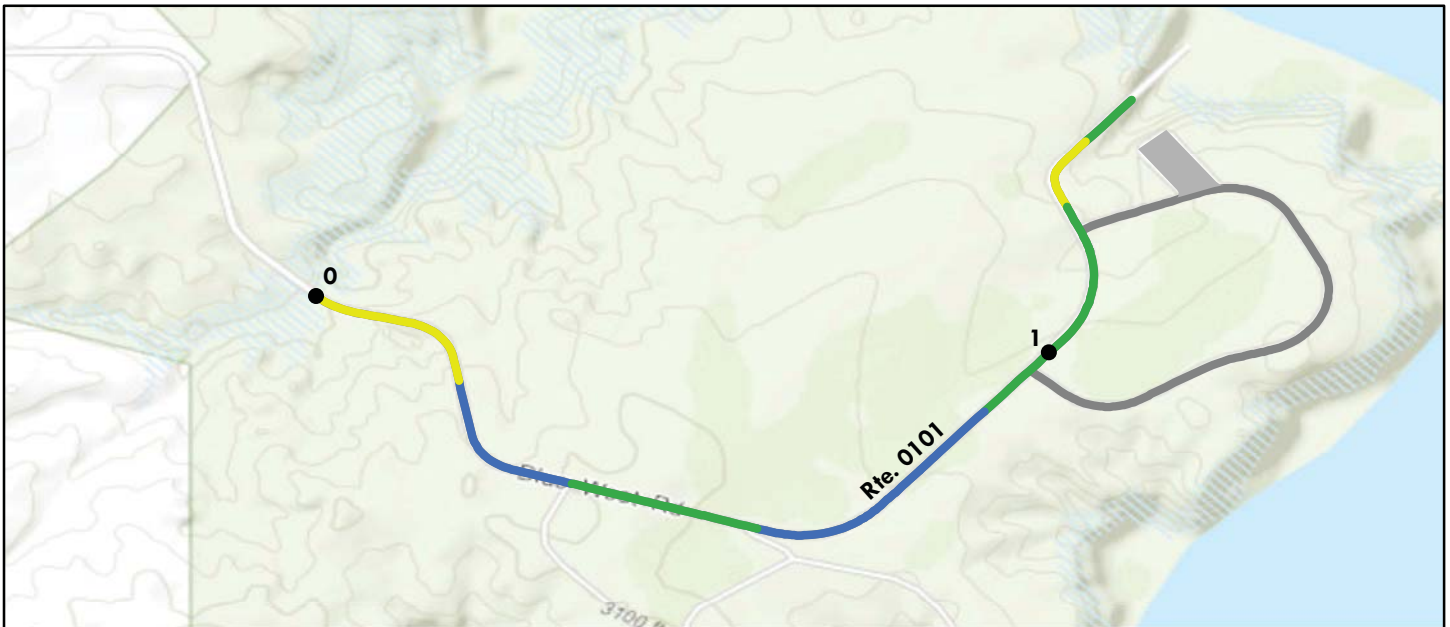
## ROUTE 0101: BLUE WEST ACCESS ROAD

Route Condition Legend – Pavement Condition Rating (PCR)									
Poor (0 - 60)		Fair (61- 84)		Good (85 - 94)		Excellent (95 - 100)		Not Rated	
Colors on map represent condition scores at 0.10-mile intervals. See Appendix for definitions and formulas.									
<b>Inspection Date:</b>	11/8/2017	<b>Beginning Section MP</b>	0	1					
<b>Paved Length (Miles):</b>	1.37	<b>Section Length (MI)</b>	1	0.37					
<b>Surface Type:</b>	ASPHALT	<b>Route Summary</b>							
<b>Roadway Condition Information</b>									
Pavement Condition Rating (PCR)	91	91	89						
Surface Condition Rating (SCR)	96	95	96						
Roughness Condition Index (RCI)	84	86	78						
<b>Distress Index Values</b>									
Structural Crack Index	99	98	100						
Alligator Crack Index	100	100	100						
Longitudinal Crack Index	99	98	100						
Transverse Cracking Index	96	95	98						
Patching Index	100	100	100						
Rutting Index	98	97	96						
International Roughness Index (IRI)	157	150	174

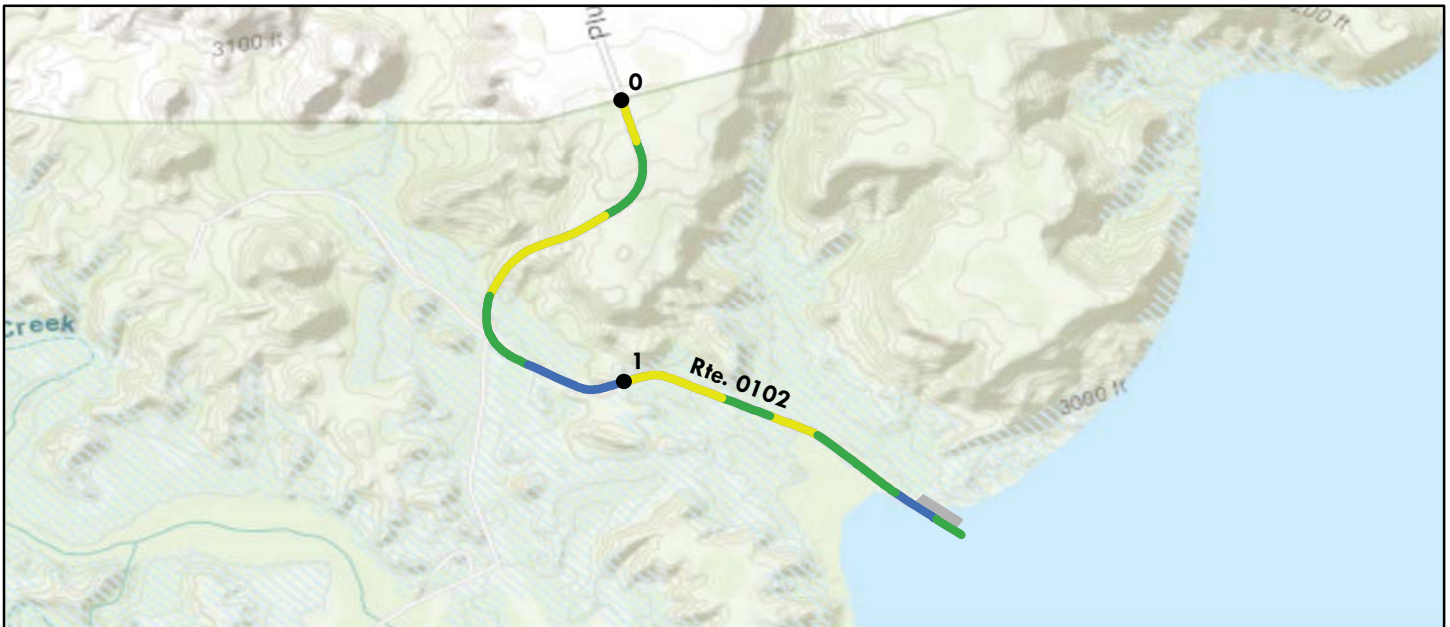
## ROUTE 0102: PLUM CREEK ACCESS ROAD

Inspection Date:	11/8/2017	Beginning Section MP	0	1			
Paved Length (Miles):	1.76	Section Length (MI)	1	0.76			
Surface Type:	ASPHALT	Route Summary					
Roadway Condition Information							
Pavement Condition Rating (PCR)	87	87	87				
Surface Condition Rating (SCR)	96	97	94				
Roughness Condition Index (RCI)	73	71	76				
Distress Index Values							
Structural Crack Index	98	99	97				
Alligator Crack Index	100	100	100				
Longitudinal Crack Index	98	99	97				
Transverse Cracking Index	96	98	94				
Patching Index	100	100	100				
Rutting Index	96	97	94				
International Roughness Index (IRI)	192	199	183				
Lane & Width Information							
Number of Lanes	2	2	2				
Paved Width (ft)	22.9	23.6	22.2				
Lane Width (ft)	9.5	9.5	9.5

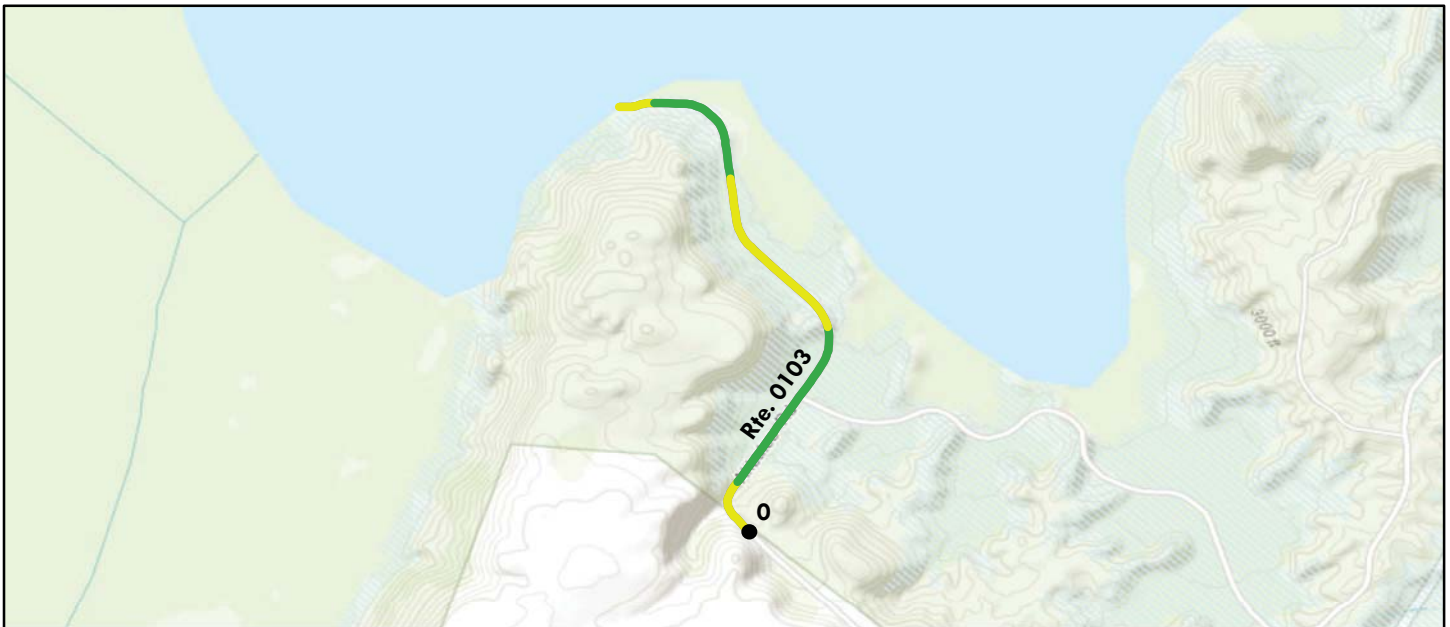
## ROUTE 0103: BATES CANYON ROAD

Route Condition Legend – Pavement Condition Rating (PCR)						
Poor (0 - 60)	Fair (61- 84)	Good (85 - 94)	Excellent (95 - 100)	Not Rated		
Colors on map represent condition scores at 0.10-mile intervals. See Appendix for definitions and formulas.						
<b>Inspection Date:</b> 11/9/2017	<b>Beginning Section MP</b>	0				
<b>Paved Length (Miles):</b> 0.95	<b>Section Length (MI)</b>	0.95				
<b>Surface Type:</b> ASPHALT	<b>Route Summary</b>					
<b>Roadway Condition Information</b>						
Pavement Condition Rating (PCR)	86	86				
Surface Condition Rating (SCR)	88	88				
Roughness Condition Index (RCI)	84	84				
<b>Distress Index Values</b>						
Structural Crack Index	88	88				
Alligator Crack Index	100	100				
Longitudinal Crack Index	88	88				
Transverse Cracking Index	89	89				
Patching Index	99	99				
Rutting Index	97	97				
International Roughness Index (IRI)	158	158				
<b>Lane &amp; Width Information</b>

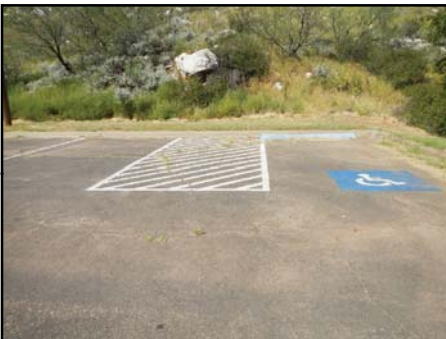
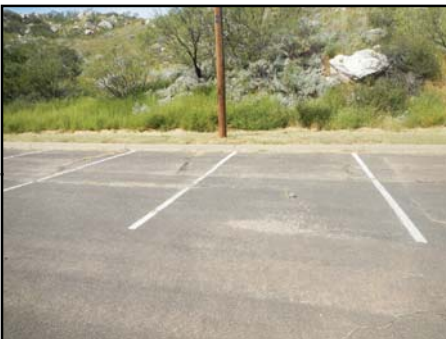
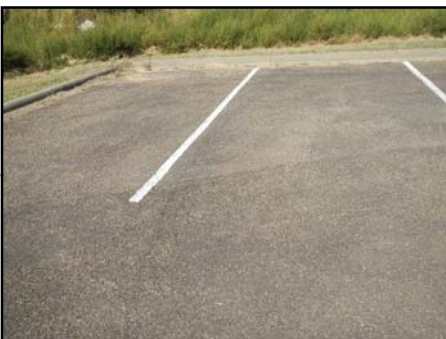
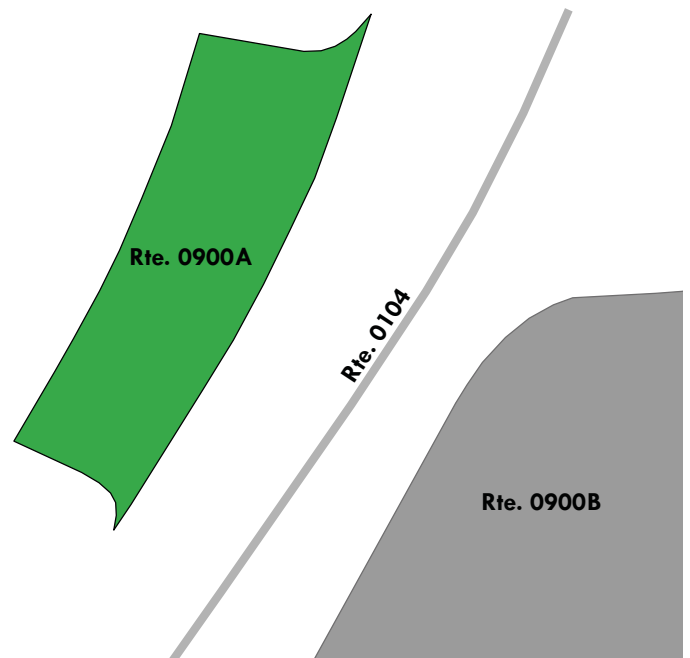
Inspection Date	FMSS Number	User Access	Surface Type
9/20/2017	91765	PUBLIC	ASPHALT
Area (Sq. Ft.)	Lane Miles (11' Widths)	Curb Reveal (Inches)	Curb Recommendation
3,430	0.059	NOT APPLICABLE	DO NOTHING
Curb Type		Curb & Gutter Type	
NO CURB		CONCRETE	
Pavement Recommendation		Condition Rating / PCR	
PREVENTIVE MAINTENANCE		GOOD / 90

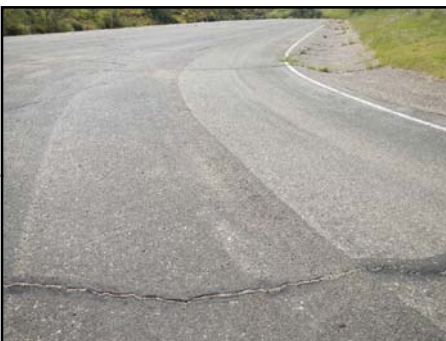
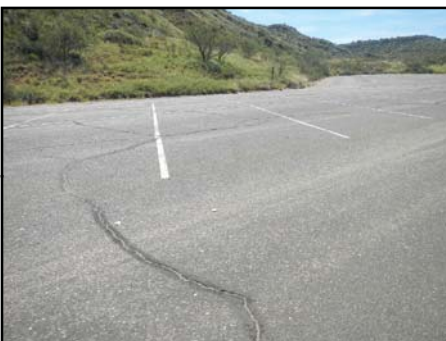
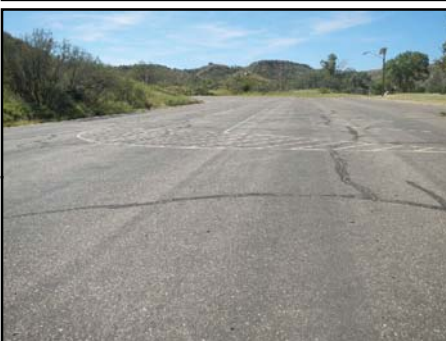
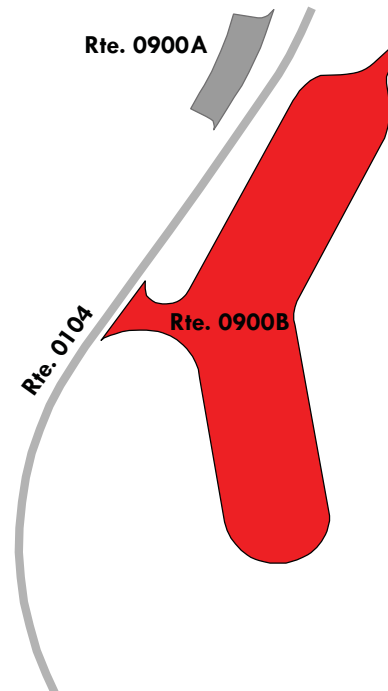
## ROUTE 0900B: HARBOR BAY PARKING B

Inspection Date	FMSS Number	User Access	Surface Type
9/20/2017	104417	PUBLIC	ASPHALT
Area (Sq. Ft.)	Lane Miles (11' Widths)	Curb Reveal (Inches)	Curb Recommendation
49,326	0.849	4	DO NOTHING
Curb Type		Curb & Gutter Type	
CONCRETE		NO CURB AND GUTTER	
Pavement Recommendation		Condition Rating / PCR	
HEAVY 3R TREATMENTS		POOR / 53

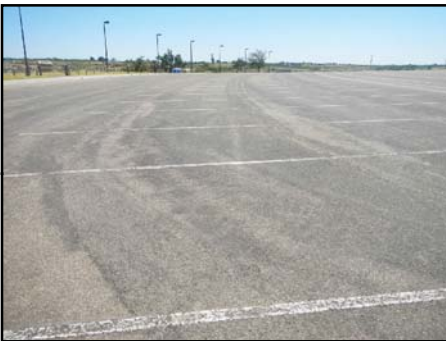
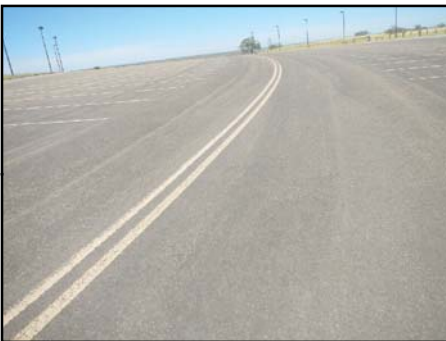
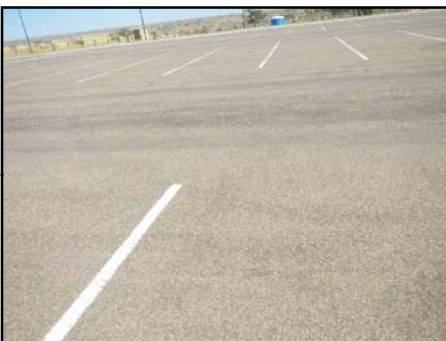
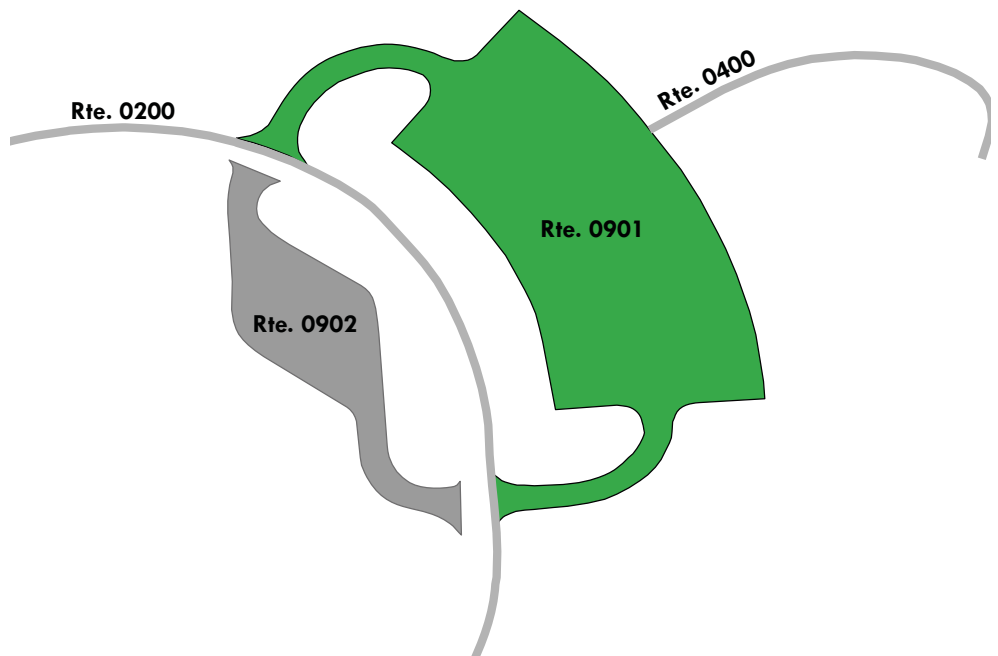
## ROUTE 0901: FRITCH FORTRESS AMPHITHEATER PARKING

Inspection Date	FMSS Number	User Access	Surface Type
9/19/2017	91766	PUBLIC	ASPHALT
Area (Sq. Ft.)	Lane Miles (11' Widths)	Curb Reveal (Inches)	Curb Recommendation
92,190	1.587	NOT APPLICABLE	LIGHT REPAIR
Curb Type		Curb & Gutter Type	
NO CURB		CONCRETE	
Pavement Recommendation		Condition Rating / PCR	
PREVENTIVE MAINTENANCE		GOOD / 90

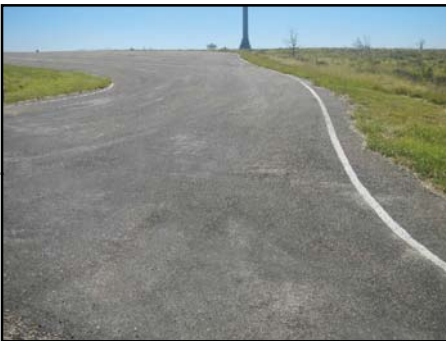
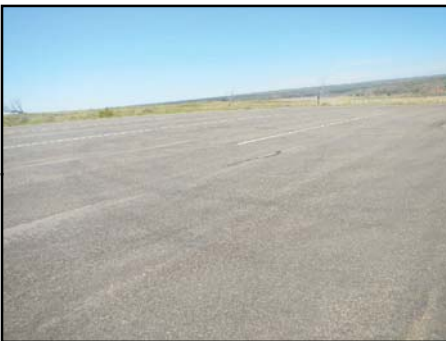
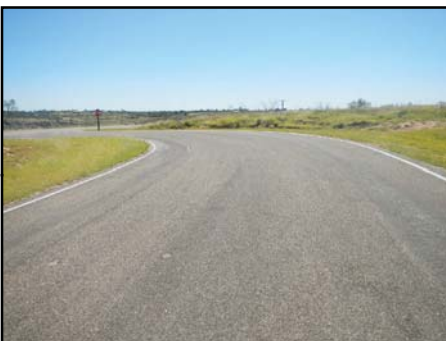
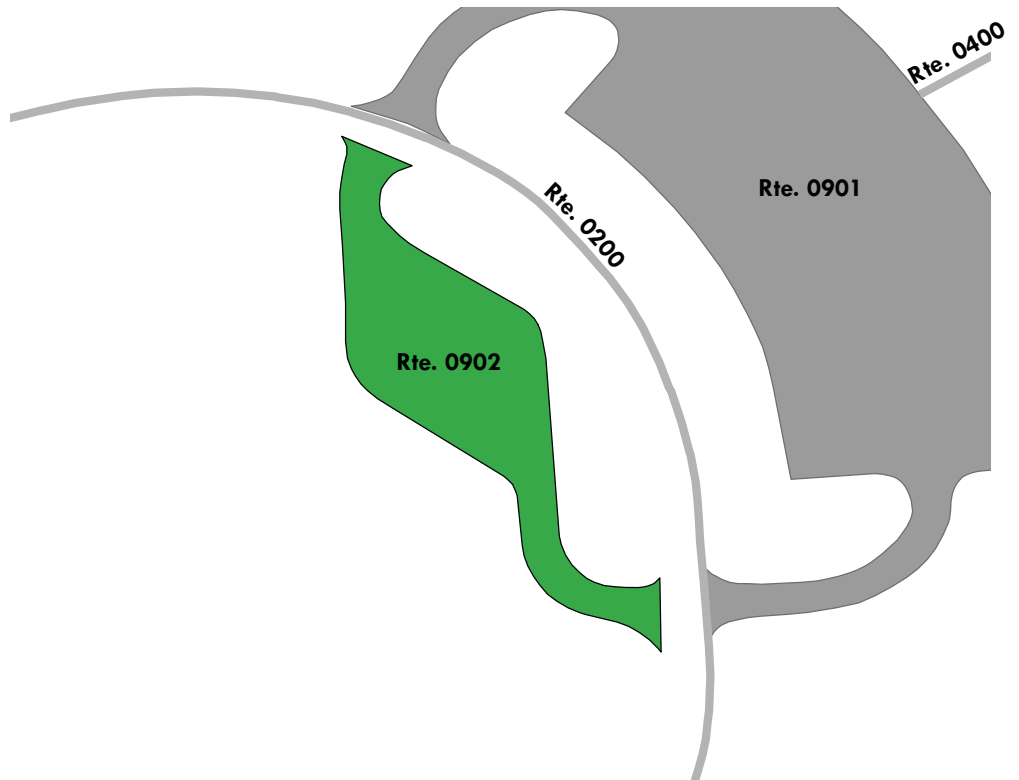
## ROUTE 0902: FRITCH FORTRESS AMPHITHEATER OVERFLOW PARKING

Inspection Date	FMSS Number	User Access	Surface Type
9/19/2017	91767	PUBLIC	ASPHALT
Area (Sq. Ft.)	Lane Miles (11' Widths)	Curb Reveal (Inches)	Curb Recommendation
25,256	0.435	NOT APPLICABLE	NOT APPLICABLE
Curb Type		Curb & Gutter Type	
NO CURB		NO CURB AND GUTTER	
Pavement Recommendation		Condition Rating / PCR	
PREVENTIVE MAINTENANCE		GOOD / 90

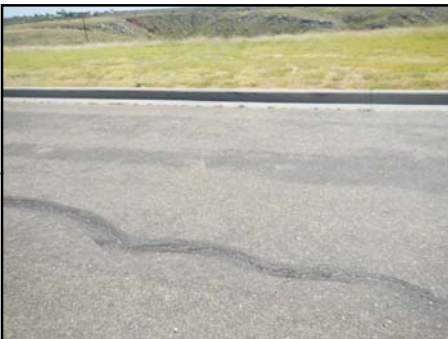
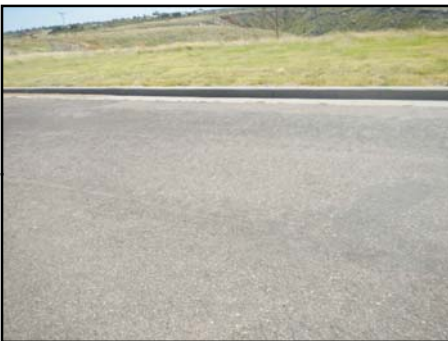
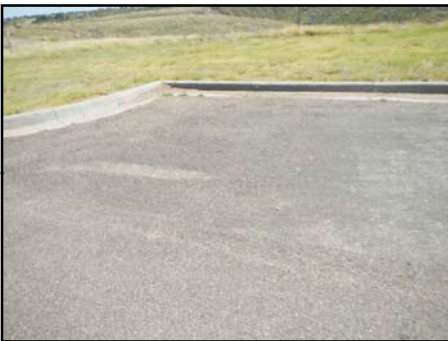
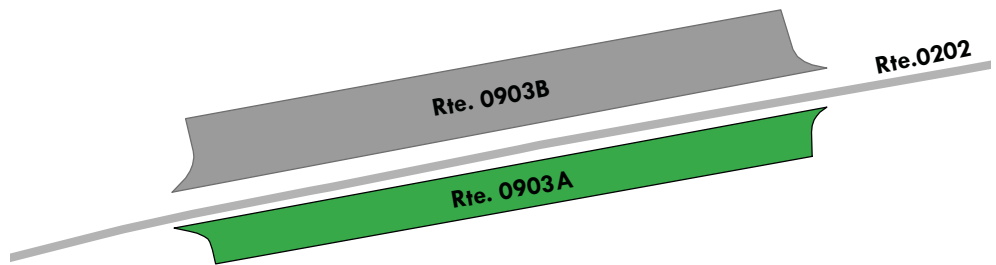
## ROUTE 0903A: FRITCH FORTRESS COMFORT STATION PARKING A

Inspection Date	FMSS Number	User Access	Surface Type
9/19/2017	91768	PUBLIC	ASPHALT
Area (Sq. Ft.)	Lane Miles (11' Widths)	Curb Reveal (Inches)	Curb Recommendation
2,030	0.035	NOT APPLICABLE	DO NOTHING
Curb Type		Curb & Gutter Type	
NO CURB		CONCRETE	
Pavement Recommendation		Condition Rating / PCR	
PREVENTIVE MAINTENANCE		GOOD / 90

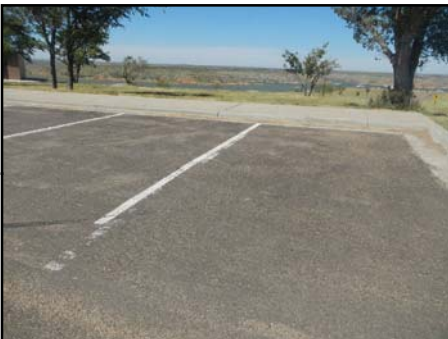
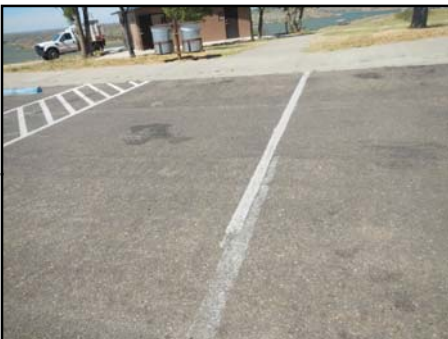
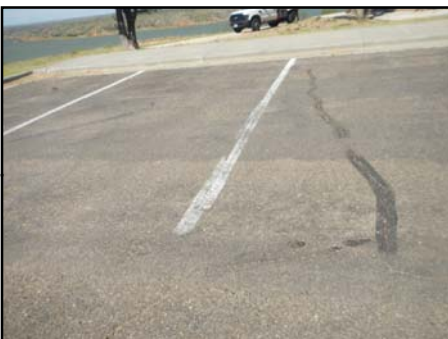
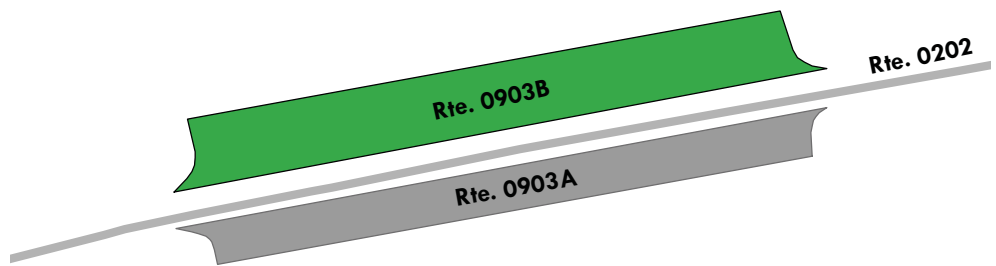
Inspection Date	FMSS Number	User Access	Surface Type
9/19/2017	104418	PUBLIC	ASPHALT
Area (Sq. Ft.)	Lane Miles (11' Widths)	Curb Reveal (Inches)	Curb Recommendation
3,091	0.053	NOT APPLICABLE	DO NOTHING
Curb Type		Curb & Gutter Type	
NO CURB		CONCRETE	
Pavement Recommendation		Condition Rating / PCR	
PREVENTIVE MAINTENANCE		GOOD / 90

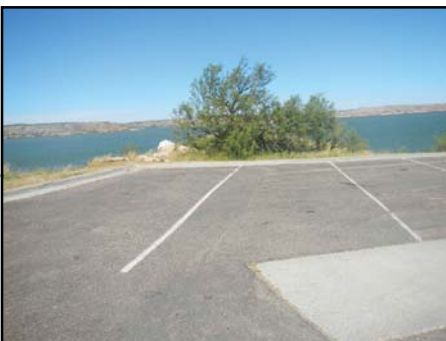
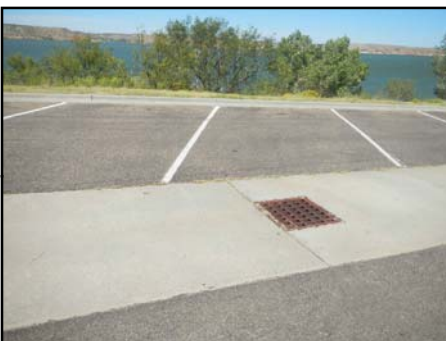
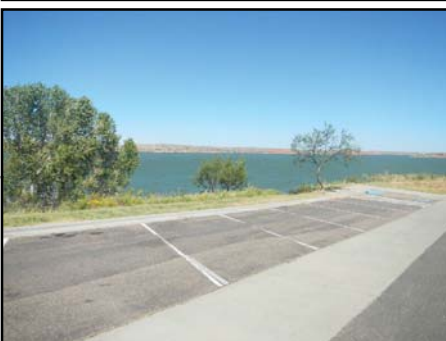
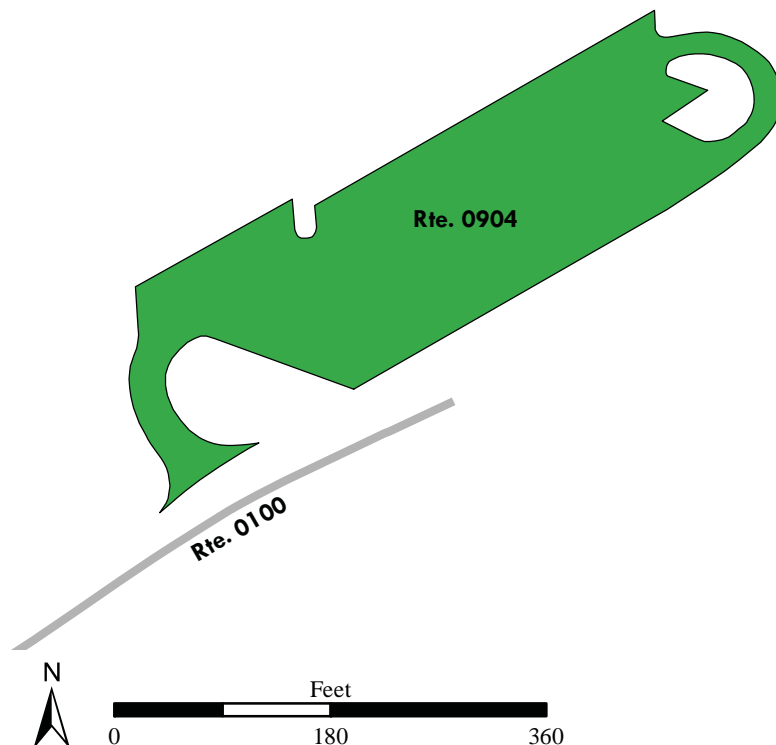
## ROUTE 0904: FRITCH FORTRESS PARKING

Inspection Date	FMSS Number	User Access	Surface Type
9/19/2017	91769	PUBLIC	ASPHALT
Area (Sq. Ft.)	Lane Miles (11' Widths)	Curb Reveal (Inches)	Curb Recommendation
60,291	1.038	NOT APPLICABLE	DO NOTHING
Curb Type		Curb & Gutter Type	
NO CURB		CONCRETE	
Pavement Recommendation		Condition Rating / PCR	
PREVENTIVE MAINTENANCE		GOOD / 90

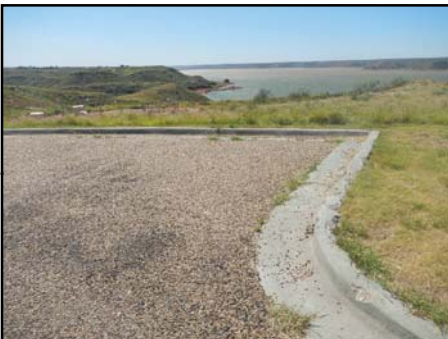
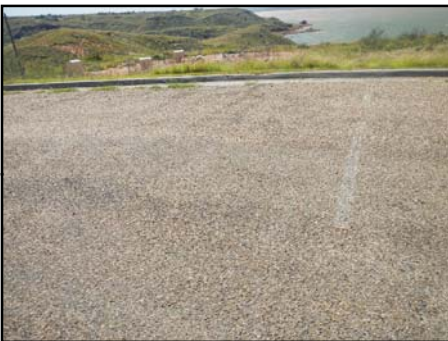
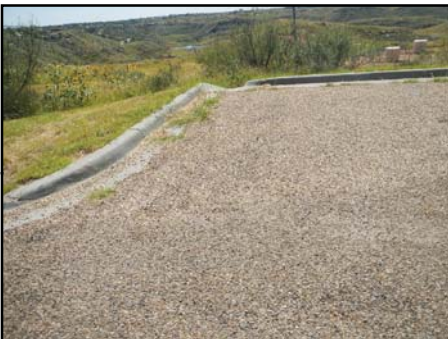
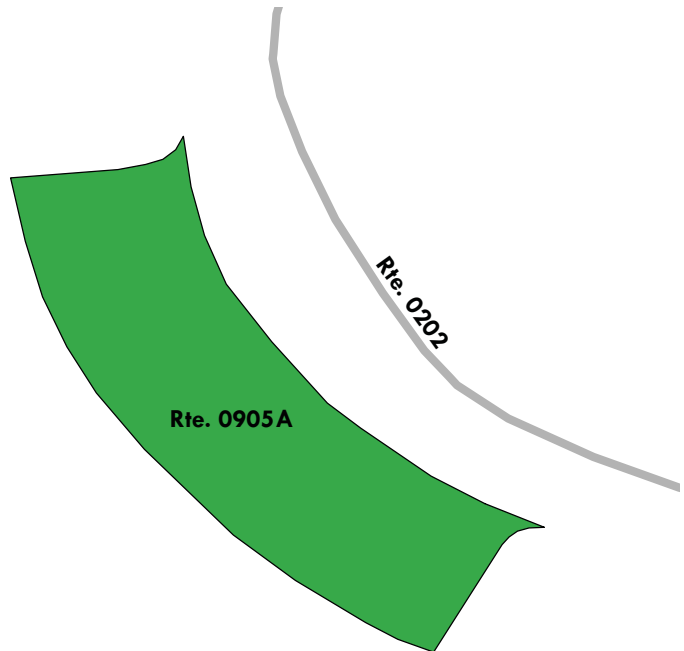
## ROUTE 0905A: FRITCH FORTRESS PICNIC PARKING A

Inspection Date	FMSS Number	User Access	Surface Type
9/19/2017	91770	PUBLIC	ASPHALT
Area (Sq. Ft.)	Lane Miles (11' Widths)	Curb Reveal (Inches)	Curb Recommendation
1,411	0.024	NOT APPLICABLE	DO NOTHING
Curb Type		Curb & Gutter Type	
NO CURB		CONCRETE	
Pavement Recommendation		Condition Rating / PCR	
PREVENTIVE MAINTENANCE		GOOD / 90

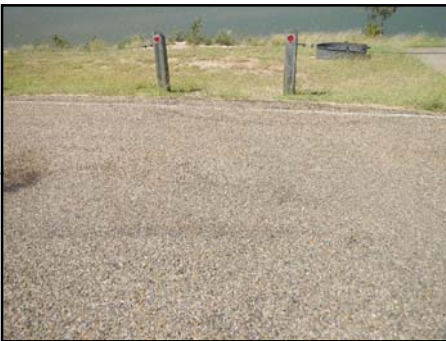
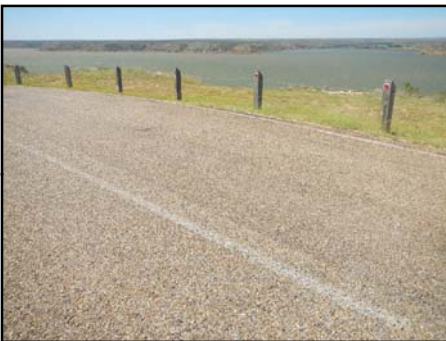
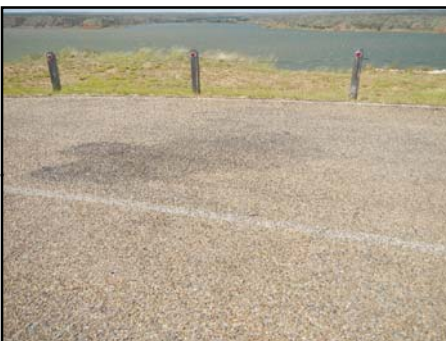
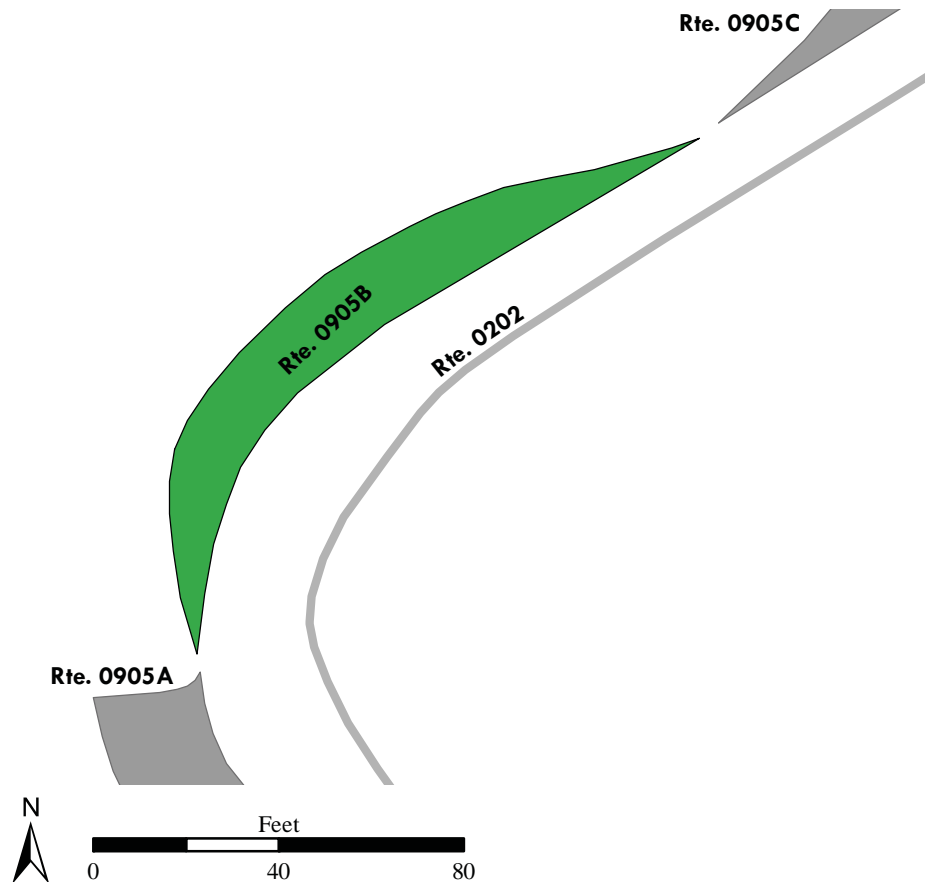
## ROUTE 0905B: FRITCH FORTRESS PICNIC PARKING B

Inspection Date	FMSS Number	User Access	Surface Type
9/19/2017	104419	PUBLIC	ASPHALT
Area (Sq. Ft.)	Lane Miles (11' Widths)	Curb Reveal (Inches)	Curb Recommendation
1,546	0.027	NOT APPLICABLE	NOT APPLICABLE
Curb Type		Curb & Gutter Type	
NO CURB		NO CURB AND GUTTER	
Pavement Recommendation		Condition Rating / PCR	
PREVENTIVE MAINTENANCE		GOOD / 90

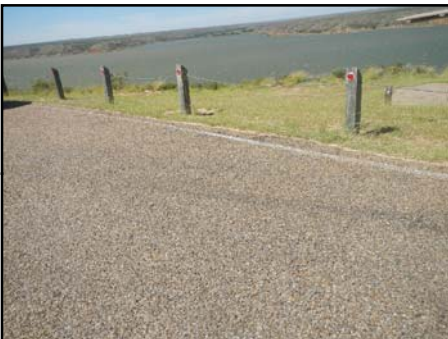
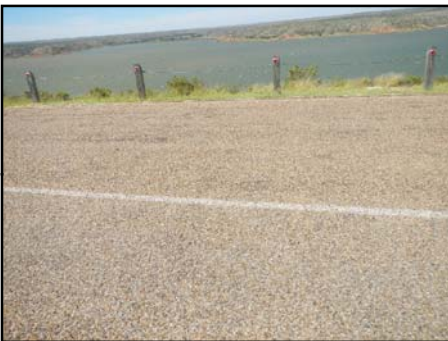
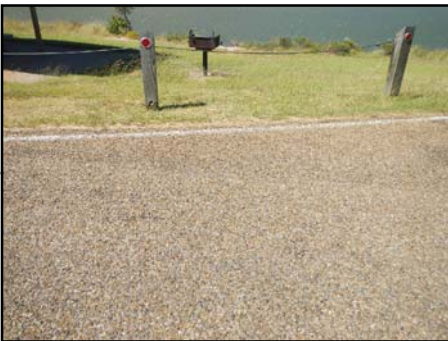
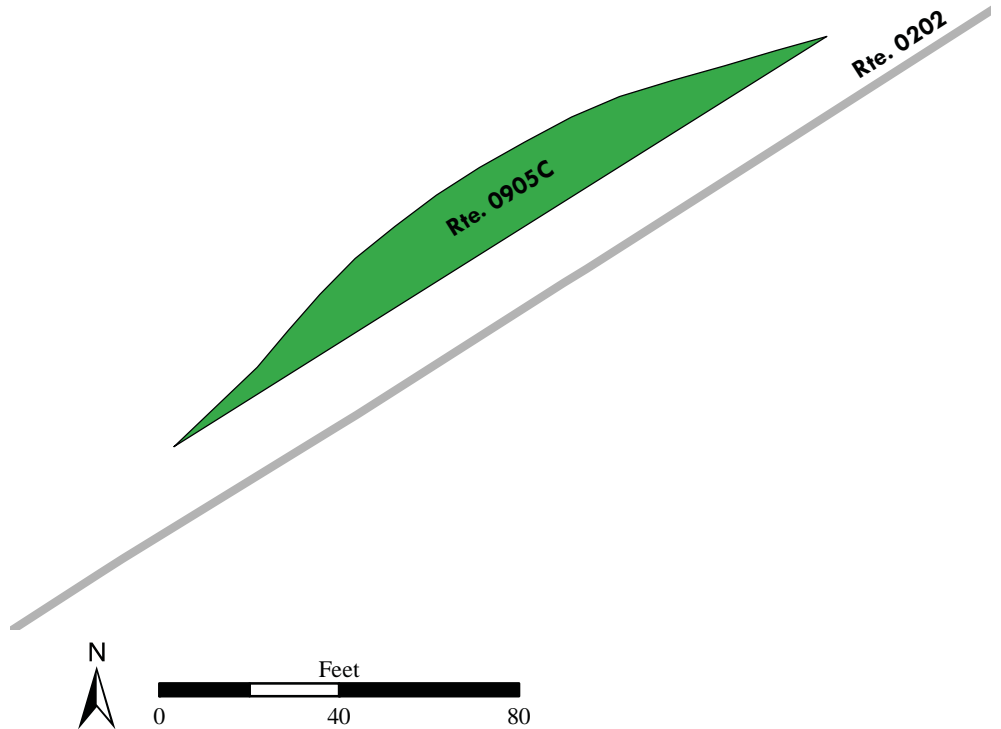
## ROUTE 0905C: FRITCH FORTRESS PICNIC PARKING C

Inspection Date	FMSS Number	User Access	Surface Type
9/19/2017	104420	PUBLIC	ASPHALT
Area (Sq. Ft.)	Lane Miles (11' Widths)	Curb Reveal (Inches)	Curb Recommendation
1,420	0.024	NOT APPLICABLE	NOT APPLICABLE
Curb Type		Curb & Gutter Type	
NO CURB		NO CURB AND GUTTER	
Pavement Recommendation		Condition Rating / PCR	
PREVENTIVE MAINTENANCE		GOOD / 90

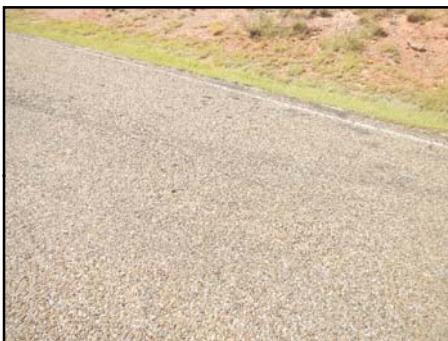
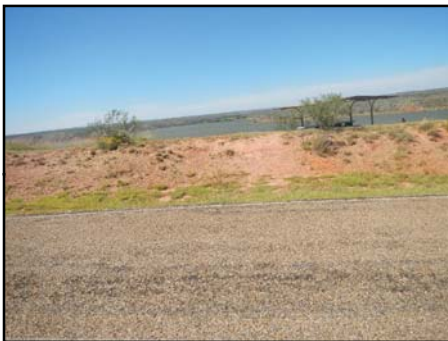
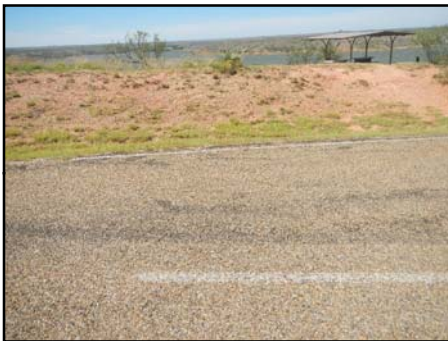
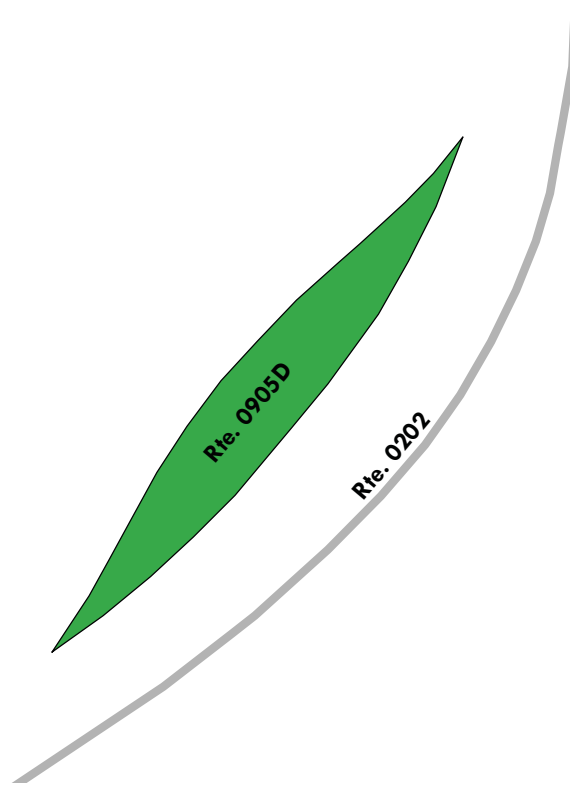
## ROUTE 0905D: FRITCH FORTRESS PICNIC PARKING D

Inspection Date	FMSS Number	User Access	Surface Type
9/19/2017	104421	PUBLIC	ASPHALT
Area (Sq. Ft.)	Lane Miles (11' Widths)	Curb Reveal (Inches)	Curb Recommendation
1,003	0.017	NOT APPLICABLE	NOT APPLICABLE
Curb Type		Curb & Gutter Type	
NO CURB		NO CURB AND GUTTER	
Pavement Recommendation		Condition Rating / PCR	
PREVENTIVE MAINTENANCE		GOOD / 90

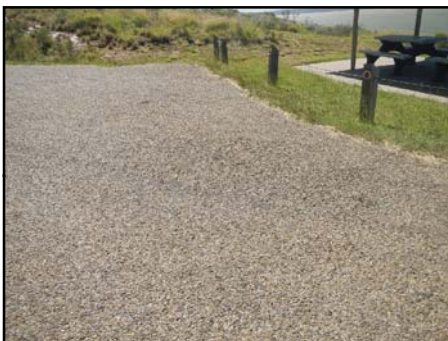
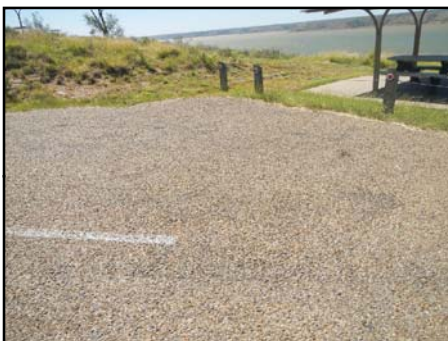
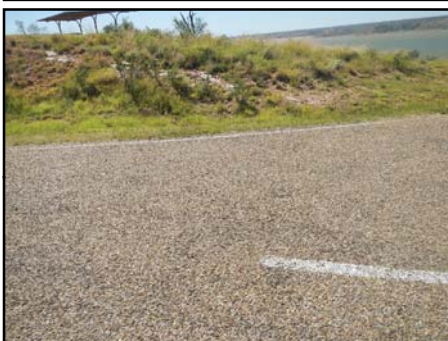
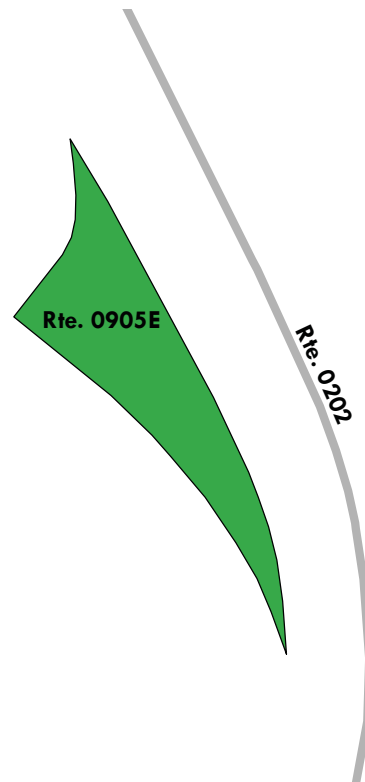
## ROUTE 0905E: FRITCH FORTRESS PICNIC PARKING E

Inspection Date	FMSS Number	User Access	Surface Type
9/19/2017	104422	PUBLIC	ASPHALT
Area (Sq. Ft.)	Lane Miles (11' Widths)	Curb Reveal (Inches)	Curb Recommendation
1,016	0.017	NOT APPLICABLE	NOT APPLICABLE
Curb Type		Curb & Gutter Type	
NO CURB		NO CURB AND GUTTER	
Pavement Recommendation		Condition Rating / PCR	
PREVENTIVE MAINTENANCE		GOOD / 90

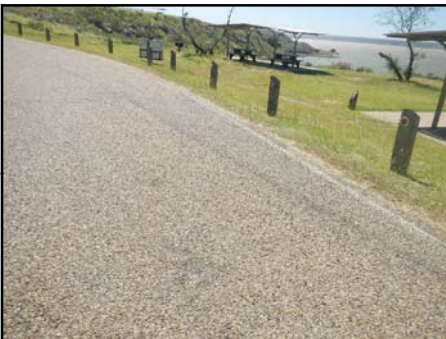
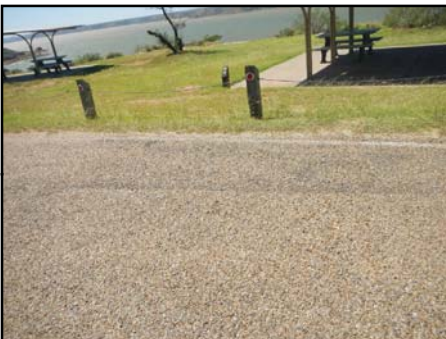
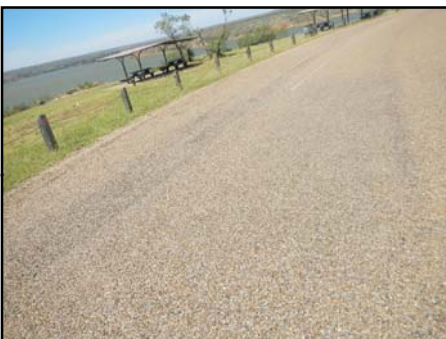
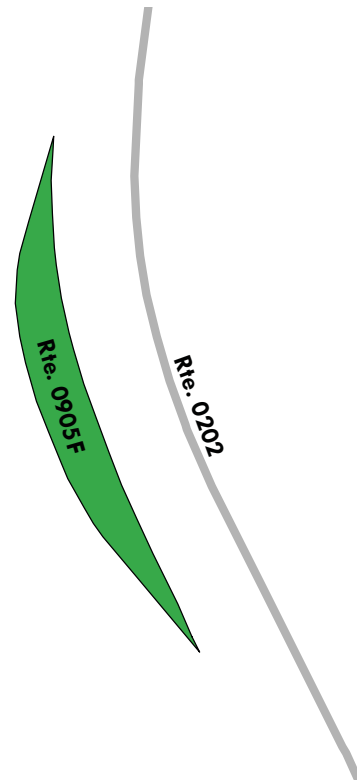
## ROUTE 0905F: FRITCH FORTRESS PICNIC PARKING F

Inspection Date	FMSS Number	User Access	Surface Type
9/19/2017	104423	PUBLIC	ASPHALT
Area (Sq. Ft.)	Lane Miles (11' Widths)	Curb Reveal (Inches)	Curb Recommendation
1,360	0.023	NOT APPLICABLE	NOT APPLICABLE
Curb Type		Curb & Gutter Type	
NO CURB		NO CURB AND GUTTER	
Pavement Recommendation		Condition Rating / PCR	
PREVENTIVE MAINTENANCE		GOOD / 90

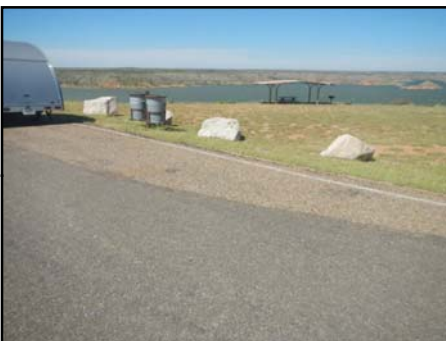
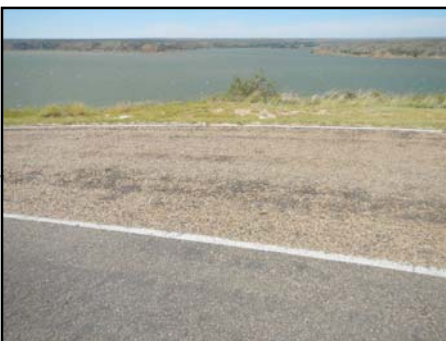
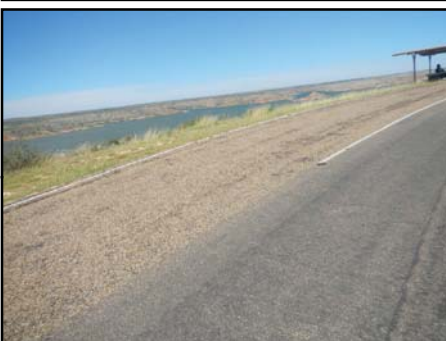
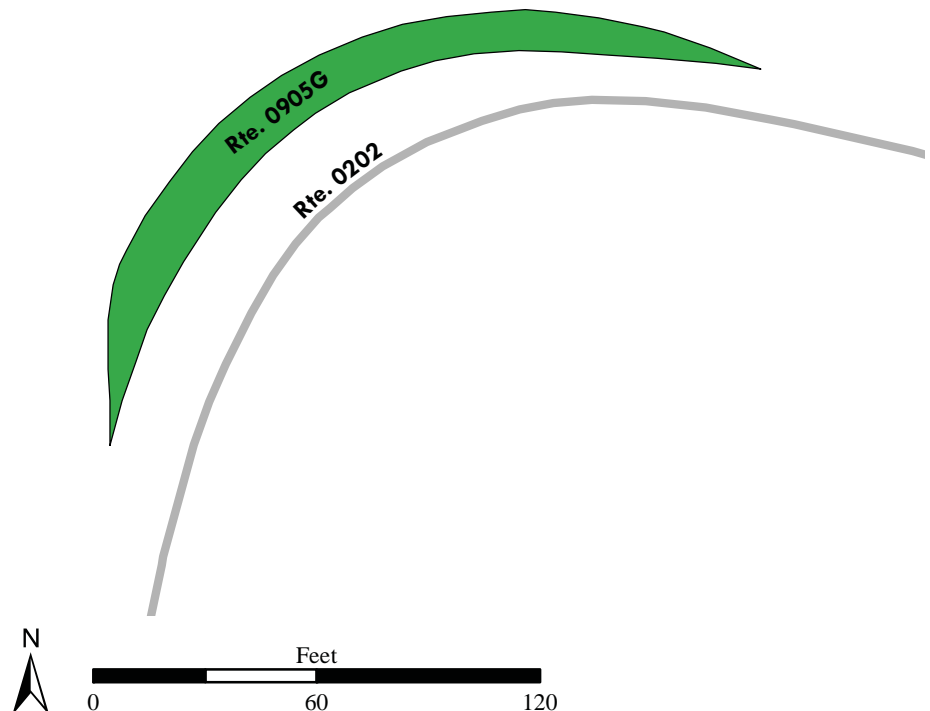
## ROUTE 0905G: FRITCH FORTRESS PICNIC PARKING G

Inspection Date	FMSS Number	User Access	Surface Type
9/19/2017	104424	PUBLIC	ASPHALT
Area (Sq. Ft.)	Lane Miles (11' Widths)	Curb Reveal (Inches)	Curb Recommendation
2,043	0.035	NOT APPLICABLE	NOT APPLICABLE
Curb Type		Curb & Gutter Type	
NO CURB		NO CURB AND GUTTER	
Pavement Recommendation		Condition Rating / PCR	
PREVENTIVE MAINTENANCE		GOOD / 90

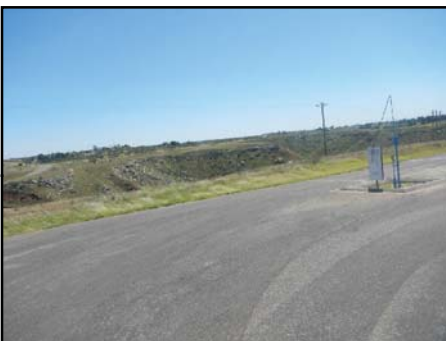
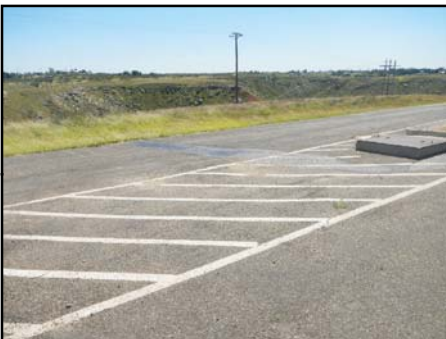
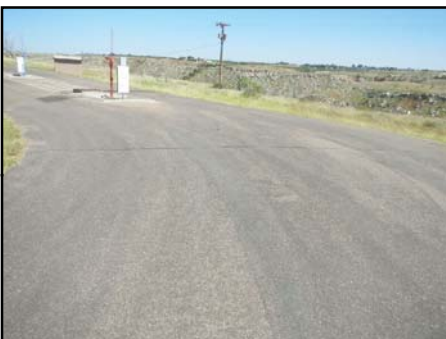
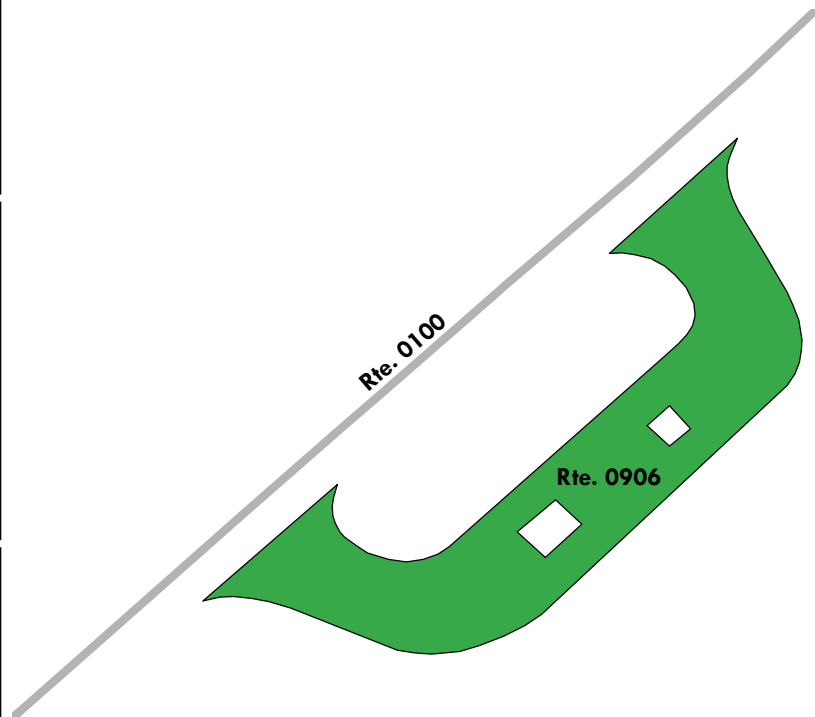
## ROUTE 0906: FRITCH FORTRESS DUMP STATION

Inspection Date	FMSS Number	User Access	Surface Type
9/19/2017	91771	PUBLIC	ASPHALT
Area (Sq. Ft.)	Lane Miles (11' Widths)	Curb Reveal (Inches)	Curb Recommendation
8,117	0.14	NOT APPLICABLE	NOT APPLICABLE
Curb Type		Curb & Gutter Type	
NO CURB		NO CURB AND GUTTER	
Pavement Recommendation		Condition Rating / PCR	
PREVENTIVE MAINTENANCE		GOOD / 90

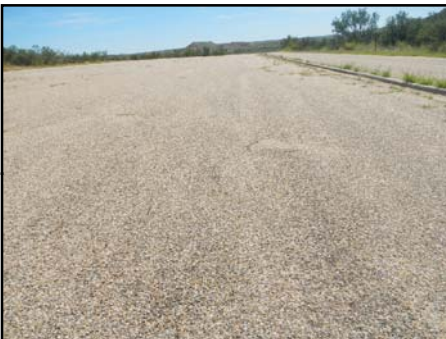
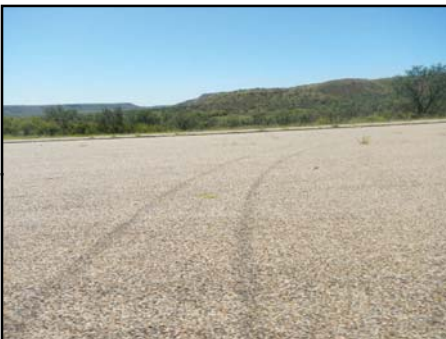
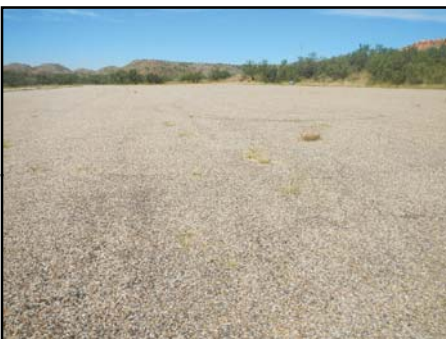
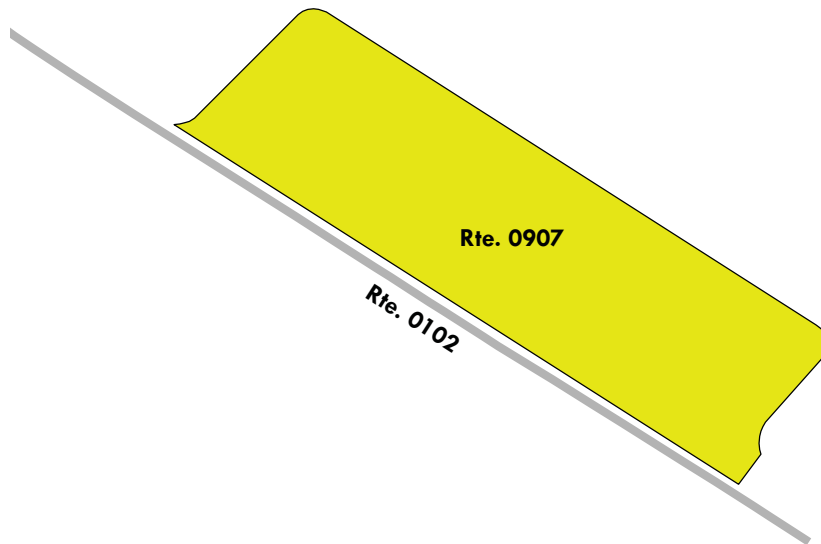
Inspection Date	FMSS Number	User Access	Surface Type
9/20/2017	91772	PUBLIC	ASPHALT
Area (Sq. Ft.)	Lane Miles (11' Widths)	Curb Reveal (Inches)	Curb Recommendation
82,602	1.422	NOT APPLICABLE	DO NOTHING
Curb Type		Curb & Gutter Type	
NO CURB		CONCRETE	
Pavement Recommendation		Condition Rating / PCR	
LIGHT 3R TREATMENTS		FAIR / 73
