# LAMR Cycle 6

## Final Report

### Road Inventory and Condition Assessment of Paved Routes Lake Meredith National Recreation Area

Report Date: April 2018

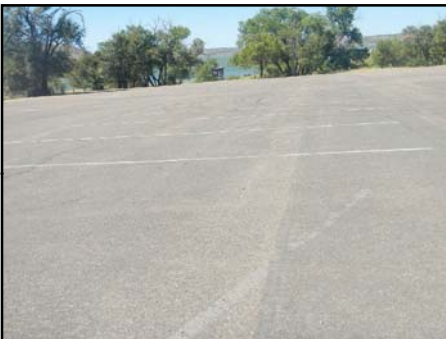
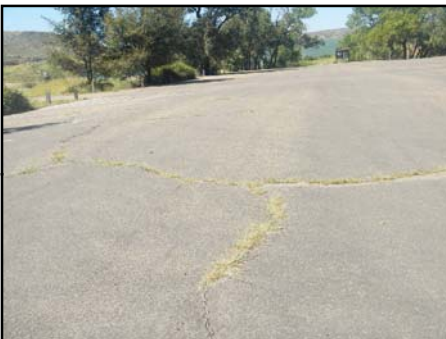
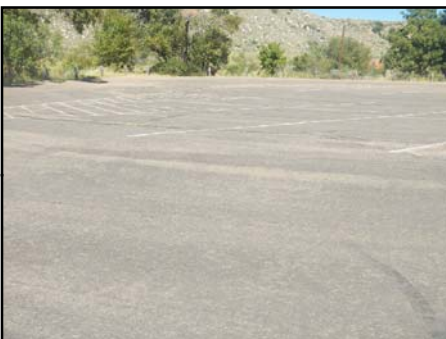
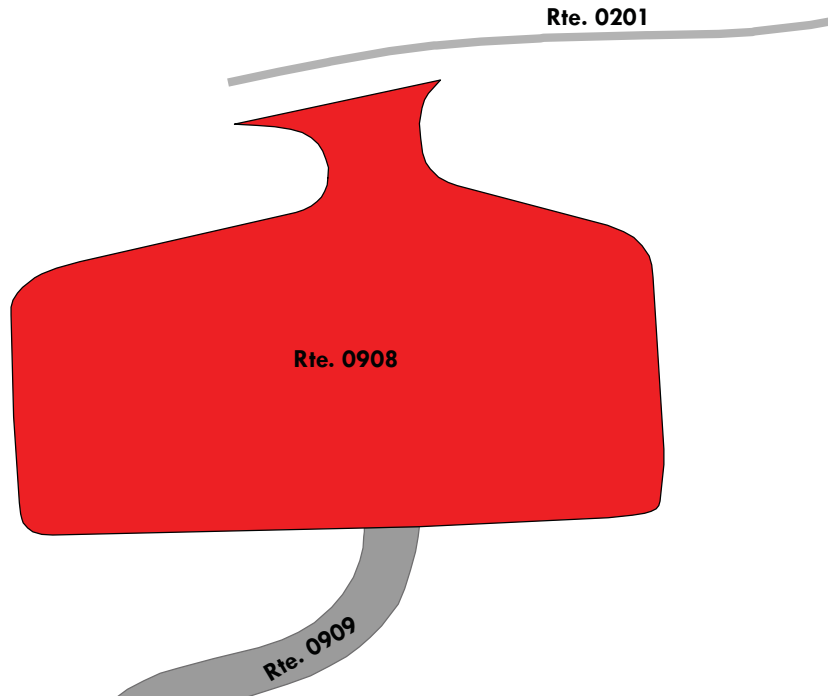
## ROUTE 0908: CEDAR CANYON PARKING

Inspection Date	FMSS Number	User Access	Surface Type
9/19/2017	91773	PUBLIC	ASPHALT
Area (Sq. Ft.)	Lane Miles (11' Widths)	Curb Reveal (Inches)	Curb Recommendation
63,110	1.087	NOT APPLICABLE	NOT APPLICABLE
Curb Type		Curb & Gutter Type	
NO CURB		NO CURB AND GUTTER	
Pavement Recommendation		Condition Rating / PCR	
HEAVY 3R TREATMENTS		POOR / 53

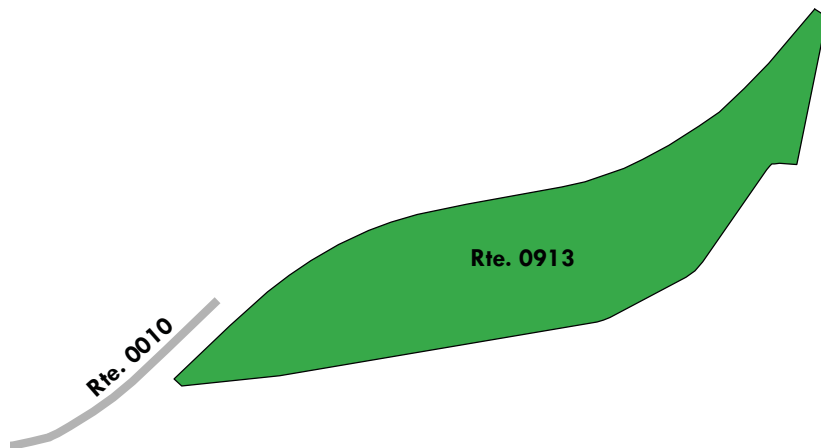
Note: The closed off area was not factored into the pavement condition rating, however, this area requires further action to address the erosion and undercutting.

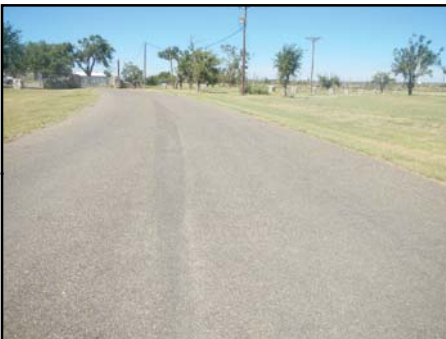
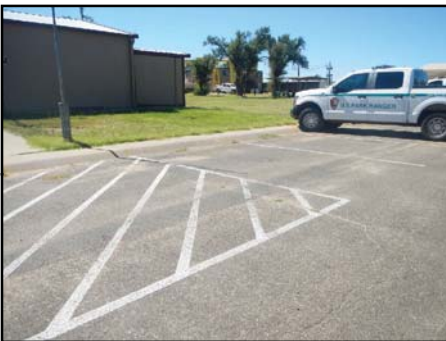
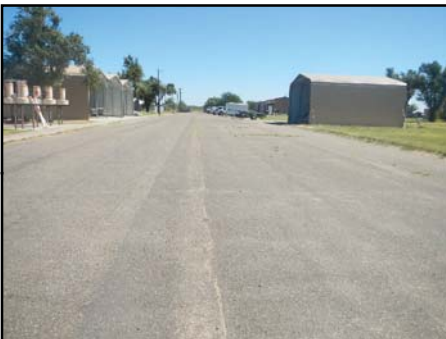
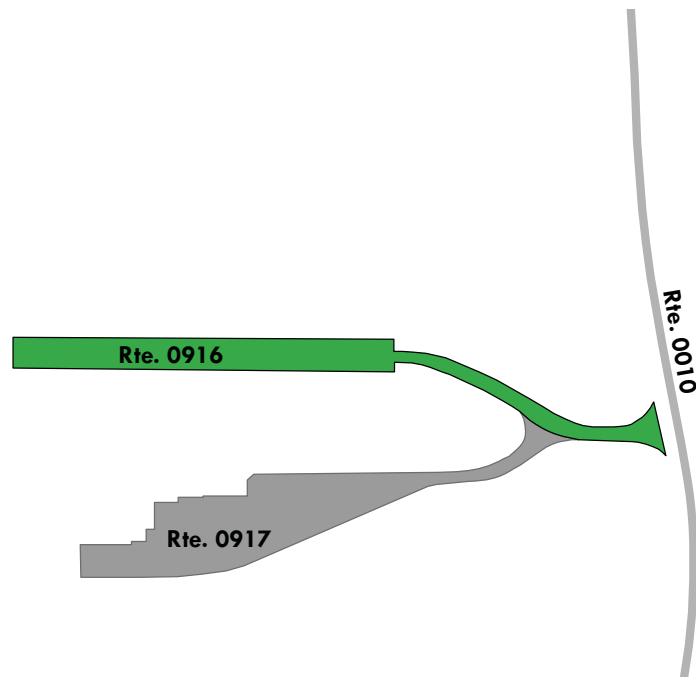
Inspection Date	FMSS Number	User Access	Surface Type
9/19/2017	91782	NONPUBLIC	ASPHALT
Area (Sq. Ft.)	Lane Miles (11' Widths)	Curb Reveal (Inches)	Curb Recommendation
33,587	0.578	4	LIGHT REPAIR
Curb Type		Curb & Gutter Type	
CONCRETE		CONCRETE	
Pavement Recommendation		Condition Rating / PCR	
PREVENTIVE MAINTENANCE		GOOD / 90

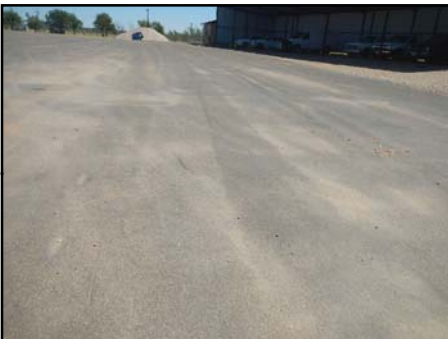
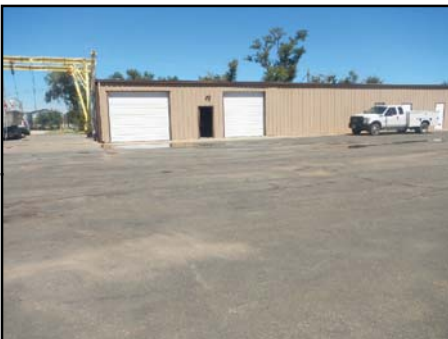
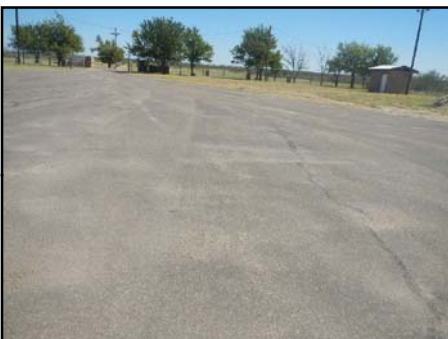
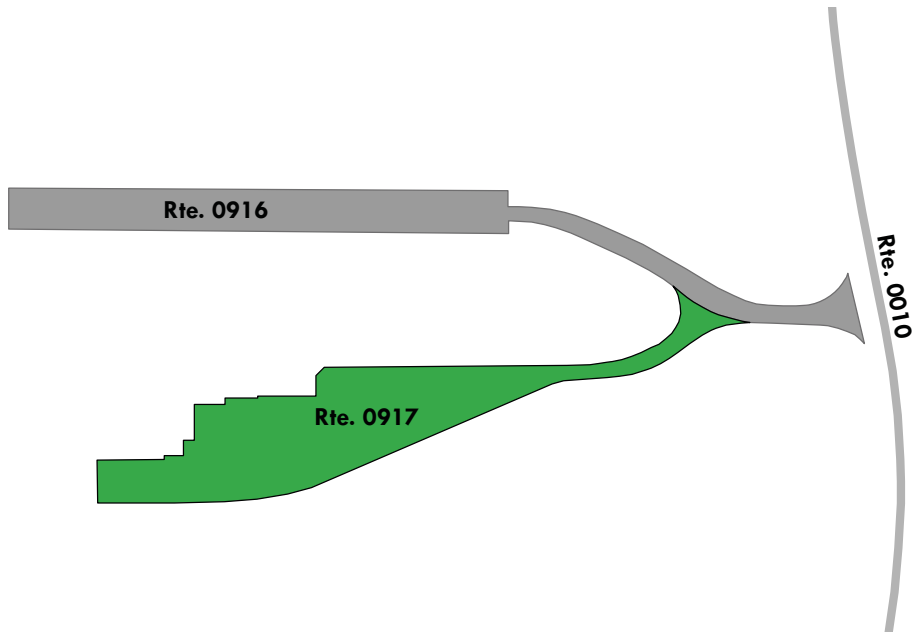
## ROUTE 0917: CEDAR CANYON MAINTENANCE AREA

Inspection Date	FMSS Number	User Access	Surface Type
9/19/2017	91783	NONPUBLIC	ASPHALT
Area (Sq. Ft.)	Lane Miles (11' Widths)	Curb Reveal (Inches)	Curb Recommendation
42,388	0.73	NOT APPLICABLE	NOT APPLICABLE
Curb Type		Curb & Gutter Type	
NO CURB		NO CURB AND GUTTER	
Pavement Recommendation		Condition Rating / PCR	
PREVENTIVE MAINTENANCE		GOOD / 90

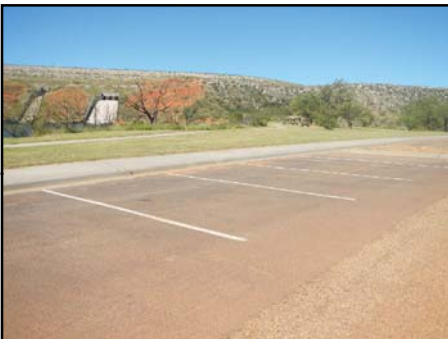
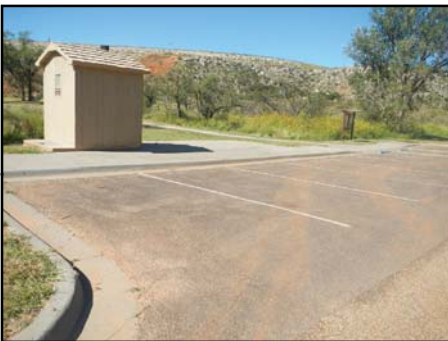
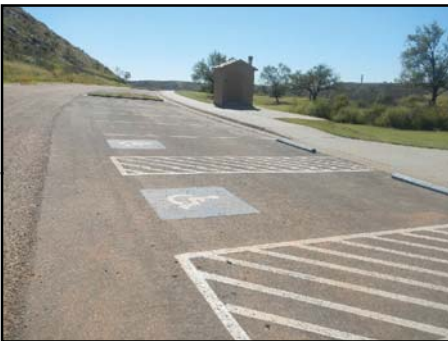
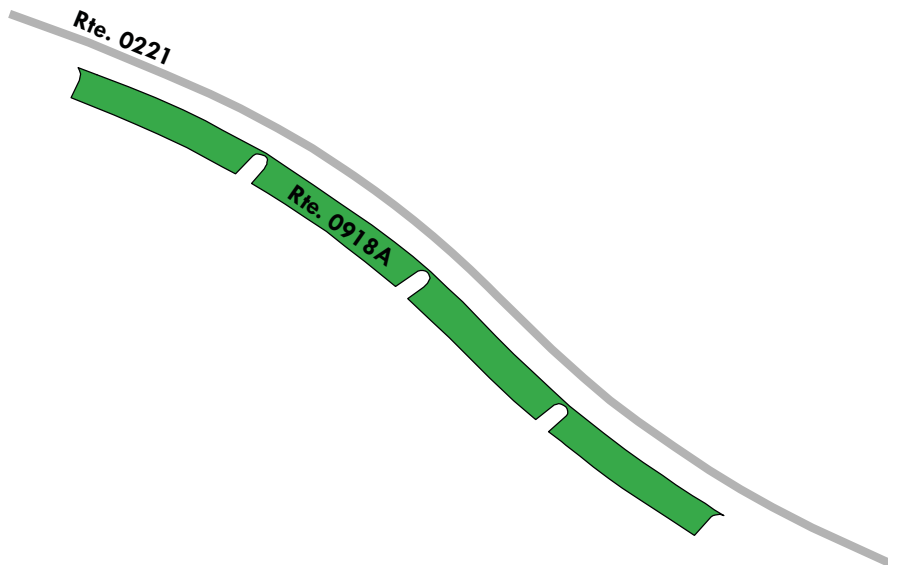
## ROUTE 0918A: SPRING CANYON PARKING A

Inspection Date	FMSS Number	User Access	Surface Type
9/19/2017	91784	PUBLIC	ASPHALT
Area (Sq. Ft.)	Lane Miles (11' Widths)	Curb Reveal (Inches)	Curb Recommendation
11,181	0.193	NOT APPLICABLE	DO NOTHING
Curb Type		Curb & Gutter Type	
NO CURB		CONCRETE	
Pavement Recommendation		Condition Rating / PCR	
PREVENTIVE MAINTENANCE		GOOD / 90

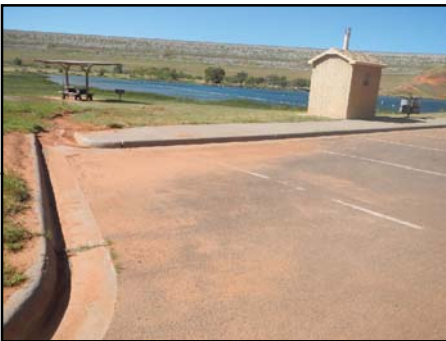
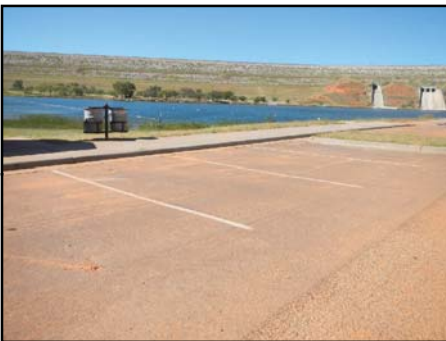
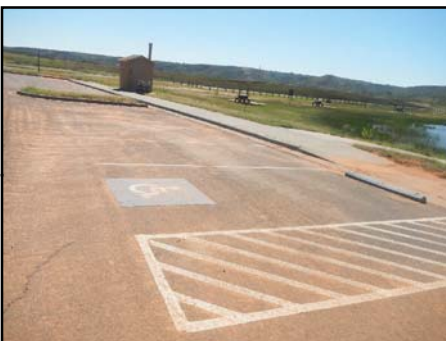
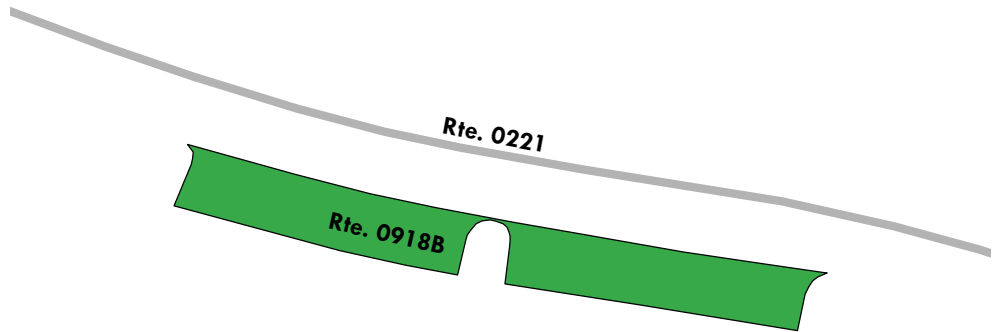
## ROUTE 0918B: SPRING CANYON PARKING B

Inspection Date	FMSS Number	User Access	Surface Type
9/19/2017	104434	PUBLIC	ASPHALT
Area (Sq. Ft.)	Lane Miles (11' Widths)	Curb Reveal (Inches)	Curb Recommendation
2,983	0.051	NOT APPLICABLE	DO NOTHING
Curb Type		Curb & Gutter Type	
NO CURB		CONCRETE	
Pavement Recommendation		Condition Rating / PCR	
PREVENTIVE MAINTENANCE		GOOD / 90

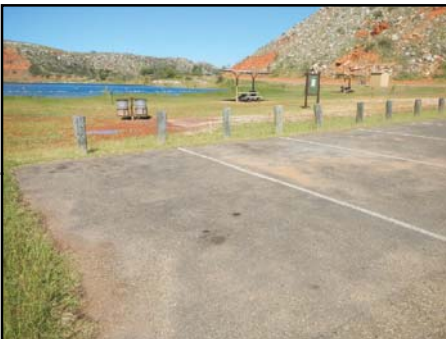
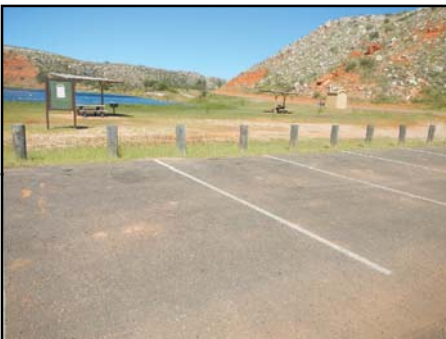
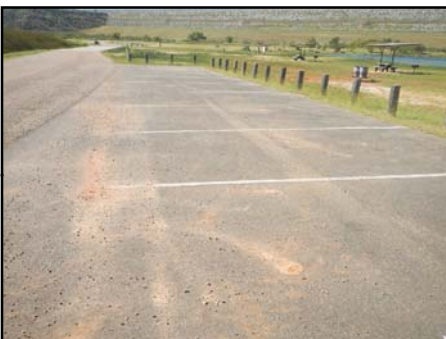
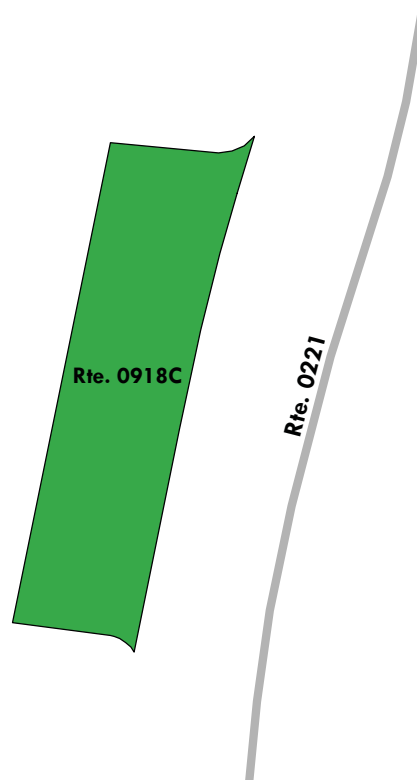
## ROUTE 0918C: SPRING CANYON PARKING C

Inspection Date	FMSS Number	User Access	Surface Type
9/19/2017	104435	PUBLIC	ASPHALT
Area (Sq. Ft.)	Lane Miles (11' Widths)	Curb Reveal (Inches)	Curb Recommendation
2,118	0.036	NOT APPLICABLE	NOT APPLICABLE
Curb Type		Curb & Gutter Type	
NO CURB		NO CURB AND GUTTER	
Pavement Recommendation		Condition Rating / PCR	
PREVENTIVE MAINTENANCE		GOOD / 90

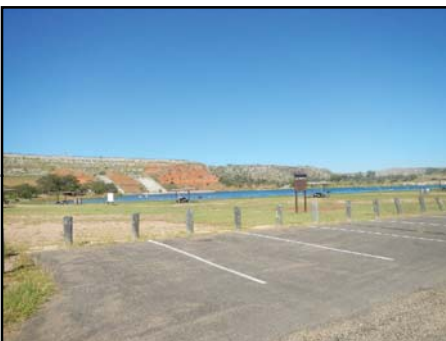
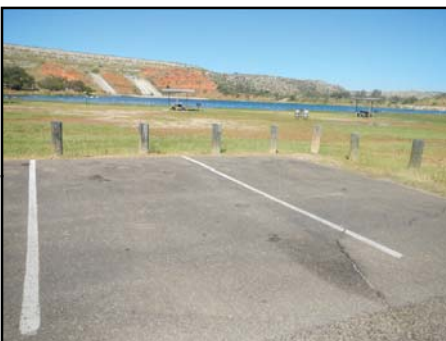
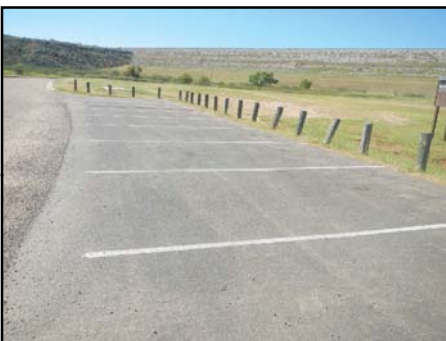
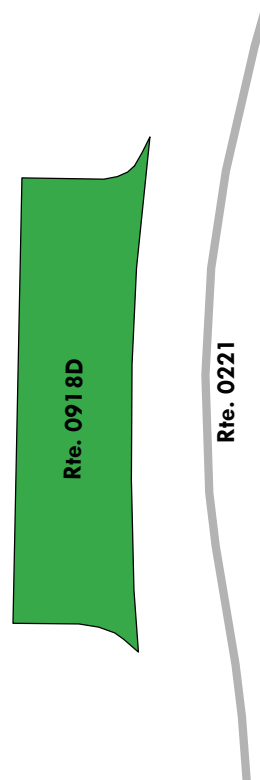
## ROUTE 0918D: SPRING CANYON PARKING D

Inspection Date	FMSS Number	User Access	Surface Type
9/19/2017	104436	PUBLIC	ASPHALT
Area (Sq. Ft.)	Lane Miles (11' Widths)	Curb Reveal (Inches)	Curb Recommendation
2,374	0.041	NOT APPLICABLE	NOT APPLICABLE
Curb Type		Curb & Gutter Type	
NO CURB		NO CURB AND GUTTER	
Pavement Recommendation		Condition Rating / PCR	
PREVENTIVE MAINTENANCE		GOOD / 90

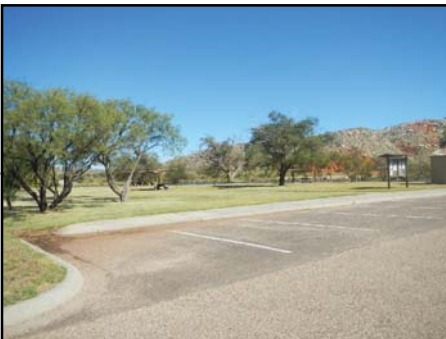
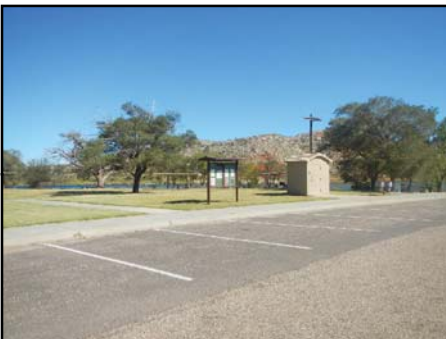
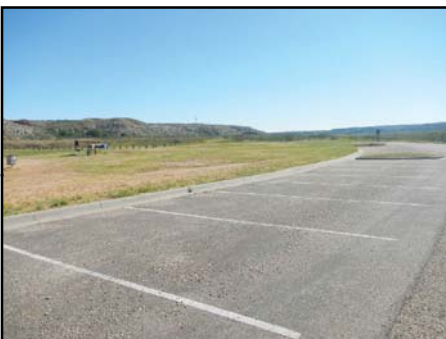
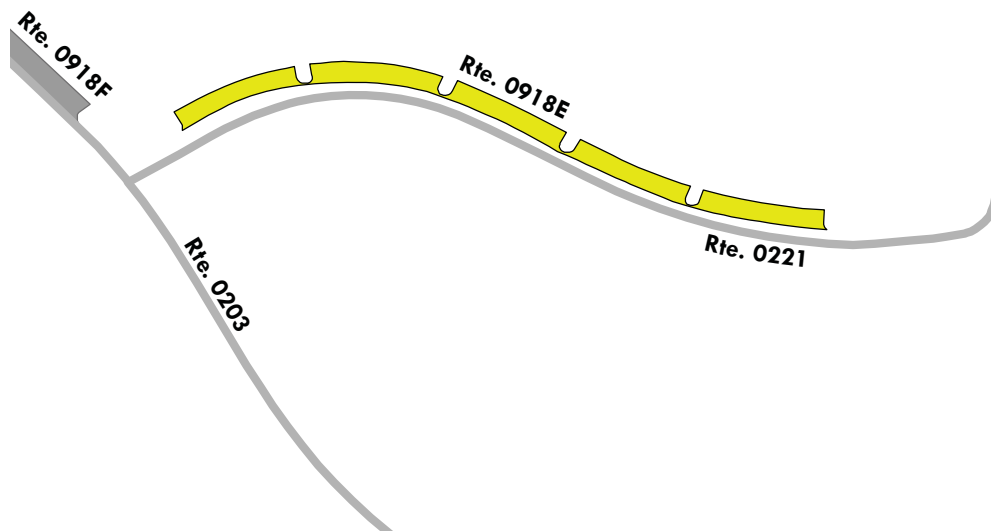
## ROUTE 0918E: SPRING CANYON PARKING E

Inspection Date	FMSS Number	User Access	Surface Type
9/19/2017	104437	PUBLIC	ASPHALT
Area (Sq. Ft.)	Lane Miles (11' Widths)	Curb Reveal (Inches)	Curb Recommendation
13,182	0.227	NOT APPLICABLE	DO NOTHING
Curb Type		Curb & Gutter Type	
NO CURB		CONCRETE	
Pavement Recommendation		Condition Rating / PCR	
LIGHT 3R TREATMENTS		FAIR / 73

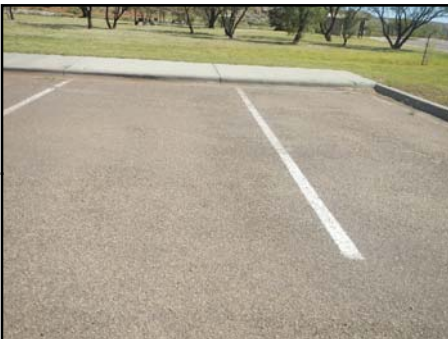
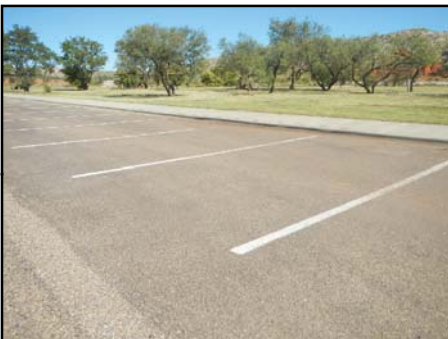
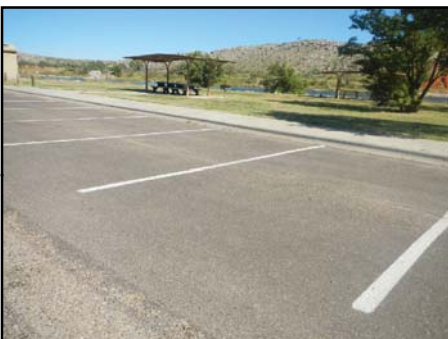
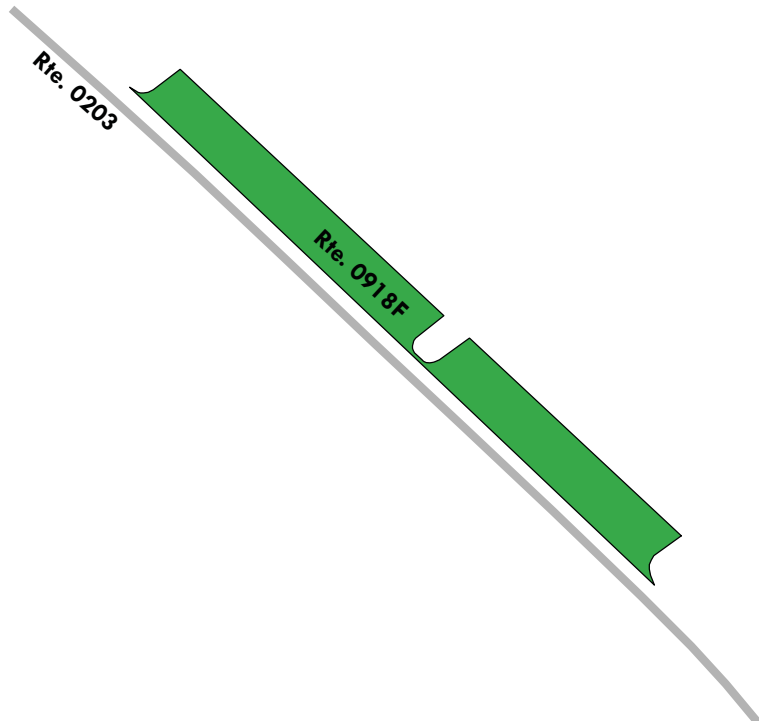
## ROUTE 0918F: SPRING CANYON PARKING F

Inspection Date	FMSS Number	User Access	Surface Type
9/19/2017	104438	PUBLIC	ASPHALT
Area (Sq. Ft.)	Lane Miles (11' Widths)	Curb Reveal (Inches)	Curb Recommendation
6,192	0.107	NOT APPLICABLE	DO NOTHING
Curb Type		Curb & Gutter Type	
NO CURB		CONCRETE	
Pavement Recommendation		Condition Rating / PCR	
PREVENTIVE MAINTENANCE		GOOD / 90

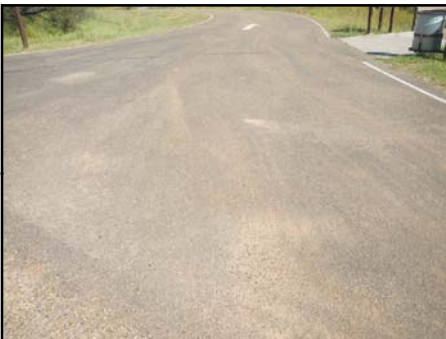
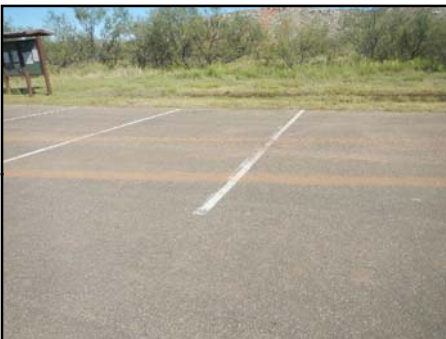
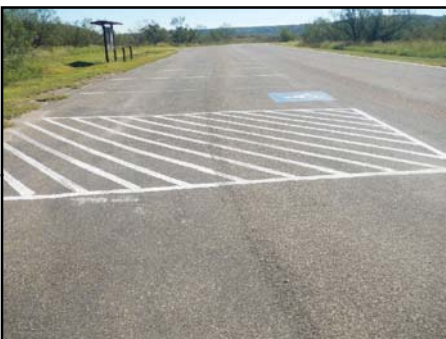
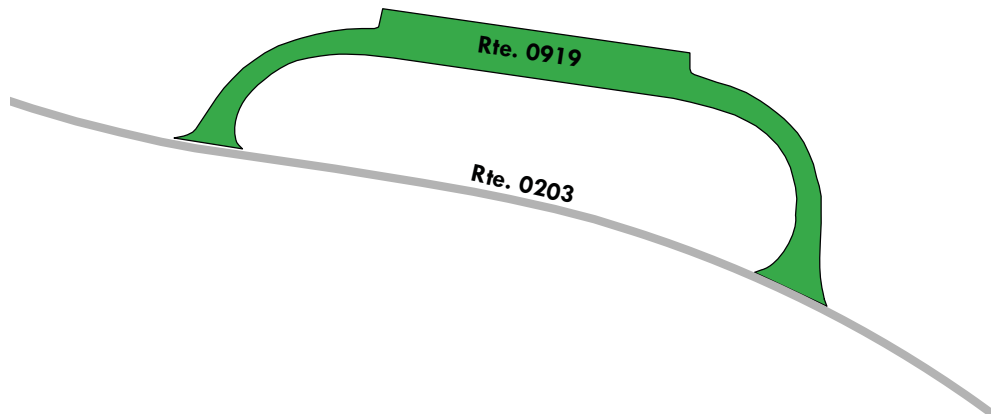
## ROUTE 0919: SPRING CANYON KIOSK PARKING

Inspection Date	FMSS Number	User Access	Surface Type
9/19/2017	91787	PUBLIC	ASPHALT
Area (Sq. Ft.)	Lane Miles (11' Widths)	Curb Reveal (Inches)	Curb Recommendation
12,271	0.211	NOT APPLICABLE	NOT APPLICABLE
Curb Type		Curb & Gutter Type	
NO CURB		NO CURB AND GUTTER	
Pavement Recommendation		Condition Rating / PCR	
PREVENTIVE MAINTENANCE		GOOD / 90

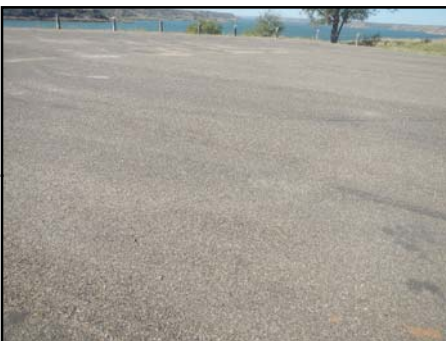
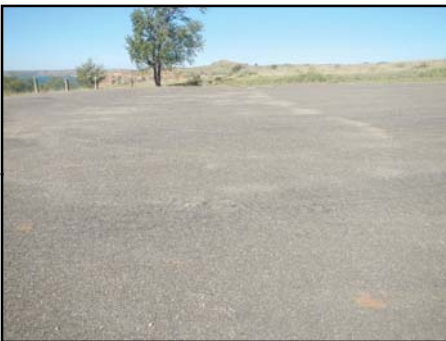
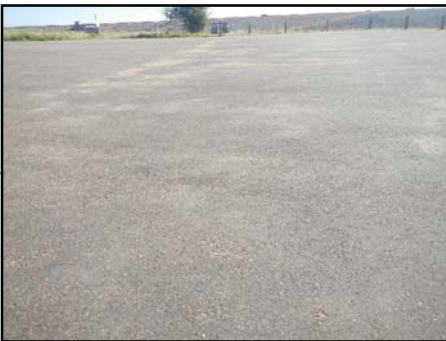
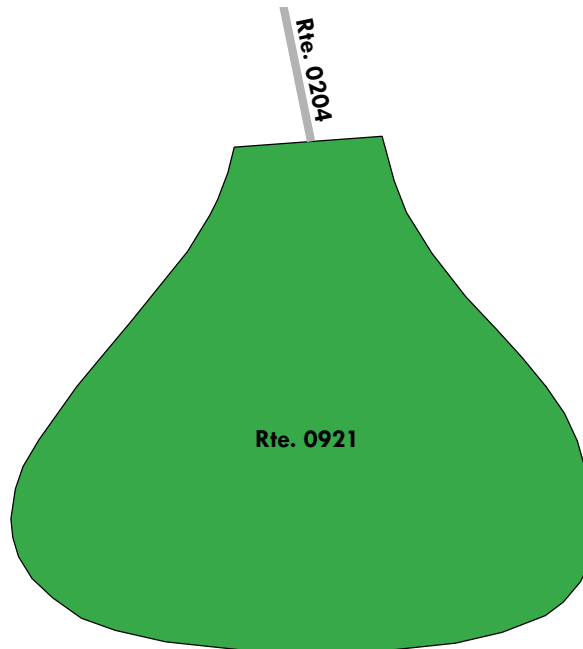
## ROUTE 0921: SPRING CANYON NORTH VIEW POINT PARKING

Inspection Date	FMSS Number	User Access	Surface Type
9/19/2017	91813	PUBLIC	ASPHALT
Area (Sq. Ft.)	Lane Miles (11' Widths)	Curb Reveal (Inches)	Curb Recommendation
9,507	0.164	NOT APPLICABLE	NOT APPLICABLE
Curb Type		Curb & Gutter Type	
NO CURB		NO CURB AND GUTTER	
Pavement Recommendation		Condition Rating / PCR	
PREVENTIVE MAINTENANCE		GOOD / 90

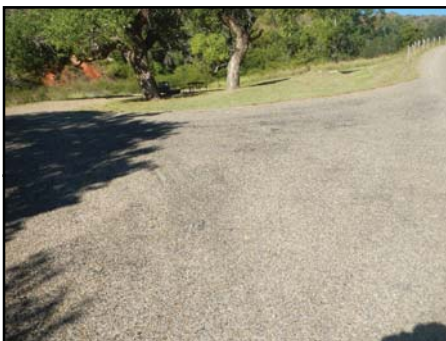
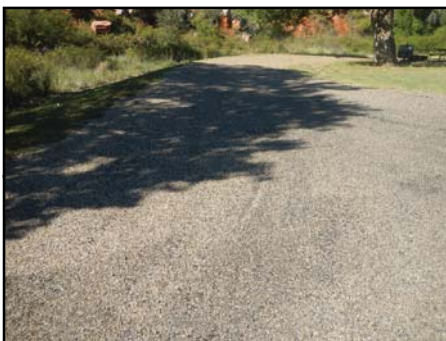
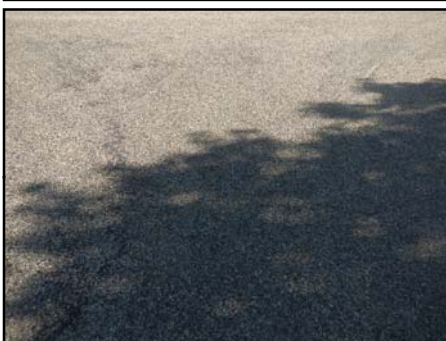
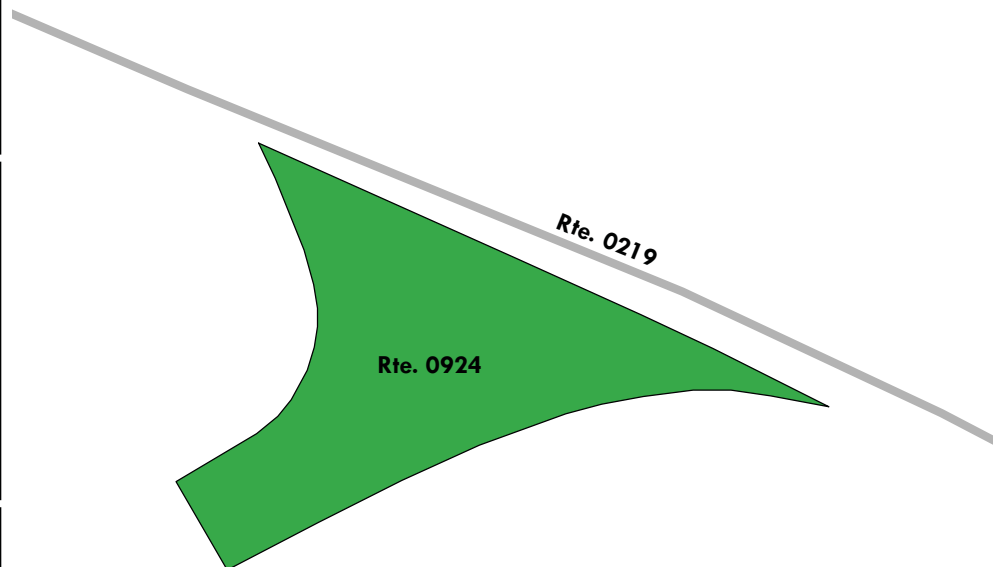
## ROUTE 0924: BUGBEE PICNIC AREA

Inspection Date	FMSS Number	User Access	Surface Type
9/19/2017	91816	PUBLIC	ASPHALT
Area (Sq. Ft.)	Lane Miles (11' Widths)	Curb Reveal (Inches)	Curb Recommendation
1,034	0.018	NOT APPLICABLE	NOT APPLICABLE
Curb Type		Curb & Gutter Type	
NO CURB		NO CURB AND GUTTER	
Pavement Recommendation		Condition Rating / PCR	
PREVENTIVE MAINTENANCE		GOOD / 90

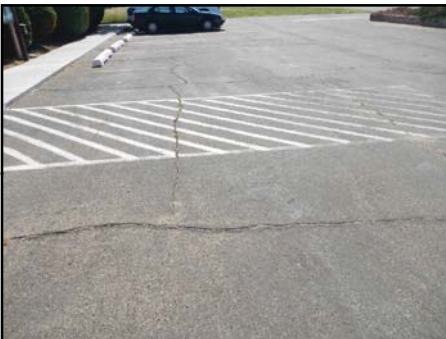
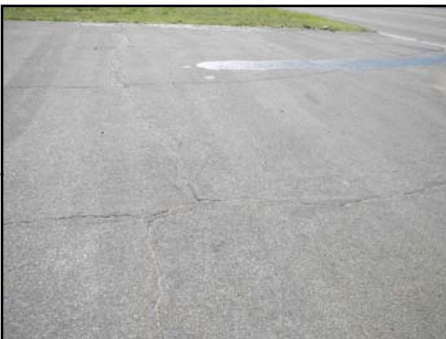
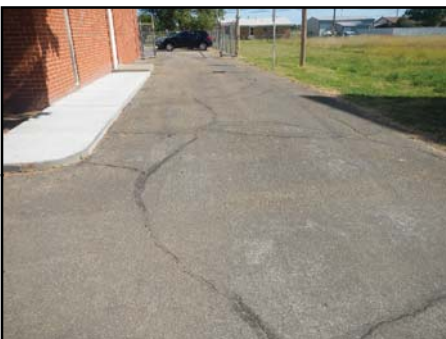
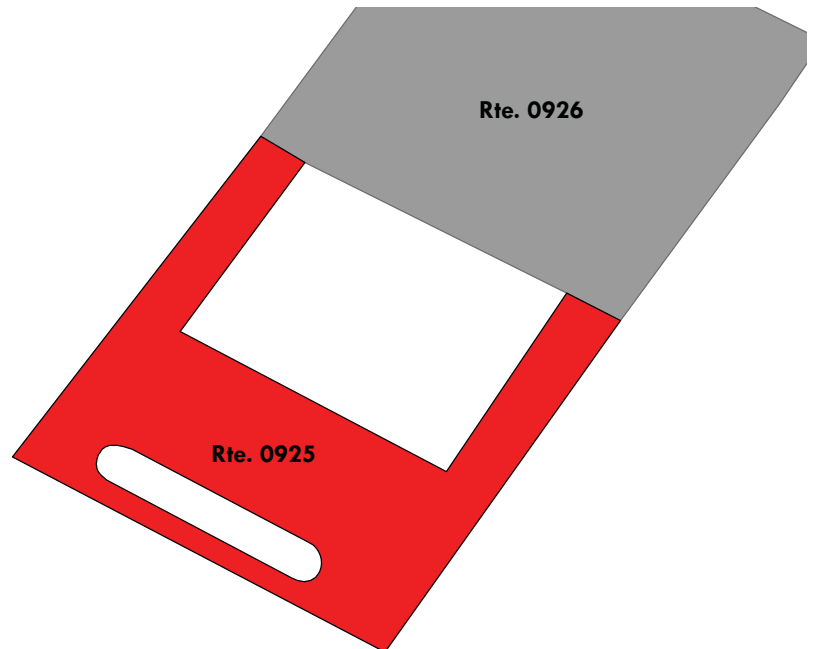
## ROUTE 0925: PARK HEADQUARTERS VISITOR PARKING

Inspection Date	FMSS Number	User Access	Surface Type
9/20/2017	104449	PUBLIC	ASPHALT
Area (Sq. Ft.)	Lane Miles (11' Widths)	Curb Reveal (Inches)	Curb Recommendation
8,761	0.151	NOT APPLICABLE	NOT APPLICABLE
Curb Type		Curb & Gutter Type	
NO CURB		NO CURB AND GUTTER	
Pavement Recommendation		Condition Rating / PCR	
HEAVY 3R TREATMENTS		POOR / 53

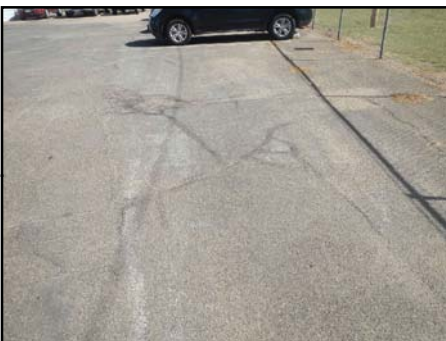
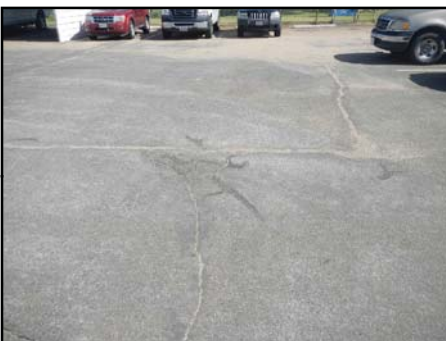
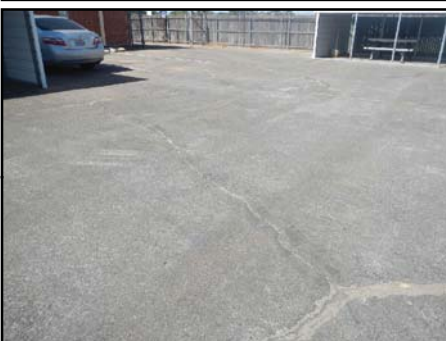
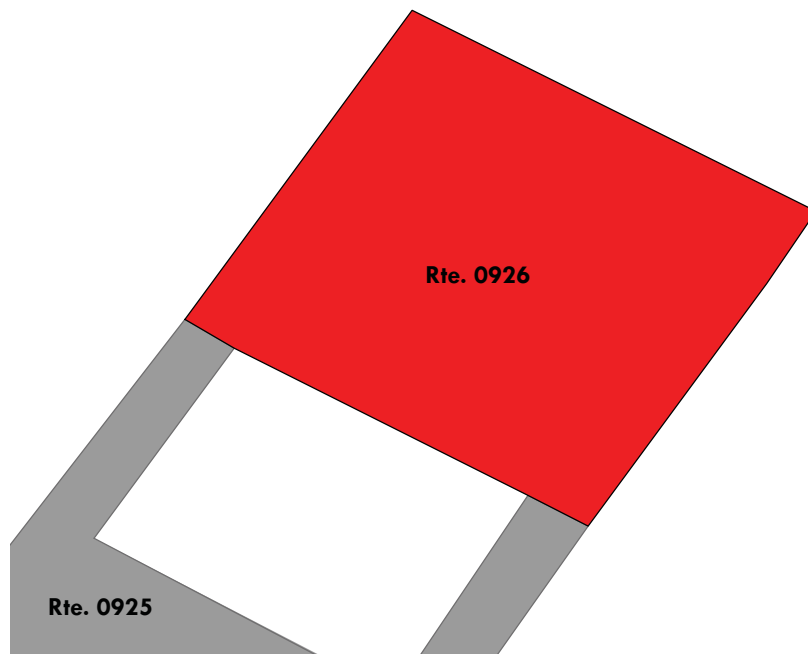
## ROUTE 0926: PARK HEADQUARTERS ADMINISTRATIVE PARKING

Inspection Date	FMSS Number	User Access	Surface Type
9/20/2017	104450	NONPUBLIC	ASPHALT
Area (Sq. Ft.)	Lane Miles (11' Widths)	Curb Reveal (Inches)	Curb Recommendation
12,963	0.223	NOT APPLICABLE	NOT APPLICABLE
Curb Type		Curb & Gutter Type	
NO CURB		NO CURB AND GUTTER	
Pavement Recommendation		Condition Rating / PCR	
HEAVY 3R TREATMENTS		POOR / 53

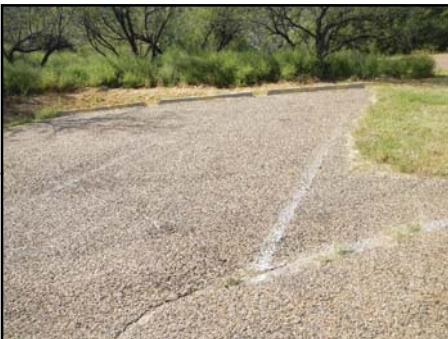
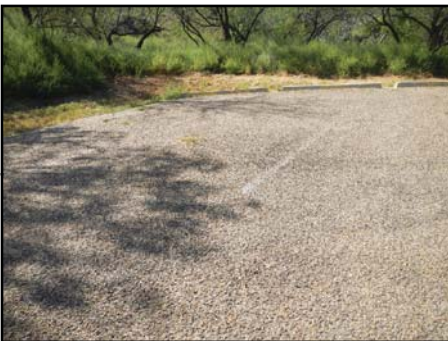
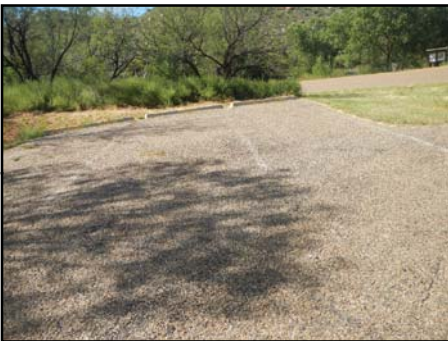
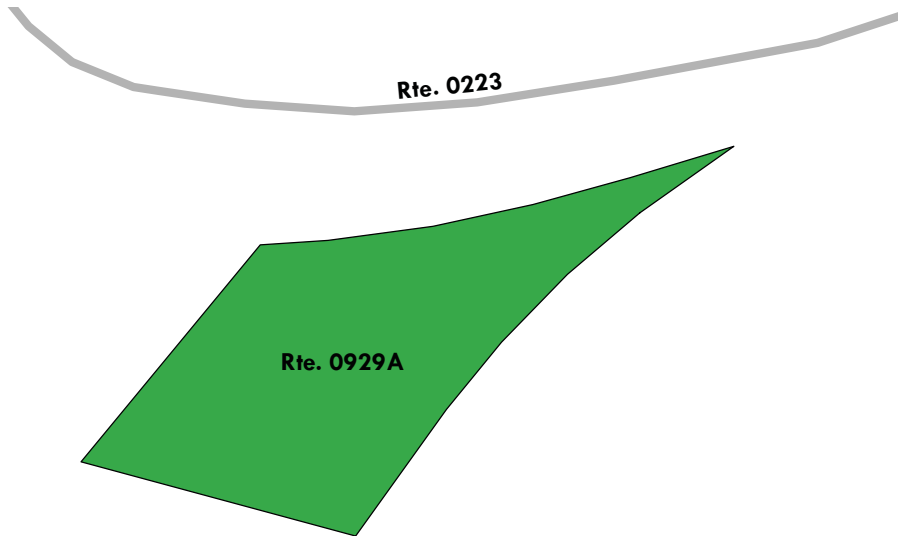
## ROUTE 0929A: HARBOR BAY PICNIC PARKING A

Inspection Date	FMSS Number	User Access	Surface Type
9/20/2017	91819	PUBLIC	ASPHALT
Area (Sq. Ft.)	Lane Miles (11' Widths)	Curb Reveal (Inches)	Curb Recommendation
826	0.014	NOT APPLICABLE	NOT APPLICABLE
Curb Type		Curb & Gutter Type	
NO CURB		NO CURB AND GUTTER	
Pavement Recommendation		Condition Rating / PCR	
PREVENTIVE MAINTENANCE		GOOD / 90

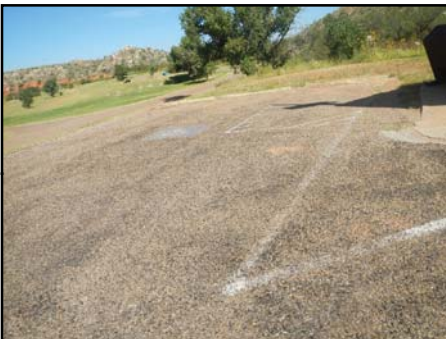
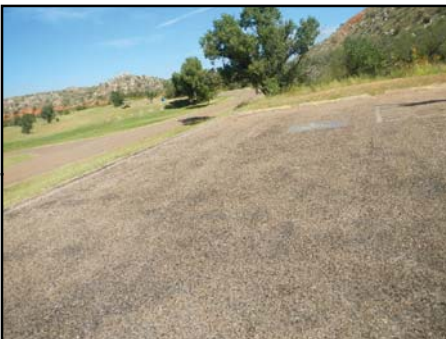
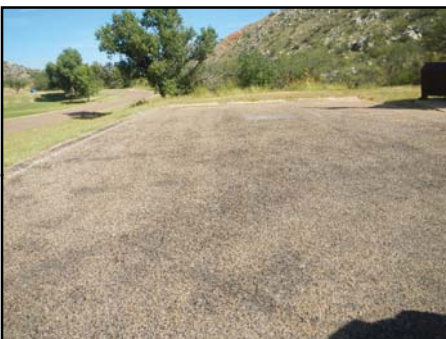
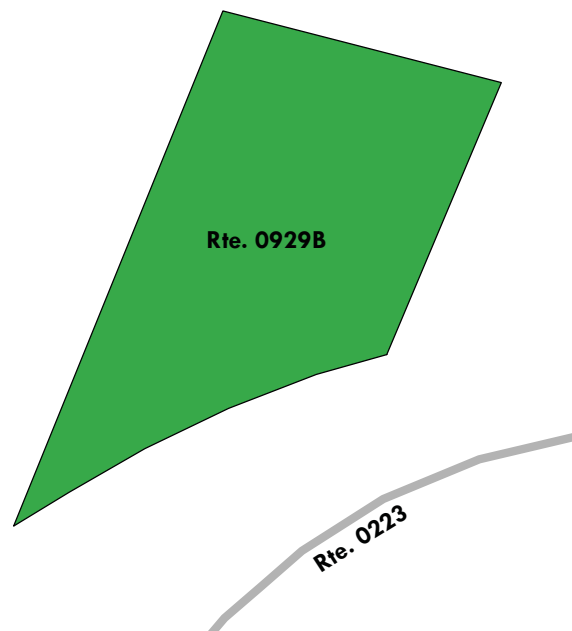
## ROUTE 0929B: HARBOR BAY PICNIC PARKING B

Inspection Date	FMSS Number	User Access	Surface Type
9/20/2017	104439	PUBLIC	ASPHALT
Area (Sq. Ft.)	Lane Miles (11' Widths)	Curb Reveal (Inches)	Curb Recommendation
1,078	0.019	NOT APPLICABLE	NOT APPLICABLE
Curb Type		Curb & Gutter Type	
NO CURB		NO CURB AND GUTTER	
Pavement Recommendation		Condition Rating / PCR	
PREVENTIVE MAINTENANCE		GOOD / 90

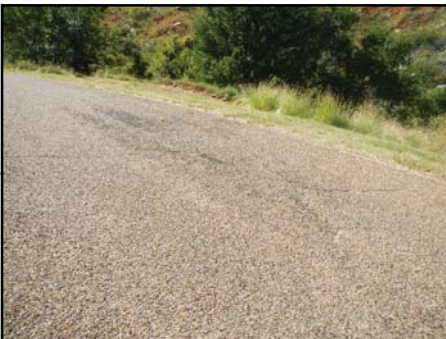
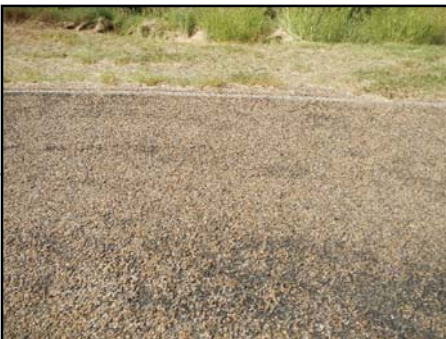
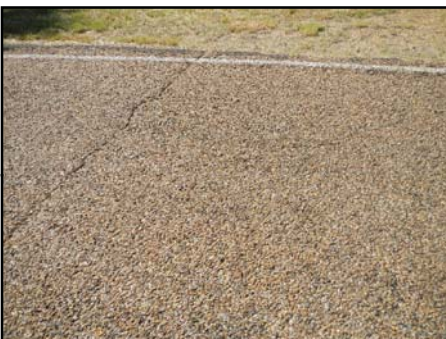
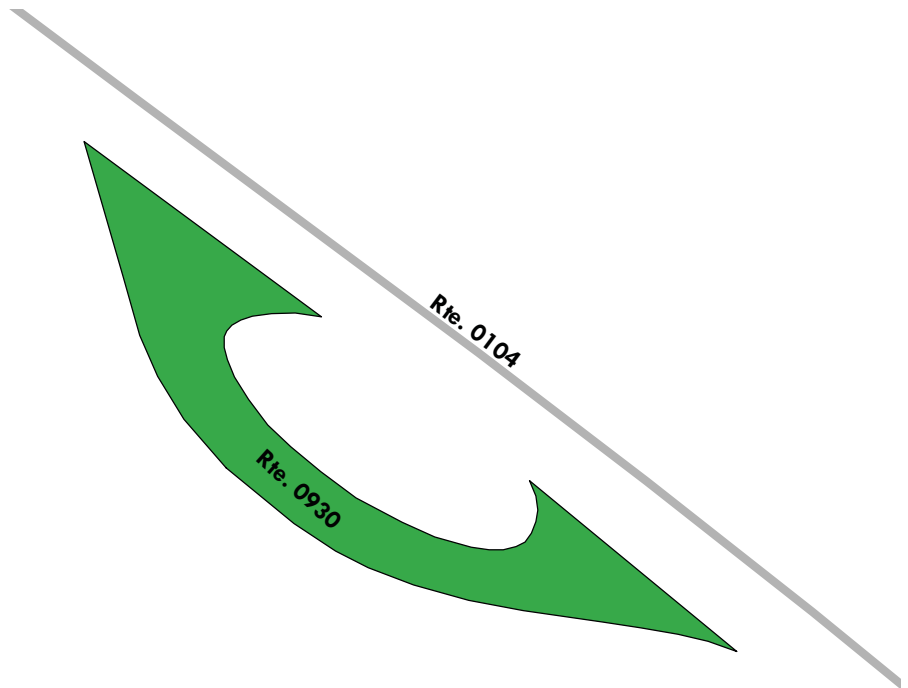
## ROUTE 0930: HARBOR BAY KIOSK PARKING

Inspection Date	FMSS Number	User Access	Surface Type
9/20/2017	91820	PUBLIC	ASPHALT
Area (Sq. Ft.)	Lane Miles (11' Widths)	Curb Reveal (Inches)	Curb Recommendation
3,678	0.063	NOT APPLICABLE	NOT APPLICABLE
Curb Type		Curb & Gutter Type	
NO CURB		NO CURB AND GUTTER	
Pavement Recommendation		Condition Rating / PCR	
PREVENTIVE MAINTENANCE		GOOD / 90
