LAVO Cycle 6

Final Report

Road Inventory and Condition Assessment of Paved Routes Lassen Volcanic National Park

Report Date: March 2016

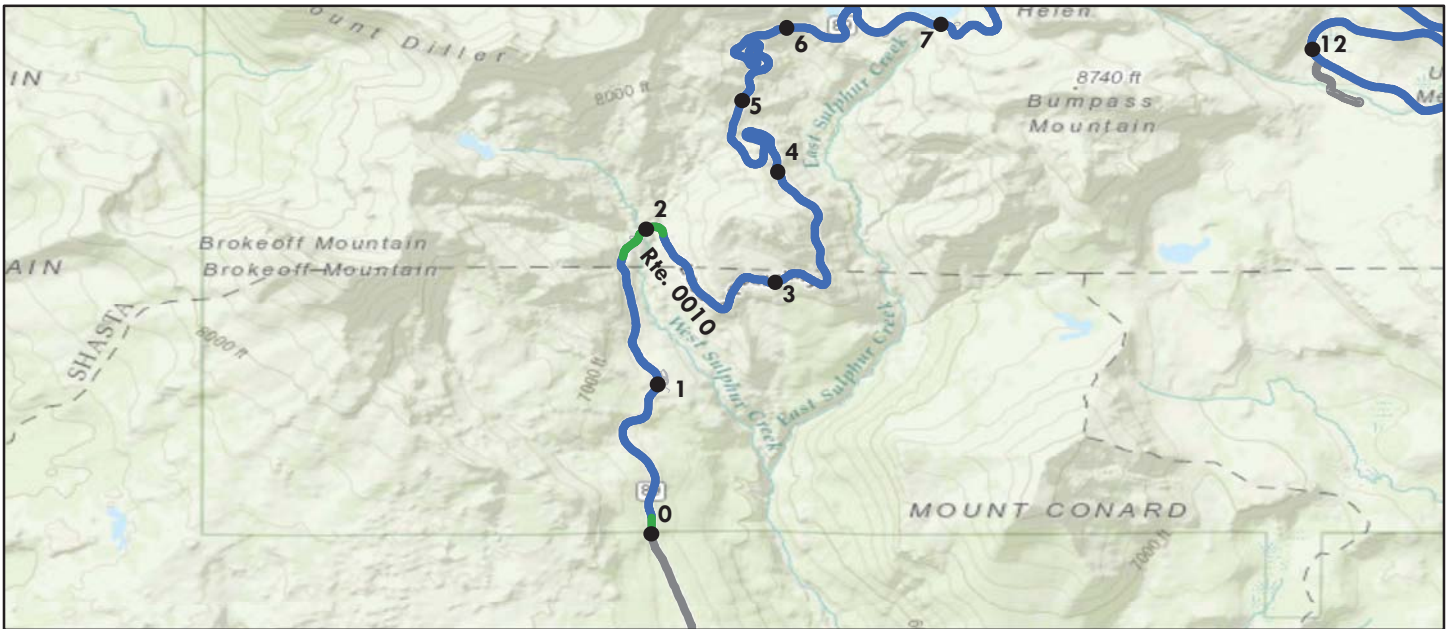
ROUTE 0010: LASSEN PARK ROAD

Route Condition Legend – Pavement Condition Rating (PCR)						
Poor (0 - 60)	Fair (61 - 84)	Good (85 - 94)	Excellent (95 - 100)	Not Rated		
See Appendix for definitions and formulas						
Inspection Date: 7/29/2015	Beginning Section MP	0	1	2	3	4
Paved Length (Miles): 29.76	Section Length (MI)	1	1	1	1	1
Surface Type: ASPHALT	Route Summary					
Roadway Condition Information						
Pavement Condition Rating (PCR)	100	99	100	100	99	99
Surface Condition Rating (SCR)	100	99	100	100	99	99
Roughness Condition Index (RCI)	100	100	100	100	100	100
Distress Index Values						
Structural Crack Index	100	100	100	100	100	100
Alligator Crack Index	100	100	100	100	100	100
Longitudinal Crack Index	100	100	100	100	100	100
Transverse Cracking Index	100	100	100	100	100	100
Patching Index	100	100	100	100	100	100
Rutting Index	100	99	100	100	99	99
International Roughness Index (IRI)	83	105	112	90	92	86
Lane & Width Information

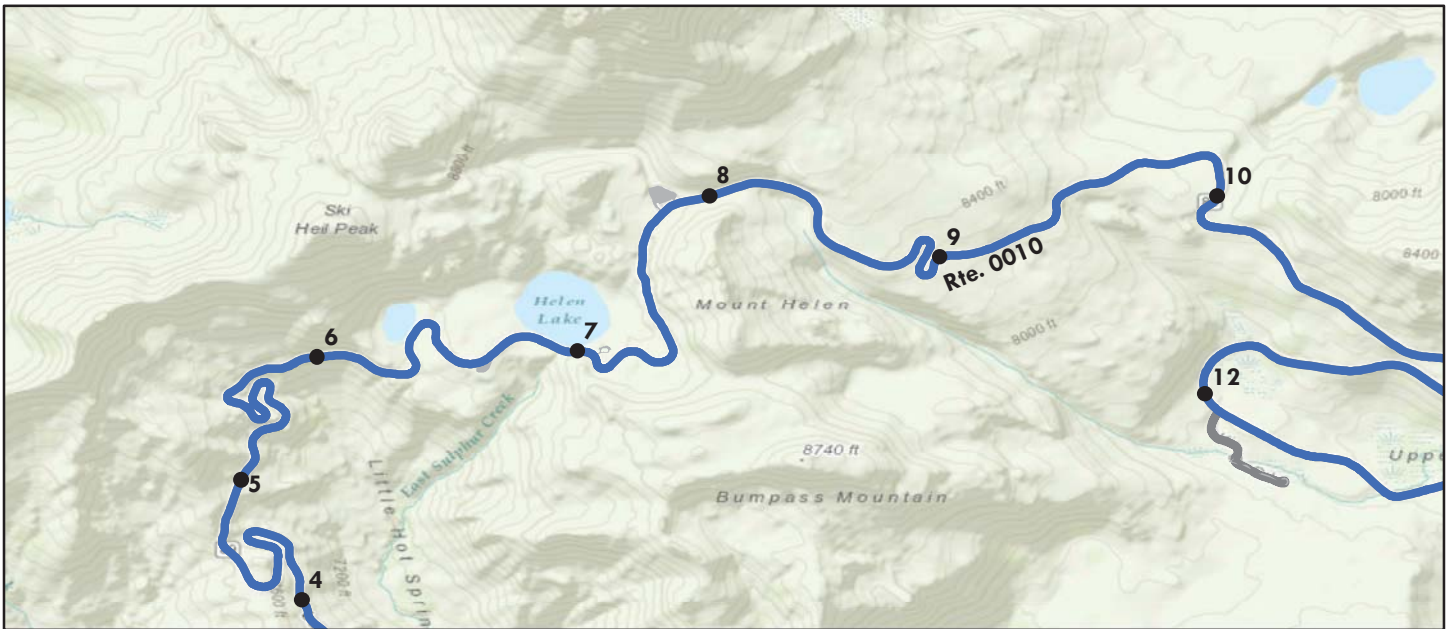
ROUTE 0010: LASSEN PARK ROAD

Route Condition Legend – Pavement Condition Rating (PCR)						
Poor (0 - 60)	Fair (61- 84)	Good (85 - 94)	Excellent (95 - 100)	Not Rated		
See Appendix for definitions and formulas						
Inspection Date: 7/29/2015	Beginning Section MP	5	6	7	8	9
Paved Length (Miles): 29.76	Section Length (MI)	1	1	1	1	1
Surface Type: ASPHALT	Route Summary					
Roadway Condition Information						
Pavement Condition Rating (PCR)	100	99	99	99	100	100
Surface Condition Rating (SCR)	100	99	99	99	100	100
Roughness Condition Index (RCI)	100	100	100	100	100	100
Distress Index Values						
Structural Crack Index	100	100	100	100	100	100
Alligator Crack Index	100	100	100	100	100	100
Longitudinal Crack Index	100	100	100	100	100	100
Transverse Cracking Index	100	100	100	100	100	100
Patching Index	100	100	100	100	100	100
Rutting Index	100	99	99	99	100	100
International Roughness Index (IRI)	83	91	86	83	87	91
Lane & Width Information

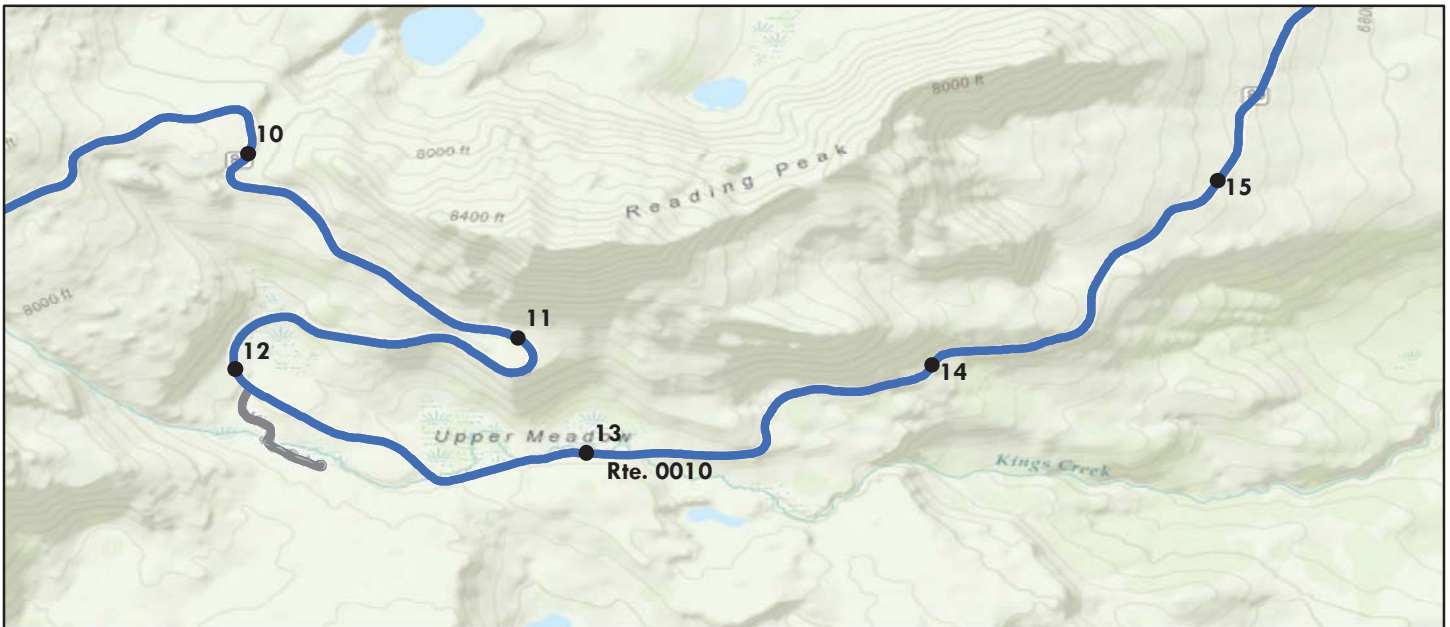
ROUTE 0010: LASSEN PARK ROAD

Route Condition Legend – Pavement Condition Rating (PCR)						
Poor (0 - 60)	Fair (61- 84)	Good (85 - 94)	Excellent (95 - 100)	Not Rated		
See Appendix for definitions and formulas						
Inspection Date: 7/29/2015	Beginning Section MP	10	11	12	13	14
Paved Length (Miles): 29.76	Section Length (MI)	1	1	1	1	1
Surface Type: ASPHALT	Route Summary					
Roadway Condition Information						
Pavement Condition Rating (PCR)	100	100	100	100	100	100
Surface Condition Rating (SCR)	100	100	100	100	100	100
Roughness Condition Index (RCI)	100	100	100	100	100	100
Distress Index Values						
Structural Crack Index	100	100	100	100	100	100
Alligator Crack Index	100	100	100	100	100	100
Longitudinal Crack Index	100	100	100	100	100	100
Transverse Cracking Index	100	100	100	100	100	100
Patching Index	100	100	100	100	100	100
Rutting Index	100	100	100	100	100	100
International Roughness Index (IRI)	83	87	81	73	79	74
Lane & Width Information

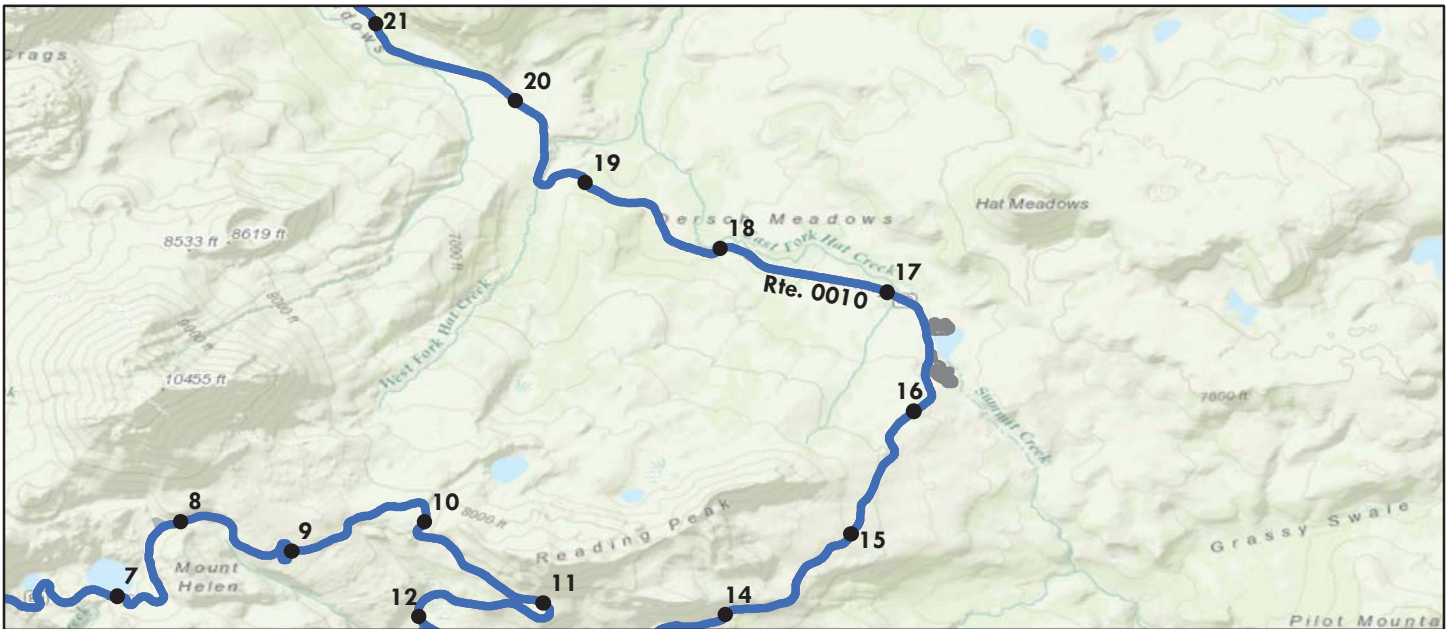
ROUTE 0010: LASSEN PARK ROAD

Route Condition Legend – Pavement Condition Rating (PCR)						
Poor (0 - 60)	Fair (61- 84)	Good (85 - 94)	Excellent (95 - 100)	Not Rated		
See Appendix for definitions and formulas						
Inspection Date: 7/29/2015	Beginning Section MP	15	16	17	18	19
Paved Length (Miles): 29.76	Section Length (MI)	1	1	1	1	1
Surface Type: ASPHALT	Route Summary					
Roadway Condition Information						
Pavement Condition Rating (PCR)	100	100	99	99	100	100
Surface Condition Rating (SCR)	100	100	98	99	100	100
Roughness Condition Index (RCI)	100	100	100	100	100	100
Distress Index Values						
Structural Crack Index	100	100	98	99	100	100
Alligator Crack Index	100	100	100	100	100	100
Longitudinal Crack Index	100	100	98	99	100	100
Transverse Cracking Index	100	100	100	100	100	100
Patching Index	100	100	100	100	100	100
Rutting Index	100	100	100	100	100	100
International Roughness Index (IRI)	83	74	81	77	71	86
Lane & Width Information

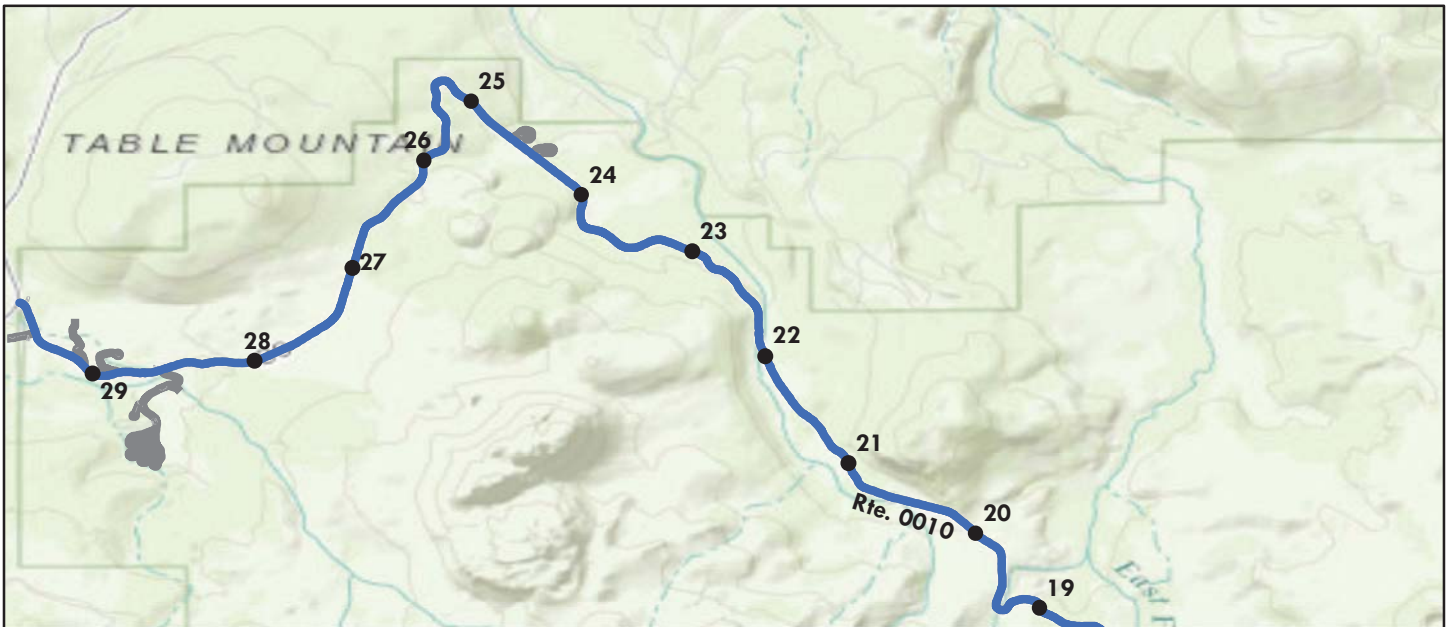
ROUTE 0010: LASSEN PARK ROAD

Route Condition Legend – Pavement Condition Rating (PCR)						
Poor (0 - 60)	Fair (61- 84)	Good (85 - 94)	Excellent (95 - 100)	Not Rated		
See Appendix for definitions and formulas						
Inspection Date: 7/29/2015	Beginning Section MP	20	21	22	23	24
Paved Length (Miles): 29.76	Section Length (MI)	1	1	1	1	1
Surface Type: ASPHALT	Route Summary					
Roadway Condition Information						
Pavement Condition Rating (PCR)	100	100	100	100	100	100
Surface Condition Rating (SCR)	100	100	100	100	100	100
Roughness Condition Index (RCI)	100	100	100	100	100	100
Distress Index Values						
Structural Crack Index	100	100	100	100	100	100
Alligator Crack Index	100	100	100	100	100	100
Longitudinal Crack Index	100	100	100	100	100	100
Transverse Cracking Index	100	100	100	100	100	100
Patching Index	100	100	100	100	100	100
Rutting Index	100	100	100	100	100	100
International Roughness Index (IRI)	83	70	71	73	74	82
Lane & Width Information

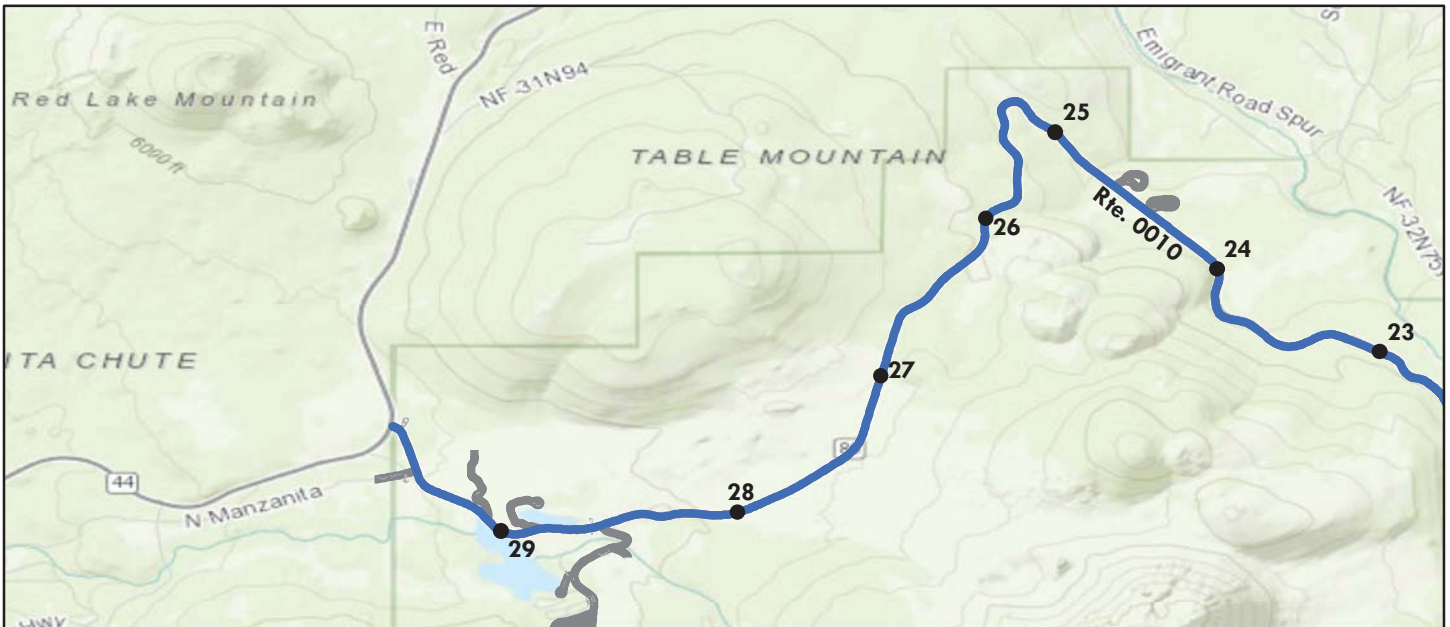
ROUTE 0010: LASSEN PARK ROAD

Route Condition Legend – Pavement Condition Rating (PCR)						
Poor (0 - 60)	Fair (61- 84)	Good (85 - 94)	Excellent (95 - 100)	Not Rated		
See Appendix for definitions and formulas						
Inspection Date: 7/29/2015	Beginning Section MP	25	26	27	28	29
Paved Length (Miles): 29.76	Section Length (MI)	1	1	1	1	0.76
Surface Type: ASPHALT	Route Summary					
Roadway Condition Information						
Pavement Condition Rating (PCR)	100	100	100	99	99	99
Surface Condition Rating (SCR)	100	100	100	99	99	99
Roughness Condition Index (RCI)	100	100	100	100	100	100
Distress Index Values						
Structural Crack Index	100	100	100	100	100	100
Alligator Crack Index	100	100	100	100	100	100
Longitudinal Crack Index	100	100	100	100	100	100
Transverse Cracking Index	100	100	100	100	100	100
Patching Index	100	100	100	100	100	100
Rutting Index	100	100	100	99	99	99
International Roughness Index (IRI)	83	80	75	83	90	87
Lane & Width Information

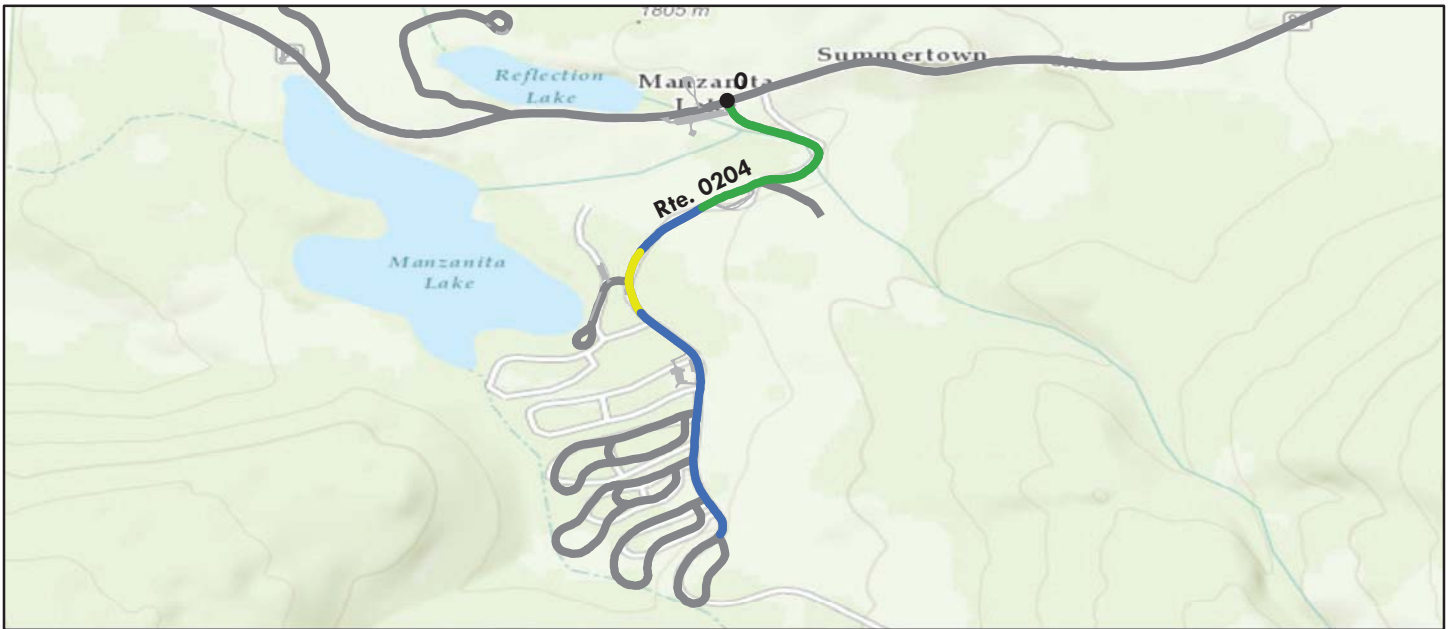
ROUTE 0204: MANZANITA CAMPGROUND ACCESS ROAD

Route Condition Legend – Pavement Condition Rating (PCR)						
Poor (0 - 60)	Fair (61- 84)	Good (85 - 94)	Excellent (95 - 100)	Not Rated		
See Appendix for definitions and formulas						
Inspection Date: 7/29/2015	Beginning Section MP	0				
Paved Length (Miles): 0.87	Section Length (MI)	0.87				
Surface Type: ASPHALT	Route Summary					
Roadway Condition Information						
Pavement Condition Rating (PCR)	91	91				
Surface Condition Rating (SCR)	99	99				
Roughness Condition Index (RCI)	78	78				
Distress Index Values						
Structural Crack Index	100	100				
Alligator Crack Index	100	100				
Longitudinal Crack Index	100	100				
Transverse Cracking Index	100	100				
Patching Index	100	100				
Rutting Index	99	99				
International Roughness Index (IRI)	176	176				
Lane & Width Information						
Number of Lanes	2	2				
Paved Width (ft)	24.9	24.9				
Lane Width (ft)	11.7	11.7

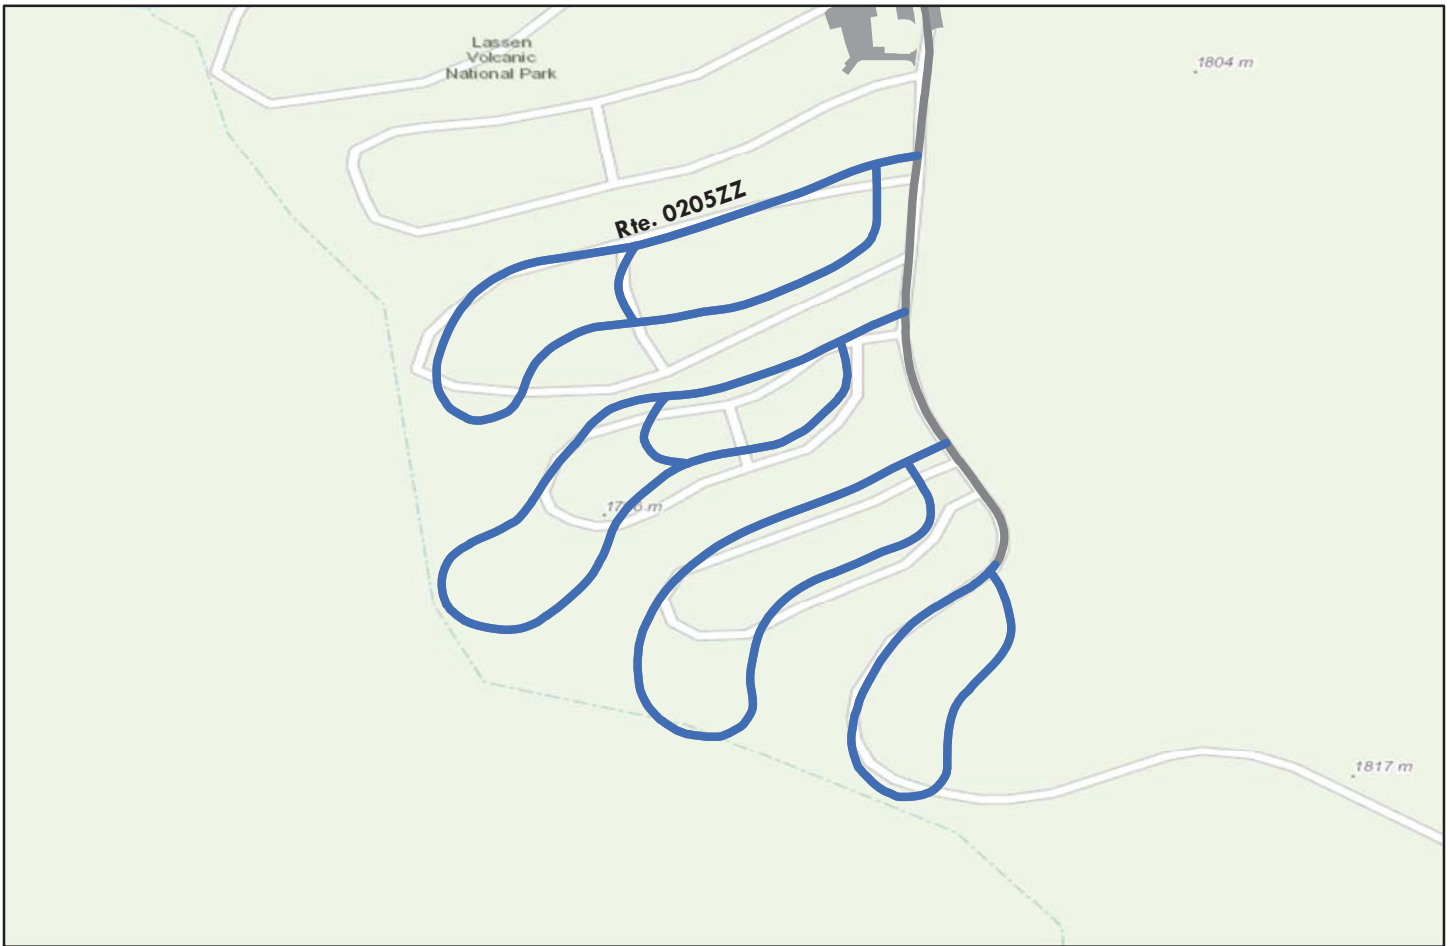
ROUTE 0205ZZ: MANZANITA CAMPGROUND ROADS

Route Condition Legend – Pavement Condition Rating (PCR)						
Poor (0 - 60)	Fair (61- 84)	Good (85 - 94)	Excellent (95 - 100)	Not Rated		
See Appendix for definitions and formulas						
Inspection Date:	7/29/2015					
Paved Length (Miles):	1.53					
Surface Type:	ASPHALT	Route Summary				
Roadway Condition Information						
Pavement Condition Rating (PCR)	98					
Lane & Width Information						
Number of Lanes	1					
Paved Width (ft)	13.5					
Lane Width (ft)	13.5

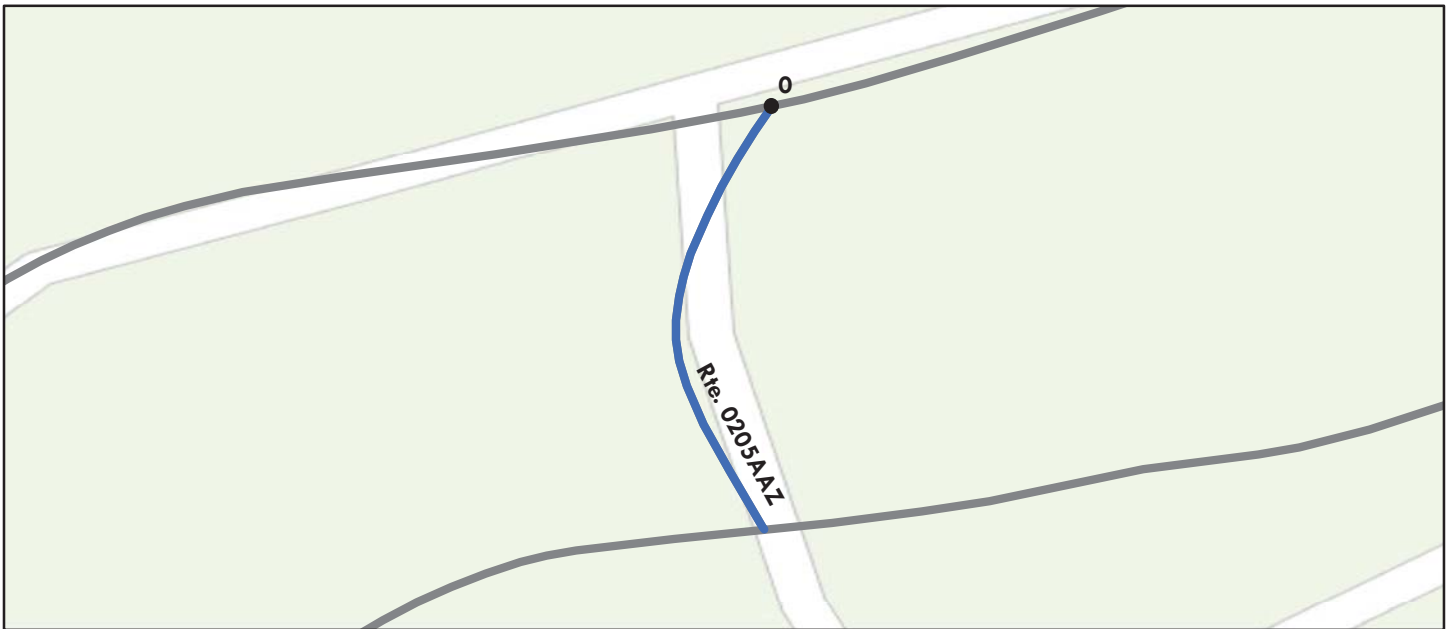
ROUTE 0205AAZ: MANZANITA CAMPGROUND LOOP A CUT-THRU

Route Condition Legend – Pavement Condition Rating (PCR)						
Poor (0 - 60)	Fair (61- 84)	Good (85 - 94)	Excellent (95 - 100)	Not Rated		
See Appendix for definitions and formulas						
Inspection Date: 7/29/2015	Beginning Section MP	0				
Paved Length (Miles): 0.03	Section Length (MI)	0.03				
Surface Type: ASPHALT	Route Summary					
Roadway Condition Information						
Pavement Condition Rating (PCR)	99	99				
Surface Condition Rating (SCR)	99	99				
Roughness Condition Index (RCI)	N/A	N/A				
Distress Index Values						
Structural Crack Index	100	100				
Alligator Crack Index	100	100				
Longitudinal Crack Index	100	100				
Transverse Cracking Index	100	100				
Patching Index	100	100				
Rutting Index	99	99				
International Roughness Index (IRI)	N/A	N/A				
Lane & Width Information						
Number of Lanes	1	1				
Paved Width (ft)	13.4	13.4				
Lane Width (ft)	13.4	13.4

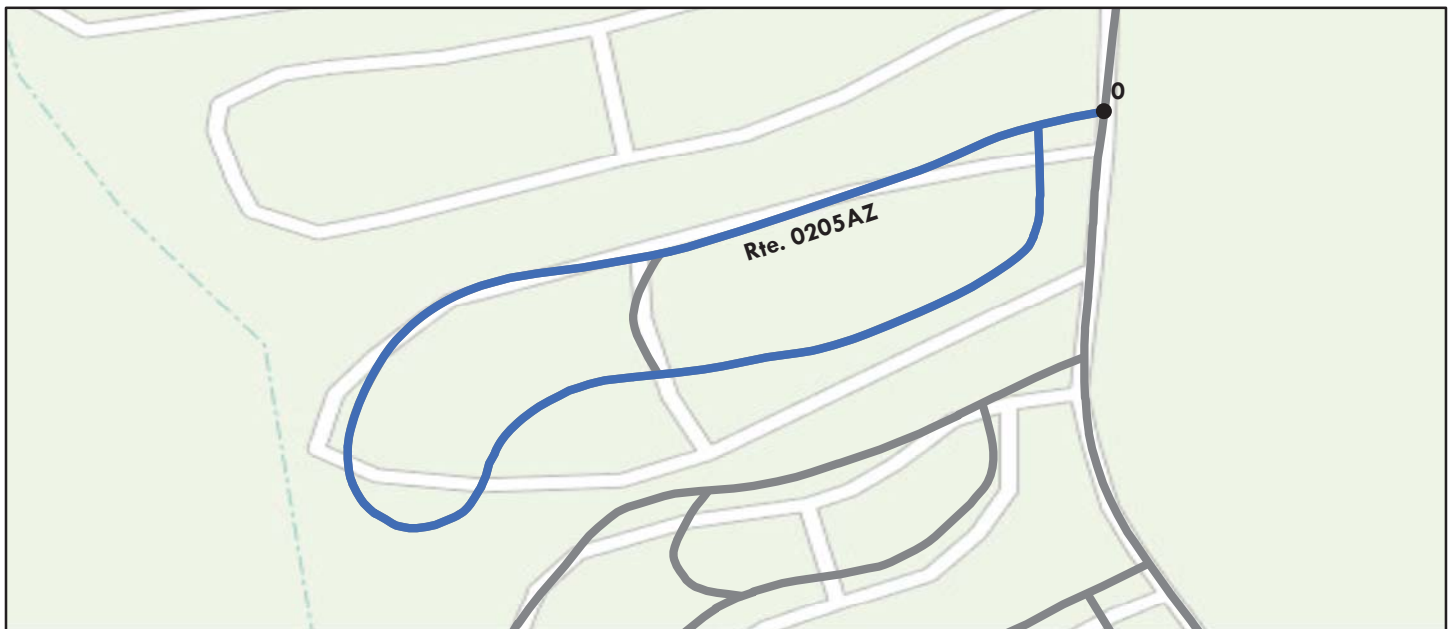
ROUTE 0205AZ: MANZANITA CAMPGROUND LOOPA

Route Condition Legend – Pavement Condition Rating (PCR)						
Poor (0 - 60)	Fair (61- 84)	Good (85 - 94)	Excellent (95 - 100)	Not Rated		
See Appendix for definitions and formulas						
Inspection Date: 7/29/2015	Beginning Section MP	0				
Paved Length (Miles): 0.43	Section Length (MI)	0.43				
Surface Type: ASPHALT	Route Summary					
Roadway Condition Information						
Pavement Condition Rating (PCR)	98	98				
Surface Condition Rating (SCR)	98	98				
Roughness Condition Index (RCI)	N/A	N/A				
Distress Index Values						
Structural Crack Index	100	100				
Alligator Crack Index	100	100				
Longitudinal Crack Index	100	100				
Transverse Cracking Index	100	100				
Patching Index	100	100				
Rutting Index	98	98				
International Roughness Index (IRI)	N/A	N/A				
Lane & Width Information						
Number of Lanes	1	1				
Paved Width (ft)	13.1	13.1				
Lane Width (ft)	13.1	13.1

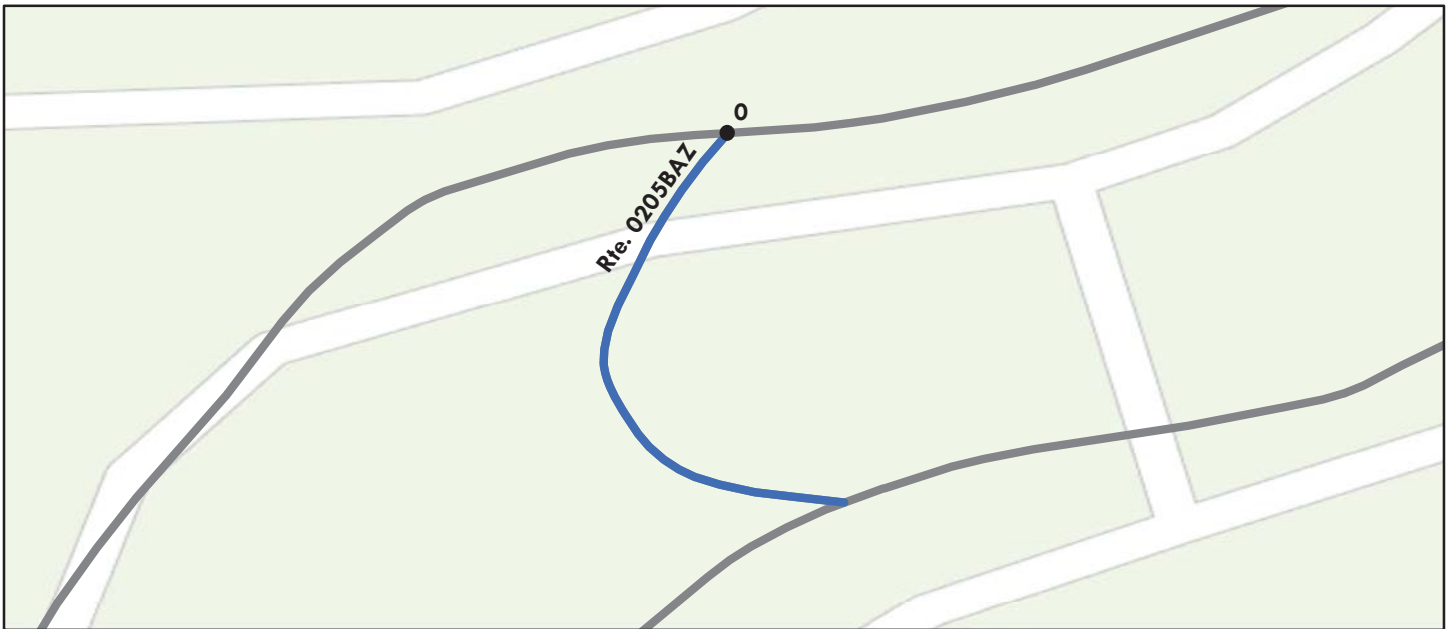
ROUTE 0205BAZ: MANZANITA CAMPGROUND LOOP B CUT-THRU

Route Condition Legend – Pavement Condition Rating (PCR)						
Poor (0 - 60)	Fair (61- 84)	Good (85 - 94)	Excellent (95 - 100)	Not Rated		
See Appendix for definitions and formulas						
Inspection Date: 7/29/2015	Beginning Section MP	0				
Paved Length (Miles): 0.04	Section Length (MI)	0.04				
Surface Type: ASPHALT	Route Summary					
Roadway Condition Information						
Pavement Condition Rating (PCR)	99	99				
Surface Condition Rating (SCR)	99	99				
Roughness Condition Index (RCI)	N/A	N/A				
Distress Index Values						
Structural Crack Index	100	100				
Alligator Crack Index	100	100				
Longitudinal Crack Index	100	100				
Transverse Cracking Index	100	100				
Patching Index	100	100				
Rutting Index	99	99				
International Roughness Index (IRI)	N/A	N/A				
Lane & Width Information						
Number of Lanes	1	1				
Paved Width (ft)	11.8	11.8				
Lane Width (ft)	11.8	11.8

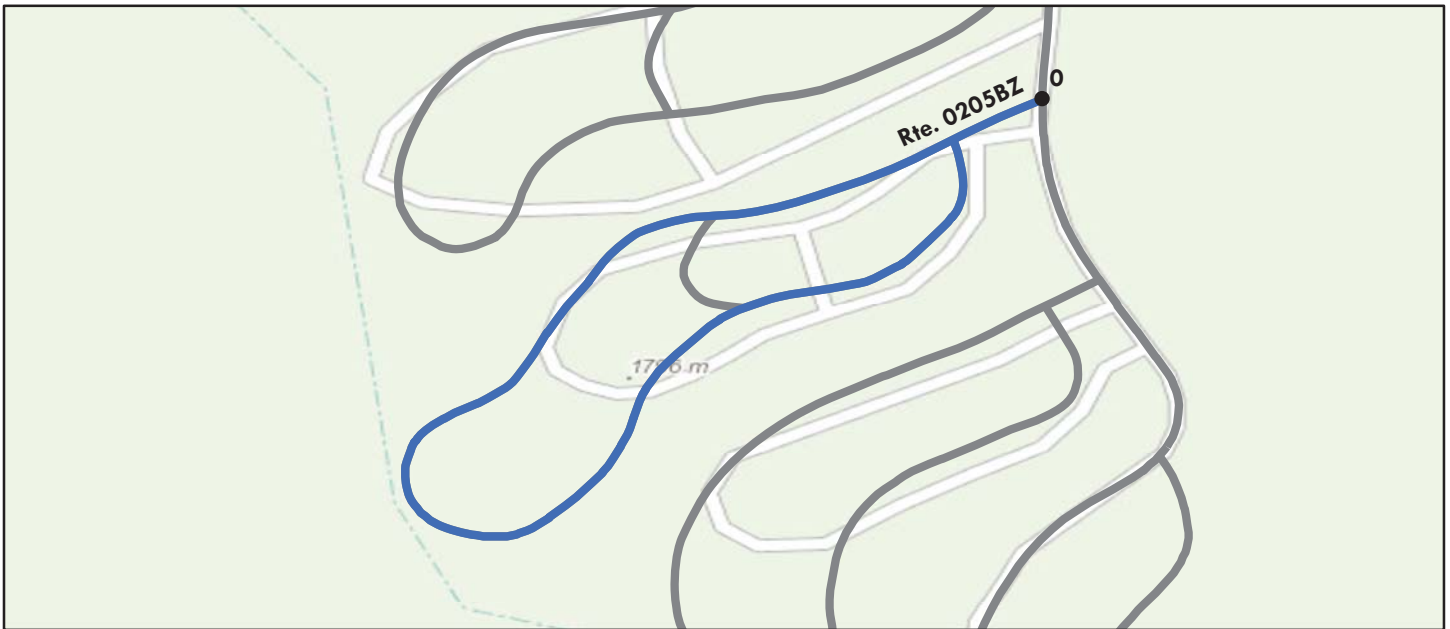
ROUTE 0205BZ: MANZANITA CAMPGROUND LOOP B

Route Condition Legend – Pavement Condition Rating (PCR)						
Poor (0 - 60)	Fair (61- 84)	Good (85 - 94)	Excellent (95 - 100)	Not Rated		
See Appendix for definitions and formulas						
Inspection Date: 7/29/2015	Beginning Section MP	0				
Paved Length (Miles): 0.43	Section Length (MI)	0.43				
Surface Type: ASPHALT	Route Summary					
Roadway Condition Information						
Pavement Condition Rating (PCR)	97	97				
Surface Condition Rating (SCR)	97	97				
Roughness Condition Index (RCI)	N/A	N/A				
Distress Index Values						
Structural Crack Index	100	100				
Alligator Crack Index	100	100				
Longitudinal Crack Index	100	100				
Transverse Cracking Index	100	100				
Patching Index	100	100				
Rutting Index	97	97				
International Roughness Index (IRI)	N/A	N/A				
Lane & Width Information						
Number of Lanes	1	1				
Paved Width (ft)	13.8	13.8				
Lane Width (ft)	13.8	13.8

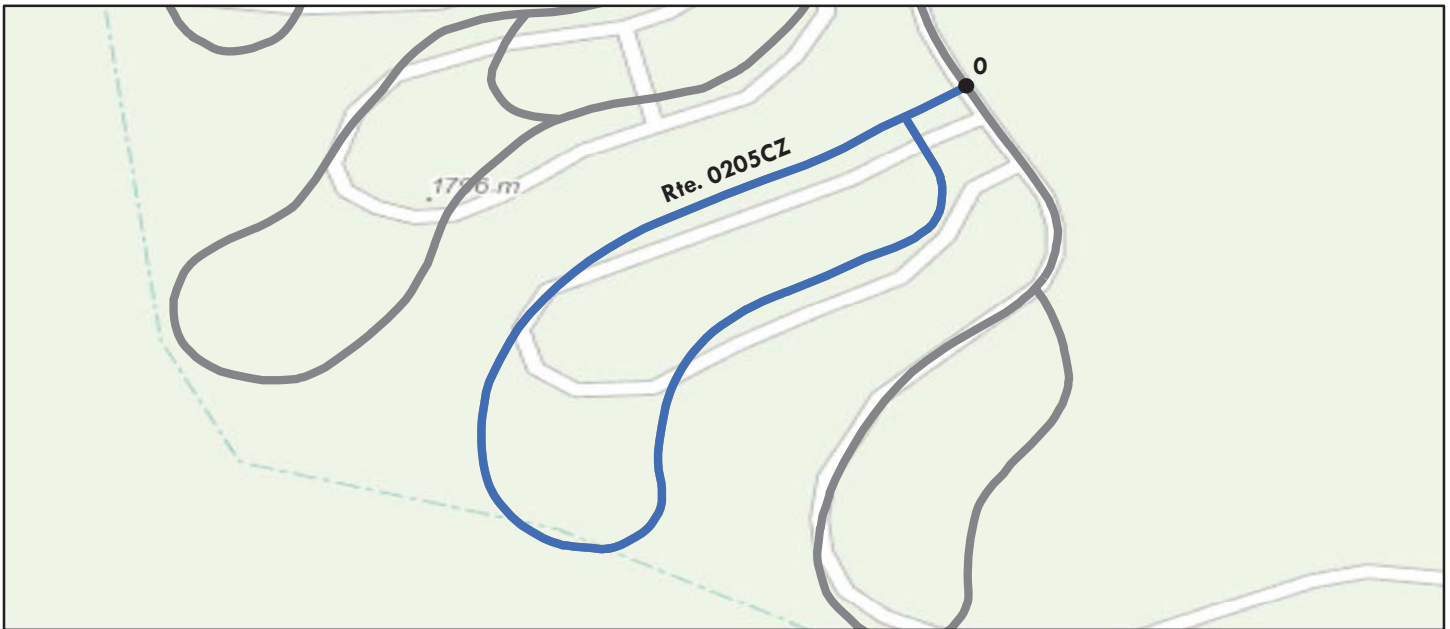
ROUTE 0205CZ: MANZANITA CAMPGROUND LOOP C

Route Condition Legend – Pavement Condition Rating (PCR)						
Poor (0 - 60)	Fair (61- 84)	Good (85 - 94)	Excellent (95 - 100)	Not Rated		
See Appendix for definitions and formulas						
Inspection Date: 7/29/2015	Beginning Section MP	0				
Paved Length (Miles): 0.36	Section Length (MI)	0.36				
Surface Type: ASPHALT	Route Summary					
Roadway Condition Information						
Pavement Condition Rating (PCR)	98	98				
Surface Condition Rating (SCR)	98	98				
Roughness Condition Index (RCI)	N/A	N/A				
Distress Index Values						
Structural Crack Index	100	100				
Alligator Crack Index	100	100				
Longitudinal Crack Index	100	100				
Transverse Cracking Index	100	100				
Patching Index	100	100				
Rutting Index	98	98				
International Roughness Index (IRI)	N/A	N/A				
Lane & Width Information						
Number of Lanes	1	1				
Paved Width (ft)	13.8	13.8				
Lane Width (ft)	13.8	13.8

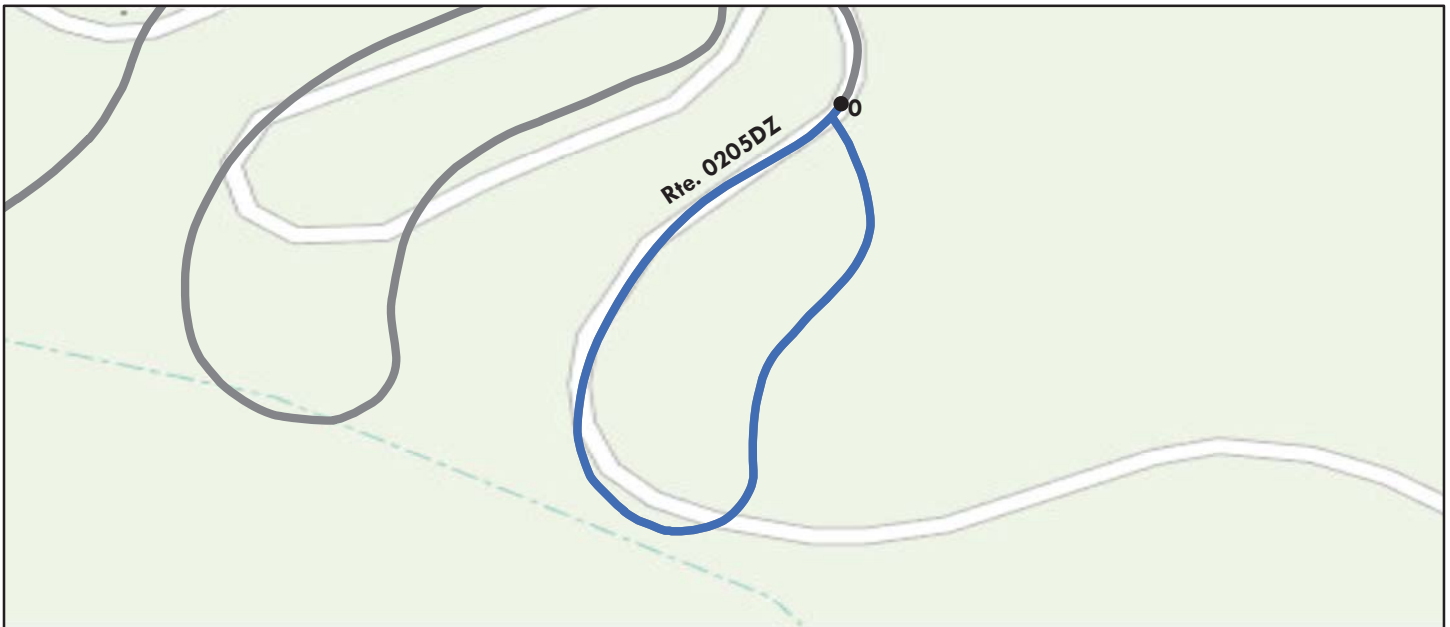
ROUTE 0205DZ: MANZANITA CAMPGROUND LOOP D

Route Condition Legend – Pavement Condition Rating (PCR)						
Poor (0 - 60)	Fair (61- 84)	Good (85 - 94)	Excellent (95 - 100)	Not Rated		
See Appendix for definitions and formulas						
Inspection Date: 7/29/2015	Beginning Section MP	0				
Paved Length (Miles): 0.24	Section Length (MI)	0.24				
Surface Type: ASPHALT	Route Summary					
Roadway Condition Information						
Pavement Condition Rating (PCR)	97	97				
Surface Condition Rating (SCR)	97	97				
Roughness Condition Index (RCI)	N/A	N/A				
Distress Index Values						
Structural Crack Index	100	100				
Alligator Crack Index	100	100				
Longitudinal Crack Index	100	100				
Transverse Cracking Index	100	100				
Patching Index	100	100				
Rutting Index	97	97				
International Roughness Index (IRI)	N/A	N/A				
Lane & Width Information						
Number of Lanes	1	1				
Paved Width (ft)	13.6	13.6				
Lane Width (ft)	13.6	13.6

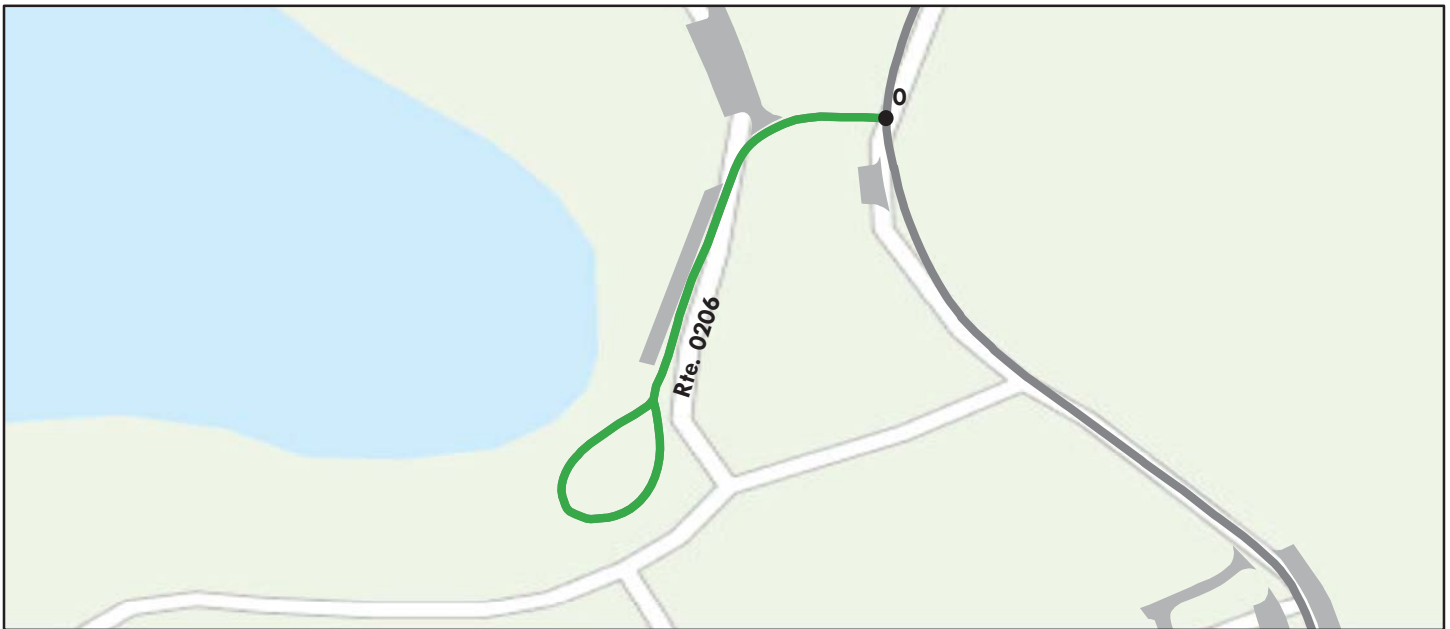
ROUTE 0206: MANZANITA LAKE ACCESS ROAD

Route Condition Legend – Pavement Condition Rating (PCR)						
Poor (0 - 60)	Fair (61- 84)	Good (85 - 94)	Excellent (95 - 100)	Not Rated		
See Appendix for definitions and formulas						
Inspection Date: 7/29/2015	Beginning Section MP	0				
Paved Length (Miles): 0.15	Section Length (MI)	0.15				
Surface Type: ASPHALT	Route Summary					
Roadway Condition Information						
Pavement Condition Rating (PCR)	92	92				
Surface Condition Rating (SCR)	92	92				
Roughness Condition Index (RCI)	N/A	N/A				
Distress Index Values						
Structural Crack Index	100	100				
Alligator Crack Index	100	100				
Longitudinal Crack Index	100	100				
Transverse Cracking Index	99	99				
Patching Index	100	100				
Rutting Index	92	92				
International Roughness Index (IRI)	N/A	N/A				
Lane & Width Information						
Number of Lanes	2	2				
Paved Width (ft)	16.4	16.4				
Lane Width (ft)	8.2	8.2

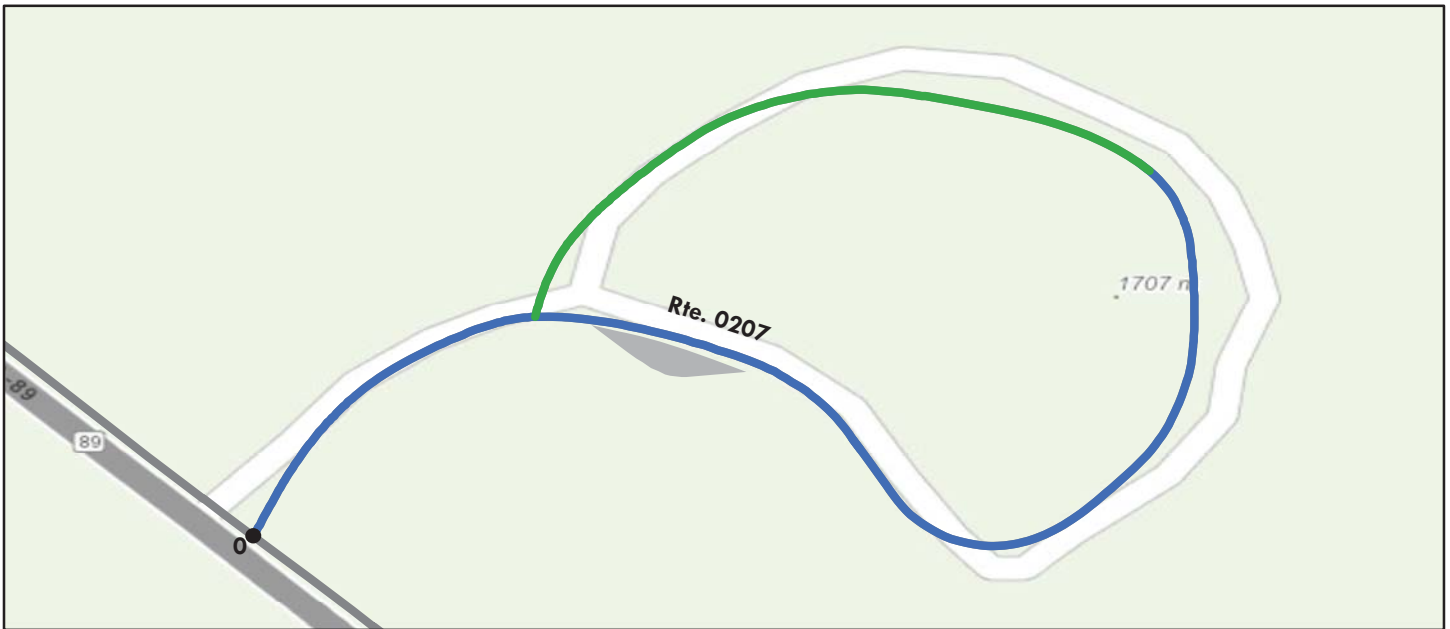
ROUTE 0207: CRAGS CAMPGROUND

Route Condition Legend – Pavement Condition Rating (PCR)						
Poor (0 - 60)	Fair (61- 84)	Good (85 - 94)	Excellent (95 - 100)	Not Rated		
See Appendix for definitions and formulas						
Inspection Date: 7/29/2015	Beginning Section MP	0				
Paved Length (Miles): 0.3	Section Length (MI)	0.3				
Surface Type: ASPHALT	Route Summary					
Roadway Condition Information						
Pavement Condition Rating (PCR)	96	96				
Surface Condition Rating (SCR)	96	96				
Roughness Condition Index (RCI)	N/A	N/A				
Distress Index Values						
Structural Crack Index	100	100				
Alligator Crack Index	100	100				
Longitudinal Crack Index	100	100				
Transverse Cracking Index	98	98				
Patching Index	100	100				
Rutting Index	96	96				
International Roughness Index (IRI)	N/A	N/A				
Lane & Width Information						
Number of Lanes	2	2				
Paved Width (ft)	19.2	19.2				
Lane Width (ft)	9.6	9.6

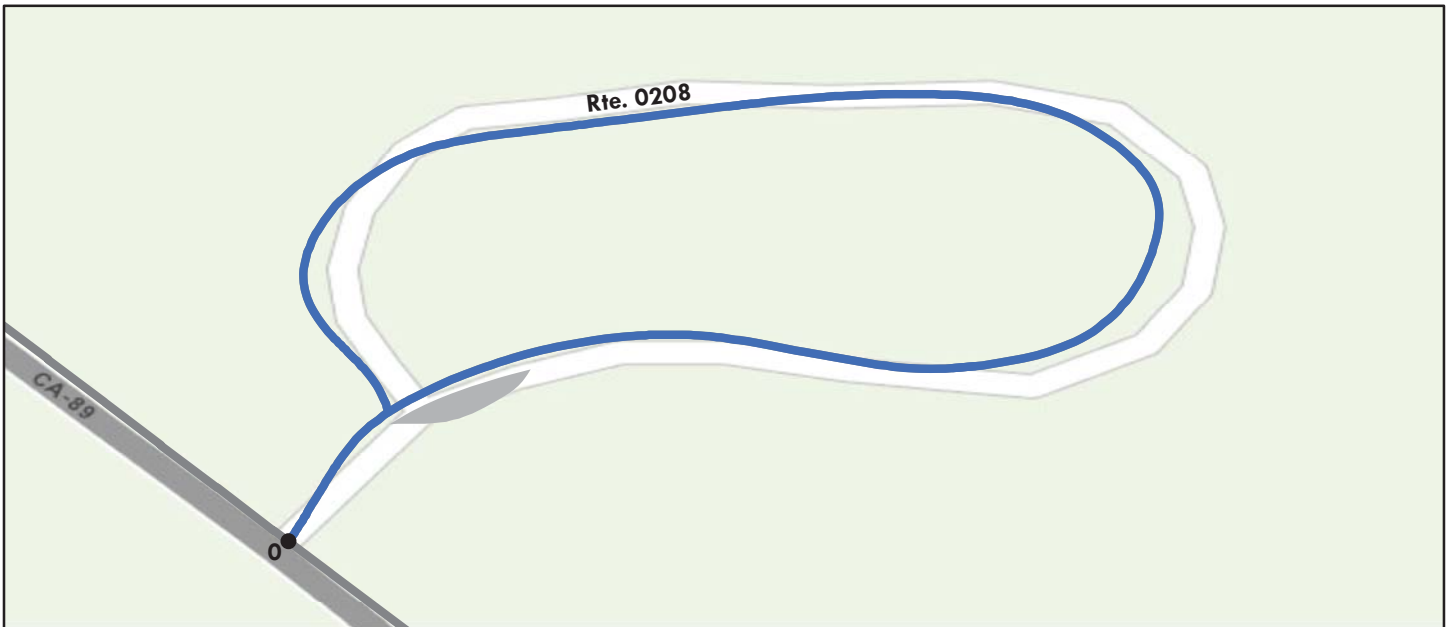
ROUTE 0208: LOST CREEK CAMPGROUND

Route Condition Legend – Pavement Condition Rating (PCR)						
Poor (0 - 60)	Fair (61- 84)	Good (85 - 94)	Excellent (95 - 100)	Not Rated		
See Appendix for definitions and formulas						
Inspection Date: 7/29/2015	Beginning Section MP	0				
Paved Length (Miles): 0.29	Section Length (MI)	0.29				
Surface Type: ASPHALT	Route Summary					
Roadway Condition Information						
Pavement Condition Rating (PCR)	97	97				
Surface Condition Rating (SCR)	97	97				
Roughness Condition Index (RCI)	N/A	N/A				
Distress Index Values						
Structural Crack Index	100	100				
Alligator Crack Index	100	100				
Longitudinal Crack Index	100	100				
Transverse Cracking Index	100	100				
Patching Index	100	100				
Rutting Index	97	97				
International Roughness Index (IRI)	N/A	N/A				
Lane & Width Information						
Number of Lanes	2	2				
Paved Width (ft)	19.2	19.2				
Lane Width (ft)	9.6	9.6

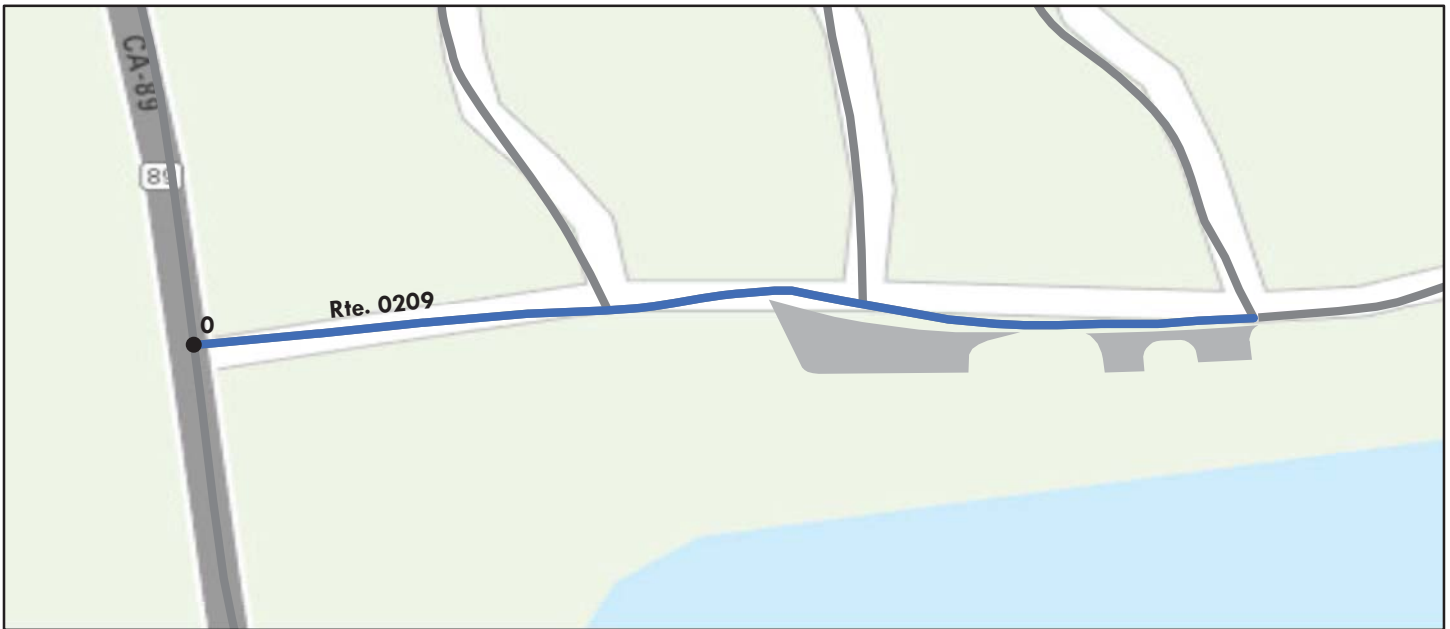
ROUTE 0209: SUMMIT LAKE NORTH CAMPGROUND ENTRANCE ROAD

Route Condition Legend – Pavement Condition Rating (PCR)						
Poor (0 - 60)	Fair (61- 84)	Good (85 - 94)	Excellent (95 - 100)	Not Rated		
See Appendix for definitions and formulas						
Inspection Date: 7/29/2015	Beginning Section MP	0				
Paved Length (Miles): 0.1	Section Length (MI)	0.1				
Surface Type: ASPHALT	Route Summary					
Roadway Condition Information						
Pavement Condition Rating (PCR)	98	98				
Surface Condition Rating (SCR)	98	98				
Roughness Condition Index (RCI)	N/A	N/A				
Distress Index Values						
Structural Crack Index	100	100				
Alligator Crack Index	100	100				
Longitudinal Crack Index	100	100				
Transverse Cracking Index	100	100				
Patching Index	100	100				
Rutting Index	98	98				
International Roughness Index (IRI)	N/A	N/A				
Lane & Width Information						
Number of Lanes	2	2				
Paved Width (ft)	17.7	17.7				
Lane Width (ft)	8.8	8.8

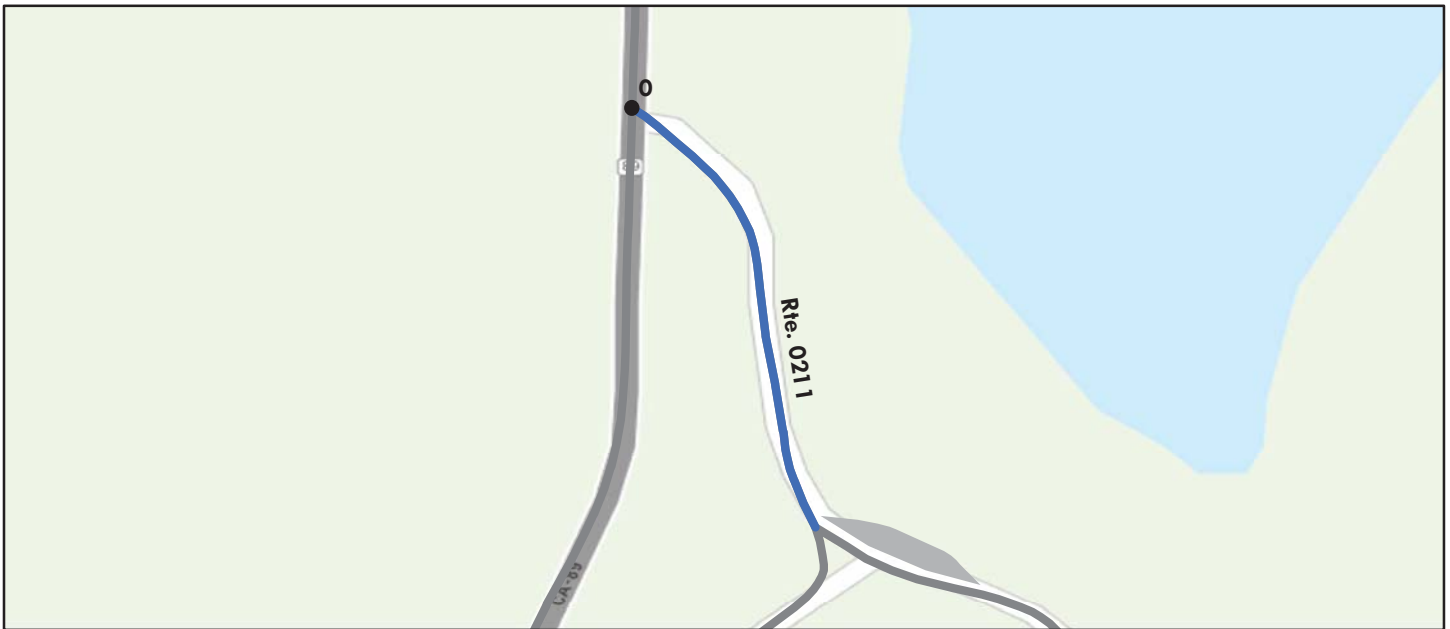
ROUTE 0211: SUMMIT LAKE SOUTH CAMPGROUND ENTRANCE ROAD

Route Condition Legend – Pavement Condition Rating (PCR)						
Poor (0 - 60)	Fair (61- 84)	Good (85 - 94)	Excellent (95 - 100)	Not Rated		
See Appendix for definitions and formulas						
Inspection Date: 7/29/2015	Beginning Section MP	0				
Paved Length (Miles): 0.1	Section Length (MI)	0.1				
Surface Type: ASPHALT	Route Summary					
Roadway Condition Information						
Pavement Condition Rating (PCR)	98	98				
Surface Condition Rating (SCR)	98	98				
Roughness Condition Index (RCI)	N/A	N/A				
Distress Index Values						
Structural Crack Index	100	100				
Alligator Crack Index	100	100				
Longitudinal Crack Index	100	100				
Transverse Cracking Index	100	100				
Patching Index	100	100				
Rutting Index	98	98				
International Roughness Index (IRI)	N/A	N/A				
Lane & Width Information						
Number of Lanes	2	2				
Paved Width (ft)	16.4	16.4				
Lane Width (ft)	8.2	8.2
