LAVO Cycle 6

Final Report

Road Inventory and Condition Assessment of Paved Routes Lassen Volcanic National Park

Report Date: March 2016

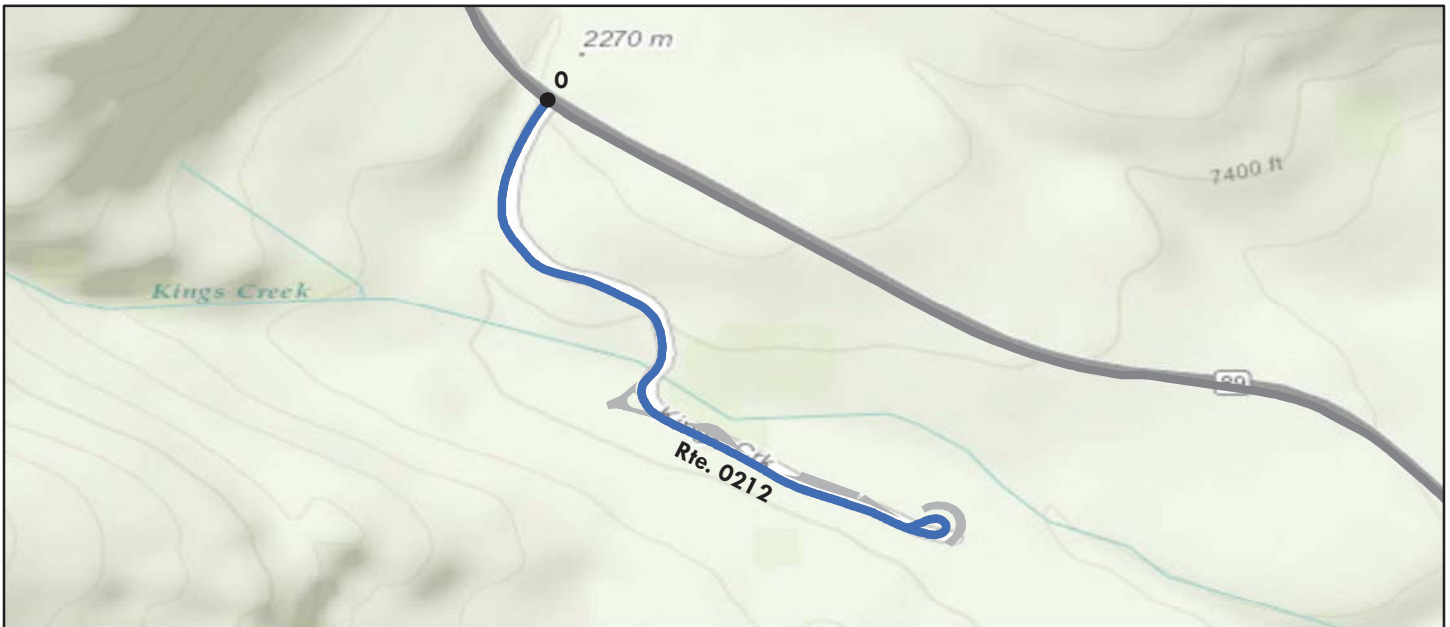
ROUTE 0212: KINGS CREEK PICNIC AREA ROAD

Route Condition Legend – Pavement Condition Rating (PCR)						
Poor (0 - 60)	Fair (61- 84)	Good (85 - 94)	Excellent (95 - 100)	Not Rated		
See Appendix for definitions and formulas						
Inspection Date: 7/29/2015	Beginning Section MP	0				
Paved Length (Miles): 0.39	Section Length (MI)	0.39				
Surface Type: ASPHALT	Route Summary					
Roadway Condition Information						
Pavement Condition Rating (PCR)	96	96				
Surface Condition Rating (SCR)	96	96				
Roughness Condition Index (RCI)	N/A	N/A				
Distress Index Values						
Structural Crack Index	99	99				
Alligator Crack Index	100	100				
Longitudinal Crack Index	99	99				
Transverse Cracking Index	100	100				
Patching Index	100	100				
Rutting Index	96	96				
International Roughness Index (IRI)	N/A	N/A				
Lane & Width Information						
Number of Lanes	2	2				
Paved Width (ft)	17.5	17.5				
Lane Width (ft)	8.8	8.8

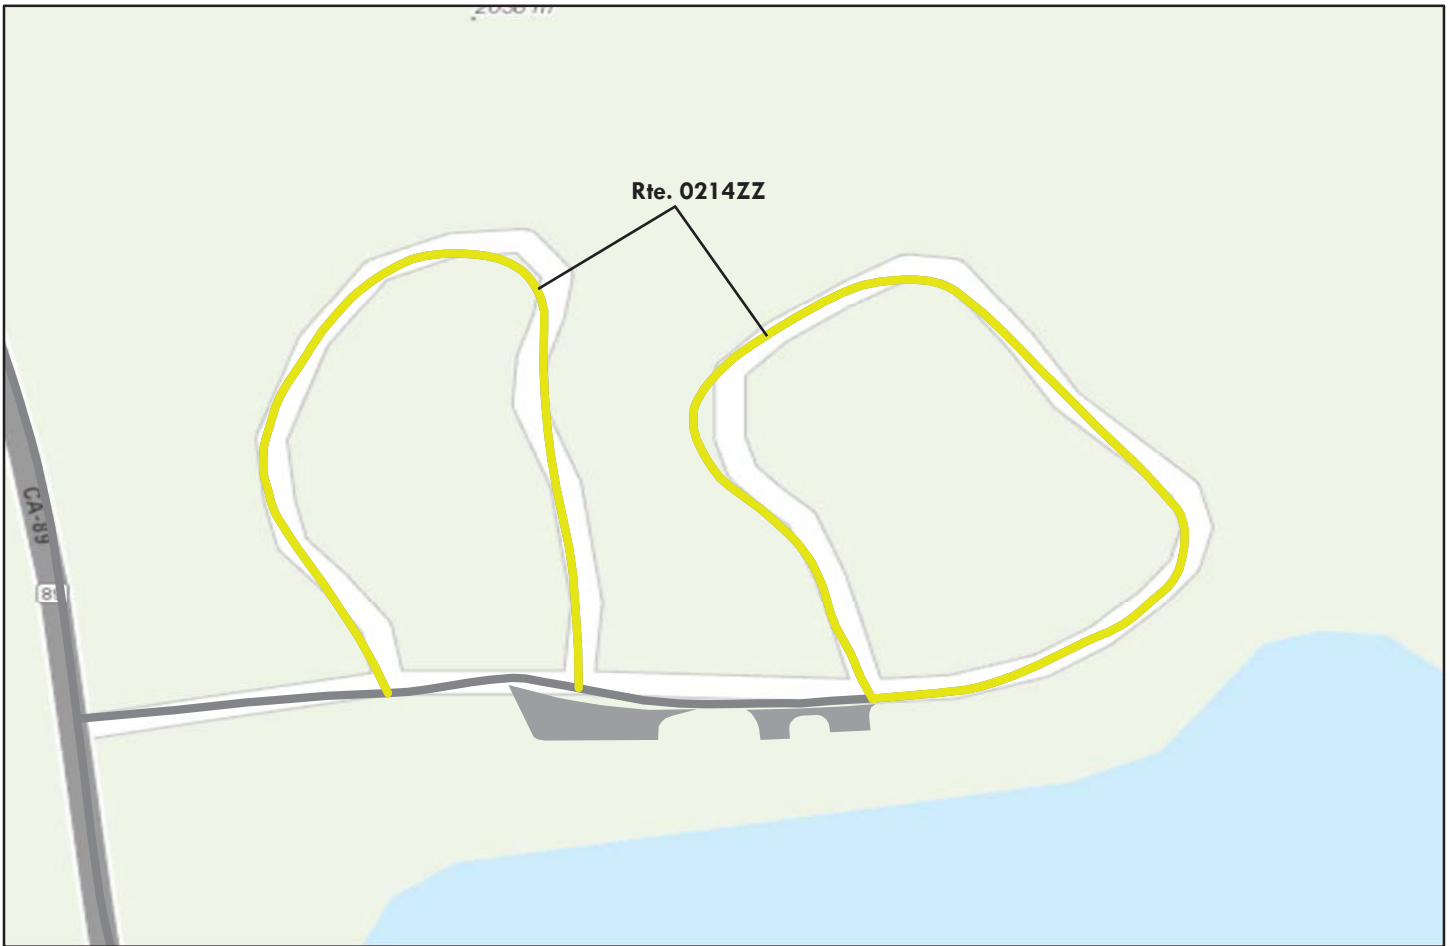
ROUTE 0214ZZ: SUMMIT LAKE NORTH CAMPGROUND LOOPS

Route Condition Legend – Pavement Condition Rating (PCR)						
Poor (0 - 60)	Fair (61- 84)	Good (85 - 94)	Excellent (95 - 100)	Not Rated		
See Appendix for definitions and formulas						
Inspection Date:	7/29/2015					
Paved Length (Miles):	0.35					
Surface Type:	ASPHALT	Route Summary				
Roadway Condition Information						
Pavement Condition Rating (PCR)	79					
Lane & Width Information						
Number of Lanes	1					
Paved Width (ft)	13.5					
Lane Width (ft)	13.5

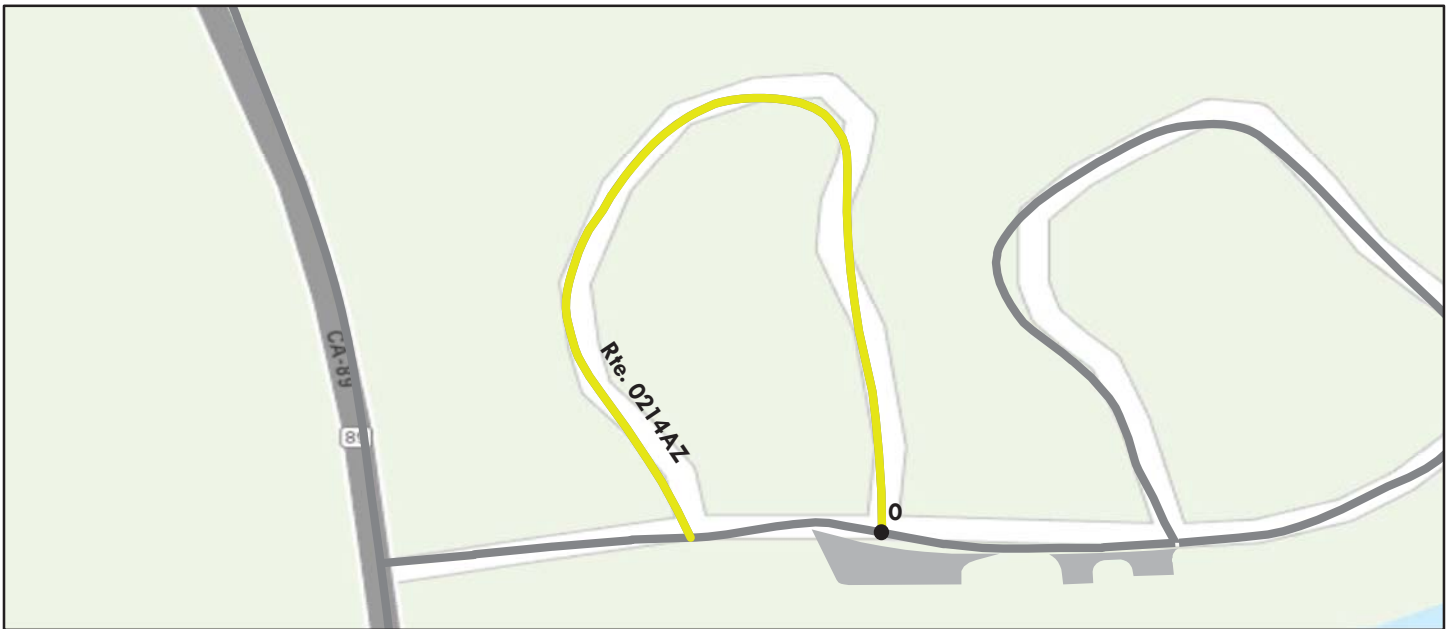
ROUTE 0214AZ: SUMMIT LAKE NORTH CAMPGROUND LOOP A

Route Condition Legend – Pavement Condition Rating (PCR)						
Poor (0 - 60)	Fair (61- 84)	Good (85 - 94)	Excellent (95 - 100)	Not Rated		
See Appendix for definitions and formulas						
Inspection Date: 7/29/2015	Beginning Section MP	0				
Paved Length (Miles): 0.16	Section Length (MI)	0.16				
Surface Type: ASPHALT	Route Summary					
Roadway Condition Information						
Pavement Condition Rating (PCR)	84	84				
Surface Condition Rating (SCR)	84	84				
Roughness Condition Index (RCI)	N/A	N/A				
Distress Index Values						
Structural Crack Index	84	84				
Alligator Crack Index	97	97				
Longitudinal Crack Index	87	87				
Transverse Cracking Index	88	88				
Patching Index	98	98				
Rutting Index	87	87				
International Roughness Index (IRI)	N/A	N/A				
Lane & Width Information						
Number of Lanes	1	1				
Paved Width (ft)	12.3	12.3				
Lane Width (ft)	12.3	12.3

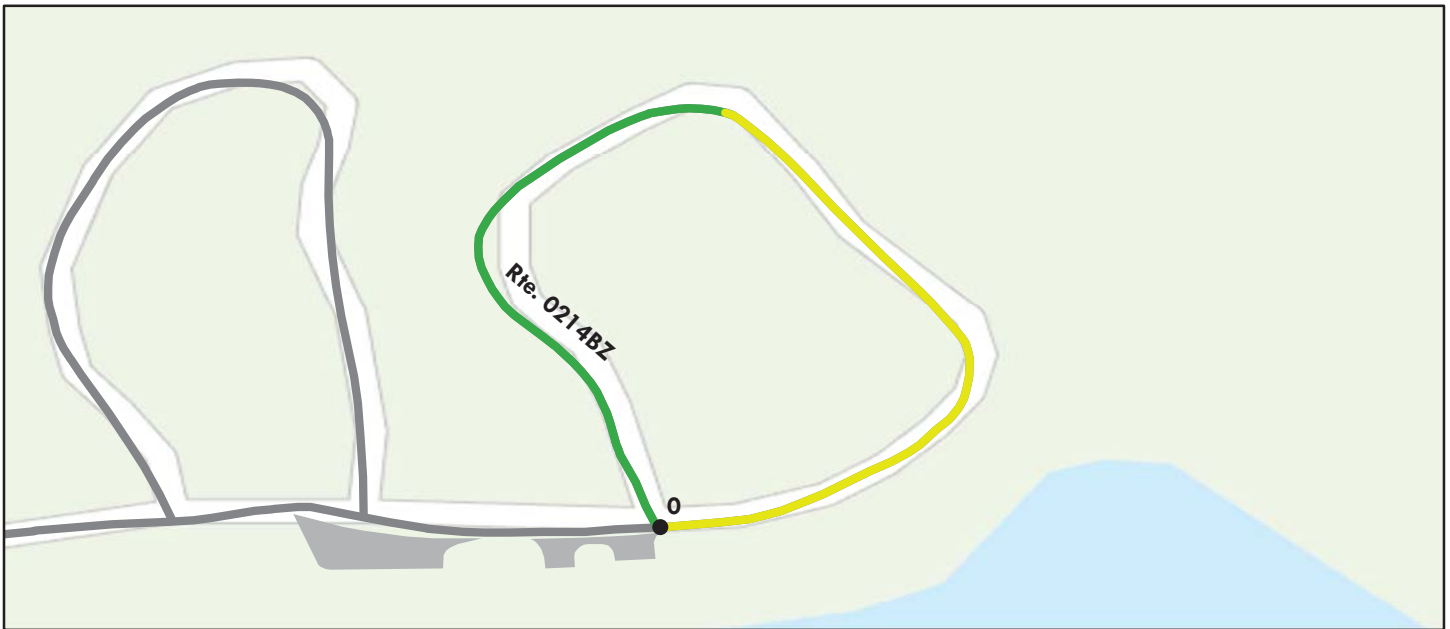
ROUTE 0214BZ: SUMMIT LAKE NORTH CAMPGROUND LOOP B

Route Condition Legend – Pavement Condition Rating (PCR)						
Poor (0 - 60)	Fair (61- 84)	Good (85 - 94)	Excellent (95 - 100)	Not Rated		
See Appendix for definitions and formulas						
Inspection Date: 7/29/2015	Beginning Section MP	0				
Paved Length (Miles): 0.19	Section Length (MI)	0.19				
Surface Type: ASPHALT	Route Summary					
Roadway Condition Information						
Pavement Condition Rating (PCR)	75	75				
Surface Condition Rating (SCR)	75	75				
Roughness Condition Index (RCI)	N/A	N/A				
Distress Index Values						
Structural Crack Index	75	75				
Alligator Crack Index	95	95				
Longitudinal Crack Index	80	80				
Transverse Cracking Index	92	92				
Patching Index	100	100				
Rutting Index	86	86				
International Roughness Index (IRI)	N/A	N/A				
Lane & Width Information						
Number of Lanes	1	1				
Paved Width (ft)	14.5	14.5				
Lane Width (ft)	14.5	14.5

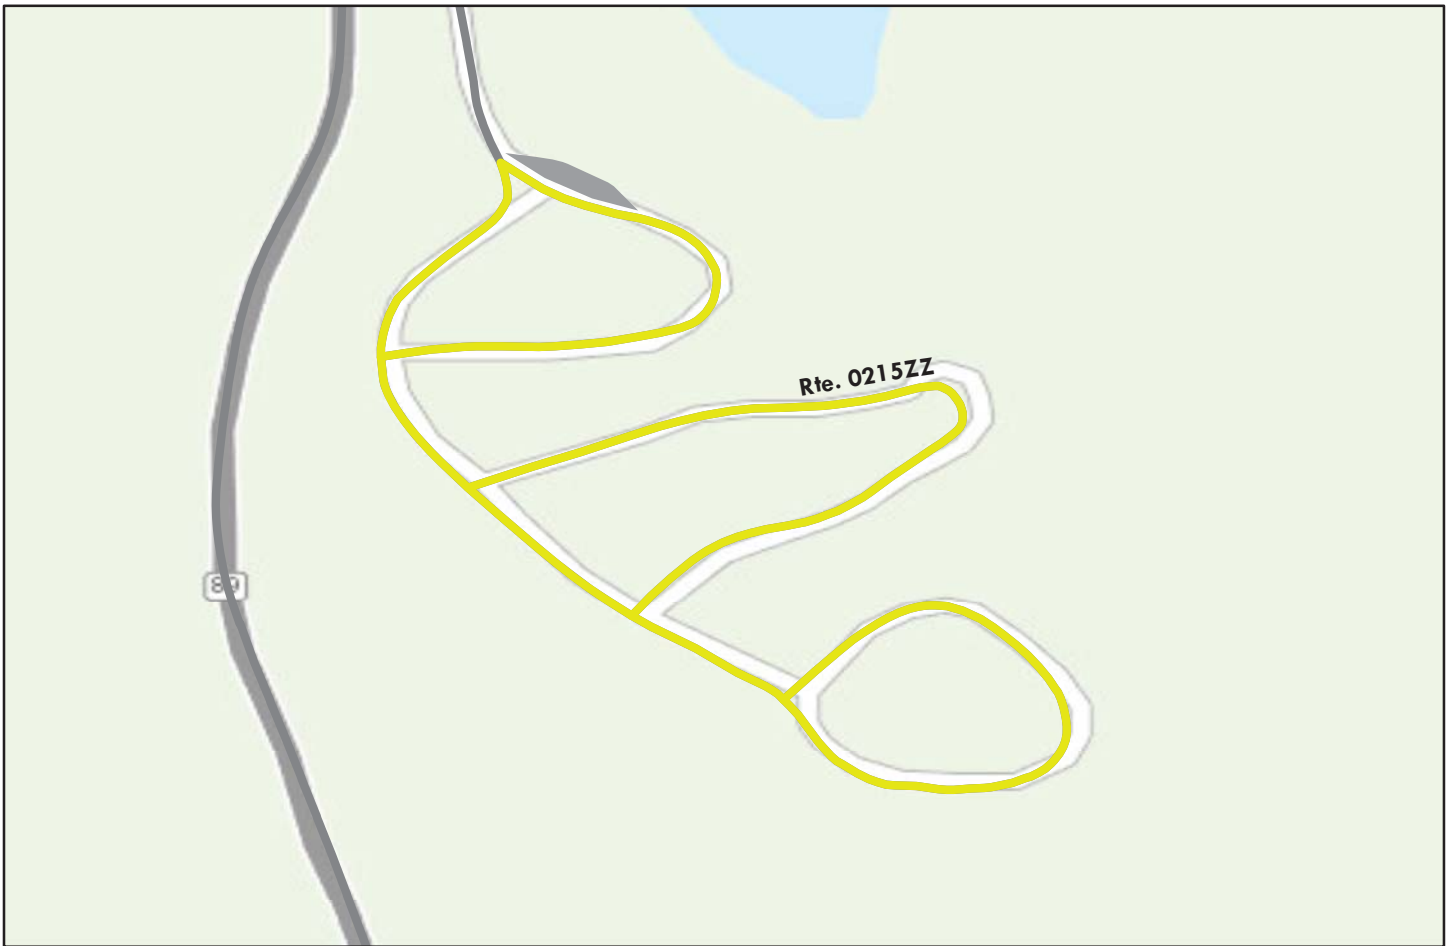
ROUTE 0215ZZ: SUMMIT LAKE SOUTH CAMPGROUND LOOPS

Route Condition Legend – Pavement Condition Rating (PCR)						
Poor (0 - 60)	Fair (61- 84)	Good (85 - 94)	Excellent (95 - 100)	Not Rated		
See Appendix for definitions and formulas						
Inspection Date:	7/29/2015					
Paved Length (Miles):	0.6					
Surface Type:	ASPHALT	Route Summary				
Roadway Condition Information						
Pavement Condition Rating (PCR)	75					
Lane & Width Information						
Number of Lanes	1					
Paved Width (ft)	14.4					
Lane Width (ft)	12.1

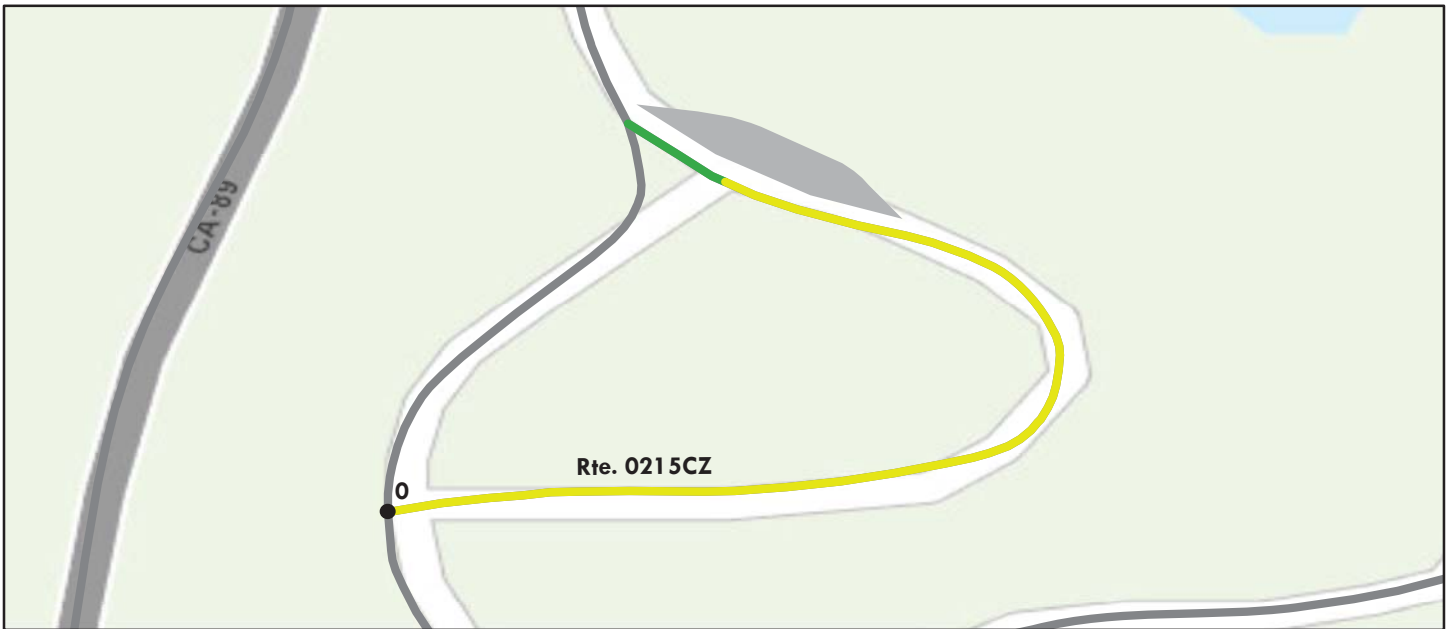
ROUTE 0215CZ: SUMMIT LAKE SOUTH CAMPGROUND LOOP C

Route Condition Legend – Pavement Condition Rating (PCR)						
Poor (0 - 60)	Fair (61- 84)	Good (85 - 94)	Excellent (95 - 100)	Not Rated		
See Appendix for definitions and formulas						
Inspection Date: 7/29/2015	Beginning Section MP	0				
Paved Length (Miles): 0.11	Section Length (MI)	0.11				
Surface Type: ASPHALT	Route Summary					
Roadway Condition Information						
Pavement Condition Rating (PCR)	69	69				
Surface Condition Rating (SCR)	69	69				
Roughness Condition Index (RCI)	N/A	N/A				
Distress Index Values						
Structural Crack Index	69	69				
Alligator Crack Index	89	89				
Longitudinal Crack Index	80	80				
Transverse Cracking Index	92	92				
Patching Index	98	98				
Rutting Index	85	85				
International Roughness Index (IRI)	N/A	N/A				
Lane & Width Information						
Number of Lanes	1	1				
Paved Width (ft)	12.7	12.7				
Lane Width (ft)	12.7	12.7

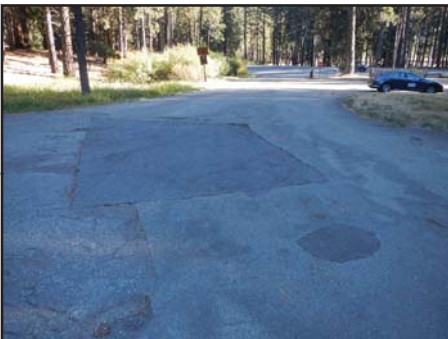
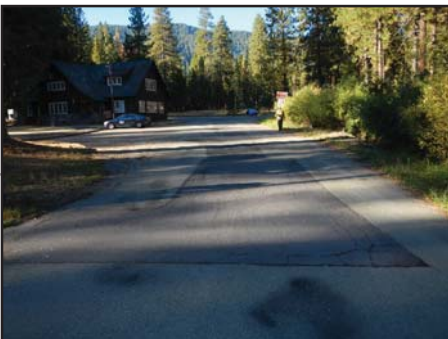
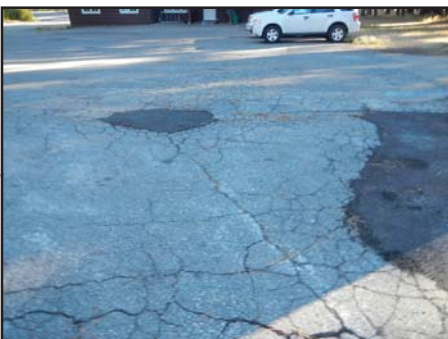
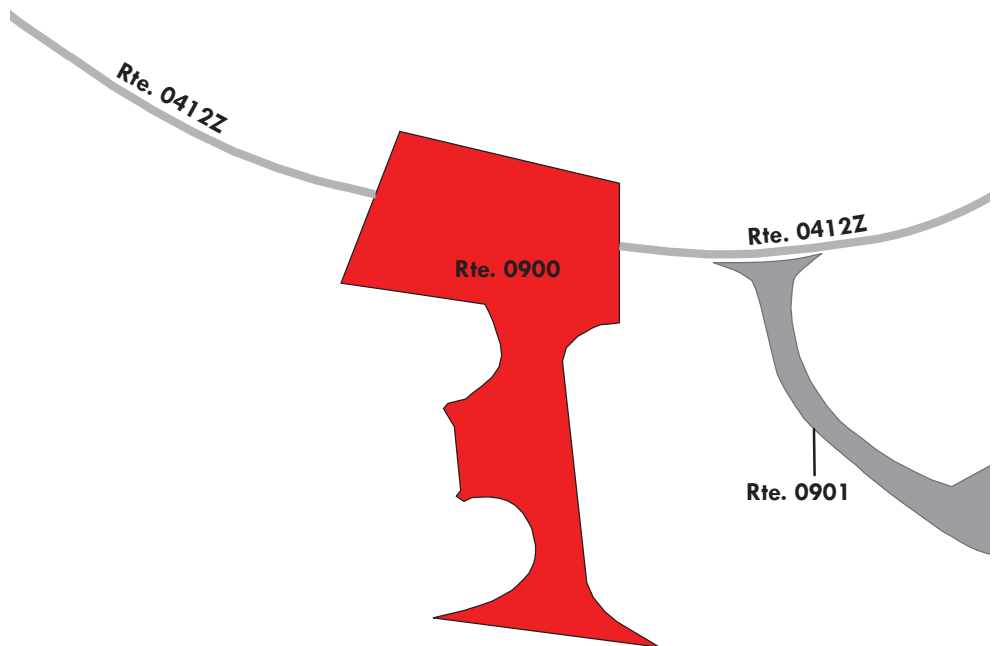
Inspection Date	FMSS Number	User Access	Surface Type
9/30/2014	73597	PUBLIC	ASPHALT
Area (Sq. Ft.)	Lane Miles (11' Widths)	Curb Reveal (Inches)	Curb Recommendation
22,142	0.381	4	REPLACE
Curb Type		Curb & Gutter Type	
CONCRETE		NO CURB AND GUTTER	
Pavement Recommendation		Condition Rating / PCR	
RECONSTRUCTION		POOR / 30

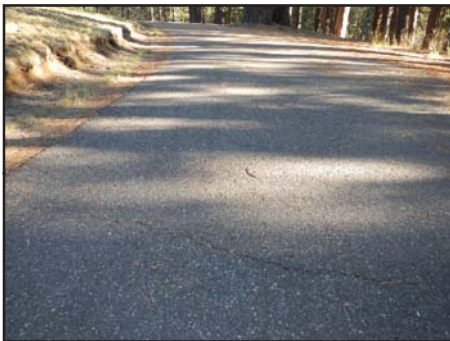
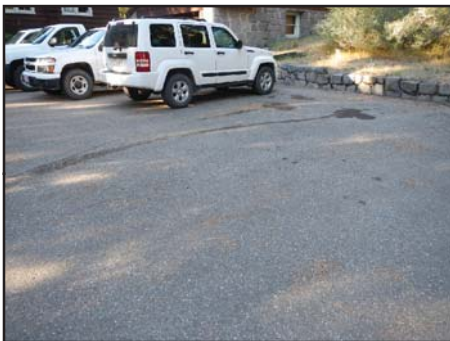
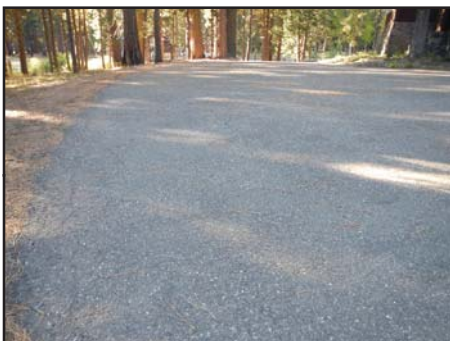
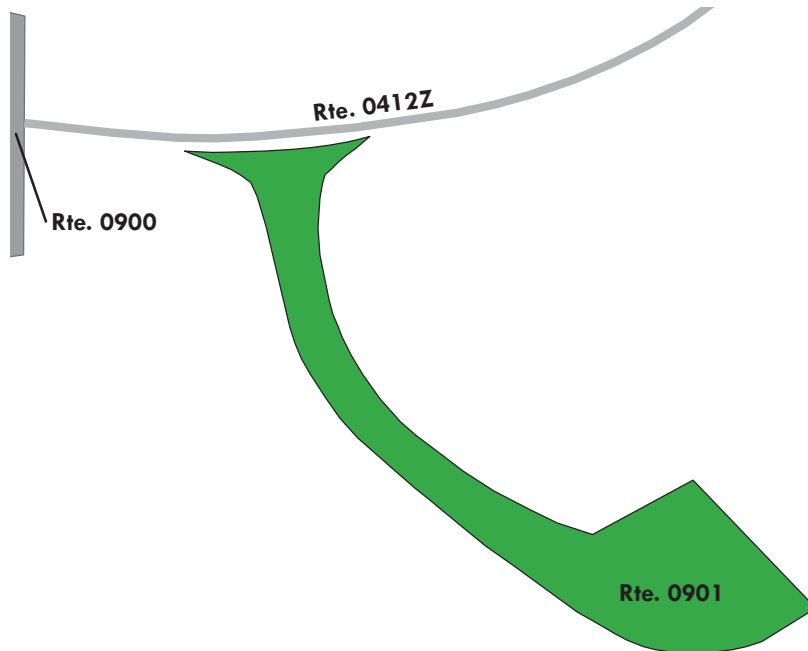
ROUTE 0901: NATURALIST DIVISION ANNEX PARKING

Inspection Date	FMSS Number	User Access	Surface Type
9/30/2014	73601	PUBLIC	ASPHALT
Area (Sq. Ft.)	Lane Miles (11' Widths)	Curb Reveal (Inches)	Curb Recommendation
6,236	0.107	NOT APPLICABLE	NOT APPLICABLE
Curb Type		Curb & Gutter Type	
NO CURB		NO CURB AND GUTTER	
Pavement Recommendation		Condition Rating / PCR	
PREVENTIVE MAINTENANCE		GOOD / 90

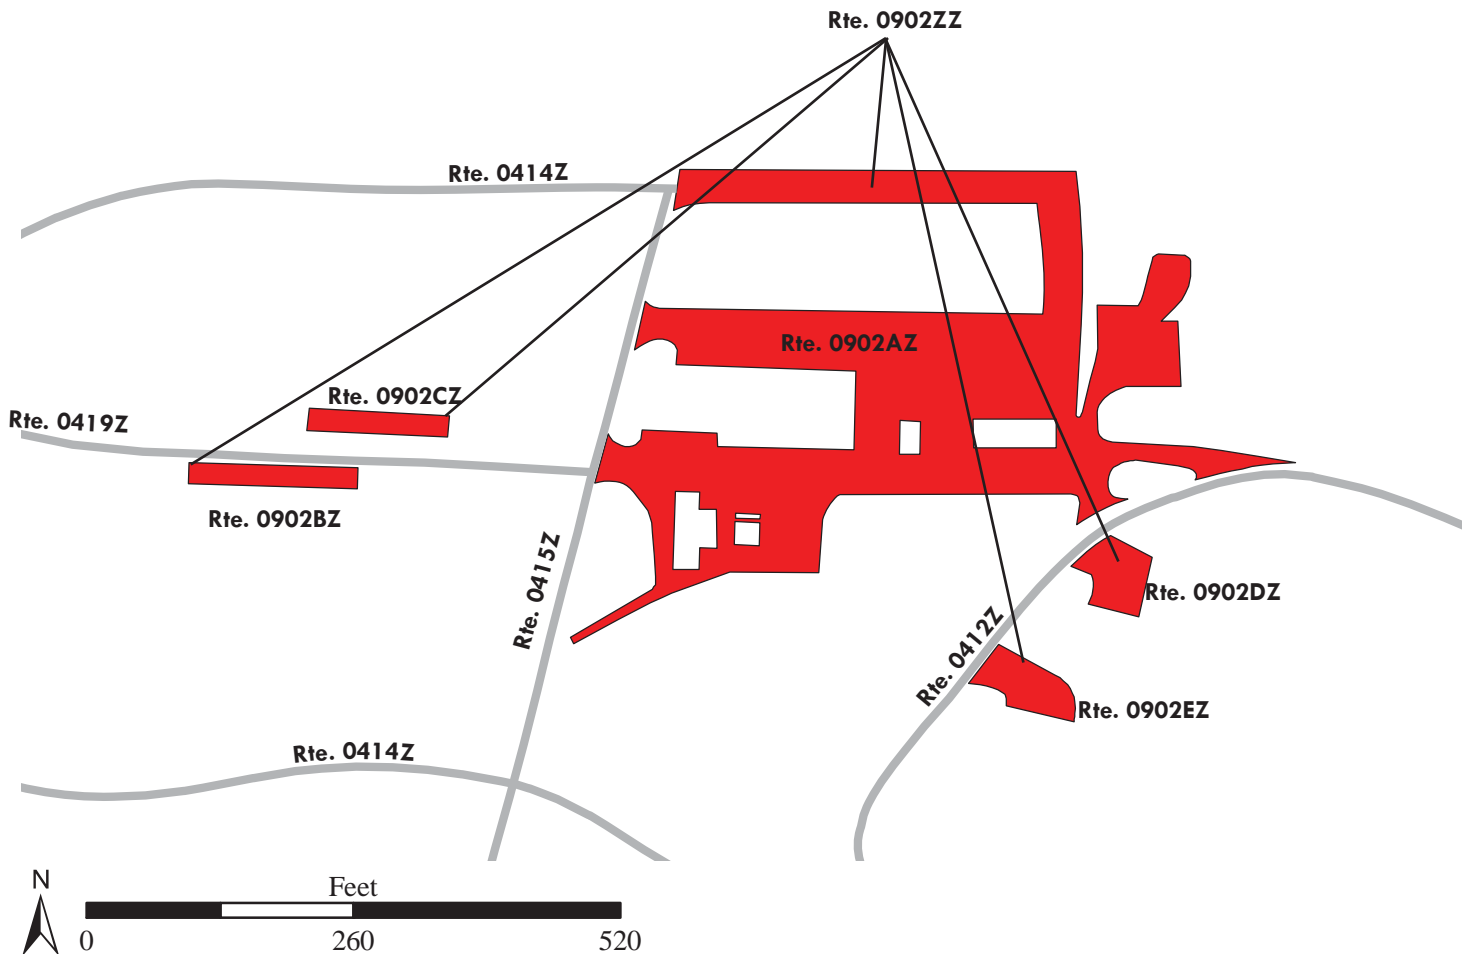
ROUTE 0902ZZ: PARK HEADQUARTERS RANGER / MAINTENANCE PARKING AREAS

Inspection Date	FMSS Number	User Access	Surface Type
9/30/2014	73607	PUBLIC	ASPHALT
Area (Sq. Ft.)	Lane Miles (11' Widths)	Condition Rating / PCR	
88,115	1.517	SUMMARY / 35

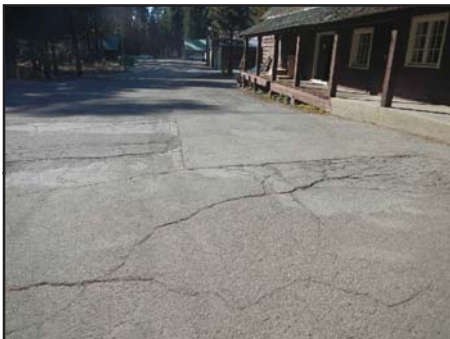
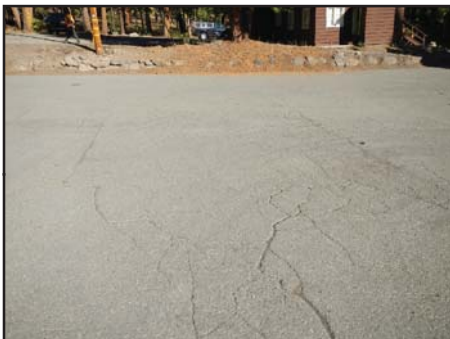
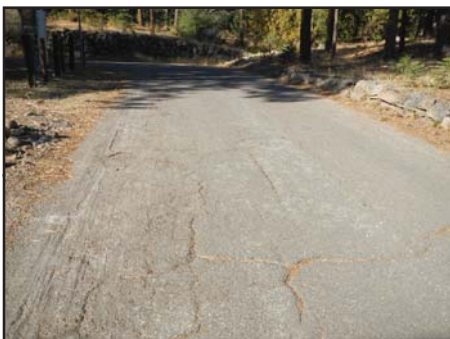
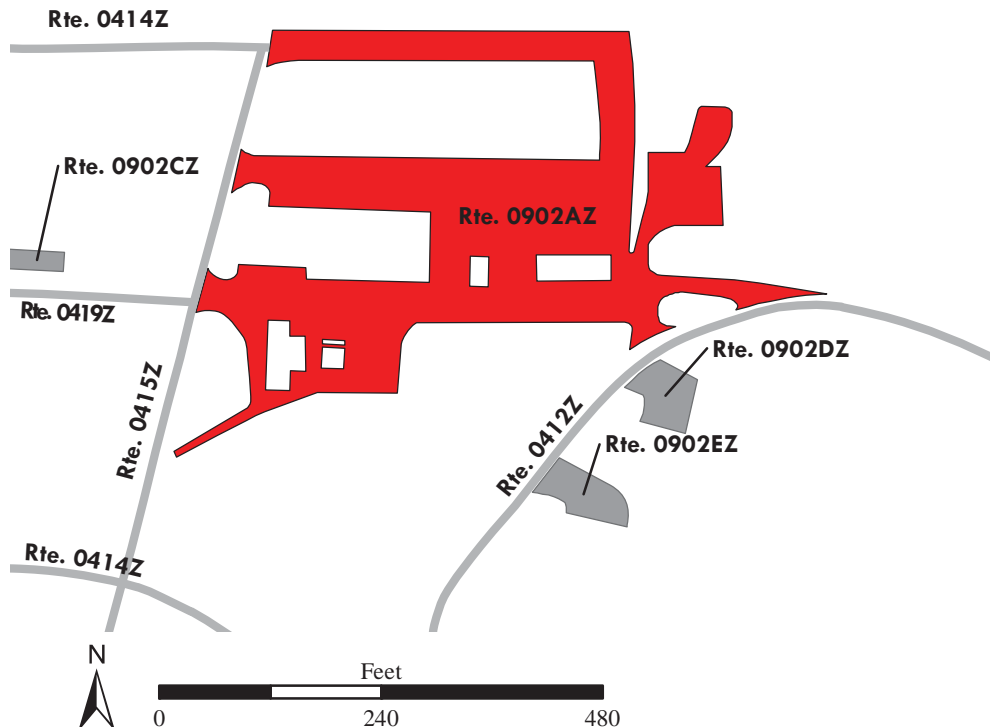
ROUTE 0902AZ: PARK HEADQUARTERS / RANGER AND MAINTENANCE PARKING A

Inspection Date	FMSS Number	User Access	Surface Type
9/30/2014	73607	PUBLIC	ASPHALT
Area (Sq. Ft.)	Lane Miles (11' Widths)	Curb Reveal (Inches)	Curb Recommendation
77,419	1.333	5	REPLACE
Curb Type		Curb & Gutter Type	
ASPHALT		NO CURB AND GUTTER	
Pavement Recommendation		Condition Rating / PCR	
RECONSTRUCTION		POOR / 30

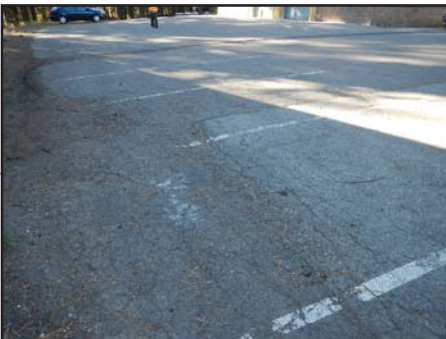
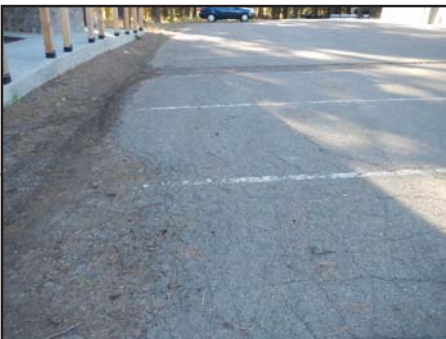
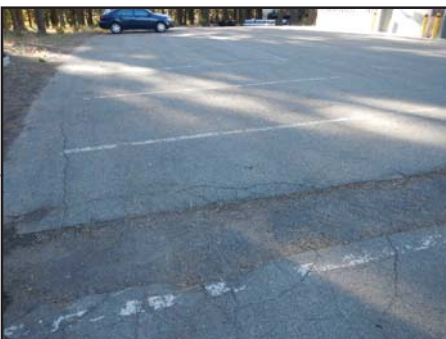
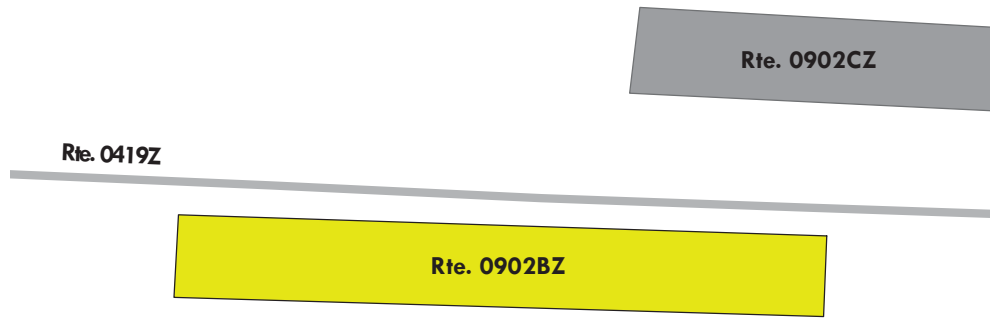
ROUTE 0902BZ: PARK HEADQUARTERS / FIRE STATION PARKING B

Inspection Date	FMSS Number	User Access	Surface Type
9/30/2014	73607	PUBLIC	ASPHALT
Area (Sq. Ft.)	Lane Miles (11' Widths)	Curb Reveal (Inches)	Curb Recommendation
2,602	0.045	NOT APPLICABLE	NOT APPLICABLE
Curb Type		Curb & Gutter Type	
NO CURB		NO CURB AND GUTTER	
Pavement Recommendation		Condition Rating / PCR	
LIGHT 3R TREATMENTS		FAIR / 73

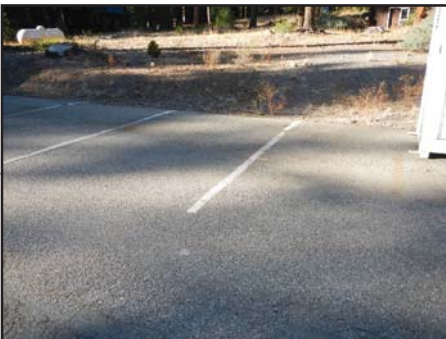
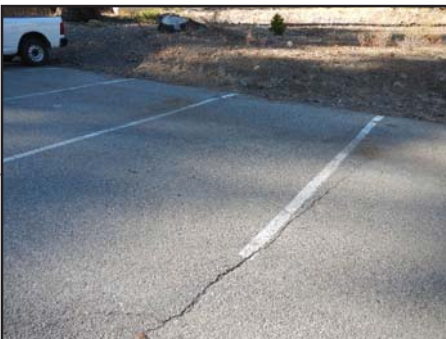
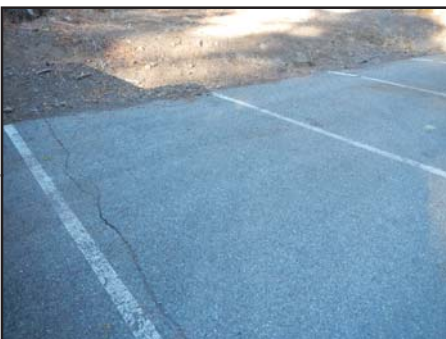
ROUTE 0902CZ: PARK HEADQUARTERS / FIRE STATION PARKING C

Inspection Date	FMSS Number	User Access	Surface Type
9/30/2014	73607	PUBLIC	ASPHALT
Area (Sq. Ft.)	Lane Miles (11' Widths)	Curb Reveal (Inches)	Curb Recommendation
2,223	0.038	NOT APPLICABLE	NOT APPLICABLE
Curb Type		Curb & Gutter Type	
NO CURB		NO CURB AND GUTTER	
Pavement Recommendation		Condition Rating / PCR	
PREVENTIVE MAINTENANCE		GOOD / 90

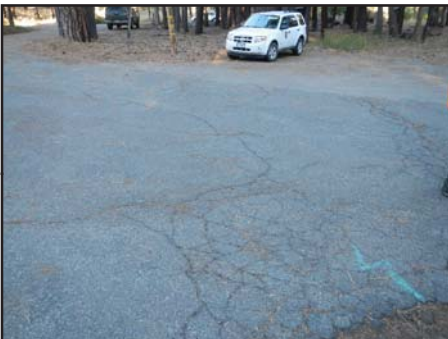
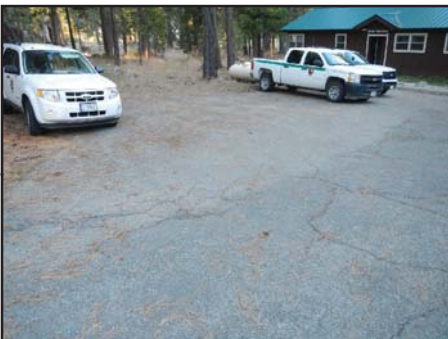
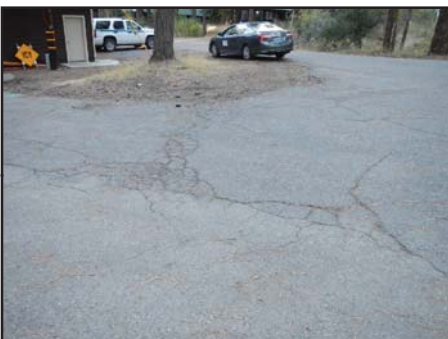
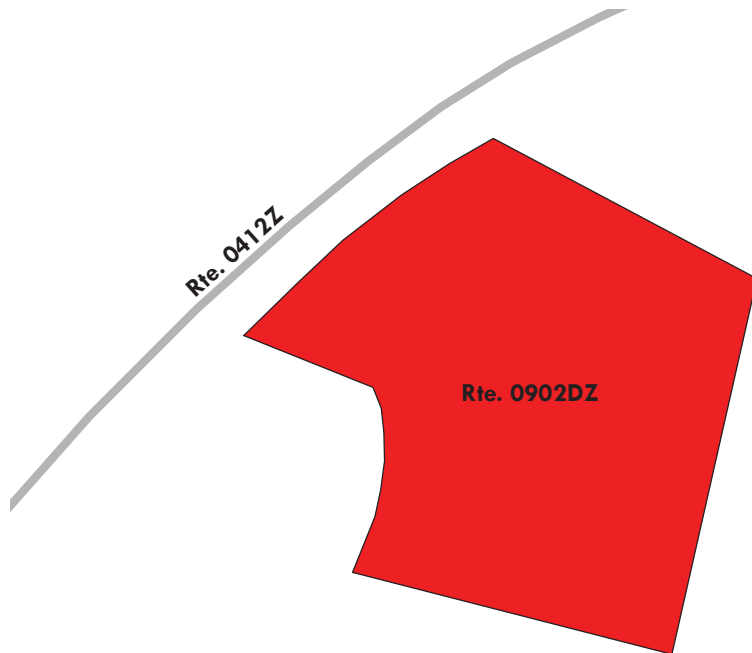
ROUTE 0902DZ: PARK HEADQUARTERS / RANGER OPERATIONS PARKING

Inspection Date	FMSS Number	User Access	Surface Type
9/30/2014	73607	PUBLIC	ASPHALT
Area (Sq. Ft.)	Lane Miles (11' Widths)	Curb Reveal (Inches)	Curb Recommendation
2,881	0.05	NOT APPLICABLE	NOT APPLICABLE
Curb Type		Curb & Gutter Type	
NO CURB		NO CURB AND GUTTER	
Pavement Recommendation		Condition Rating / PCR	
RECONSTRUCTION		POOR / 30

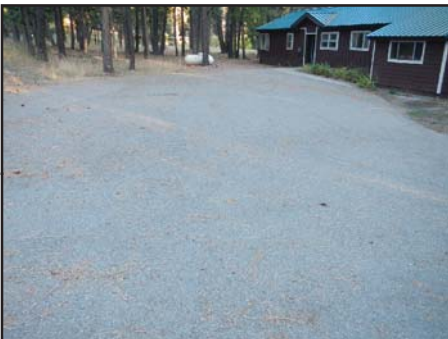
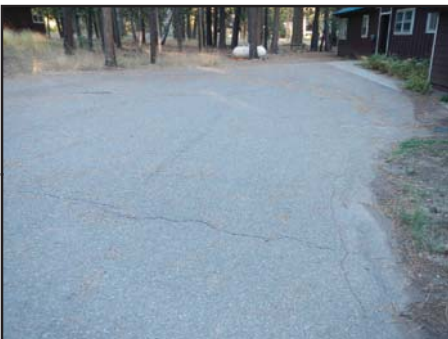
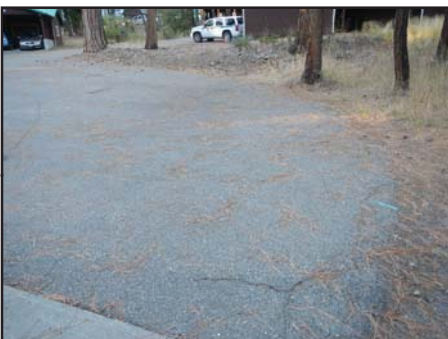
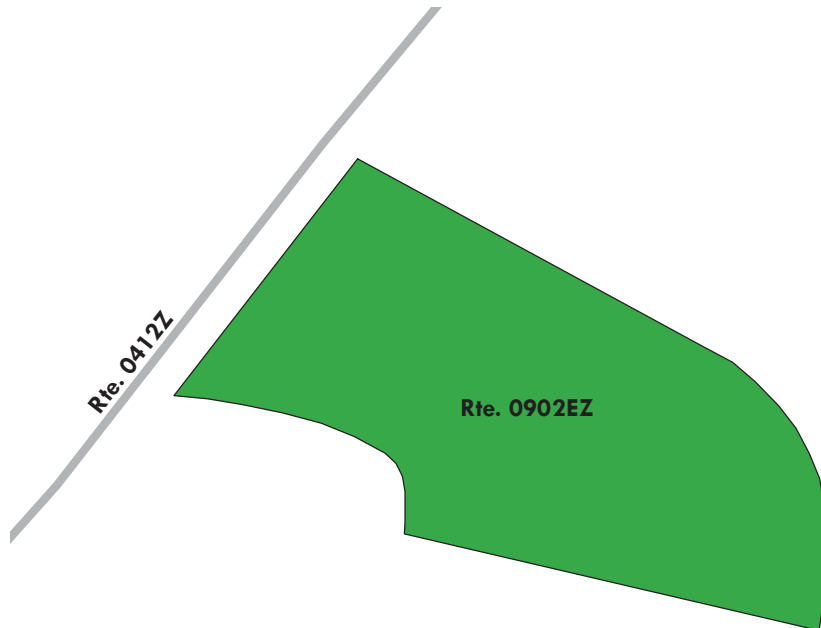
Inspection Date	FMSS Number	User Access	Surface Type
9/30/2014	73607	PUBLIC	ASPHALT
Area (Sq. Ft.)	Lane Miles (11' Widths)	Curb Reveal (Inches)	Curb Recommendation
2,990	0.051	NOT APPLICABLE	NOT APPLICABLE
Curb Type		Curb & Gutter Type	
NO CURB		NO CURB AND GUTTER	
Pavement Recommendation		Condition Rating / PCR	
PREVENTIVE MAINTENANCE		GOOD / 90

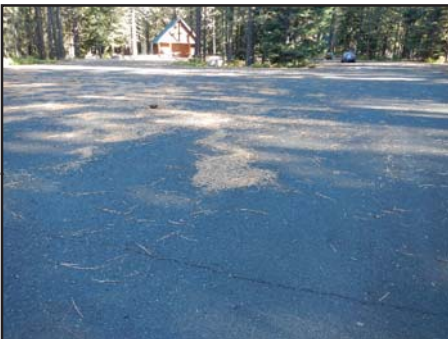
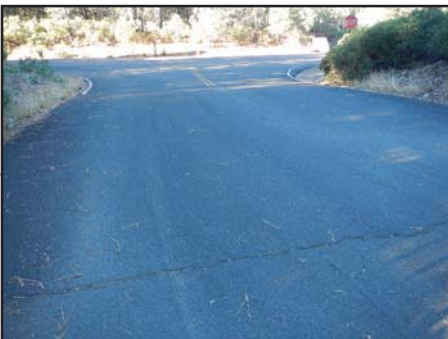
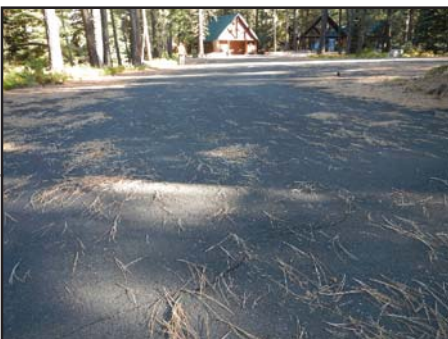
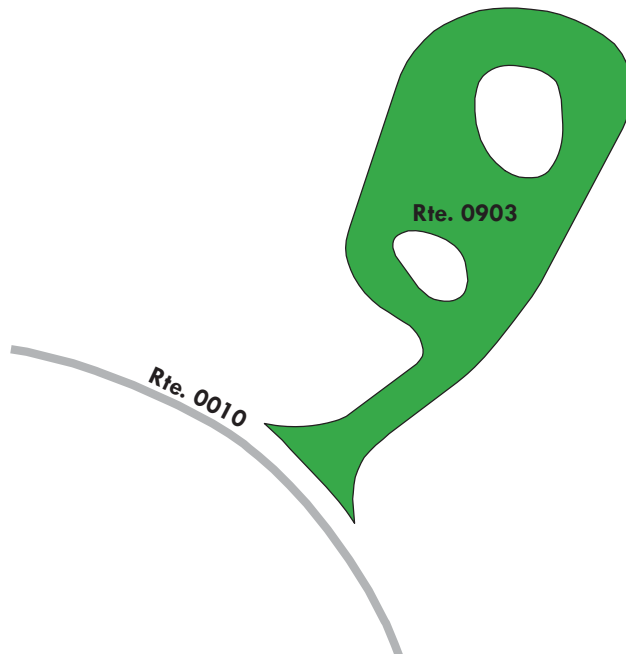
ROUTE 0903: CROSSROAD PAVILION PARKING

Inspection Date	FMSS Number	User Access	Surface Type
10/1/2014	73610	PUBLIC	ASPHALT
Area (Sq. Ft.)	Lane Miles (11' Widths)	Curb Reveal (Inches)	Curb Recommendation
29,111	0.501	NOT APPLICABLE	DO NOTHING
Curb Type		Curb & Gutter Type	
NO CURB		CONCRETE	
Pavement Recommendation		Condition Rating / PCR	
PREVENTIVE MAINTENANCE		GOOD / 90

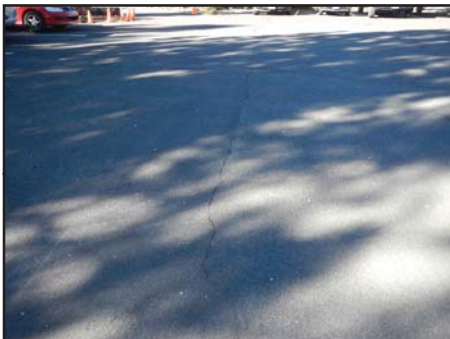
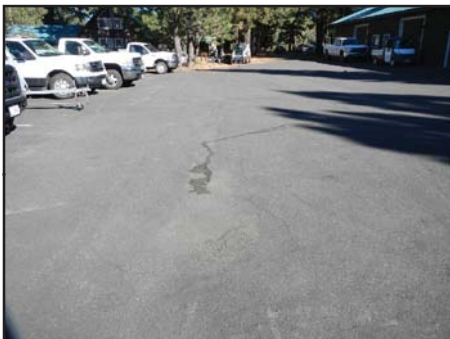
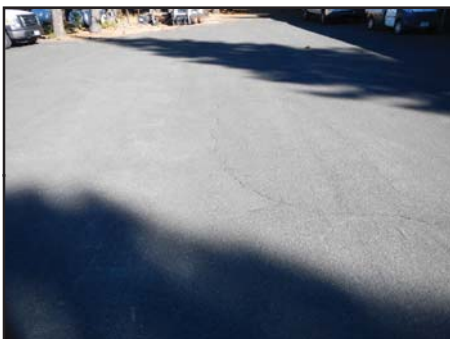
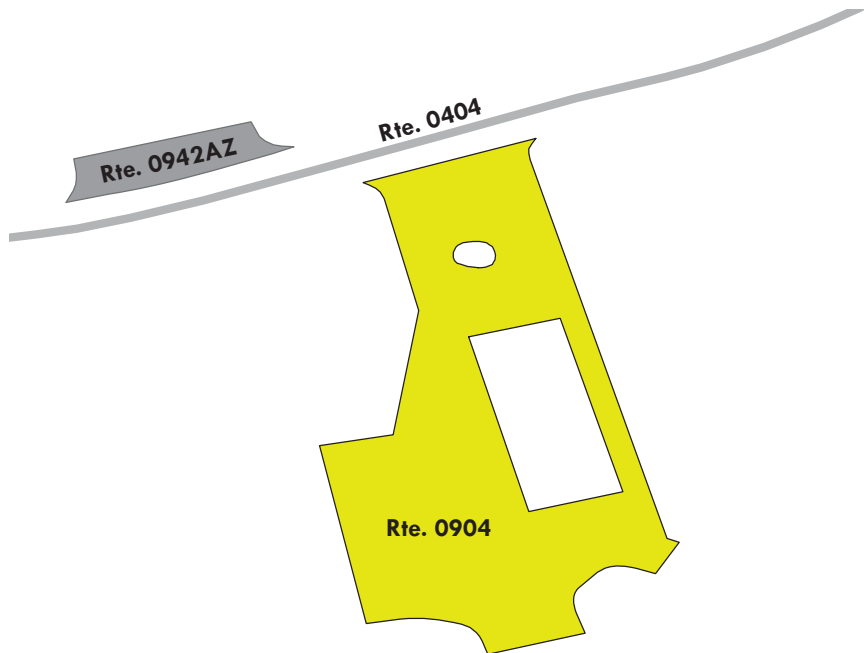
ROUTE 0904: MANZANITA MAINTENANCE PARKING

Inspection Date	FMSS Number	User Access	Surface Type
10/1/2014	73616	PUBLIC	ASPHALT
Area (Sq. Ft.)	Lane Miles (11' Widths)	Curb Reveal (Inches)	Curb Recommendation
18,112	0.312	NOT APPLICABLE	NOT APPLICABLE
Curb Type		Curb & Gutter Type	
NO CURB		NO CURB AND GUTTER	
Pavement Recommendation		Condition Rating / PCR	
LIGHT 3R TREATMENTS		FAIR / 73

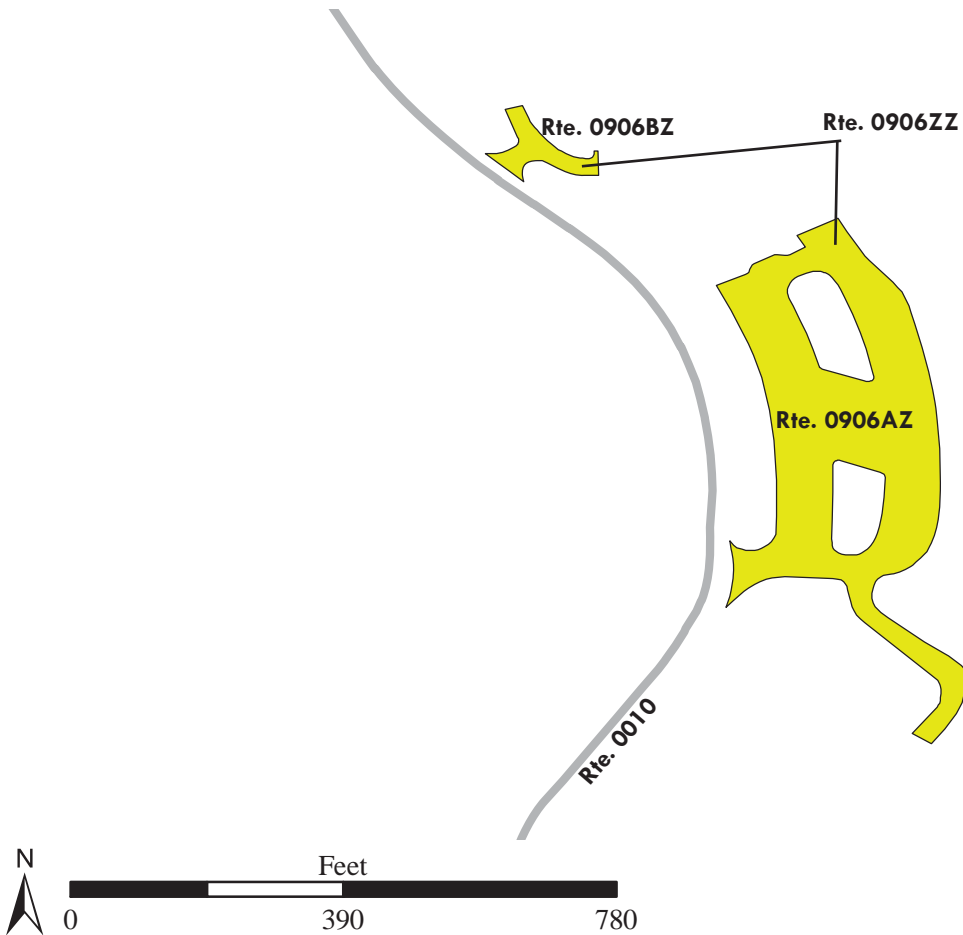
ROUTE 0906ZZ: SOUTHWEST VISITORS CENTER PARKING AREAS

Inspection Date	FMSS Number	User Access	Surface Type
10/1/2014	73618	PUBLIC	ASPHALT
Area (Sq. Ft.)	Lane Miles (11' Widths)	Condition Rating / PCR	
83,506	1.438	SUMMARY / 74

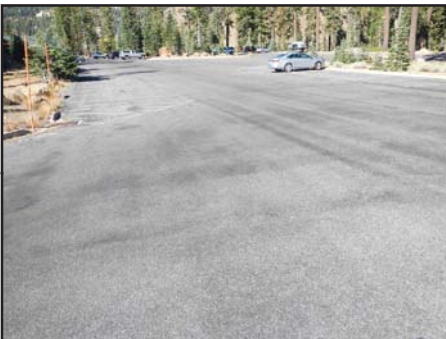
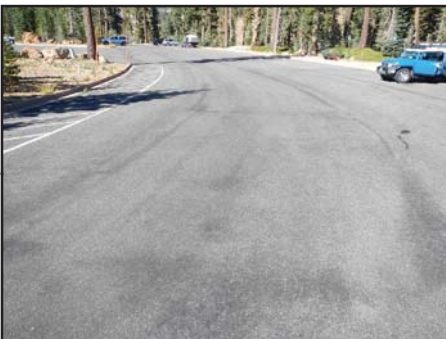
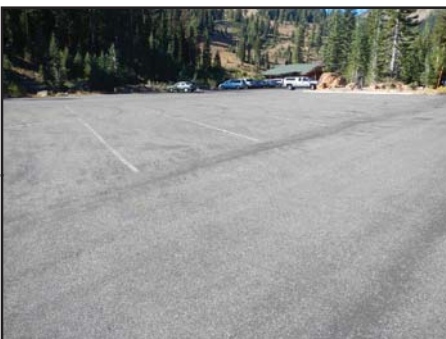
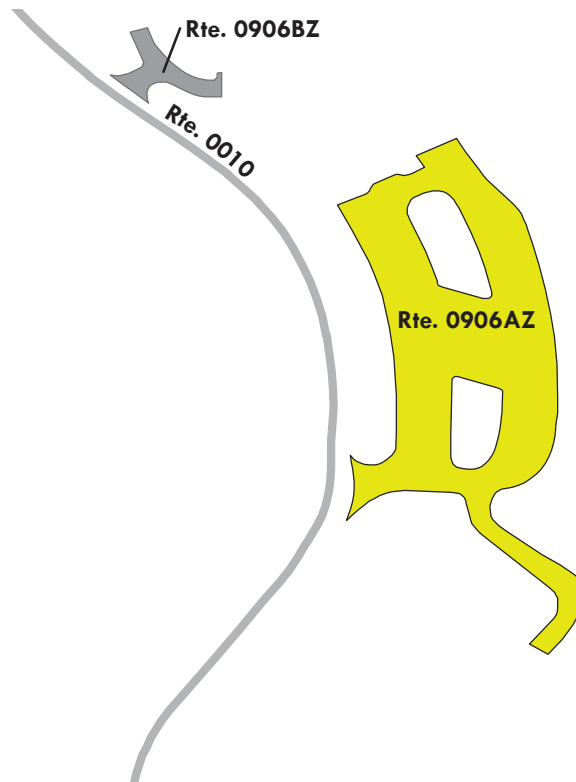
ROUTE 0906AZ: SOUTHWEST VISITORS CENTER PARKING

Inspection Date	FMSS Number	User Access	Surface Type
10/1/2014	73618	PUBLIC	ASPHALT
Area (Sq. Ft.)	Lane Miles (11' Widths)	Curb Reveal (Inches)	Curb Recommendation
79,053	1.361	NOT APPLICABLE	DO NOTHING
Curb Type		Curb & Gutter Type	
NO CURB		CONCRETE	
Pavement Recommendation		Condition Rating / PCR	
LIGHT 3R TREATMENTS		FAIR / 73

The parking area consists of multiple surface types, one part asphalt at 77,884 square feet; one part concrete at 1,169 square feet.

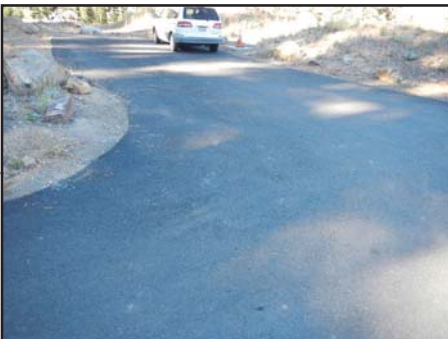
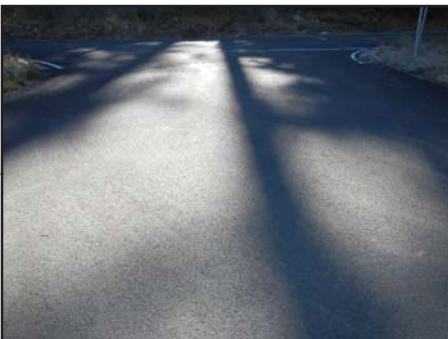
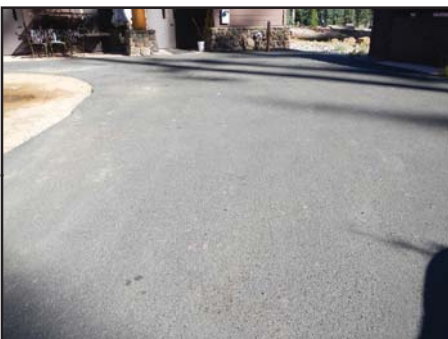
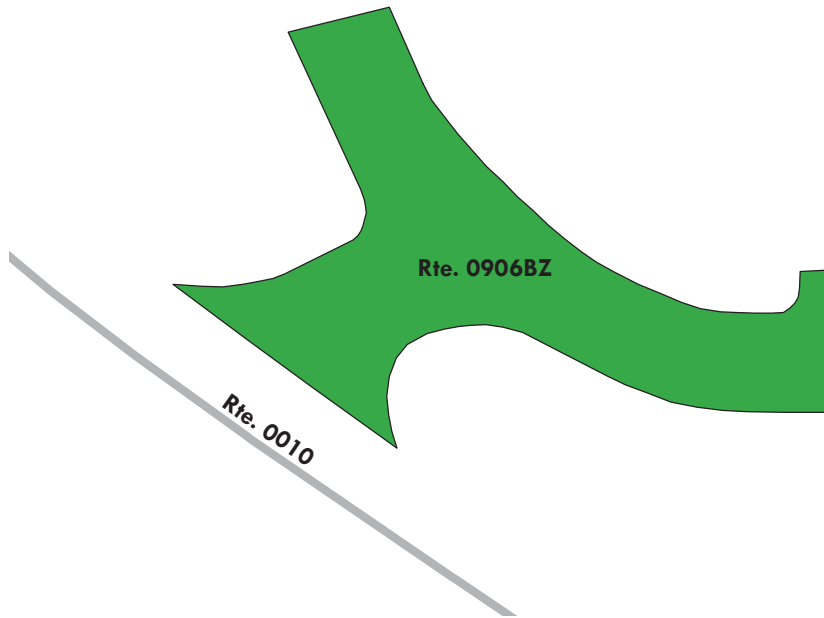
ROUTE 0906BZ: SERVICE ENTRY PARKING

Inspection Date	FMSS Number	User Access	Surface Type
10/1/2014	73618	NONPUBLIC	ASPHALT
Area (Sq. Ft.)	Lane Miles (11' Widths)	Curb Reveal (Inches)	Curb Recommendation
4,453	0.077	NOT APPLICABLE	NOT APPLICABLE
Curb Type		Curb & Gutter Type	
NO CURB		NO CURB AND GUTTER	
Pavement Recommendation		Condition Rating / PCR	
PREVENTIVE MAINTENANCE		GOOD / 90

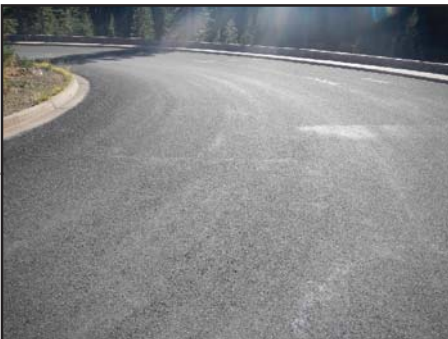
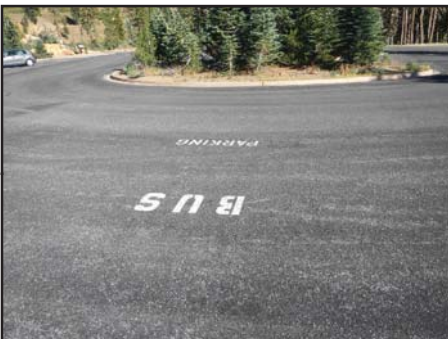
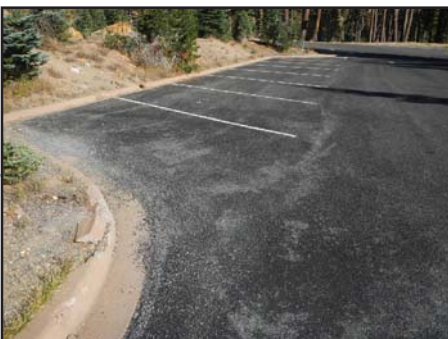
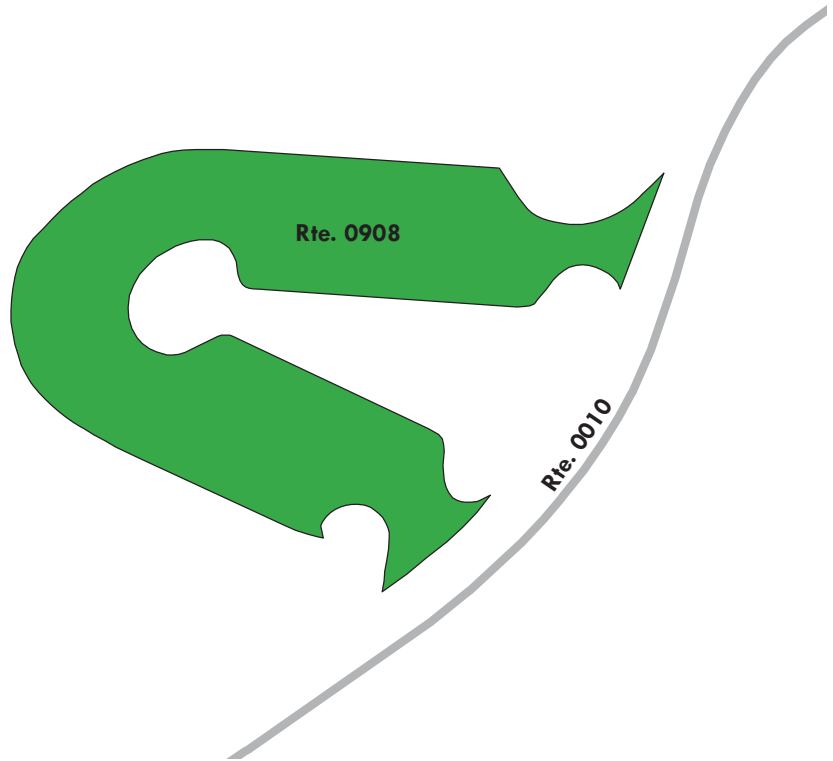
ROUTE 0908: SULPHUR WORKS PARKING

Inspection Date	FMSS Number	User Access	Surface Type
10/1/2014	73621	NONPUBLIC	ASPHALT
Area (Sq. Ft.)	Lane Miles (11' Widths)	Curb Reveal (Inches)	Curb Recommendation
19,608	0.338	NOT APPLICABLE	LIGHT REPAIR
Curb Type		Curb & Gutter Type	
NO CURB		CONCRETE	
Pavement Recommendation		Condition Rating / PCR	
PREVENTIVE MAINTENANCE		GOOD / 90
