LAVO Cycle 6

Final Report

Road Inventory and Condition Assessment of Paved Routes Lassen Volcanic National Park

Report Date: March 2016

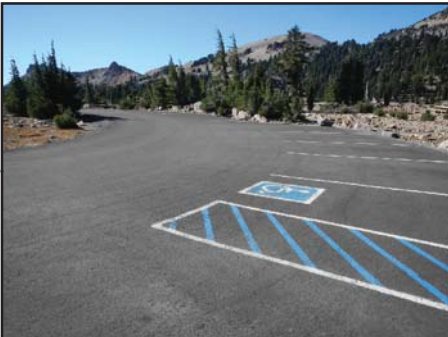
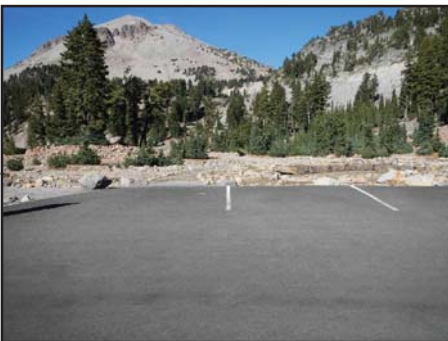
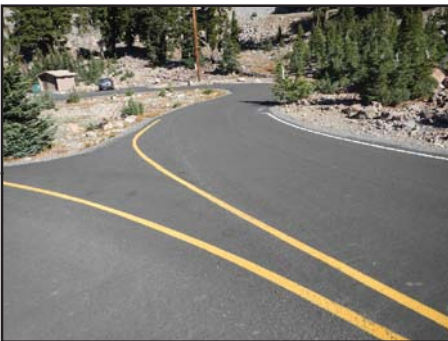
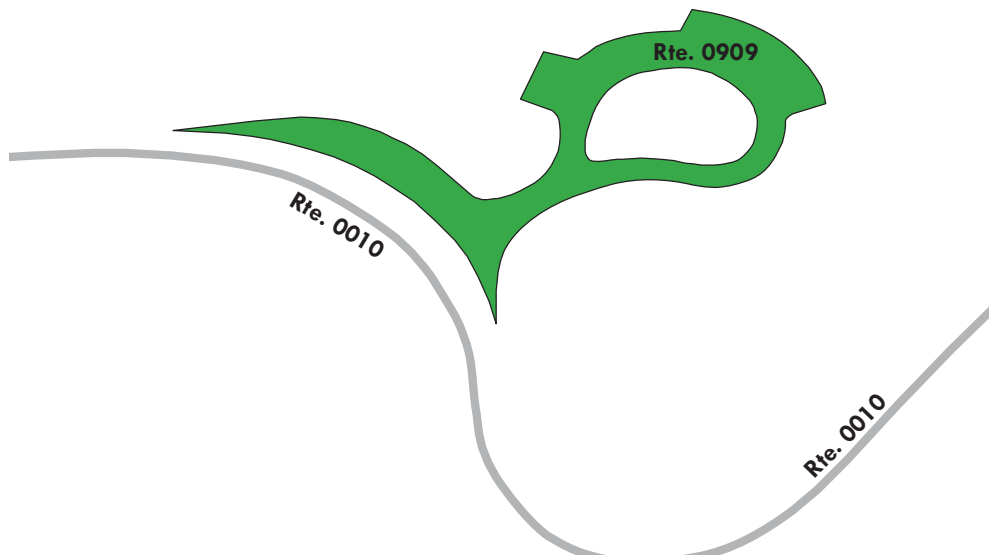
ROUTE 0909: LAKE HELEN PICNIC AREA LOOP

Inspection Date	FMSS Number	User Access	Surface Type
10/1/2014	73623	PUBLIC	ASPHALT
Area (Sq. Ft.)	Lane Miles (11' Widths)	Curb Reveal (Inches)	Curb Recommendation
17,129	0.295	NOT APPLICABLE	NOT APPLICABLE
Curb Type		Curb & Gutter Type	
NO CURB		NO CURB AND GUTTER	
Pavement Recommendation		Condition Rating / PCR	
PREVENTIVE MAINTENANCE		GOOD / 90

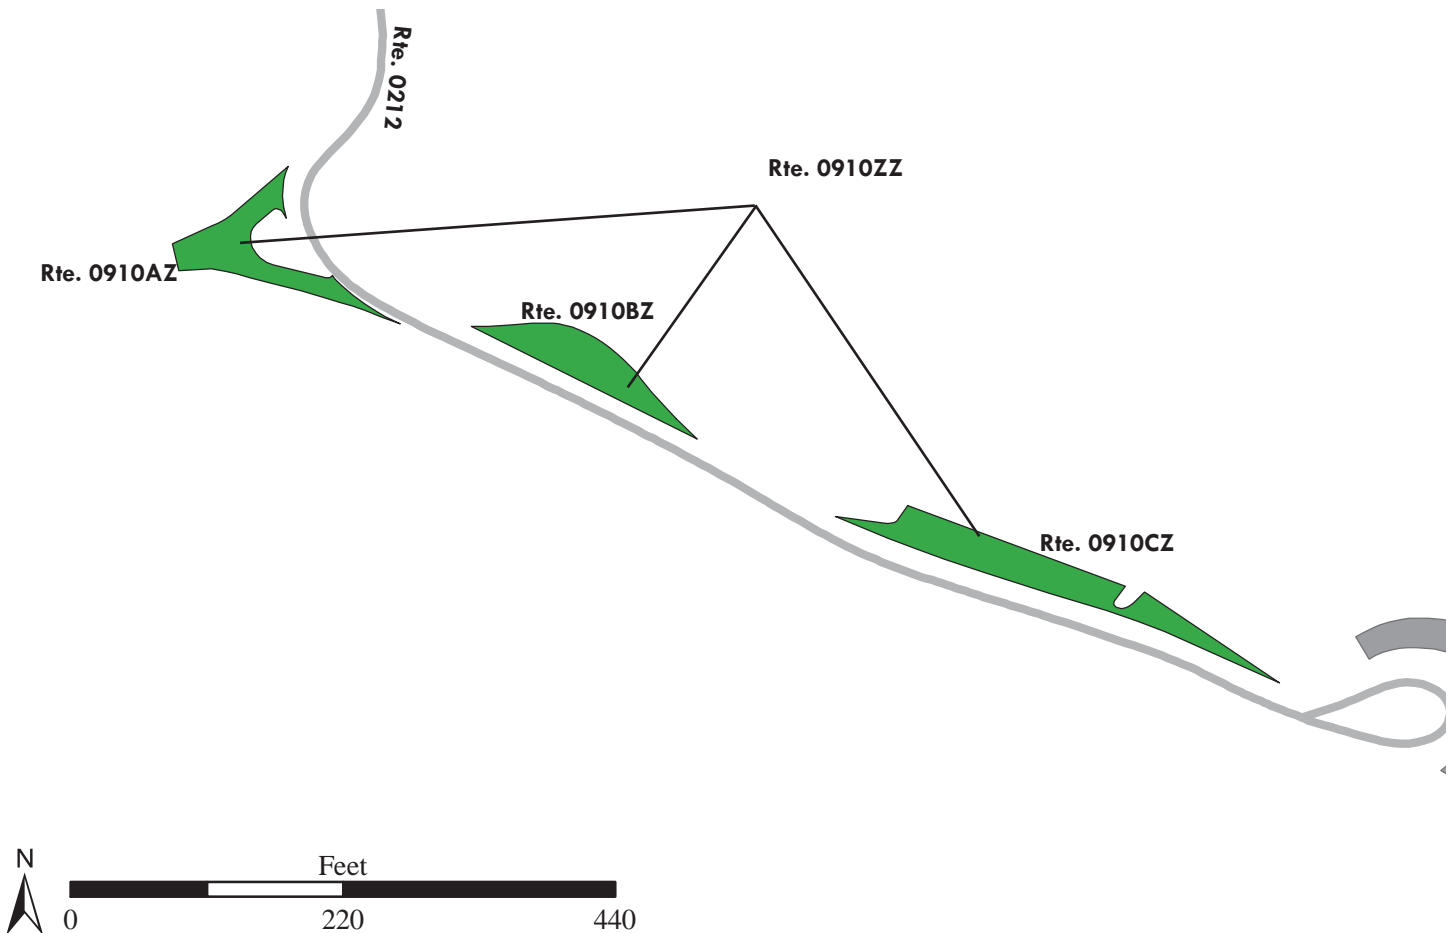
ROUTE 0910ZZ: KINGS CREEK PICNIC PARKING AREAS

Inspection Date	FMSS Number	User Access	Surface Type
10/1/2014	73625	PUBLIC	ASPHALT
Area (Sq. Ft.)	Lane Miles (11' Widths)	Condition Rating / PCR	
12,253	0.21	SUMMARY / 90

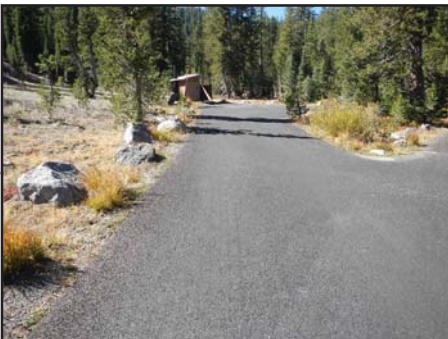
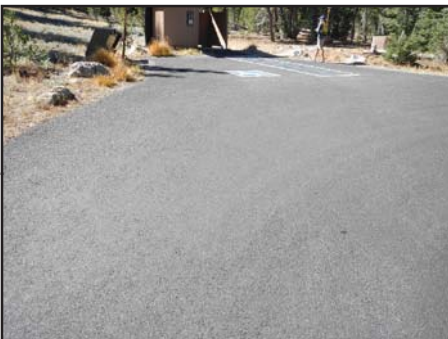
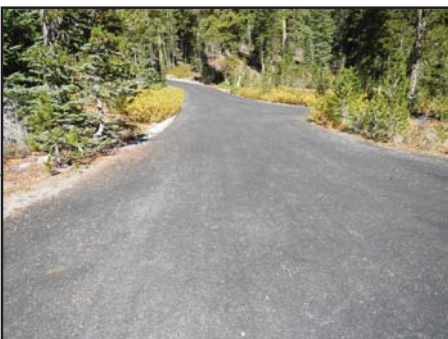
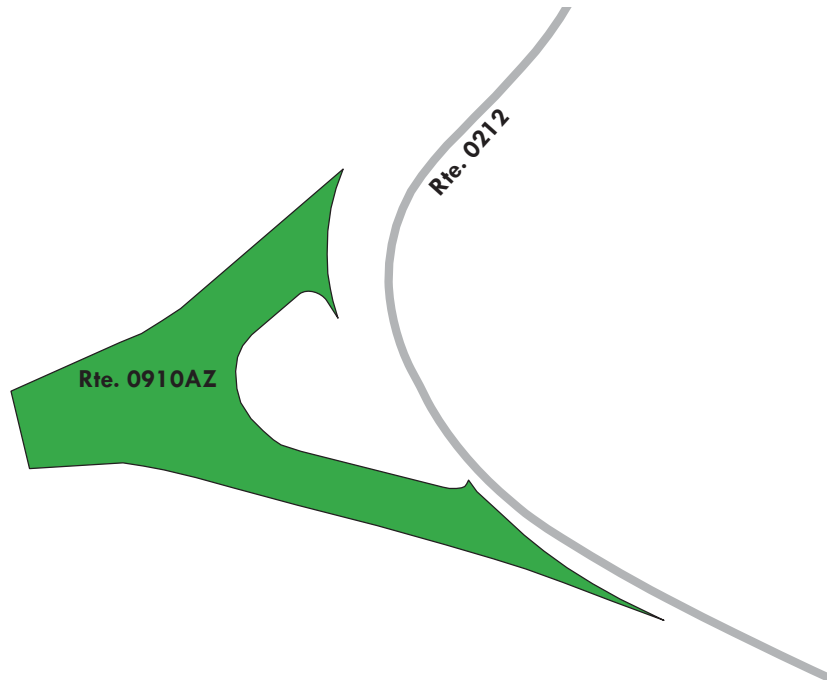
ROUTE 0910AZ: KINGS CREEK PICNIC AREA TURNOUT PARKING A

Inspection Date	FMSS Number	User Access	Surface Type
10/1/2014	73625	PUBLIC	ASPHALT
Area (Sq. Ft.)	Lane Miles (11' Widths)	Curb Reveal (Inches)	Curb Recommendation
3,440	0.059	NOT APPLICABLE	NOT APPLICABLE
Curb Type		Curb & Gutter Type	
NO CURB		NO CURB AND GUTTER	
Pavement Recommendation		Condition Rating / PCR	
PREVENTIVE MAINTENANCE		GOOD / 90

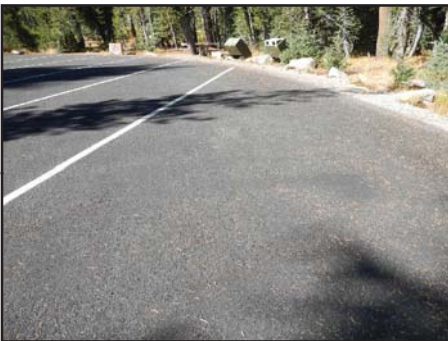
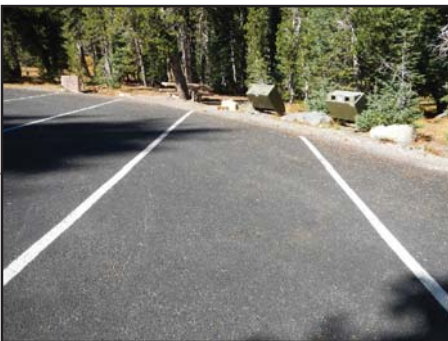
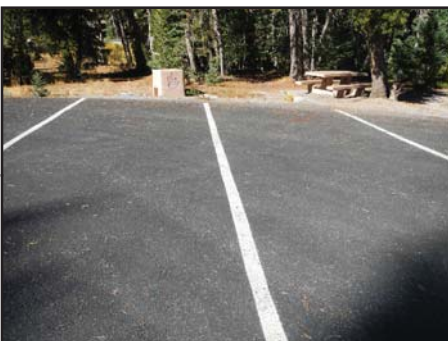
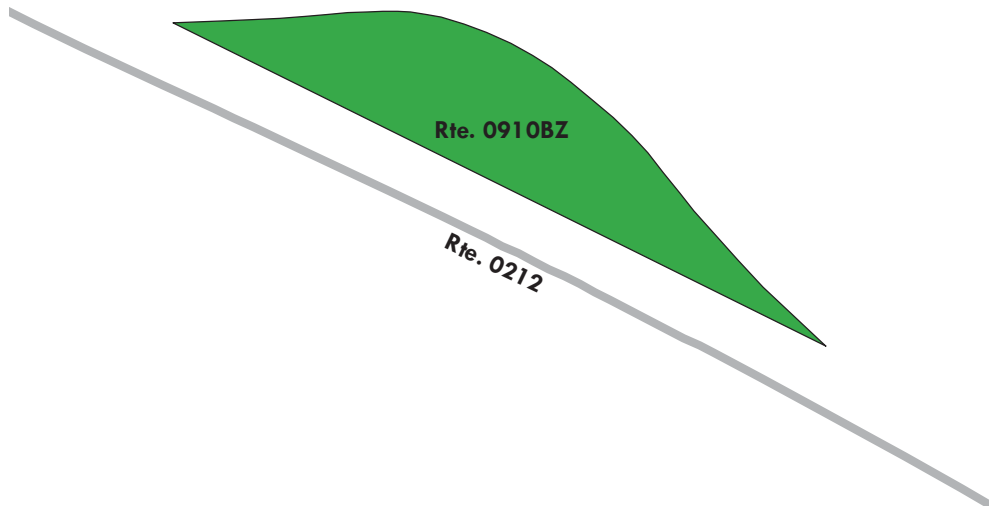
ROUTE 0910BZ: KINGS CREEK PICNIC AREA TURNOUT PARKING B

Inspection Date	FMSS Number	User Access	Surface Type
10/1/2014	73625	PUBLIC	ASPHALT
Area (Sq. Ft.)	Lane Miles (11' Widths)	Curb Reveal (Inches)	Curb Recommendation
3,332	0.057	NOT APPLICABLE	NOT APPLICABLE
Curb Type		Curb & Gutter Type	
NO CURB		NO CURB AND GUTTER	
Pavement Recommendation		Condition Rating / PCR	
PREVENTIVE MAINTENANCE		GOOD / 90

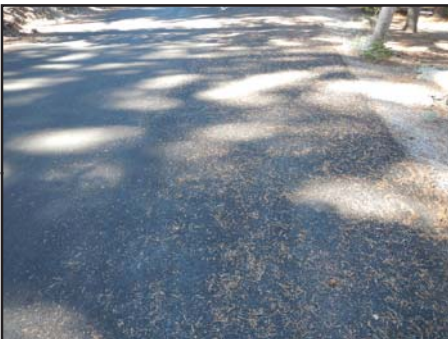
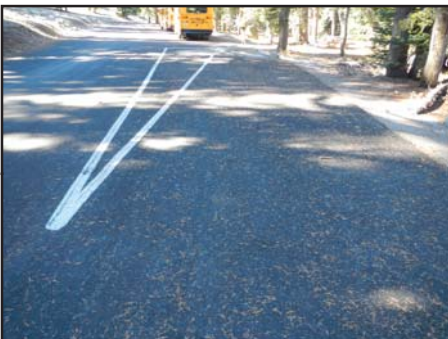
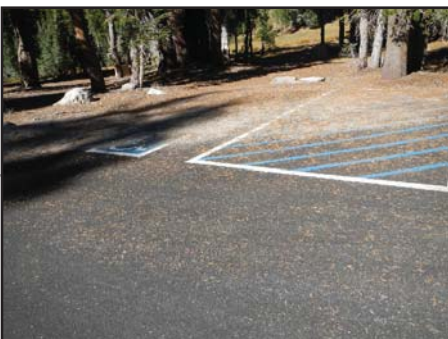
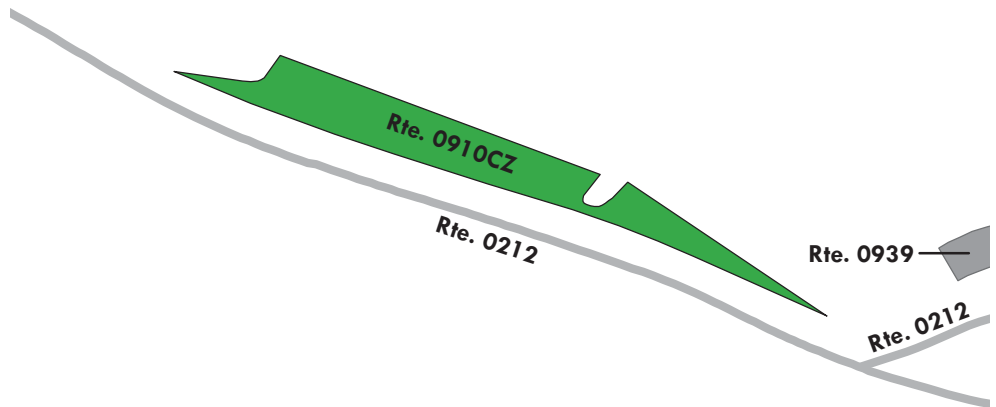
Inspection Date	FMSS Number	User Access	Surface Type
10/1/2014	73625	PUBLIC	ASPHALT
Area (Sq. Ft.)	Lane Miles (11' Widths)	Curb Reveal (Inches)	Curb Recommendation
5,481	0.094	NOT APPLICABLE	NOT APPLICABLE
Curb Type		Curb & Gutter Type	
NO CURB		NO CURB AND GUTTER	
Pavement Recommendation		Condition Rating / PCR	
PREVENTIVE MAINTENANCE		GOOD / 90

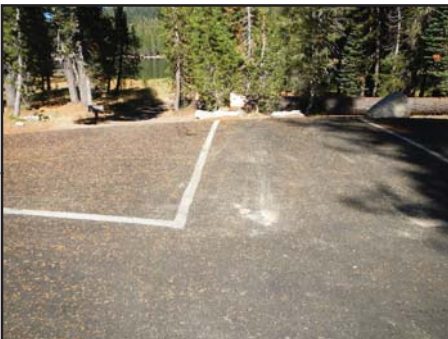
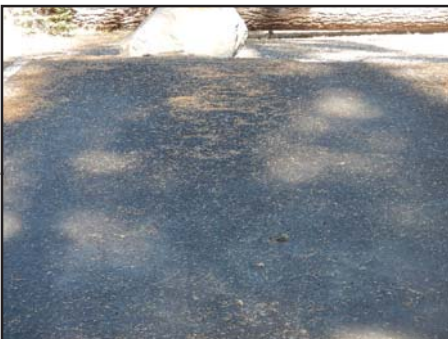
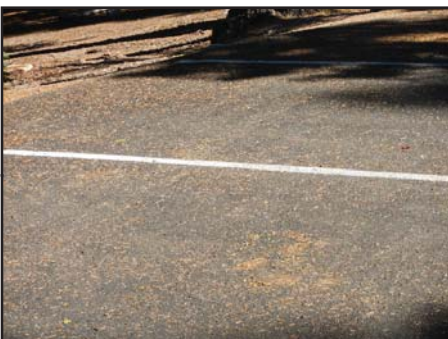
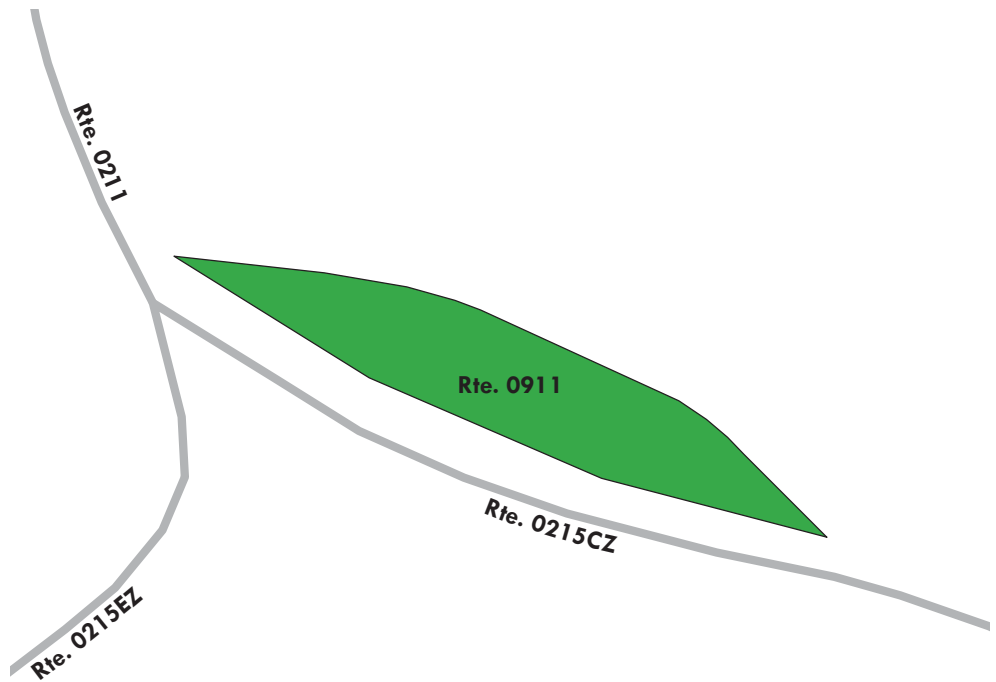
ROUTE 0911: SUMMIT LAKE SOUTH CAMPGROUND PARKING

Inspection Date	FMSS Number	User Access	Surface Type
10/1/2014	73626	PUBLIC	ASPHALT
Area (Sq. Ft.)	Lane Miles (11' Widths)	Curb Reveal (Inches)	Curb Recommendation
2,778	0.048	NOT APPLICABLE	NOT APPLICABLE
Curb Type		Curb & Gutter Type	
NO CURB		NO CURB AND GUTTER	
Pavement Recommendation		Condition Rating / PCR	
PREVENTIVE MAINTENANCE		GOOD / 90

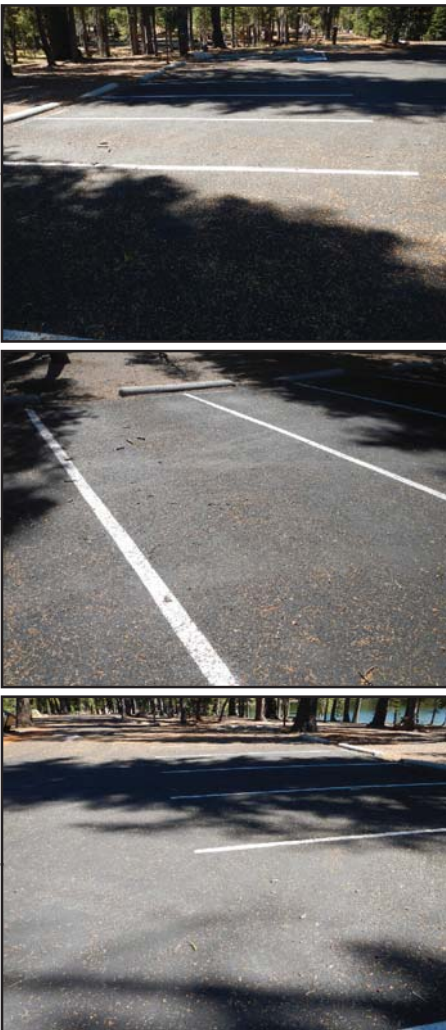
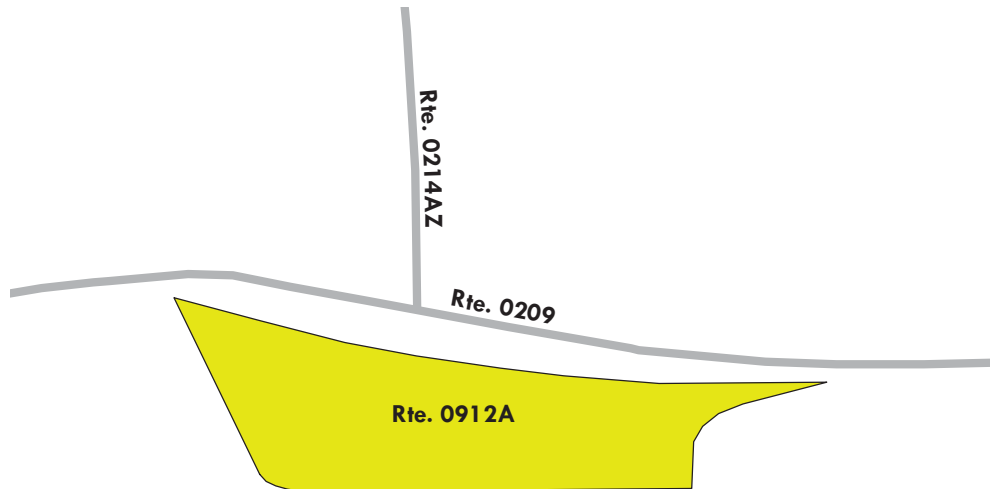
ROUTE 0912A: SUMMIT LAKE NORTH CAMPGROUND PARKING A

Inspection Date	FMSS Number	User Access	Surface Type
10/1/2014	73628	PUBLIC	ASPHALT
Area (Sq. Ft.)	Lane Miles (11' Widths)	Curb Reveal (Inches)	Curb Recommendation
3,097	0.053	NOT APPLICABLE	NOT APPLICABLE
Curb Type		Curb & Gutter Type	
NO CURB		NO CURB AND GUTTER	
Pavement Recommendation		Condition Rating / PCR	
LIGHT 3R TREATMENTS		FAIR / 73

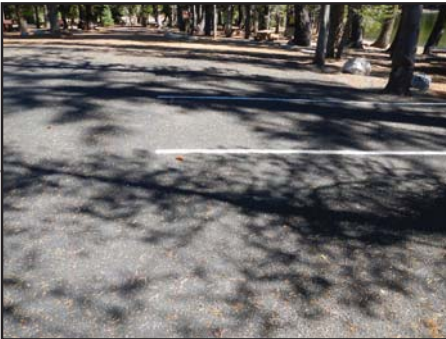
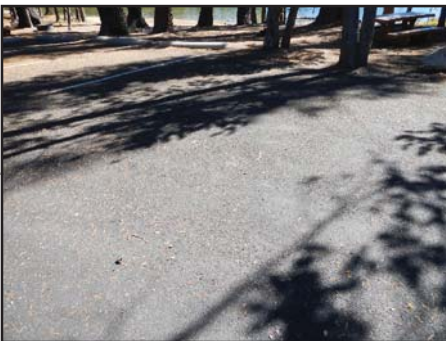
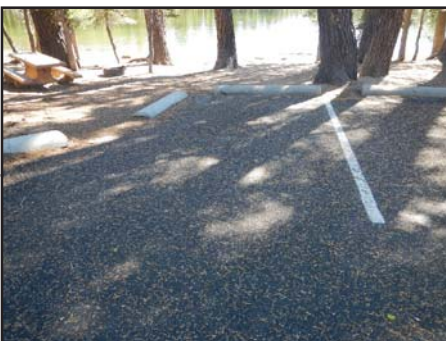
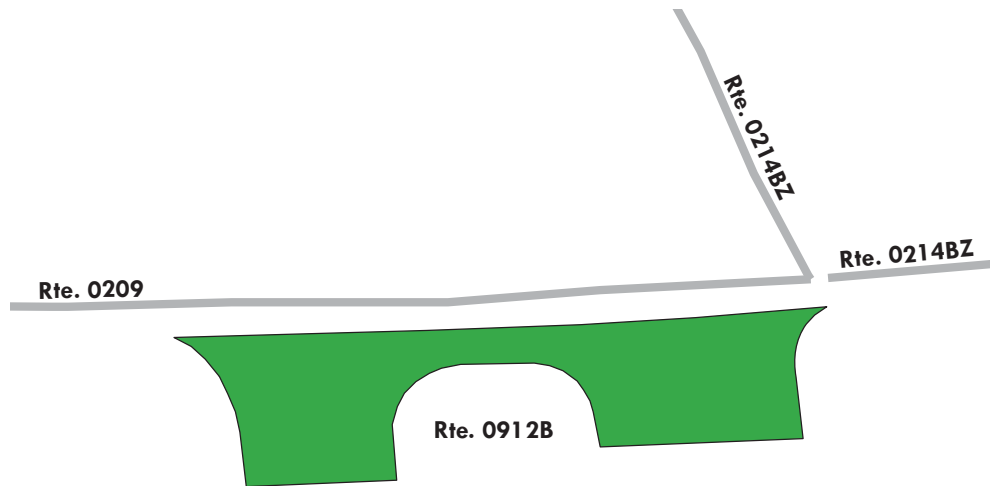
ROUTE 0912B: SUMMIT LAKE NORTH CAMPGROUND PARKING B

Inspection Date	FMSS Number	User Access	Surface Type
10/1/2014	105047	PUBLIC	ASPHALT
Area (Sq. Ft.)	Lane Miles (11' Widths)	Curb Reveal (Inches)	Curb Recommendation
1,352	0.023	NOT APPLICABLE	NOT APPLICABLE
Curb Type		Curb & Gutter Type	
NO CURB		NO CURB AND GUTTER	
Pavement Recommendation		Condition Rating / PCR	
PREVENTIVE MAINTENANCE		GOOD / 90

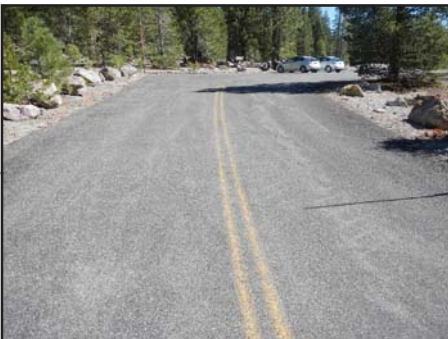
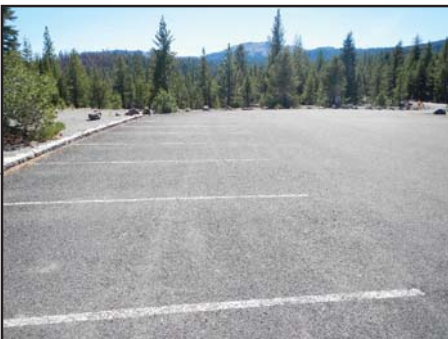
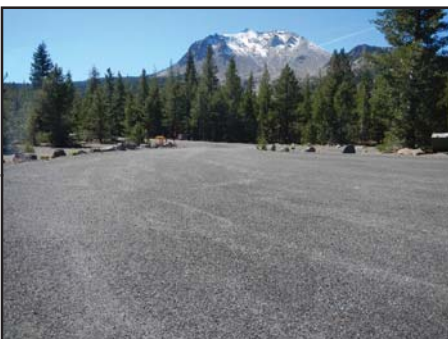
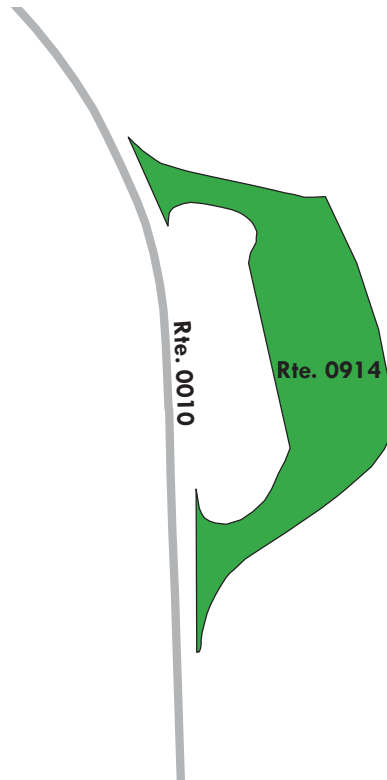
ROUTE 0914: DEVASTATED AREA INTERPRETIVE TRAIL PARKING

Inspection Date	FMSS Number	User Access	Surface Type
10/1/2014	73633	PUBLIC	ASPHALT
Area (Sq. Ft.)	Lane Miles (11' Widths)	Curb Reveal (Inches)	Curb Recommendation
22,881	0.394	6	DO NOTHING
Curb Type		Curb & Gutter Type	
STONE		NO CURB AND GUTTER	
Pavement Recommendation		Condition Rating / PCR	
PREVENTIVE MAINTENANCE		GOOD / 90

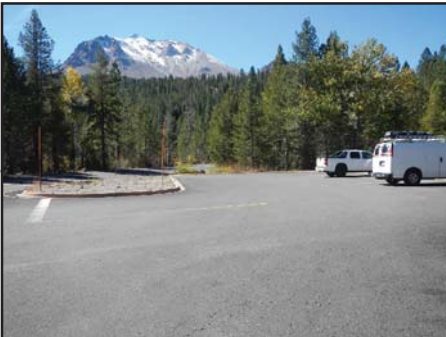
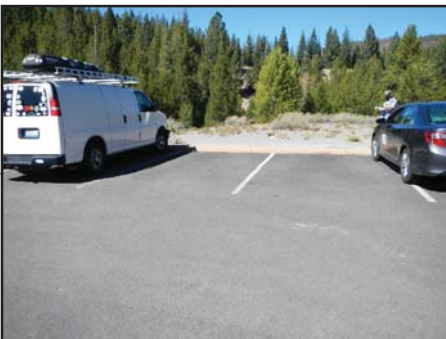
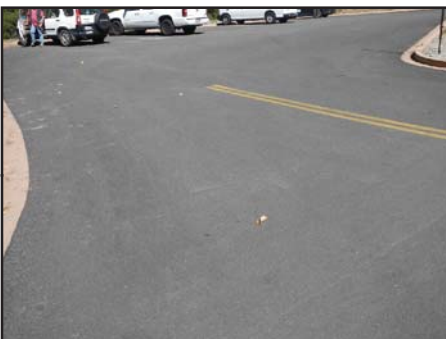
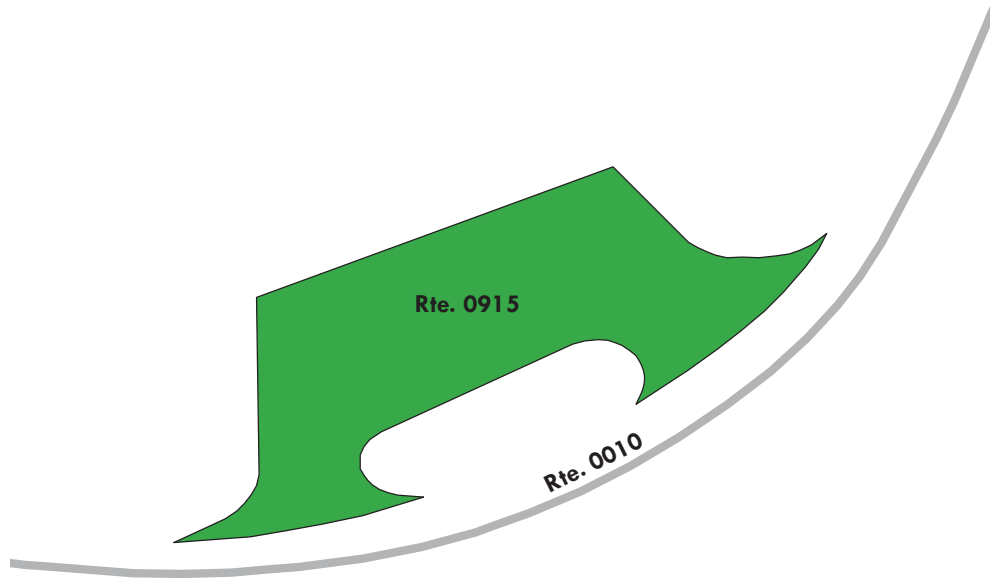
ROUTE 0915: HAT LAKE PARKING

Inspection Date	FMSS Number	User Access	Surface Type
10/1/2014	73635	PUBLIC	ASPHALT
Area (Sq. Ft.)	Lane Miles (11' Widths)	Curb Reveal (Inches)	Curb Recommendation
7,017	0.121	NOT APPLICABLE	DO NOTHING
Curb Type		Curb & Gutter Type	
NO CURB		CONCRETE	
Pavement Recommendation		Condition Rating / PCR	
PREVENTIVE MAINTENANCE		GOOD / 90

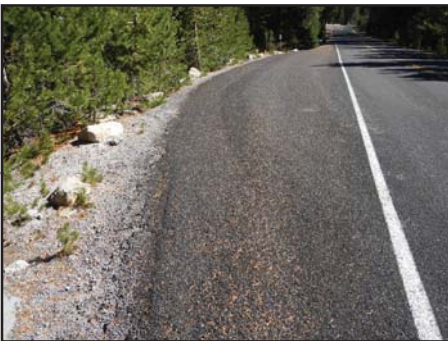
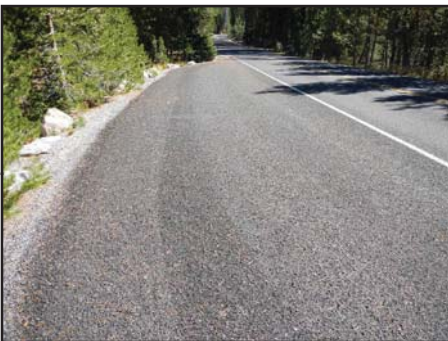
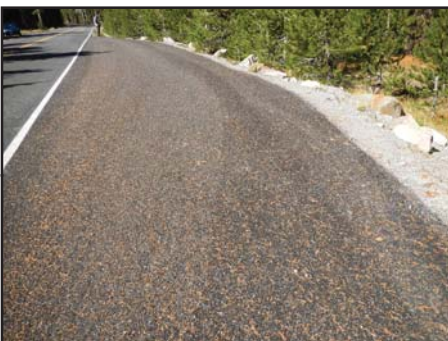
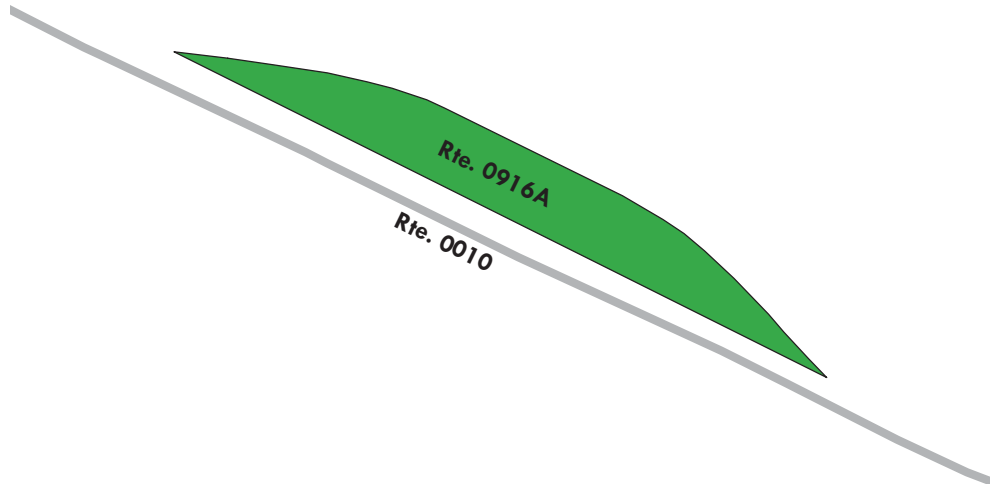
ROUTE 0916A: DERSCH MEADOWS PULLOUT PARKING A

Inspection Date	FMSS Number	User Access	Surface Type
10/1/2014	105048	PUBLIC	ASPHALT
Area (Sq. Ft.)	Lane Miles (11' Widths)	Curb Reveal (Inches)	Curb Recommendation
1,823	0.031	NOT APPLICABLE	NOT APPLICABLE
Curb Type		Curb & Gutter Type	
NO CURB		NO CURB AND GUTTER	
Pavement Recommendation		Condition Rating / PCR	
PREVENTIVE MAINTENANCE		GOOD / 90

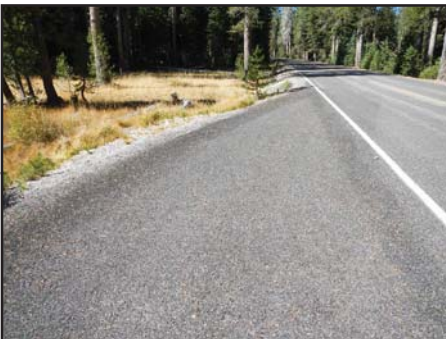
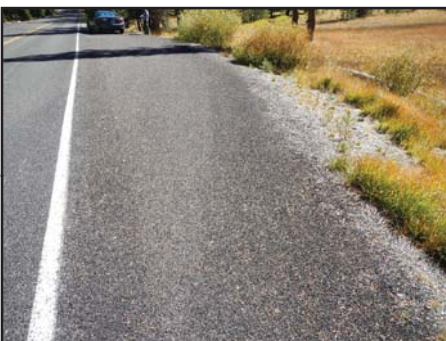
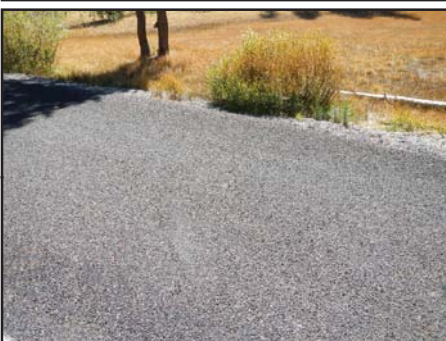
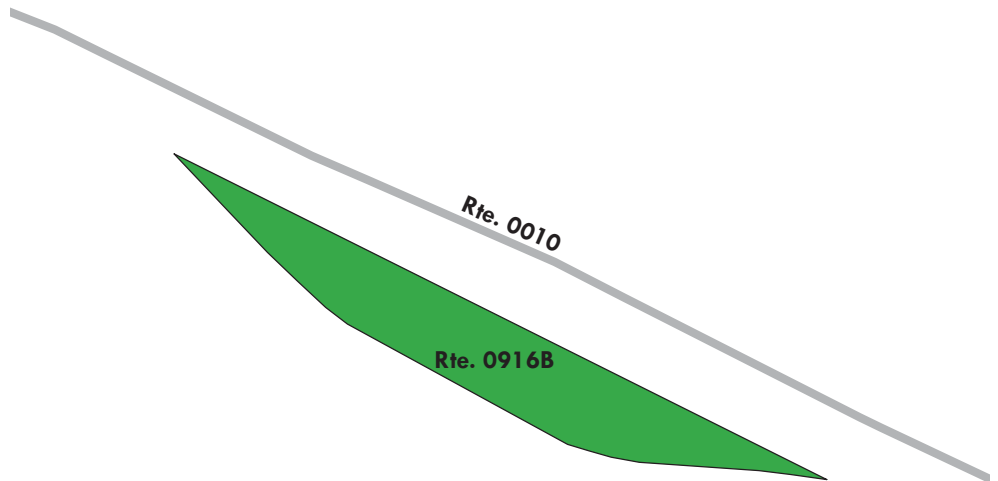
ROUTE 0916B: DERSCH MEADOWS PULLOUT PARKING B

Inspection Date	FMSS Number	User Access	Surface Type
10/1/2014	105049	PUBLIC	ASPHALT
Area (Sq. Ft.)	Lane Miles (11' Widths)	Curb Reveal (Inches)	Curb Recommendation
1,534	0.026	NOT APPLICABLE	NOT APPLICABLE
Curb Type		Curb & Gutter Type	
NO CURB		NO CURB AND GUTTER	
Pavement Recommendation		Condition Rating / PCR	
PREVENTIVE MAINTENANCE		GOOD / 90

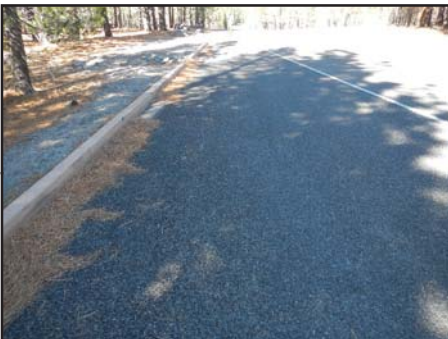
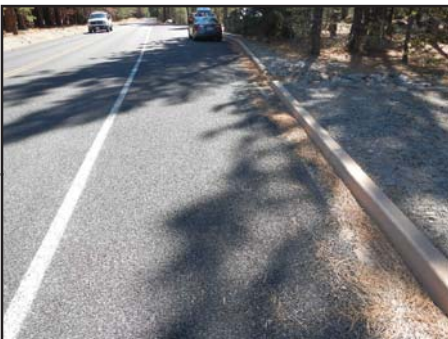
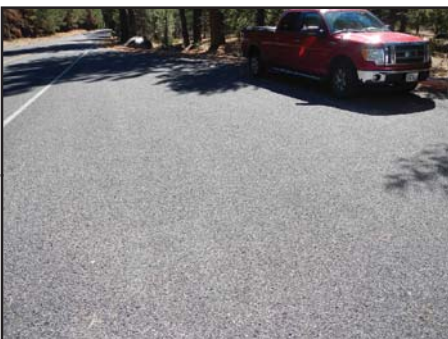
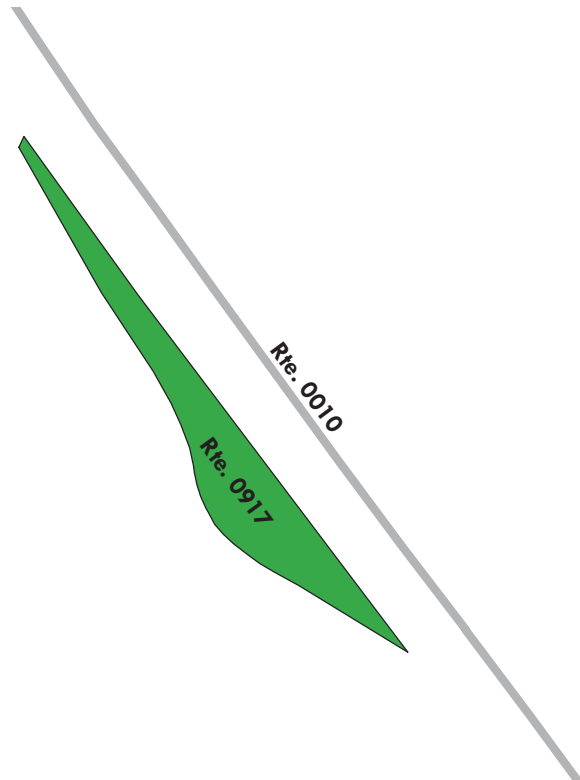
ROUTE 0917: HOT ROCK PARKING

Inspection Date	FMSS Number	User Access	Surface Type
10/1/2014	73638	PUBLIC	ASPHALT
Area (Sq. Ft.)	Lane Miles (11' Widths)	Curb Reveal (Inches)	Curb Recommendation
5,423	0.093	NOT APPLICABLE	DO NOTHING
Curb Type		Curb & Gutter Type	
NO CURB		CONCRETE	
Pavement Recommendation		Condition Rating / PCR	
PREVENTIVE MAINTENANCE		GOOD / 90

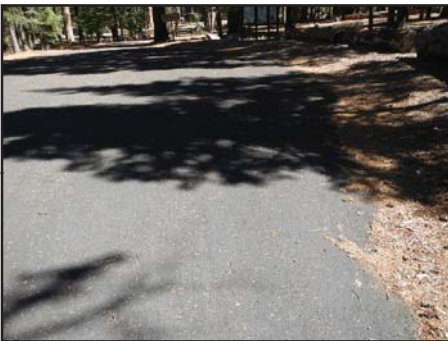
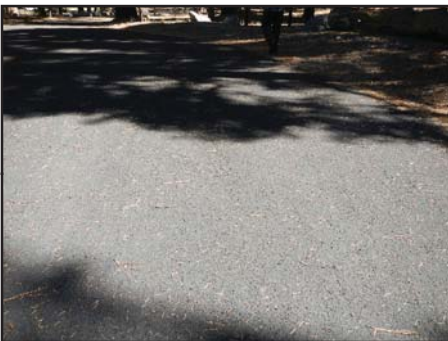
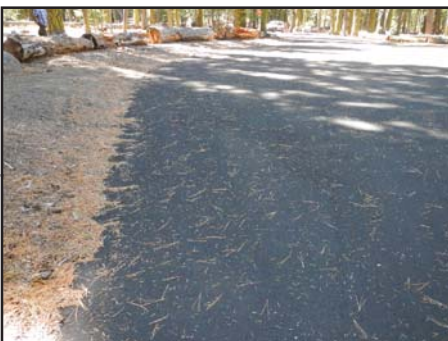
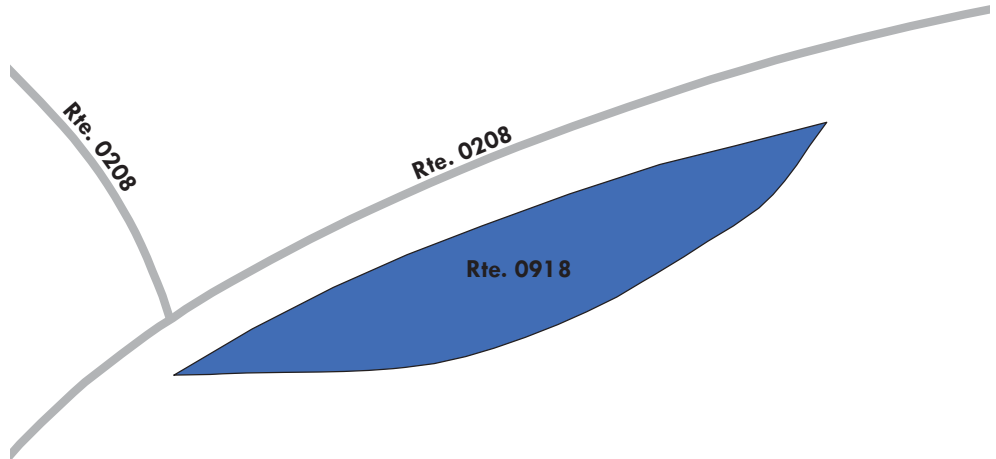
ROUTE 0918: LOST CREEK GROUP CAMP PARKING

Inspection Date	FMSS Number	User Access	Surface Type
10/1/2014	73640	PUBLIC	ASPHALT
Area (Sq. Ft.)	Lane Miles (11' Widths)	Curb Reveal (Inches)	Curb Recommendation
1,513	0.026	NOT APPLICABLE	NOT APPLICABLE
Curb Type		Curb & Gutter Type	
NO CURB		NO CURB AND GUTTER	
Pavement Recommendation		Condition Rating / PCR	
DO NOTHING		EXCELLENT / 97

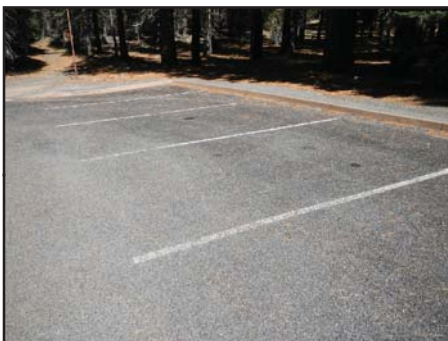
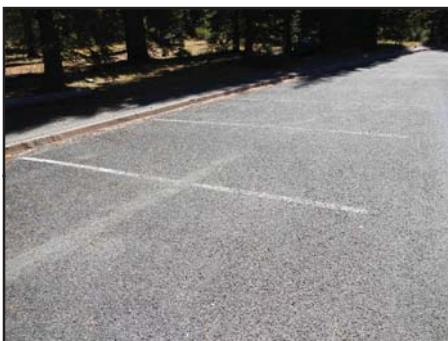
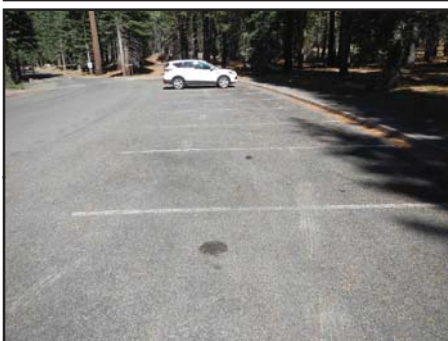
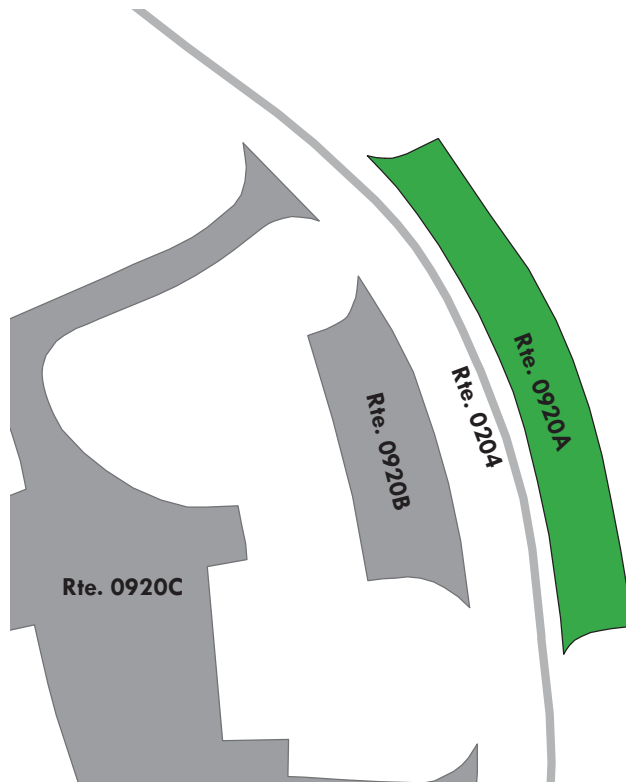
ROUTE 0920A: MANZANITA STORE SPUR PARKING A

Inspection Date	FMSS Number	User Access	Surface Type
10/1/2014	73645	PUBLIC	ASPHALT
Area (Sq. Ft.)	Lane Miles (11' Widths)	Curb Reveal (Inches)	Curb Recommendation
4,357	0.075	NOT APPLICABLE	DO NOTHING
Curb Type		Curb & Gutter Type	
NO CURB		CONCRETE	
Pavement Recommendation		Condition Rating / PCR	
PREVENTIVE MAINTENANCE		GOOD / 90

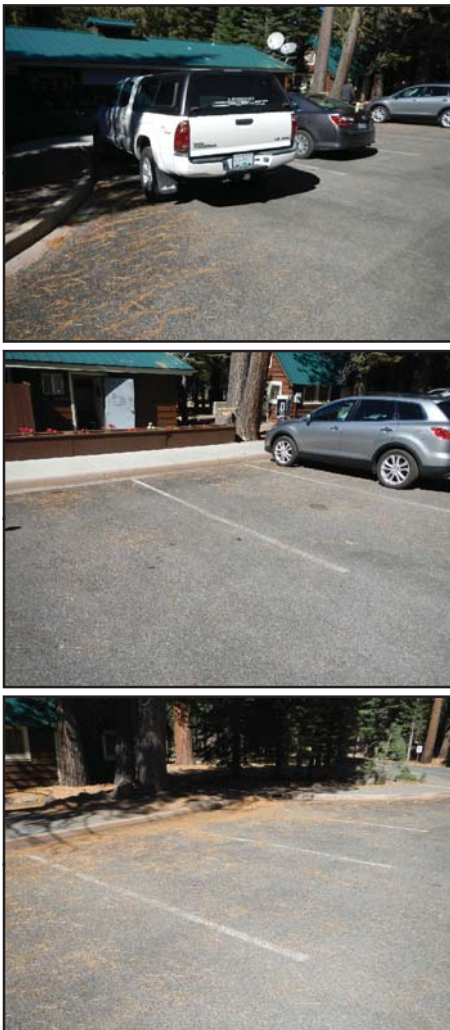
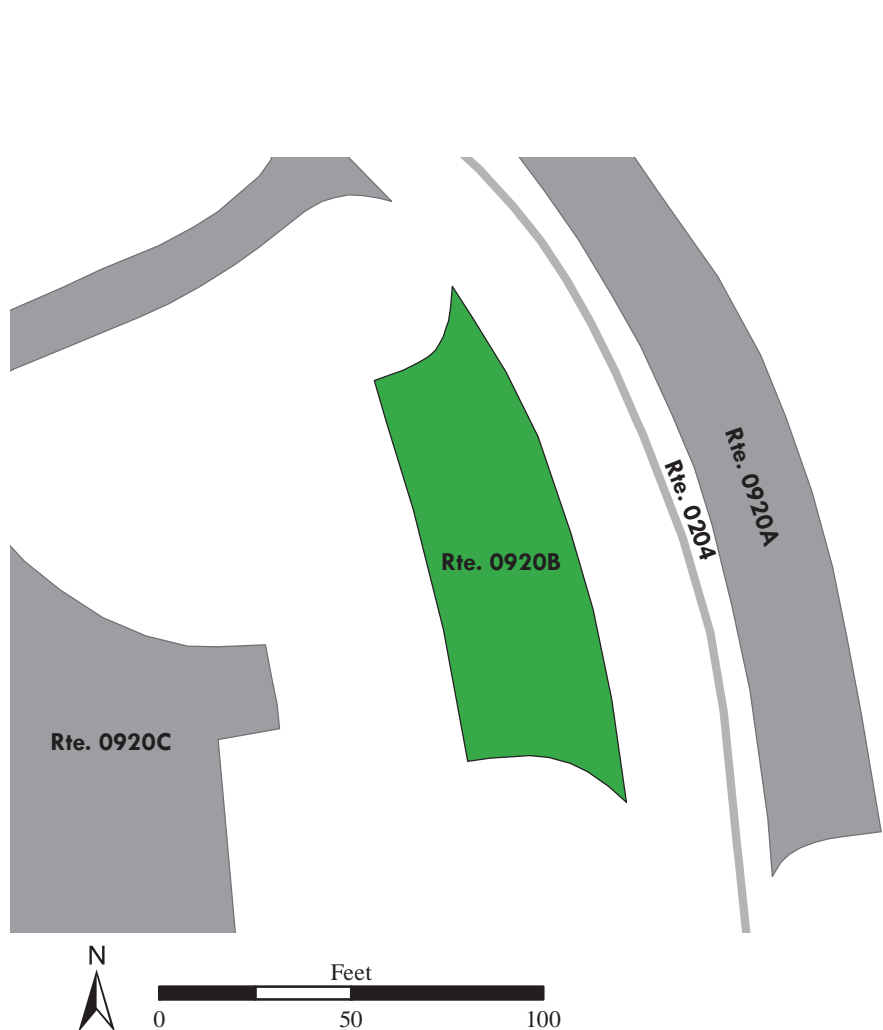
ROUTE 0920B: MANZANITA STORE SPUR PARKING B

Inspection Date	FMSS Number	User Access	Surface Type
10/1/2014	105050	PUBLIC	ASPHALT
Area (Sq. Ft.)	Lane Miles (11' Widths)	Curb Reveal (Inches)	Curb Recommendation
3,229	0.056	NOT APPLICABLE	DO NOTHING
Curb Type		Curb & Gutter Type	
NO CURB		CONCRETE	
Pavement Recommendation		Condition Rating / PCR	
PREVENTIVE MAINTENANCE		GOOD / 90

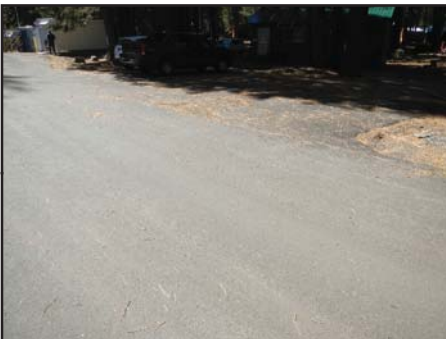
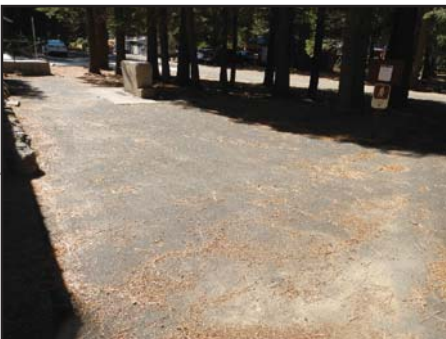
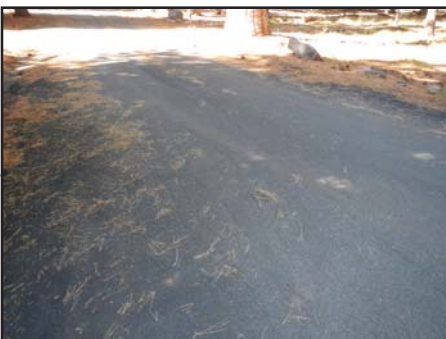
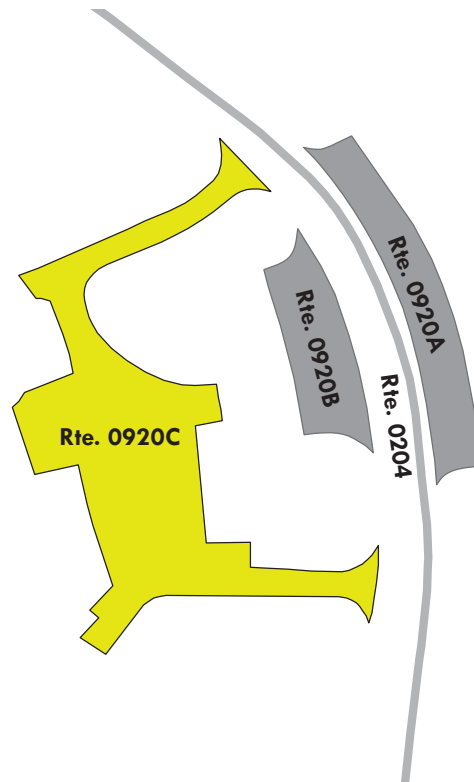
ROUTE 0920C: MANZANITA STORE SPUR PARKING C

Inspection Date	FMSS Number	User Access	Surface Type
10/1/2014	105075	PUBLIC	ASPHALT
Area (Sq. Ft.)	Lane Miles (11' Widths)	Curb Reveal (Inches)	Curb Recommendation
13,539	0.233	NOT APPLICABLE	NOT APPLICABLE
Curb Type		Curb & Gutter Type	
NO CURB		NO CURB AND GUTTER	
Pavement Recommendation		Condition Rating / PCR	
LIGHT 3R TREATMENTS		FAIR / 73

The parking area consists of multiple surface types, two parts asphalt at 12,816 square feet; one part concrete at 723 square feet.

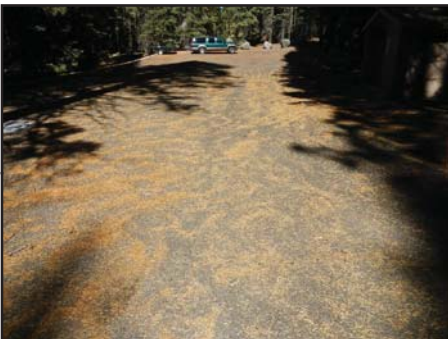
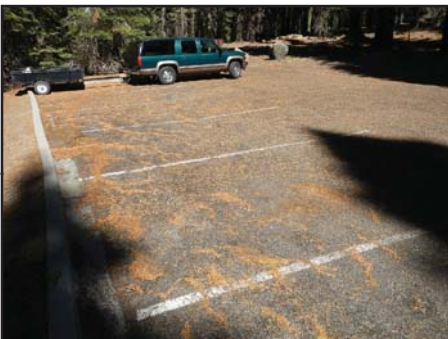
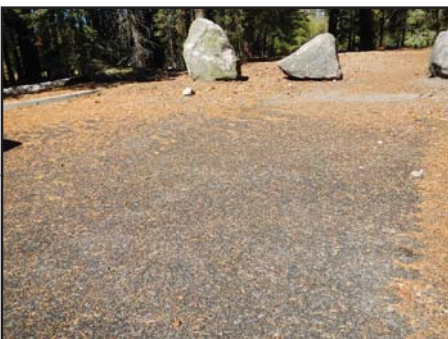
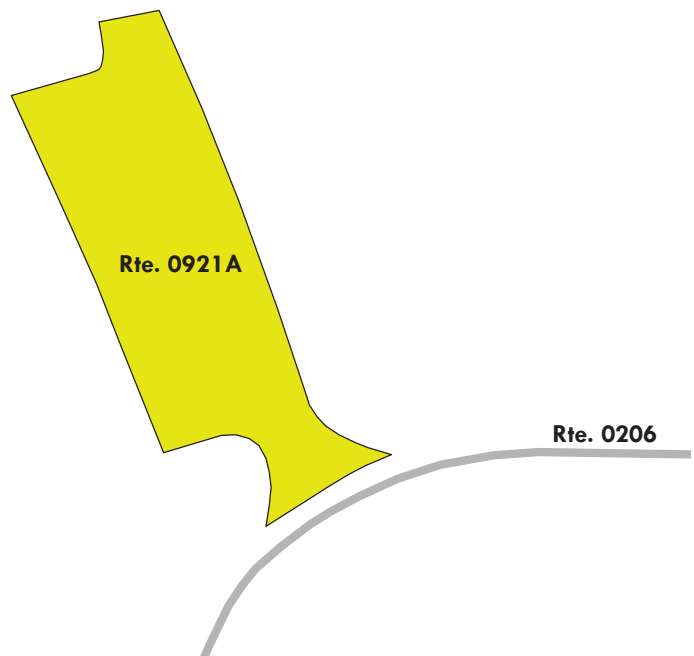
ROUTE 0921A: MANZANITA LAKE ACCESS PARKING A

Inspection Date	FMSS Number	User Access	Surface Type
10/1/2014	73647	PUBLIC	ASPHALT
Area (Sq. Ft.)	Lane Miles (11' Widths)	Curb Reveal (Inches)	Curb Recommendation
6,251	0.108	NOT APPLICABLE	LIGHT REPAIR
Curb Type		Curb & Gutter Type	
NO CURB		CONCRETE	
Pavement Recommendation		Condition Rating / PCR	
LIGHT 3R TREATMENTS		FAIR / 73

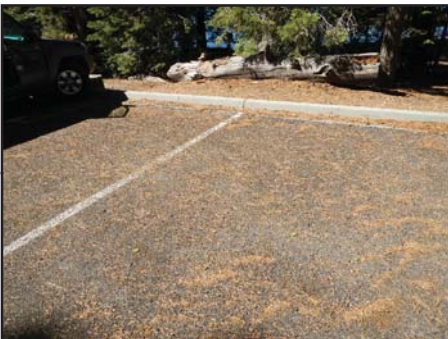
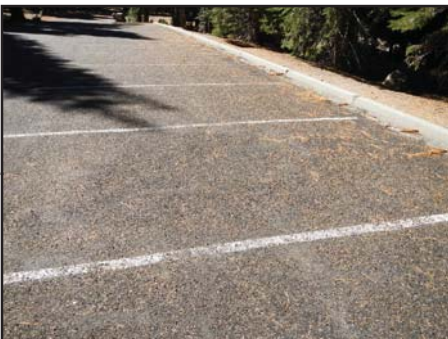
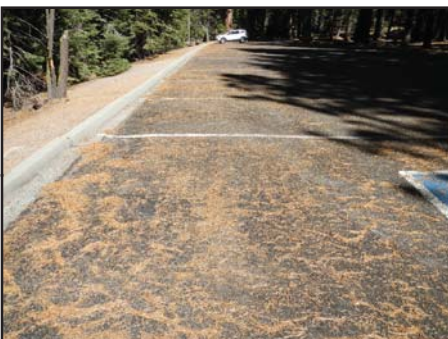
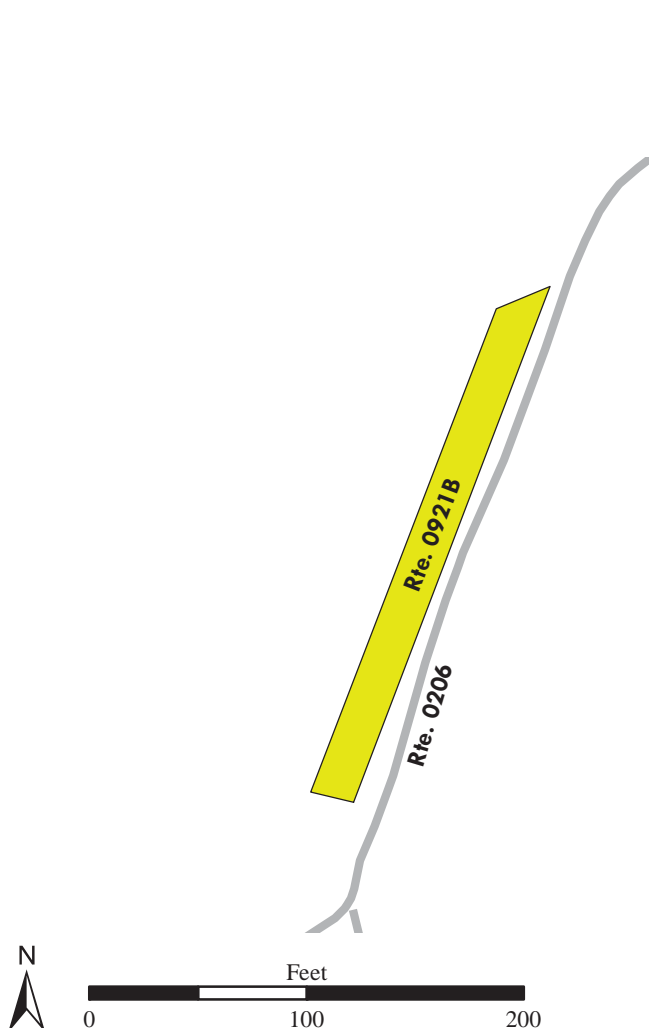
ROUTE 0921B: MANZANITA LAKE ACCESS PARKING B

Inspection Date	FMSS Number	User Access	Surface Type
10/1/2014	105076	PUBLIC	ASPHALT
Area (Sq. Ft.)	Lane Miles (11' Widths)	Curb Reveal (Inches)	Curb Recommendation
3,696	0.064	NOT APPLICABLE	DO NOTHING
Curb Type		Curb & Gutter Type	
NO CURB		CONCRETE	
Pavement Recommendation		Condition Rating / PCR	
LIGHT 3R TREATMENTS		FAIR / 73

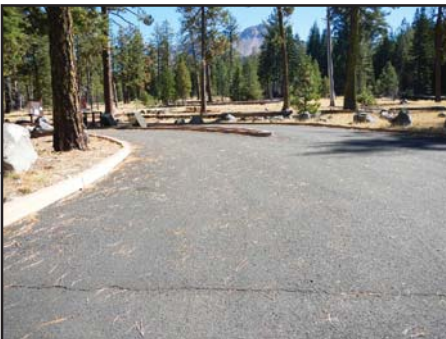
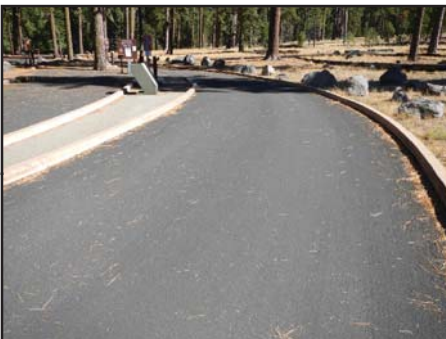
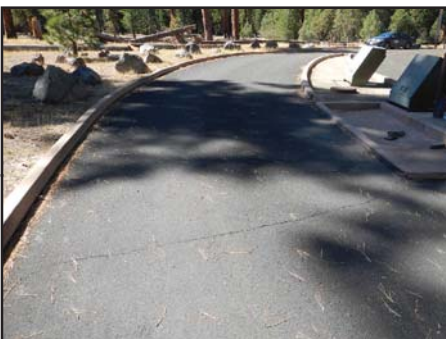
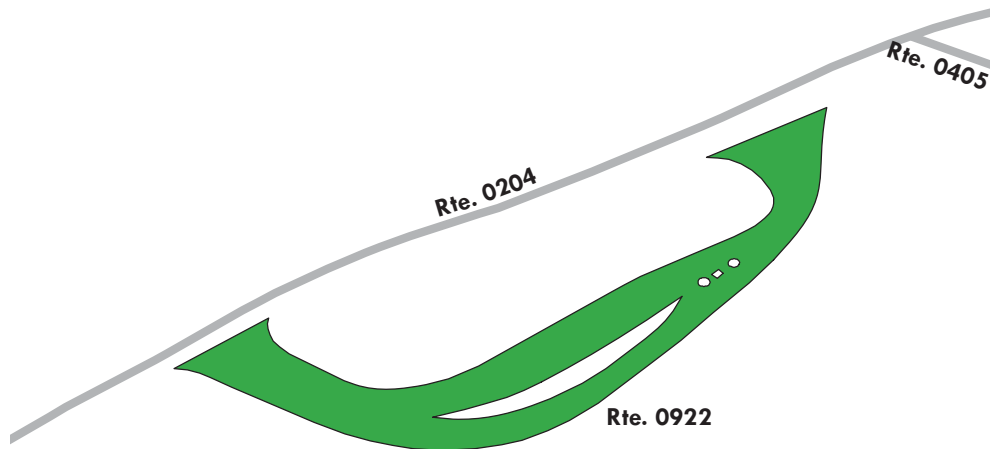
ROUTE 0922: MANZANITA DUMP STATION PARKING

Inspection Date	FMSS Number	User Access	Surface Type
10/1/2014	73648	PUBLIC	ASPHALT
Area (Sq. Ft.)	Lane Miles (11' Widths)	Curb Reveal (Inches)	Curb Recommendation
10,149	0.175	5	DO NOTHING
Curb Type		Curb & Gutter Type	
CONCRETE		NO CURB AND GUTTER	
Pavement Recommendation		Condition Rating / PCR	
PREVENTIVE MAINTENANCE		GOOD / 90

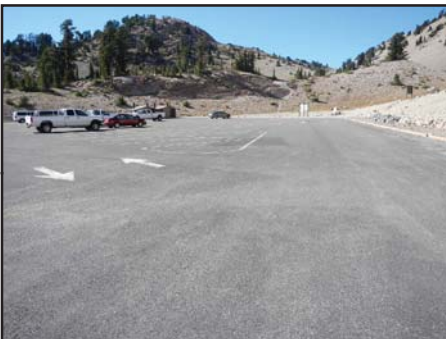
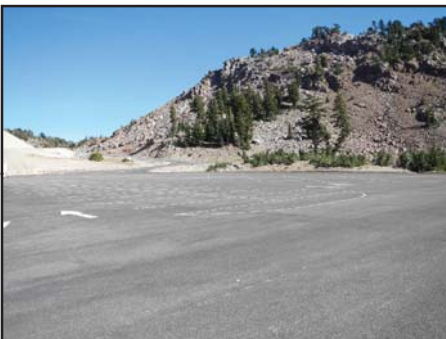
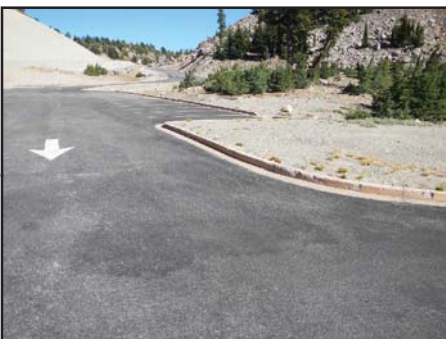
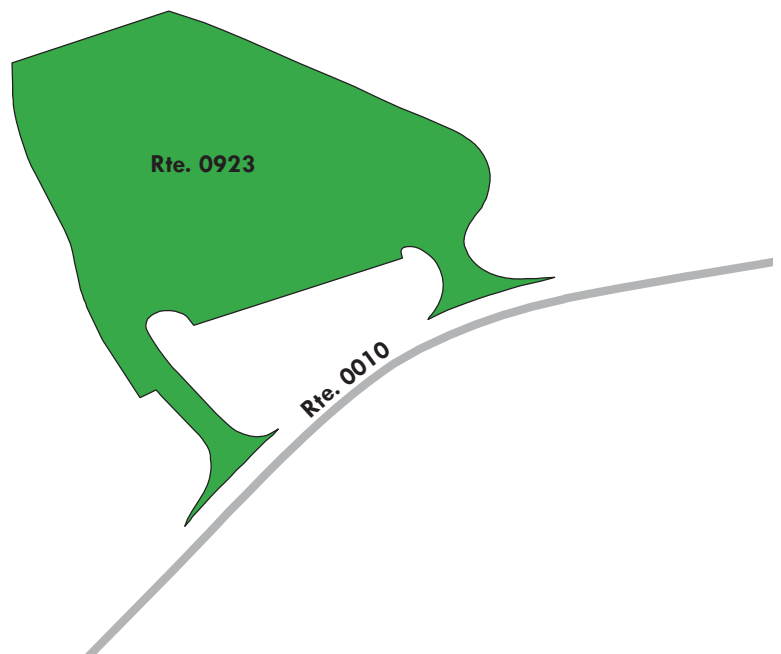
ROUTE 0923: LASSEN PEAK TRAILHEAD PARKING

Inspection Date	FMSS Number	User Access	Surface Type
10/1/2014	73649	PUBLIC	ASPHALT
Area (Sq. Ft.)	Lane Miles (11' Widths)	Curb Reveal (Inches)	Curb Recommendation
97,575	1.68	NOT APPLICABLE	DO NOTHING
Curb Type		Curb & Gutter Type	
NO CURB		CONCRETE	
Pavement Recommendation		Condition Rating / PCR	
PREVENTIVE MAINTENANCE		GOOD / 90
