LAVO Cycle 6

Final Report

Road Inventory and Condition Assessment of Paved Routes Lassen Volcanic National Park

Report Date: March 2016

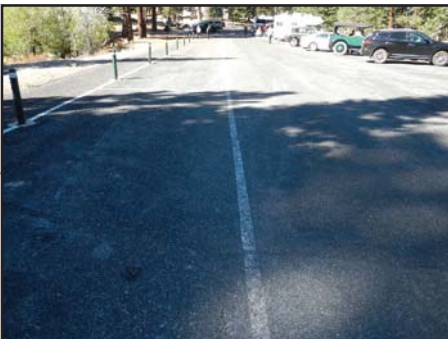
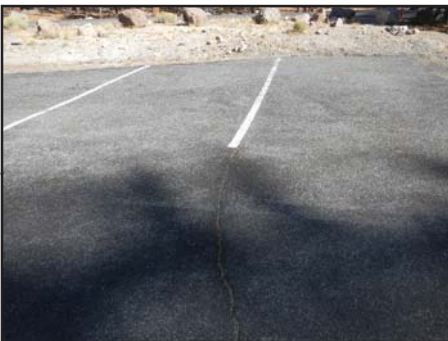
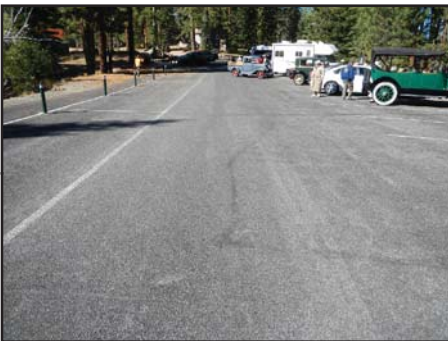
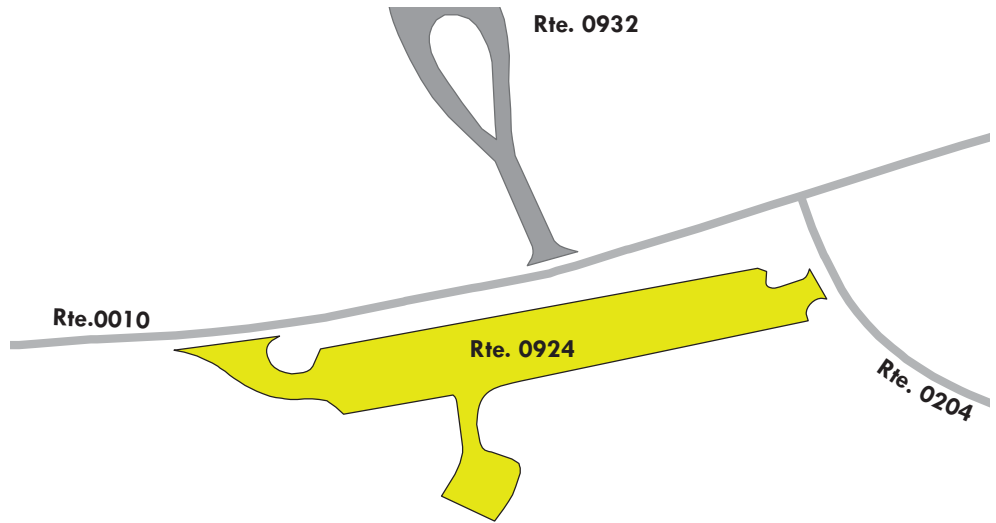
ROUTE 0924: LOOMIS MUSEUM PARKING

Inspection Date	FMSS Number	User Access	Surface Type
10/1/2014	73651	PUBLIC	ASPHALT
Area (Sq. Ft.)	Lane Miles (11' Widths)	Curb Reveal (Inches)	Curb Recommendation
24,391	0.42	NOT APPLICABLE	NOT APPLICABLE
Curb Type		Curb & Gutter Type	
NO CURB		NO CURB AND GUTTER	
Pavement Recommendation		Condition Rating / PCR	
LIGHT 3R TREATMENTS		FAIR / 73

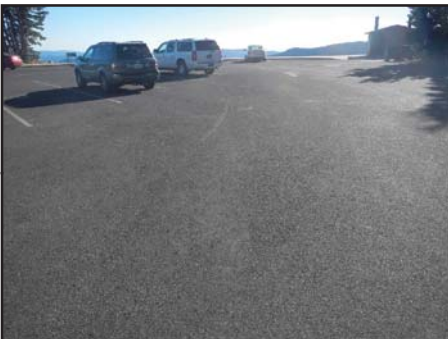
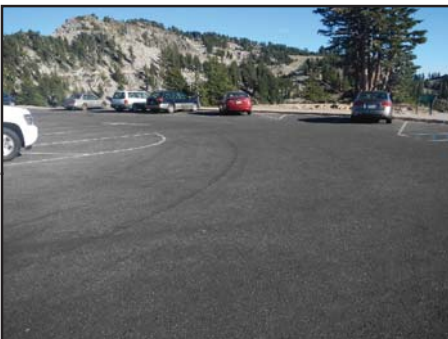
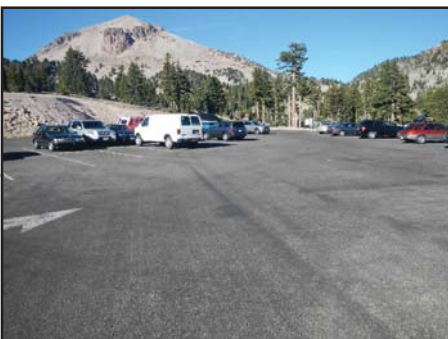
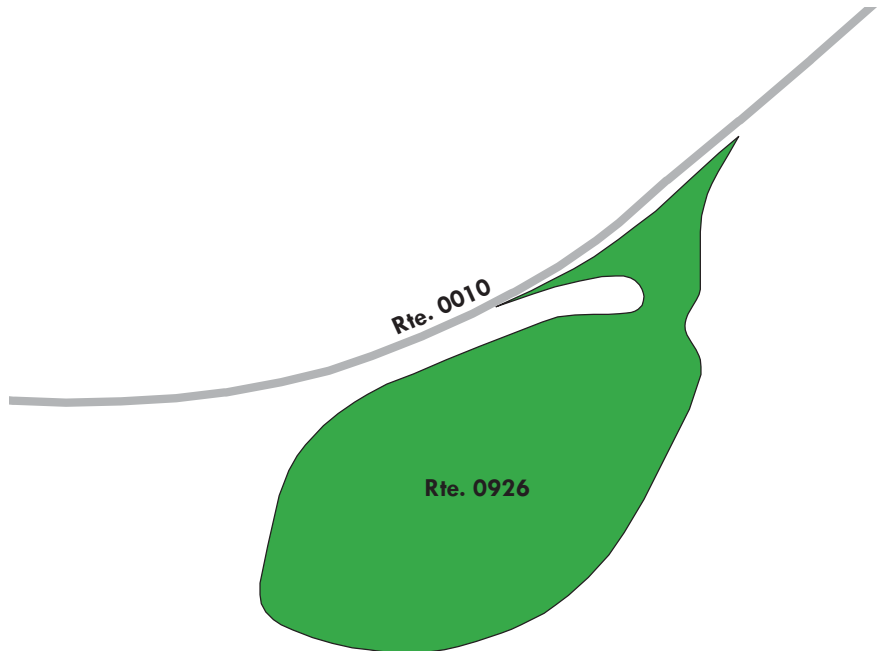
ROUTE 0926: BUMPASS PARKING

Inspection Date	FMSS Number	User Access	Surface Type
10/1/2014	73653	PUBLIC	ASPHALT
Area (Sq. Ft.)	Lane Miles (11' Widths)	Curb Reveal (Inches)	Curb Recommendation
35,384	0.609	NOT APPLICABLE	LIGHT REPAIR
Curb Type		Curb & Gutter Type	
NO CURB		CONCRETE	
Pavement Recommendation		Condition Rating / PCR	
PREVENTIVE MAINTENANCE		GOOD / 90

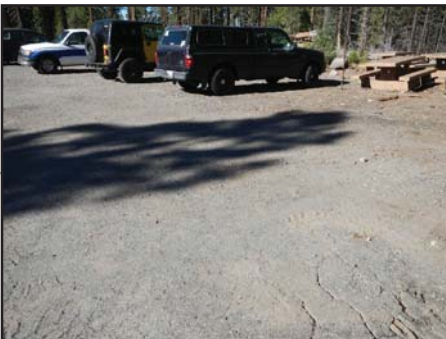
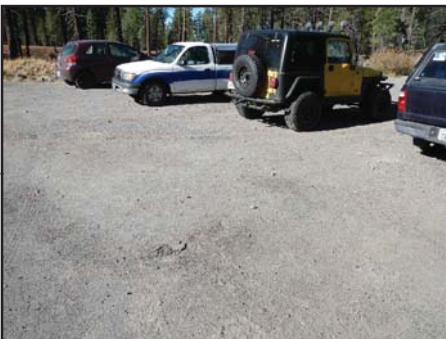
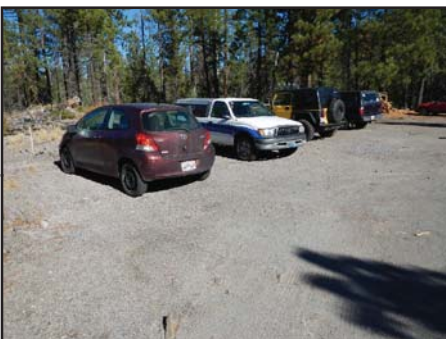
Inspection Date	FMSS Number	User Access	Surface Type
10/1/2014	73671	NONPUBLIC	ASPHALT
Area (Sq. Ft.)	Lane Miles (11' Widths)	Curb Reveal (Inches)	Curb Recommendation
3,494	0.06	NOT APPLICABLE	NOT APPLICABLE
Curb Type		Curb & Gutter Type	
NO CURB		NO CURB AND GUTTER	
Pavement Recommendation		Condition Rating / PCR	
RECONSTRUCTION		POOR / 0

Route was rated POOR (PCR = 0) because it is in very poor condition and appears to be unpaved.

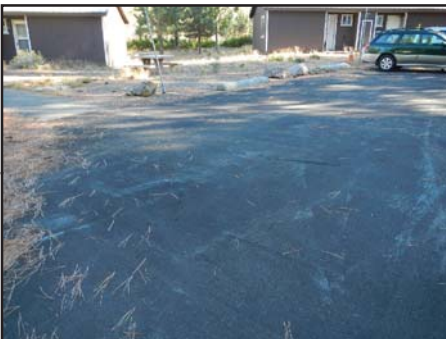
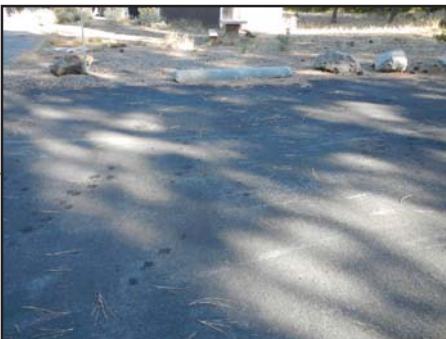
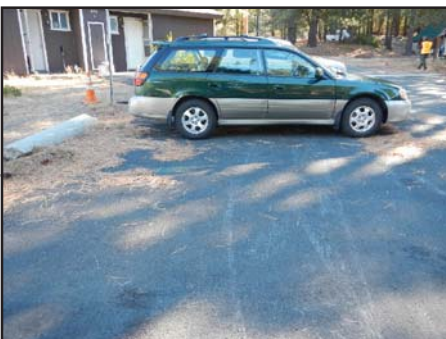
ROUTE 0942AZ: MANZANITA RESIDENCE BUILDINGS 1-3 PARKING

Inspection Date	FMSS Number	User Access	Surface Type
10/1/2014	73673	NONPUBLIC	ASPHALT
Area (Sq. Ft.)	Lane Miles (11' Widths)	Curb Reveal (Inches)	Curb Recommendation
1,634	0.028	NOT APPLICABLE	NOT APPLICABLE
Curb Type		Curb & Gutter Type	
NO CURB		NO CURB AND GUTTER	
Pavement Recommendation		Condition Rating / PCR	
PREVENTIVE MAINTENANCE		GOOD / 90

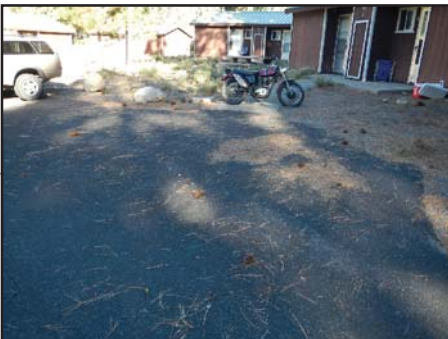
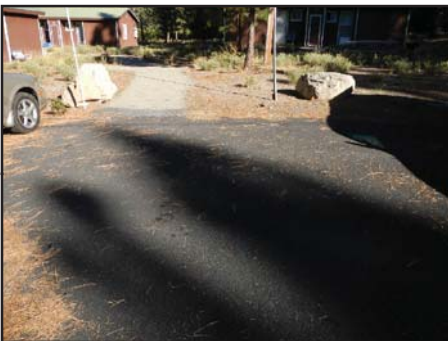
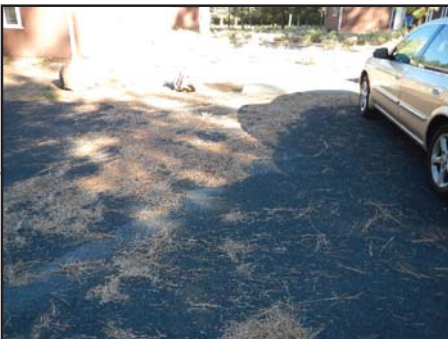
ROUTE 0942BZ: MANZANITA RESIDENCE BUILDINGS 8-11 PARKING

Inspection Date	FMSS Number	User Access	Surface Type
10/1/2014	73673	NONPUBLIC	ASPHALT
Area (Sq. Ft.)	Lane Miles (11' Widths)	Curb Reveal (Inches)	Curb Recommendation
2,095	0.036	NOT APPLICABLE	NOT APPLICABLE
Curb Type		Curb & Gutter Type	
NO CURB		NO CURB AND GUTTER	
Pavement Recommendation		Condition Rating / PCR	
PREVENTIVE MAINTENANCE		GOOD / 90

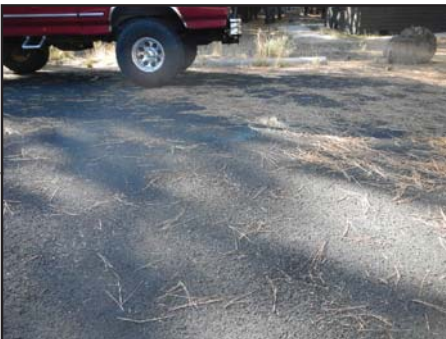
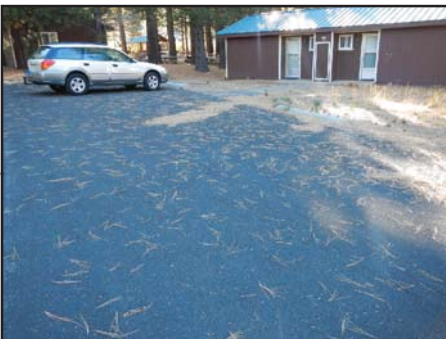
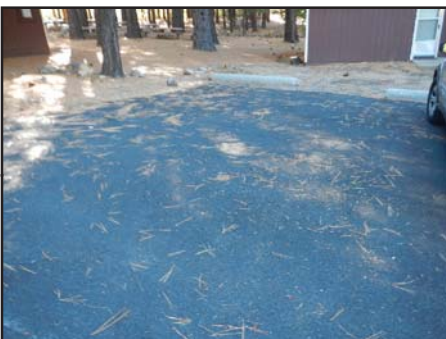
ROUTE 0942CZ: MANZANITA RESIDENCE BUILDINGS 12-14 PARKING

Inspection Date	FMSS Number	User Access	Surface Type
10/1/2014	73673	NONPUBLIC	ASPHALT
Area (Sq. Ft.)	Lane Miles (11' Widths)	Curb Reveal (Inches)	Curb Recommendation
3,878	0.067	NOT APPLICABLE	NOT APPLICABLE
Curb Type		Curb & Gutter Type	
NO CURB		NO CURB AND GUTTER	
Pavement Recommendation		Condition Rating / PCR	
PREVENTIVE MAINTENANCE		GOOD / 90

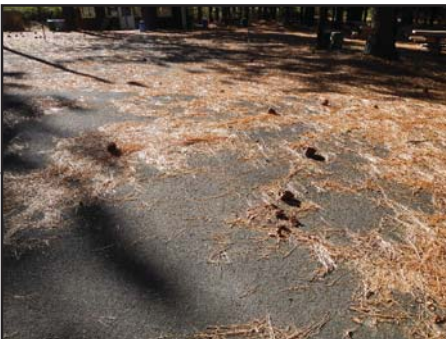
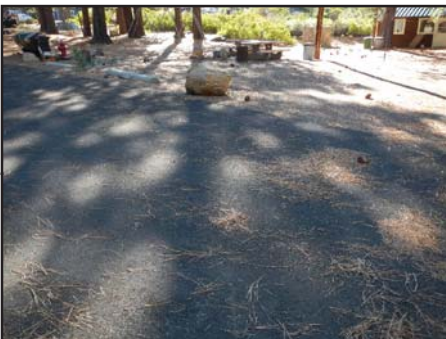
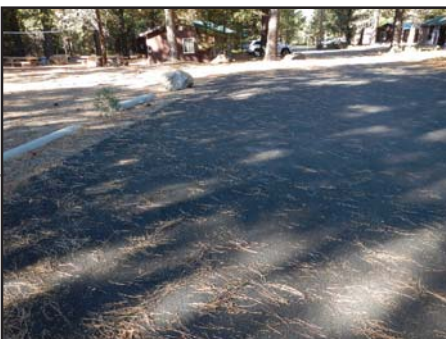
ROUTE 0942DZ: MANZANITA RESIDENCE BUILDING 653 PARKING

Inspection Date	FMSS Number	User Access	Surface Type
10/1/2014	73673	NONPUBLIC	ASPHALT
Area (Sq. Ft.)	Lane Miles (11' Widths)	Curb Reveal (Inches)	Curb Recommendation
1,824	0.031	NOT APPLICABLE	NOT APPLICABLE
Curb Type		Curb & Gutter Type	
NO CURB		NO CURB AND GUTTER	
Pavement Recommendation		Condition Rating / PCR	
PREVENTIVE MAINTENANCE		GOOD / 90

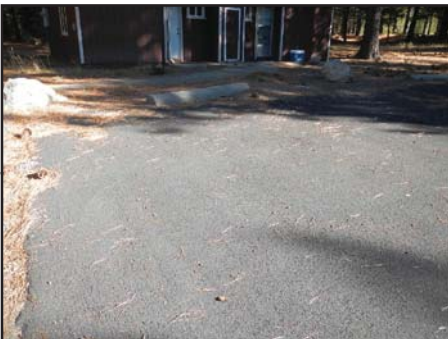
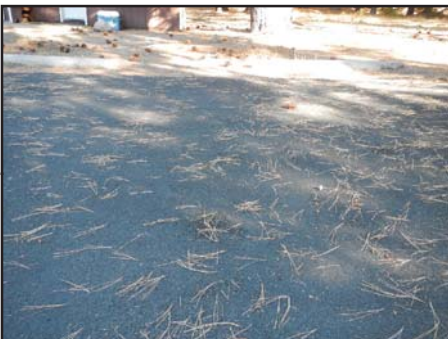
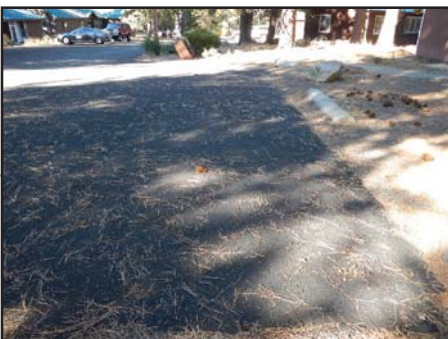
ROUTE 0942EZ: MANZANITA RESIDENCE BUILDING 7 PARKING

Inspection Date	FMSS Number	User Access	Surface Type
10/1/2014	73673	NONPUBLIC	ASPHALT
Area (Sq. Ft.)	Lane Miles (11' Widths)	Curb Reveal (Inches)	Curb Recommendation
1,325	0.023	NOT APPLICABLE	NOT APPLICABLE
Curb Type		Curb & Gutter Type	
NO CURB		NO CURB AND GUTTER	
Pavement Recommendation		Condition Rating / PCR	
PREVENTIVE MAINTENANCE		GOOD / 90

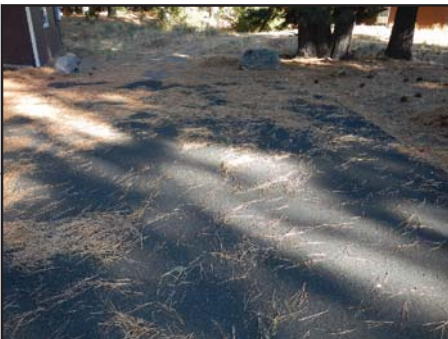
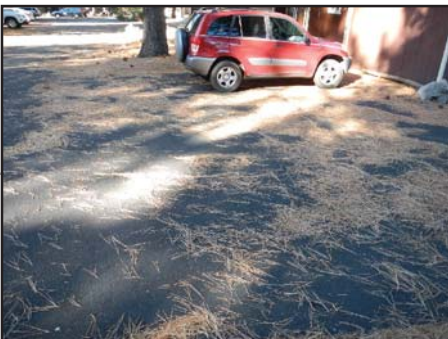
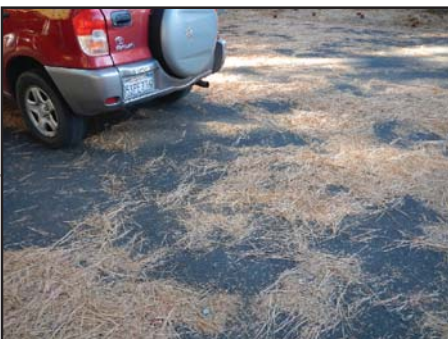
ROUTE 0942FZ: MANZANITA RESIDENCE BUILDING 6 PARKING

Inspection Date	FMSS Number	User Access	Surface Type
10/1/2014	73673	NONPUBLIC	ASPHALT
Area (Sq. Ft.)	Lane Miles (11' Widths)	Curb Reveal (Inches)	Curb Recommendation
718	0.012	NOT APPLICABLE	NOT APPLICABLE
Curb Type		Curb & Gutter Type	
NO CURB		NO CURB AND GUTTER	
Pavement Recommendation		Condition Rating / PCR	
PREVENTIVE MAINTENANCE		GOOD / 90

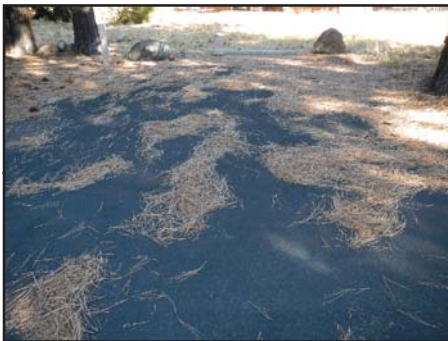
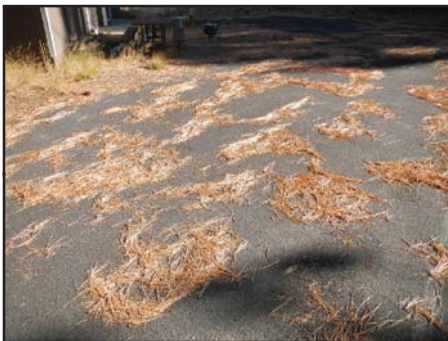
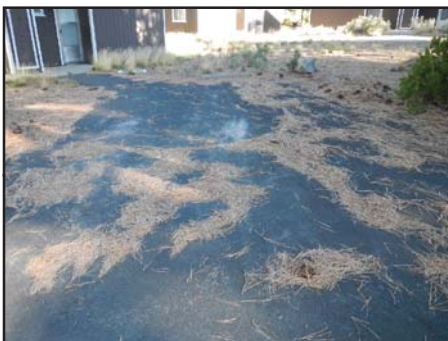
ROUTE 0942GZ: MANZANITA RESIDENCE BUILDINGS 4-5 PARKING

Inspection Date	FMSS Number	User Access	Surface Type
10/1/2014	73673	NONPUBLIC	ASPHALT
Area (Sq. Ft.)	Lane Miles (11' Widths)	Curb Reveal (Inches)	Curb Recommendation
2,415	0.042	NOT APPLICABLE	NOT APPLICABLE
Curb Type		Curb & Gutter Type	
NO CURB		NO CURB AND GUTTER	
Pavement Recommendation		Condition Rating / PCR	
PREVENTIVE MAINTENANCE		GOOD / 90

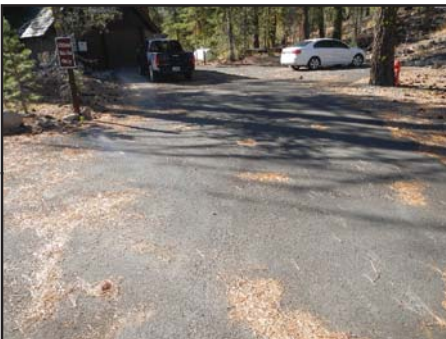
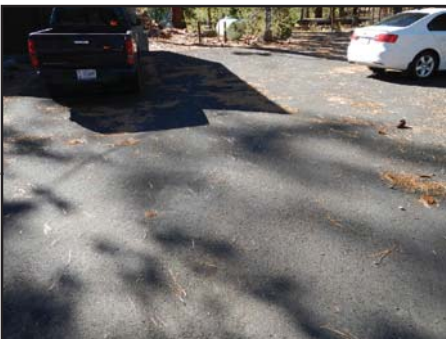
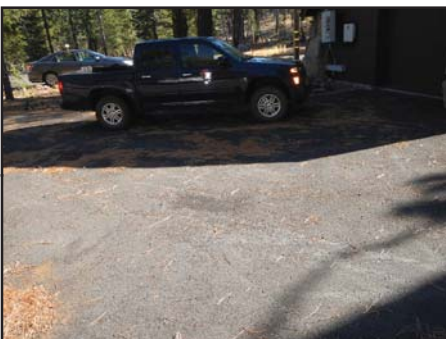
ROUTE 0944: NORTHWEST MANZANITA FEE STATION PARKING

Inspection Date	FMSS Number	User Access	Surface Type
10/1/2014	73677	NONPUBLIC	ASPHALT
Area (Sq. Ft.)	Lane Miles (11' Widths)	Curb Reveal (Inches)	Curb Recommendation
2,975	0.051	NOT APPLICABLE	NOT APPLICABLE
Curb Type		Curb & Gutter Type	
NO CURB		NO CURB AND GUTTER	
Pavement Recommendation		Condition Rating / PCR	
PREVENTIVE MAINTENANCE		GOOD / 90

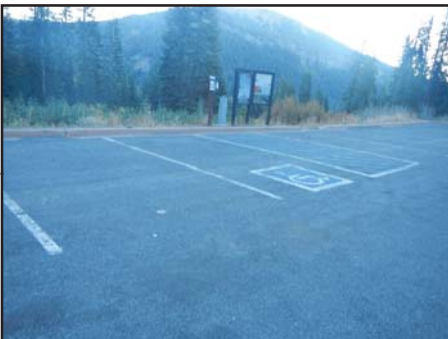
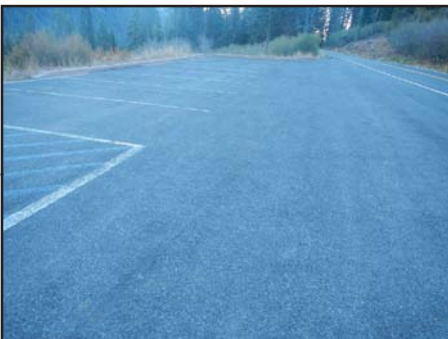
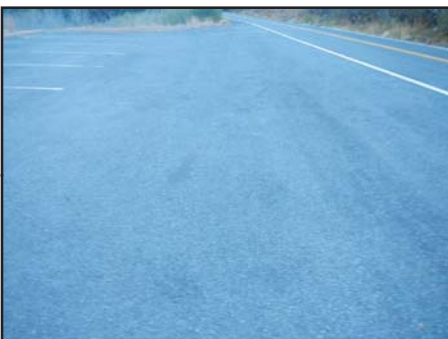
ROUTE 0947: BROKEOFF TRAILHEAD PARKING

Inspection Date	FMSS Number	User Access	Surface Type
10/2/2014	105037	PUBLIC	ASPHALT
Area (Sq. Ft.)	Lane Miles (11' Widths)	Curb Reveal (Inches)	Curb Recommendation
8,192	0.141	NOT APPLICABLE	LIGHT REPAIR
Curb Type		Curb & Gutter Type	
NO CURB		CONCRETE	
Pavement Recommendation		Condition Rating / PCR	
PREVENTIVE MAINTENANCE		GOOD / 90
