# LYJO Cycle 6

## Final Report

### Road Inventory and Condition Assessment of Paved Routes Lyndon B. Johnson National Historical Park

**Report Date: July 2017**

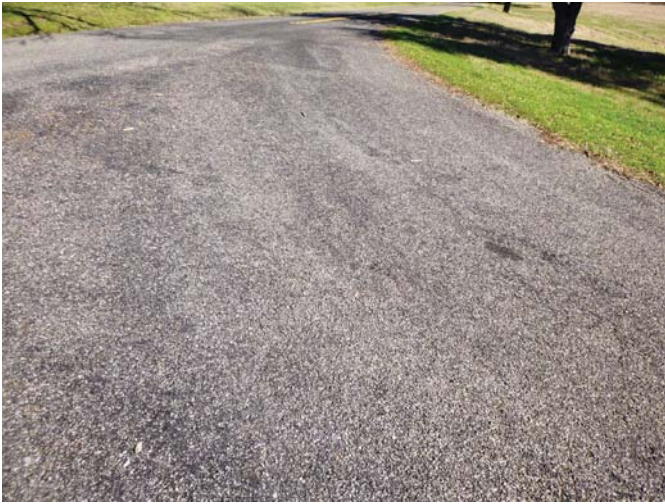
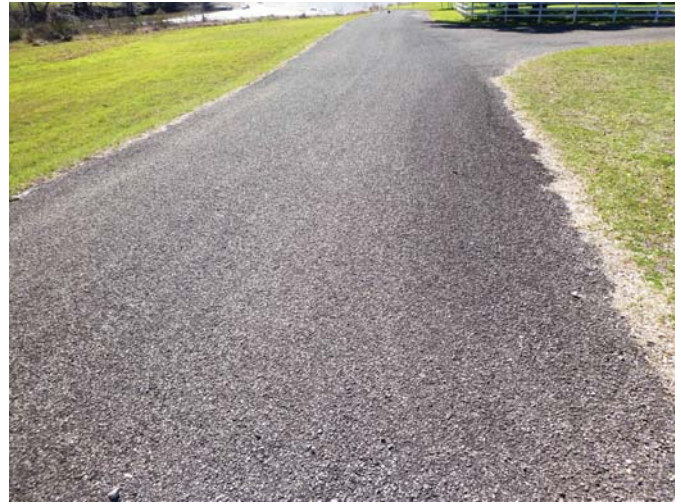
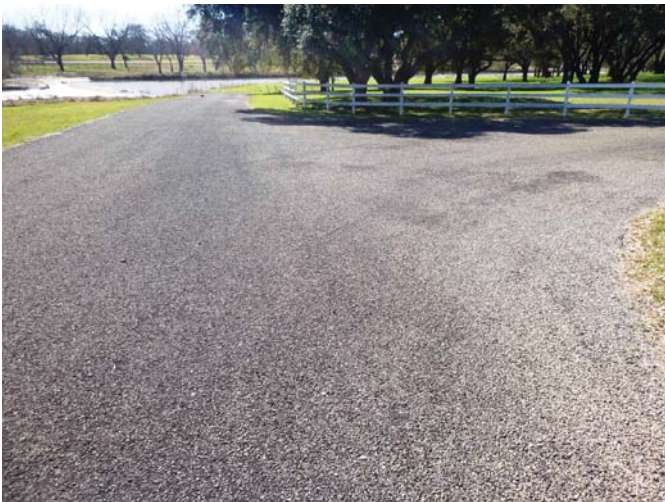
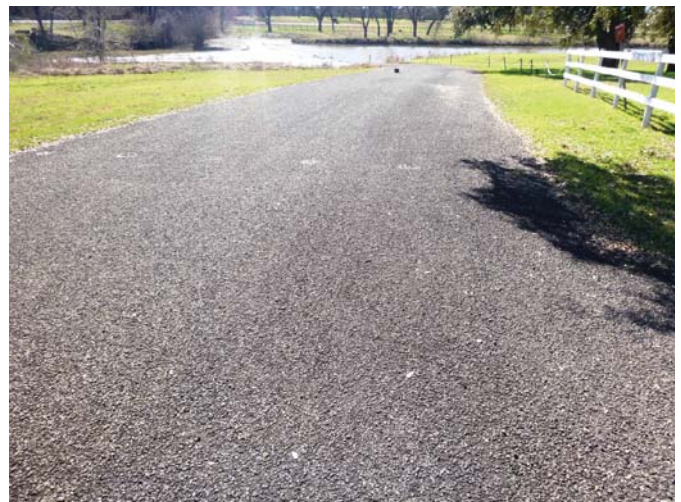
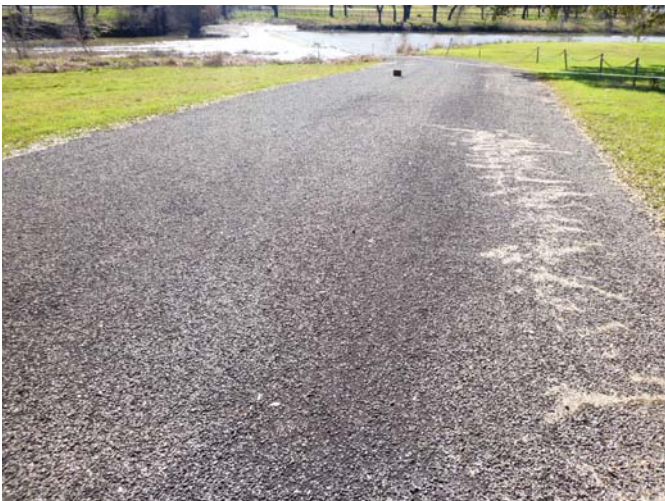
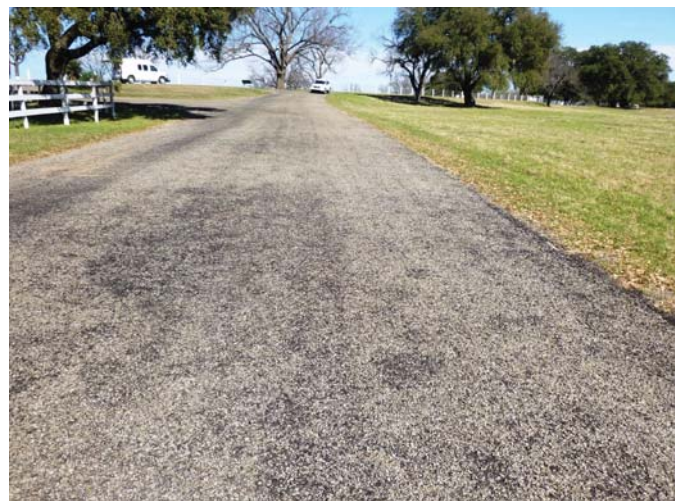
<b>Inspection Date:</b> 2/17/2017	<b>Beginning Section MP</b>	0.00				
<b>Paved Length (Miles):</b> 0.06	<b>Section Length (MI)</b>	0.06				
<b>Surface Type:</b> ASPHALT	<b>Route Summary</b>					
<b>Roadway Condition Information</b>						
Pavement Condition Rating (PCR)	90	90				
Surface Condition Rating (SCR)	90	90				
Roughness Condition Index (RCI)	N/A	N/A				
<b>Distress Index Values</b>						
Structural Crack Index	N/A	N/A				
Alligator Crack Index	97	97				
Longitudinal Crack Index	90	90				
Transverse Cracking Index	97	97				
Patching Index	97	97				
Rutting Index	97	97				
International Roughness Index (IRI)	N/A	N/A				
<b>Lane &amp; Width Information</b>						
Number of Lanes	1	1				
Paved Width (ft)	22	22				
Lane Width (ft)	22	22

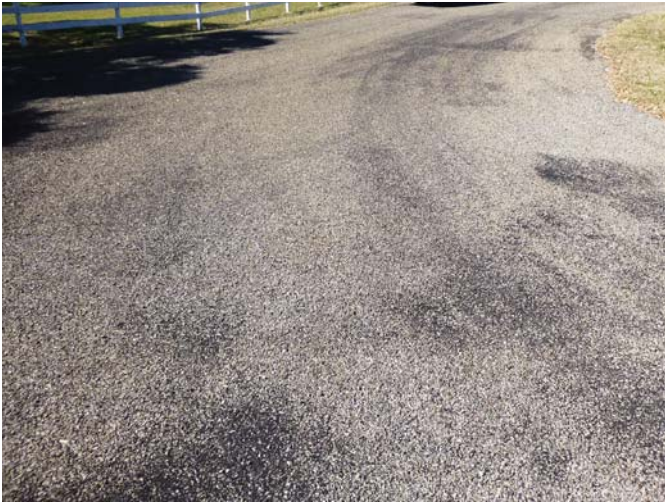
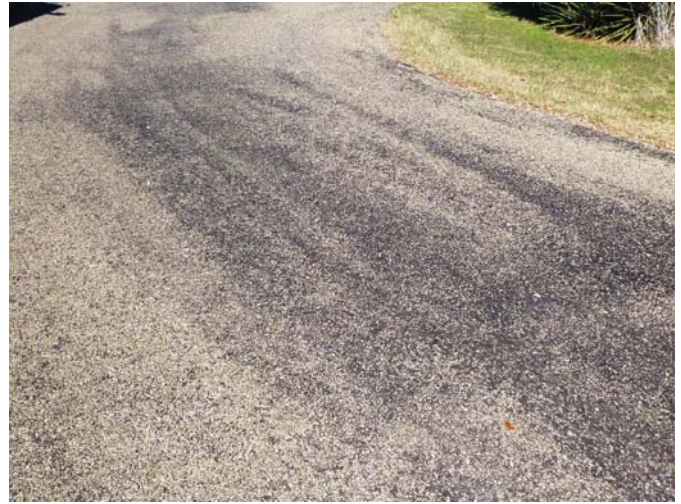
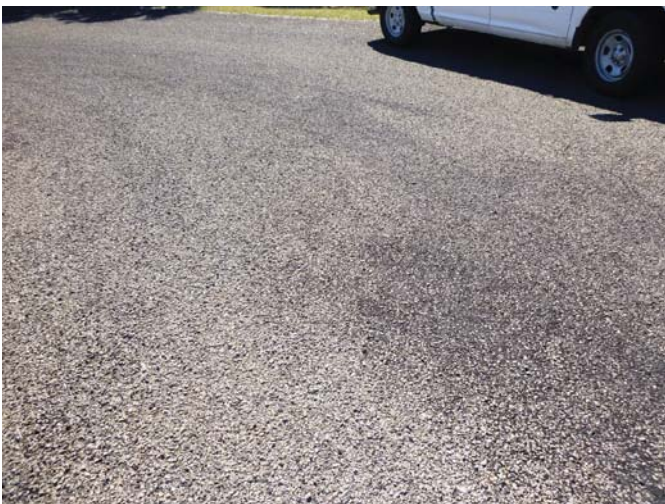
<b>Inspection Date:</b> 2/17/2017	<b>Beginning Section MP</b>	0.00				
<b>Paved Length (Miles):</b> 0.02	<b>Section Length (MI)</b>	0.02				
<b>Surface Type:</b> ASPHALT	<b>Route Summary</b>					
<b>Roadway Condition Information</b>						
Pavement Condition Rating (PCR)	90	90				
Surface Condition Rating (SCR)	90	90				
Roughness Condition Index (RCI)	N/A	N/A				
<b>Distress Index Values</b>						
Structural Crack Index	N/A	N/A				
Alligator Crack Index	97	97				
Longitudinal Crack Index	90	90				
Transverse Cracking Index	97	97				
Patching Index	97	97				
Rutting Index	97	97				
International Roughness Index (IRI)	N/A	N/A				
<b>Lane &amp; Width Information</b>						
Number of Lanes	1	1				
Paved Width (ft)	22	22				
Lane Width (ft)	22	22
