NACE Cycle 6

Final Report

Road Inventory and Condition Assessment of Paved Routes National Capital Parks - East

Report Date: October 2019

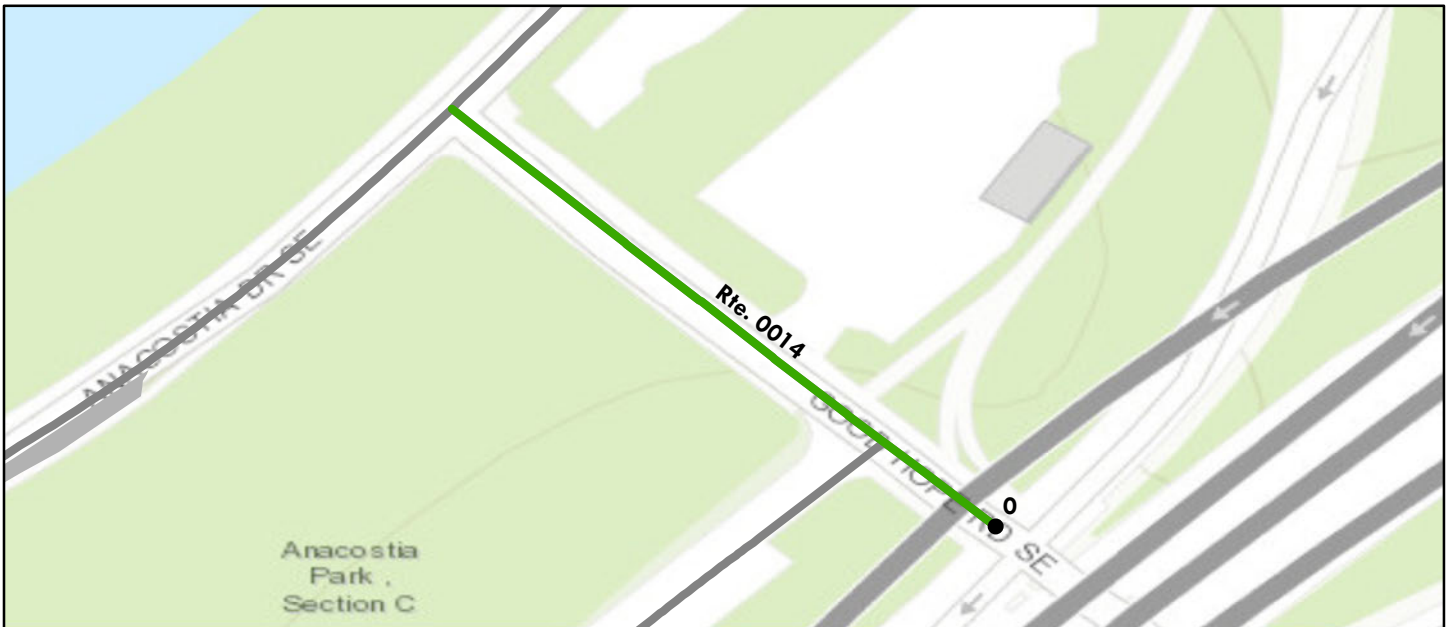
ROUTE 0014: GOOD HOPE ROAD

Inspection Date: 6/7/2018	Beginning Section MP	0				
Paved Length (Miles): 0.07	Section Length (MI)	0.07				
Surface Type: ASPHALT	Route Summary					
Roadway Condition Information						
Pavement Condition Rating (PCR)	89	89				
Surface Condition Rating (SCR)	89	89				
Roughness Condition Index (RCI)	N/A	N/A				
Distress Index Values						
Structural Crack Index	89	89				
Alligator Crack Index	100	100				
Longitudinal Crack Index	89	89				
Transverse Cracking Index	93	93				
Patching Index	100	100				
Rutting Index	99	99				
International Roughness Index (IRI)	N/A	N/A				
Lane & Width Information						
Number of Lanes	2	2				
Paved Width (ft)	26.1	26.1				
Lane Width (ft)	12.9	12.9

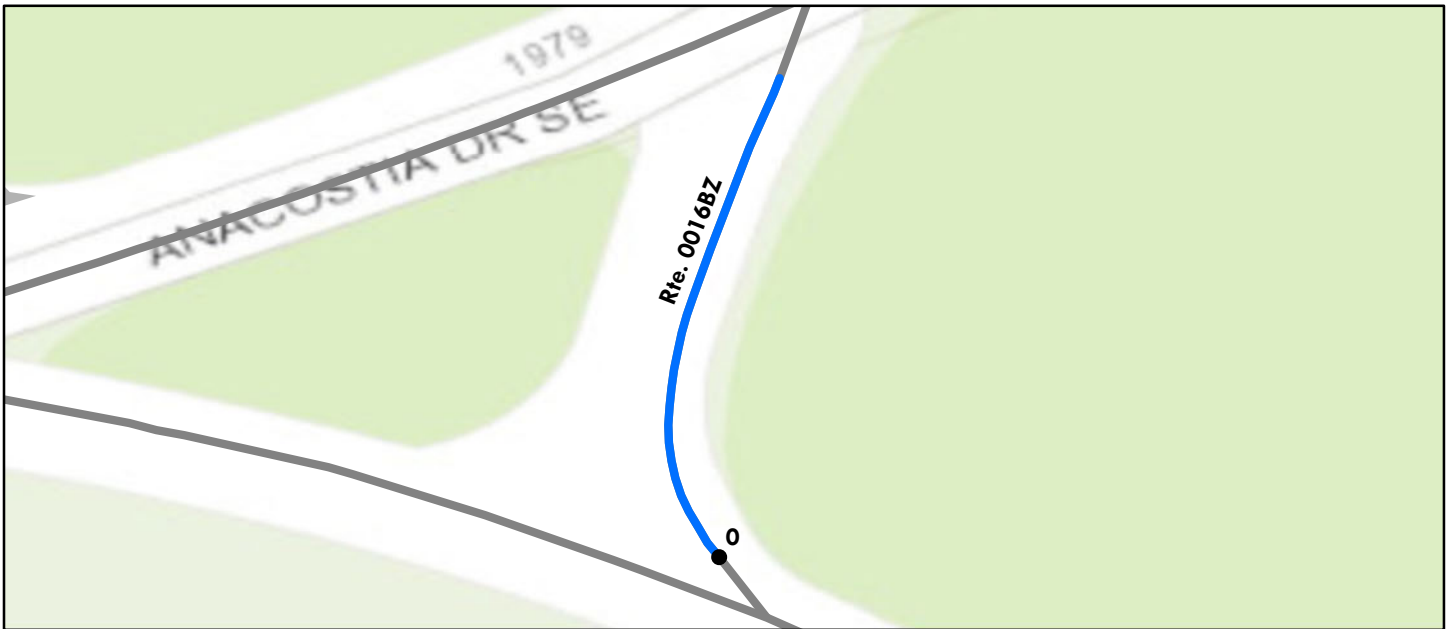
ROUTE 0016BZ: ANACOSTIA PAVILION LOOP ROAD SPUR

Route Condition Legend – Pavement Condition Rating (PCR)						
Poor (0 - 60)	Fair (61- 84)	Good (85 - 94)	Excellent (95 - 100)	Not Rated		
Colors on map represent condition scores at 0.10-mile intervals. See Appendix for definitions and formulas.						
Inspection Date: 6/7/2018	Beginning Section MP	0				
Paved Length (Miles): 0.02	Section Length (MI)	0.02				
Surface Type: ASPHALT	Route Summary					
Roadway Condition Information						
Pavement Condition Rating (PCR)	99	99				
Surface Condition Rating (SCR)	99	99				
Roughness Condition Index (RCI)	N/A	N/A				
Distress Index Values						
Structural Crack Index	100	100				
Alligator Crack Index	100	100				
Longitudinal Crack Index	100	100				
Transverse Cracking Index	100	100				
Patching Index	100	100				
Rutting Index	99	99				
International Roughness Index (IRI)	N/A	N/A				
Lane & Width Information						
Number of Lanes	2	2				
Paved Width (ft)	24.2	24.2

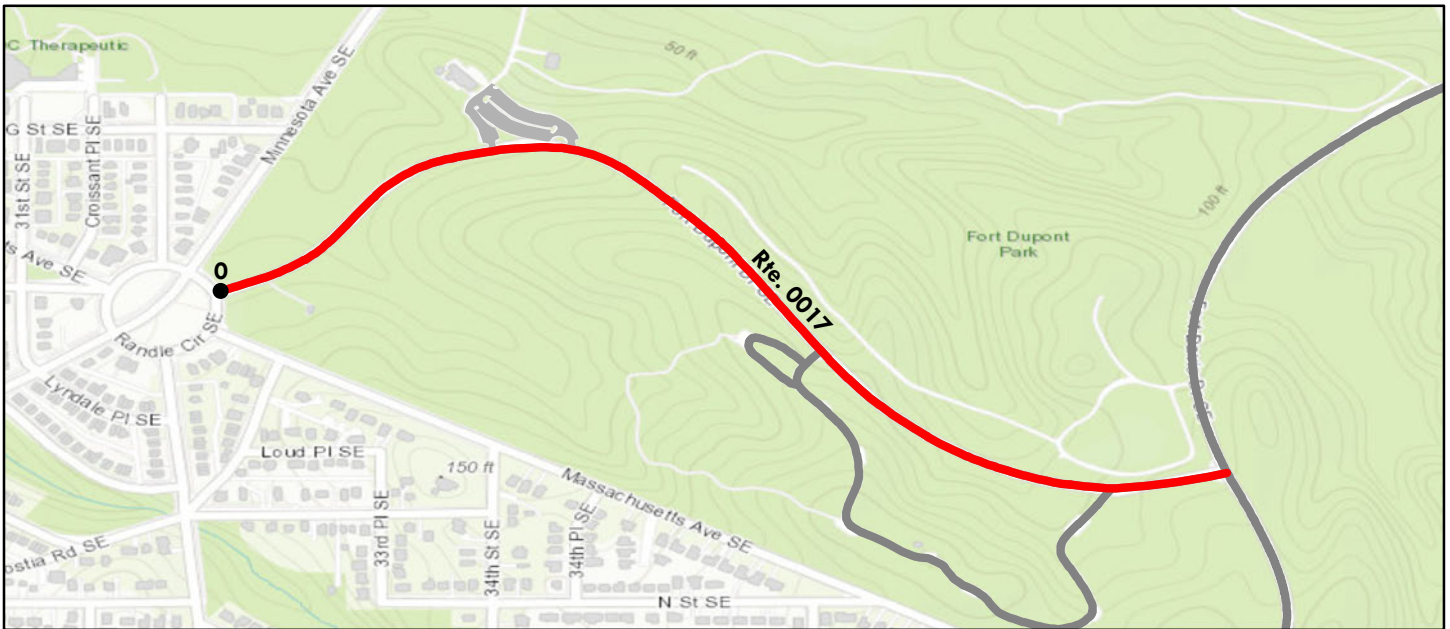
ROUTE 0017: FORT DUPONT DRIVE

Route Condition Legend – Pavement Condition Rating (PCR)						
Poor (0 - 60)	Fair (61- 84)	Good (85 - 94)	Excellent (95 - 100)	Not Rated		
Colors on map represent condition scores at 0.10-mile intervals. See Appendix for definitions and formulas.						
Inspection Date: 6/8/2018	Beginning Section MP	0				
Paved Length (Miles): 0.8	Section Length (MI)	0.8				
Surface Type: ASPHALT	Route Summary					
Roadway Condition Information						
Pavement Condition Rating (PCR)	7	7				
Surface Condition Rating (SCR)	0	0				
Roughness Condition Index (RCI)	18	18				
Distress Index Values						
Structural Crack Index	0	0				
Alligator Crack Index	90	90				
Longitudinal Crack Index	0	0				
Transverse Cracking Index	65	65				
Patching Index	85	85				
Rutting Index	84	84				
International Roughness Index (IRI)	530	530				
Lane & Width Information						
Number of Lanes	2	2				
Paved Width (ft)	24.5	24.5				
Lane Width (ft)	10.8	10.8

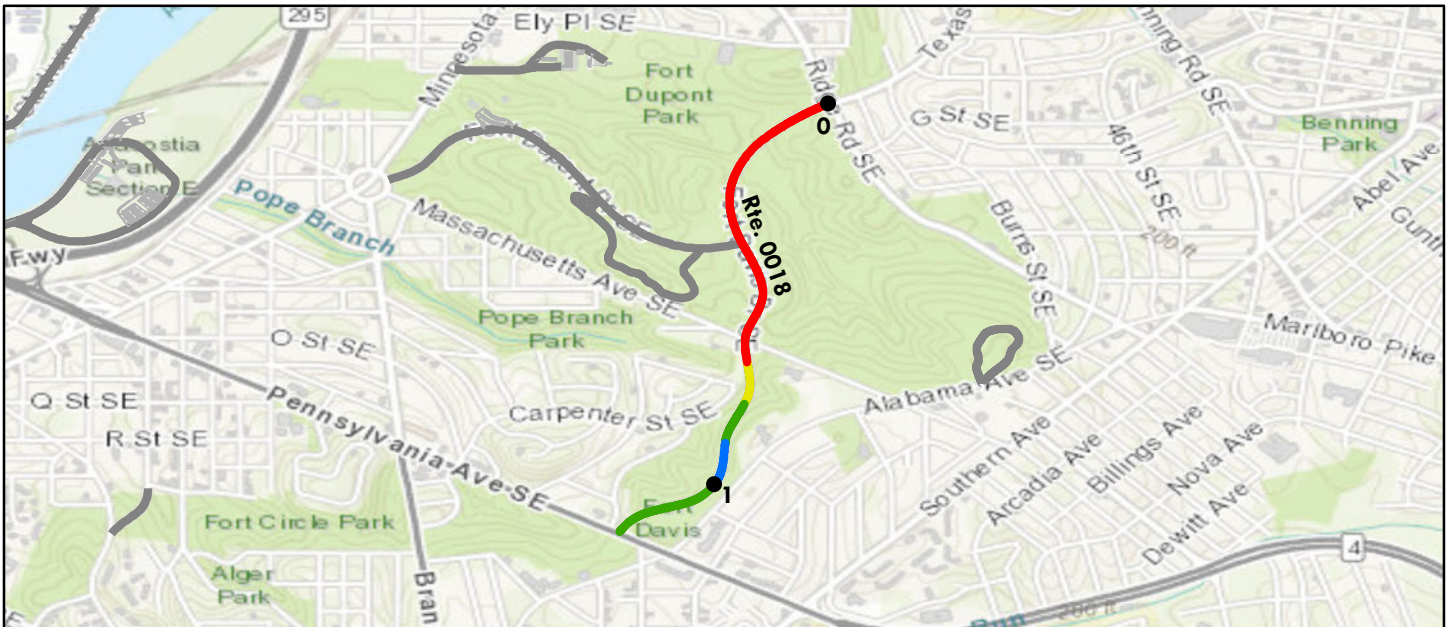
ROUTE 0018: FORT DAVIS DRIVE

Route Condition Legend – Pavement Condition Rating (PCR)										
Poor (0 - 60)		Fair (61 - 84)		Good (85 - 94)		Excellent (95 - 100)		Not Rated		
Colors on map represent condition scores at 0.10-mile intervals. See Appendix for definitions and formulas.										
Inspection Date:	6/8/2018	Beginning Section MP	0	1						
Paved Length (Miles):	1.21	Section Length (MI)	1	0.21						
Surface Type:	ASPHALT	Route Summary								
Roadway Condition Information										
Pavement Condition Rating (PCR)	22	20	90							
Surface Condition Rating (SCR)	0	0	94							
Roughness Condition Index (RCI)	56	51	84							
Distress Index Values										
Structural Crack Index	0	0	96							
Alligator Crack Index	60	52	100							
Longitudinal Crack Index	39	27	96							
Transverse Cracking Index	44	33	96							
Patching Index	95	94	100							
Rutting Index	91	91	94							
International Roughness Index (IRI)	258	277	158							
Lane & Width Information

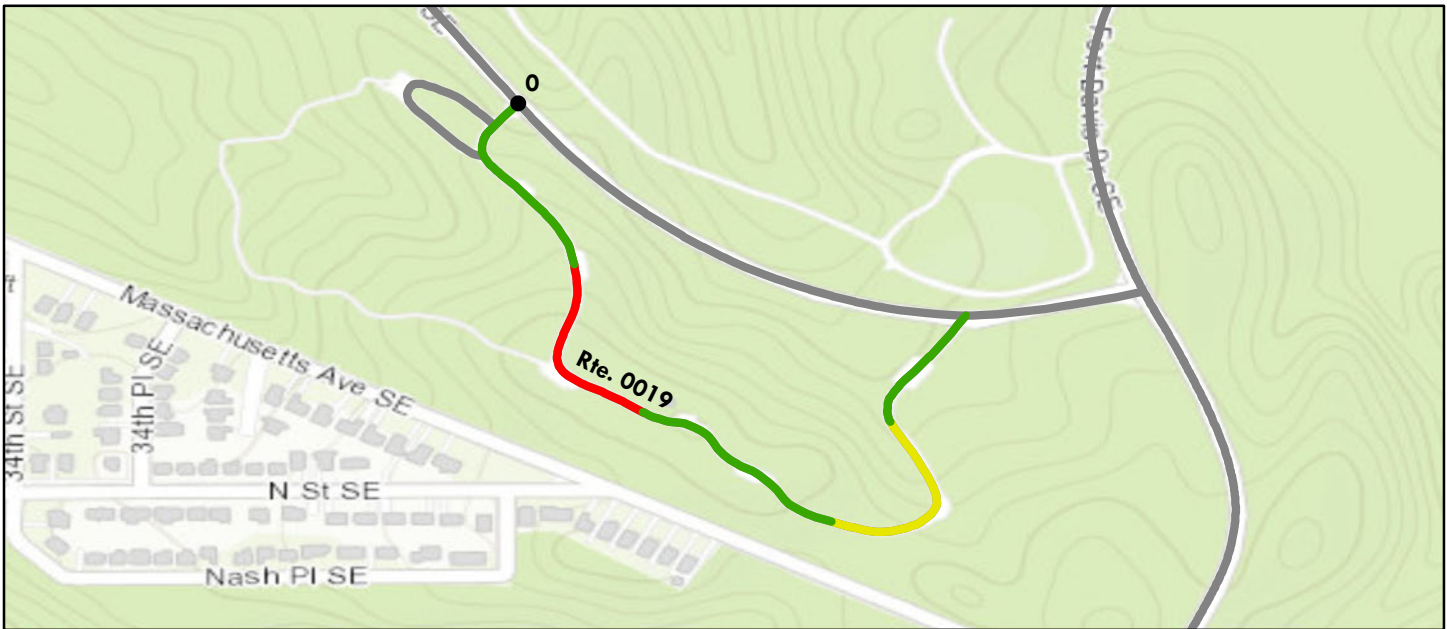
ROUTE 0019: RIDGE PICNIC AREA ROAD

Route Condition Legend – Pavement Condition Rating (PCR)						
Poor (0 - 60)	Fair (61- 84)	Good (85 - 94)	Excellent (95 - 100)	Not Rated		
Colors on map represent condition scores at 0.10-mile intervals. See Appendix for definitions and formulas.						
Inspection Date: 6/8/2018	Beginning Section MP	0				
Paved Length (Miles): 0.46	Section Length (MI)	0.46				
Surface Type: ASPHALT	Route Summary					
Roadway Condition Information						
Pavement Condition Rating (PCR)	73	73				
Surface Condition Rating (SCR)	73	73				
Roughness Condition Index (RCI)	N/A	N/A				
Distress Index Values						
Structural Crack Index	73	73				
Alligator Crack Index	96	96				
Longitudinal Crack Index	77	77				
Transverse Cracking Index	95	95				
Patching Index	87	87				
Rutting Index	90	90				
International Roughness Index (IRI)	N/A	N/A				
Lane & Width Information						
Number of Lanes	1	1				
Paved Width (ft)	14.4	14.4				
Lane Width (ft)	14.4	14.4

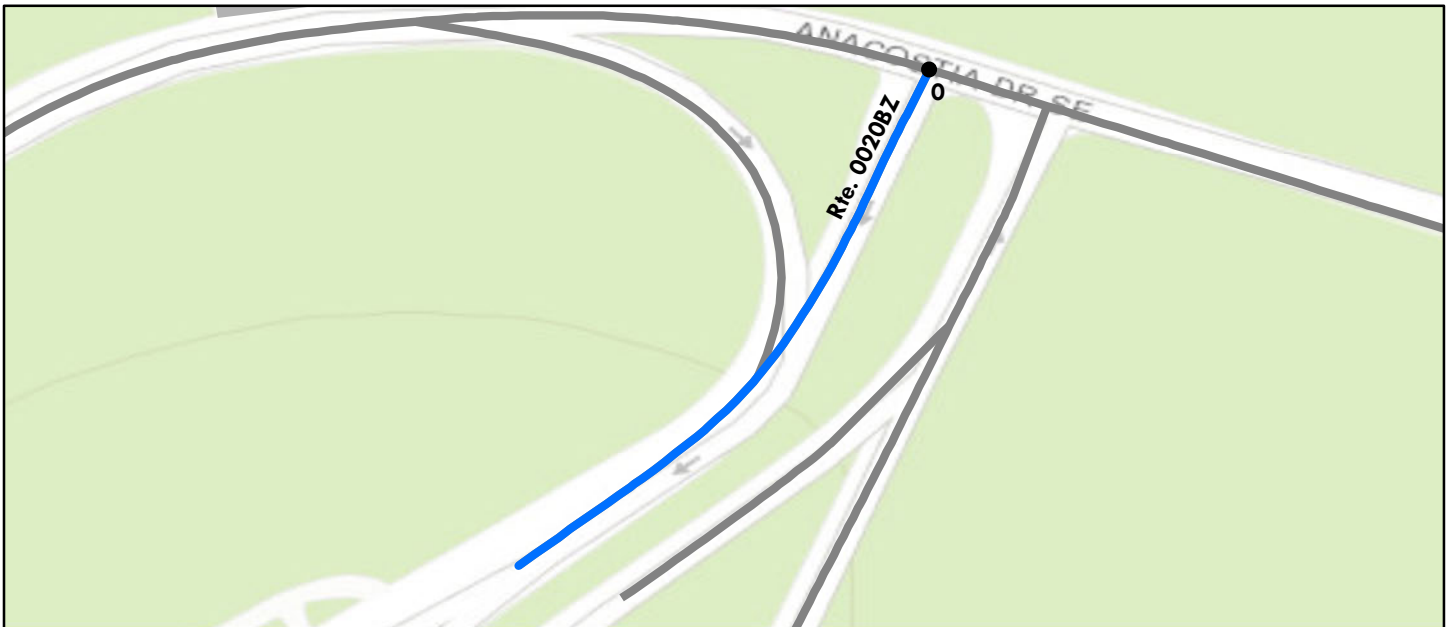
ROUTE 0020BZ: ANACOSTIA DRIVE SE RAMP TO S CAPITAL STREET SE

Route Condition Legend – Pavement Condition Rating (PCR)						
Poor (0 - 60)	Fair (61- 84)	Good (85 - 94)	Excellent (95 - 100)	Not Rated		
Colors on map represent condition scores at 0.10-mile intervals. See Appendix for definitions and formulas.						
Inspection Date: 6/7/2018	Beginning Section MP	0				
Paved Length (Miles): 0.07	Section Length (MI)	0.07				
Surface Type: ASPHALT	Route Summary					
Roadway Condition Information						
Pavement Condition Rating (PCR)	95	95				
Surface Condition Rating (SCR)	95	95				
Roughness Condition Index (RCI)	N/A	N/A				
Distress Index Values						
Structural Crack Index	95	95				
Alligator Crack Index	100	100				
Longitudinal Crack Index	95	95				
Transverse Cracking Index	100	100				
Patching Index	100	100				
Rutting Index	100	100				
International Roughness Index (IRI)	N/A	N/A				
Lane & Width Information						
Number of Lanes	1	1				
Paved Width (ft)	14.7	14.7				
Lane Width (ft)	14.7	14.7

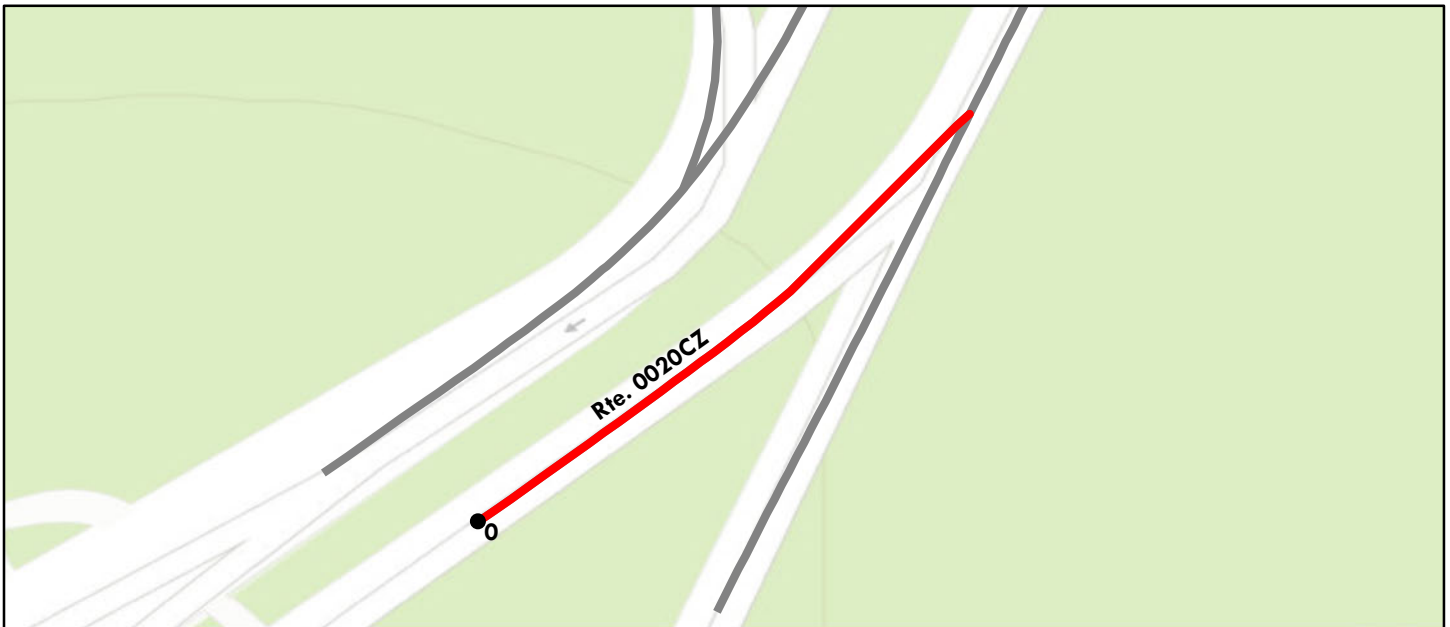
ROUTE 0020CZ: S CAPITAL STREET SE RAMP TO HOWARD ROAD SE RAMP

Route Condition Legend – Pavement Condition Rating (PCR)						
Poor (0 - 60)	Fair (61- 84)	Good (85 - 94)	Excellent (95 - 100)	Not Rated		
Colors on map represent condition scores at 0.10-mile intervals. See Appendix for definitions and formulas.						
Inspection Date: 6/7/2018	Beginning Section MP	0				
Paved Length (Miles): 0.04	Section Length (MI)	0.04				
Surface Type: CONCRETE	Route Summary					
Roadway Condition Information						
Pavement Condition Rating (PCR)	53	53				
Surface Condition Rating (SCR)	N/A	N/A				
Roughness Condition Index (RCI)	N/A	N/A				
Distress Index Values						
Structural Crack Index	N/A	N/A				
Alligator Crack Index	N/A	N/A				
Longitudinal Crack Index	N/A	N/A				
Transverse Cracking Index	N/A	N/A				
Patching Index	N/A	N/A				
Rutting Index	N/A	N/A				
International Roughness Index (IRI)	N/A	N/A				
Lane & Width Information						
Number of Lanes	1	1				
Paved Width (ft)	18.1	18.1

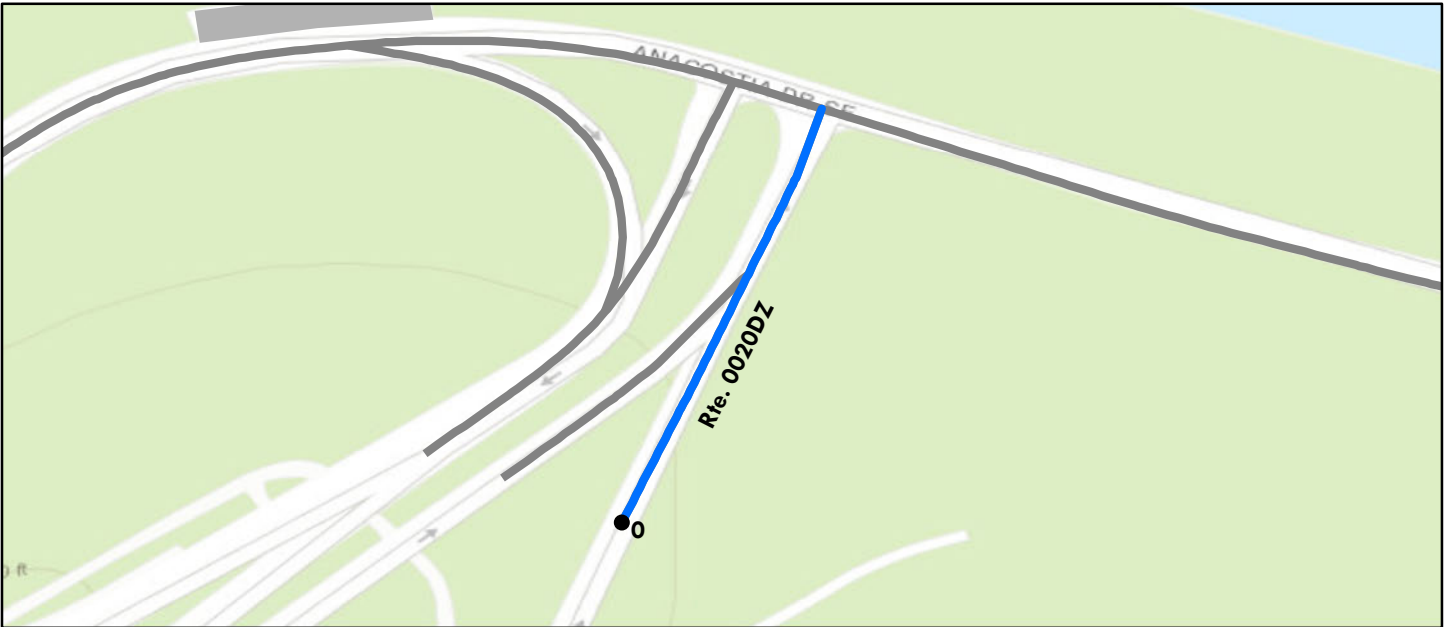
ROUTE 0020DZ: HOWARD ROAD SE RAMP TO ANACOSTIA DRIVE SE

Route Condition Legend – Pavement Condition Rating (PCR)						
Poor (0 - 60)		Fair (61- 84)		Good (85 - 94)		Excellent (95 - 100)
						Not Rated
Colors on map represent condition scores at 0.10-mile intervals. See Appendix for definitions and formulas.						
Inspection Date:	6/7/2018	Beginning Section MP	0			
Paved Length (Miles):	0.07	Section Length (MI)	0.07			
Surface Type:	ASPHALT	Route Summary				
Roadway Condition Information						
Pavement Condition Rating (PCR)	97	97				
Surface Condition Rating (SCR)	97	97				
Roughness Condition Index (RCI)	N/A	N/A				
Distress Index Values						
Structural Crack Index	97	97				
Alligator Crack Index	100	100				
Longitudinal Crack Index	97	97				
Transverse Cracking Index	97	97				
Patching Index	100	100				
Rutting Index	97	97				
International Roughness Index (IRI)	N/A	N/A				
Lane & Width Information						
Number of Lanes	1	1				
Paved Width (ft)	15	15				
Lane Width (ft)	13.6	13.6

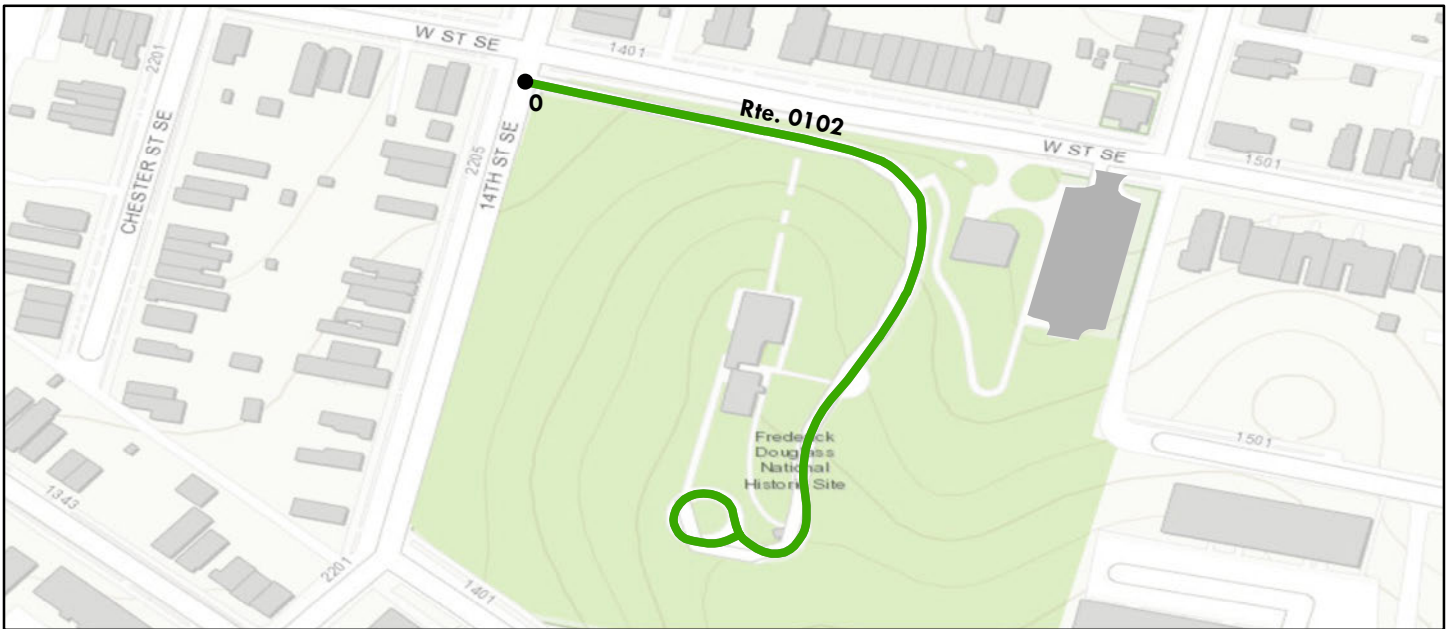
ROUTE 0102: FREDERICK DOUGLAS HOME ACCESS ROAD

Route Condition Legend – Pavement Condition Rating (PCR)						
Poor (0 - 60)	Fair (61- 84)	Good (85 - 94)	Excellent (95 - 100)	Not Rated		
Colors on map represent condition scores at 0.10-mile intervals. See Appendix for definitions and formulas.						
Inspection Date: 6/7/2018	Beginning Section MP	0				
Paved Length (Miles): 0.18	Section Length (MI)	0.18				
Surface Type: ASPHALT	Route Summary					
Roadway Condition Information						
Pavement Condition Rating (PCR)	92	92				
Surface Condition Rating (SCR)	92	92				
Roughness Condition Index (RCI)	N/A	N/A				
Distress Index Values						
Structural Crack Index	97	97				
Alligator Crack Index	100	100				
Longitudinal Crack Index	97	97				
Transverse Cracking Index	98	98				
Patching Index	100	100				
Rutting Index	92	92				
International Roughness Index (IRI)	N/A	N/A				
Lane & Width Information						
Number of Lanes	1	1				
Paved Width (ft)	12.1	12.1				
Lane Width (ft)	12.1	12.1

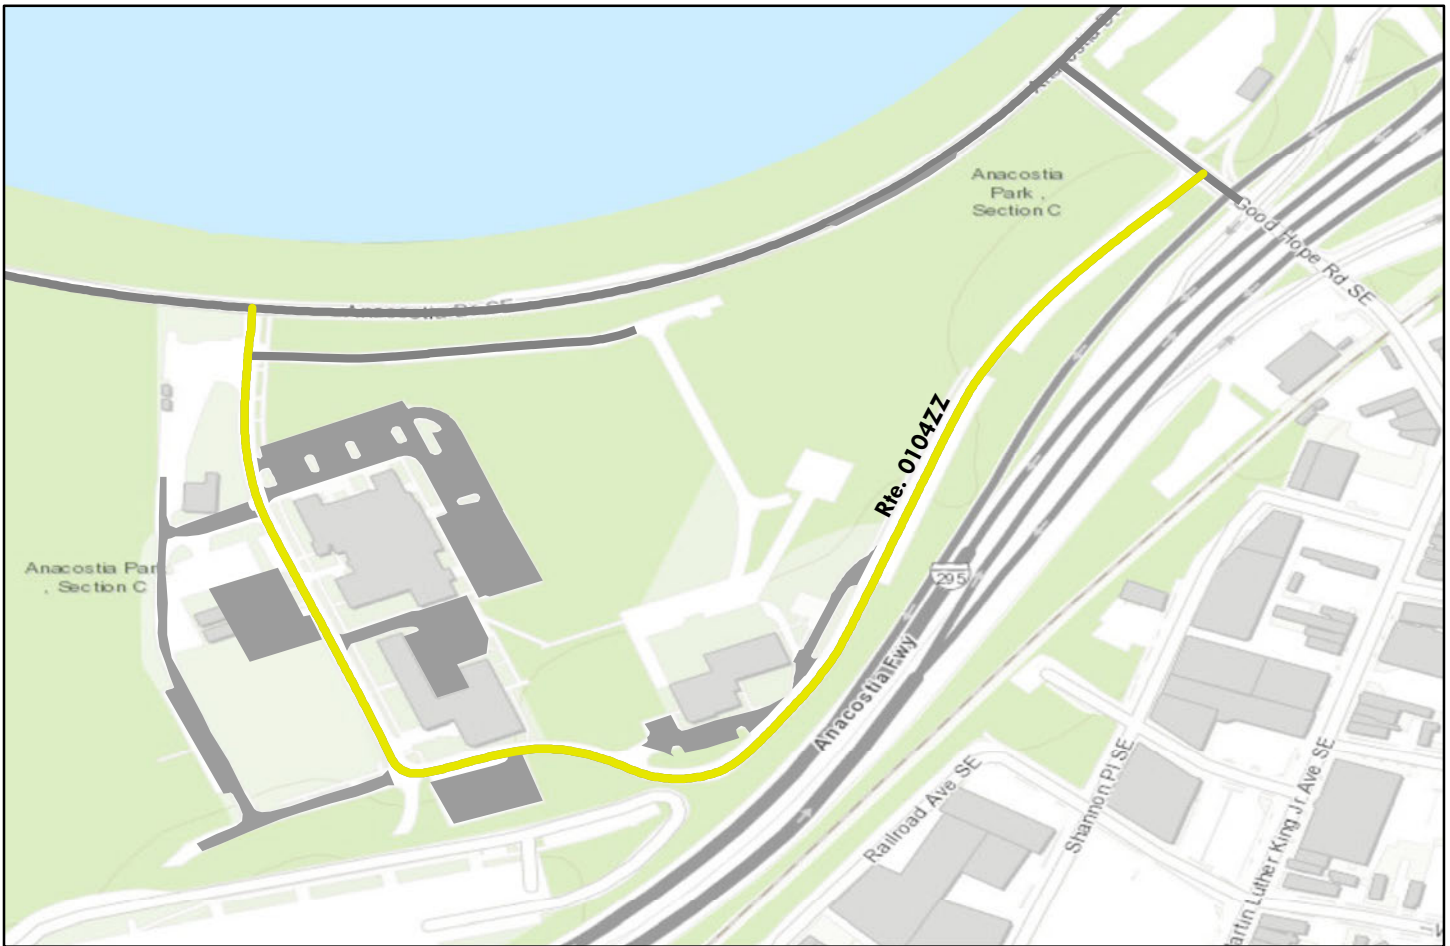
ROUTE 0104ZZ: ANACOSTIA COMPOUND ACCESS AND AVIATION DRIVE

Inspection Date:	6/7/2018					
Paved Length (Miles):	0.54					
Surface Type:	ASPHALT	Route Summary				
Roadway Condition Information						
Pavement Condition Rating (PCR)	71					
Lane & Width Information						
Number of Lanes	2					
Paved Width (ft)	23.7					
Lane Width (ft)	11

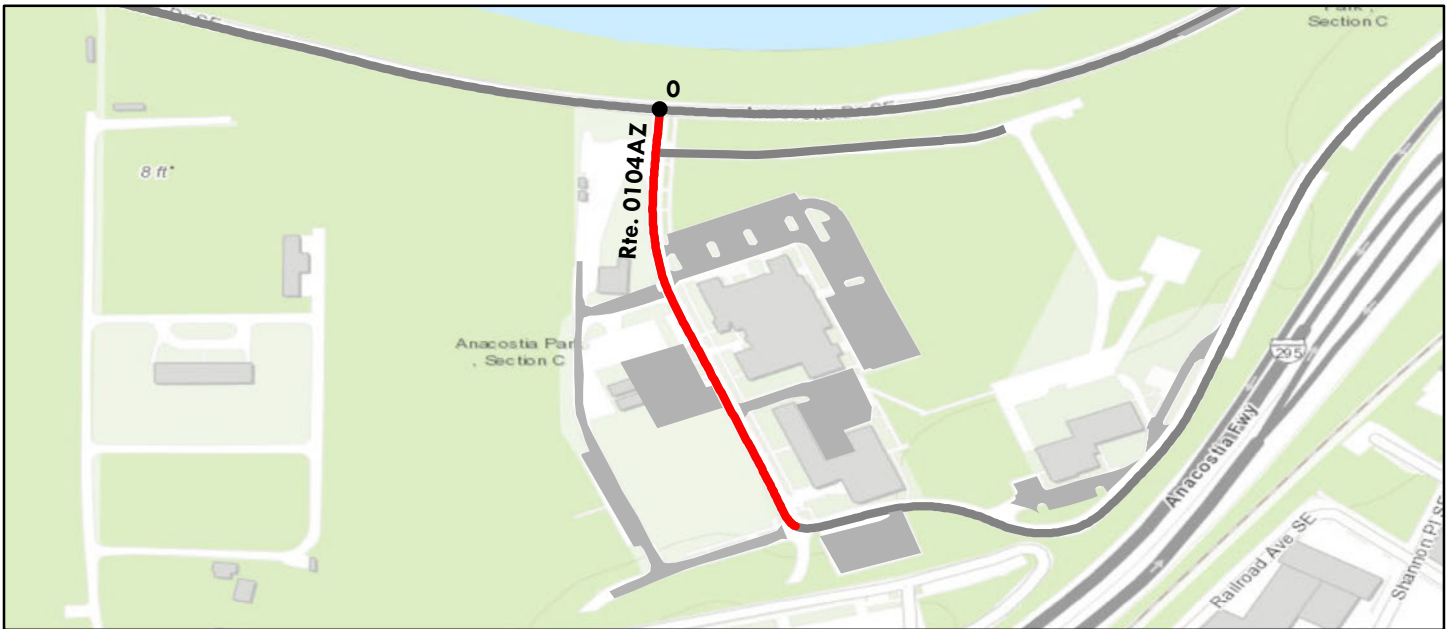
ROUTE 0104AZ: ANACOSTIA COMPOUND ACCESS

Route Condition Legend – Pavement Condition Rating (PCR)						
Poor (0 - 60)	Fair (61- 84)	Good (85 - 94)	Excellent (95 - 100)	Not Rated		
Colors on map represent condition scores at 0.10-mile intervals. See Appendix for definitions and formulas.						
Inspection Date: 6/7/2018	Beginning Section MP	0				
Paved Length (Miles): 0.18	Section Length (MI)	0.18				
Surface Type: ASPHALT	Route Summary					
Roadway Condition Information						
Pavement Condition Rating (PCR)	10	10				
Surface Condition Rating (SCR)	10	10				
Roughness Condition Index (RCI)	N/A	N/A				
Distress Index Values						
Structural Crack Index	61	61				
Alligator Crack Index	97	97				
Longitudinal Crack Index	64	64				
Transverse Cracking Index	10	10				
Patching Index	96	96				
Rutting Index	97	97				
International Roughness Index (IRI)	N/A	N/A				
Lane & Width Information						
Number of Lanes	2	2				
Paved Width (ft)	22.8	22.8				
Lane Width (ft)	10.8	10.8

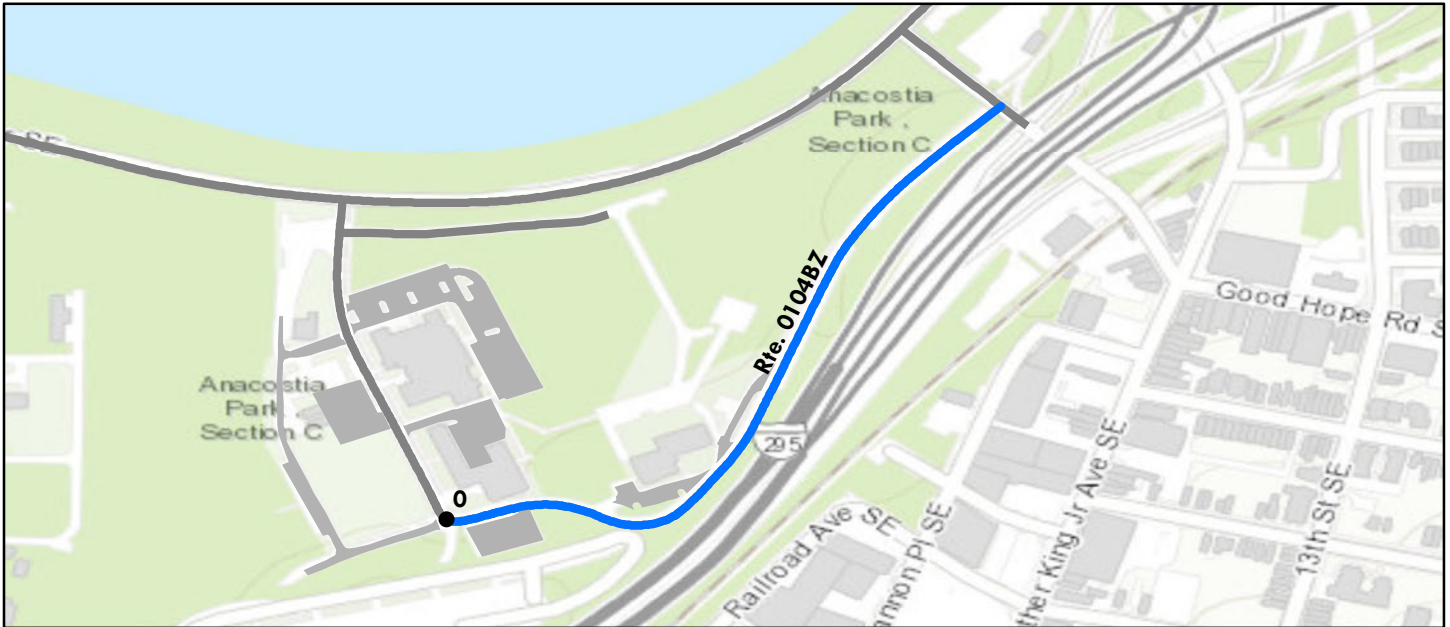
Subcomponent of Route NACE-0104ZZ

Inspection Date: 6/7/2018	Beginning Section MP	0				
Paved Length (Miles): 0.36	Section Length (MI)	0.36				
Surface Type: ASPHALT	Route Summary					
Roadway Condition Information						
Pavement Condition Rating (PCR)	100	100				
Surface Condition Rating (SCR)	100	100				
Roughness Condition Index (RCI)	N/A	N/A				
Distress Index Values						
Structural Crack Index	100	100				
Alligator Crack Index	100	100				
Longitudinal Crack Index	100	100				
Transverse Cracking Index	100	100				
Patching Index	100	100				
Rutting Index	100	100				
International Roughness Index (IRI)	N/A	N/A				
Lane & Width Information						
Number of Lanes	2	2				
Paved Width (ft)	24.1	24.1				
Lane Width (ft)	11.1	11.1

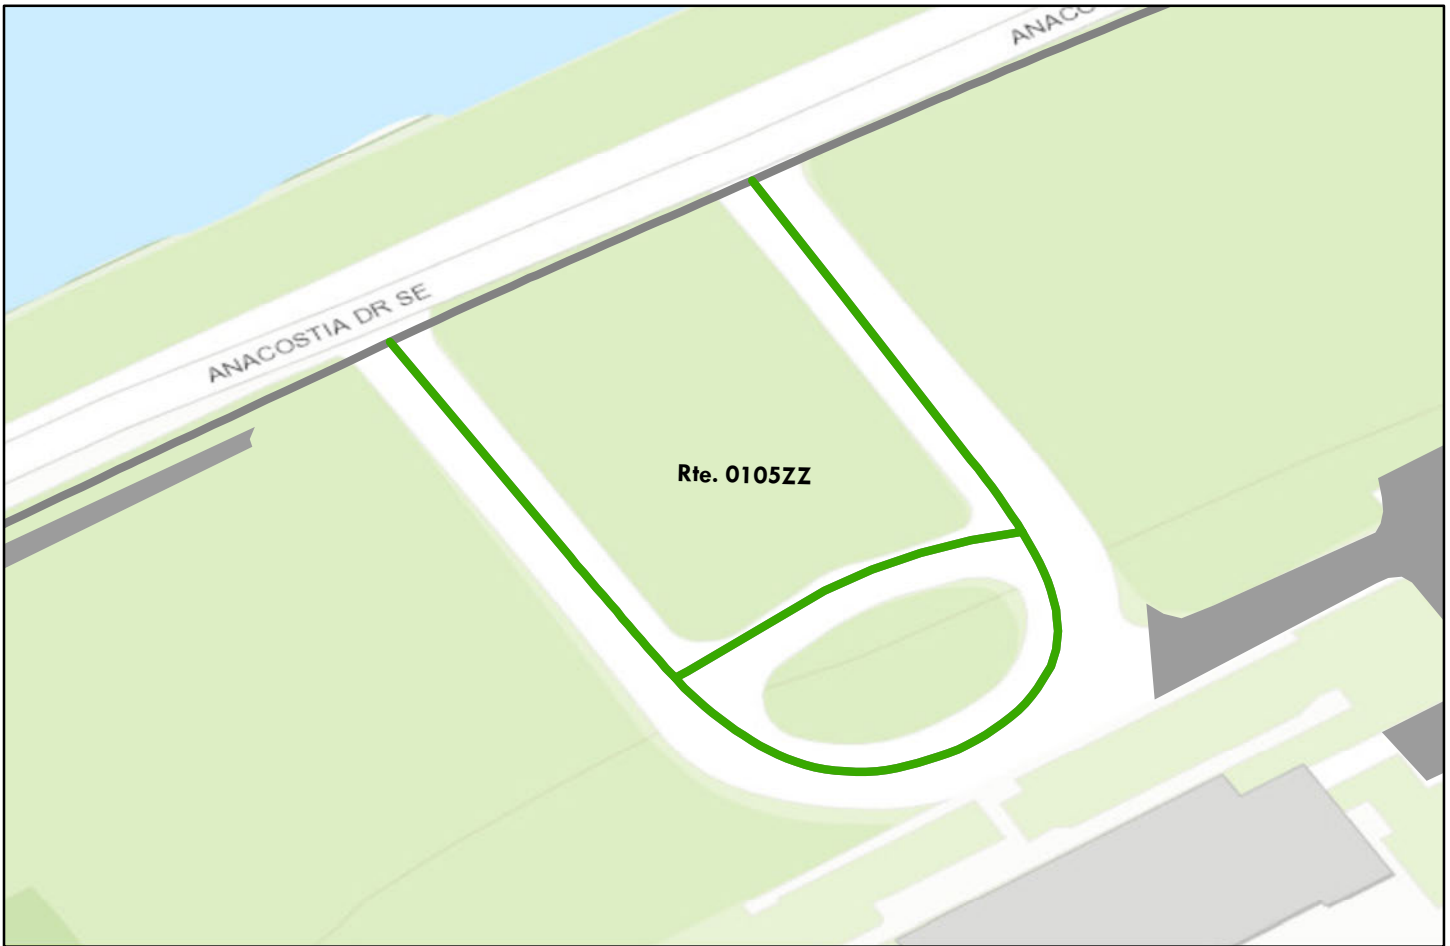
ROUTE 0105ZZ: ANACOSTIA POOL AND RECREATION FACILITY ROADS

Route Condition Legend – Pavement Condition Rating (PCR)						
Poor (0 - 60)	Fair (61- 84)	Good (85 - 94)	Excellent (95 - 100)	Not Rated		
See Appendix for definitions and formulas						
Inspection Date: 6/7/2018						
Paved Length (Miles): 0.13						
Surface Type: ASPHALT	Route Summary					
Roadway Condition Information						
Pavement Condition Rating (PCR)	94					
Lane & Width Information						
Number of Lanes	1					
Paved Width (ft)	24.3					
Lane Width (ft)	24.3

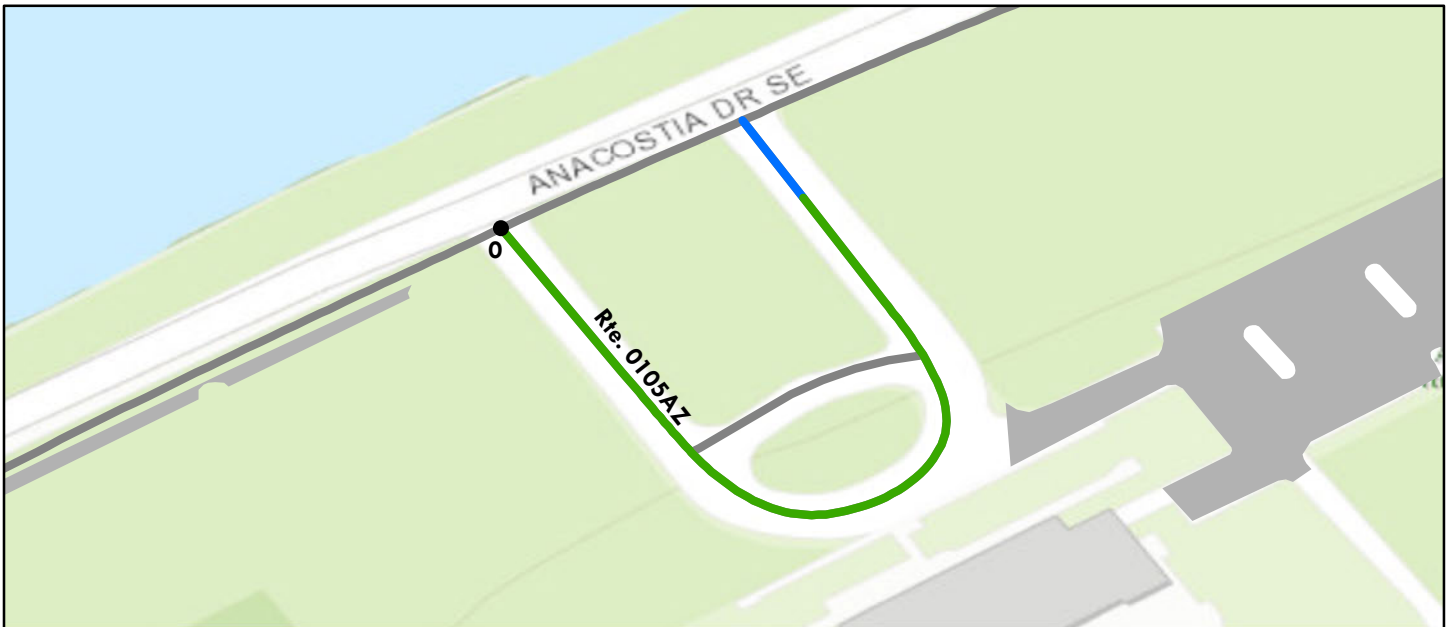
ROUTE 0105AZ: ANACOSTIA POOL AND RECREATION FACILITY ROAD

Inspection Date: 6/7/2018	Beginning Section MP	0				
Paved Length (Miles): 0.11	Section Length (MI)	0.11				
Surface Type: ASPHALT	Route Summary					
Roadway Condition Information						
Pavement Condition Rating (PCR)	94	94				
Surface Condition Rating (SCR)	94	94				
Roughness Condition Index (RCI)	N/A	N/A				
Distress Index Values						
Structural Crack Index	94	94				
Alligator Crack Index	100	100				
Longitudinal Crack Index	94	94				
Transverse Cracking Index	98	98				
Patching Index	100	100				
Rutting Index	97	97				
International Roughness Index (IRI)	N/A	N/A				
Lane & Width Information						
Number of Lanes	1	1				
Paved Width (ft)	26	26				
Lane Width (ft)	26	26

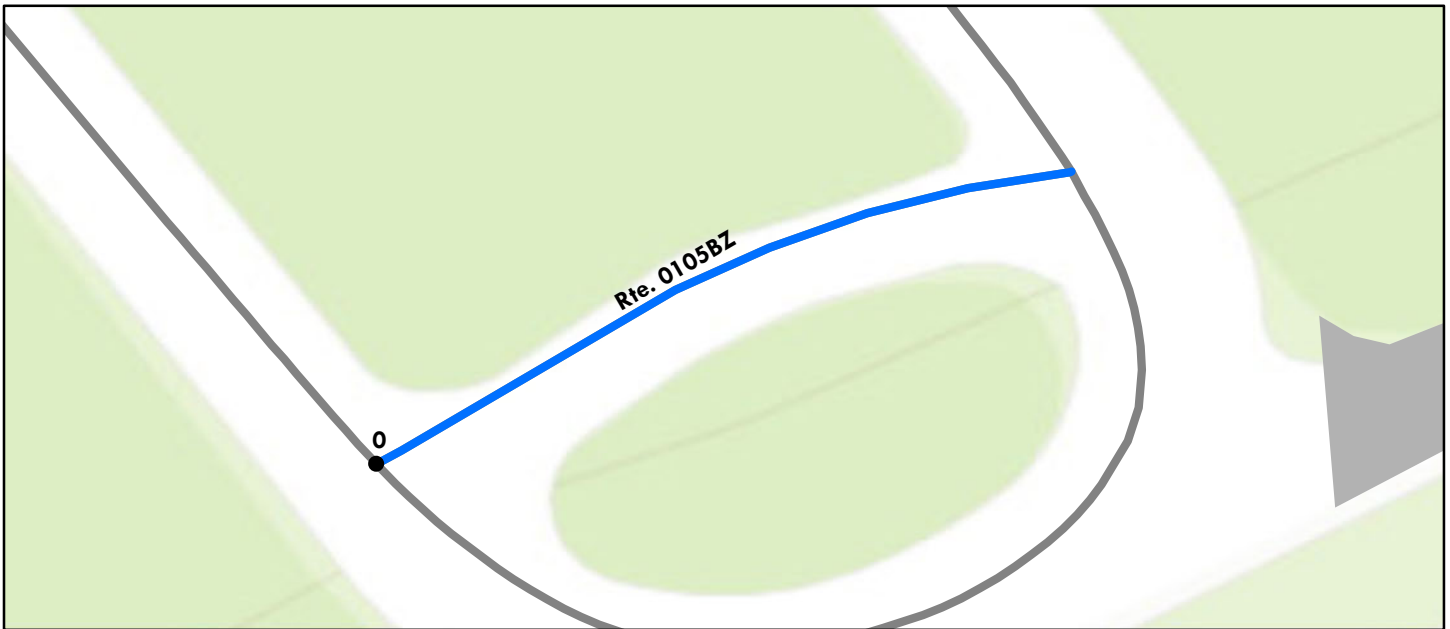
ROUTE 0105BZ: ANACOSTIA POOL AND RECREATION FACILITY ROAD CUT-THRU

Inspection Date: 6/7/2018	Beginning Section MP	0				
Paved Length (Miles): 0.02	Section Length (MI)	0.02				
Surface Type: ASPHALT	Route Summary					
Roadway Condition Information						
Pavement Condition Rating (PCR)	96	96				
Surface Condition Rating (SCR)	96	96				
Roughness Condition Index (RCI)	N/A	N/A				
Distress Index Values						
Structural Crack Index	100	100				
Alligator Crack Index	100	100				
Longitudinal Crack Index	100	100				
Transverse Cracking Index	100	100				
Patching Index	100	100				
Rutting Index	96	96				
International Roughness Index (IRI)	N/A	N/A				
Lane & Width Information						
Number of Lanes	1	1				
Paved Width (ft)	16.1	16.1				
Lane Width (ft)	16.1	16.1

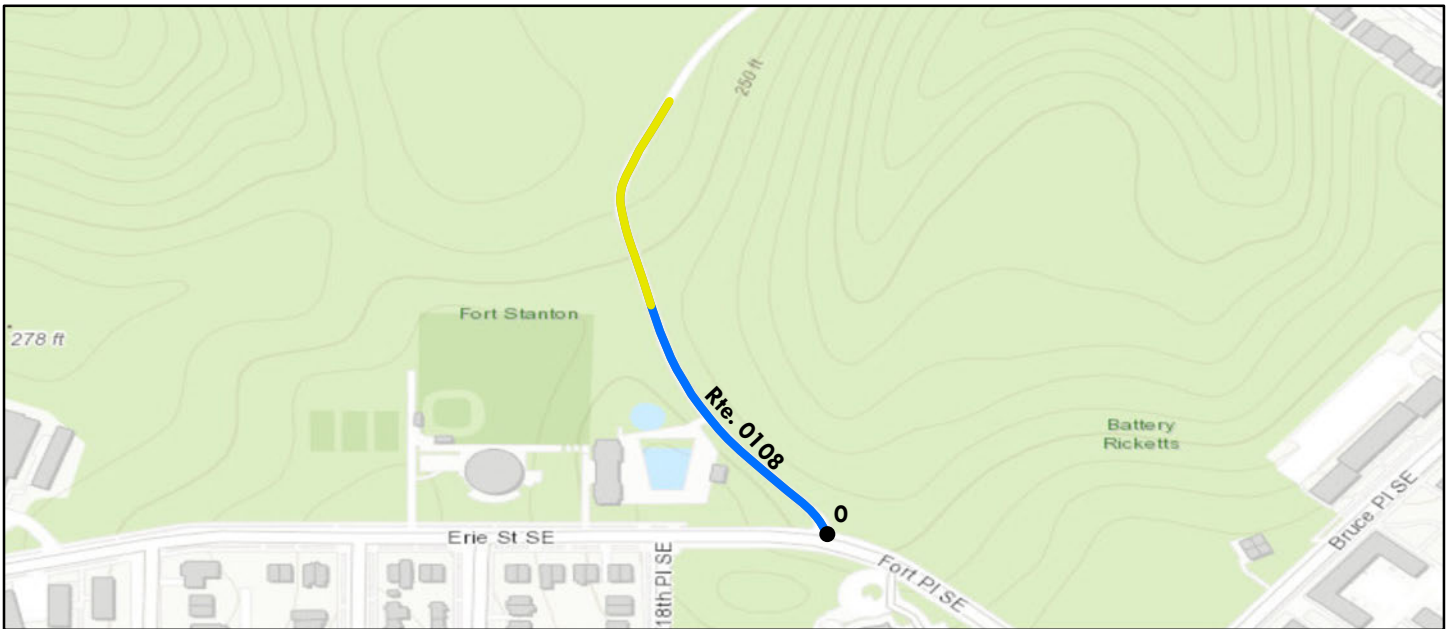
ROUTE 0108: FORT STANTON RESERVOIR ACCESS ROAD

Route Condition Legend – Pavement Condition Rating (PCR)						
Poor (0 - 60)	Fair (61- 84)	Good (85 - 94)	Excellent (95 - 100)	Not Rated		
Colors on map represent condition scores at 0.10-mile intervals. See Appendix for definitions and formulas.						
Inspection Date: 6/7/2018	Beginning Section MP	0				
Paved Length (Miles): 0.18	Section Length (MI)	0.18				
Surface Type: ASPHALT	Route Summary					
Roadway Condition Information						
Pavement Condition Rating (PCR)	90	90				
Surface Condition Rating (SCR)	90	90				
Roughness Condition Index (RCI)	N/A	N/A				
Distress Index Values						
Structural Crack Index	97	97				
Alligator Crack Index	100	100				
Longitudinal Crack Index	97	97				
Transverse Cracking Index	90	90				
Patching Index	100	100				
Rutting Index	97	97				
International Roughness Index (IRI)	N/A	N/A				
Lane & Width Information						
Number of Lanes	1	1				
Paved Width (ft)	12.6	12.6				
Lane Width (ft)	12.6	12.6

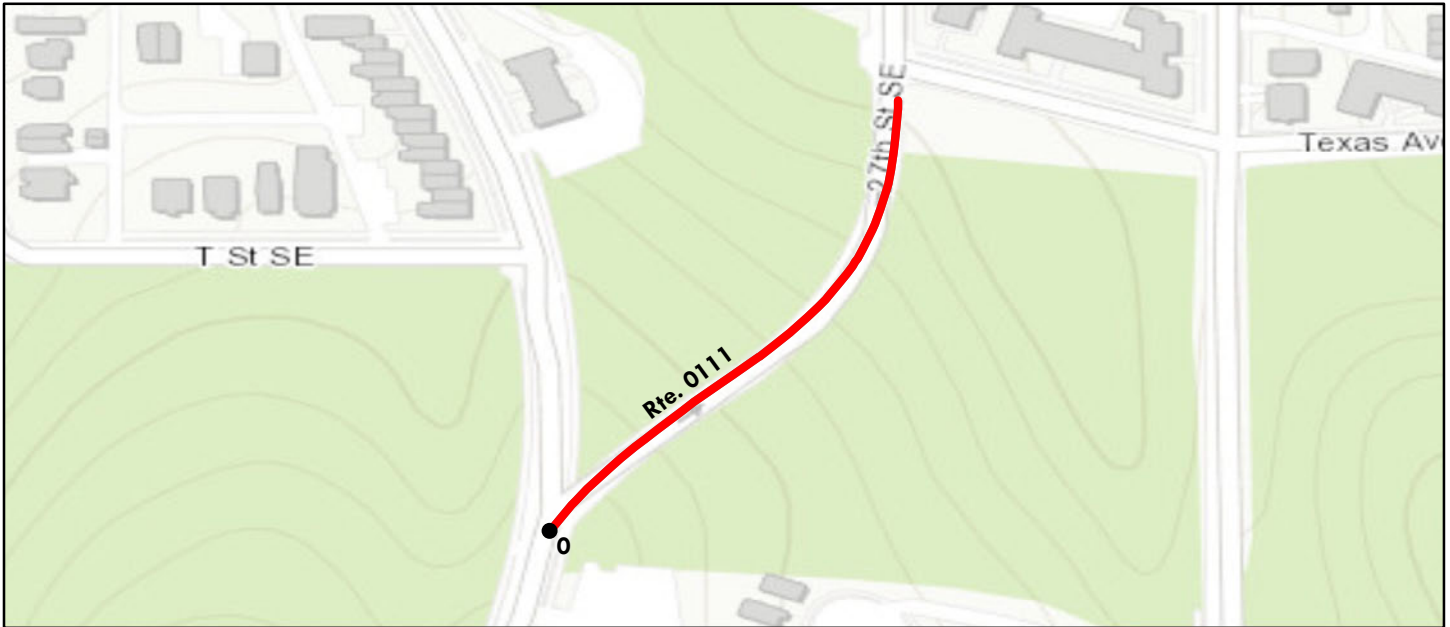
ROUTE 0111: 27TH STREET SE

Inspection Date: 6/7/2018	Beginning Section MP	0				
Paved Length (Miles): 0.13	Section Length (MI)	0.13				
Surface Type: ASPHALT	Route Summary					
Roadway Condition Information						
Pavement Condition Rating (PCR)	29	29				
Surface Condition Rating (SCR)	29	29				
Roughness Condition Index (RCI)	N/A	N/A				
Distress Index Values						
Structural Crack Index	29	29				
Alligator Crack Index	60	60				
Longitudinal Crack Index	69	69				
Transverse Cracking Index	77	77				
Patching Index	100	100				
Rutting Index	93	93				
International Roughness Index (IRI)	N/A	N/A				
Lane & Width Information						
Number of Lanes	1	1				
Paved Width (ft)	23	23				
Lane Width (ft)	23	23

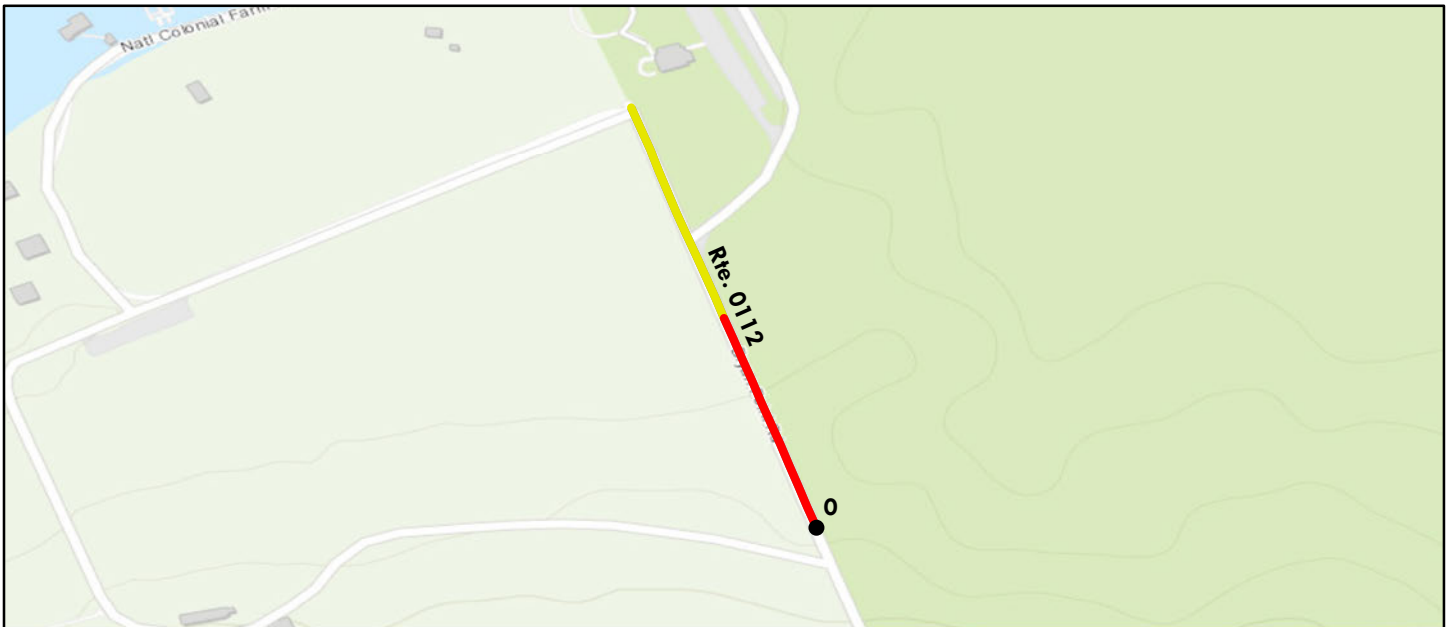
ROUTE 0112: BRYAN POINT ROAD

Inspection Date: 6/8/2018	Beginning Section MP	0				
Paved Length (Miles): 0.2	Section Length (MI)	0.2				
Surface Type: ASPHALT	Route Summary					
Roadway Condition Information						
Pavement Condition Rating (PCR)	66	66				
Surface Condition Rating (SCR)	66	66				
Roughness Condition Index (RCI)	N/A	N/A				
Distress Index Values						
Structural Crack Index	66	66				
Alligator Crack Index	82	82				
Longitudinal Crack Index	84	84				
Transverse Cracking Index	92	92				
Patching Index	100	100				
Rutting Index	99	99				
International Roughness Index (IRI)	N/A	N/A				
Lane & Width Information						
Number of Lanes	2	2				
Paved Width (ft)	14.8	14.8				
Lane Width (ft)	9.3	9.3

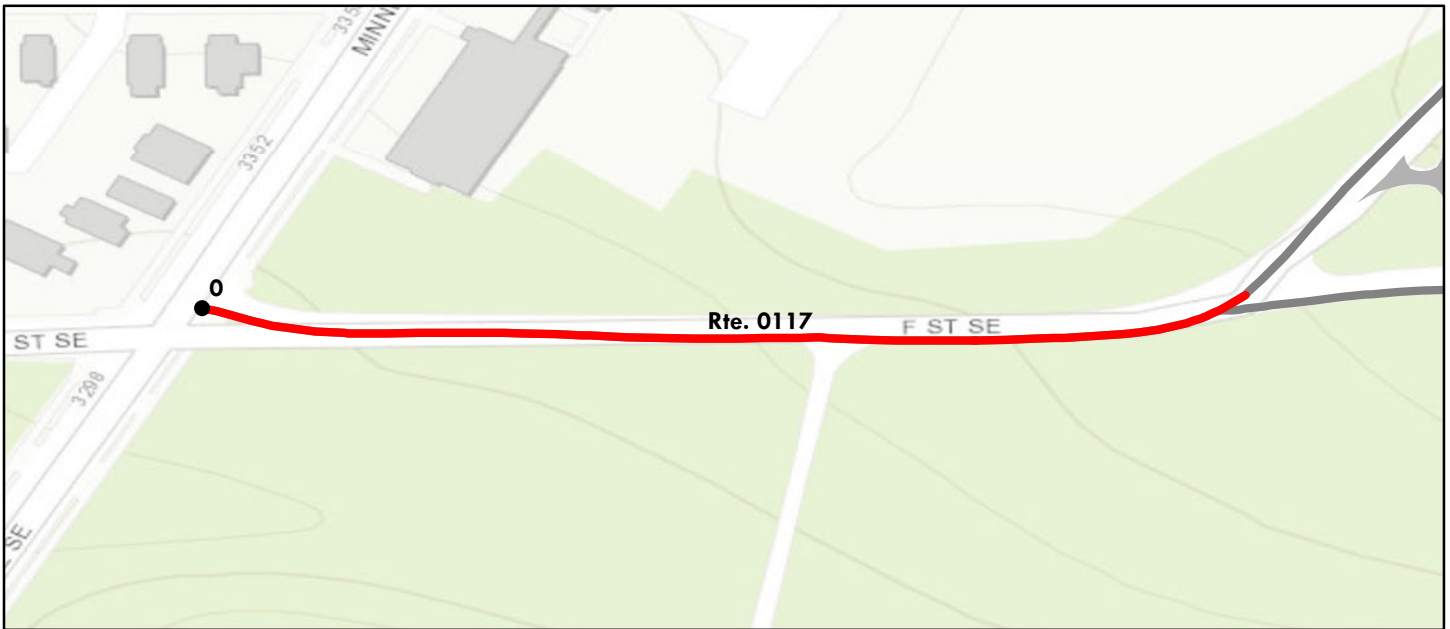
ROUTE 0117: FORT DUPONT MAINTENANCE ACCESS ROAD (F STREET SE)

Inspection Date: 6/8/2018	Beginning Section MP	0				
Paved Length (Miles): 0.14	Section Length (MI)	0.14				
Surface Type: ASPHALT	Route Summary					
Roadway Condition Information						
Pavement Condition Rating (PCR)	0	0				
Surface Condition Rating (SCR)	0	0				
Roughness Condition Index (RCI)	N/A	N/A				
Distress Index Values						
Structural Crack Index	7	7				
Alligator Crack Index	82	82				
Longitudinal Crack Index	25	25				
Transverse Cracking Index	0	0				
Patching Index	97	97				
Rutting Index	99	99				
International Roughness Index (IRI)	N/A	N/A				
Lane & Width Information						
Number of Lanes	2	2				
Paved Width (ft)	16.3	16.3				
Lane Width (ft)	8.3	8.3
