NACE Cycle 6

Final Report

Road Inventory and Condition Assessment of Paved Routes National Capital Parks - East

Report Date: October 2019

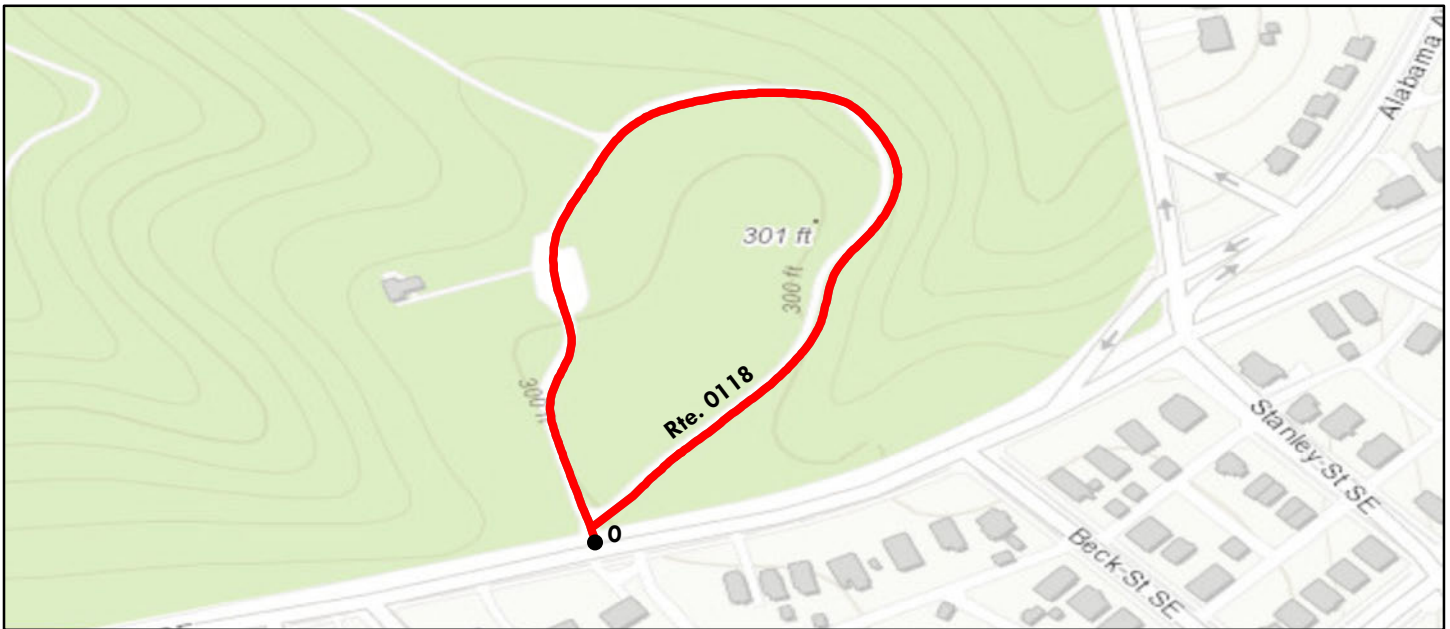
ROUTE 0118: LANHAM ESTATES LOOP ROAD

Route Condition Legend – Pavement Condition Rating (PCR)						
Poor (0 - 60)	Fair (61- 84)	Good (85 - 94)	Excellent (95 - 100)	Not Rated		
Colors on map represent condition scores at 0.10-mile intervals. See Appendix for definitions and formulas.						
Inspection Date: 6/8/2018	Beginning Section MP	0				
Paved Length (Miles): 0.33	Section Length (MI)	0.33				
Surface Type: ASPHALT	Route Summary					
Roadway Condition Information						
Pavement Condition Rating (PCR)	3	3				
Surface Condition Rating (SCR)	3	3				
Roughness Condition Index (RCI)	N/A	N/A				
Distress Index Values						
Structural Crack Index	3	3				
Alligator Crack Index	30	30				
Longitudinal Crack Index	73	73				
Transverse Cracking Index	68	68				
Patching Index	94	94				
Rutting Index	71	71				
International Roughness Index (IRI)	N/A	N/A				
Lane & Width Information						
Number of Lanes	1	1				
Paved Width (ft)	11	11				
Lane Width (ft)	11	11

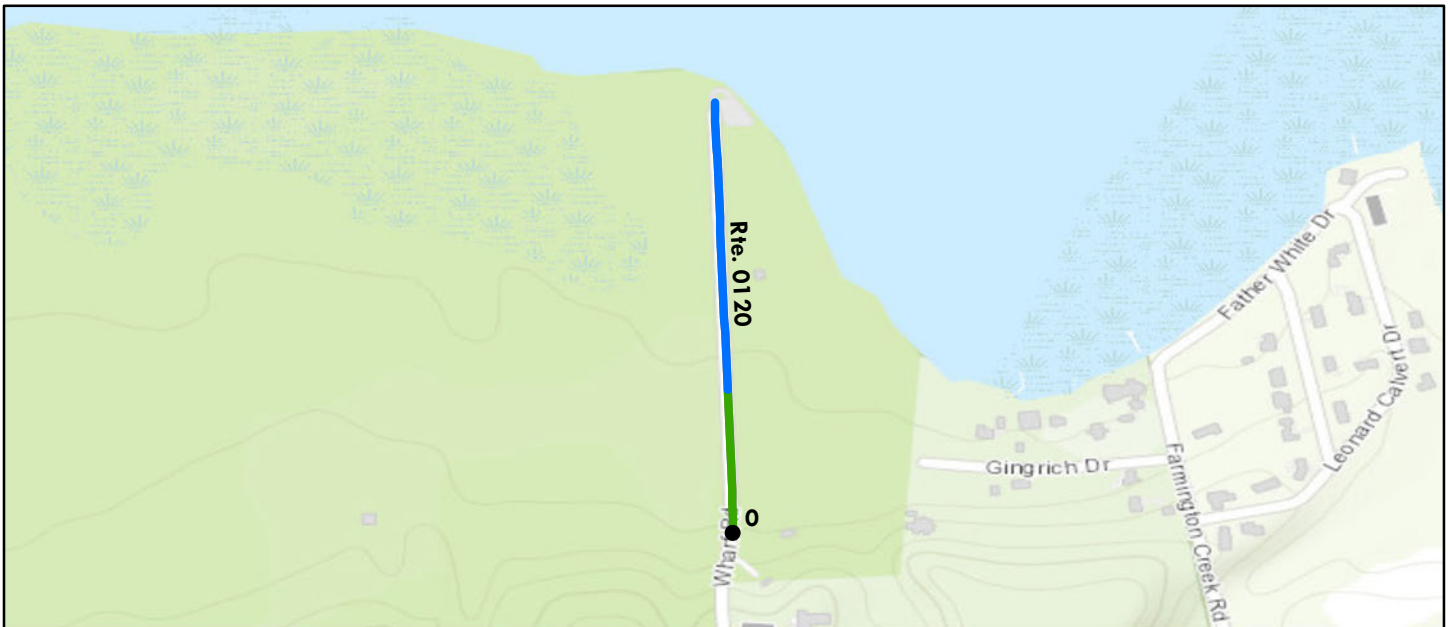
ROUTE 0120: WHARF ROAD

Inspection Date: 6/8/2018	Beginning Section MP	0				
Paved Length (Miles): 0.32	Section Length (MI)	0.32				
Surface Type: ASPHALT	Route Summary					
Roadway Condition Information						
Pavement Condition Rating (PCR)	94	94				
Surface Condition Rating (SCR)	94	94				
Roughness Condition Index (RCI)	N/A	N/A				
Distress Index Values						
Structural Crack Index	94	94				
Alligator Crack Index	99	99				
Longitudinal Crack Index	95	95				
Transverse Cracking Index	96	96				
Patching Index	98	98				
Rutting Index	98	98				
International Roughness Index (IRI)	N/A	N/A				
Lane & Width Information						
Number of Lanes	1	1				
Paved Width (ft)	16	16				
Lane Width (ft)	16	16

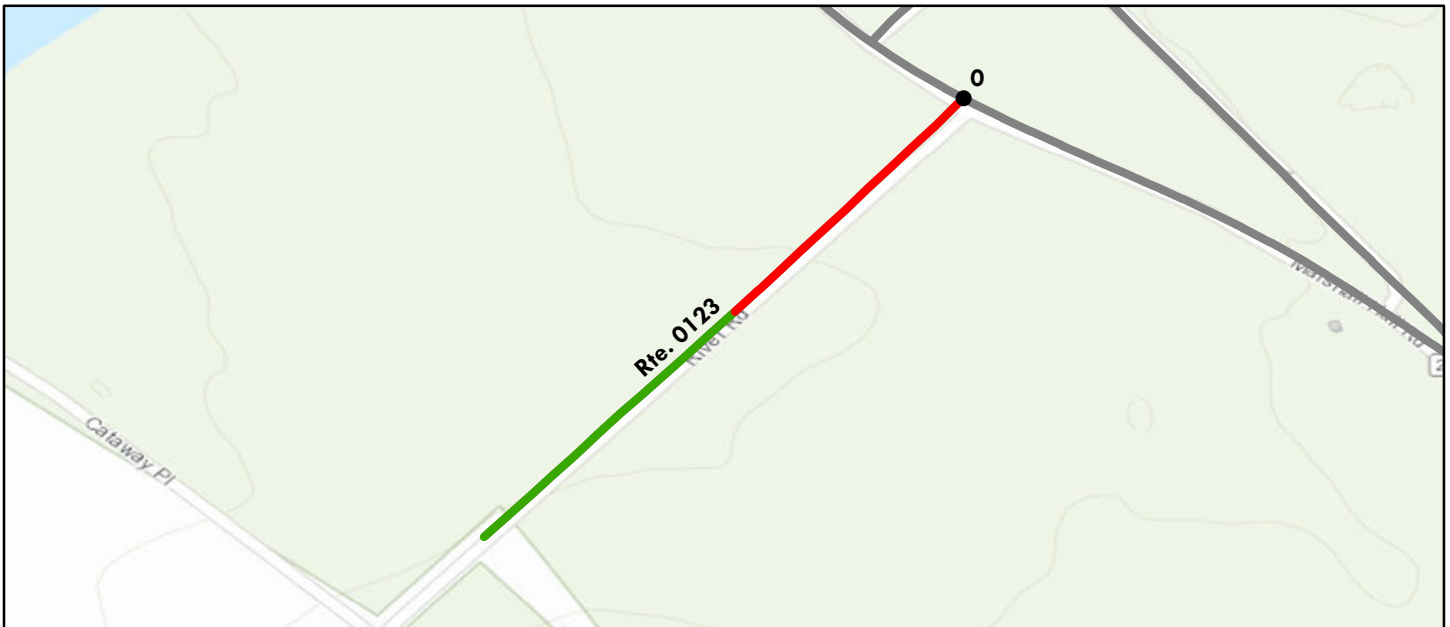
ROUTE 0123: RIVER ROAD

Inspection Date: 6/8/2018	Beginning Section MP	0				
Paved Length (Miles): 0.21	Section Length (MI)	0.21				
Surface Type: ASPHALT	Route Summary					
Roadway Condition Information						
Pavement Condition Rating (PCR)	52	52				
Surface Condition Rating (SCR)	52	52				
Roughness Condition Index (RCI)	N/A	N/A				
Distress Index Values						
Structural Crack Index	52	52				
Alligator Crack Index	94	94				
Longitudinal Crack Index	58	58				
Transverse Cracking Index	71	71				
Patching Index	99	99				
Rutting Index	99	99				
International Roughness Index (IRI)	N/A	N/A				
Lane & Width Information						
Number of Lanes	2	2				
Paved Width (ft)	20.5	20.5				
Lane Width (ft)	8.7	8.7

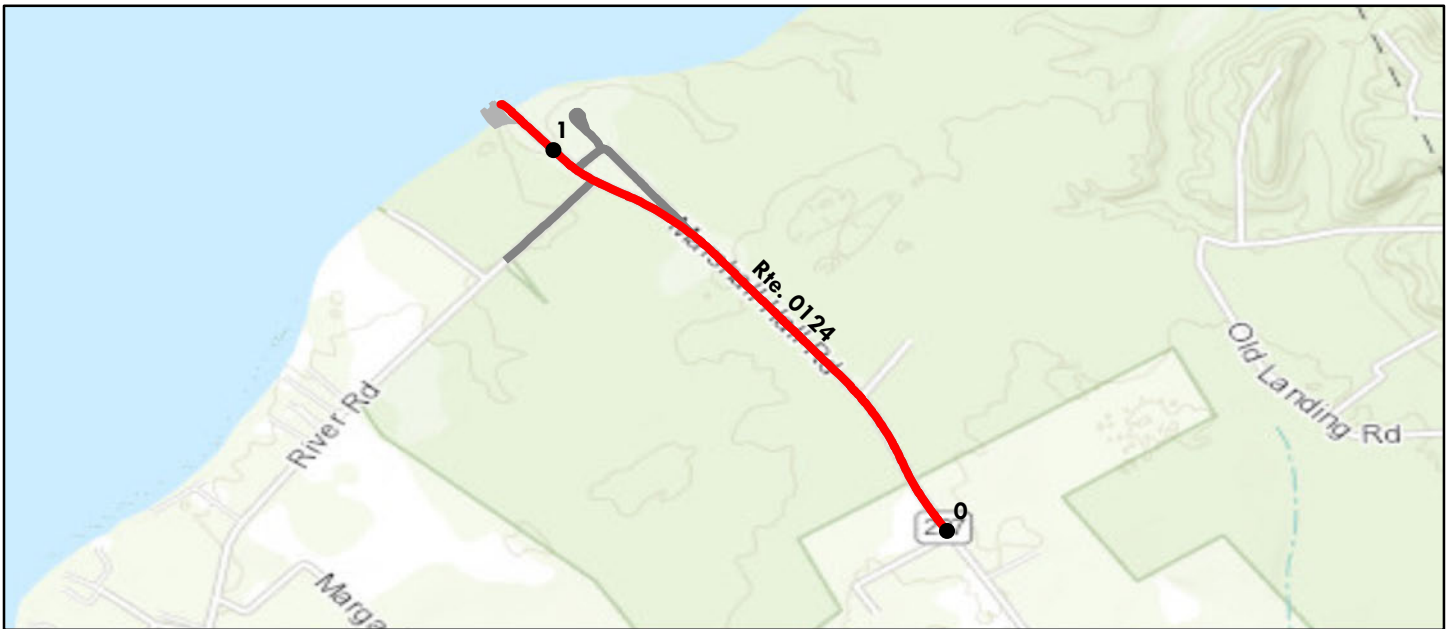
ROUTE 0124: MARYLAND STATE HIGHWAY 227

Route Condition Legend – Pavement Condition Rating (PCR)						
Poor (0 - 60)	Fair (61- 84)	Good (85 - 94)	Excellent (95 - 100)	Not Rated		
Colors on map represent condition scores at 0.10-mile intervals. See Appendix for definitions and formulas.						
Inspection Date: 6/8/2018	Beginning Section MP	0	1			
Paved Length (Miles): 1.12	Section Length (MI)	1	0.12			
Surface Type: ASPHALT	Route Summary					
Roadway Condition Information						
Pavement Condition Rating (PCR)	38	40	23			
Surface Condition Rating (SCR)	0	0	0			
Roughness Condition Index (RCI)	95	100	57			
Distress Index Values						
Structural Crack Index	0	0	0			
Alligator Crack Index	94	97	64			
Longitudinal Crack Index	1	0	27			
Transverse Cracking Index	0	0	2			
Patching Index	100	100	100			
Rutting Index	98	99	90			
International Roughness Index (IRI)	128	115	252			
Lane & Width Information						
Number of Lanes	2	2	2			
Paved Width (ft)	34.9	36.6	20.8

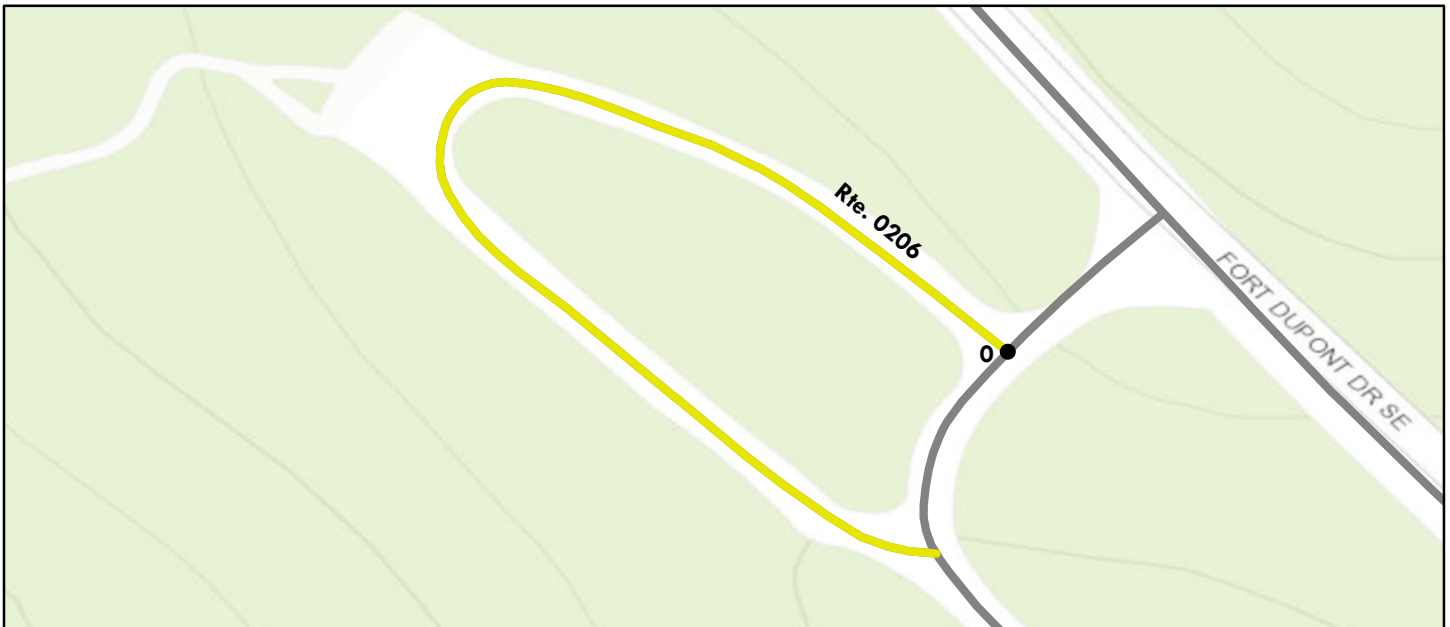
ROUTE 0206: RIDGE PICNIC AREA LOOP

Route Condition Legend – Pavement Condition Rating (PCR)						
Poor (0 - 60)	Fair (61- 84)	Good (85 - 94)	Excellent (95 - 100)	Not Rated		
Colors on map represent condition scores at 0.10-mile intervals. See Appendix for definitions and formulas.						
Inspection Date: 6/8/2018	Beginning Section MP	0				
Paved Length (Miles): 0.09	Section Length (MI)	0.09				
Surface Type: ASPHALT	Route Summary					
Roadway Condition Information						
Pavement Condition Rating (PCR)	75	75				
Surface Condition Rating (SCR)	75	75				
Roughness Condition Index (RCI)	N/A	N/A				
Distress Index Values						
Structural Crack Index	75	75				
Alligator Crack Index	97	97				
Longitudinal Crack Index	78	78				
Transverse Cracking Index	89	89				
Patching Index	91	91				
Rutting Index	85	85				
International Roughness Index (IRI)	N/A	N/A				
Lane & Width Information						
Number of Lanes	1	1				
Paved Width (ft)	14	14				
Lane Width (ft)	14	14

NOTE: Cycle 6 condition rating was collected before the 2018/2019 rehab and repaving project.

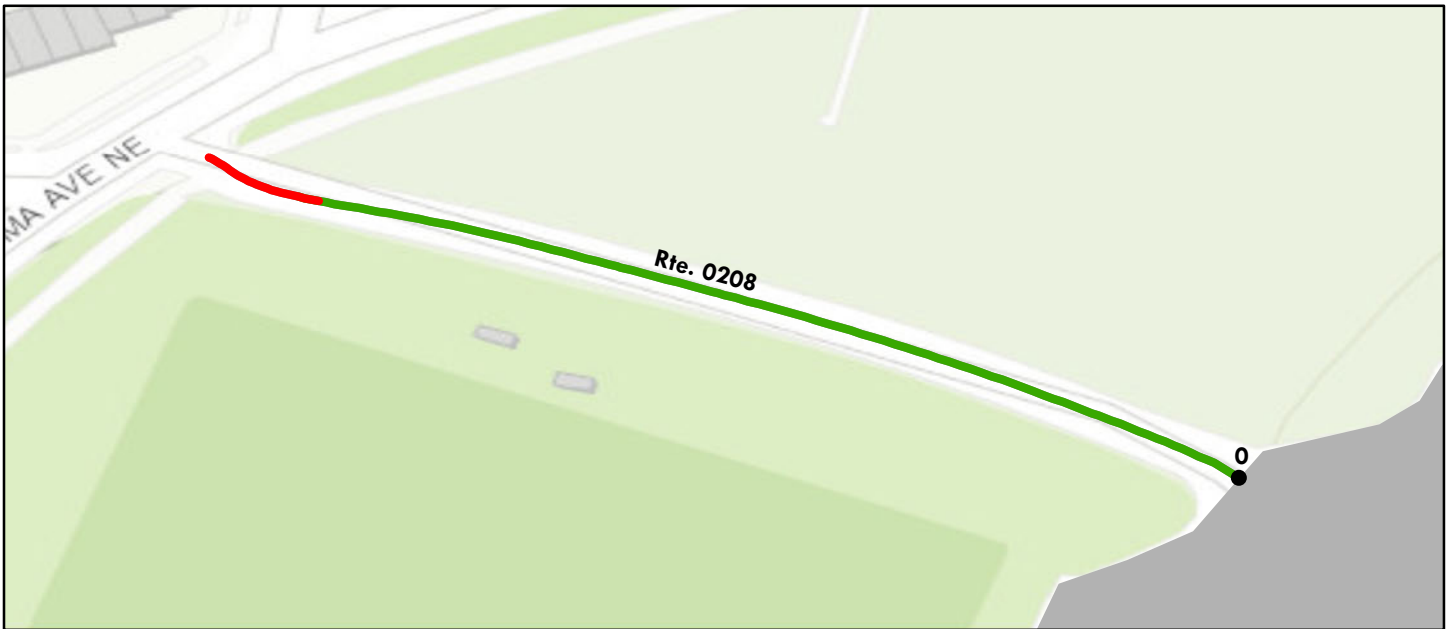
ROUTE 0208: NORTH STADIUM ENTRANCE ROAD

Route Condition Legend – Pavement Condition Rating (PCR)						
Poor (0 - 60)	Fair (61- 84)	Good (85 - 94)	Excellent (95 - 100)	Not Rated		
Colors on map represent condition scores at 0.10-mile intervals. See Appendix for definitions and formulas.						
Inspection Date: 6/8/2018	Beginning Section MP	0				
Paved Length (Miles): 0.11	Section Length (MI)	0.11				
Surface Type: ASPHALT	Route Summary					
Roadway Condition Information						
Pavement Condition Rating (PCR)	86	86				
Surface Condition Rating (SCR)	86	86				
Roughness Condition Index (RCI)	N/A	N/A				
Distress Index Values						
Structural Crack Index	86	86				
Alligator Crack Index	93	93				
Longitudinal Crack Index	93	93				
Transverse Cracking Index	95	95				
Patching Index	99	99				
Rutting Index	95	95				
International Roughness Index (IRI)	N/A	N/A				
Lane & Width Information						
Number of Lanes	2	2				
Paved Width (ft)	23.3	23.3				
Lane Width (ft)	11.6	11.6

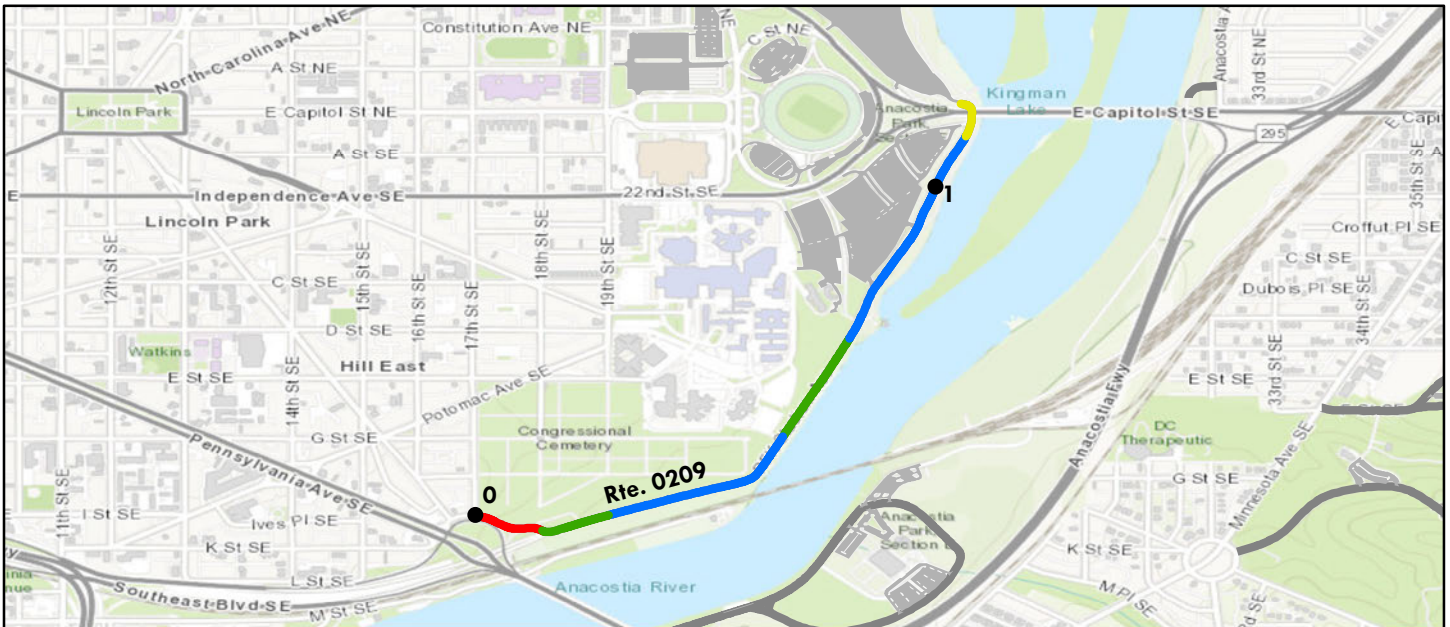
ROUTE 0209: SOUTH STADIUM ACCESS ROAD

Inspection Date: 6/8/2018	Beginning Section MP	0	1			
Paved Length (Miles): 1.15	Section Length (MI)	1	0.17			
Surface Type: ASPHALT	Route Summary					
Roadway Condition Information						
Pavement Condition Rating (PCR)	94	94	89			
Surface Condition Rating (SCR)	94	94	89			
Roughness Condition Index (RCI)	N/A	N/A	N/A			
Distress Index Values						
Structural Crack Index	94	95	89			
Alligator Crack Index	98	99	93			
Longitudinal Crack Index	96	96	96			
Transverse Cracking Index	94	94	98			
Patching Index	99	99	100			
Rutting Index	98	98	97			
International Roughness Index (IRI)	N/A	N/A	N/A			
Lane & Width Information						
Number of Lanes	2	2	2			
Paved Width (ft)	22.2	21.8	24.7			
Lane Width (ft)	11.2	11	12.2

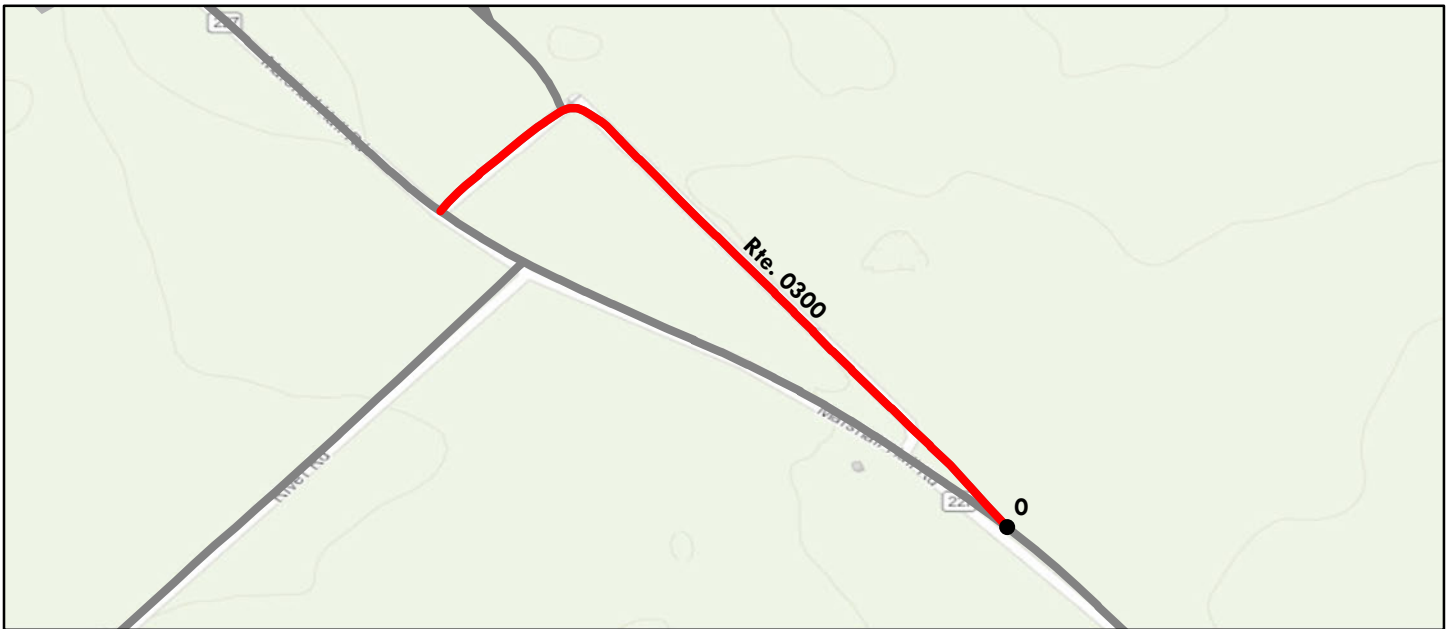
ROUTE 0300: MARSHALL HALL ACCESS ROAD

Route Condition Legend – Pavement Condition Rating (PCR)						
Poor (0 - 60)	Fair (61- 84)	Good (85 - 94)	Excellent (95 - 100)	Not Rated		
Colors on map represent condition scores at 0.10-mile intervals. See Appendix for definitions and formulas.						
Inspection Date: 6/8/2018	Beginning Section MP	0				
Paved Length (Miles): 0.26	Section Length (MI)	0.28				
Surface Type: ASPHALT	Route Summary					
Roadway Condition Information						
Pavement Condition Rating (PCR)	0	0				
Surface Condition Rating (SCR)	0	0				
Roughness Condition Index (RCI)	N/A	N/A				
Distress Index Values						
Structural Crack Index	0	0				
Alligator Crack Index	56	56				
Longitudinal Crack Index	33	33				
Transverse Cracking Index	0	0				
Patching Index	100	100				
Rutting Index	91	91				
International Roughness Index (IRI)	N/A	N/A				
Lane & Width Information						
Number of Lanes	2	2				
Paved Width (ft)	14.7	14.7				
Lane Width (ft)	7.3	7.3

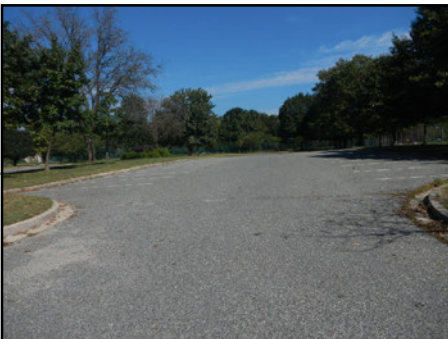
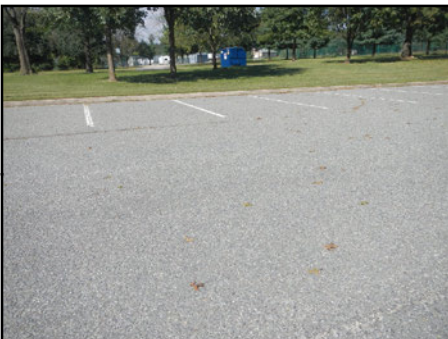
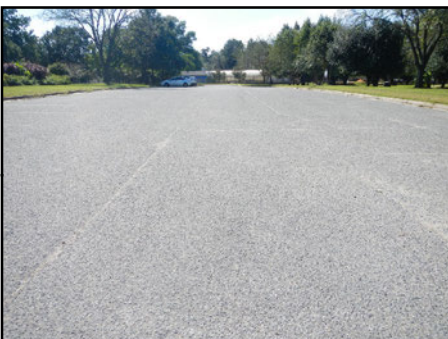
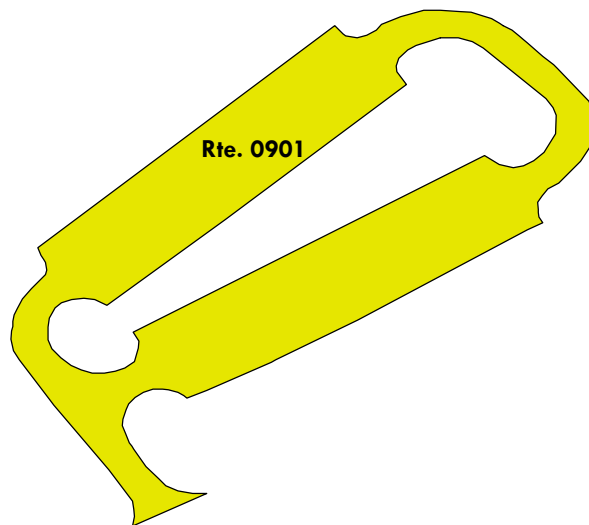
Inspection Date	FMSS Number	User Access	Surface Type
10/4/2018	21271	PUBLIC	ASPHALT
Area (Sq. Ft.)	Lane Miles (11' Widths)	Curb Reveal (Inches)	Curb Recommendation
40,446	0.696	NOT APPLICABLE	DO NOTHING
Curb Type		Curb & Gutter Type	
NO CURB		CONCRETE	
Pavement Recommendation		Condition Rating / PCR	
LIGHT 3R TREATMENTS		FAIR / 73

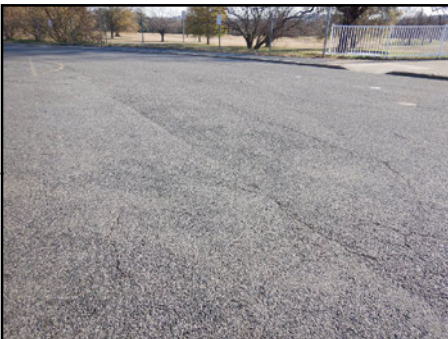
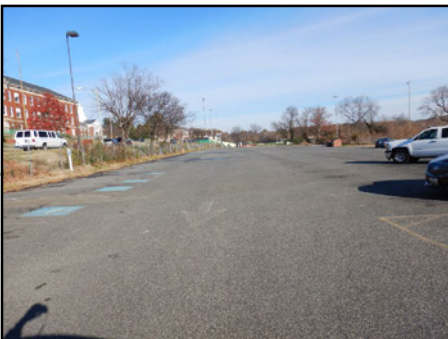
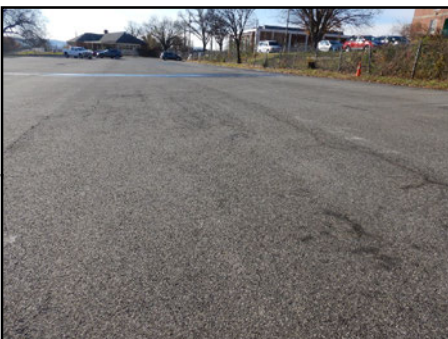
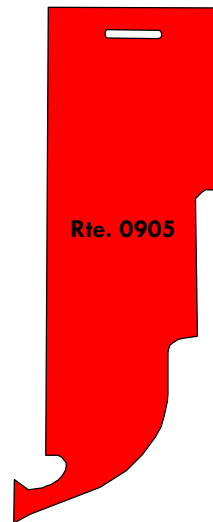
ROUTE 0905: LANGSTON GOLF COURSE PARKING

Inspection Date	FMSS Number	User Access	Surface Type
11/29/2018	52129	PUBLIC	ASPHALT
Area (Sq. Ft.)	Lane Miles (11' Widths)	Curb Reveal (Inches)	Curb Recommendation
51,130	0.88	3	MODERATE REPAIR
Curb Type		Curb & Gutter Type	
CONCRETE		NO CURB AND GUTTER	
Pavement Recommendation		Condition Rating / PCR	
HEAVY 3R TREATMENTS		POOR / 53

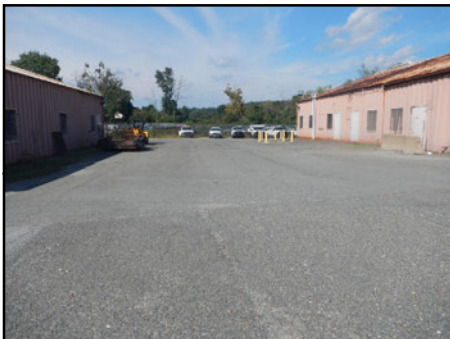
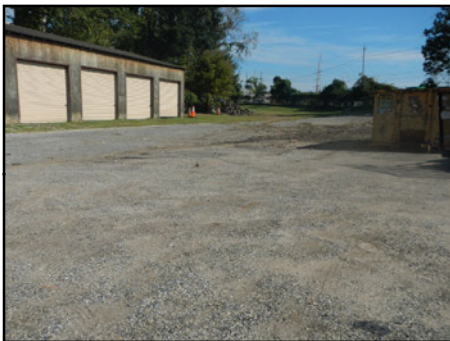
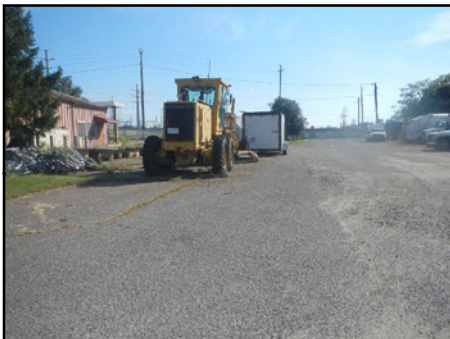
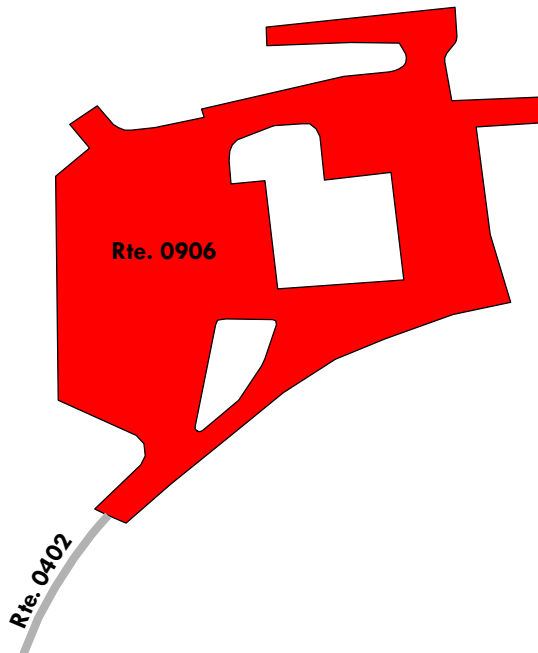
ROUTE 0906: KENILWORTH MAINTENANCE YARD

Inspection Date	FMSS Number	User Access	Surface Type
10/4/2018	21434	NONPUBLIC	ASPHALT
Area (Sq. Ft.)	Lane Miles (11' Widths)	Curb Reveal (Inches)	Curb Recommendation
52,432	0.903	6	DO NOTHING
Curb Type		Curb & Gutter Type	
WOOD		NO CURB AND GUTTER	
Pavement Recommendation		Condition Rating / PCR	
RECONSTRUCTION		POOR / 30

Note: Parking area consists of multiple surface types: 1 part Asphalt at 51,165 square feet; 1 part Concrete at 1,267 square feet.

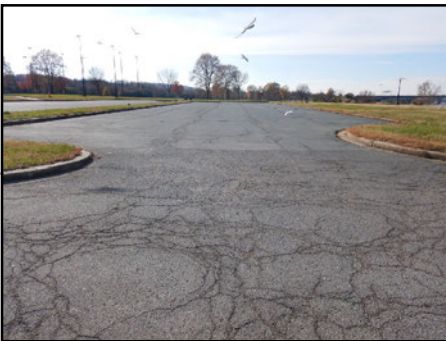
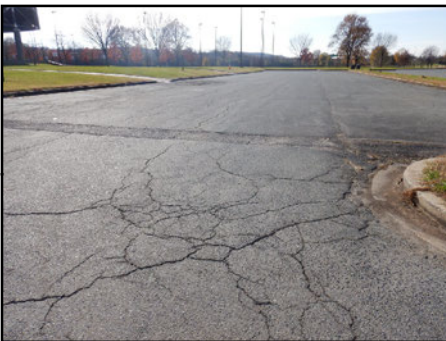
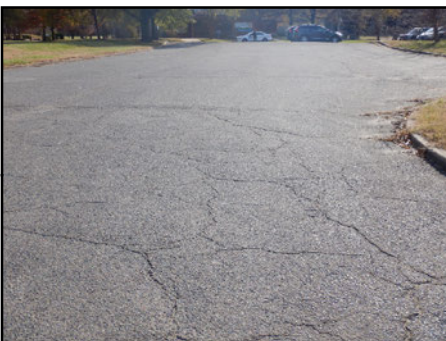
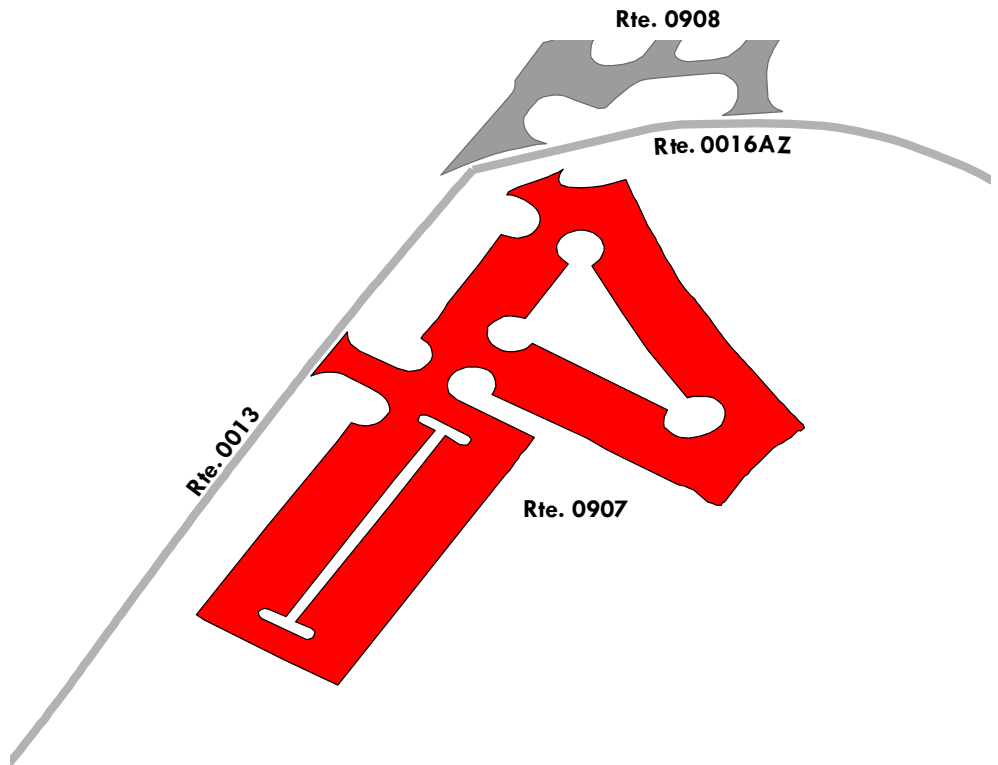
ROUTE 0907: PAVILION PARKING NORTH

Inspection Date	FMSS Number	User Access	Surface Type
11/29/2018	52217	PUBLIC	ASPHALT
Area (Sq. Ft.)	Lane Miles (11' Widths)	Curb Reveal (Inches)	Curb Recommendation
65,686	1.131	NOT APPLICABLE	MODERATE REPAIR
Curb Type		Curb & Gutter Type	
NO CURB		CONCRETE	
Pavement Recommendation		Condition Rating / PCR	
RECONSTRUCTION		POOR / 30

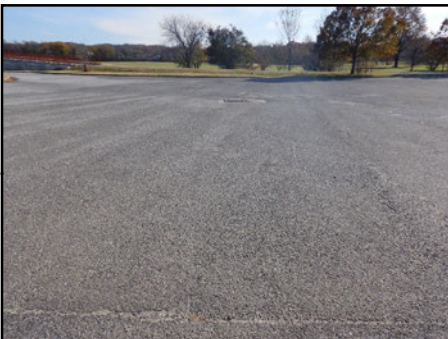
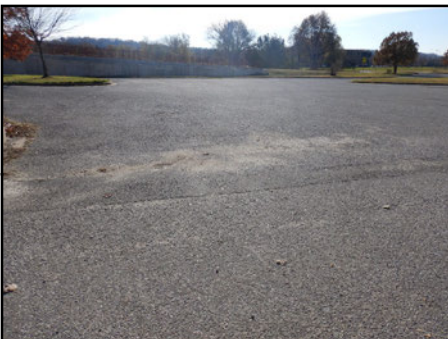
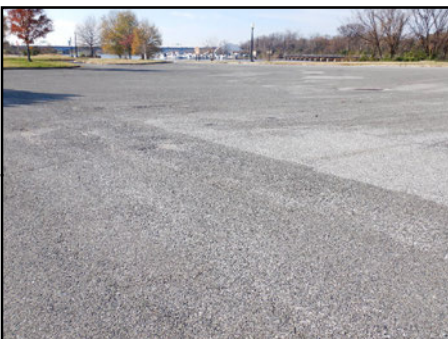
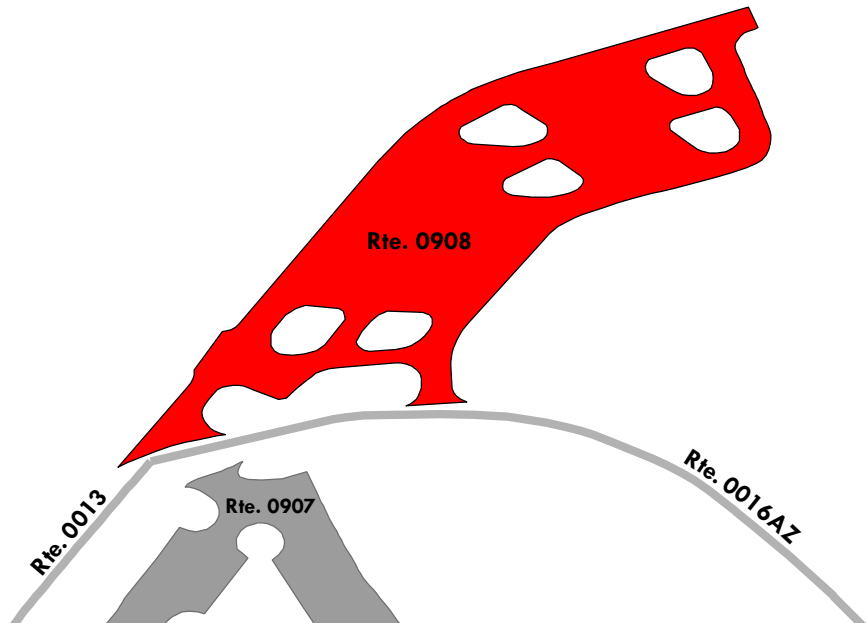
ROUTE 0908: ANACOSTIA BOAT RAMP PARKING

Inspection Date	FMSS Number	User Access	Surface Type
11/29/2018	21471	PUBLIC	ASPHALT
Area (Sq. Ft.)	Lane Miles (11' Widths)	Curb Reveal (Inches)	Curb Recommendation
54,654	0.941	NOT APPLICABLE	LIGHT REPAIR
Curb Type		Curb & Gutter Type	
NO CURB		CONCRETE	
Pavement Recommendation		Condition Rating / PCR	
HEAVY 3R TREATMENTS		POOR / 53

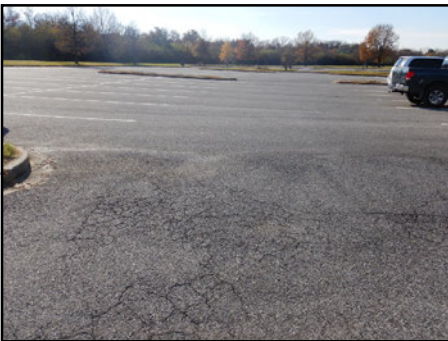
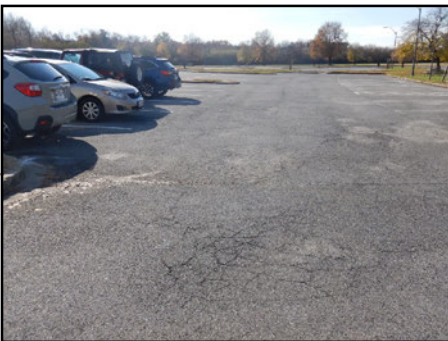
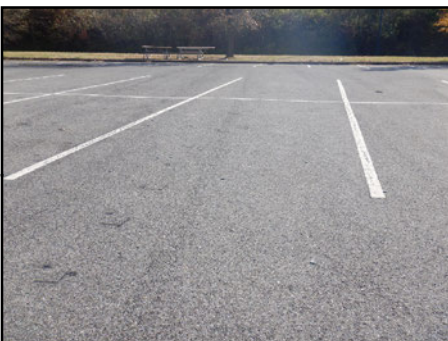
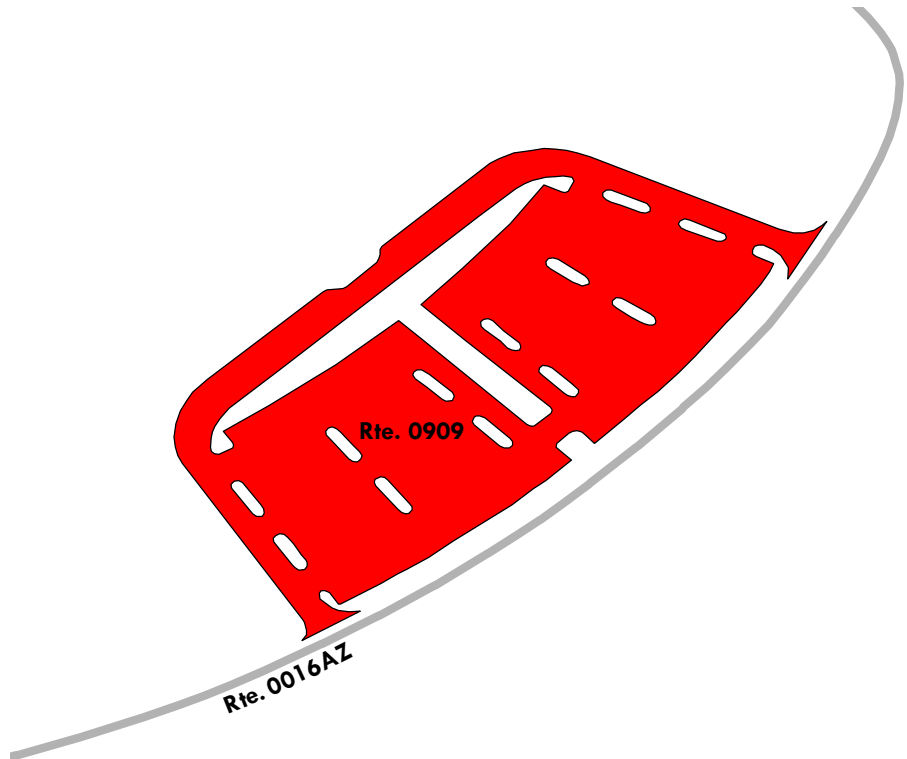
ROUTE 0909: PAVILION PARKING SOUTH

Inspection Date	FMSS Number	User Access	Surface Type
11/29/2018	21429	PUBLIC	ASPHALT
Area (Sq. Ft.)	Lane Miles (11' Widths)	Curb Reveal (Inches)	Curb Recommendation
101,439	1.747	NOT APPLICABLE	LIGHT REPAIR
Curb Type		Curb & Gutter Type	
NO CURB		CONCRETE	
Pavement Recommendation		Condition Rating / PCR	
HEAVY 3R TREATMENTS		POOR / 53

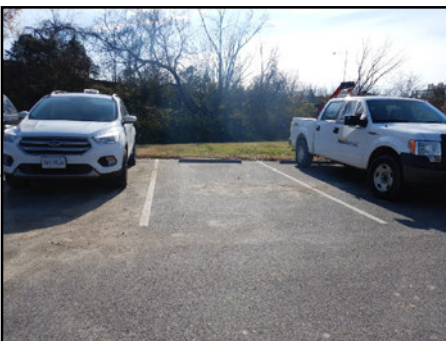
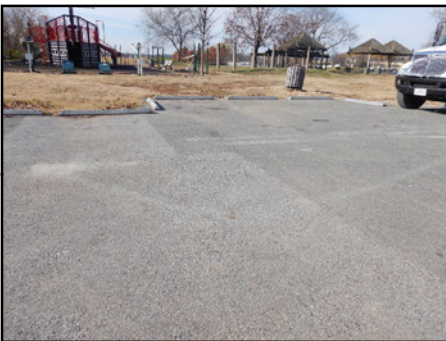
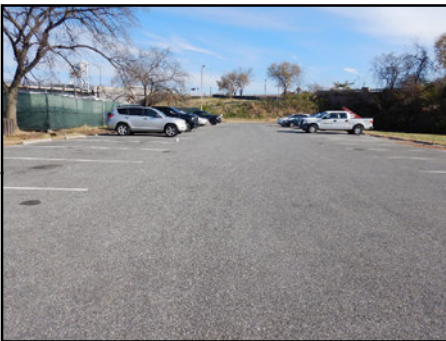
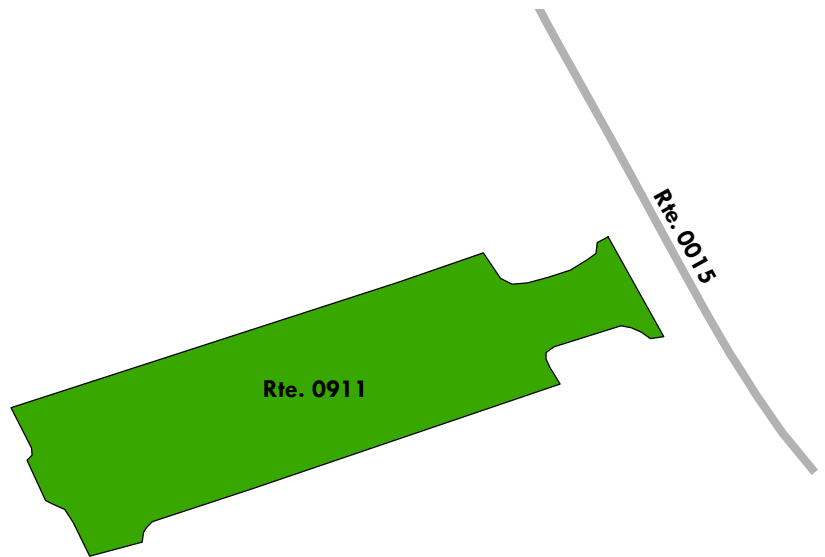
ROUTE 0911: NICHOLSON COMFORT STATION PARKING

Inspection Date	FMSS Number	User Access	Surface Type
11/29/2018	52222	PUBLIC	ASPHALT
Area (Sq. Ft.)	Lane Miles (11' Widths)	Curb Reveal (Inches)	Curb Recommendation
13,448	0.232	NOT APPLICABLE	NOT APPLICABLE
Curb Type		Curb & Gutter Type	
NO CURB		NO CURB AND GUTTER	
Pavement Recommendation		Condition Rating / PCR	
PREVENTIVE MAINTENANCE		GOOD / 90

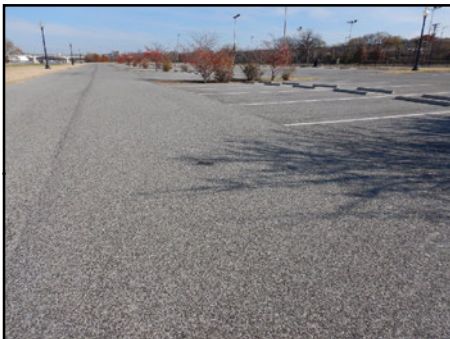
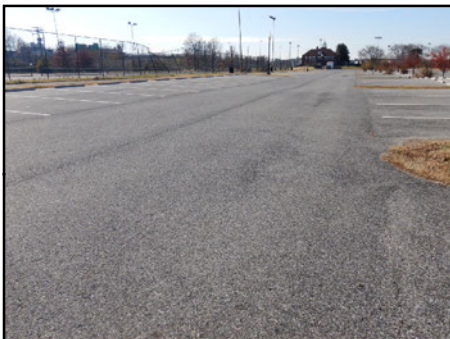
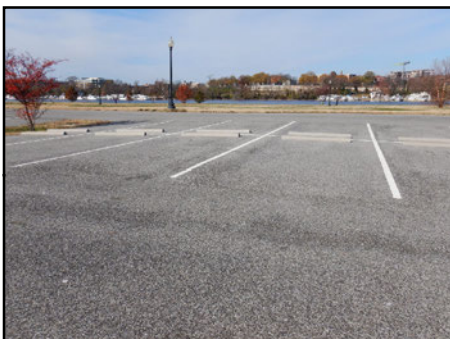
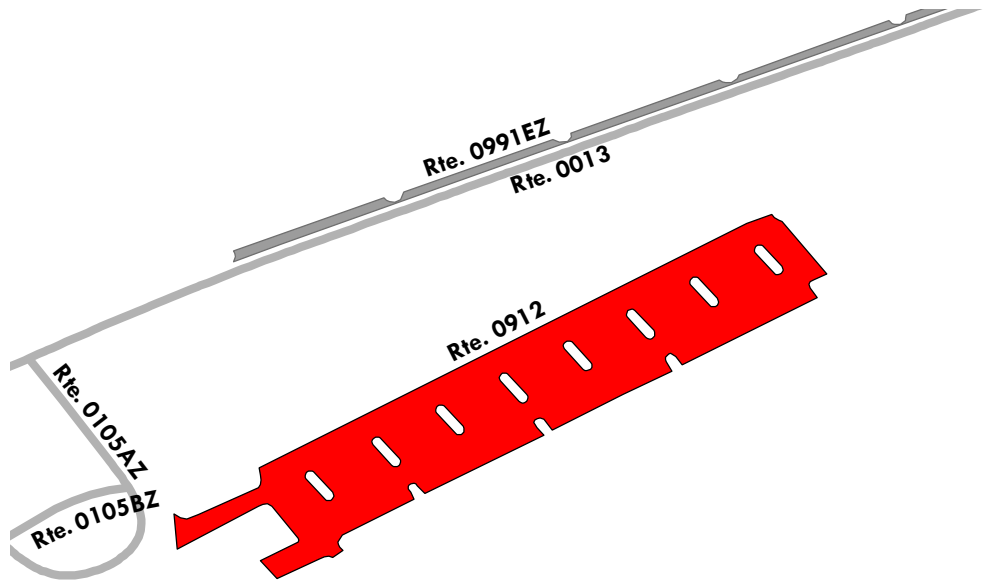
Inspection Date	FMSS Number	User Access	Surface Type
11/29/2018	52223	PUBLIC	ASPHALT
Area (Sq. Ft.)	Lane Miles (11' Widths)	Curb Reveal (Inches)	Curb Recommendation
61,953	1.067	NOT APPLICABLE	NOT APPLICABLE
Curb Type		Curb & Gutter Type	
NO CURB		NO CURB AND GUTTER	
Pavement Recommendation		Condition Rating / PCR	
HEAVY 3R TREATMENTS		POOR / 53

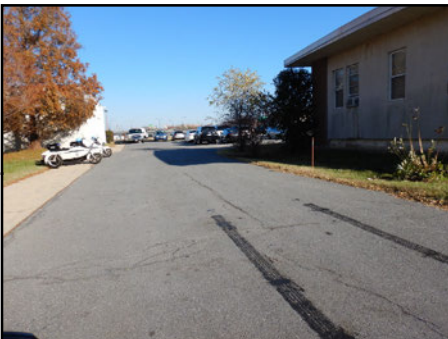
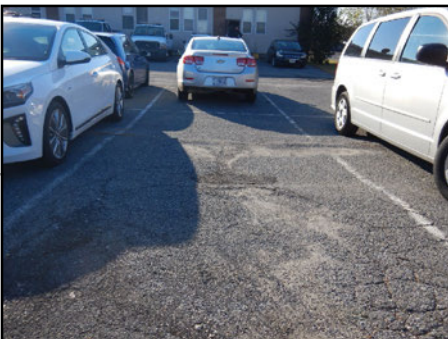
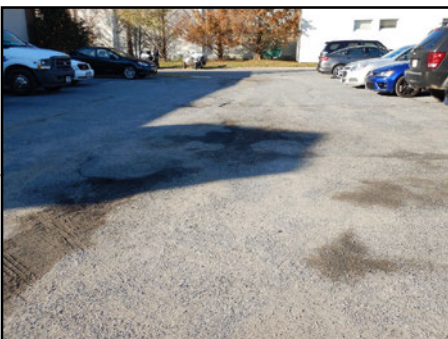
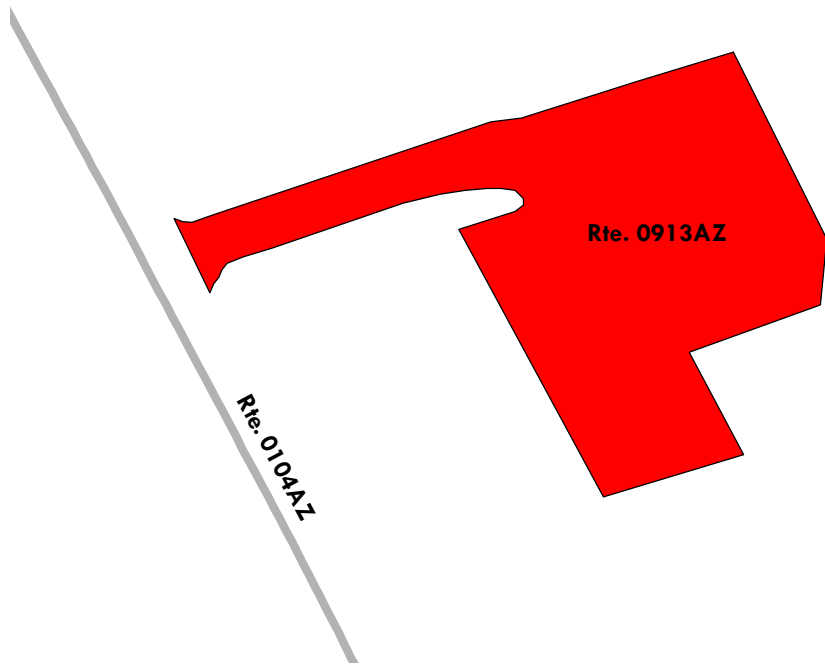
ROUTE 0913AZ: NACE PARK HEADQUARTERS PARKING A

Inspection Date	FMSS Number	User Access	Surface Type
11/29/2018	21430	NONPUBLIC	ASPHALT
Area (Sq. Ft.)	Lane Miles (11' Widths)	Curb Reveal (Inches)	Curb Recommendation
17,972	0.309	NOT APPLICABLE	NOT APPLICABLE
Curb Type		Curb & Gutter Type	
NO CURB		NO CURB AND GUTTER	
Pavement Recommendation		Condition Rating / PCR	
RECONSTRUCTION		POOR / 30

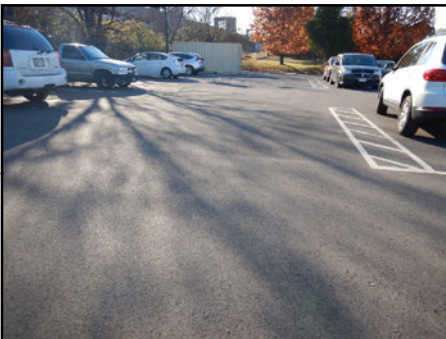
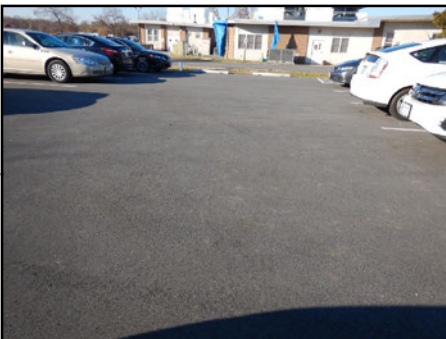
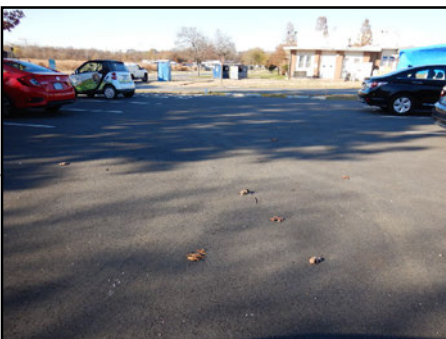
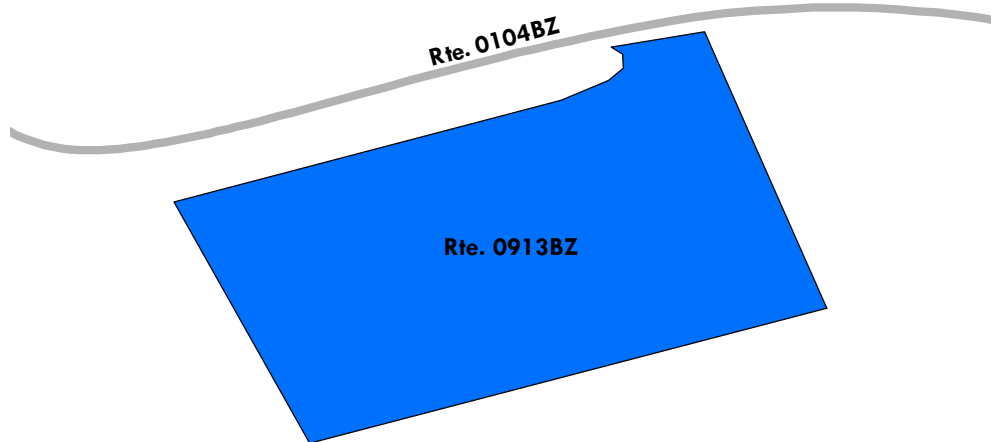
ROUTE 0913BZ: NACE PARK HEADQUARTERS PARKING B

Inspection Date	FMSS Number	User Access	Surface Type
11/29/2018	21430	NONPUBLIC	ASPHALT
Area (Sq. Ft.)	Lane Miles (11' Widths)	Curb Reveal (Inches)	Curb Recommendation
13,220	0.228	NOT APPLICABLE	NOT APPLICABLE
Curb Type		Curb & Gutter Type	
NO CURB		NO CURB AND GUTTER	
Pavement Recommendation		Condition Rating / PCR	
DO NOTHING		EXCELLENT / 97

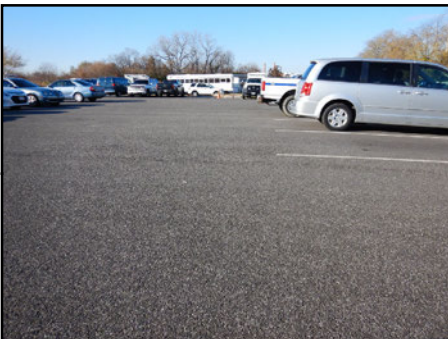
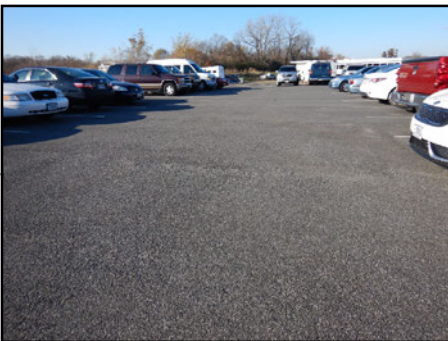
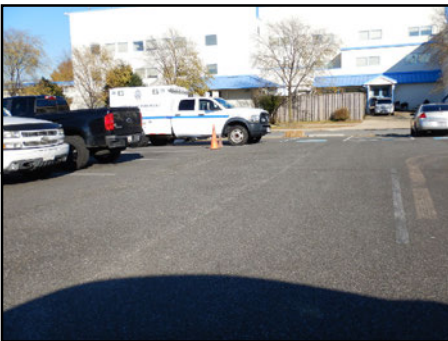
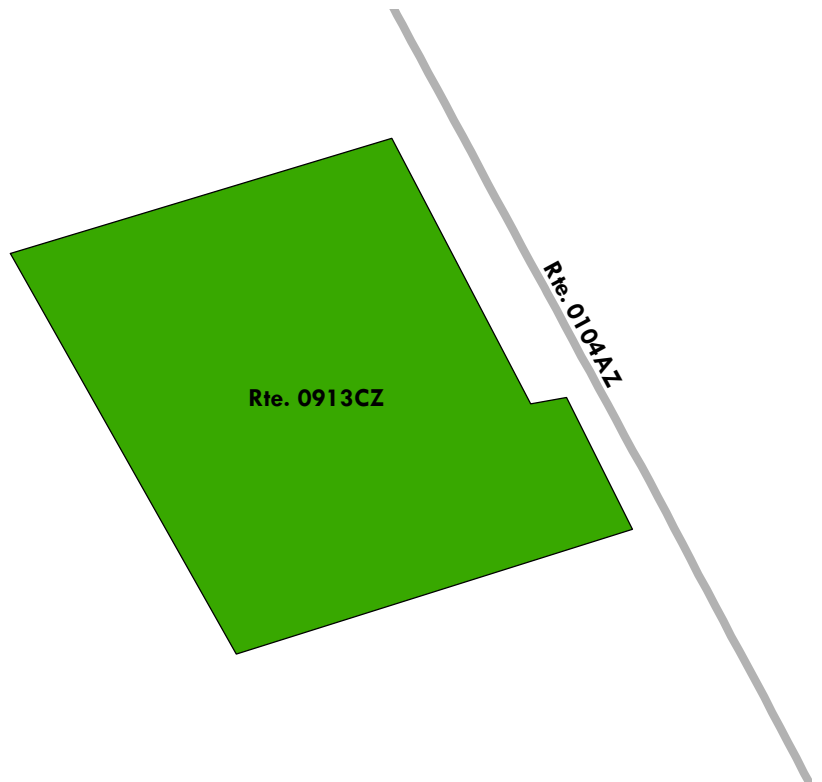
ROUTE 0913CZ: NACE PARK HEADQUARTERS PARKING C

Inspection Date	FMSS Number	User Access	Surface Type
11/29/2018	21430	NONPUBLIC	ASPHALT
Area (Sq. Ft.)	Lane Miles (11' Widths)	Curb Reveal (Inches)	Curb Recommendation
17,777	0.306	NOT APPLICABLE	NOT APPLICABLE
Curb Type		Curb & Gutter Type	
NO CURB		NO CURB AND GUTTER	
Pavement Recommendation		Condition Rating / PCR	
PREVENTIVE MAINTENANCE		GOOD / 90

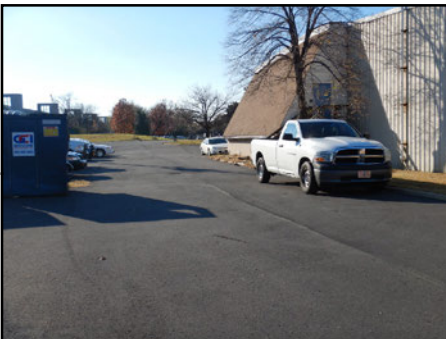
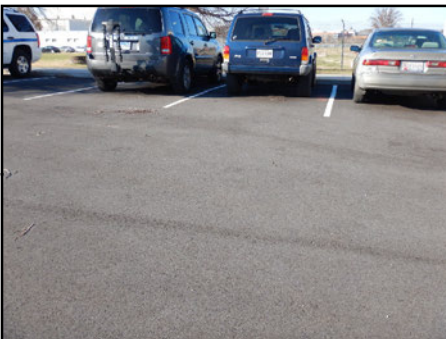
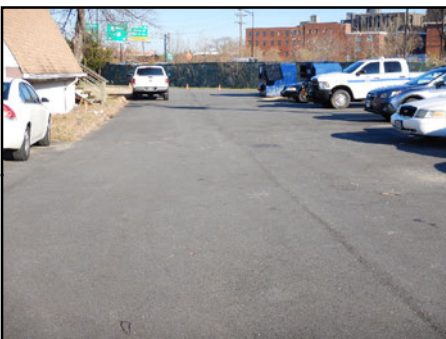
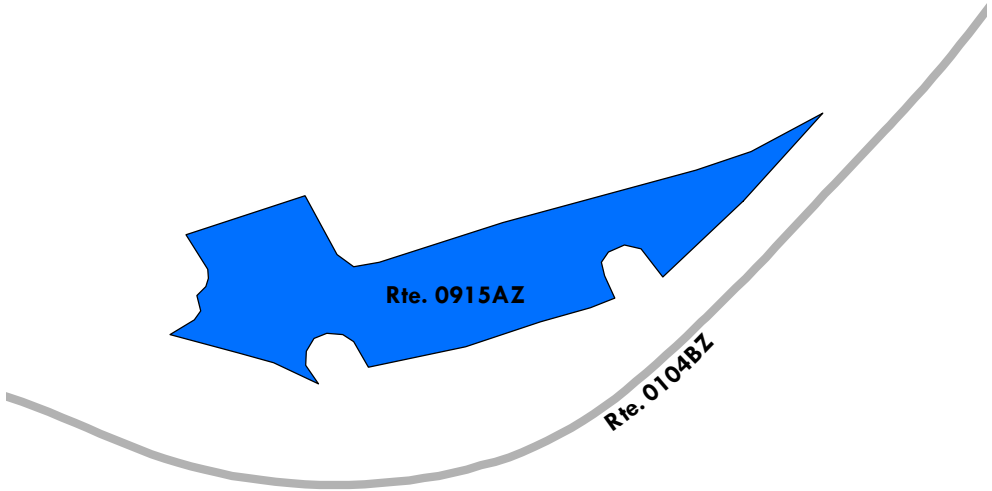
ROUTE 0915AZ: U.S. PARK POLICE AVIATION PARKING

Inspection Date	FMSS Number	User Access	Surface Type
11/29/2018	52225	NONPUBLIC	ASPHALT
Area (Sq. Ft.)	Lane Miles (11' Widths)	Curb Reveal (Inches)	Curb Recommendation
8,537	0.147	6	DO NOTHING
Curb Type		Curb & Gutter Type	
CONCRETE		NO CURB AND GUTTER	
Pavement Recommendation		Condition Rating / PCR	
DO NOTHING		EXCELLENT / 97

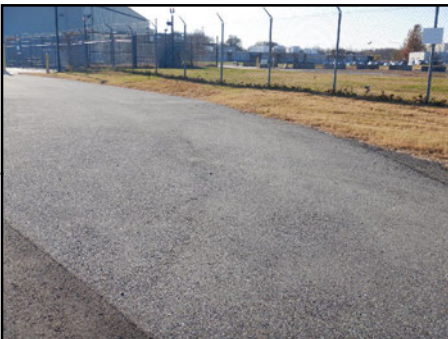
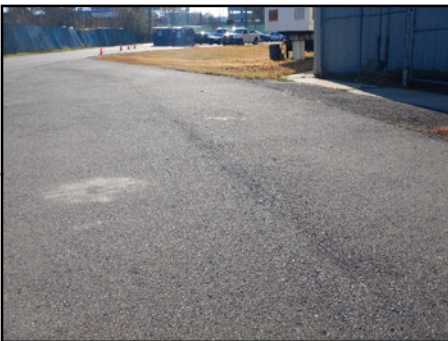
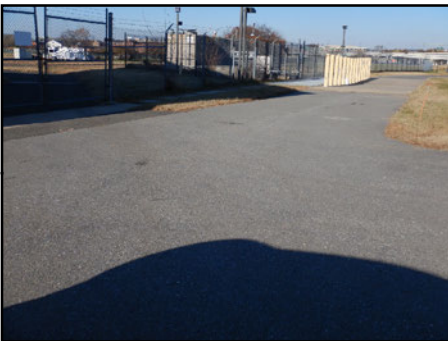
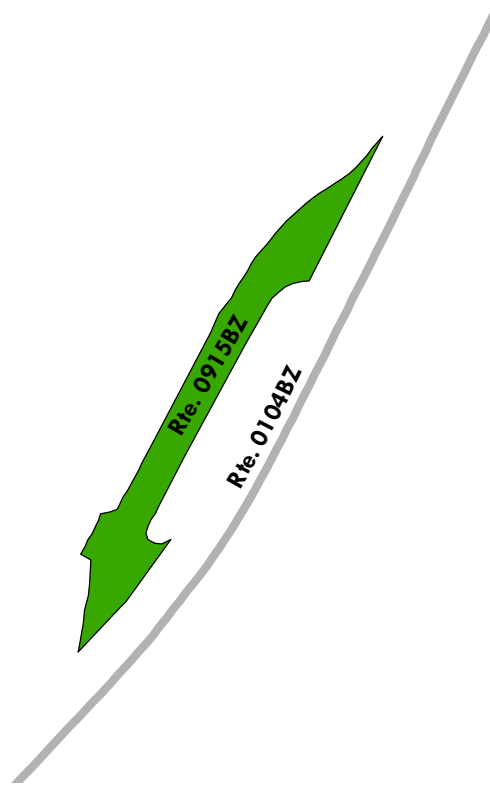
ROUTE 0915BZ: USPP AVIATION FUEL RAMP

Inspection Date	FMSS Number	User Access	Surface Type
11/29/2018	52225	NONPUBLIC	ASPHALT
Area (Sq. Ft.)	Lane Miles (11' Widths)	Curb Reveal (Inches)	Curb Recommendation
4,998	0.086	2	DO NOTHING
Curb Type		Curb & Gutter Type	
CONCRETE		NO CURB AND GUTTER	
Pavement Recommendation		Condition Rating / PCR	
PREVENTIVE MAINTENANCE		GOOD / 90

Note: Parking area consists of multiple surface types: 1 part Asphalt at 3,945 square feet; 1 part Concrete at 1,053 square feet.
