NACE Cycle 6

Final Report

Road Inventory and Condition Assessment of Paved Routes National Capital Parks - East

Report Date: October 2019

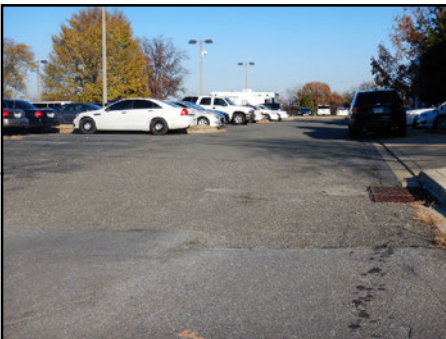
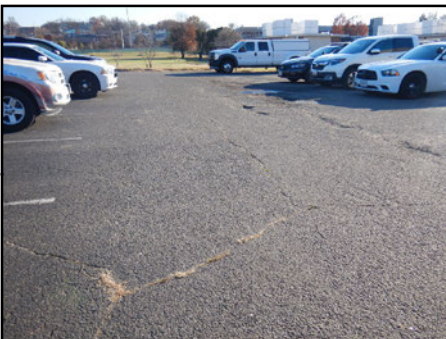
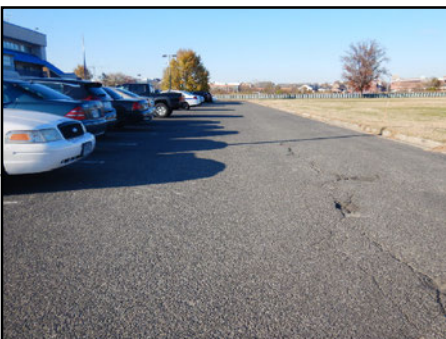
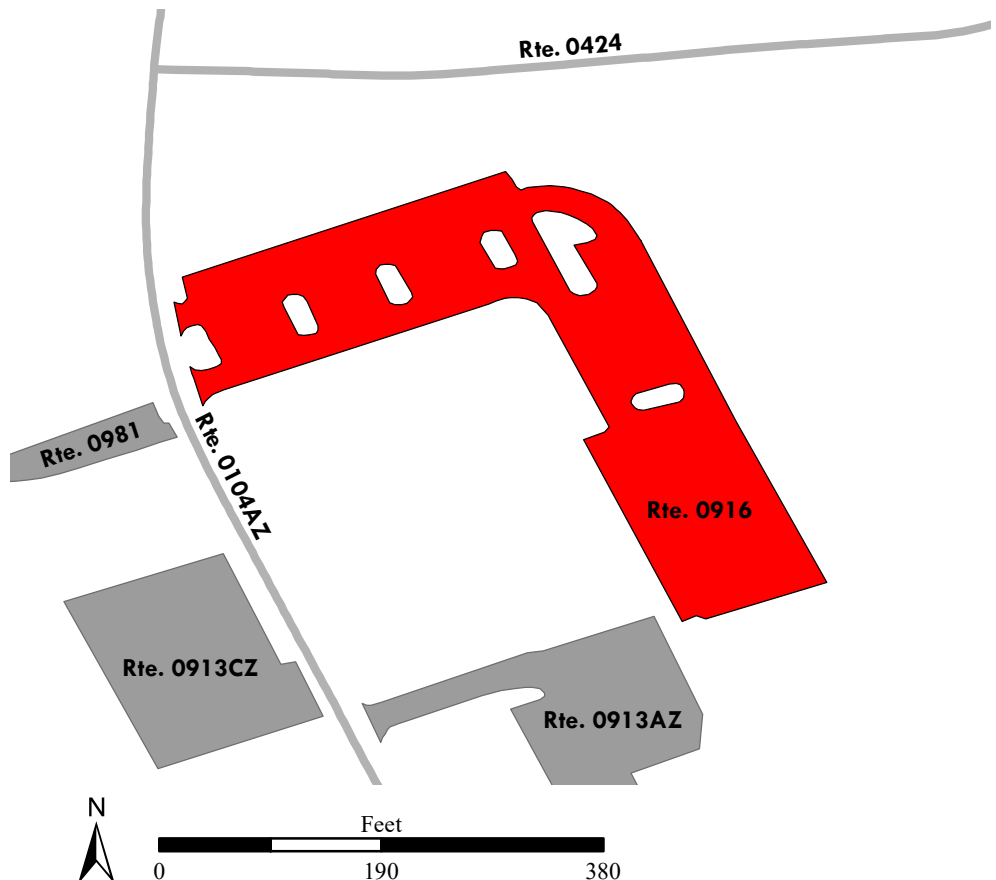
ROUTE 0916: U.S. PARK POLICE OFFICE PARKING

Inspection Date	FMSS Number	User Access	Surface Type
11/29/2018	21432	PUBLIC	ASPHALT
Area (Sq. Ft.)	Lane Miles (11' Widths)	Curb Reveal (Inches)	Curb Recommendation
52,940	0.912	NOT APPLICABLE	DO NOTHING
Curb Type		Curb & Gutter Type	
NO CURB		CONCRETE	
Pavement Recommendation		Condition Rating / PCR	
RECONSTRUCTION		POOR / 30

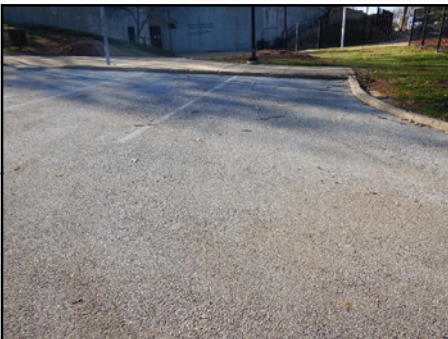
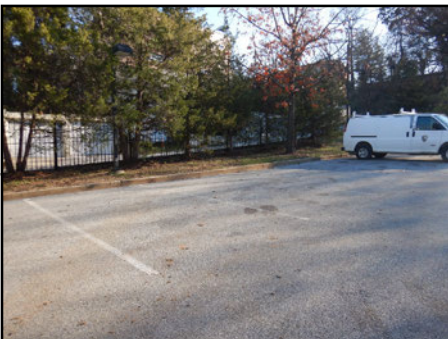
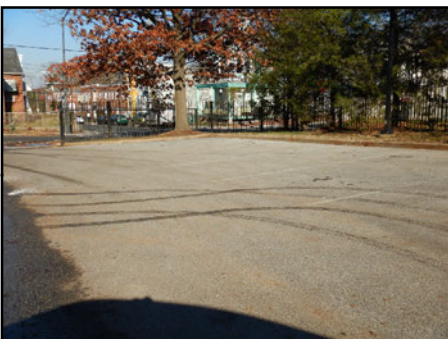
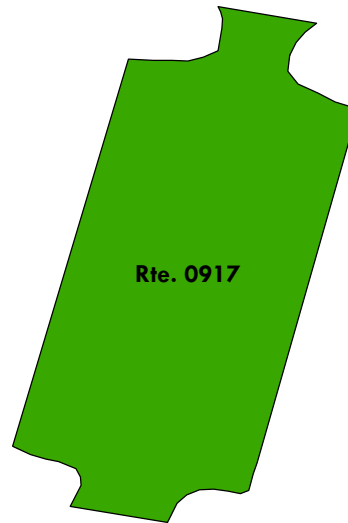
ROUTE 0917: FREDERICK DOUGLASS HOME PARKING

Inspection Date	FMSS Number	User Access	Surface Type
11/29/2018	21316	PUBLIC	ASPHALT
Area (Sq. Ft.)	Lane Miles (11' Widths)	Curb Reveal (Inches)	Curb Recommendation
10,727	0.185	5	DO NOTHING
Curb Type		Curb & Gutter Type	
CONCRETE		NO CURB AND GUTTER	
Pavement Recommendation		Condition Rating / PCR	
PREVENTIVE MAINTENANCE		GOOD / 90

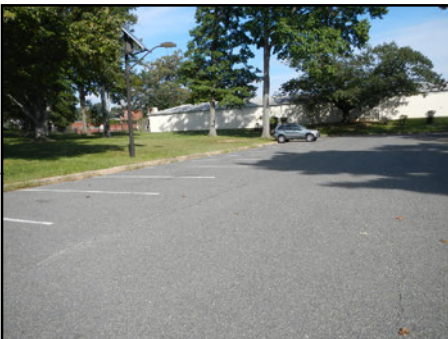
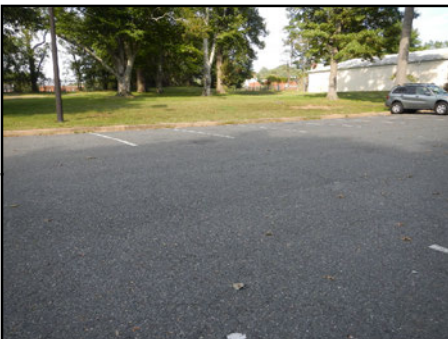
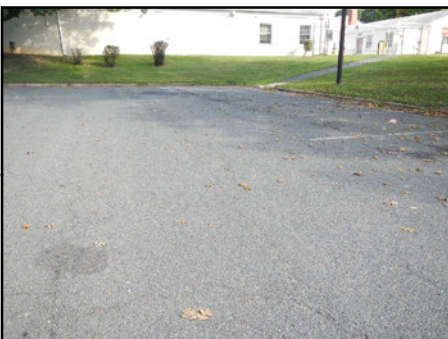
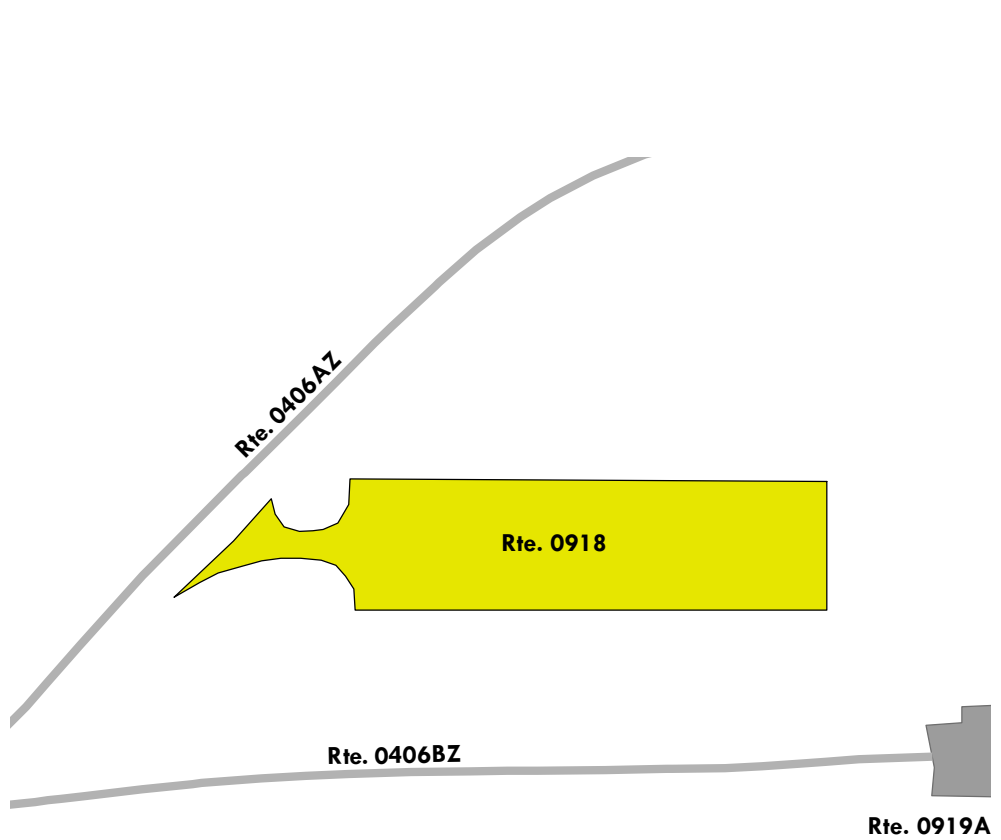
ROUTE 0918: FORT DUPONT MAINTENANCE YARD PARKING

Inspection Date	FMSS Number	User Access	Surface Type
10/4/2018	21427	NONPUBLIC	ASPHALT
Area (Sq. Ft.)	Lane Miles (11' Widths)	Curb Reveal (Inches)	Curb Recommendation
9,416	0.162	NOT APPLICABLE	DO NOTHING
Curb Type		Curb & Gutter Type	
NO CURB		CONCRETE	
Pavement Recommendation		Condition Rating / PCR	
LIGHT 3R TREATMENTS		FAIR / 73

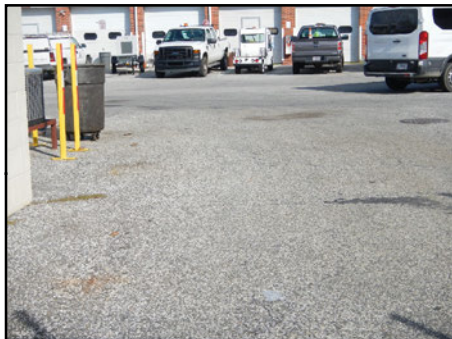
ROUTE 0919A: FORT DUPONT INTERIOR MAINTENANCE AREA

Inspection Date	FMSS Number	User Access	Surface Type
10/4/2018	52111	NONPUBLIC	ASPHALT
Area (Sq. Ft.)	Lane Miles (11' Widths)	Curb Reveal (Inches)	Curb Recommendation
18,281	0.315	NOT APPLICABLE	NOT APPLICABLE
Curb Type		Curb & Gutter Type	
NO CURB		NO CURB AND GUTTER	
Pavement Recommendation		Condition Rating / PCR	
HEAVY 3R TREATMENTS		POOR / 53

Note: Parking area consists of multiple surface types: 1 part Asphalt at 15,909 square feet; 1 part Concrete at 2,372 square feet.

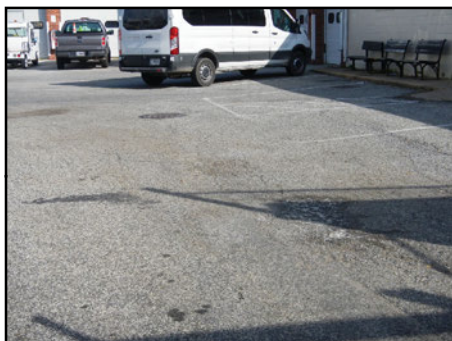
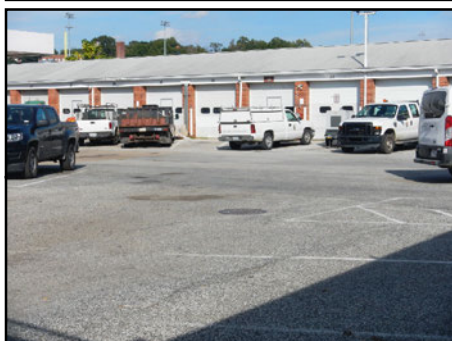
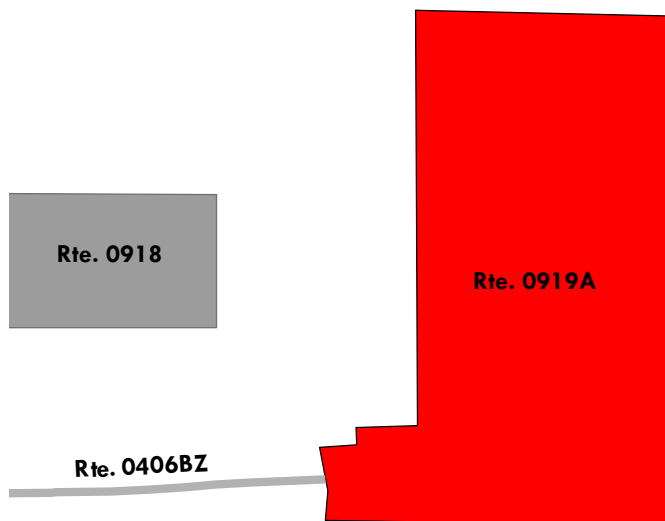
ROUTE 0919B: FORT DUPONT REAR MAINTENANCE AREA

Inspection Date	FMSS Number	User Access	Surface Type
10/4/2018	104060	NONPUBLIC	ASPHALT
Area (Sq. Ft.)	Lane Miles (11' Widths)	Curb Reveal (Inches)	Curb Recommendation
5,466	0.094	NOT APPLICABLE	NOT APPLICABLE
Curb Type		Curb & Gutter Type	
NO CURB		NO CURB AND GUTTER	
Pavement Recommendation		Condition Rating / PCR	
PREVENTIVE MAINTENANCE		GOOD / 90

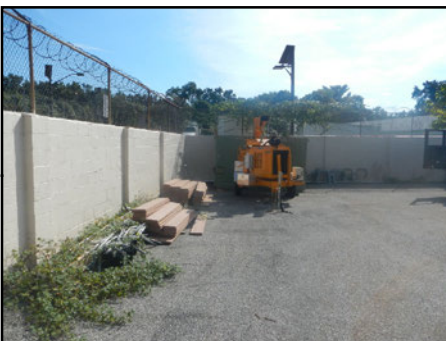
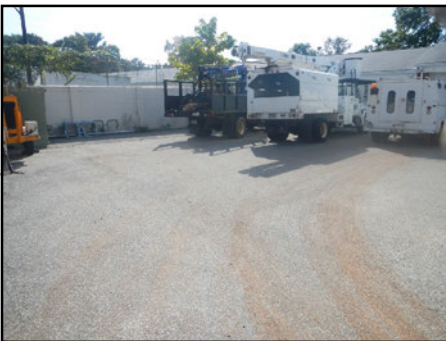
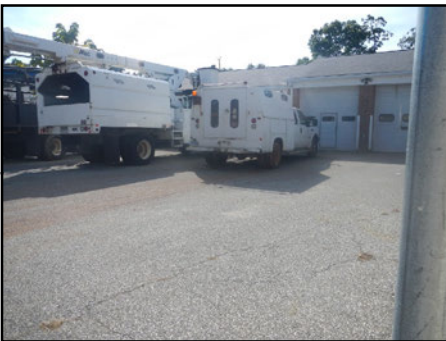
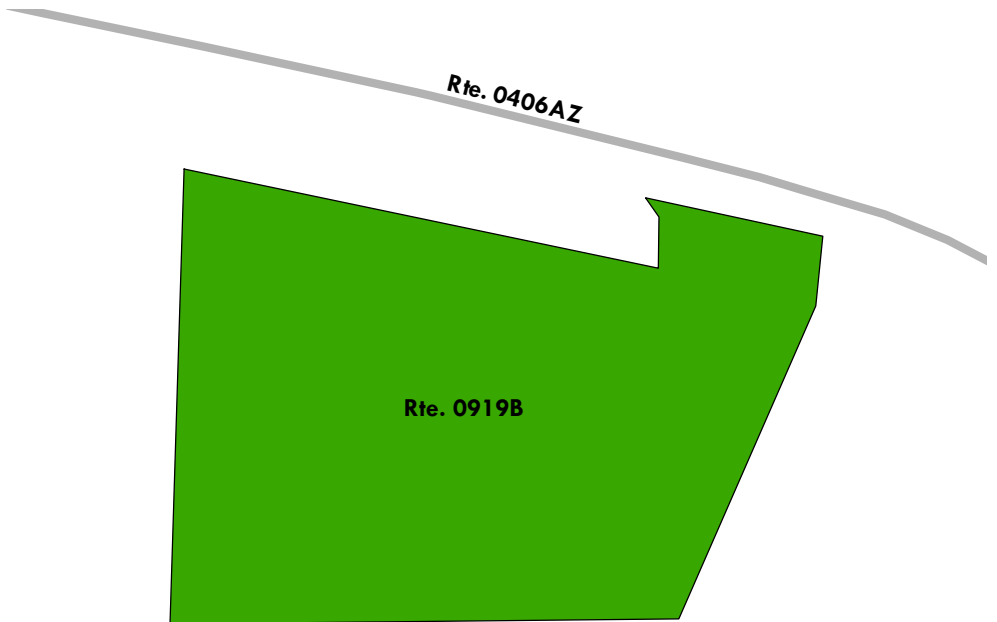
ROUTE 0920: U.S. PARK POLICE FORT DUPONT STABLES AND PARKING

Inspection Date	FMSS Number	User Access	Surface Type
10/4/2018	52112	NONPUBLIC	ASPHALT
Area (Sq. Ft.)	Lane Miles (11' Widths)	Curb Reveal (Inches)	Curb Recommendation
10,927	0.188	5	LIGHT REPAIR
Curb Type		Curb & Gutter Type	
ASPHALT		NO CURB AND GUTTER	
Pavement Recommendation		Condition Rating / PCR	
RECONSTRUCTION		POOR / 30

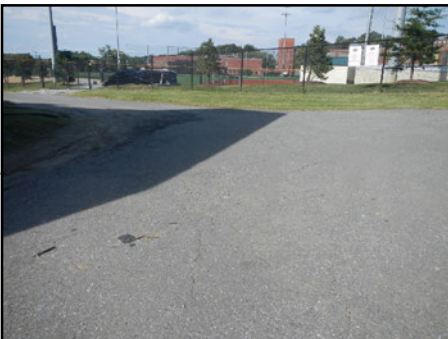
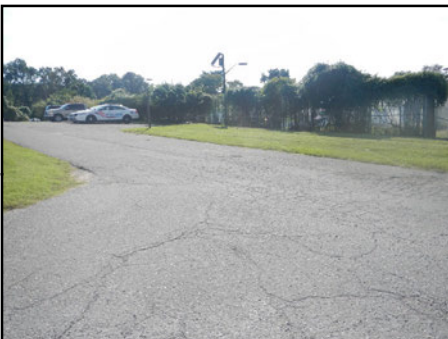
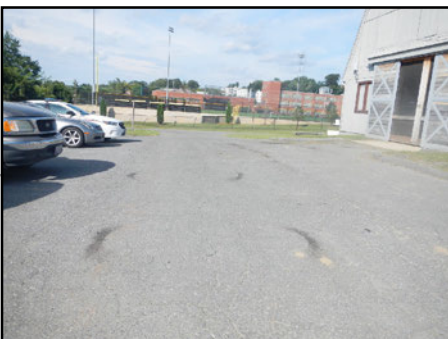
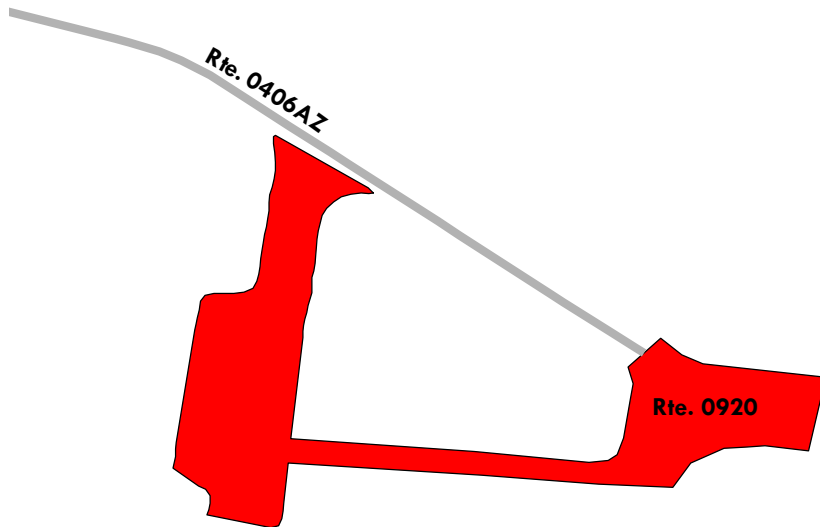
ROUTE 0922: FORT DUPONT ACTIVITY CENTER PARKING

Inspection Date	FMSS Number	User Access	Surface Type
10/4/2018	21428	PUBLIC	ASPHALT
Area (Sq. Ft.)	Lane Miles (11' Widths)	Curb Reveal (Inches)	Curb Recommendation
45,358	0.781	6	DO NOTHING
Curb Type		Curb & Gutter Type	
CONCRETE		NO CURB AND GUTTER	
Pavement Recommendation		Condition Rating / PCR	
HEAVY 3R TREATMENTS		POOR / 53

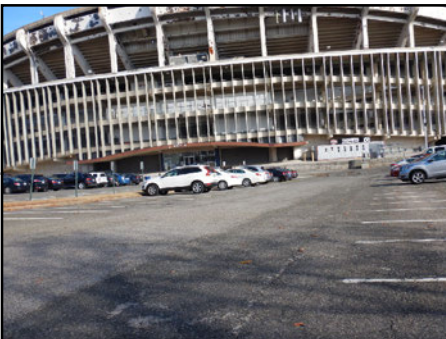
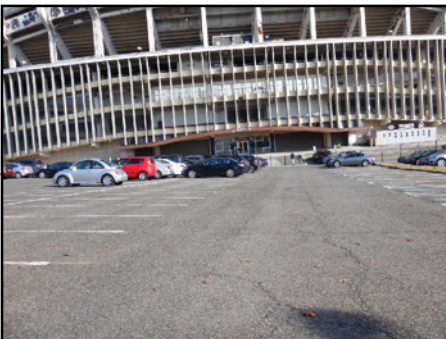
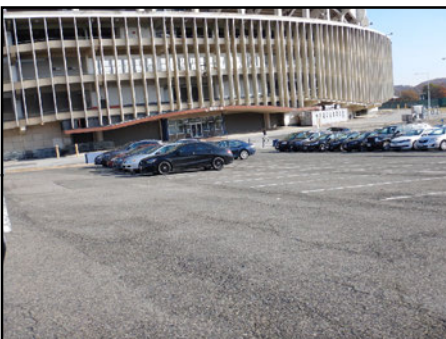
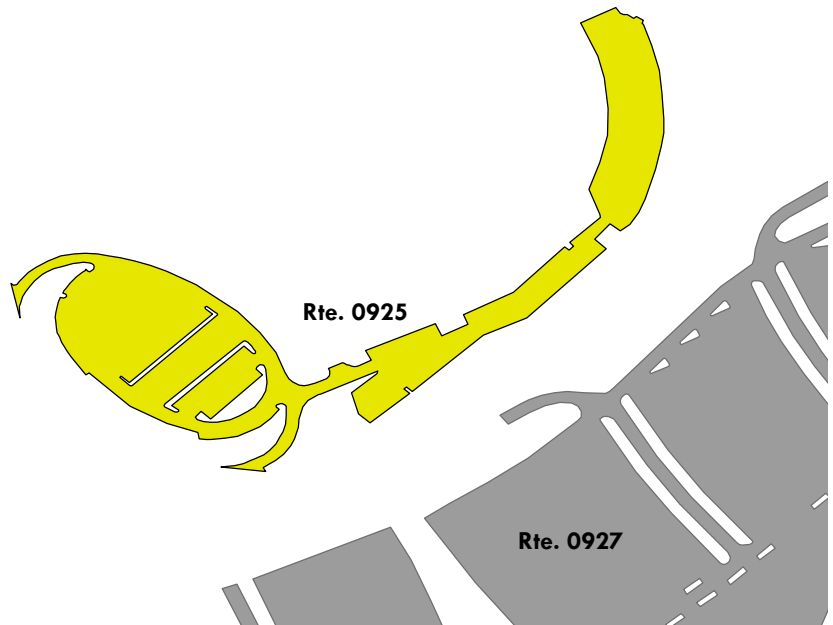
ROUTE 0926: RFK STADIUM NORTH PARKING / DC POLICE

Inspection Date	FMSS Number	User Access	Surface Type
11/29/2018	252453	PUBLIC	ASPHALT
Area (Sq. Ft.)	Lane Miles (11' Widths)	Curb Reveal (Inches)	Curb Recommendation
109,904	1.892	2	LIGHT REPAIR
Curb Type		Curb & Gutter Type	
CONCRETE		NO CURB AND GUTTER	
Pavement Recommendation		Condition Rating / PCR	
RECONSTRUCTION		POOR / 30

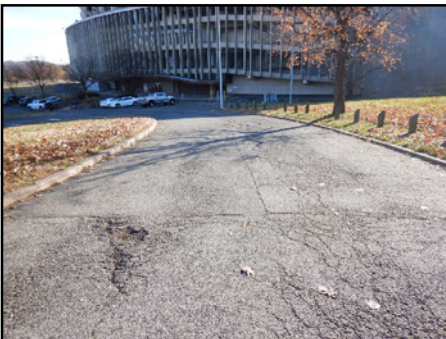
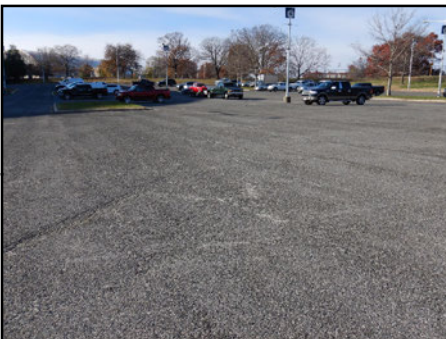
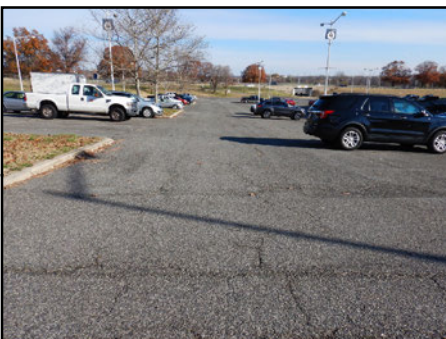
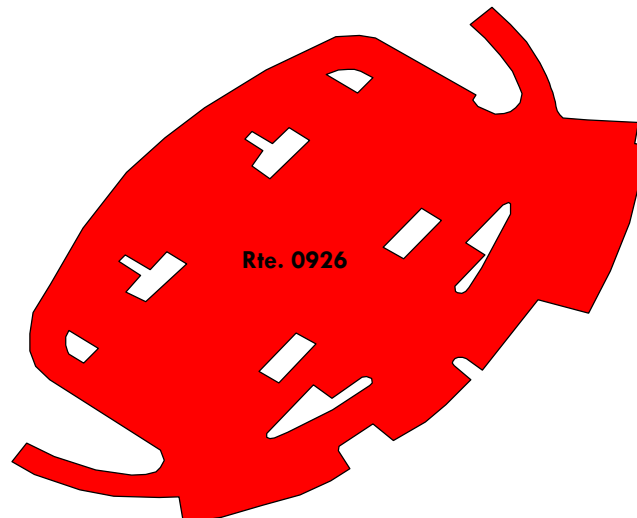
ROUTE 0927: RFK STADIUM SOUTHEAST PARKING

Inspection Date	FMSS Number	User Access	Surface Type
11/29/2018	252454	PUBLIC	ASPHALT
Area (Sq. Ft.)	Lane Miles (11' Widths)	Curb Reveal (Inches)	Curb Recommendation
796,587	13.715	4	LIGHT REPAIR
Curb Type		Curb & Gutter Type	
CONCRETE		CONCRETE	
Pavement Recommendation		Condition Rating / PCR	
LIGHT 3R TREATMENTS		FAIR / 73

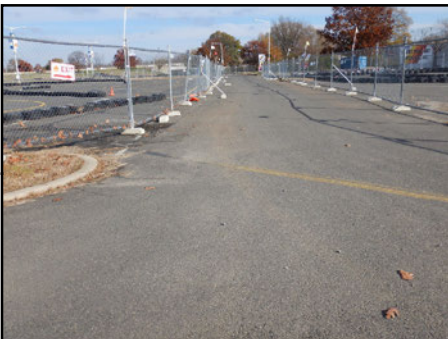
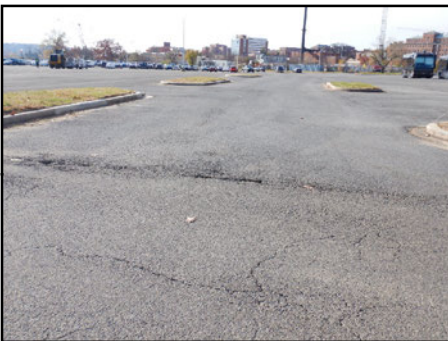
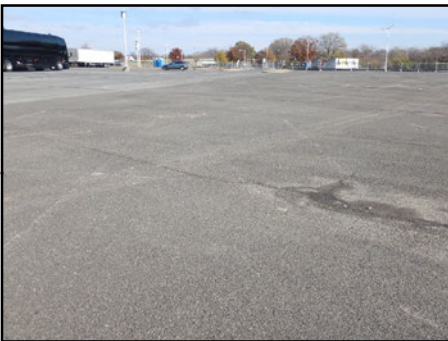
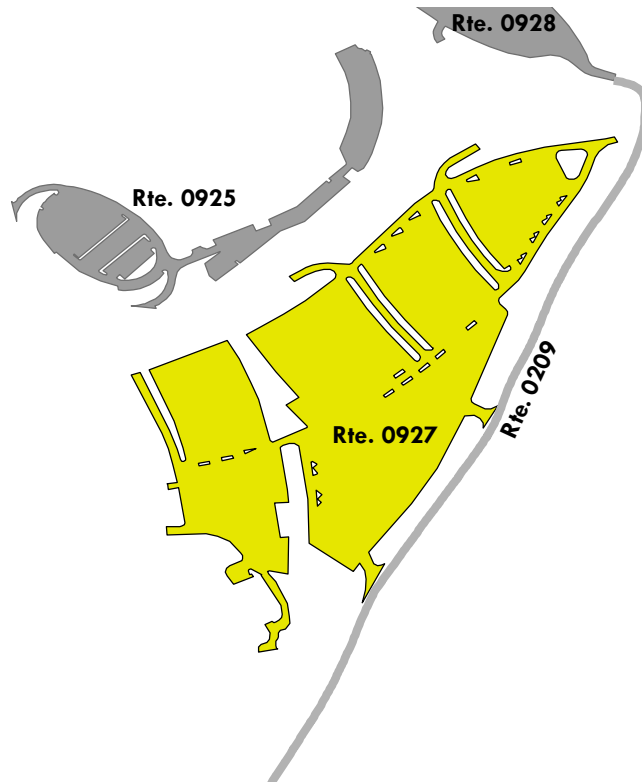
ROUTE 0928: RFK STADIUM NORTH PARKING

Inspection Date	FMSS Number	User Access	Surface Type
11/29/2018	252455	PUBLIC	ASPHALT
Area (Sq. Ft.)	Lane Miles (11' Widths)	Curb Reveal (Inches)	Curb Recommendation
1,624,889	27.977	NOT APPLICABLE	LIGHT REPAIR
Curb Type		Curb & Gutter Type	
NO CURB		CONCRETE	
Pavement Recommendation		Condition Rating / PCR	
RECONSTRUCTION		POOR / 30

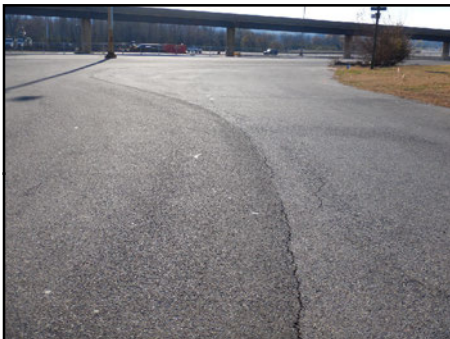
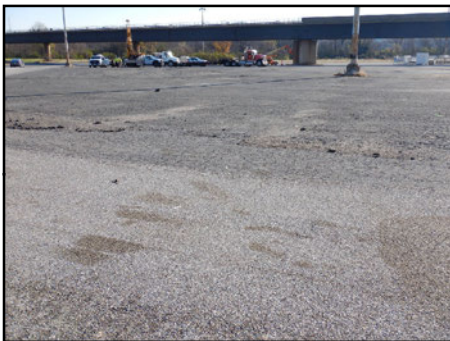
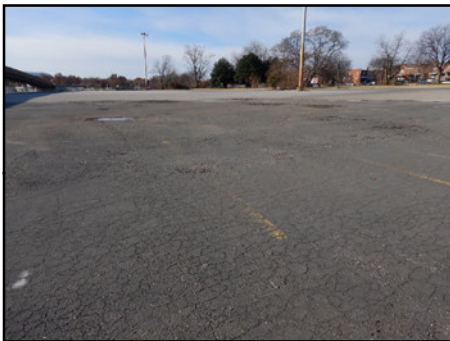
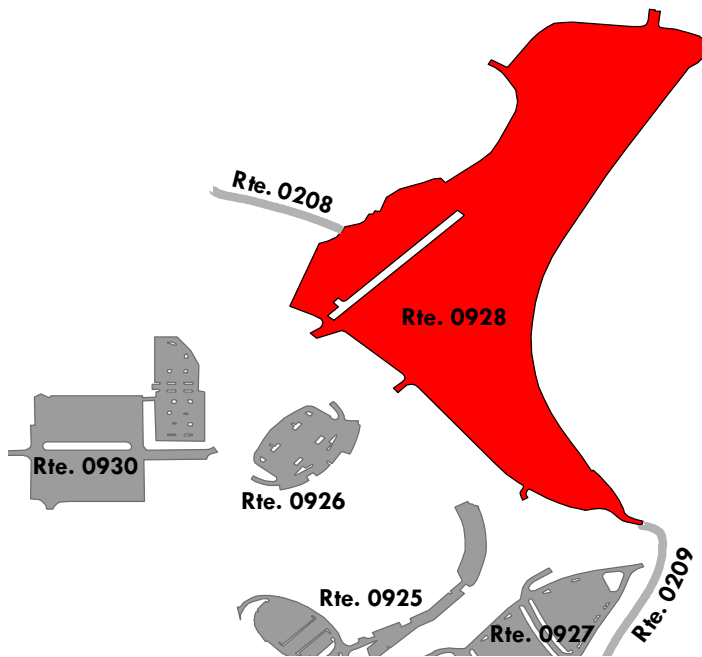
ROUTE 0930: RFK STADIUM EAST / DC ARMORY OVERFLOW PARKING

Inspection Date	FMSS Number	User Access	Surface Type
11/29/2018	252456	PUBLIC	ASPHALT
Area (Sq. Ft.)	Lane Miles (11' Widths)	Curb Reveal (Inches)	Curb Recommendation
343,823	5.92	NOT APPLICABLE	LIGHT REPAIR
Curb Type		Curb & Gutter Type	
NO CURB		CONCRETE	
Pavement Recommendation		Condition Rating / PCR	
LIGHT 3R TREATMENTS		FAIR / 73

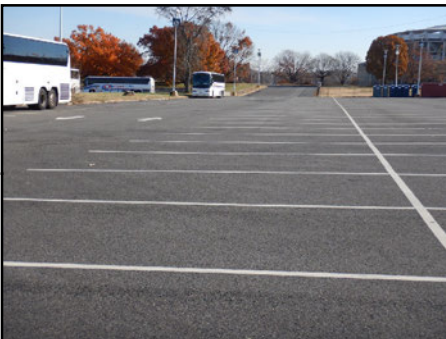
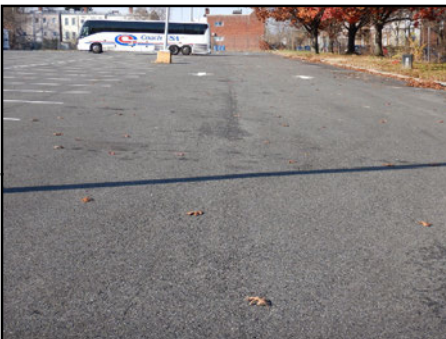
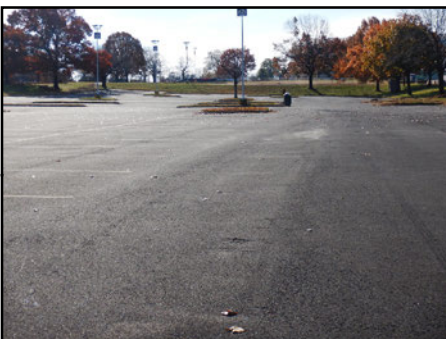
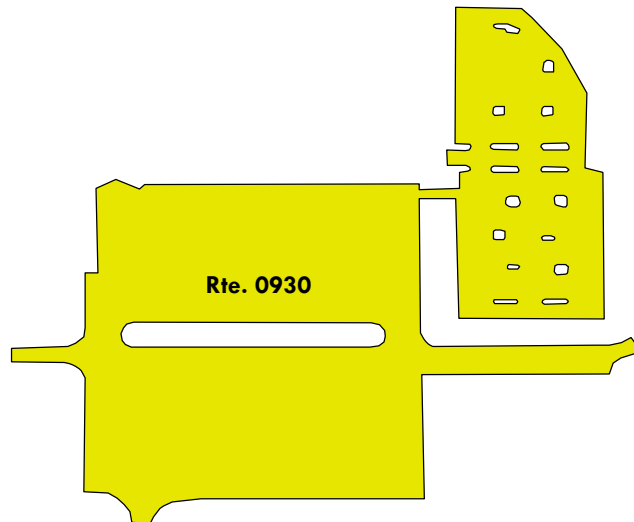
ROUTE 0950: OXON HILL VISITORS CENTER PARKING

Inspection Date	FMSS Number	User Access	Surface Type
11/29/2018	20708	PUBLIC	ASPHALT
Area (Sq. Ft.)	Lane Miles (11' Widths)	Curb Reveal (Inches)	Curb Recommendation
40,739	0.701	NOT APPLICABLE	NOT APPLICABLE
Curb Type		Curb & Gutter Type	
NO CURB		NO CURB AND GUTTER	
Pavement Recommendation		Condition Rating / PCR	
PREVENTIVE MAINTENANCE		GOOD / 90

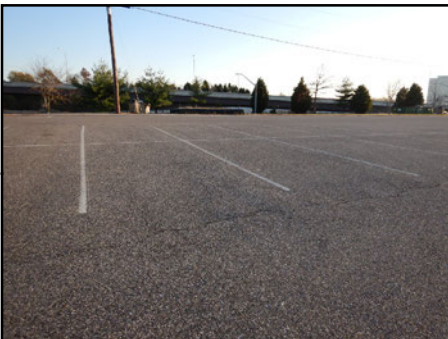
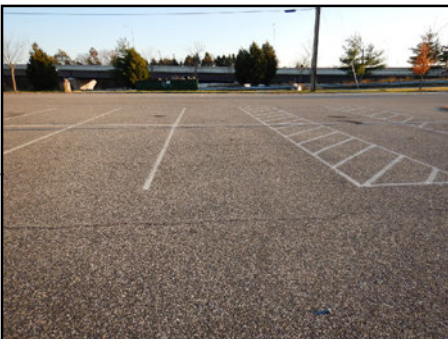
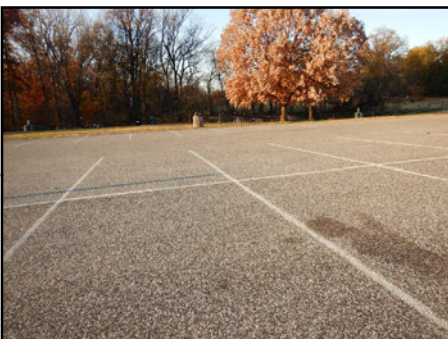
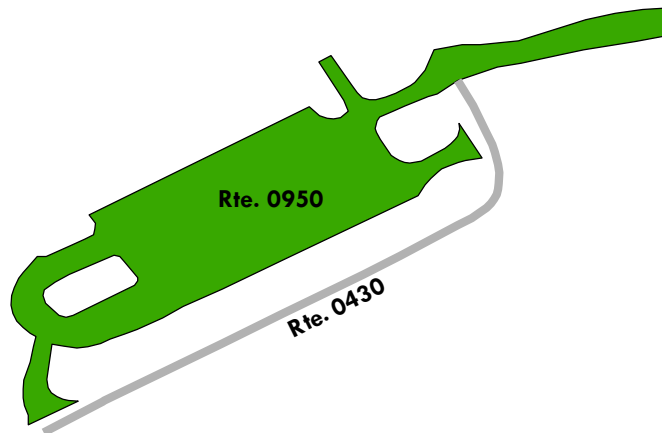
ROUTE 0956: MARSHALL HALL BOAT RAMP PARKING

Inspection Date	FMSS Number	User Access	Surface Type
11/29/2018	52377	PUBLIC	ASPHALT
Area (Sq. Ft.)	Lane Miles (11' Widths)	Curb Reveal (Inches)	Curb Recommendation
47,445	0.817	NOT APPLICABLE	NOT APPLICABLE
Curb Type		Curb & Gutter Type	
NO CURB		NO CURB AND GUTTER	
Pavement Recommendation		Condition Rating / PCR	
HEAVY 3R TREATMENTS		POOR / 53

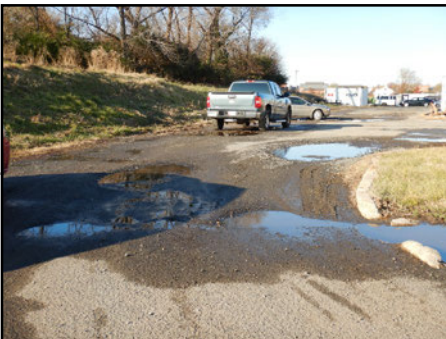
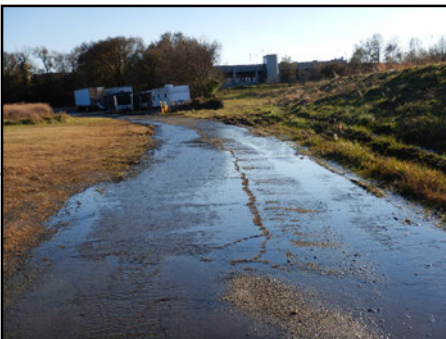
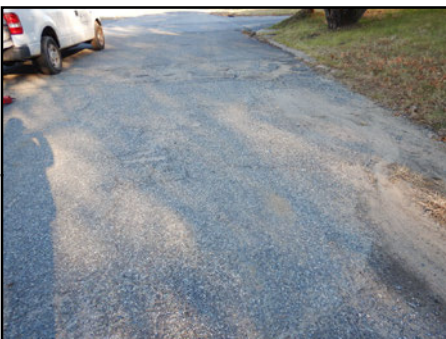
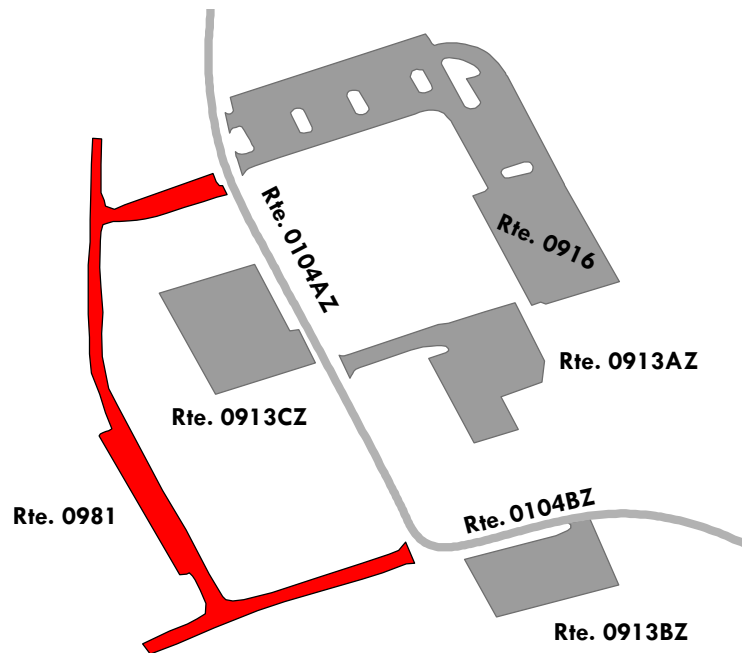
ROUTE 0981: U.S. PARK POLICE IMPOUND PARKING / AOF SOUTH ROADWAY

Inspection Date	FMSS Number	User Access	Surface Type
11/29/2018	252458	NONPUBLIC	ASPHALT
Area (Sq. Ft.)	Lane Miles (11' Widths)	Curb Reveal (Inches)	Curb Recommendation
24,431	0.421	NOT APPLICABLE	NOT APPLICABLE
Curb Type		Curb & Gutter Type	
NO CURB		NO CURB AND GUTTER	
Pavement Recommendation		Condition Rating / PCR	
RECONSTRUCTION		POOR / 30

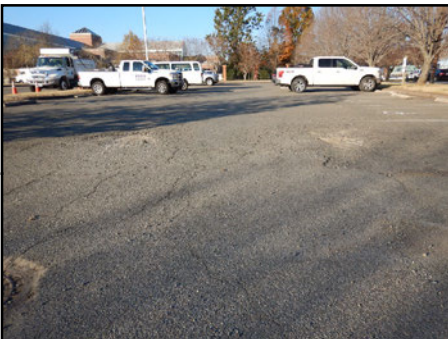
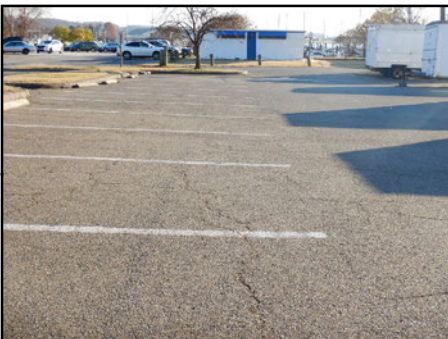
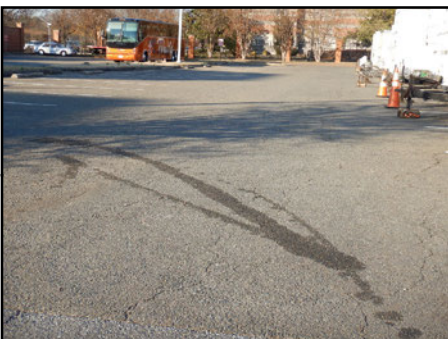
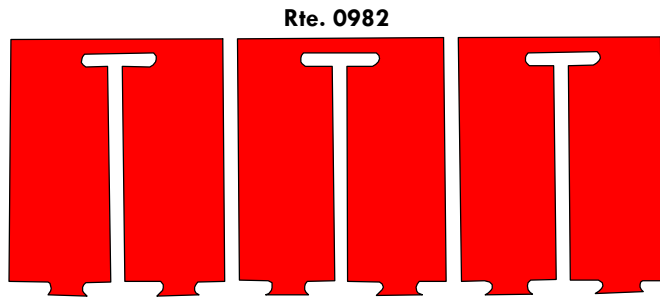
ROUTE 0982: JAMES CREEK PAVED PARKING

Inspection Date	FMSS Number	User Access	Surface Type
11/29/2018	252459	PUBLIC	ASPHALT
Area (Sq. Ft.)	Lane Miles (11' Widths)	Curb Reveal (Inches)	Curb Recommendation
72,158	1.242	6	MODERATE REPAIR
Curb Type		Curb & Gutter Type	
ASPHALT AND CONCRETE		NO CURB AND GUTTER	
Pavement Recommendation		Condition Rating / PCR	
HEAVY 3R TREATMENTS		POOR / 53

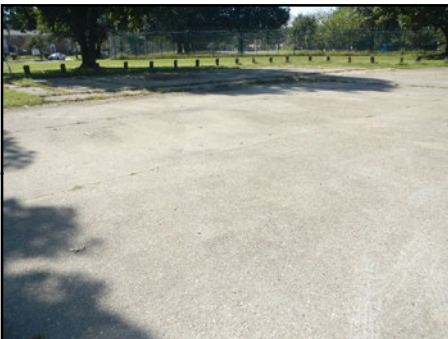
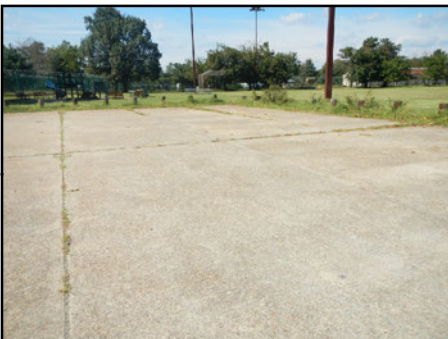
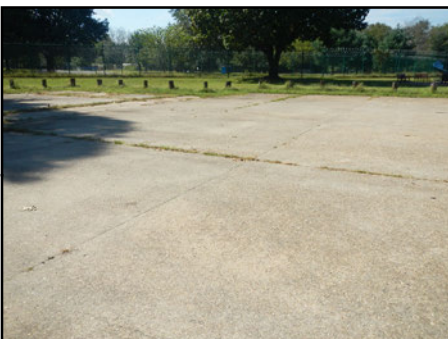
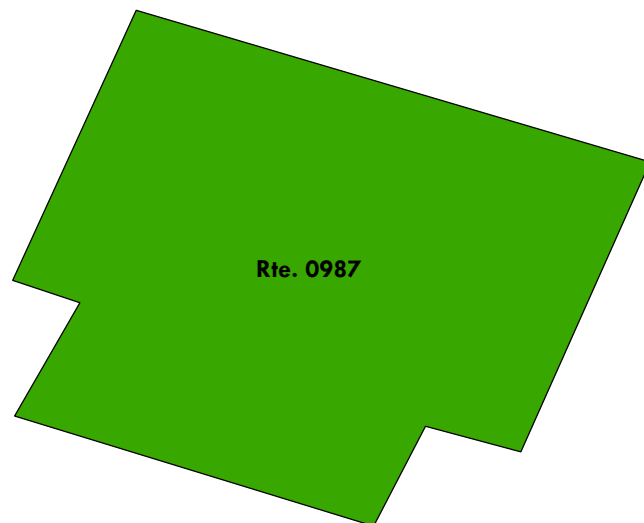
ROUTE 0987: QUARLES FIELD PARKING

Inspection Date	FMSS Number	User Access	Surface Type
10/4/2018	252460	PUBLIC	CONCRETE
Area (Sq. Ft.)	Lane Miles (11' Widths)	Curb Reveal (Inches)	Curb Recommendation
9,051	0.156	NOT APPLICABLE	NOT APPLICABLE
Curb Type		Curb & Gutter Type	
NO CURB		NO CURB AND GUTTER	
Pavement Recommendation		Condition Rating / PCR	
PREVENTIVE MAINTENANCE		GOOD / 90

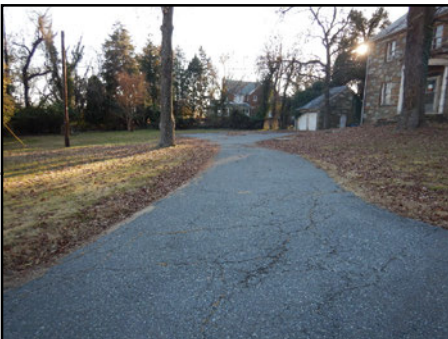
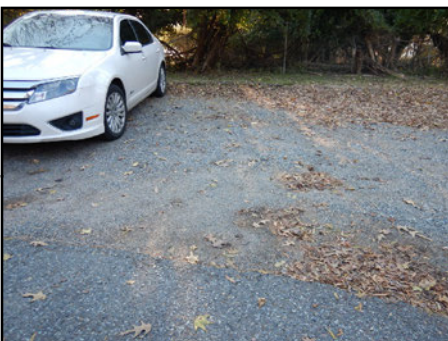
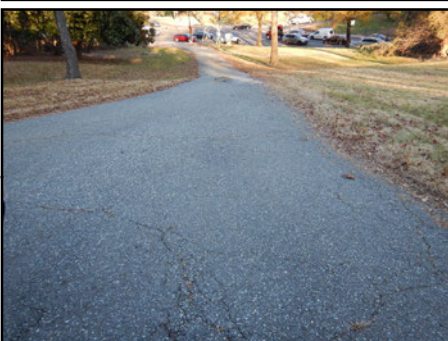
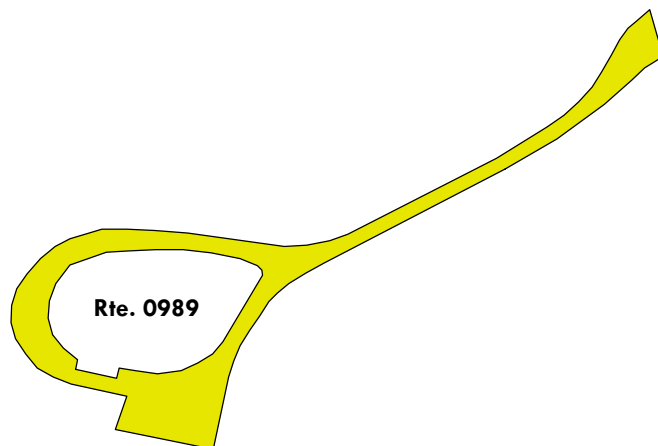
ROUTE 0989: 3801 SOUTH CAPITOL STREET HOUSE PARKING AND COMPLEX

Inspection Date	FMSS Number	User Access	Surface Type
11/29/2018	252461	NONPUBLIC	ASPHALT
Area (Sq. Ft.)	Lane Miles (11' Widths)	Curb Reveal (Inches)	Curb Recommendation
8,797	0.151	NOT APPLICABLE	NOT APPLICABLE
Curb Type		Curb & Gutter Type	
NO CURB		NO CURB AND GUTTER	
Pavement Recommendation		Condition Rating / PCR	
LIGHT 3R TREATMENTS		FAIR / 73

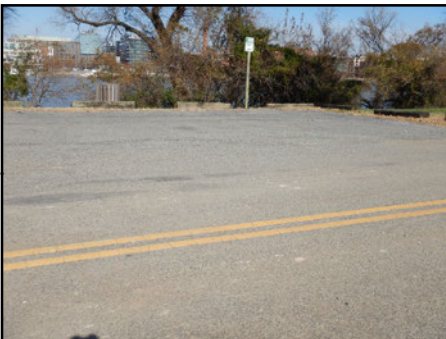
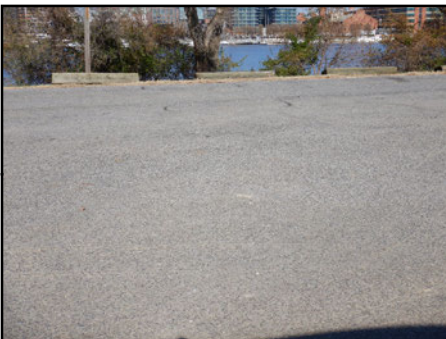
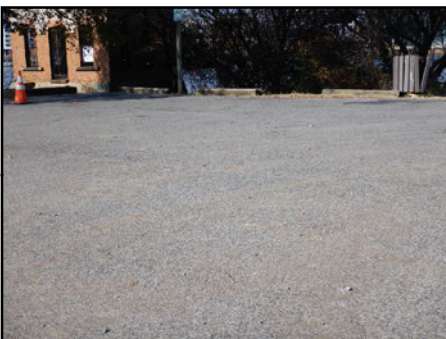
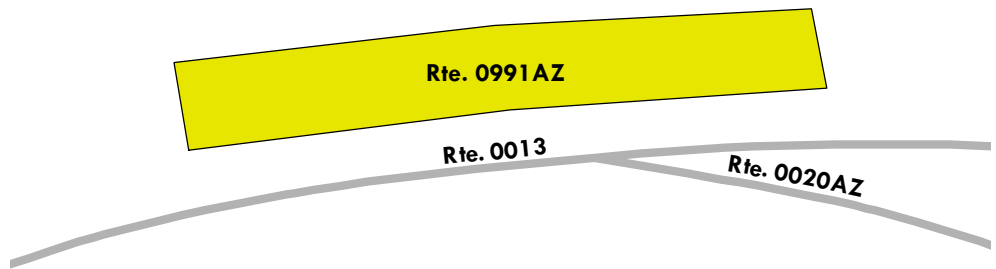
ROUTE 0991AZ: ANACOSTIA DRIVE PULLOFF AREA A

Inspection Date	FMSS Number	User Access	Surface Type
11/29/2018	252463	PUBLIC	ASPHALT
Area (Sq. Ft.)	Lane Miles (11' Widths)	Curb Reveal (Inches)	Curb Recommendation
4,275	0.074	NOT APPLICABLE	NOT APPLICABLE
Curb Type		Curb & Gutter Type	
NO CURB		NO CURB AND GUTTER	
Pavement Recommendation		Condition Rating / PCR	
LIGHT 3R TREATMENTS		FAIR / 73

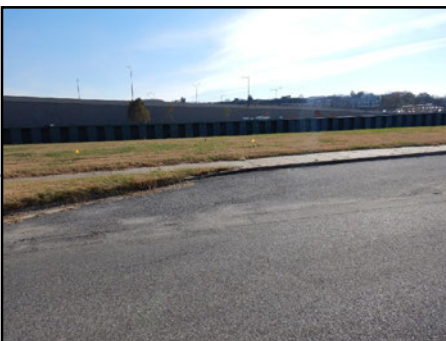
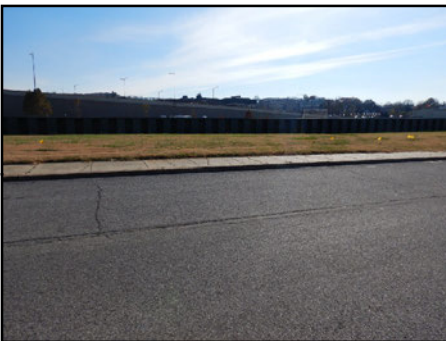
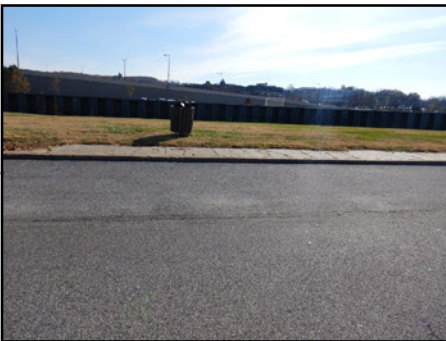
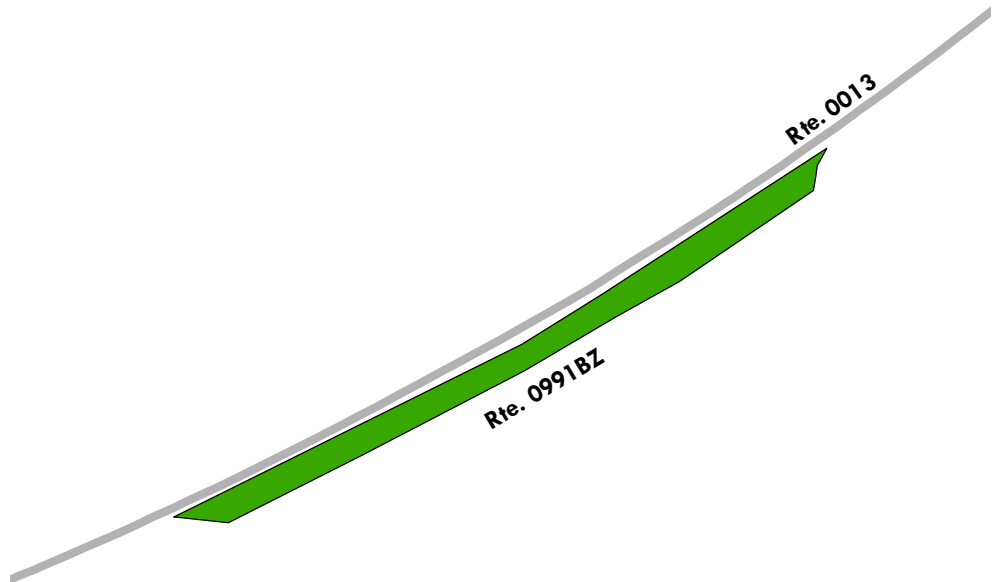
ROUTE 0991BZ: ANACOSTIA DRIVE PULLOFF AREA B

Inspection Date	FMSS Number	User Access	Surface Type
11/29/2018	252463	PUBLIC	ASPHALT
Area (Sq. Ft.)	Lane Miles (11' Widths)	Curb Reveal (Inches)	Curb Recommendation
2,449	0.042	NOT APPLICABLE	DO NOTHING
Curb Type		Curb & Gutter Type	
NO CURB		CONCRETE	
Pavement Recommendation		Condition Rating / PCR	
PREVENTIVE MAINTENANCE		GOOD / 90

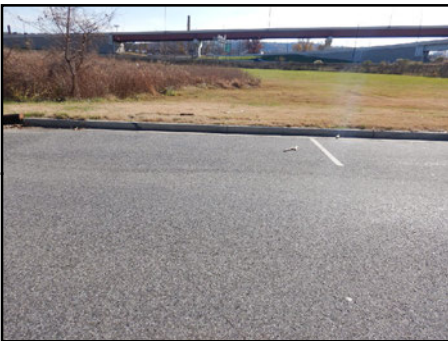
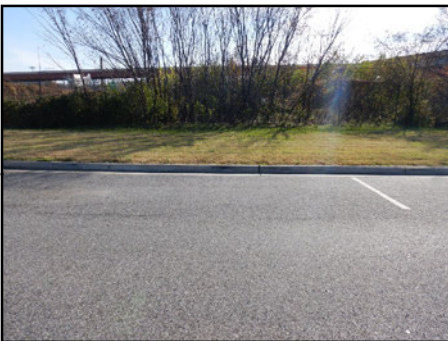
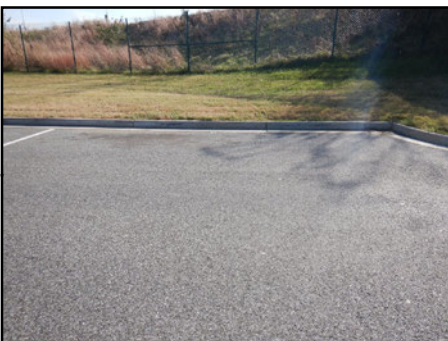
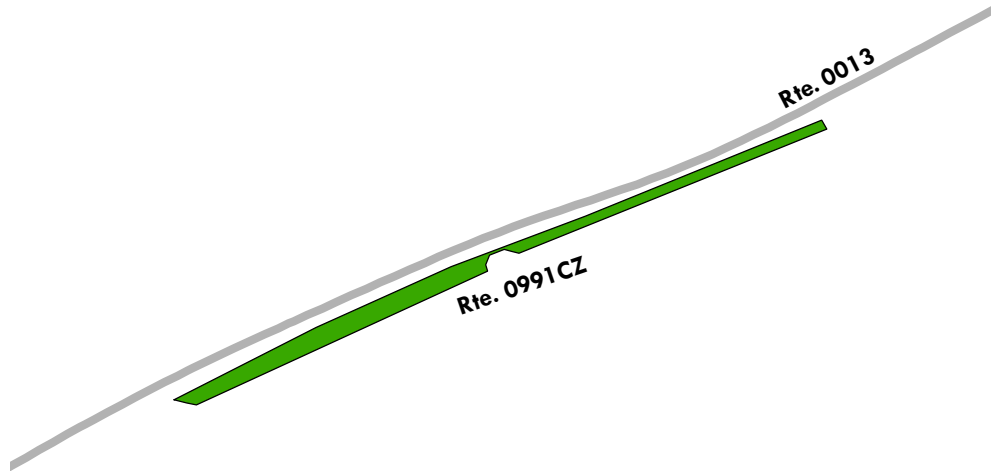
ROUTE 0991CZ: ANACOSTIA DRIVE PULLOFF AREA C

Inspection Date	FMSS Number	User Access	Surface Type
11/29/2018	252463	PUBLIC	ASPHALT
Area (Sq. Ft.)	Lane Miles (11' Widths)	Curb Reveal (Inches)	Curb Recommendation
2,431	0.042	NOT APPLICABLE	DO NOTHING
Curb Type		Curb & Gutter Type	
NO CURB		CONCRETE	
Pavement Recommendation		Condition Rating / PCR	
PREVENTIVE MAINTENANCE		GOOD / 90

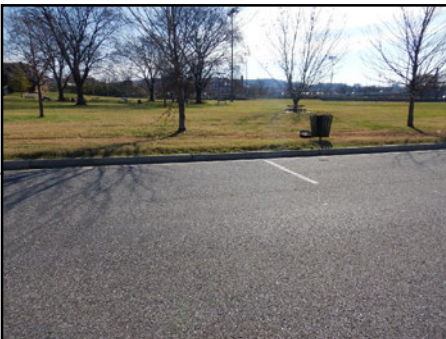
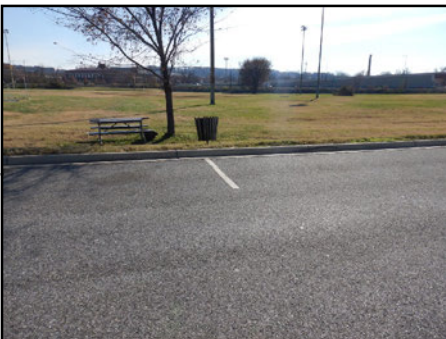
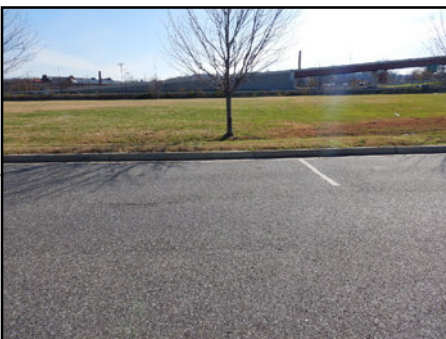
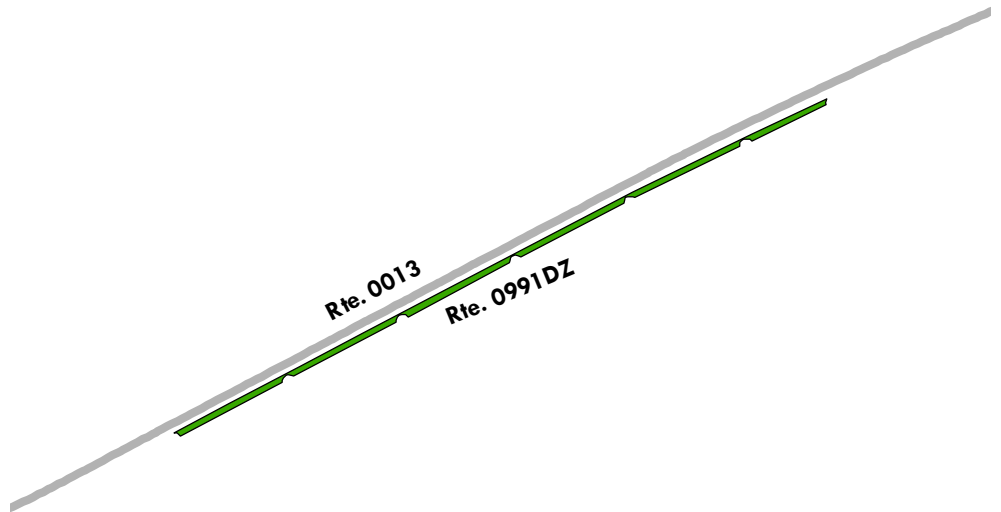
ROUTE 0991DZ: ANACOSTIA DRIVE PULLOFF AREA D

Inspection Date	FMSS Number	User Access	Surface Type
11/29/2018	252463	PUBLIC	ASPHALT
Area (Sq. Ft.)	Lane Miles (11' Widths)	Curb Reveal (Inches)	Curb Recommendation
7,964	0.137	NOT APPLICABLE	DO NOTHING
Curb Type		Curb & Gutter Type	
NO CURB		CONCRETE	
Pavement Recommendation		Condition Rating / PCR	
PREVENTIVE MAINTENANCE		GOOD / 90

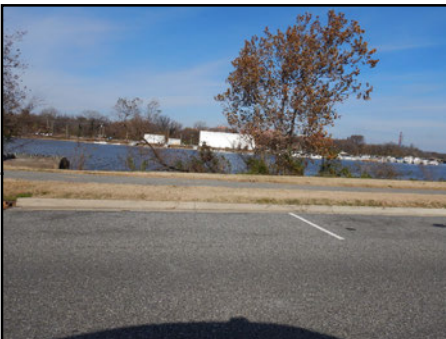
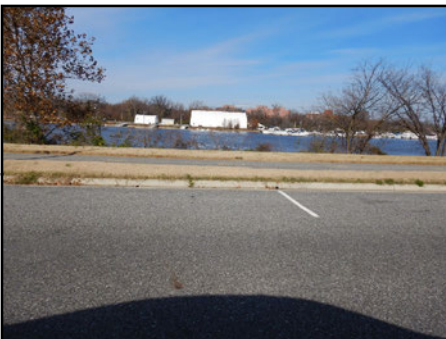
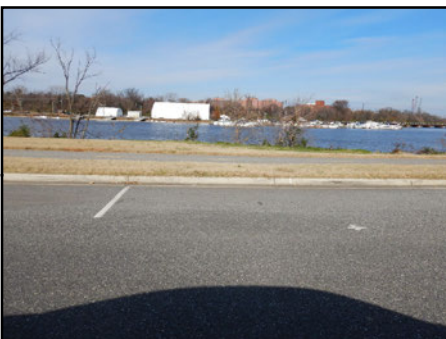
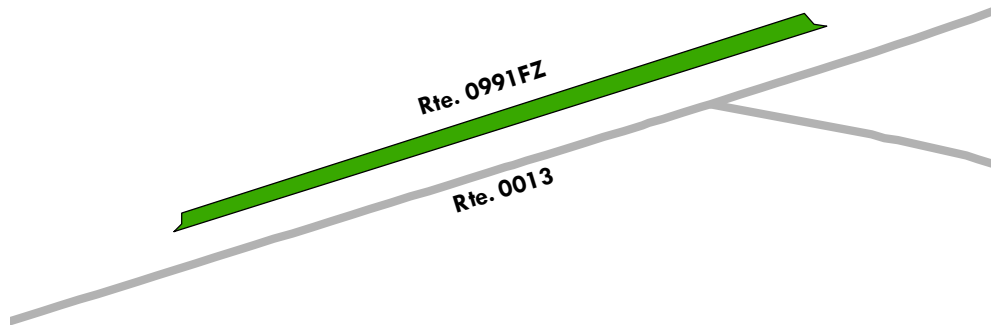
ROUTE 0991FZ: ANACOSTIA DRIVE PULLOFF AREA F

Inspection Date	FMSS Number	User Access	Surface Type
11/29/2018	252463	PUBLIC	ASPHALT
Area (Sq. Ft.)	Lane Miles (11' Widths)	Curb Reveal (Inches)	Curb Recommendation
1,830	0.032	NOT APPLICABLE	DO NOTHING
Curb Type		Curb & Gutter Type	
NO CURB		CONCRETE	
Pavement Recommendation		Condition Rating / PCR	
PREVENTIVE MAINTENANCE		GOOD / 90
