ORPI Cycle 6

Final Report

Road Inventory and Condition Assessment of Paved Routes Organ Pipe Cactus National Monument

Report Date: July 2017

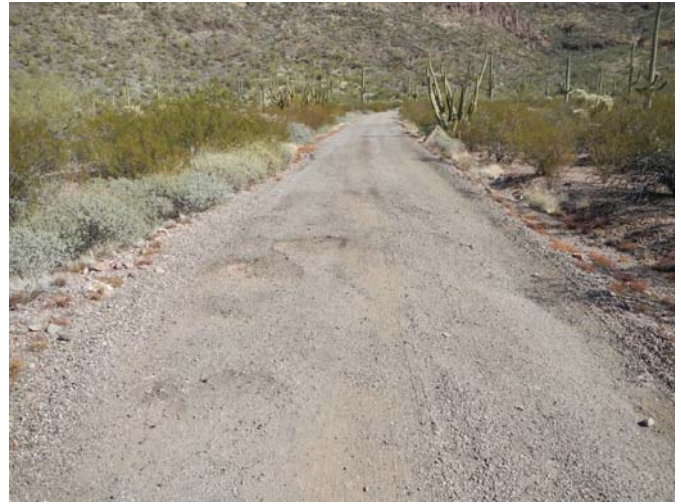
ORPI_0011_MP 5.76-5.86_3152.JPG

Condition Photos Section 10 (5.76 MP To 5.86 MP)

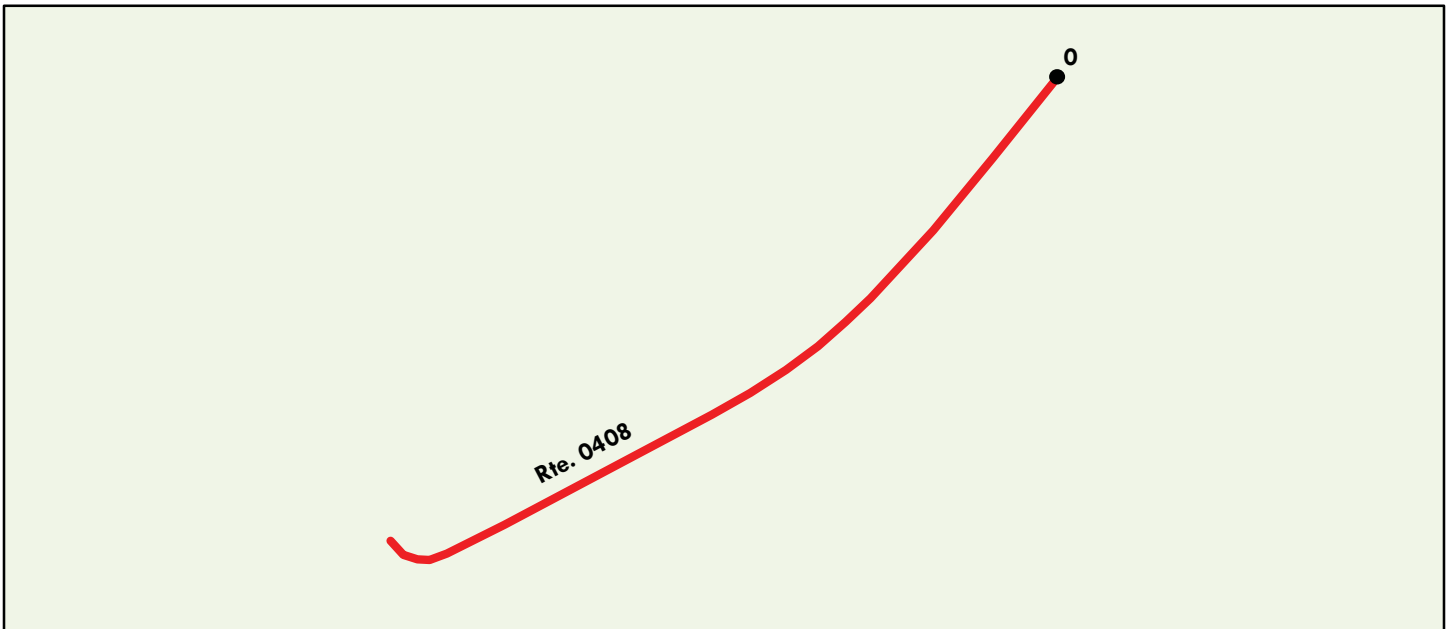
ROUTE 0408: 100 K WATER TANK ROAD

Route Condition Legend – Pavement Condition Rating (PCR)						
Poor (0 - 60)	Fair (61- 84)	Good (85 - 94)	Excellent (95 - 100)	Not Rated		
See Appendix for definitions and formulas						
Inspection Date: 1/25/2016	Beginning Section MP	0.00				
Paved Length (Miles): 0.10	Section Length (MI)	0.10				
Surface Type: ASPHALT	Route Summary					
Roadway Condition Information						
Pavement Condition Rating (PCR)	53	53				
Surface Condition Rating (SCR)	53	53				
Roughness Condition Index (RCI)	N/A	N/A				
Distress Index Values						
Structural Crack Index	N/A	N/A				
Alligator Crack Index	73	73				
Longitudinal Crack Index	53	53				
Transverse Cracking Index	53	53				
Patching Index	73	73				
Rutting Index	90	90				
International Roughness Index (IRI)	N/A	N/A				
Lane & Width Information						
Number of Lanes	1	1				
Paved Width (ft)	13	13				
Lane Width (ft)	13	13

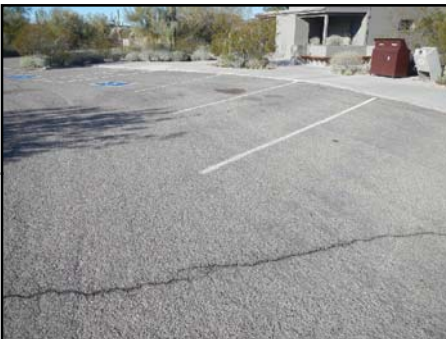
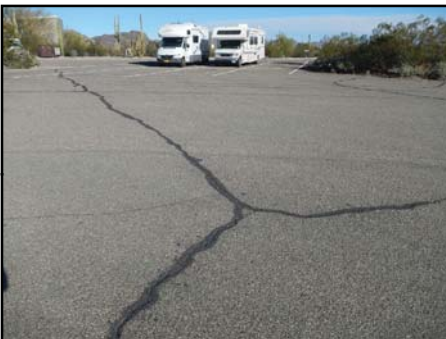
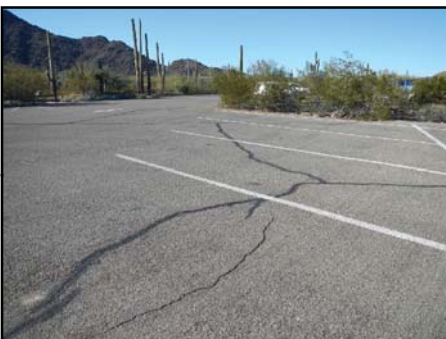
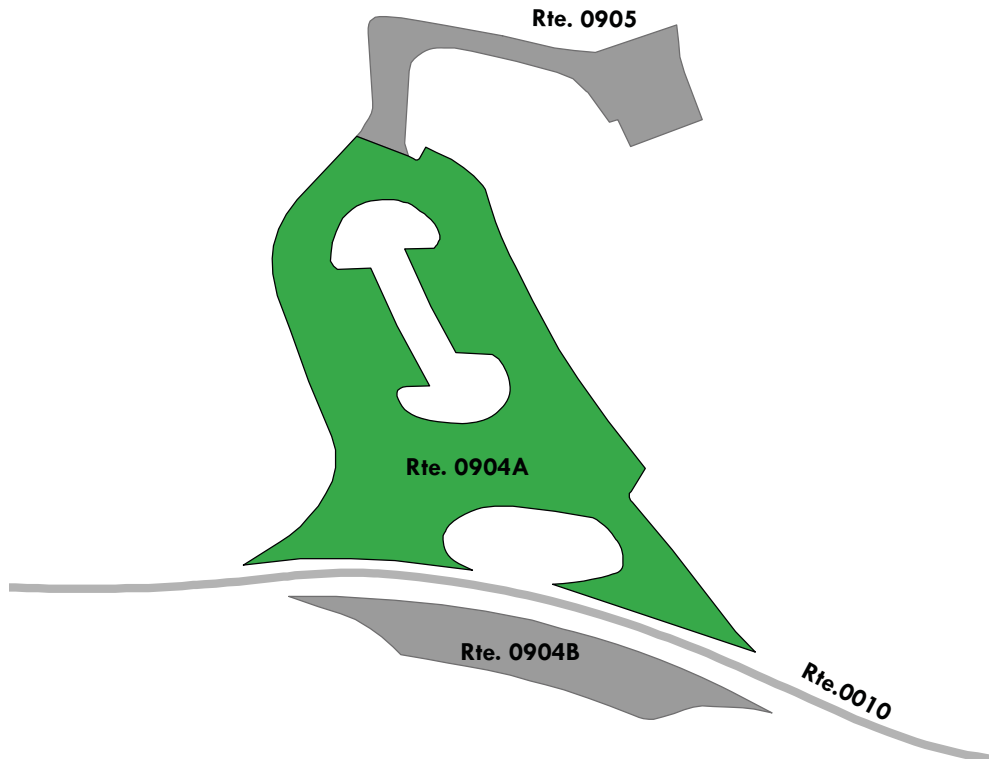
ROUTE 0904A: VISITOR CENTER PARKING A

Inspection Date	FMSS Number	User Access	Surface Type
1/25/2016	72424	PUBLIC	ASPHALT
Area (Sq. Ft.)	Lane Miles (11' Widths)	Curb Reveal (Inches)	Curb Recommendation
36,266	0.624	5	DO NOTHING
Curb Type		Curb & Gutter Type	
CONCRETE		NO CURB AND GUTTER	
Pavement Recommendation		Condition Rating / PCR	
PREVENTIVE MAINTENANCE		GOOD / 90

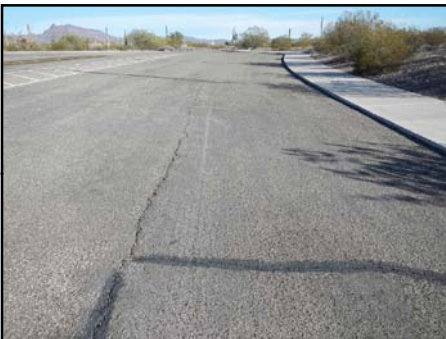
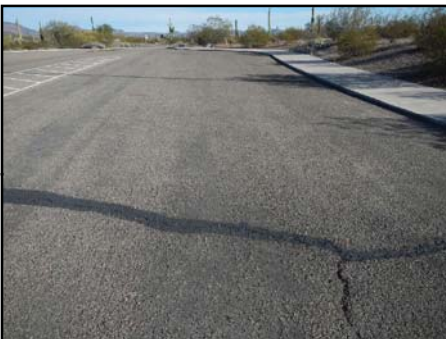
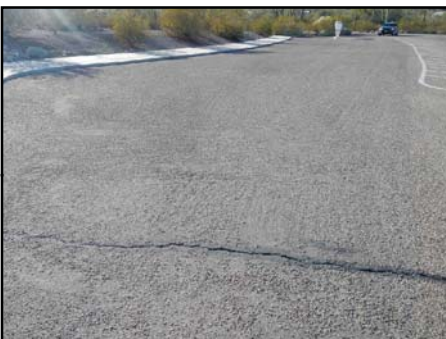
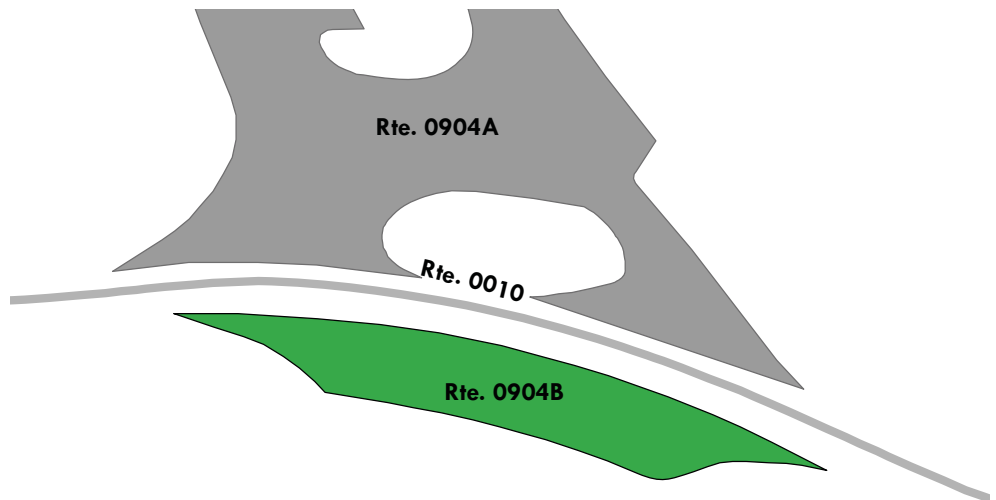
ROUTE 0904B: VISITOR CENTER PARKING B

Inspection Date	FMSS Number	User Access	Surface Type
1/25/2016	105672	PUBLIC	ASPHALT
Area (Sq. Ft.)	Lane Miles (11' Widths)	Curb Reveal (Inches)	Curb Recommendation
8,145	0.14	5	DO NOTHING
Curb Type		Curb & Gutter Type	
CONCRETE		NO CURB AND GUTTER	
Pavement Recommendation		Condition Rating / PCR	
PREVENTIVE MAINTENANCE		GOOD / 90

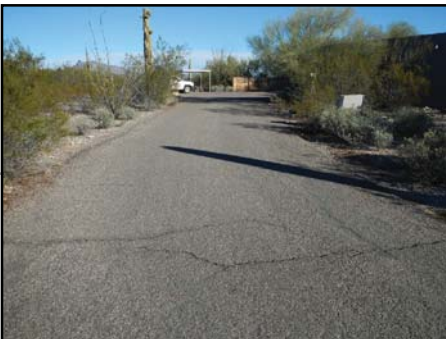
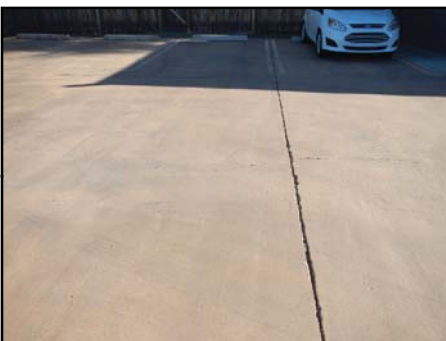
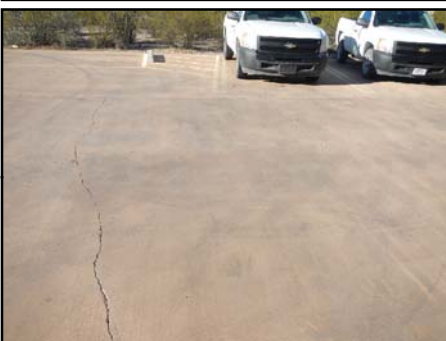
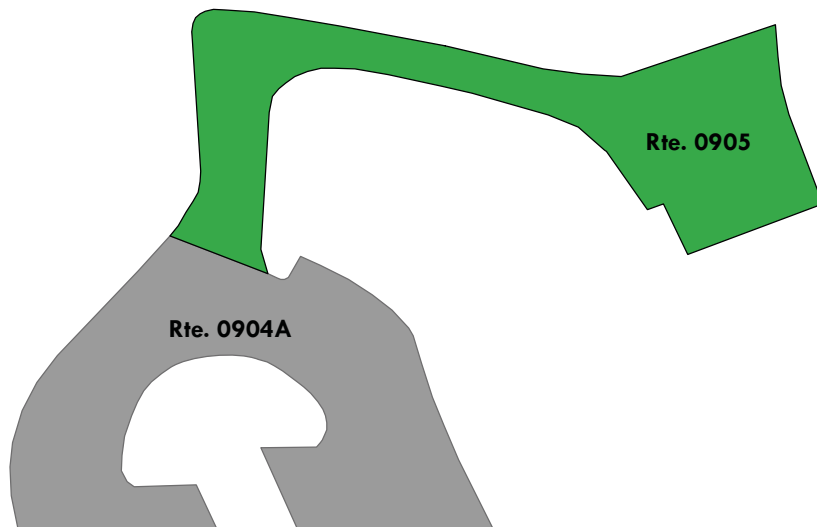
ROUTE 0905: OFFICE PARKING

Inspection Date	FMSS Number	User Access	Surface Type
1/25/2016	102991	NONPUBLIC	ASPHALT
Area (Sq. Ft.)	Lane Miles (11' Widths)	Curb Reveal (Inches)	Curb Recommendation
7,277	0.125	NOT APPLICABLE	NOT APPLICABLE
Curb Type		Curb & Gutter Type	
NO CURB		NO CURB AND GUTTER	
Pavement Recommendation		Condition Rating / PCR	
PREVENTIVE MAINTENANCE		GOOD / 90

Note: Parking area consists of multiple surface types: 1 part Asphalt at 3,817 square feet; 1 part Concrete at 3,460 square feet.

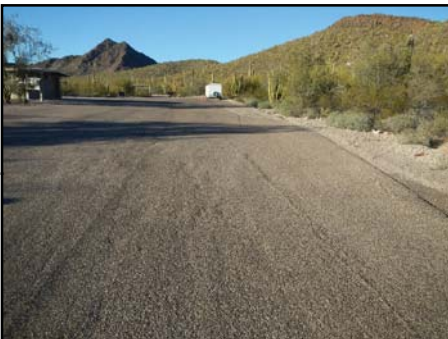
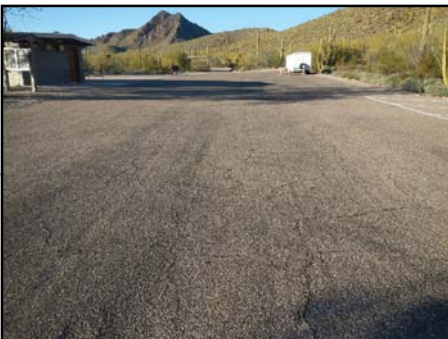
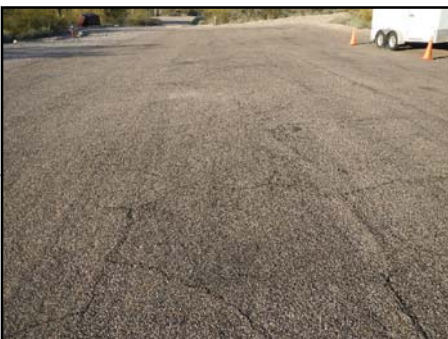
ROUTE 0906: GROUP CAMPGROUND PARKING

Inspection Date	FMSS Number	User Access	Surface Type
1/25/2016	102987	PUBLIC	ASPHALT
Area (Sq. Ft.)	Lane Miles (11' Widths)	Curb Reveal (Inches)	Curb Recommendation
12,611	0.217	NOT APPLICABLE	NOT APPLICABLE
Curb Type		Curb & Gutter Type	
NO CURB		NO CURB AND GUTTER	
Pavement Recommendation		Condition Rating / PCR	
HEAVY 3R TREATMENTS		POOR / 53

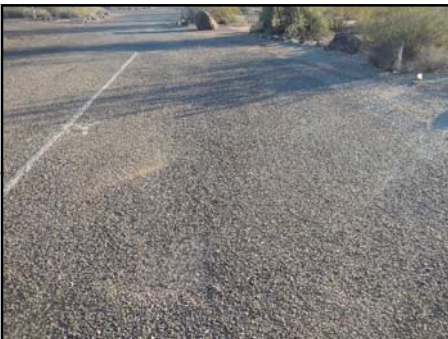
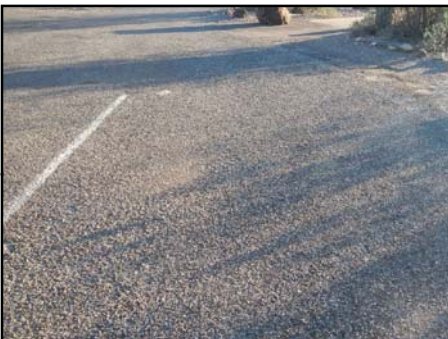
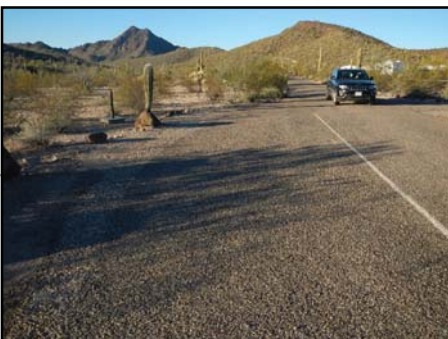
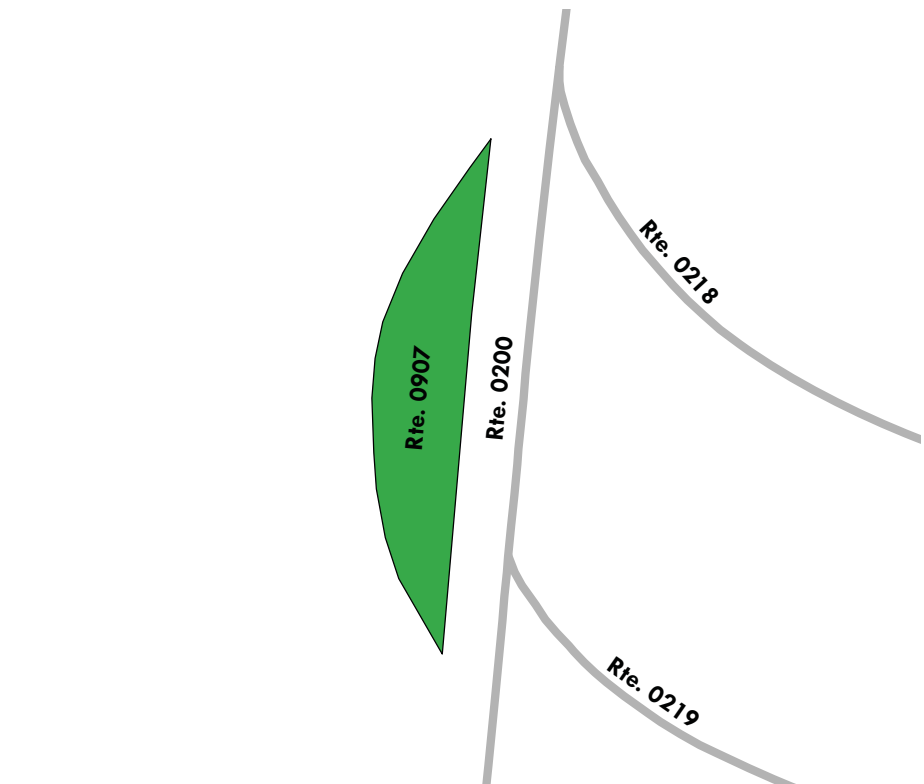
ROUTE 0907: CAMPGROUND PARKING

Inspection Date	FMSS Number	User Access	Surface Type
1/25/2016	102774	PUBLIC	ASPHALT
Area (Sq. Ft.)	Lane Miles (11' Widths)	Curb Reveal (Inches)	Curb Recommendation
995	0.017	NOT APPLICABLE	NOT APPLICABLE
Curb Type		Curb & Gutter Type	
NO CURB		NO CURB AND GUTTER	
Pavement Recommendation		Condition Rating / PCR	
PREVENTIVE MAINTENANCE		GOOD / 90

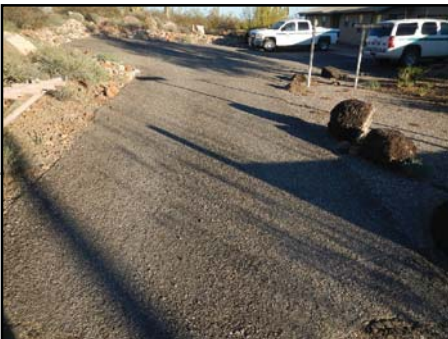
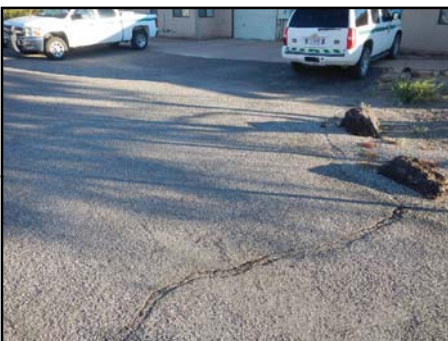
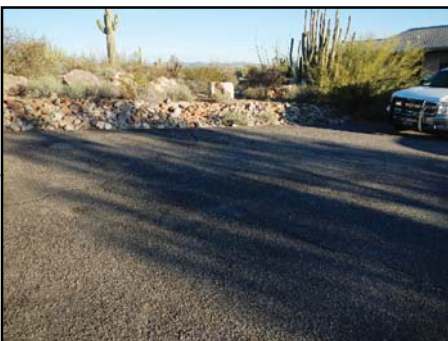
ROUTE 0909: CAMPGROUND HOUSING PARKING

Inspection Date	FMSS Number	User Access	Surface Type
1/25/2016	102773	NONPUBLIC	ASPHALT
Area (Sq. Ft.)	Lane Miles (11' Widths)	Curb Reveal (Inches)	Curb Recommendation
2,638	0.045	NOT APPLICABLE	NOT APPLICABLE
Curb Type		Curb & Gutter Type	
NO CURB		NO CURB AND GUTTER	
Pavement Recommendation		Condition Rating / PCR	
PREVENTIVE MAINTENANCE		GOOD / 90

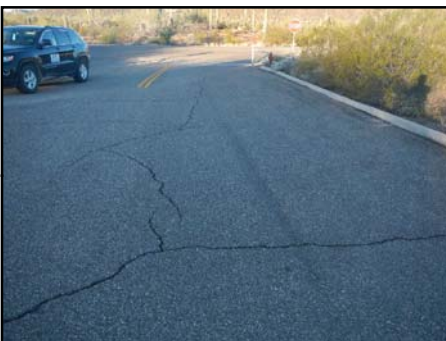
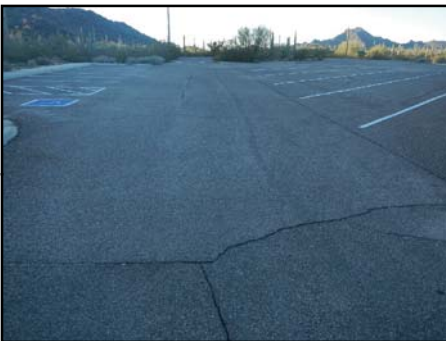
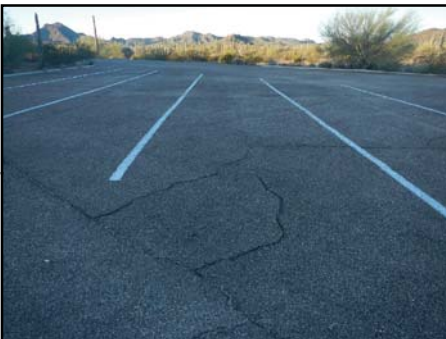
ROUTE 0910: TILLOTSON PEAK WAYSIDE PARKING

Inspection Date	FMSS Number	User Access	Surface Type
1/26/2016	109708	PUBLIC	ASPHALT
Area (Sq. Ft.)	Lane Miles (11' Widths)	Curb Reveal (Inches)	Curb Recommendation
28,505	0.491	7	DO NOTHING
Curb Type		Curb & Gutter Type	
CONCRETE		NO CURB AND GUTTER	
Pavement Recommendation		Condition Rating / PCR	
PREVENTIVE MAINTENANCE		GOOD / 90

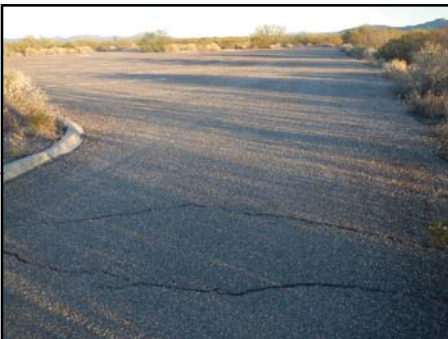
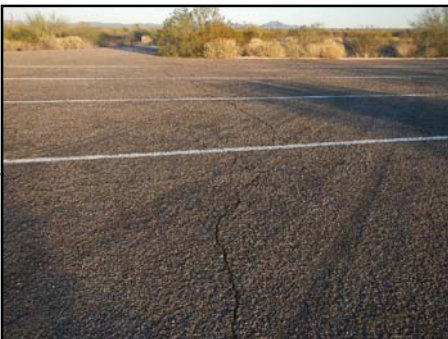
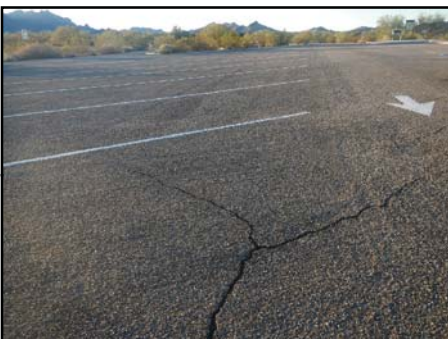
ROUTE 0911: AJO MOUNTAINS WAYSIDE PARKING

Inspection Date	FMSS Number	User Access	Surface Type
1/26/2016	109712	PUBLIC	ASPHALT
Area (Sq. Ft.)	Lane Miles (11' Widths)	Curb Reveal (Inches)	Curb Recommendation
30,415	0.524	7	DO NOTHING
Curb Type		Curb & Gutter Type	
CONCRETE		NO CURB AND GUTTER	
Pavement Recommendation		Condition Rating / PCR	
PREVENTIVE MAINTENANCE		GOOD / 90

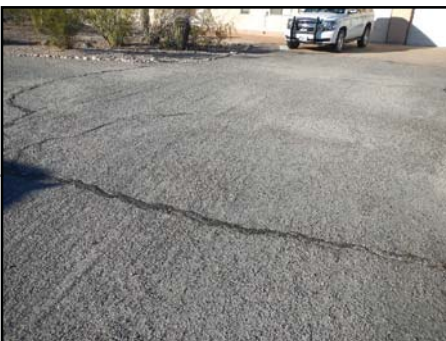
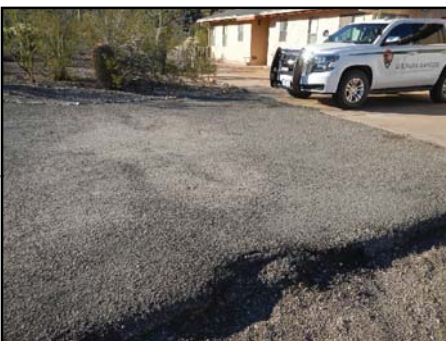
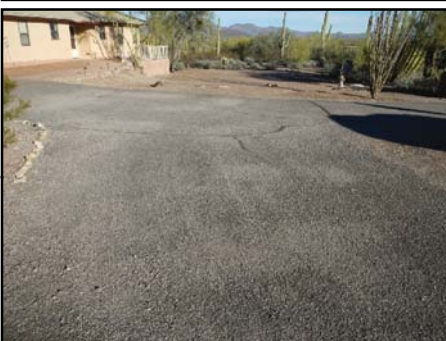
ROUTE 0912: HOUSING AREA DUPLEX HOUSING PARKING

Inspection Date	FMSS Number	User Access	Surface Type
1/25/2016	115987	NONPUBLIC	ASPHALT
Area (Sq. Ft.)	Lane Miles (11' Widths)	Curb Reveal (Inches)	Curb Recommendation
1,747	0.03	NOT APPLICABLE	NOT APPLICABLE
Curb Type		Curb & Gutter Type	
NO CURB		NO CURB AND GUTTER	
Pavement Recommendation		Condition Rating / PCR	
PREVENTIVE MAINTENANCE		GOOD / 90
