# PAIS Cycle 6

### Road Inventory and Condition Assessment of Paved Routes Padre Island National Seashore

Federal Highway Administration  
Eastern Federal Lands Highway Division  
Road Inventory Program (RIP)

Report Date: July 2017

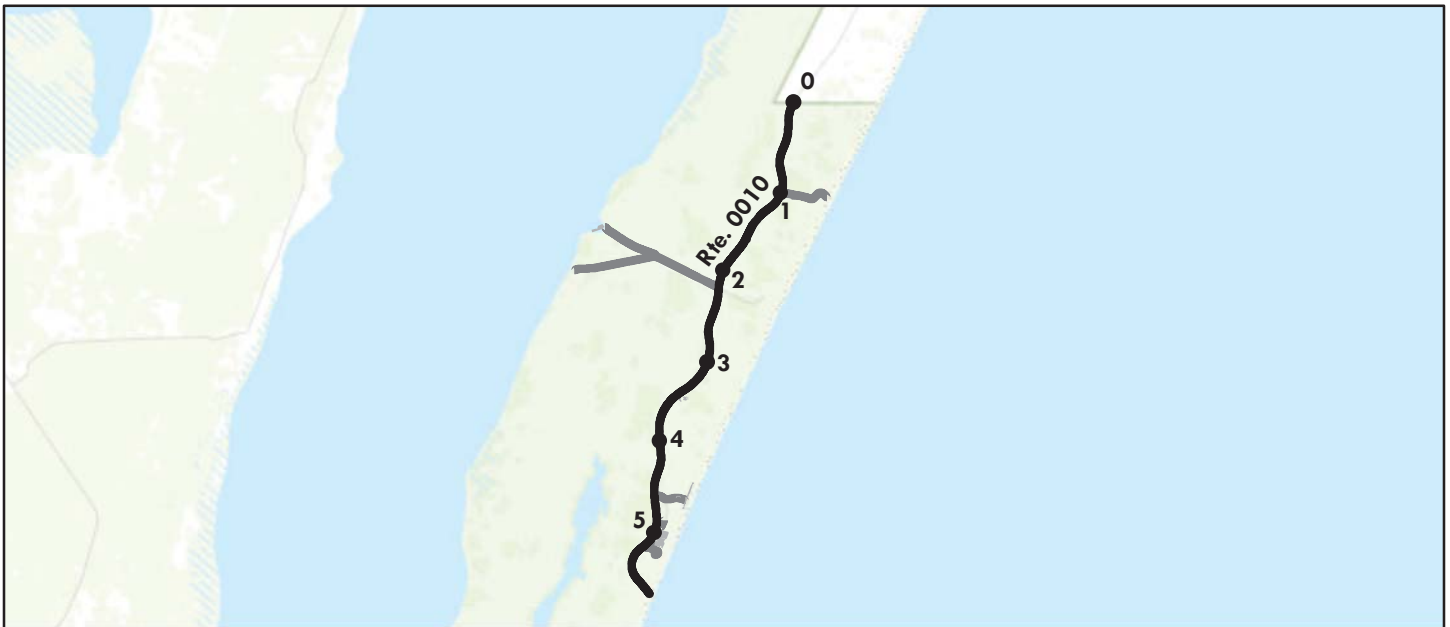
## ROUTE 0010: PARK ROAD

Route Condition Legend – Pavement Condition Rating (PCR)						
Poor (0 - 60)	Fair (61- 84)	Good (85 - 94)	Excellent (95 - 100)	Not Rated		
See Appendix for definitions and formulas						
<b>Inspection Date:</b> 2/19/2017	<b>Beginning Section MP</b>	0	1	2	3	4
<b>Paved Length (Miles):</b> 5.77	<b>Section Length (MI)</b>	1	1	1	1	1
<b>Surface Type:</b> ASPHALT	<b>Route Summary</b>					
<b>Roadway Condition Information</b>						
Pavement Condition Rating (PCR)	N/A	N/A	N/A	N/A	N/A	N/A
Surface Condition Rating (SCR)	N/A	N/A	N/A	N/A	N/A	N/A
Roughness Condition Index (RCI)	N/A	N/A	N/A	N/A	N/A	N/A
<b>Distress Index Values</b>						
Structural Crack Index	N/A	N/A	N/A	N/A	N/A	N/A
Alligator Crack Index	N/A	N/A	N/A	N/A	N/A	N/A
Longitudinal Crack Index	N/A	N/A	N/A	N/A	N/A	N/A
Transverse Cracking Index	N/A	N/A	N/A	N/A	N/A	N/A
Patching Index	N/A	N/A	N/A	N/A	N/A	N/A
Rutting Index	N/A	N/A	N/A	N/A	N/A	N/A
International Roughness Index (IRI)	N/A	N/A	N/A	N/A	N/A	N/A

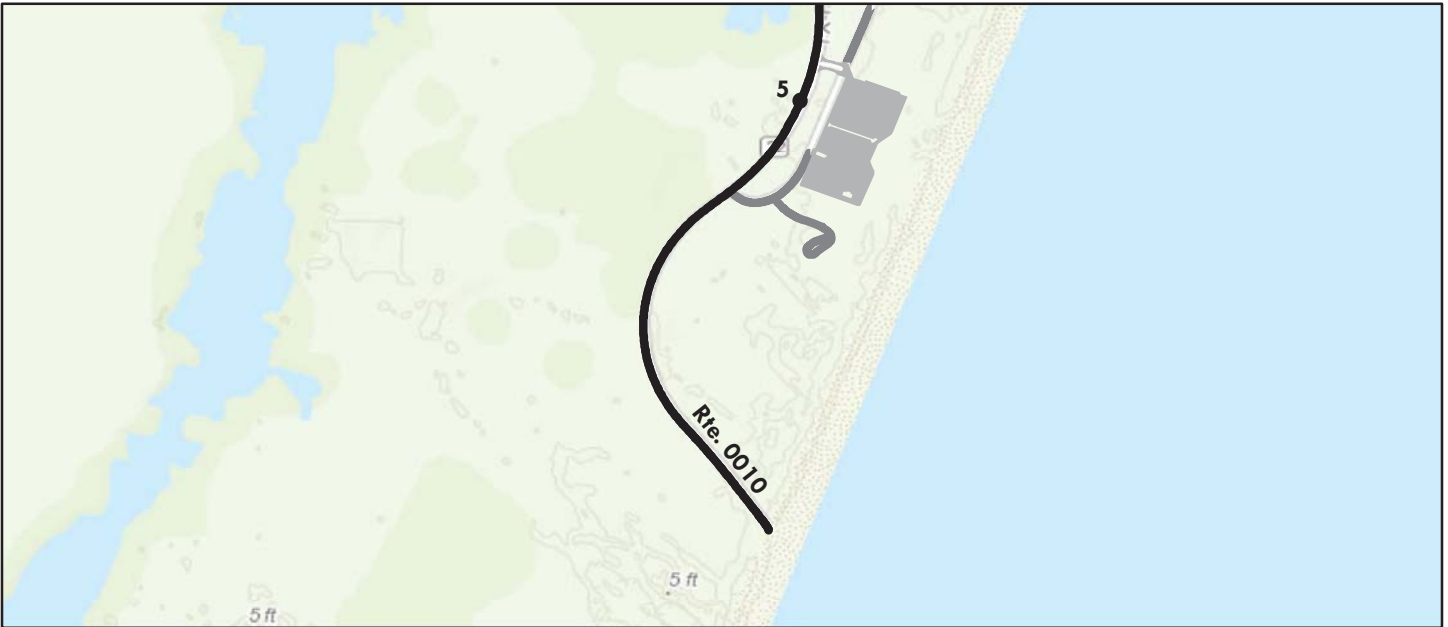
## ROUTE 0010: PARK ROAD

Route Condition Legend – Pavement Condition Rating (PCR)						
Poor (0 - 60)	Fair (61- 84)	Good (85 - 94)	Excellent (95 - 100)	Not Rated		
See Appendix for definitions and formulas						
<b>Inspection Date:</b> 2/19/2017	<b>Beginning Section MP</b>	5				
<b>Paved Length (Miles):</b> 5.77	<b>Section Length (MI)</b>	0.77				
<b>Surface Type:</b> ASPHALT	<b>Route Summary</b>					
<b>Roadway Condition Information</b>						
Pavement Condition Rating (PCR)	N/A	N/A				
Surface Condition Rating (SCR)	N/A	N/A				
Roughness Condition Index (RCI)	N/A	N/A				
<b>Distress Index Values</b>						
Structural Crack Index	N/A	N/A				
Alligator Crack Index	N/A	N/A				
Longitudinal Crack Index	N/A	N/A				
Transverse Cracking Index	N/A	N/A				
Patching Index	N/A	N/A				
Rutting Index	N/A	N/A				
International Roughness Index (IRI)	N/A	N/A				
<b>Lane &amp; Width Information</b>						
Number of Lanes	2	2				
Paved Width (ft)	26.9

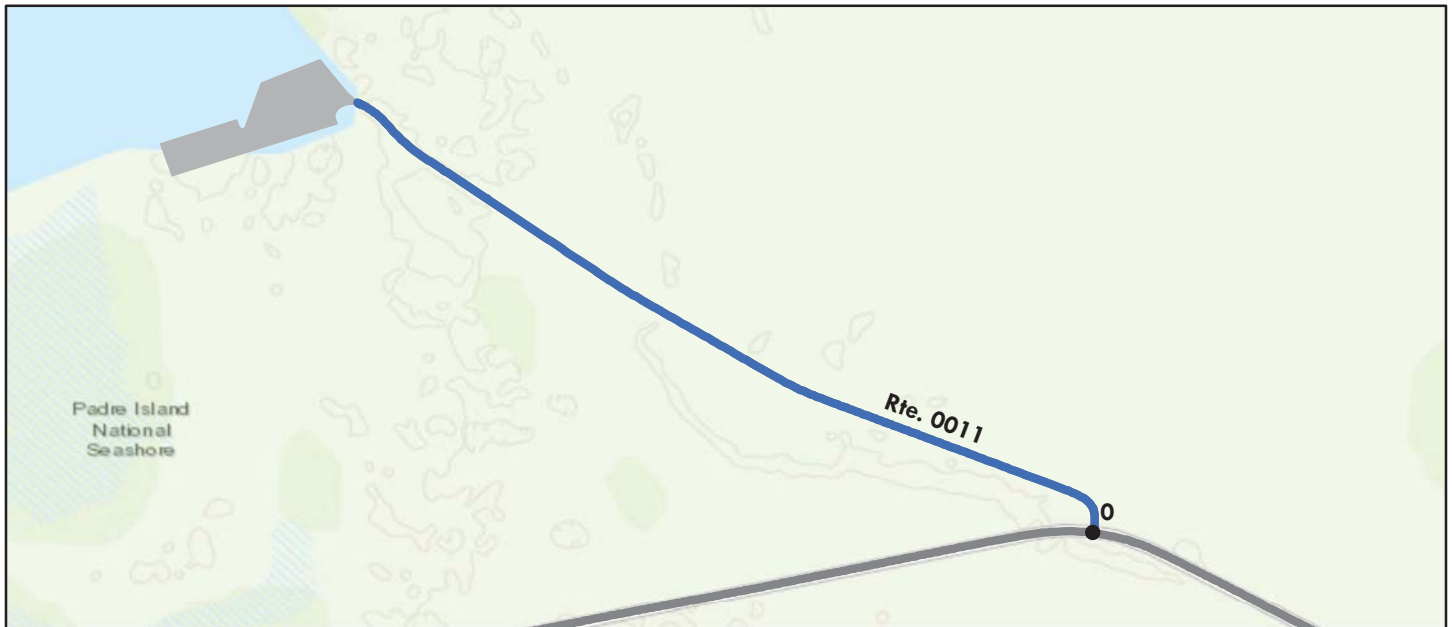
## ROUTE 0011: BOAT RAMP ROAD

Route Condition Legend – Pavement Condition Rating (PCR)						
Poor (0 - 60)	Fair (61- 84)	Good (85 - 94)	Excellent (95 - 100)	Not Rated		
See Appendix for definitions and formulas						
<b>Inspection Date:</b> 2/19/2017	<b>Beginning Section MP</b>	0				
<b>Paved Length (Miles):</b> 0.59	<b>Section Length (MI)</b>	0.59				
<b>Surface Type:</b> ASPHALT	<b>Route Summary</b>					
<b>Roadway Condition Information</b>						
Pavement Condition Rating (PCR)	100	100				
Surface Condition Rating (SCR)	100	100				
Roughness Condition Index (RCI)	N/A	N/A				
<b>Distress Index Values</b>						
Structural Crack Index	100	100				
Alligator Crack Index	100	100				
Longitudinal Crack Index	100	100				
Transverse Cracking Index	100	100				
Patching Index	100	100				
Rutting Index	100	100				
International Roughness Index (IRI)	N/A	N/A				
<b>Lane &amp; Width Information</b>						
Number of Lanes	2	2				
Paved Width (ft)	20.8	20.8

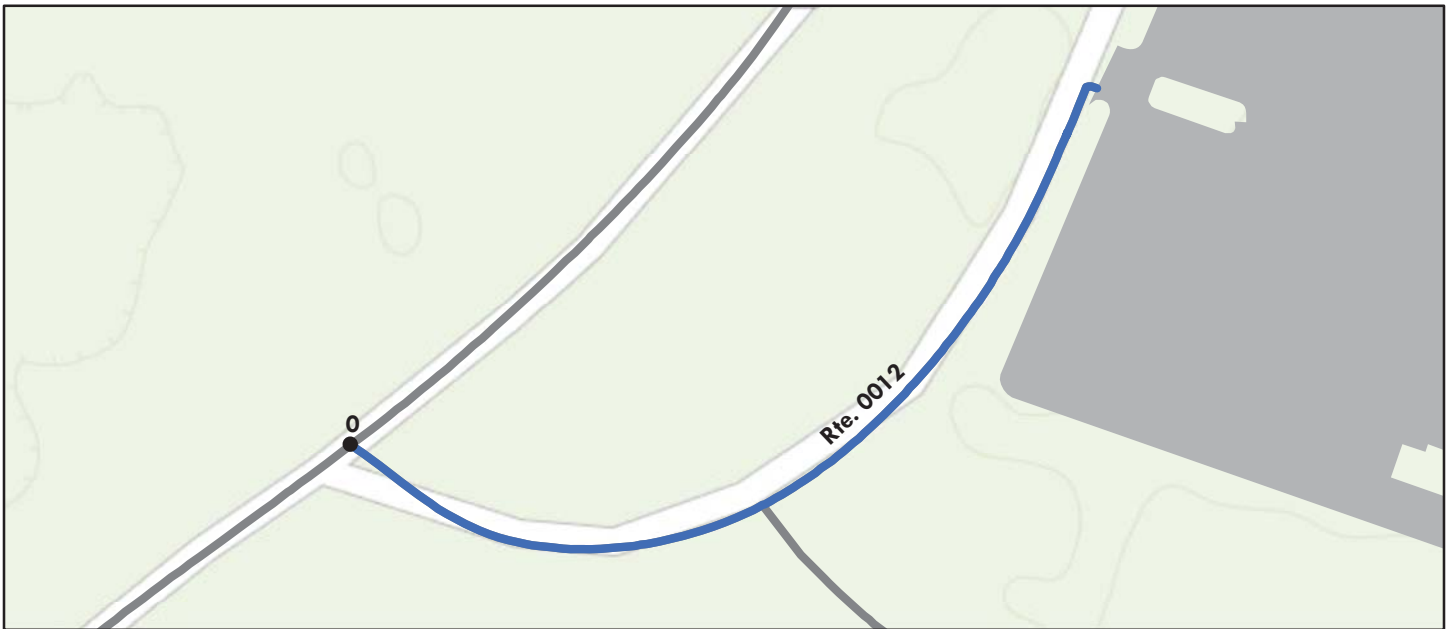
## ROUTE 0012: SOUTH MALAQUITE VISITOR CENTER ROAD

<b>Route Condition Legend – Pavement Condition Rating (PCR)</b>						
<b>Poor (0 - 60)</b>	<b>Fair (61- 84)</b>	<b>Good (85 - 94)</b>	<b>Excellent (95 - 100)</b>	<b>Not Rated</b>		
See Appendix for definitions and formulas						
<b>Inspection Date:</b> 2/19/2017	<b>Beginning Section MP</b>	0				
<b>Paved Length (Miles):</b> 0.15	<b>Section Length (MI)</b>	0.15				
<b>Surface Type:</b> ASPHALT	<b>Route Summary</b>					
<b>Roadway Condition Information</b>						
Pavement Condition Rating (PCR)	97	97				
Surface Condition Rating (SCR)	97	97				
Roughness Condition Index (RCI)	N/A	N/A				
<b>Distress Index Values</b>						
Structural Crack Index	99	99				
Alligator Crack Index	100	100				
Longitudinal Crack Index	99	99				
Transverse Cracking Index	99	99				
Patching Index	100	100				
Rutting Index	97	97				
International Roughness Index (IRI)	N/A	N/A				
<b>Lane &amp; Width Information</b>						
Number of Lanes	2	2

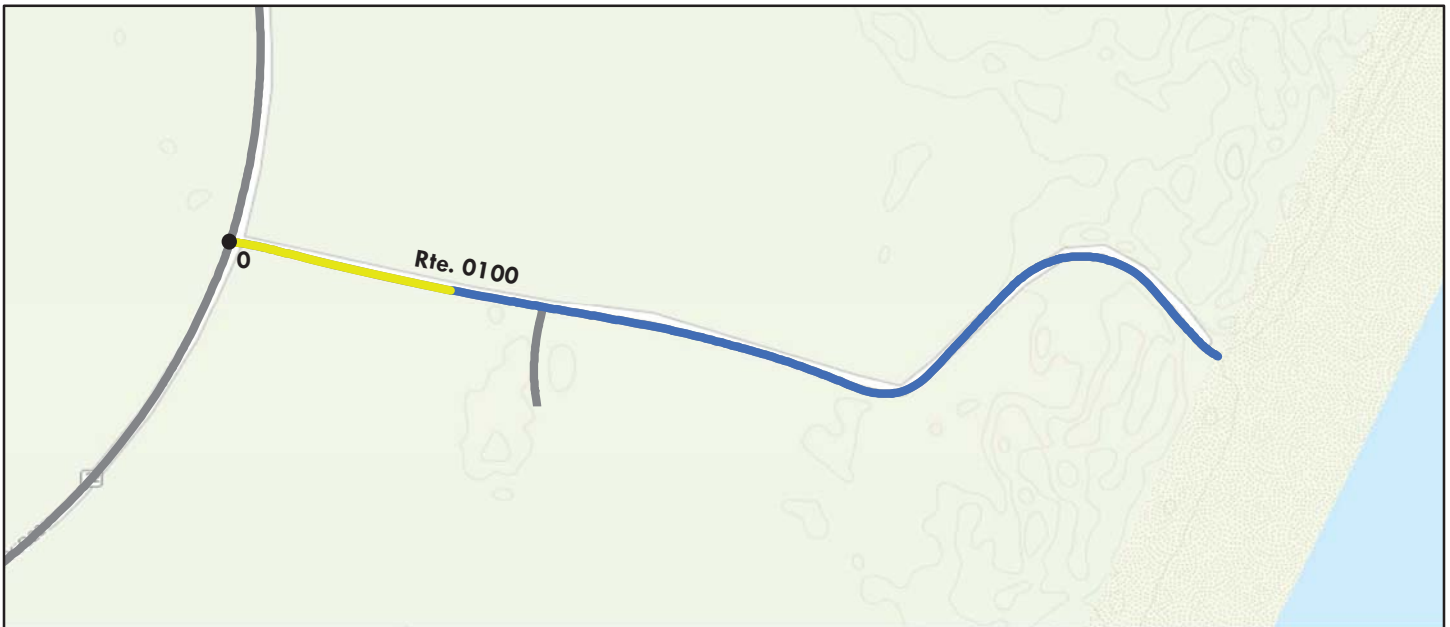
## ROUTE 0100: NORTH BEACH ACCESS ROAD

Route Condition Legend – Pavement Condition Rating (PCR)						
Poor (0 - 60)	Fair (61- 84)	Good (85 - 94)	Excellent (95 - 100)	Not Rated		
See Appendix for definitions and formulas						
<b>Inspection Date:</b> 2/19/2017	<b>Beginning Section MP</b>	0				
<b>Paved Length (Miles):</b> 0.49	<b>Section Length (MI)</b>	0.49				
<b>Surface Type:</b> ASPHALT	<b>Route Summary</b>					
<b>Roadway Condition Information</b>						
Pavement Condition Rating (PCR)	95	95				
Surface Condition Rating (SCR)	95	95				
Roughness Condition Index (RCI)	N/A	N/A				
<b>Distress Index Values</b>						
Structural Crack Index	100	100				
Alligator Crack Index	100	100				
Longitudinal Crack Index	100	100				
Transverse Cracking Index	99	99				
Patching Index	100	100				
Rutting Index	95	95				
International Roughness Index (IRI)	N/A	N/A				
<b>Lane &amp; Width Information</b>						
Number of Lanes	2	2				
Paved Width (ft)	24.3	24.3

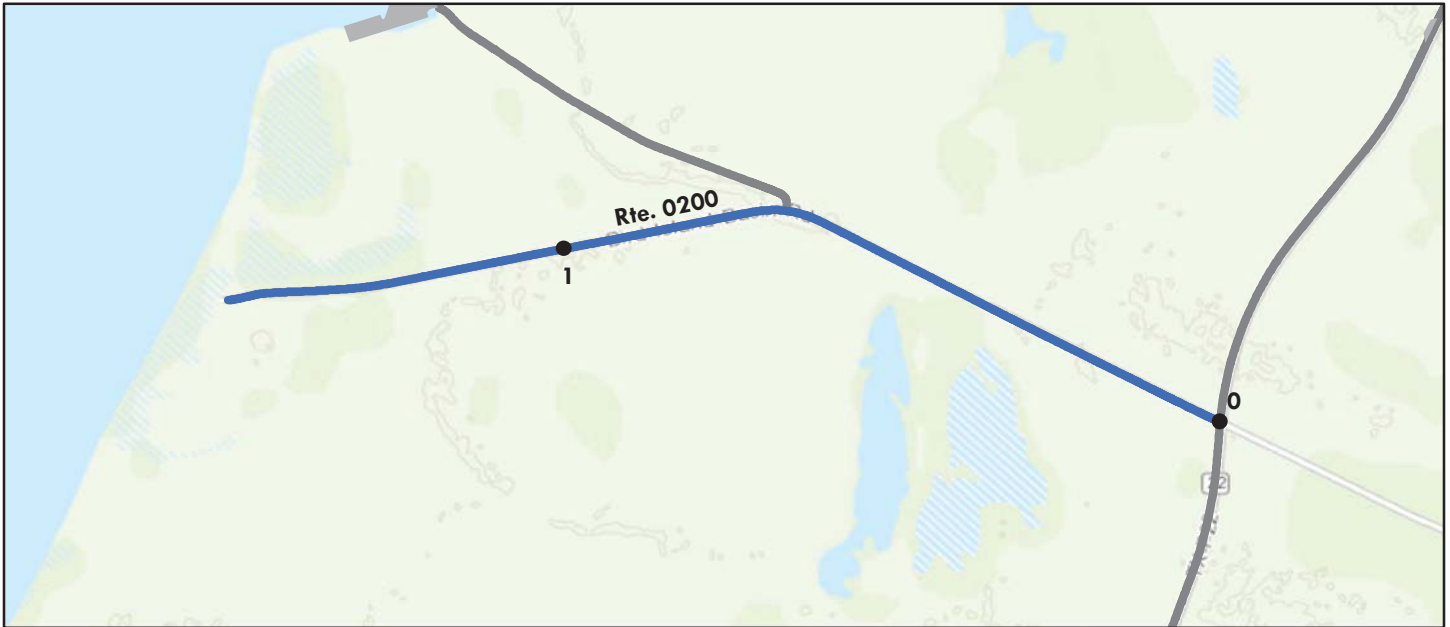
## ROUTE 0200: BIRD ISLAND BASIN ROAD

Route Condition Legend – Pavement Condition Rating (PCR)						
Poor (0 - 60)	Fair (61- 84)	Good (85 - 94)	Excellent (95 - 100)	Not Rated		
See Appendix for definitions and formulas						
<b>Inspection Date:</b> 2/19/2017	<b>Beginning Section MP</b>	0	1			
<b>Paved Length (Miles):</b> 1.47	<b>Section Length (MI)</b>	1	0.47			
<b>Surface Type:</b> ASPHALT	<b>Route Summary</b>					
<b>Roadway Condition Information</b>						
Pavement Condition Rating (PCR)	100	99	100			
Surface Condition Rating (SCR)	100	99	100			
Roughness Condition Index (RCI)	100	100	100			
<b>Distress Index Values</b>						
Structural Crack Index	100	100	100			
Alligator Crack Index	100	100	100			
Longitudinal Crack Index	100	100	100			
Transverse Cracking Index	100	100	100			
Patching Index	100	100	100			
Rutting Index	100	99	100			
International Roughness Index (IRI)	60	57	66			
<b>Lane &amp; Width Information</b>						
Number of Lanes	2	2	2

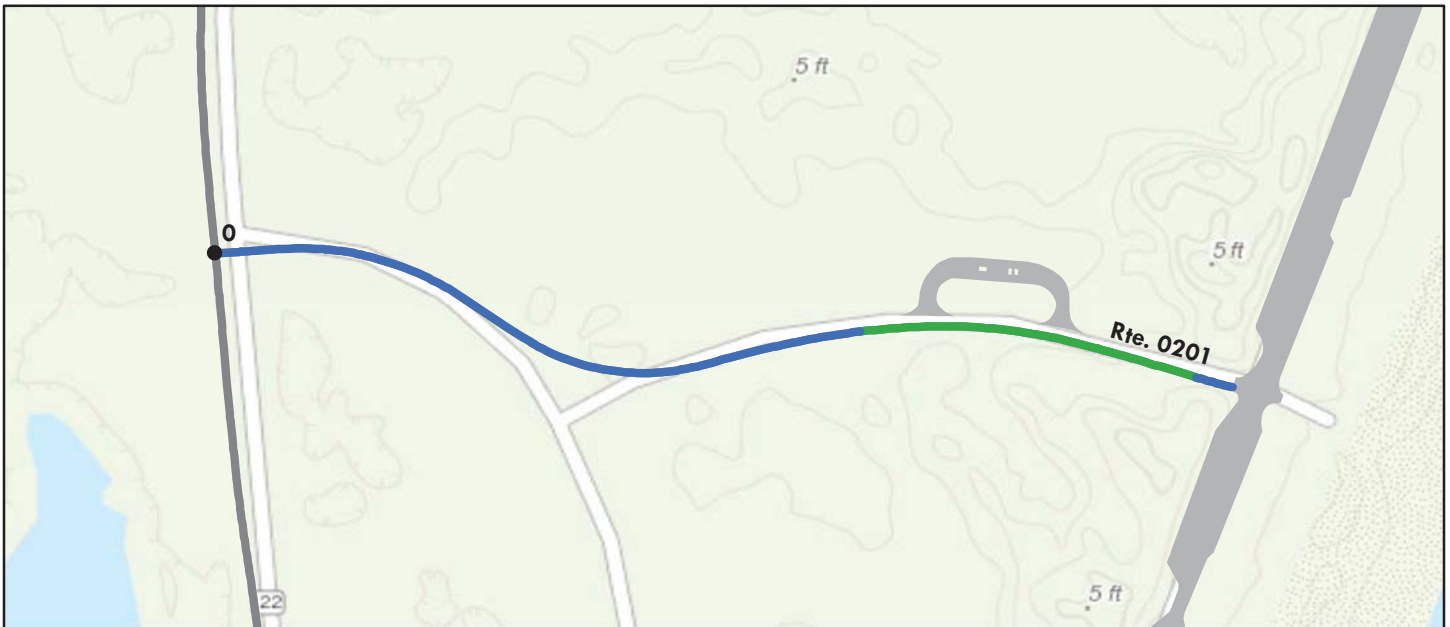
## ROUTE 0201: CAMPGROUND ACCESS ROAD

Route Condition Legend – Pavement Condition Rating (PCR)						
Poor (0 - 60)	Fair (61- 84)	Good (85 - 94)	Excellent (95 - 100)	Not Rated		
See Appendix for definitions and formulas						
<b>Inspection Date:</b> 2/19/2017	<b>Beginning Section MP</b>	0				
<b>Paved Length (Miles):</b> 0.31	<b>Section Length (MI)</b>	0.31				
<b>Surface Type:</b> ASPHALT	<b>Route Summary</b>					
<b>Roadway Condition Information</b>						
Pavement Condition Rating (PCR)	98	98				
Surface Condition Rating (SCR)	98	98				
Roughness Condition Index (RCI)	N/A	N/A				
<b>Distress Index Values</b>						
Structural Crack Index	100	100				
Alligator Crack Index	100	100				
Longitudinal Crack Index	100	100				
Transverse Cracking Index	99	99				
Patching Index	100	100				
Rutting Index	98	98				
International Roughness Index (IRI)	N/A	N/A				
<b>Lane &amp; Width Information</b>						
Number of Lanes	2	2				
Paved Width (ft)	23.3	23.3

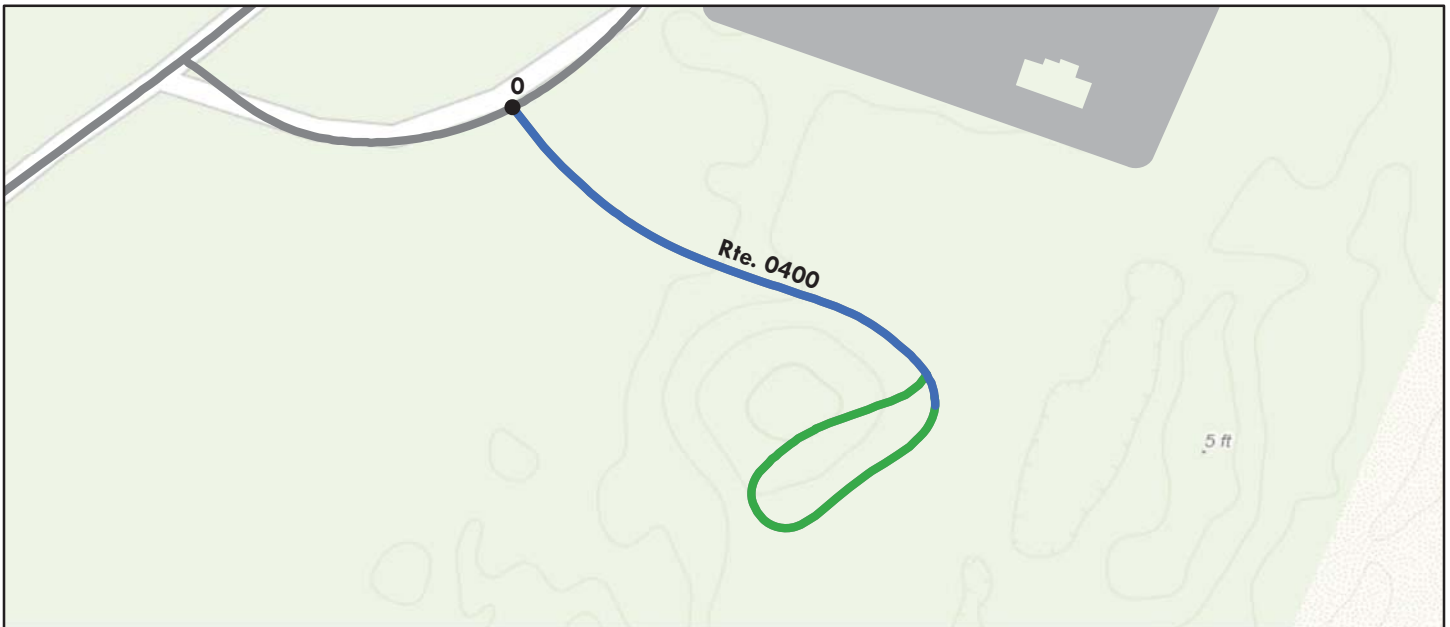
## ROUTE 0400: VIP CAMPGROUND ROAD

Route Condition Legend – Pavement Condition Rating (PCR)						
Poor (0 - 60)	Fair (61- 84)	Good (85 - 94)	Excellent (95 - 100)	Not Rated		
See Appendix for definitions and formulas						
<b>Inspection Date:</b> 2/19/2017	<b>Beginning Section MP</b>	0				
<b>Paved Length (Miles):</b> 0.19	<b>Section Length (MI)</b>	0.19				
<b>Surface Type:</b> ASPHALT	<b>Route Summary</b>					
<b>Roadway Condition Information</b>						
Pavement Condition Rating (PCR)	94	94				
Surface Condition Rating (SCR)	94	94				
Roughness Condition Index (RCI)	N/A	N/A				
<b>Distress Index Values</b>						
Structural Crack Index	99	99				
Alligator Crack Index	100	100				
Longitudinal Crack Index	99	99				
Transverse Cracking Index	100	100				
Patching Index	99	99				
Rutting Index	94	94				
International Roughness Index (IRI)	N/A	N/A				
<b>Lane &amp; Width Information</b>						
Number of Lanes	2	2				
Paved Width (ft)	17.4	17.4				
Lane Width (ft)	9.9	9.9

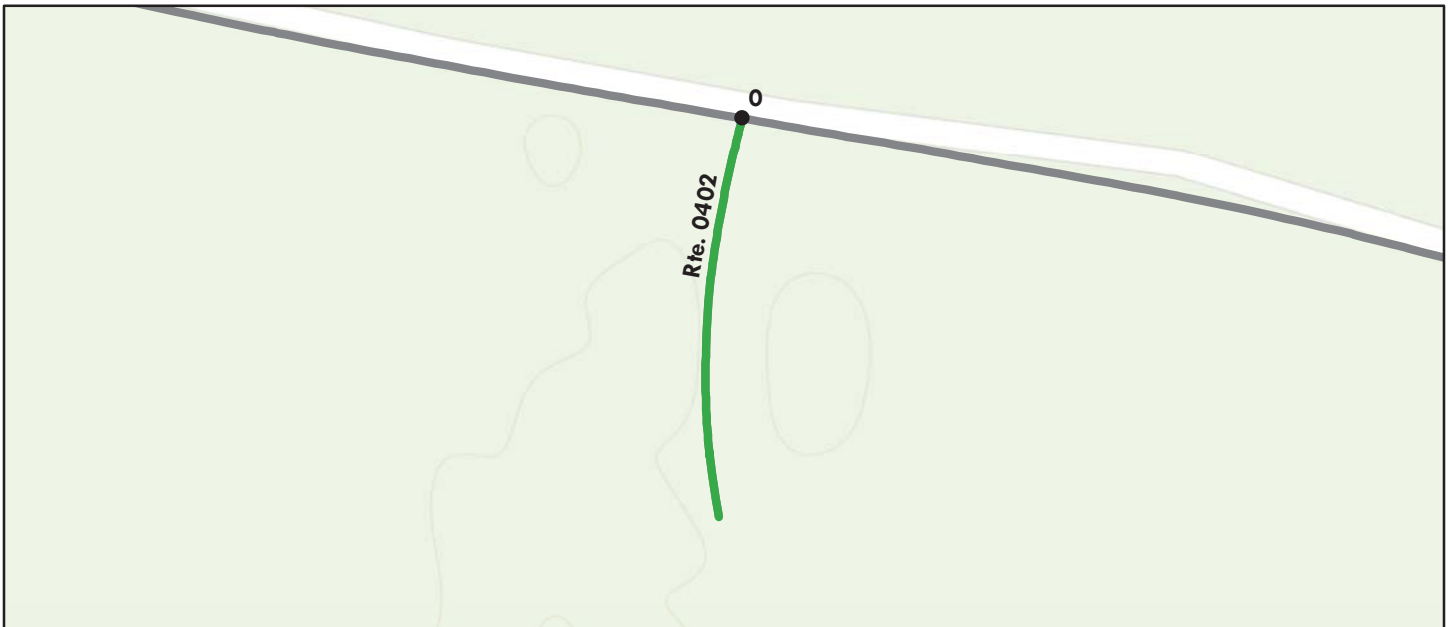
## ROUTE 0402: WATER TANK ROAD

Route Condition Legend – Pavement Condition Rating (PCR)						
Poor (0 - 60)	Fair (61- 84)	Good (85 - 94)	Excellent (95 - 100)	Not Rated		
See Appendix for definitions and formulas						
<b>Inspection Date:</b> 2/19/2017	<b>Beginning Section MP</b>	0				
<b>Paved Length (Miles):</b> 0.05	<b>Section Length (MI)</b>	0.05				
<b>Surface Type:</b> ASPHALT	<b>Route Summary</b>					
<b>Roadway Condition Information</b>						
Pavement Condition Rating (PCR)	90	90				
Surface Condition Rating (SCR)	90	90				
Roughness Condition Index (RCI)	N/A	N/A				
<b>Distress Index Values</b>						
Structural Crack Index	90	90				
Alligator Crack Index	100	100				
Longitudinal Crack Index	90	90				
Transverse Cracking Index	97	97				
Patching Index	100	100				
Rutting Index	96	96				
International Roughness Index (IRI)	N/A	N/A				
<b>Lane &amp; Width Information</b>						
Number of Lanes	2	2				
Paved Width (ft)	18.8	18.8				
Lane Width (ft)	9.4	9.4

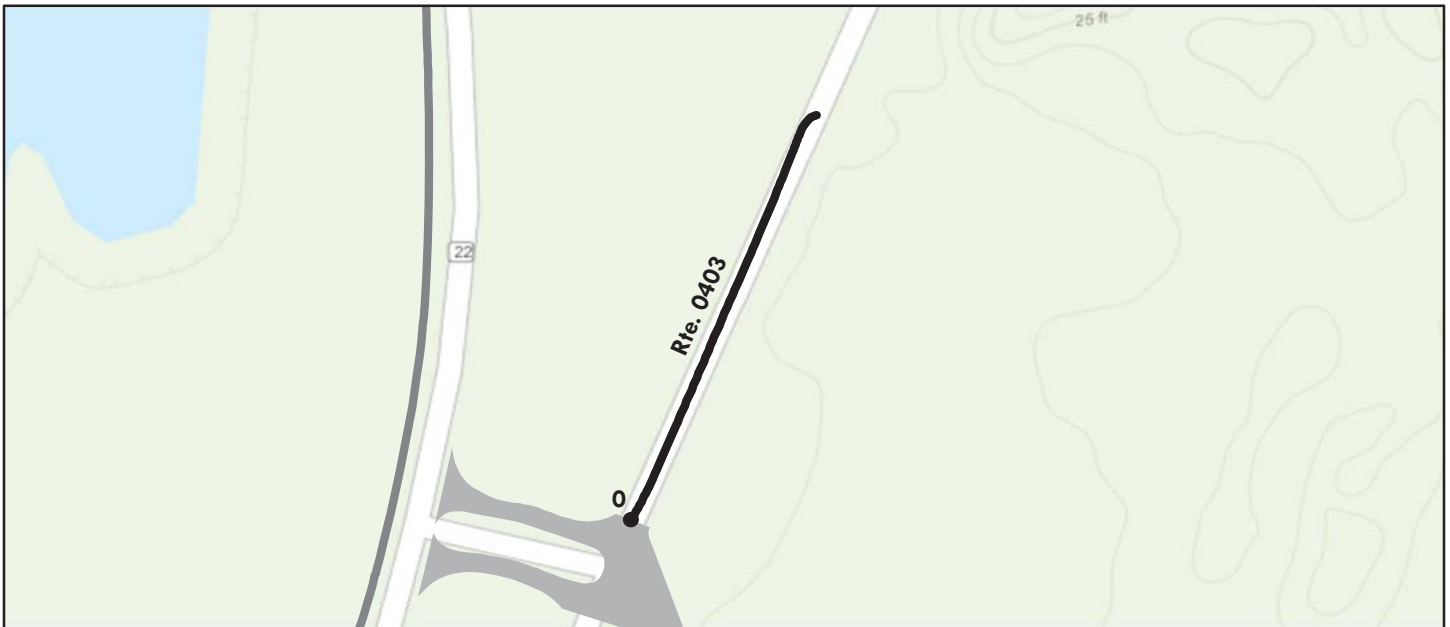
## ROUTE 0403: VIEW TOWER ROAD

Route Condition Legend – Pavement Condition Rating (PCR)						
Poor (0 - 60)	Fair (61- 84)	Good (85 - 94)	Excellent (95 - 100)	Not Rated		
See Appendix for definitions and formulas						
<b>Inspection Date:</b> 2/19/2017	<b>Beginning Section MP</b>	0				
<b>Paved Length (Miles):</b> 0.09	<b>Section Length (MI)</b>	0.09				
<b>Surface Type:</b> ASPHALT	<b>Route Summary</b>					
<b>Roadway Condition Information</b>						
Pavement Condition Rating (PCR)	N/A	N/A				
Surface Condition Rating (SCR)	N/A	N/A				
Roughness Condition Index (RCI)	N/A	N/A				
<b>Distress Index Values</b>						
Structural Crack Index	N/A	N/A				
Alligator Crack Index	N/A	N/A				
Longitudinal Crack Index	N/A	N/A				
Transverse Cracking Index	N/A	N/A				
Patching Index	N/A	N/A				
Rutting Index	N/A	N/A				
International Roughness Index (IRI)	N/A	N/A				
<b>Lane &amp; Width Information</b>						
Number of Lanes	1	1				
Paved Width (ft)

Note: Route was under construction, therefore, it could not be rated.
