# PEFO Cycle 6

## Final Report

### Road Inventory and Condition Assessment of Paved Routes Petrified Forest National Park

Report Date: June 2017

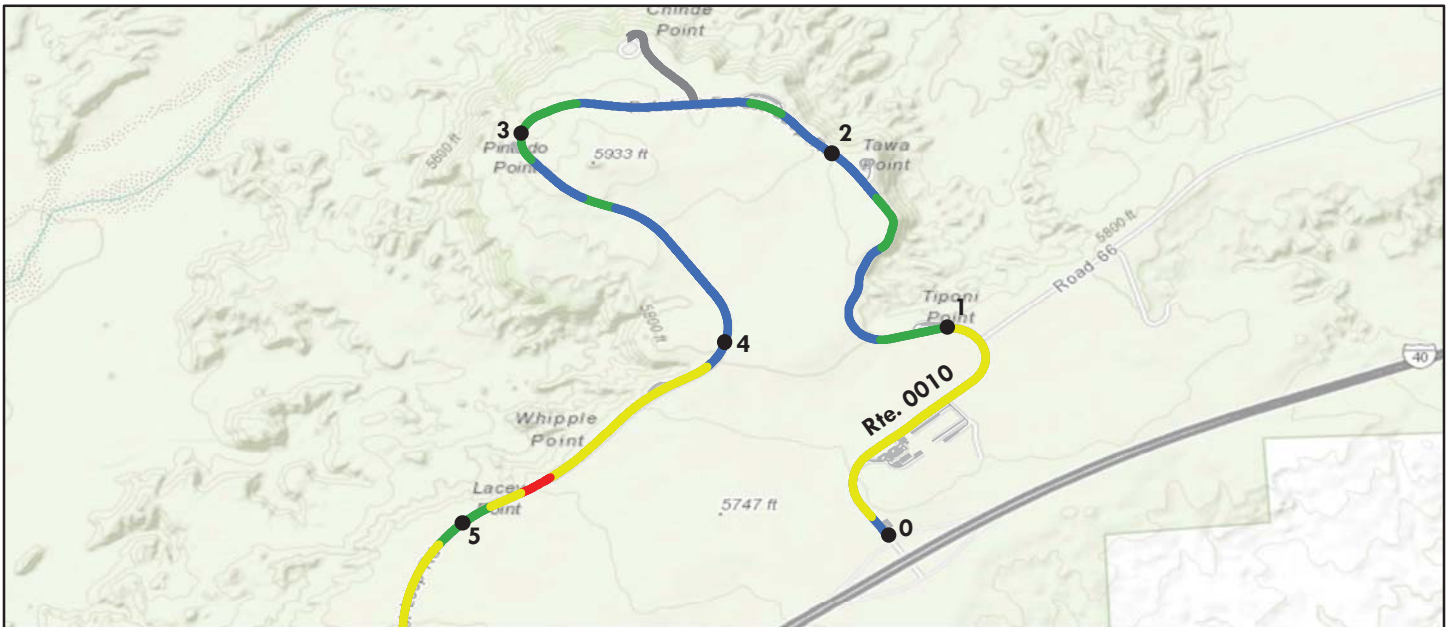
## ROUTE 0010: NORTH-SOUTH HIGHWAY

Route Condition Legend – Pavement Condition Rating (PCR)						
Poor (0 - 60)	Fair (61- 84)	Good (85 - 94)	Excellent (95 - 100)	Not Rated		
See Appendix for definitions and formulas						
<b>Inspection Date:</b> 1/5/2017	<b>Beginning Section MP</b>	0	1	2	3	4
<b>Paved Length (Miles):</b> 28.48	<b>Section Length (MI)</b>	1	1	1	1	1
<b>Surface Type:</b> ASPHALT	<b>Route Summary</b>					
<b>Roadway Condition Information</b>						
Pavement Condition Rating (PCR)	87	79	98	96	97	78
Surface Condition Rating (SCR)	93	91	99	97	97	95
Roughness Condition Index (RCI)	77	62	96	95	97	53
<b>Distress Index Values</b>						
Structural Crack Index	99	100	100	100	100	100
Alligator Crack Index	100	100	100	100	100	100
Longitudinal Crack Index	99	100	100	100	100	100
Transverse Cracking Index	99	98	99	99	100	98
Patching Index	100	100	100	100	100	100
Rutting Index	93	91	99	97	97	95
International Roughness Index (IRI)	178	233	125	126	121	270

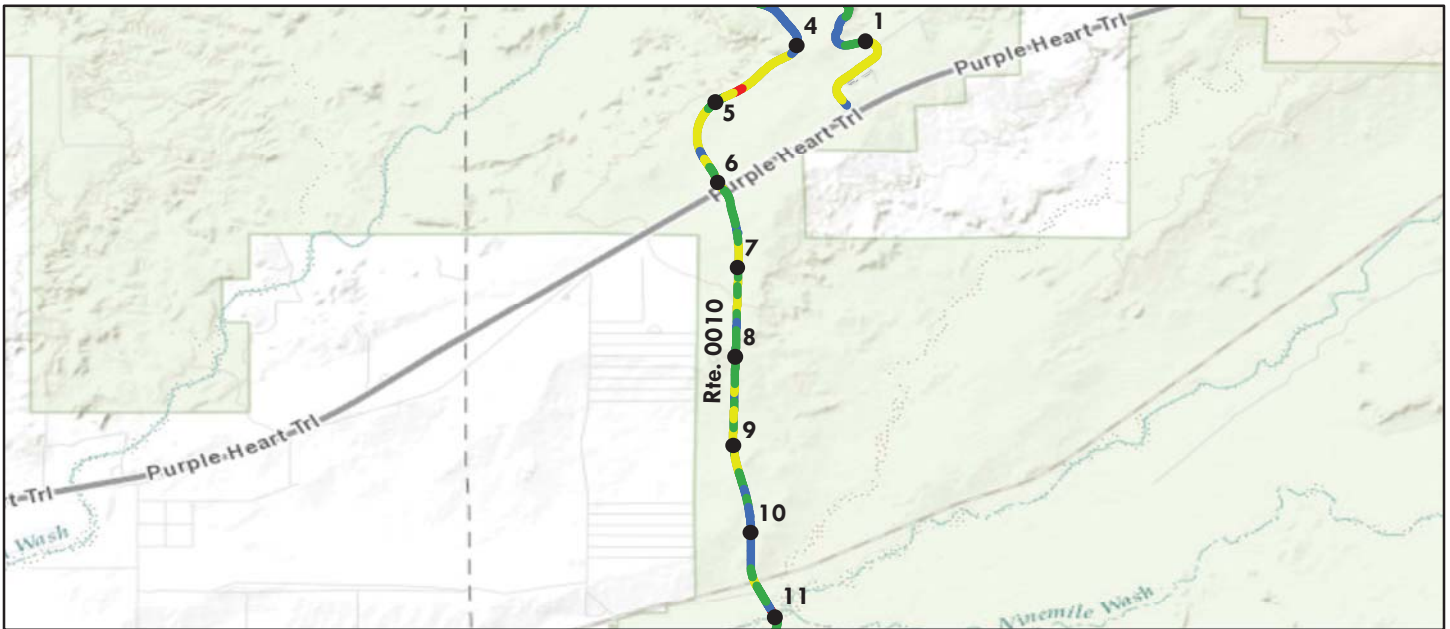
## ROUTE 0010: NORTH-SOUTH HIGHWAY

Route Condition Legend – Pavement Condition Rating (PCR)						
Poor (0 - 60)	Fair (61- 84)	Good (85 - 94)	Excellent (95 - 100)	Not Rated		
See Appendix for definitions and formulas						
<b>Inspection Date:</b> 1/5/2017	<b>Beginning Section MP</b>	5	6	7	8	9
<b>Paved Length (Miles):</b> 28.48	<b>Section Length (MI)</b>	1	1	1	1	1
<b>Surface Type:</b> ASPHALT	<b>Route Summary</b>					
<b>Roadway Condition Information</b>						
Pavement Condition Rating (PCR)	87	83	85	86	86	88
Surface Condition Rating (SCR)	93	95	94	89	91	89
Roughness Condition Index (RCI)	77	65	71	81	78	87
<b>Distress Index Values</b>						
Structural Crack Index	99	100	99	100	100	100
Alligator Crack Index	100	100	100	100	100	100
Longitudinal Crack Index	99	100	99	100	100	100
Transverse Cracking Index	99	98	99	100	100	100
Patching Index	100	100	100	100	100	100
Rutting Index	93	95	94	89	91	89
International Roughness Index (IRI)	178	218	199	165	176	150

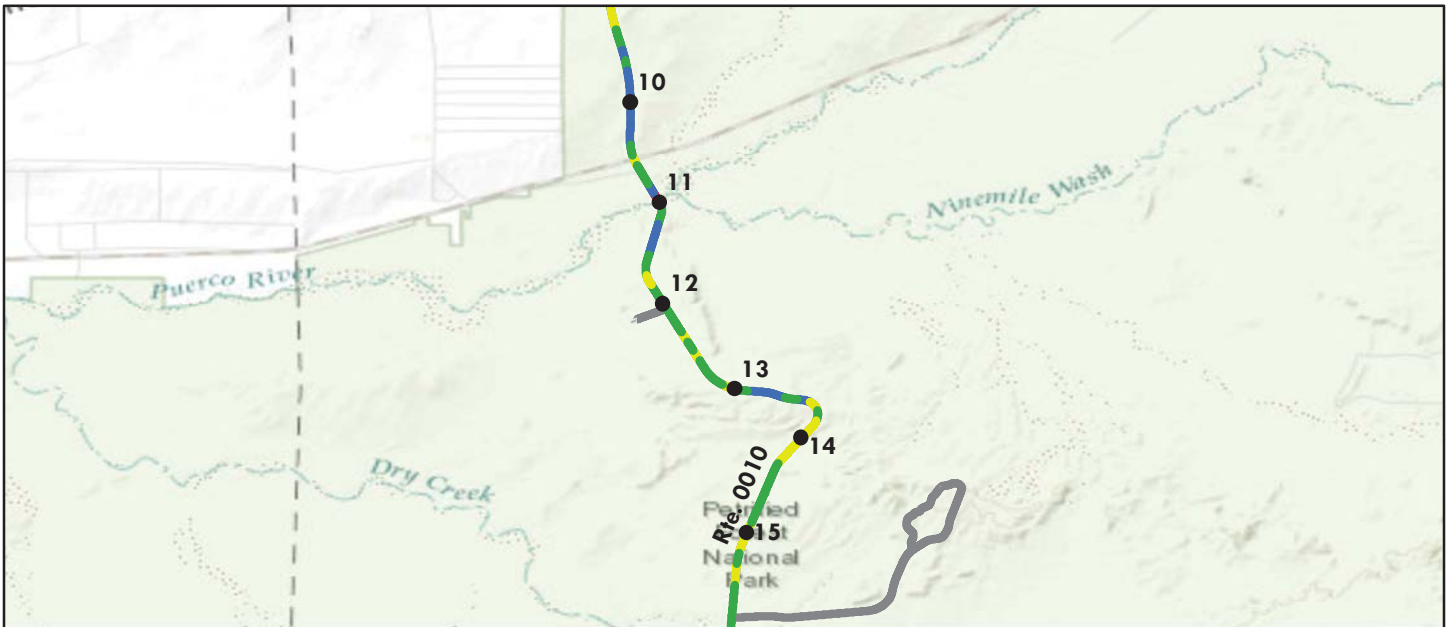
## ROUTE 0010: NORTH-SOUTH HIGHWAY

Route Condition Legend – Pavement Condition Rating (PCR)						
Poor (0 - 60)	Fair (61- 84)	Good (85 - 94)	Excellent (95 - 100)	Not Rated		
See Appendix for definitions and formulas						
<b>Inspection Date:</b> 1/5/2017	<b>Beginning Section MP</b>	10	11	12	13	14
<b>Paved Length (Miles):</b> 28.48	<b>Section Length (MI)</b>	1	1	1	1	1
<b>Surface Type:</b> ASPHALT	<b>Route Summary</b>					
<b>Roadway Condition Information</b>						
Pavement Condition Rating (PCR)	87	93	91	88	89	86
Surface Condition Rating (SCR)	93	97	91	85	93	86
Roughness Condition Index (RCI)	77	87	91	93	83	86
<b>Distress Index Values</b>						
Structural Crack Index	99	100	100	100	100	100
Alligator Crack Index	100	100	100	100	100	100
Longitudinal Crack Index	99	100	100	100	100	100
Transverse Cracking Index	99	98	99	100	100	100
Patching Index	100	100	100	100	100	100
Rutting Index	93	97	91	85	93	86
International Roughness Index (IRI)	178	148	138	132	161	152

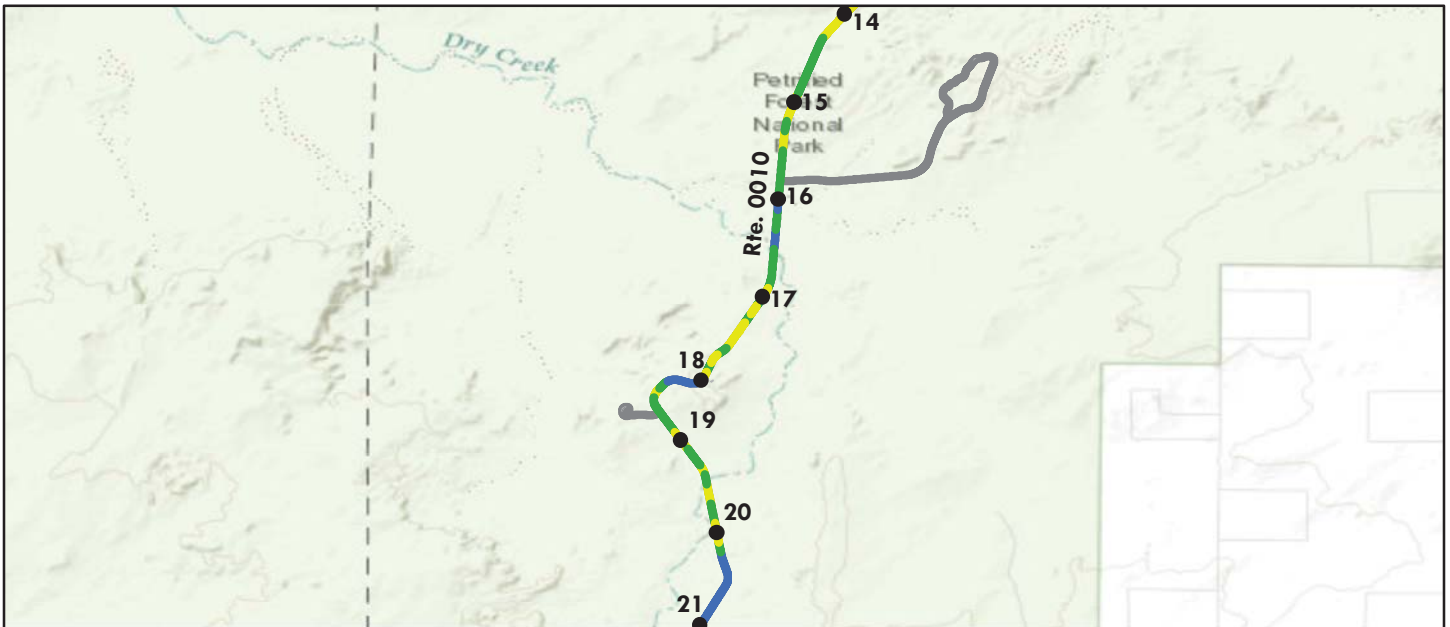
## ROUTE 0010: NORTH-SOUTH HIGHWAY

Route Condition Legend – Pavement Condition Rating (PCR)						
Poor (0 - 60)	Fair (61- 84)	Good (85 - 94)	Excellent (95 - 100)	Not Rated		
See Appendix for definitions and formulas						
<b>Inspection Date:</b> 1/5/2017	<b>Beginning Section MP</b>	15	16	17	18	19
<b>Paved Length (Miles):</b> 28.48	<b>Section Length (MI)</b>	1	1	1	1	1
<b>Surface Type:</b> ASPHALT	<b>Route Summary</b>					
<b>Roadway Condition Information</b>						
Pavement Condition Rating (PCR)	87	83	93	81	91	84
Surface Condition Rating (SCR)	93	87	96	93	97	95
Roughness Condition Index (RCI)	77	78	88	64	81	67
<b>Distress Index Values</b>						
Structural Crack Index	99	100	97	93	100	100
Alligator Crack Index	100	100	100	100	100	100
Longitudinal Crack Index	99	100	97	93	100	100
Transverse Cracking Index	99	100	96	97	97	96
Patching Index	100	100	100	100	100	100
Rutting Index	93	87	99	98	99	95
International Roughness Index (IRI)	178	176	146	222	166	212

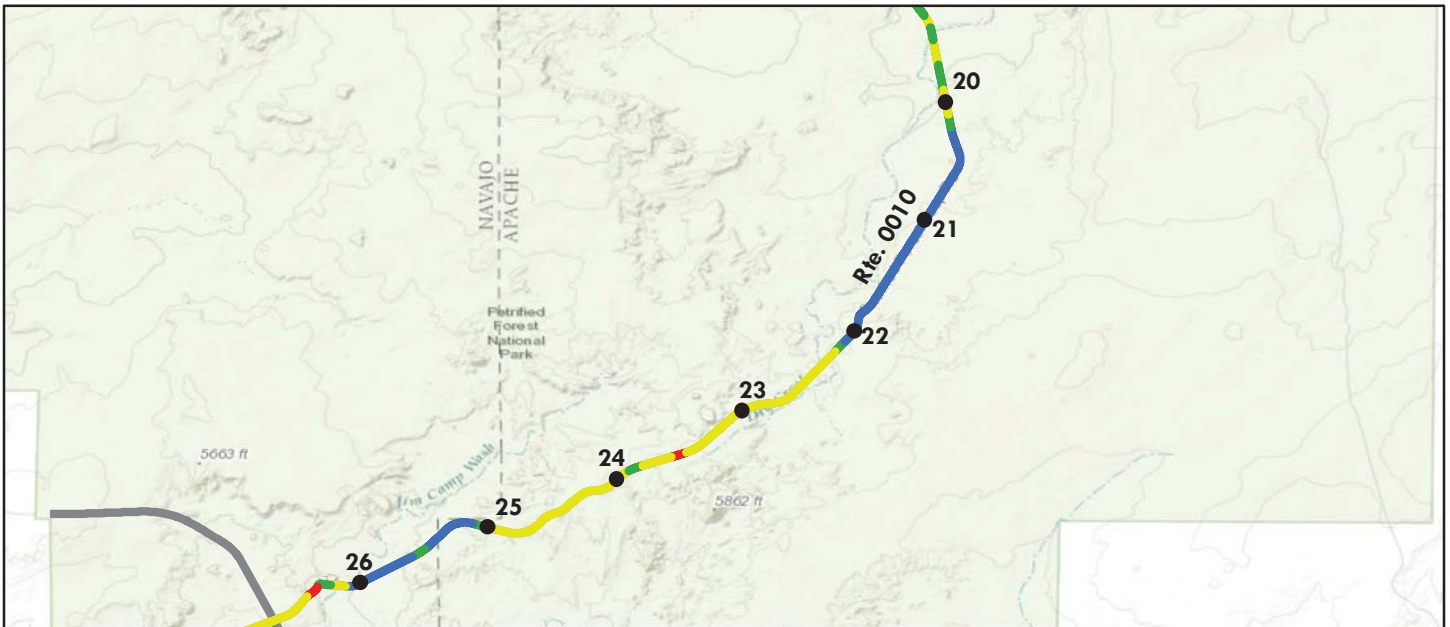
## ROUTE 0010: NORTH-SOUTH HIGHWAY

Route Condition Legend – Pavement Condition Rating (PCR)						
Poor (0 - 60)	Fair (61- 84)	Good (85 - 94)	Excellent (95 - 100)	Not Rated		
See Appendix for definitions and formulas						
<b>Inspection Date:</b> 1/5/2017	<b>Beginning Section MP</b>	20	21	22	23	24
<b>Paved Length (Miles):</b> 28.48	<b>Section Length (MI)</b>	1	1	1	1	1
<b>Surface Type:</b> ASPHALT	<b>Route Summary</b>					
<b>Roadway Condition Information</b>						
Pavement Condition Rating (PCR)	87	99	100	74	71	75
Surface Condition Rating (SCR)	93	99	100	88	87	91
Roughness Condition Index (RCI)	77	100	100	53	46	51
<b>Distress Index Values</b>						
Structural Crack Index	99	100	100	100	99	100
Alligator Crack Index	100	100	100	100	100	100
Longitudinal Crack Index	99	100	100	100	99	100
Transverse Cracking Index	99	99	100	100	96	98
Patching Index	100	100	100	100	99	100
Rutting Index	93	99	100	88	87	91
International Roughness Index (IRI)	178	94	82	270	305	279

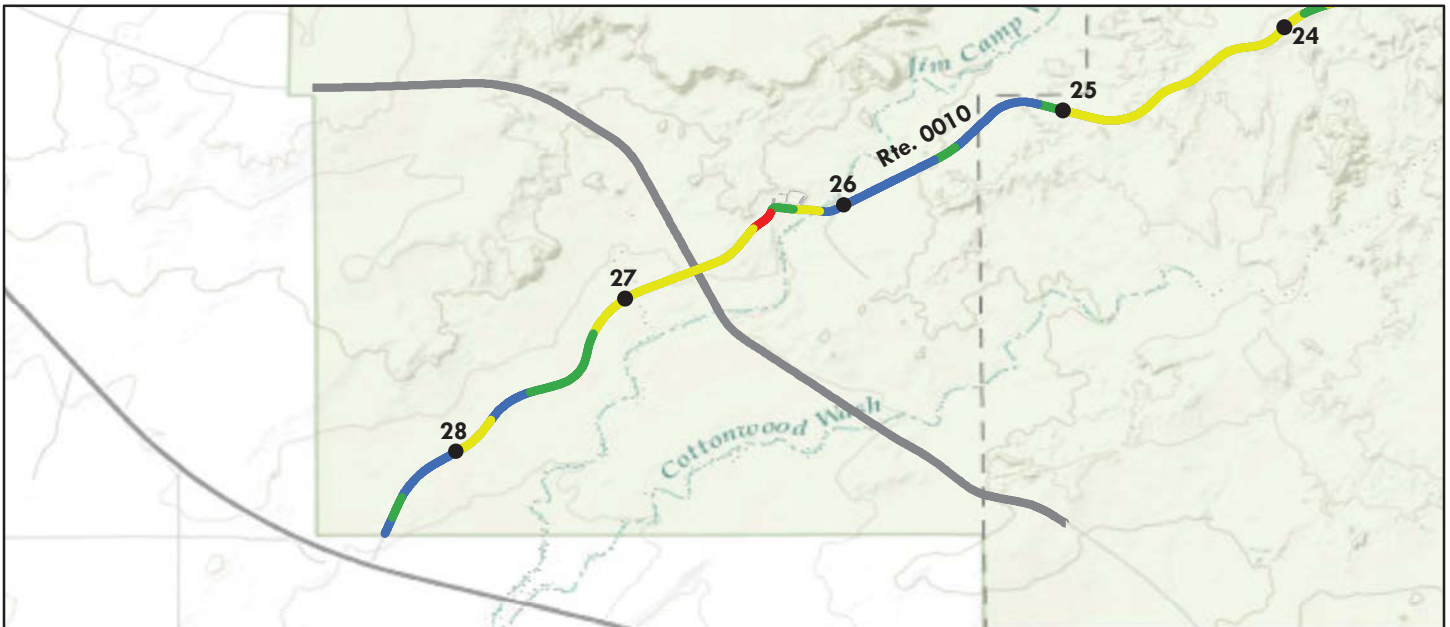
## ROUTE 0010: NORTH-SOUTH HIGHWAY

Route Condition Legend – Pavement Condition Rating (PCR)						
Poor (0 - 60)	Fair (61- 84)	Good (85 - 94)	Excellent (95 - 100)	Not Rated		
See Appendix for definitions and formulas						
<b>Inspection Date:</b> 1/5/2017	<b>Beginning Section MP</b>	25	26	27	28	
<b>Paved Length (Miles):</b> 28.48	<b>Section Length (MI)</b>	1	1	1	0.48	
<b>Surface Type:</b> ASPHALT	<b>Route Summary</b>					
<b>Roadway Condition Information</b>						
Pavement Condition Rating (PCR)	87	97	76	88	95	
Surface Condition Rating (SCR)	93	99	90	94	97	
Roughness Condition Index (RCI)	77	93	56	79	93	
<b>Distress Index Values</b>						
Structural Crack Index	99	100	99	99	97	
Alligator Crack Index	100	100	100	100	100	
Longitudinal Crack Index	99	100	99	99	97	
Transverse Cracking Index	99	100	99	100	100	
Patching Index	100	99	100	100	100	
Rutting Index	93	99	90	94	99	
International Roughness Index (IRI)	178	132	257	171	131	
<b>Lane &amp; Width Information</b>

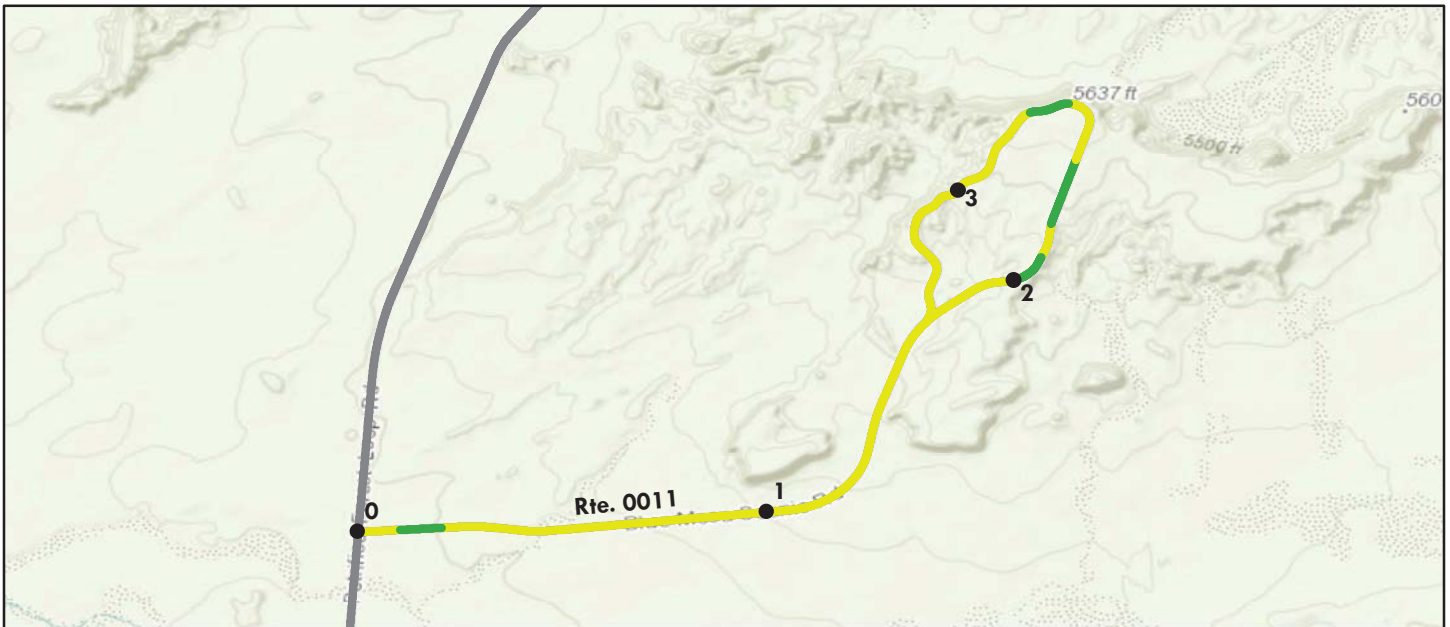
## ROUTE 0011: BLUE MESA ROAD

Route Condition Legend – Pavement Condition Rating (PCR)						
Poor (0 - 60)	Fair (61- 84)	Good (85 - 94)	Excellent (95 - 100)	Not Rated		
See Appendix for definitions and formulas						
<b>Inspection Date:</b> 1/5/2017	<b>Beginning Section MP</b>	0	1	2	3	
<b>Paved Length (Miles):</b> 3.45	<b>Section Length (MI)</b>	1	1	1	0.45	
<b>Surface Type:</b> ASPHALT	<b>Route Summary</b>					
<b>Roadway Condition Information</b>						
Pavement Condition Rating (PCR)	79	78	79	82	71	
Surface Condition Rating (SCR)	92	93	93	90	89	
Roughness Condition Index (RCI)	59	55	59	71	44	
<b>Distress Index Values</b>						
Structural Crack Index	99	99	99	100	100	
Alligator Crack Index	100	100	100	100	100	
Longitudinal Crack Index	99	99	99	100	100	
Transverse Cracking Index	92	93	93	90	95	
Patching Index	100	99	100	100	100	
Rutting Index	94	96	96	94	89	
International Roughness Index (IRI)	245	260	244	200	317	
<b>Lane &amp; Width Information</b>

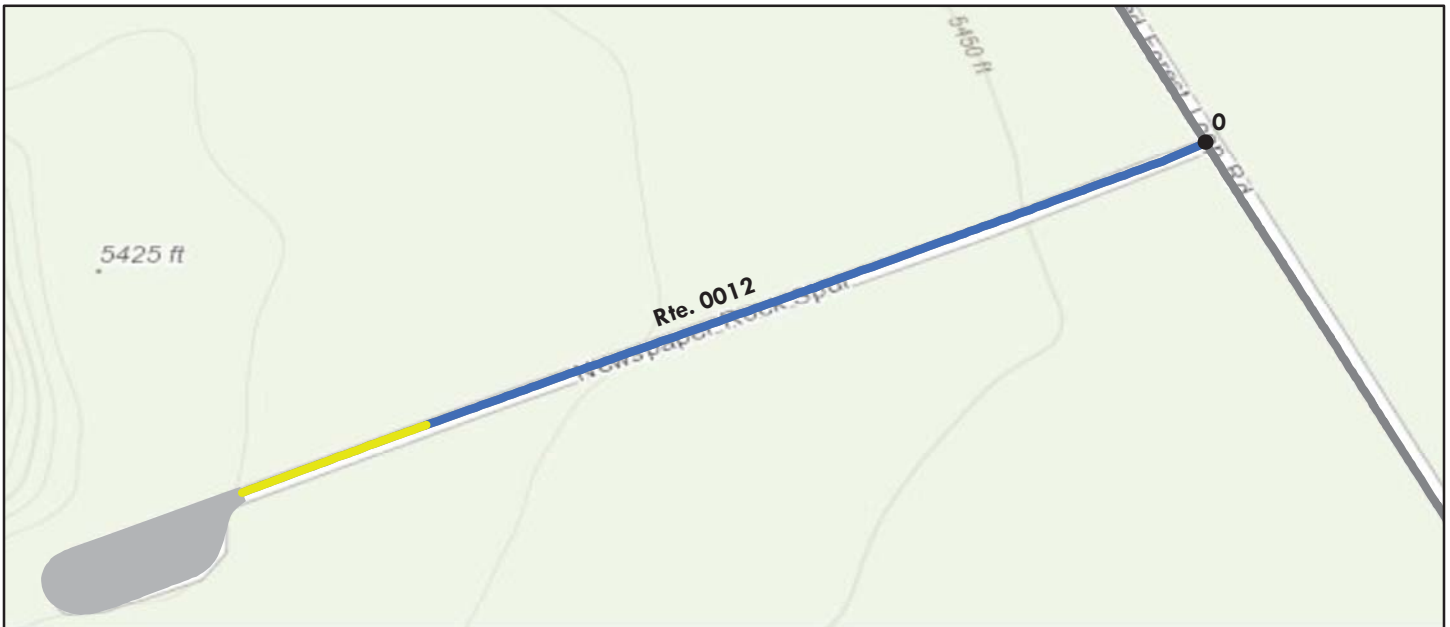
## ROUTE 0012: NEWSPAPER ROCK ROAD

Route Condition Legend – Pavement Condition Rating (PCR)						
Poor (0 - 60)	Fair (61- 84)	Good (85 - 94)	Excellent (95 - 100)	Not Rated		
See Appendix for definitions and formulas						
<b>Inspection Date:</b> 1/5/2017	<b>Beginning Section MP</b>	0				
<b>Paved Length (Miles):</b> 0.25	<b>Section Length (MI)</b>	0.25				
<b>Surface Type:</b> ASPHALT	<b>Route Summary</b>					
<b>Roadway Condition Information</b>						
Pavement Condition Rating (PCR)	93	93				
Surface Condition Rating (SCR)	93	93				
Roughness Condition Index (RCI)	N/A	N/A				
<b>Distress Index Values</b>						
Structural Crack Index	99	99				
Alligator Crack Index	100	100				
Longitudinal Crack Index	99	99				
Transverse Cracking Index	98	98				
Patching Index	100	100				
Rutting Index	93	93				
International Roughness Index (IRI)	N/A	N/A				
<b>Lane &amp; Width Information</b>						
Number of Lanes	2	2				
Paved Width (ft)	22.4	22.4				
Lane Width (ft)	9	9

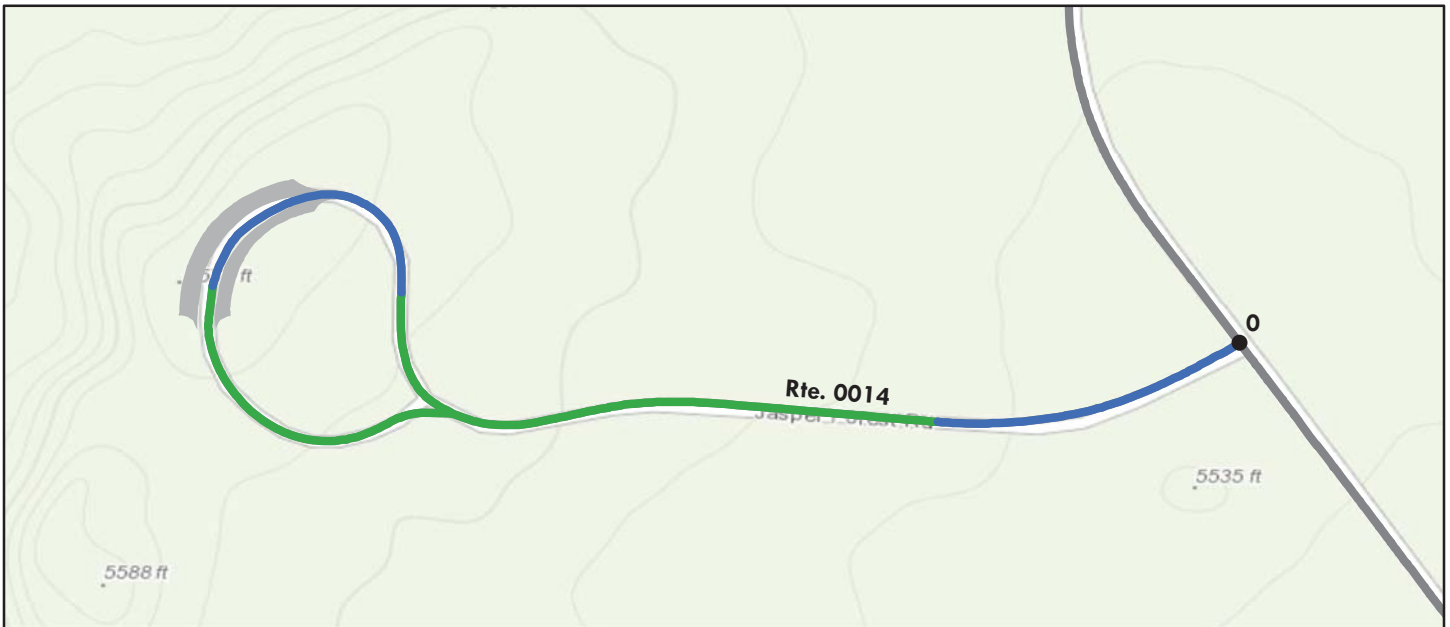
## ROUTE 0014: JASPER FOREST ROAD

Route Condition Legend – Pavement Condition Rating (PCR)						
Poor (0 - 60)	Fair (61- 84)	Good (85 - 94)	Excellent (95 - 100)	Not Rated		
See Appendix for definitions and formulas						
<b>Inspection Date:</b> 1/5/2017	<b>Beginning Section MP</b>	0				
<b>Paved Length (Miles):</b> 0.51	<b>Section Length (MI)</b>	0.51				
<b>Surface Type:</b> ASPHALT	<b>Route Summary</b>					
<b>Roadway Condition Information</b>						
Pavement Condition Rating (PCR)	88	88				
Surface Condition Rating (SCR)	98	98				
Roughness Condition Index (RCI)	74	74				
<b>Distress Index Values</b>						
Structural Crack Index	100	100				
Alligator Crack Index	100	100				
Longitudinal Crack Index	100	100				
Transverse Cracking Index	98	98				
Patching Index	100	100				
Rutting Index	98	98				
International Roughness Index (IRI)	189	189				
<b>Lane &amp; Width Information</b>						
Number of Lanes	2	2				
Paved Width (ft)	18.6	18.6				
Lane Width (ft)	9.7	9.7

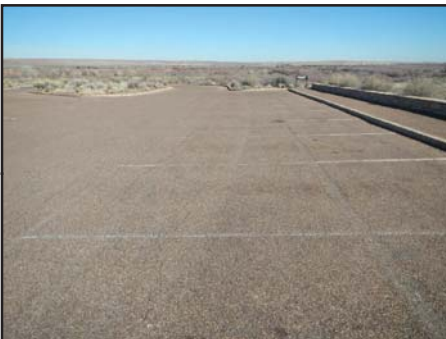
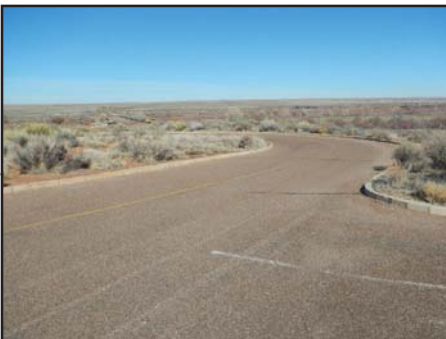
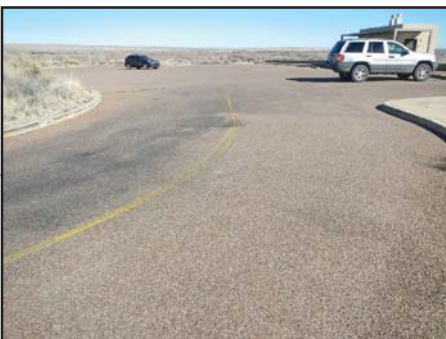
Inspection Date	FMSS Number	User Access	Surface Type
1/12/2016	74110	PUBLIC	ASPHALT
Area (Sq. Ft.)	Lane Miles (11' Widths)	Curb Reveal (Inches)	Curb Recommendation
38,018	0.655	6	DO NOTHING
Curb Type		Curb & Gutter Type	
STONE		NO CURB AND GUTTER	
Pavement Recommendation		Condition Rating / PCR	
PREVENTIVE MAINTENANCE		GOOD / 90

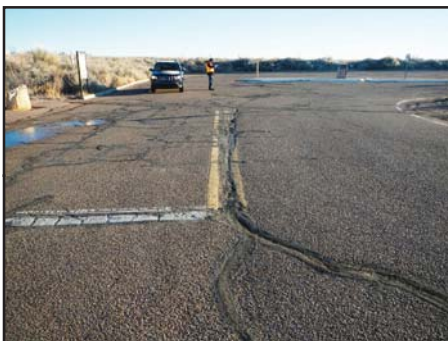
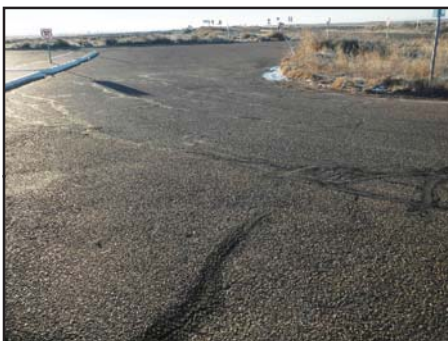
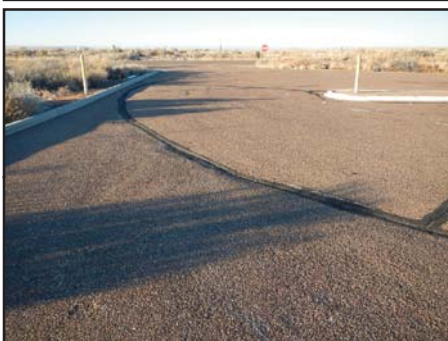
## ROUTE 0913: NORTH ENTRANCE PARKING

Inspection Date	FMSS Number	User Access	Surface Type
1/12/2016	74113	PUBLIC	ASPHALT
Area (Sq. Ft.)	Lane Miles (11' Widths)	Curb Reveal (Inches)	Curb Recommendation
25,330	0.436	6	DO NOTHING
Curb Type		Curb & Gutter Type	
CONCRETE		NO CURB AND GUTTER	
Pavement Recommendation		Condition Rating / PCR	
HEAVY 3R TREATMENTS		POOR / 53

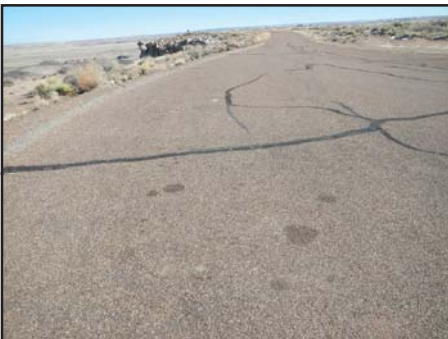
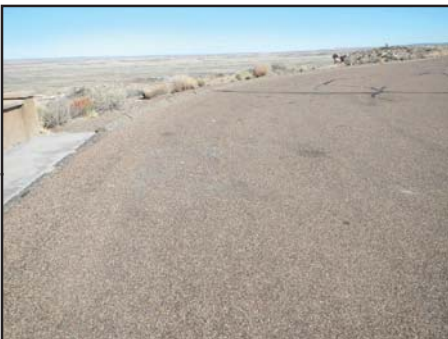
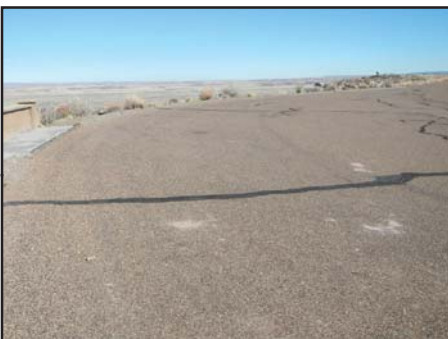
## ROUTE 0914: BLUE MESA LOOP TRAIL PARKING

Inspection Date	FMSS Number	User Access	Surface Type
1/12/2016	74120	PUBLIC	ASPHALT
Area (Sq. Ft.)	Lane Miles (11' Widths)	Curb Reveal (Inches)	Curb Recommendation
5,395	0.093	4	DO NOTHING
Curb Type		Curb & Gutter Type	
ASPHALT		NO CURB AND GUTTER	
Pavement Recommendation		Condition Rating / PCR	
PREVENTIVE MAINTENANCE		GOOD / 90

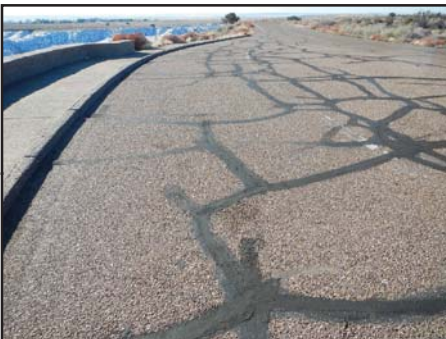
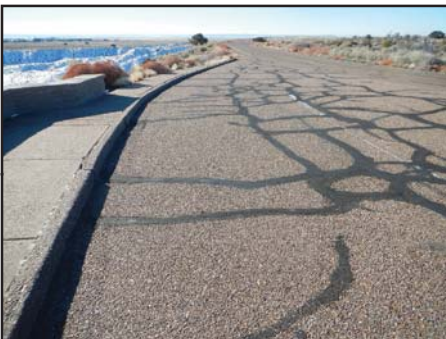
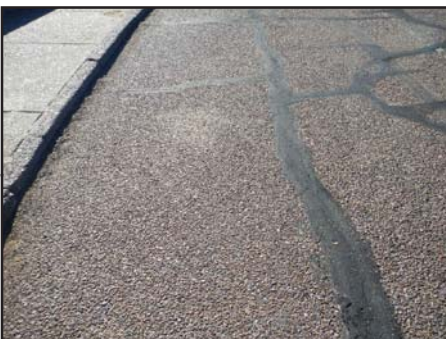
## ROUTE 0915: NO NAME OVERLOOK PARKING

Inspection Date	FMSS Number	User Access	Surface Type
1/12/2016	74130	PUBLIC	ASPHALT
Area (Sq. Ft.)	Lane Miles (11' Widths)	Curb Reveal (Inches)	Curb Recommendation
7,247	0.125	6	DO NOTHING
Curb Type		Curb & Gutter Type	
CONCRETE		NO CURB AND GUTTER	
Pavement Recommendation		Condition Rating / PCR	
HEAVY 3R TREATMENTS		POOR / 53

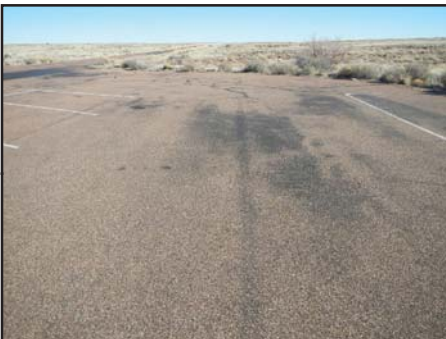
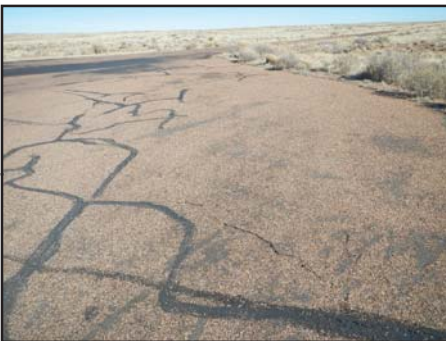
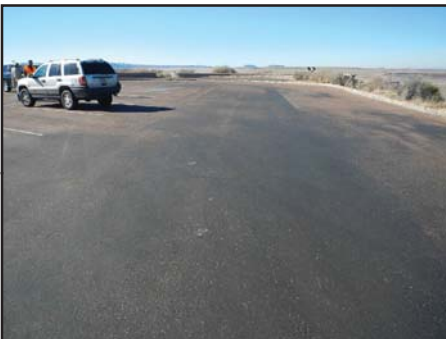
## ROUTE 0916: NEWSPAPER ROCK PARKING

Inspection Date	FMSS Number	User Access	Surface Type
1/12/2016	74132	PUBLIC	ASPHALT
Area (Sq. Ft.)	Lane Miles (11' Widths)	Curb Reveal (Inches)	Curb Recommendation
24,577	0.423	6	DO NOTHING
Curb Type		Curb & Gutter Type	
STONE		NO CURB AND GUTTER	
Pavement Recommendation		Condition Rating / PCR	
LIGHT 3R TREATMENTS		FAIR / 73

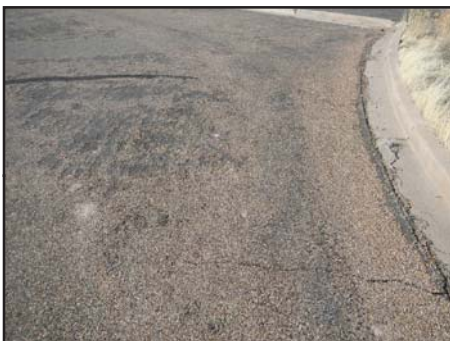
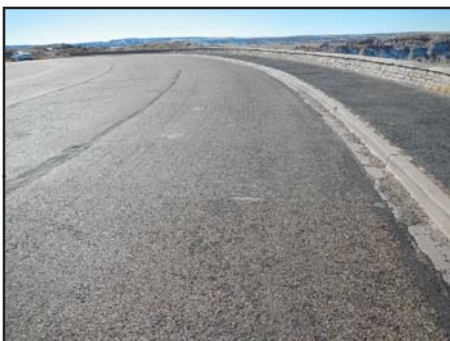
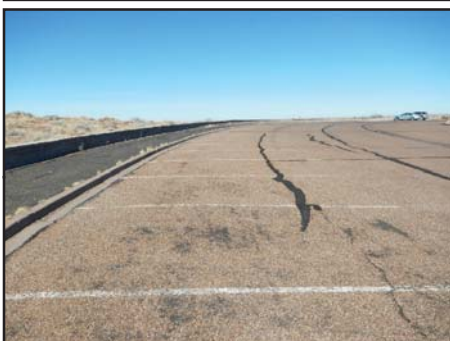
## ROUTE 0917AZ: JASPER FOREST PARKING AREA A

Inspection Date	FMSS Number	User Access	Surface Type
1/12/2016	74133	PUBLIC	ASPHALT
Area (Sq. Ft.)	Lane Miles (11' Widths)	Curb Reveal (Inches)	Curb Recommendation
11,199	0.193	NOT APPLICABLE	DO NOTHING
Curb Type		Curb & Gutter Type	
NO CURB		CONCRETE	
Pavement Recommendation		Condition Rating / PCR	
LIGHT 3R TREATMENTS		FAIR / 73

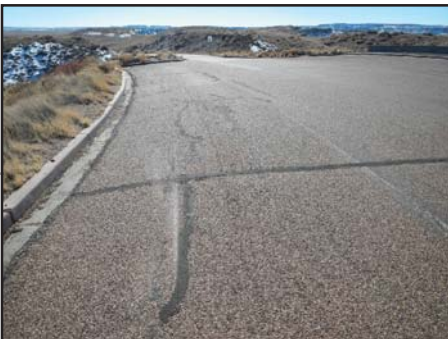
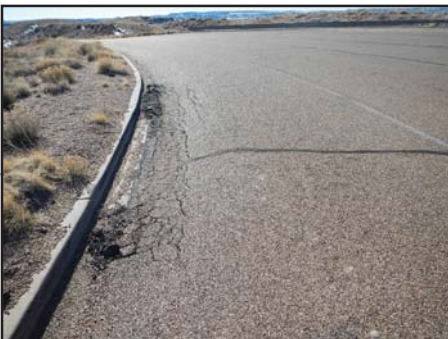
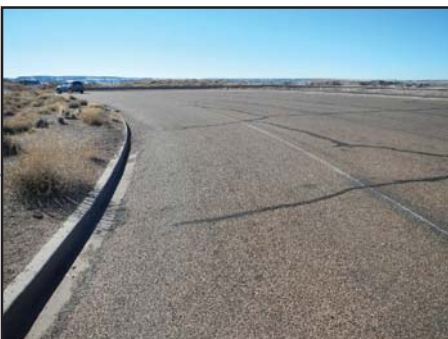
## ROUTE 0917BZ: JASPER FOREST PARKING AREA B

Inspection Date	FMSS Number	User Access	Surface Type
1/12/2016	74133	PUBLIC	ASPHALT
Area (Sq. Ft.)	Lane Miles (11' Widths)	Curb Reveal (Inches)	Curb Recommendation
6,613	0.114	NOT APPLICABLE	DO NOTHING
Curb Type		Curb & Gutter Type	
NO CURB		CONCRETE	
Pavement Recommendation		Condition Rating / PCR	
LIGHT 3R TREATMENTS		FAIR / 73

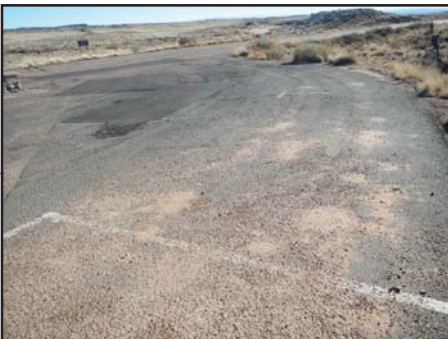
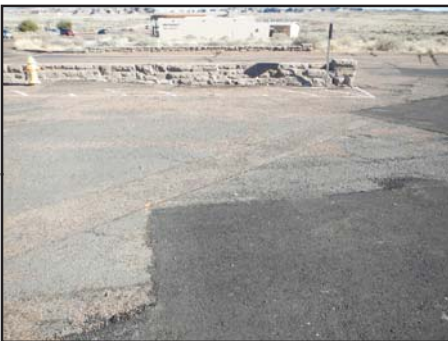
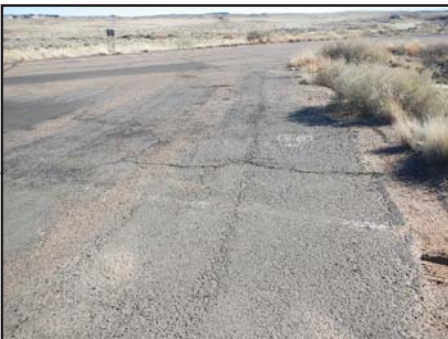
## ROUTE 0919: SOUTH AREA RANGER PARKING

Inspection Date	FMSS Number	User Access	Surface Type
1/12/2016	74136	NONPUBLIC	ASPHALT
Area (Sq. Ft.)	Lane Miles (11' Widths)	Curb Reveal (Inches)	Curb Recommendation
4,506	0.078	NOT APPLICABLE	NOT APPLICABLE
Curb Type		Curb & Gutter Type	
NO CURB		NO CURB AND GUTTER	
Pavement Recommendation		Condition Rating / PCR	
HEAVY 3R TREATMENTS		POOR / 53

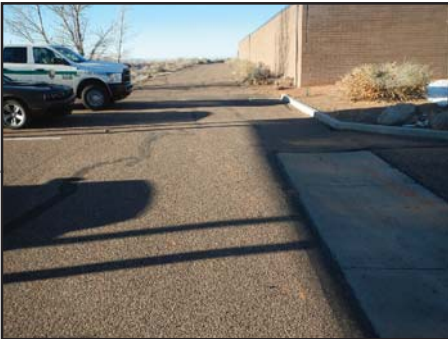
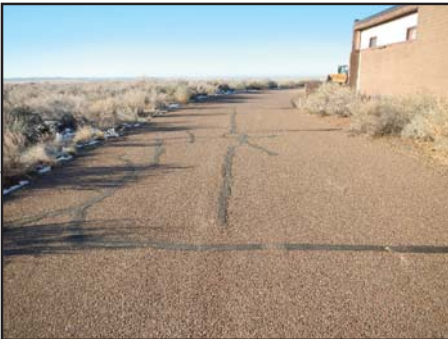
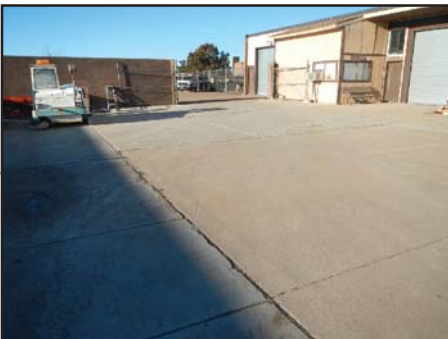
## ROUTE 0920: PD MAINTENANCE AND ADMINISTRATION AREA PARKING

Inspection Date	FMSS Number	User Access	Surface Type
1/12/2016	90618	NONPUBLIC	ASPHALT
Area (Sq. Ft.)	Lane Miles (11' Widths)	Curb Reveal (Inches)	Curb Recommendation
53,408	0.92	6	DO NOTHING
Curb Type		Curb & Gutter Type	
CONCRETE		CONCRETE	
Pavement Recommendation		Condition Rating / PCR	
PREVENTIVE MAINTENANCE		GOOD / 90

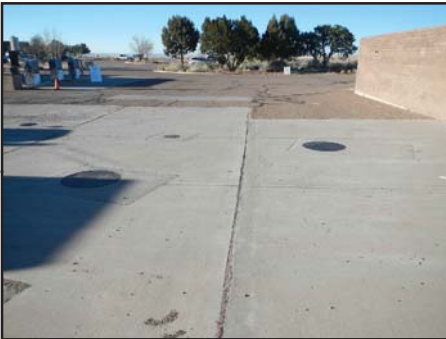
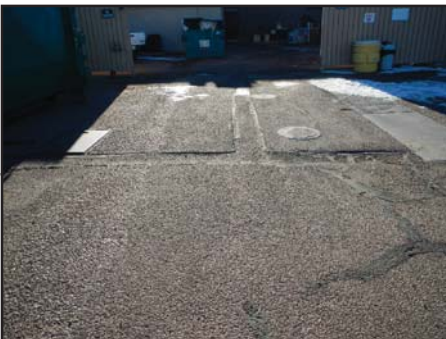
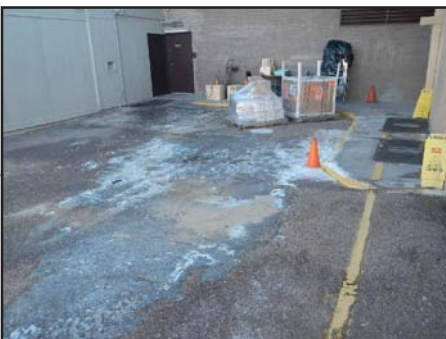
## ROUTE 0921: PDC GAS STATION PARKING

Inspection Date	FMSS Number	User Access	Surface Type
1/12/2016	232465	PUBLIC	ASPHALT
Area (Sq. Ft.)	Lane Miles (11' Widths)	Curb Reveal (Inches)	Curb Recommendation
12,625	0.217	NOT APPLICABLE	NOT APPLICABLE
Curb Type		Curb & Gutter Type	
NO CURB		NO CURB AND GUTTER	
Pavement Recommendation		Condition Rating / PCR	
LIGHT 3R TREATMENTS		FAIR / 73

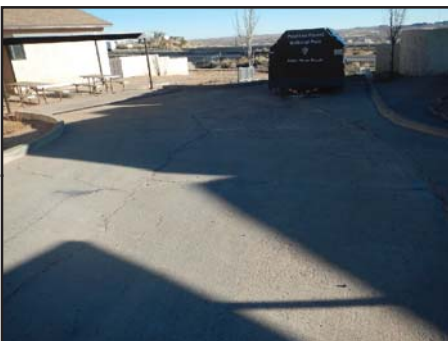
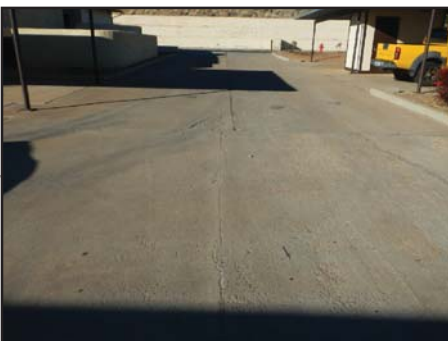
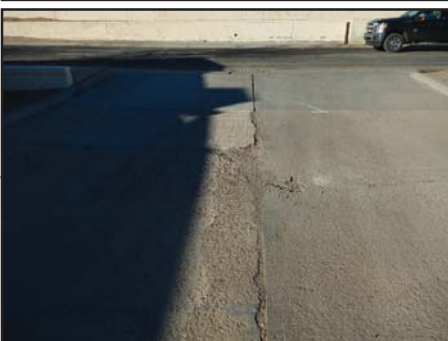
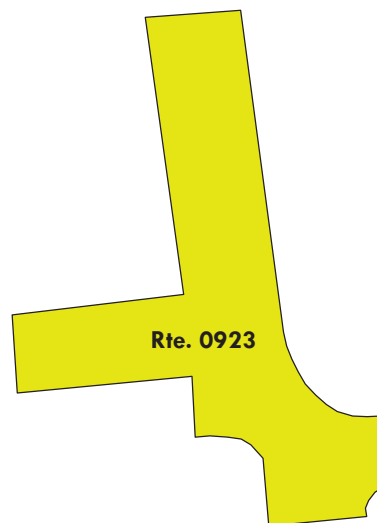
## ROUTE 0923: HH PARKING 1

Inspection Date	FMSS Number	User Access	Surface Type
1/12/2016	237649	NONPUBLIC	CONCRETE
Area (Sq. Ft.)	Lane Miles (11' Widths)	Curb Reveal (Inches)	Curb Recommendation
5,367	0.092	6	DO NOTHING
Curb Type		Curb & Gutter Type	
CONCRETE		NO CURB AND GUTTER	
Pavement Recommendation		Condition Rating / PCR	
LIGHT 3R TREATMENTS		FAIR / 73

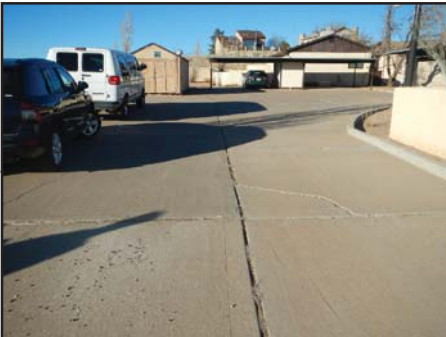
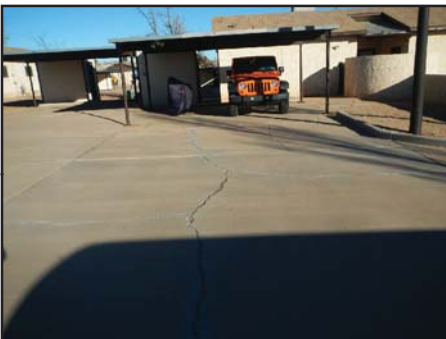
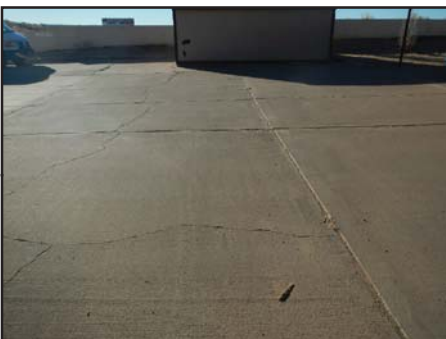
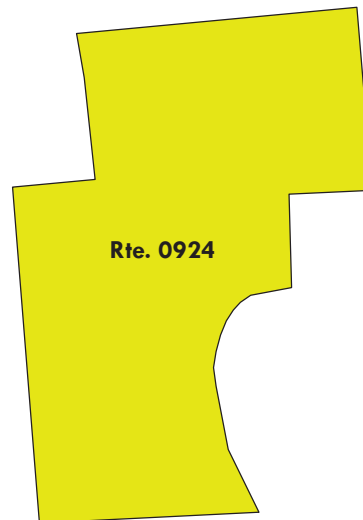
## ROUTE 0924: HH PARKING 2

Inspection Date	FMSS Number	User Access	Surface Type
1/12/2016	237651	NONPUBLIC	CONCRETE
Area (Sq. Ft.)	Lane Miles (11' Widths)	Curb Reveal (Inches)	Curb Recommendation
4,070	0.07	6	DO NOTHING
Curb Type		Curb & Gutter Type	
CONCRETE		NO CURB AND GUTTER	
Pavement Recommendation		Condition Rating / PCR	
LIGHT 3R TREATMENTS		FAIR / 73
