PETE Cycle 6

Final Report

Road Inventory and Condition Assessment of Paved Routes Petersburg National Battlefield

Federal Highway Administration Eastern Federal Lands Highway Division Road Inventory Program (RIP)

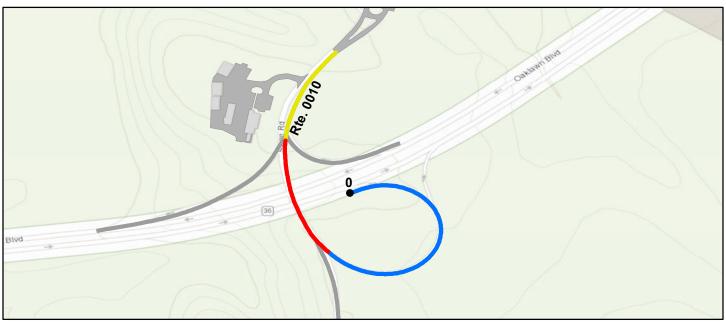
ROUTE 0010: VA 36 EAST TO VISITOR CENTER

Route (Condition Legend – Pav	ement Condi	ition Rating (PCR)		
Poor (0 - 60			(85 - 94)	Excellent (Not Ra	ted
Colors	on map represent con-	dition scores at 0.10-mile	S	e Appendix fo	or definitions	and formulas.	
Inspection Date:	12/10/2020	Beginning Section MP	0				
Paved Length (Mile	s): 0.39	Section Length (MI)	0.39				
Surface Type:	ASPHALT	Route Summary		!		!	
Roadway Condition	Information						
Pavement Condition	n Rating (PCR)	80	80				
Surface Condition Ra	ating (SCR)	80	80				
Roughness Condition	n Index (RCI)	N/A	N/A				
Distress Index Value	es						
Structural Crack Inc	dex	80	80				
Alligator Crack Ind	ex	100	100				
Longitudinal Crack	Index	80	80				
Transverse Cracking	g Index	80	80				
Patching Index		95	95				
Rutting Index		99	99				
International Rough	nness Index (IRI)	N/A	N/A				
Lane & Width Infor	rmation						
Number of Lanes		2	2				
Paved Width (ft)		33.4	33.4				
Lane Width (ft)		16.7	16.7

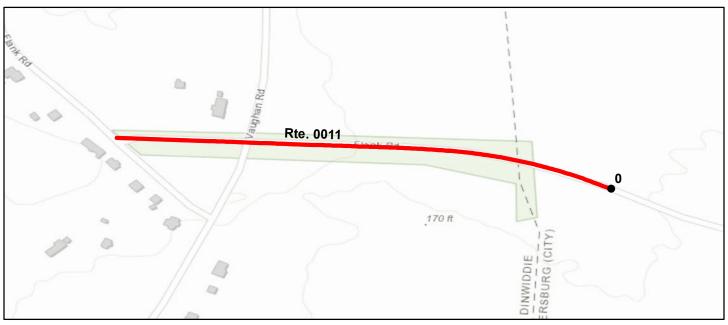
ROUTE 0011: SHORT FLANK ROAD

Doute (Condition Legend – Pav	omant Candi	tion Doting (DCD)		
Poor (0 - 60)	Fair (6		(85 - 94)	Excellent (Not Ra	tod
	•	*	× /	,	5		ieu
	map represent con-	dition scores at 0.10-mile	intervals. Se	e Appendix fo	or definitions	and formulas.	
Inspection Date:	12/10/2020	Beginning Section MP	0				
Paved Length (Miles):	0.29	Section Length (MI)	0.29				
Surface Type:	ASPHALT	Route Summary					
Roadway Condition In	formation						
Pavement Condition R	ating (PCR)	44	44				
Surface Condition Ratin	ng (SCR)	44	44				
Roughness Condition Ir	ndex (RCI)	N/A	N/A				
Distress Index Values							
Structural Crack Index		90	90				
Alligator Crack Index		100	100				
Longitudinal Crack Inc	dex	90	90				
Transverse Cracking In	ndex	44	44				
Patching Index		99	99				
Rutting Index		99	99				
International Roughne	ss Index (IRI)	N/A	N/A				
Lane & Width Informa	ation						
Number of Lanes		2	2				
Paved Width (ft)		20.5	20.5

Lane Width (ft)		9.3	9.3

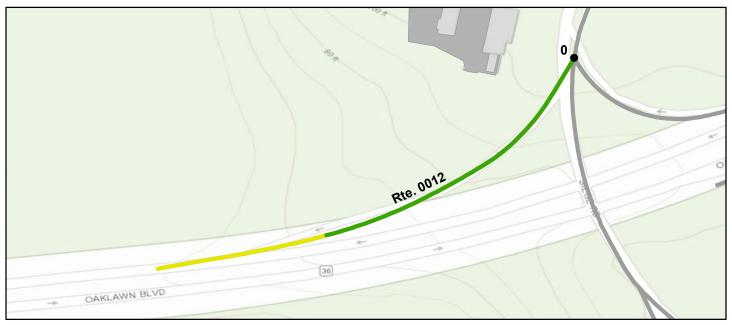
Petersburg National Battlefield ROUTE 0012: VA 36 WEST ON RAMP

Pouto (Condition Legend – Pav	amant Candi	ition Poting (PCD)		
Poor (0 - 60)	Fair (6		(85 - 94)	Excellent (Not Ra	ted
` ` `	•	dition scores at 0.10-mile	× /	*	5		icu
				e Appendix id	or definitions	and formulas.	
Inspection Date:	12/10/2020	Beginning Section MP	0				
Paved Length (Miles)	: 0.16	Section Length (MI)	0.16				
Surface Type:	ASPHALT	Route Summary				-	
Roadway Condition I	nformation						
Pavement Condition	Rating (PCR)	93	93				
Surface Condition Rat	ing (SCR)	93	93				
Roughness Condition	Index (RCI)	N/A	N/A				
Distress Index Values							
Structural Crack Inde	ex	93	93				
Alligator Crack Index	K	100	100				
Longitudinal Crack In	ndex	93	93				
Transverse Cracking	Index	93	93				
Patching Index		100	100				
Rutting Index		100	100				
International Roughn	ess Index (IRI)	N/A	N/A				
Lane & Width Inforn	nation						
Number of Lanes		1	1				
Paved Width (ft)		13.5	13.5				
Lane Width (ft)		13.5	13.5

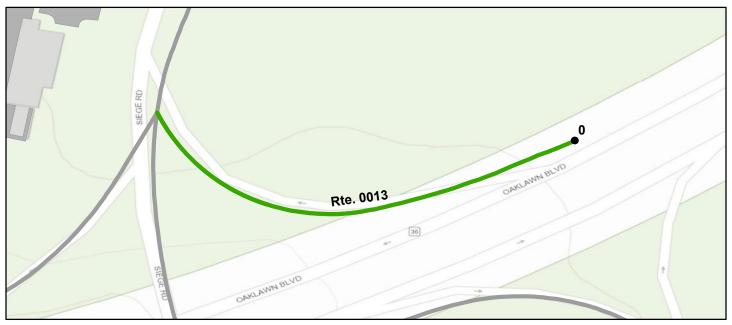
Petersburg National Battlefield ROUTE 0013: VA 36 WEST OFF RAMP

Route (Condition Legend – Pav	ement Condi	ition Rating (PCR)		
Poor (0 - 60			(85 - 94)	Excellent (Not Ra	ted
Colors	on map represent con-	dition scores at 0.10-mile	intervals. Se	e Appendix fo	or definitions	and formulas.	
Inspection Date:	12/10/2020	Beginning Section MP	0				
Paved Length (Mile	es): 0.09	Section Length (MI)	0.09				
Surface Type:	ASPHALT	Route Summary		!		!	
Roadway Condition	1 Information						
Pavement Conditio	n Rating (PCR)	91	91				
Surface Condition R	ating (SCR)	91	91				
Roughness Conditio	n Index (RCI)	N/A	N/A				
Distress Index Valu	es						
Structural Crack In	dex	94	94				
Alligator Crack Inc	lex	100	100				
Longitudinal Crack	Index	94	94				
Transverse Crackin	ig Index	91	91				
Patching Index		100	100				
Rutting Index		99	99				
International Rough	hness Index (IRI)	N/A	N/A				
Lane & Width Info	rmation						
Number of Lanes		1	1				
Paved Width (ft)		16.8	16.8				
Lane Width (ft)		16.8	16.8

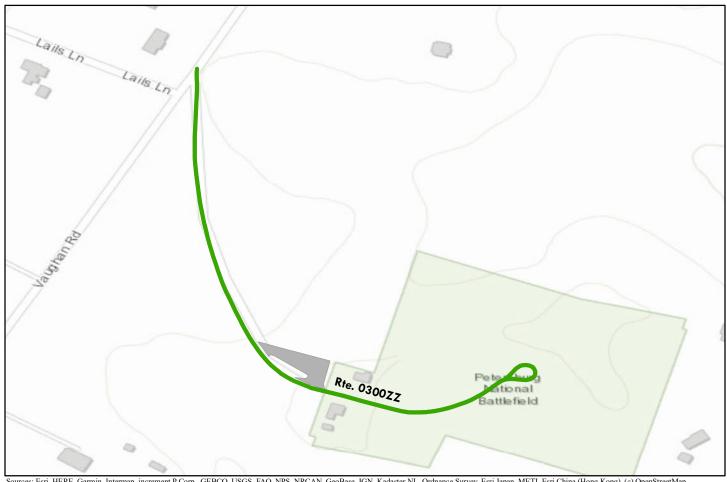
ROUTE 0300ZZ: CARRIAGE LANES

Toute may not reflect mur	viduai subcomponent i a	ımgs.						
	Route C	Condition Leg	gend – Pav	ement Cond	ition Rating (PCR)		
Poor (0 - 60)	Fair (6	Good ((85 - 94)	Excellent (95 - 100)		Not Ra	ted
		See Appen	dix for def	finitions and f	ormulas			
Inspection Date:	12/10/2020							
Paved Length (Miles): 0.33							
Surface Type:	ASPHALT	Route Summ	nary					
Roadway Condition	Information							
Pavement Condition	Rating (PCR)	94						
Lane & Width Inform	mation							
Number of Lanes		1						
Paved Width (ft)		11						
Lane Width (ft)		11

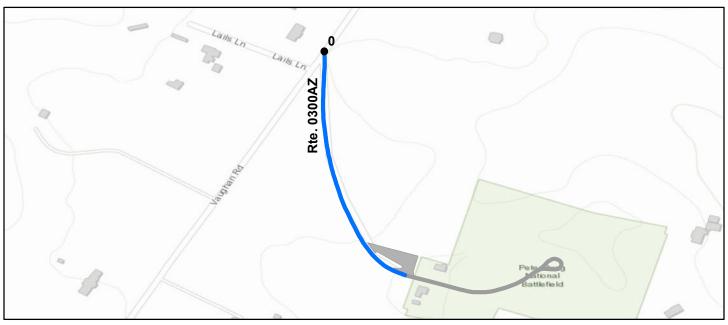
ROUTE 0300AZ: CARRIAGE LANE A

Rout	e Condition Legend – Pav	ement Candi	ition Rating (PC	' P)	
		(85 - 94)	Excellent (95		Not Rated
	ondition scores at 0.10-mile		· · · · · · · · · · · · · · · · · · ·		
Inspection Date: 12/10/2020	Beginning Section MP	0			
Paved Length (Miles): 0.2	Section Length (MI)	0.2			
Surface Type: ASPHALT	Route Summary			· · · · · · · · · · · · · · · · · · ·	'
Roadway Condition Information					
Pavement Condition Rating (PCR)	96	96			
Surface Condition Rating (SCR)	96	96			
Roughness Condition Index (RCI)	N/A	N/A			
Distress Index Values					
Structural Crack Index	98	98			
Alligator Crack Index	100	100			
Longitudinal Crack Index	98	98			
Transverse Cracking Index	96	96			
Patching Index	100	100			
Rutting Index	99	99			
International Roughness Index (IRI)	N/A	N/A			
Lane & Width Information					
Number of Lanes	1	1			
Paved Width (ft)	11	11			
Lane Width (ft)	11	11

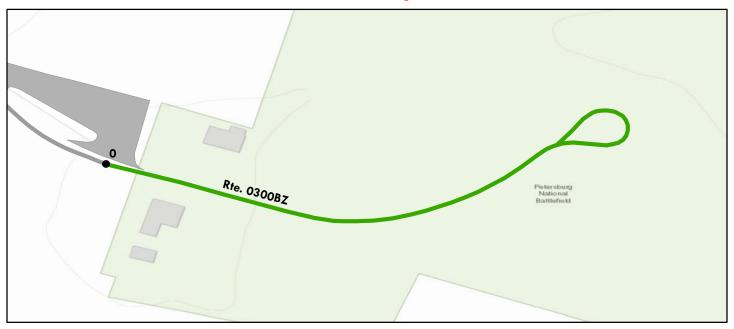
ROUTE 0300BZ: CARRIAGE LANE B

Pouta (Condition Legend – Pav	amant Candi	tion Rating (PCD)		
Poor (0 - 60			(85 - 94)	Excellent (Not Ra	ted
1001 (0 00	7 mi (0	See Appendix for det	· /		70 100)	1100 110	· · ·
Ingression Dates	12/10/2020			l	Ι	T	
Inspection Date:		Beginning Section MP					
Paved Length (Mile	s): 0.13	Section Length (MI)	0.13				
Surface Type:	ASPHALT	Route Summary					
Roadway Condition	Information						
Pavement Condition	n Rating (PCR)	90	90				
Surface Condition Ra	ating (SCR)	90	90				
Roughness Condition	n Index (RCI)	N/A	N/A				
Distress Index Value	es						
Structural Crack Inc	dex	N/A	N/A				
Alligator Crack Ind	ex	97	97				
Longitudinal Crack	Index	90	90				
Transverse Cracking	g Index	90	90				
Patching Index		97	97				
Rutting Index		97	97				
International Rough	nness Index (IRI)	N/A	N/A				
Lane & Width Infor	rmation						
Number of Lanes		1	1				
Paved Width (ft)		11	11				
Lane Width (ft)		11	11

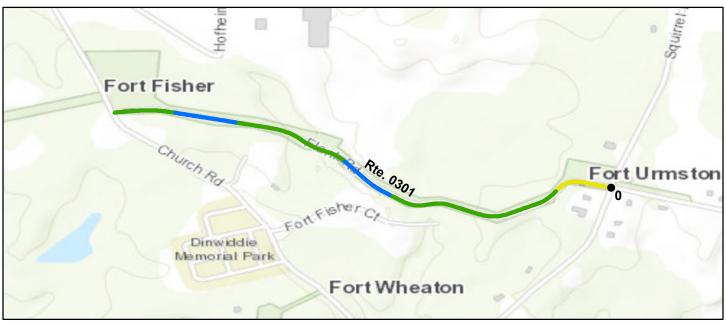
ROUTE 0301: LONG FLANK ROAD

Route (Condition Legend – Pav	ement Condi	tion Rating (PCR)		
Poor (0 - 60			(85 - 94)	Excellent (Not Ra	ted
Colors	on map represent con	dition scores at 0.10-mile		e Appendix fo	or definitions	and formulas.	
Inspection Date:	12/10/2020	Beginning Section MP	0				
Paved Length (Mile	es): 0.9	Section Length (MI)	0.9				
Surface Type:	ASPHALT	Route Summary				!	
Roadway Condition	1 Information						
Pavement Conditio	n Rating (PCR)	91	91				
Surface Condition R	ating (SCR)	98	98				
Roughness Conditio	n Index (RCI)	81	81				
Distress Index Valu	es						
Structural Crack In	dex	99	99				
Alligator Crack Inc	lex	100	100				
Longitudinal Crack	Index	99	99				
Transverse Crackin	ig Index	98	98				
Patching Index		100	100				
Rutting Index		100	100				
International Rough	hness Index (IRI)	165	165				
Lane & Width Info	rmation						
Number of Lanes		2	2				
Paved Width (ft)		19.5	19.5				
Lane Width (ft)		9.4	9.4

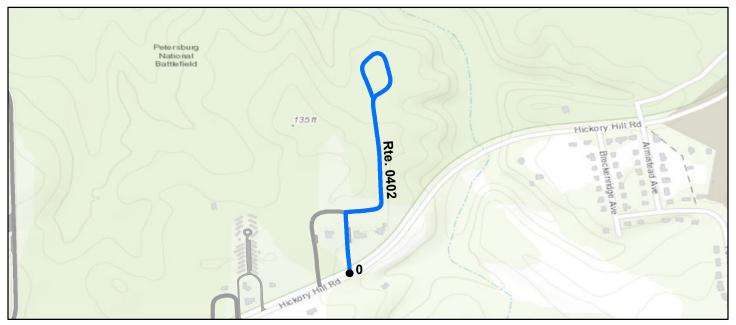
ROUTE 0402: HEADQUARTERS ACCESS ROAD

Route (Condition Legend – Pav	ement Condi	ition Rating (PCR)		
Poor (0 - 60			(85 - 94)	Excellent (Not Ra	ted
Colors	on map represent con-	dition scores at 0.10-mile	intervals. Se	e Appendix fo	or definitions	and formulas.	
Inspection Date:	12/10/2020	Beginning Section MP	0				
Paved Length (Mile	es): 0.49	Section Length (MI)	0.49				
Surface Type:	ASPHALT	Route Summary		!		!	
Roadway Condition	Information						
Pavement Conditio	n Rating (PCR)	98	98				
Surface Condition R	ating (SCR)	98	98				
Roughness Condition	n Index (RCI)	N/A	N/A				
Distress Index Value	es						
Structural Crack In-	dex	99	99				
Alligator Crack Ind	lex	100	100				
Longitudinal Crack	Index	99	99				
Transverse Crackin	g Index	100	100				
Patching Index		100	100				
Rutting Index		98	98				
International Rough	nness Index (IRI)	N/A	N/A				
Lane & Width Info	rmation						
Number of Lanes		1	1				
Paved Width (ft)		11.5	11.5				
Lane Width (ft)		11.5	11.5

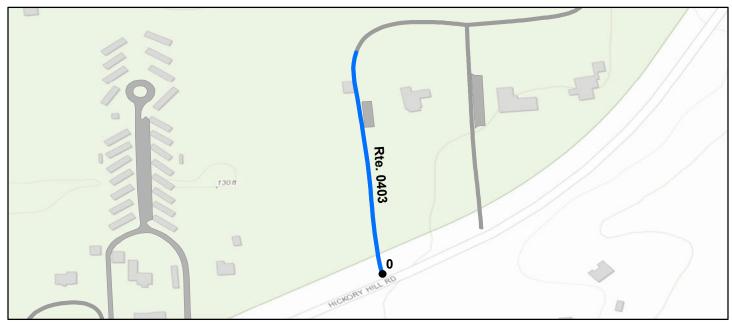
ROUTE 0403: RANGER STATION ACCESS ROAD

Pouto (Condition Legend – Pav	ramant Candi	ition Poting (PCD)		
Poor (0 - 60)	Fair (6		(85 - 94)	Excellent (Not Ra	ted
	`	dition scores at 0.10-mile	· /	*	1		icu
				e Appendix ic	or definitions	and formulas.	
Inspection Date:	12/10/2020	Beginning Section MP	0				
Paved Length (Miles):	0.11	Section Length (MI)	0.11				
Surface Type:	ASPHALT	Route Summary					
Roadway Condition In	formation						
Pavement Condition R	ating (PCR)	99	99				
Surface Condition Ratin	g (SCR)	99	99				
Roughness Condition In	dex (RCI)	N/A	N/A				
Distress Index Values							
Structural Crack Index		100	100				
Alligator Crack Index		100	100				
Longitudinal Crack Inc	lex	100	100				
Transverse Cracking In	ndex	100	100				
Patching Index		100	100				
Rutting Index		99	99				
International Roughnes	ss Index (IRI)	N/A	N/A				
Lane & Width Informa	ntion						
Number of Lanes		1	1				
Paved Width (ft)		11.5	11.5				
Lane Width (ft)		11.5	11.5

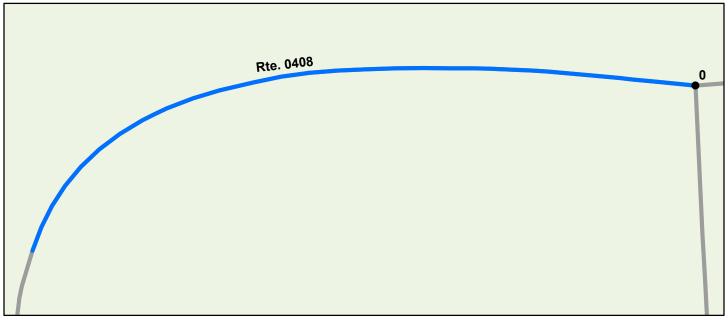
ROUTE 0408: RANGER STATION TO HQ SHORTCUT

Route (Condition Legend – Pav	ement Condi	ition Rating (PCR)		
Poor (0 - 6			(85 - 94)	Excellent (Not Ra	ted
Colors	on map represent con	dition scores at 0.10-mile	intervals. Se	e Appendix fo	or definitions	and formulas.	
Inspection Date:	12/10/2020	Beginning Section MP	0				
Paved Length (Mil	es): 0.05	Section Length (MI)	0.05				
Surface Type:	ASPHALT	Route Summary		!			
Roadway Conditio	n Information						
Pavement Condition	on Rating (PCR)	99	99				
Surface Condition I	Rating (SCR)	99	99				
Roughness Condition	on Index (RCI)	N/A	N/A				
Distress Index Valu	ies						
Structural Crack In	ndex	100	100				
Alligator Crack In	dex	100	100				
Longitudinal Crack	k Index	100	100				
Transverse Cracking	ng Index	100	100				
Patching Index		100	100				
Rutting Index		99	99				
International Roug	ghness Index (IRI)	N/A	N/A				
Lane & Width Info	ormation						
Number of Lanes		1	1				
Paved Width (ft)		12.8	12.8

Lane Width (ft)		12.8	12.8

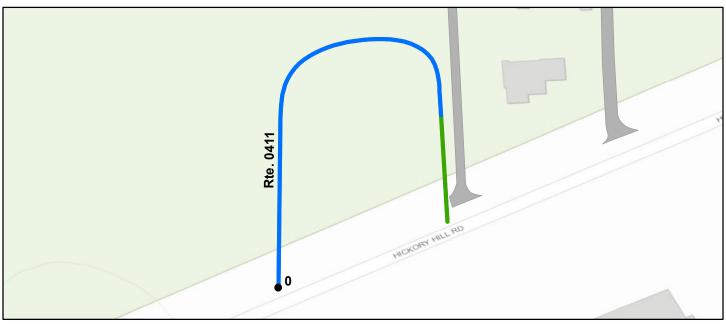
ROUTE 0411: QUARTERS #29 ACCESS ROAD

Route Condition Legend – Pavement Condition Rating (PCR)							
Poor (0 - 60)	Fair (61		d (85 - 94)	Excellent (9		Not Ra	ted
Colors on map represent con-		· ·		· · · · · · · · · · · · · · · · · · ·	100		
Inspection Date: 12/10		Beginning Section M				T	
Paved Length (Miles): 0.13		Section Length (MI)

0.13				
Surface Type: ASPH		Route Summary					
Roadway Condition Informa	ation						
Pavement Condition Rating	(PCR)	96	96				
Surface Condition Rating (SC)	R)	96	96				
Roughness Condition Index (F	RCI)	N/A	N/A				
Distress Index Values							
Structural Crack Index		100	100				
Alligator Crack Index		100	100				
Longitudinal Crack Index		100	100				
Transverse Cracking Index		100	100				
Patching Index		100	100				
Rutting Index		96	96				
International Roughness Inde	ex (IRI)	N/A	N/A				
Lane & Width Information							
Number of Lanes		1	1				
Paved Width (ft)		12.7	12.7				
Lane Width (ft)		12.7	12.7

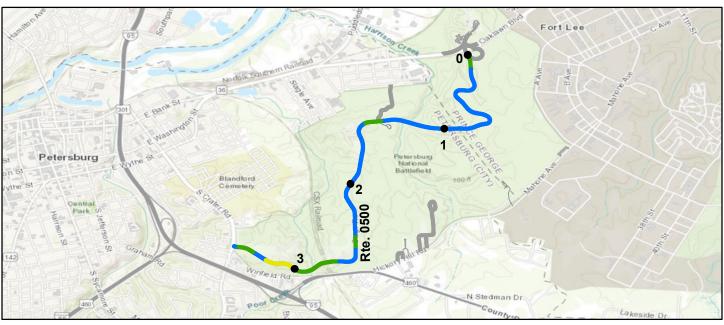
ROUTE 0500: SIEGE ROAD

Route Condition Legend – Pavement Condition Rating (PCR)						
l		(85 - 94)	Excellent (Not Ra	ted
Colors on map represent of	ondition scores at 0.10-mile	intervals. Se	e Appendix fo	or definitions	and formulas.	
Inspection Date: 12/10/2020	Beginning Section MP	0	1	2	3	
Paved Length (Miles): 3.43	Section Length (MI)	1	1	1	0.43	
Surface Type: ASPHALT	Route Summary		!		!	
Roadway Condition Information						
Pavement Condition Rating (PCR)	98	99	99	97	86	
Surface Condition Rating (SCR)	98	99	99	98	88	
Roughness Condition Index (RCI)	97	100	100	95	84	
Distress Index Values						
Structural Crack Index	98	100	100	100	91	
Alligator Crack Index	100	100	100	100	100	
Longitudinal Crack Index	98	100	100	100	91	
Transverse Cracking Index	98	99	100	99	88	
Patching Index	100	100	100	100	100	
Rutting Index	99	99	99	98	97	
International Roughness Index (IRI)	122	112	113	127	156	
Lane & Width Information						
Number of Lanes	1	1	1	1	1

Paved Width (ft)	20.1	20.7	19.9	20	19.2	
Lane Width (ft)	12.6	12.1	12.9	12.7	12.6
