PETR Cycle 6

Final Report

Road Inventory and Condition Assessment of Paved Routes Petroglyph National Monument

Report Date: November 2017

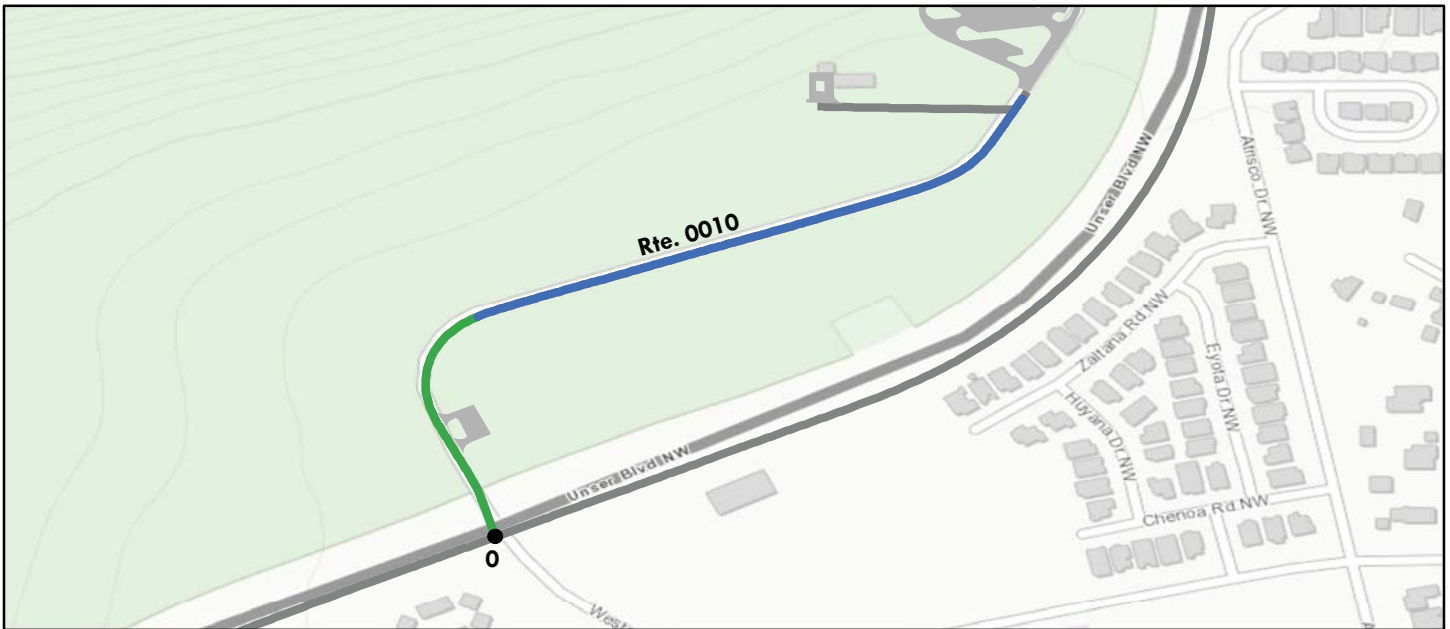
ROUTE 0010: LAS IMAGENES ENTRANCE ROAD

Route Condition Legend – Pavement Condition Rating (PCR)						
Poor (0 - 60)	Fair (61- 84)	Good (85 - 94)	Excellent (95 - 100)	Not Rated		
See Appendix for definitions and formulas						
Inspection Date: 6/3/2017	Beginning Section MP	0				
Paved Length (Miles): 0.33	Section Length (MI)	0.33				
Surface Type: ASPHALT	Route Summary					
Roadway Condition Information						
Pavement Condition Rating (PCR)	98	98				
Surface Condition Rating (SCR)	98	98				
Roughness Condition Index (RCI)	N/A	N/A				
Distress Index Values						
Structural Crack Index	99	99				
Alligator Crack Index	100	100				
Longitudinal Crack Index	99	99				
Transverse Cracking Index	98	98				
Patching Index	100	100				
Rutting Index	99	99				
International Roughness Index (IRI)	N/A	N/A				
Lane & Width Information						
Number of Lanes	2	2				
Paved Width (ft)	20.4	20.4				
Lane Width (ft)	13.8	13.8

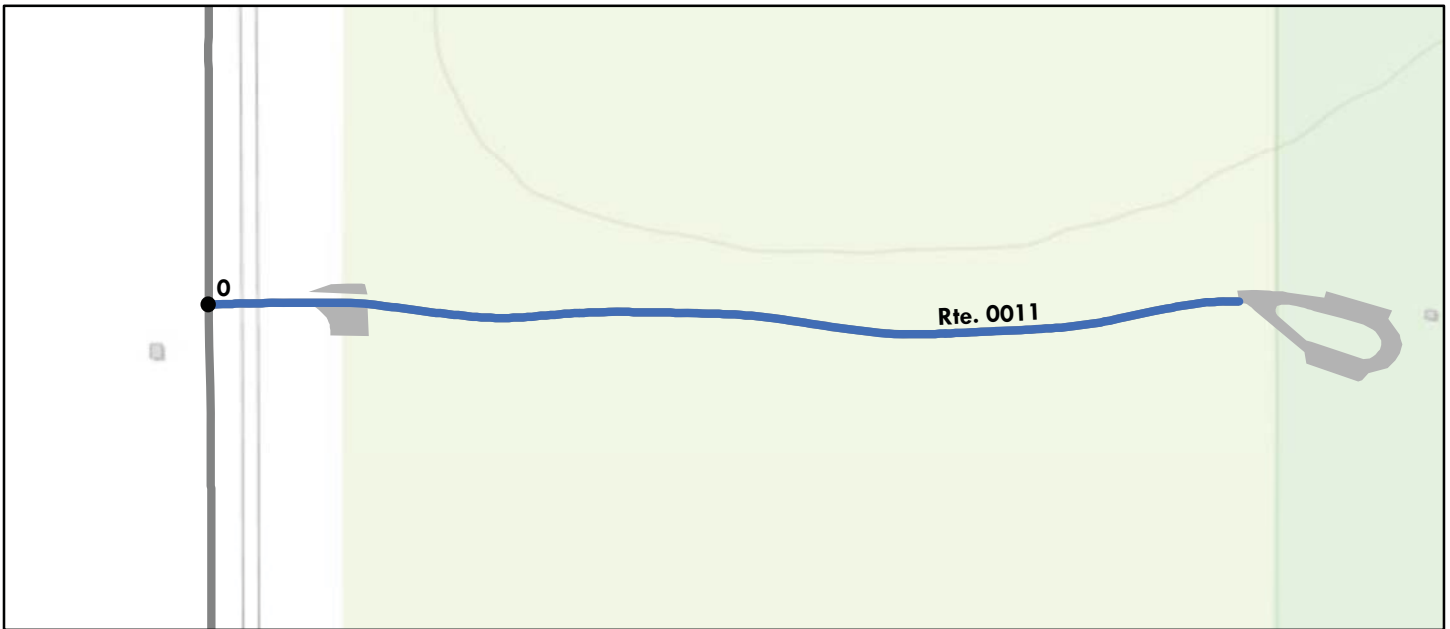
ROUTE 0011: VOLCANO ENTRANCE ROAD

Route Condition Legend – Pavement Condition Rating (PCR)						
Poor (0 - 60)	Fair (61- 84)	Good (85 - 94)	Excellent (95 - 100)	Not Rated		
See Appendix for definitions and formulas						
Inspection Date: 6/3/2017	Beginning Section MP	0				
Paved Length (Miles): 0.28	Section Length (MI)	0.28				
Surface Type: ASPHALT	Route Summary					
Roadway Condition Information						
Pavement Condition Rating (PCR)	98	98				
Surface Condition Rating (SCR)	98	98				
Roughness Condition Index (RCI)	N/A	N/A				
Distress Index Values						
Structural Crack Index	100	100				
Alligator Crack Index	100	100				
Longitudinal Crack Index	100	100				
Transverse Cracking Index	98	98				
Patching Index	100	100				
Rutting Index	99	99				
International Roughness Index (IRI)	N/A	N/A				
Lane & Width Information						
Number of Lanes	2	2				
Paved Width (ft)	16.5	16.5				
Lane Width (ft)	7.7	7.7

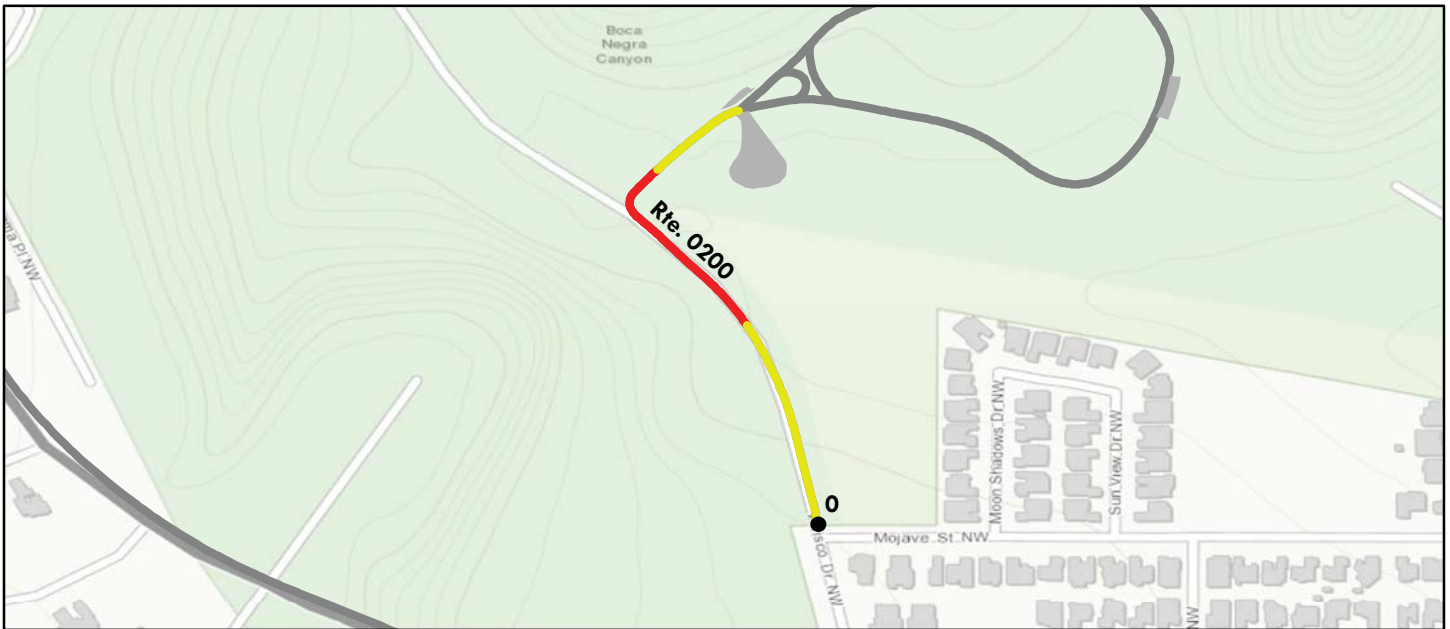
ROUTE 0200: BOCA NEGRA ENTRANCE ROAD

Route Condition Legend – Pavement Condition Rating (PCR)						
Poor (0 - 60)	Fair (61- 84)	Good (85 - 94)	Excellent (95 - 100)	Not Rated		
See Appendix for definitions and formulas						
Inspection Date: 6/3/2017	Beginning Section MP	0				
Paved Length (Miles): 0.25	Section Length (MI)	0.25				
Surface Type: ASPHALT	Route Summary					
Roadway Condition Information						
Pavement Condition Rating (PCR)	67	67				
Surface Condition Rating (SCR)	67	67				
Roughness Condition Index (RCI)	N/A	N/A				
Distress Index Values						
Structural Crack Index	84	84				
Alligator Crack Index	99	99				
Longitudinal Crack Index	85	85				
Transverse Cracking Index	67	67				
Patching Index	100	100				
Rutting Index	97	97				
International Roughness Index (IRI)	N/A	N/A				
Lane & Width Information						
Number of Lanes	2	2				
Paved Width (ft)	22.2	22.2				
Lane Width (ft)	9.1	9.1

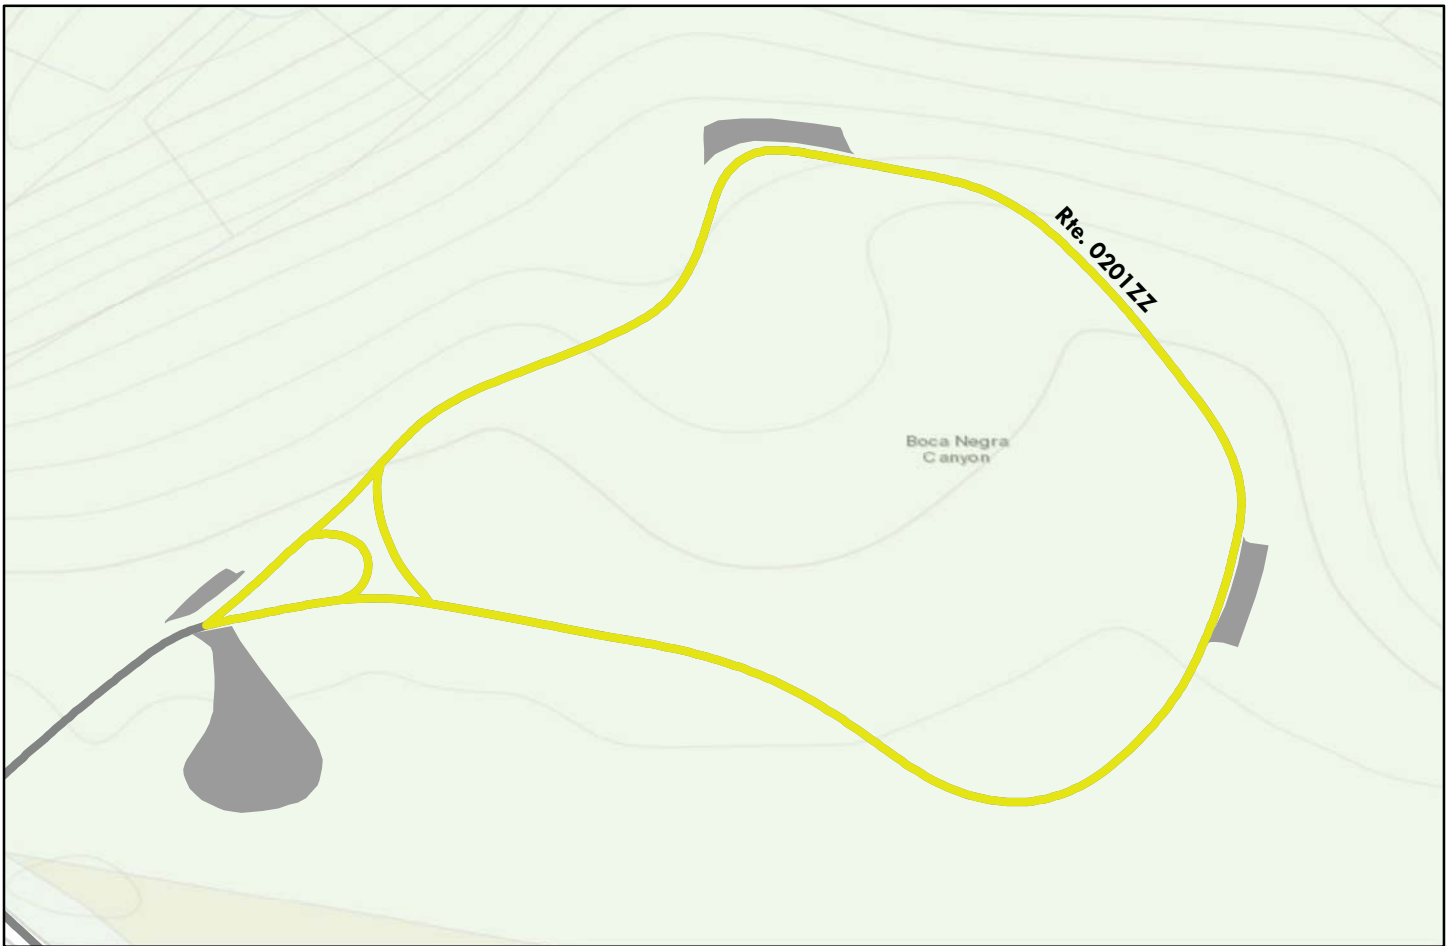
ROUTE 0201ZZ: BOCA NEGRA LOOP ROAD

Route Condition Legend – Pavement Condition Rating (PCR)						
Poor (0 - 60)	Fair (61- 84)	Good (85 - 94)	Excellent (95 - 100)	Not Rated		
See Appendix for definitions and formulas						
Inspection Date: 6/3/2017						
Paved Length (Miles): 0.52						
Surface Type: ASPHALT	Route Summary					
Roadway Condition Information						
Pavement Condition Rating (PCR)	72					
Lane & Width Information						
Number of Lanes	1					
Paved Width (ft)	10.9					
Lane Width (ft)	8.1

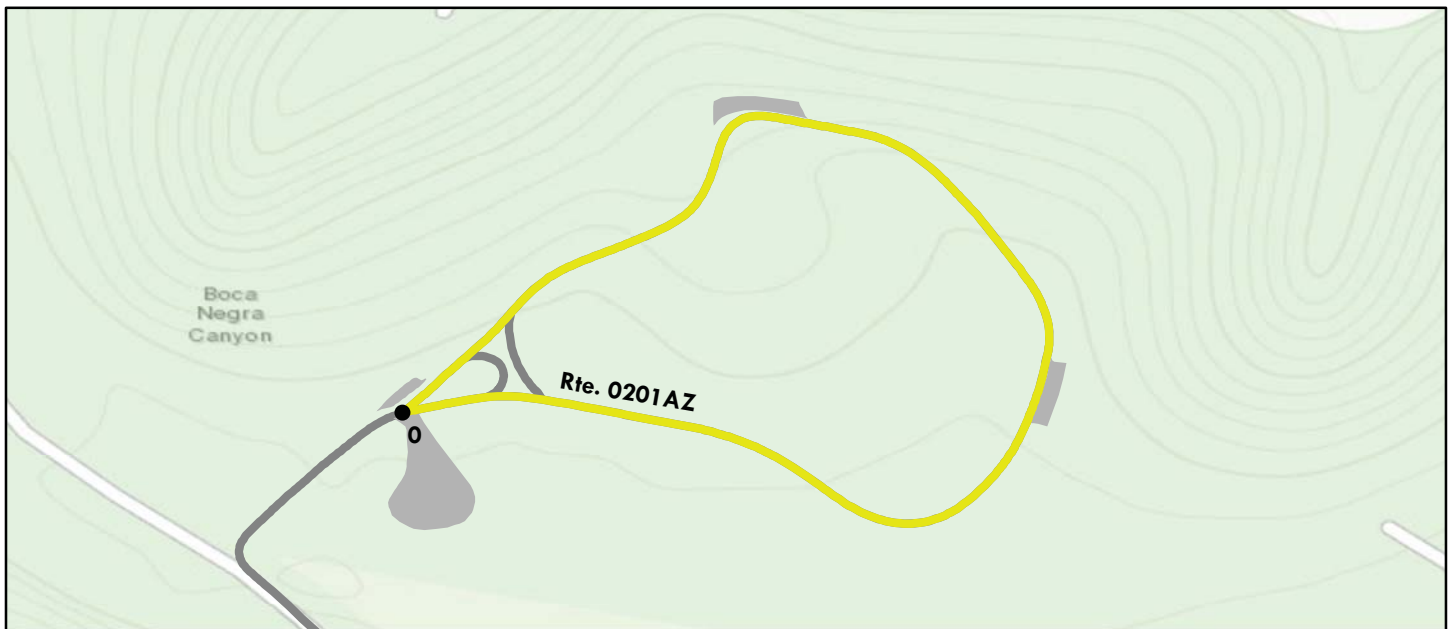
ROUTE 0201AZ: BOCA NEGRA MAIN LOOP ROAD

Route Condition Legend – Pavement Condition Rating (PCR)						
Poor (0 - 60)	Fair (61- 84)	Good (85 - 94)	Excellent (95 - 100)	Not Rated		
See Appendix for definitions and formulas						
Inspection Date: 6/3/2017	Beginning Section MP	0				
Paved Length (Miles): 0.48	Section Length (MI)	0.48				
Surface Type: ASPHALT	Route Summary					
Roadway Condition Information						
Pavement Condition Rating (PCR)	71	71				
Surface Condition Rating (SCR)	71	71				
Roughness Condition Index (RCI)	N/A	N/A				
Distress Index Values						
Structural Crack Index	81	81				
Alligator Crack Index	100	100				
Longitudinal Crack Index	81	81				
Transverse Cracking Index	71	71				
Patching Index	100	100				
Rutting Index	94	94				
International Roughness Index (IRI)	N/A	N/A				
Lane & Width Information						
Number of Lanes	1	1				
Paved Width (ft)	10.8	10.8				
Lane Width (ft)	7.8	7.8

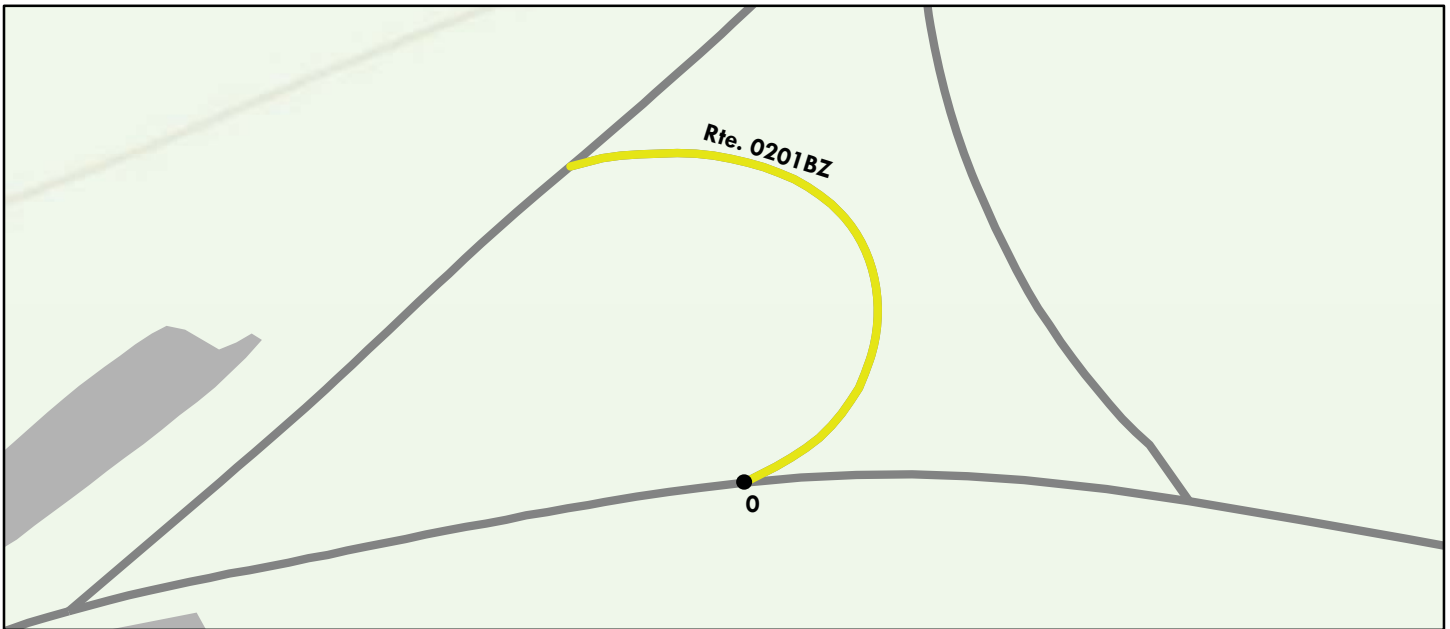
ROUTE 0201BZ: BOCA NEGRA LOOP CUT-THROUGH 1

Route Condition Legend – Pavement Condition Rating (PCR)						
Poor (0 - 60)	Fair (61- 84)	Good (85 - 94)	Excellent (95 - 100)	Not Rated		
See Appendix for definitions and formulas						
Inspection Date: 6/3/2017	Beginning Section MP	0				
Paved Length (Miles): 0.02	Section Length (MI)	0.02				
Surface Type: ASPHALT	Route Summary					
Roadway Condition Information						
Pavement Condition Rating (PCR)	78	78				
Surface Condition Rating (SCR)	78	78				
Roughness Condition Index (RCI)	N/A	N/A				
Distress Index Values						
Structural Crack Index	86	86				
Alligator Crack Index	100	100				
Longitudinal Crack Index	86	86				
Transverse Cracking Index	78	78				
Patching Index	100	100				
Rutting Index	92	92				
International Roughness Index (IRI)	N/A	N/A				
Lane & Width Information						
Number of Lanes	1	1				
Paved Width (ft)	12.8	12.8				
Lane Width (ft)	11.8	11.8

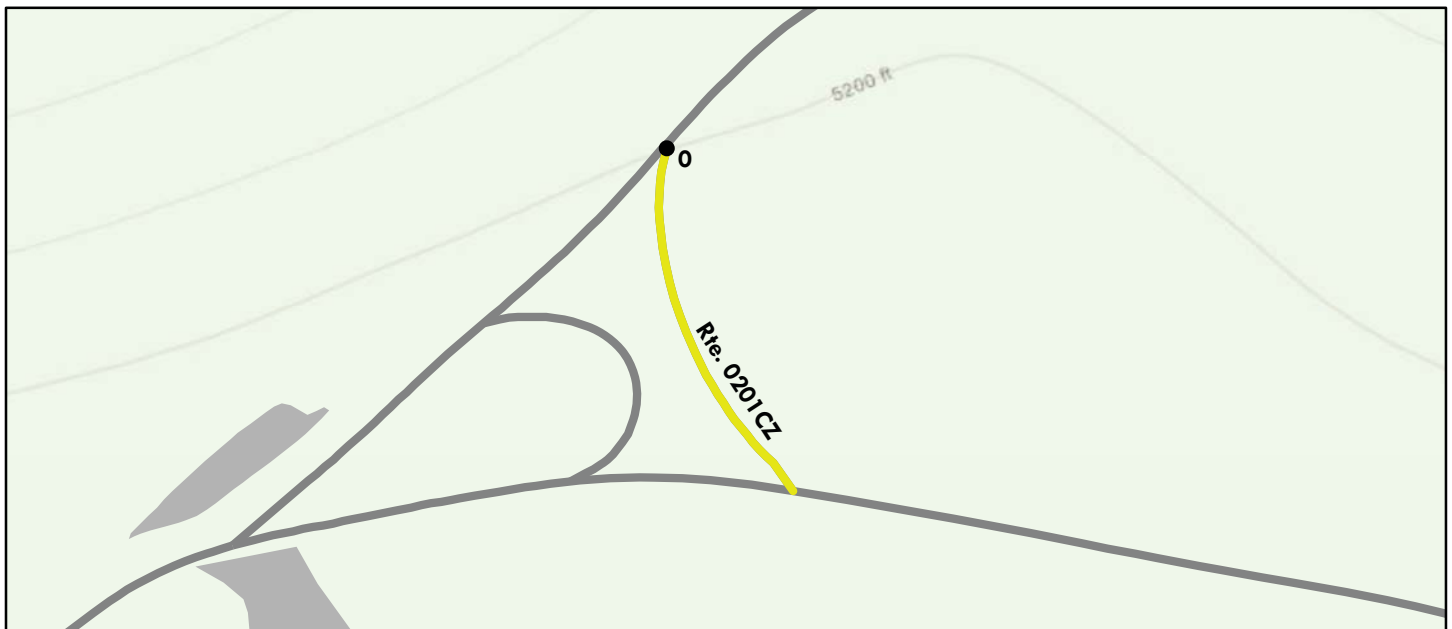
ROUTE 0201CZ: BOCA NEGRA LOOP CUT-THROUGH 2

Route Condition Legend – Pavement Condition Rating (PCR)						
Poor (0 - 60)	Fair (61- 84)	Good (85 - 94)	Excellent (95 - 100)	Not Rated		
See Appendix for definitions and formulas						
Inspection Date: 6/3/2017	Beginning Section MP	0				
Paved Length (Miles): 0.03	Section Length (MI)	0.03				
Surface Type: ASPHALT	Route Summary					
Roadway Condition Information						
Pavement Condition Rating (PCR)	77	77				
Surface Condition Rating (SCR)	77	77				
Roughness Condition Index (RCI)	N/A	N/A				
Distress Index Values						
Structural Crack Index	81	81				
Alligator Crack Index	100	100				
Longitudinal Crack Index	81	81				
Transverse Cracking Index	77	77				
Patching Index	100	100				
Rutting Index	95	95				
International Roughness Index (IRI)	N/A	N/A				
Lane & Width Information						
Number of Lanes	1	1				
Paved Width (ft)	11.2	11.2				
Lane Width (ft)	9.7	9.7

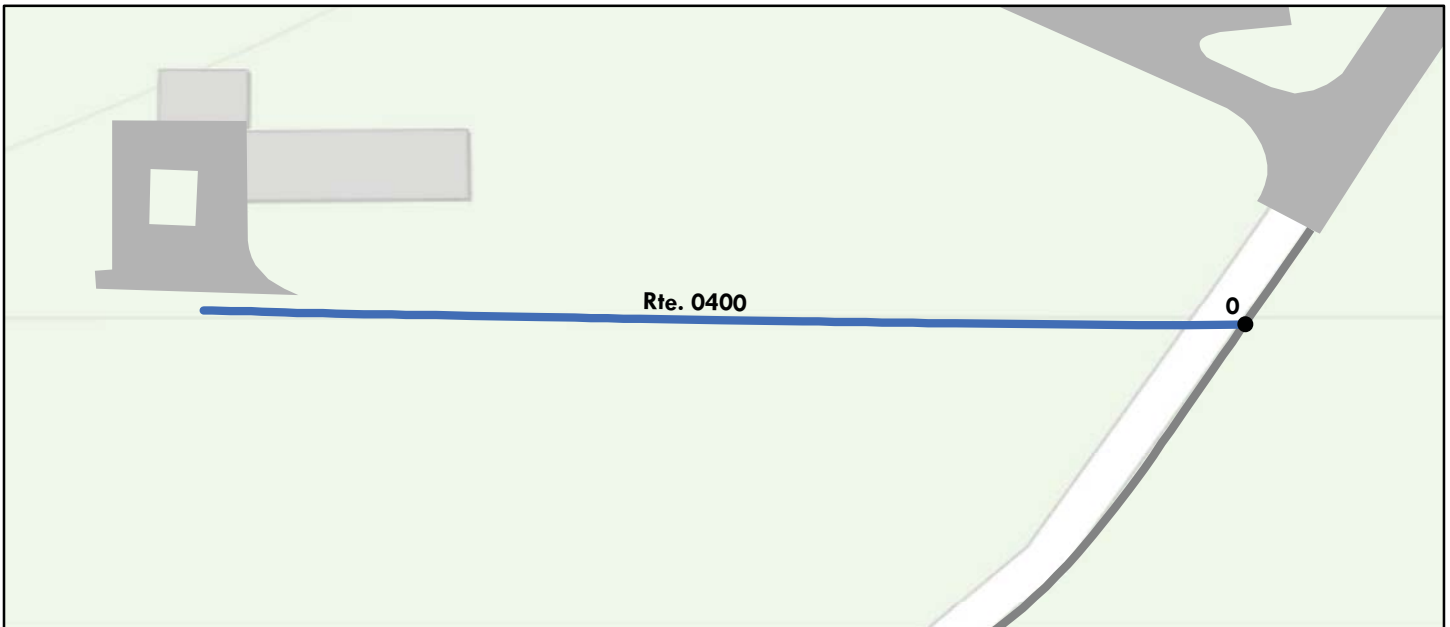
ROUTE 0400: LAVA SHADOWS ROAD

Route Condition Legend – Pavement Condition Rating (PCR)						
Poor (0 - 60)	Fair (61- 84)	Good (85 - 94)	Excellent (95 - 100)	Not Rated		
See Appendix for definitions and formulas						
Inspection Date: 6/3/2017	Beginning Section MP	0				
Paved Length (Miles): 0.07	Section Length (MI)	0.07				
Surface Type: ASPHALT	Route Summary					
Roadway Condition Information						
Pavement Condition Rating (PCR)	97	97				
Surface Condition Rating (SCR)	97	97				
Roughness Condition Index (RCI)	N/A	N/A				
Distress Index Values						
Structural Crack Index	100	100				
Alligator Crack Index	100	100				
Longitudinal Crack Index	100	100				
Transverse Cracking Index	97	97				
Patching Index	100	100				
Rutting Index	100	100				
International Roughness Index (IRI)	N/A	N/A				
Lane & Width Information						
Number of Lanes	2	2				
Paved Width (ft)	20.2	20.2				
Lane Width (ft)	10.1	10.1

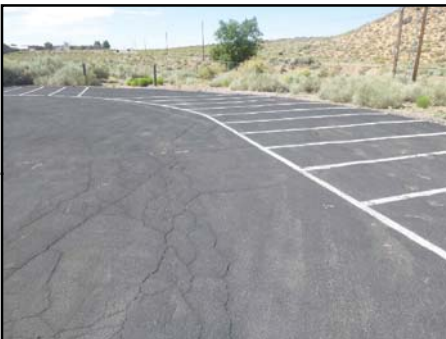
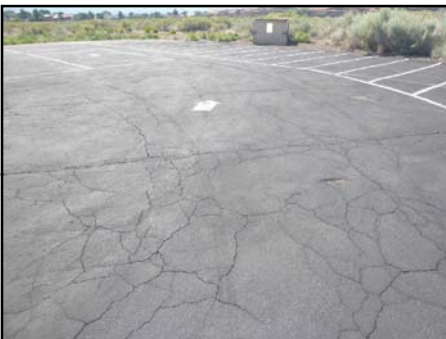
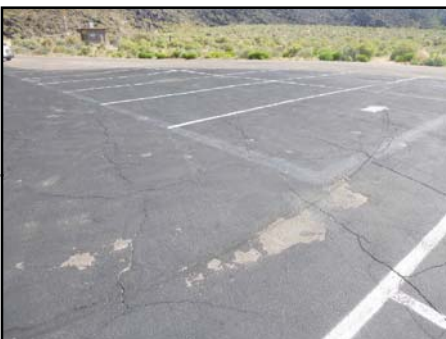
ROUTE 0910AZ: BOCA NEGRA OVERFLOW PARKING AREA A

Inspection Date	FMSS Number	User Access	Surface Type
6/3/2017	90001	PUBLIC	ASPHALT
Area (Sq. Ft.)	Lane Miles (11' Widths)	Curb Reveal (Inches)	Curb Recommendation
14,905	0.257	NOT APPLICABLE	NOT APPLICABLE
Curb Type		Curb & Gutter Type	
NO CURB		NO CURB AND GUTTER	
Pavement Recommendation		Condition Rating / PCR	
HEAVY 3R TREATMENTS		POOR / 53

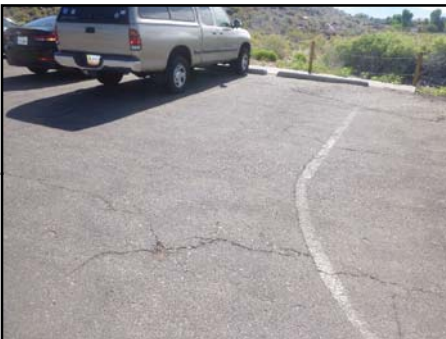
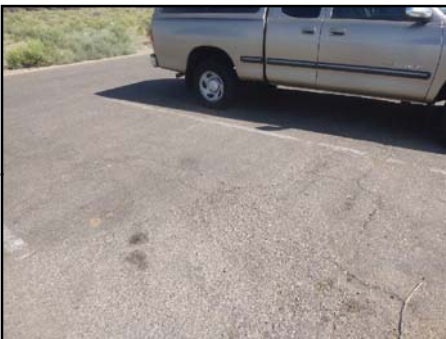
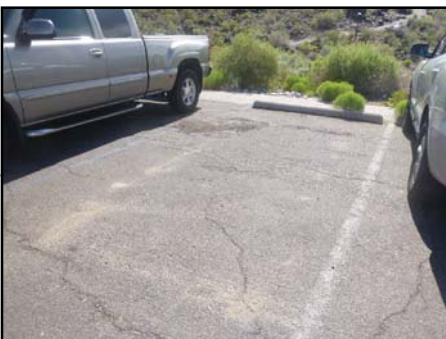
Inspection Date	FMSS Number	User Access	Surface Type
6/3/2017	90002	PUBLIC	ASPHALT
Area (Sq. Ft.)	Lane Miles (11' Widths)	Curb Reveal (Inches)	Curb Recommendation
2,721	0.047	NOT APPLICABLE	NOT APPLICABLE
Curb Type		Curb & Gutter Type	
NO CURB		NO CURB AND GUTTER	
Pavement Recommendation		Condition Rating / PCR	
HEAVY 3R TREATMENTS		POOR / 53
