Final Report

Road Inventory and Condition Assessment of Paved Routes Pictured Rocks National Lakeshore

**Federal Highway Administration
Eastern Federal Lands Highway Division
Road Inventory Program (RIP)**

Report Date: May 2019

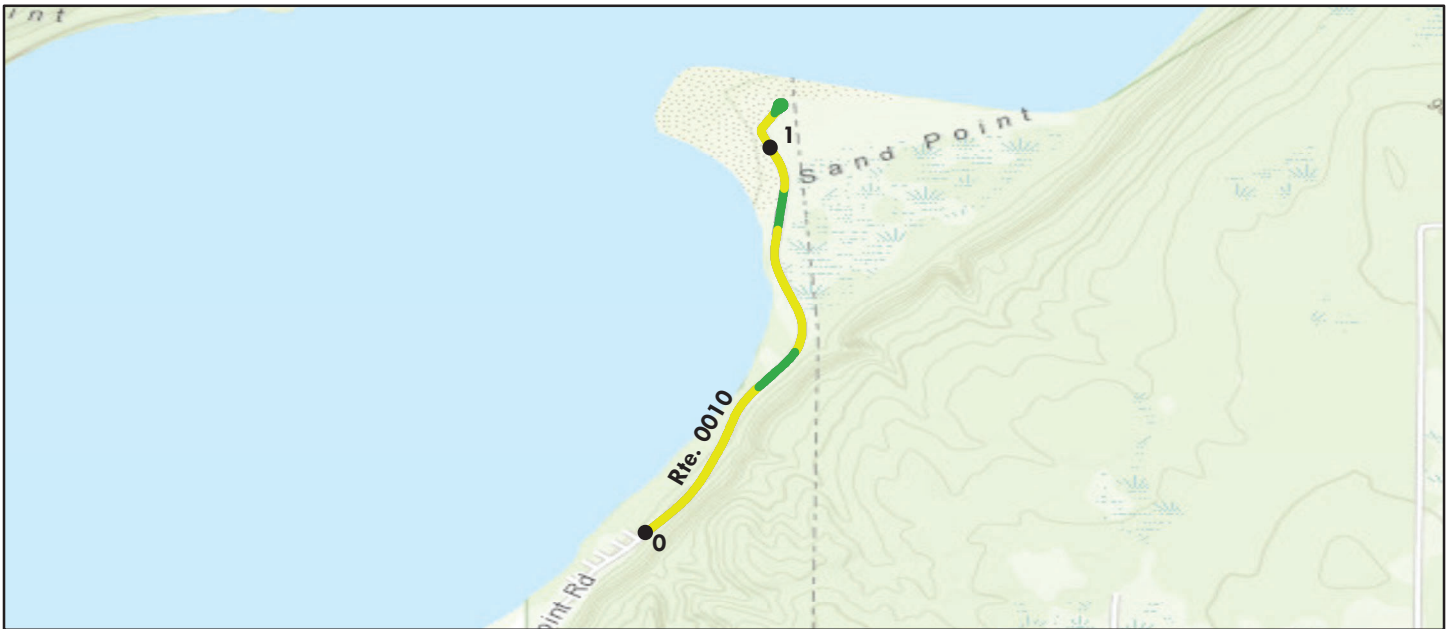
ROUTE 0010: SAND POINT ROAD

Inspection Date:	10/15/2018	Beginning Section MP	0	1			
Paved Length (Miles):	1.15	Section Length (MI)	1	0.15			
Surface Type:	ASPHALT	Route Summary					
Roadway Condition Information							
Pavement Condition Rating (PCR)	80	79	78				
Surface Condition Rating (SCR)	90	89	78				
Roughness Condition Index (RCI)	65	65	N/A				
Distress Index Values							
Structural Crack Index	95	95	94				
Alligator Crack Index	99	99	100				
Longitudinal Crack Index	96	96	94				
Transverse Cracking Index	90	92	78				
Patching Index	99	99	100				
Rutting Index	90	89	97				
International Roughness Index (IRI)	218	220	N/A				
Lane & Width Information							
Number of Lanes	2	2	2				
Paved Width (ft)	22.5	22.4	22.8				
Lane Width (ft)	11.2	11.2	11.4

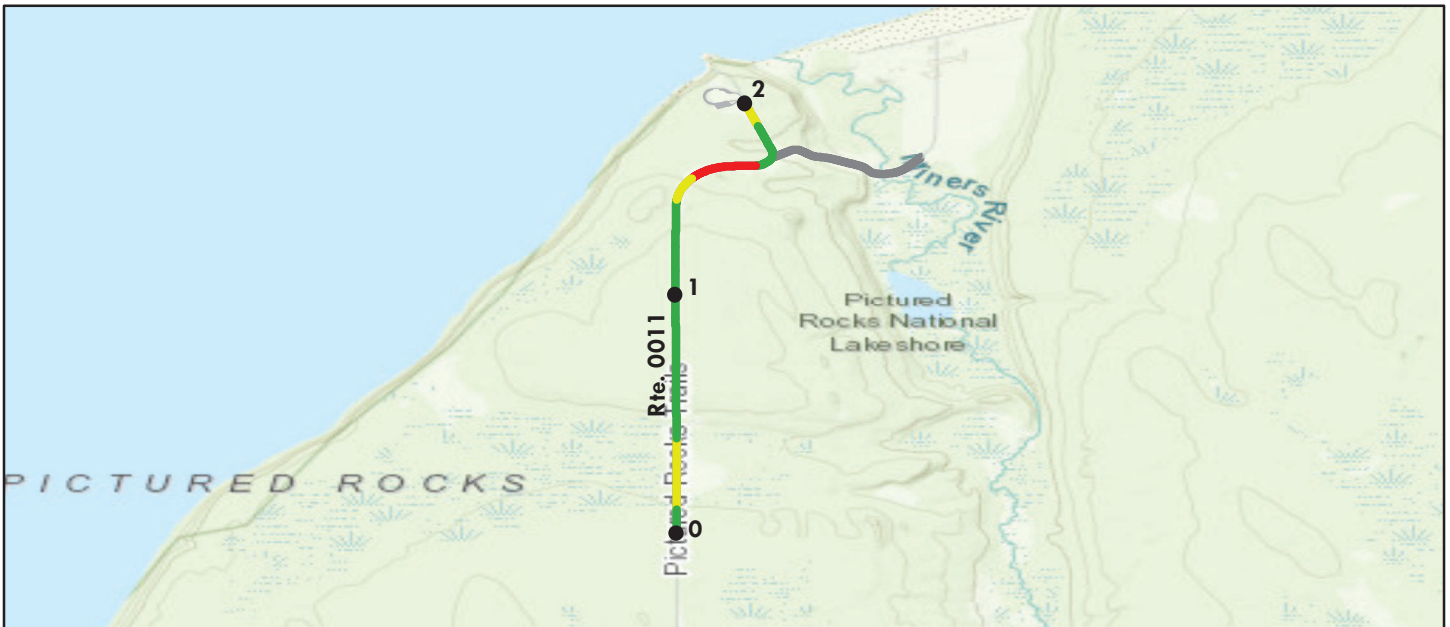
ROUTE 0011: MINERS CASTLE ROAD

Inspection Date:	10/14/2018	Beginning Section MP	0	1	2		
Paved Length (Miles):	2.01	Section Length (MI)	1	1	0.01		
Surface Type:	ASPHALT	Route Summary					
Roadway Condition Information							
Pavement Condition Rating (PCR)	85	88	82	66			
Surface Condition Rating (SCR)	84	86	81	95			
Roughness Condition Index (RCI)	86	91	83	23			
Distress Index Values							
Structural Crack Index	96	98	95	100			
Alligator Crack Index	100	100	100	100			
Longitudinal Crack Index	96	98	95	100			
Transverse Cracking Index	100	100	100	100			
Patching Index	100	100	100	100			
Rutting Index	84	86	81	95			
International Roughness Index (IRI)	151	138	160	475			
Lane & Width Information							
Number of Lanes	2	2	2	2			
Paved Width (ft)	23.9	24.1	23.8	23.8			
Lane Width (ft)	12	12	11.9	11.9

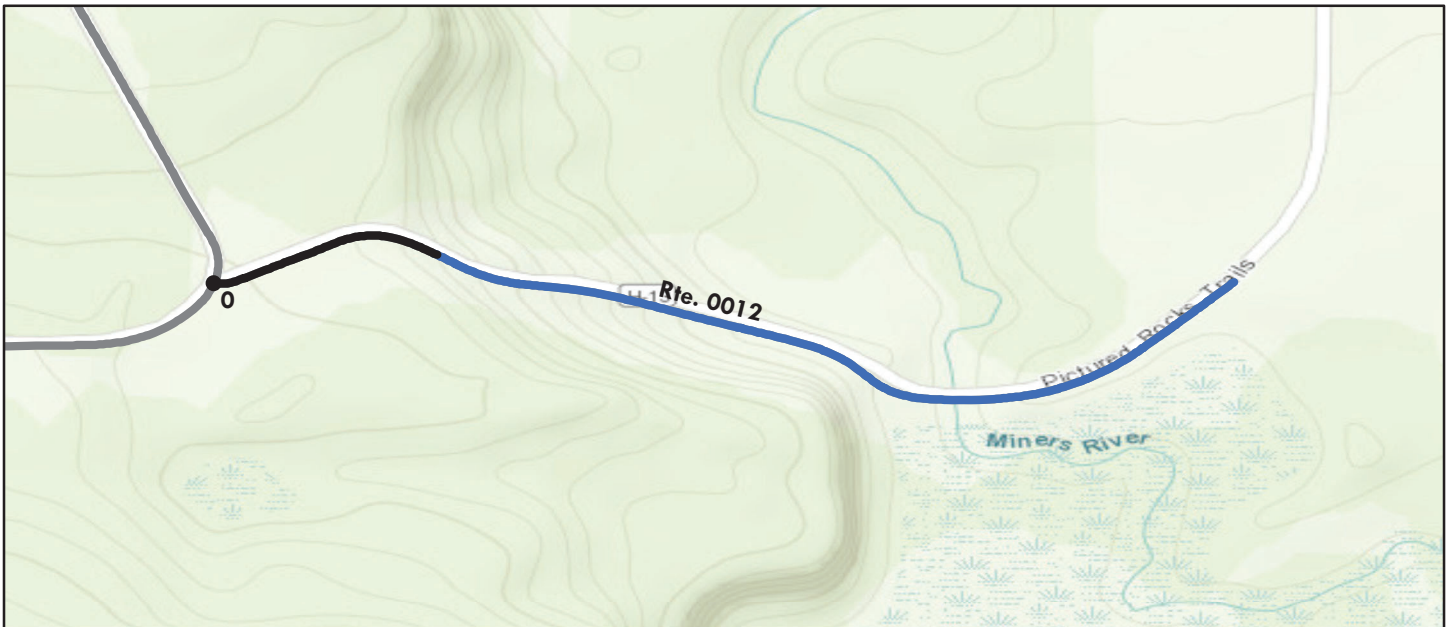
ROUTE 0012: MINERS BEACH ROAD

Route Condition Legend – Pavement Condition Rating (PCR)									
Poor (0 - 60)		Fair (61- 84)		Good (85 - 94)		Excellent (95 - 100)		Not Rated	
Colors on map represent condition scores at 0.10-mile intervals. See Appendix for definitions and formulas.									
Inspection Date:	10/14/2018	Beginning Section MP	0						
Paved Length (Miles):	0.43	Section Length (MI)	0.49						
Surface Type:	ASPHALT	Route Summary							
Roadway Condition Information									
Pavement Condition Rating (PCR)		99	99						
Surface Condition Rating (SCR)		99	99						
Roughness Condition Index (RCI)		N/A	N/A						
Distress Index Values									
Structural Crack Index		100	100						
Alligator Crack Index		100	100						
Longitudinal Crack Index		100	100						
Transverse Cracking Index		100	100						
Patching Index		99	99						
Rutting Index		99	99						
International Roughness Index (IRI)		N/A	N/A						
Lane & Width Information

Note: Route 0012 is unpaved from Milepost 0 to 0.06 and from Milepost 0.49 to 1.18. The Data Collection Vehicle drove the unpaved segment at the start of the route. The condition score on this page is only for the paved portion from Milepost 0.06 to 0.49.

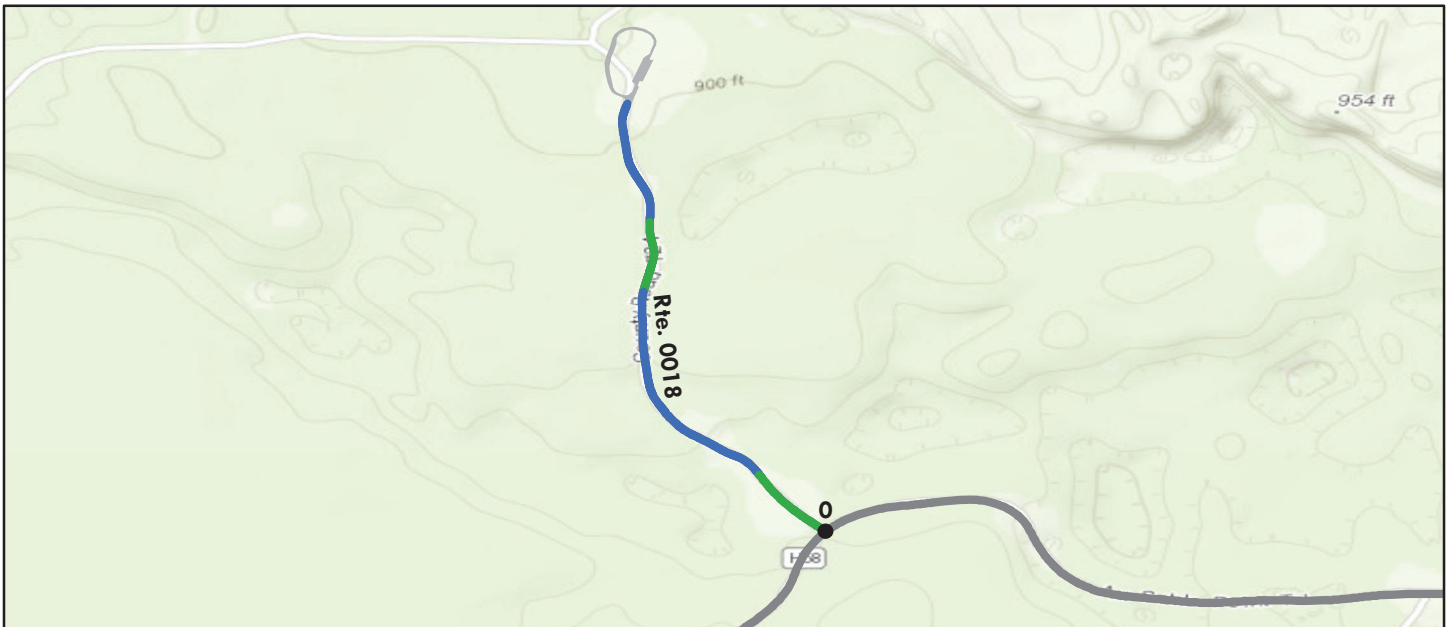
ROUTE 0018: LOG SLIDE ROAD

Inspection Date:	10/14/2018	Beginning Section MP	0				
Paved Length (Miles):	0.67	Section Length (MI)	0.67				
Surface Type:	ASPHALT	Route Summary					
Roadway Condition Information							
Pavement Condition Rating (PCR)	97	97					
Surface Condition Rating (SCR)	95	95					
Roughness Condition Index (RCI)	100	100					
Distress Index Values							
Structural Crack Index	100	100					
Alligator Crack Index	100	100					
Longitudinal Crack Index	100	100					
Transverse Cracking Index	100	100					
Patching Index	100	100					
Rutting Index	95	95					
International Roughness Index (IRI)	114	114					
Lane & Width Information							
Number of Lanes	2	2					
Paved Width (ft)	18	18					
Lane Width (ft)	8.5	8.5

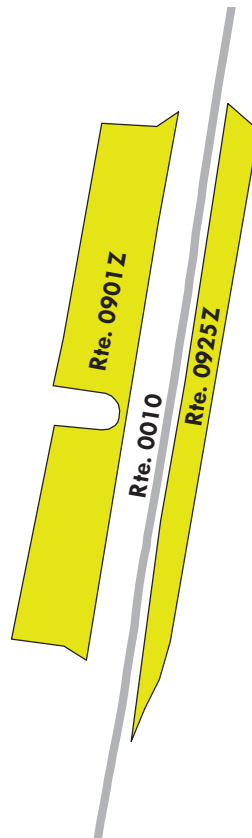
ROUTE 0901Z: SAND POINT BEACH PARKING A

Inspection Date	FMSS Number	User Access	Surface Type
8/8/2018	29608	PUBLIC	ASPHALT
Area (Sq. Ft.)	Lane Miles (11' Widths)	Curb Reveal (Inches)	Curb Recommendation
8,907	0.153	NOT APPLICABLE	NOT APPLICABLE
Curb Type		Curb & Gutter Type	
NO CURB		NO CURB AND GUTTER	
Pavement Recommendation		Condition Rating / PCR	
LIGHT 3R TREATMENTS		FAIR / 73

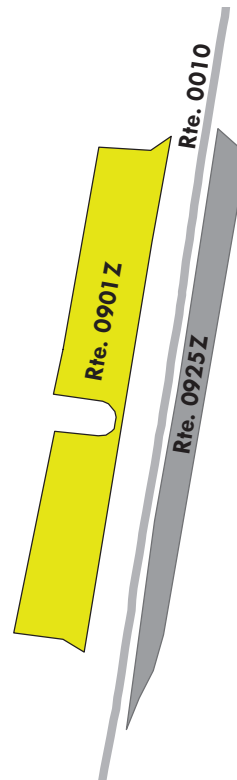
ROUTE 0925Z: SAND POINT BEACH PARKING B

Inspection Date	FMSS Number	User Access	Surface Type
8/8/2018	29608	PUBLIC	ASPHALT
Area (Sq. Ft.)	Lane Miles (11' Widths)	Curb Reveal (Inches)	Curb Recommendation
4,296	0.074	NOT APPLICABLE	NOT APPLICABLE
Curb Type		Curb & Gutter Type	
NO CURB		NO CURB AND GUTTER	
Pavement Recommendation		Condition Rating / PCR	
PREVENTIVE MAINTENANCE		GOOD / 90

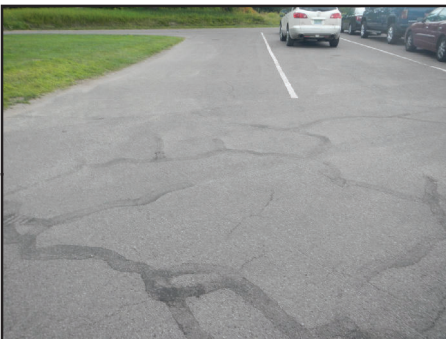
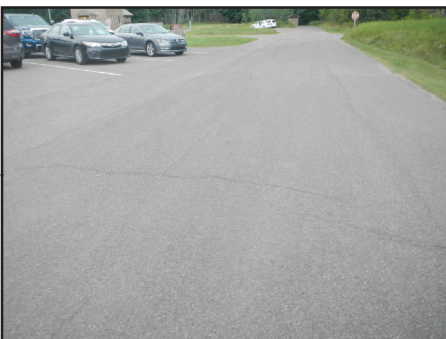
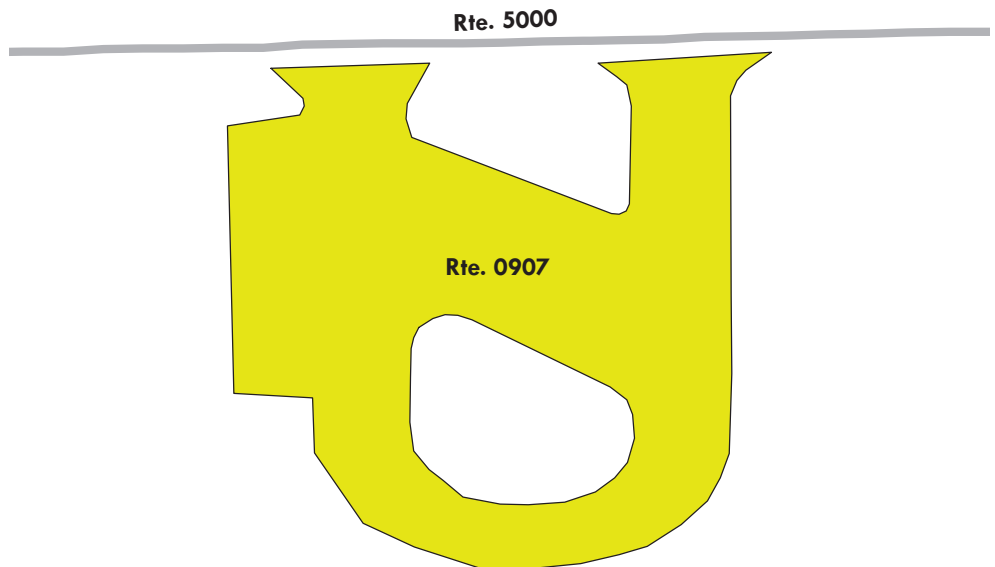
ROUTE 0908: SABLE FALLS PARKING

Inspection Date	FMSS Number	User Access	Surface Type
8/8/2018	30332	PUBLIC	ASPHALT
Area (Sq. Ft.)	Lane Miles (11' Widths)	Curb Reveal (Inches)	Curb Recommendation
56,041	0.965	5	DO NOTHING
Curb Type		Curb & Gutter Type	
CONCRETE		NO CURB AND GUTTER	
Pavement Recommendation		Condition Rating / PCR	
PREVENTIVE MAINTENANCE		GOOD / 90
