PORE Cycle 6

Final Report

Road Inventory and Condition Assessment of Paved Routes Point Reyes National Seashore

Report Date: November 2015

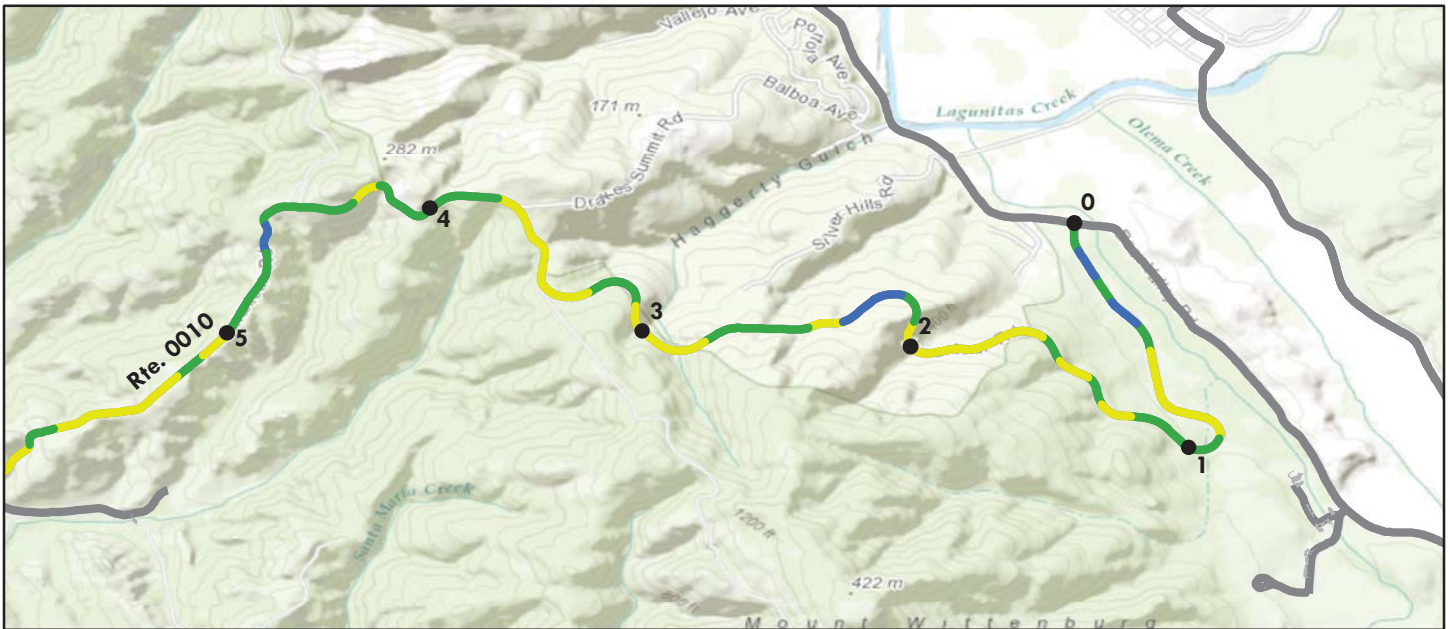
ROUTE 0010: LIMANTOUR ROAD

Route Condition Legend – Pavement Condition Rating (PCR)						
Poor (0 - 60)	Fair (61- 84)	Good (85 - 94)	Excellent (95 - 100)	Not Rated		
See Appendix for definitions and formulas						
Inspection Date: 3/5/2015	Beginning Section MP	0	1	2	3	4
Paved Length (Miles): 7.57	Section Length (MI)	1	1	1	1	1
Surface Type: ASPHALT	Route Summary					
Roadway Condition Information						
Pavement Condition Rating (PCR)	83	88	84	88	84	91
Surface Condition Rating (SCR)	92	87	96	95	96	97
Roughness Condition Index (RCI)	69	90	67	77	66	82
Distress Index Values						
Structural Crack Index	92	87	97	95	96	97
Alligator Crack Index	99	98	100	99	99	100
Longitudinal Crack Index	93	89	97	96	97	97
Transverse Cracking Index	97	92	99	99	99	98
Patching Index	99	100	97	98	100	100
Rutting Index	97	96	96	98	97	99
International Roughness Index (IRI)	206	140	211	180	217	164
Lane & Width Information						
Number of Lanes	2	2	2	2	2	2
Paved Width (ft)	27.7	32.7	32.1	31	27.9	24.2

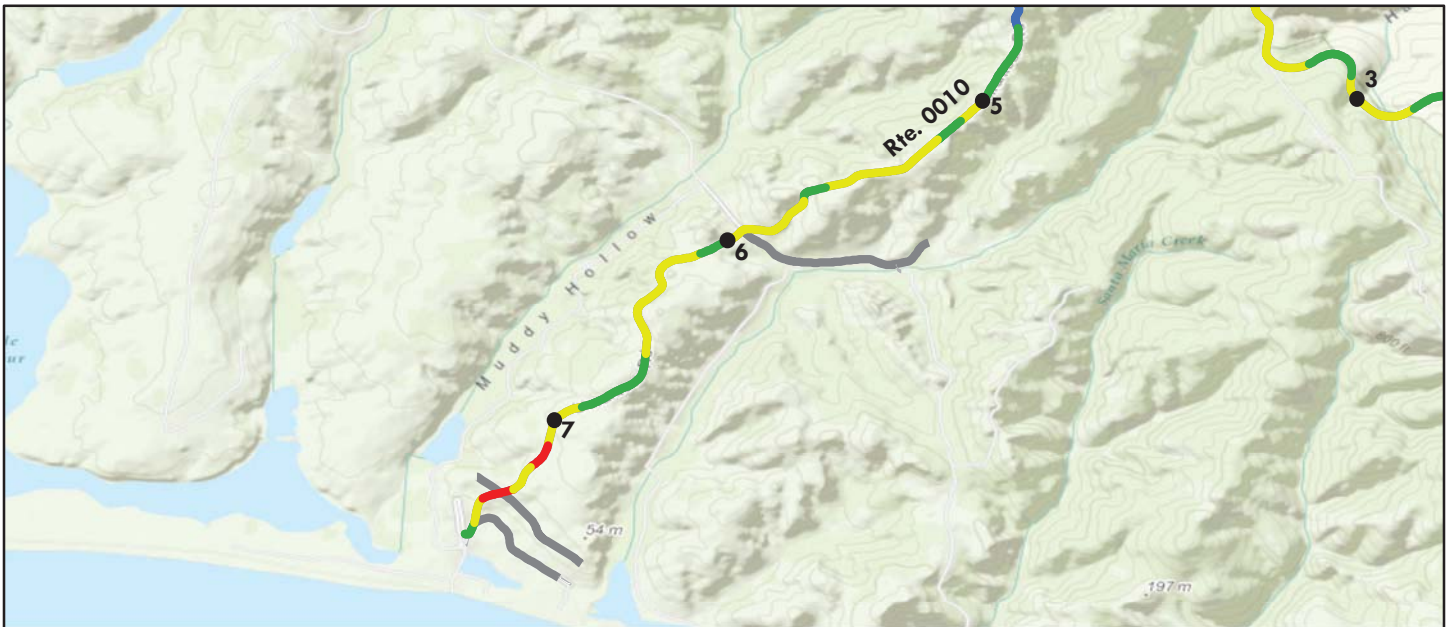
ROUTE 0010: LIMANTOUR ROAD

Route Condition Legend – Pavement Condition Rating (PCR)						
Poor (0 - 60)	Fair (61- 84)	Good (85 - 94)	Excellent (95 - 100)	Not Rated		
See Appendix for definitions and formulas						
Inspection Date: 3/5/2015	Beginning Section MP	5	6	7		
Paved Length (Miles): 7.57	Section Length (MI)	1	1	0.57		
Surface Type: ASPHALT	Route Summary					
Roadway Condition Information						
Pavement Condition Rating (PCR)	83	82	80	63		
Surface Condition Rating (SCR)	92	95	94	73		
Roughness Condition Index (RCI)	69	62	58	48		
Distress Index Values						
Structural Crack Index	92	95	94	73		
Alligator Crack Index	99	100	100	100		
Longitudinal Crack Index	93	95	94	73		
Transverse Cracking Index	97	96	99	98		
Patching Index	99	100	100	100		
Rutting Index	97	97	98	93		
International Roughness Index (IRI)	206	233	249	295		
Lane & Width Information						
Number of Lanes	2	2	2	2		
Paved Width (ft)	27.7	24.3	24	24.4		
Lane Width (ft)	12.7	11.4	11.5	12.1

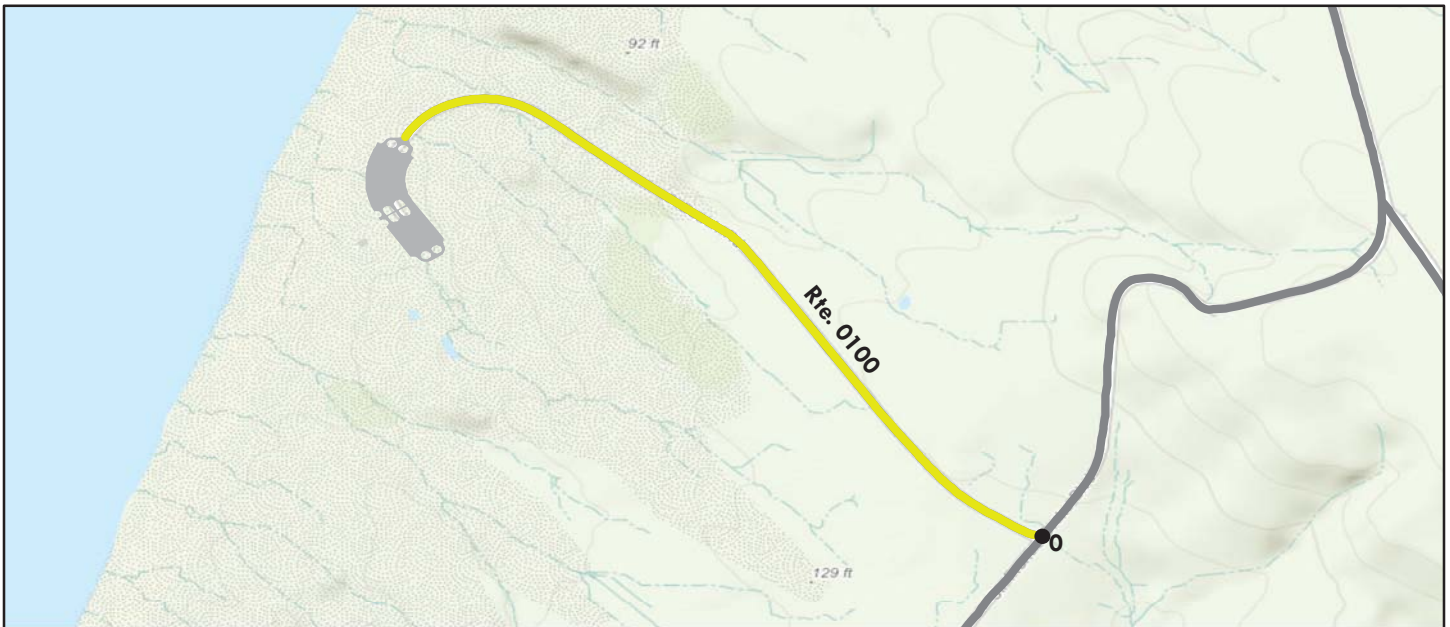
ROUTE 0100: SOUTH BEACH ROAD

Route Condition Legend – Pavement Condition Rating (PCR)						
Poor (0 - 60)	Fair (61- 84)	Good (85 - 94)	Excellent (95 - 100)	Not Rated		
See Appendix for definitions and formulas						
Inspection Date: 3/6/2015	Beginning Section MP	0				
Paved Length (Miles): 0.7	Section Length (MI)	0.7				
Surface Type: ASPHALT	Route Summary					
Roadway Condition Information						
Pavement Condition Rating (PCR)	76	76				
Surface Condition Rating (SCR)	97	97				
Roughness Condition Index (RCI)	45	45				
Distress Index Values						
Structural Crack Index	100	100				
Alligator Crack Index	100	100				
Longitudinal Crack Index	100	100				
Transverse Cracking Index	98	98				
Patching Index	100	100				
Rutting Index	97	97				
International Roughness Index (IRI)	309	309				
Lane & Width Information						
Number of Lanes	2	2				
Paved Width (ft)	22.6	22.6				
Lane Width (ft)	10.5	10.5

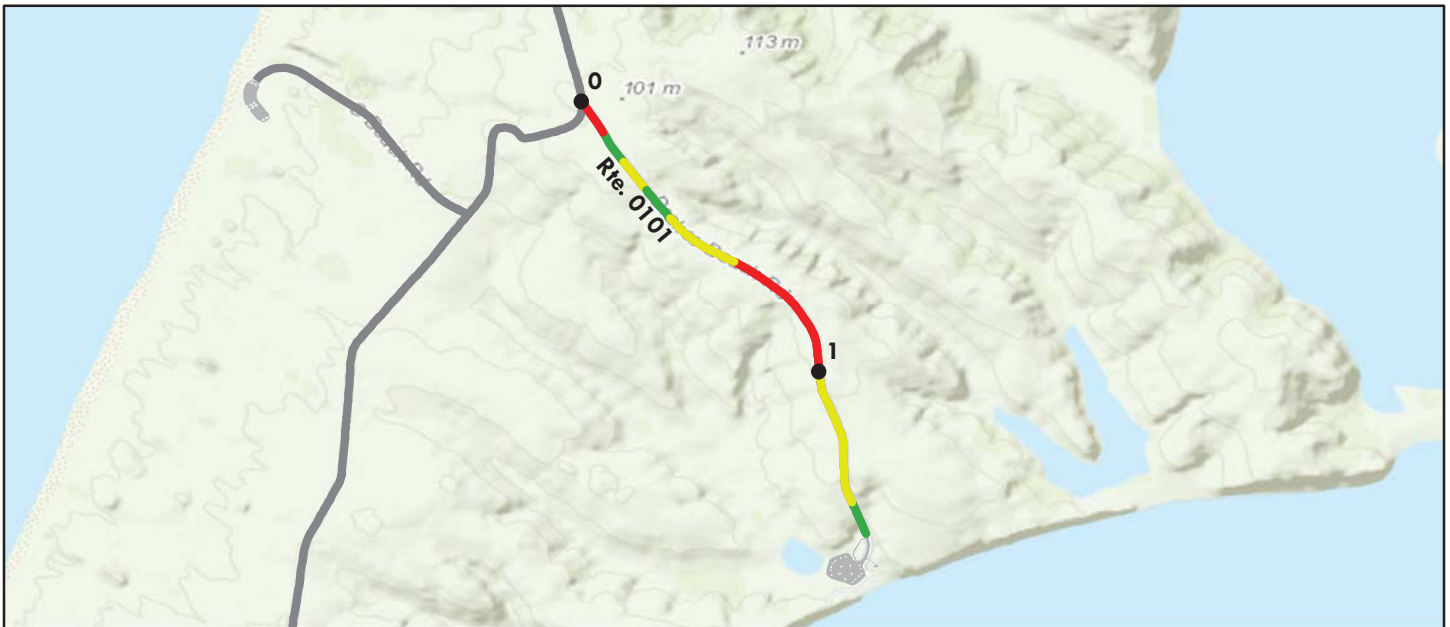
ROUTE 0101: DRAKES BEACH ROAD

Route Condition Legend – Pavement Condition Rating (PCR)						
Poor (0 - 60)	Fair (61- 84)	Good (85 - 94)	Excellent (95 - 100)	Not Rated		
See Appendix for definitions and formulas						
Inspection Date: 3/6/2015	Beginning Section MP	0	1			
Paved Length (Miles): 1.5	Section Length (MI)	1	0.5			
Surface Type: ASPHALT	Route Summary					
Roadway Condition Information						
Pavement Condition Rating (PCR)	60	49	80			
Surface Condition Rating (SCR)	46	26	83			
Roughness Condition Index (RCI)	80	83	76			
Distress Index Values						
Structural Crack Index	46	26	85			
Alligator Crack Index	56	39	88			
Longitudinal Crack Index	90	87	97			
Transverse Cracking Index	96	95	97			
Patching Index	100	100	100			
Rutting Index	78	76	83			
International Roughness Index (IRI)	168	161	180			
Lane & Width Information						
Number of Lanes	2	2	2			
Paved Width (ft)	32.8	33.1	32.1			
Lane Width (ft)	13.5	13.6	13.4

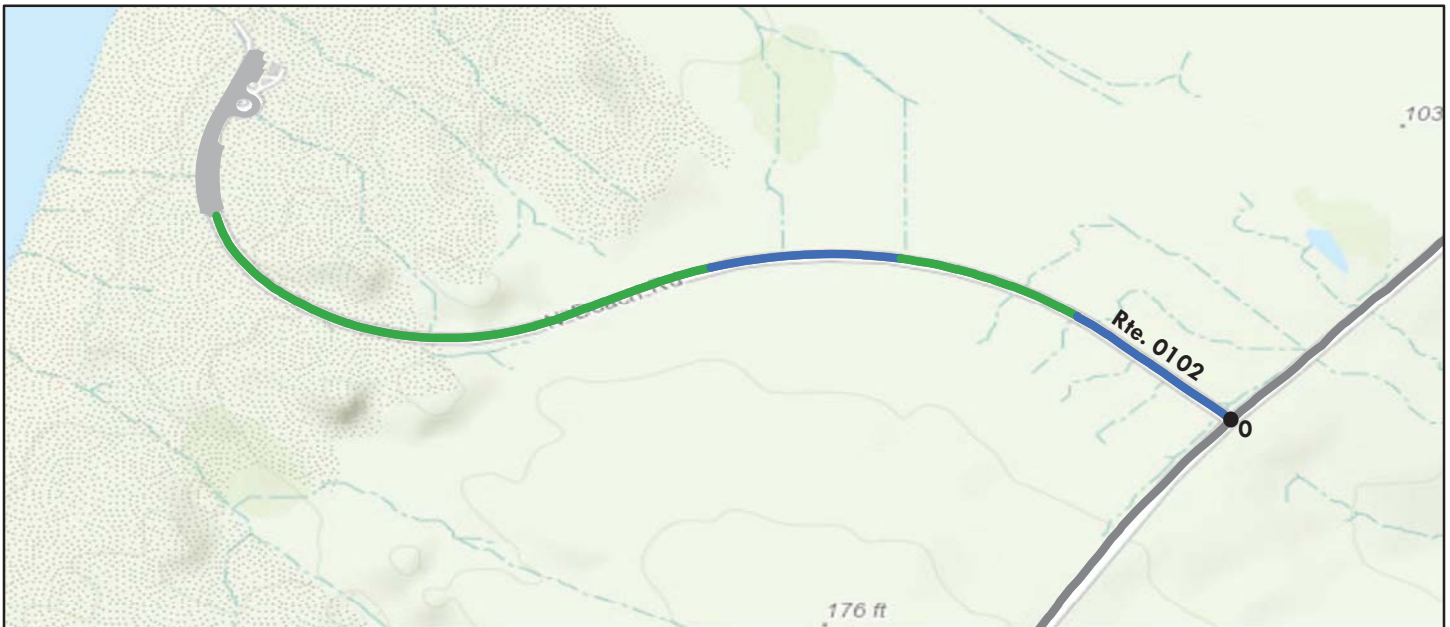
ROUTE 0102: NORTH BEACH ROAD

Route Condition Legend – Pavement Condition Rating (PCR)						
Poor (0 - 60)	Fair (61- 84)	Good (85 - 94)	Excellent (95 - 100)	Not Rated		
See Appendix for definitions and formulas						
Inspection Date: 3/6/2015	Beginning Section MP	0				
Paved Length (Miles): 0.6	Section Length (MI)	0.6				
Surface Type: ASPHALT	Route Summary					
Roadway Condition Information						
Pavement Condition Rating (PCR)	93	93				
Surface Condition Rating (SCR)	89	89				
Roughness Condition Index (RCI)	100	100				
Distress Index Values						
Structural Crack Index	99	99				
Alligator Crack Index	100	100				
Longitudinal Crack Index	99	99				
Transverse Cracking Index	99	99				
Patching Index	100	100				
Rutting Index	89	89				
International Roughness Index (IRI)	106	106				
Lane & Width Information						
Number of Lanes	2	2				
Paved Width (ft)	32.6	32.6				
Lane Width (ft)	13.3	13.3

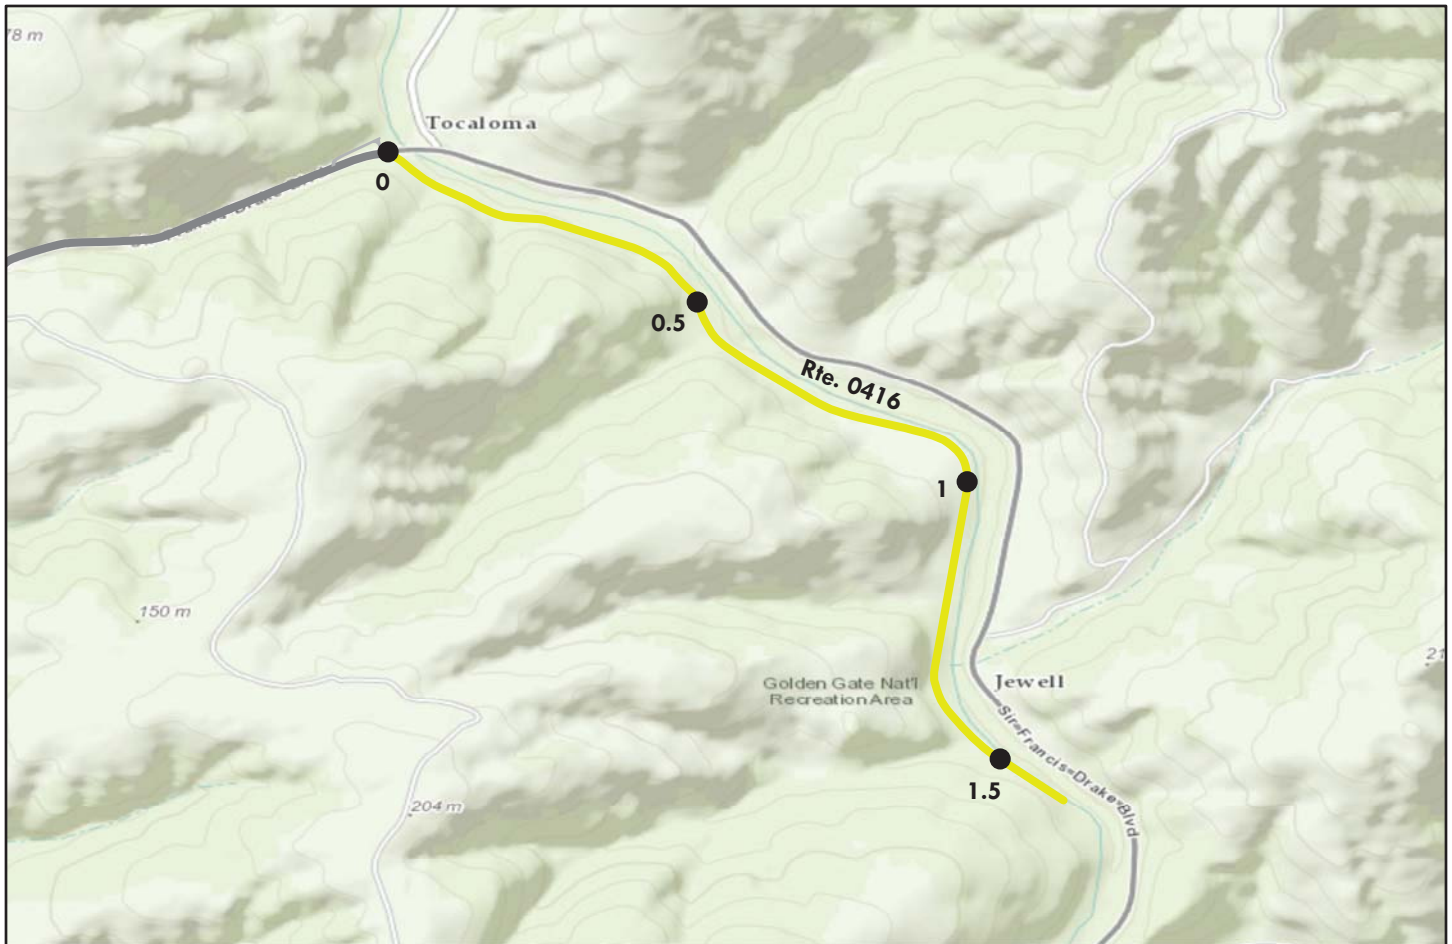
ROUTE 0416: CROSS MARIN TRAIL ROAD

Route Condition Legend – Pavement Condition Rating (PCR)						
Poor (0 - 60)	Fair (61- 84)	Good (85 - 94)	Excellent (95 - 100)	Not Rated		
See Appendix for definitions and formulas						
Inspection Date: 4/29/2014	Beginning Section MP	0.00	0.50	1.00	1.50	
Paved Length (Miles): 1.61	Section Length (MI)	0.50	0.50	0.50	0.11	
Surface Type: ASPHALT	Route Summary					
Roadway Condition Information						
Pavement Condition Rating (PCR)	73	73	73	73	73	
Lane & Width Information						
Number of Lanes	1	1	1	1	1	
Paved Width (ft)	9.5	9.5	9.5	9.5	9.5	
Lane Width (ft)	9.5	9.5	9.5	9.5	9.5

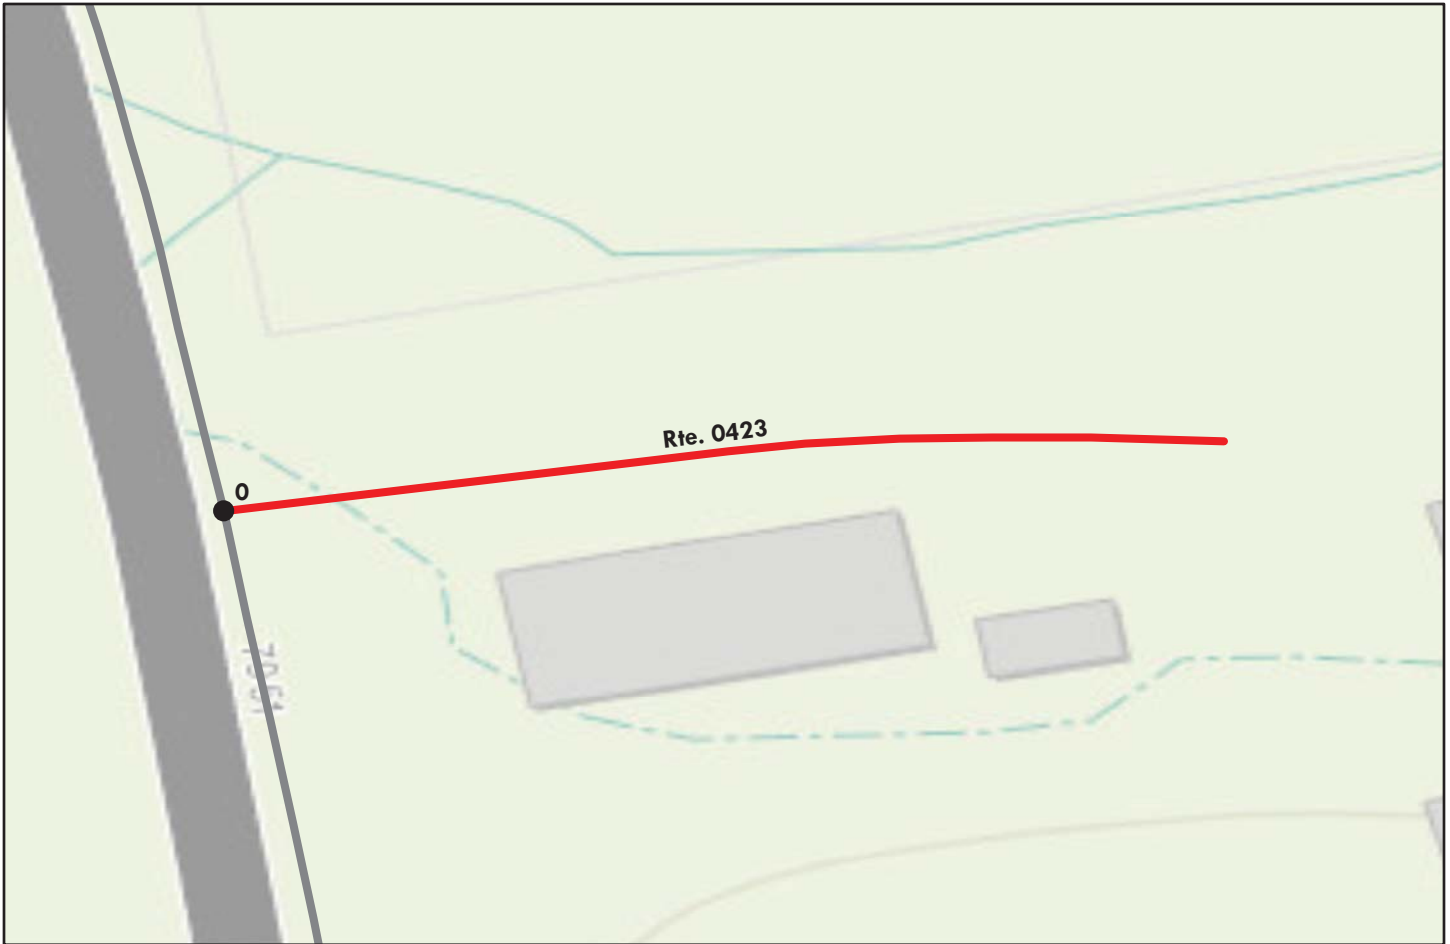
ROUTE 0423: HISTORIC GIACOMINI RANCH ROAD

Route Condition Legend – Pavement Condition Rating (PCR)						
Poor (0 - 60)	Fair (61- 84)	Good (85 - 94)	Excellent (95 - 100)	Not Rated		
See Appendix for definitions and formulas						
Inspection Date: 4/29/2014	Beginning Section MP	0.00				
Paved Length (Miles): 0.03	Section Length (MI)	0.03				
Surface Type: ASPHALT	Route Summary					
Roadway Condition Information						
Pavement Condition Rating (PCR)	0	0				
Lane & Width Information						
Number of Lanes	2	2				
Paved Width (ft)	15	15				
Lane Width (ft)	7.5	7.5

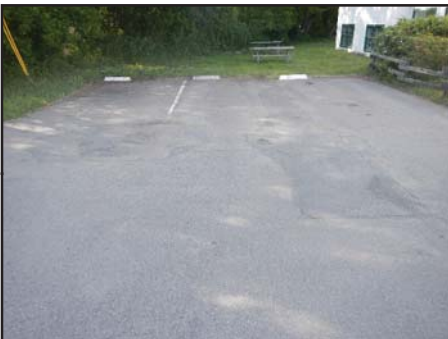
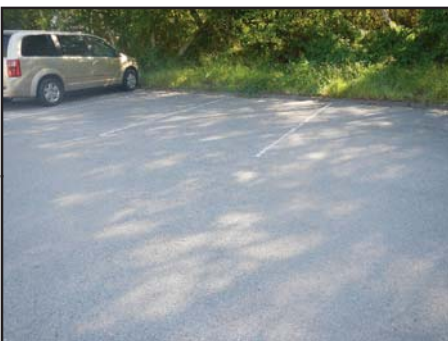
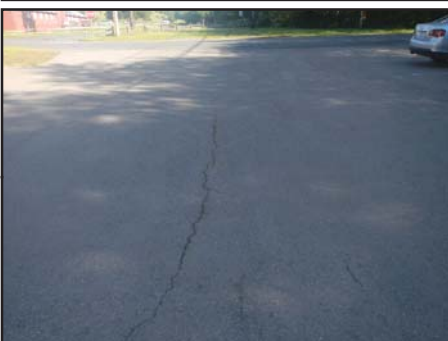
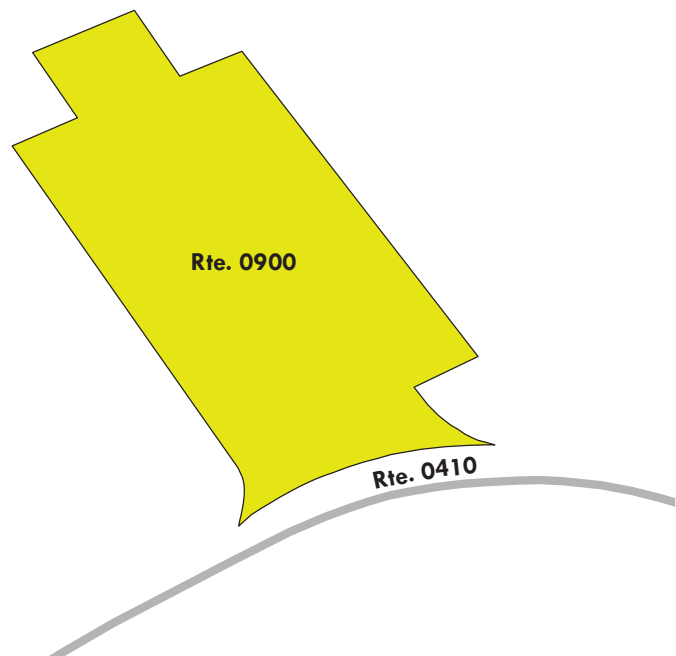
Inspection Date	FMSS Number	User Access	Surface Type
4/29/2014	89506	PUBLIC	ASPHALT
Area (Sq. Ft.)	Lane Miles (11' Widths)	Curb Reveal (Inches)	Curb Recommendation
8,998	0.155	5	LIGHT REPAIR
Curb Type		Curb & Gutter Type	
ASPHALT		NO CURB AND GUTTER	
Pavement Recommendation		Condition Rating / PCR	
LIGHT 3R TREATMENTS		FAIR / 73

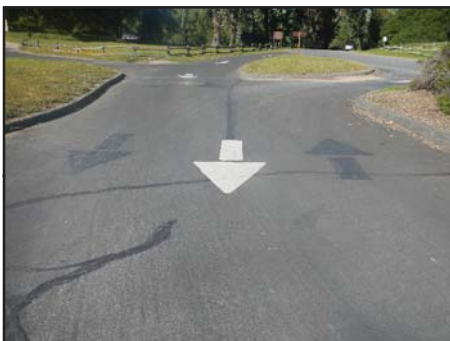
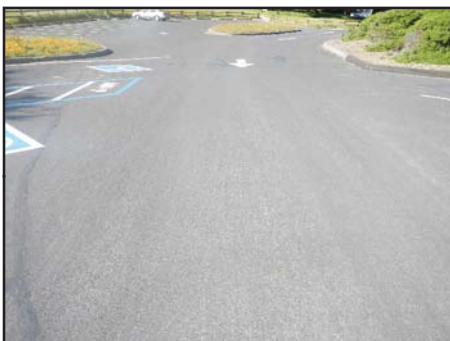
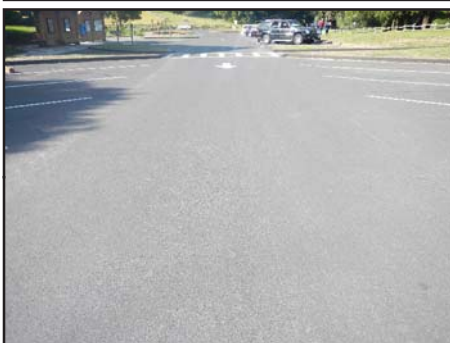
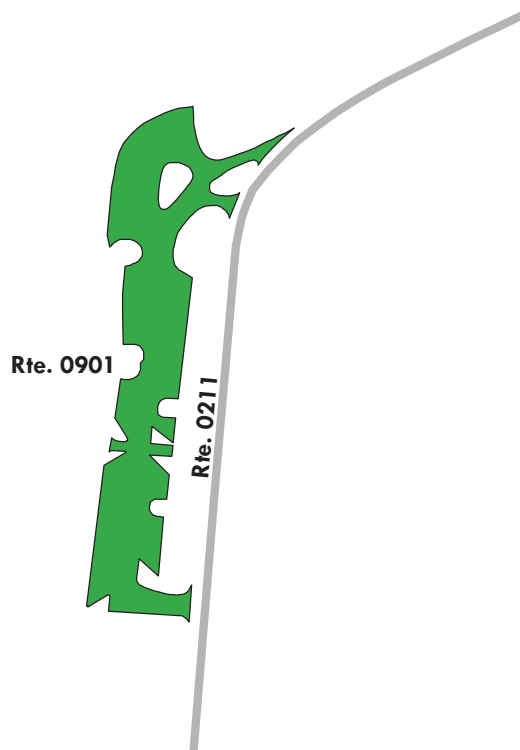
ROUTE 0901: BEAR VALLEY VISITOR CENTER PARKING LOT

Inspection Date	FMSS Number	User Access	Surface Type
4/29/2014	89505	PUBLIC	ASPHALT
Area (Sq. Ft.)	Lane Miles (11' Widths)	Curb Reveal (Inches)	Curb Recommendation
28,546	0.491	6	LIGHT REPAIR
Curb Type		Curb & Gutter Type	
ASPHALT		NO CURB AND GUTTER	
Pavement Recommendation		Condition Rating / PCR	
PREVENTIVE MAINTENANCE		GOOD / 90

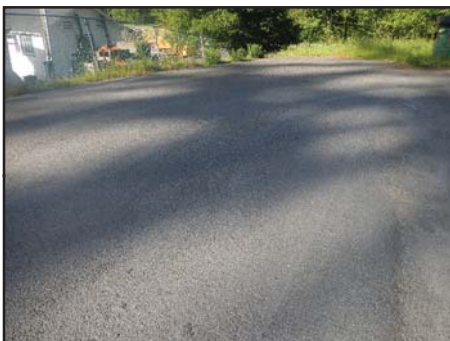
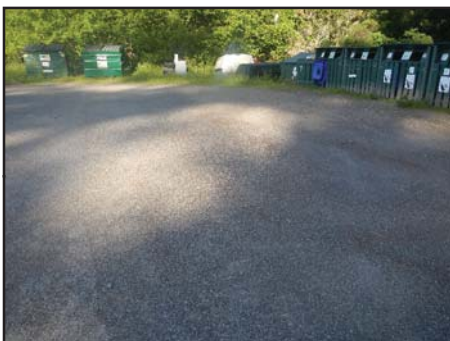
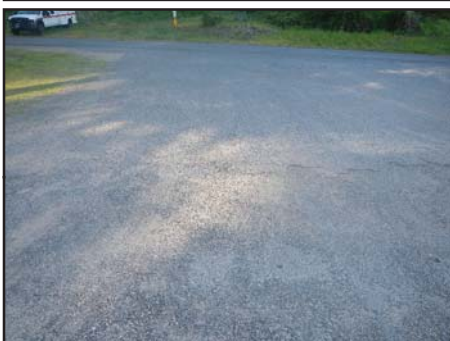
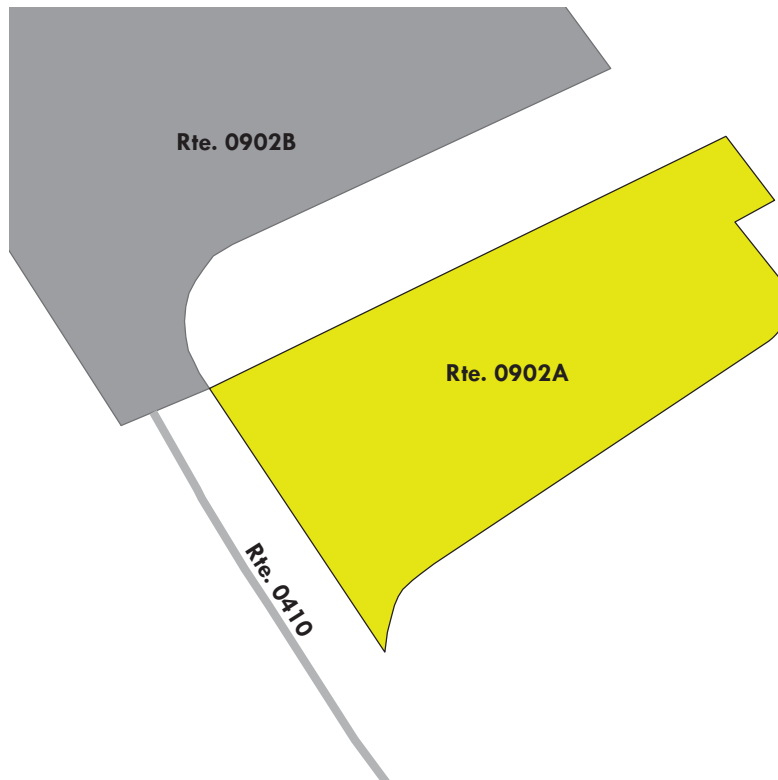
ROUTE 0902A: BEAR VALLEY R&T PARKING LOT

Inspection Date	FMSS Number	User Access	Surface Type
4/29/2014	105920	PUBLIC	ASPHALT
Area (Sq. Ft.)	Lane Miles (11' Widths)	Curb Reveal (Inches)	Curb Recommendation
7,880	0.136	NOT APPLICABLE	NOT APPLICABLE
Curb Type		Curb & Gutter Type	
NO CURB		NO CURB AND GUTTER	
Pavement Recommendation		Condition Rating / PCR	
LIGHT 3R TREATMENTS		FAIR / 73

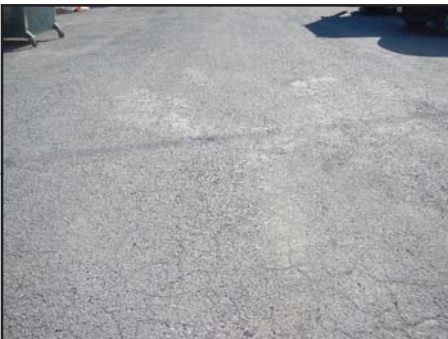
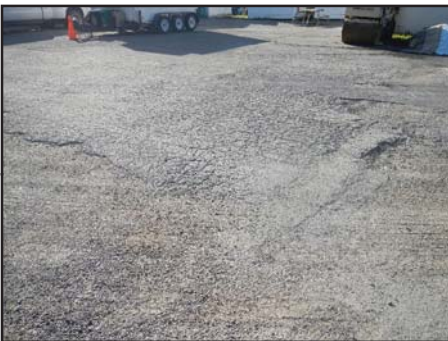
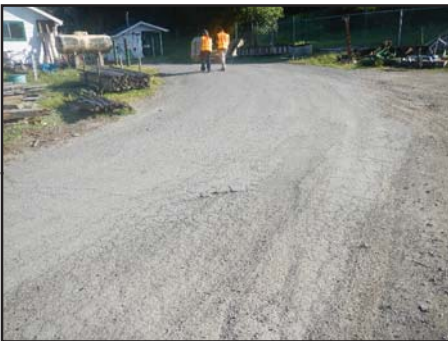
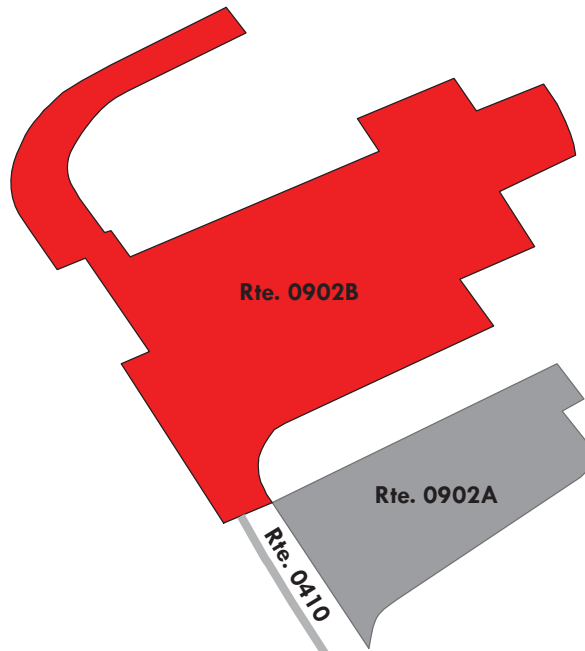
ROUTE 0902B: BEAR VALLEY R&T PAD PARKING LOT

Inspection Date	FMSS Number	User Access	Surface Type
4/29/2014	89520	NONPUBLIC	ASPHALT
Area (Sq. Ft.)	Lane Miles (11' Widths)	Curb Reveal (Inches)	Curb Recommendation
22,455	0.387	6	LIGHT REPAIR
Curb Type		Curb & Gutter Type	
ASPHALT		NO CURB AND GUTTER	
Pavement Recommendation		Condition Rating / PCR	
RECONSTRUCTION		POOR / 30

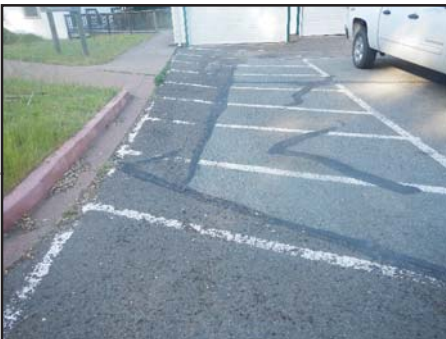
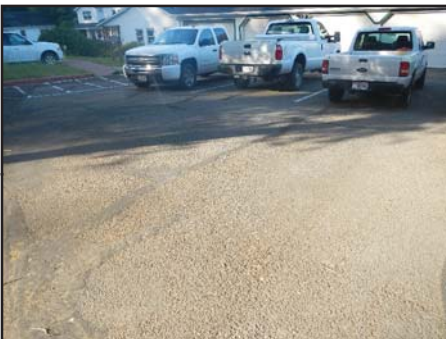
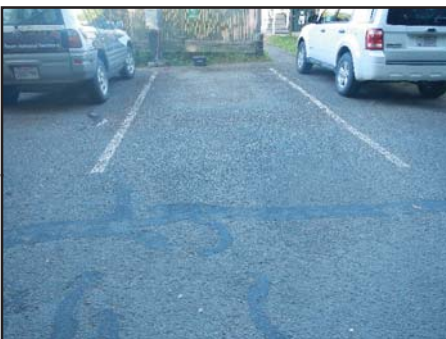
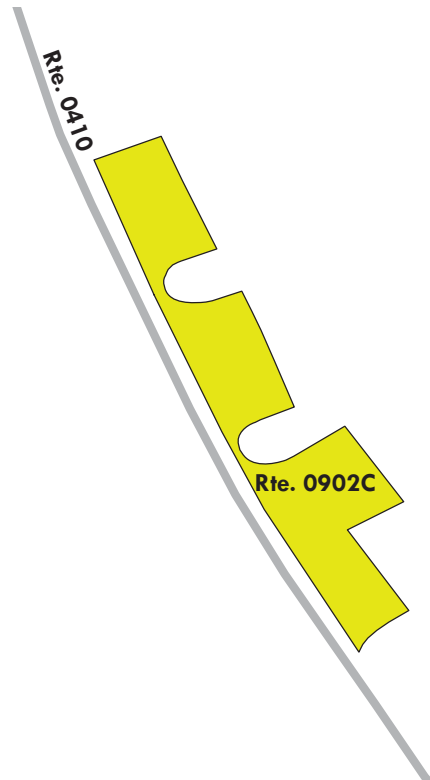
ROUTE 0902C: SCIENCE CAMPUS PARKING LOT

Inspection Date	FMSS Number	User Access	Surface Type
4/29/2014	89508	PUBLIC	ASPHALT
Area (Sq. Ft.)	Lane Miles (11' Widths)	Curb Reveal (Inches)	Curb Recommendation
7,389	0.127	NOT APPLICABLE	LIGHT REPAIR
Curb Type		Curb & Gutter Type	
NO CURB		CONCRETE	
Pavement Recommendation		Condition Rating / PCR	
LIGHT 3R TREATMENTS		FAIR / 73

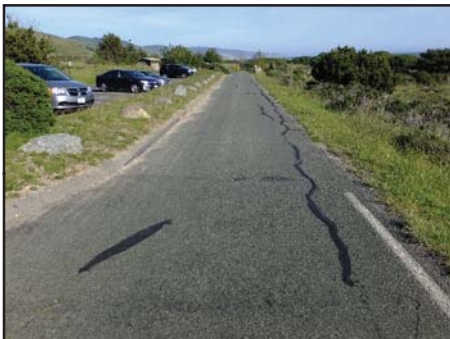
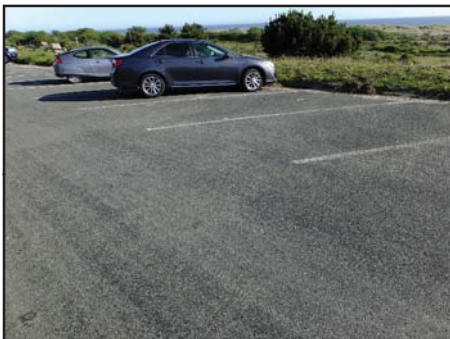
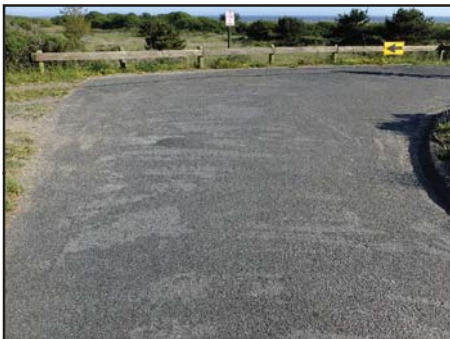
ROUTE 0904: LIMANTOUR (SOUTH) PARKING LOT

Inspection Date	FMSS Number	User Access	Surface Type
4/29/2014	89517	PUBLIC	ASPHALT
Area (Sq. Ft.)	Lane Miles (11' Widths)	Curb Reveal (Inches)	Curb Recommendation
10,119	0.174	5	MODERATE REPAIR
Curb Type		Curb & Gutter Type	
ASPHALT		NO CURB AND GUTTER	
Pavement Recommendation		Condition Rating / PCR	
LIGHT 3R TREATMENTS		FAIR / 73

The presence of sand and overgrown vegetation on curb sections in this parking area may result in poor drainage and pavement distresses.

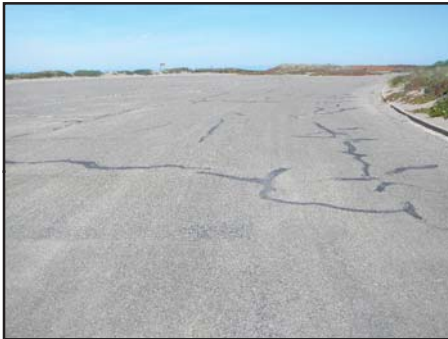
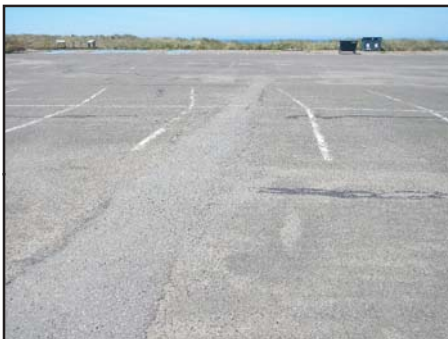
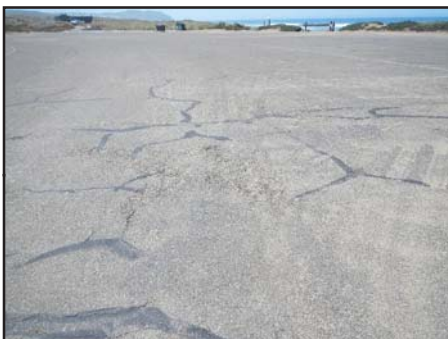
ROUTE 0909: SOUTH BEACH PARKING LOT

Inspection Date	FMSS Number	User Access	Surface Type
4/29/2014	89514	PUBLIC	ASPHALT
Area (Sq. Ft.)	Lane Miles (11' Widths)	Curb Reveal (Inches)	Curb Recommendation
96,288	1.658	NOT APPLICABLE	LIGHT REPAIR
Curb Type		Curb & Gutter Type	
NO CURB		CONCRETE	
Pavement Recommendation		Condition Rating / PCR	
HEAVY 3R TREATMENTS		POOR / 53

The presence of overgrown vegetation on curb sections in this parking area may result in poor drainage and pavement distresses.

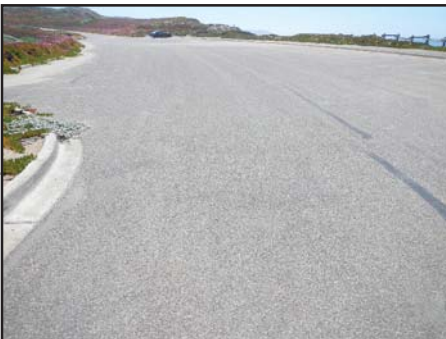
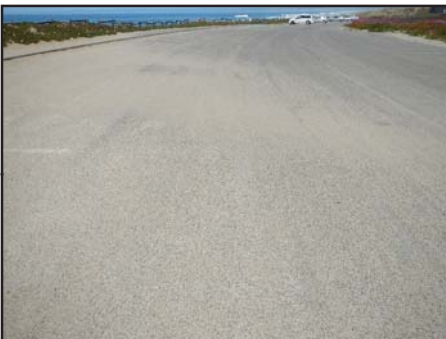
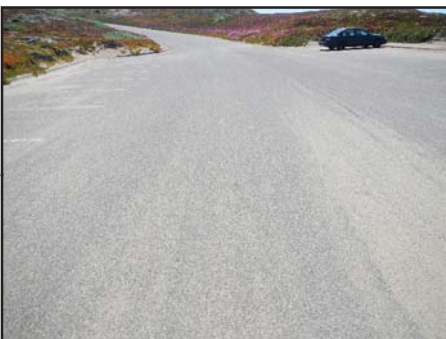
ROUTE 0910: NORTH BEACH PARKING LOT

Inspection Date	FMSS Number	User Access	Surface Type
4/29/2014	89512	PUBLIC	ASPHALT
Area (Sq. Ft.)	Lane Miles (11' Widths)	Curb Reveal (Inches)	Curb Recommendation
37,356	0.643	NOT APPLICABLE	LIGHT REPAIR
Curb Type		Curb & Gutter Type	
NO CURB		CONCRETE	
Pavement Recommendation		Condition Rating / PCR	
LIGHT 3R TREATMENTS		FAIR / 73

The presence of sand and overgrown vegetation on curb sections in this parking area may result in poor drainage and pavement distresses.

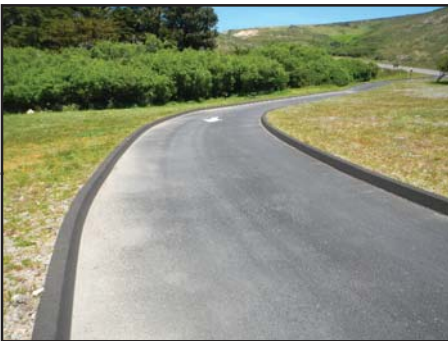
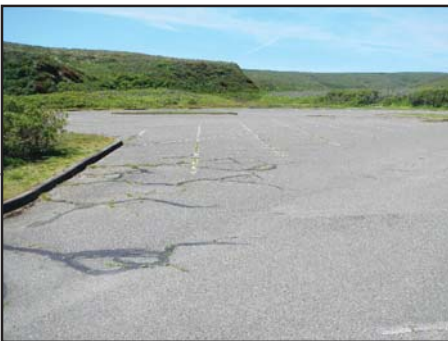
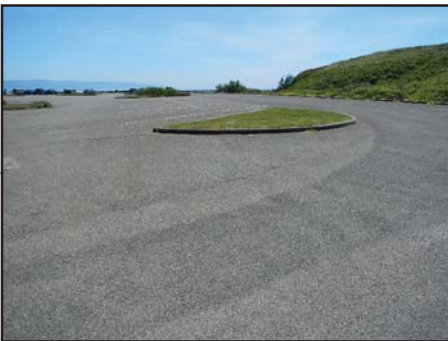
ROUTE 0911: DRAKES BEACH PARKING LOT

Inspection Date	FMSS Number	User Access	Surface Type
4/29/2014	89513	PUBLIC	ASPHALT
Area (Sq. Ft.)	Lane Miles (11' Widths)	Curb Reveal (Inches)	Curb Recommendation
184,364	3.174	5	LIGHT REPAIR
Curb Type		Curb & Gutter Type	
ASPHALT AND CONCRETE		NO CURB AND GUTTER	
Pavement Recommendation		Condition Rating / PCR	
LIGHT 3R TREATMENTS		FAIR / 73

The presence of sand and overgrown vegetation on curb sections in this parking area may result in poor drainage and pavement distresses.

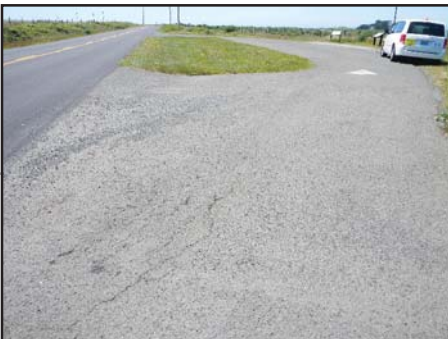
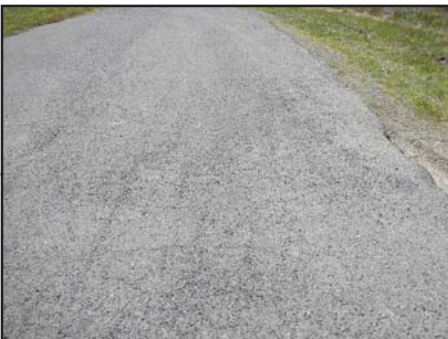
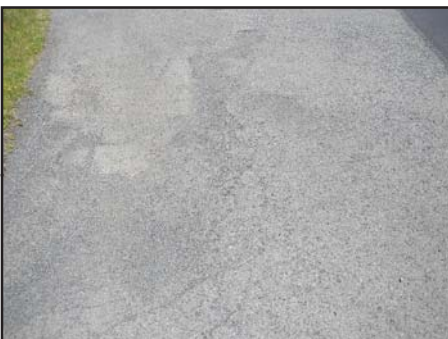
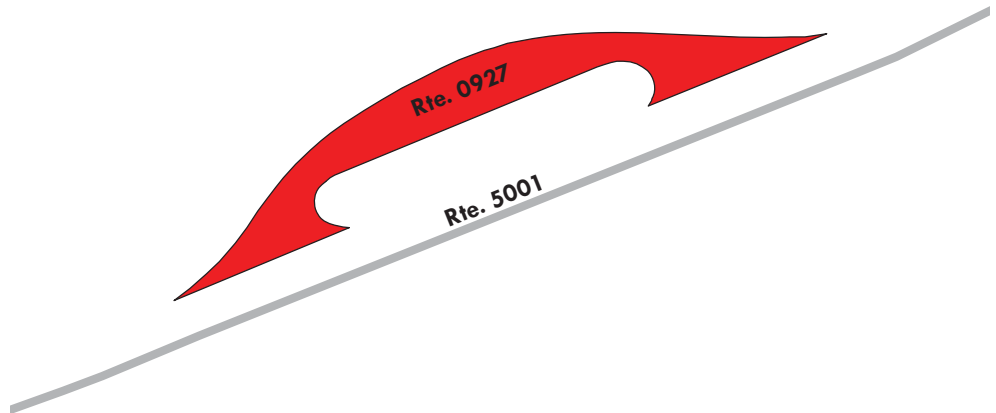
Inspection Date	FMSS Number	User Access	Surface Type
4/29/2014	89510	PUBLIC	ASPHALT
Area (Sq. Ft.)	Lane Miles (11' Widths)	Curb Reveal (Inches)	Curb Recommendation
4,713	0.081	NOT APPLICABLE	NOT APPLICABLE
Curb Type		Curb & Gutter Type	
NO CURB		NO CURB AND GUTTER	
Pavement Recommendation		Condition Rating / PCR	
HEAVY 3R TREATMENTS		POOR / 53

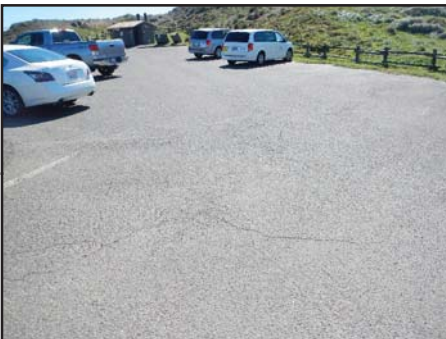
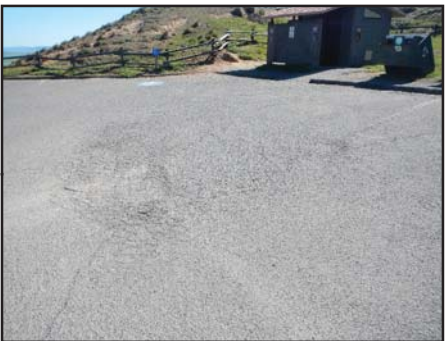
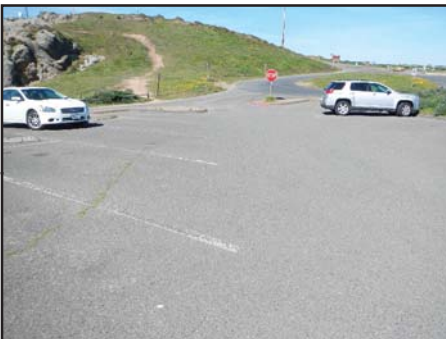
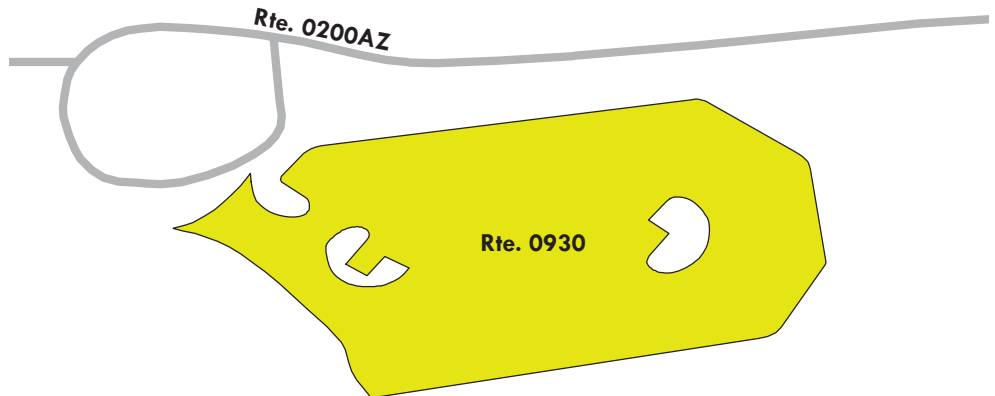
ROUTE 0930: LIGHTHOUSE PARKING LOT

Inspection Date	FMSS Number	User Access	Surface Type
4/29/2014	89515	PUBLIC	ASPHALT
Area (Sq. Ft.)	Lane Miles (11' Widths)	Curb Reveal (Inches)	Curb Recommendation
14,357	0.247	5	LIGHT REPAIR
Curb Type		Curb & Gutter Type	
ASPHALT		NO CURB AND GUTTER	
Pavement Recommendation		Condition Rating / PCR	
LIGHT 3R TREATMENTS		FAIR / 73

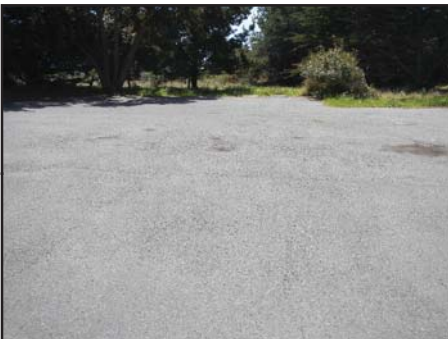
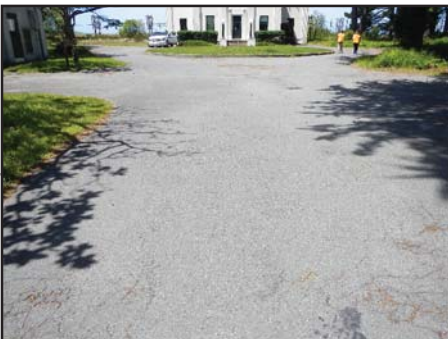
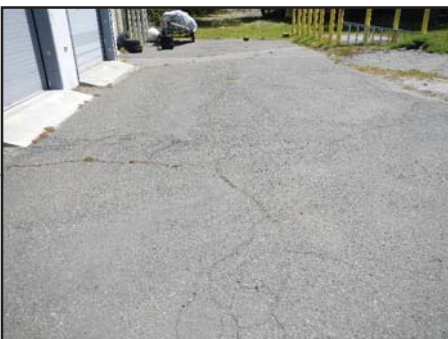
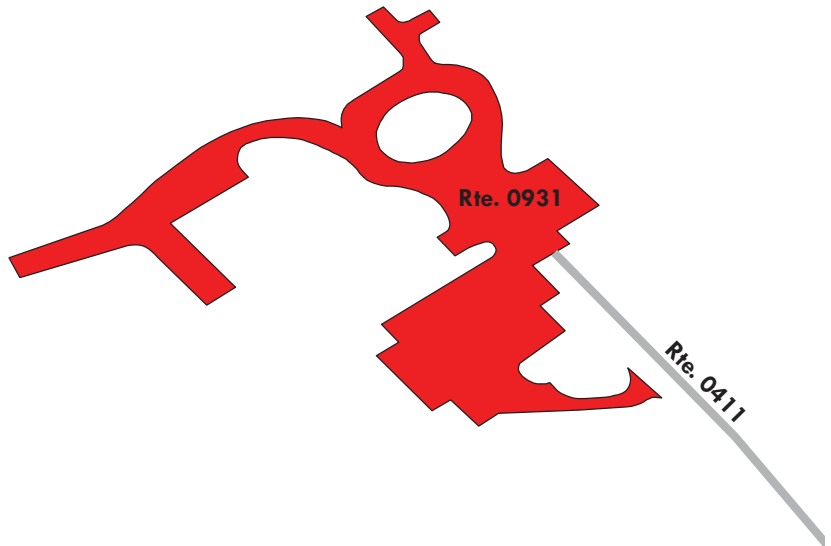
ROUTE 0931: NDOC OFFICE PARKING LOT

Inspection Date	FMSS Number	User Access	Surface Type
4/29/2014	89511	PUBLIC	ASPHALT
Area (Sq. Ft.)	Lane Miles (11' Widths)	Curb Reveal (Inches)	Curb Recommendation
20,955	0.361	6	DO NOTHING
Curb Type		Curb & Gutter Type	
CONCRETE		NO CURB AND GUTTER	
Pavement Recommendation		Condition Rating / PCR	
HEAVY 3R TREATMENTS		POOR / 53

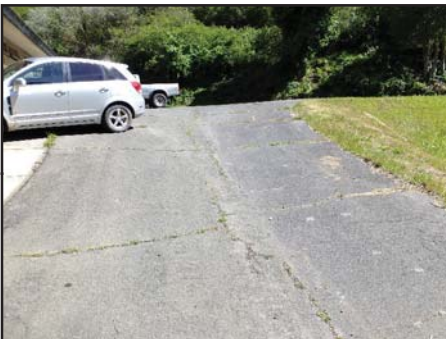
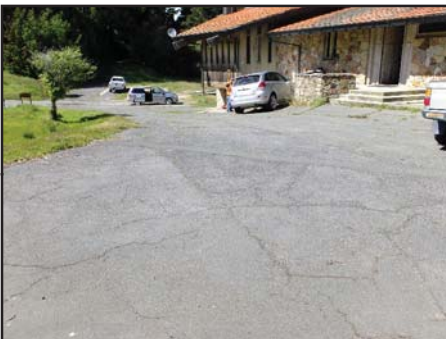
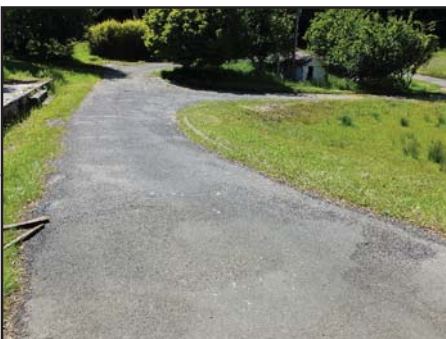
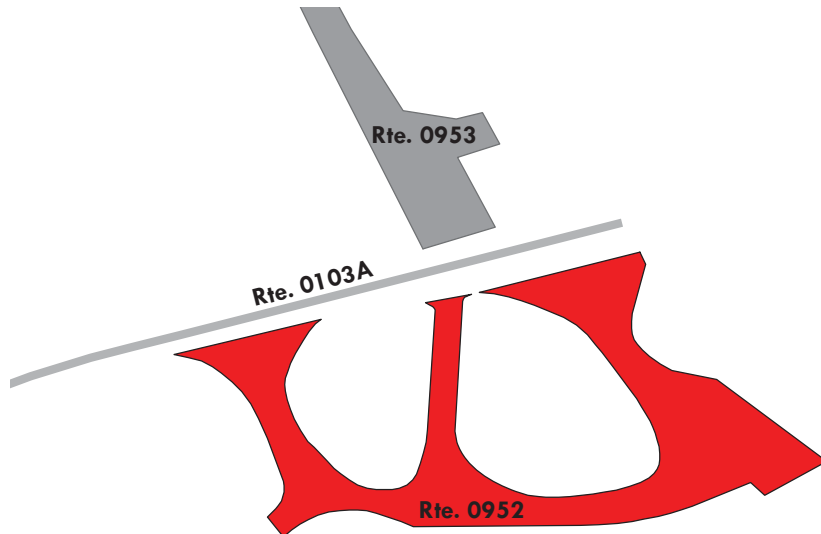
ROUTE 0952: SACRAMENTO LANDING MAIN HOUSE PARKING LOT

Inspection Date	FMSS Number	User Access	Surface Type
4/29/2014	90633	PUBLIC	ASPHALT
Area (Sq. Ft.)	Lane Miles (11' Widths)	Curb Reveal (Inches)	Curb Recommendation
7,645	0.132	0	REPLACE
Curb Type		Curb & Gutter Type	
CONCRETE		NO CURB AND GUTTER	
Pavement Recommendation		Condition Rating / PCR	
RECONSTRUCTION		POOR / 30

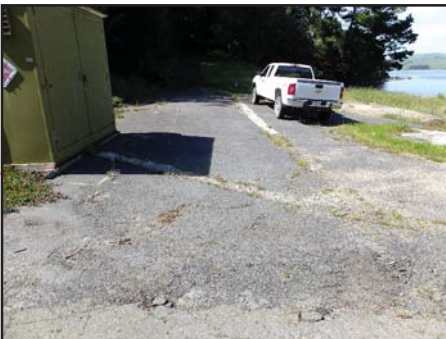
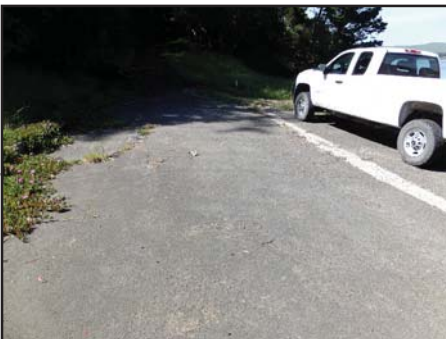
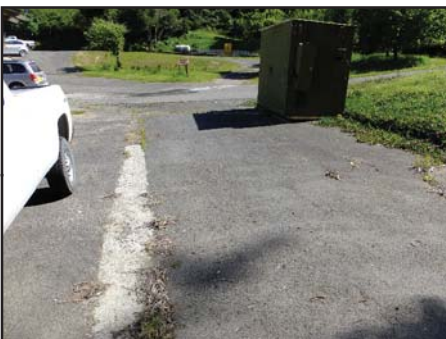
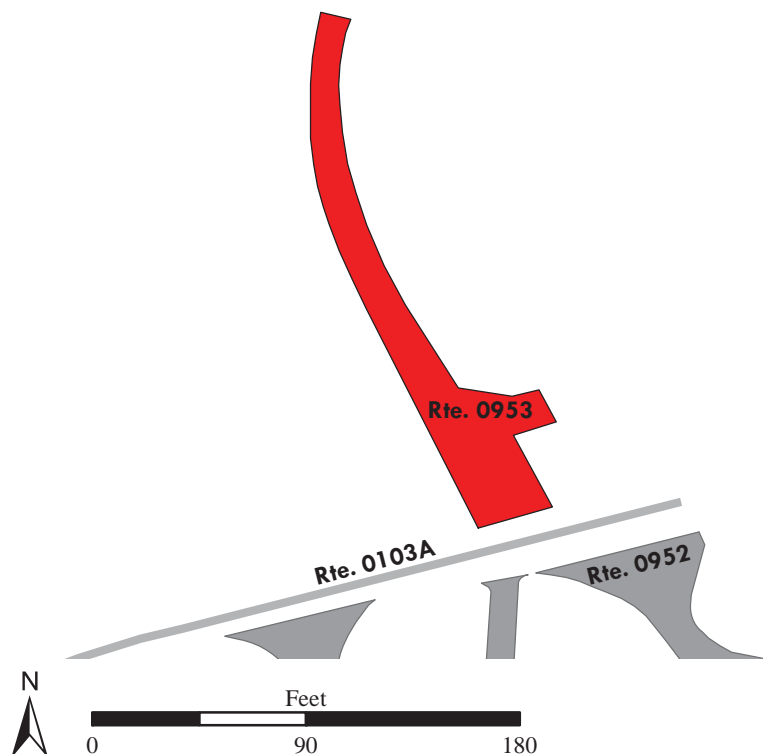
ROUTE 0953: SACRAMENTO PIER PARKING LOT

Inspection Date	FMSS Number	User Access	Surface Type
4/29/2014	97171	PUBLIC	ASPHALT
Area (Sq. Ft.)	Lane Miles (11' Widths)	Curb Reveal (Inches)	Curb Recommendation
3,642	0.063	NOT APPLICABLE	NOT APPLICABLE
Curb Type		Curb & Gutter Type	
NO CURB		NO CURB AND GUTTER	
Pavement Recommendation		Condition Rating / PCR	
RECONSTRUCTION		POOR / 30

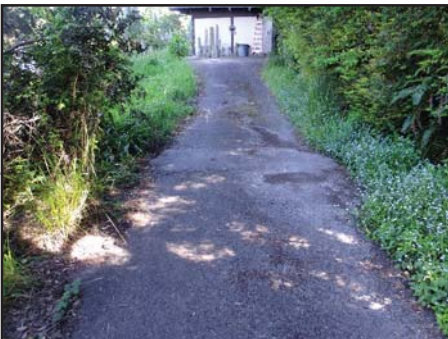
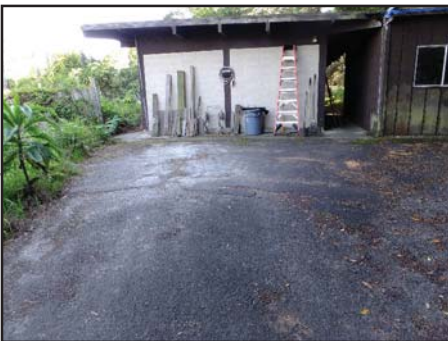
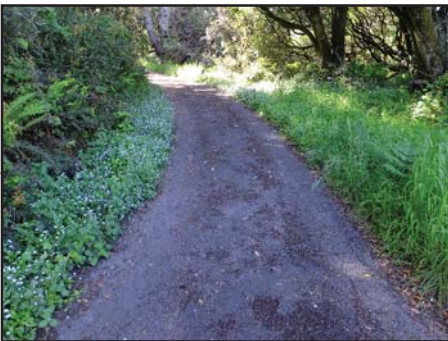
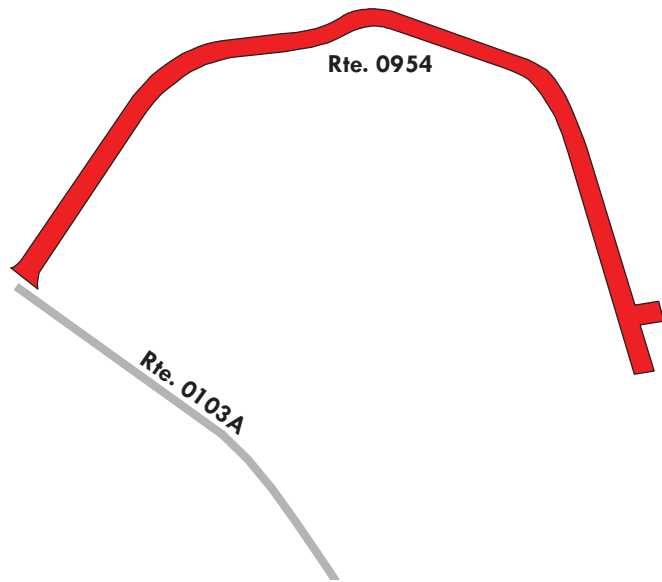
ROUTE 0954: SACRAMENTO LANDING SUPPORT PARKING LOT

Inspection Date	FMSS Number	User Access	Surface Type
4/29/2014	97175	PUBLIC	ASPHALT
Area (Sq. Ft.)	Lane Miles (11' Widths)	Curb Reveal (Inches)	Curb Recommendation
6,381	0.11	NOT APPLICABLE	NOT APPLICABLE
Curb Type		Curb & Gutter Type	
NO CURB		NO CURB AND GUTTER	
Pavement Recommendation		Condition Rating / PCR	
RECONSTRUCTION		POOR / 30
