PORE Cycle 6

Final Report

Road Inventory and Condition Assessment of Paved Routes Point Reyes National Seashore

Report Date: November 2015

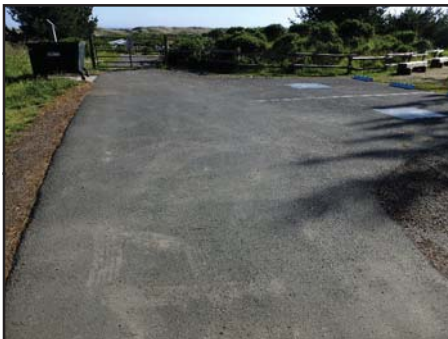
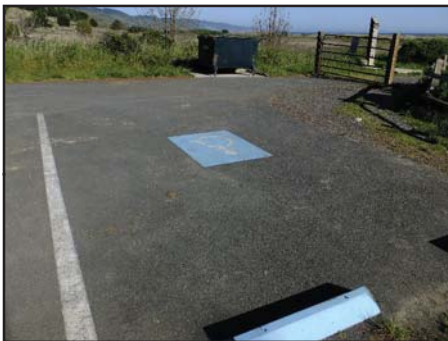
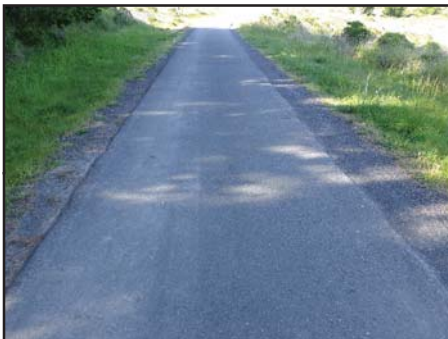
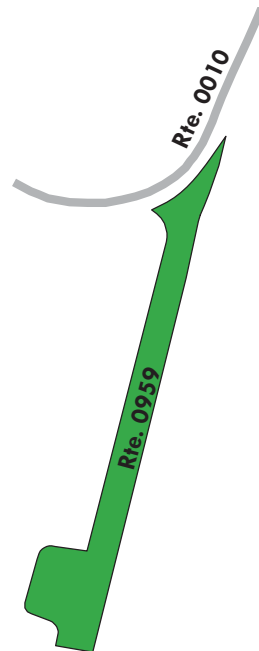
ROUTE 0959: LIMANTOUR PICNIC AREA ADA PARKING LOT

Inspection Date	FMSS Number	User Access	Surface Type
4/29/2014	116372	PUBLIC	ASPHALT
Area (Sq. Ft.)	Lane Miles (11' Widths)	Curb Reveal (Inches)	Curb Recommendation
4,264	0.073	NOT APPLICABLE	NOT APPLICABLE
Curb Type		Curb & Gutter Type	
NO CURB		NO CURB AND GUTTER	
Pavement Recommendation		Condition Rating / PCR	
PREVENTIVE MAINTENANCE		GOOD / 90

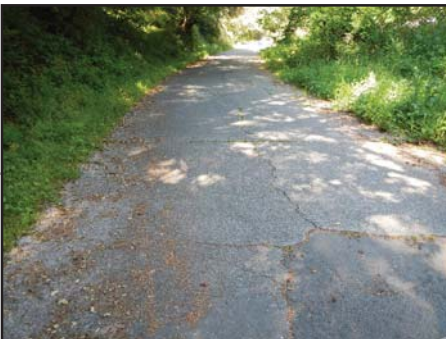
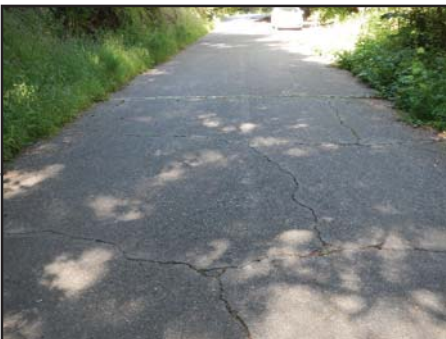
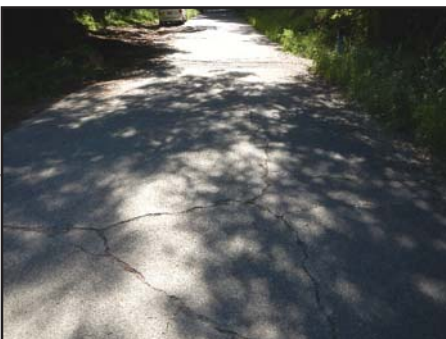
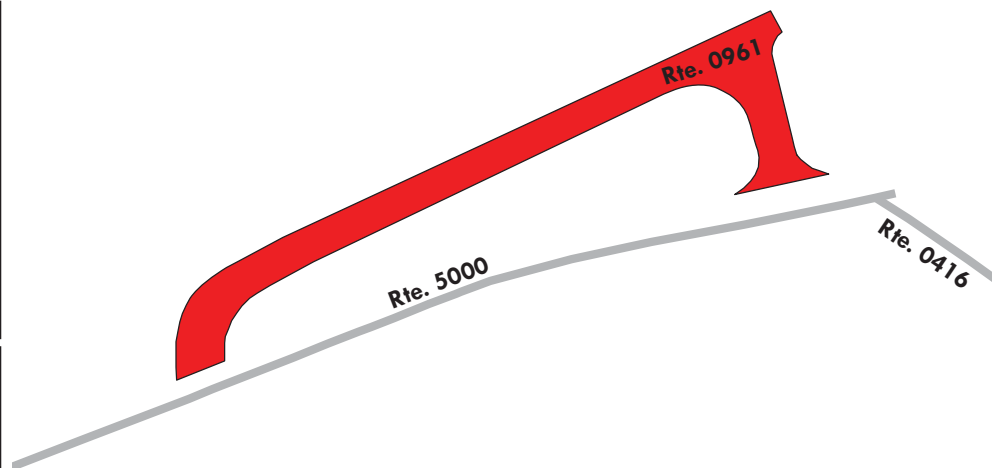
ROUTE 0961: CROSS MARIN TRAILHEAD PARKING LOT

Inspection Date	FMSS Number	User Access	Surface Type
4/29/2014	89519	PUBLIC	CONCRETE
Area (Sq. Ft.)	Lane Miles (11' Widths)	Curb Reveal (Inches)	Curb Recommendation
12,708	0.219	NOT APPLICABLE	NOT APPLICABLE
Curb Type		Curb & Gutter Type	
NO CURB		NO CURB AND GUTTER	
Pavement Recommendation		Condition Rating / PCR	
HEAVY 3R TREATMENTS		POOR / 53

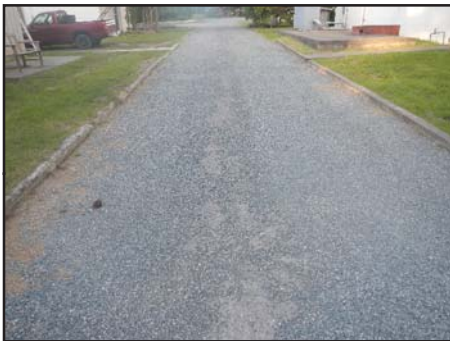
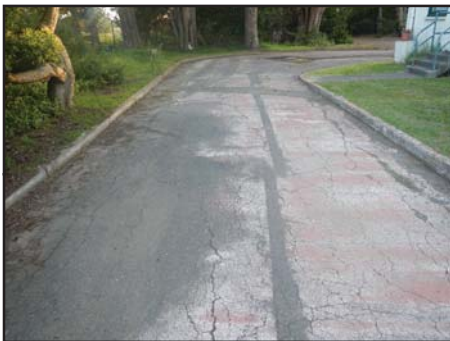
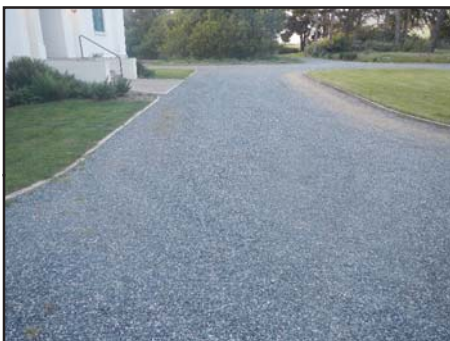
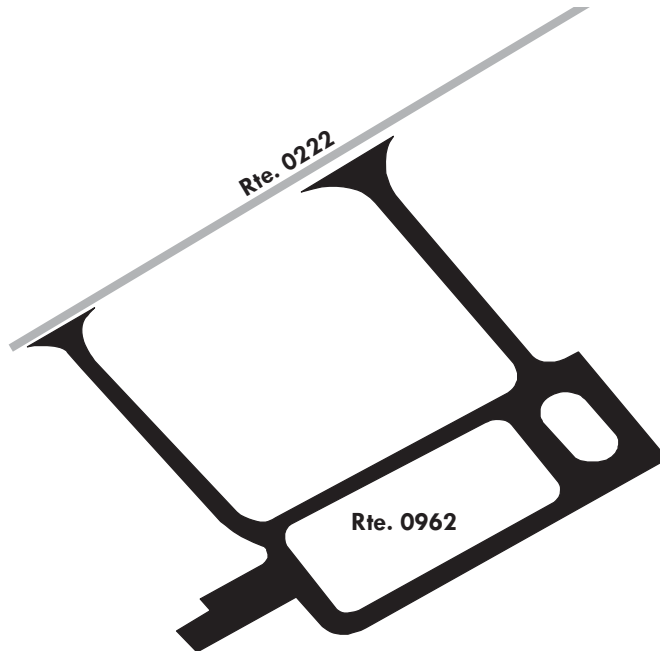
ROUTE 0962: COMMONWEAL PARKING LOT

Inspection Date	FMSS Number	User Access	Surface Type
4/29/2014	230204	PUBLIC	ASPHALT
Area (Sq. Ft.)	Lane Miles (11' Widths)	Curb Reveal (Inches)	Curb Recommendation
28,248	0.486	4	LIGHT REPAIR
Curb Type		Curb & Gutter Type	
CONCRETE		NO CURB AND GUTTER	
Pavement Recommendation		Condition Rating / PCR	
NOT APPLICABLE		NOT RATED / -1

Pavement condition was not rated because more than half of the paved surface was covered with gravel.

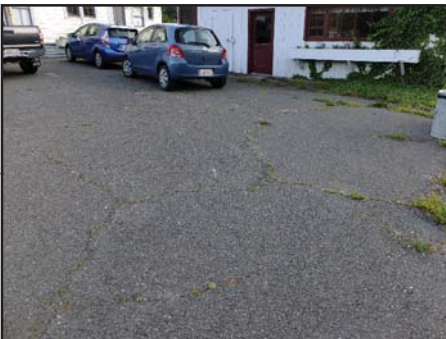
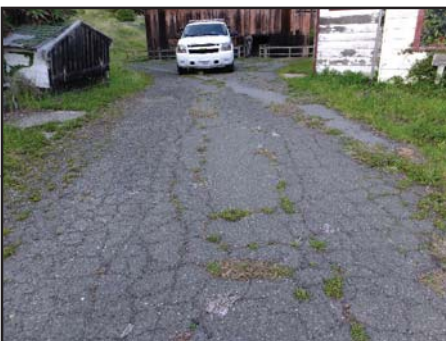
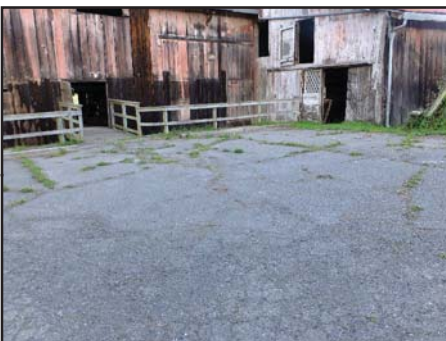
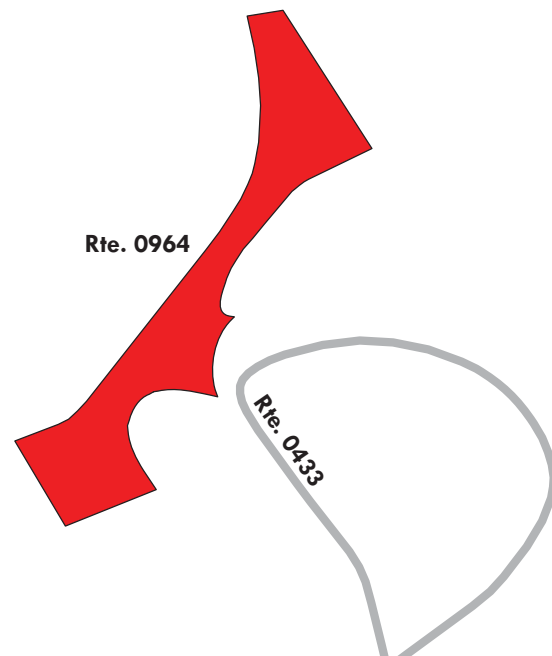
ROUTE 0964: WILKINS RESIDENCE PARKING LOT

Inspection Date	FMSS Number	User Access	Surface Type
4/29/2014	N/A	NONPUBLIC	ASPHALT
Area (Sq. Ft.)	Lane Miles (11' Widths)	Curb Reveal (Inches)	Curb Recommendation
6,412	0.11	NOT APPLICABLE	NOT APPLICABLE
Curb Type		Curb & Gutter Type	
NO CURB		NO CURB AND GUTTER	
Pavement Recommendation		Condition Rating / PCR	
RECONSTRUCTION		POOR / 30
