# PRES Cycle 6

## Final Report

### Road Inventory and Condition Assessment of Paved Routes Presidio of San Francisco

**Report Date: August 2015**

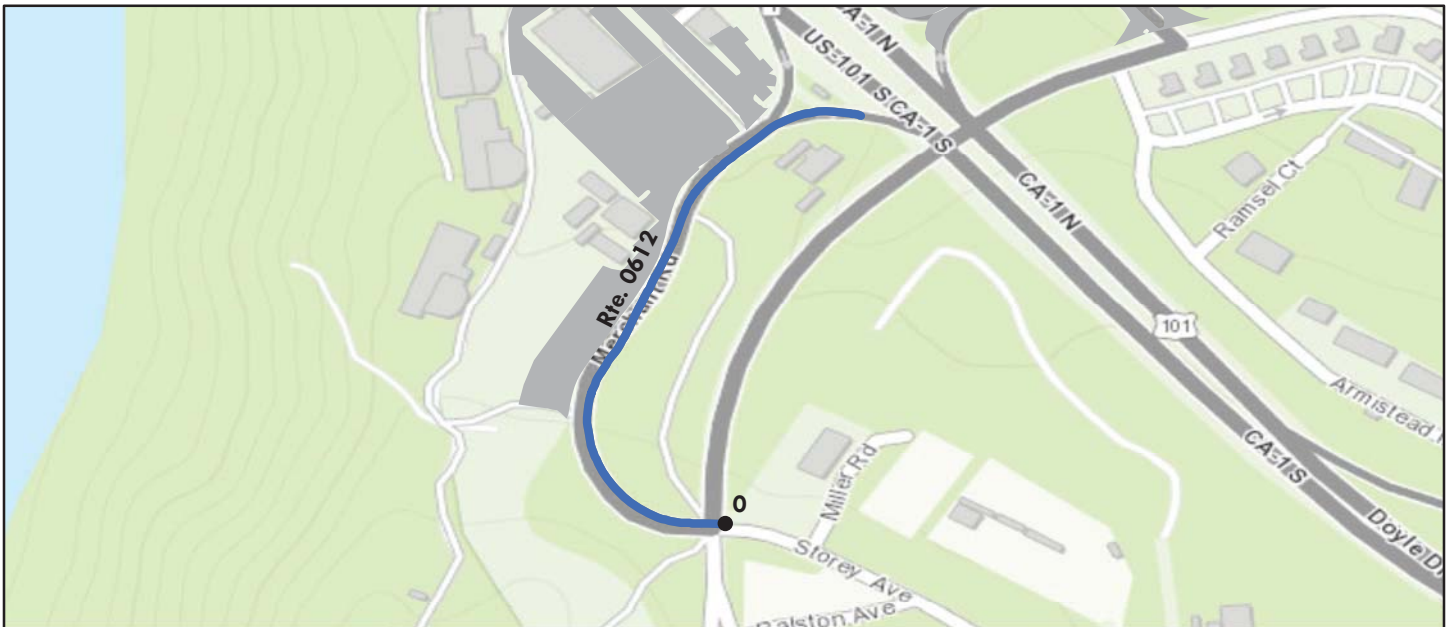
## ROUTE 0612: MERCHANT DRIVE

Route Condition Legend – Pavement Condition Rating (PCR)						
Poor (0 - 60)	Fair (61- 84)	Good (85 - 94)	Excellent (95 - 100)	Not Rated		
See Appendix for definitions and formulas						
<b>Inspection Date:</b> 1/19/2015	<b>Beginning Section MP</b>	0				
<b>Paved Length (Miles):</b> 0.19	<b>Section Length (MI)</b>	0.19				
<b>Surface Type:</b> ASPHALT	<b>Route Summary</b>					
<b>Roadway Condition Information</b>						
Pavement Condition Rating (PCR)	96	96				
Surface Condition Rating (SCR)	96	96				
Roughness Condition Index (RCI)	N/A	N/A				
<b>Distress Index Values</b>						
Structural Crack Index	96	96				
Alligator Crack Index	100	100				
Longitudinal Crack Index	96	96				
Transverse Cracking Index	98	98				
Patching Index	100	100				
Rutting Index	97	97				
International Roughness Index (IRI)	N/A	N/A				
<b>Lane &amp; Width Information</b>						
Number of Lanes	3	3				
Paved Width (ft)	35.3	35.3				
Lane Width (ft)	11.8	11.8

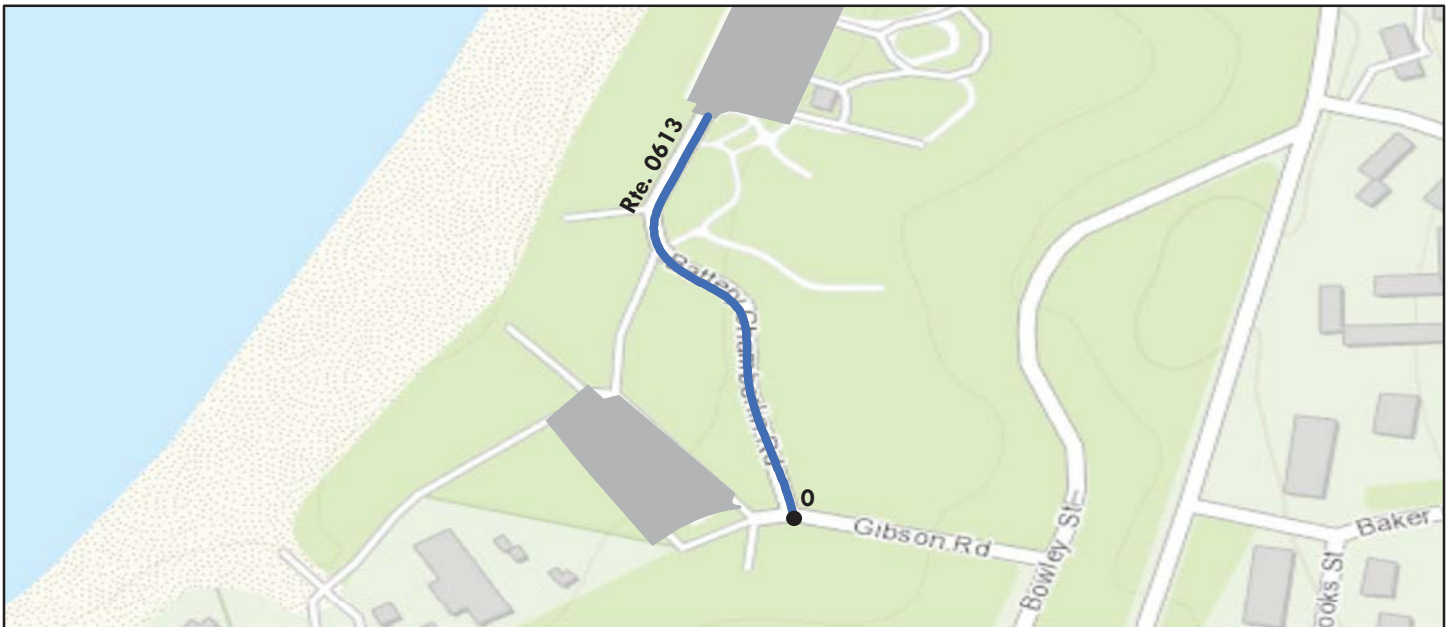
## ROUTE 0613: BATTERY CHAMBERLIN / NORTH BAKER BEACH ROAD

Route Condition Legend – Pavement Condition Rating (PCR)						
Poor (0 - 60)	Fair (61- 84)	Good (85 - 94)	Excellent (95 - 100)	Not Rated		
See Appendix for definitions and formulas						
<b>Inspection Date:</b> 1/19/2015	<b>Beginning Section MP</b>	0				
<b>Paved Length (Miles):</b> 0.13	<b>Section Length (MI)</b>	0.13				
<b>Surface Type:</b> ASPHALT	<b>Route Summary</b>					
<b>Roadway Condition Information</b>						
Pavement Condition Rating (PCR)	97	97				
Surface Condition Rating (SCR)	97	97				
Roughness Condition Index (RCI)	N/A	N/A				
<b>Distress Index Values</b>						
Structural Crack Index	99	99				
Alligator Crack Index	100	100				
Longitudinal Crack Index	99	99				
Transverse Cracking Index	97	97				
Patching Index	100	100				
Rutting Index	98	98				
International Roughness Index (IRI)	N/A	N/A				
<b>Lane &amp; Width Information</b>						
Number of Lanes	2	2				
Paved Width (ft)	17.1	17.1				
Lane Width (ft)	8.8	8.8

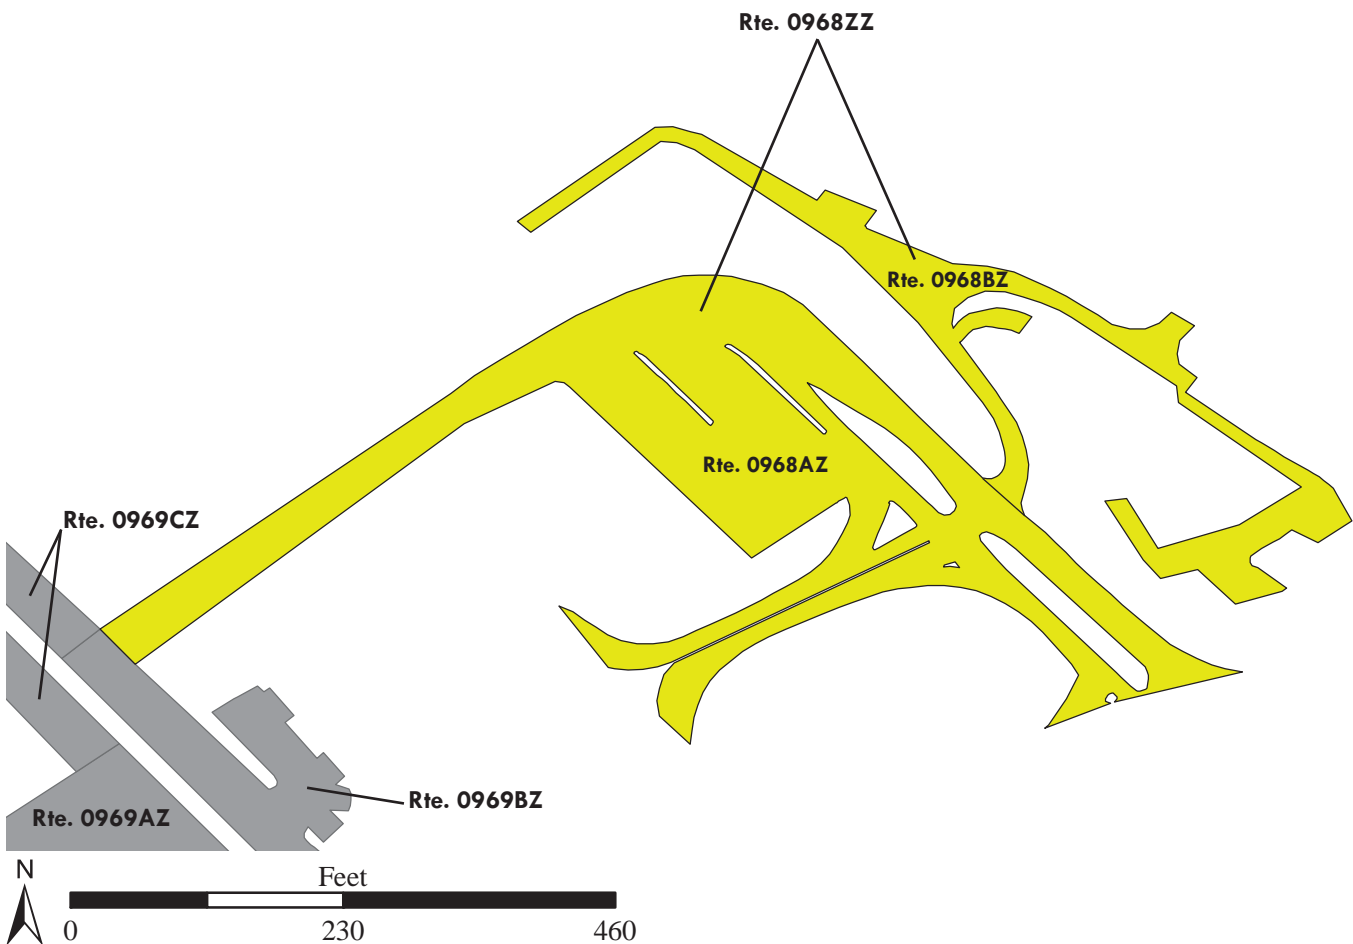
## ROUTE 0968AZ: GOLDEN GATE BRIDGE NORTHEAST PARKING LOT A

Inspection Date	FMSS Number	User Access	Surface Type
5/1/2014	104003	PUBLIC	ASPHALT
Area (Sq. Ft.)	Lane Miles (11' Widths)	Curb Reveal (Inches)	Curb Recommendation
69,400	1.195	4	DO NOTHING
Curb Type		Curb & Gutter Type	
CONCRETE		CONCRETE	
Pavement Recommendation		Condition Rating / PCR	
PREVENTIVE MAINTENANCE		GOOD / 90

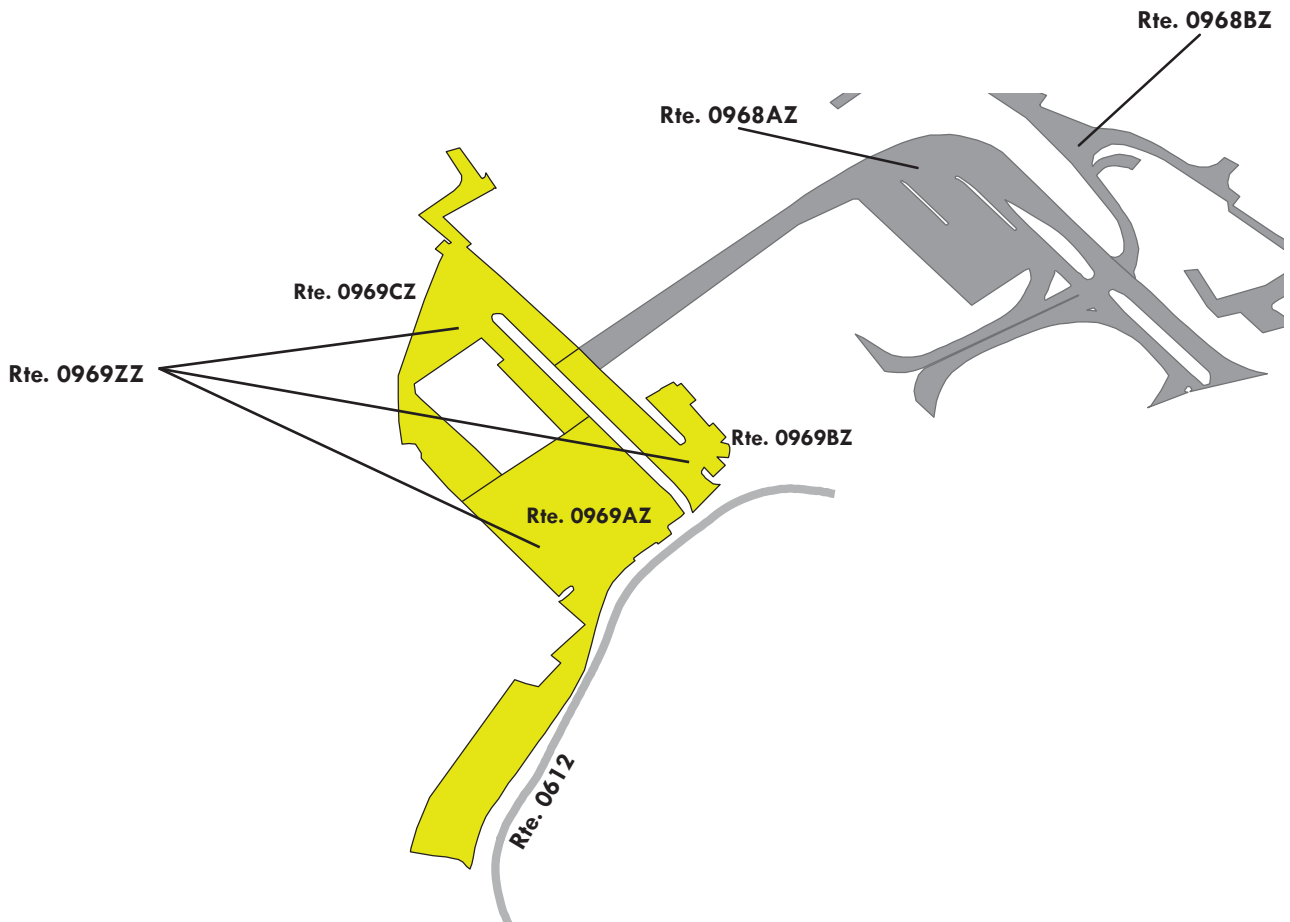
## ROUTE 0969AZ: GOLDEN GATE BRIDGE SOUTHWEST PARKING LOT A

Inspection Date	FMSS Number	User Access	Surface Type
5/1/2014	104004	PUBLIC	ASPHALT
Area (Sq. Ft.)	Lane Miles (11' Widths)	Curb Reveal (Inches)	Curb Recommendation
55,776	0.96	5	LIGHT REPAIR
Curb Type		Curb & Gutter Type	
CONCRETE		NO CURB AND GUTTER	
Pavement Recommendation		Condition Rating / PCR	
PREVENTIVE MAINTENANCE		GOOD / 90
