ROCA Cycle 6

Final Report

Road Inventory and Condition Assessment of Paved Routes Roosevelt Campobello International Park

Report Date: November 2020

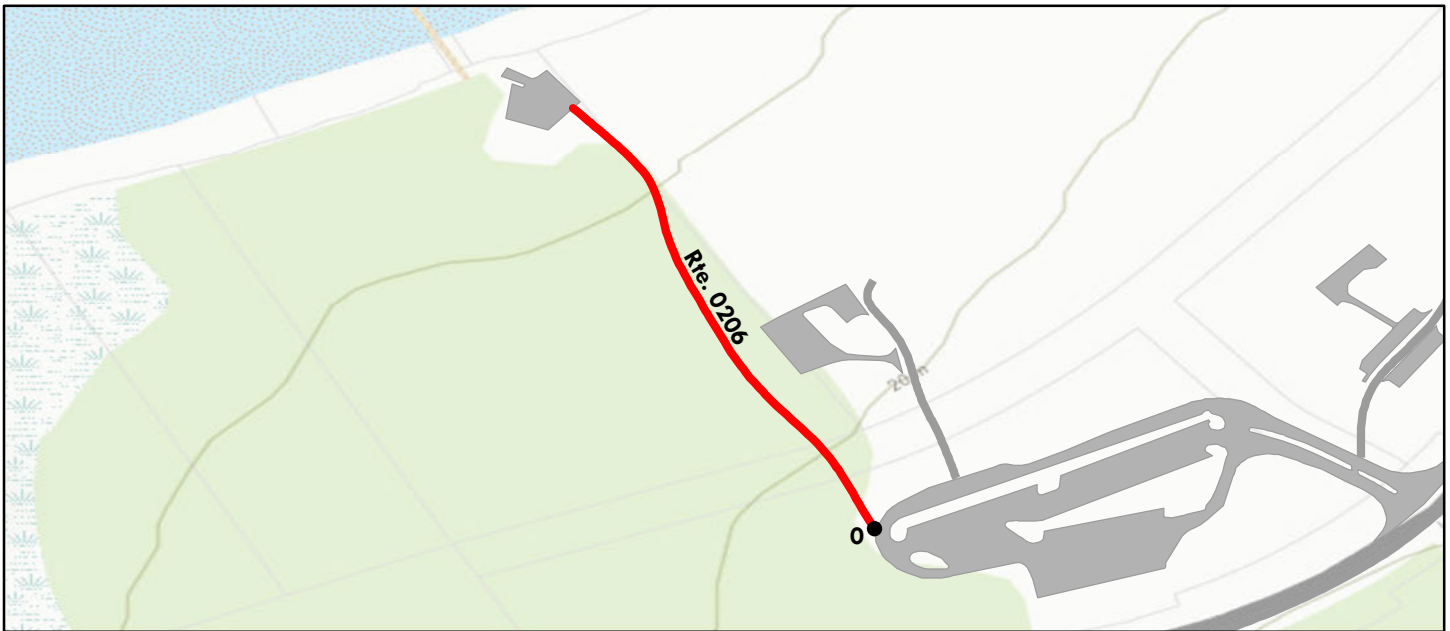
ROUTE 0206: DOCK ACCESS ROAD

Route Condition Legend – Pavement Condition Rating (PCR)						
Poor (0 - 60)	Fair (61- 84)	Good (85 - 94)	Excellent (95 - 100)	Not Rated		
See Appendix for definitions and formulas						
Inspection Date:	9/11/2019	Beginning Section MP	0.00			
Paved Length (Miles):	0.16	Section Length (MI)	0.16			
Surface Type:	ASPHALT	Route Summary				
Roadway Condition Information						
Pavement Condition Rating (PCR)	53	53				
Surface Condition Rating (SCR)	53	53				
Roughness Condition Index (RCI)	N/A	N/A				
Distress Index Values						
Structural Crack Index	N/A	N/A				
Alligator Crack Index	53	53				
Longitudinal Crack Index	73	73				
Transverse Cracking Index	90	90				
Patching Index	90	90				
Rutting Index	90	90				
International Roughness Index (IRI)	N/A	N/A				
Lane & Width Information						
Number of Lanes	1	1				
Paved Width (ft)	13	13				
Lane Width (ft)	13	13

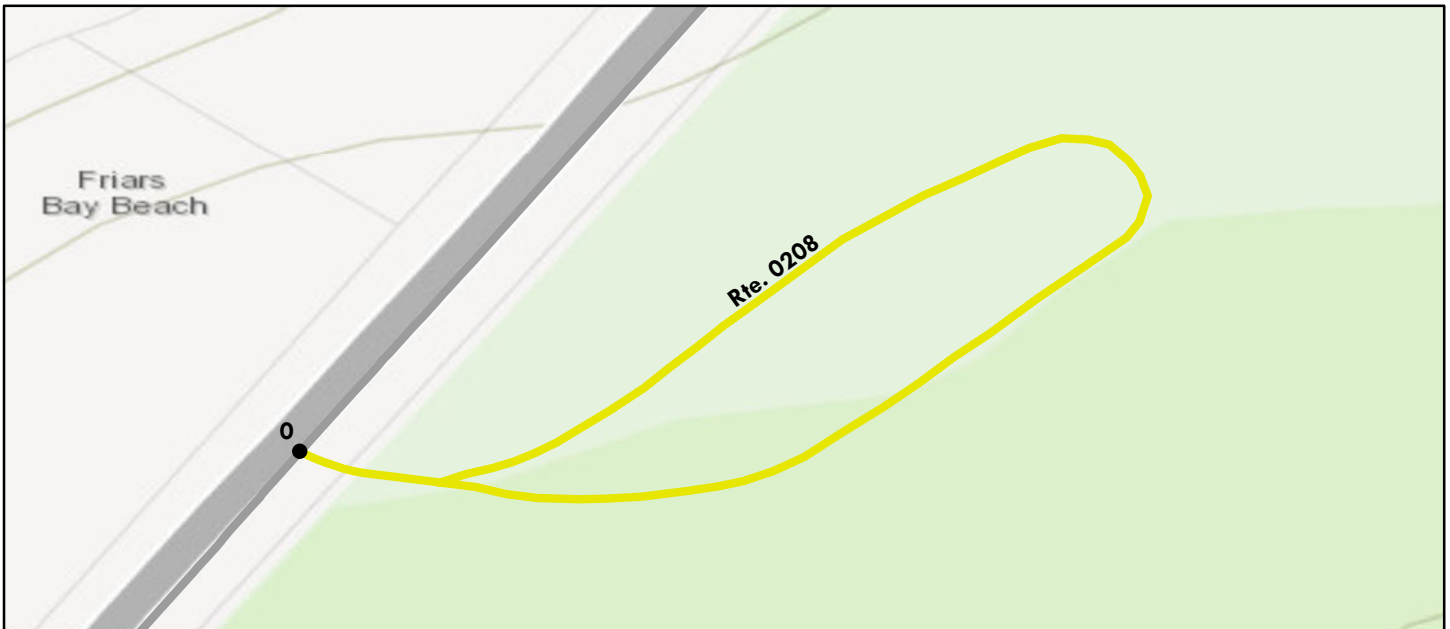
ROUTE 0208: ADAMS LODGE ACCESS ROAD

Route Condition Legend – Pavement Condition Rating (PCR)						
Poor (0 - 60)	Fair (61- 84)	Good (85 - 94)	Excellent (95 - 100)	Not Rated		
See Appendix for definitions and formulas						
Inspection Date:	9/11/2019	Beginning Section MP	0.00			
Paved Length (Miles):	0.17	Section Length (MI)	0.17			
Surface Type:	ASPHALT	Route Summary				
Roadway Condition Information						
Pavement Condition Rating (PCR)	73	73				
Surface Condition Rating (SCR)	73	73				
Roughness Condition Index (RCI)	N/A	N/A				
Distress Index Values						
Structural Crack Index	N/A	N/A				
Alligator Crack Index	73	73				
Longitudinal Crack Index	90	90				
Transverse Cracking Index	90	90				
Patching Index	73	73				
Rutting Index	90	90				
International Roughness Index (IRI)	N/A	N/A				
Lane & Width Information						
Number of Lanes	1	1				
Paved Width (ft)	12	12				
Lane Width (ft)	12	12

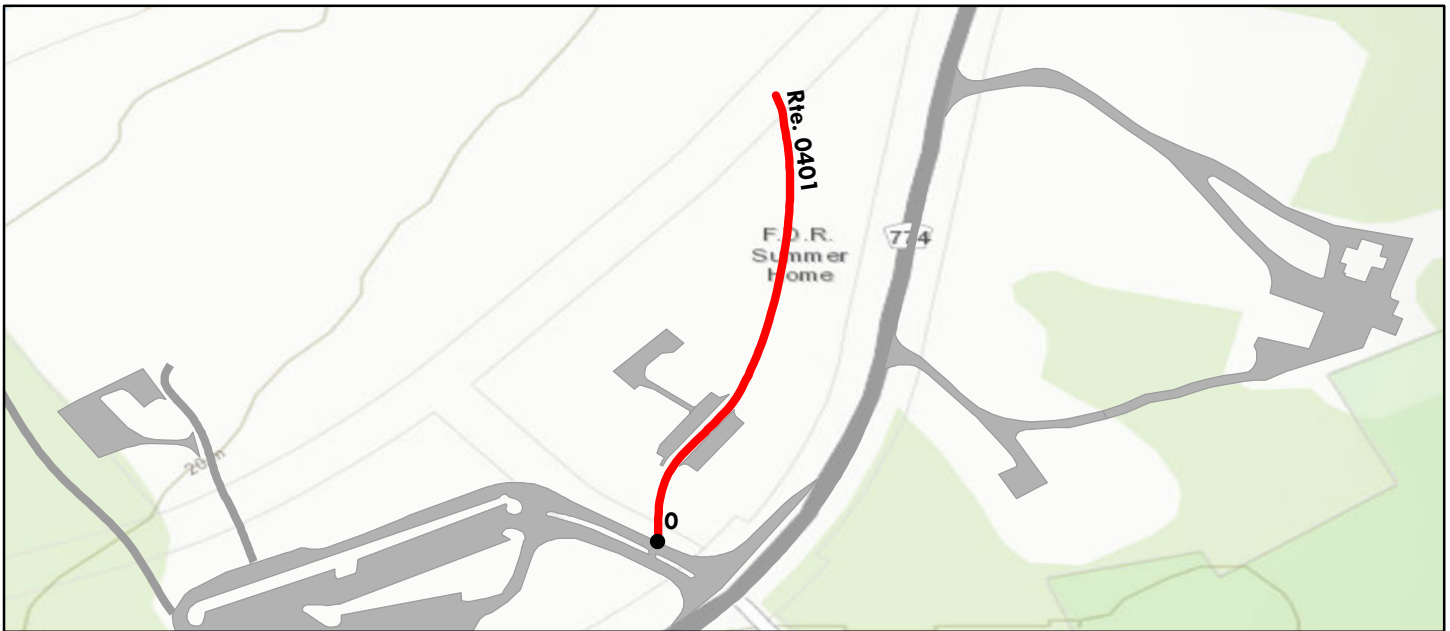
ROUTE 0401: STAFF PARKING ROAD

Route Condition Legend – Pavement Condition Rating (PCR)						
Poor (0 - 60)	Fair (61- 84)	Good (85 - 94)	Excellent (95 - 100)	Not Rated		
See Appendix for definitions and formulas						
Inspection Date:	9/11/2019	Beginning Section MP	0.00			
Paved Length (Miles):	0.15	Section Length (MI)	0.15			
Surface Type:	ASPHALT	Route Summary				
Roadway Condition Information						
Pavement Condition Rating (PCR)	53	53				
Surface Condition Rating (SCR)	53	53				
Roughness Condition Index (RCI)	N/A	N/A				
Distress Index Values						
Structural Crack Index	N/A	N/A				
Alligator Crack Index	53	53				
Longitudinal Crack Index	73	73				
Transverse Cracking Index	90	90				
Patching Index	73	73				
Rutting Index	90	90				
International Roughness Index (IRI)	N/A	N/A				
Lane & Width Information						
Number of Lanes	1	1				
Paved Width (ft)	12.8	12.8				
Lane Width (ft)	12.8	12.8

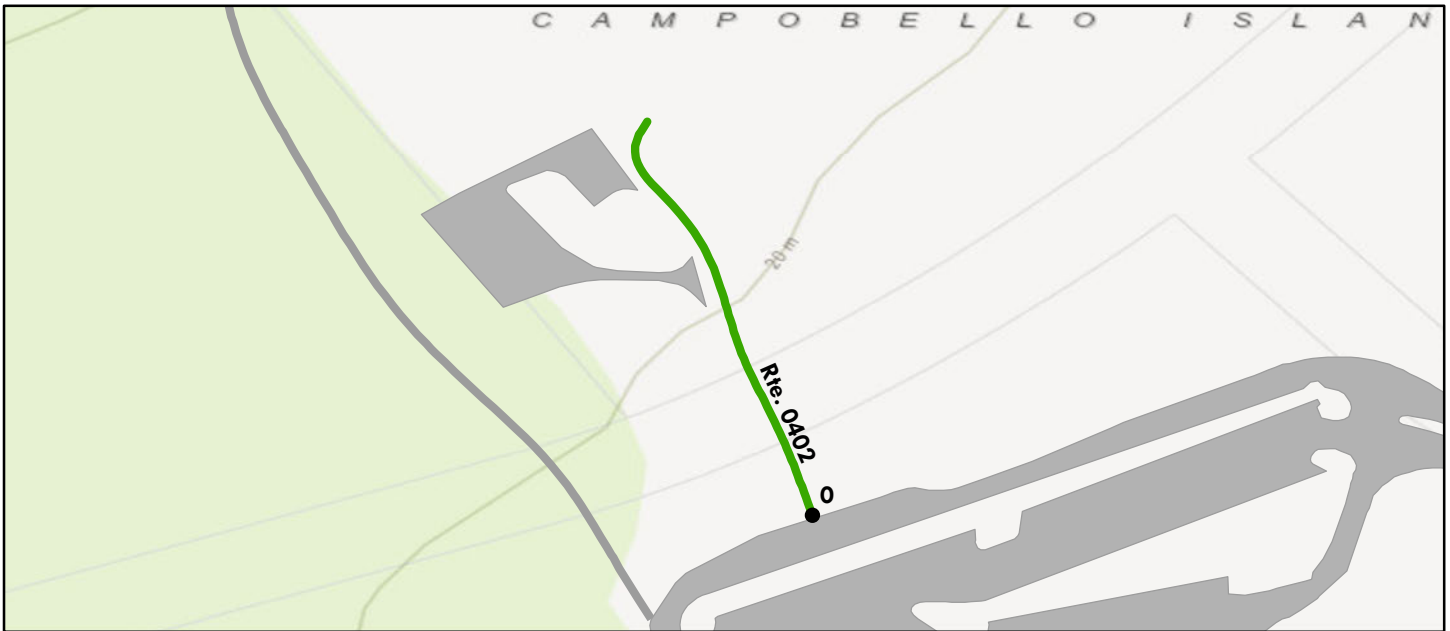
ROUTE 0402: PRINCE COTTAGE ROAD

Inspection Date:	9/11/2019	Beginning Section MP	0.00				
Paved Length (Miles):	0.07	Section Length (MI)	0.07				
Surface Type:	ASPHALT	Route Summary					
Roadway Condition Information							
Pavement Condition Rating (PCR)	90	90					
Surface Condition Rating (SCR)	90	90					
Roughness Condition Index (RCI)	N/A	N/A					
Distress Index Values							
Structural Crack Index	N/A	N/A					
Alligator Crack Index	90	90					
Longitudinal Crack Index	90	90					
Transverse Cracking Index	90	90					
Patching Index	97	97					
Rutting Index	90	90					
International Roughness Index (IRI)	N/A	N/A					
Lane & Width Information							
Number of Lanes	1	1					
Paved Width (ft)	10.8	10.8					
Lane Width (ft)	10.8	10.8

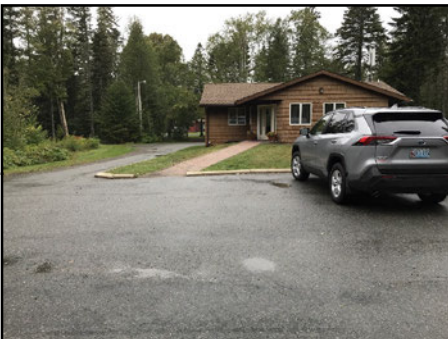
ROUTE 0901B: STAFF PARKING B

Inspection Date	FMSS Number	User Access	Surface Type
9/11/2019	N/A	NONPUBLIC	ASPHALT
Area (Sq. Ft.)	Lane Miles (11' Widths)	Curb Reveal (Inches)	Curb Recommendation
2,608	0.045	4	DO NOTHING
Curb Type		Curb & Gutter Type	
CONCRETE		NO CURB AND GUTTER	
Pavement Recommendation		Condition Rating / PCR	
HEAVY 3R TREATMENTS		POOR / 53

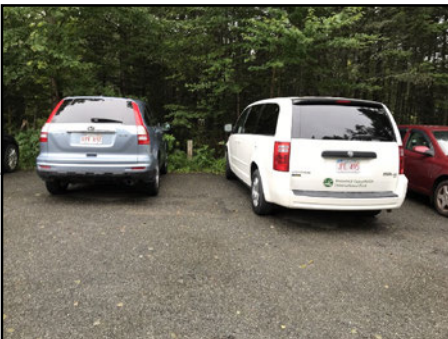
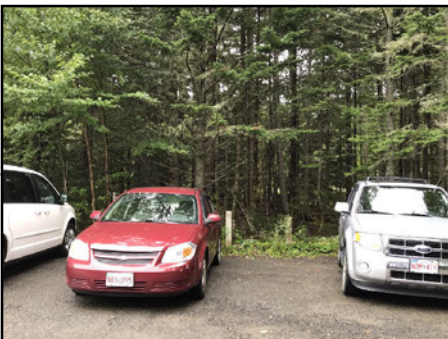
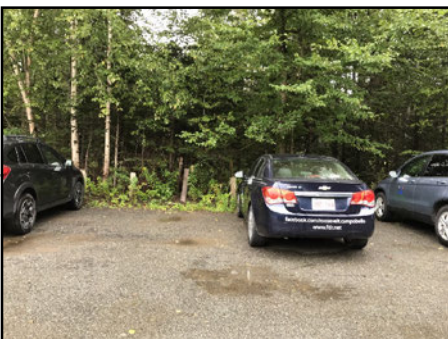
ROUTE 0901C: STAFF PARKING C

Inspection Date	FMSS Number	User Access	Surface Type
9/11/2019	N/A	NONPUBLIC	ASPHALT
Area (Sq. Ft.)	Lane Miles (11' Widths)	Curb Reveal (Inches)	Curb Recommendation
2,392	0.041	NOT APPLICABLE	NOT APPLICABLE
Curb Type		Curb & Gutter Type	
NO CURB		NO CURB AND GUTTER	
Pavement Recommendation		Condition Rating / PCR	
HEAVY 3R TREATMENTS		POOR / 53

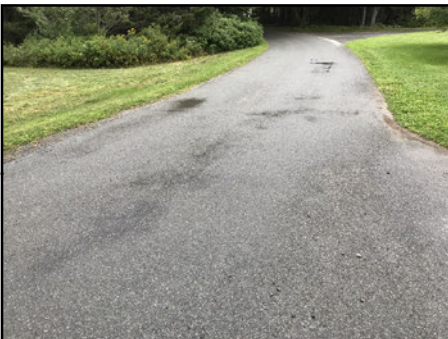
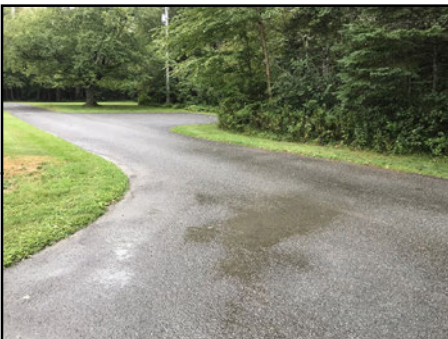
ROUTE 0902A: JOHNSTON COTTAGE PARKING

Inspection Date	FMSS Number	User Access	Surface Type
9/11/2019	N/A	PUBLIC	ASPHALT
Area (Sq. Ft.)	Lane Miles (11' Widths)	Curb Reveal (Inches)	Curb Recommendation
8,837	0.152	NOT APPLICABLE	NOT APPLICABLE
Curb Type		Curb & Gutter Type	
NO CURB		NO CURB AND GUTTER	
Pavement Recommendation		Condition Rating / PCR	
PREVENTIVE MAINTENANCE		GOOD / 90

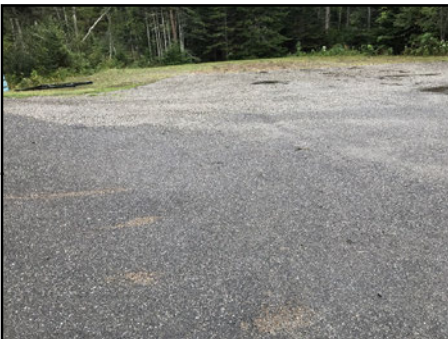
ROUTE 0907: DOCK PARKING

Inspection Date	FMSS Number	User Access	Surface Type
9/11/2019	N/A	PUBLIC	ASPHALT
Area (Sq. Ft.)	Lane Miles (11' Widths)	Curb Reveal (Inches)	Curb Recommendation
6,200	0.107	NOT APPLICABLE	NOT APPLICABLE
Curb Type		Curb & Gutter Type	
NO CURB		NO CURB AND GUTTER	
Pavement Recommendation		Condition Rating / PCR	
HEAVY 3R TREATMENTS		POOR / 53

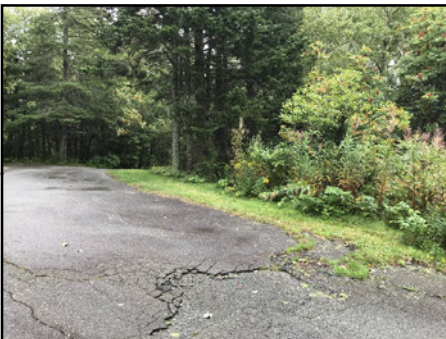
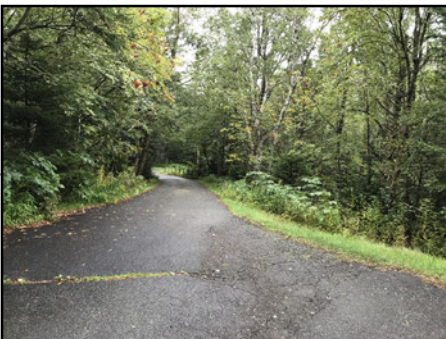
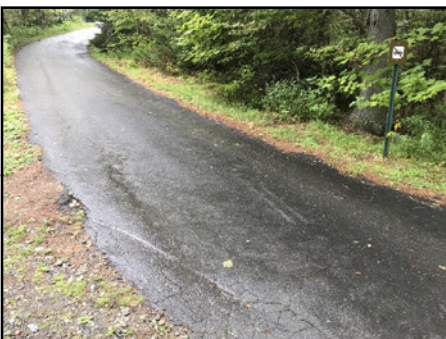
ROUTE 0908: FRIARS HEAD HANDICAPPED PARKING

Inspection Date	FMSS Number	User Access	Surface Type
9/11/2019	N/A	PUBLIC	ASPHALT
Area (Sq. Ft.)	Lane Miles (11' Widths)	Curb Reveal (Inches)	Curb Recommendation
6,442	0.111	NOT APPLICABLE	NOT APPLICABLE
Curb Type		Curb & Gutter Type	
NO CURB		NO CURB AND GUTTER	
Pavement Recommendation		Condition Rating / PCR	
LIGHT 3R TREATMENTS		FAIR / 73

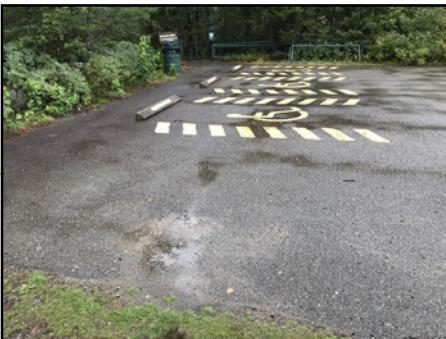
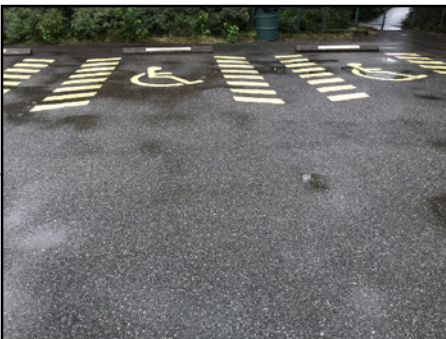
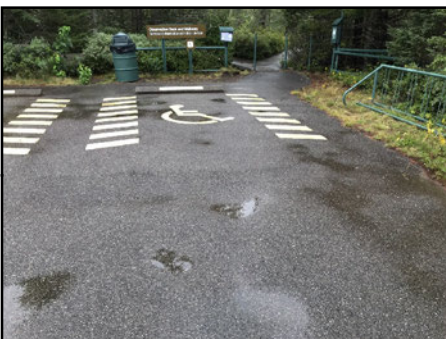
ROUTE 0913: EAGLE BOG HANDICAPPED PARKING

Inspection Date	FMSS Number	User Access	Surface Type
9/11/2019	N/A	PUBLIC	ASPHALT
Area (Sq. Ft.)	Lane Miles (11' Widths)	Curb Reveal (Inches)	Curb Recommendation
1,342	0.023	NOT APPLICABLE	NOT APPLICABLE
Curb Type		Curb & Gutter Type	
NO CURB		NO CURB AND GUTTER	
Pavement Recommendation		Condition Rating / PCR	
PREVENTIVE MAINTENANCE		GOOD / 90

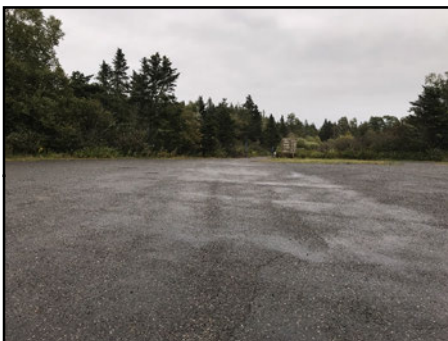
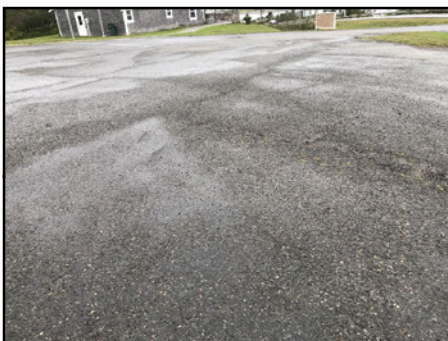
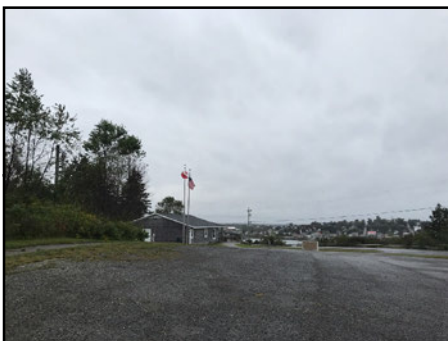
ROUTE 0920: ADVENTURE CENTER PARKING

Inspection Date	FMSS Number	User Access	Surface Type
9/11/2019	N/A	PUBLIC	ASPHALT
Area (Sq. Ft.)	Lane Miles (11' Widths)	Curb Reveal (Inches)	Curb Recommendation
24,733	0.426	NOT APPLICABLE	NOT APPLICABLE
Curb Type		Curb & Gutter Type	
NO CURB		NO CURB AND GUTTER	
Pavement Recommendation		Condition Rating / PCR	
HEAVY 3R TREATMENTS		POOR / 53
