SAAN Cycle 6

Final Report

Road Inventory and Condition Assessment of Paved Routes San Antonio Missions National Historical Park

Report Date: May 2017

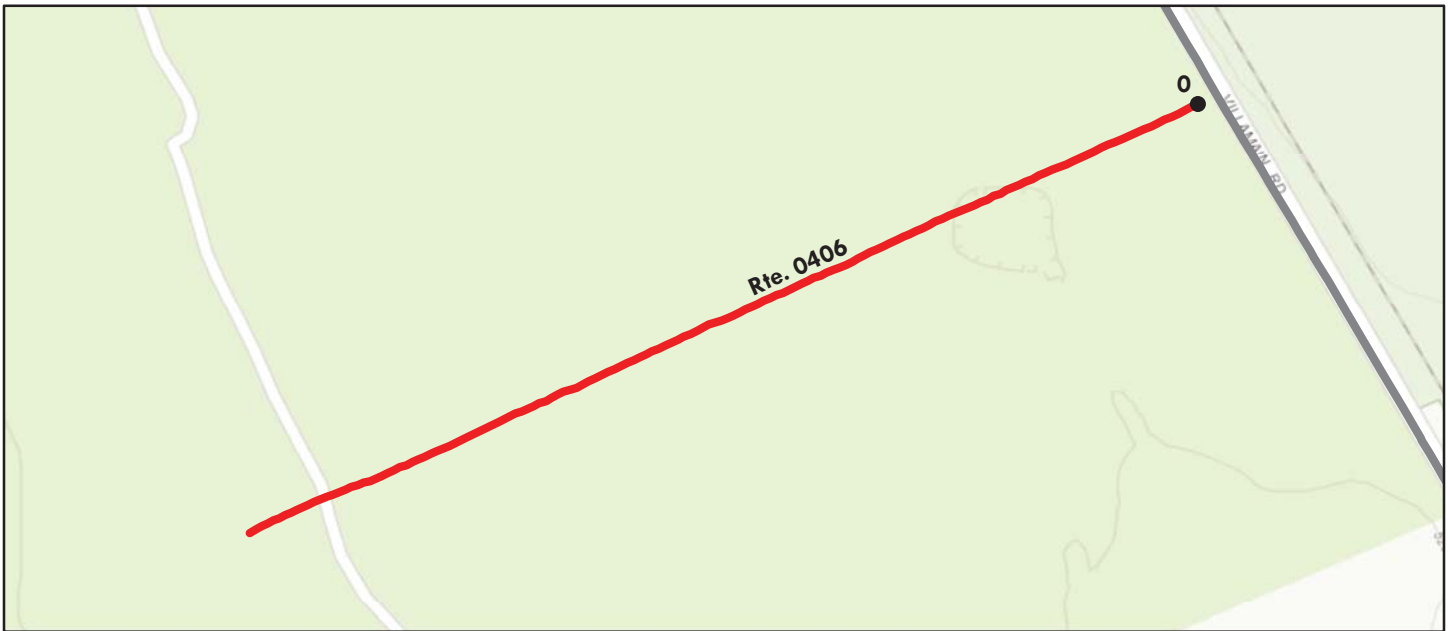
ROUTE 0406: FINLEY ROAD

Route Condition Legend – Pavement Condition Rating (PCR)						
Poor (0 - 60)	Fair (61- 84)	Good (85 - 94)	Excellent (95 - 100)	Not Rated		
See Appendix for definitions and formulas						
Inspection Date: 2/17/2017	Beginning Section MP	0.00				
Paved Length (Miles): 0.23	Section Length (MI)	0.23				
Surface Type: ASPHALT	Route Summary					
Roadway Condition Information						
Pavement Condition Rating (PCR)	0	0				
Surface Condition Rating (SCR)	0	0				
Roughness Condition Index (RCI)	N/A	N/A				
Distress Index Values						
Structural Crack Index	N/A	N/A				
Alligator Crack Index	N/A	N/A				
Longitudinal Crack Index	N/A	N/A				
Transverse Cracking Index	N/A	N/A				
Patching Index	N/A	N/A				
Rutting Index	N/A	N/A				
International Roughness Index (IRI)	N/A	N/A				
Lane & Width Information						
Number of Lanes	1	1				
Paved Width (ft)	12	12				
Lane Width (ft)	12	12

NOTE: Route is in very poor condition and covered by overgrown grass.

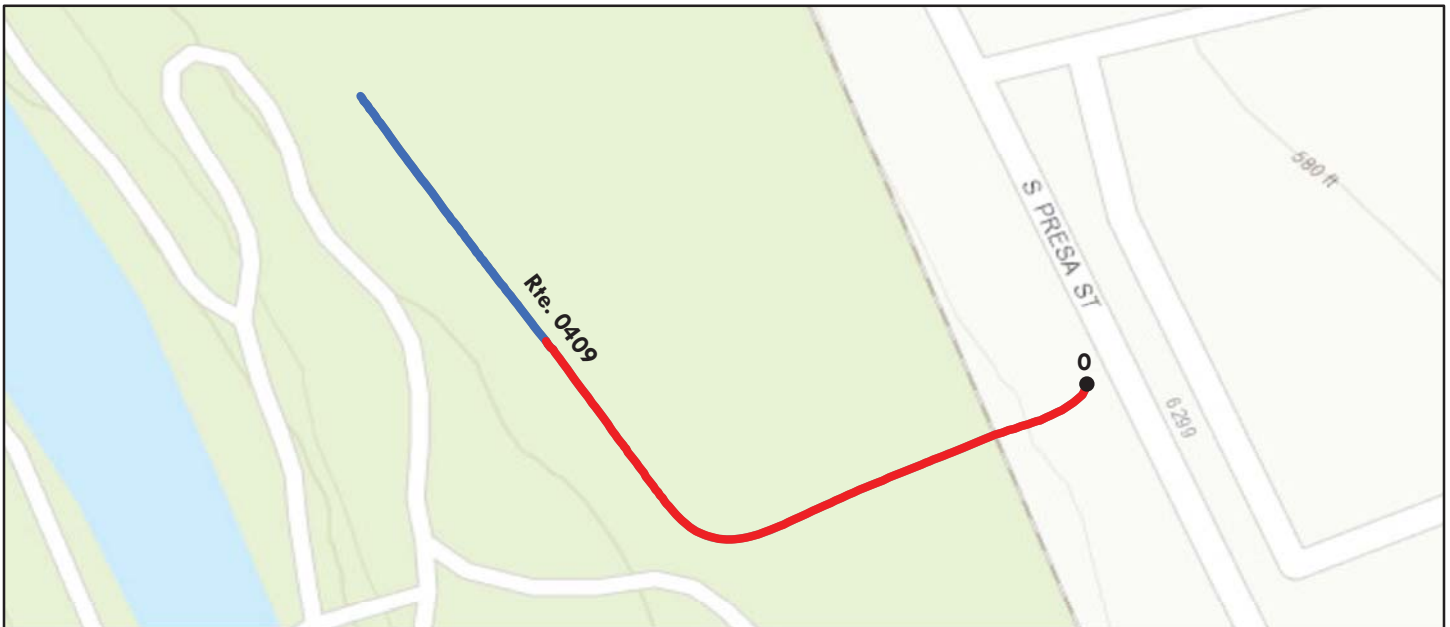
ROUTE 0409: PUMP HOUSE ROAD

Route Condition Legend – Pavement Condition Rating (PCR)						
Poor (0 - 60)	Fair (61- 84)	Good (85 - 94)	Excellent (95 - 100)	Not Rated		
See Appendix for definitions and formulas						
Inspection Date: 3/15/2017	Beginning Section MP	0				
Paved Length (Miles): 0.15	Section Length (MI)	0.15				
Surface Type: ASPHALT	Route Summary					
Roadway Condition Information						
Pavement Condition Rating (PCR)	73	73				
Surface Condition Rating (SCR)	73	73				
Roughness Condition Index (RCI)	N/A	N/A				
Distress Index Values						
Structural Crack Index	73	73				
Alligator Crack Index	99	99				
Longitudinal Crack Index	74	74				
Transverse Cracking Index	90	90				
Patching Index	100	100				
Rutting Index	95	95				
International Roughness Index (IRI)	N/A	N/A				
Lane & Width Information						
Number of Lanes	2	2				
Paved Width (ft)	21.8	21.8				
Lane Width (ft)	10.9	10.9

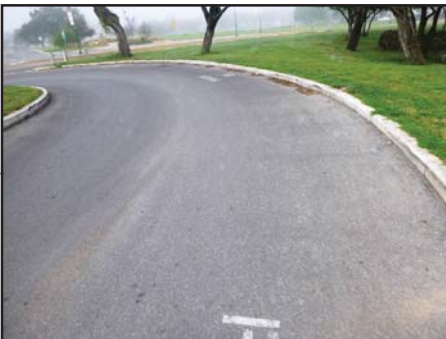
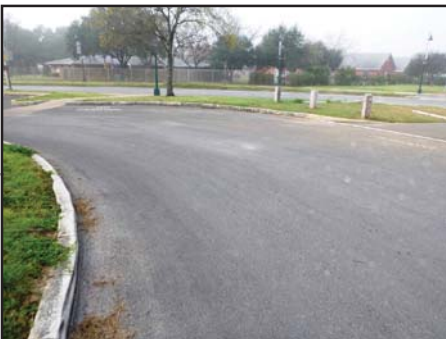
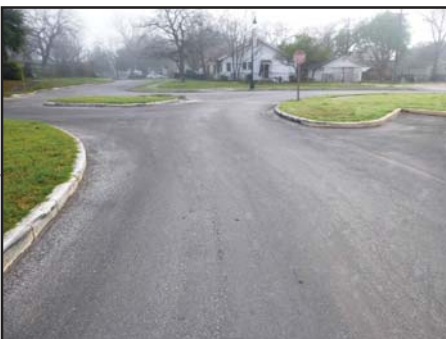
Inspection Date	FMSS Number	User Access	Surface Type
2/18/2017	75115	PUBLIC	ASPHALT
Area (Sq. Ft.)	Lane Miles (11' Widths)	Curb Reveal (Inches)	Curb Recommendation
23,603	0.406	5	LIGHT REPAIR
Curb Type		Curb & Gutter Type	
CONCRETE		NO CURB AND GUTTER	
Pavement Recommendation		Condition Rating / PCR	
PREVENTIVE MAINTENANCE		GOOD / 90

Note: Parking area consists of multiple surface types; 5 parts asphalt at 22,708 square feet and 6 parts concrete at 895 square feet.

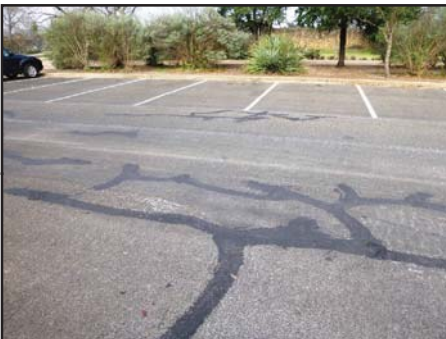
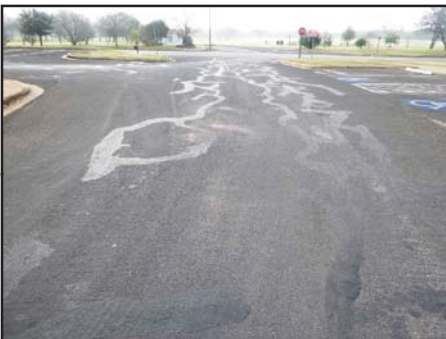
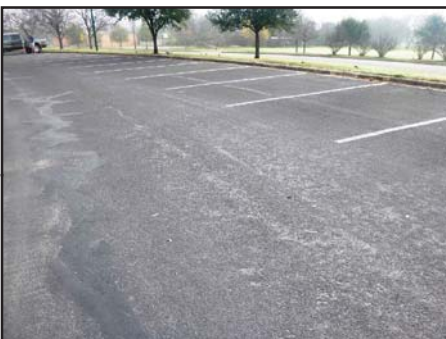
ROUTE 0901: VISITOR CENTER PARKING

Inspection Date	FMSS Number	User Access	Surface Type
2/18/2017	75522	PUBLIC	ASPHALT
Area (Sq. Ft.)	Lane Miles (11' Widths)	Curb Reveal (Inches)	Curb Recommendation
52,231	0.899	NOT APPLICABLE	DO NOTHING
Curb Type		Curb & Gutter Type	
NO CURB		CONCRETE	
Pavement Recommendation		Condition Rating / PCR	
PREVENTIVE MAINTENANCE		GOOD / 90

Note: Parking area consists of multiple surface types; 1 part asphalt at 49,243 square feet and 1 part concrete at 2,988 square feet.

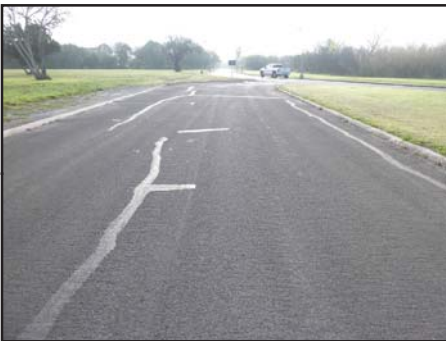
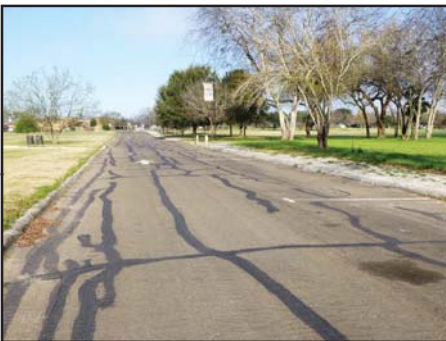
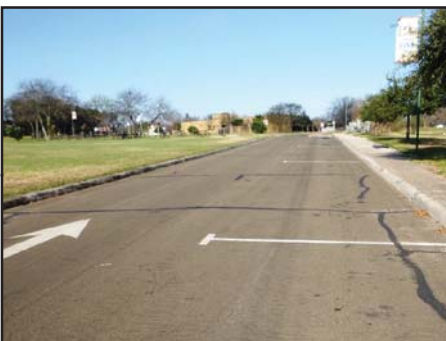
ROUTE 0902: BUS LANE PARKING

Inspection Date	FMSS Number	User Access	Surface Type
2/18/2017	92450	PUBLIC	ASPHALT
Area (Sq. Ft.)	Lane Miles (11' Widths)	Curb Reveal (Inches)	Curb Recommendation
22,311	0.384	9	DO NOTHING
Curb Type		Curb & Gutter Type	
CONCRETE		NO CURB AND GUTTER	
Pavement Recommendation		Condition Rating / PCR	
PREVENTIVE MAINTENANCE		GOOD / 90

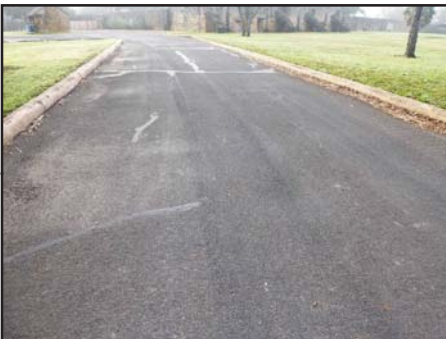
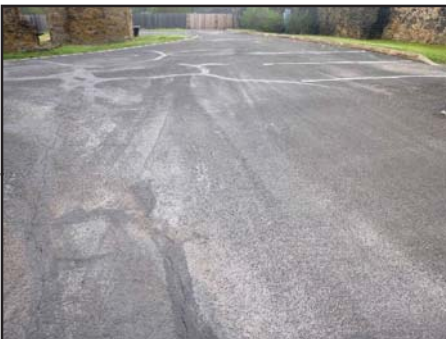
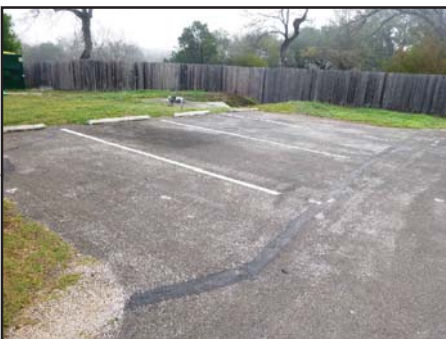
ROUTE 0903: SERVICE PARKING

Inspection Date	FMSS Number	User Access	Surface Type
2/18/2017	75965	NONPUBLIC	ASPHALT
Area (Sq. Ft.)	Lane Miles (11' Widths)	Curb Reveal (Inches)	Curb Recommendation
16,997	0.293	8	DO NOTHING
Curb Type		Curb & Gutter Type	
CONCRETE		NO CURB AND GUTTER	
Pavement Recommendation		Condition Rating / PCR	
PREVENTIVE MAINTENANCE		GOOD / 90

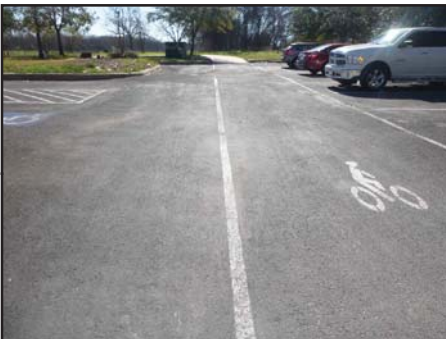
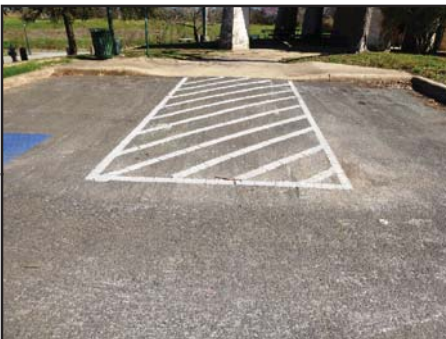
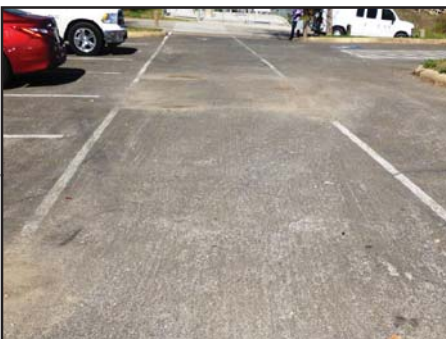
ROUTE 0905: RIVER REST COMFORT STATION

Inspection Date	FMSS Number	User Access	Surface Type
2/18/2017	103848	PUBLIC	ASPHALT
Area (Sq. Ft.)	Lane Miles (11' Widths)	Curb Reveal (Inches)	Curb Recommendation
4,056	0.07	7	DO NOTHING
Curb Type		Curb & Gutter Type	
CONCRETE		NO CURB AND GUTTER	
Pavement Recommendation		Condition Rating / PCR	
PREVENTIVE MAINTENANCE		GOOD / 90

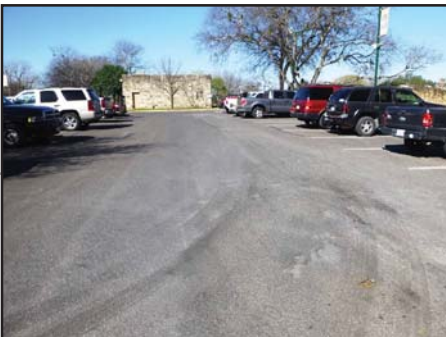
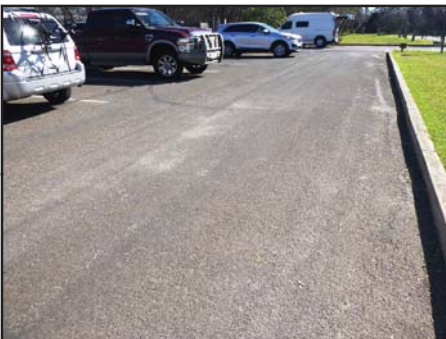
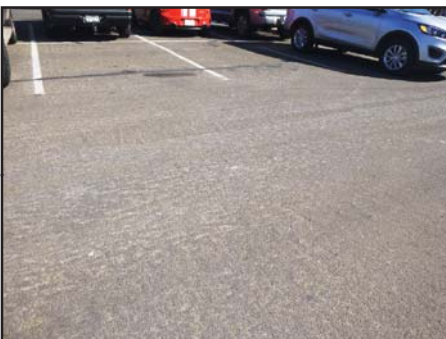
ROUTE 0908: ESPADA AQUEDUCT PARKING

Inspection Date	FMSS Number	User Access	Surface Type
2/18/2017	76439	PUBLIC	ASPHALT
Area (Sq. Ft.)	Lane Miles (11' Widths)	Curb Reveal (Inches)	Curb Recommendation
19,814	0.341	4	DO NOTHING
Curb Type		Curb & Gutter Type	
CONCRETE		NO CURB AND GUTTER	
Pavement Recommendation		Condition Rating / PCR	
PREVENTIVE MAINTENANCE		GOOD / 90

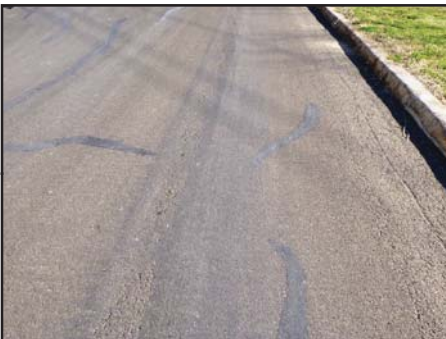
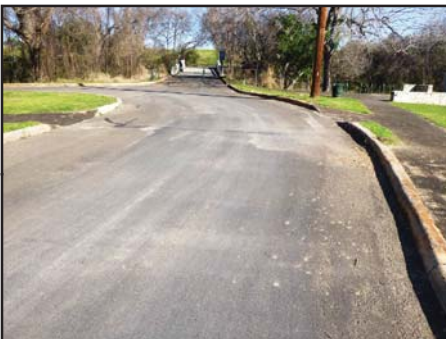
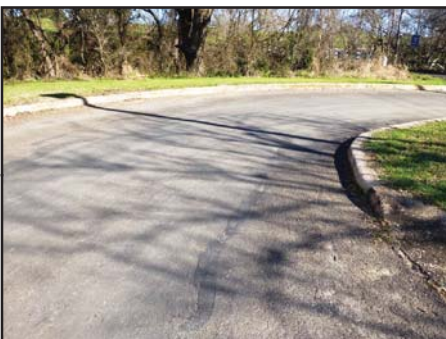
ROUTE 0912: SAN JUAN BARN PARKING

Inspection Date	FMSS Number	User Access	Surface Type
2/18/2017	248464	PUBLIC	ASPHALT
Area (Sq. Ft.)	Lane Miles (11' Widths)	Curb Reveal (Inches)	Curb Recommendation
8,620	0.148	0	DO NOTHING
Curb Type		Curb & Gutter Type	
CONCRETE		NO CURB AND GUTTER	
Pavement Recommendation		Condition Rating / PCR	
PREVENTIVE MAINTENANCE		GOOD / 90

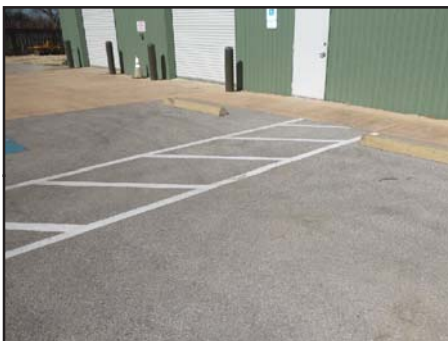
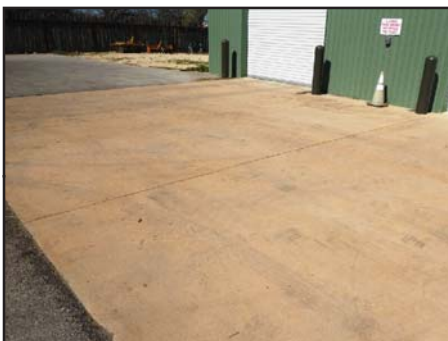
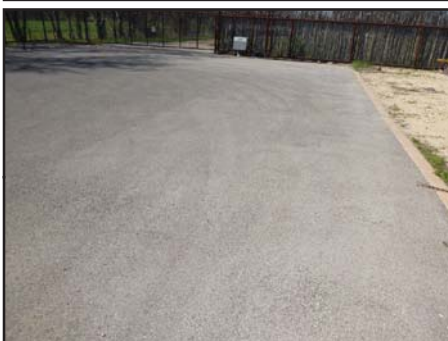
ROUTE 0913: SAN JUAN PARKING

Note: Parking area consists of multiple surface types; 1 part asphalt at 7,503 square feet and 2 parts concrete at 1,117 square feet.

Inspection Date	FMSS Number	User Access	Surface Type
2/18/2017	76068	PUBLIC	ASPHALT
Area (Sq. Ft.)	Lane Miles (11' Widths)	Curb Reveal (Inches)	Curb Recommendation
36,636	0.631	8	DO NOTHING
Curb Type		Curb & Gutter Type	
CONCRETE		CONCRETE	
Pavement Recommendation		Condition Rating / PCR	
PREVENTIVE MAINTENANCE		GOOD / 90
