# SACN Cycle 6

## Final Report

### Road Inventory and Condition Assessment of Paved Routes St. Croix National Scenic Riverway

**Report Date: August 2019**

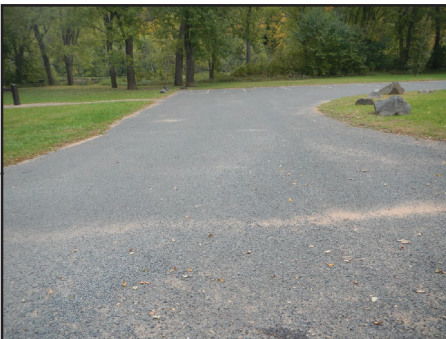
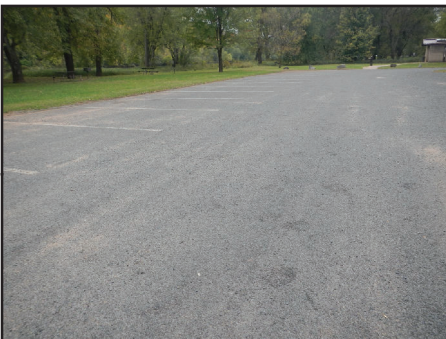
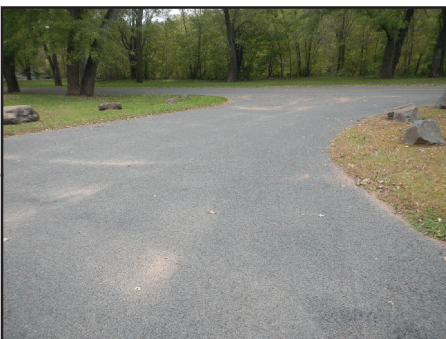
Inspection Date	FMSS Number	User Access	Surface Type
9/30/2018	24192	PUBLIC	ASPHALT
Area (Sq. Ft.)	Lane Miles (11' Widths)	Curb Reveal (Inches)	Curb Recommendation
9,303	0.16	NOT APPLICABLE	NOT APPLICABLE
Curb Type		Curb & Gutter Type	
NO CURB		NO CURB AND GUTTER	
Pavement Recommendation		Condition Rating / PCR	
LIGHT 3R TREATMENTS		FAIR / 73

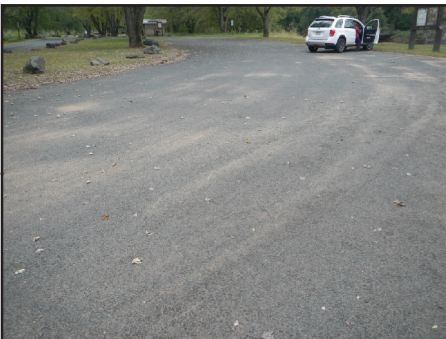
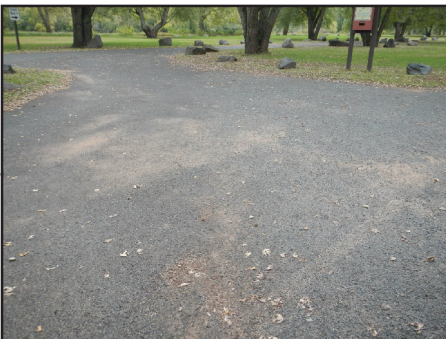
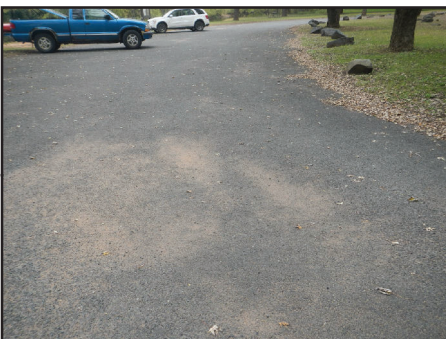
Inspection Date	FMISS Number	User Access	Surface Type
9/30/2018	24192	PUBLIC	ASPHALT
Area (Sq. Ft.)	Lane Miles (11' Widths)	Curb Reveal (Inches)	Curb Recommendation
4,434	0.076	NOT APPLICABLE	NOT APPLICABLE
Curb Type		Curb & Gutter Type	
NO CURB		NO CURB AND GUTTER	
Pavement Recommendation		Condition Rating / PCR	
LIGHT 3R TREATMENTS		FAIR / 73

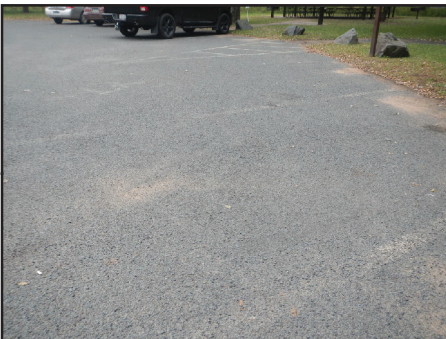
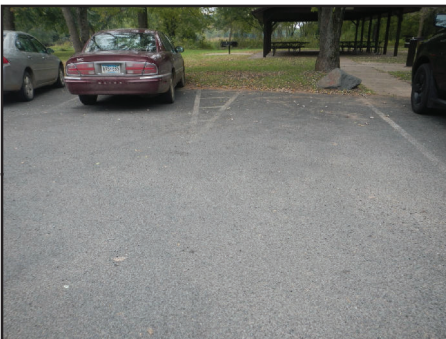
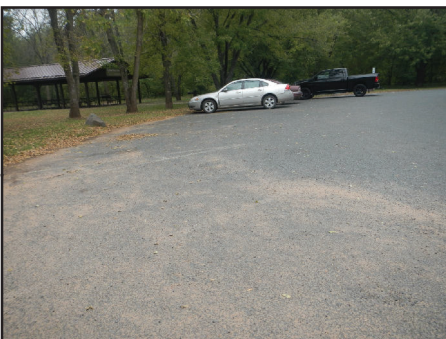
Inspection Date	FMSS Number	User Access	Surface Type
9/30/2018	23819	PUBLIC	ASPHALT
Area (Sq. Ft.)	Lane Miles (11' Widths)	Curb Reveal (Inches)	Curb Recommendation
27,316	0.47	NOT APPLICABLE	NOT APPLICABLE
Curb Type		Curb & Gutter Type	
NO CURB		NO CURB AND GUTTER	
Pavement Recommendation		Condition Rating / PCR	
LIGHT 3R TREATMENTS		FAIR / 73

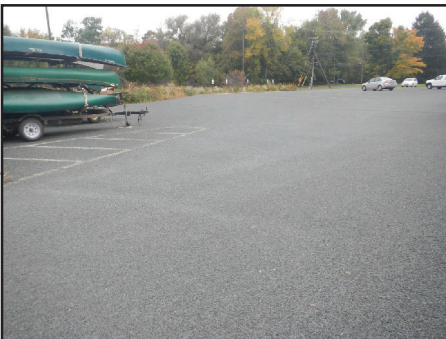
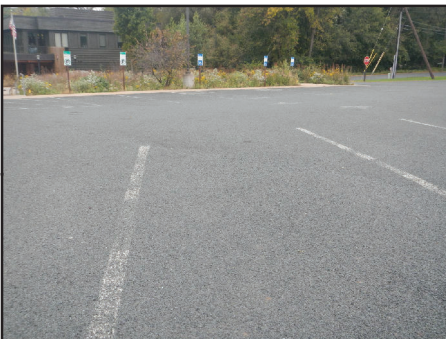
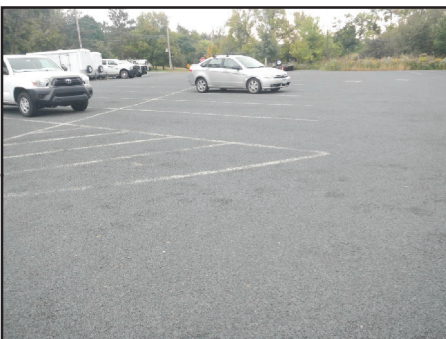
Inspection Date	FMSS Number	User Access	Surface Type
9/30/2018	23878	PUBLIC	ASPHALT
Area (Sq. Ft.)	Lane Miles (11' Widths)	Curb Reveal (Inches)	Curb Recommendation
31,941	0.55	NOT APPLICABLE	NOT APPLICABLE
Curb Type		Curb & Gutter Type	
NO CURB		NO CURB AND GUTTER	
Pavement Recommendation		Condition Rating / PCR	
PREVENTIVE MAINTENANCE		GOOD / 90

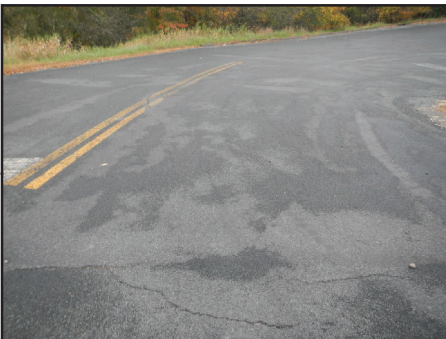
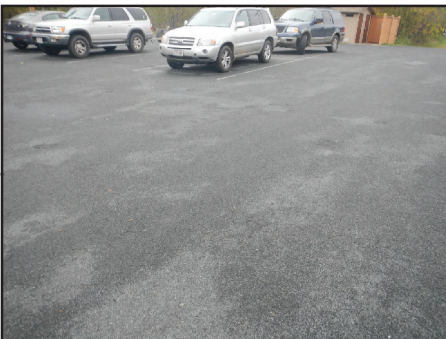
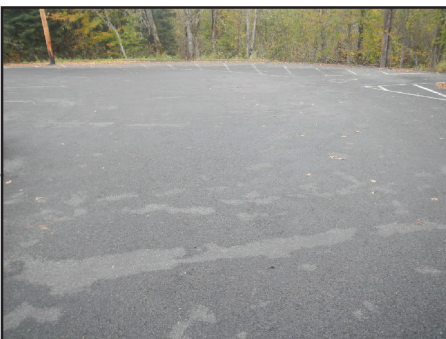
Inspection Date	FMSS Number	User Access	Surface Type
10/1/2018	37388	PUBLIC	ASPHALT
Area (Sq. Ft.)	Lane Miles (11' Widths)	Curb Reveal (Inches)	Curb Recommendation
16,444	0.283	5	MODERATE REPAIR
Curb Type		Curb & Gutter Type	
ASPHALT		NO CURB AND GUTTER	
Pavement Recommendation		Condition Rating / PCR	
PREVENTIVE MAINTENANCE		GOOD / 90

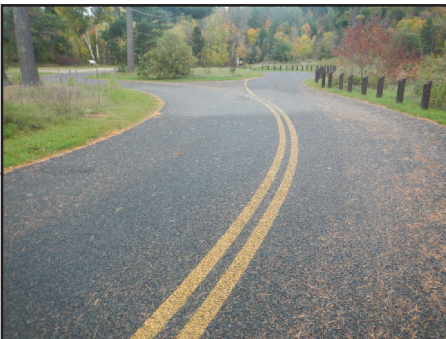
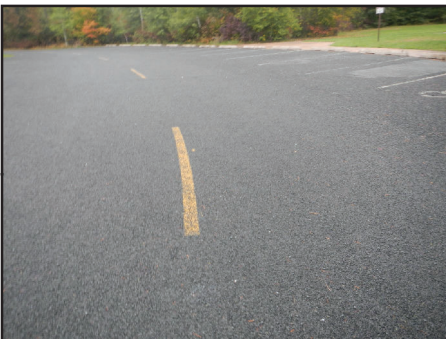
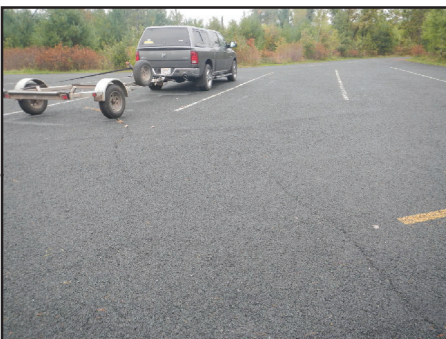
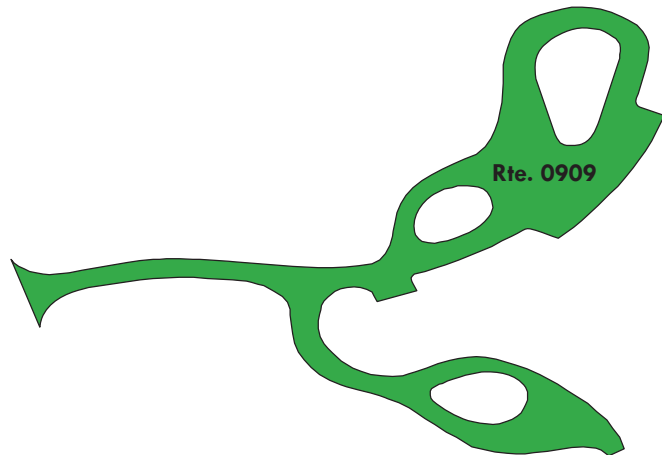
Inspection Date	FMSS Number	User Access	Surface Type
10/1/2018	54633	PUBLIC	ASPHALT
Area (Sq. Ft.)	Lane Miles (11' Widths)	Curb Reveal (Inches)	Curb Recommendation
46,464	0.8	NOT APPLICABLE	DO NOTHING
Curb Type		Curb & Gutter Type	
NO CURB		CONCRETE	
Pavement Recommendation		Condition Rating / PCR	
PREVENTIVE MAINTENANCE		GOOD / 90

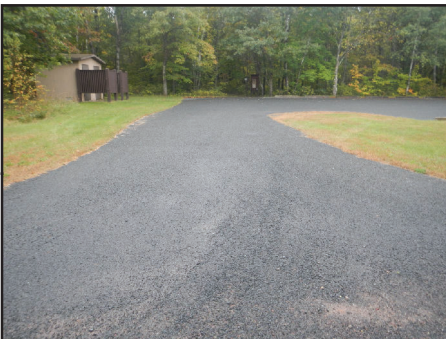
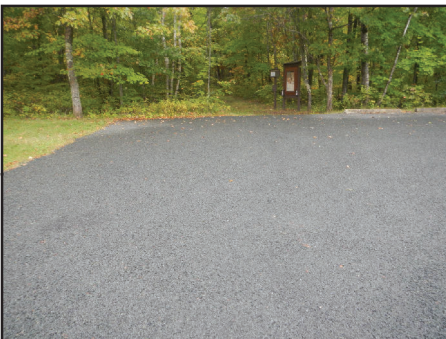
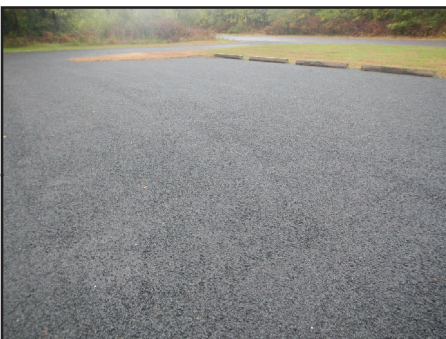
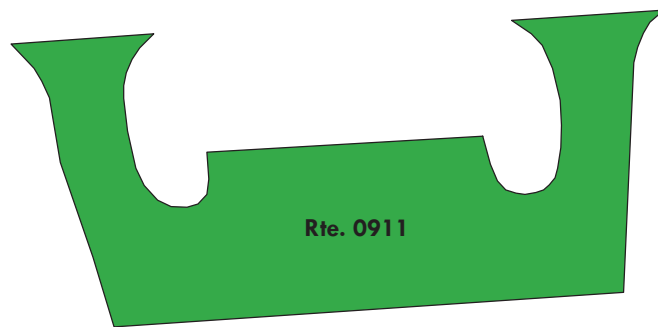
Inspection Date	FMSS Number	User Access	Surface Type
10/1/2018	86647	PUBLIC	ASPHALT
Area (Sq. Ft.)	Lane Miles (11' Widths)	Curb Reveal (Inches)	Curb Recommendation
8,573	0.148	NOT APPLICABLE	NOT APPLICABLE
Curb Type		Curb & Gutter Type	
NO CURB		NO CURB AND GUTTER	
Pavement Recommendation		Condition Rating / PCR	
PREVENTIVE MAINTENANCE		GOOD / 90

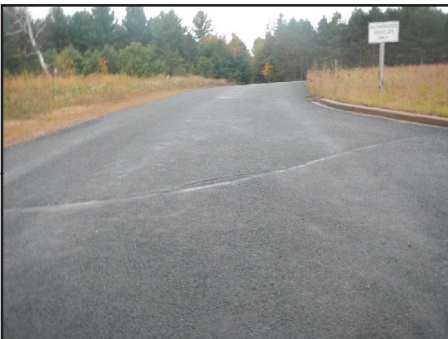
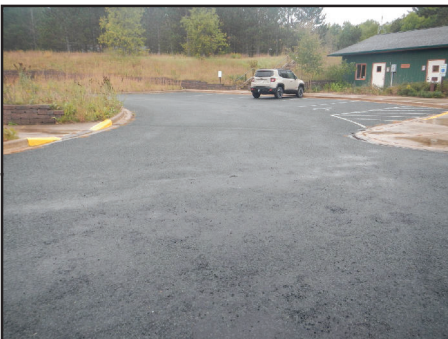
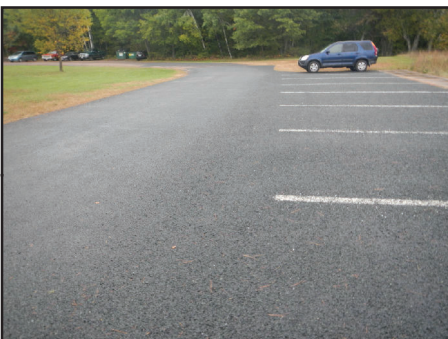
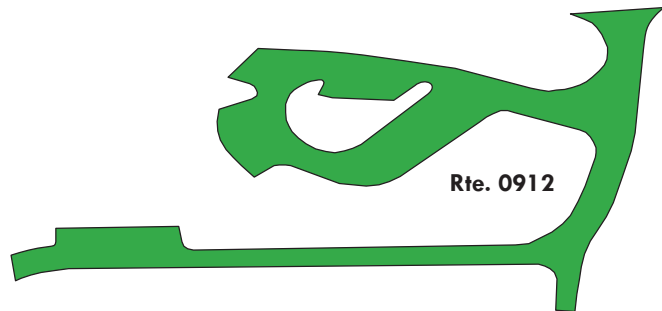
Inspection Date	FMSS Number	User Access	Surface Type
10/1/2018	24816	PUBLIC	ASPHALT
Area (Sq. Ft.)	Lane Miles (11' Widths)	Curb Reveal (Inches)	Curb Recommendation
27,018	0.465	NOT APPLICABLE	DO NOTHING
Curb Type		Curb & Gutter Type	
NO CURB		CONCRETE	
Pavement Recommendation		Condition Rating / PCR	
PREVENTIVE MAINTENANCE		GOOD / 90

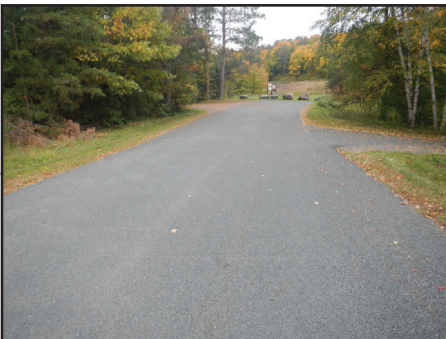
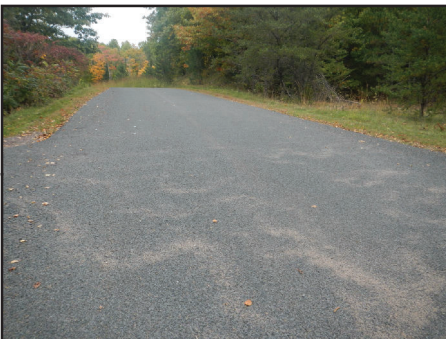
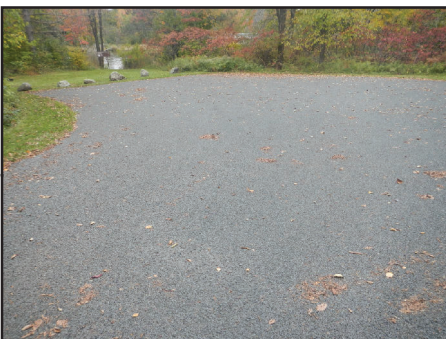
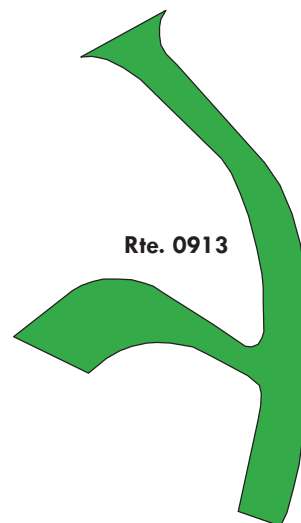
Inspection Date	FMSS Number	User Access	Surface Type
10/1/2018	88675	PUBLIC	ASPHALT
Area (Sq. Ft.)	Lane Miles (11' Widths)	Curb Reveal (Inches)	Curb Recommendation
12,979	0.223	NOT APPLICABLE	NOT APPLICABLE
Curb Type		Curb & Gutter Type	
NO CURB		NO CURB AND GUTTER	
Pavement Recommendation		Condition Rating / PCR	
PREVENTIVE MAINTENANCE		GOOD / 90
