SAGA Cycle 6

Final Report

Road Inventory and Condition Assessment for Saint-Gaudens National Historical Park

Report Date: September 2020

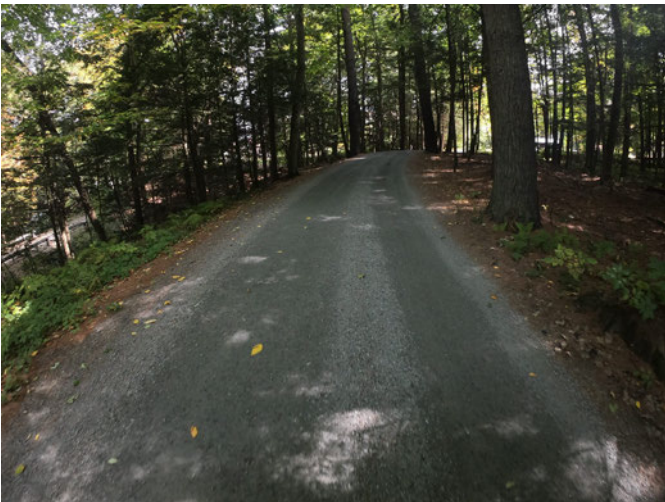
SAGA_0401_0.017_REPORT.jpg

Begin MP	End MP	Section Length	# of Lanes	Lane Width	Road Width	Treatment Recommendation	Treatment Cost	Unpaved Rating (Paser +)	Crown Severity	Drainage Severity	Rutting, Washboard Severity	Potholes / Loose Aggregate Severity
0.00	0.07	0.07	1	12.0	12.0	Routine Maintenance	\$700	4	Low	Med	Med	Med
Route Level Data:		0.07	1	12.0	12.00	Routine Maintenance	\$700	4	Low	Med	Med	Med

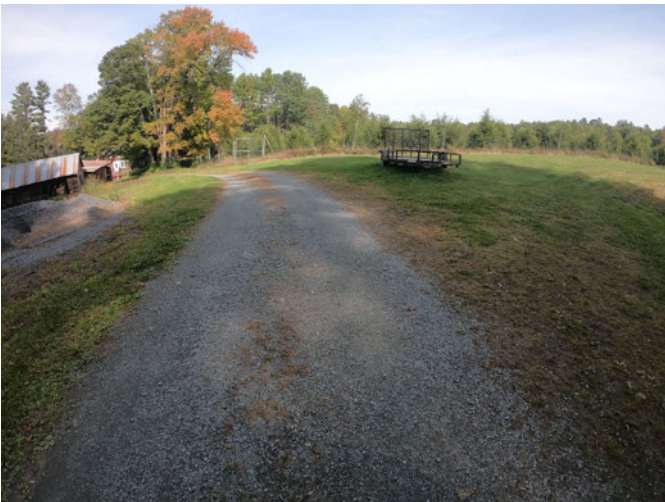
SAGA_0403_0.029_REPORT.jpg

Begin MP	End MP	Section Length	# of Lanes	Lane Width	Road Width	Treatment Recommendation	Treatment Cost	Unpaved Rating (Paser +)	Crown Severity	Drainage Severity	Rutting, Washboard Severity	Potholes / Loose Aggregate Severity
0.00	0.08	0.08	1	12.0	12.0	Heavy Rehabilitation	\$12,320	2	High	Med	High	Med
Route Level Data:		0.08	1	12.0	12.00	Heavy Rehabilitation	\$12,320	2	High	Med	High	Med

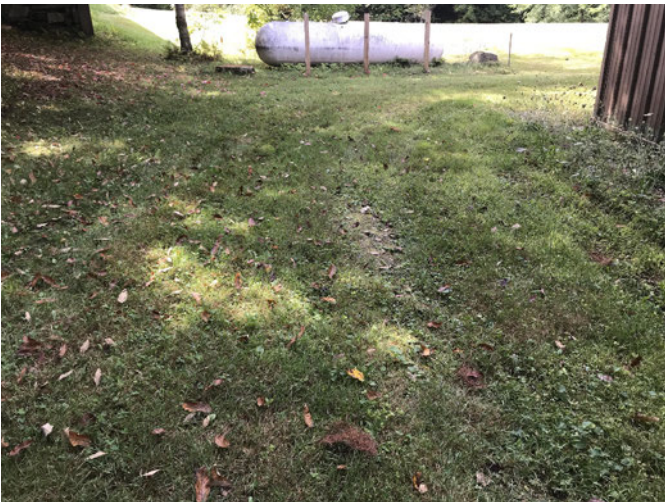
SAGA_0405_0.010_REPORT.jpg

Begin MP	End MP	Section Length	# of Lanes	Lane Width	Road Width	Treatment Recommendation	Treatment Cost	Unpaved Rating (Paser +)	Crown Severity	Drainage Severity	Rutting, Washboard Severity	Potholes / Loose Aggregate Severity
0.00	0.02	0.02	1	9.0	9.0	Routine Maintenance	\$34	3	Med	Med	Med	Low
Route Level Data:		0.02	1	9.0	9.00	Routine Maintenance	\$34	3	Med	Med	Med	Low

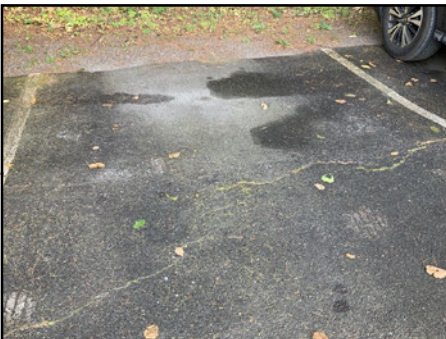
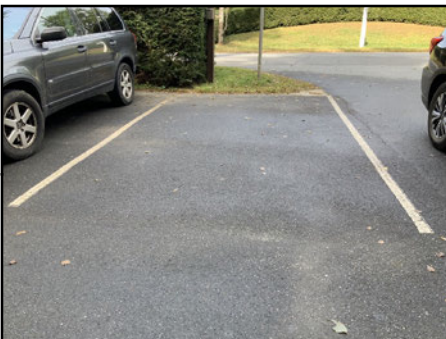
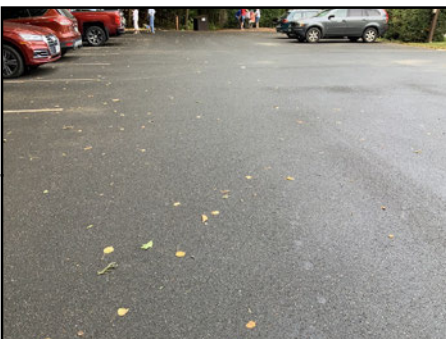
Inspection Date	FMSS Number	User Access	Surface Type
9/22/2019	102729	PUBLIC	ASPHALT
Area (Sq. Ft.)	Lane Miles (11' Widths)	Curb Reveal (Inches)	Curb Recommendation
4,318	0.074	NOT APPLICABLE	NOT APPLICABLE
Curb Type		Curb & Gutter Type	
NO CURB		NO CURB AND GUTTER	
Pavement Recommendation		Condition Rating / PCR	
LIGHT 3R TREATMENTS		FAIR / 73

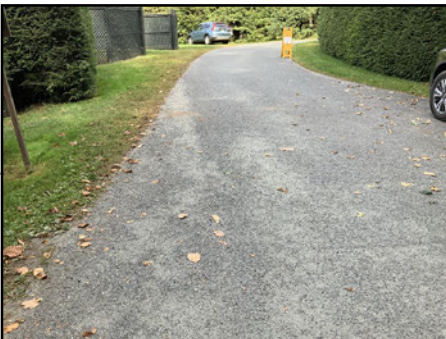
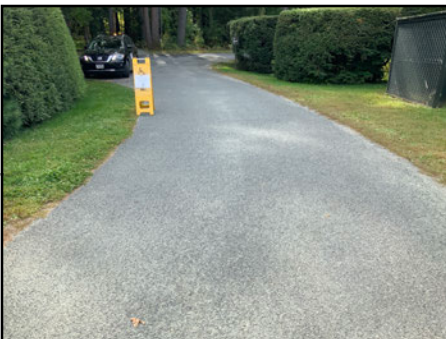
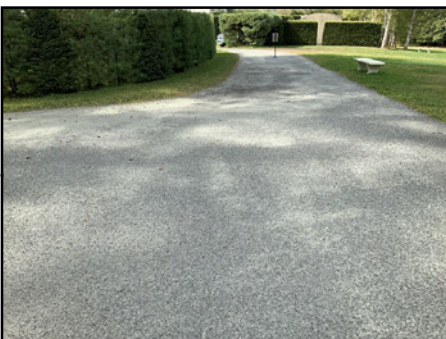
ROUTE 0901: VISITOR CENTER DRIVE PARKING

Inspection Date	FMSS Number	User Access	Surface Type
9/22/2019	102730	PUBLIC	ASPHALT
Area (Sq. Ft.)	Lane Miles (11' Widths)	Curb Reveal (Inches)	Curb Recommendation
5,134	0.088	NOT APPLICABLE	NOT APPLICABLE
Curb Type		Curb & Gutter Type	
NO CURB		NO CURB AND GUTTER	
Pavement Recommendation		Condition Rating / PCR	
HEAVY 3R TREATMENTS		POOR / 53

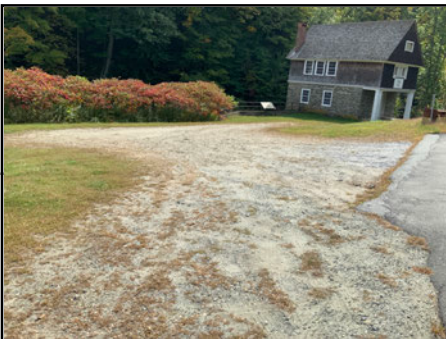
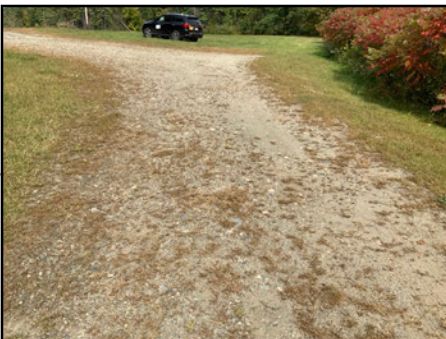
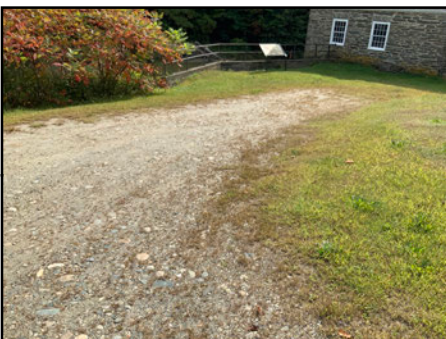
ROUTE 0902: MILL PARKING

Inspection Date	FMSS Number	User Access	Surface Type
9/22/2019	102732	PUBLIC	GRAVEL
Area (Sq. Ft.)	Lane Miles (11' Widths)	Curb Reveal (Inches)	Curb Recommendation
2,877	0.05	NOT APPLICABLE	NOT APPLICABLE
Curb Type		Curb & Gutter Type	
NO CURB		NO CURB AND GUTTER	
Treatment Recommendation		Condition Rating	
HEAVY REHABILITATION		2

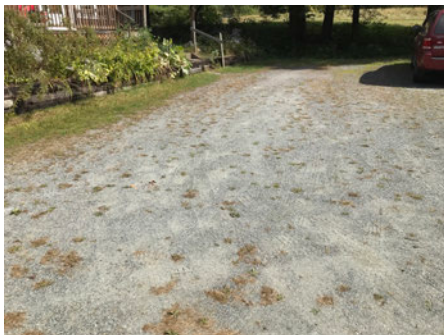
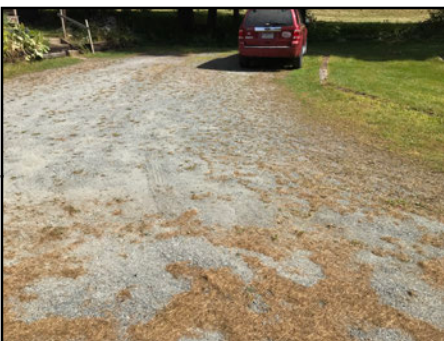
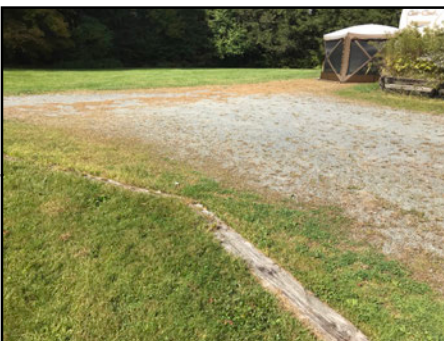
ROUTE 0903: QUARTERS PARKING AREA

Inspection Date	FMSS Number	User Access	Surface Type
9/22/2019	102733	NONPUBLIC	GRAVEL
Area (Sq. Ft.)	Lane Miles (11' Widths)	Curb Reveal (Inches)	Curb Recommendation
973	0.017	4	LIGHT REPAIR
Curb Type		Curb & Gutter Type	
WOOD		NO CURB AND GUTTER	
Treatment Recommendation		Condition Rating	
LIGHT REHABILITATION		3

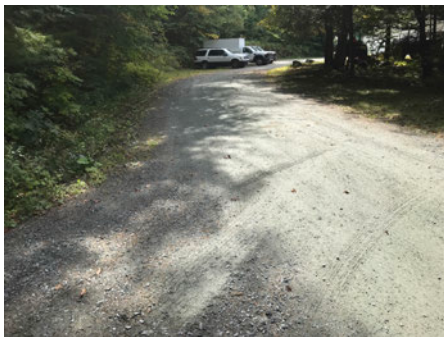
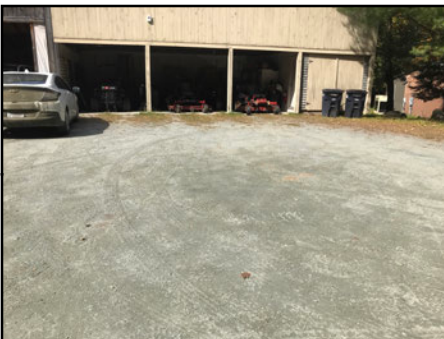
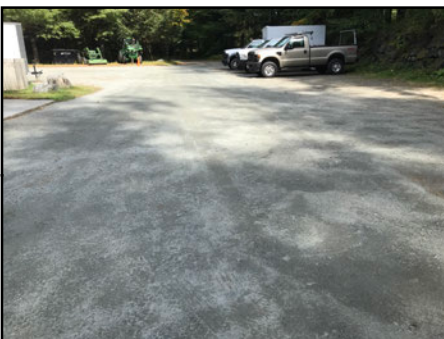
ROUTE 0905: MAINTENANCE AREA PARKING

Inspection Date	FMSS Number	User Access	Surface Type
9/22/2019	102735	NONPUBLIC	GRAVEL
Area (Sq. Ft.)	Lane Miles (11' Widths)	Curb Reveal (Inches)	Curb Recommendation
11,091	0.191	NOT APPLICABLE	NOT APPLICABLE
Curb Type		Curb & Gutter Type	
NO CURB		NO CURB AND GUTTER	
Treatment Recommendation		Condition Rating	
ROUTINE MAINTENANCE		4

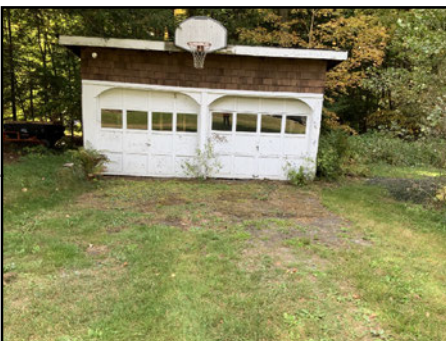
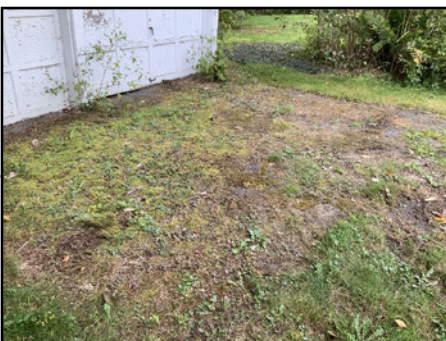
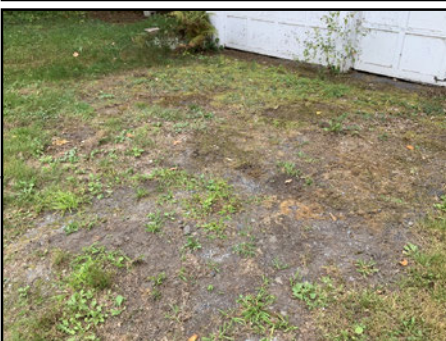
ROUTE 0906: QUARTERS GARAGE PARKING

Inspection Date	FMSS Number	User Access	Surface Type
9/22/2019	102736	NONPUBLIC	ASPHALT
Area (Sq. Ft.)	Lane Miles (11' Widths)	Curb Reveal (Inches)	Curb Recommendation
192	0.003	NOT APPLICABLE	NOT APPLICABLE
Curb Type		Curb & Gutter Type	
NO CURB		NO CURB AND GUTTER	
Pavement Recommendation		Condition Rating / PCR	
RECONSTRUCTION		POOR / 0

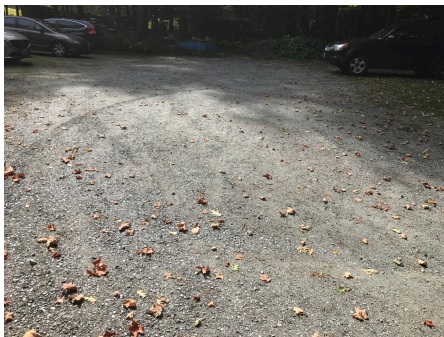
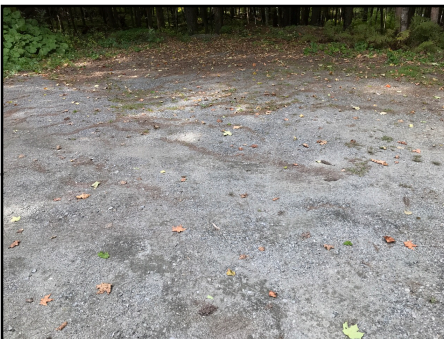
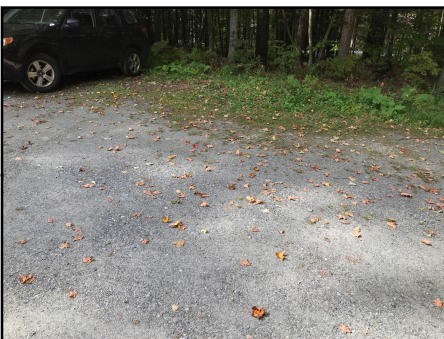
ROUTE 0907: EMPLOYEE PARKING

Inspection Date	FMSS Number	User Access	Surface Type
9/22/2019	102737	NONPUBLIC	GR
Area (Sq. Ft.)	Lane Miles (11' Widths)	Curb Reveal (Inches)	Curb Recommendation
2,063	0.036	NOT APPLICABLE	NOT APPLICABLE
Curb Type		Curb & Gutter Type	
NO CURB		NO CURB AND GUTTER	
Treatment Recommendation		Condition Rating	
ROUTINE MAINTENANCE		4

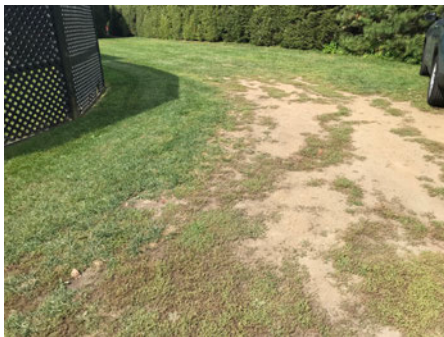
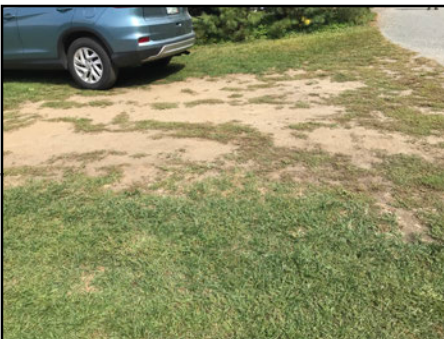
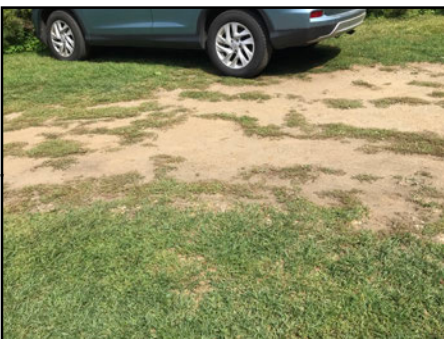
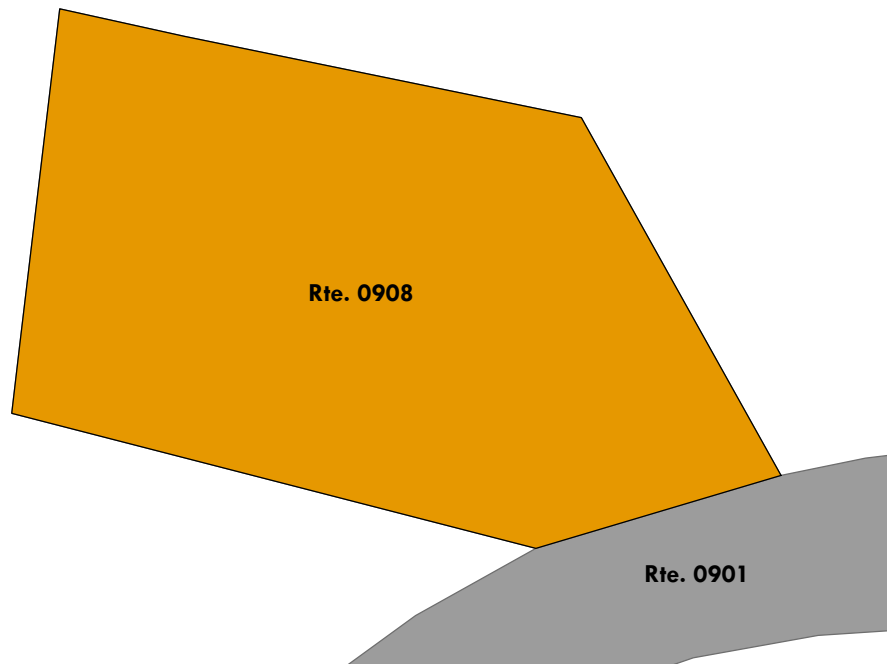
ROUTE 0909: DANCE HALL PARKING

Inspection Date	FMSS Number	User Access	Surface Type
9/22/2019	115589	PUBLIC	ASPHALT
Area (Sq. Ft.)	Lane Miles (11' Widths)	Curb Reveal (Inches)	Curb Recommendation
4,025	0.069	4	REPLACE
Curb Type		Curb & Gutter Type	
STONE AND WOOD		NO CURB AND GUTTER	
Pavement Recommendation		Condition Rating / PCR	
RECONSTRUCTION		POOR / 30

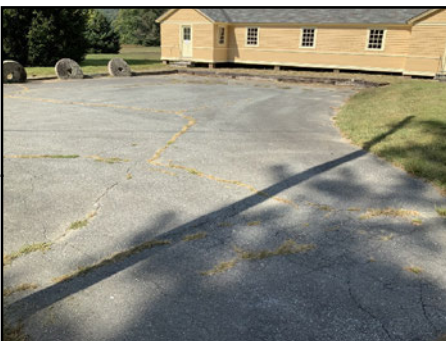
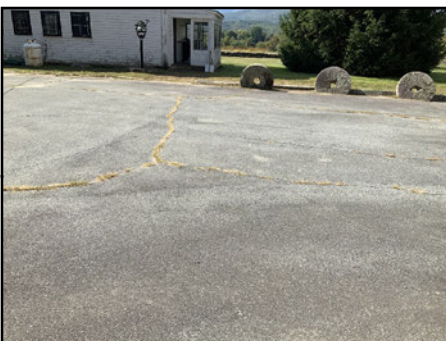
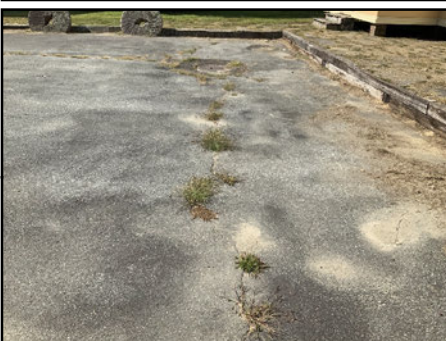
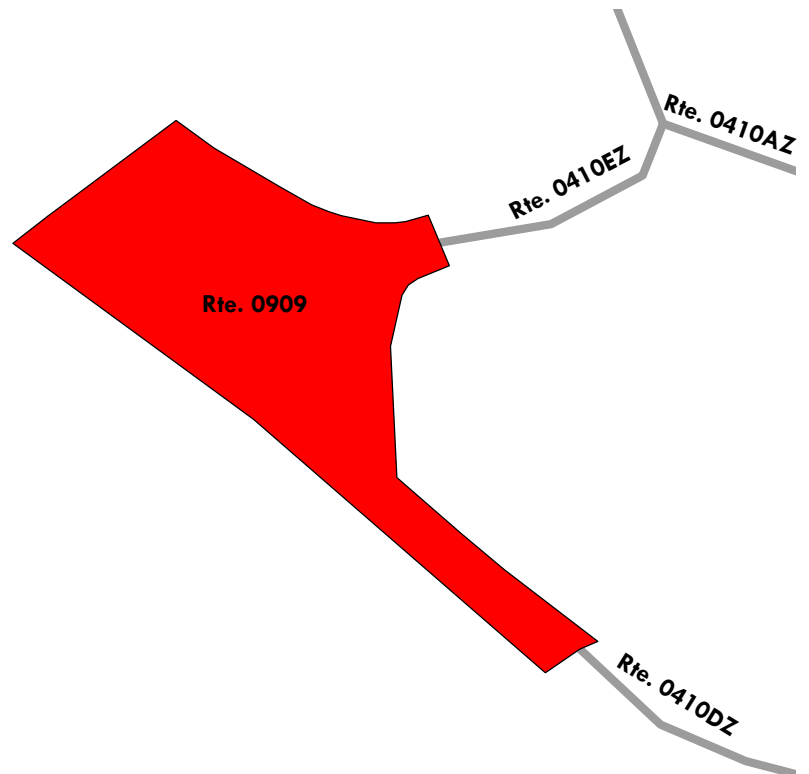
ROUTE 0910: COLLECTIONS STORAGE PARKING

Inspection Date	FMSS Number	User Access	Surface Type
9/22/2019	N/A	PUBLIC	ASPHALT
Area (Sq. Ft.)	Lane Miles (11' Widths)	Curb Reveal (Inches)	Curb Recommendation
2,775	0.048	NOT APPLICABLE	NOT APPLICABLE
Curb Type		Curb & Gutter Type	
NO CURB		NO CURB AND GUTTER	
Pavement Recommendation		Condition Rating / PCR	
PREVENTIVE MAINTENANCE		GOOD / 90

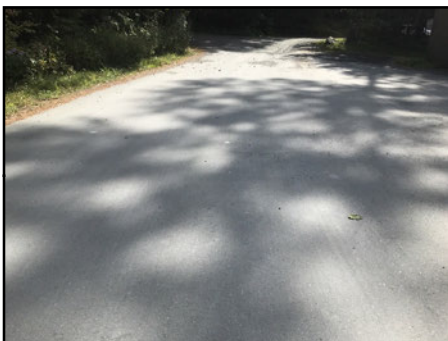
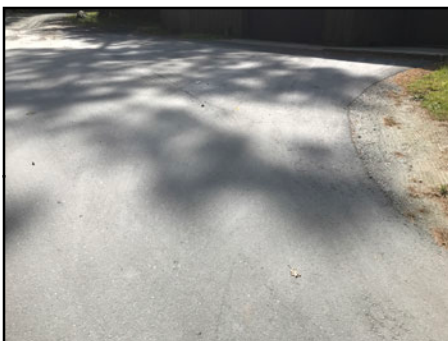
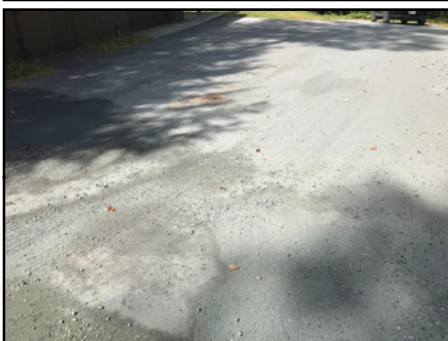
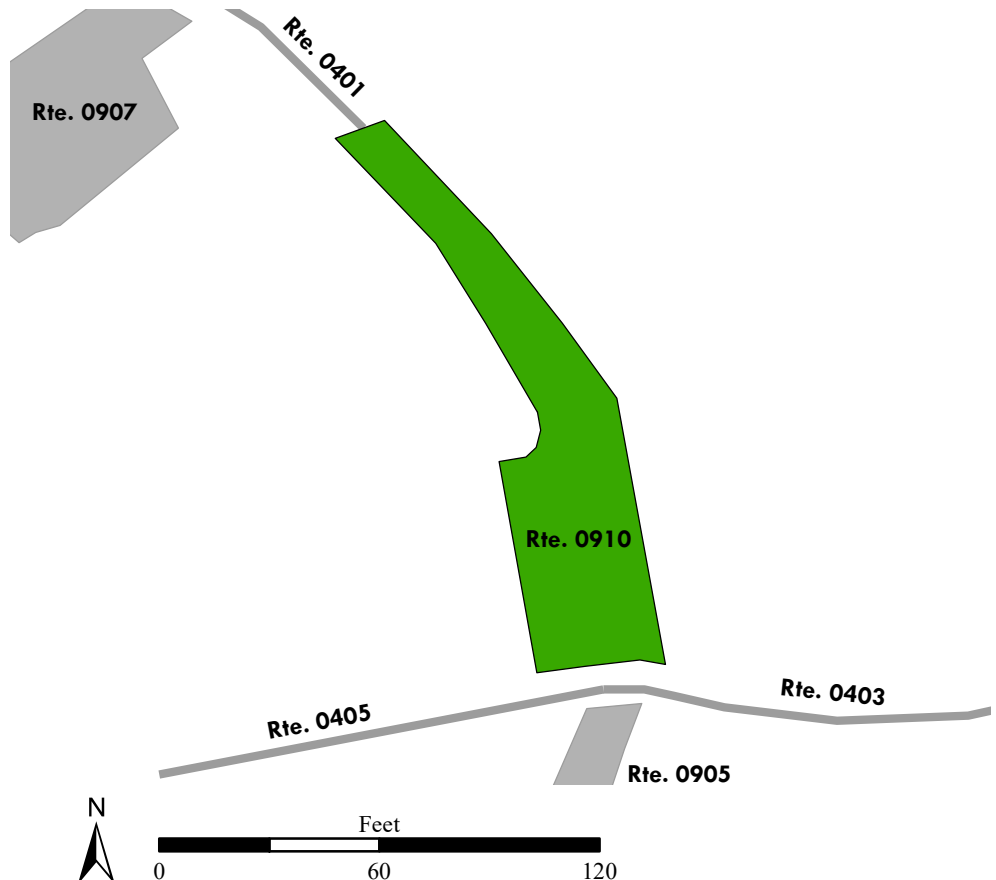
ROUTE 0912: OVERFLOW PARKING

Inspection Date	FMSS Number	User Access	Surface Type
9/22/2019	N/A	PUBLIC	NATIVE
Area (Sq. Ft.)	Lane Miles (11' Widths)	Curb Reveal (Inches)	Curb Recommendation
96,595	1.663	NOT APPLICABLE	NOT APPLICABLE
Curb Type		Curb & Gutter Type	
NO CURB		NO CURB AND GUTTER	
Treatment Recommendation		Condition Rating	
ROUTINE MAINTENANCE		3
