SAGU Cycle 6

Final Report

Road Inventory and Condition Assessment of Paved Routes Saguaro National Park

Report Date: May 2017

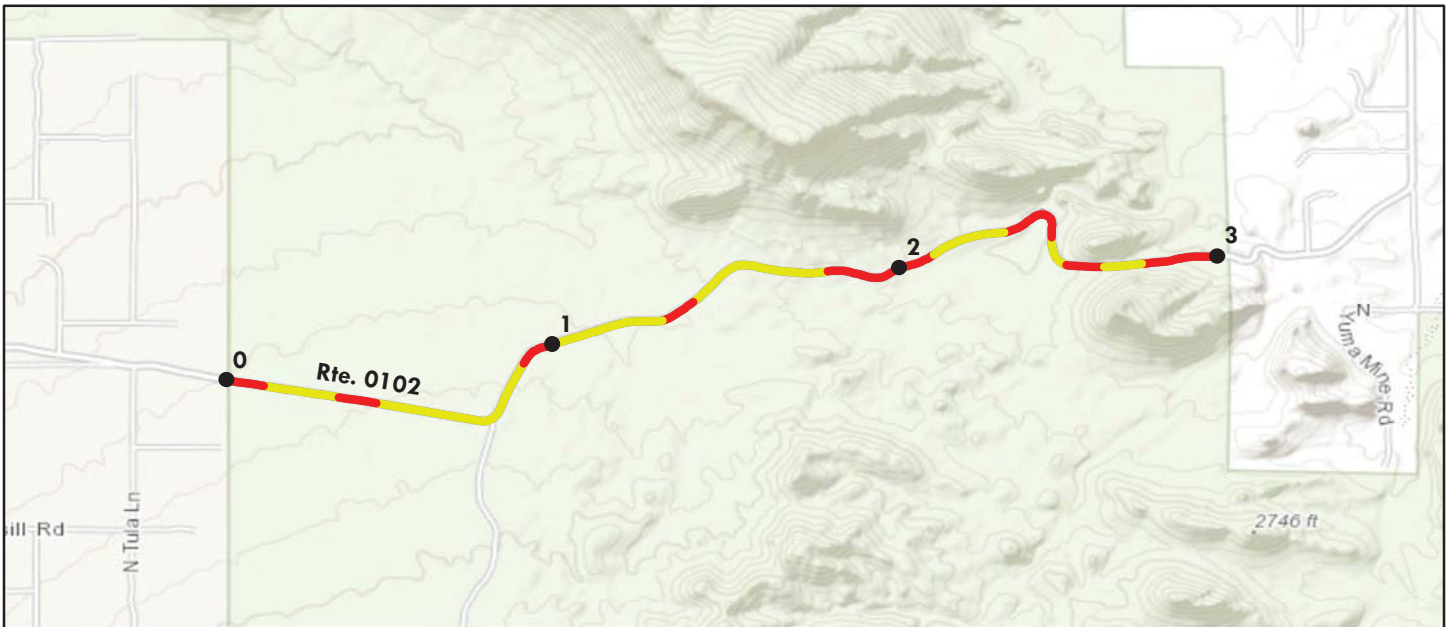
ROUTE 0102: PICTURE ROCKS ROAD

| Route Condition Legend – Pavement Condition Rating (PCR) | | | | | | |
|---|---|---|---|---|---|--|
| Pavement Condition Rating (PCR) | 56 | 63 | 61 | 46 | 37 | |
| Surface Condition Rating (SCR) | 52 | 63 | 60 | 34 | 49 | |
| Roughness Condition Index (RCI) | 63 | 63 | 63 | 65 | 20 | |

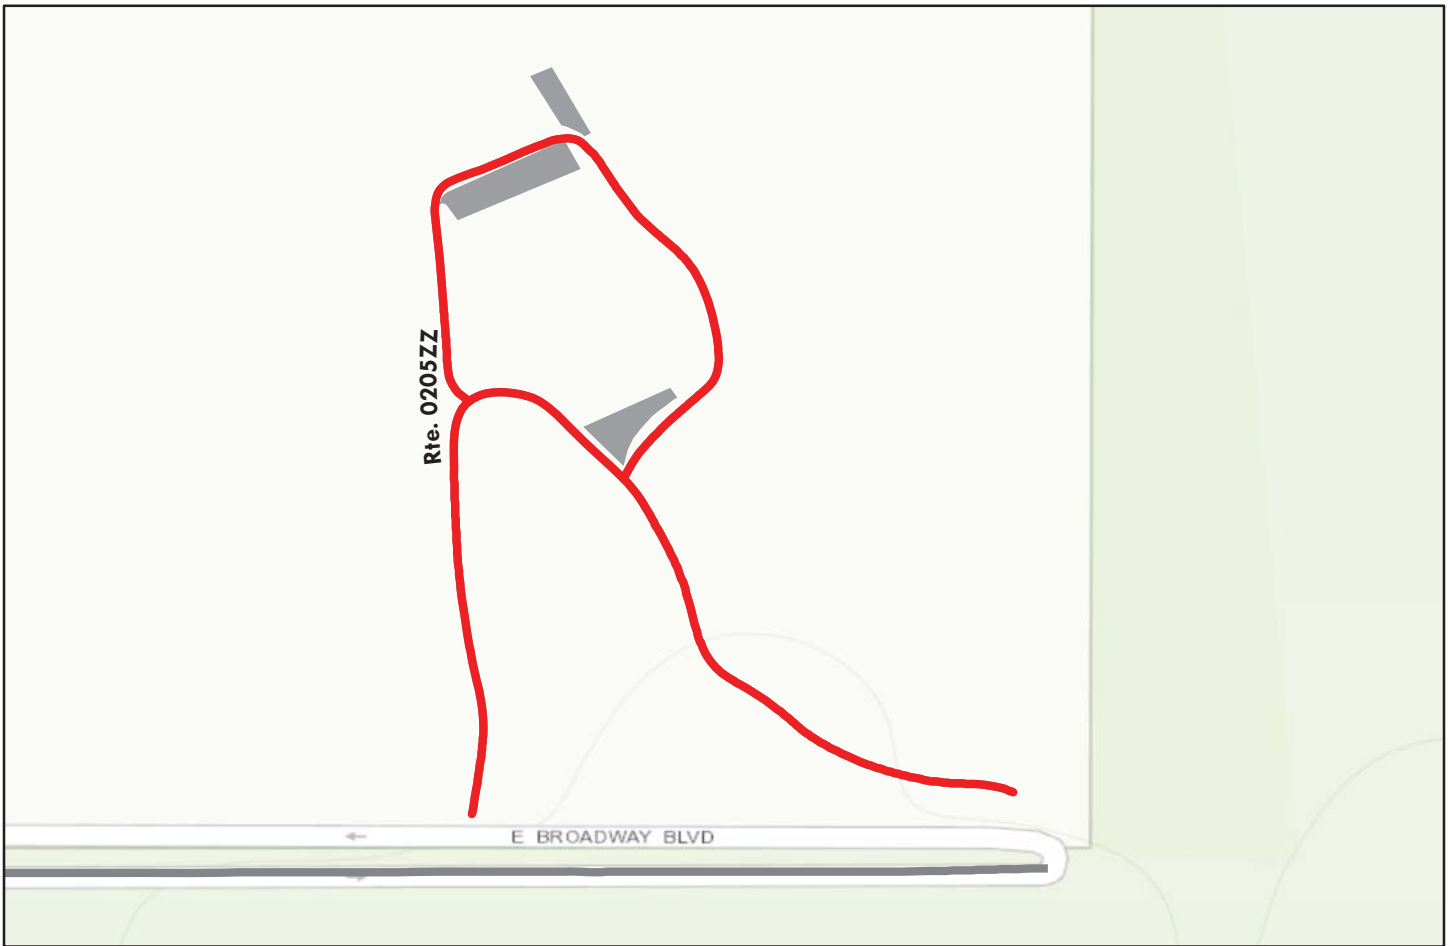
ROUTE 0205ZZ: RINCON MOUNTAIN FIRE / SODN KINGSTON ROAD

| Route Condition Legend – Pavement Condition Rating (PCR) | | | | | | |
|--|---|---|---|---|--|--|
| Pavement Condition Rating (PCR) | 0 | | | | | |

Badly degraded Asphalt.

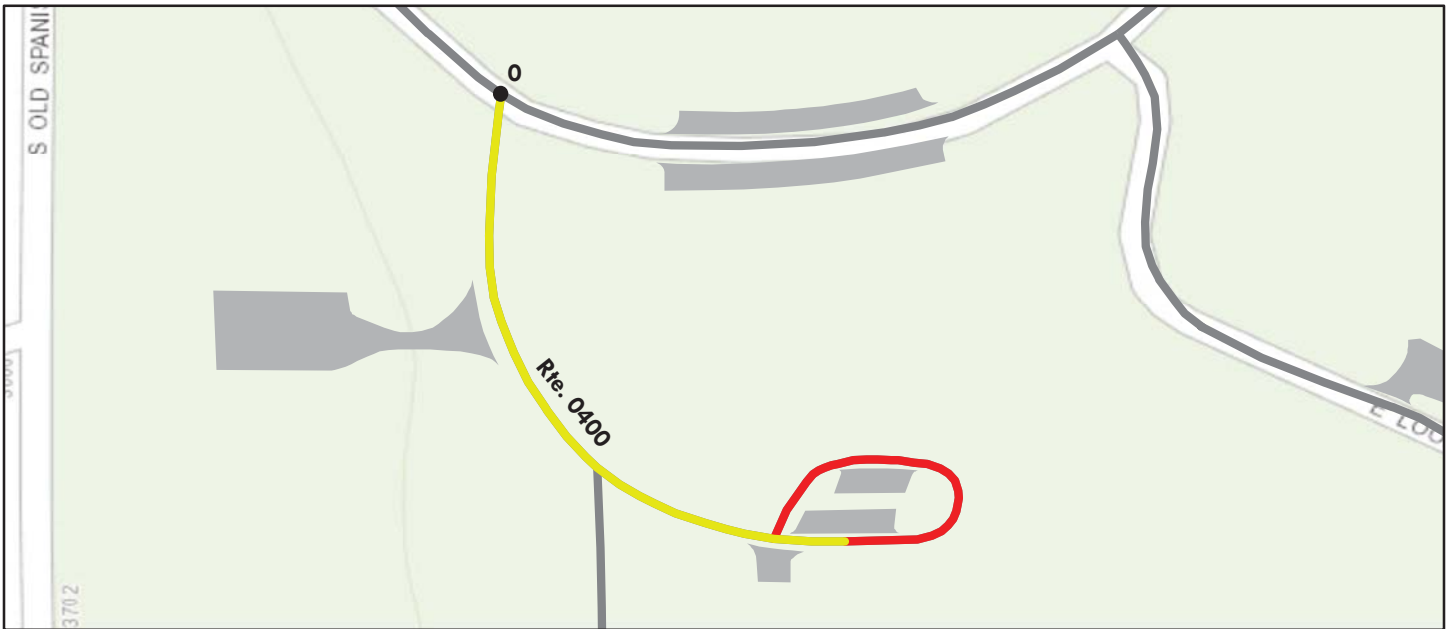
ROUTE 0400: HEADQUARTERS ACCESS ROAD

| Route Condition Legend – Pavement Condition Rating (PCR) | | | | | | |
|---|---|---|---|---|--|--|
| Pavement Condition Rating (PCR) | 64 | 64 | | | | |
| Transverse Cracking Index | 64 | 64 | | | | |

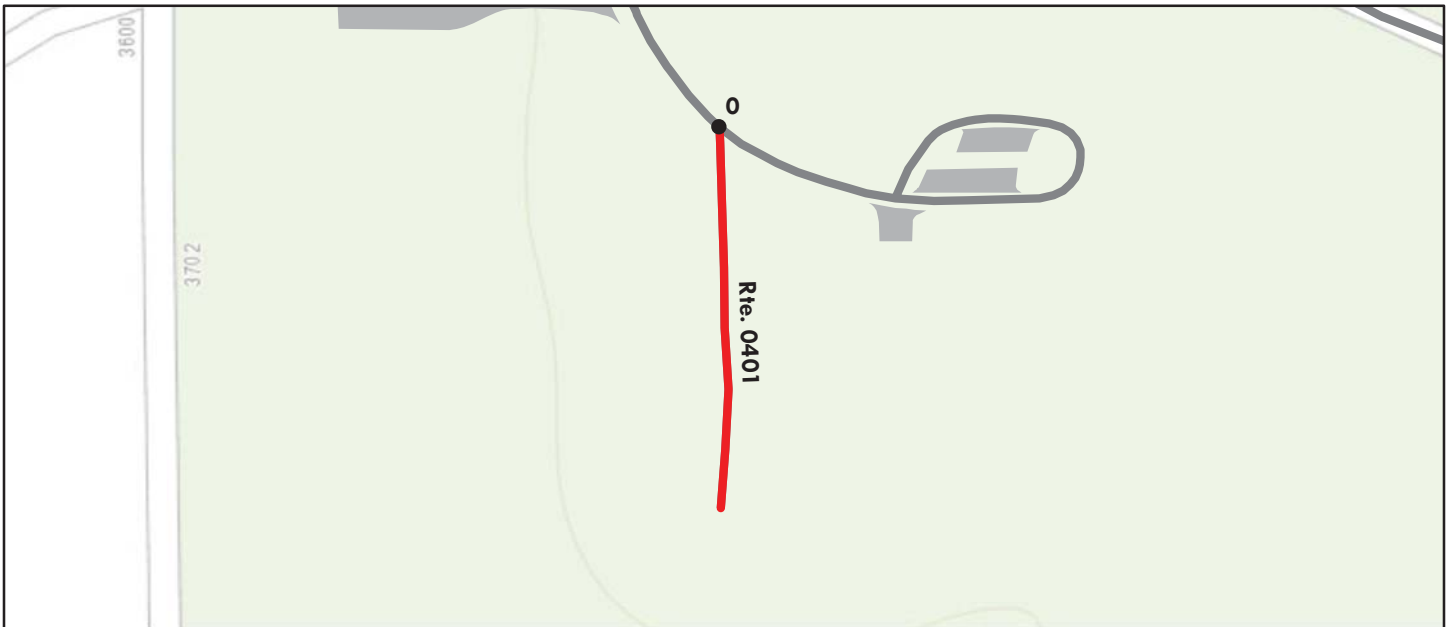
ROUTE 0401: RESIDENCE ROAD (PAVED)

| Route Condition Legend – Pavement Condition Rating (PCR) | | | | | | |
|---|---|---|---|---|--|--|
| Pavement Condition Rating (PCR) | 60 | 60 | | | | |
| Surface Condition Rating (SCR) | 60 | 60 | | | | |

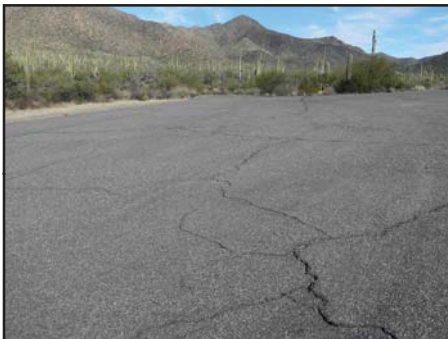
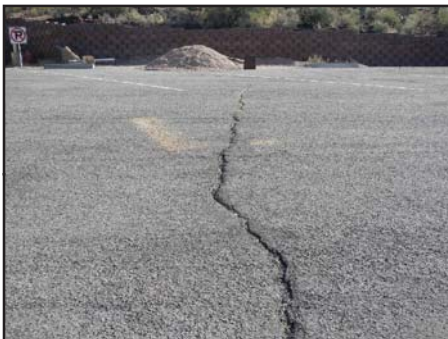
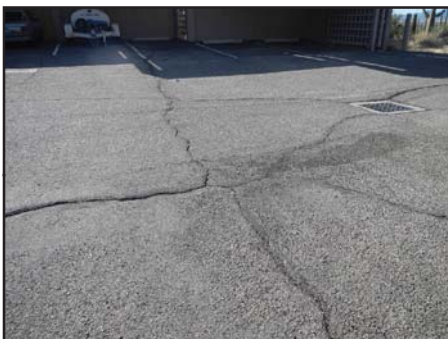
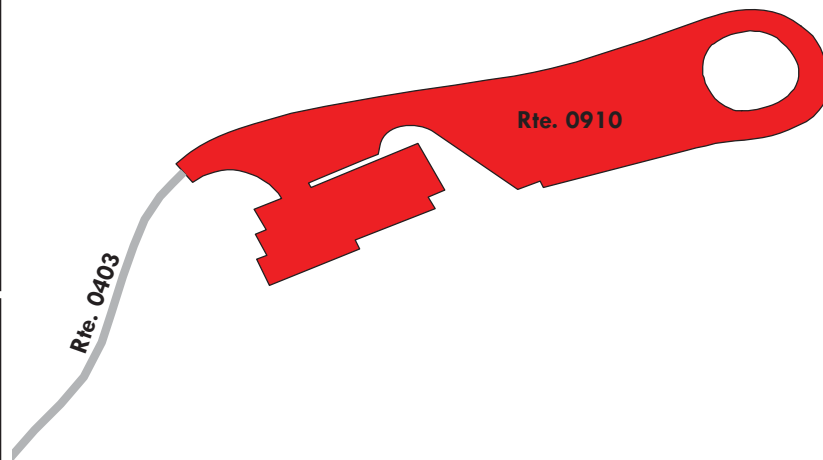
ROUTE 0911: RED HILLS VISITOR CENTER PARKING

Parking area consists of multiple surface types: 1 part Asphalt at 30,714 square feet; 1 part Concrete at 630 square feet.

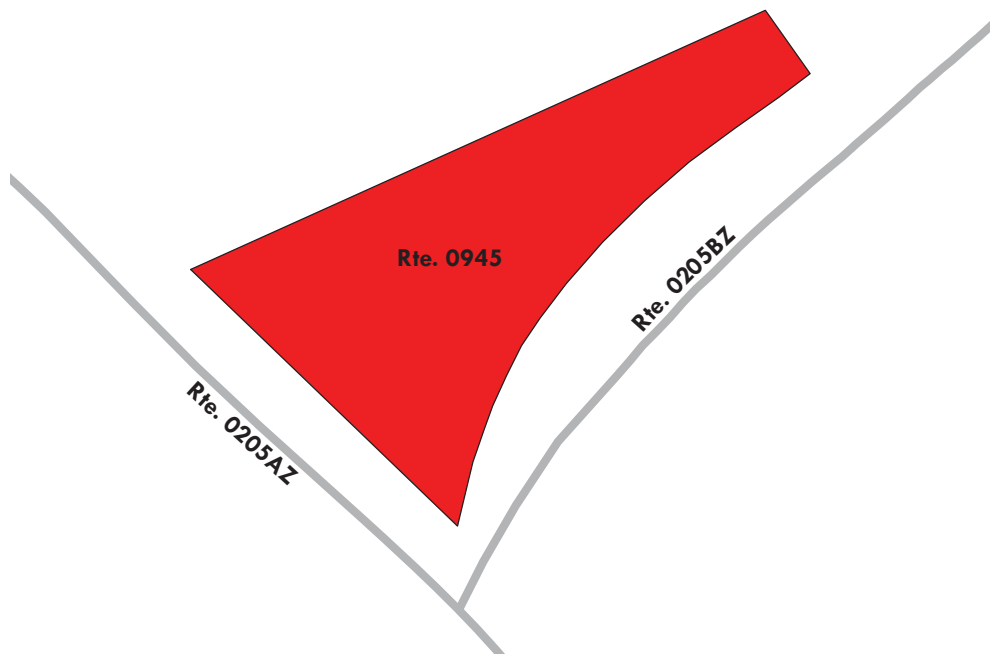
Asphalt has deteriorated to the point where only traces remain. Parking area appears to be mostly unpaved.
