Final Report

Road Inventory and Condition Assessment of Paved Routes Sagamore Hill National Historic Site

**Federal Lands Highway
Road Inventory Program**

Report Date: January 2022

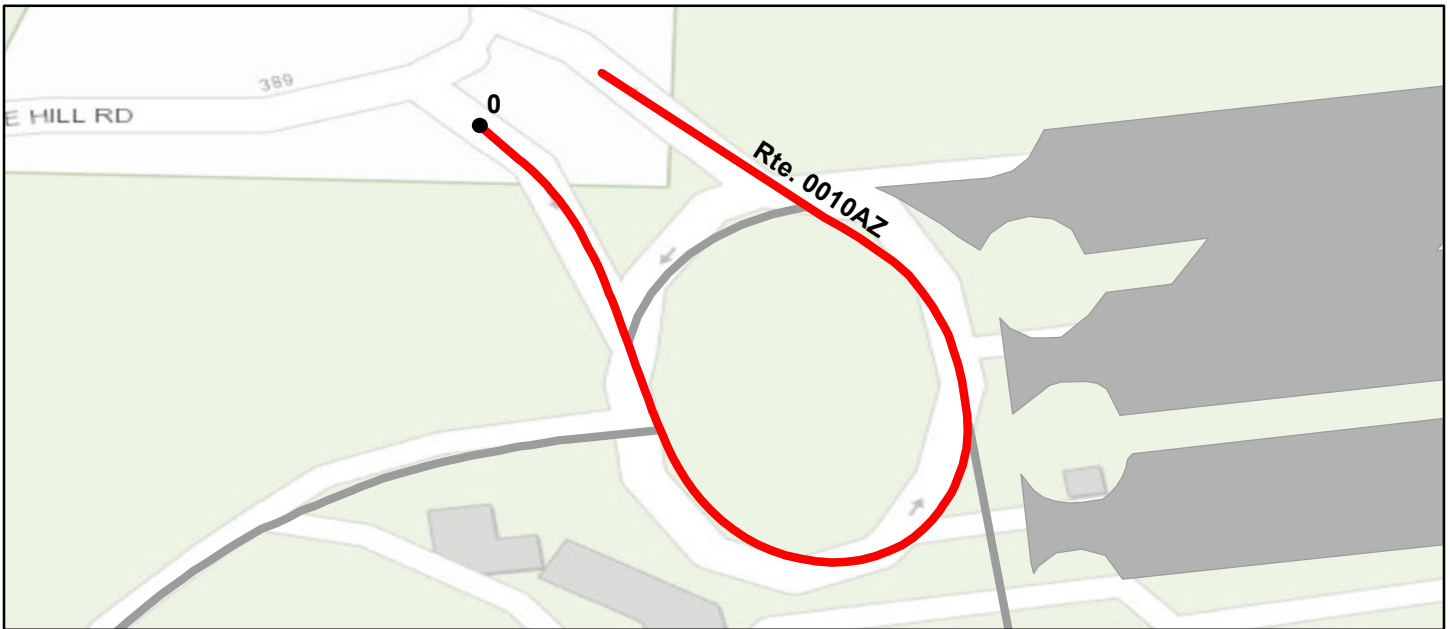
Subcomponent of Route SAHI-0010ZZ

Inspection Date: 4/24/2021	Beginning Section MP	0				
Paved Length (Miles): 0.1	Section Length (MI)	0.1				
Surface Type: ASPHALT	Route Summary					
Roadway Condition Information						
Pavement Condition Rating (PCR)	42	42				
Surface Condition Rating (SCR)	42	42				
Roughness Condition Index (RCI)	N/A	N/A				
Distress Index Values						
Structural Crack Index	60	60				
Alligator Crack Index	100	100				
Longitudinal Crack Index	60	60				
Transverse Cracking Index	42	42				
Patching Index	100	100				
Rutting Index	96	96				
International Roughness Index (IRI)	N/A	N/A				
Lane & Width Information						
Number of Lanes	1	1				
Paved Width (ft)	19.8	19.8				
Lane Width (ft)	19.8	19.8

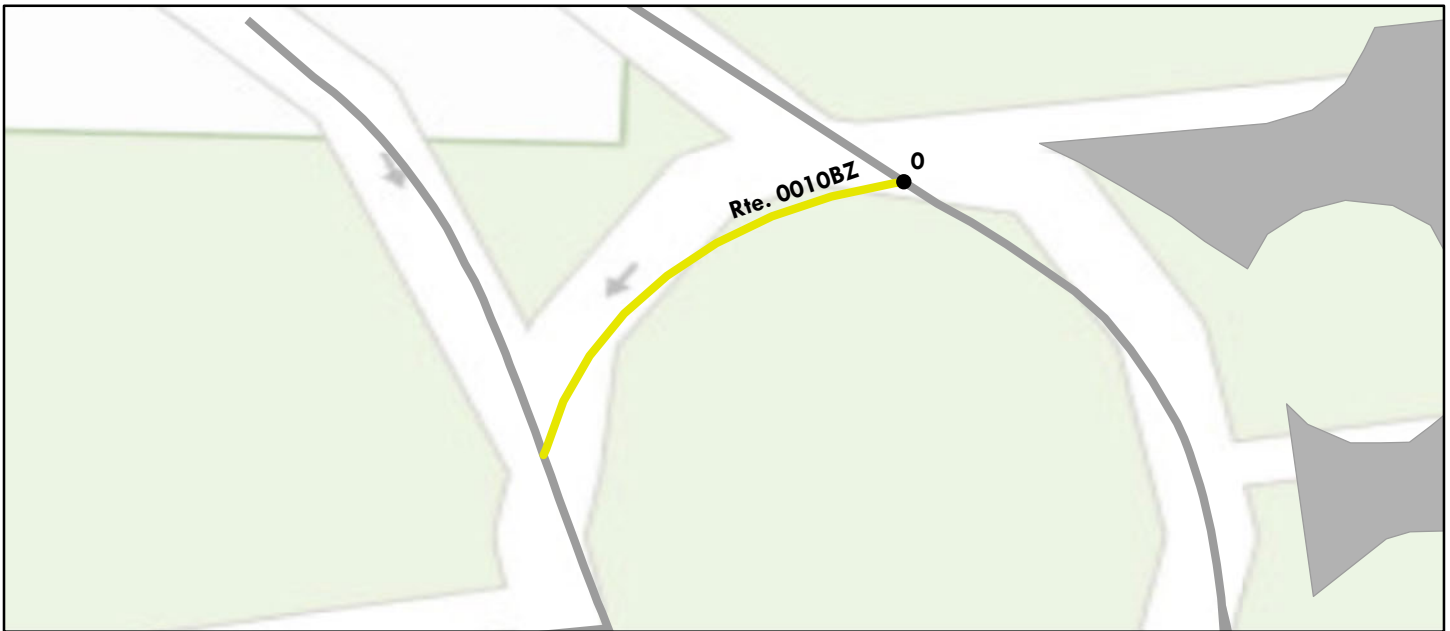
Subcomponent of Route SAHI-0010ZZ

Route Condition Legend – Pavement Condition Rating (PCR)						
Poor (0 - 60)	Fair (61- 84)	Good (85 - 94)	Excellent (95 - 100)	Not Rated		
See Appendix for definitions and formulas						
Inspection Date: 3/2/2021	Beginning Section MP	0.00				
Paved Length (Miles): 0.02	Section Length (MI)	0.02				
Surface Type: ASPHALT	Route Summary					
Roadway Condition Information						
Pavement Condition Rating (PCR)	82	82				
Surface Condition Rating (SCR)	82	82				
Roughness Condition Index (RCI)	N/A	N/A				
Distress Index Values						
Structural Crack Index	83	83				
Alligator Crack Index	100	100				
Longitudinal Crack Index	83	83				
Transverse Cracking Index	82	82				
Patching Index	100	100				
Rutting Index	100	100				
International Roughness Index (IRI)	N/A	N/A				
Lane & Width Information						
Number of Lanes	2	2				
Paved Width (ft)	17	17				
Lane Width (ft)	8.5	8.5

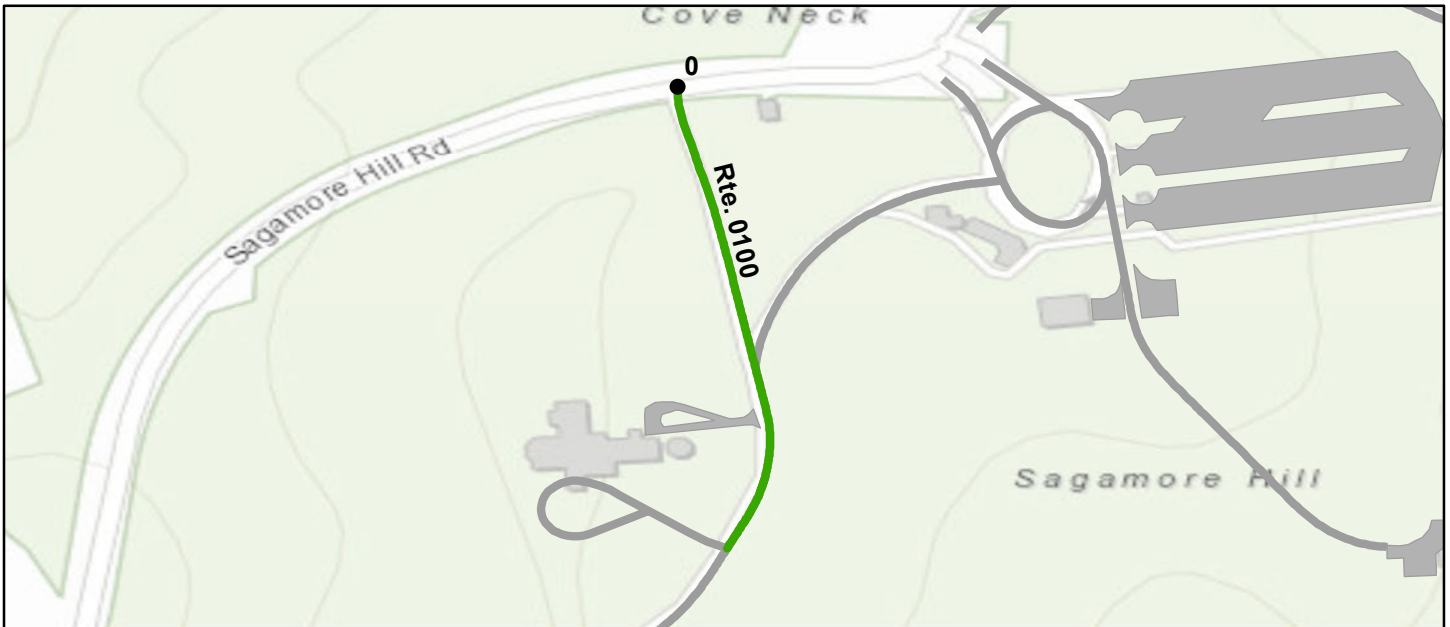
ROUTE 0100: THEODORE ROOSEVELT HOUSE ROAD

Inspection Date: 4/24/2021	Beginning Section MP	0				
Paved Length (Miles): 0.12	Section Length (MI)	0.12				
Surface Type: ASPHALT	Route Summary					
Roadway Condition Information						
Pavement Condition Rating (PCR)	89	89				
Surface Condition Rating (SCR)	89	89				
Roughness Condition Index (RCI)	N/A	N/A				
Distress Index Values						
Structural Crack Index	95	95				
Alligator Crack Index	100	100				
Longitudinal Crack Index	95	95				
Transverse Cracking Index	89	89				
Patching Index	100	100				
Rutting Index	100	100				
International Roughness Index (IRI)	N/A	N/A				
Lane & Width Information						
Number of Lanes	1	1				
Paved Width (ft)	12.8	12.8				
Lane Width (ft)	12.8	12.8

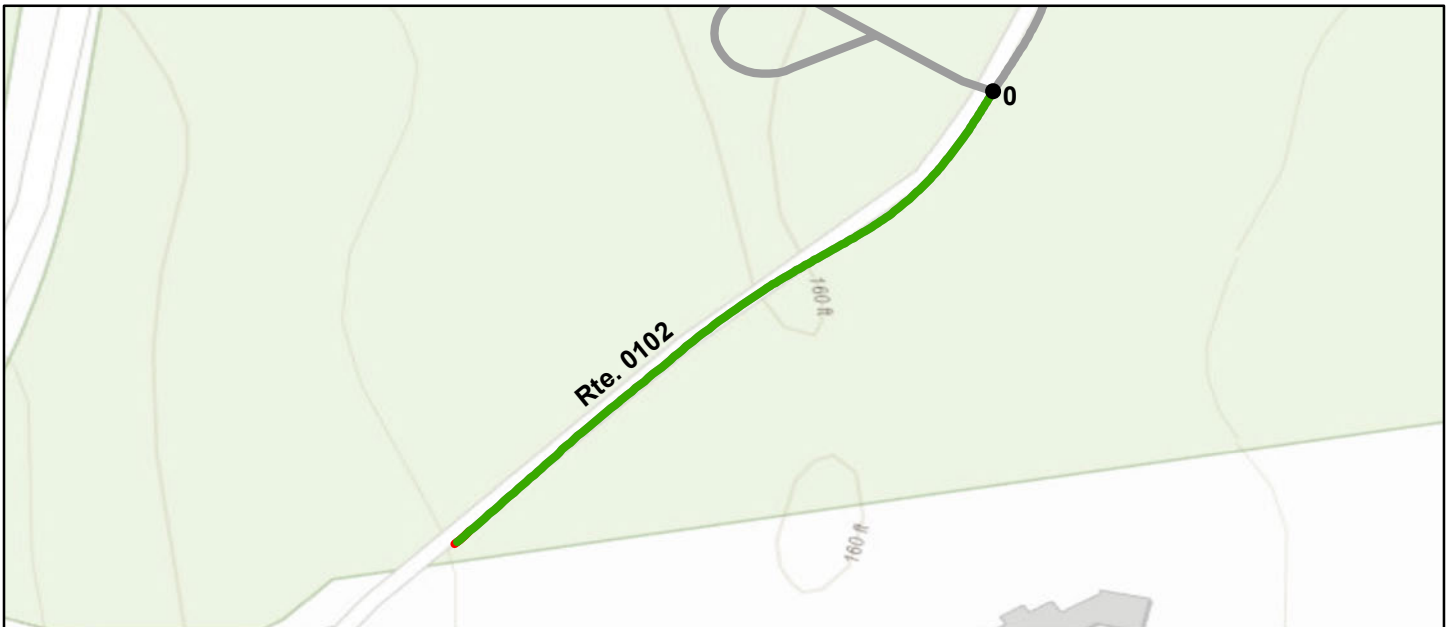
ROUTE 0102: OLD HISTORIC ROAD

Inspection Date: 4/24/2021	Beginning Section MP	0				
Paved Length (Miles): 0.1	Section Length (MI)	0.1				
Surface Type: ASPHALT	Route Summary					
Roadway Condition Information						
Pavement Condition Rating (PCR)	86	86				
Surface Condition Rating (SCR)	86	86				
Roughness Condition Index (RCI)	N/A	N/A				
Distress Index Values						
Structural Crack Index	94	94				
Alligator Crack Index	100	100				
Longitudinal Crack Index	94	94				
Transverse Cracking Index	86	86				
Patching Index	100	100				
Rutting Index	100	100				
International Roughness Index (IRI)	N/A	N/A				
Lane & Width Information						
Number of Lanes	1	1				
Paved Width (ft)	13.6	13.6				
Lane Width (ft)	13.6	13.6

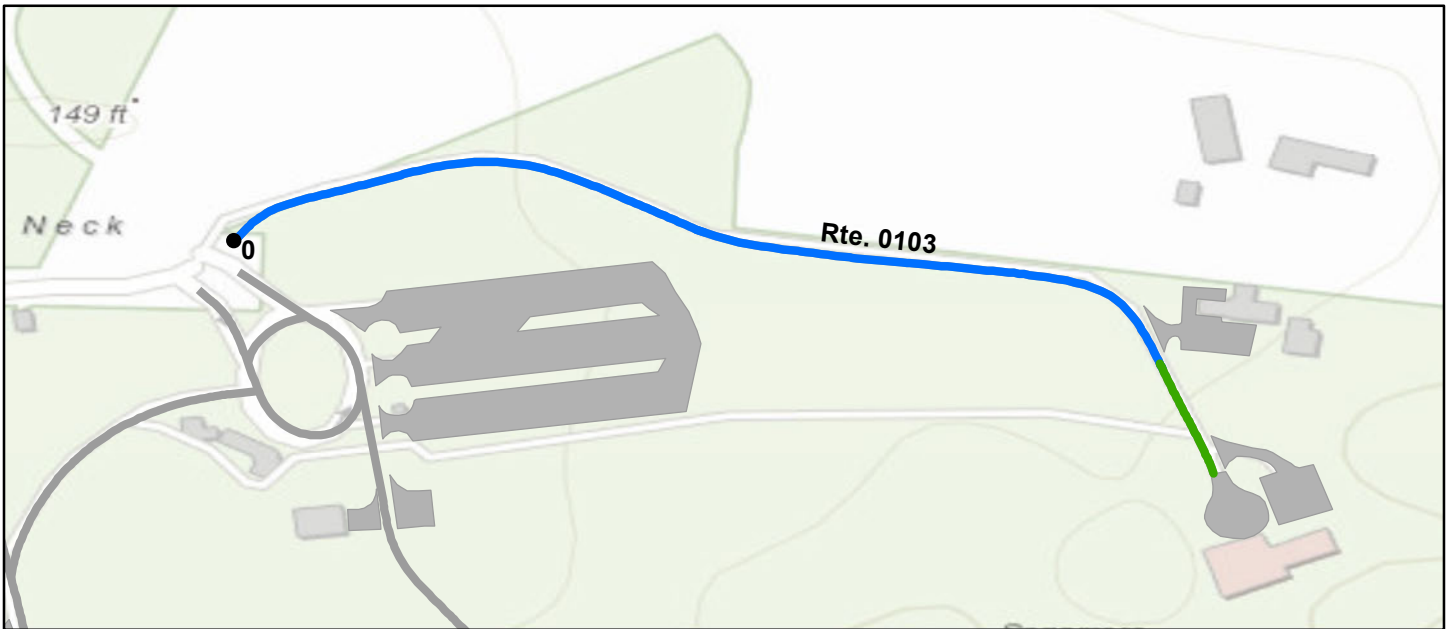
ROUTE 0103: ACCESS ROAD TO OLD ORCHARD MUSEUM

Route Condition Legend – Pavement Condition Rating (PCR)						
Poor (0 - 60)	Fair (61- 84)	Good (85 - 94)	Excellent (95 - 100)	Not Rated		
Colors on map represent condition scores at 0.10-mile intervals. See Appendix for definitions and formulas.						
Inspection Date:	4/24/2021	Beginning Section MP	0			
Paved Length (Miles):	0.23	Section Length (MI)	0.23			
Surface Type:	ASPHALT	Route Summary				
Roadway Condition Information						
Pavement Condition Rating (PCR)	95	95				
Surface Condition Rating (SCR)	95	95				
Roughness Condition Index (RCI)	N/A	N/A				
Distress Index Values						
Structural Crack Index	99	99				
Alligator Crack Index	100	100				
Longitudinal Crack Index	99	99				
Transverse Cracking Index	95	95				
Patching Index	100	100				
Rutting Index	100	100				
International Roughness Index (IRI)	N/A	N/A				
Lane & Width Information						
Number of Lanes	1	1				
Paved Width (ft)	13.5	13.5				
Lane Width (ft)	13.5	13.5

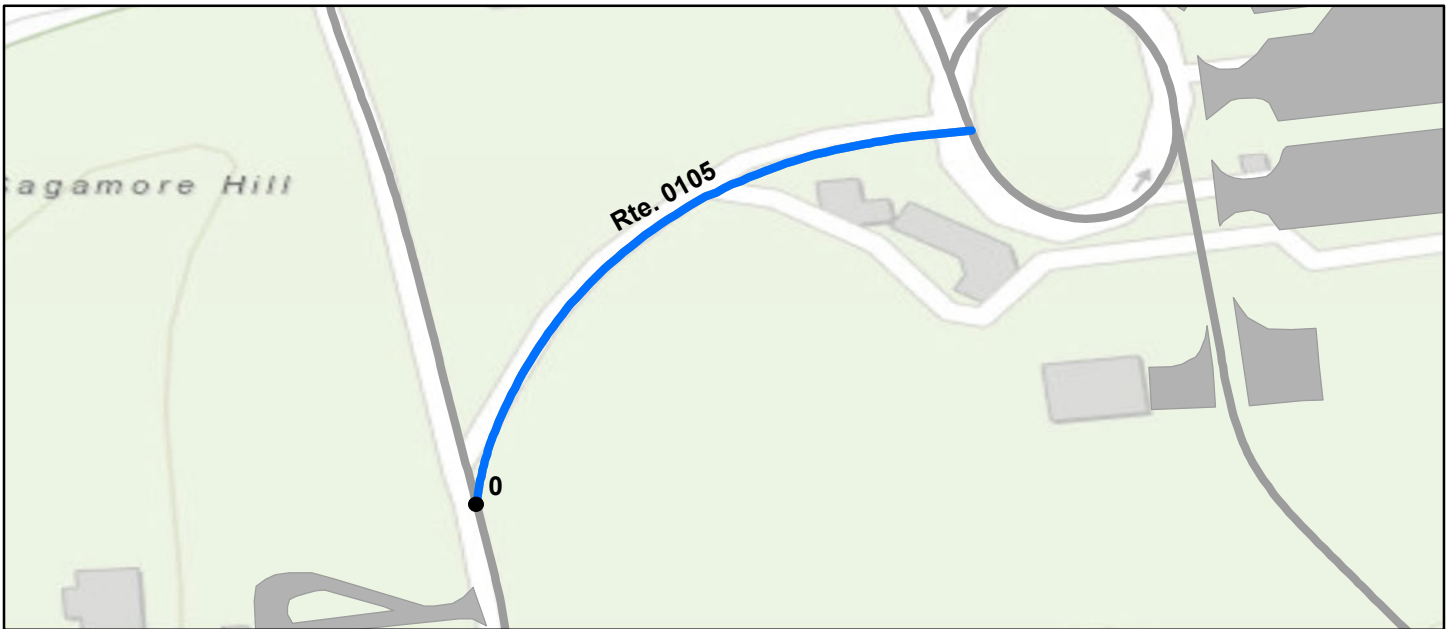
ROUTE 0105: SPUR TO THEODORE ROOSEVELT HOUSE ROAD

Route Condition Legend – Pavement Condition Rating (PCR)						
Poor (0 - 60)	Fair (61- 84)	Good (85 - 94)	Excellent (95 - 100)	Not Rated		
Colors on map represent condition scores at 0.10-mile intervals. See Appendix for definitions and formulas.						
Inspection Date: 4/24/2021	Beginning Section MP	0				
Paved Length (Miles): 0.07	Section Length (MI)	0.07				
Surface Type: ASPHALT	Route Summary					
Roadway Condition Information						
Pavement Condition Rating (PCR)	96	96				
Surface Condition Rating (SCR)	96	96				
Roughness Condition Index (RCI)	N/A	N/A				
Distress Index Values						
Structural Crack Index	100	100				
Alligator Crack Index	100	100				
Longitudinal Crack Index	100	100				
Transverse Cracking Index	99	99				
Patching Index	100	100				
Rutting Index	96	96				
International Roughness Index (IRI)	N/A	N/A				
Lane & Width Information						
Number of Lanes	1	1				
Paved Width (ft)	12.7	12.7

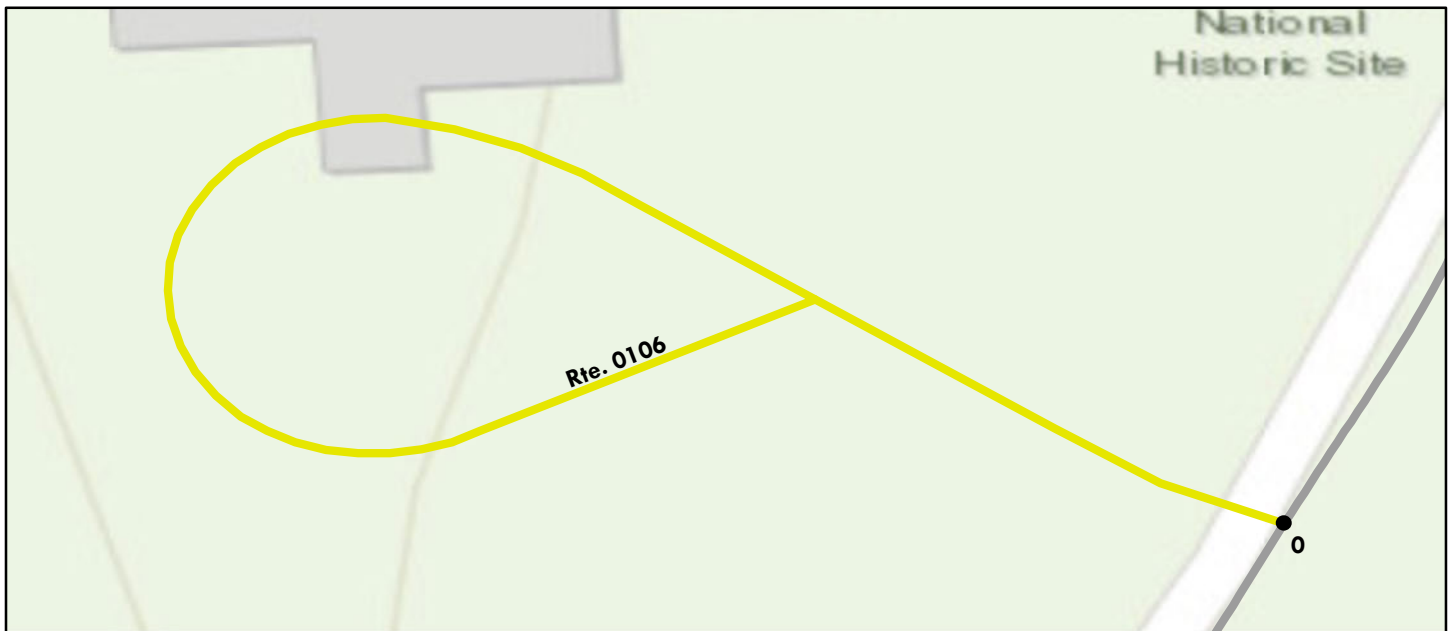
ROUTE 0106: HOUSE ENTRANCE ROAD

Route Condition Legend – Pavement Condition Rating (PCR)						
Poor (0 - 60)	Fair (61- 84)	Good (85 - 94)	Excellent (95 - 100)	Not Rated		
See Appendix for definitions and formulas						
Inspection Date: 3/2/2021	Beginning Section MP	0.00				
Paved Length (Miles): 0.07	Section Length (MI)	0.07				
Surface Type: ASPHALT	Route Summary					
Roadway Condition Information						
Pavement Condition Rating (PCR)	78	78				
Surface Condition Rating (SCR)	78	78				
Roughness Condition Index (RCI)	N/A	N/A				
Distress Index Values						
Structural Crack Index	78	78				
Alligator Crack Index	85	85				
Longitudinal Crack Index	93	93				
Transverse Cracking Index	98	98				
Patching Index	99	99				
Rutting Index	100	100				
International Roughness Index (IRI)	N/A	N/A				
Lane & Width Information						
Number of Lanes	2	2				
Paved Width (ft)	24	24				
Lane Width (ft)	12	12

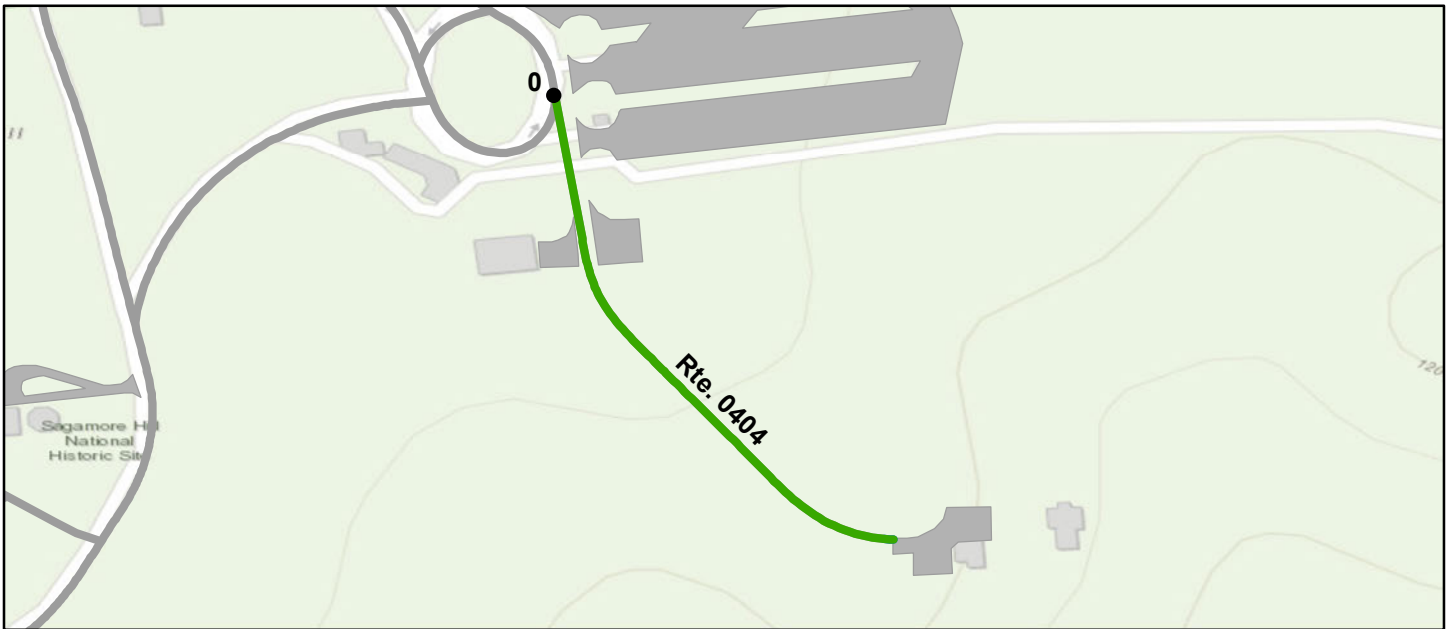
ROUTE 0404: GRAY COTTAGE ACCESS ROAD

Route Condition Legend – Pavement Condition Rating (PCR)						
Poor (0 - 60)	Fair (61- 84)	Good (85 - 94)	Excellent (95 - 100)	Not Rated		
Colors on map represent condition scores at 0.10-mile intervals. See Appendix for definitions and formulas.						
Inspection Date: 4/24/2021	Beginning Section MP	0				
Paved Length (Miles): 0.1	Section Length (MI)	0.1				
Surface Type: ASPHALT	Route Summary					
Roadway Condition Information						
Pavement Condition Rating (PCR)	92	92				
Surface Condition Rating (SCR)	92	92				
Roughness Condition Index (RCI)	N/A	N/A				
Distress Index Values						
Structural Crack Index	92	92				
Alligator Crack Index	100	100				
Longitudinal Crack Index	92	92				
Transverse Cracking Index	93	93				
Patching Index	100	100				
Rutting Index	98	98				
International Roughness Index (IRI)	N/A	N/A				
Lane & Width Information						
Number of Lanes	1	1				
Paved Width (ft)	10.5	10.5				
Lane Width (ft)	10.5	10.5

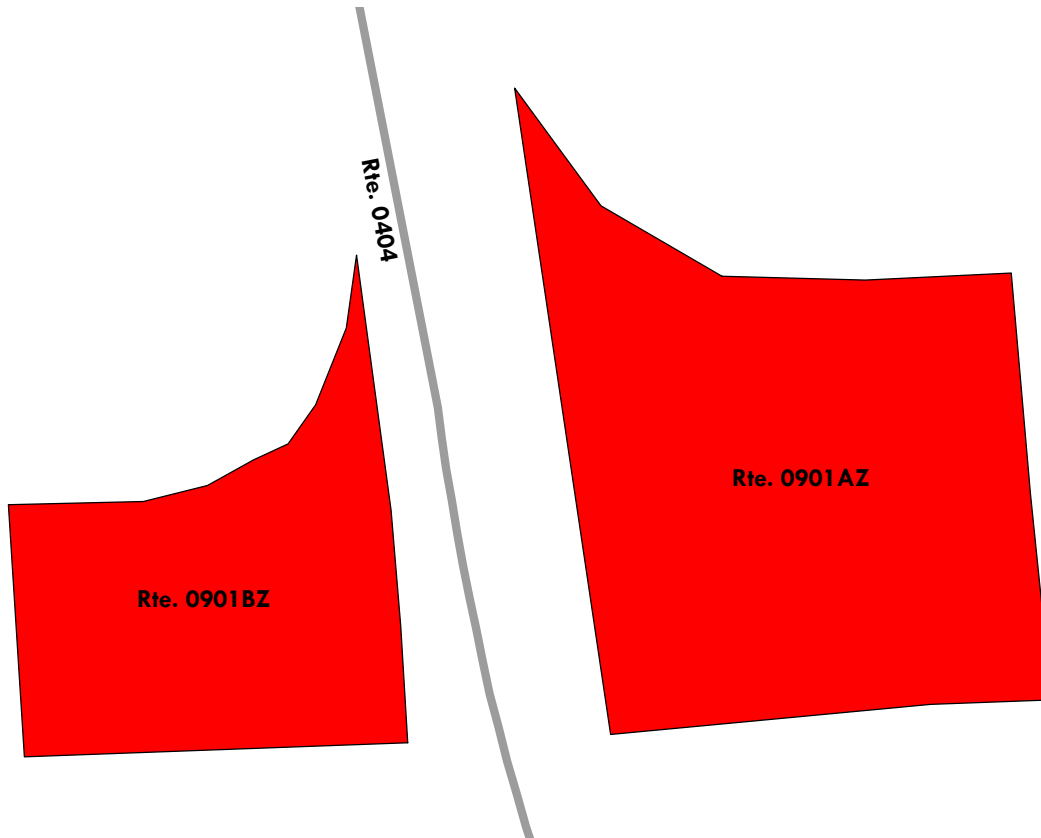
ROUTE 0901AZ: BARN PARKING A

Inspection Date	FMSS Number	User Access	Surface Type
3/2/2021	104625	NONPUBLIC	ASPHALT
Area (Sq. Ft.)	Lane Miles (11' Widths)	Curb Reveal (Inches)	Curb Recommendation
1,894	0.033	NOT APPLICABLE	NOT APPLICABLE
Curb Type		Curb & Gutter Type	
NO CURB		NO CURB AND GUTTER	
Pavement Recommendation		Condition Rating / PCR	
HEAVY 3R TREATMENTS		POOR / 53
