# SAJU Cycle 6

## Final Report

### Road Inventory and Condition Assessment of Paved Routes San Juan National Historic Site

**Report Date: August 2022**

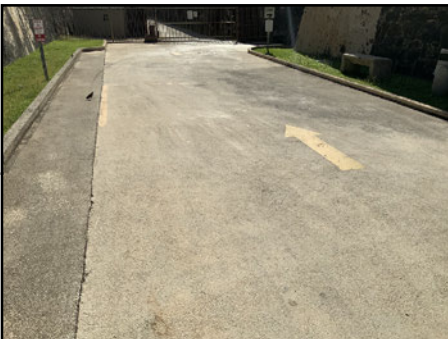
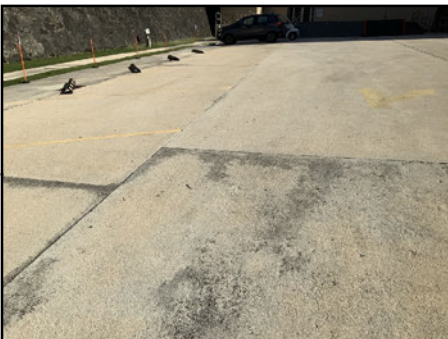
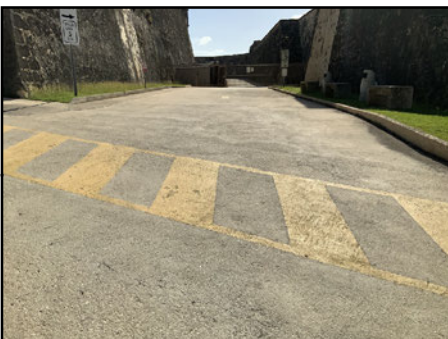
Inspection Date	FMSS Number	User Access	Surface Type
3/18/2022	103448	PUBLIC	CONCRETE
Area (Sq. Ft.)	Lane Miles (11' Widths)	Curb Reveal (Inches)	Curb Recommendation
16,963	0.292	7	DO NOTHING
Curb Type		Curb & Gutter Type	
CONCRETE		NO CURB AND GUTTER	
Pavement Recommendation		Condition Rating / PCR	
PREVENTIVE MAINTENANCE		GOOD / 90

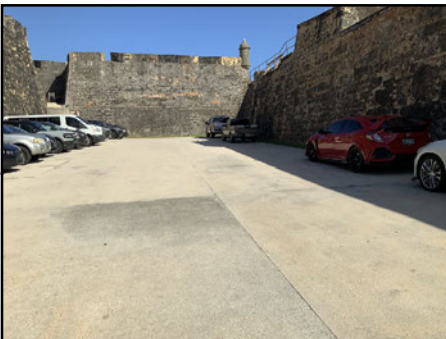
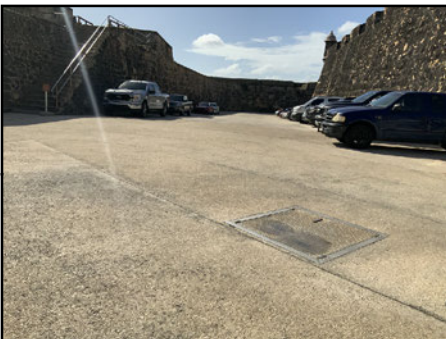
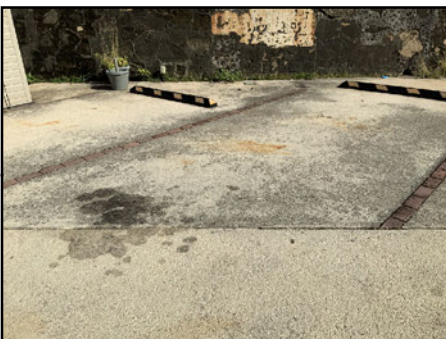
## ROUTE 0901: VISITOR CENTER ADMINISTRATIVE PARKING

Inspection Date	FMSS Number	User Access	Surface Type
3/18/2022	103445	NONPUBLIC	CONCRETE
Area (Sq. Ft.)	Lane Miles (11' Widths)	Curb Reveal (Inches)	Curb Recommendation
21,992	0.379	NOT APPLICABLE	NOT APPLICABLE
Curb Type		Curb & Gutter Type	
NO CURB		NO CURB AND GUTTER	
Pavement Recommendation		Condition Rating / PCR	
LIGHT 3R TREATMENTS		FAIR / 73
