# SAMO Cycle 6

## Final Report

### Road Inventory and Condition Assessment of Paved Routes Santa Monica Mountains National Recreation Area

Federal Highway Administration  
Eastern Federal Lands Highway Division  
Road Inventory Program (RIP)

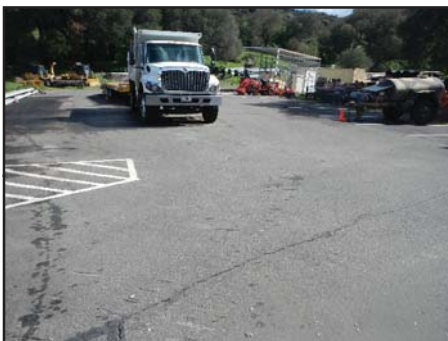
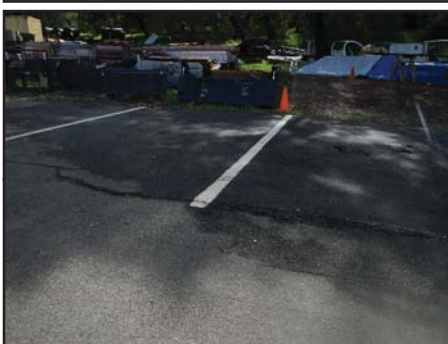
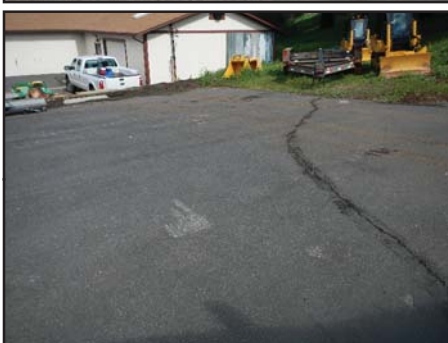
## ROUTE 0901: GSA PARKING

Inspection Date	FMSS Number	User Access	Surface Type
3/2/2015	17251	NONPUBLIC	ASPHALT
Area (Sq. Ft.)	Lane Miles (11' Widths)	Curb Reveal (Inches)	Curb Recommendation
9,876	0.17	NOT APPLICABLE	NOT APPLICABLE
Curb Type		Curb & Gutter Type	
NO CURB		NO CURB AND GUTTER	
Pavement Recommendation		Condition Rating / PCR	
PREVENTIVE MAINTENANCE		GOOD / 90

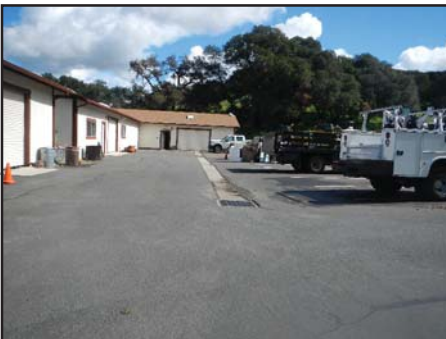
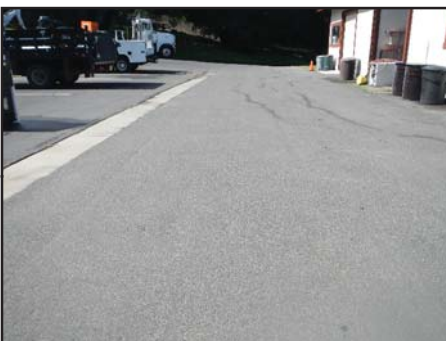
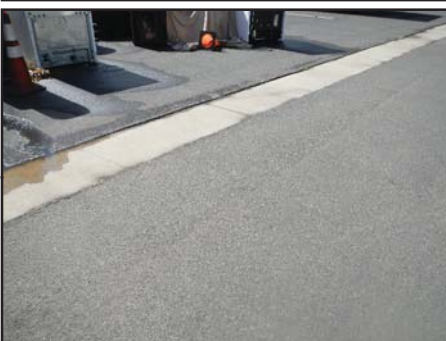
## ROUTE 0902: P.O.V. PARKING

Inspection Date	FMSS Number	User Access	Surface Type
3/2/2015	17252	NONPUBLIC	ASPHALT
Area (Sq. Ft.)	Lane Miles (11' Widths)	Curb Reveal (Inches)	Curb Recommendation
5,884	0.101	NOT APPLICABLE	NOT APPLICABLE
Curb Type		Curb & Gutter Type	
NO CURB		NO CURB AND GUTTER	
Pavement Recommendation		Condition Rating / PCR	
PREVENTIVE MAINTENANCE		GOOD / 90

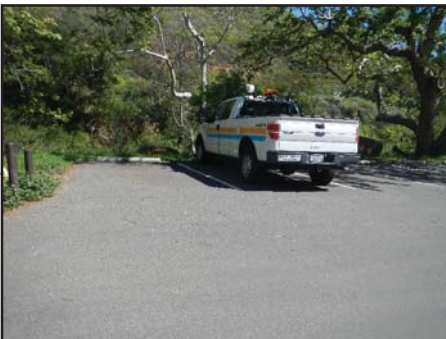
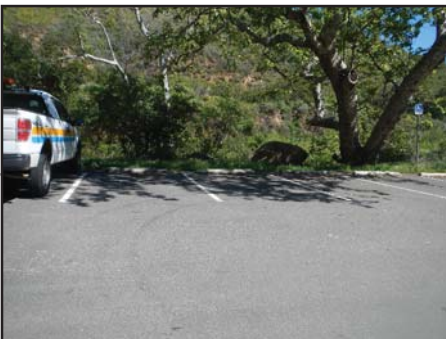
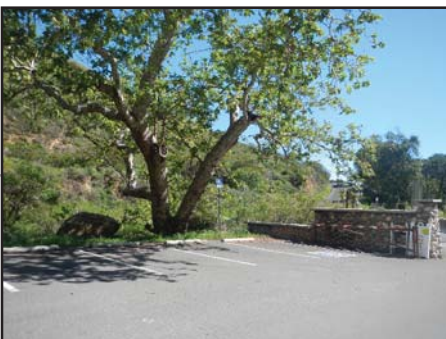
## ROUTE 0903: SOLSTICE CANYON TRAILHEAD PARKING

Inspection Date	FMSS Number	User Access	Surface Type
3/2/2015	17253	PUBLIC	ASPHALT
Area (Sq. Ft.)	Lane Miles (11' Widths)	Curb Reveal (Inches)	Curb Recommendation
1,916	0.033	NOT APPLICABLE	NOT APPLICABLE
Curb Type		Curb & Gutter Type	
NO CURB		NO CURB AND GUTTER	
Pavement Recommendation		Condition Rating / PCR	
PREVENTIVE MAINTENANCE		GOOD / 90

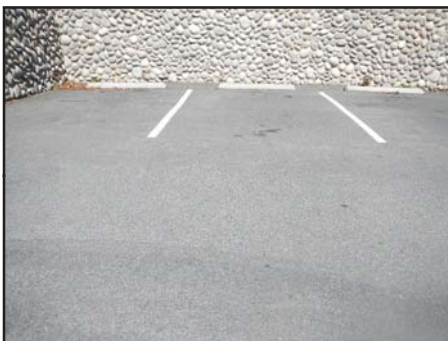
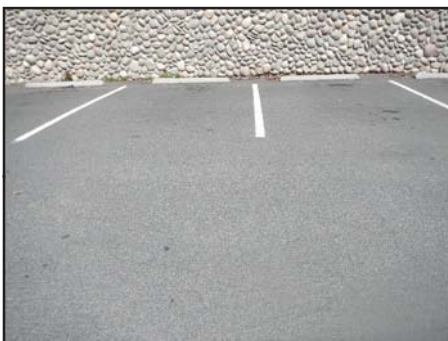
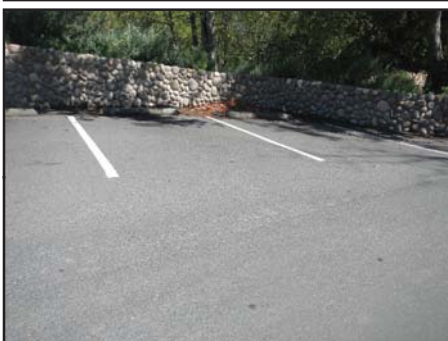
## ROUTE 0904A: DRY CANYON TRAILHEAD PARKING A

Inspection Date	FMSS Number	User Access	Surface Type
3/2/2015	17254	PUBLIC	ASPHALT
Area (Sq. Ft.)	Lane Miles (11' Widths)	Curb Reveal (Inches)	Curb Recommendation
1,451	0.025	NOT APPLICABLE	NOT APPLICABLE
Curb Type		Curb & Gutter Type	
NO CURB		NO CURB AND GUTTER	
Pavement Recommendation		Condition Rating / PCR	
PREVENTIVE MAINTENANCE		GOOD / 90

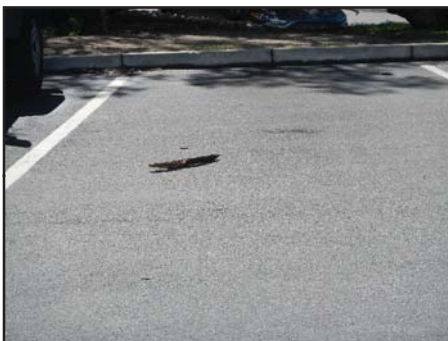
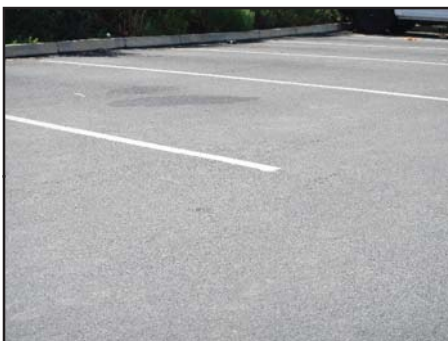
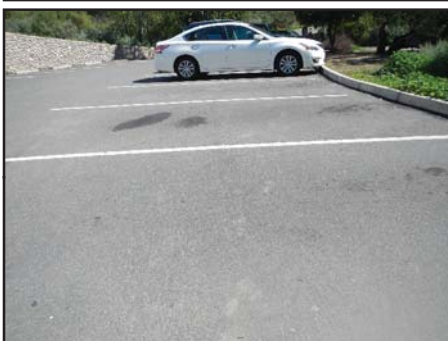
## ROUTE 0904B: DRY CANYON TRAILHEAD PARKING B

Inspection Date	FMSS Number	User Access	Surface Type
3/2/2015	102386	PUBLIC	ASPHALT
Area (Sq. Ft.)	Lane Miles (11' Widths)	Curb Reveal (Inches)	Curb Recommendation
2,667	0.046	4	DO NOTHING
Curb Type		Curb & Gutter Type	
CONCRETE		NO CURB AND GUTTER	
Pavement Recommendation		Condition Rating / PCR	
PREVENTIVE MAINTENANCE		GOOD / 90

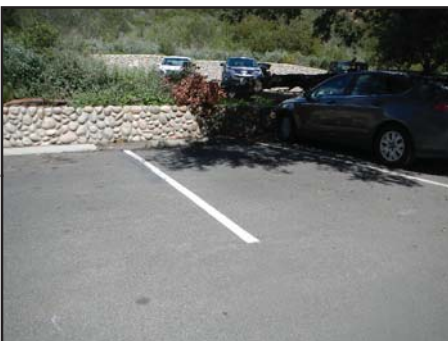
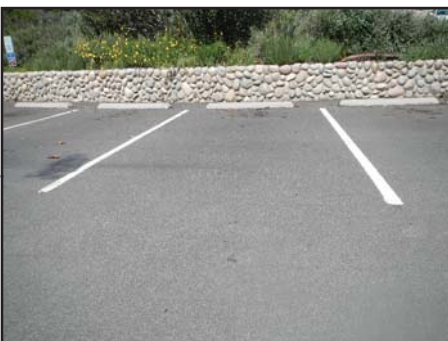
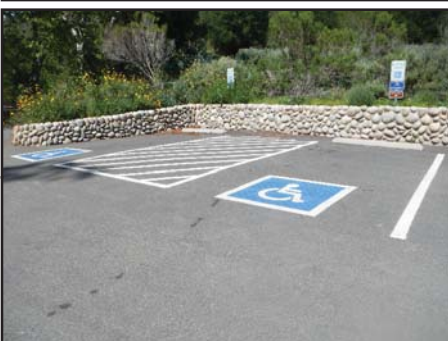
## ROUTE 0904C: DRY CANYON TRAILHEAD PARKING C

Inspection Date	FMSS Number	User Access	Surface Type
3/2/2015	102387	PUBLIC	ASPHALT
Area (Sq. Ft.)	Lane Miles (11' Widths)	Curb Reveal (Inches)	Curb Recommendation
1,467	0.025	NOT APPLICABLE	NOT APPLICABLE
Curb Type		Curb & Gutter Type	
NO CURB		NO CURB AND GUTTER	
Pavement Recommendation		Condition Rating / PCR	
PREVENTIVE MAINTENANCE		GOOD / 90

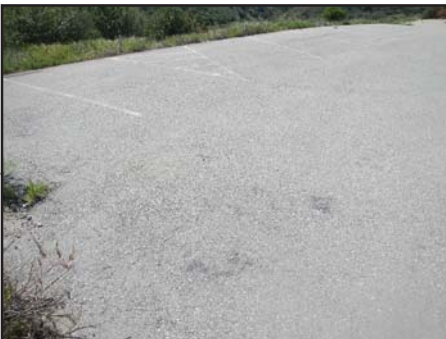
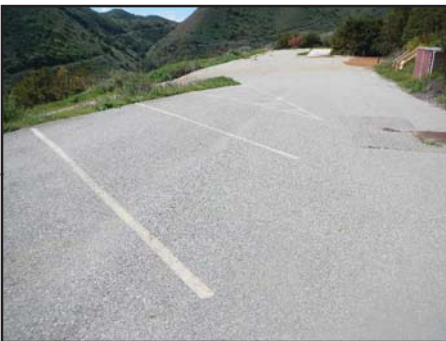
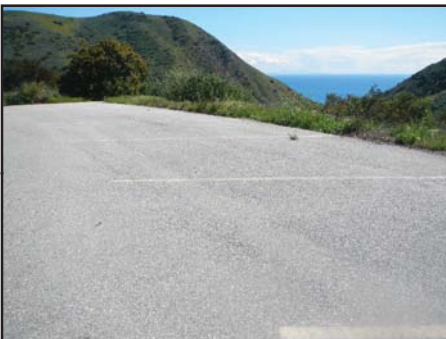
## ROUTE 0905A: TRW RESIDENCE PARKING AREA A

Inspection Date	FMSS Number	User Access	Surface Type
3/2/2015	17255	NONPUBLIC	ASPHALT
Area (Sq. Ft.)	Lane Miles (11' Widths)	Curb Reveal (Inches)	Curb Recommendation
2,128	0.037	NOT APPLICABLE	NOT APPLICABLE
Curb Type		Curb & Gutter Type	
NO CURB		NO CURB AND GUTTER	
Pavement Recommendation		Condition Rating / PCR	
LIGHT 3R TREATMENTS		FAIR / 73

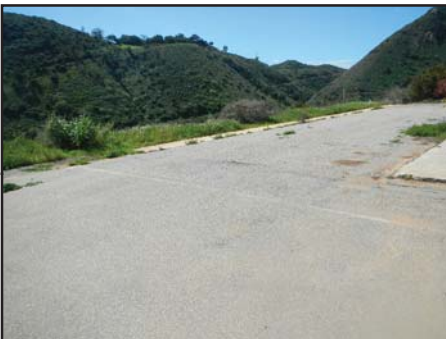
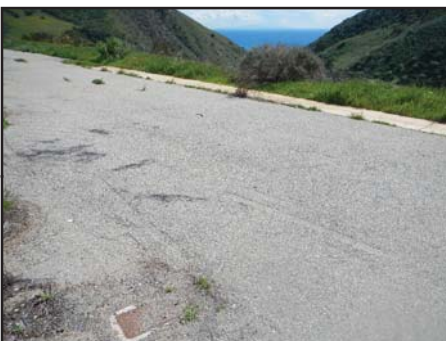
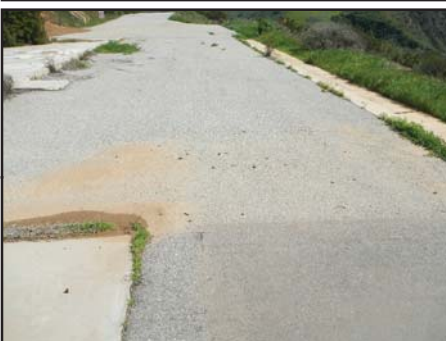
## ROUTE 0905B: TRW RESIDENCE PARKING AREA B

Inspection Date	FMSS Number	User Access	Surface Type
3/2/2015	102388	NONPUBLIC	ASPHALT
Area (Sq. Ft.)	Lane Miles (11' Widths)	Curb Reveal (Inches)	Curb Recommendation
5,196	0.089	NOT APPLICABLE	NOT APPLICABLE
Curb Type		Curb & Gutter Type	
NO CURB		NO CURB AND GUTTER	
Pavement Recommendation		Condition Rating / PCR	
PREVENTIVE MAINTENANCE		GOOD / 90

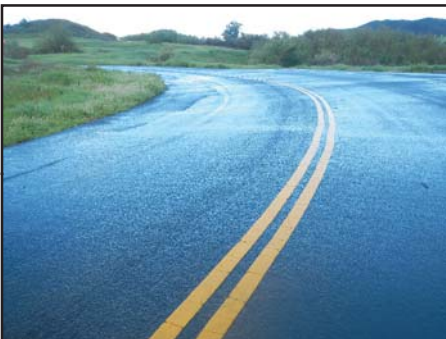
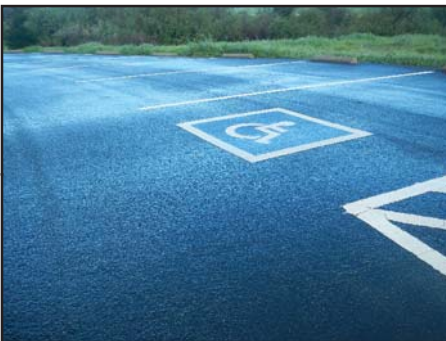
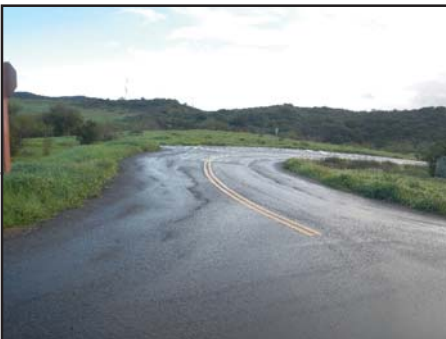
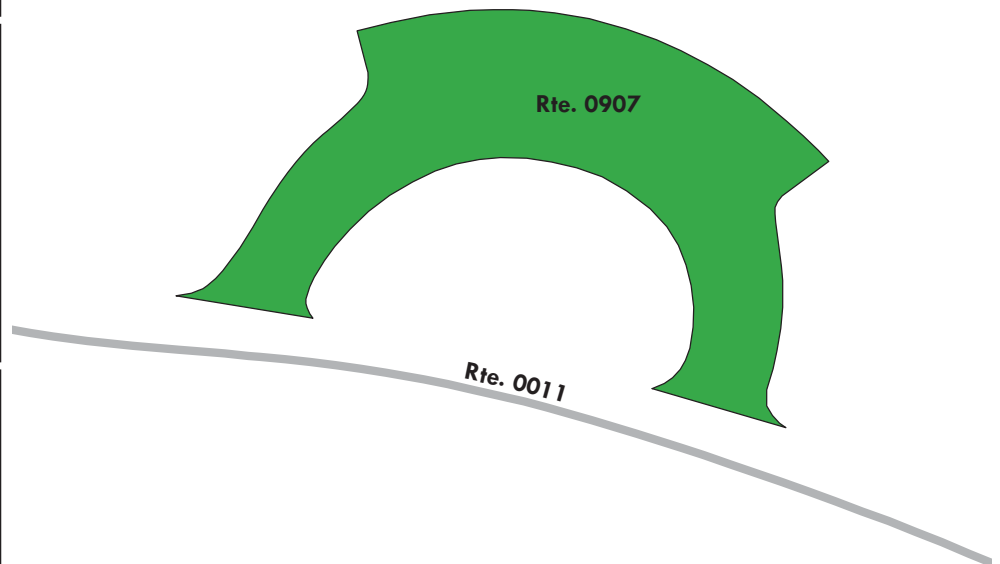
## ROUTE 0908: RANCHO SIERRA VISTA/SATWIWA MAIN PARKING

Inspection Date	FMSS Number	User Access	Surface Type
3/2/2015	17258	PUBLIC	ASPHALT
Area (Sq. Ft.)	Lane Miles (11' Widths)	Curb Reveal (Inches)	Curb Recommendation
33,702	0.58	NOT APPLICABLE	NOT APPLICABLE
Curb Type		Curb & Gutter Type	
NO CURB		NO CURB AND GUTTER	
Pavement Recommendation		Condition Rating / PCR	
PREVENTIVE MAINTENANCE		GOOD / 90

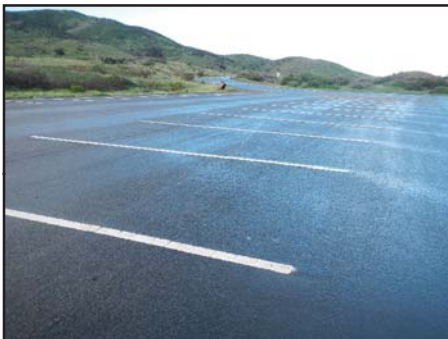
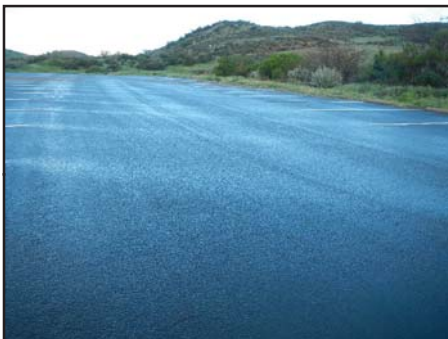
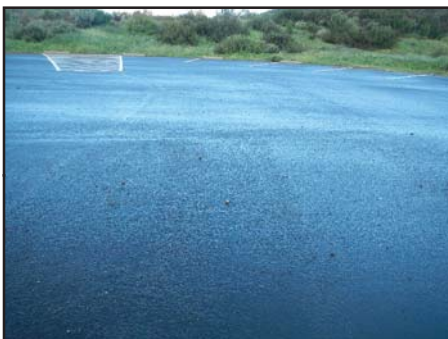
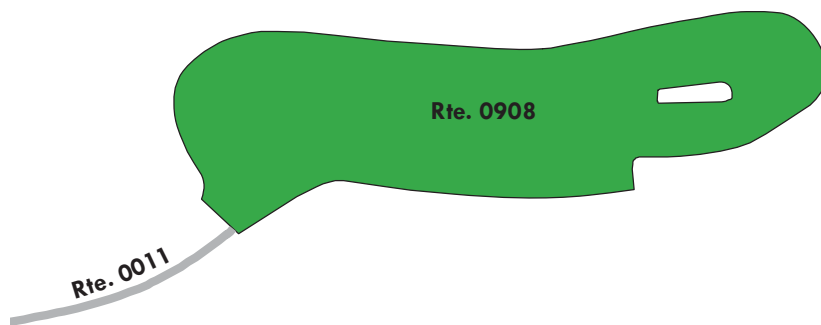
## ROUTE 0909A: CHEESEBORO CANYON ENTRANCE PARKING A

Inspection Date	FMSS Number	User Access	Surface Type
3/2/2015	17259	PUBLIC	ASPHALT
Area (Sq. Ft.)	Lane Miles (11' Widths)	Curb Reveal (Inches)	Curb Recommendation
1,604	0.028	NOT APPLICABLE	NOT APPLICABLE
Curb Type		Curb & Gutter Type	
NO CURB		NO CURB AND GUTTER	
Pavement Recommendation		Condition Rating / PCR	
LIGHT 3R TREATMENTS		FAIR / 73

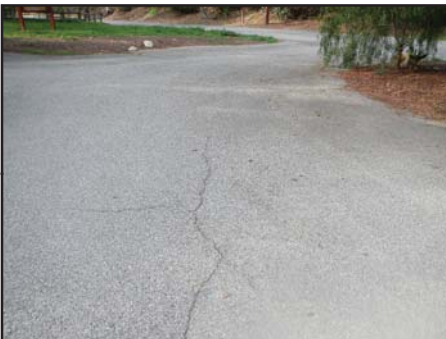
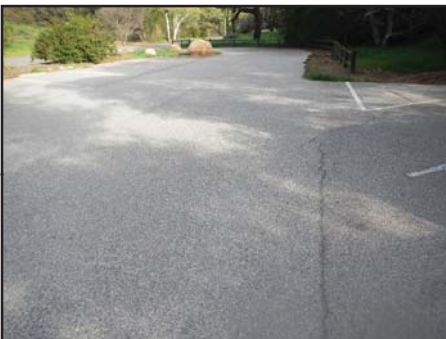
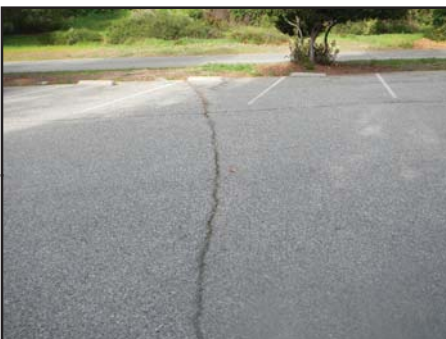
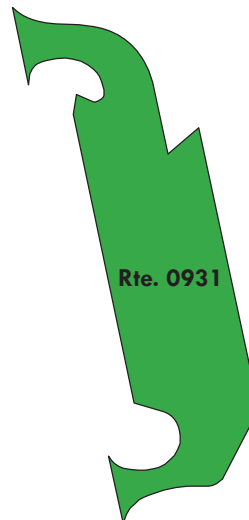
## ROUTE 0933: ROCKY OAKS MUSEUM PARKING

Inspection Date	FMSS Number	User Access	Surface Type
2/28/2015	103069	PUBLIC	CONCRETE
Area (Sq. Ft.)	Lane Miles (11' Widths)	Curb Reveal (Inches)	Curb Recommendation
662	0.011	NOT APPLICABLE	NOT APPLICABLE
Curb Type		Curb & Gutter Type	
NO CURB		NO CURB AND GUTTER	
Pavement Recommendation		Condition Rating / PCR	
LIGHT 3R TREATMENTS		FAIR / 73

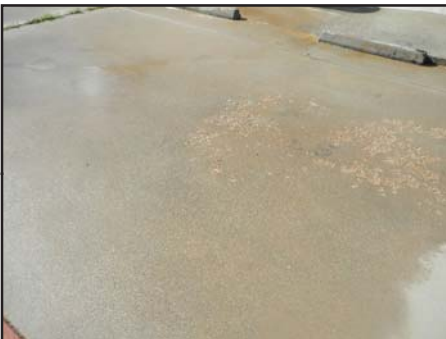
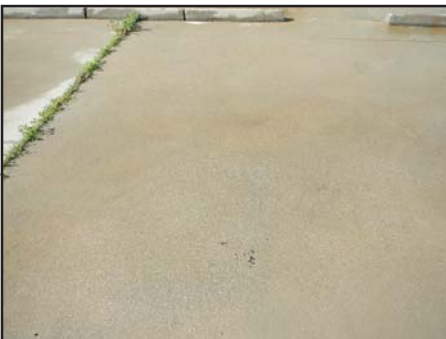
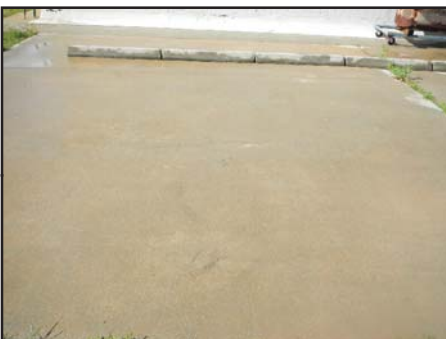
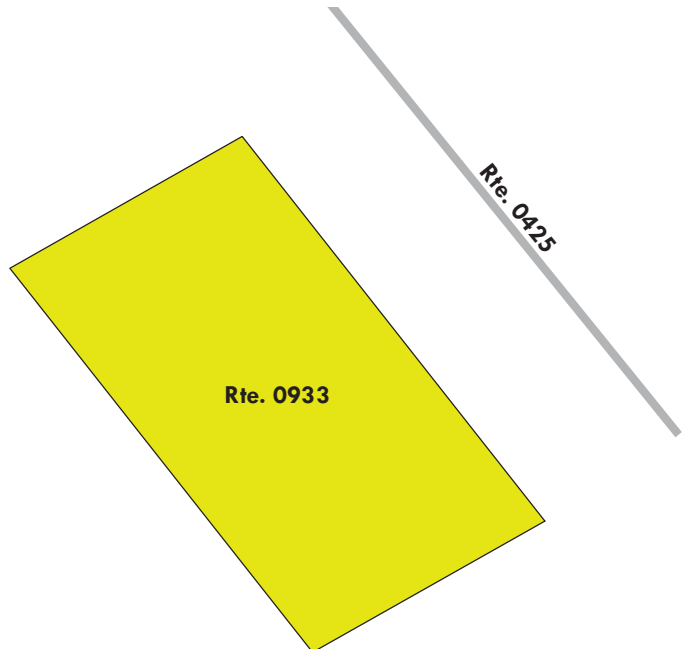
## ROUTE 0934: PETER STRAUSS WEST PARKING

Inspection Date	FMSS Number	User Access	Surface Type
3/2/2015	12838	PUBLIC	ASPHALT
Area (Sq. Ft.)	Lane Miles (11' Widths)	Curb Reveal (Inches)	Curb Recommendation
12,731	0.219	NOT APPLICABLE	NOT APPLICABLE
Curb Type		Curb & Gutter Type	
NO CURB		NO CURB AND GUTTER	
Pavement Recommendation		Condition Rating / PCR	
PREVENTIVE MAINTENANCE		GOOD / 90

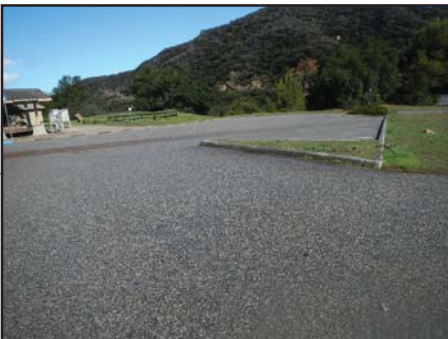
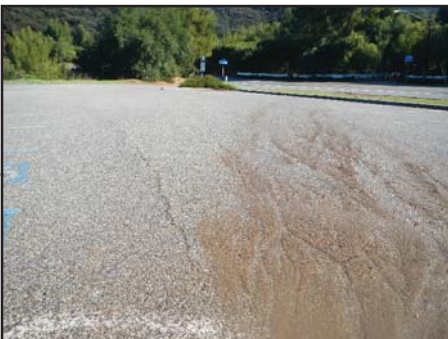
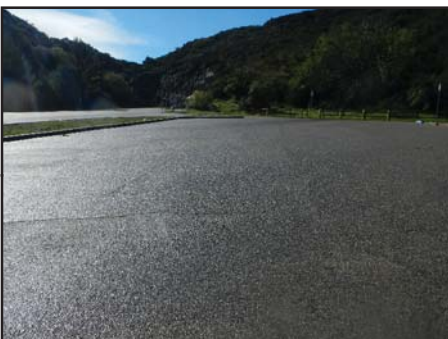
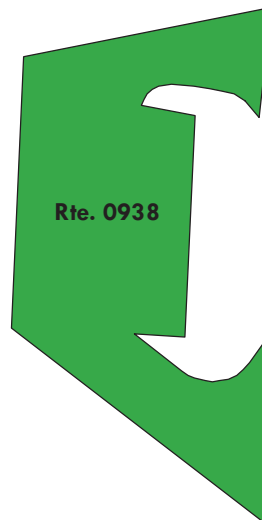
## ROUTE 0940B: INTERN CENTER HANDICAP PARKING

Inspection Date	FMSS Number	User Access	Surface Type
3/2/2015	234664	PUBLIC	CONCRETE
Area (Sq. Ft.)	Lane Miles (11' Widths)	Curb Reveal (Inches)	Curb Recommendation
675	0.012	NOT APPLICABLE	NOT APPLICABLE
Curb Type		Curb & Gutter Type	
NO CURB		NO CURB AND GUTTER	
Pavement Recommendation		Condition Rating / PCR	
PREVENTIVE MAINTENANCE		GOOD / 90
